# Situation Photo Log

Saturday, March 24, 2012

Kalamazoo River / Enbridge Spill

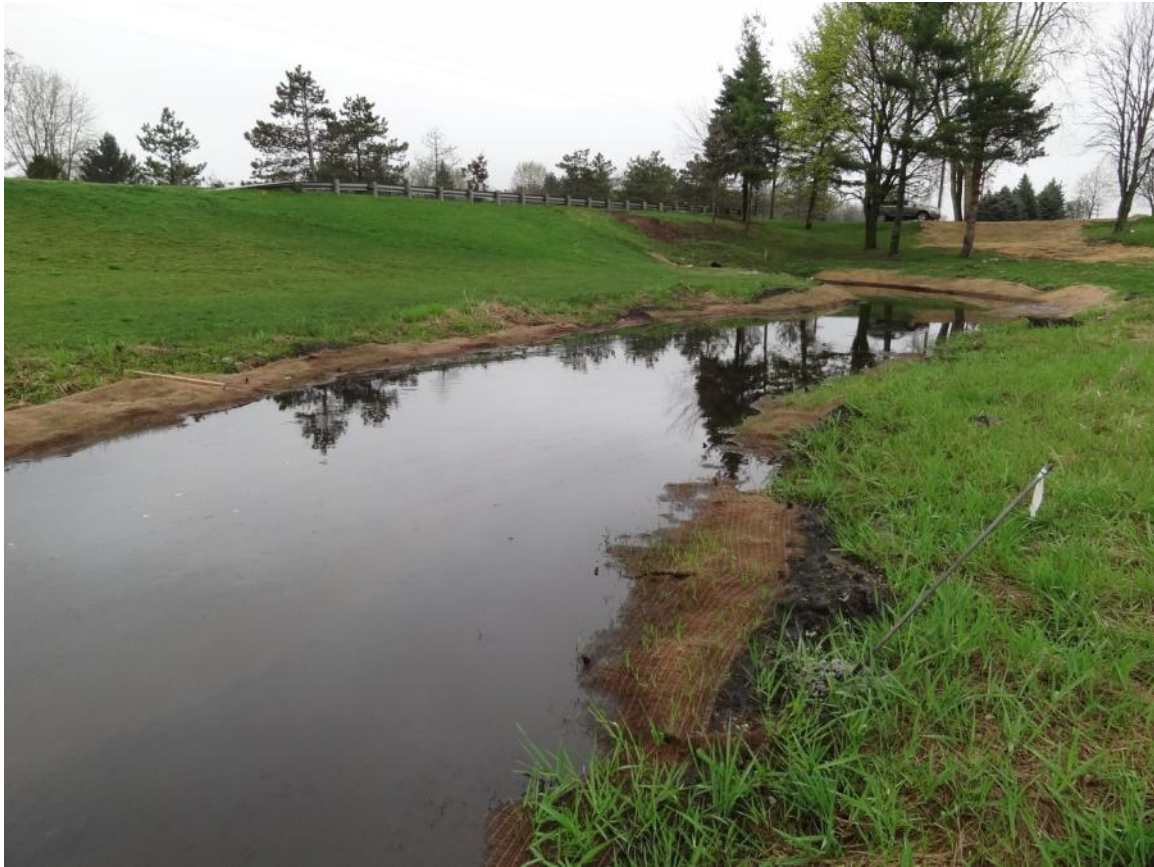
27. Talmadge Creek east of 16 Mile Rd, no turbidity or sheen observed.

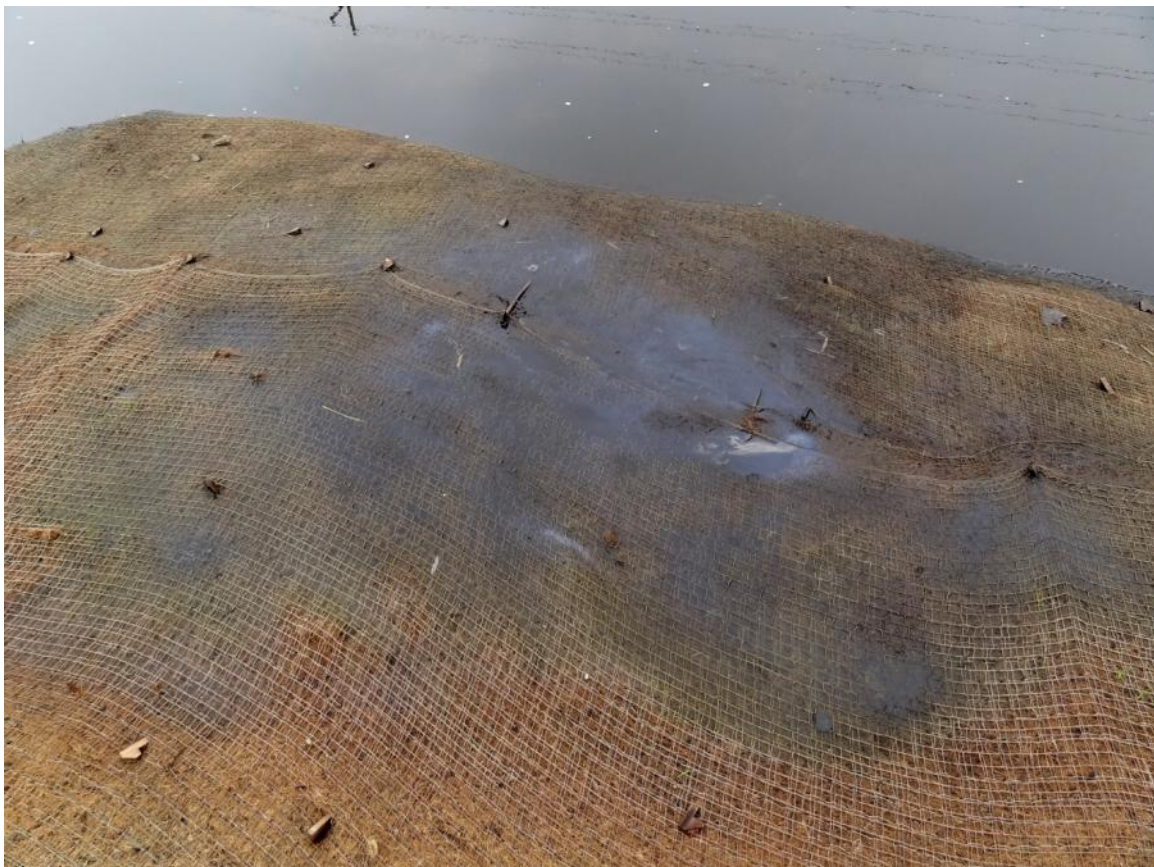
28. Talmadge Creek east of 16 Mile Rd, RDB sheen observed.

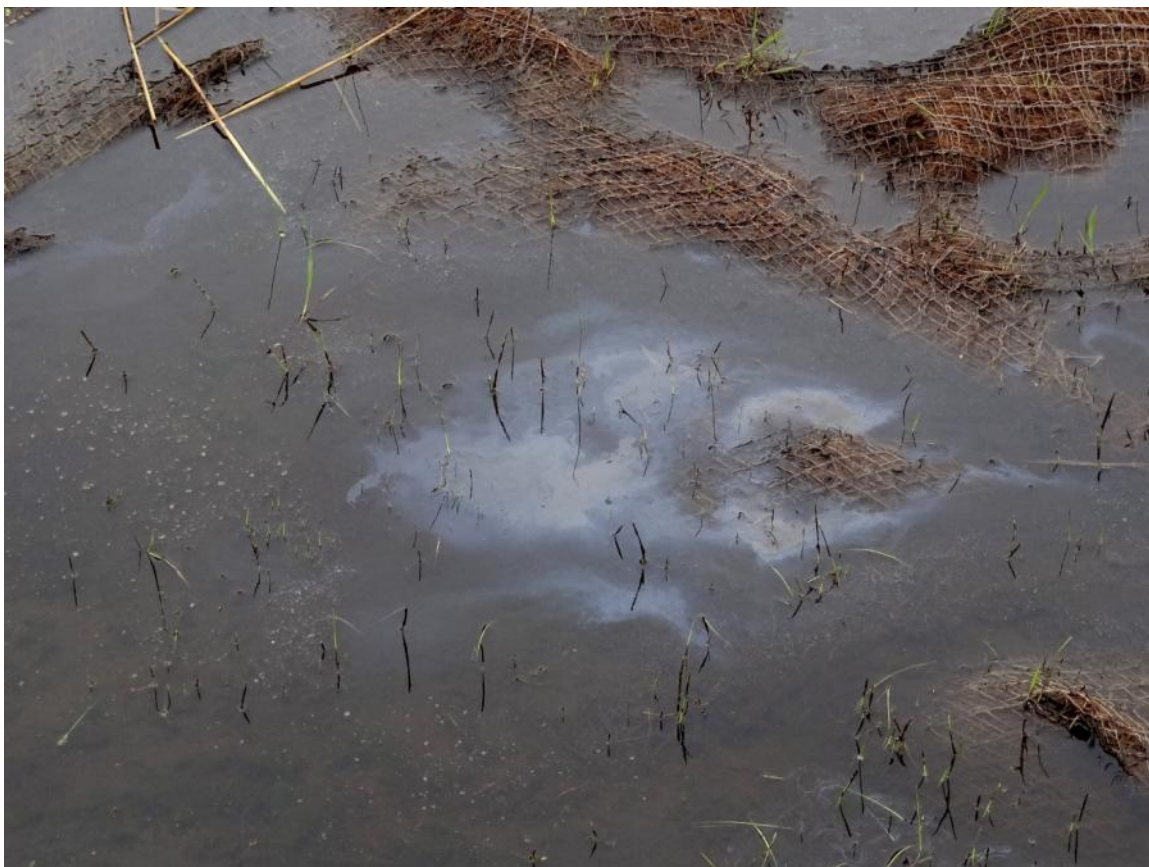
29. Talmadge Creek MP1.0 RDB overbank sheen observed.

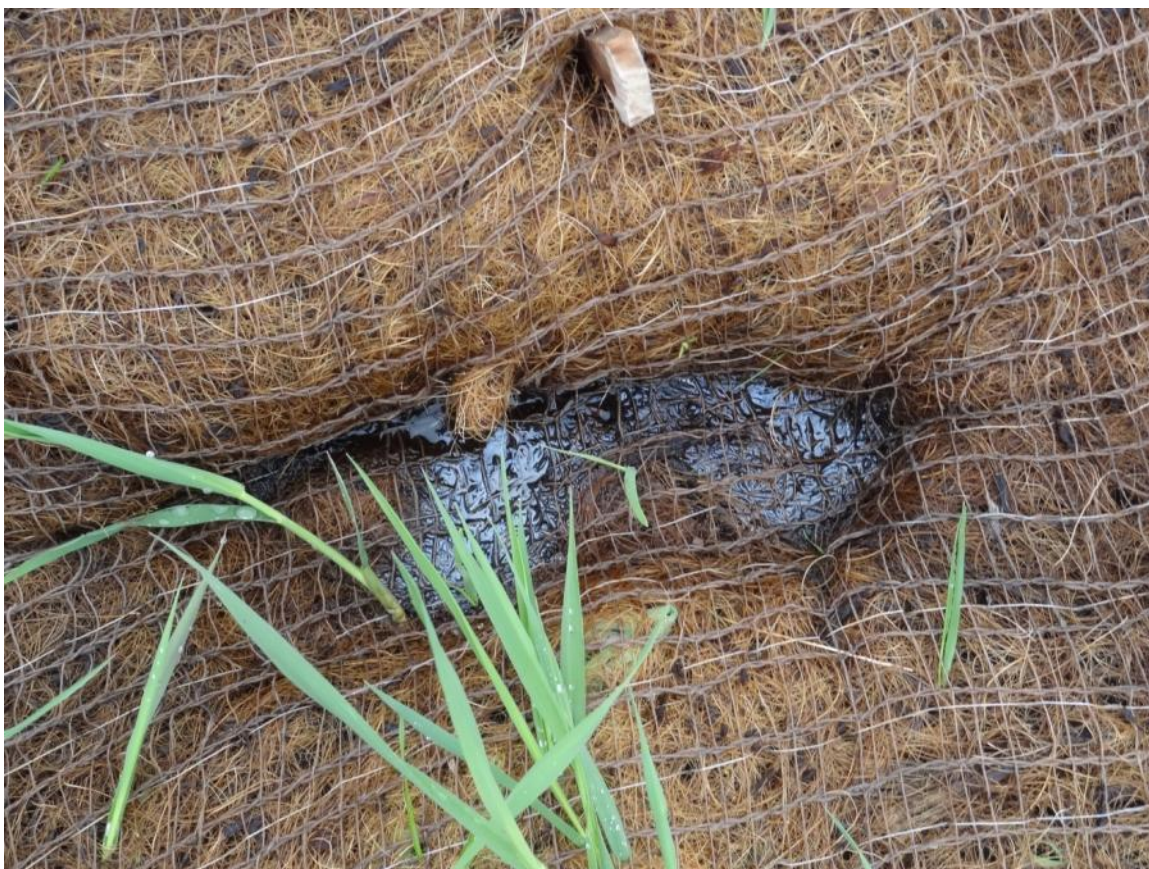
30. Talmadge Creek MP1.0 RDB overbank sheen observed.

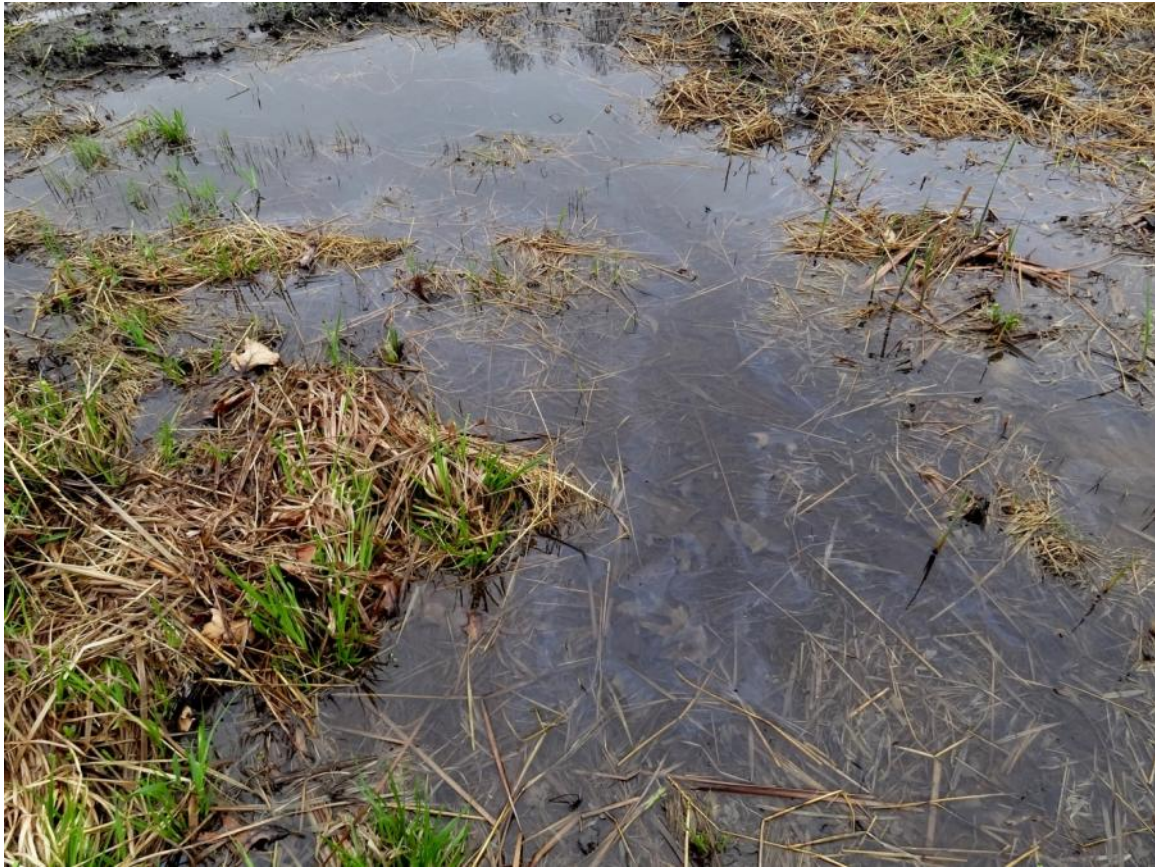
**31. Talmadge Creek MP0.8 RDB sheen observed.**

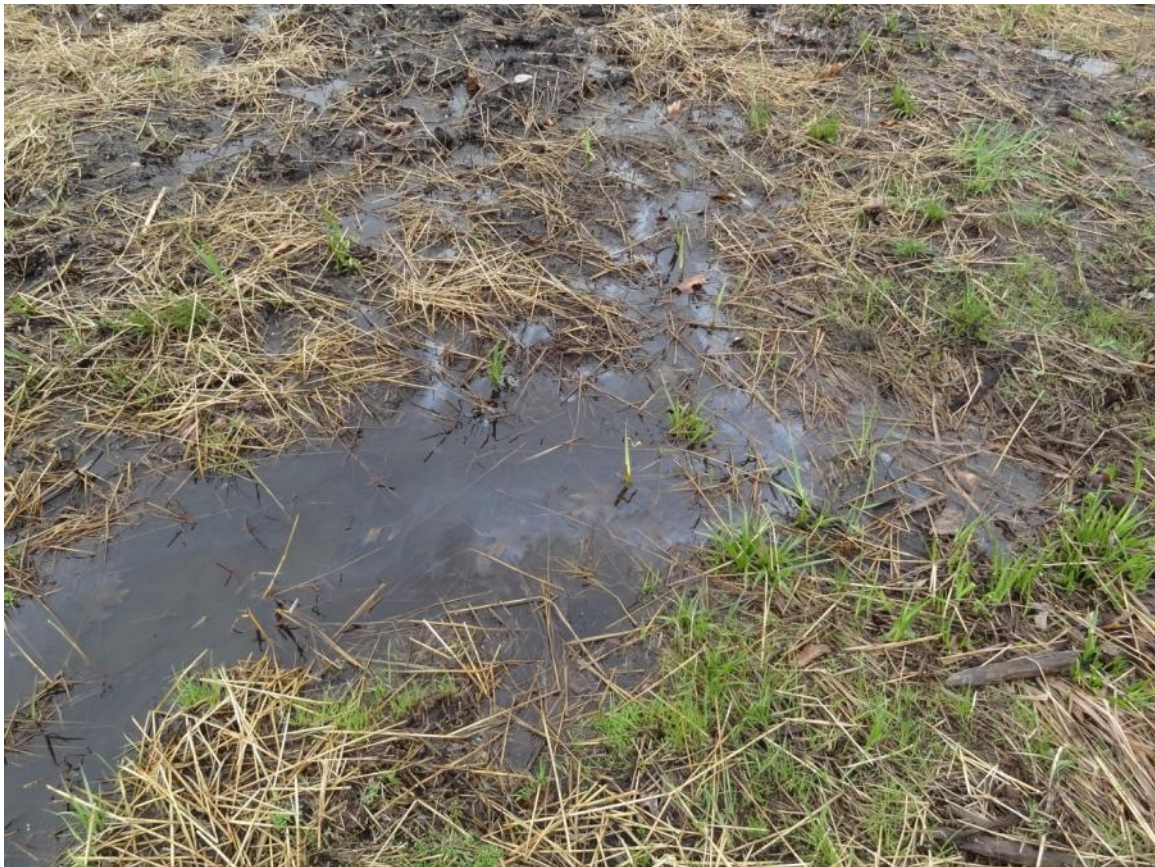
**32. Talmadge Creek MP0.8 RDB sheen observed.**
