# Situation Photo Log

Tuesday, March 27, 2012

Kalamazoo River / Enbridge Spill

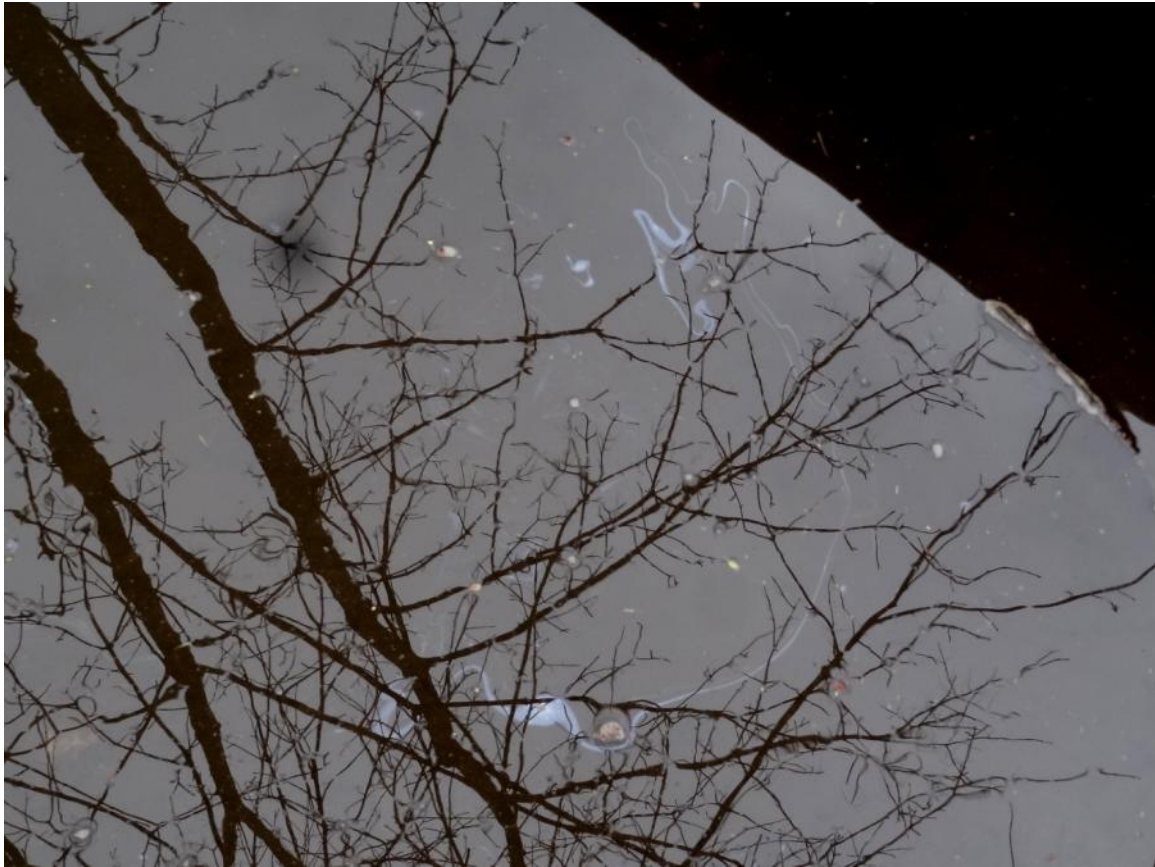
1. MP30.0 sheen observed at E4 boat launch. Sheen observed after boat was launched.

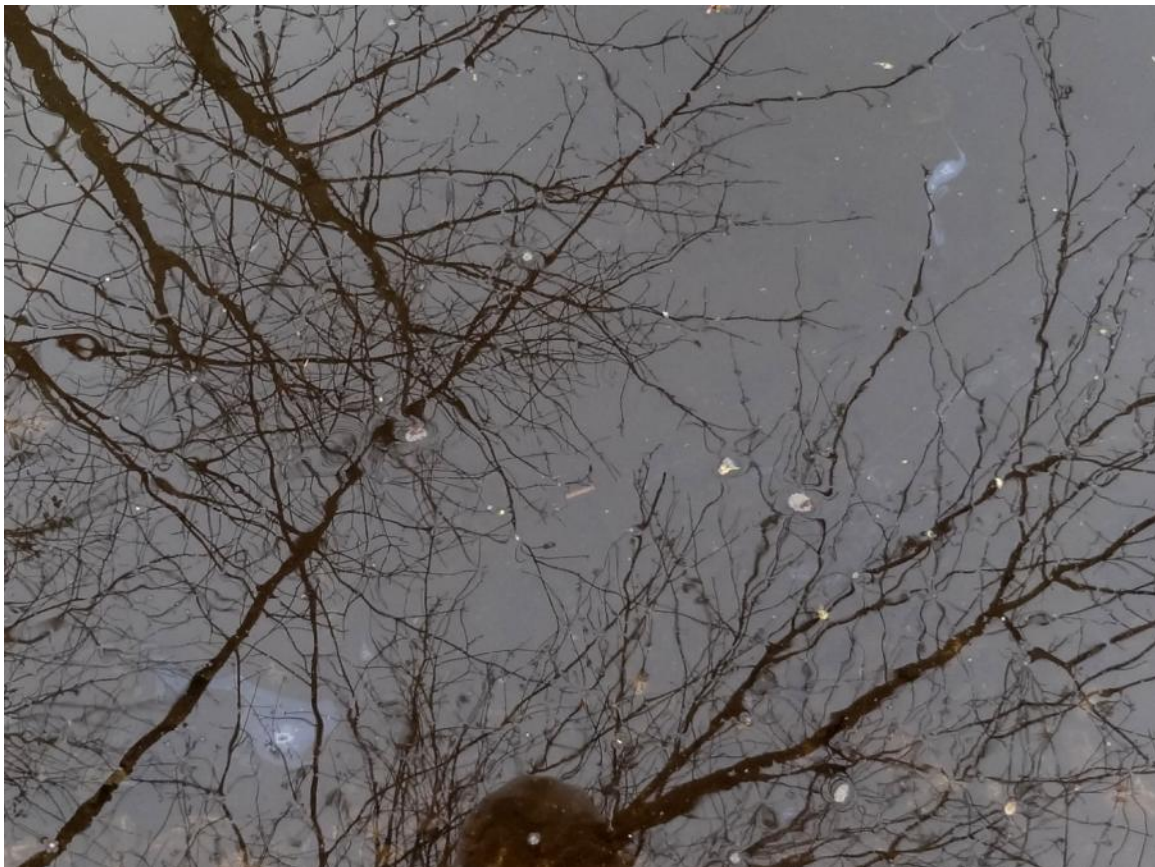
2. MP30.0 sheen observed at E4 boat launch. Sheen observed after boat was launched.

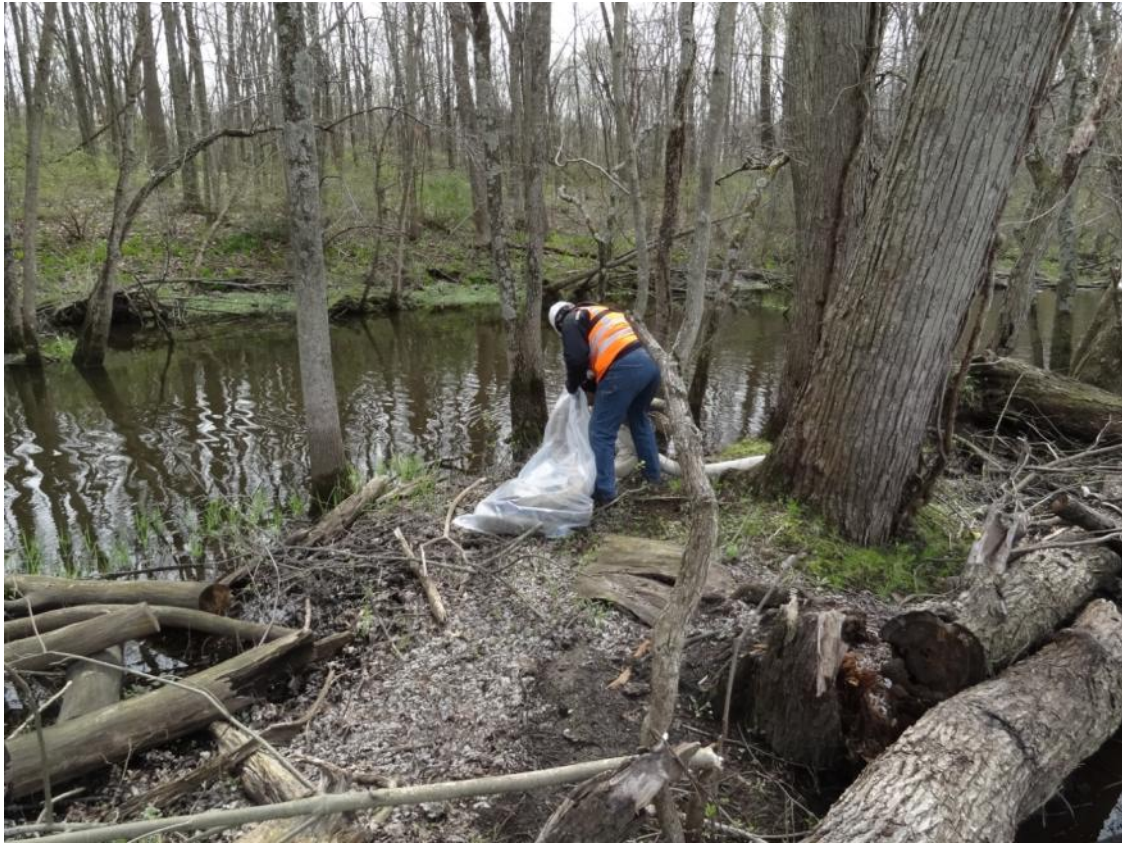
3. MP32.0 LDB during river assessment observed absorbent boom from last year submerged oil work was observed. SWAT disposed of boom.

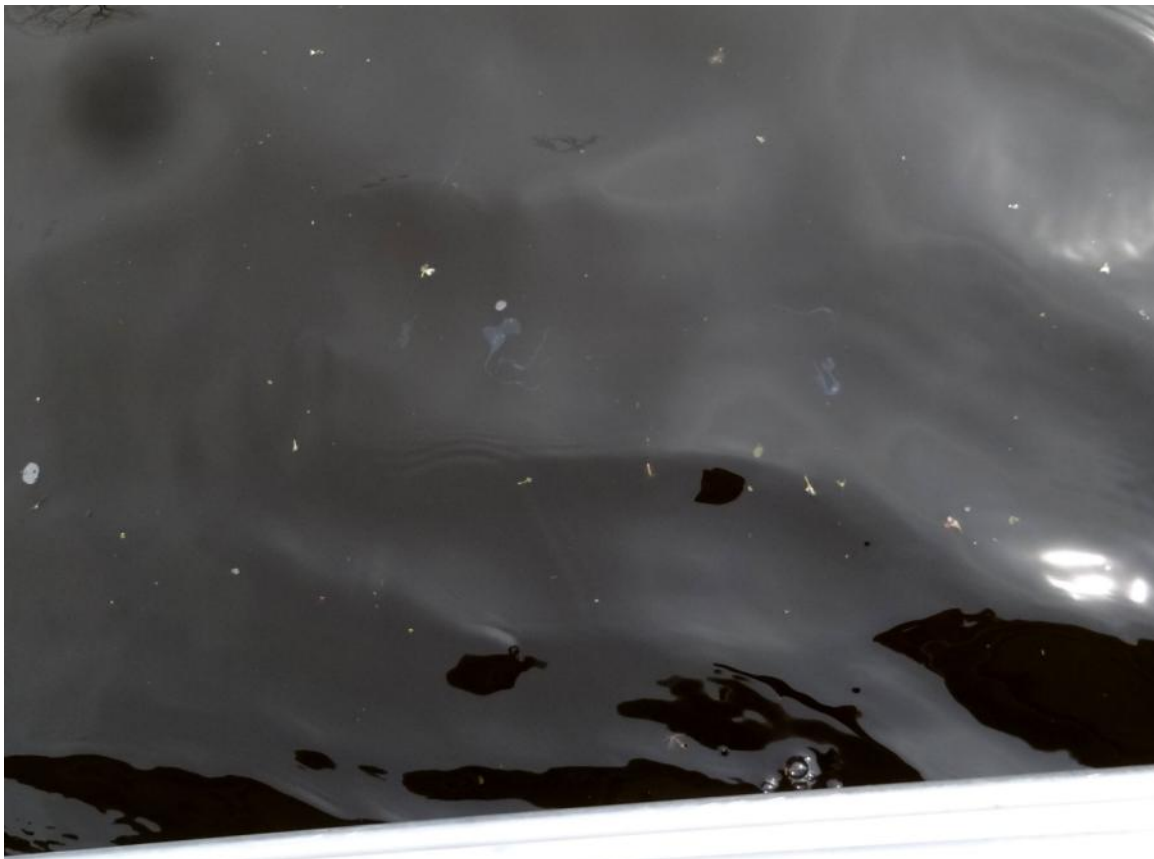
4. MP32.0 sheen observed in center of river channel. Typical size of sheen spots observed in river system when observed.

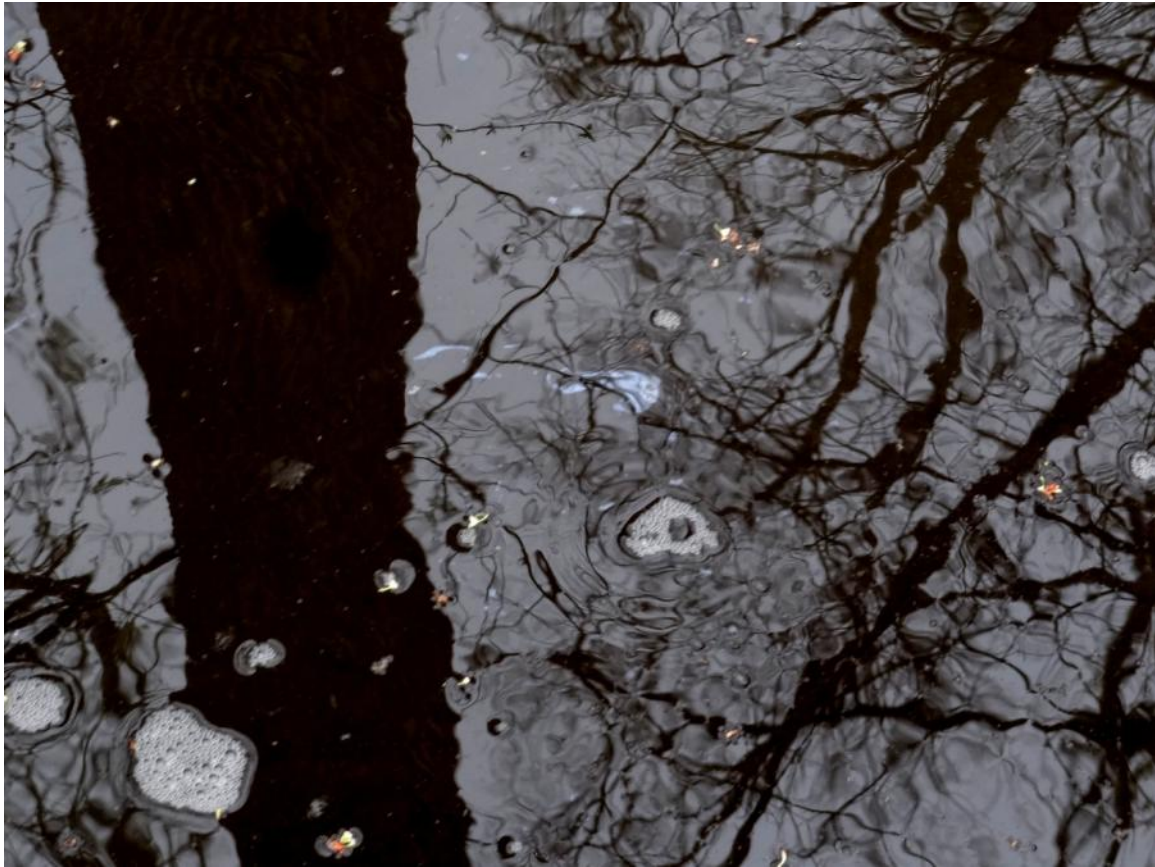
5. MP33.0 LDB former submerged oil location sheen observed.

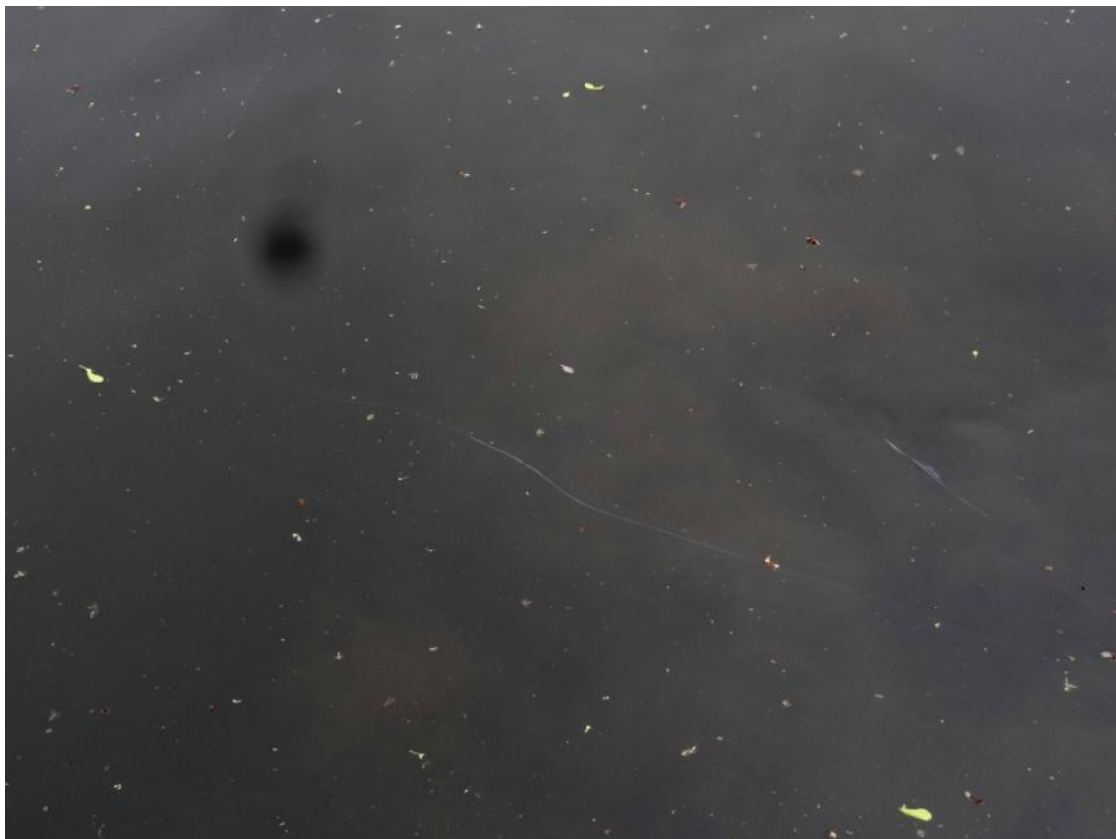
6. MP33.0 LDB former submerged oil location sheen observed.
