# Situation Photo Log

Wednesday, March 28, 2012

Kalamazoo River / Enbridge Spill

Matthew Haak  
START-USEPA  
Situation Unit Leader

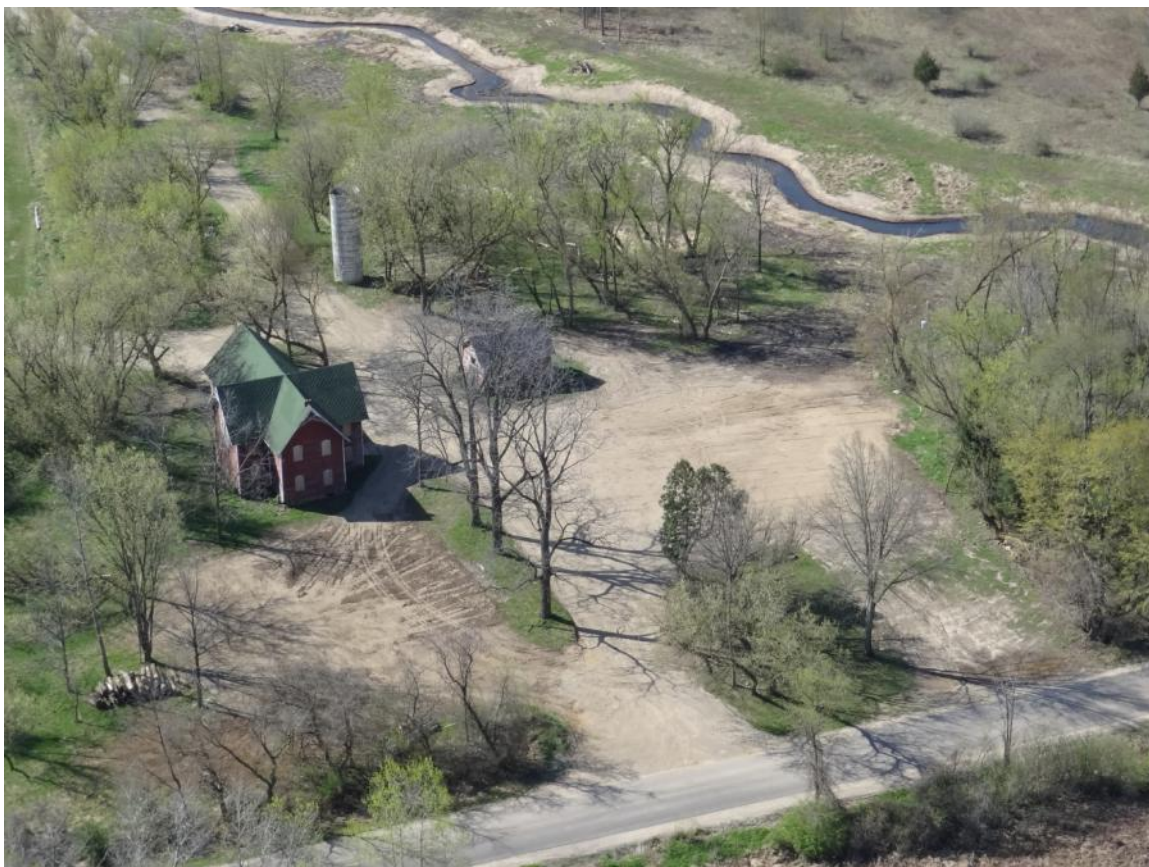
**1. Demobilization of the staging area at the farmhouse on Division Drive appears complete.**

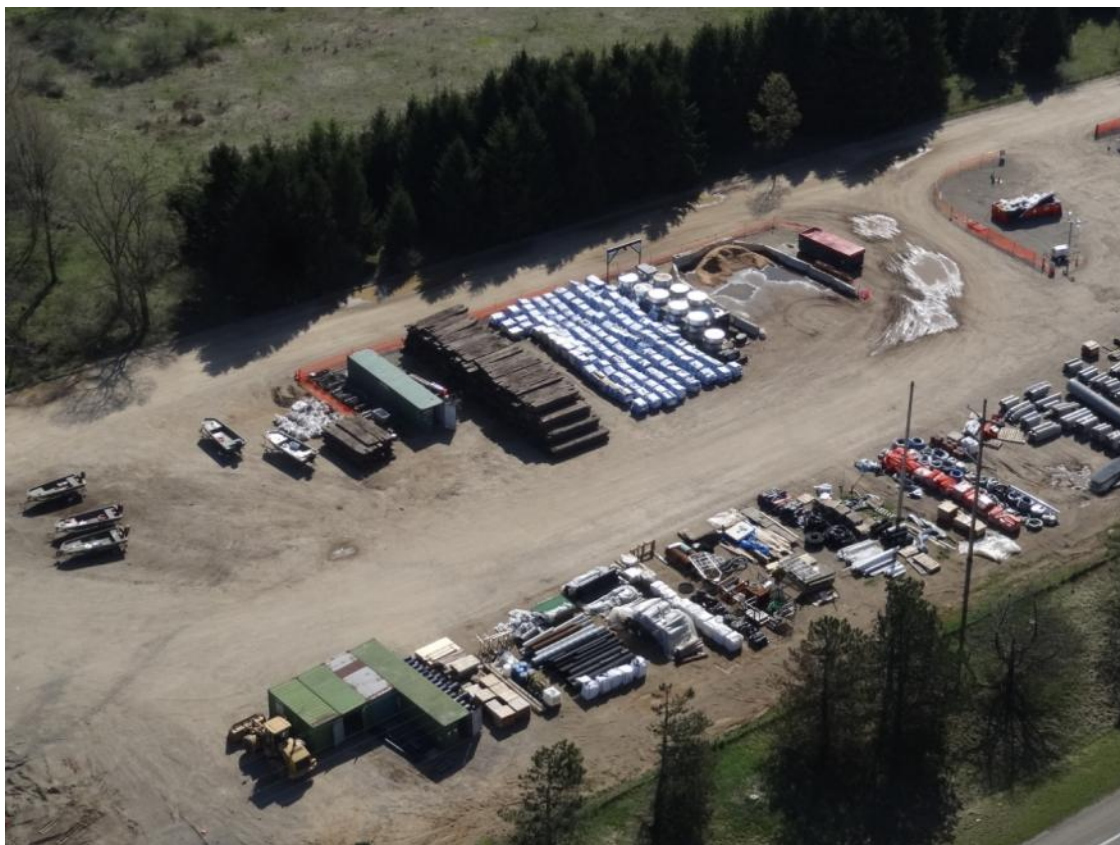
**2. Frac-City observed foot print reduction.**

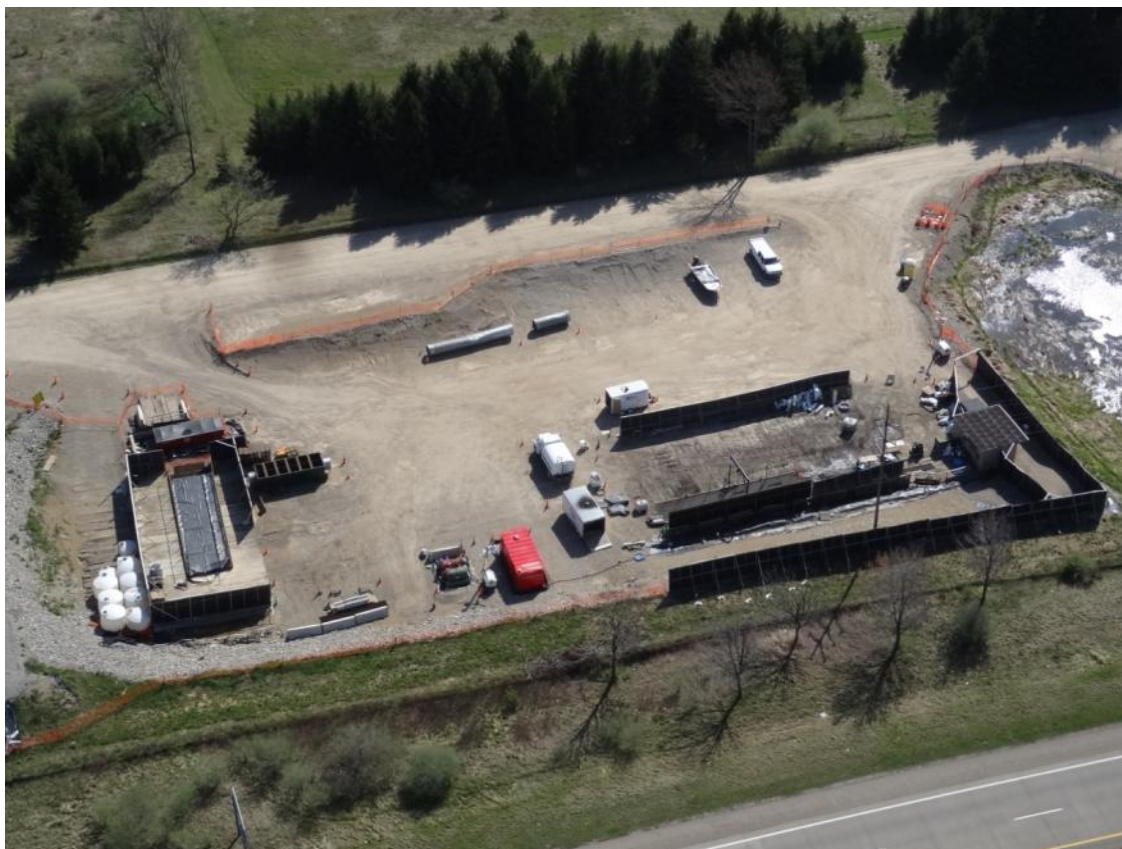
3. Frac-City no decontamination activities observed.

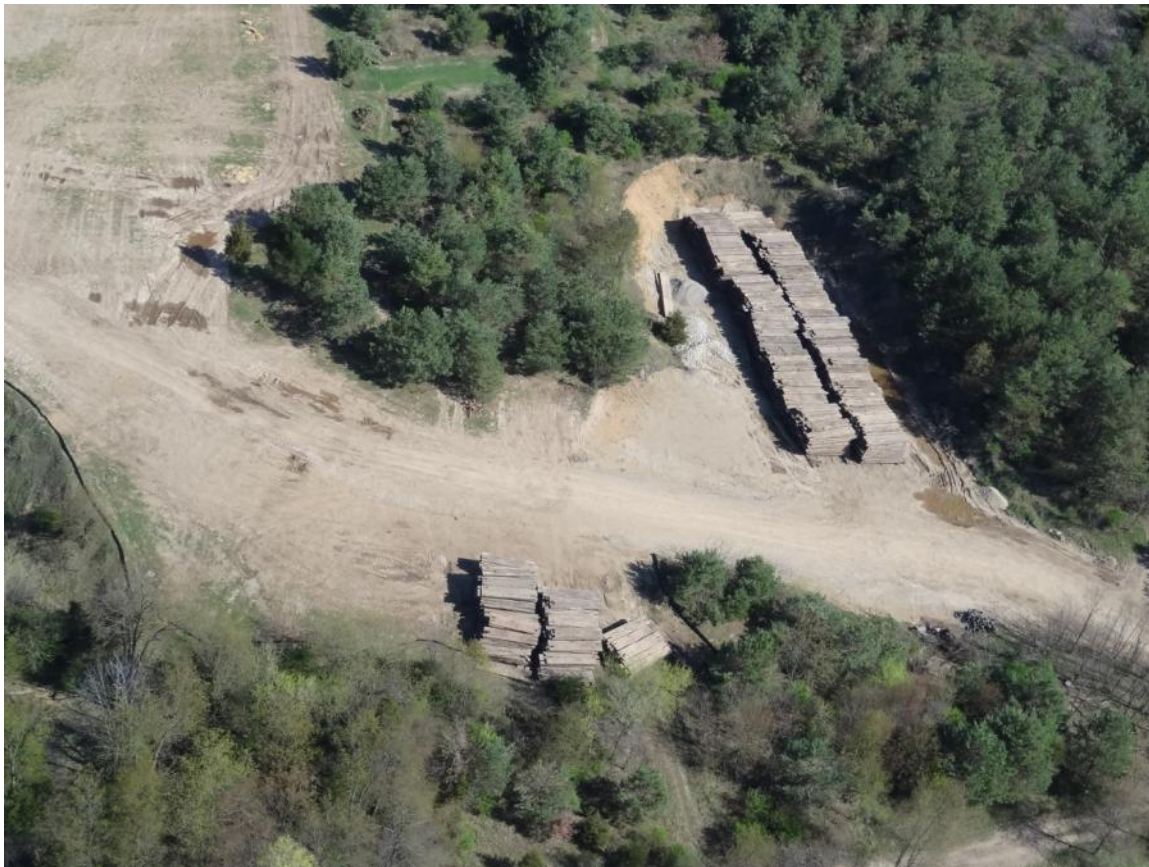
5. Timber mat staged off Talmadge Creek near MP1.5.

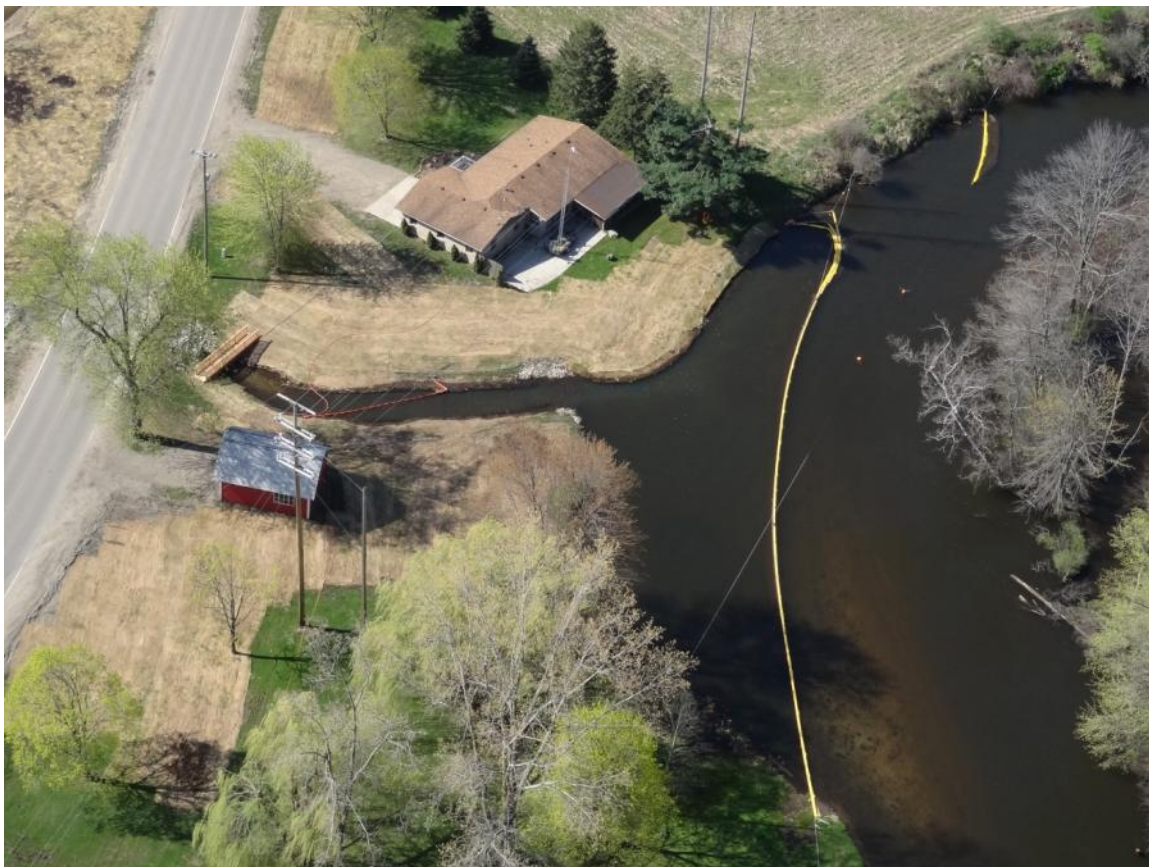
6. Confluence, observed no turbidity or sheen.

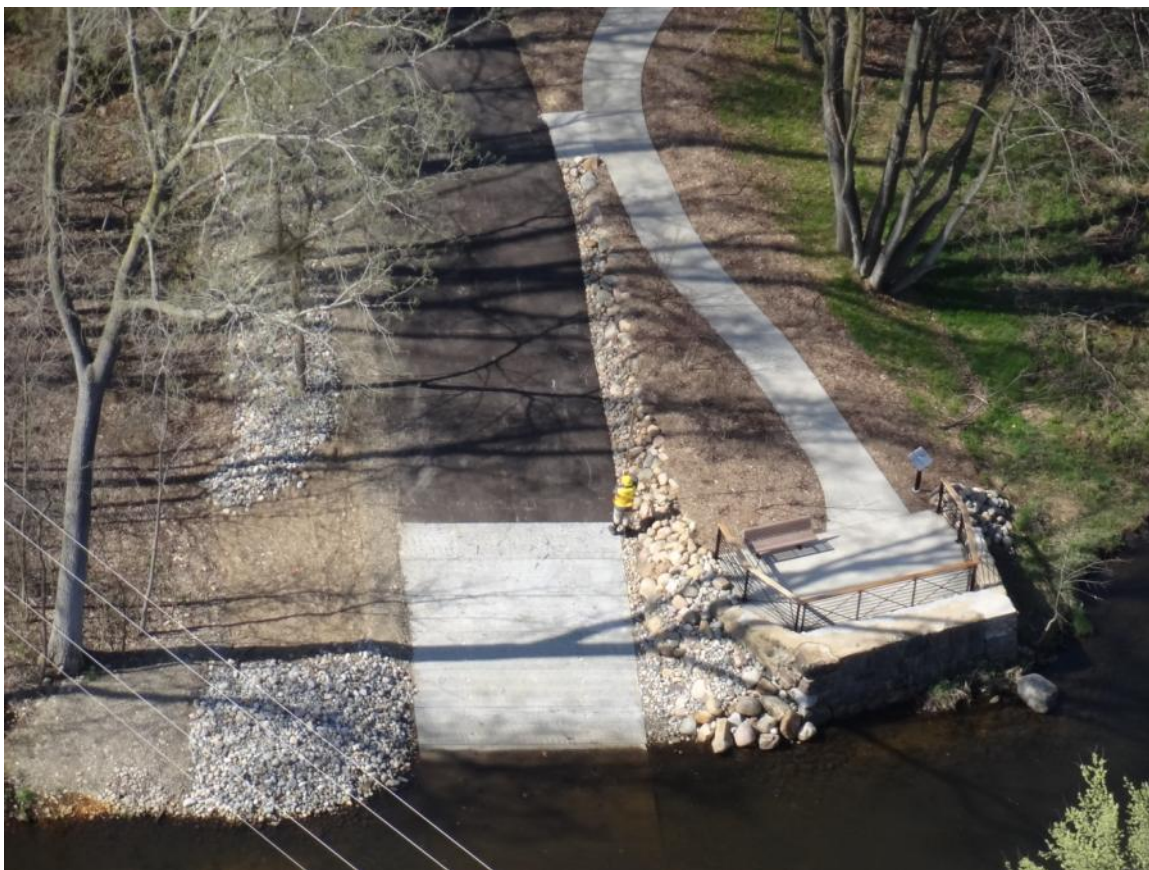
7. Survey crew observed at Saylor Landing.

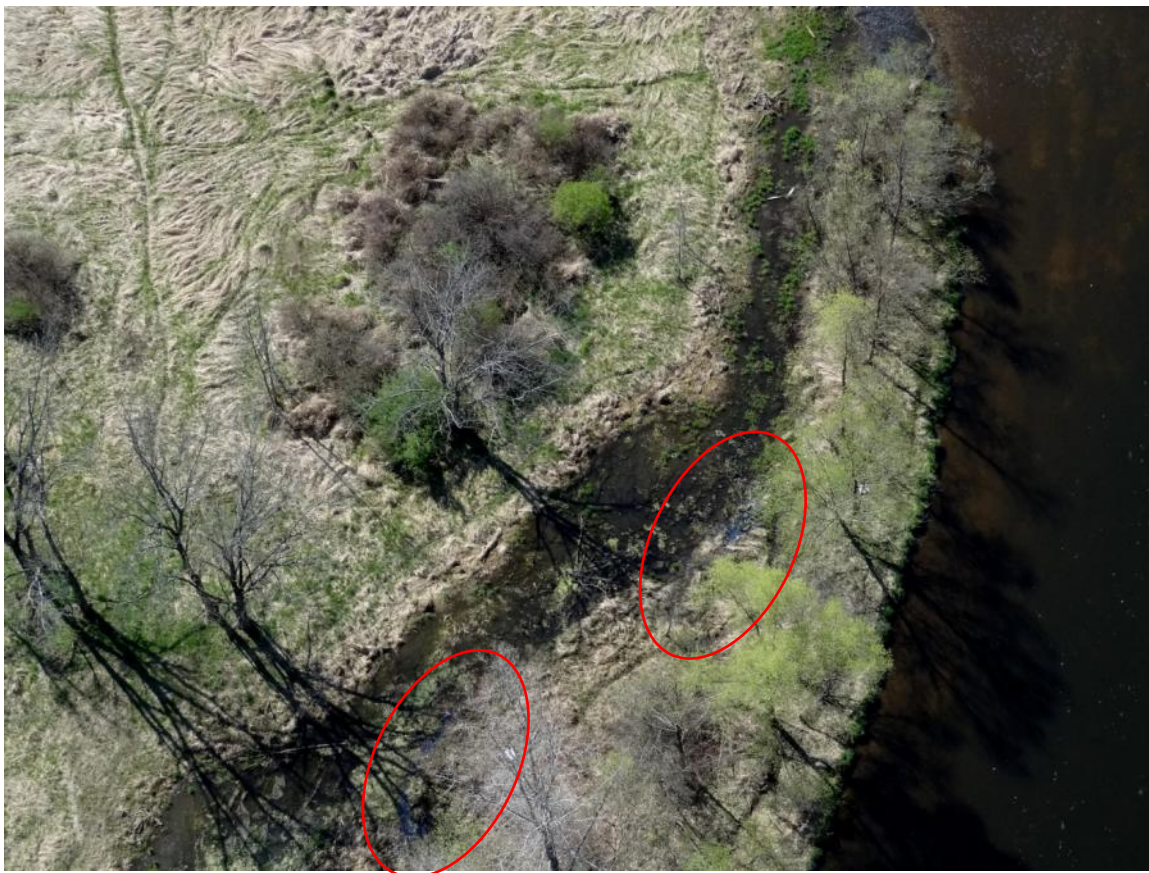
8. MP2.5 LDB sheen observed.

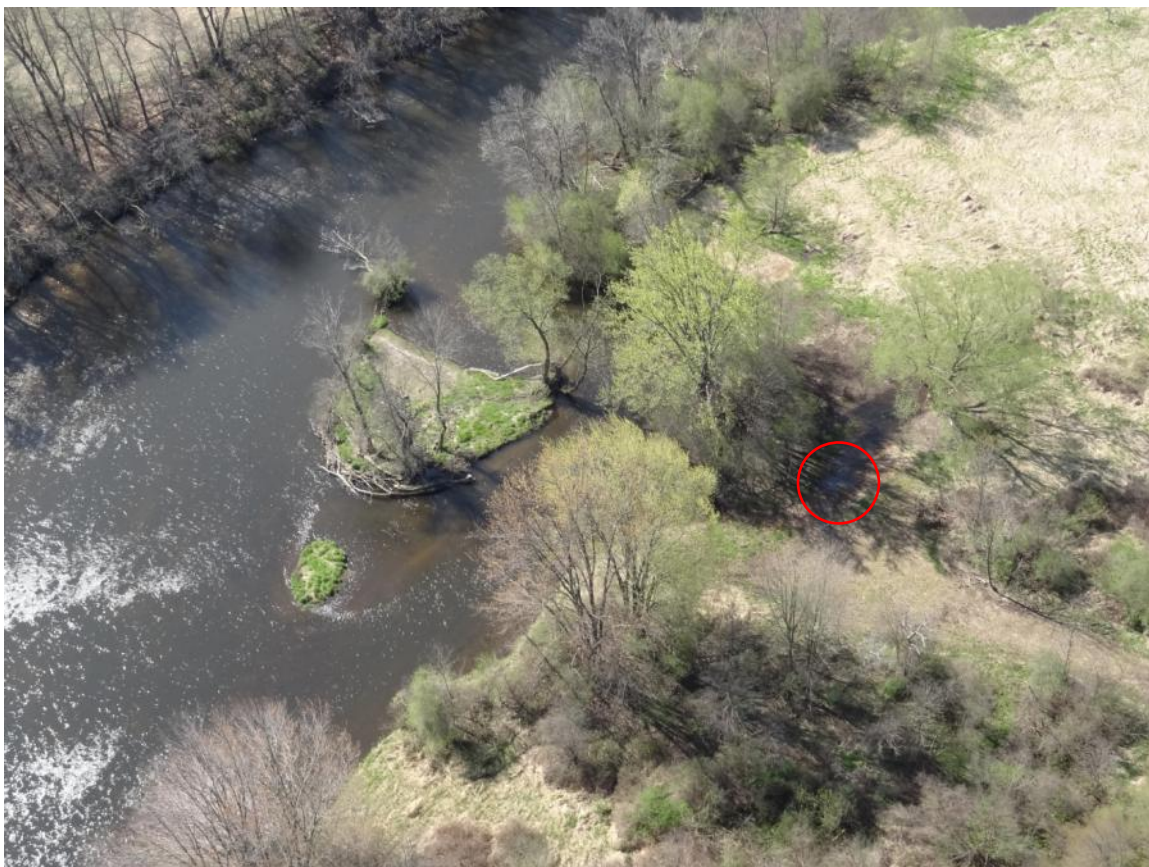
9. MP2.75 RDB sheen observed.

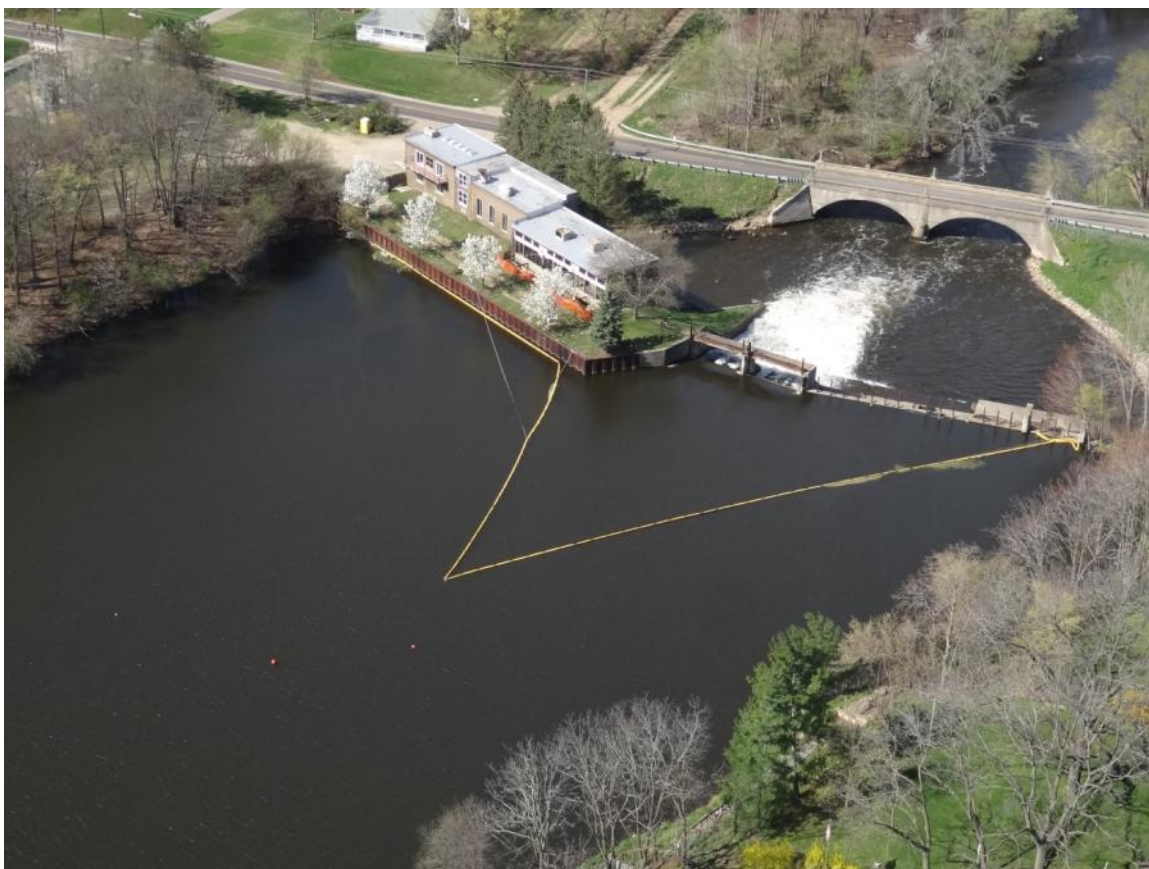
10. Ceresco Dam observed newly installed boom.

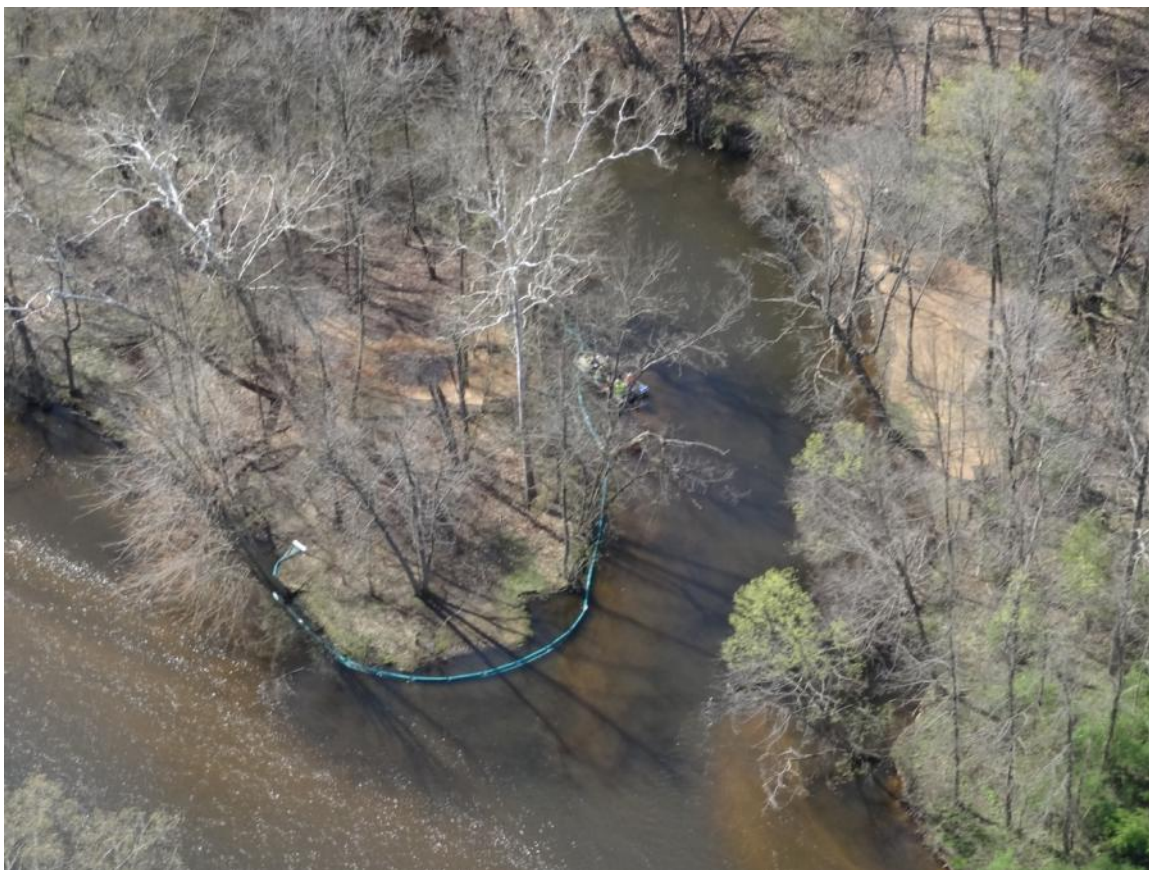
13. OB8.97 crew observed.

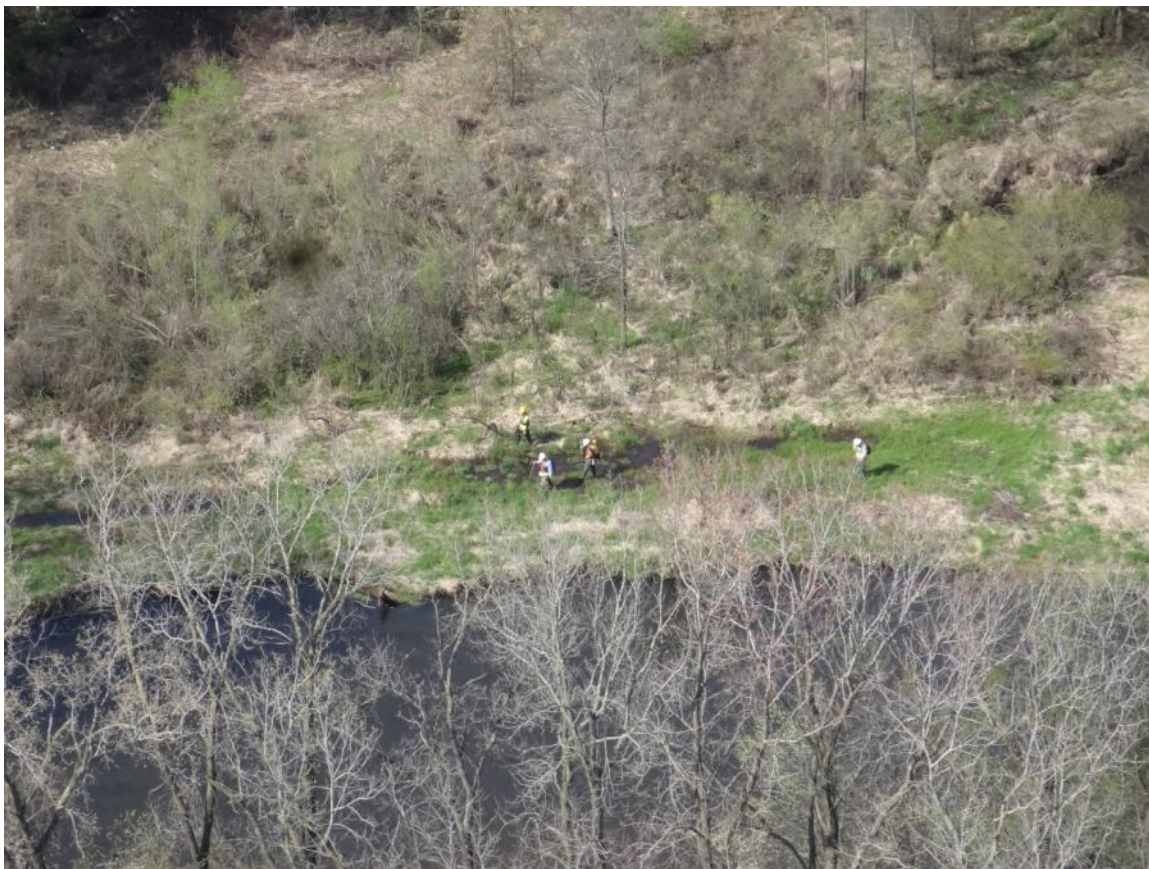
14. MP10.5 SORT crew observed.

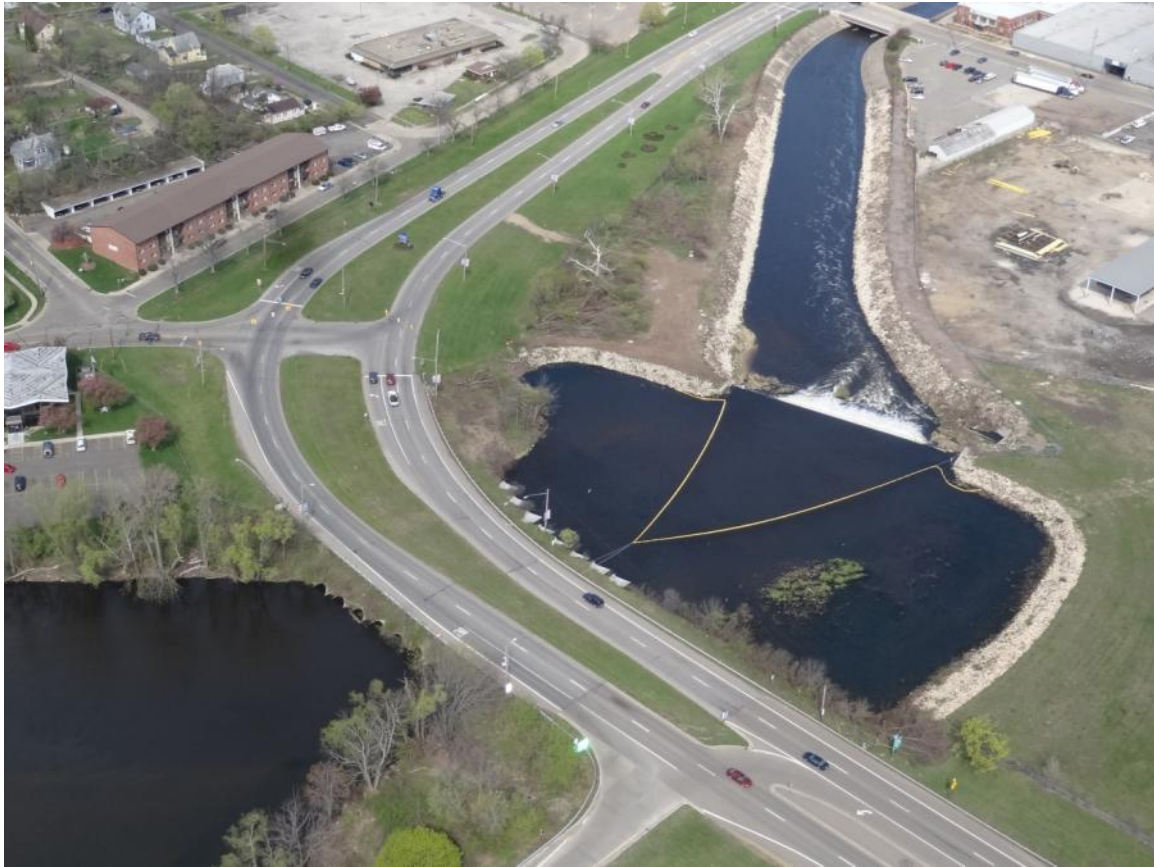
**15. MP15.75 boom installed at the Battle Creek Spillway.**

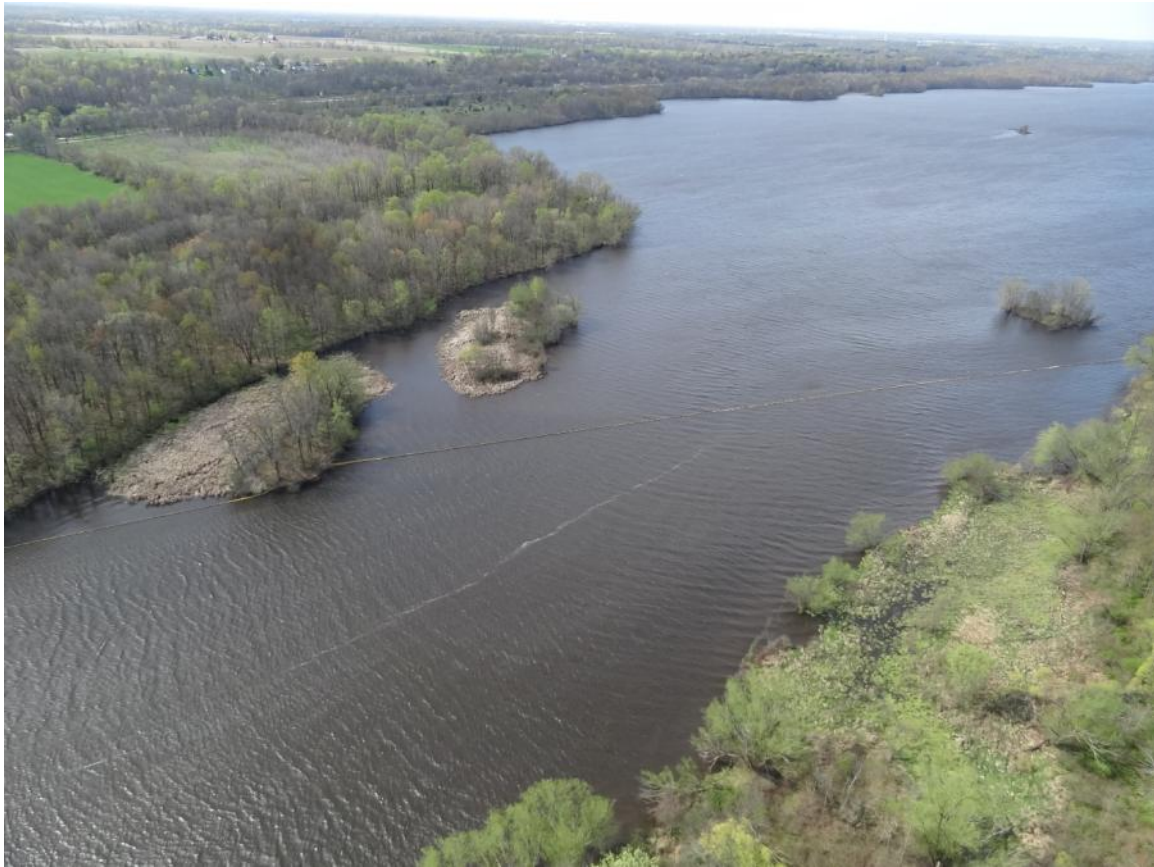
**17. Morrow Lake E4 Boom installed.**
