Situation Photo Log

Friday, March 30, 2012

Kalamazoo River / Enbridge Spill

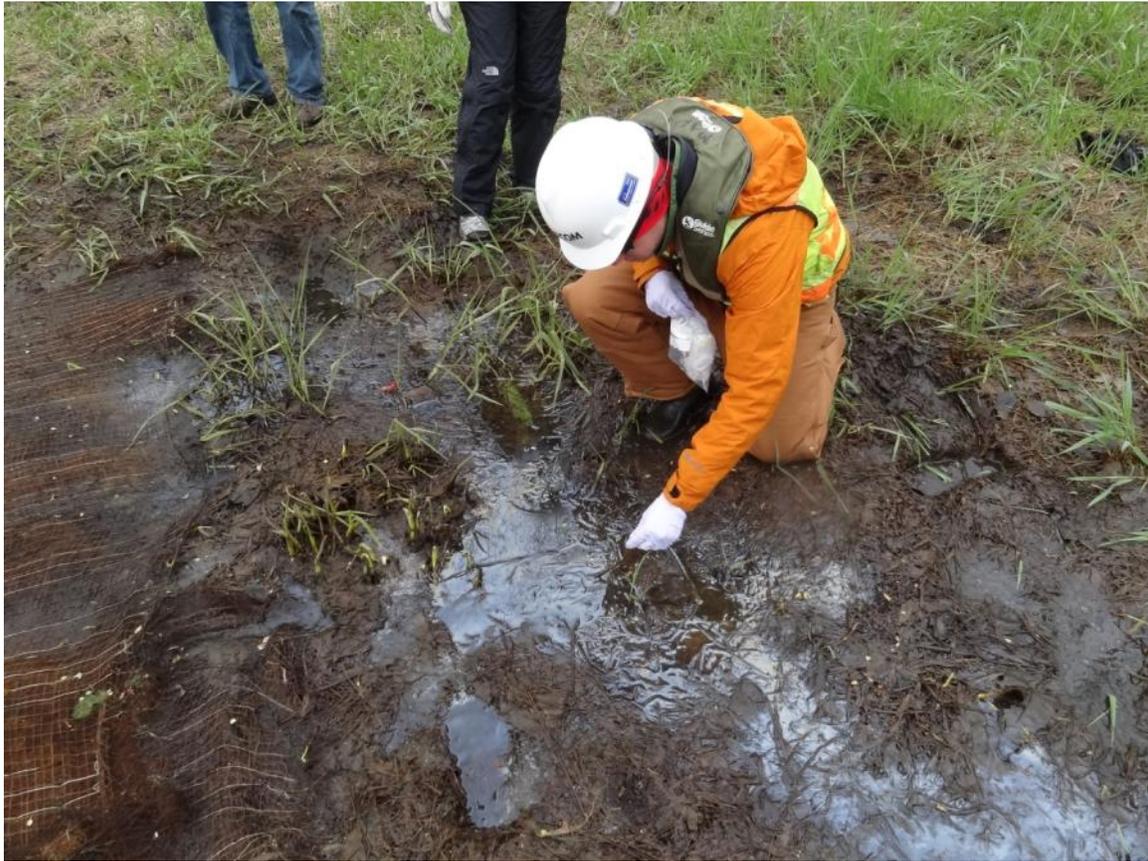
1. OB10.37 hexane test.

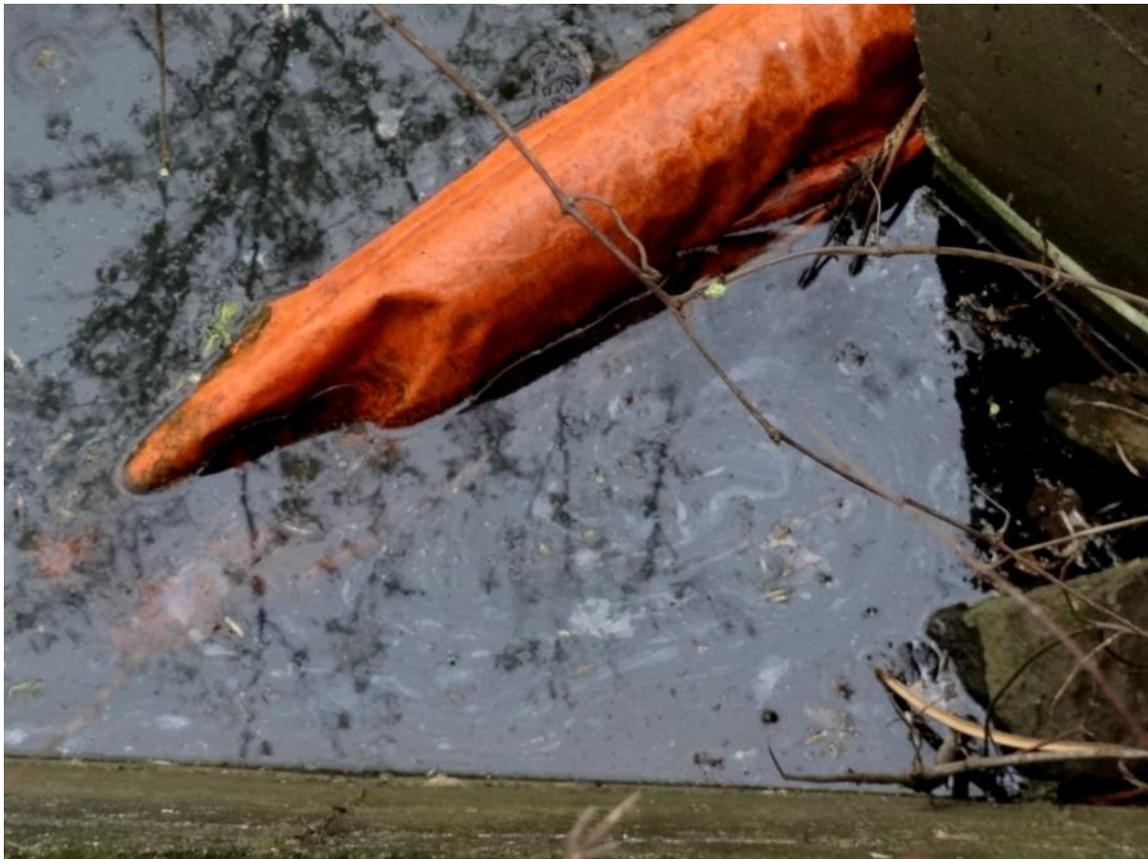
2. MP17.0 LDB RockTenn sheen observed within boom.

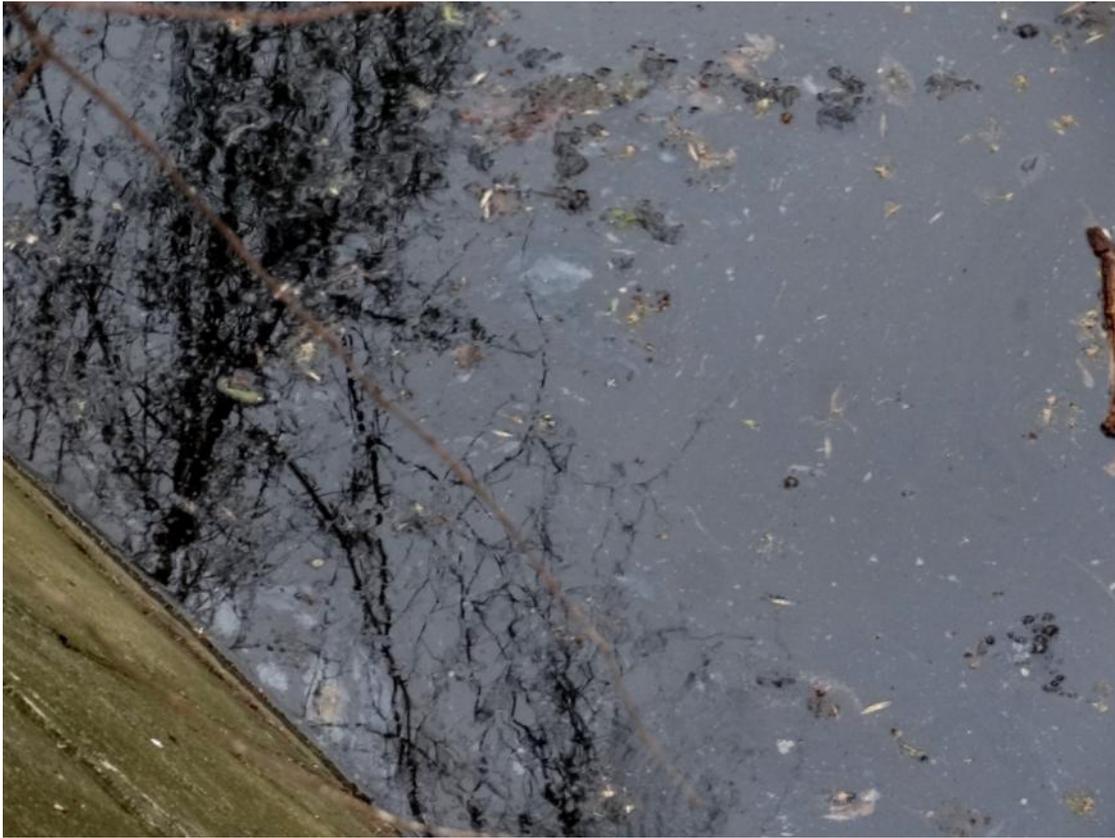
3. MP17.0 LDB RockTenn sheen observed within boom.

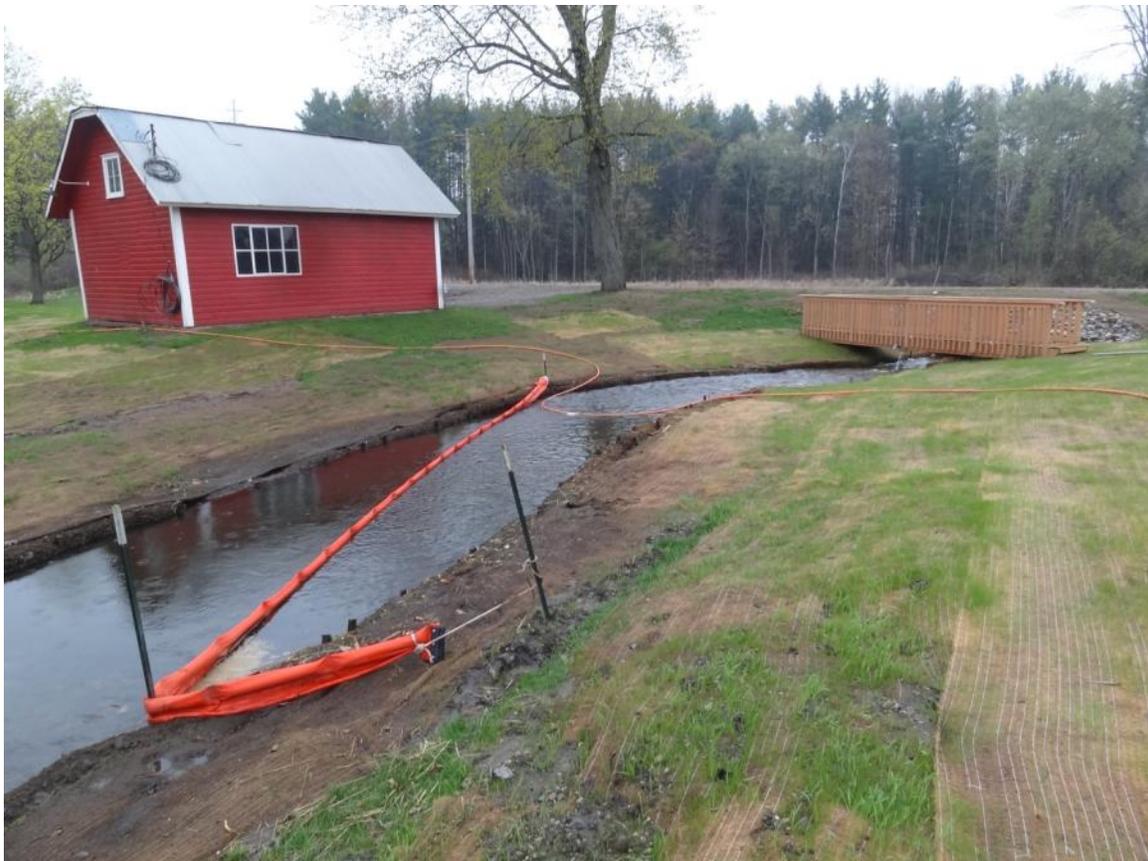
4. Talmadge Creek entering into the confluence no sheen or turbidity observed.

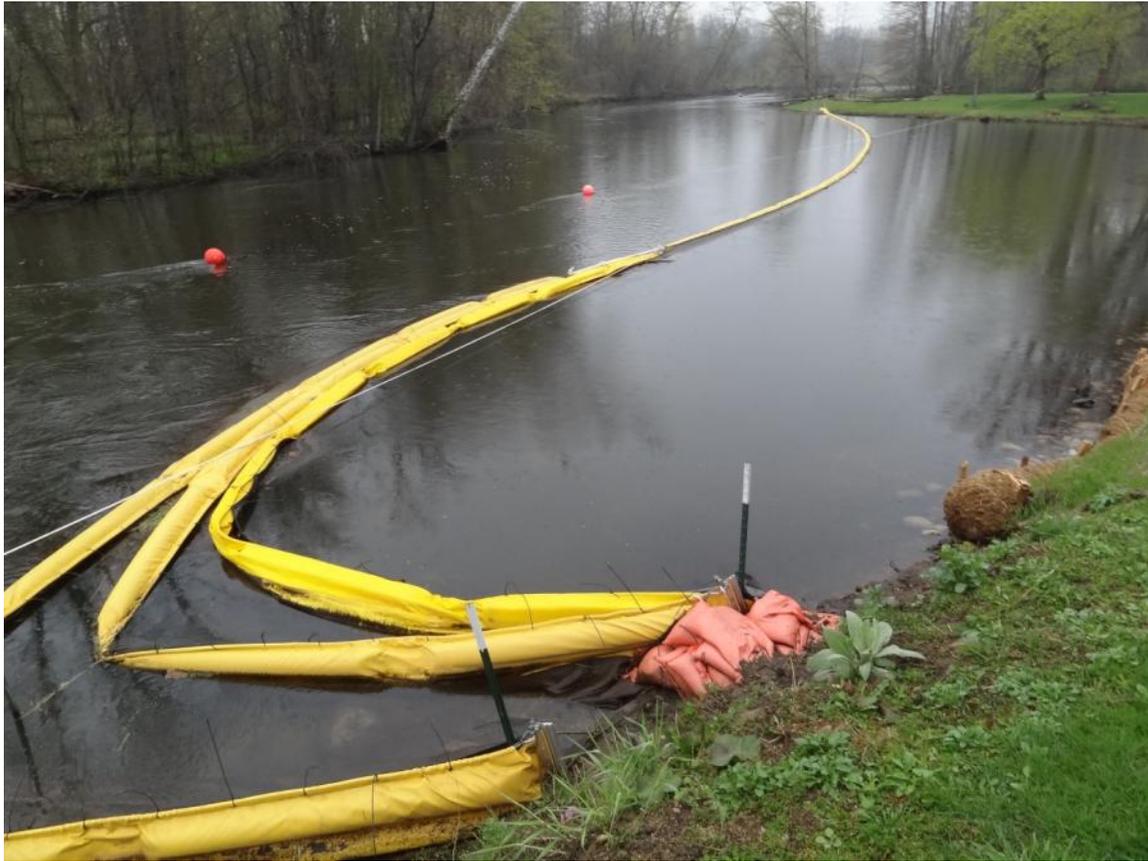
5. Confluence no turbidity or sheen observed.

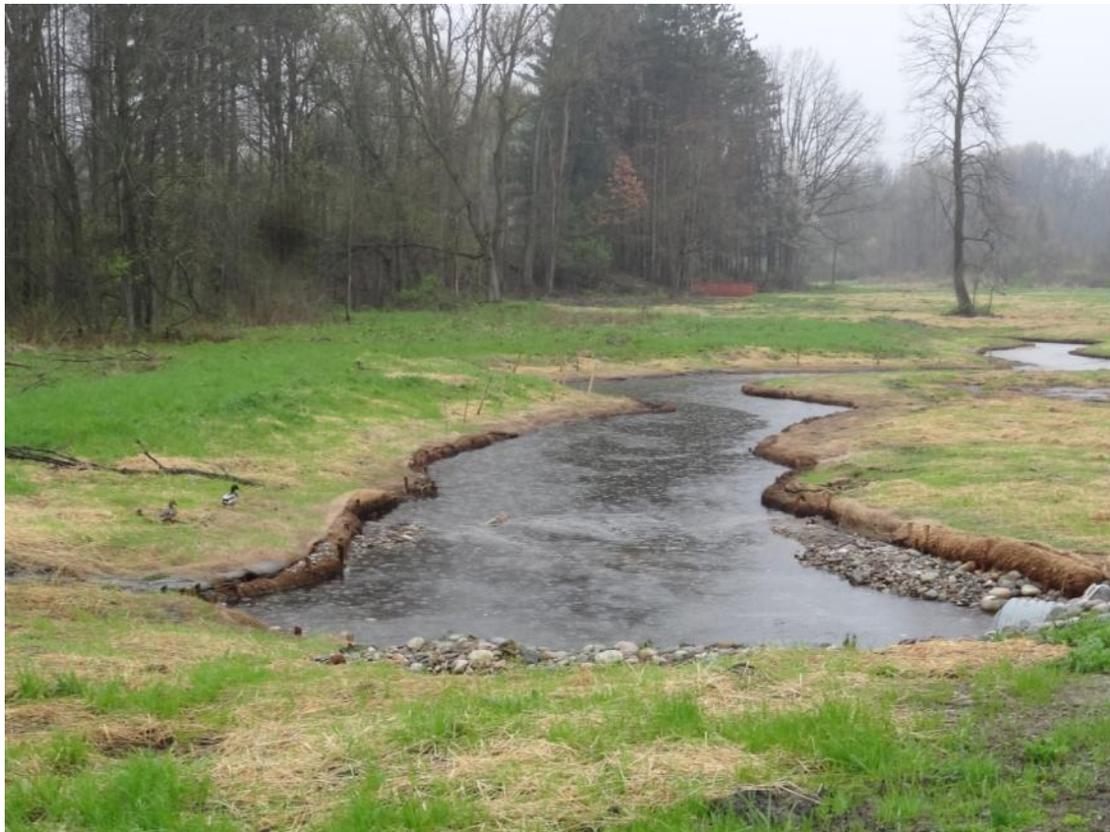
6. Talmadge Creek south of A Drive no turbidity or sheen observed.

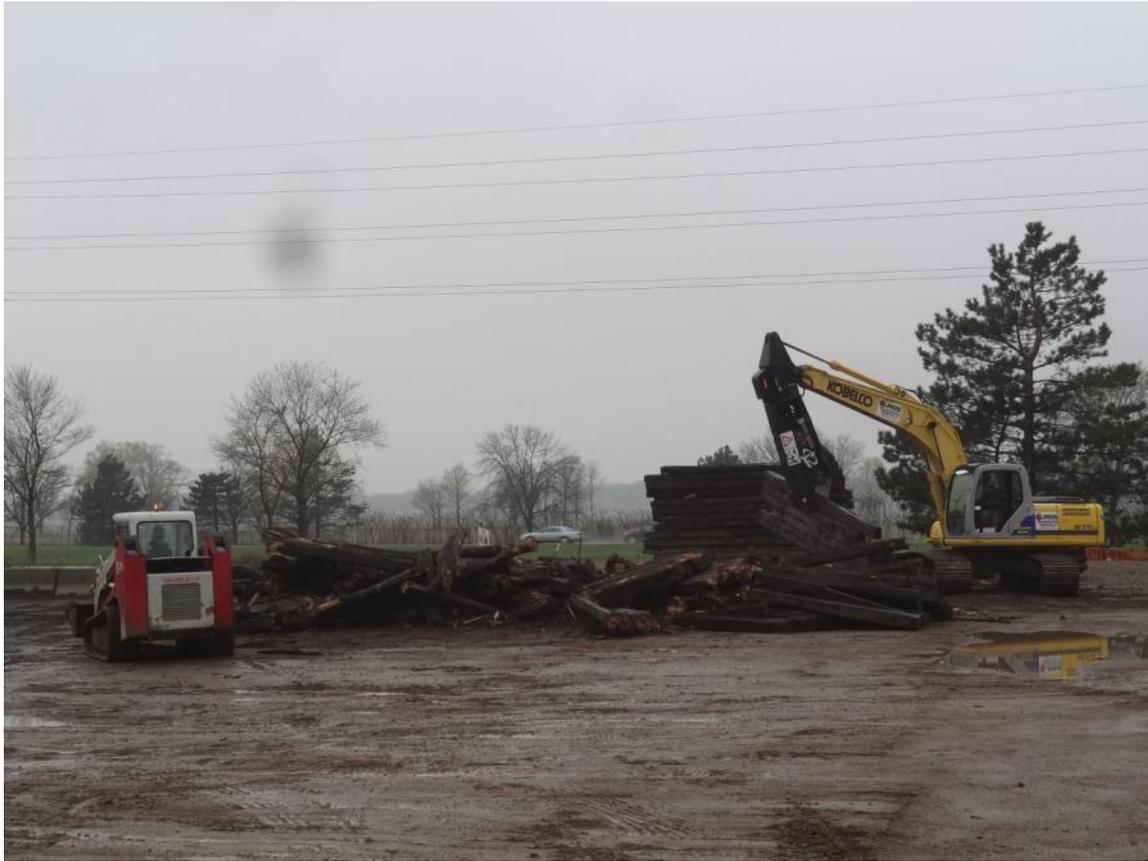
7. Frac-City timber mats observed being shredded.

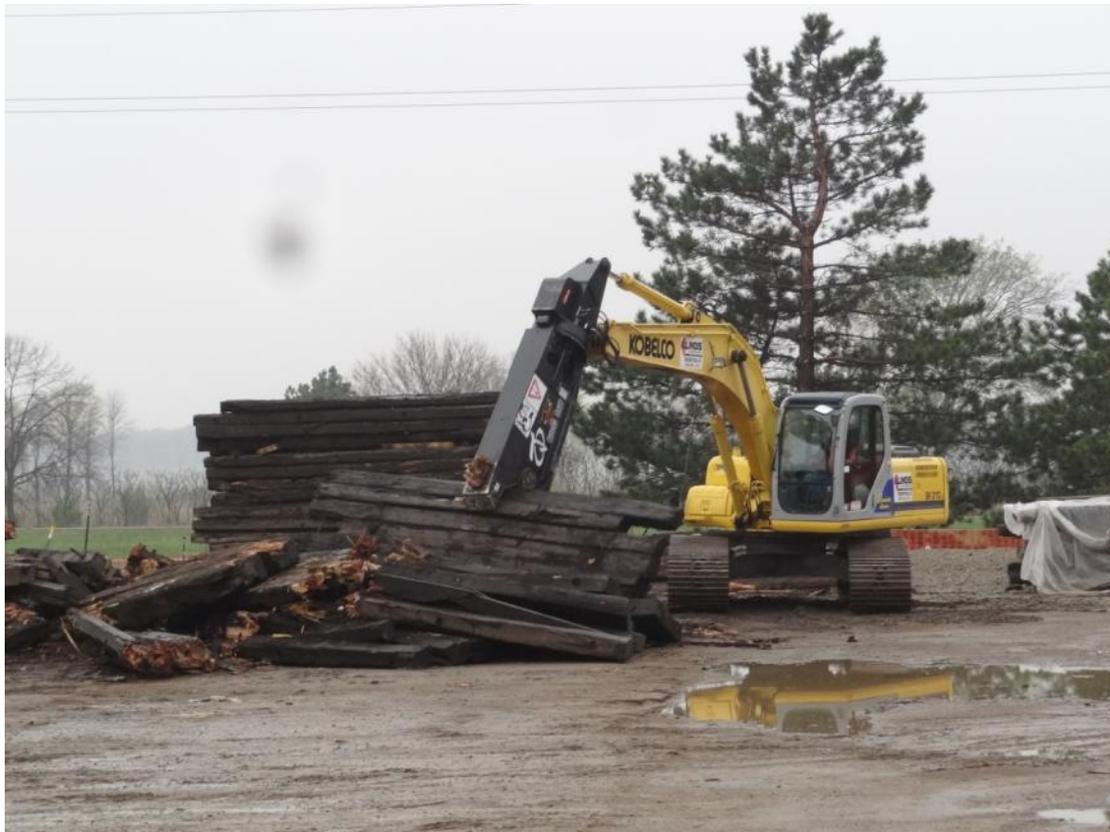
8. Frac-City timber mats observed being shredded.
