# Situation Photo Log

Saturday, March 31, 2012

Kalamazoo River / Enbridge Spill

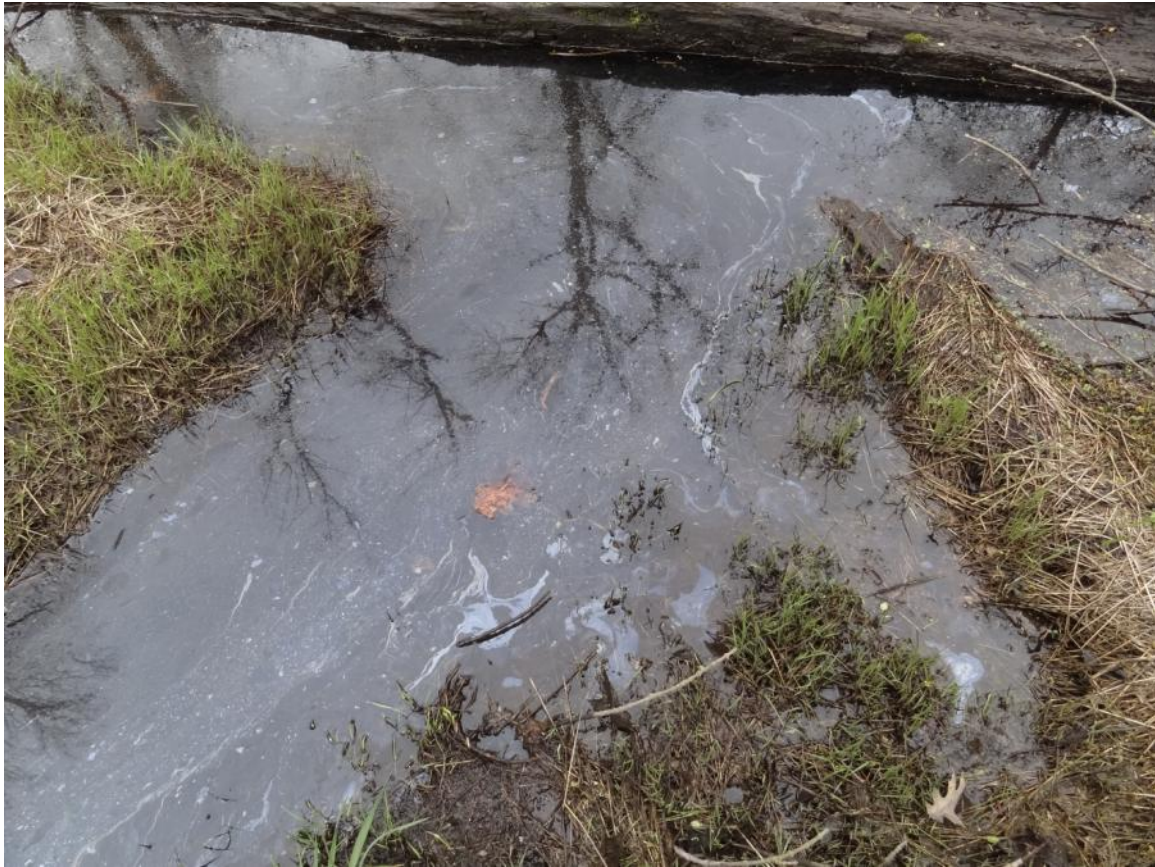
1. MP9.00 R1 sheen observed.

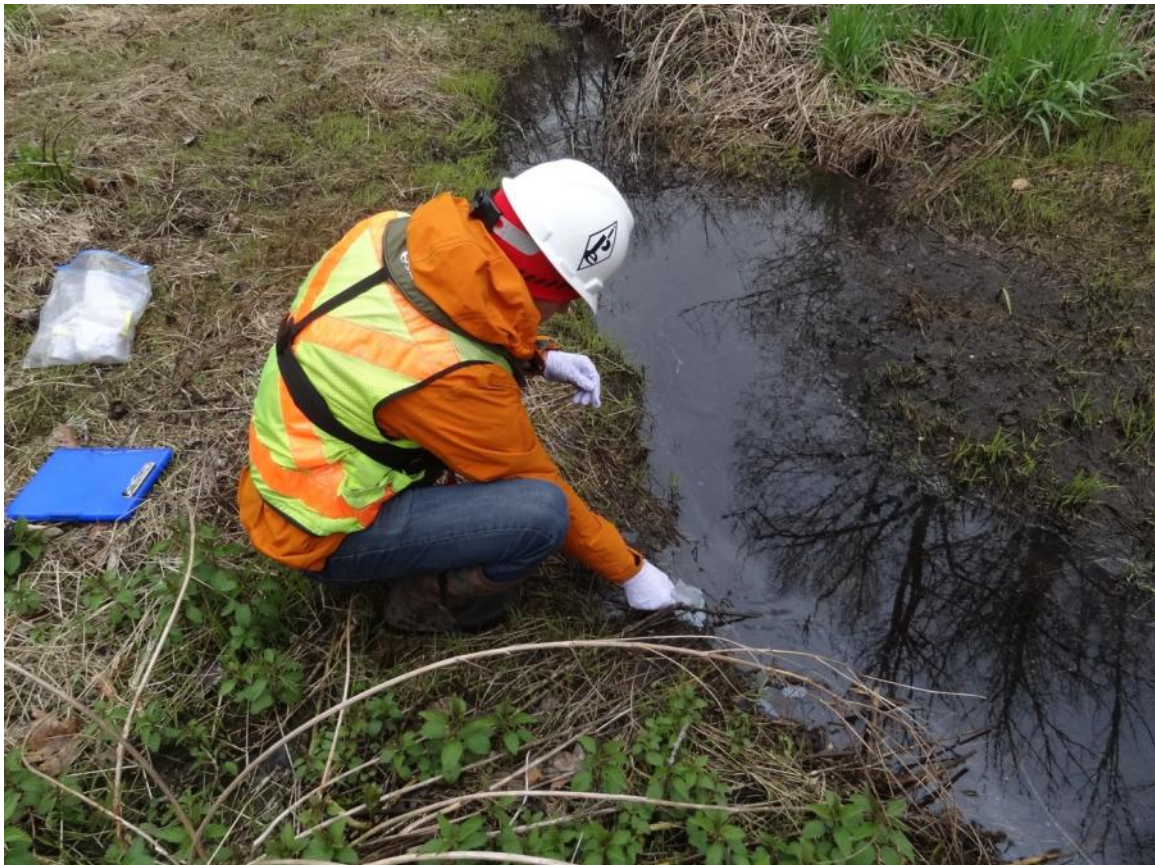
2. Hexane Test at MP9.00 R1.

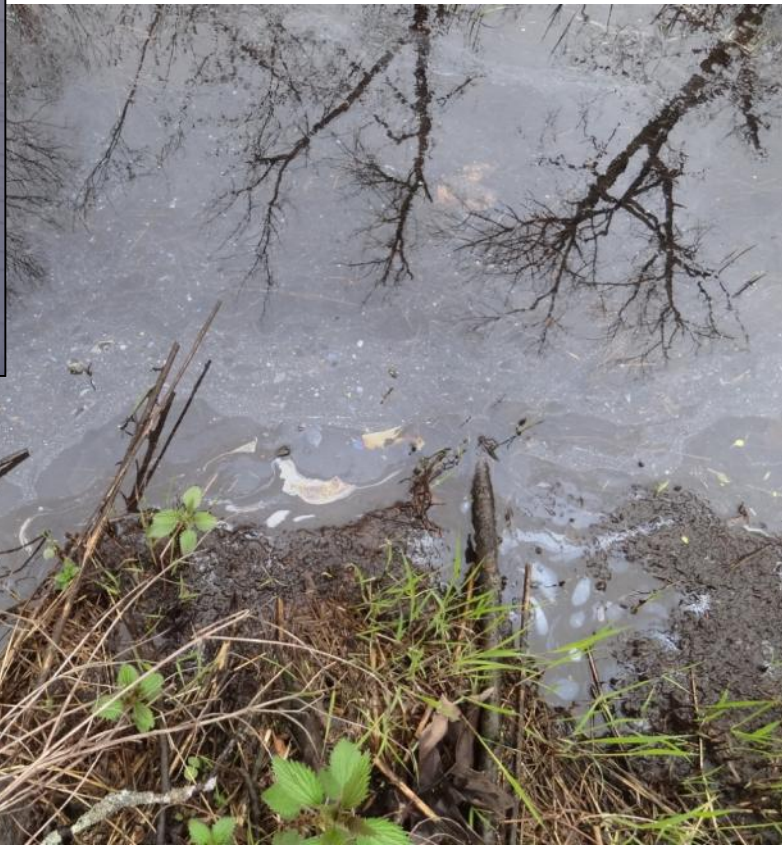
3. MP9.00 R1 hexane test result.

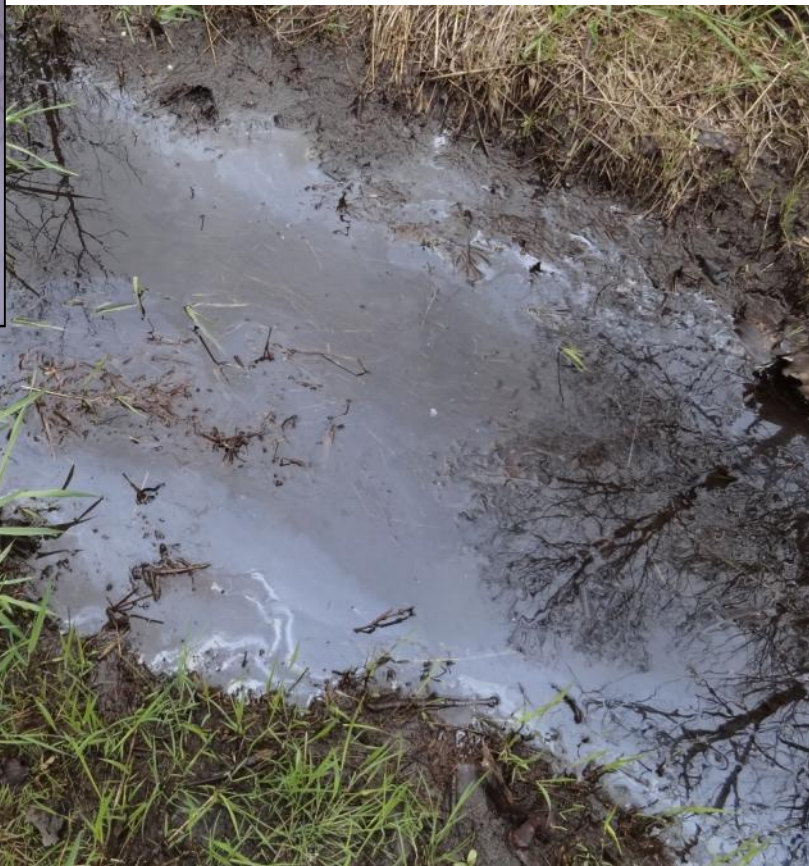
4. MP9.00 R1 hexane test result.

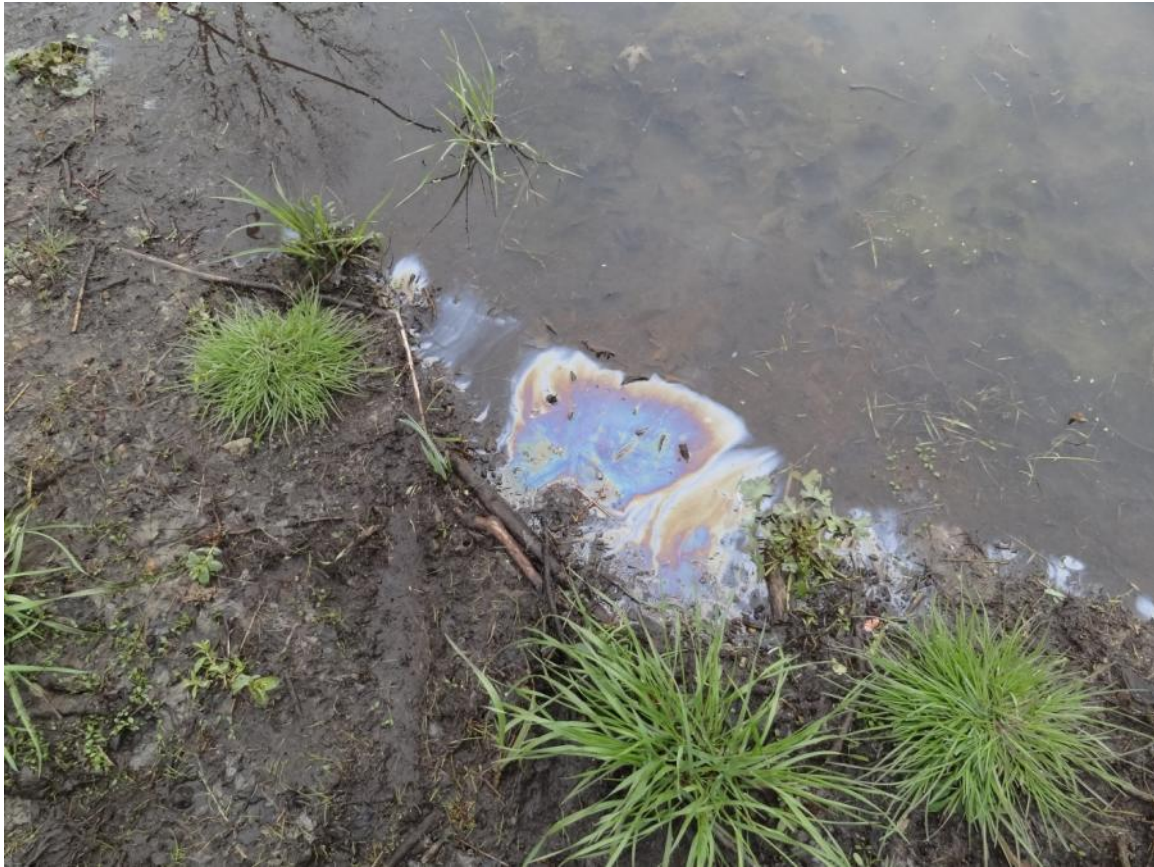
5. MP11.25R2 sheen observed.

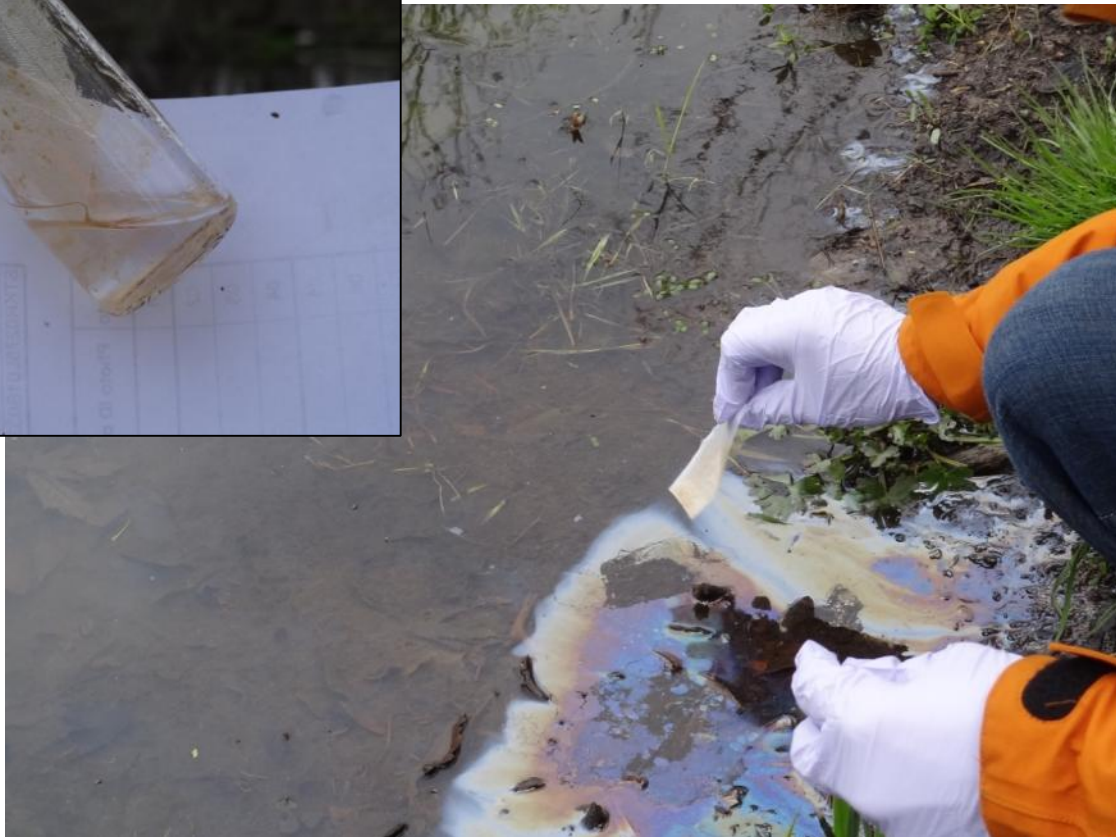
6. MP11.25R2 hexane test result.

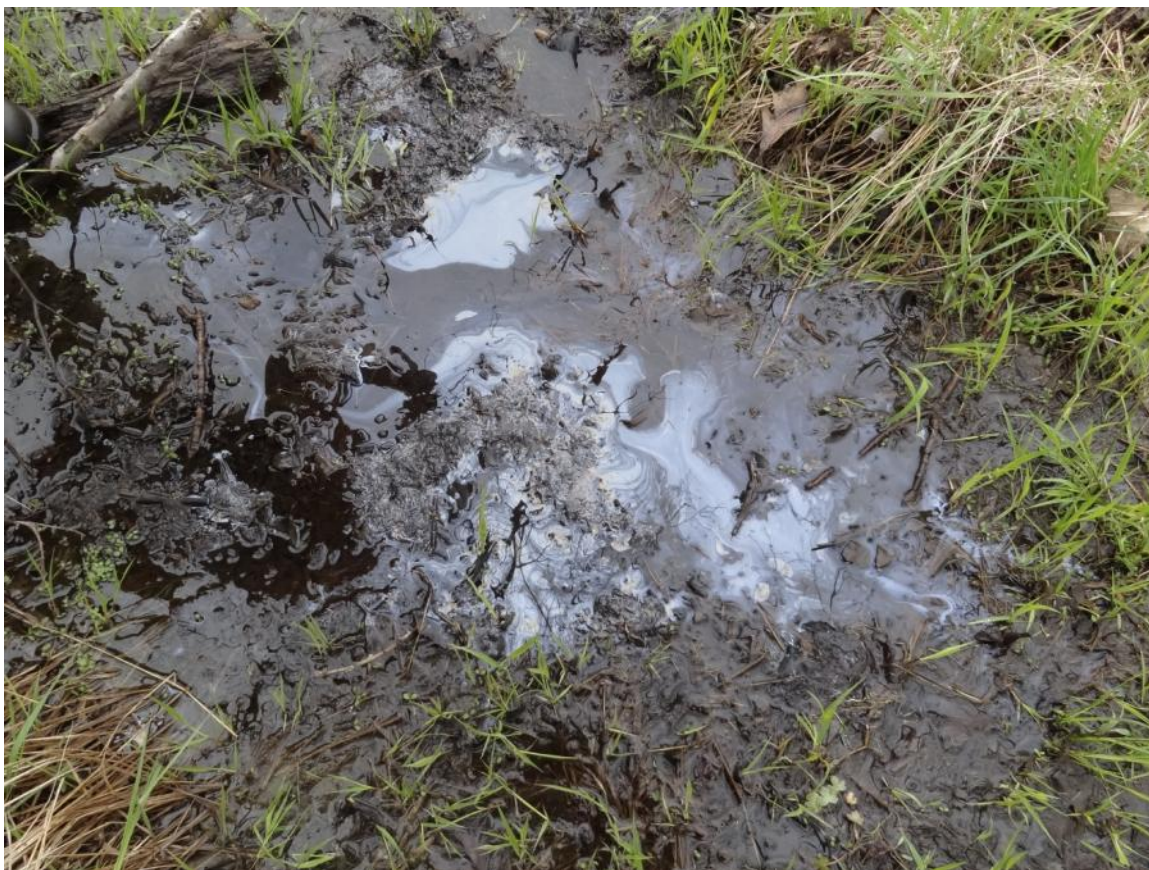
7. MP11.25R2 sheen observed.

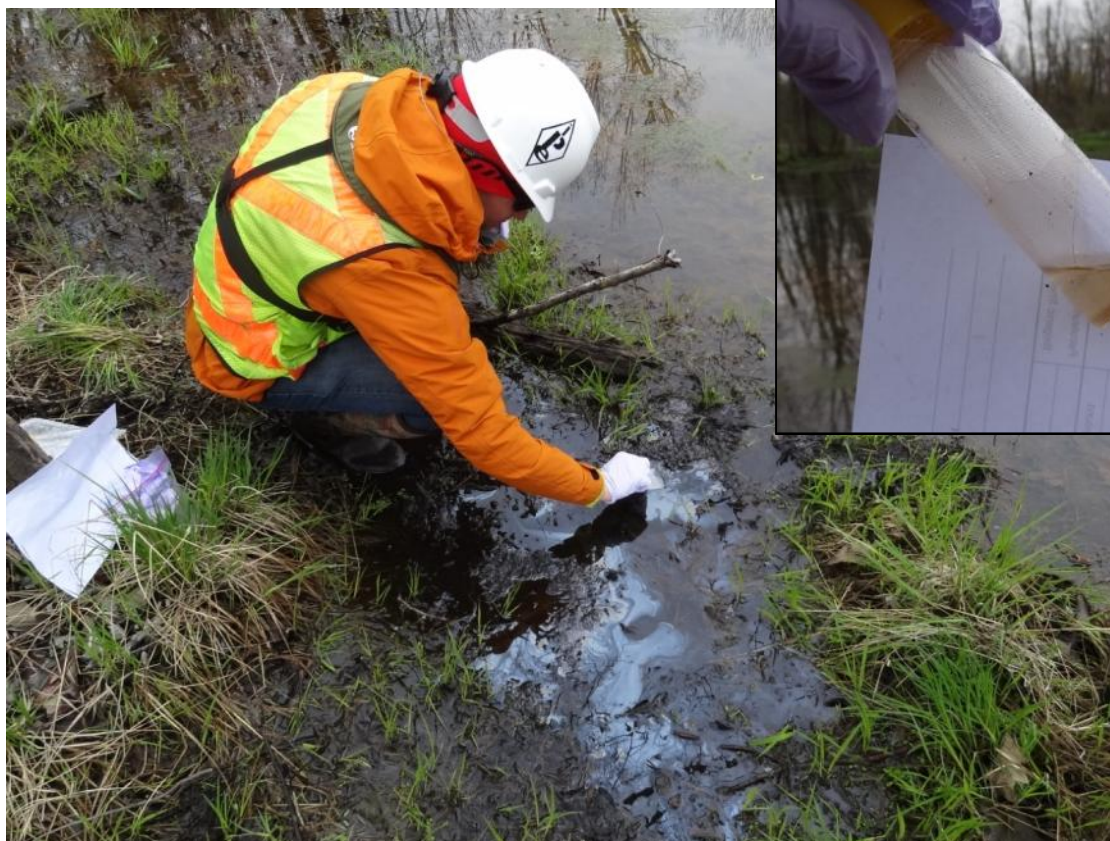
8. MP11.25R2 hexane test result.

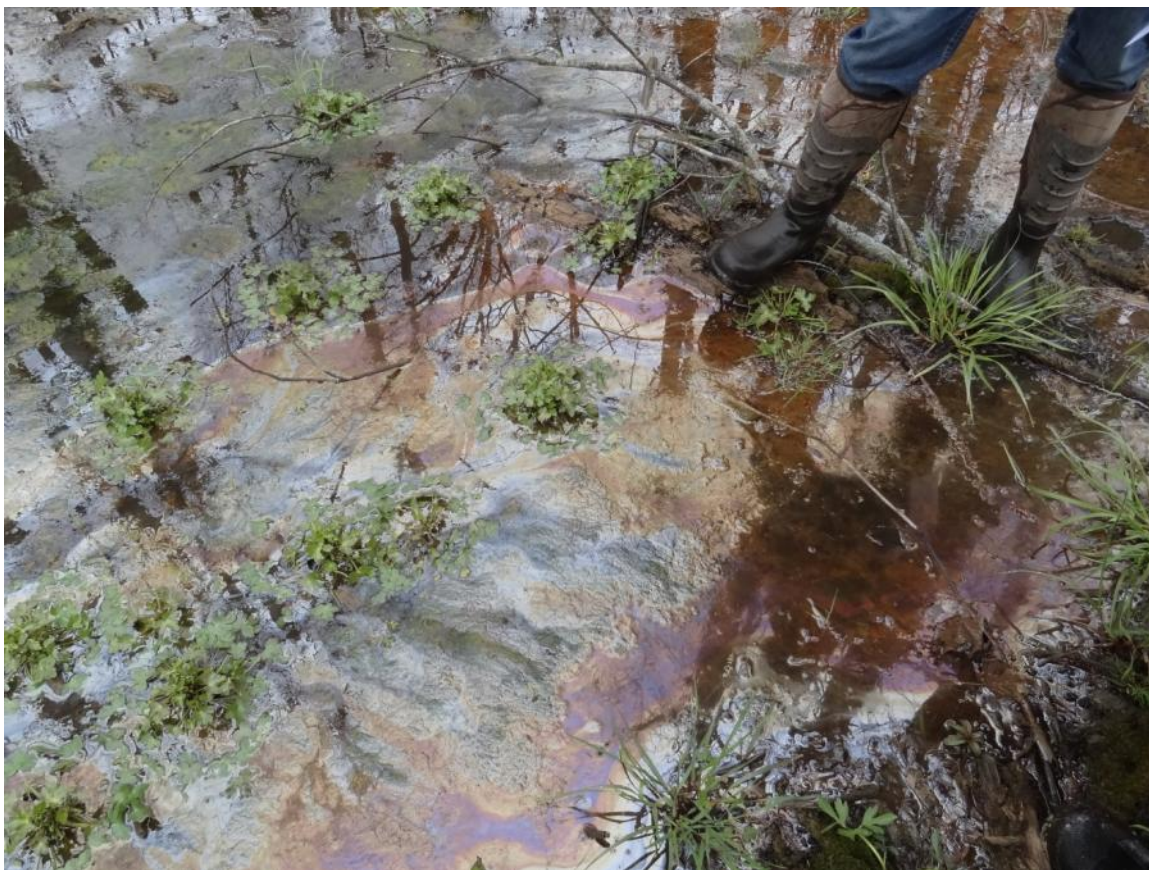
9. MP11.25R2 sheen observed.

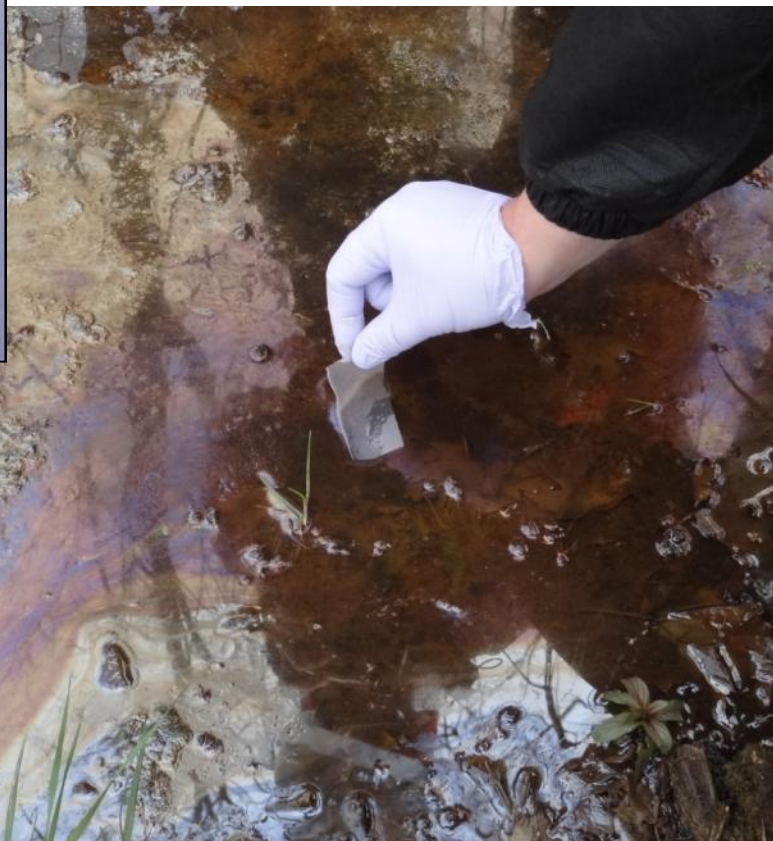
10. MP11.25R2 hexane test result.

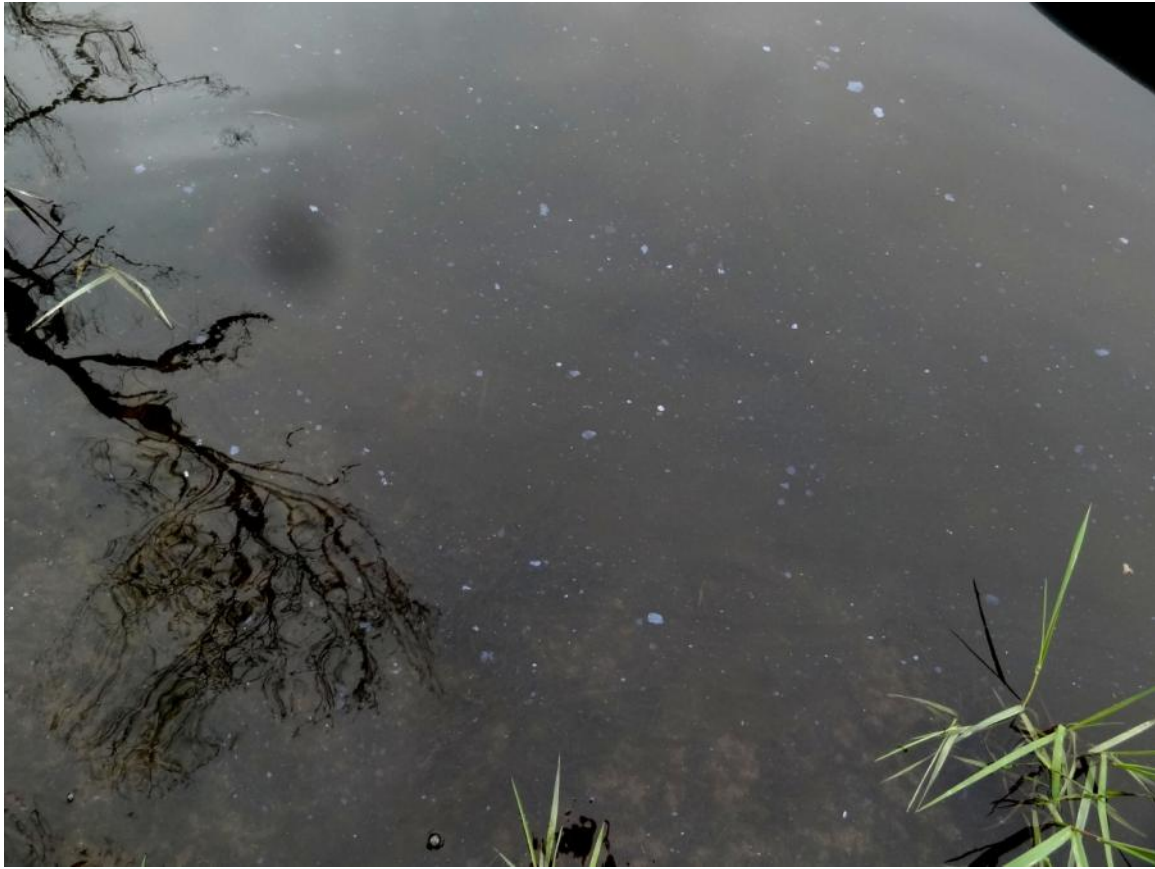
11. MP11.75 LDB sheen observed.

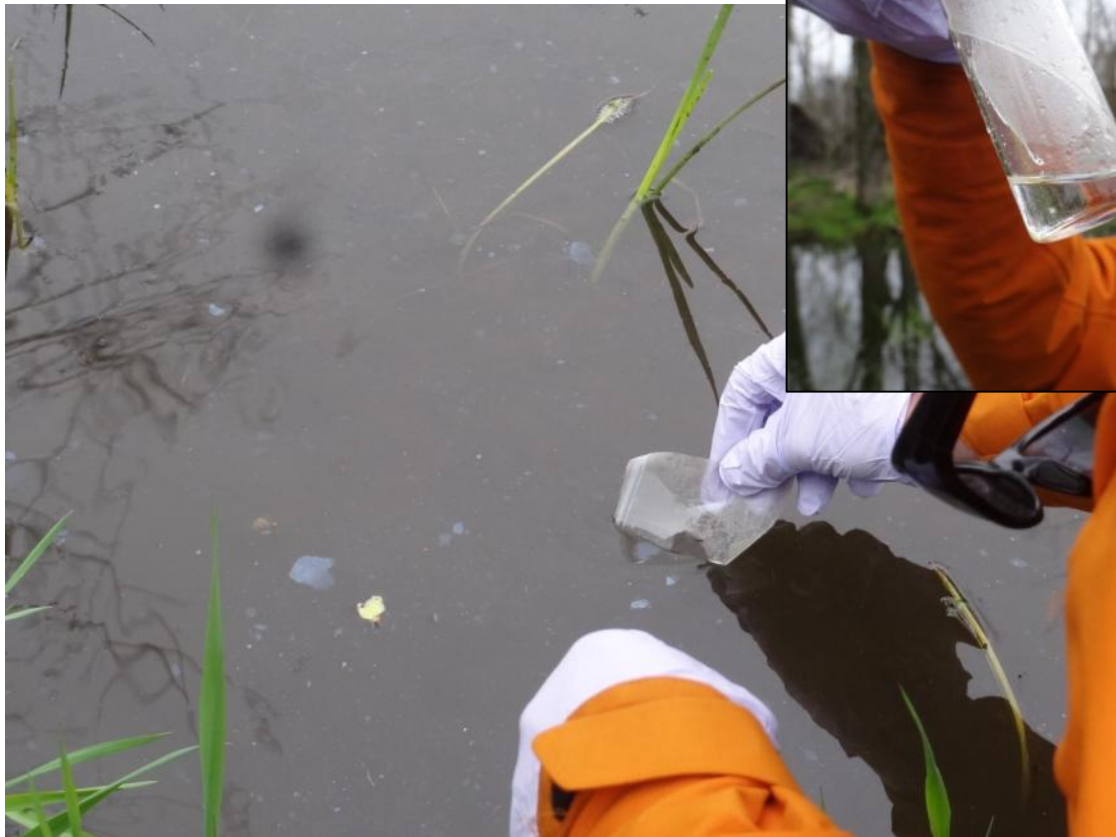
12. MP11.75 LDB hexane test result.

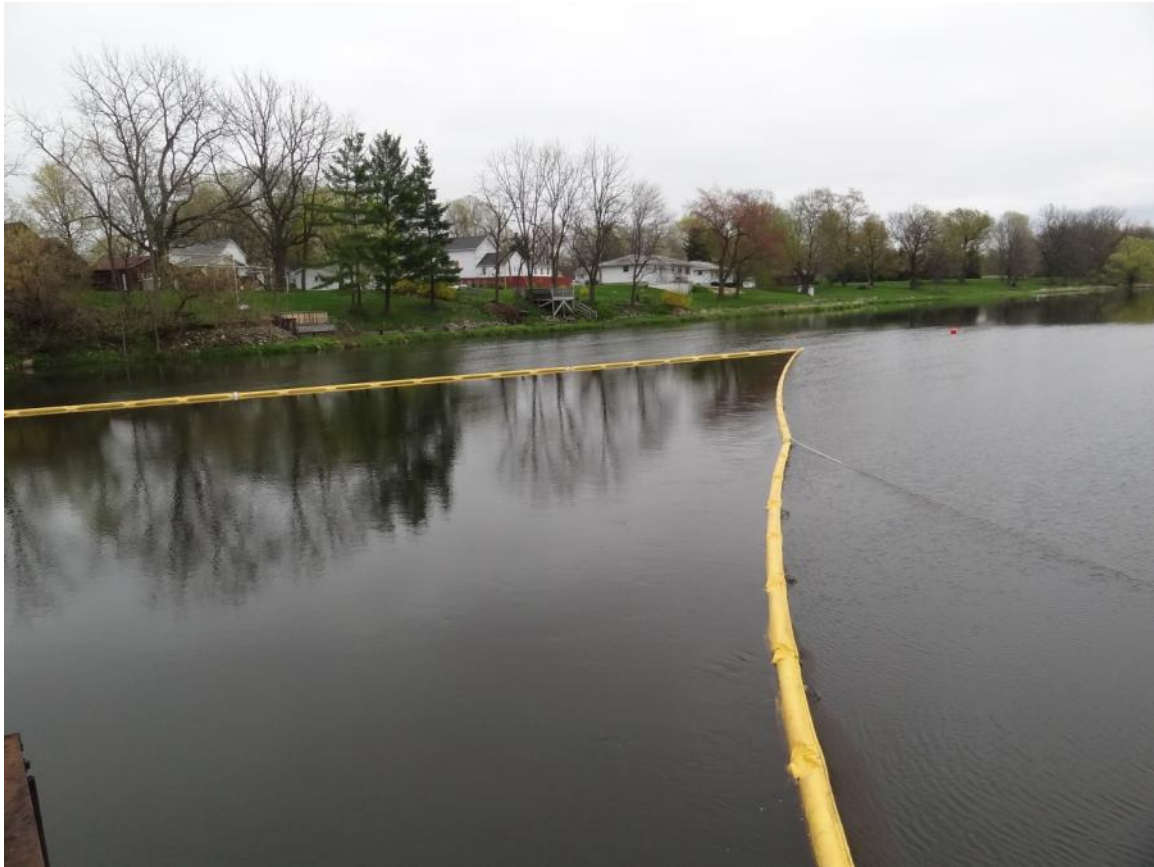
13. Ceresco Dam boom.

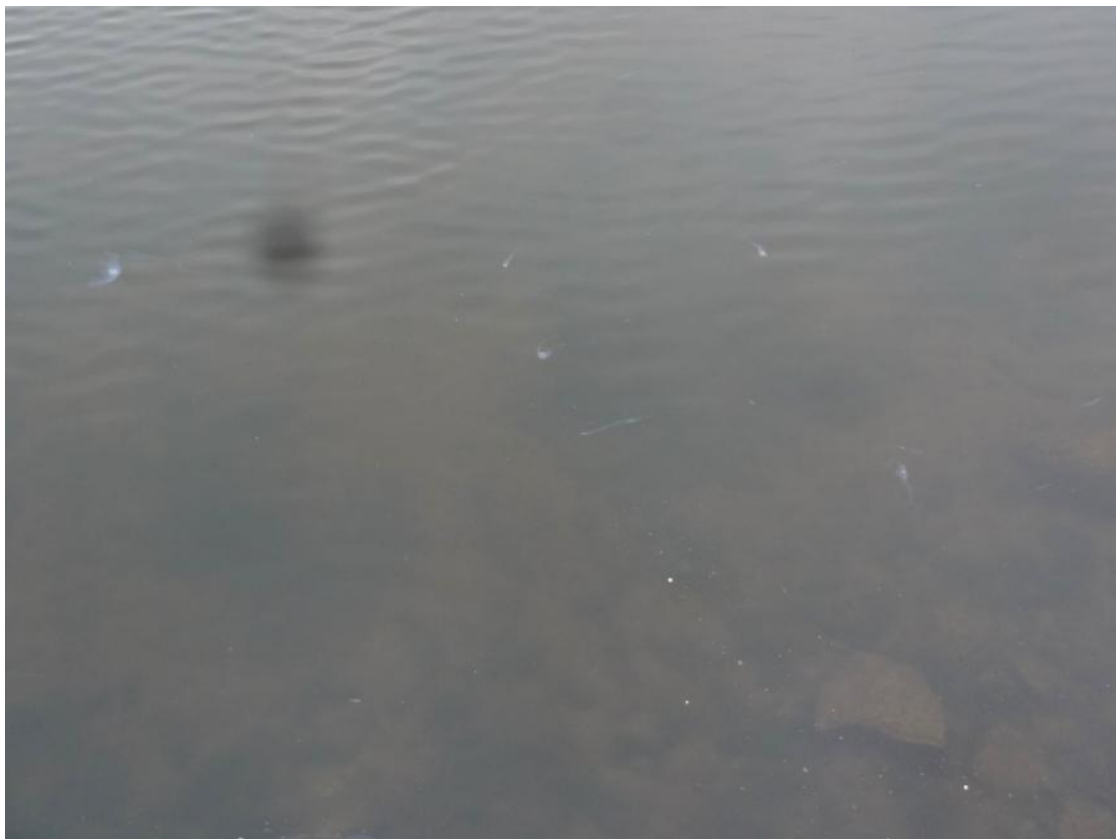
14. Ceresco Dam sheen observed.
