# Situation Photo Log

Tuesday, April 3, 2012

Kalamazoo River / Enbridge Spill

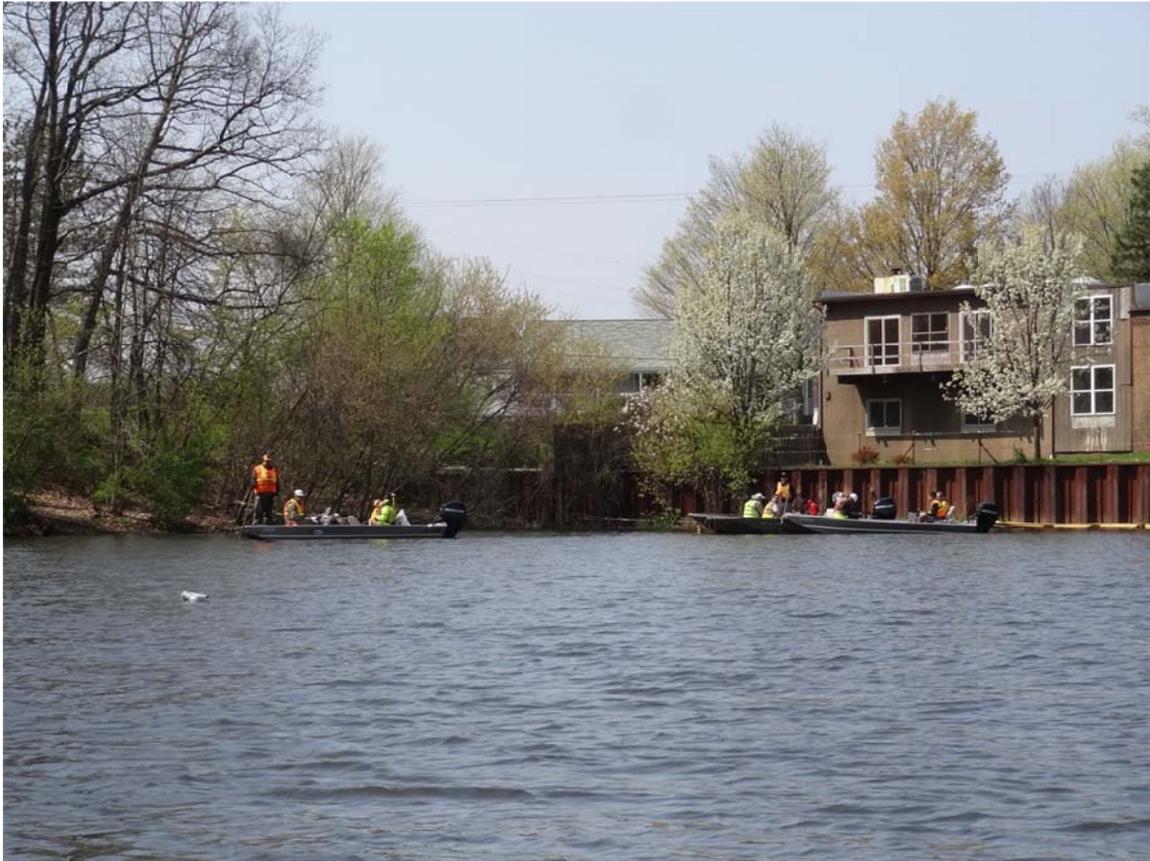
1. Crews conducting TarGOST survey on upstream side of Ceresco Dam.

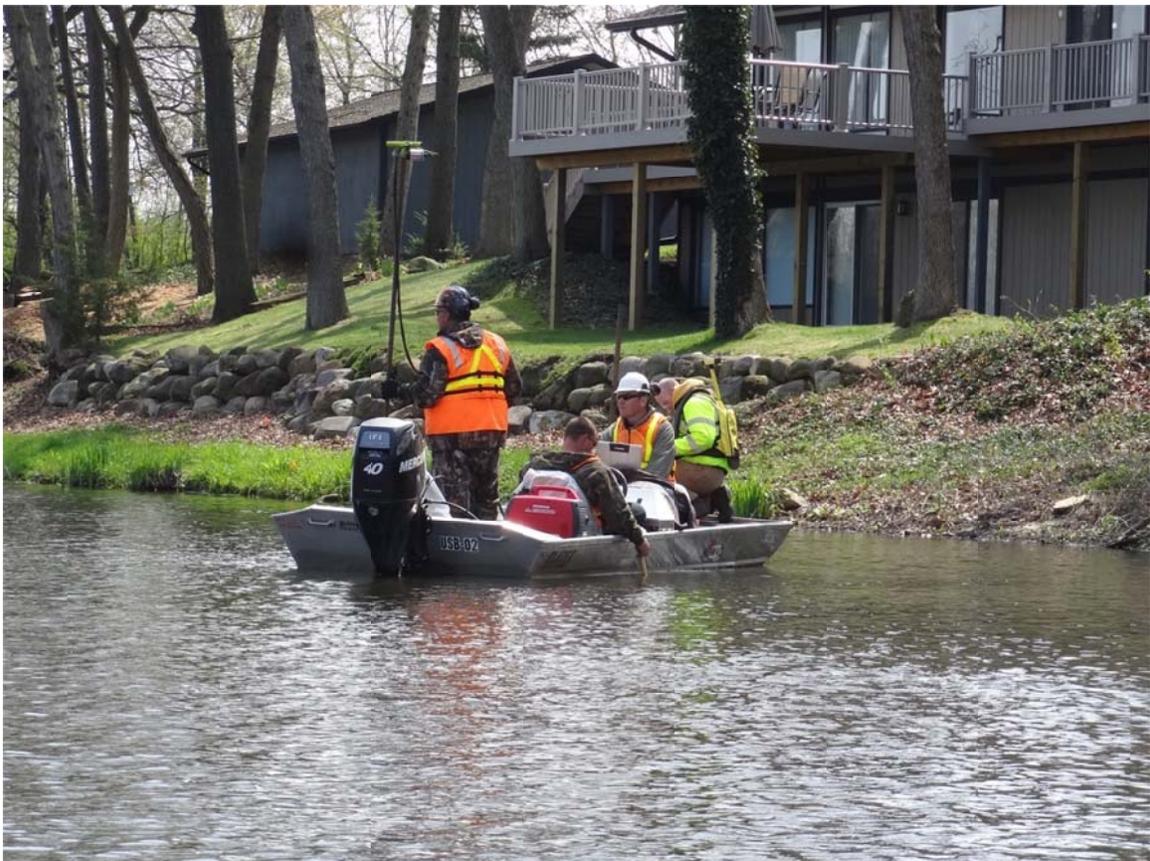
2. Close up of TarGOST survey boat.

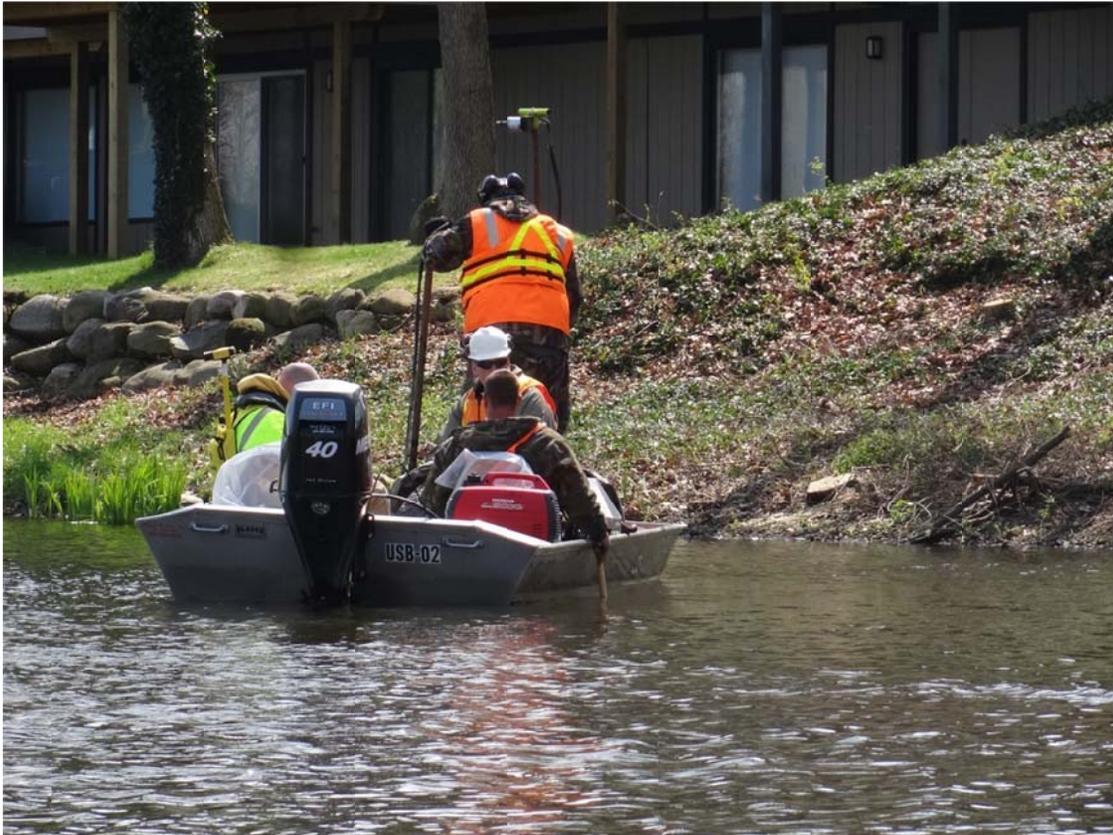
3. Crews deploying TarGOST probe along LDB above Ceresco Dam.

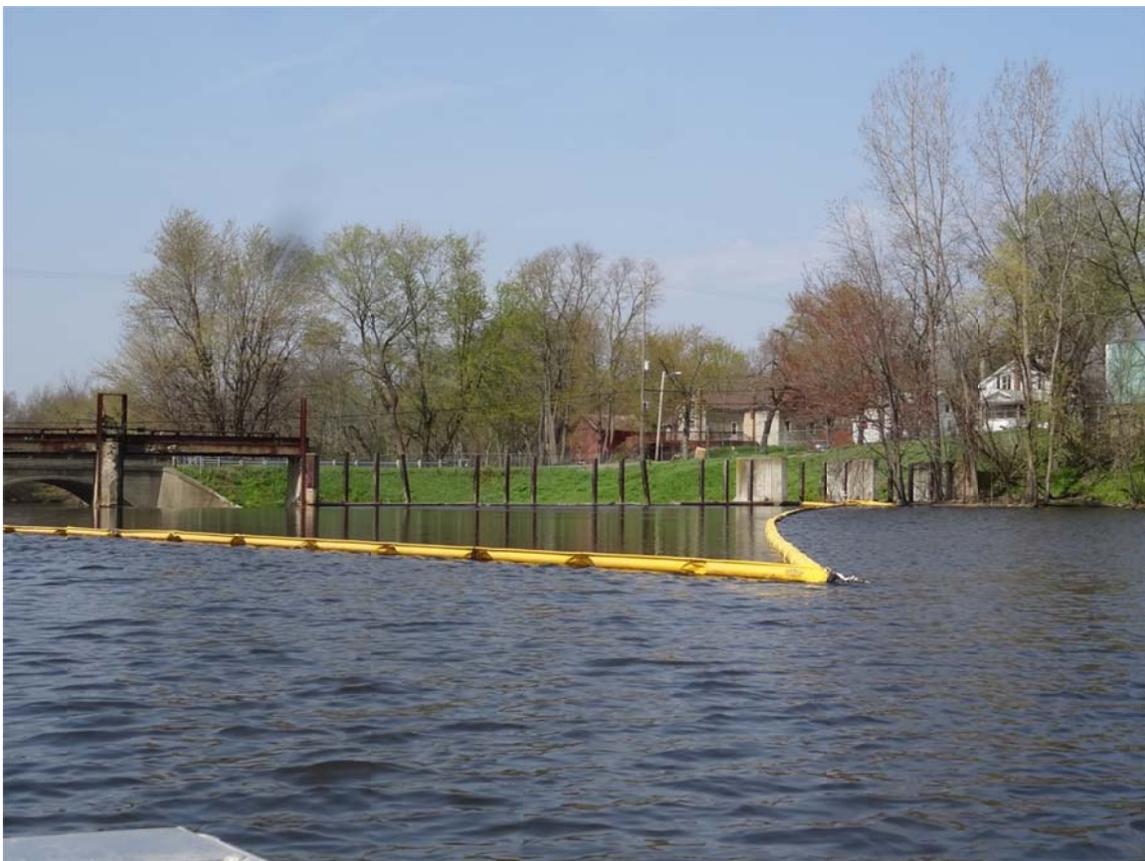
4. Chevron boom in place above Ceresco Dam.

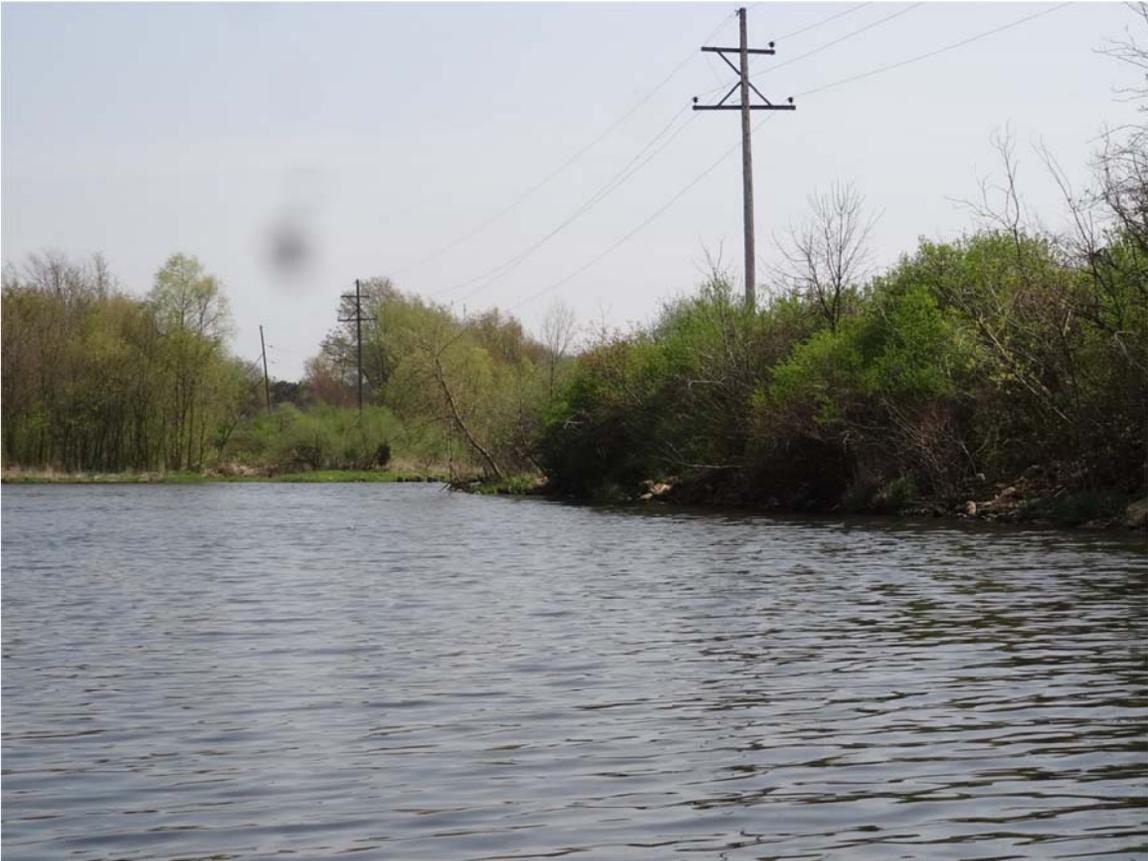
5. Peninsula along LDB above Ceresco Dam. No sheen observed.

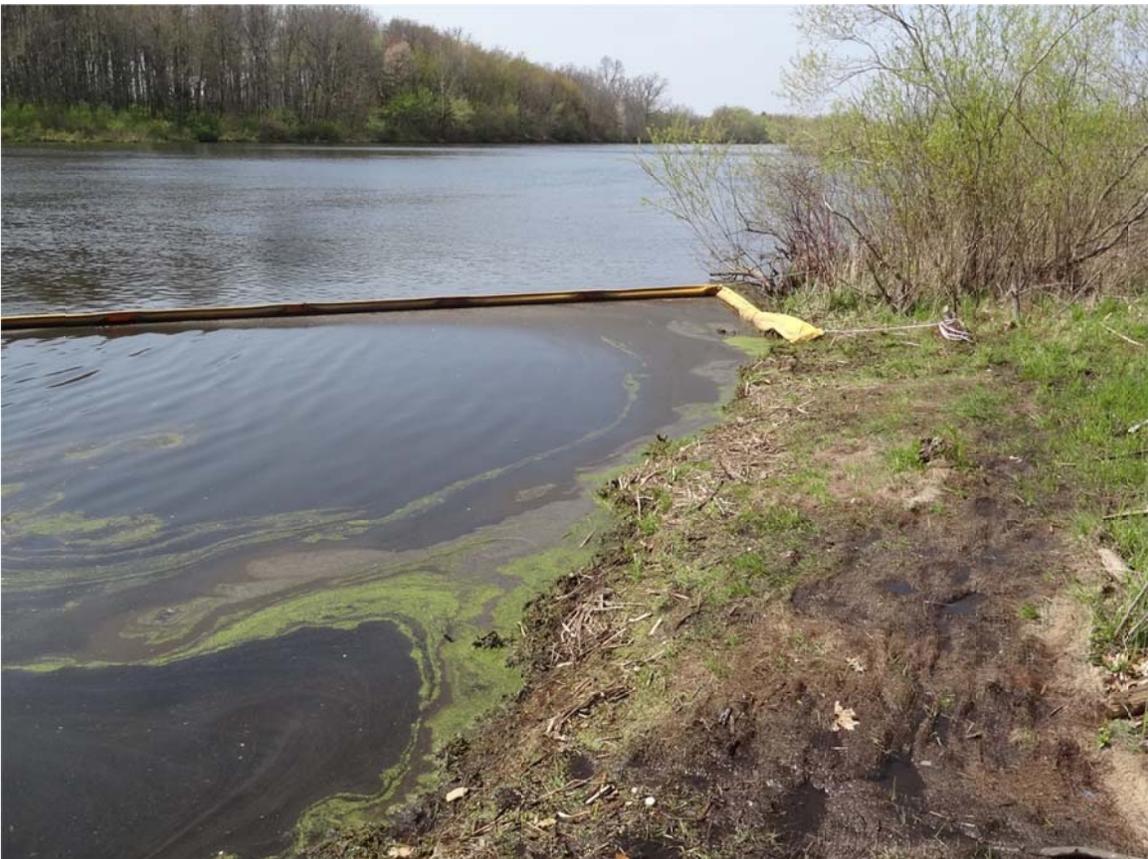
6. Collection point at C0.4 boat launch. No sheen, some minor debris observed in containment.

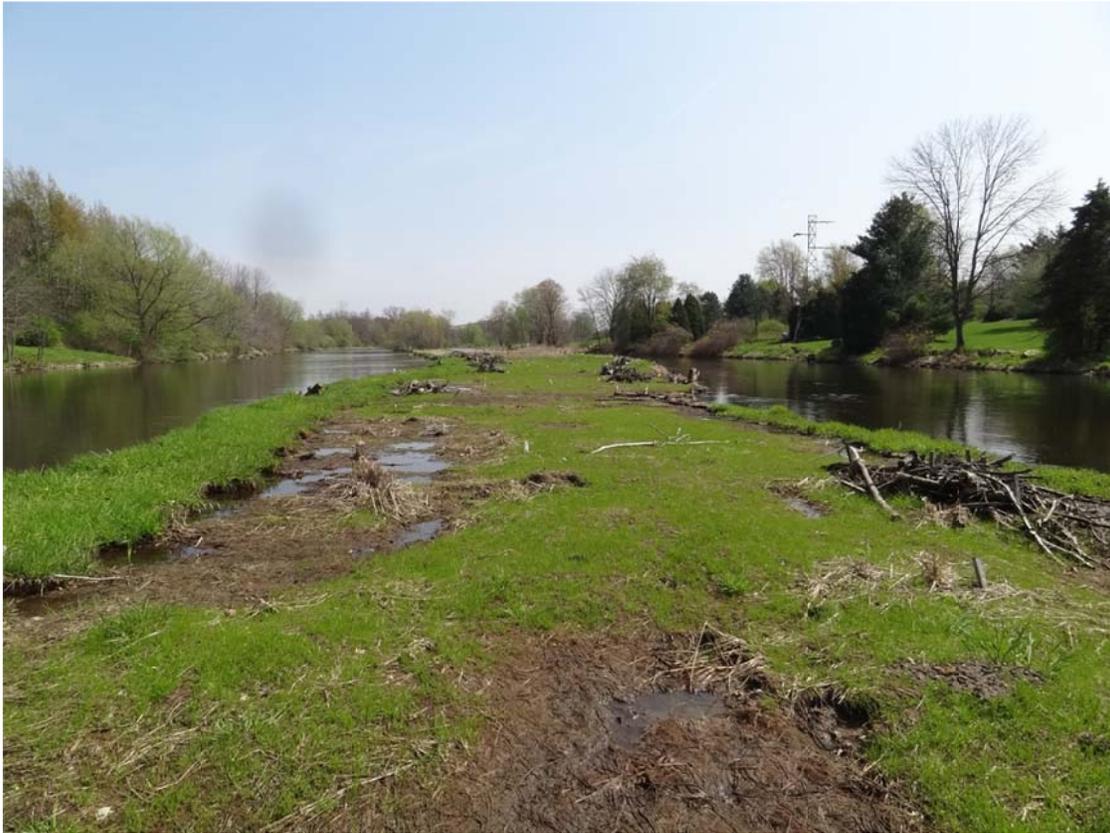
7. West end of Island A, looking east (upstream).

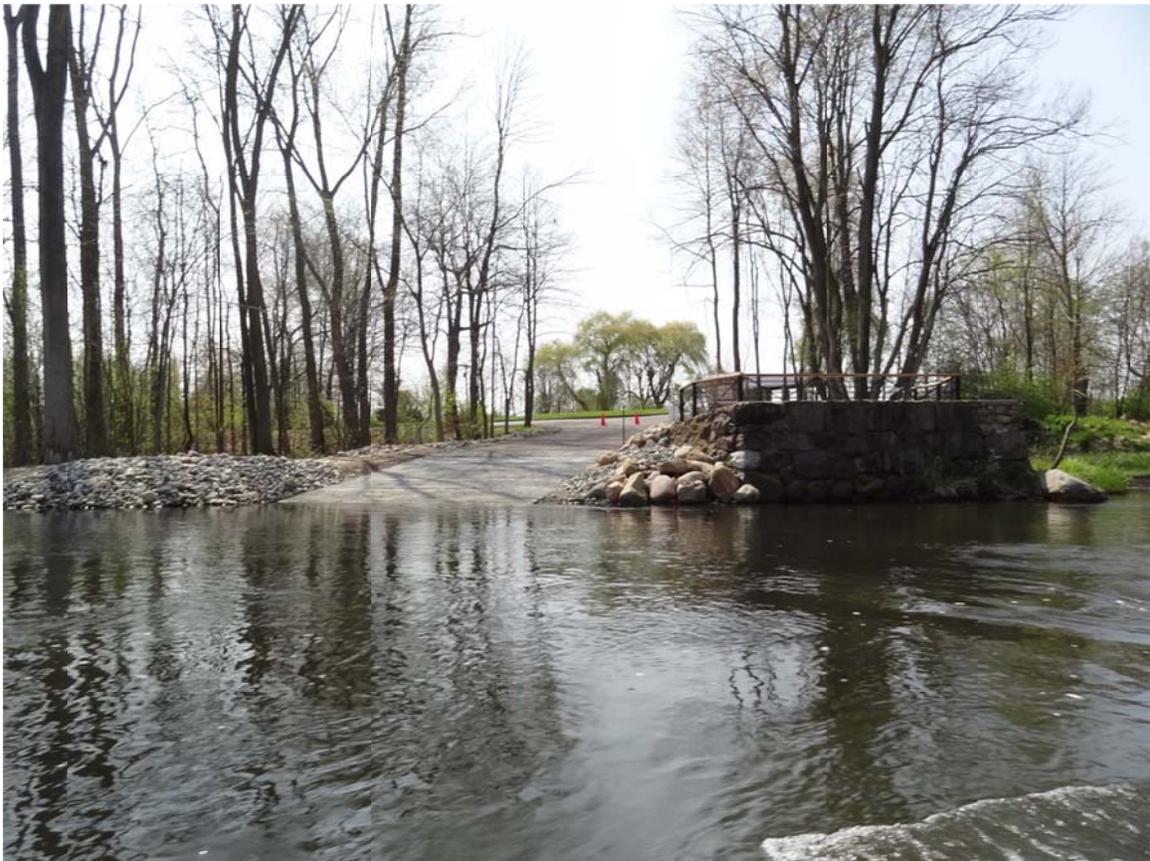
8. View of Saylor's Landing boat launch from river.

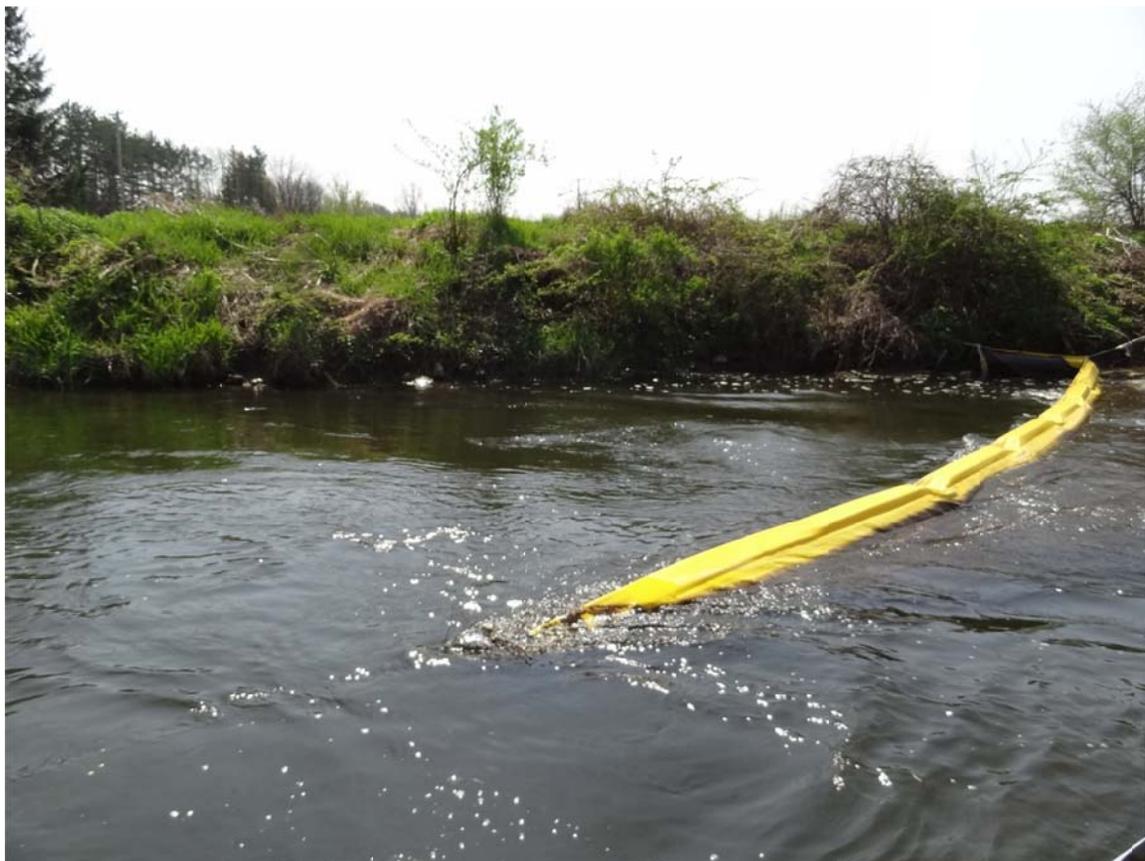
9. Containment boom downstream from Confluence. No sheen or turbidity observed.

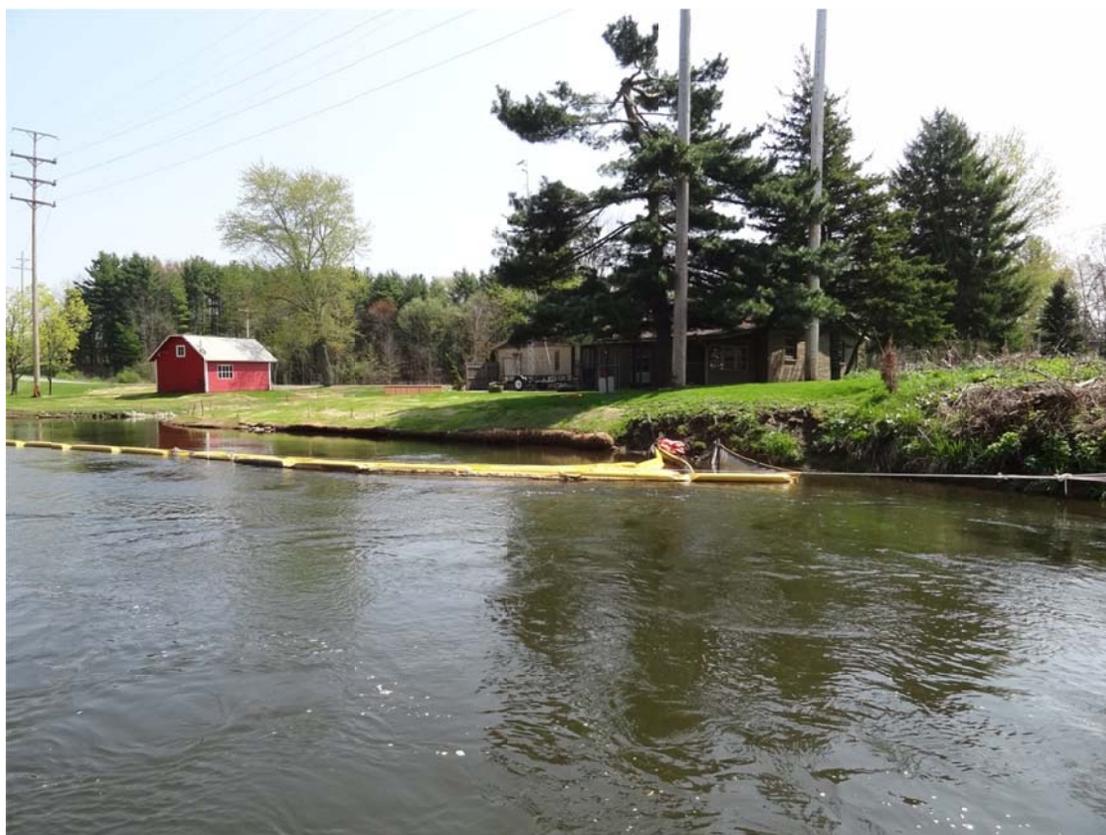
10. Confluence from river. No sheen or turbidity observed.

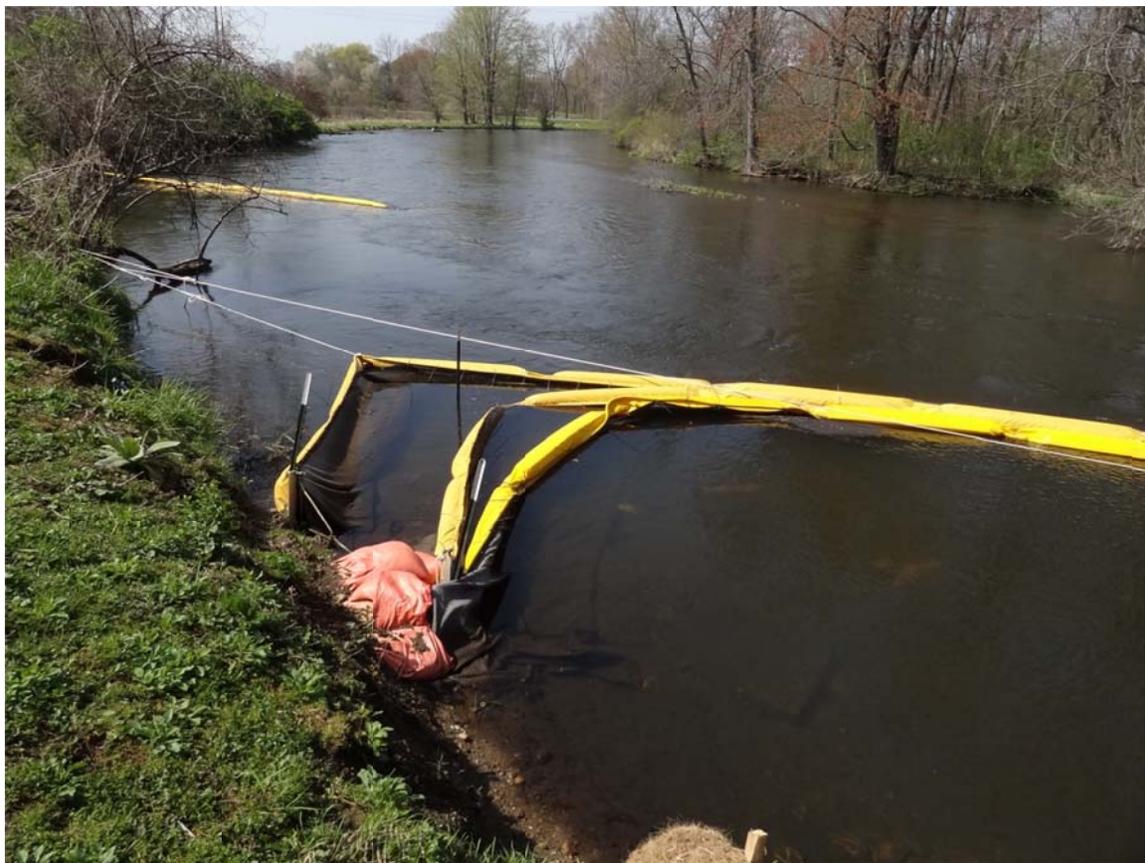
11. Confluence boom from shoreline. No sheen or turbidity observed.

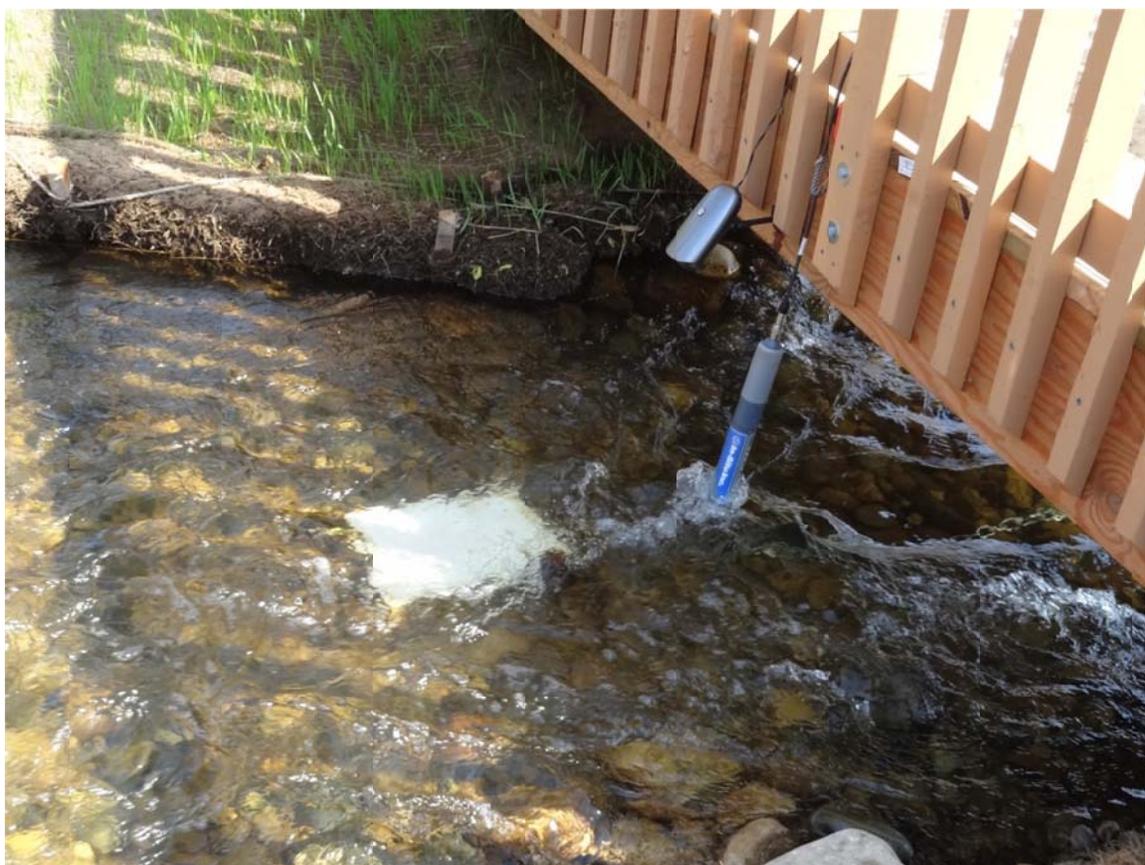
12. Remote monitoring equipment on bridge at Confluence.

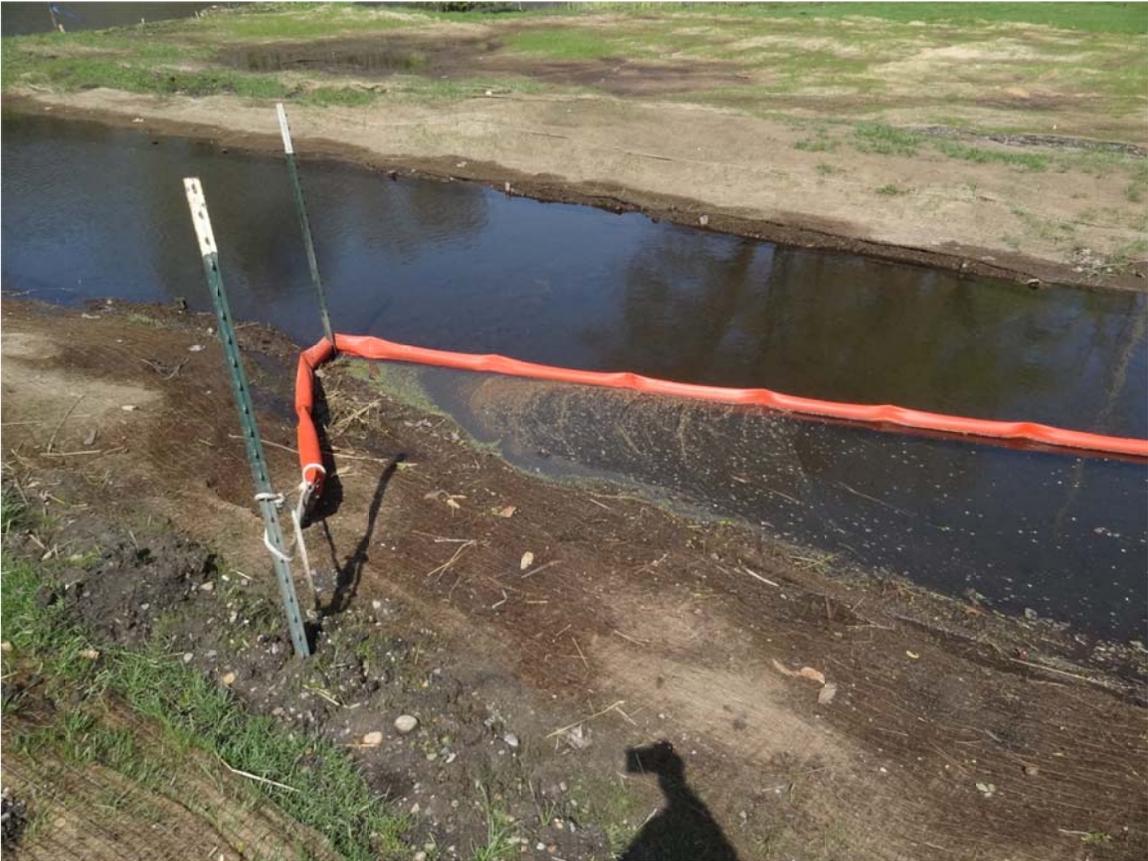
**13. Containment boom in place at Confluence. No sheen or turbidity observed.**

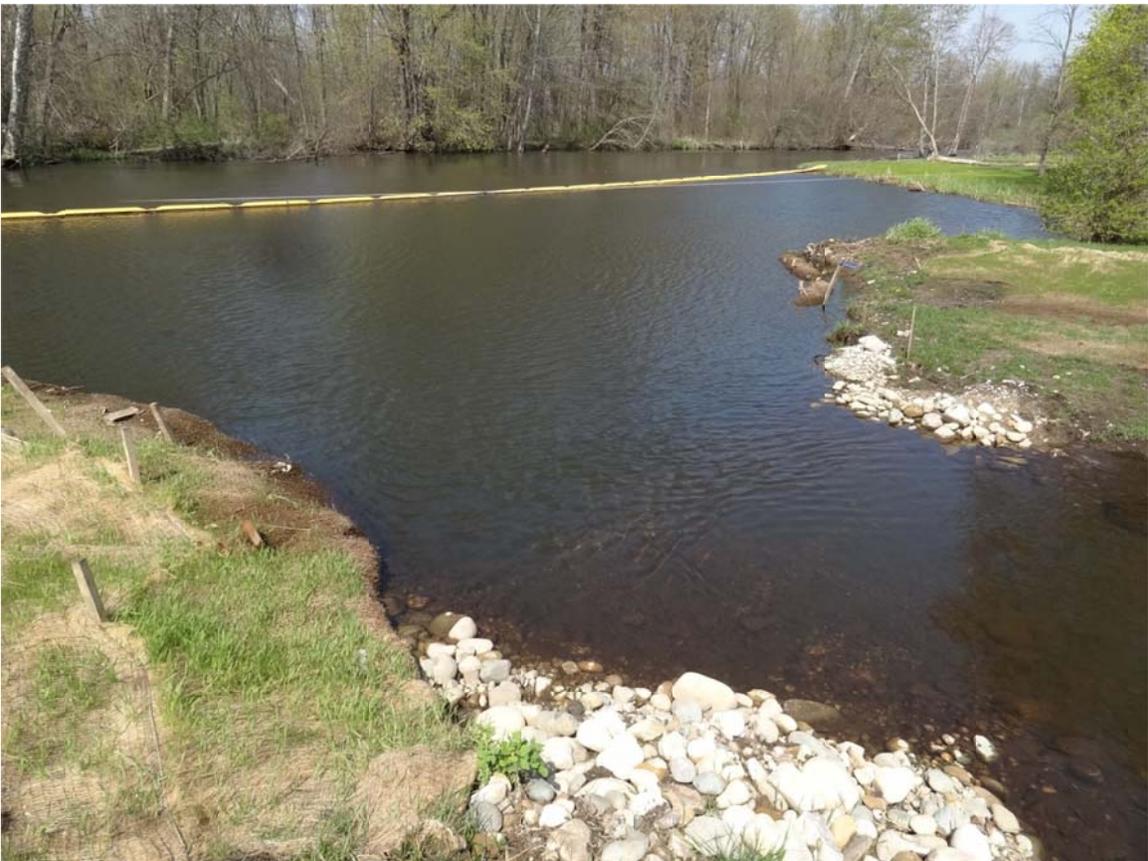
**14. Confluence from LDB. No sheen or turbidity observed.**

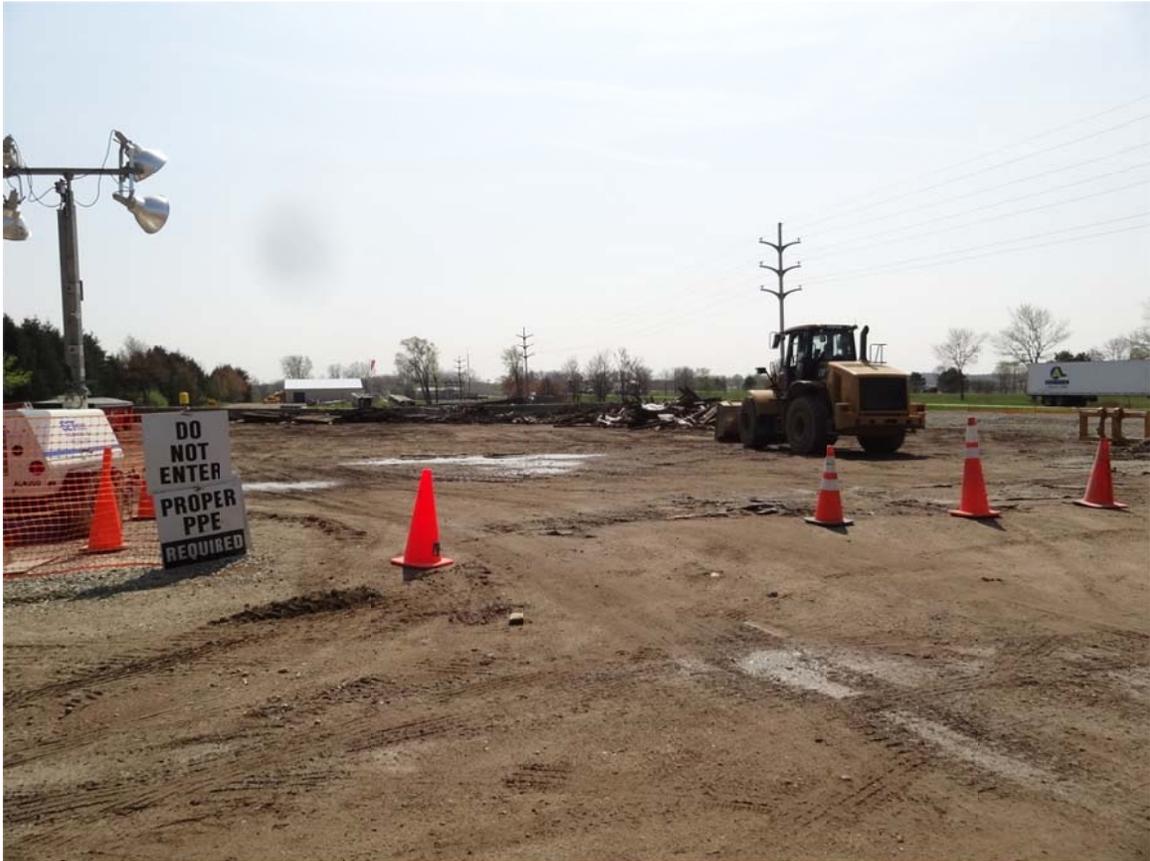
15. Frac tank city soil cells. One roll-off observed in Cell A and mat timbers observed in Cell B.

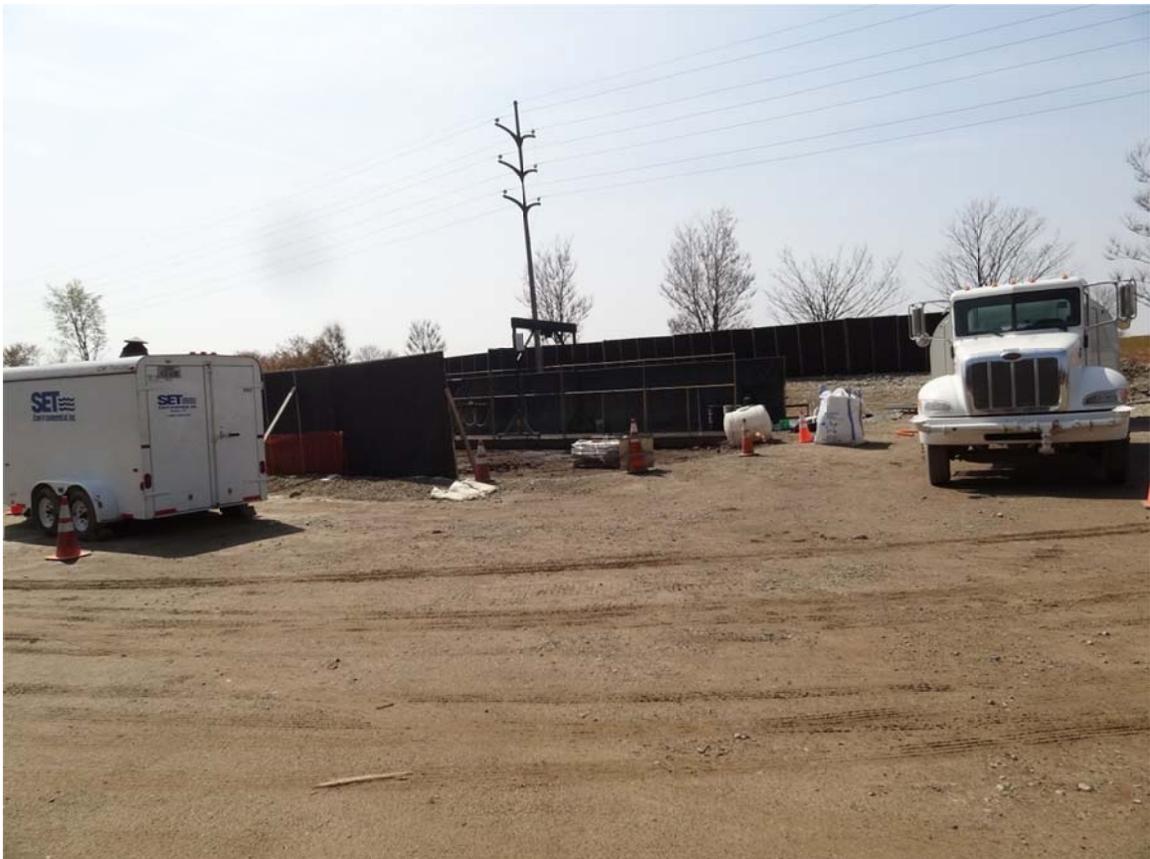
16. Frac tank city southern decon pad.
