# Situation Photo Log

Wednesday, April 4, 2012

Kalamazoo River / Enbridge Spill

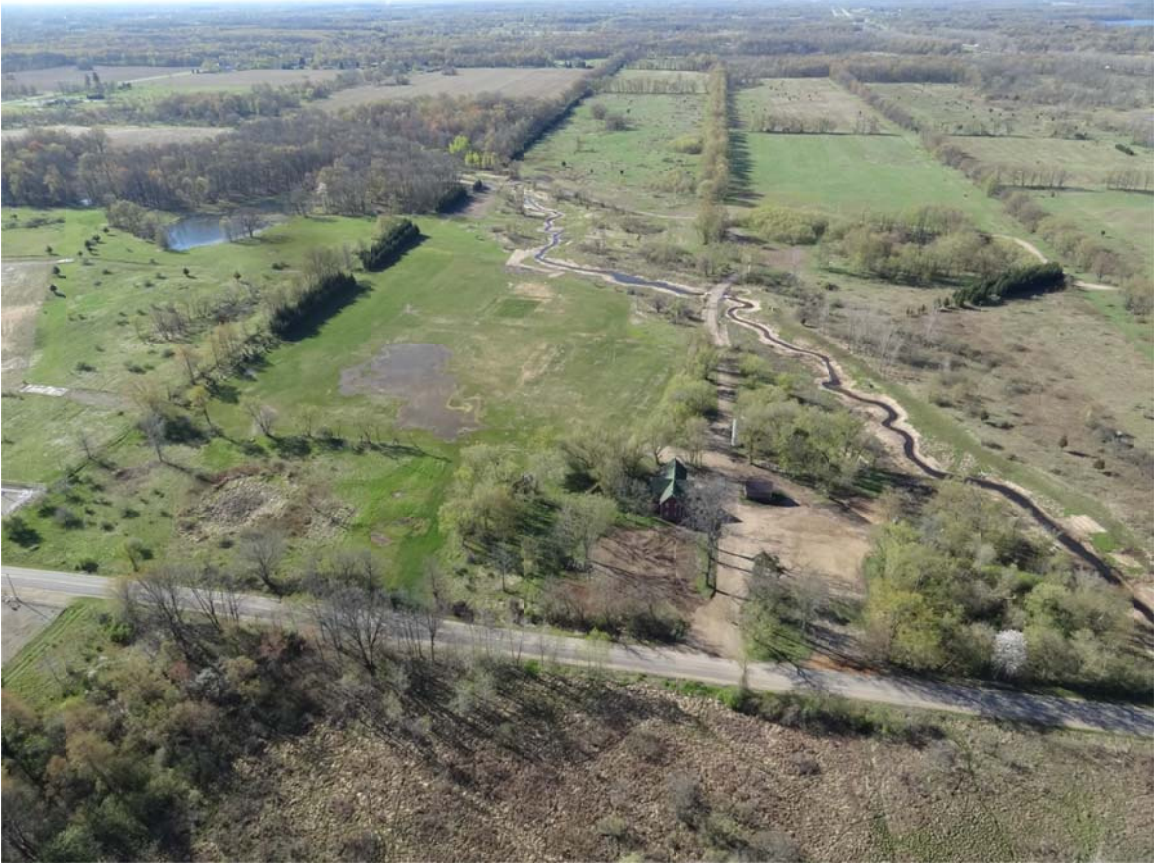
1. Overview of the source area and first half mile of Talmadge Creek.

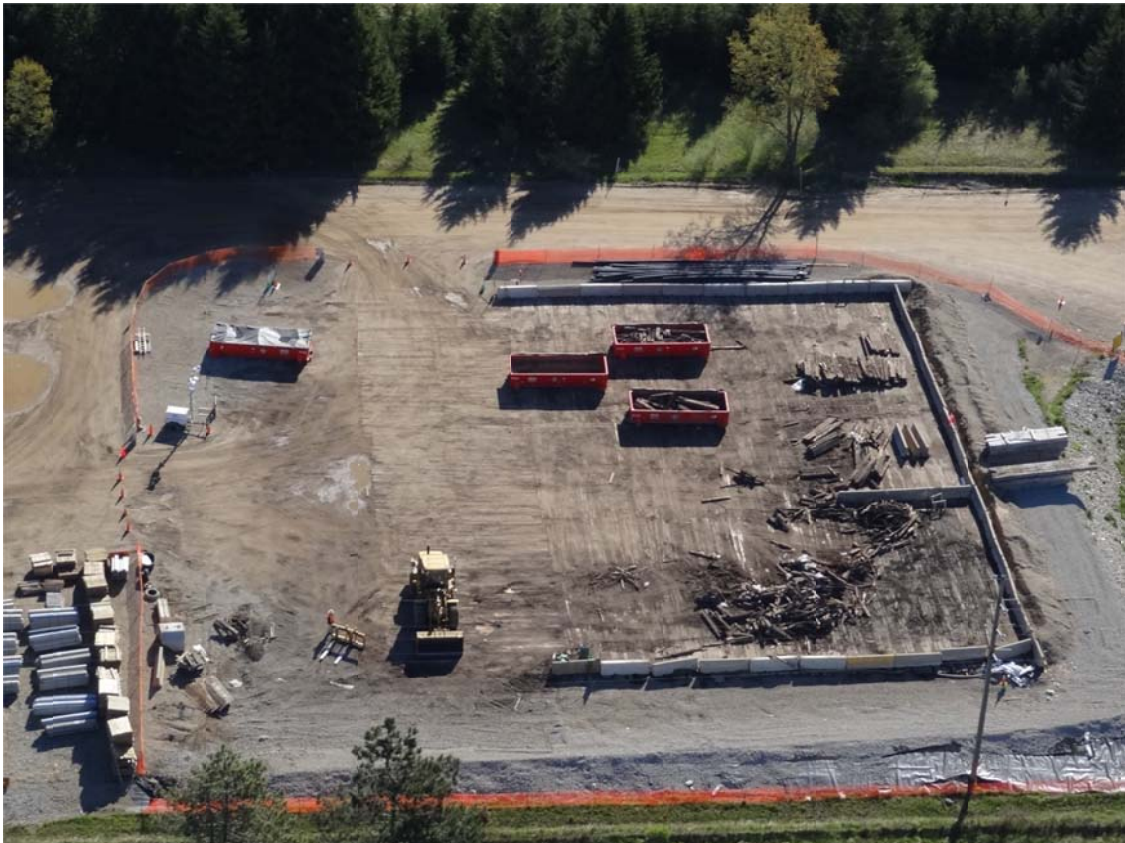
2. Frac-City Soil Cells A & B.

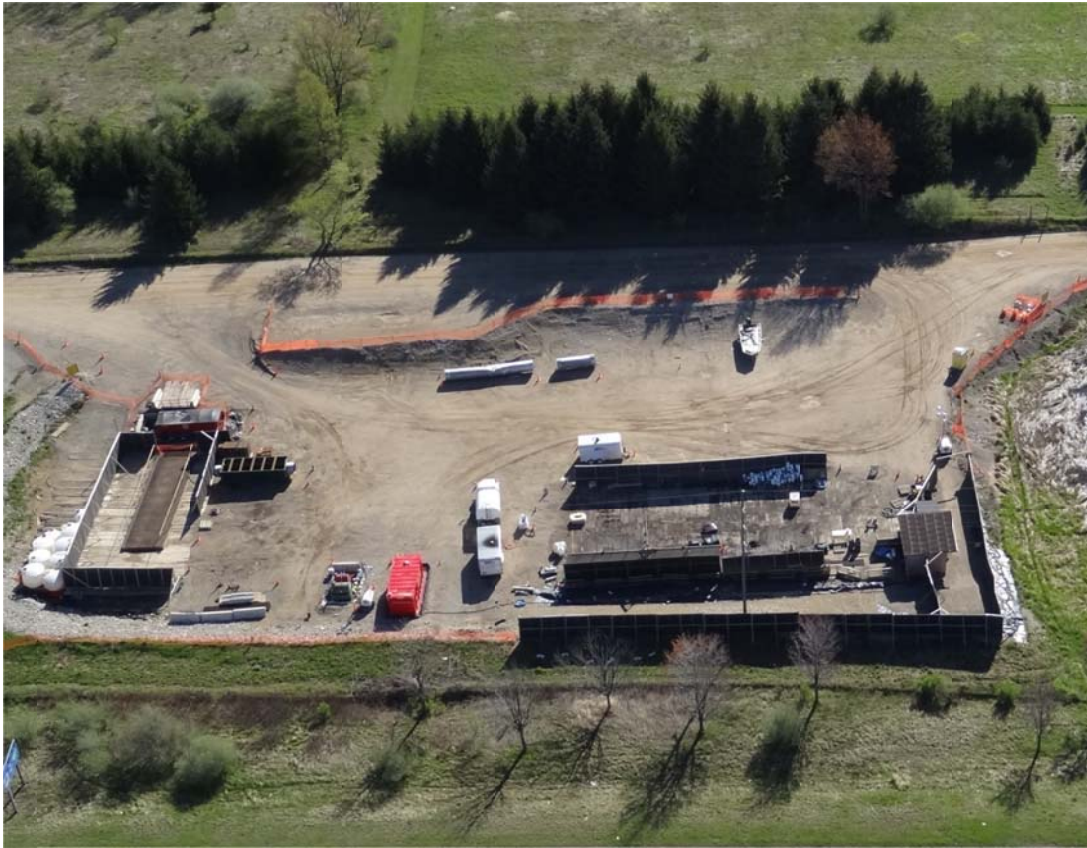
3. Frac-City decontamination pads.

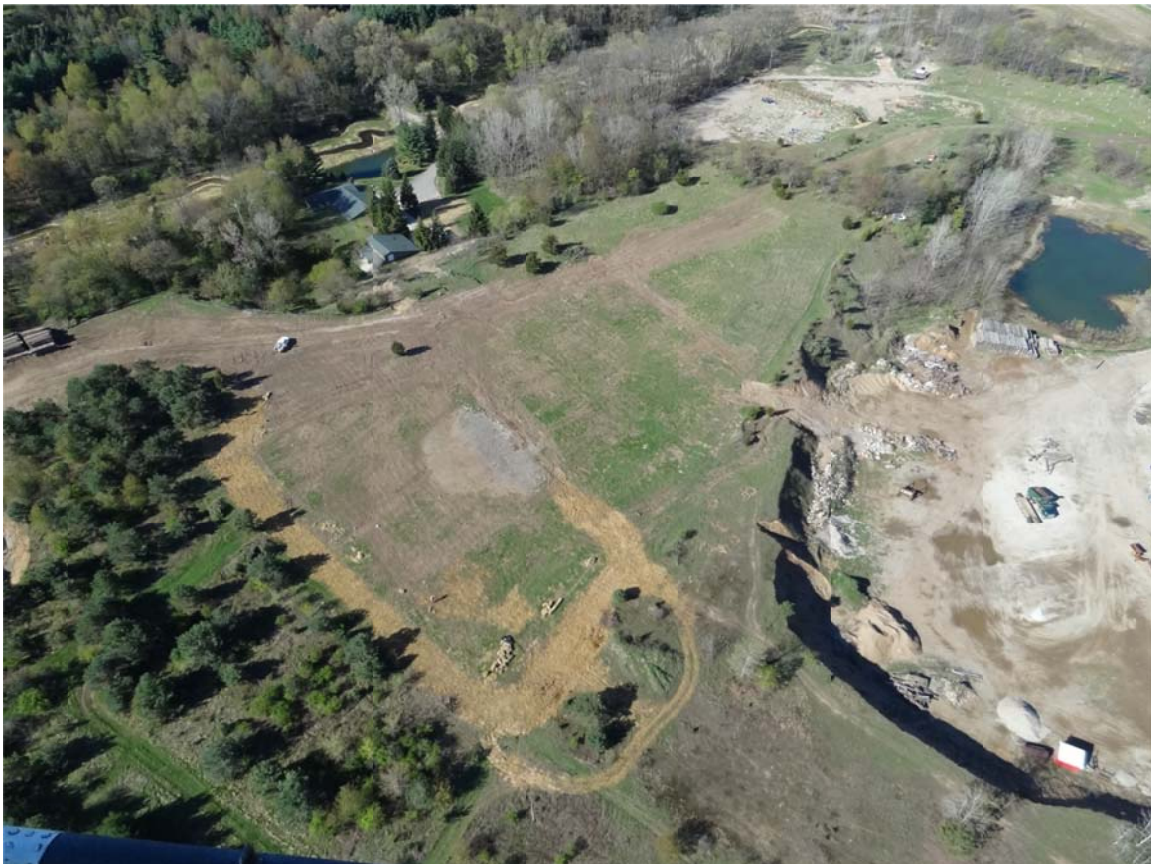
4. Observed crews spreading straw for ground cover at the former location of the turbidity control structure.

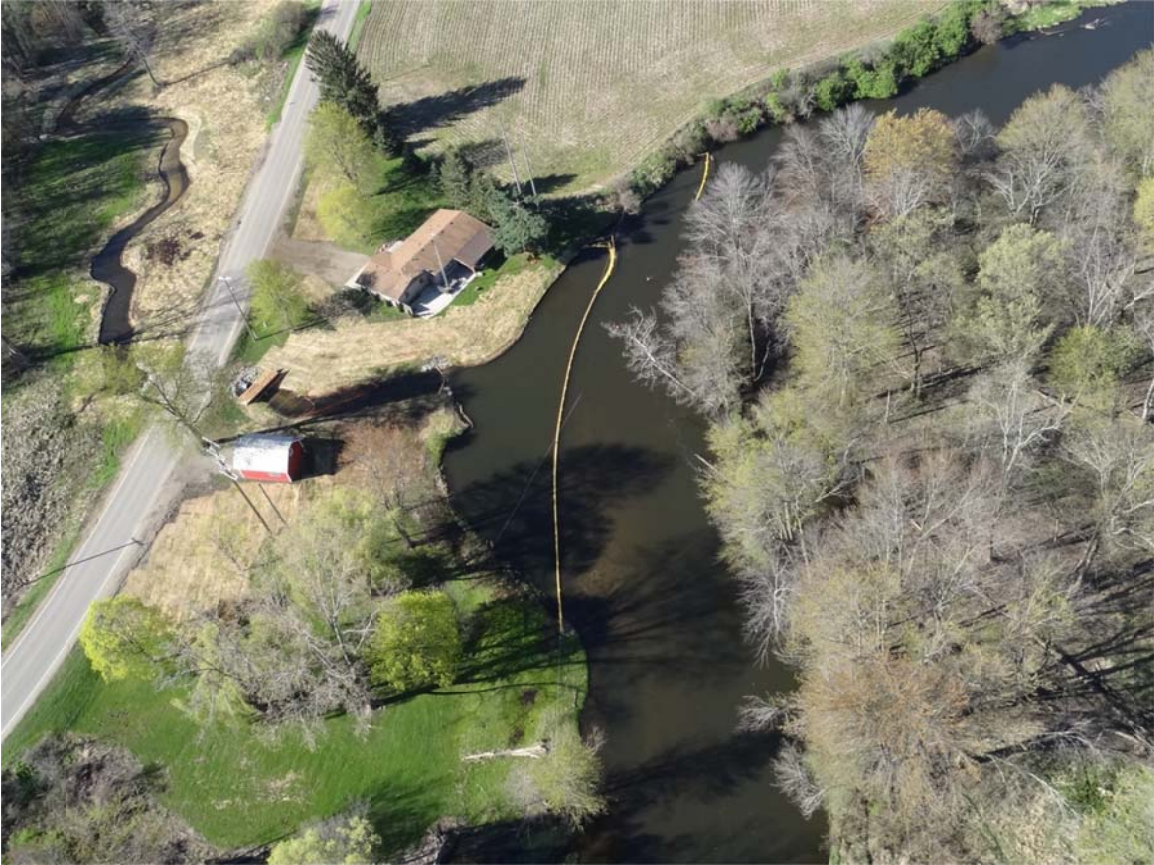
5. Confluence, no sheen or turbidity observed.

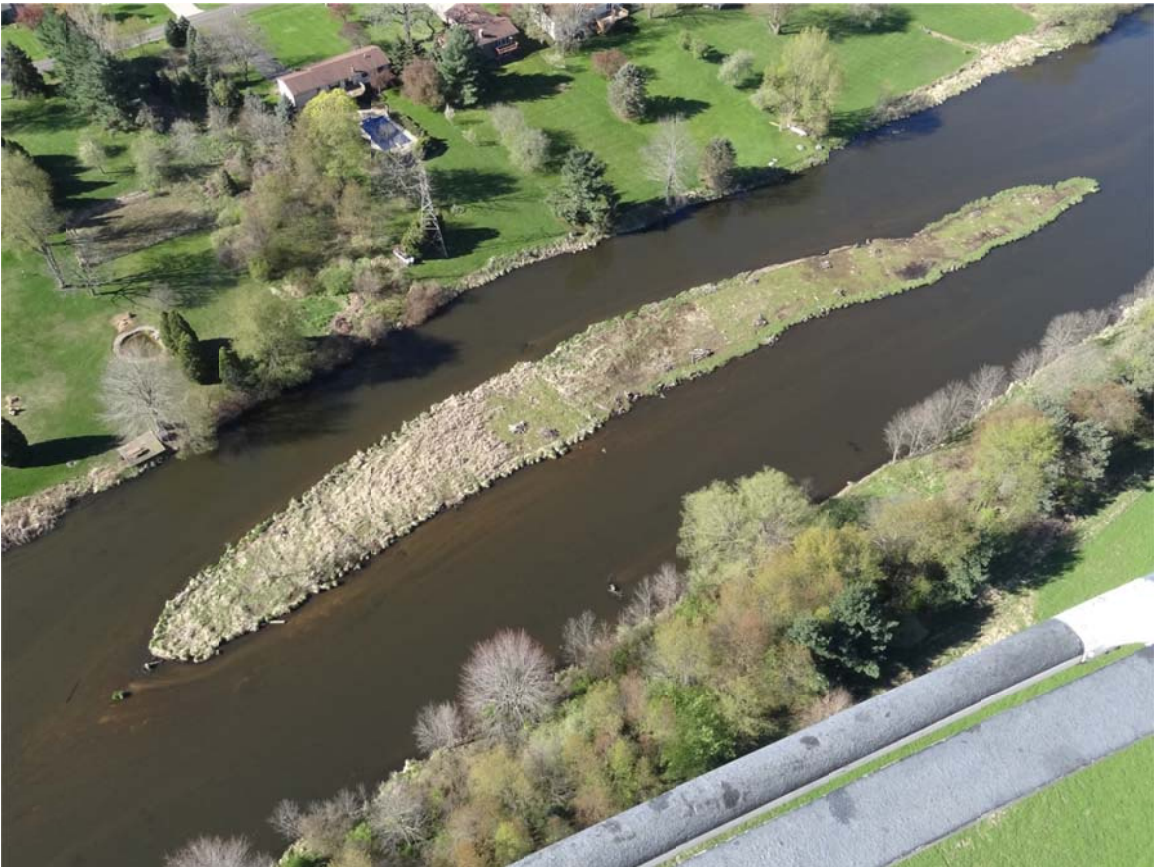
7. Island A, no sheen observed.

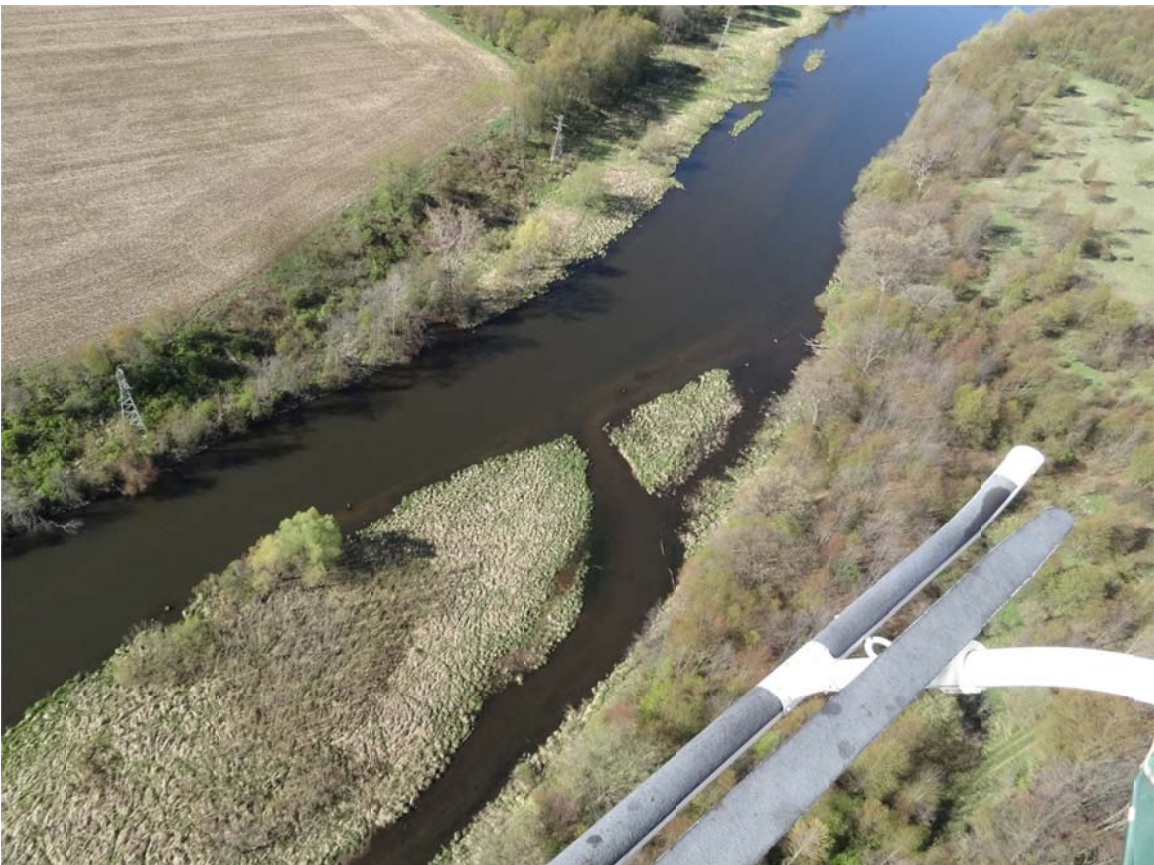
8. MP3.25 RDB, no sheen observed.

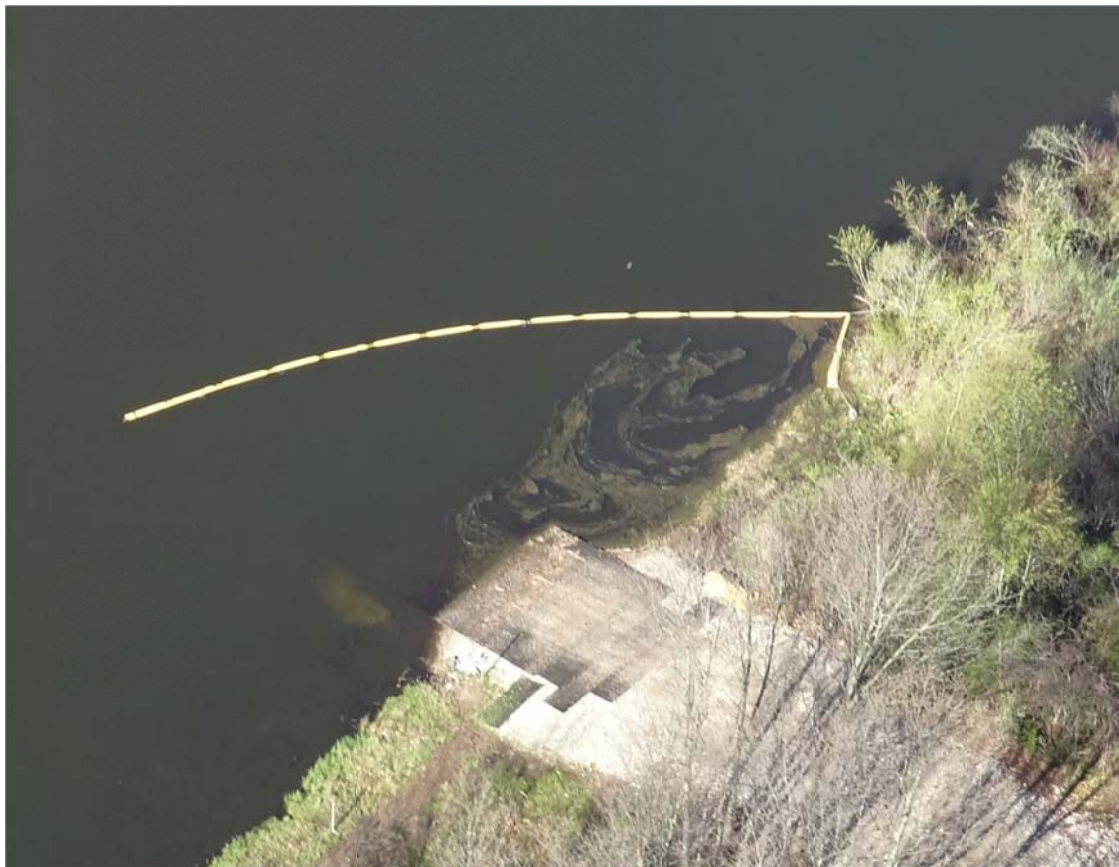
10. Control point at C0.4 boat launch. No sheen, minor debris observed.

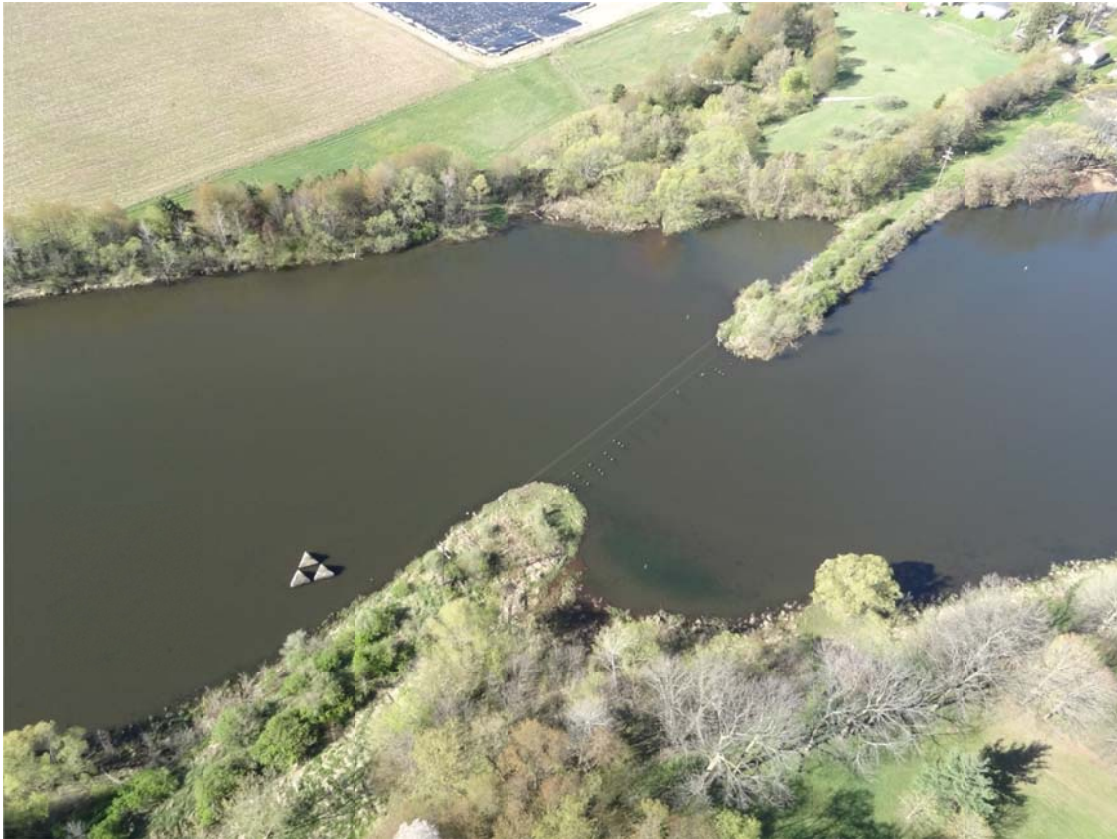
**11. Peninsulas above Ceresco Dam. No sheen observed.**

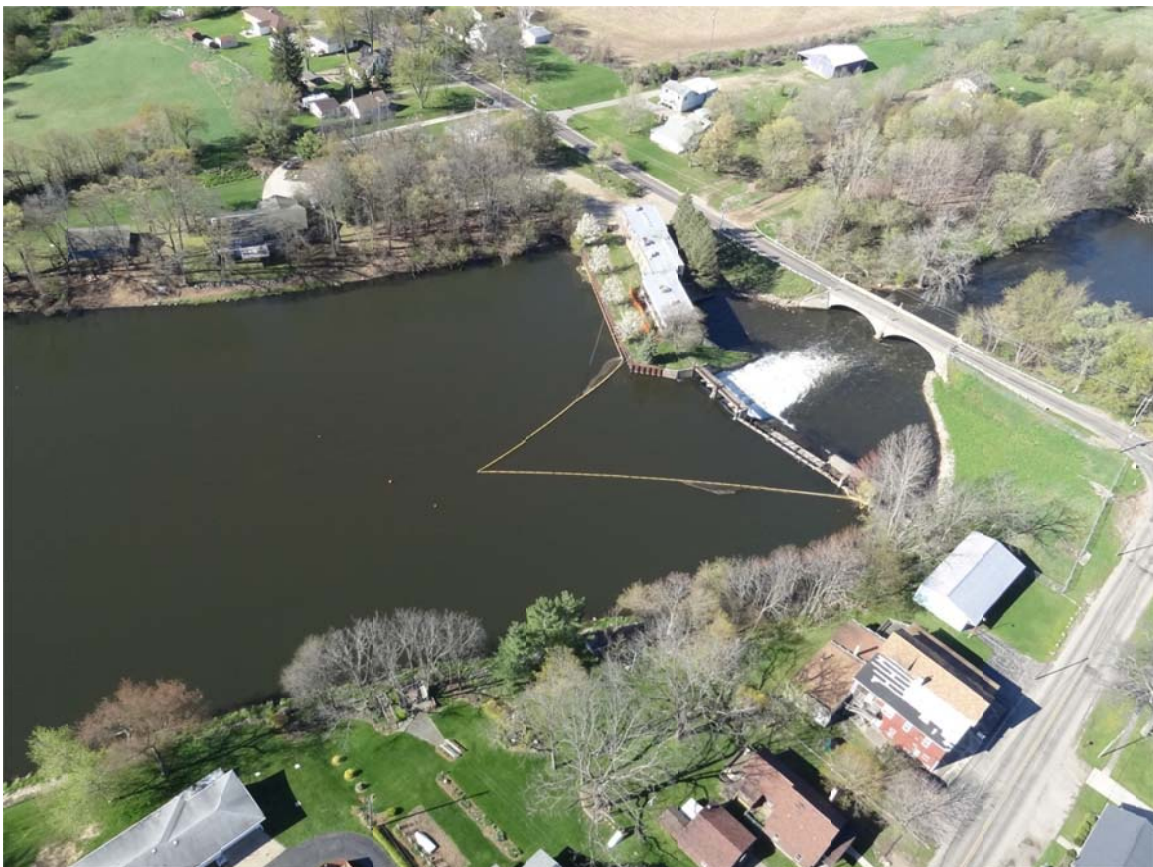
**12. Ceresco Dam, no sheen or activity observed.**

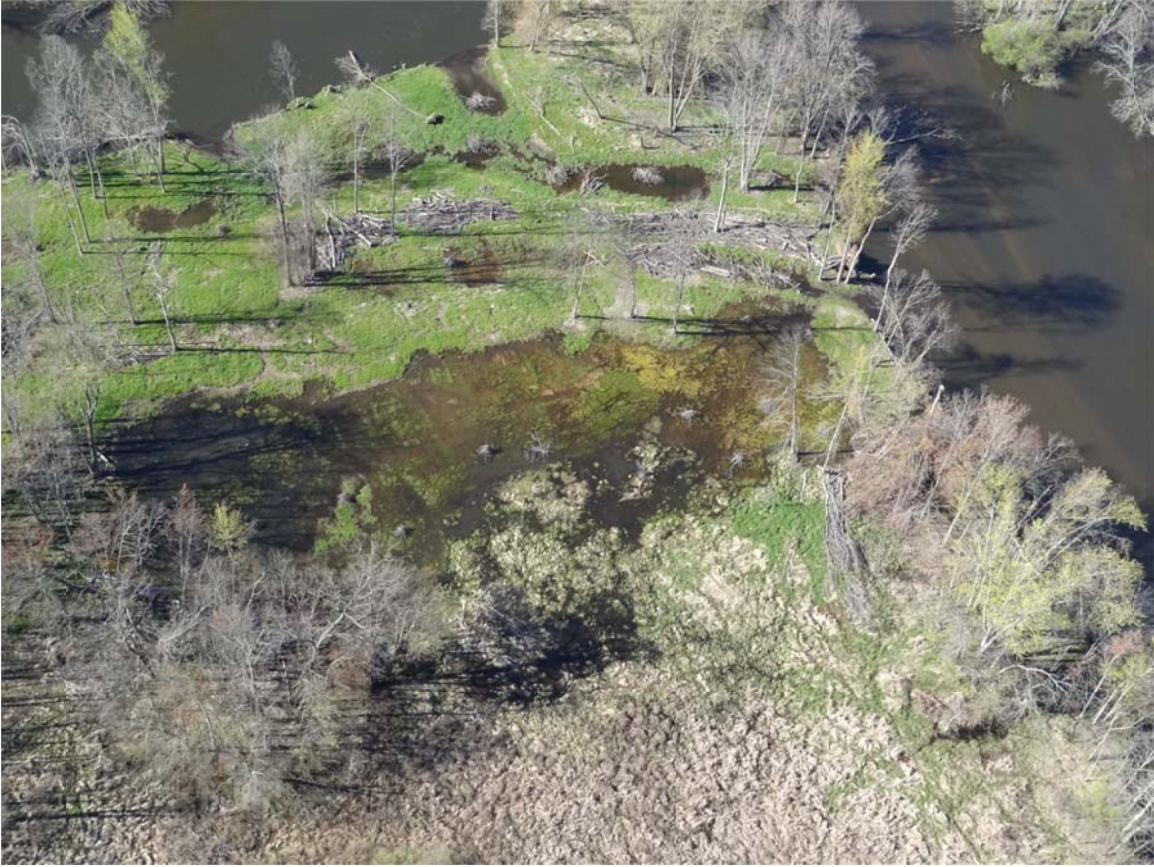
13. MP11.25 RDB. No sheen observed.

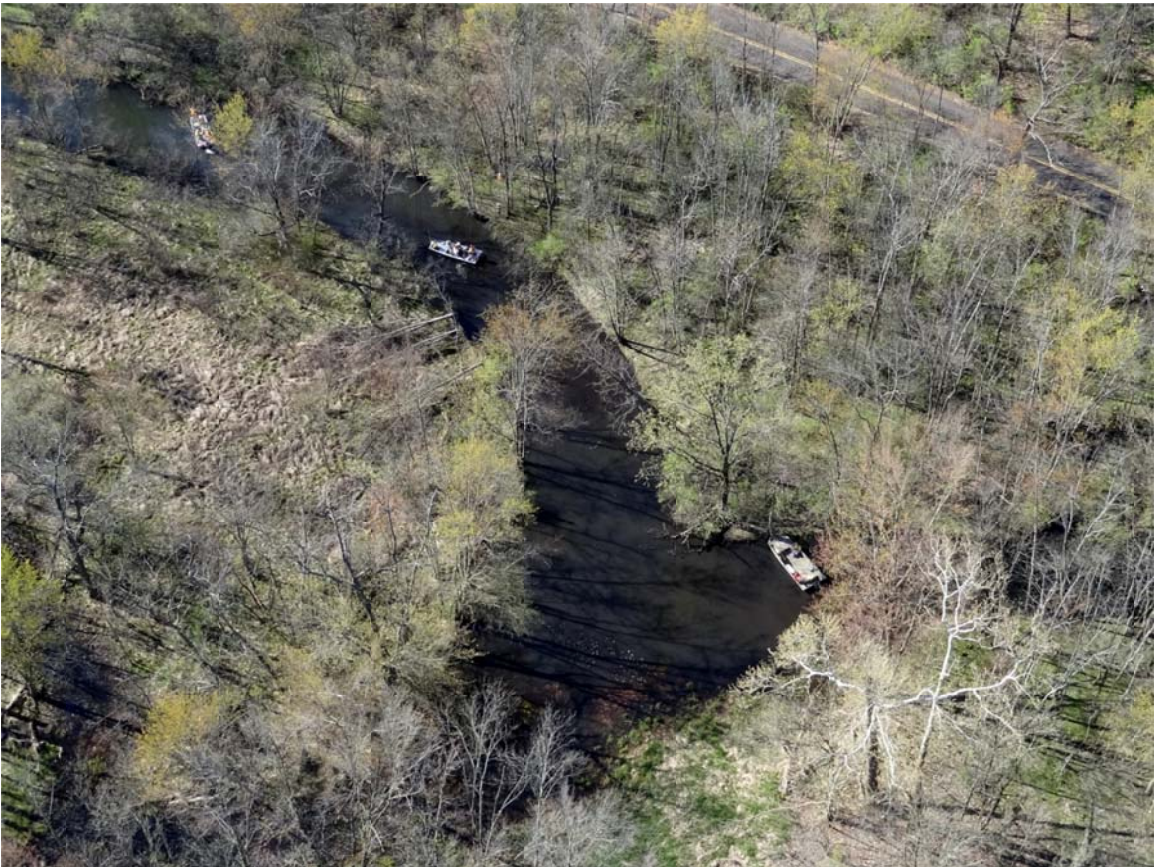
14. MP11.25 LDB, TarGOST survey crew observed in back channel south of river.

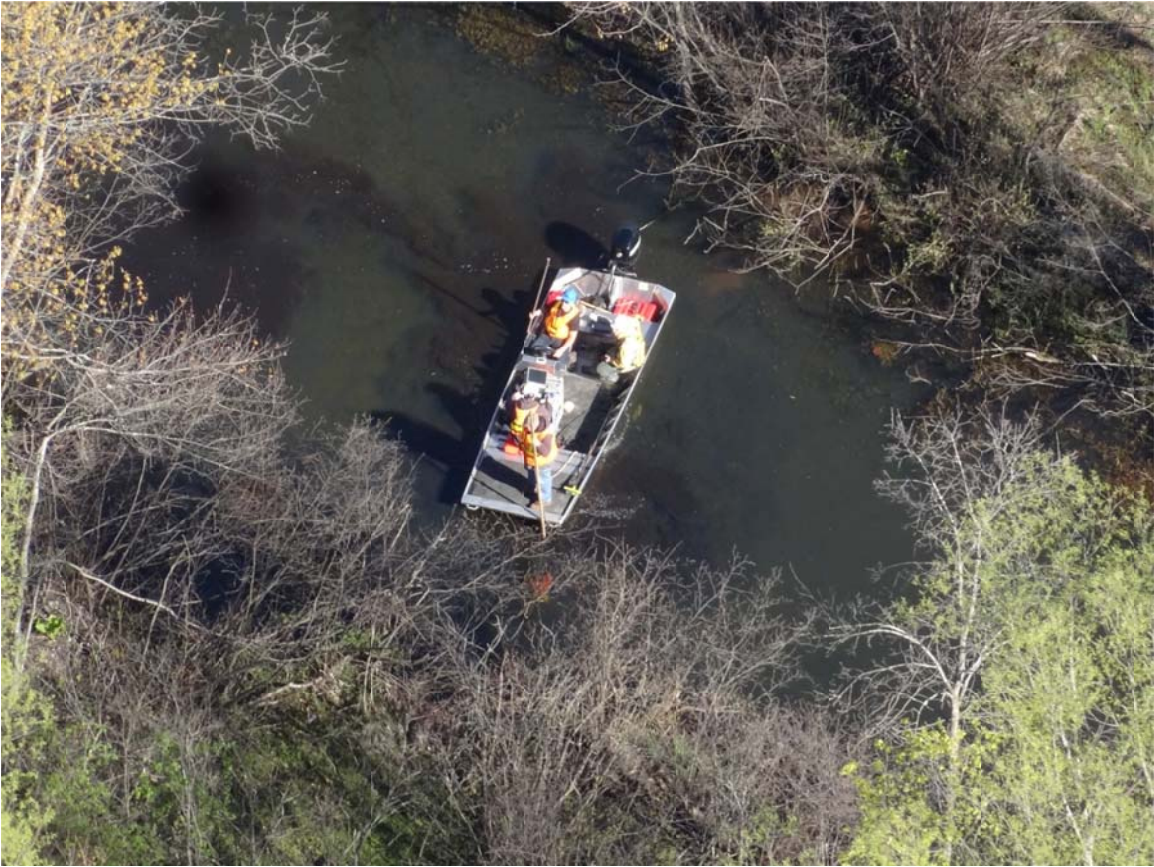
15. MP11.25 LDB, close up of TarGOST survey crew. No sheen observed.

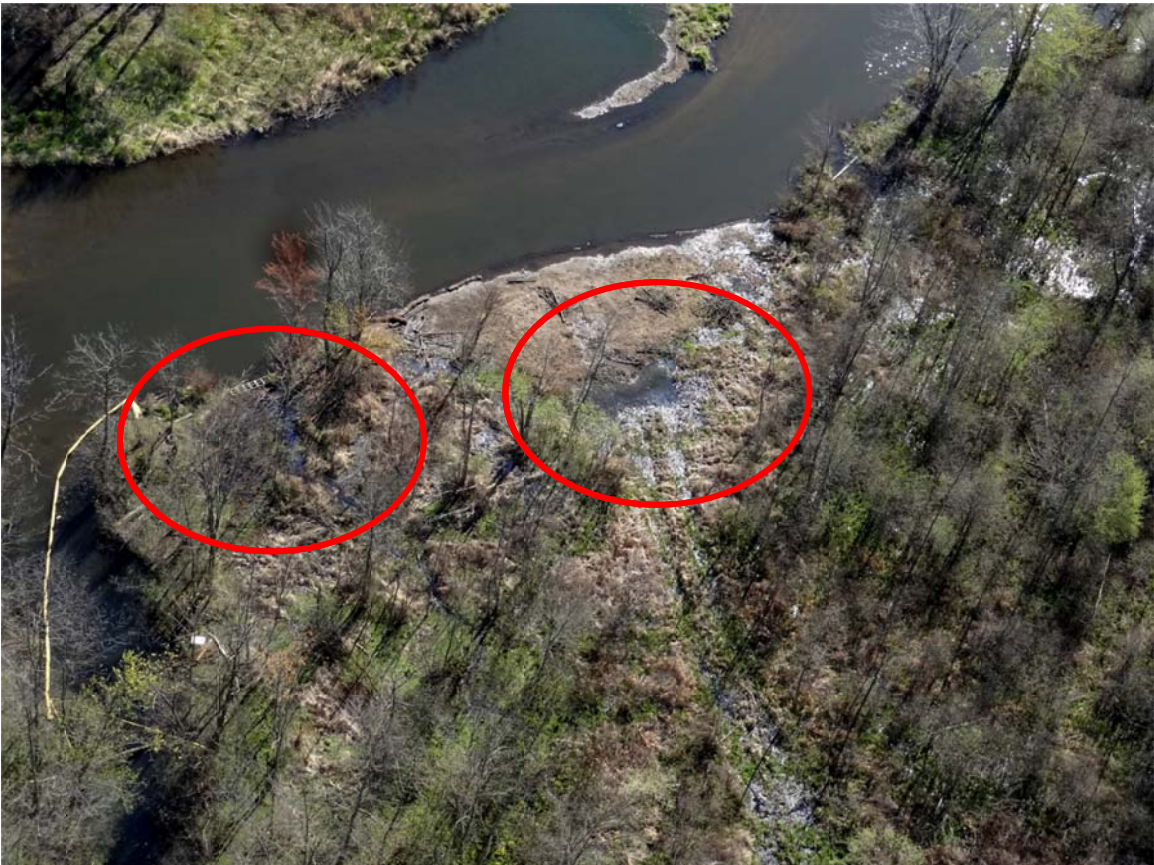
16. MP15.00 LDB, sheen observed in overbank in area of former mat road and near storm sewer release.

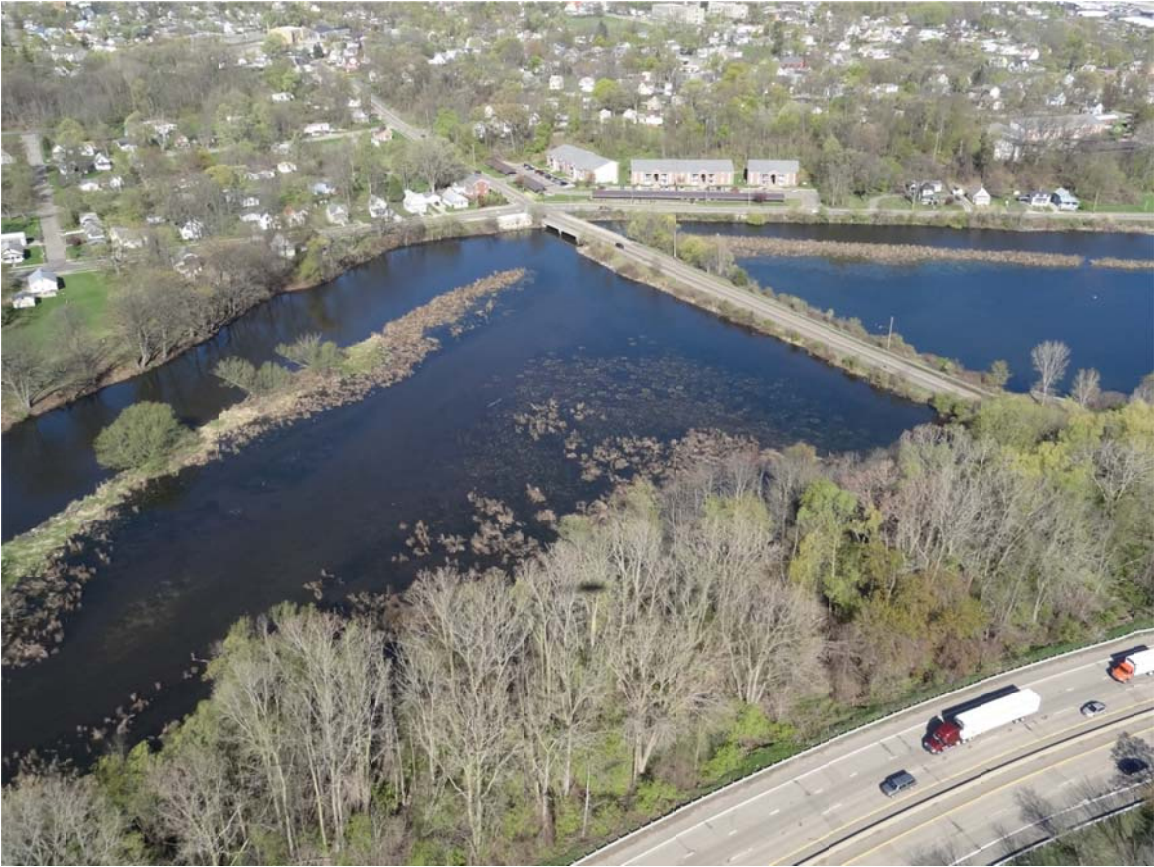
17. South end of Mill Pond, no sheen observed.

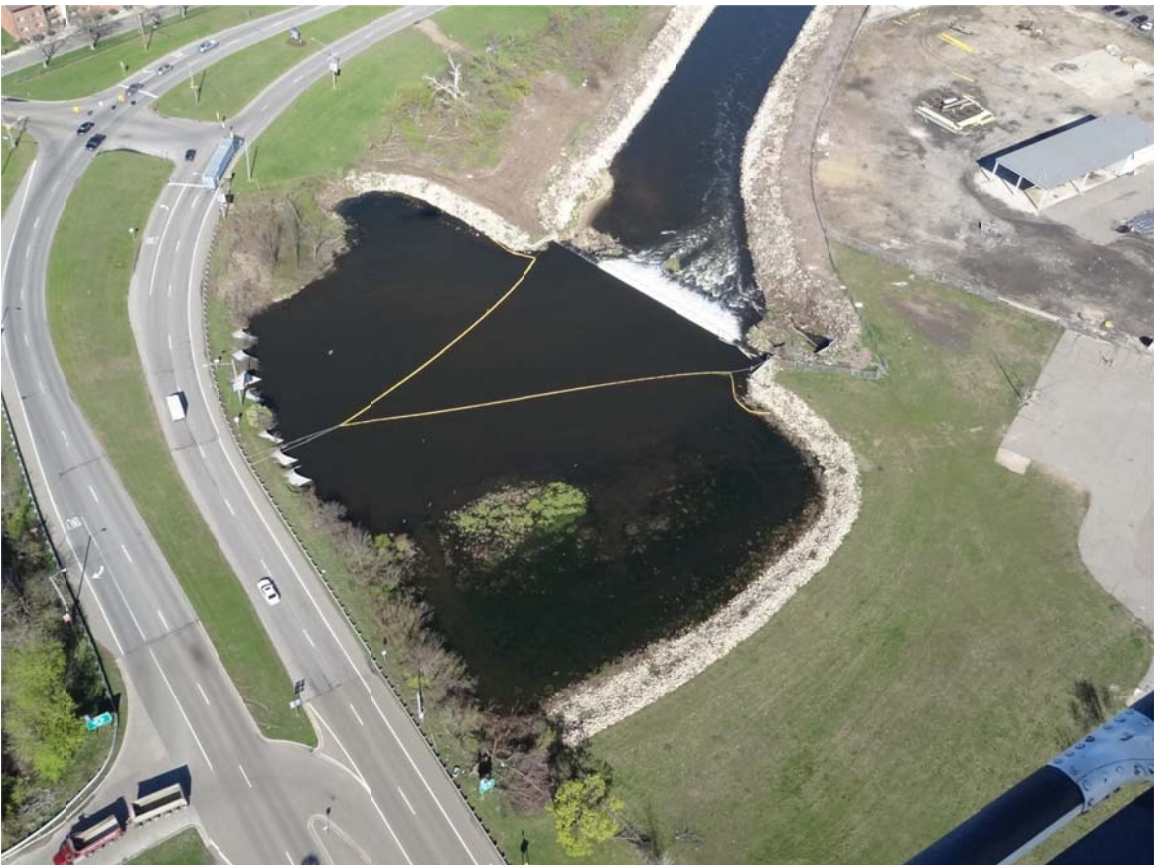
18. MP15.75 spillway, no sheen observed.

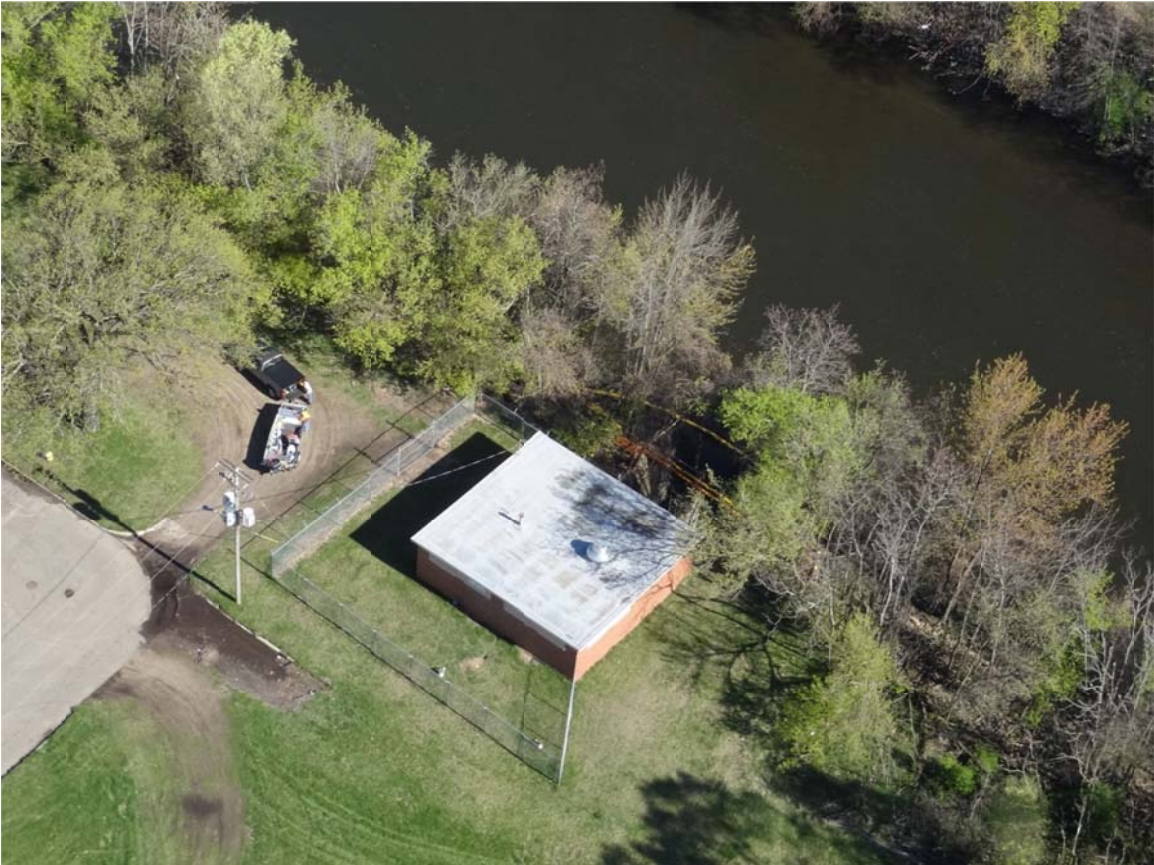
19. RockTenn (MP 17.00), one boat crew observed west of building.

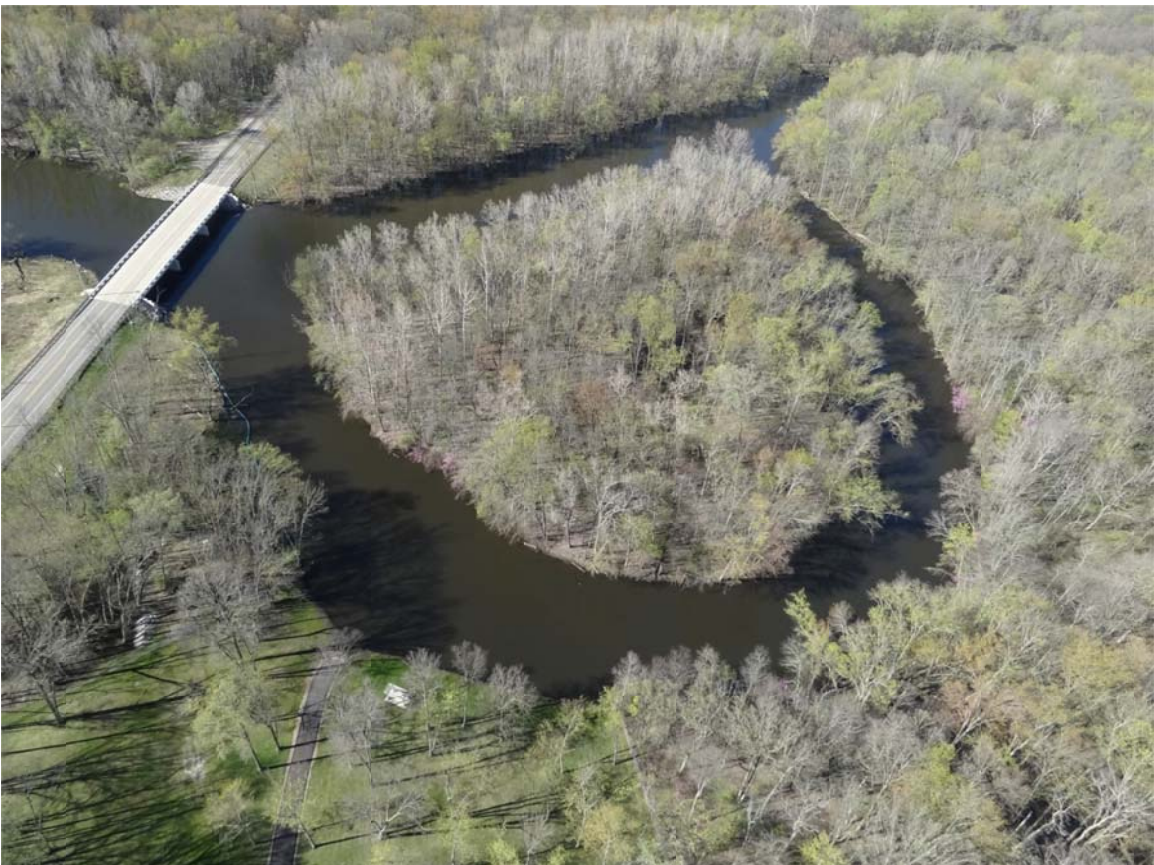
20. MP21.25 oxbow. No sheen observed.

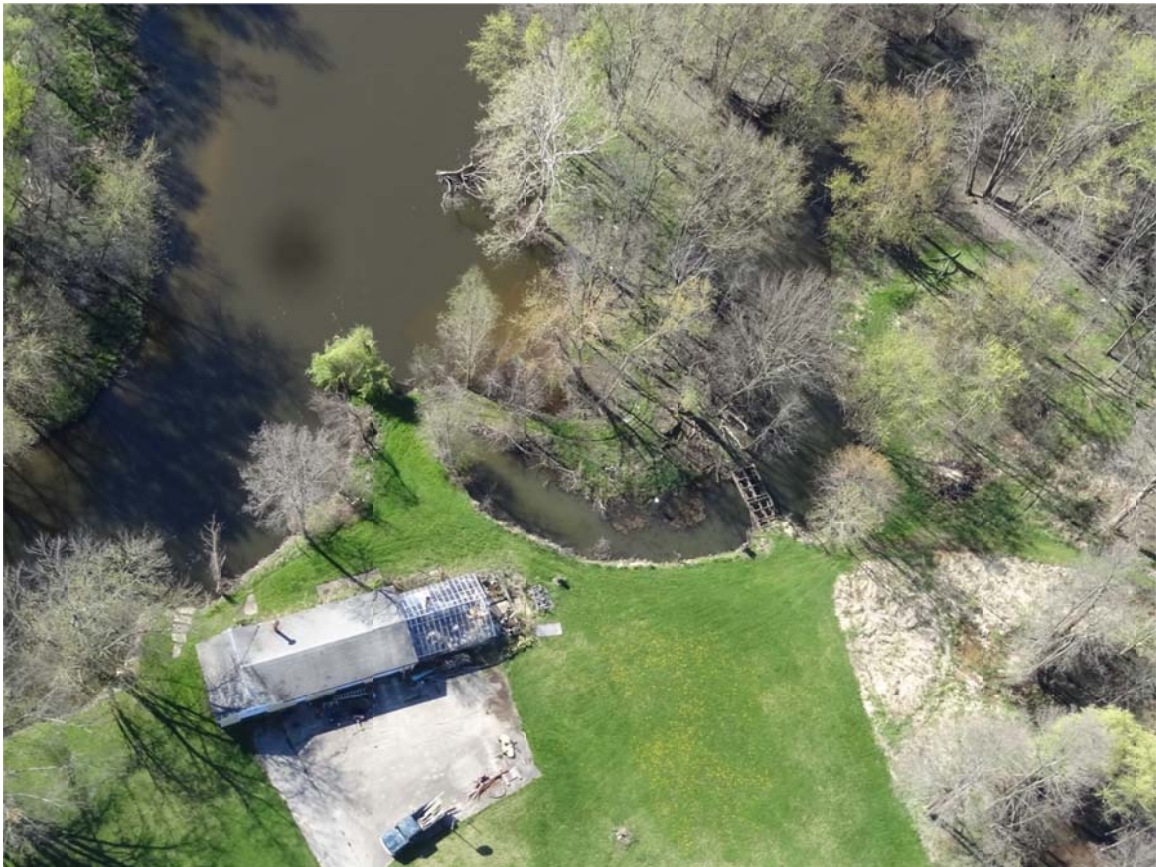
21. MP26.25 RDB, no sheen observed.

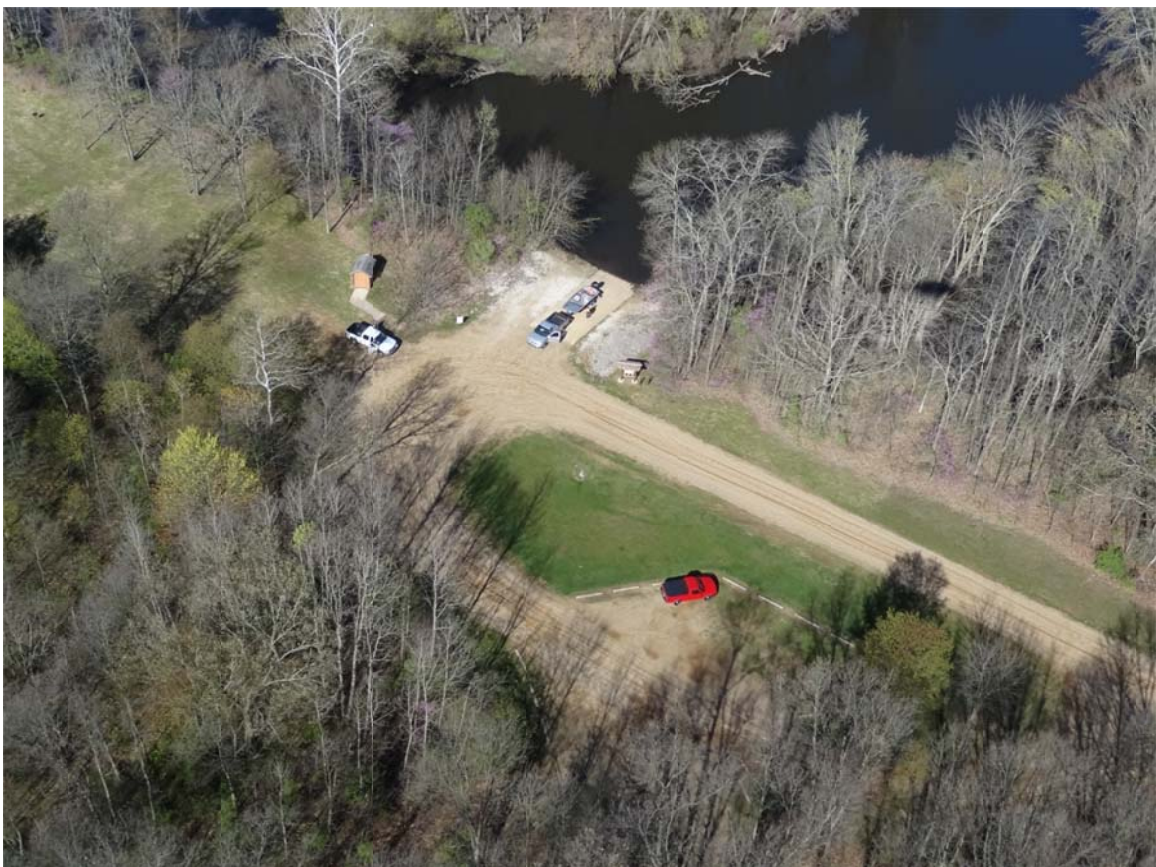
22. MP 30.0, E2 boat launch, one boat crew observed.

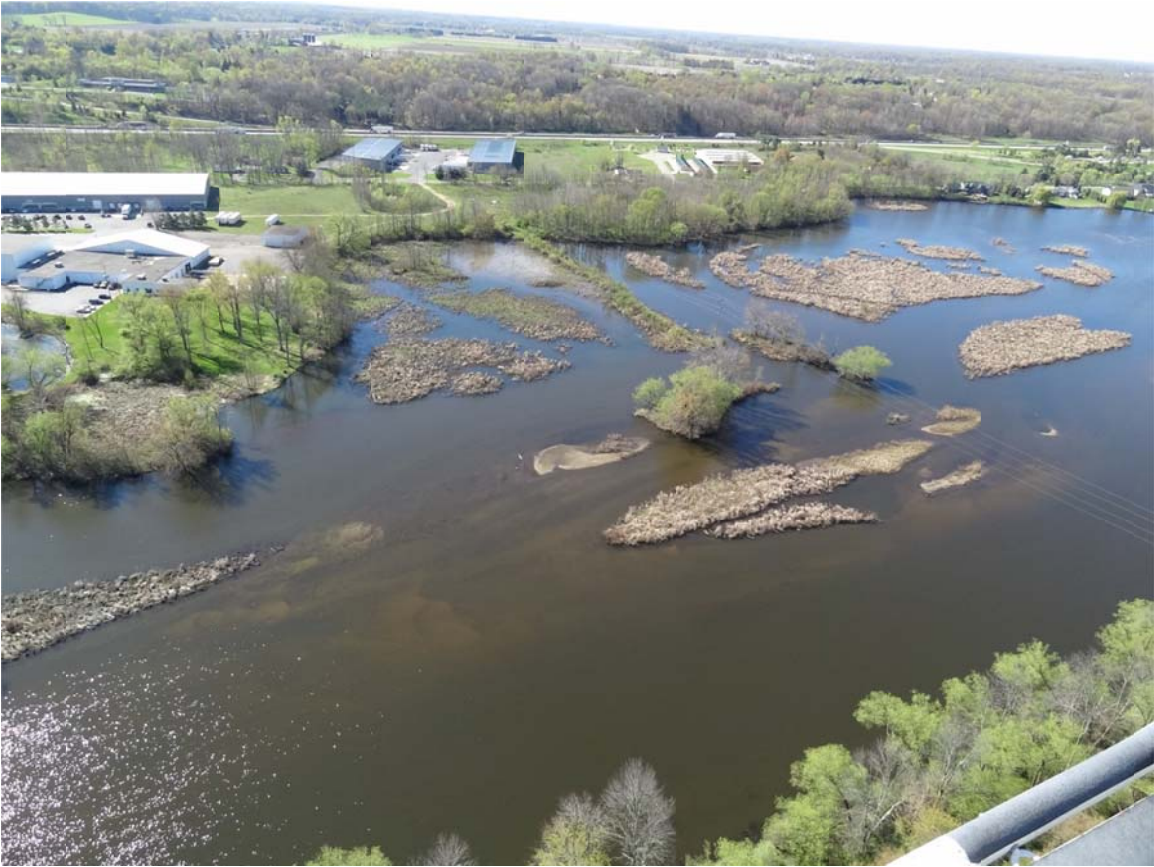
23. East end of Morrow Lake Delta. No sheen observed.

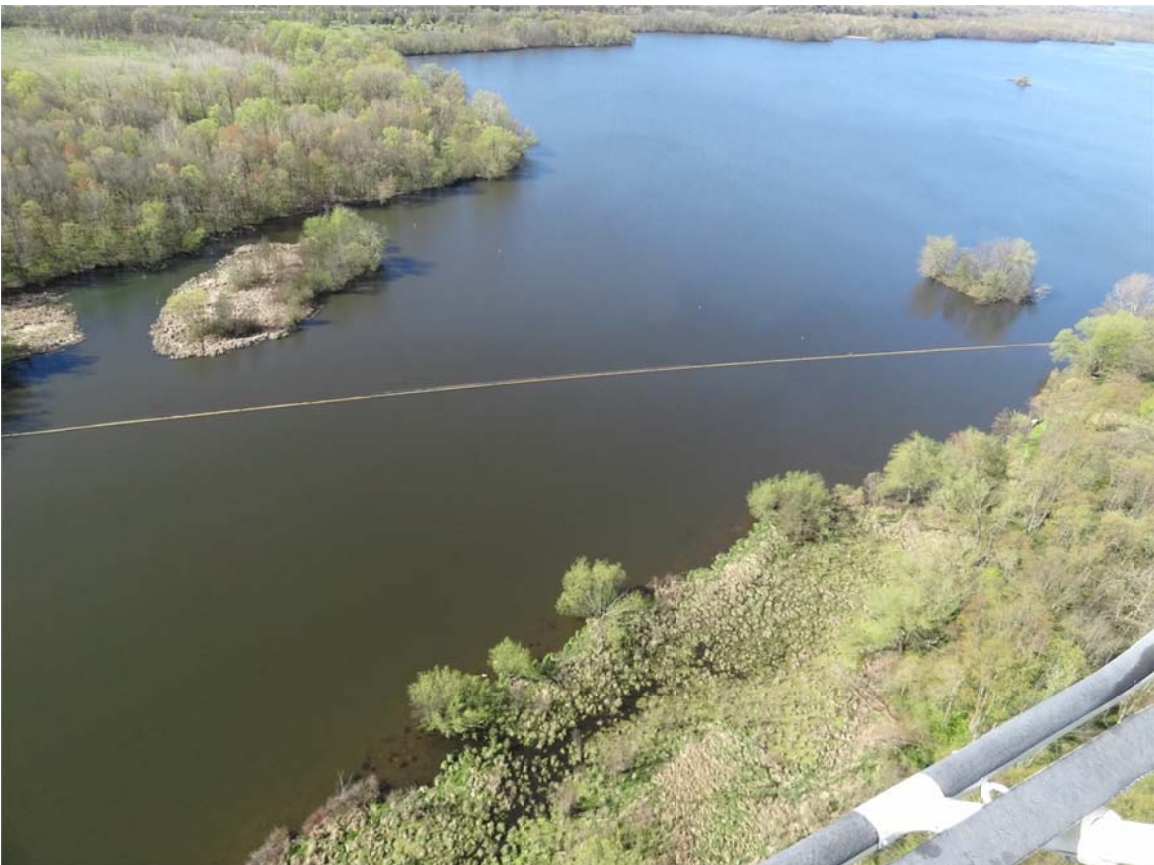
24. Control Point E4, no sheen observed.

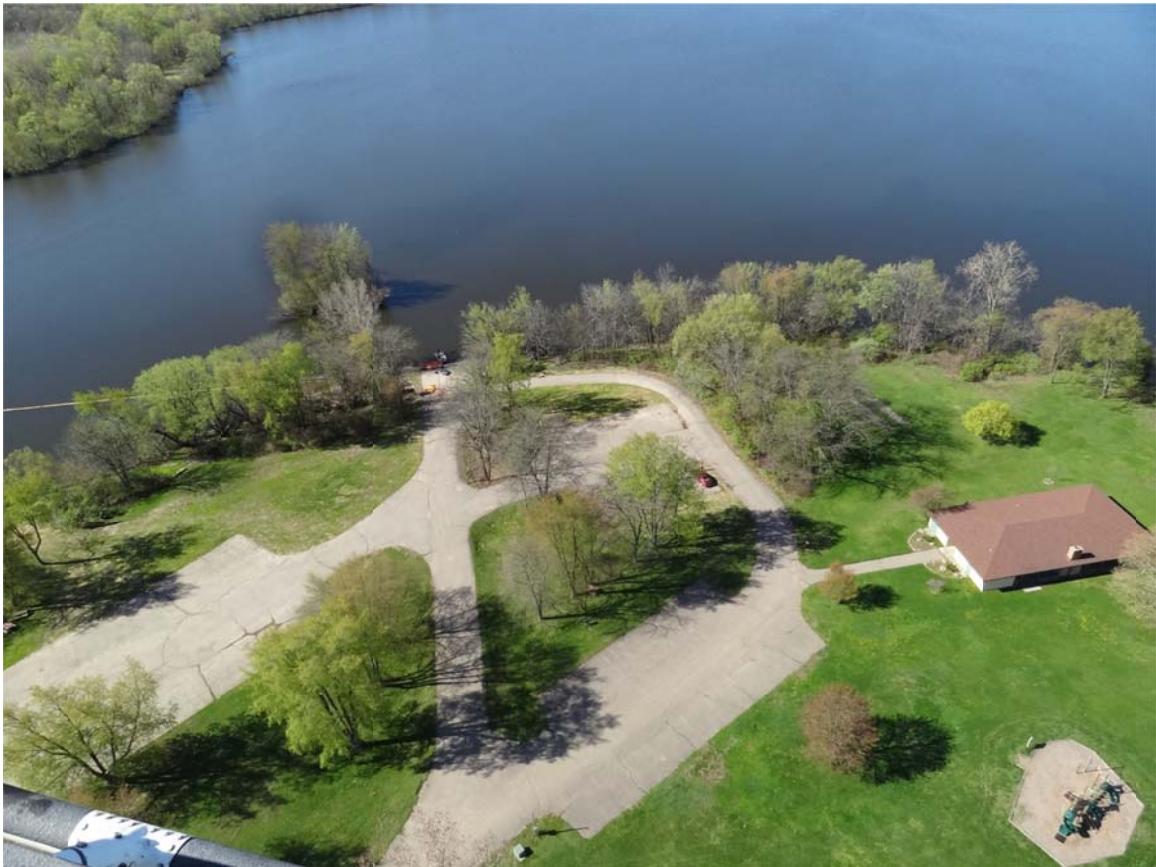
25. E4 boat launch, one boat crew observed.
