Situation Photo Log

Tuesday, April 10, 2012

Kalamazoo River / Enbridge Spill

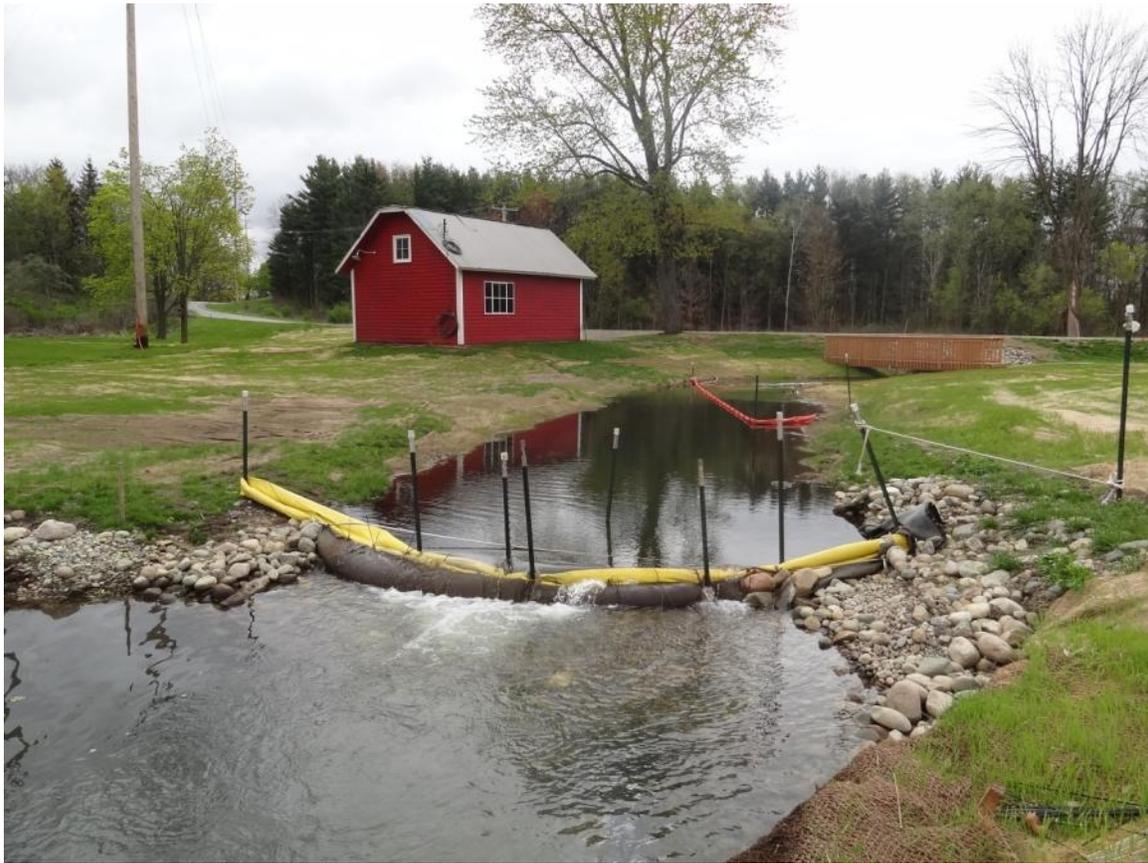
1. Confluence, sediment control structure.

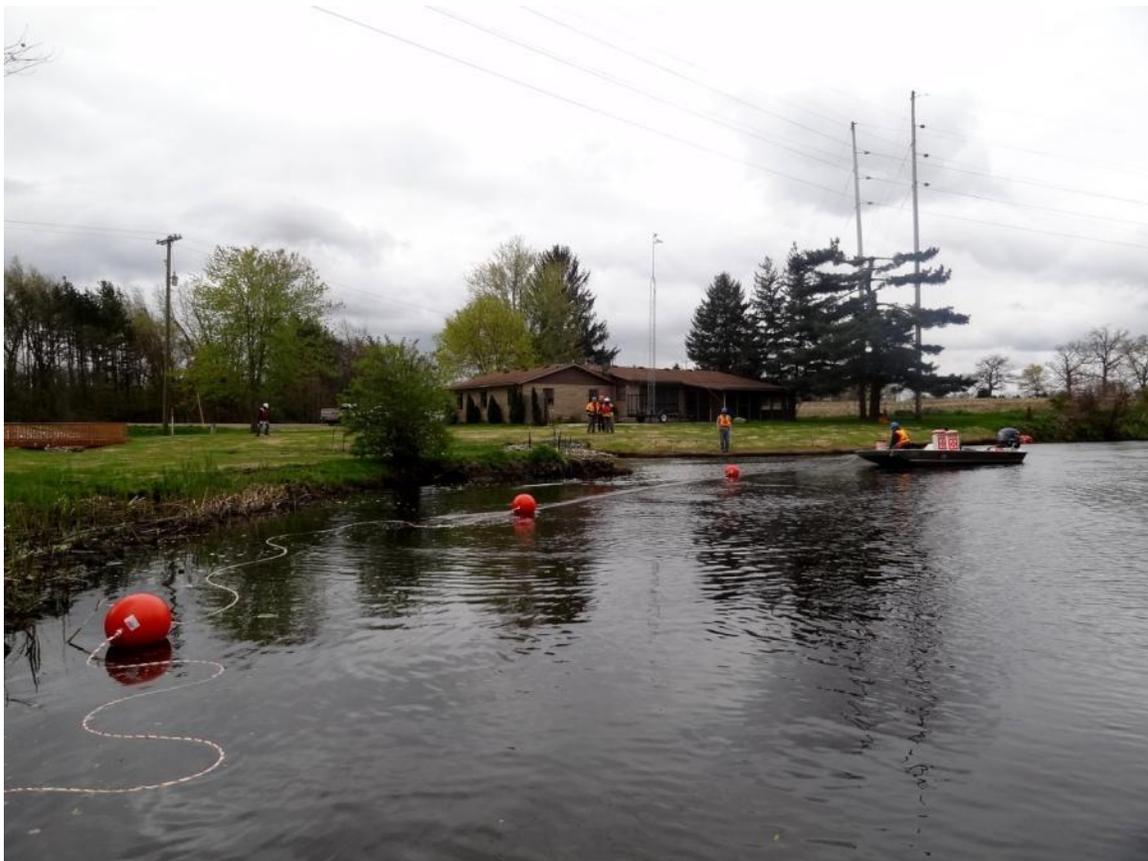
2. SWAT crews observed deploying buoys at the Confluence.

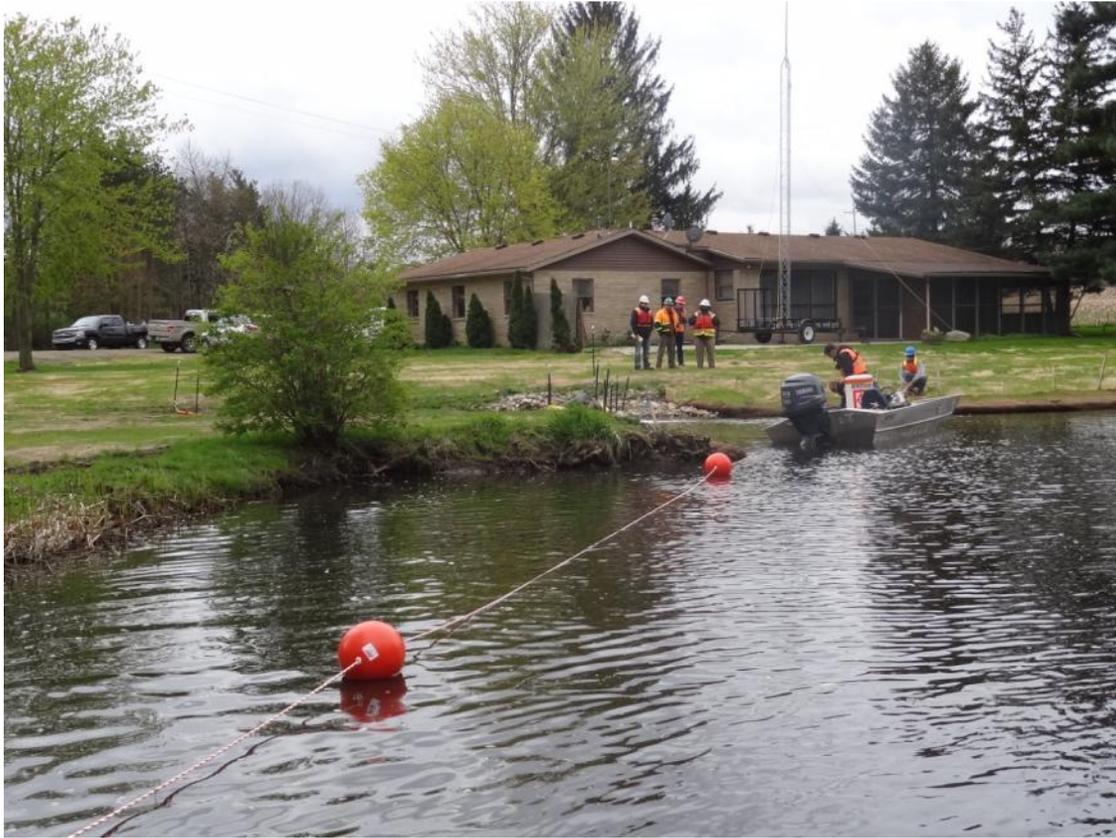
3. SWAT crews observed deploying buoys at the Confluence.

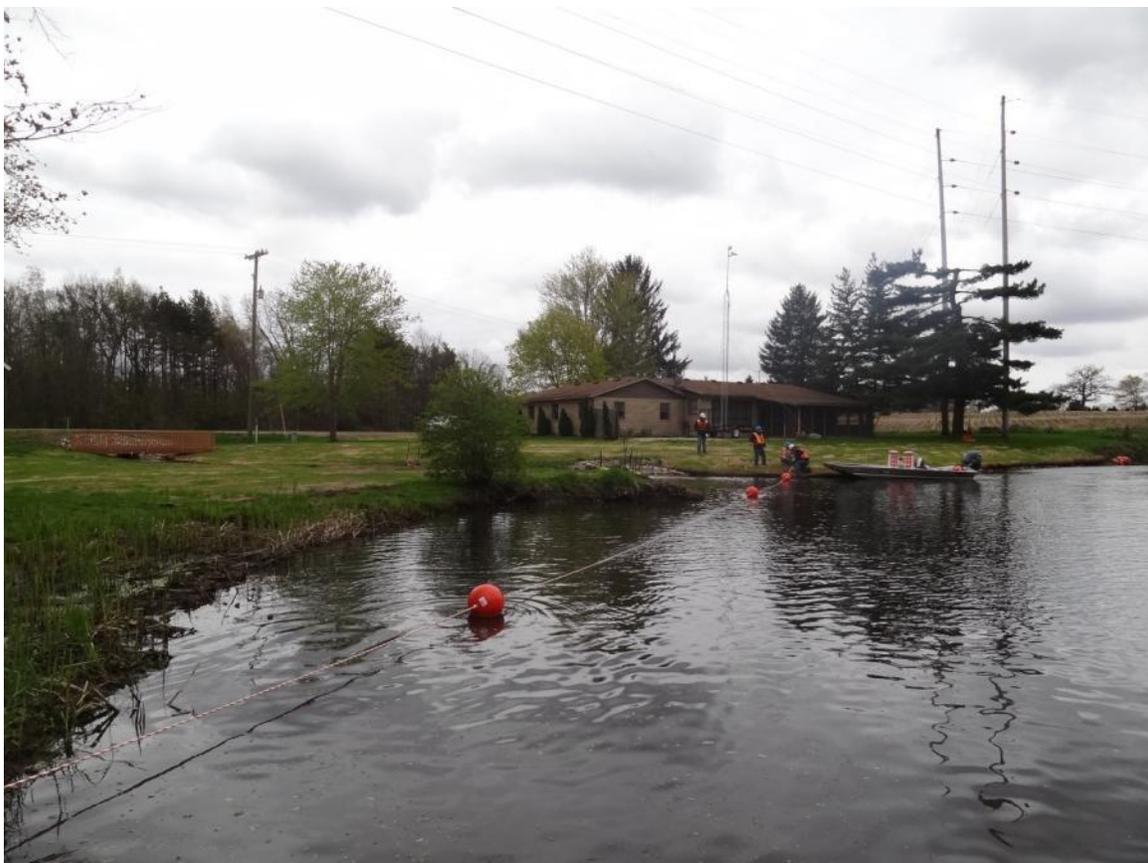
4. SWAT crews observed deploying buoys at the Confluence.

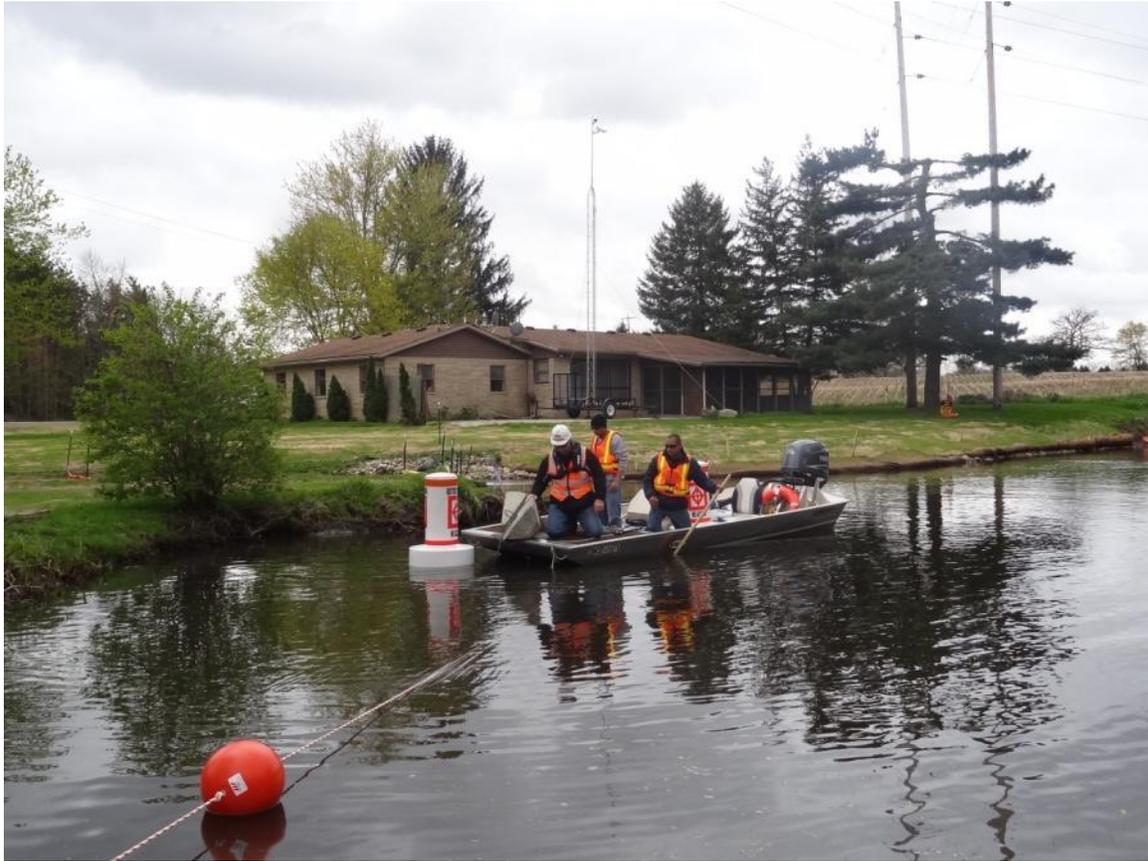
5. SWAT crews observed deploying buoys at the Confluence.

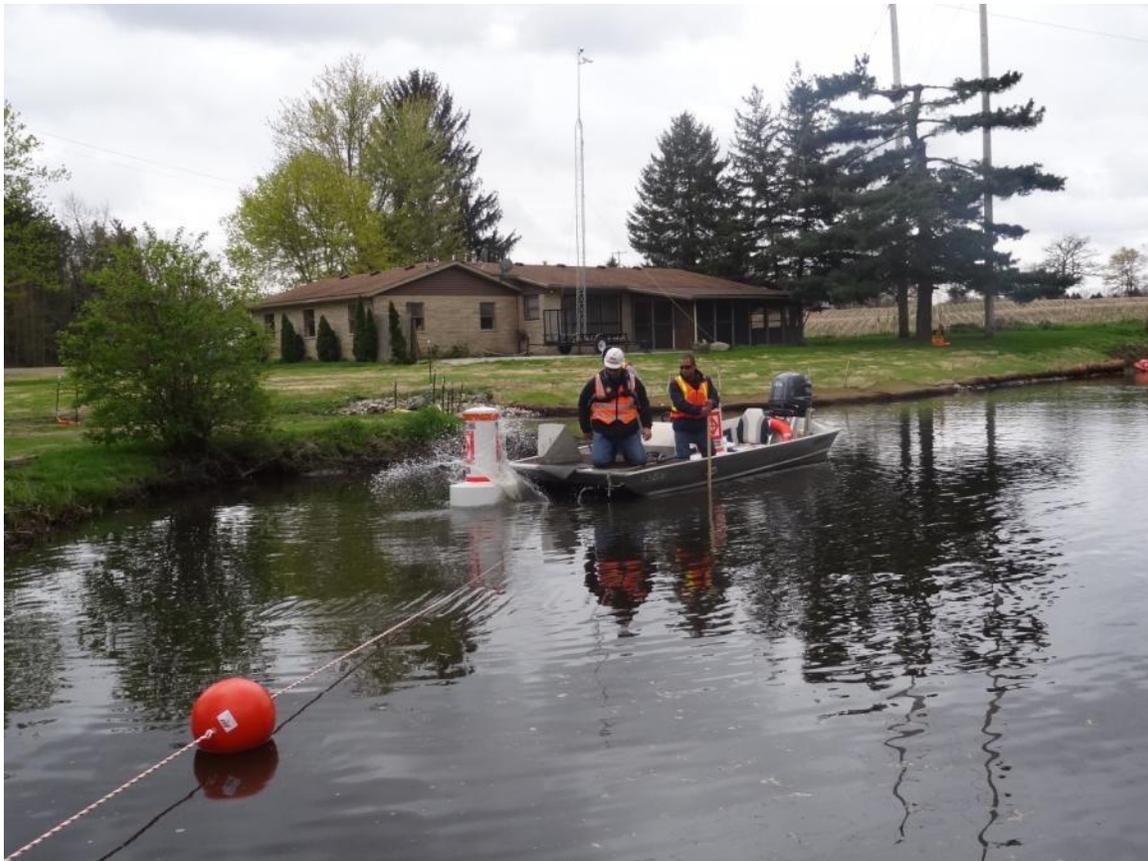
6. SWAT crews observed deploying buoys at the Confluence.

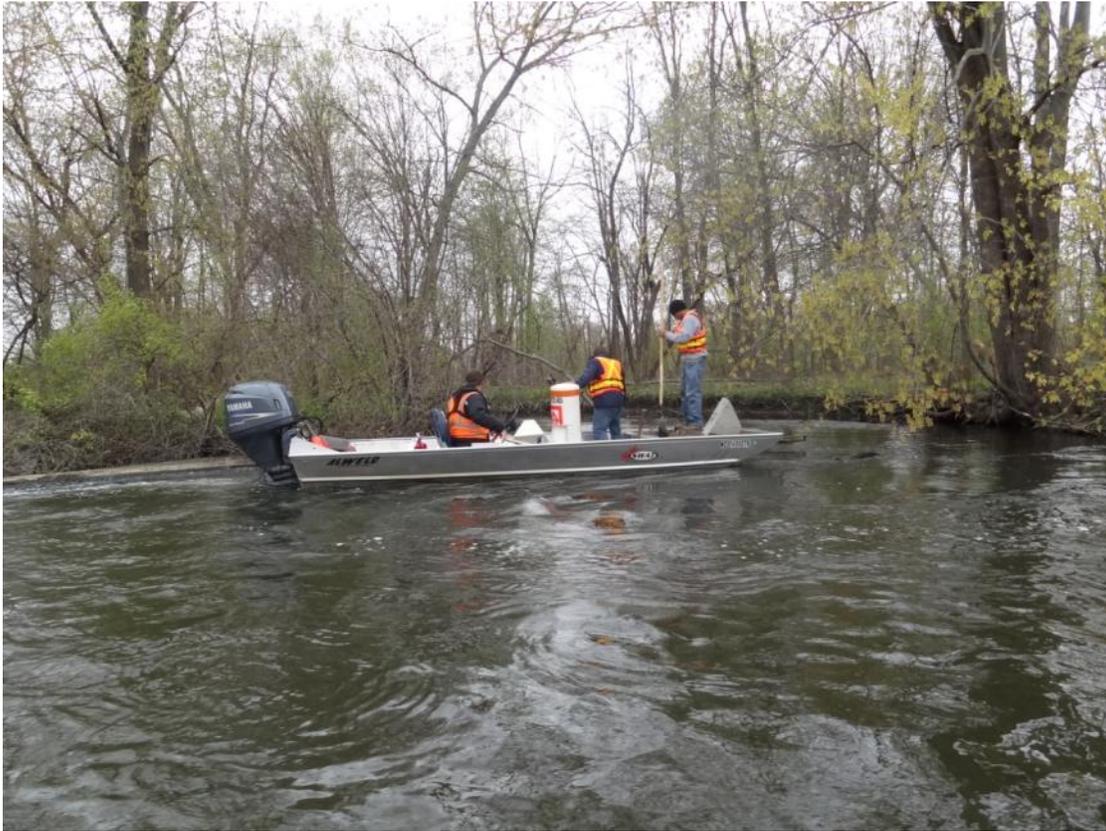
7. SWAT crews observed deploying buoys across from the Confluence at a side channel.

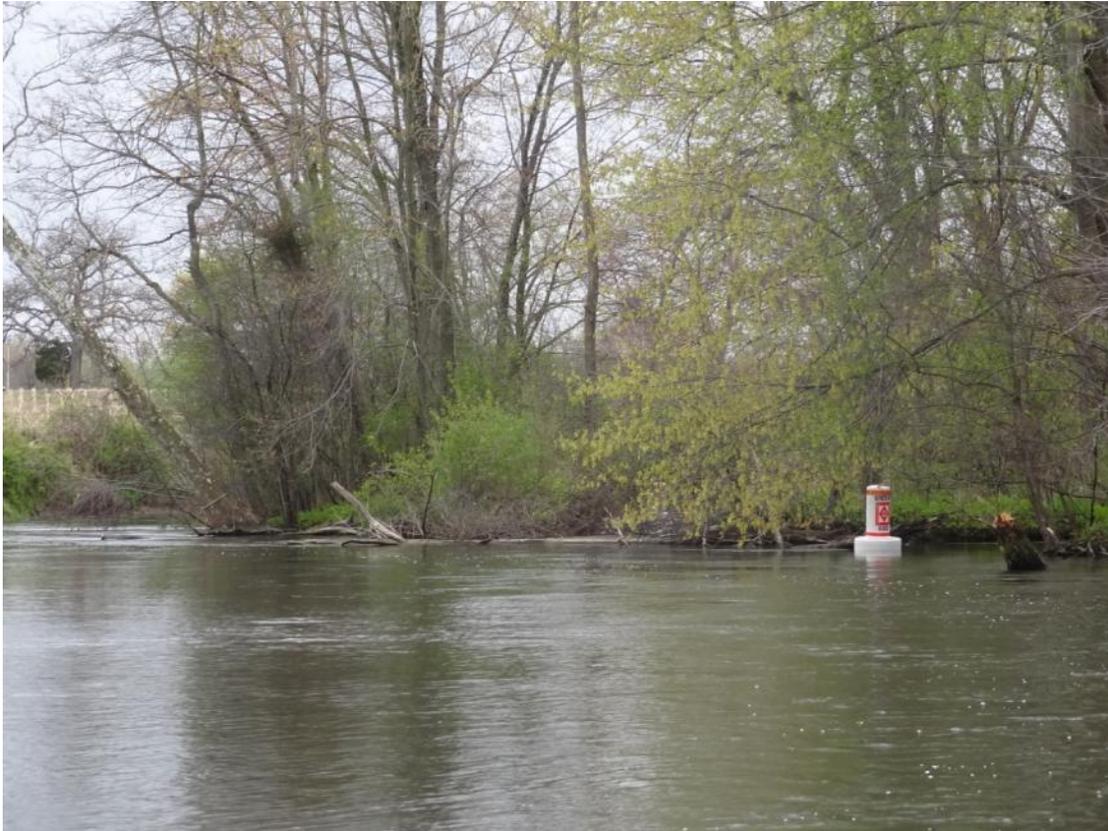
8. Buoys deployed across from the Confluence at a side channel.

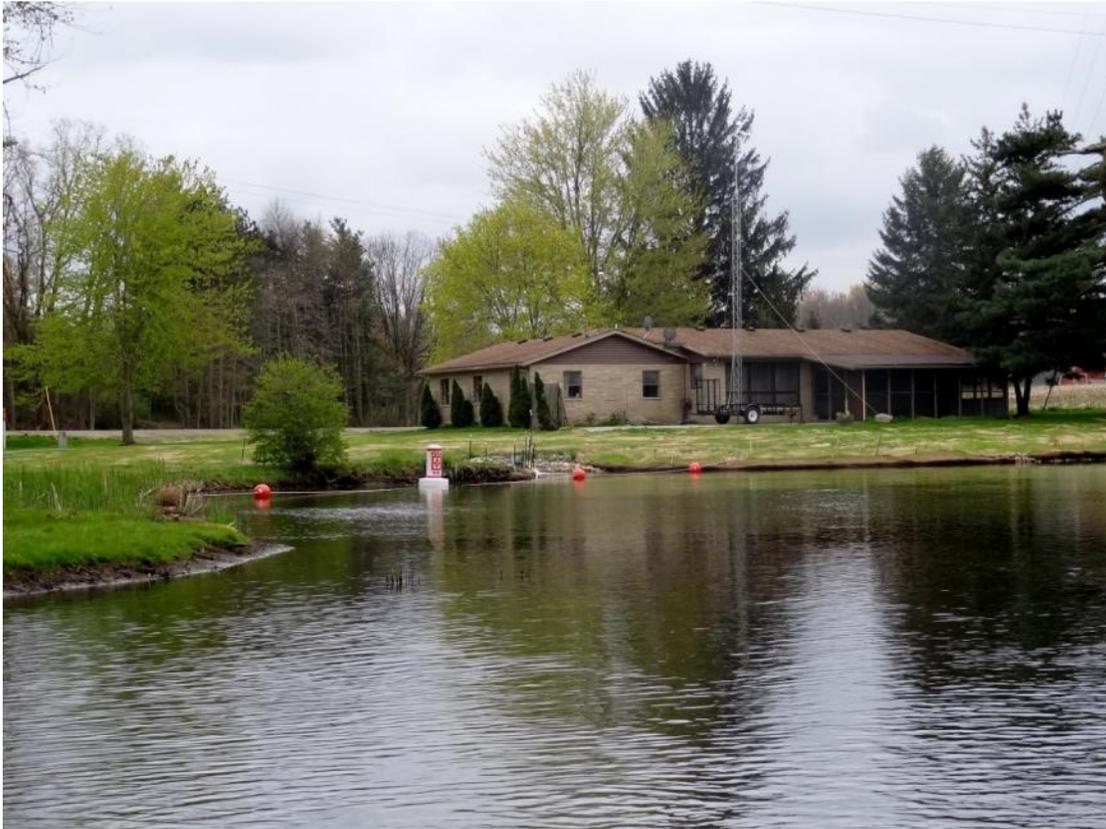
9. Buoys deployed at the confluence.

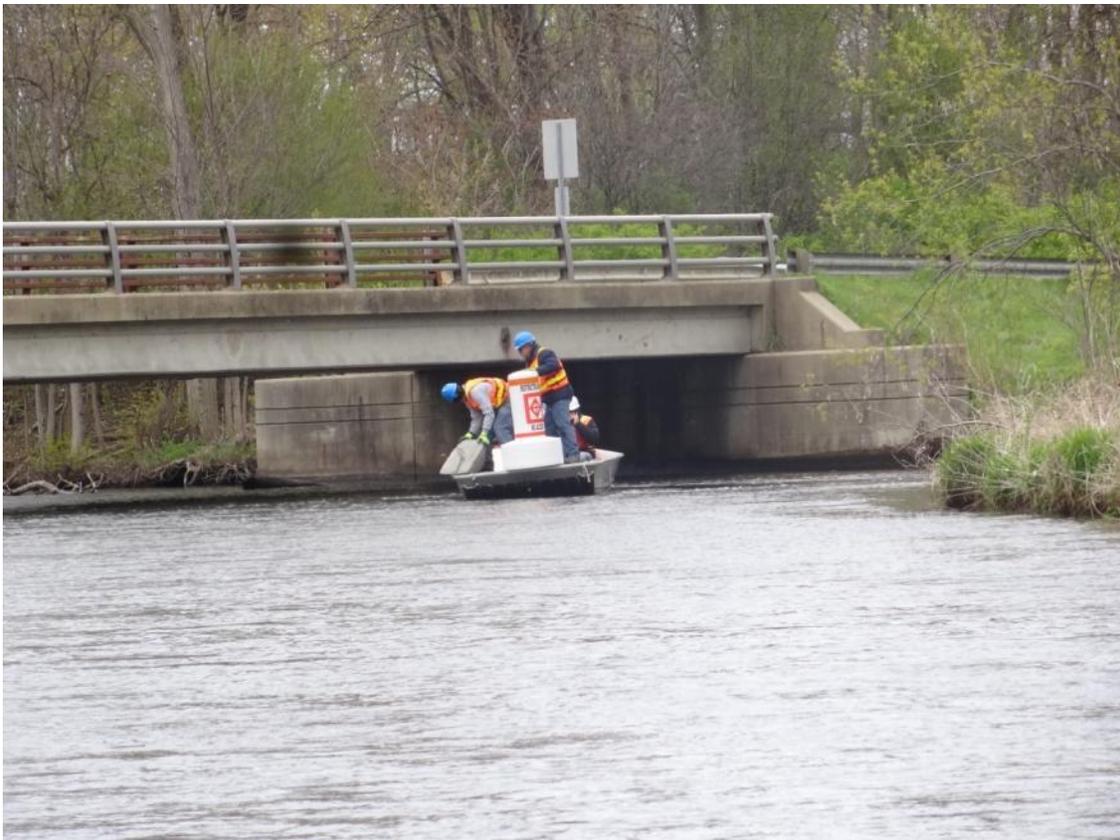
10. SWAT crew deploying buoy east of 15 Mile RD just up from Saylor's Landing.

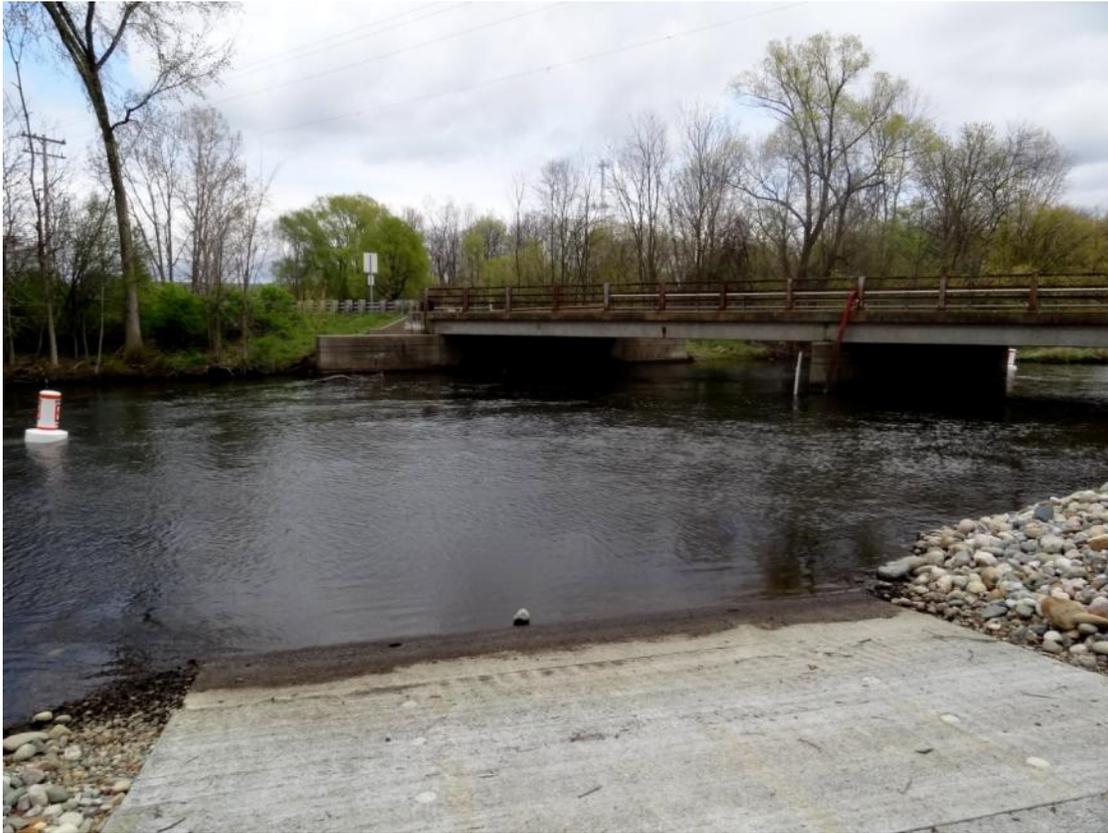
11. SWAT crew deploying buoy at Saylor's Landing.

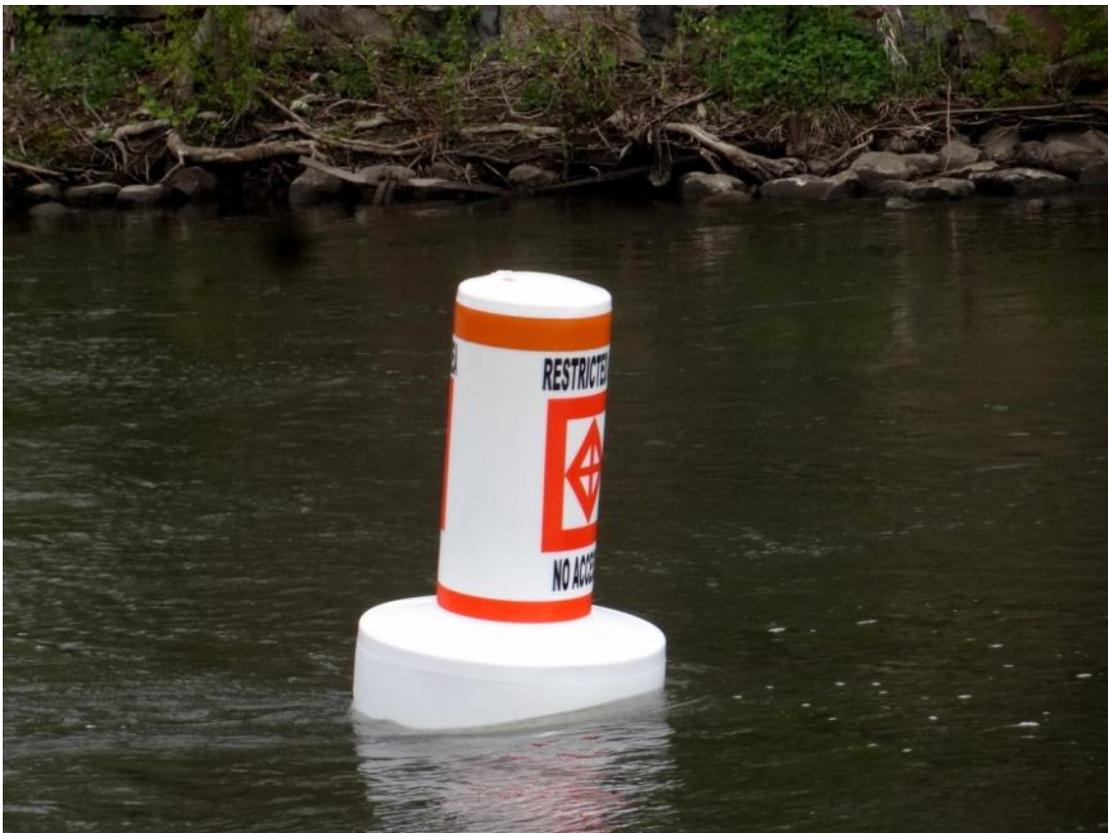
12. SWAT crew deploying buoy at Saylor's Landing.

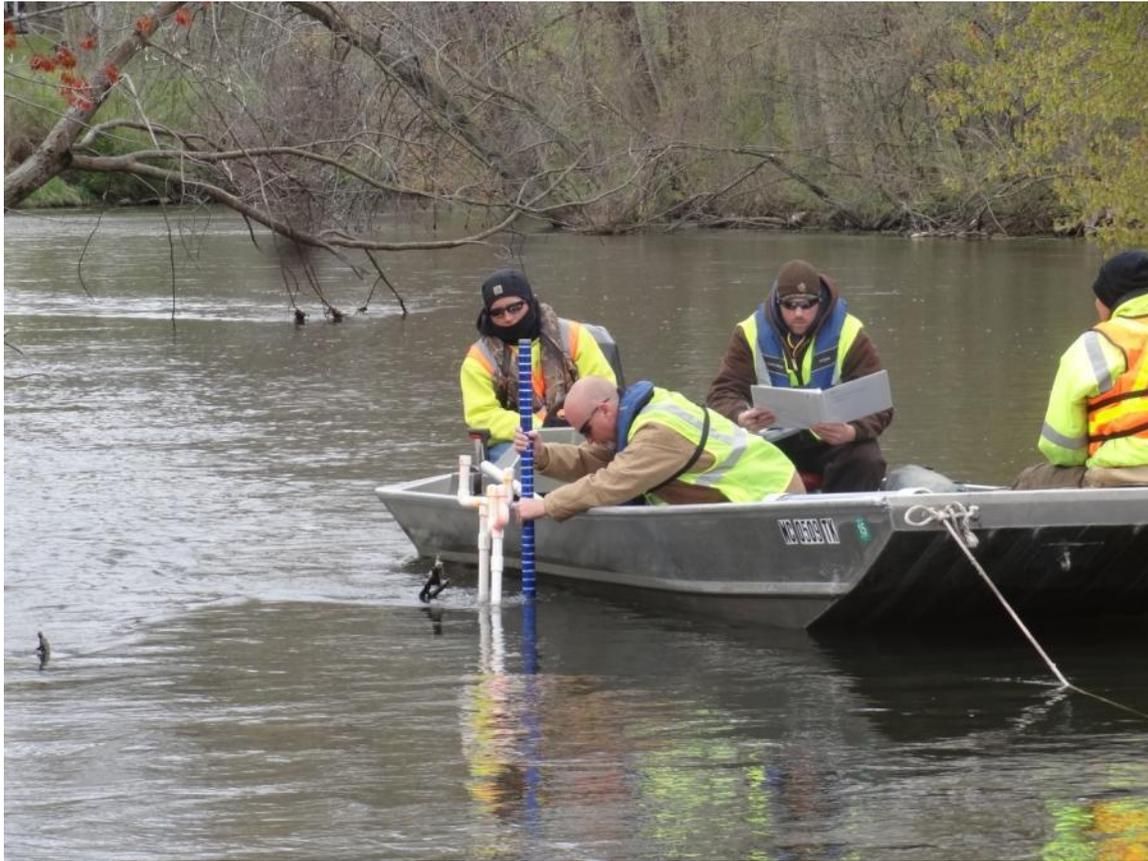
13. Observed crew deploying Walling Tubes upstream of the confluence.

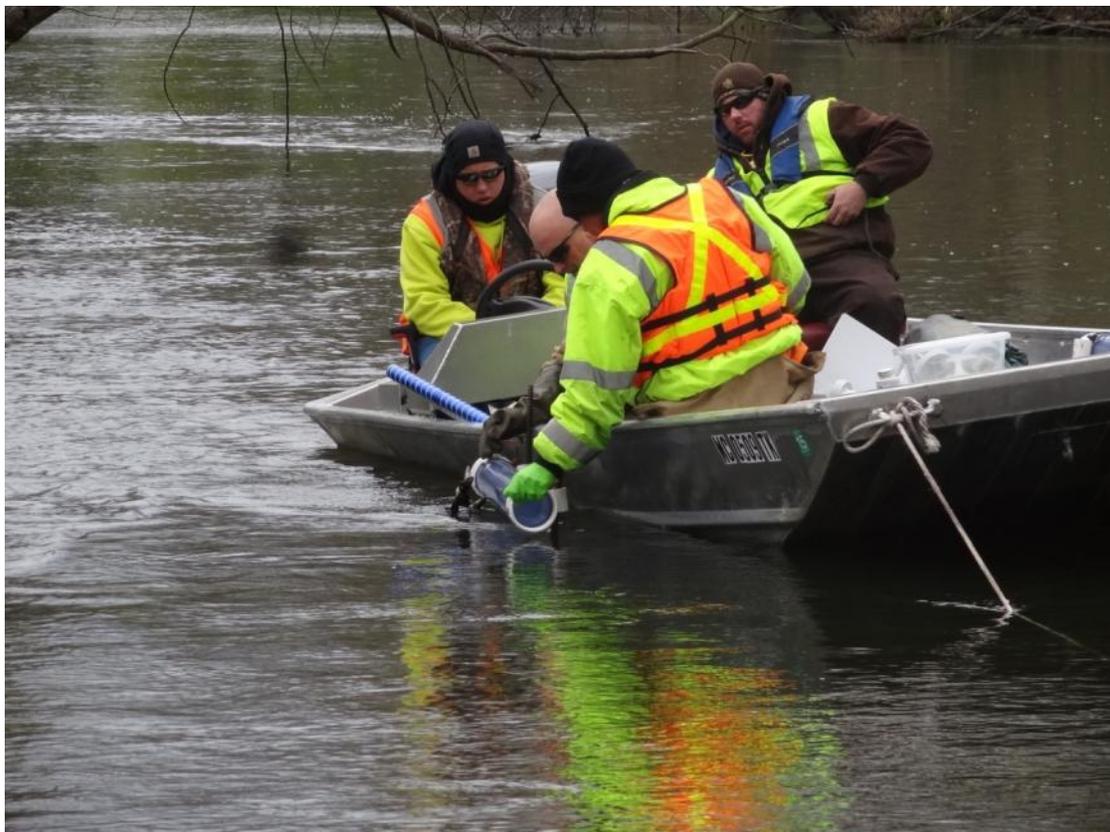
14. Observed crew deploying Walling Tubes upstream of the confluence.

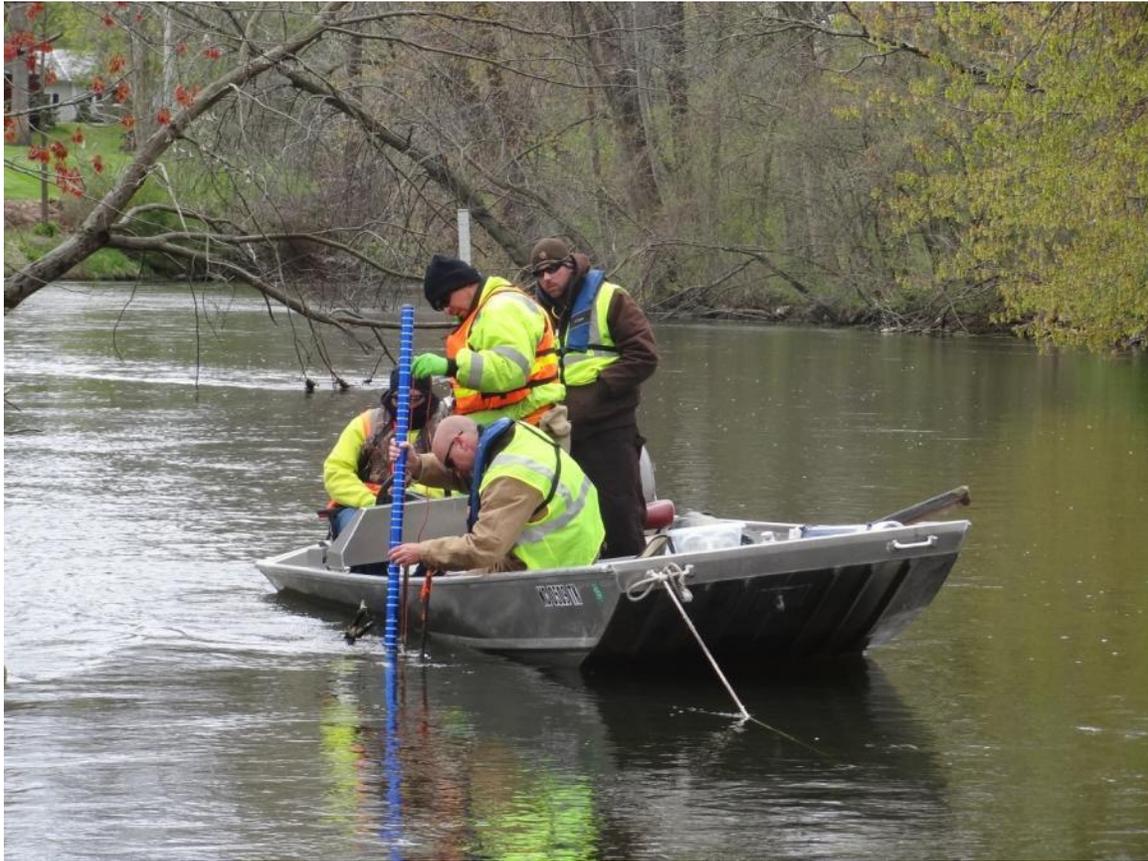
15. Observed crew adjusting Walling Tube within the water column.

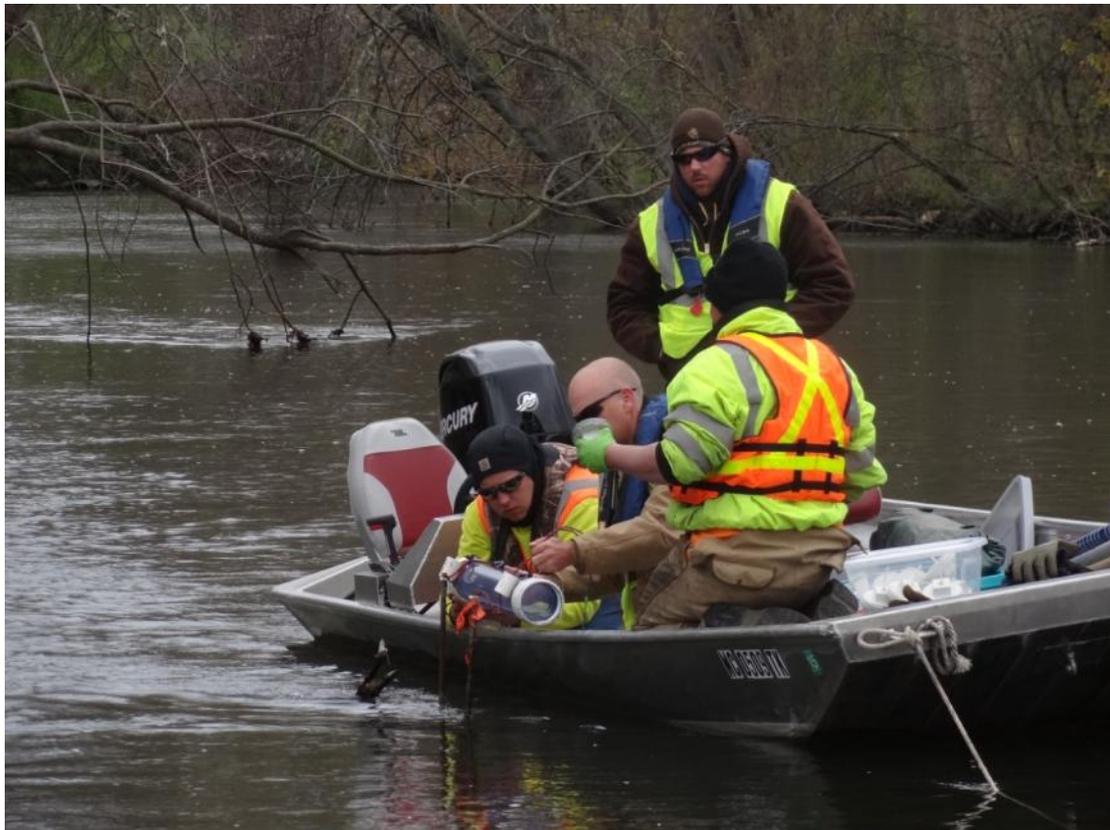
16. Observed crew deploying second Walling Tube at this location upstream of the confluence.

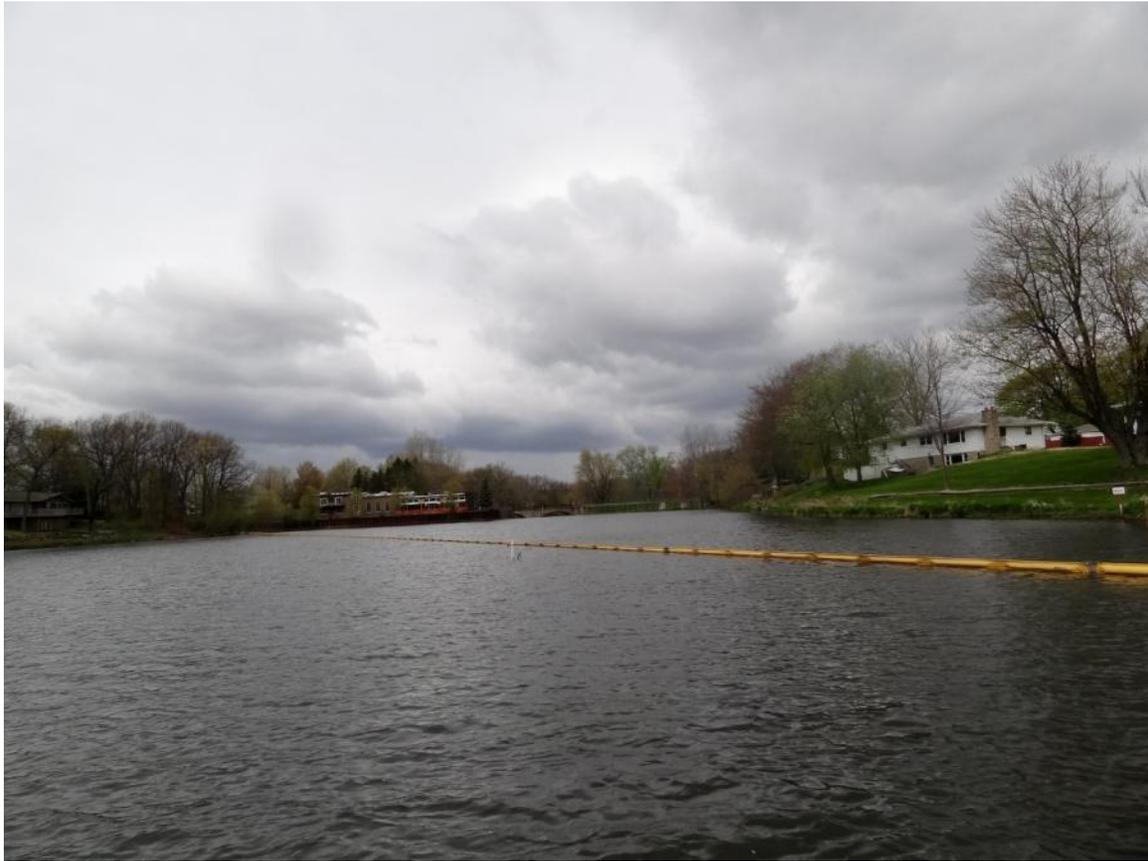
17. New boom configuration above Ceresco Dam.

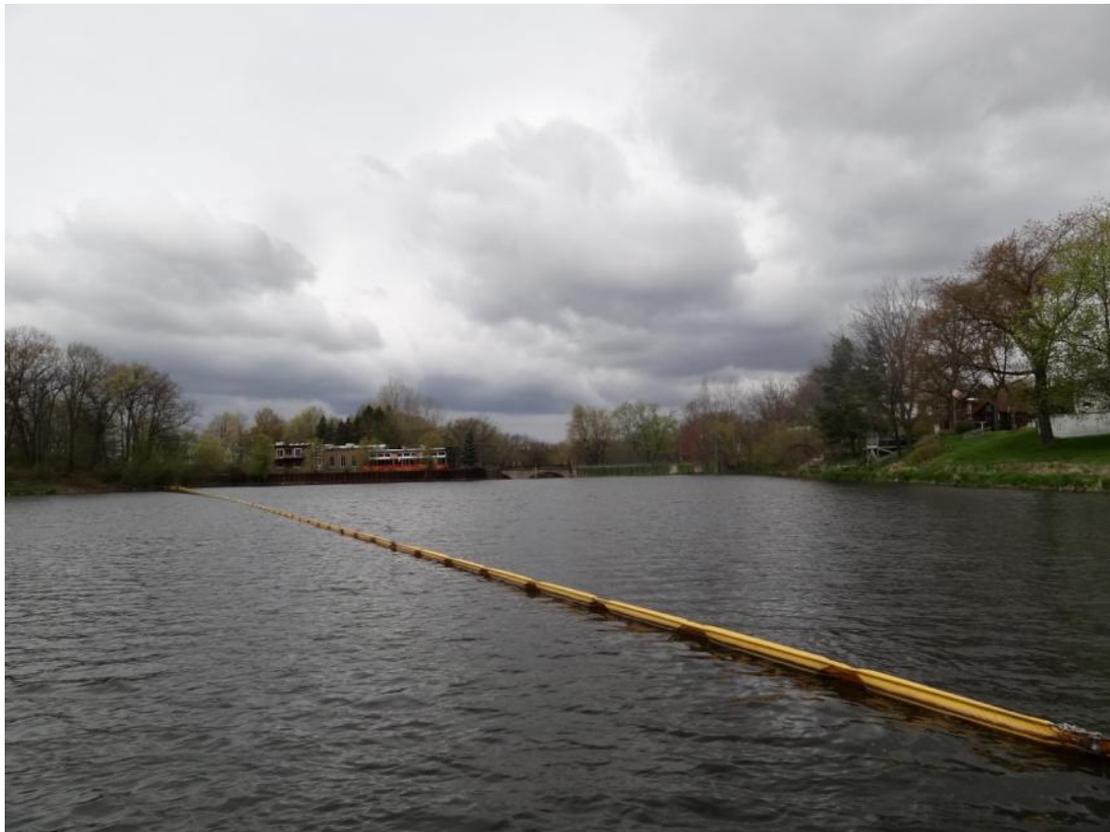
18. New boom configuration above Ceresco Dam.

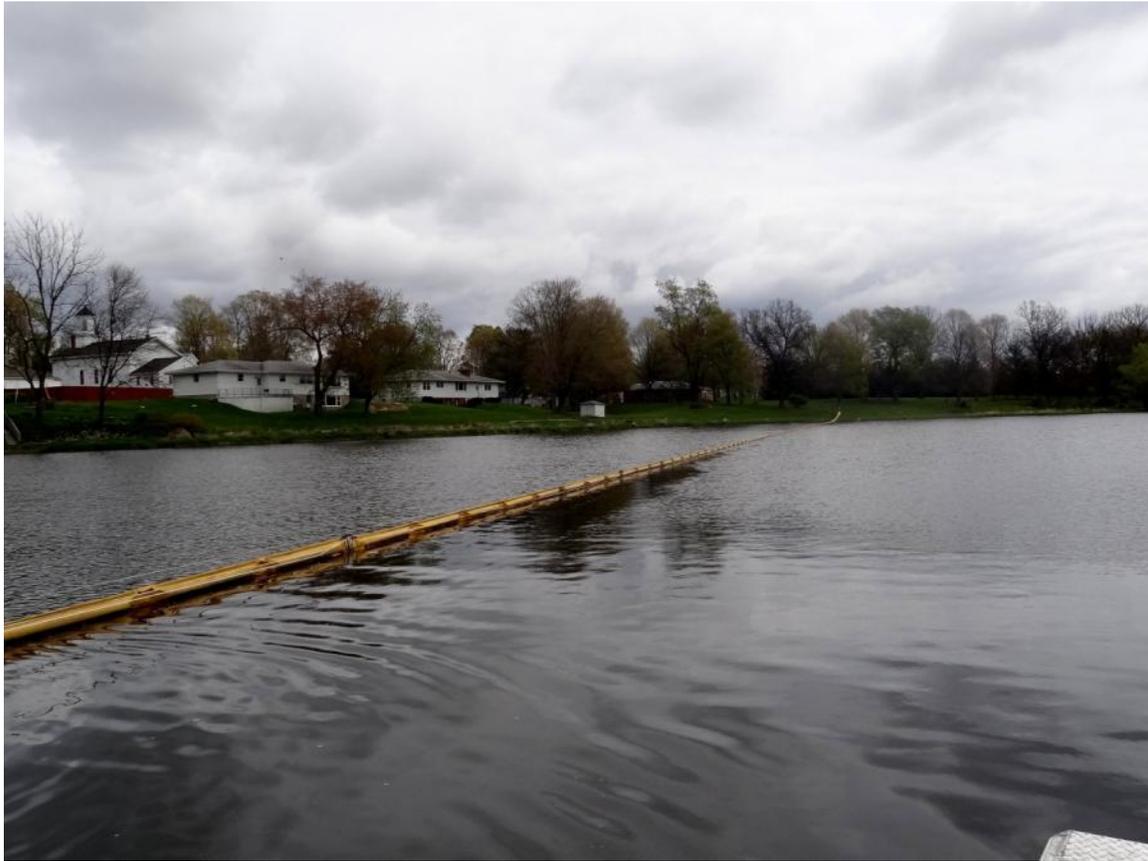
19. New boom configuration above Ceresco Dam.

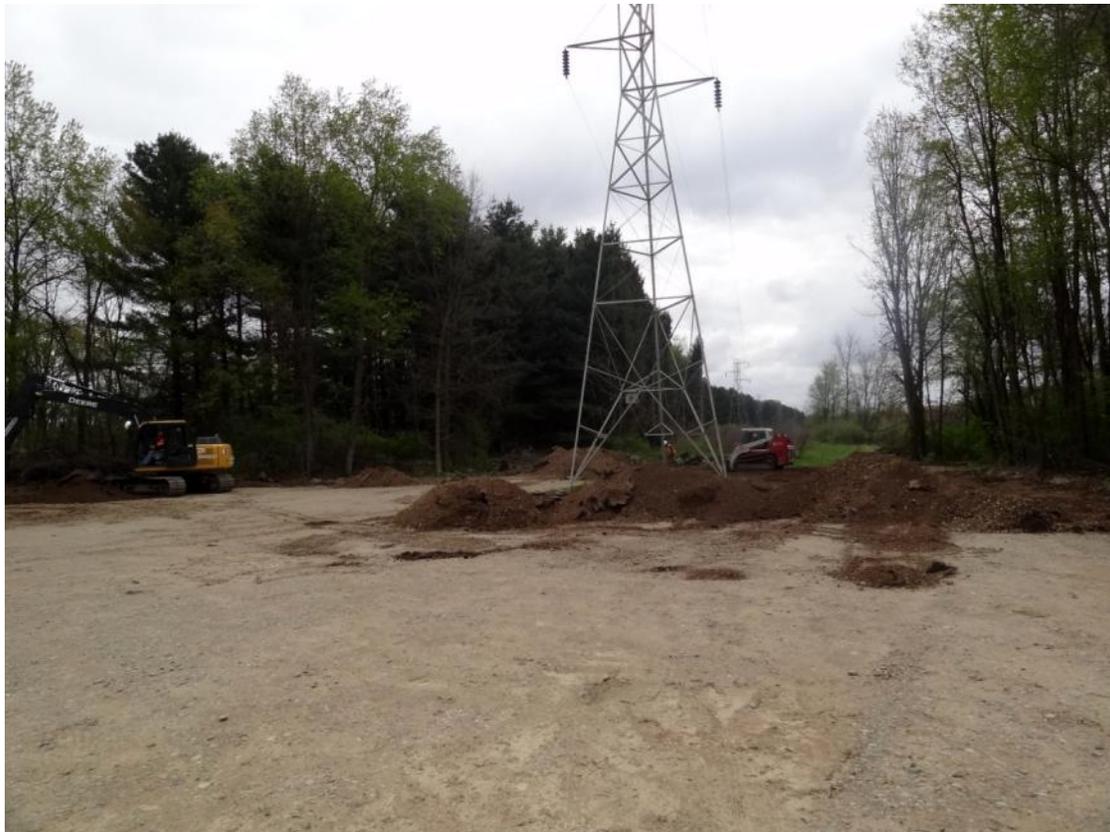
20. Observed crew reducing the foot print at the C0.4 boat launch.

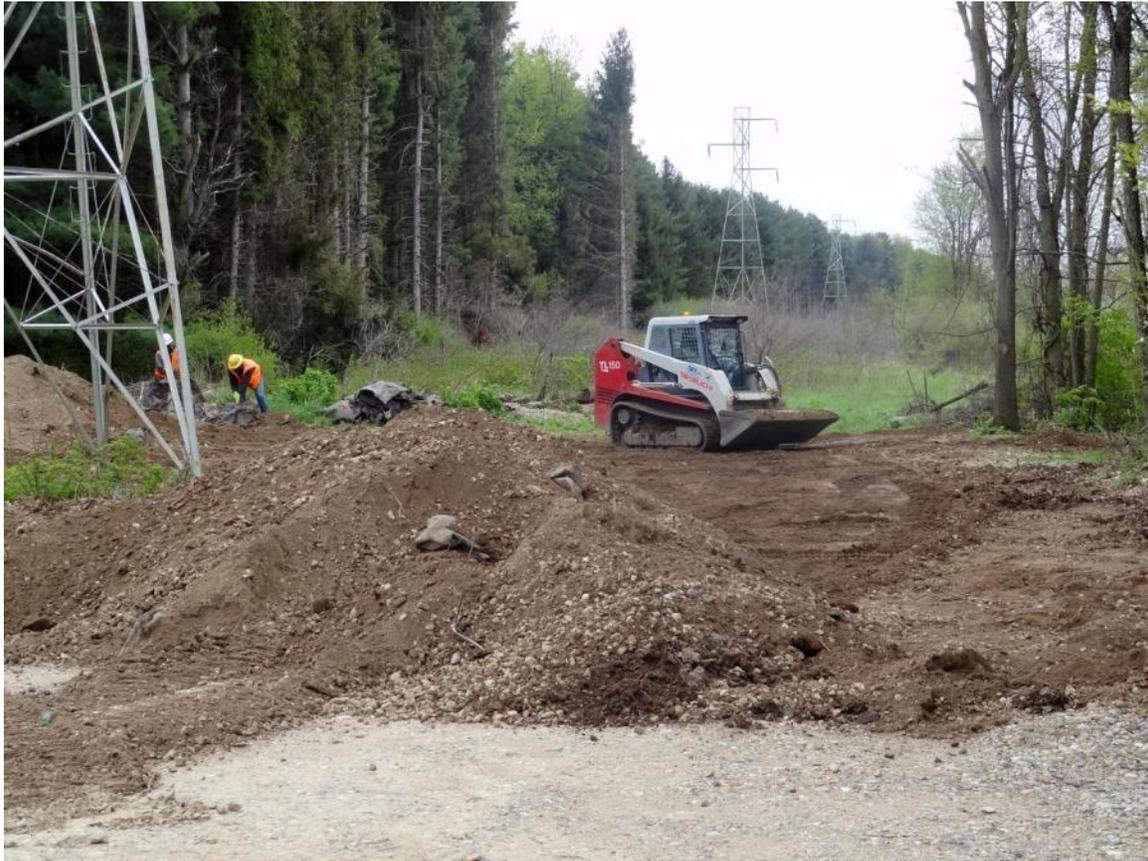
21. Observed crew reducing the foot print at the C0.4 boat launch.

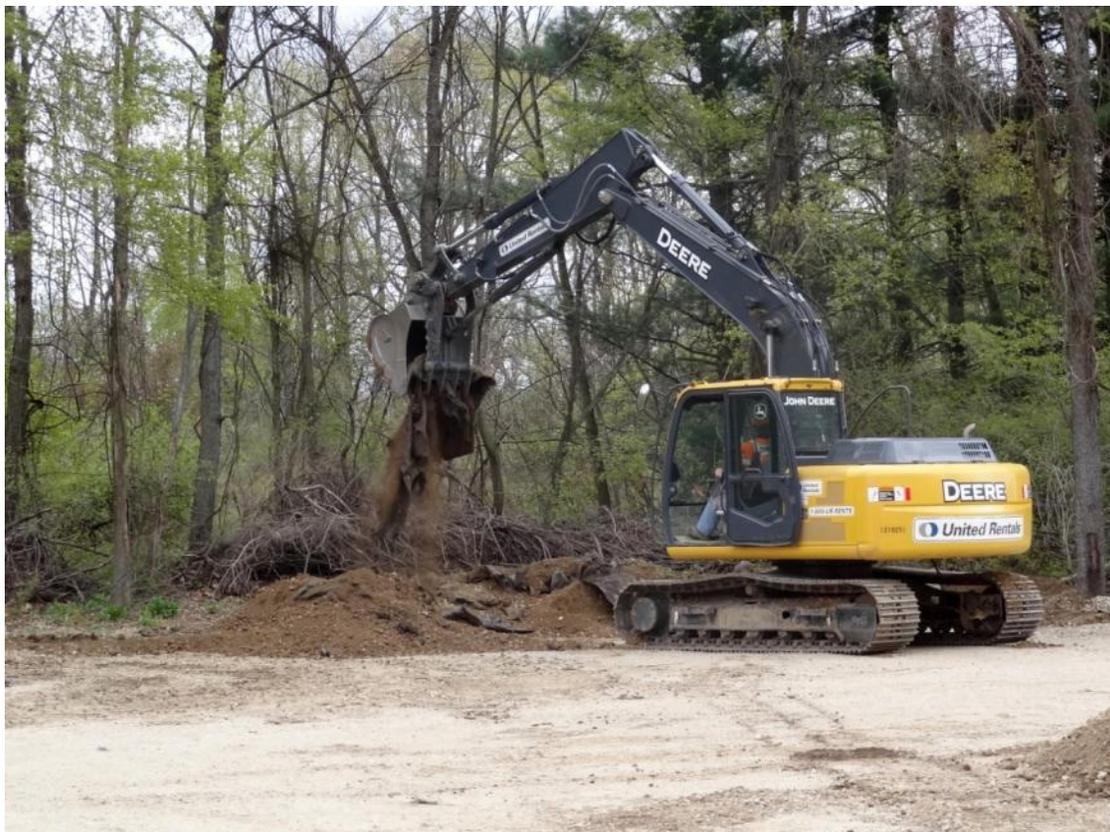
22. Observed crew reducing the foot print at the C0.4 boat launch.
