# Situation Photo Log

Wednesday, April 11, 2012

Kalamazoo River / Enbridge Spill

Matthew Haak  
START-USEPA  
Situation Unit Leader

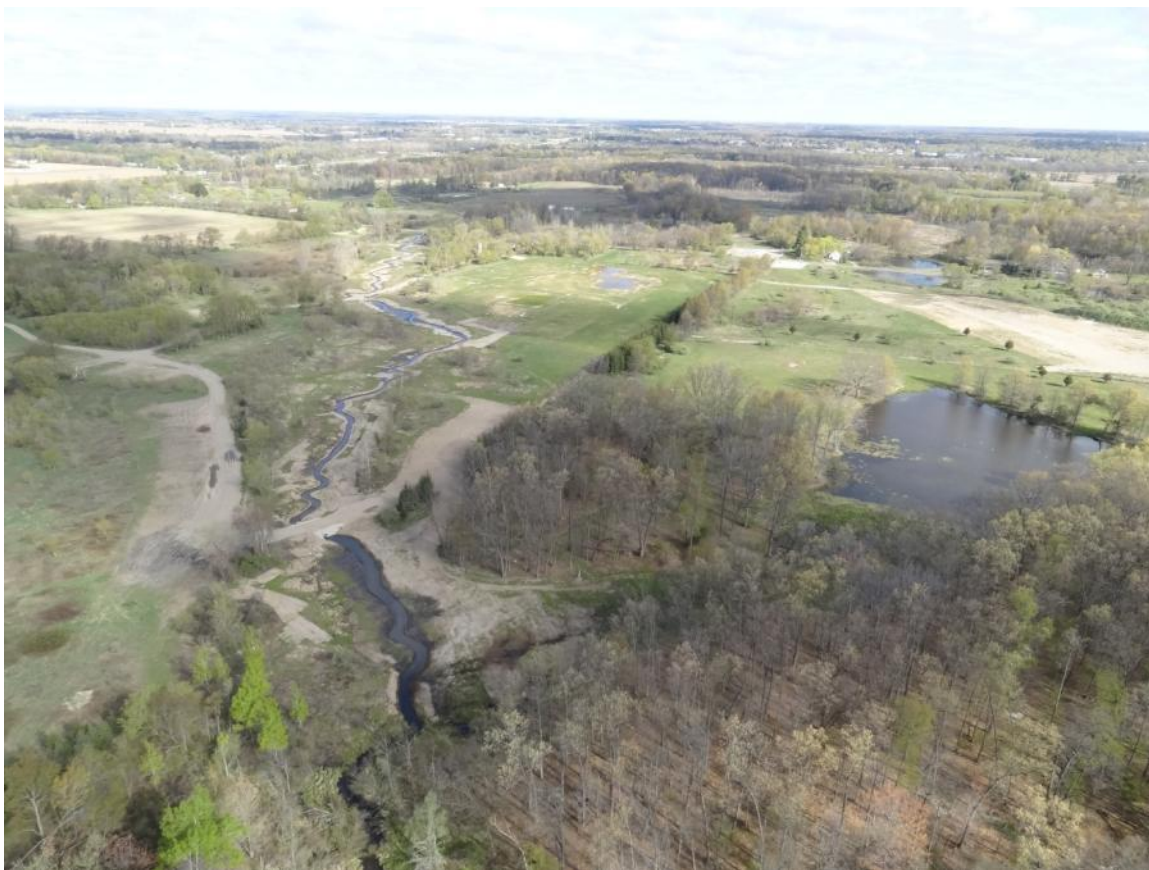
1. Overview of the source area and first half mile of Talmadge Creek.

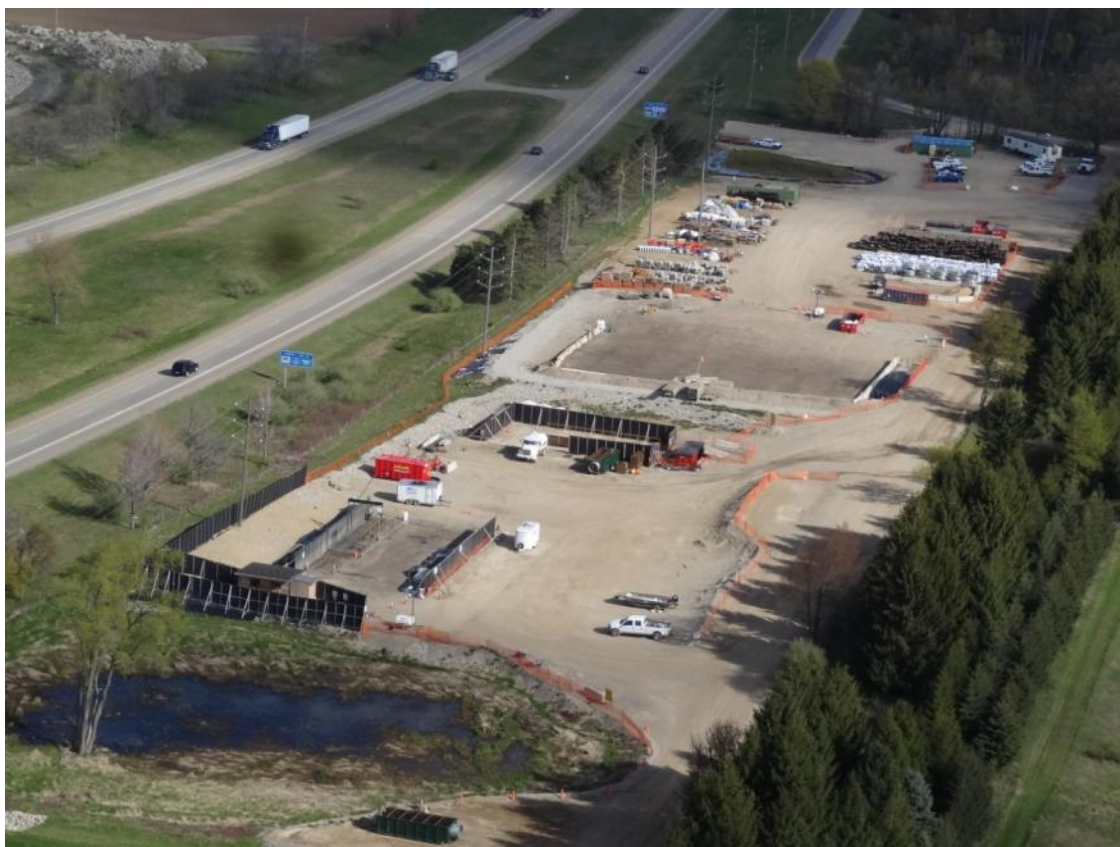
2. Overview of Frac-City.

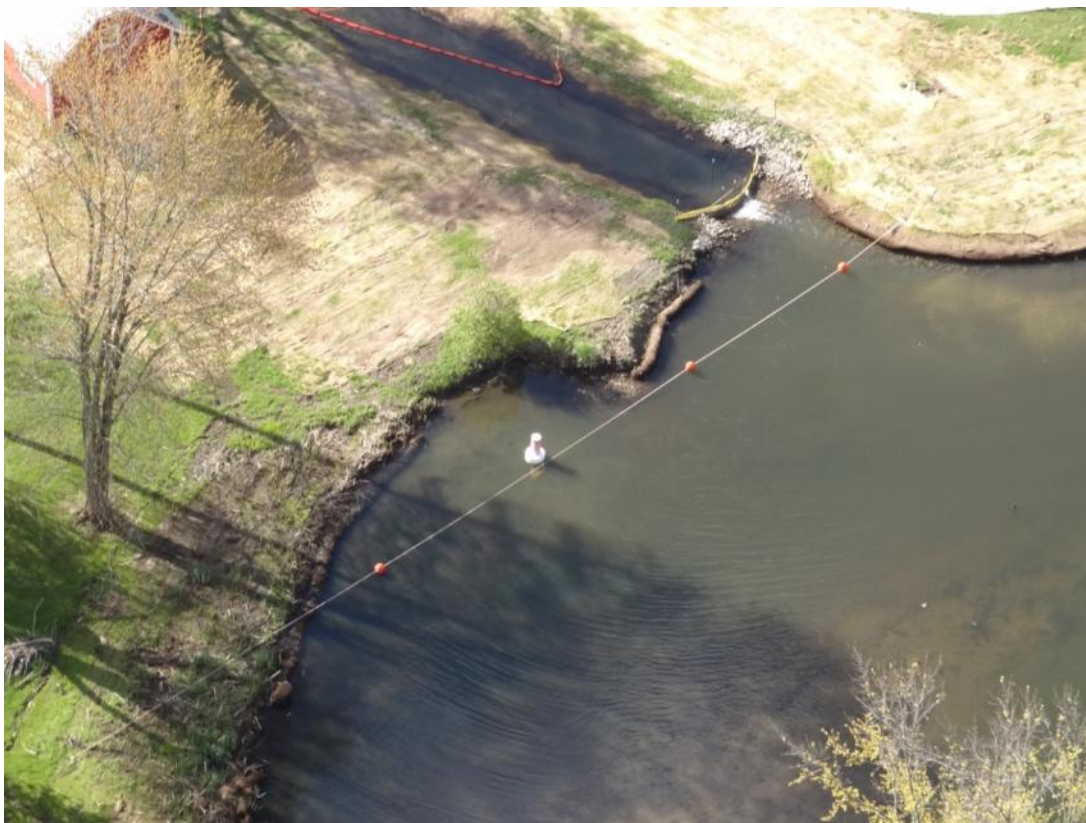
3. Buoys deployed at the confluence.

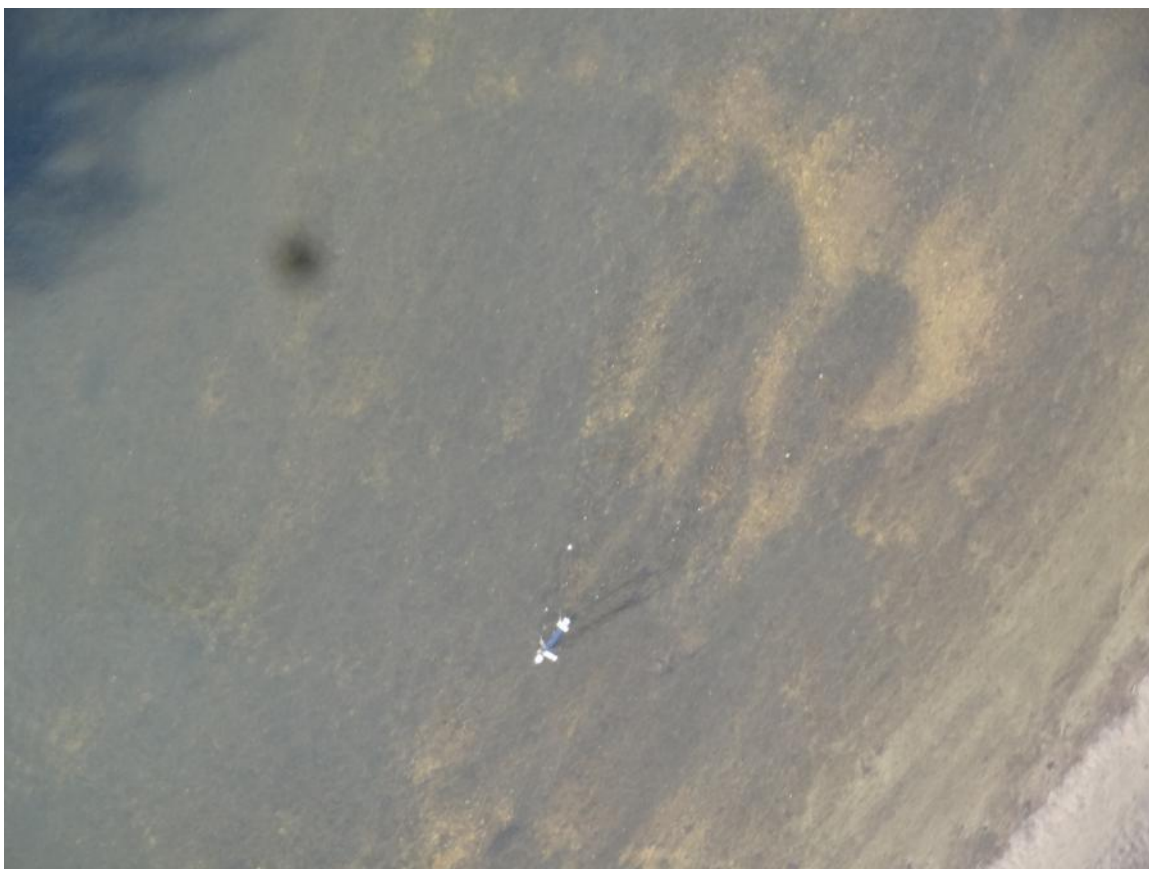
4. Walling Tube located within the river at the confluence.

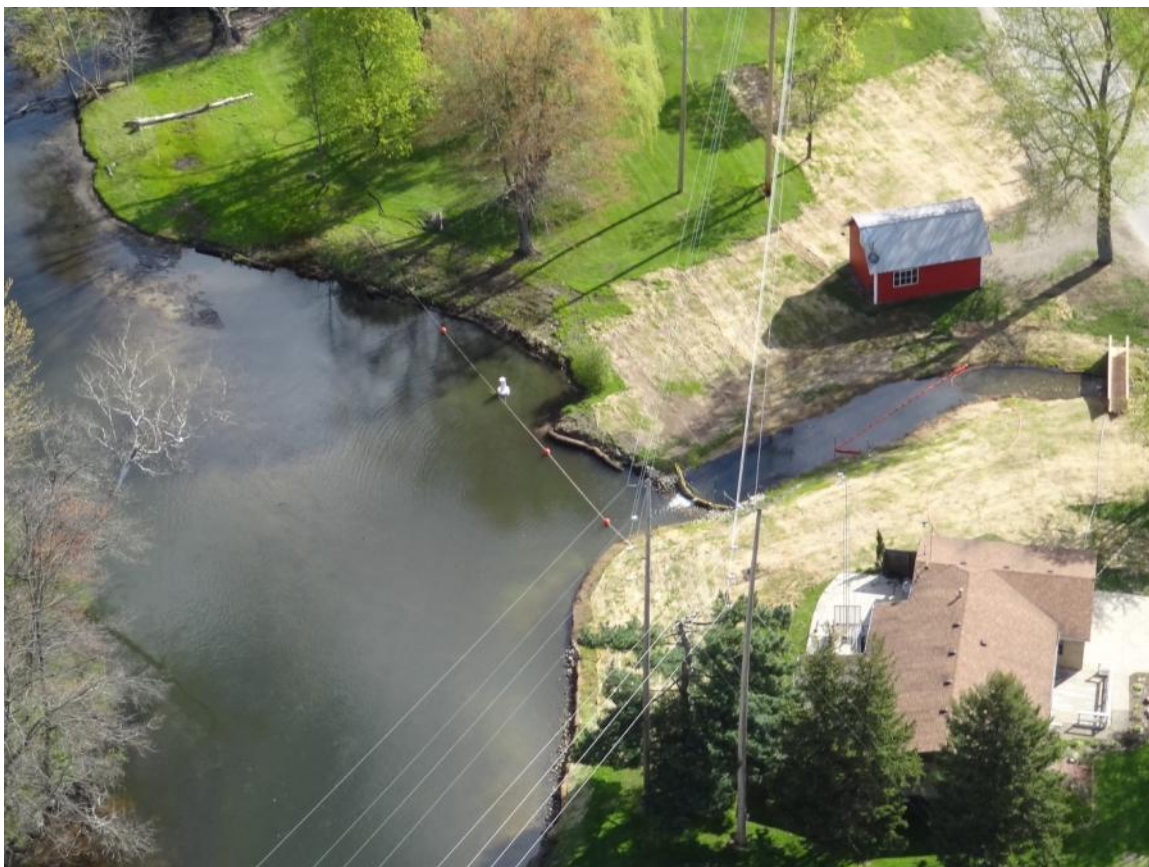
5. Walling Tube located within the river at the confluence.

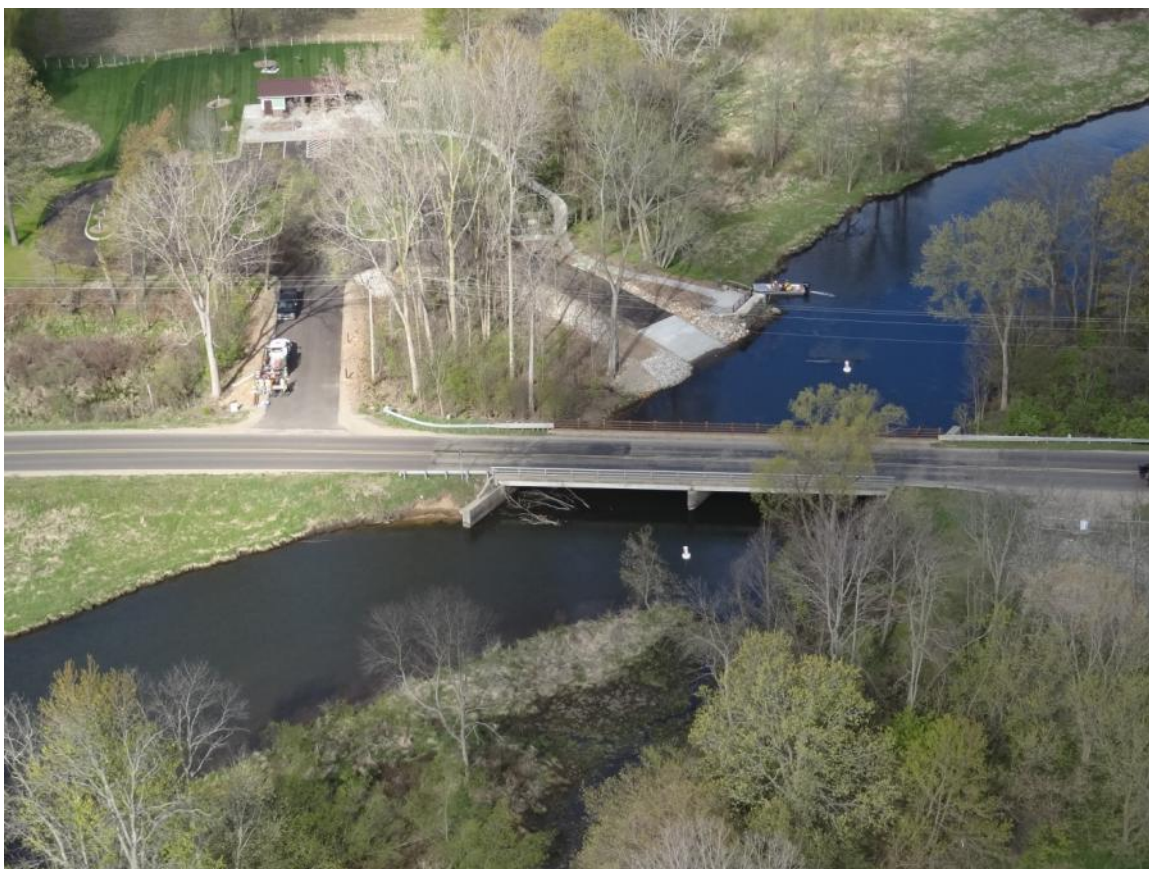
6. Buoy Cans deployed at Saylor's landing.

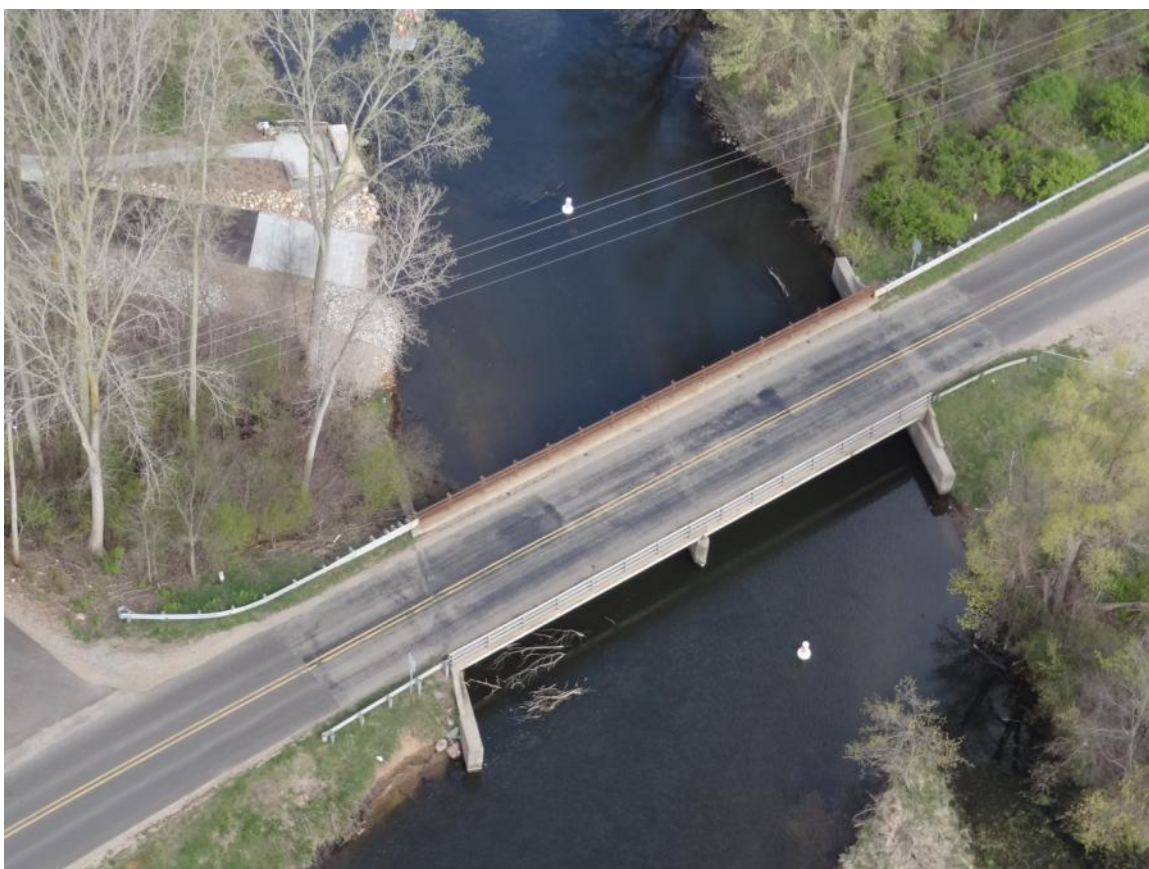
7. Buoy Cans deployed at Saylor's landing.

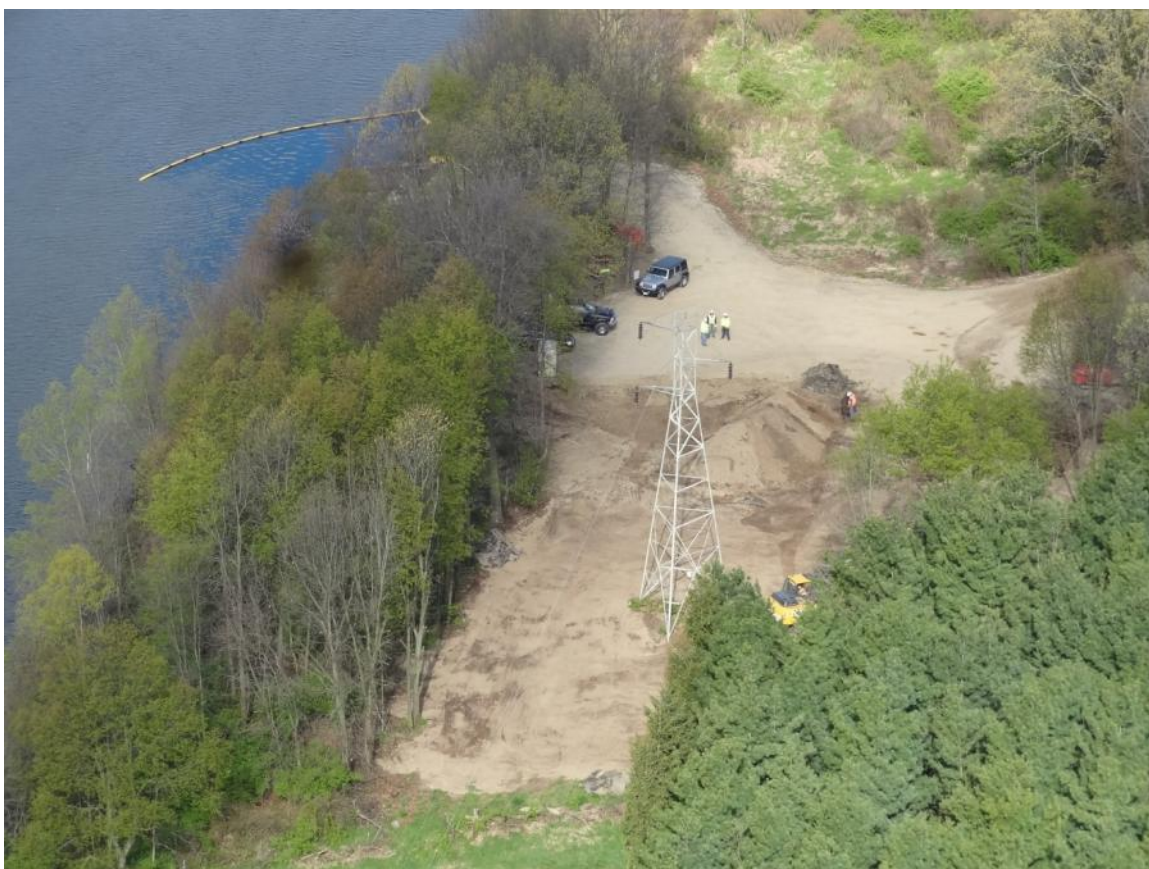
8. C0.4 Boat Launch footprint reduction.

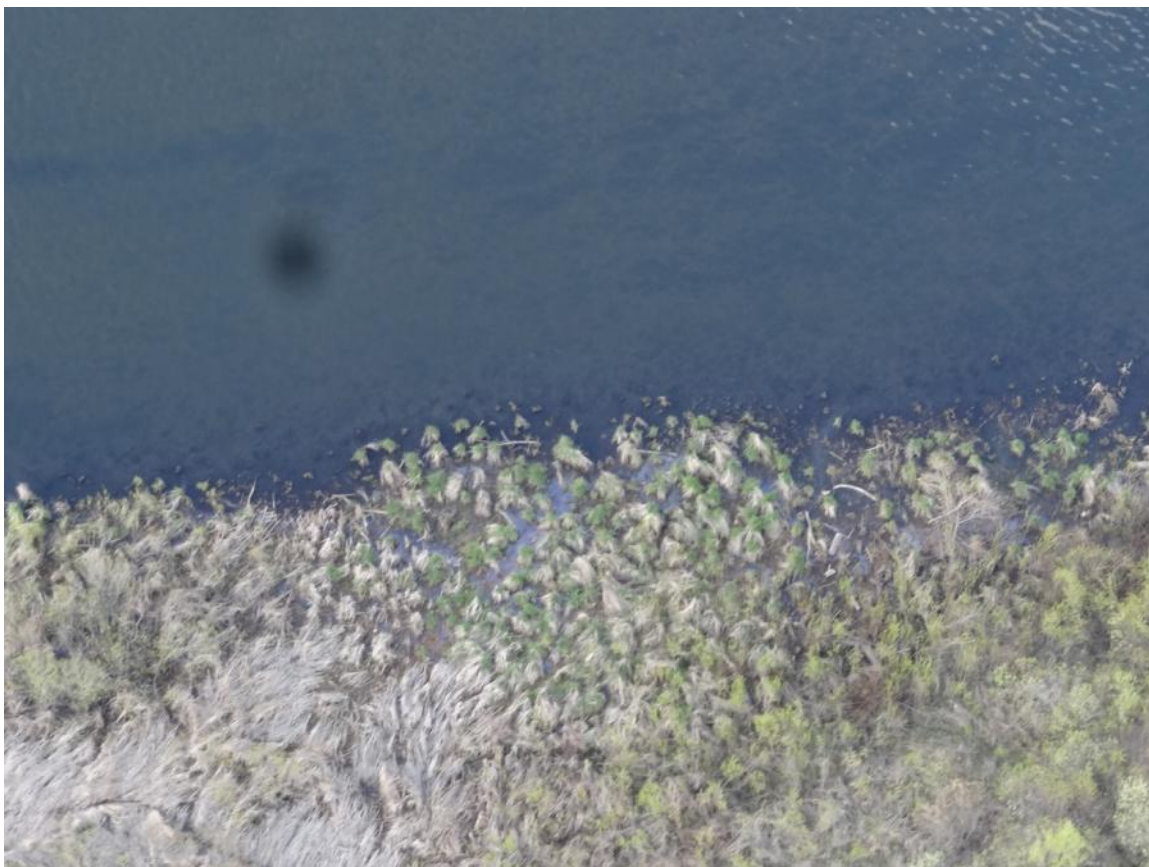
9. MP5.50 RDB sheen observed.

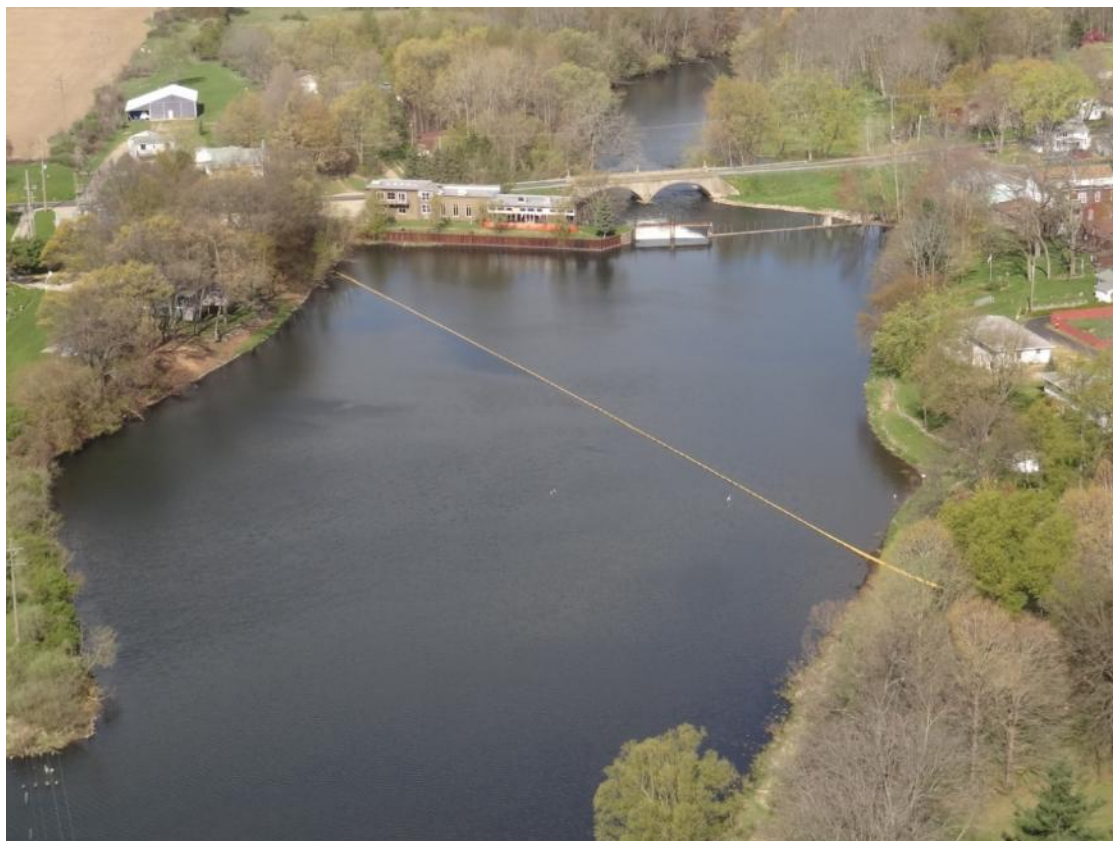
10. New boom deployment above Ceresco Dam.

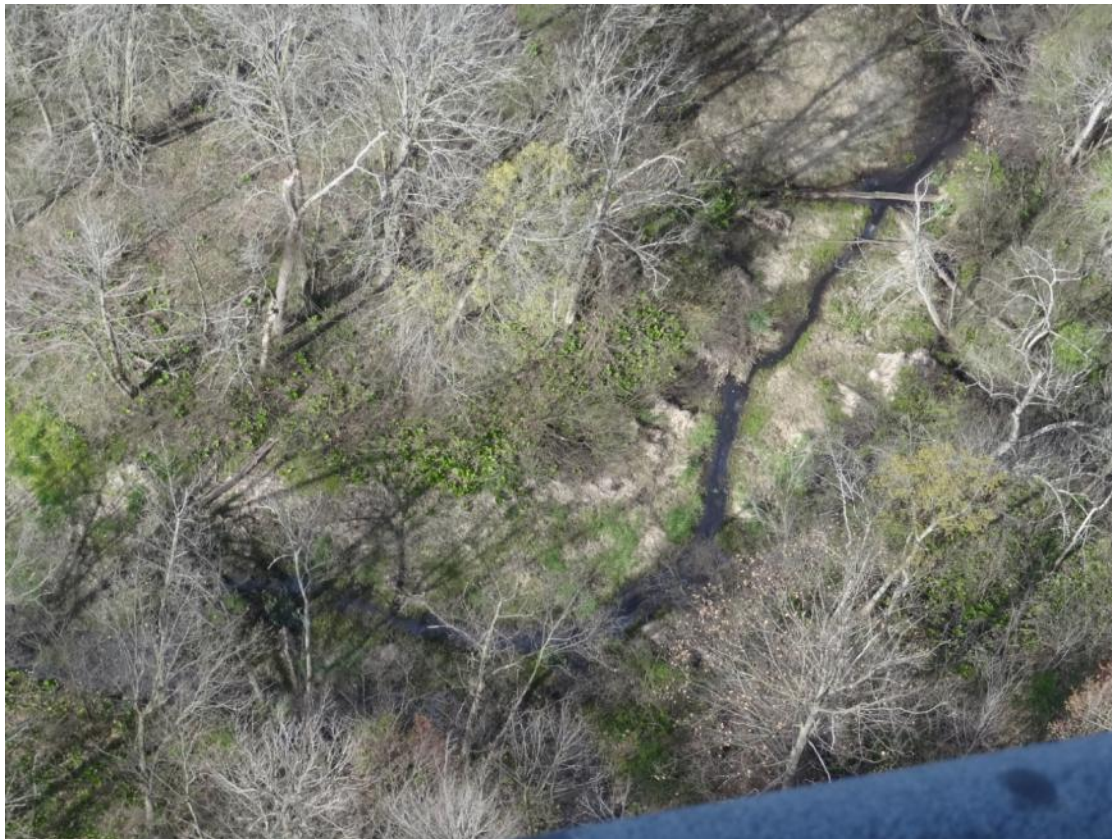
**11. MP9.0 RDB sheen observed in side channel.**

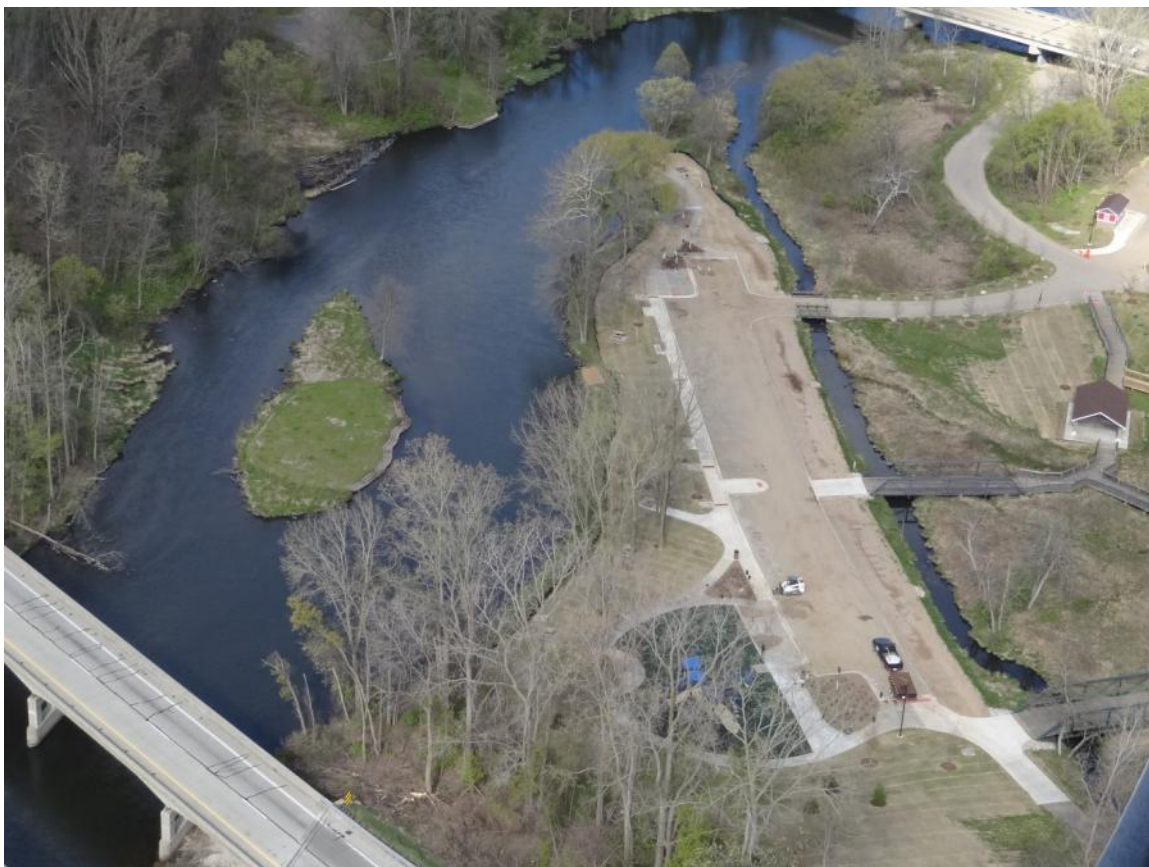
**12. Historic Bridge park observed crews planting trees.**

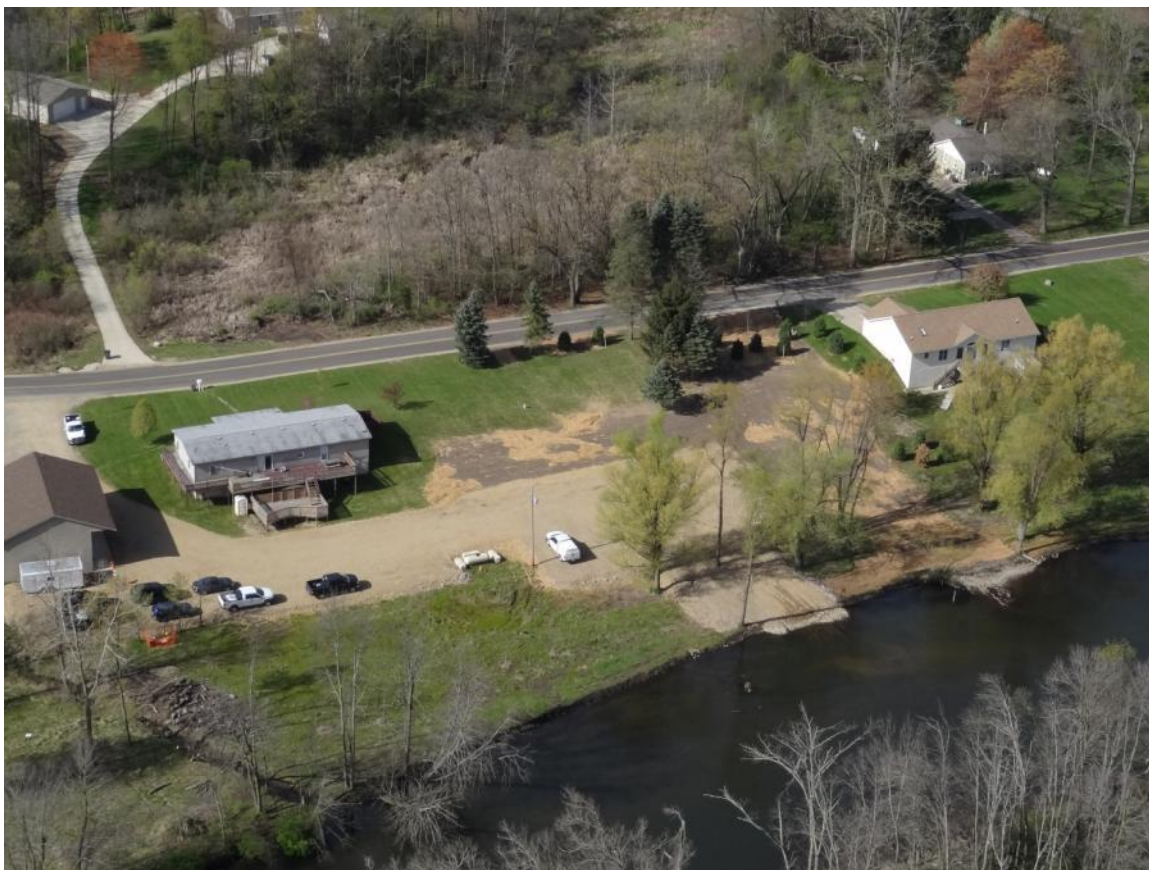
13. C3.2 Boat Launch foot print reduction.

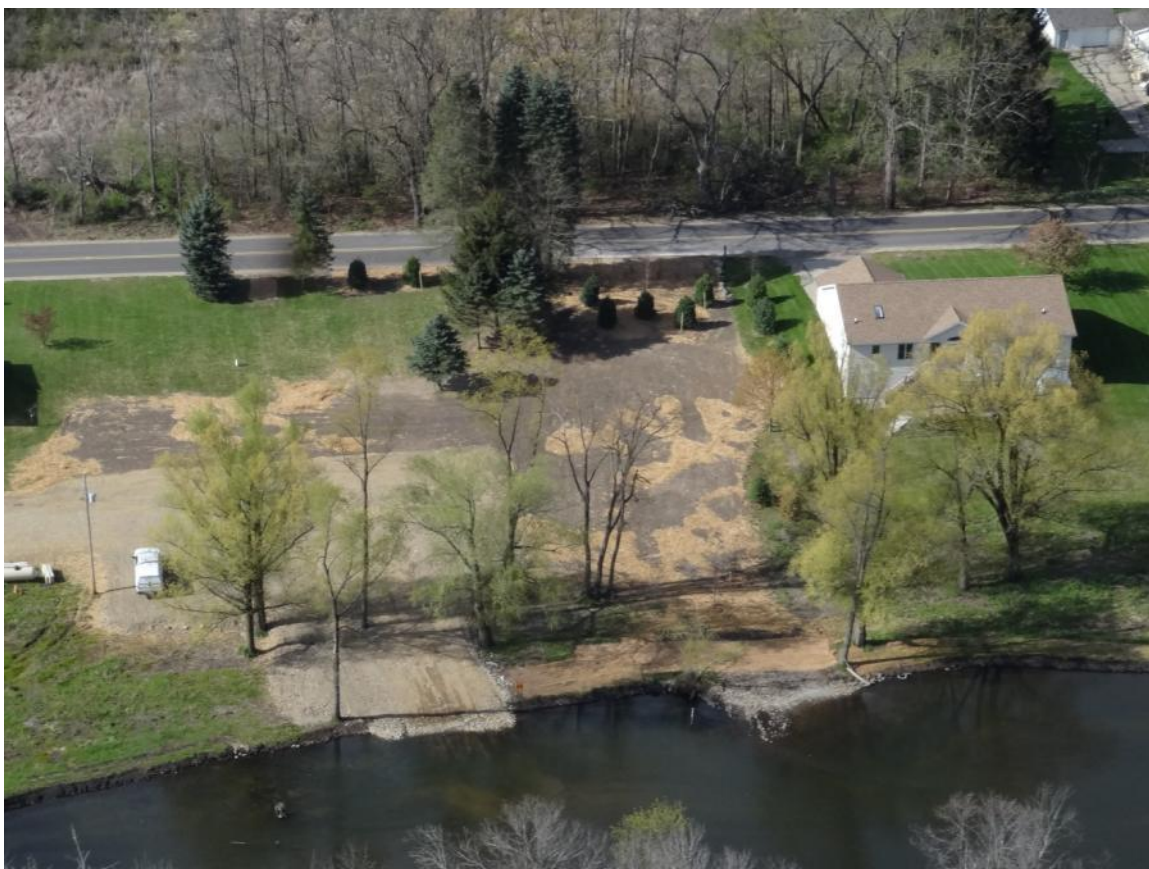
14. C3.2 Boat Launch foot print reduction.

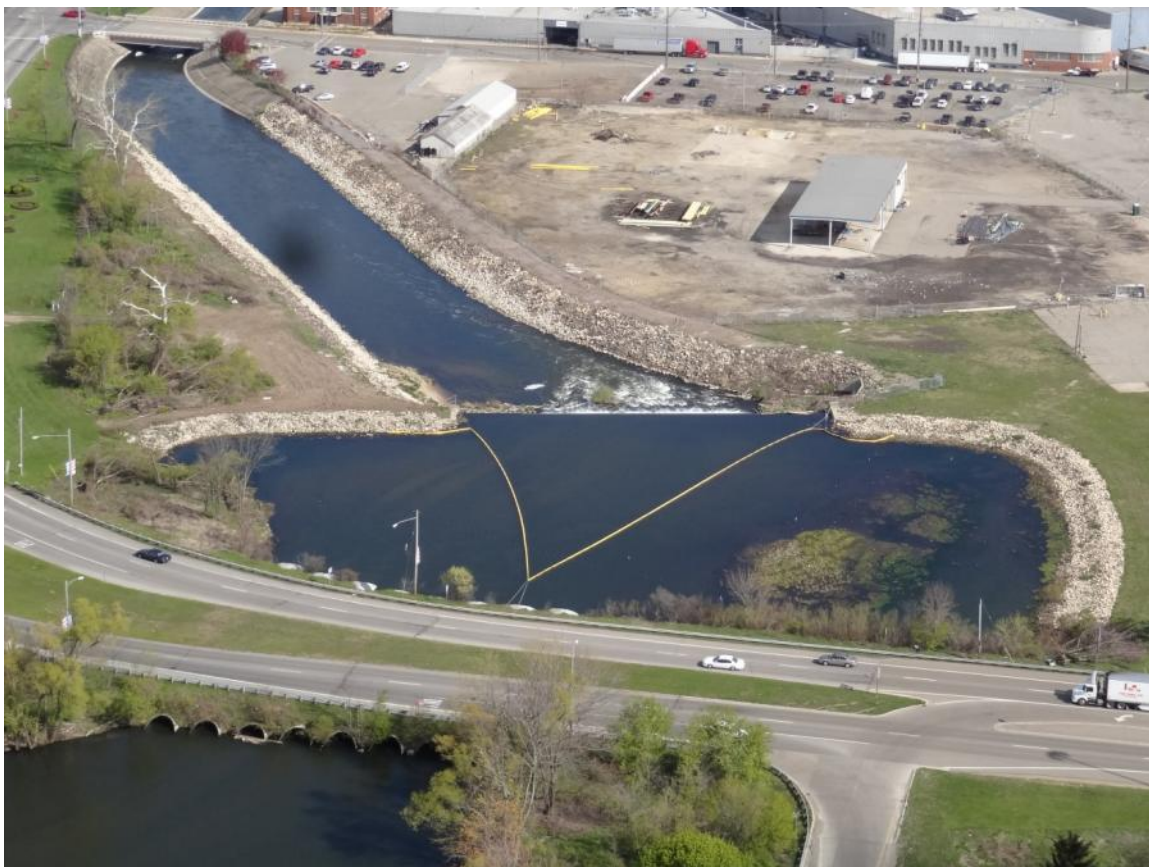
15. MP15.75 Control Point no sheen observed.

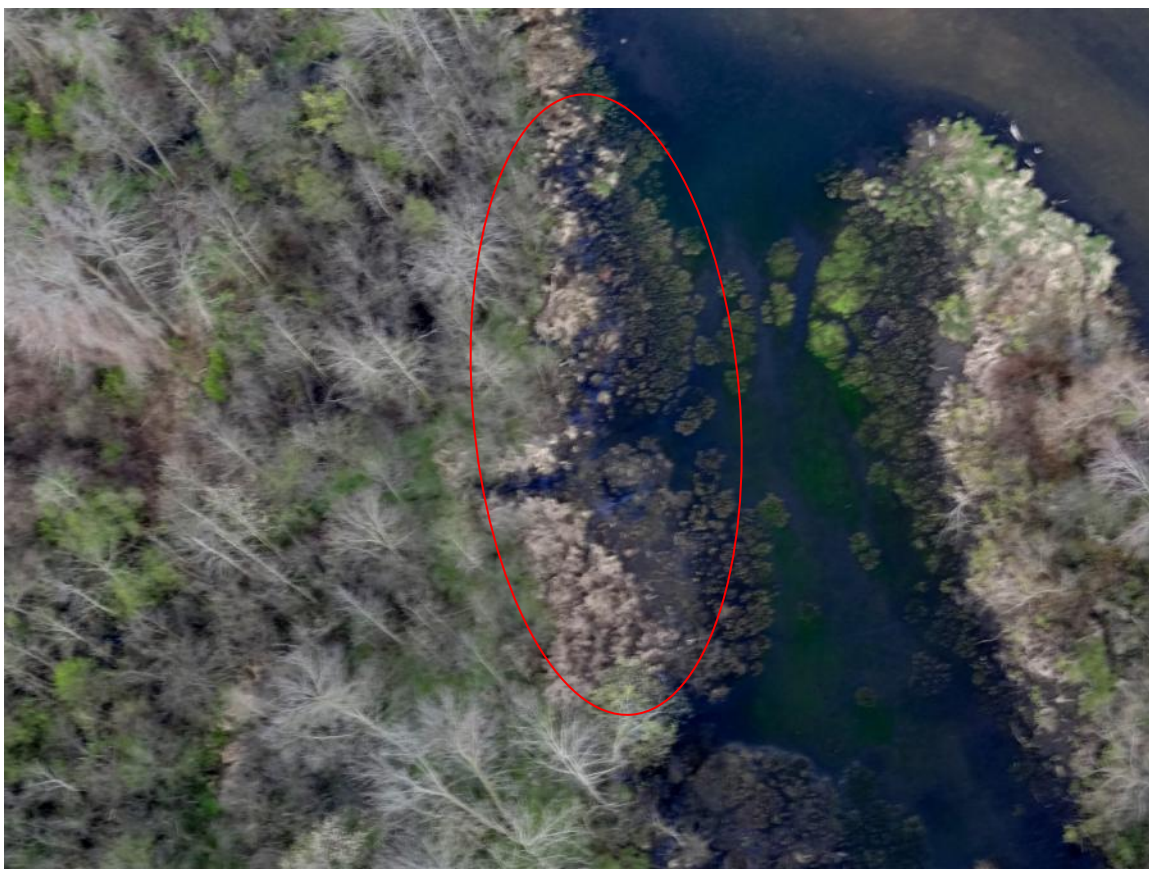
16. MP15.00 LDB, sheen observed LDB.

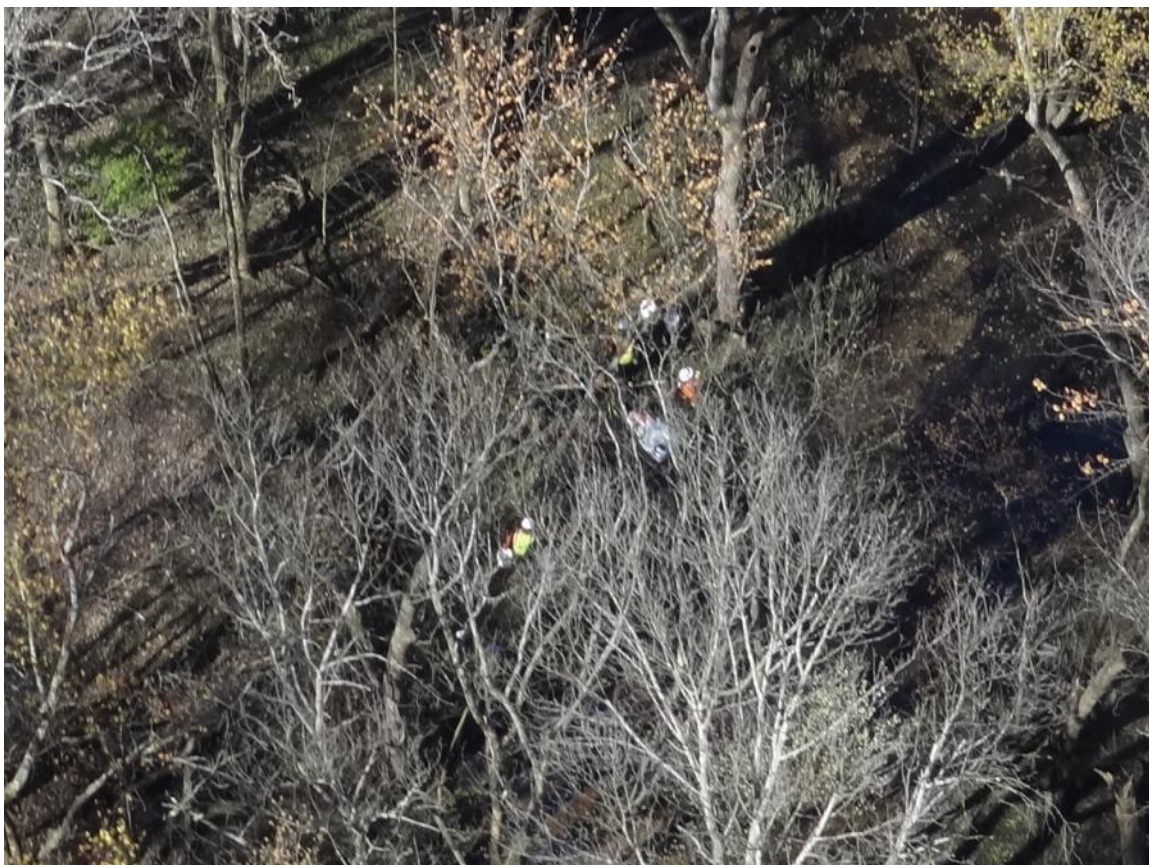
17. MP21.5 LDB overbank RI crew observed.

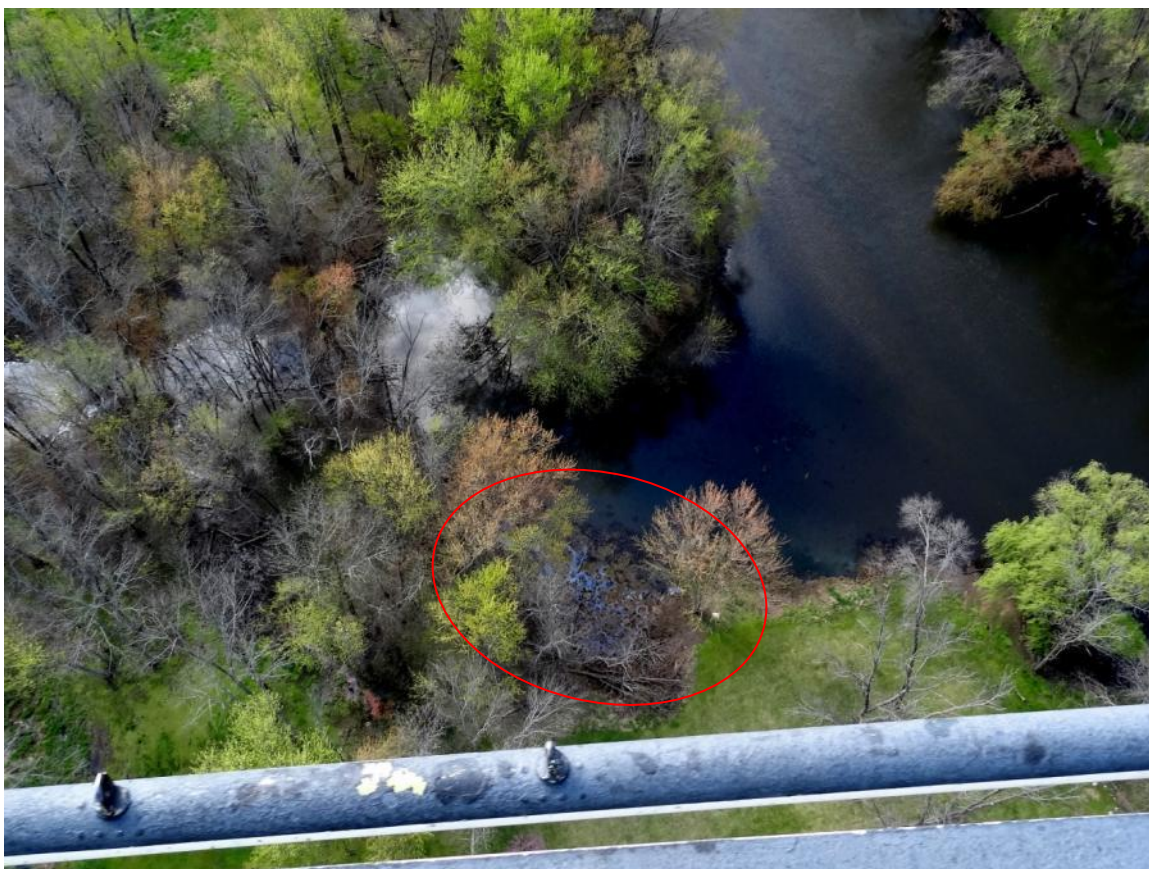
18. MP26.75 RDB sheen observed.

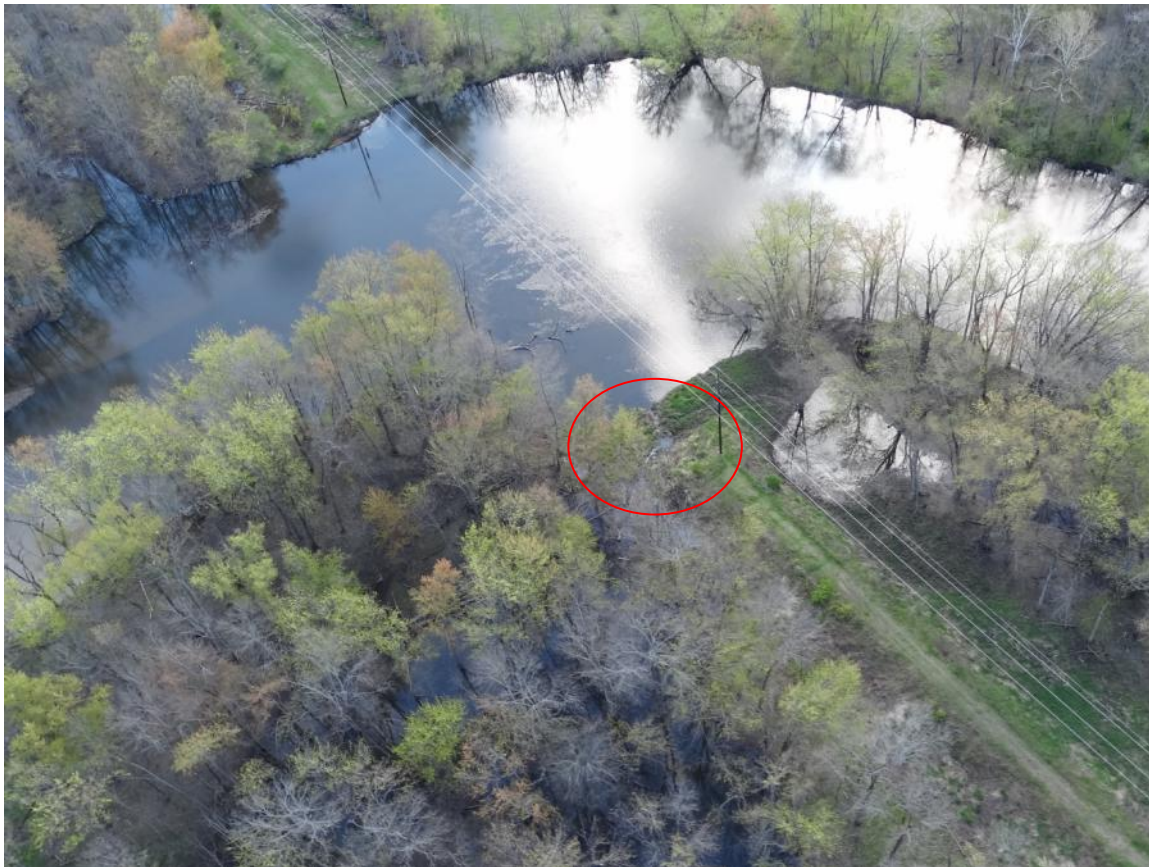
19. MP27.75 RDB sheen observed.

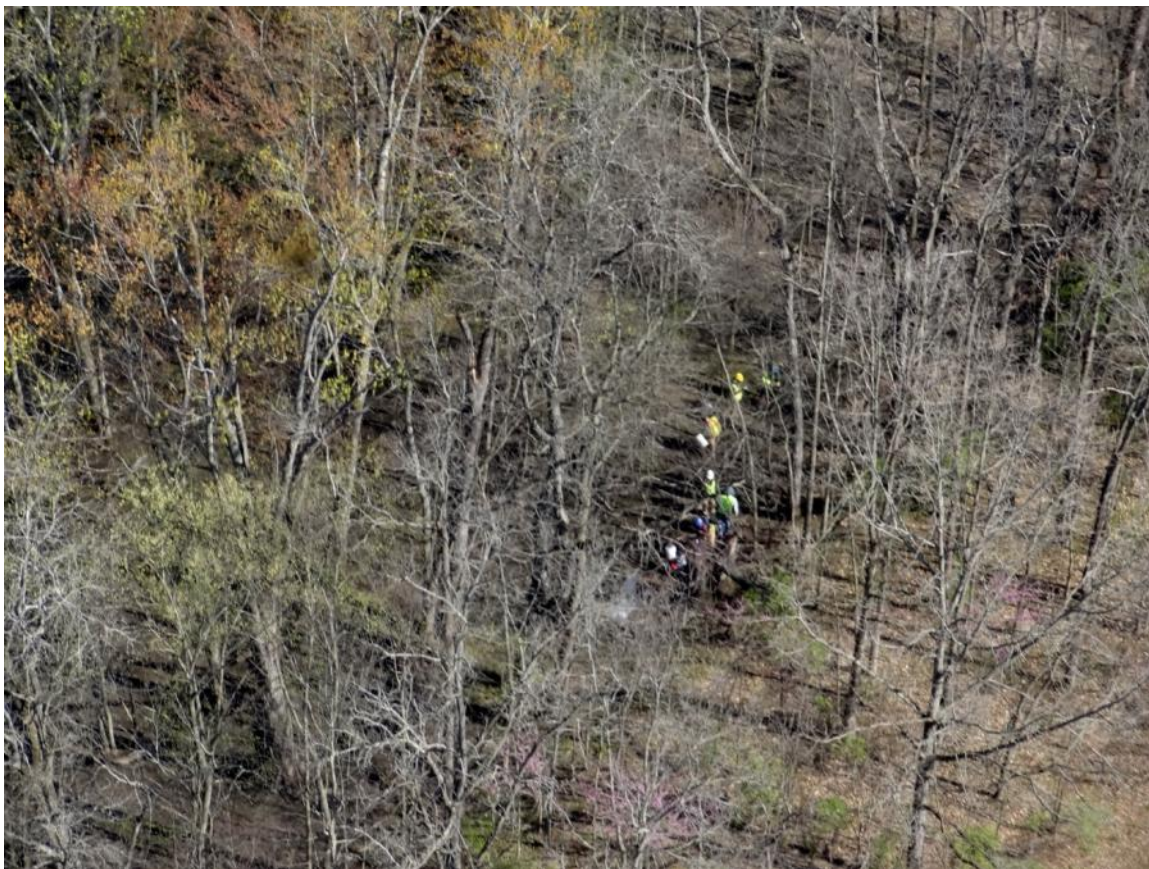
20. MP33.0 E2 Boat Launch RI crew observed.

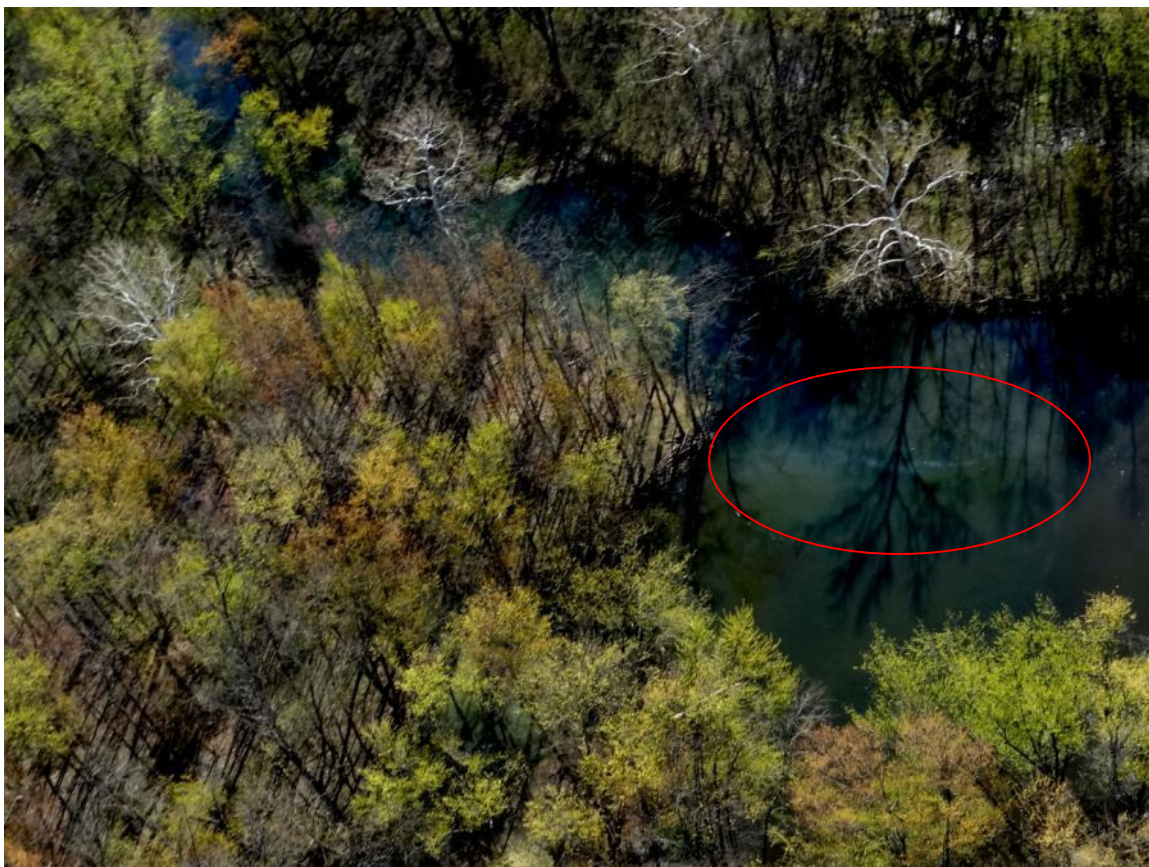
21. MP31.0 LDB sheen observed.

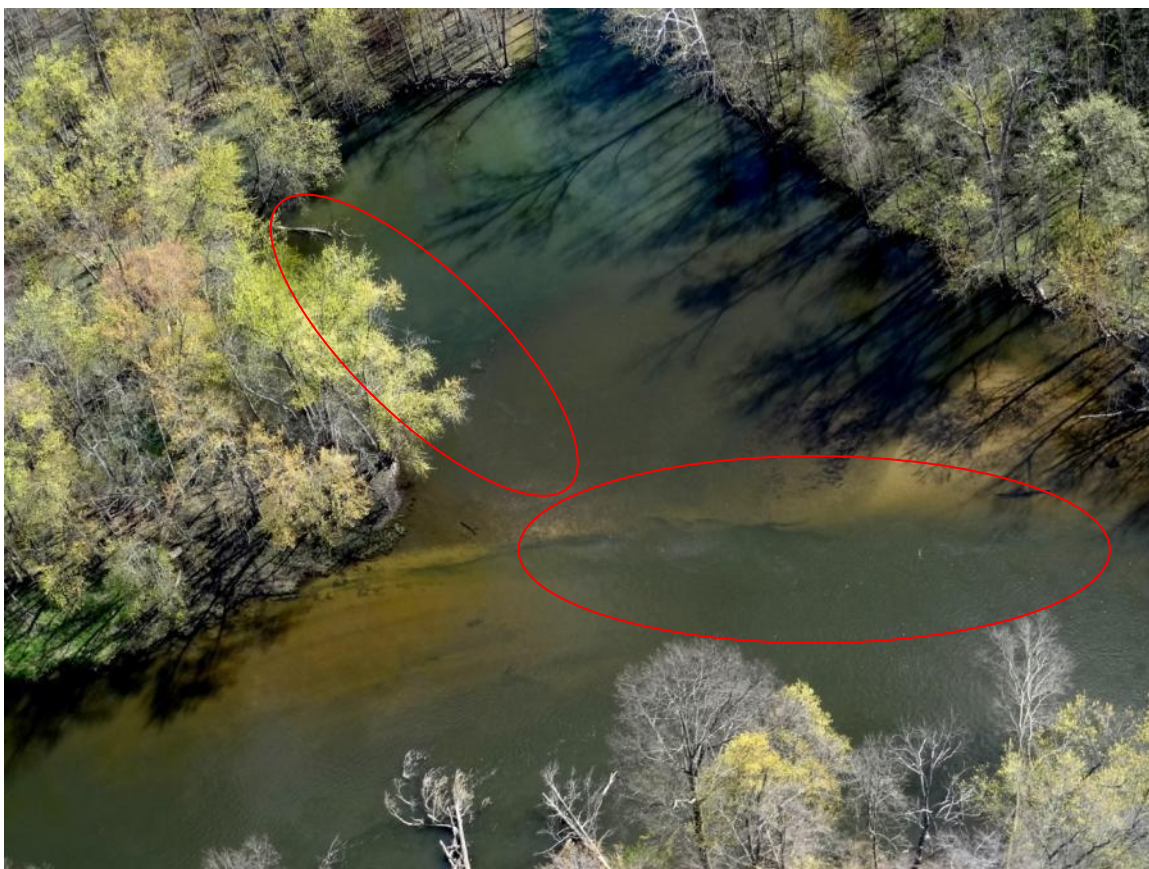
22. MP31.0 LDB sheen observed.

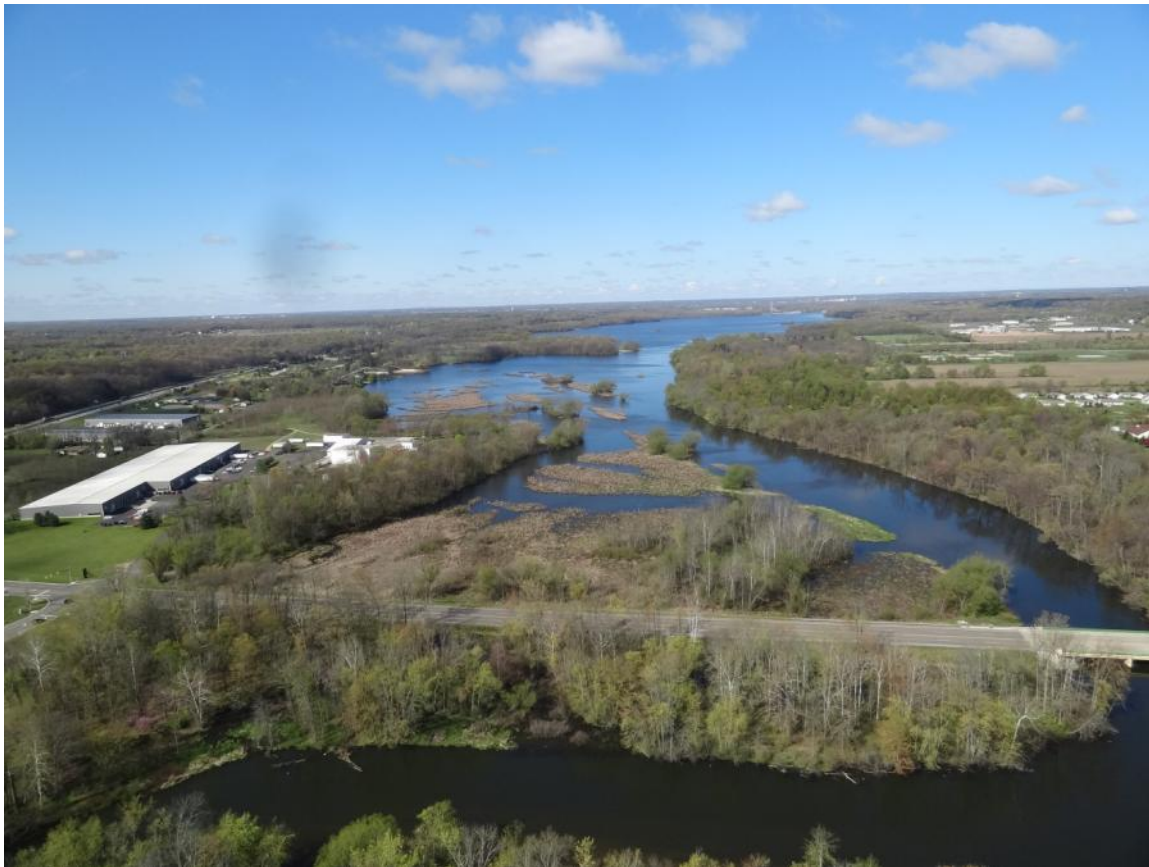
**23. Morrow Lake Delta. No sheen observed.**
