# Situation Photo Log

Wednesday, April 11, 2012

Kalamazoo River / Enbridge Spill

Matthew Haak  
START-USEPA  
Situation Unit Leader

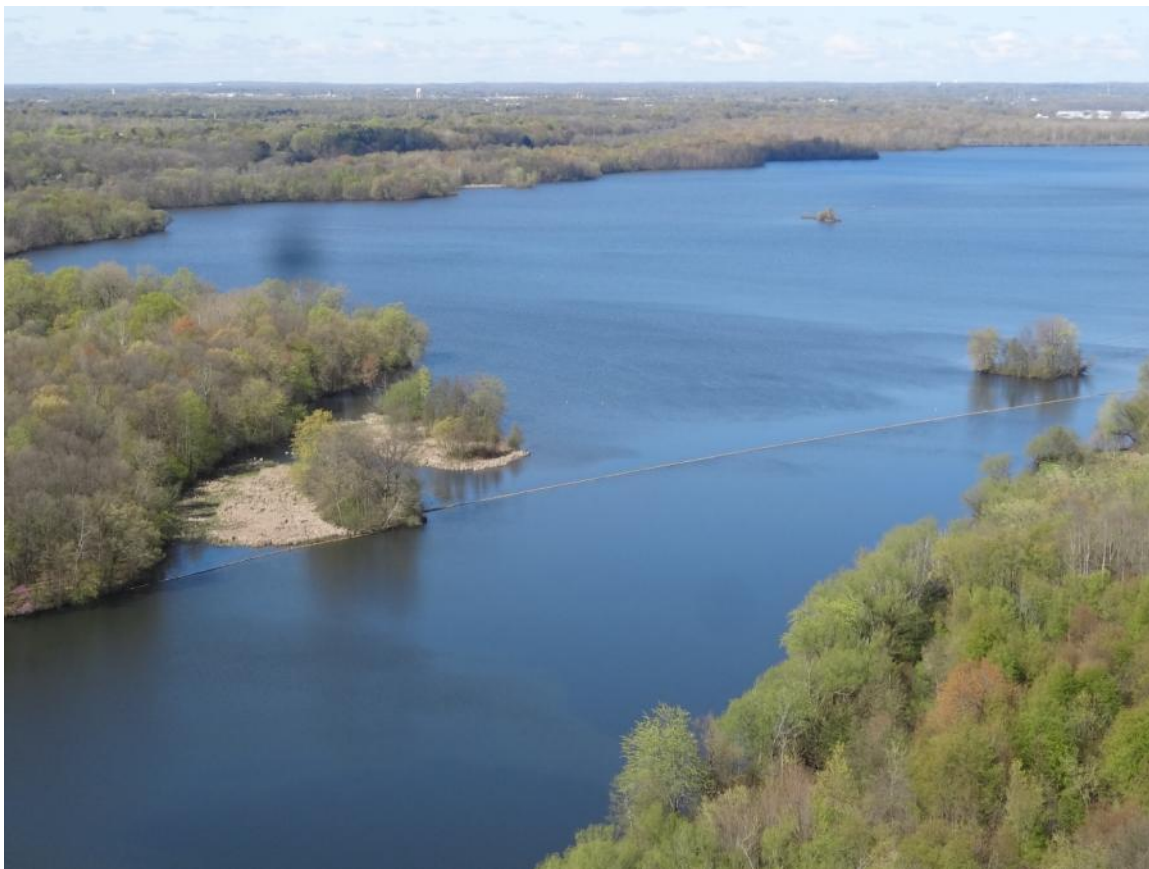
**24. Control Point E4, no sheen observed.**

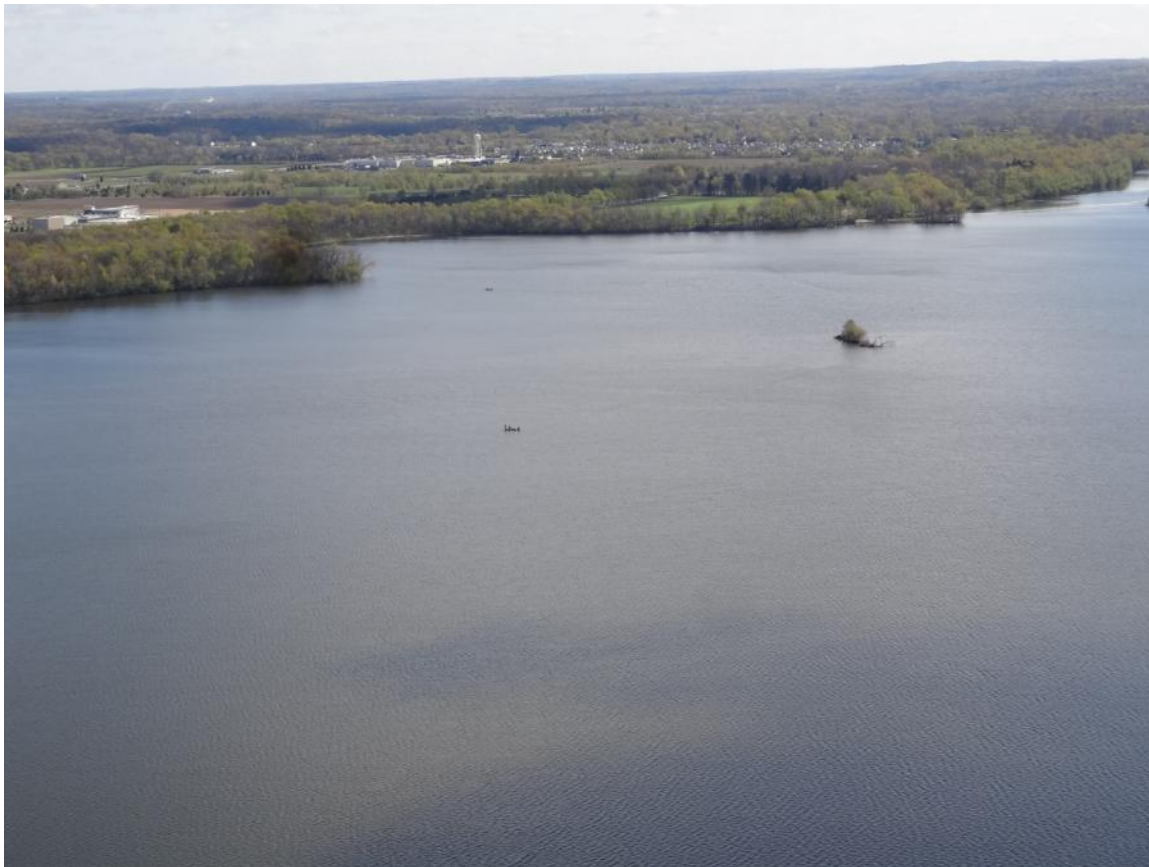
**25. Poling crew and crew installing Walling Tubes on Lake Morrow.**

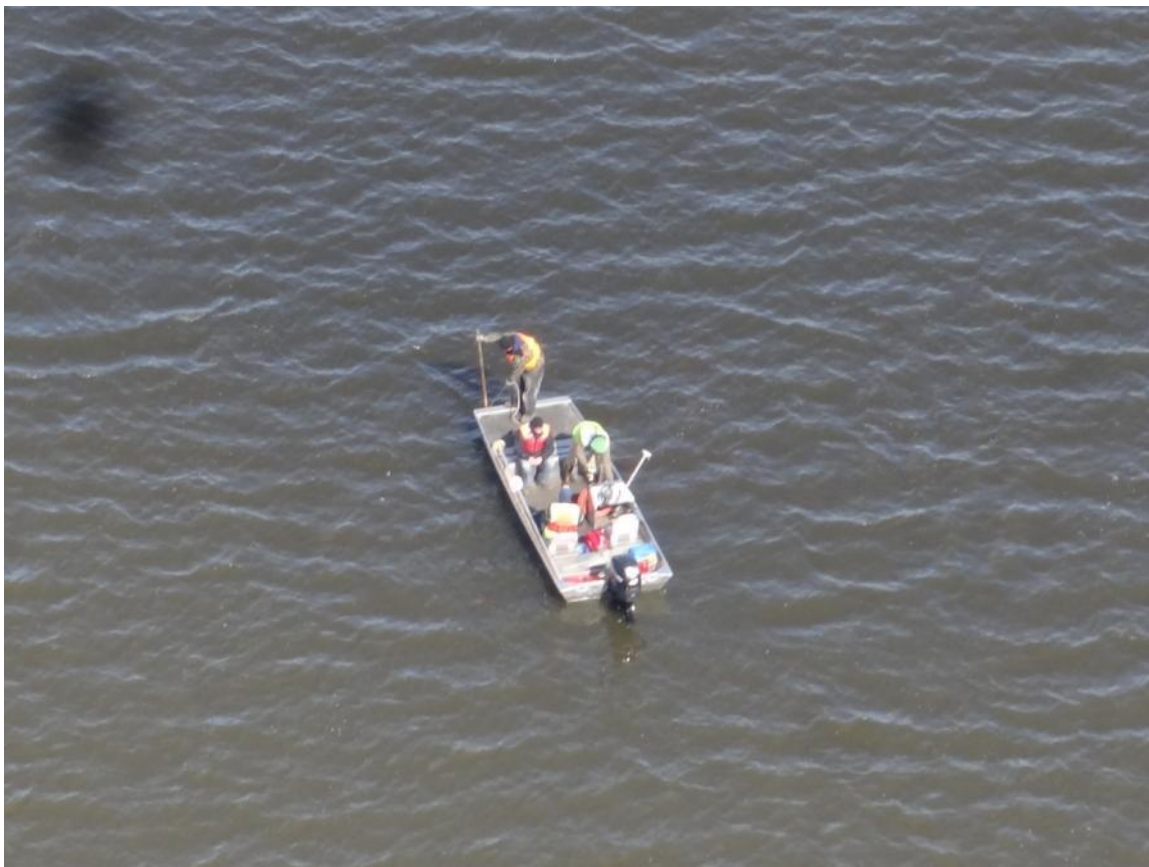
**26. Poling Crew on Lake Morrow.**

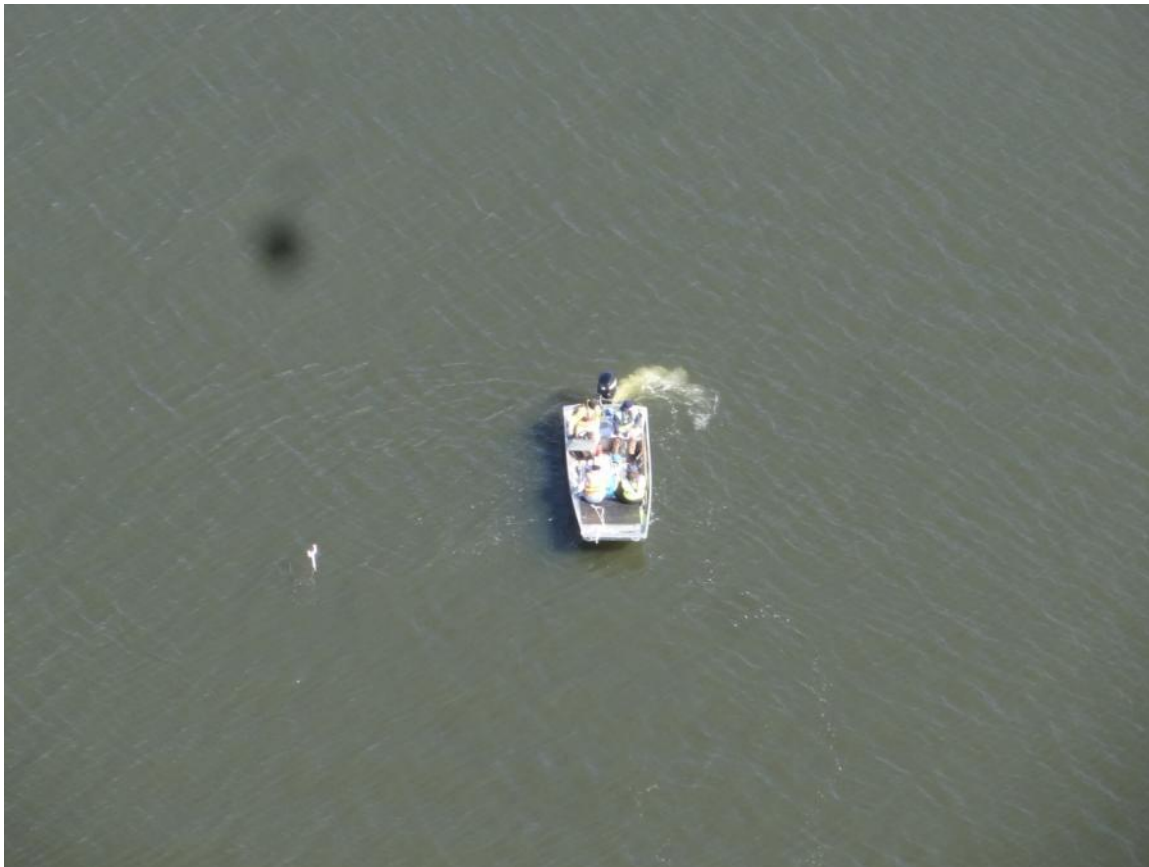
**27. Crew installing Walling Tubes in Lake Morrow.**

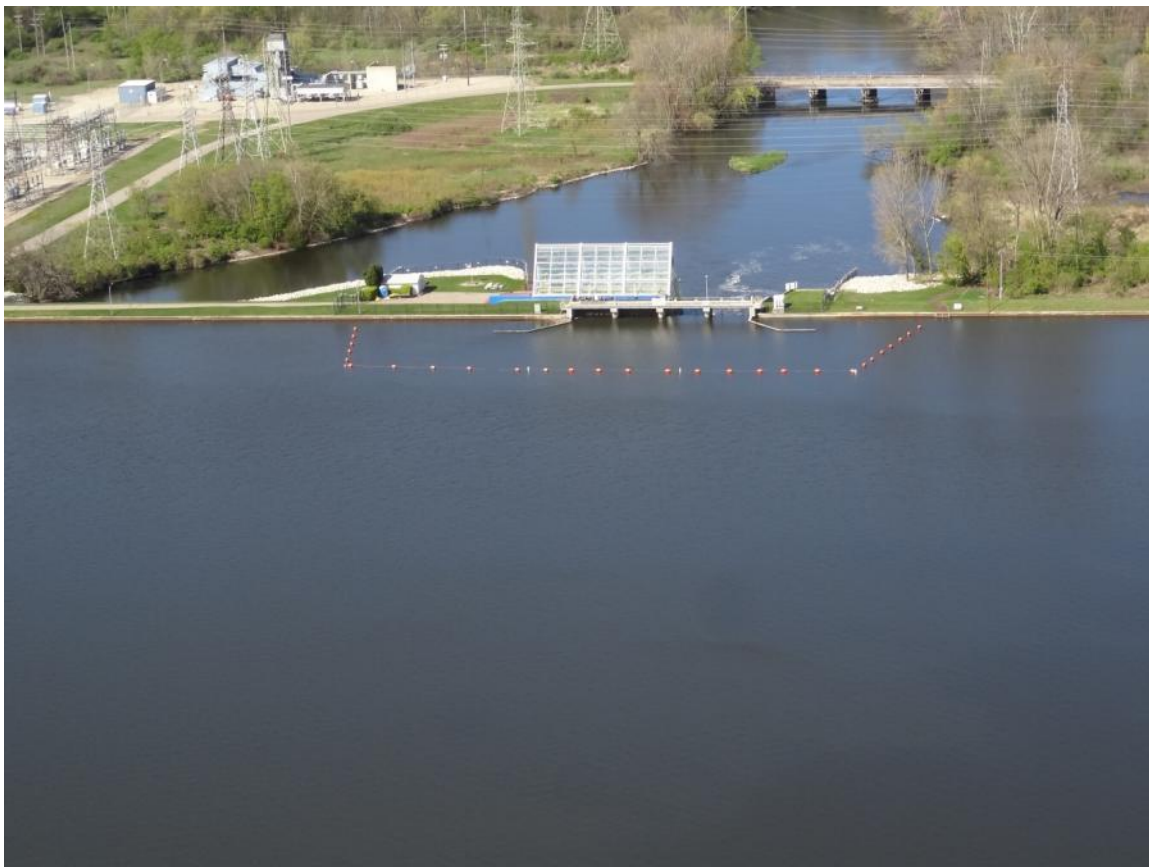
**28. Morrow Lake Dam buoys reinstalled.**
