Situation Photo Log

Friday, April 13, 2012

Kalamazoo River / Enbridge Spill

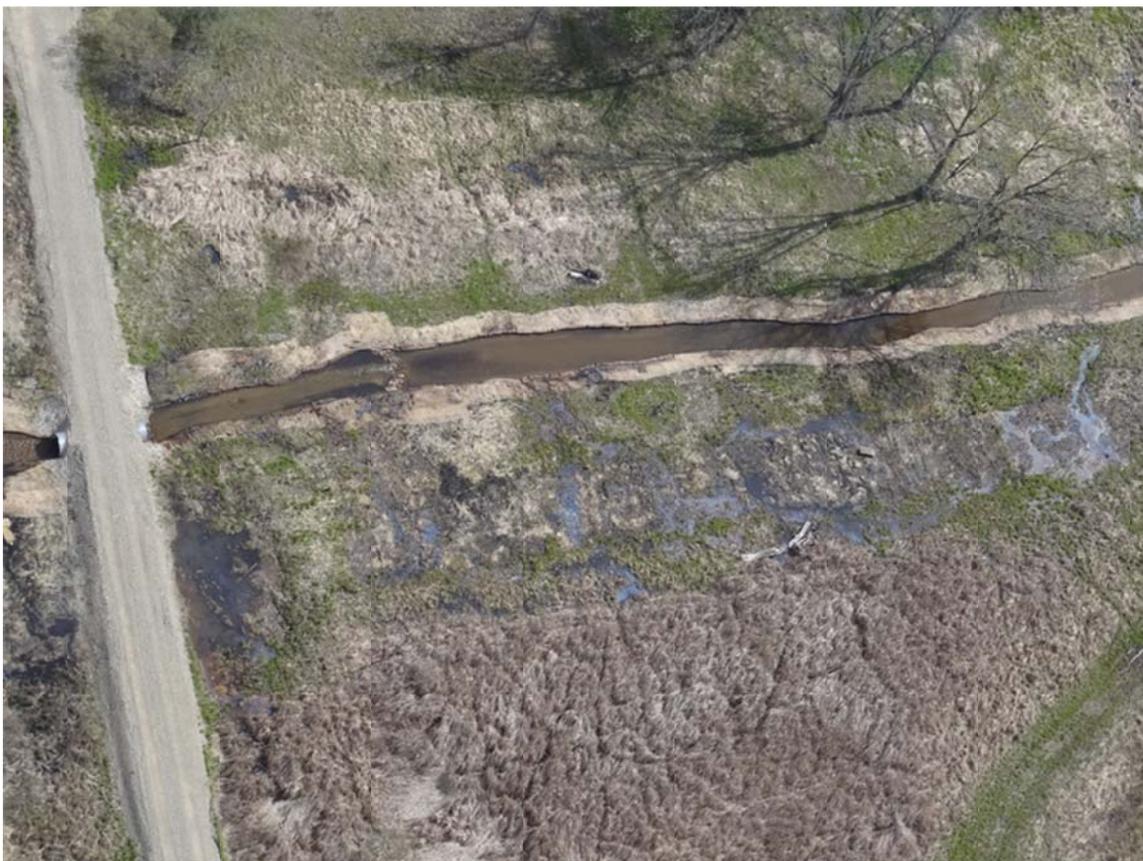
1. MP0.75 sheen observed LDB Talmadge Creek.

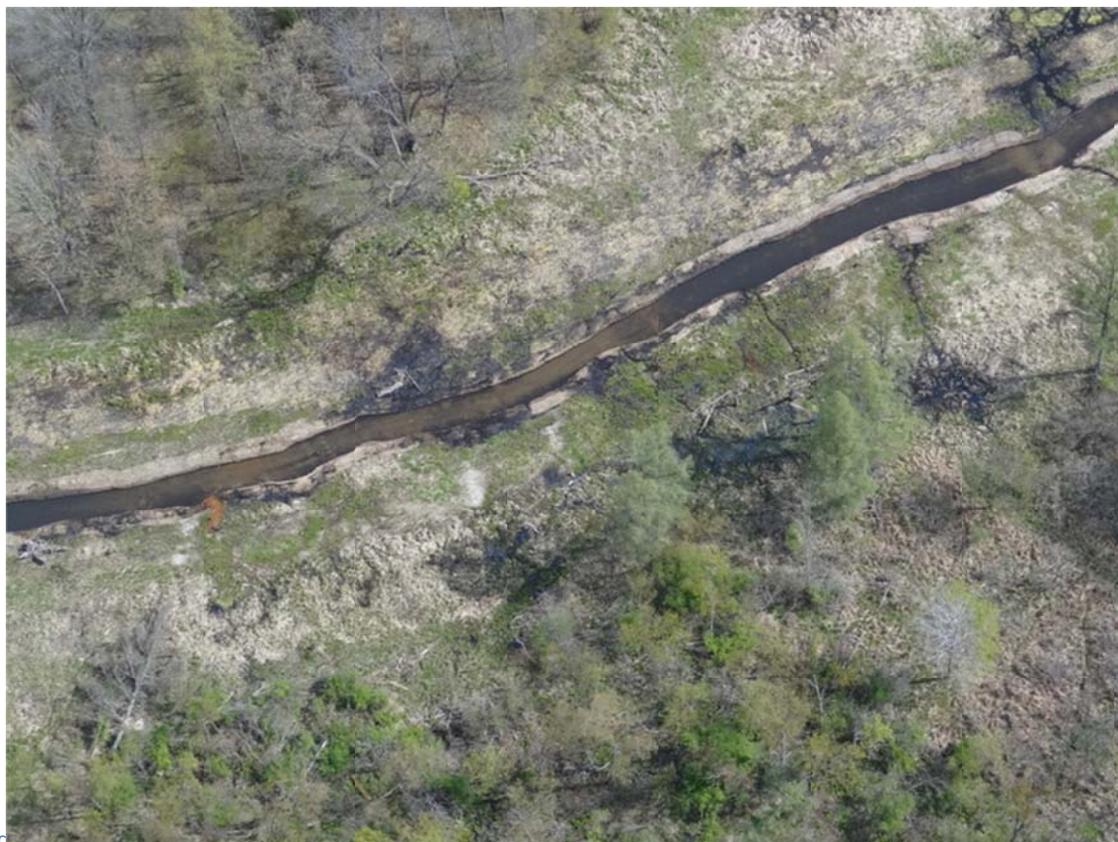
2. MP1.0 LDB sheen observed along Talmadge Creek.

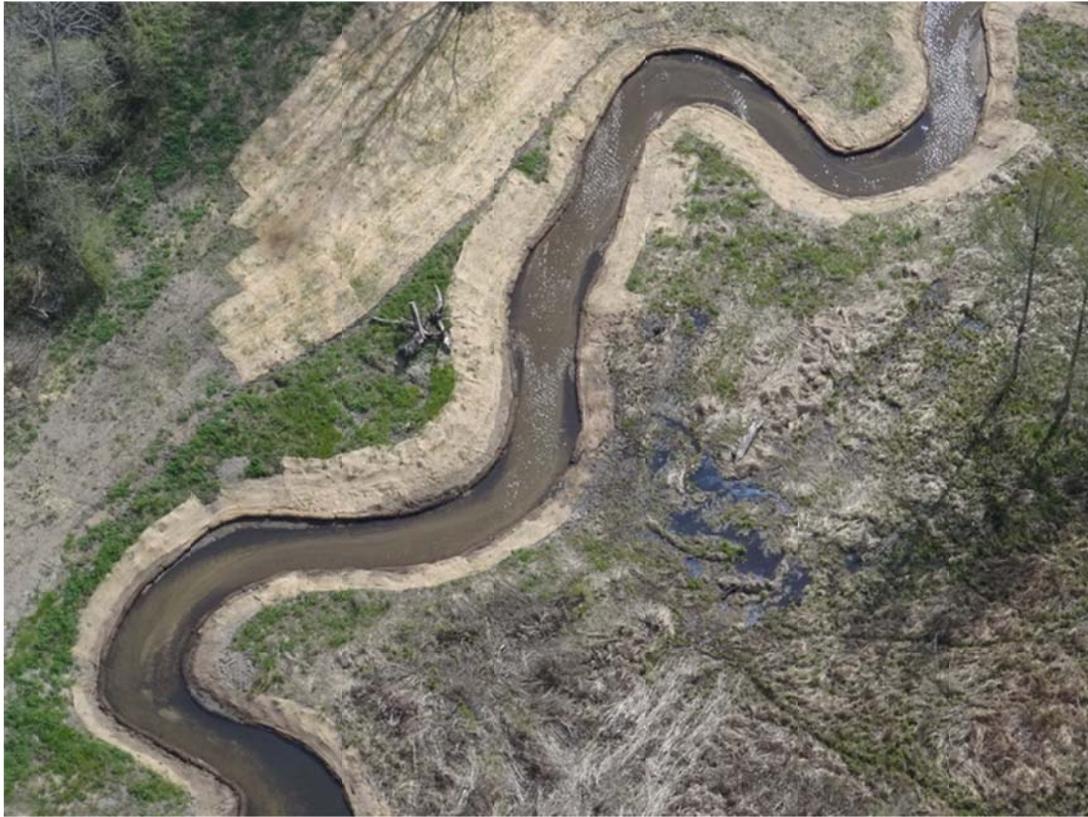
3. MP1.75 LDB sheen observed along Talmadge Creek.

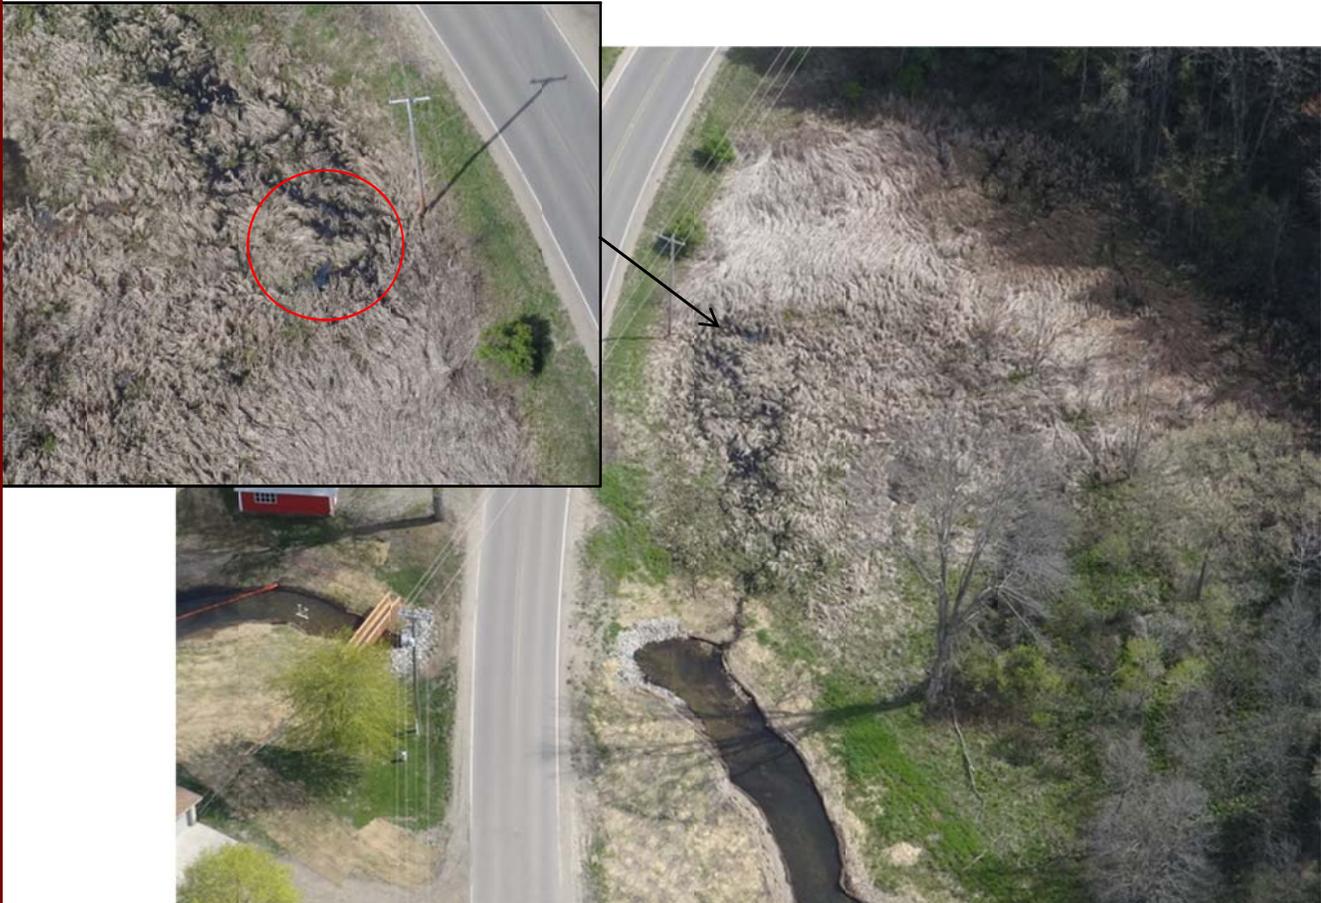
4. Sheen observed along Talmadge Creek at A Drive.

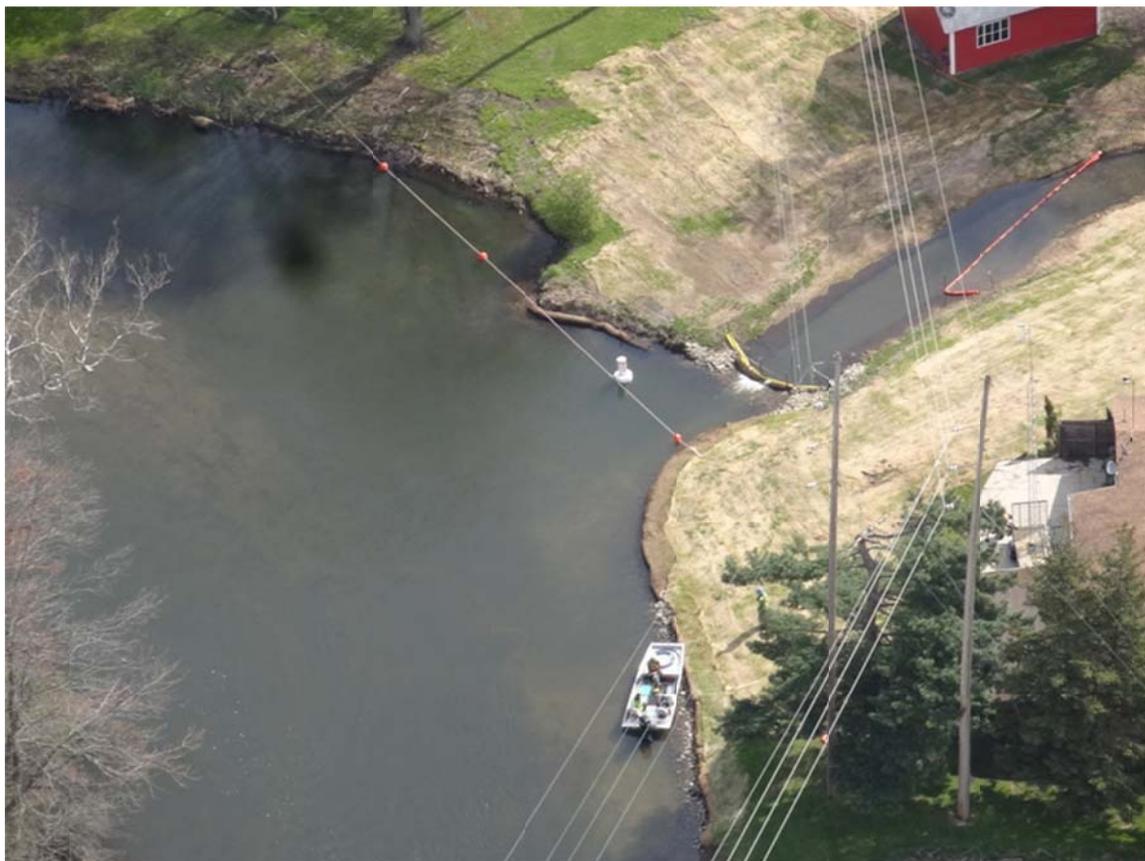
5. Crews reconfigured buoys at the confluence.

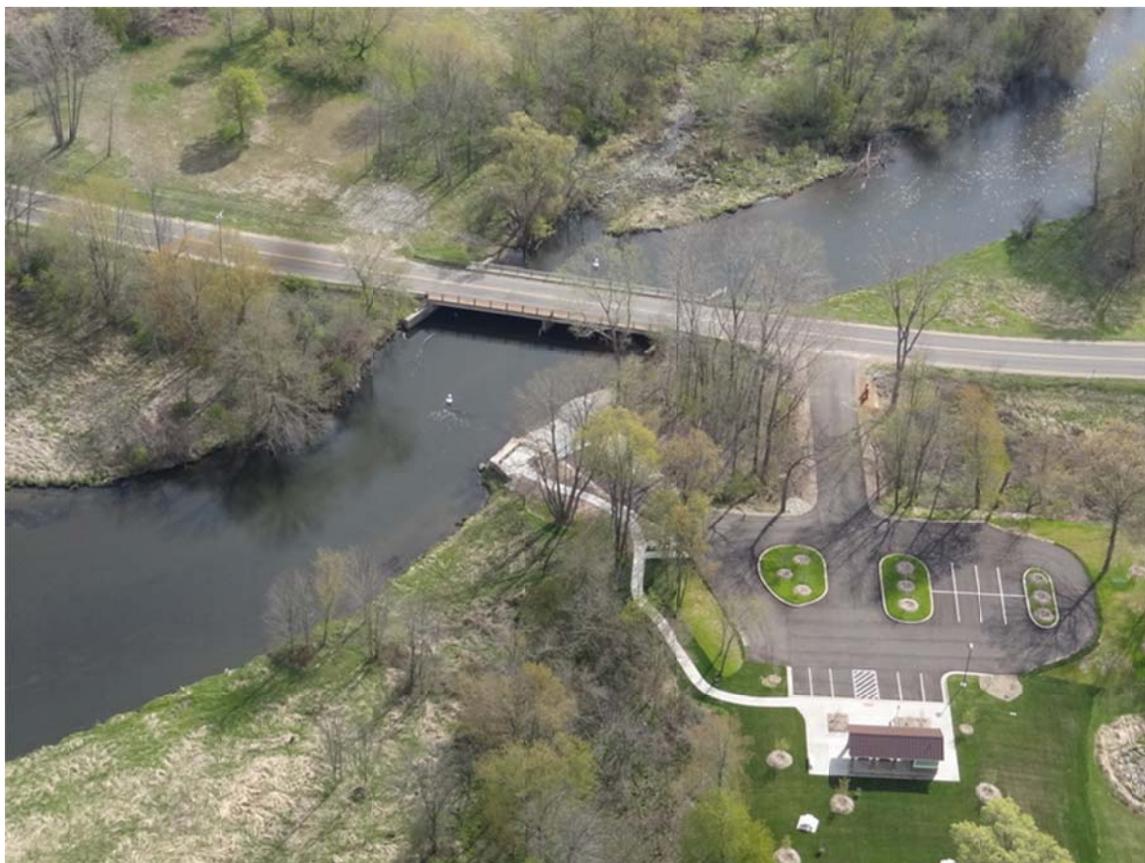
6. Buoy Cans deployed at Saylor's landing.

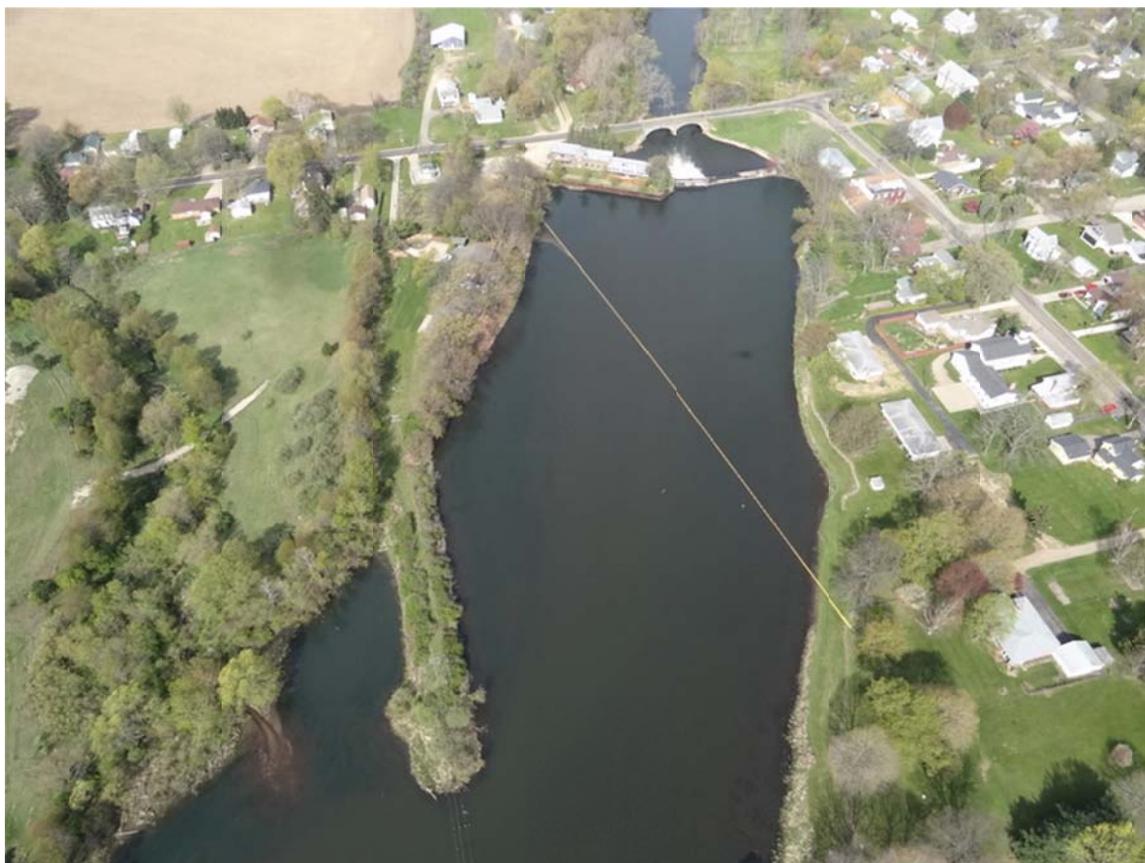
7. Ceresco Dam containment boom.

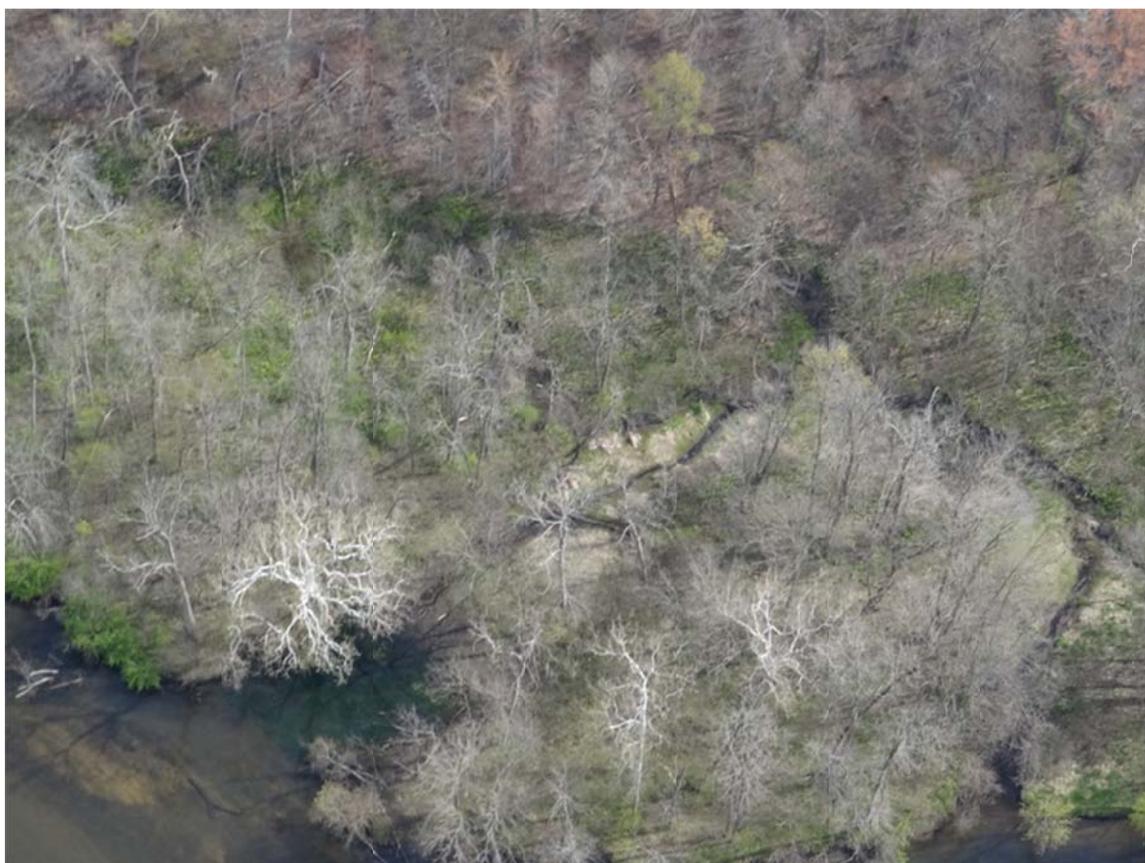
8. MP9.0R1 sheen observed in side channel.

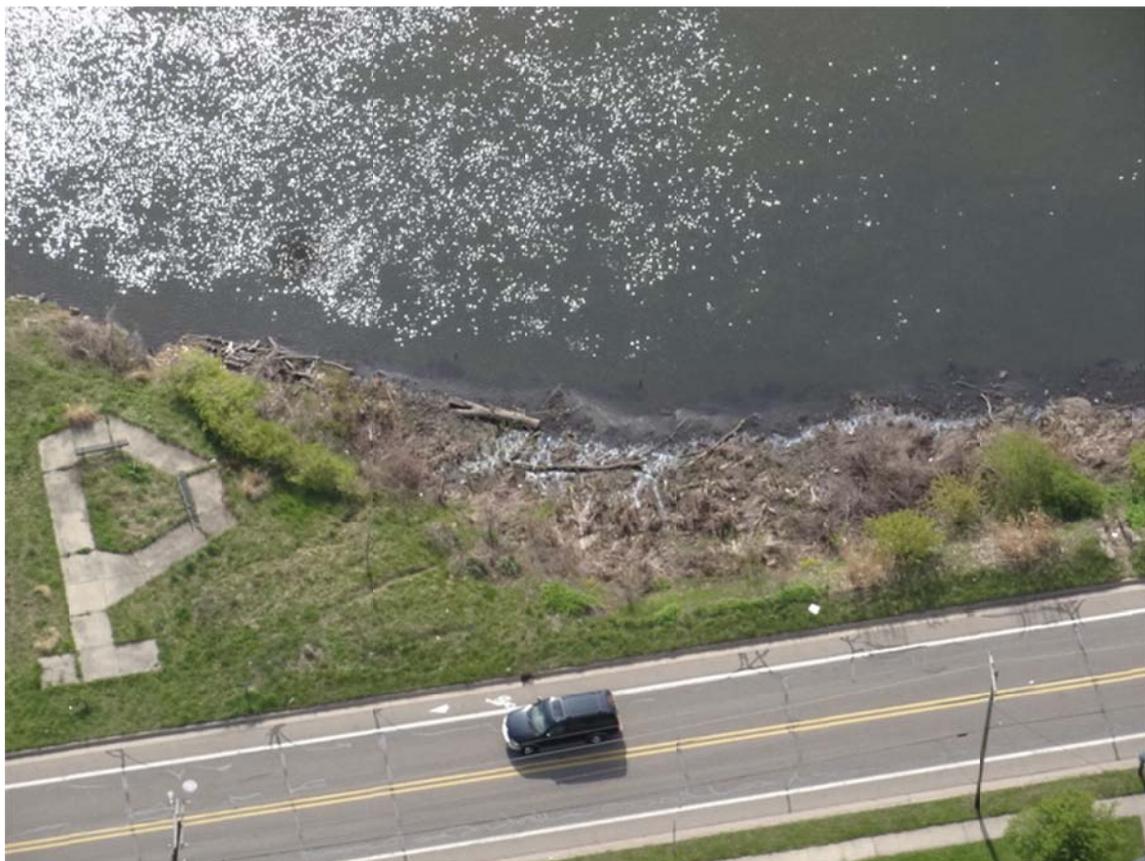
9. MP15.25 Mill Pond sheen observed along the LDB.

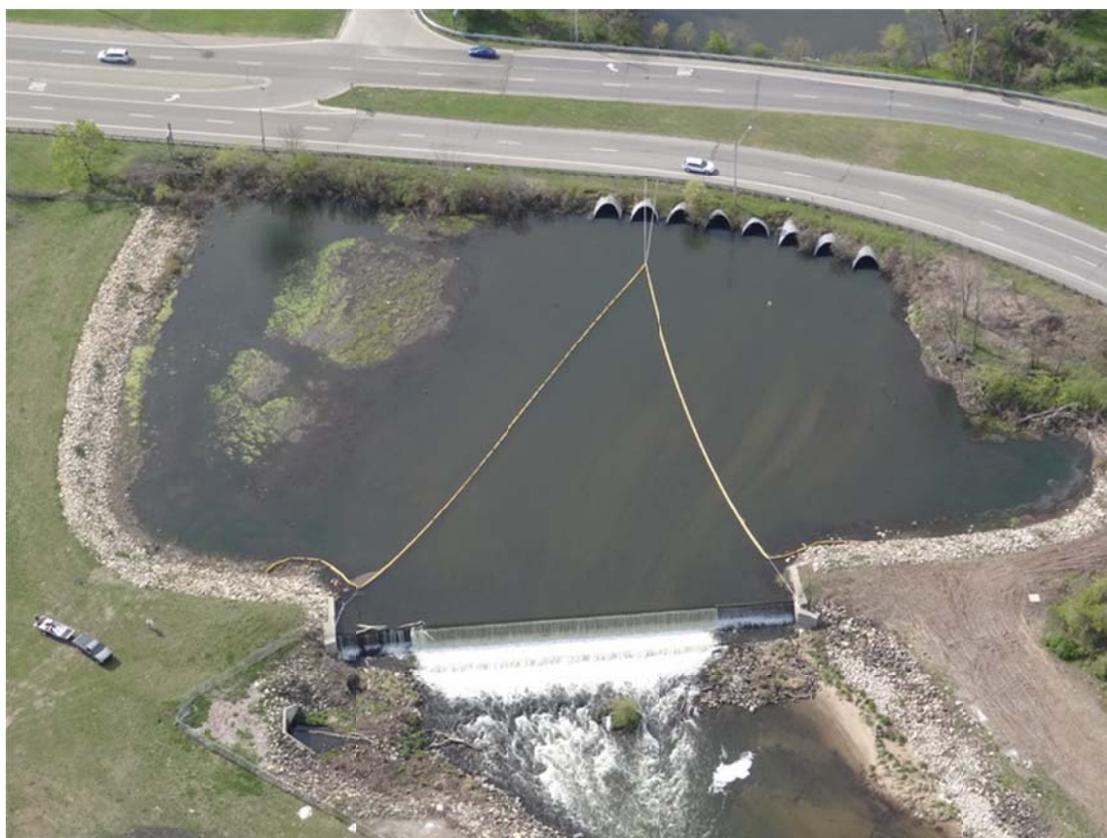
10. MP15.75 Containment Boom, observed SWAT.

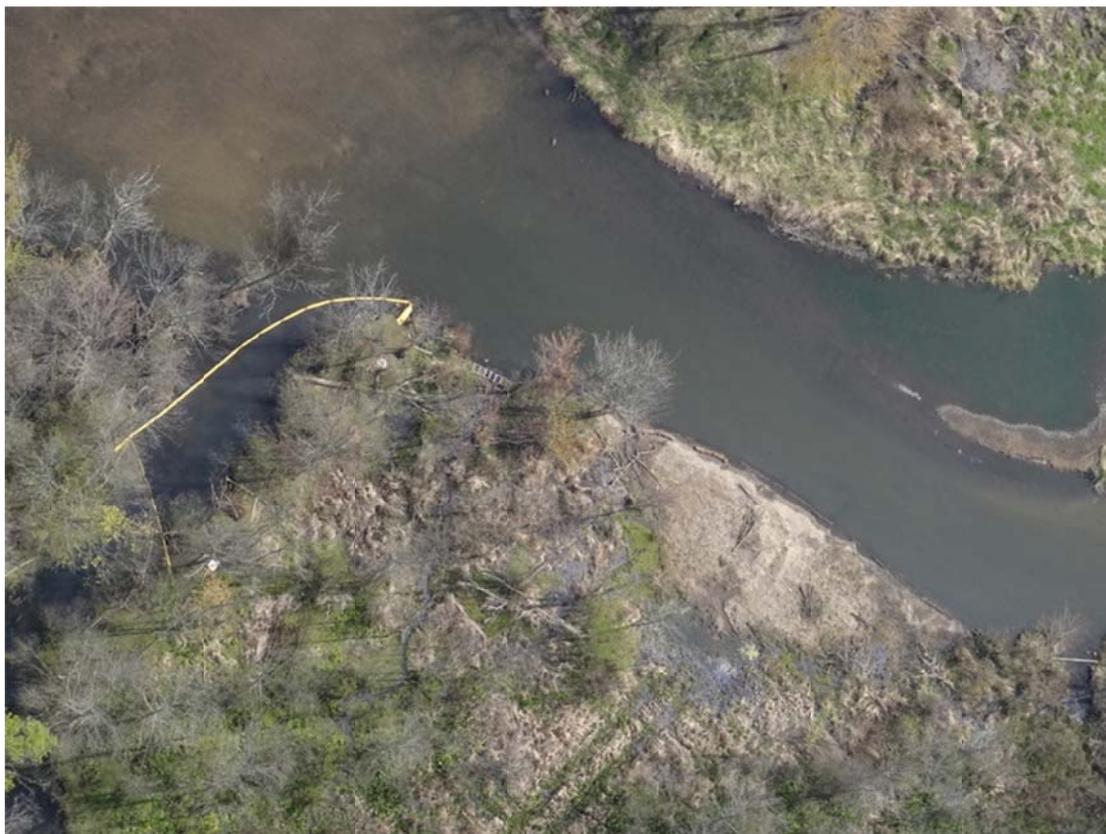
11. MP15.0 LDB sheen observed on overbank.

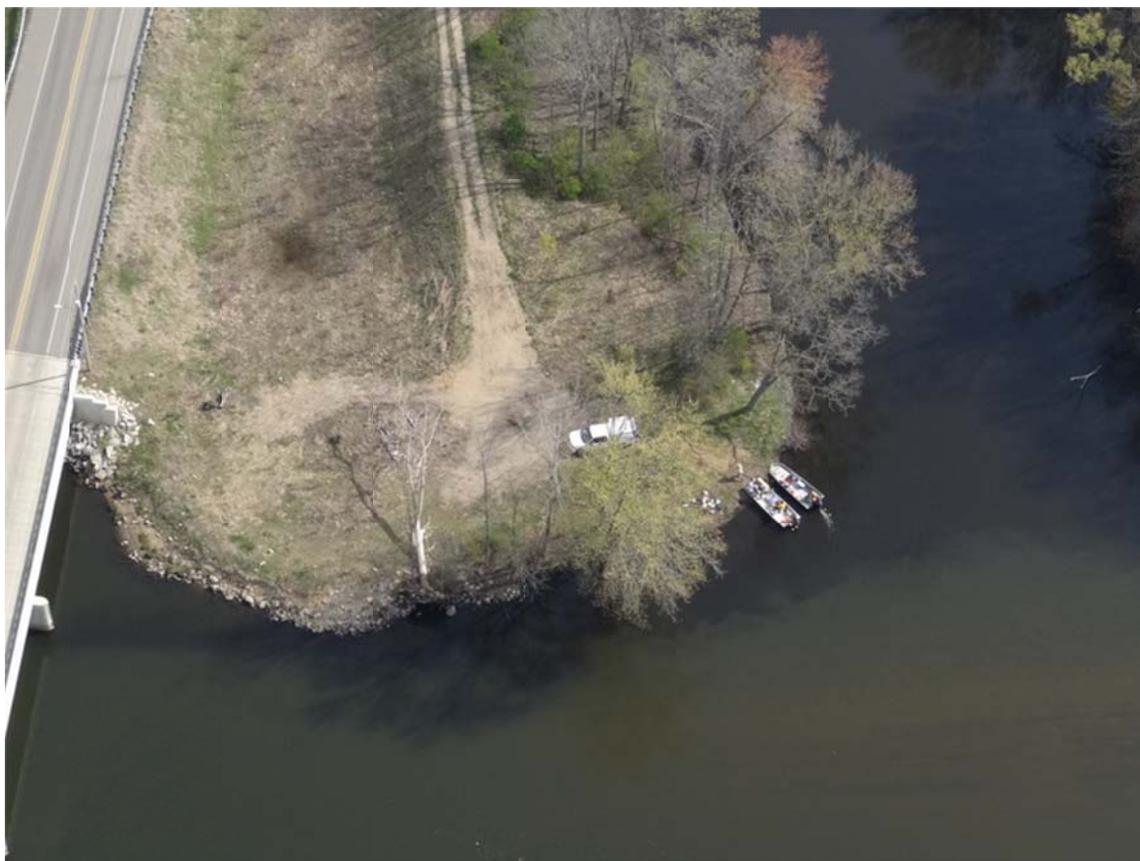
12. MP21.5 observed crews.

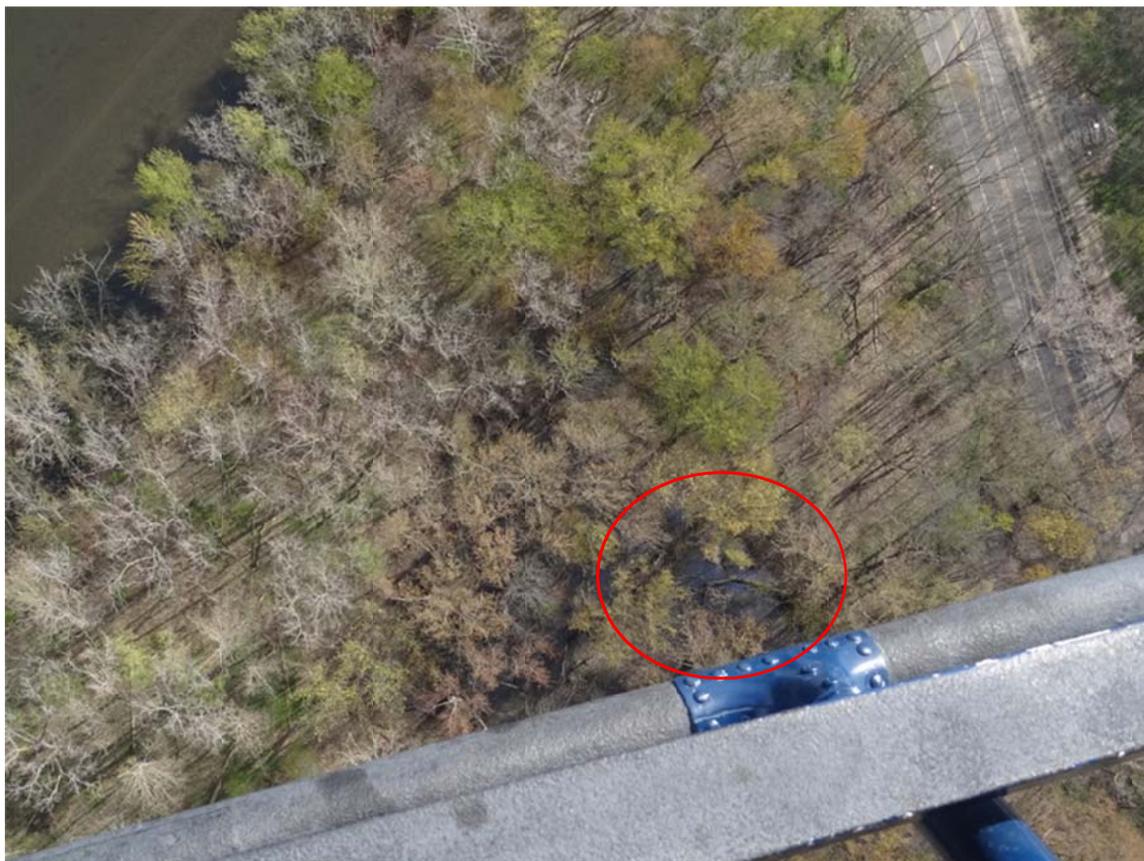
13. MP21.5 LDB sheen observed in area where RI crew was working.

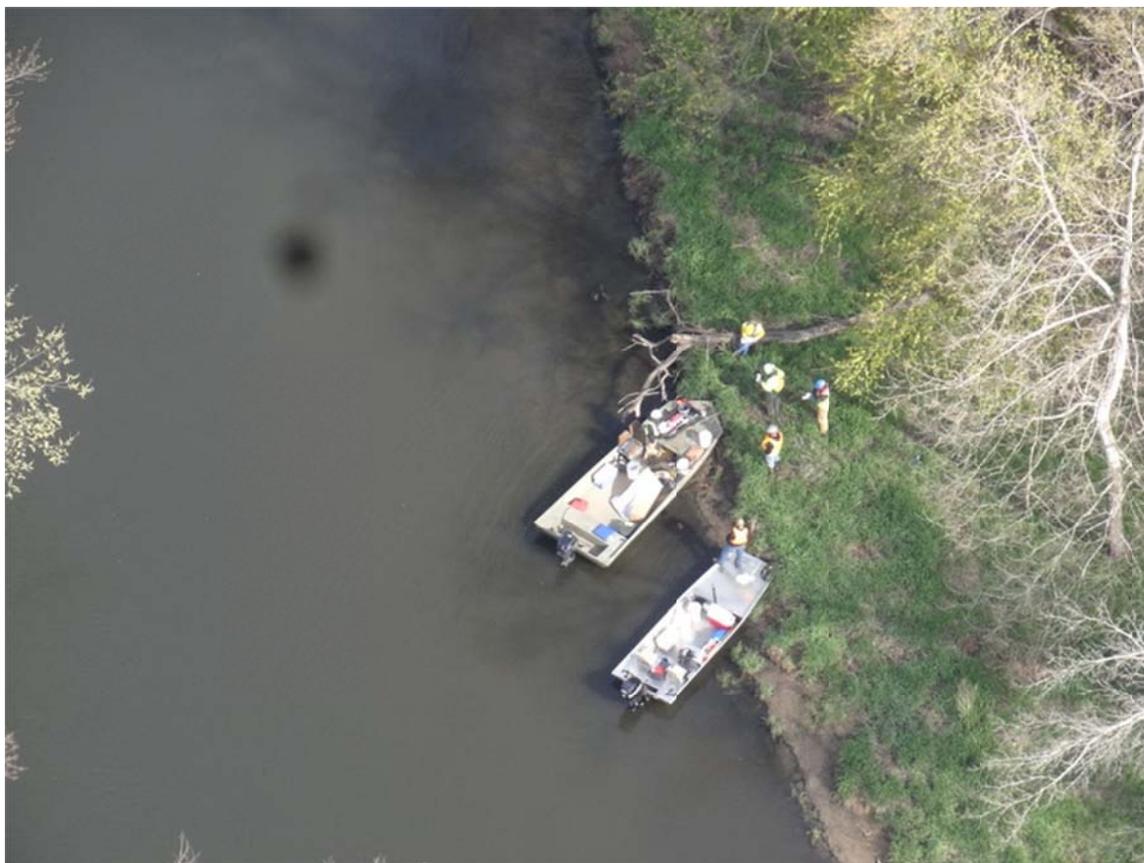
14. RI crew observed near MP30.5.

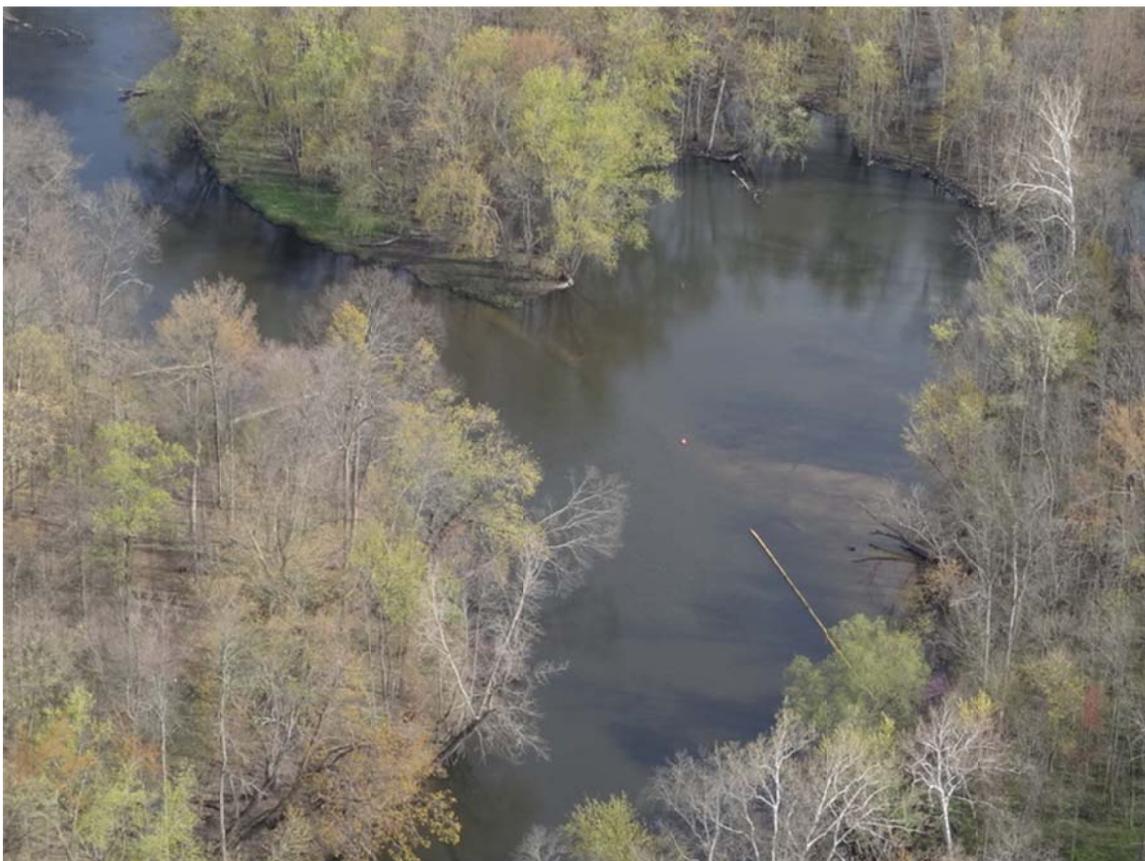
15. MP30.8 new boom deployed.

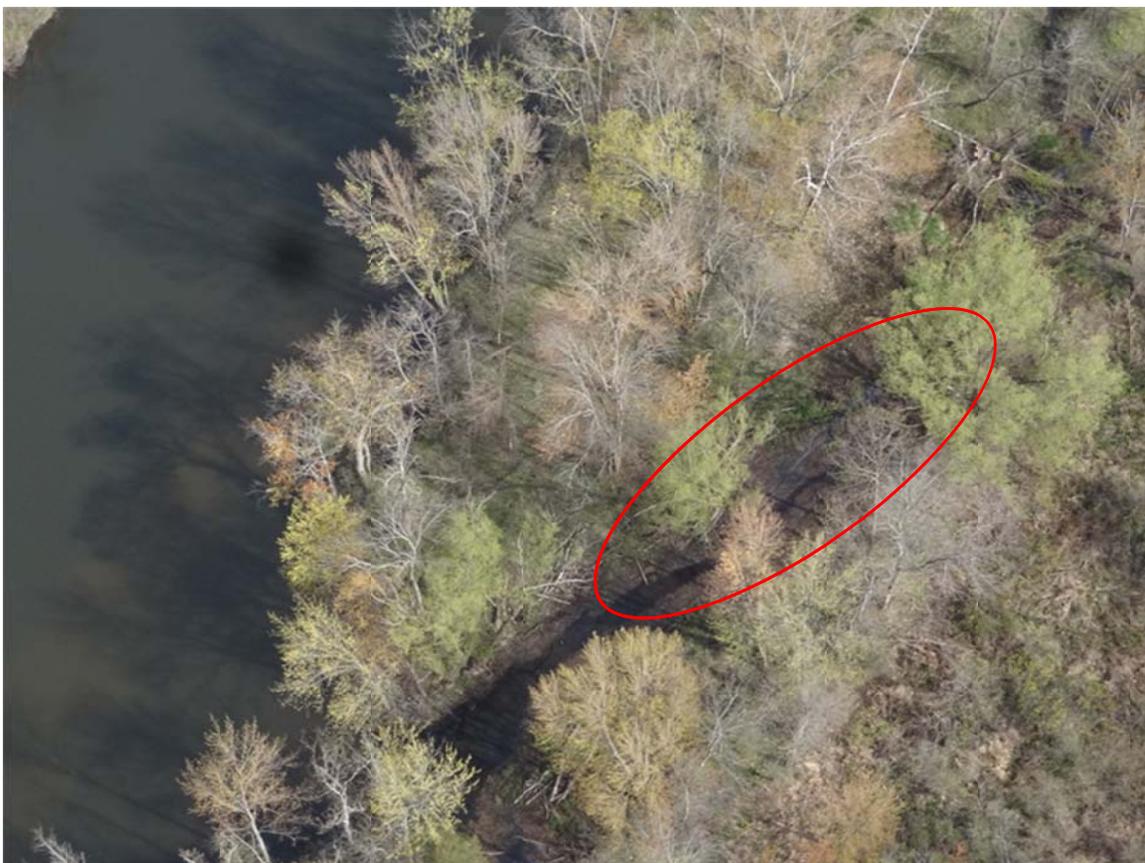
16. MP35.00 LDB, sheen observed LDB.

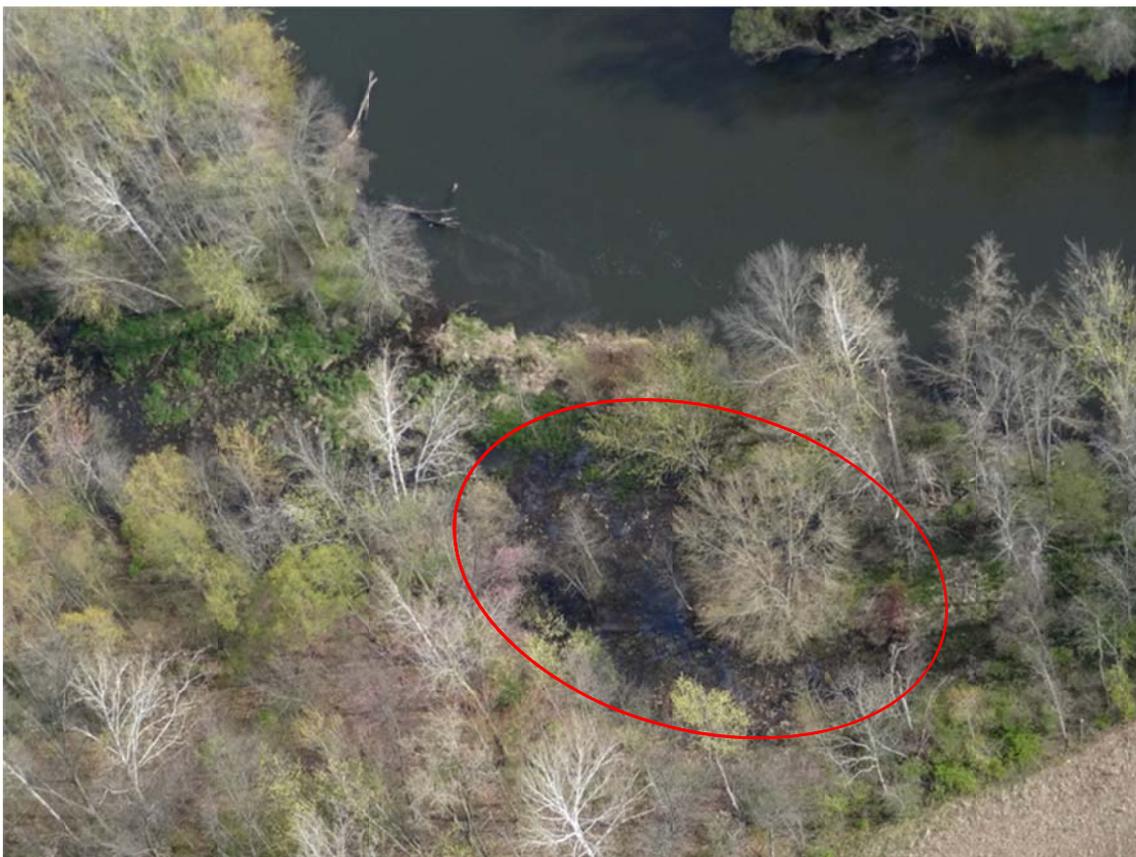
17. MP36.5 LDB sheen observed.

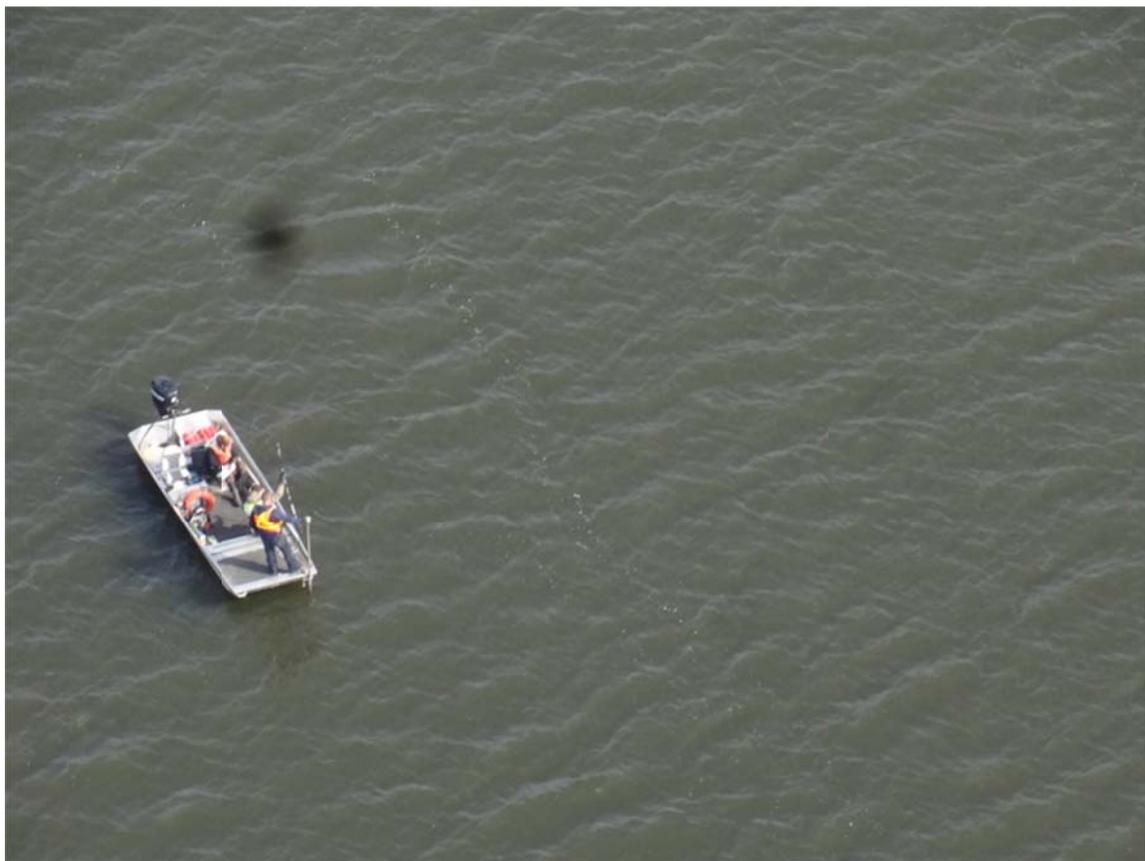
19. Poling Crew on Lake Morrow.

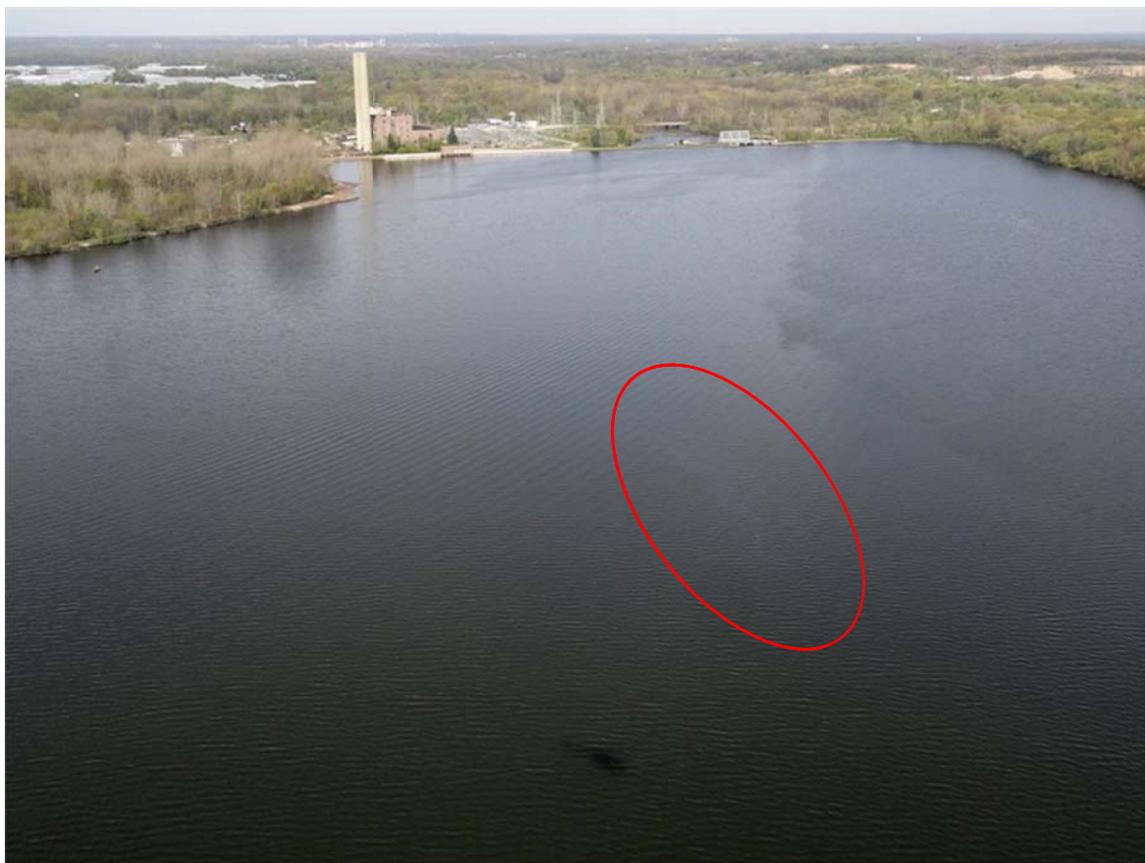
20. Sheen observed on Lake Morrow.

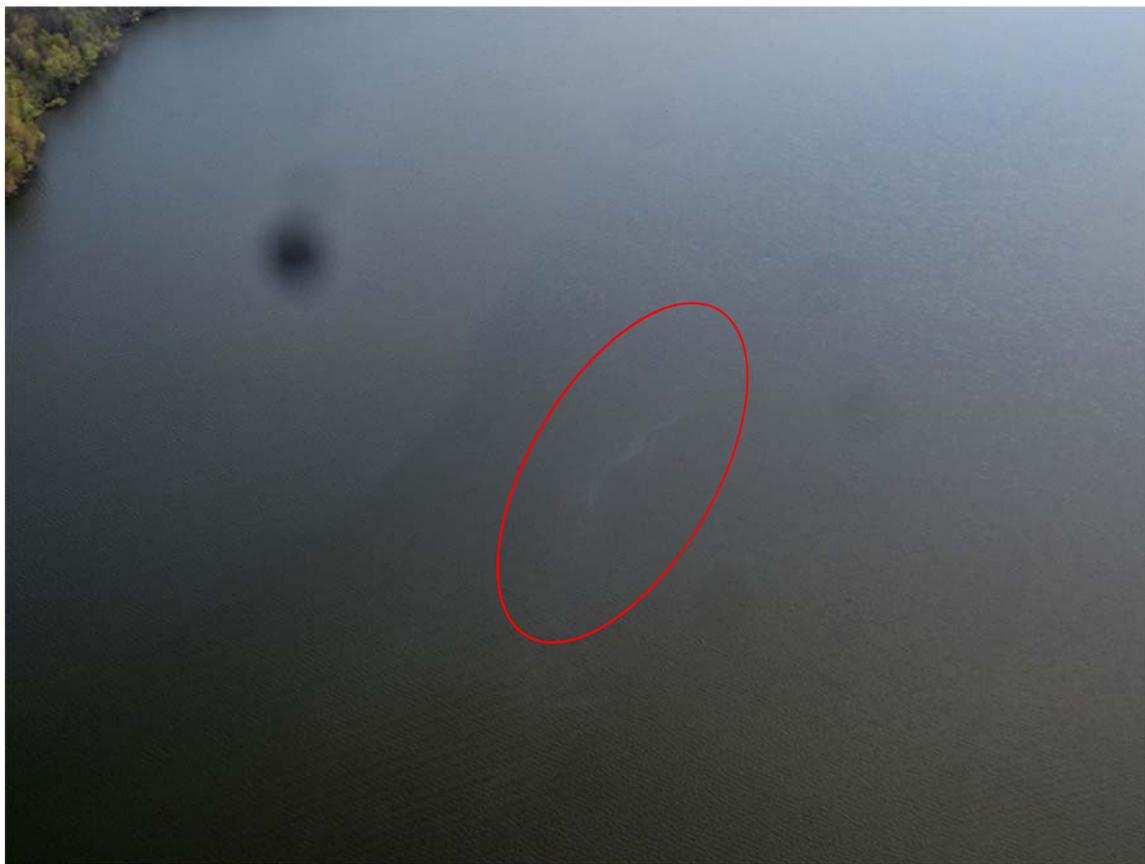
21. Sheen observed on Lake Morrow.

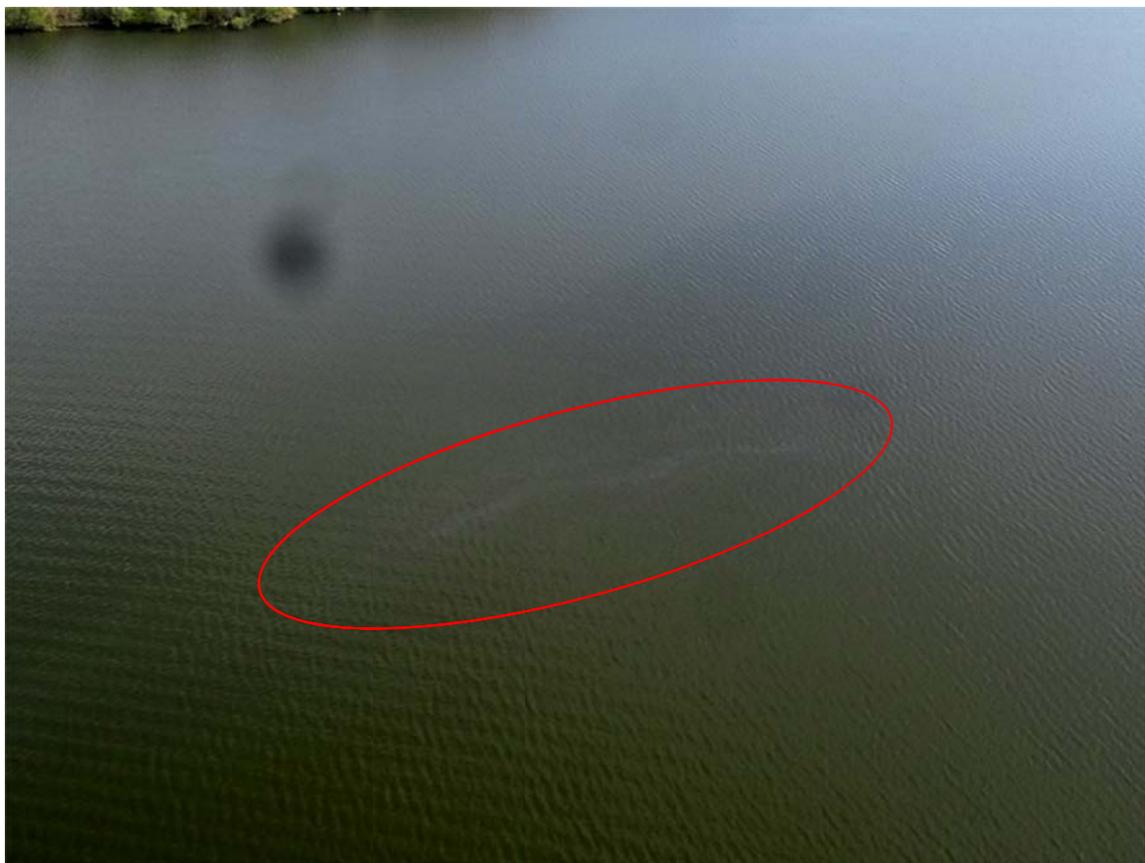
22. Sheen observed on Lake Morrow.

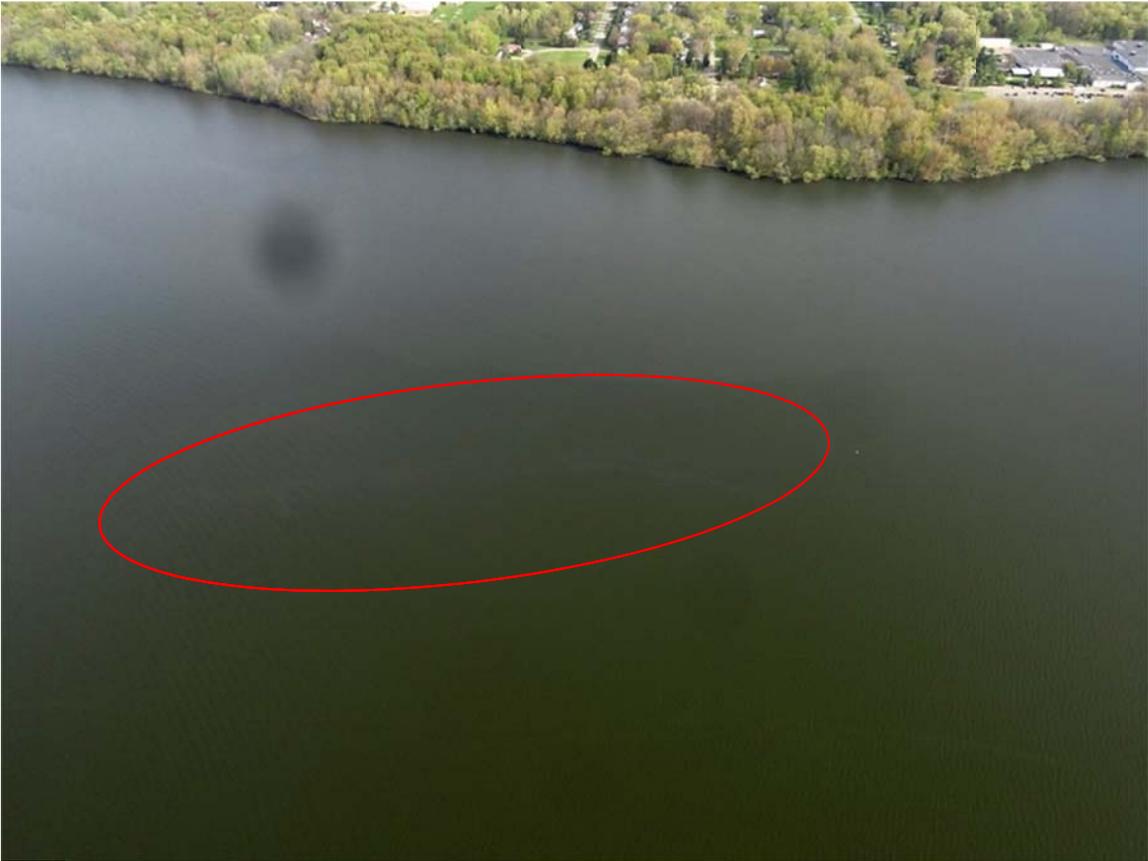
23. Sheen observed on Lake Morrow.

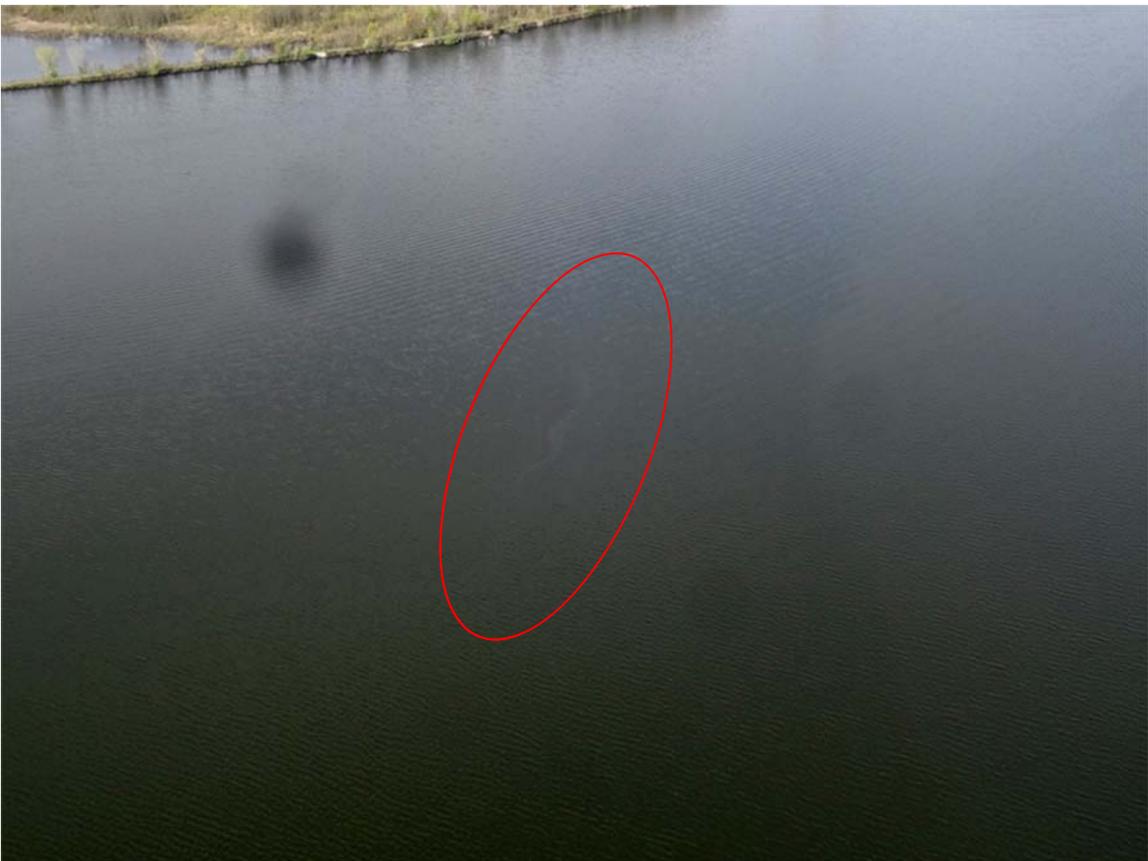
24. Sheen observed on Lake Morrow.
