Situation Photo Log

Tuesday, April 17, 2012

Kalamazoo River / Enbridge Spill

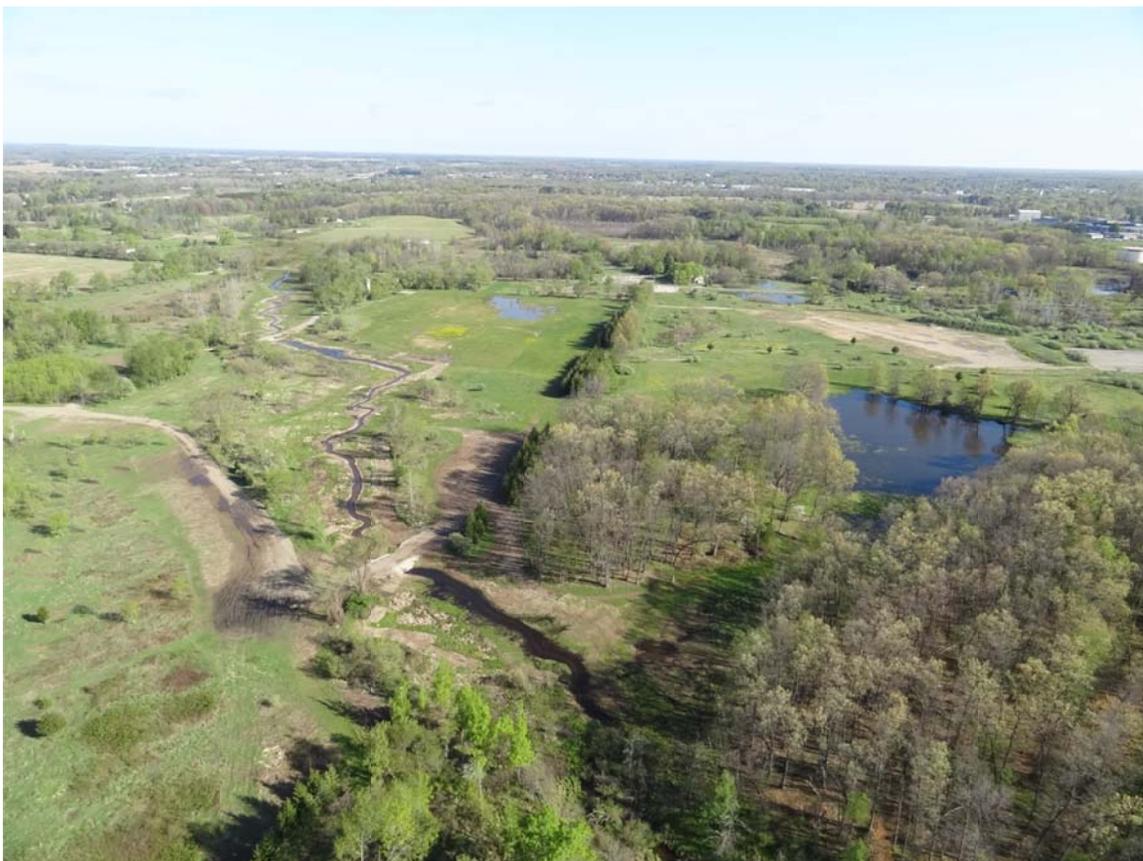
1. Talmadge Creek and Source Area Pond.

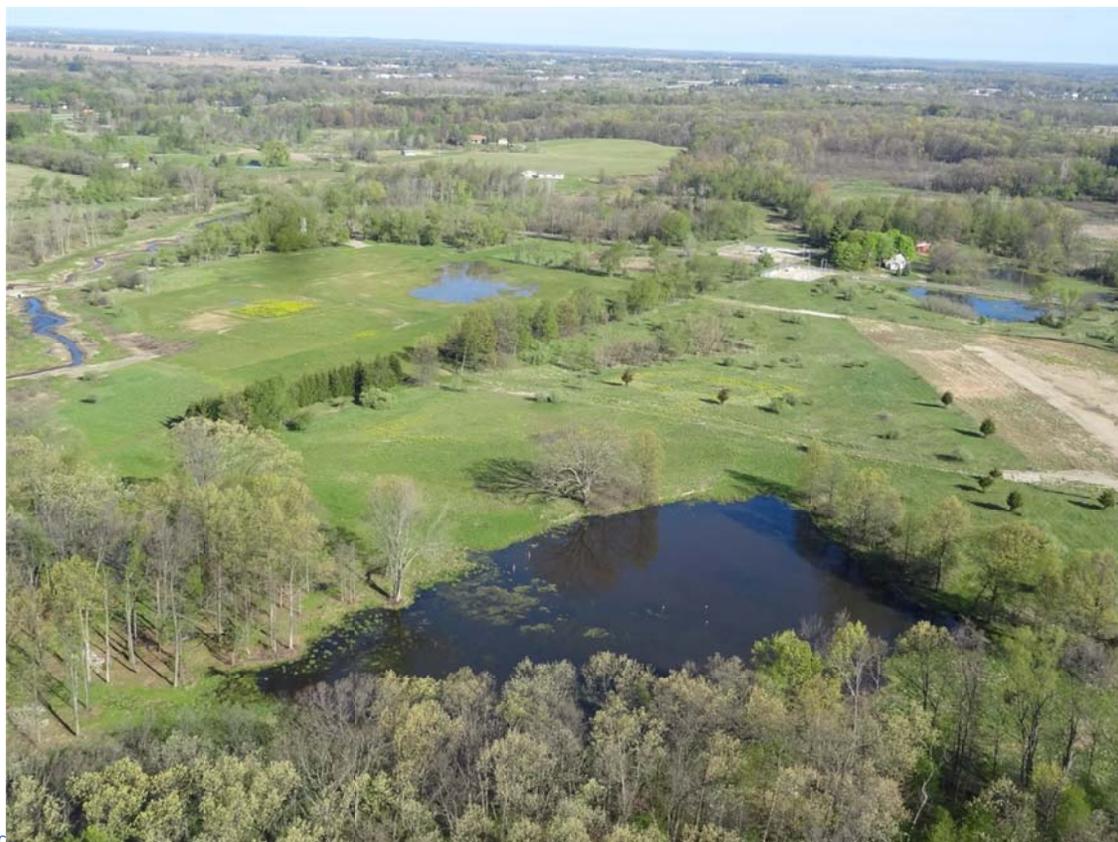
2. Source Area, area of recent land owner complaint.

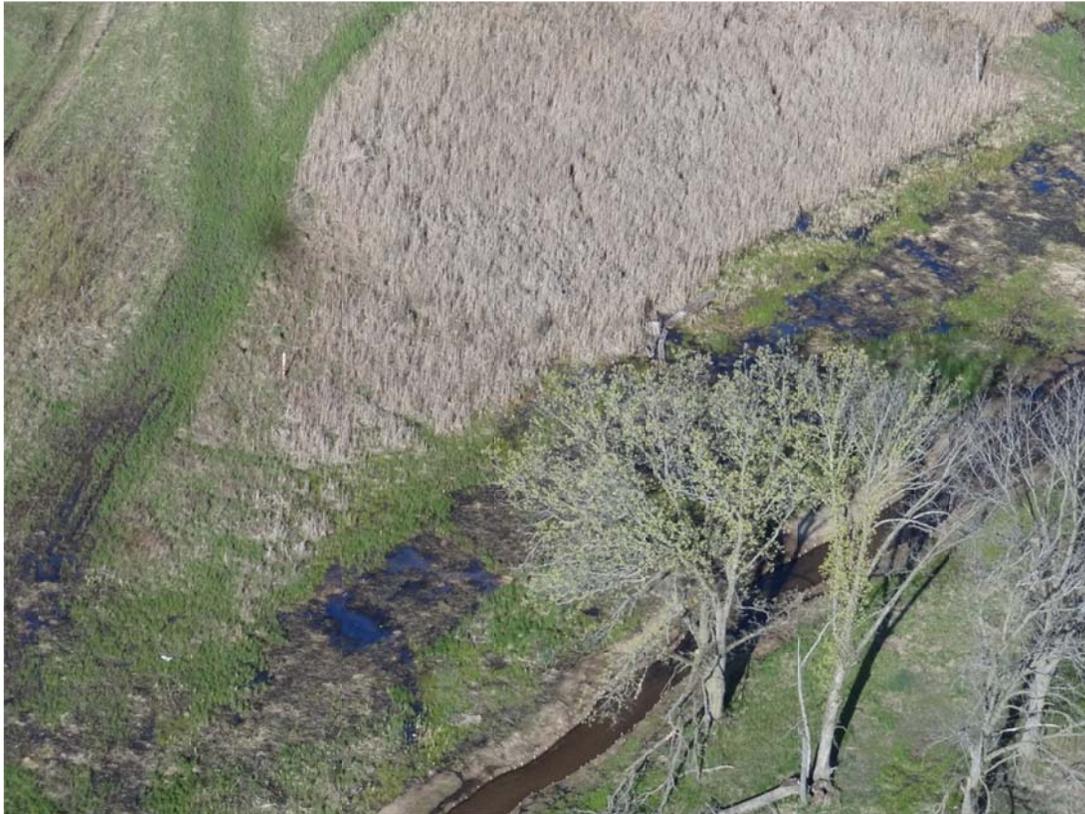
3. MP0.75 LDB sheen observed along Talmadge Creek.

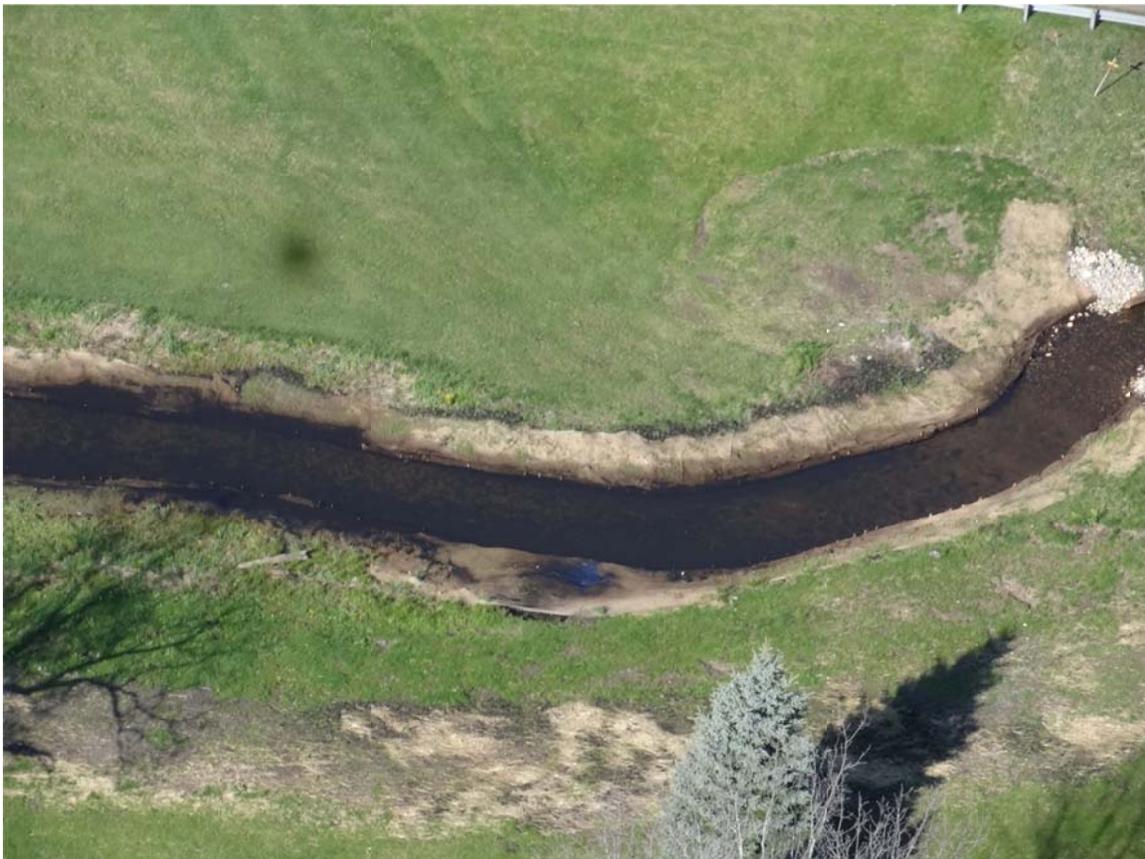
4. MP1.0 sheen observed along Talmadge Creek at 16 Mile Rd.

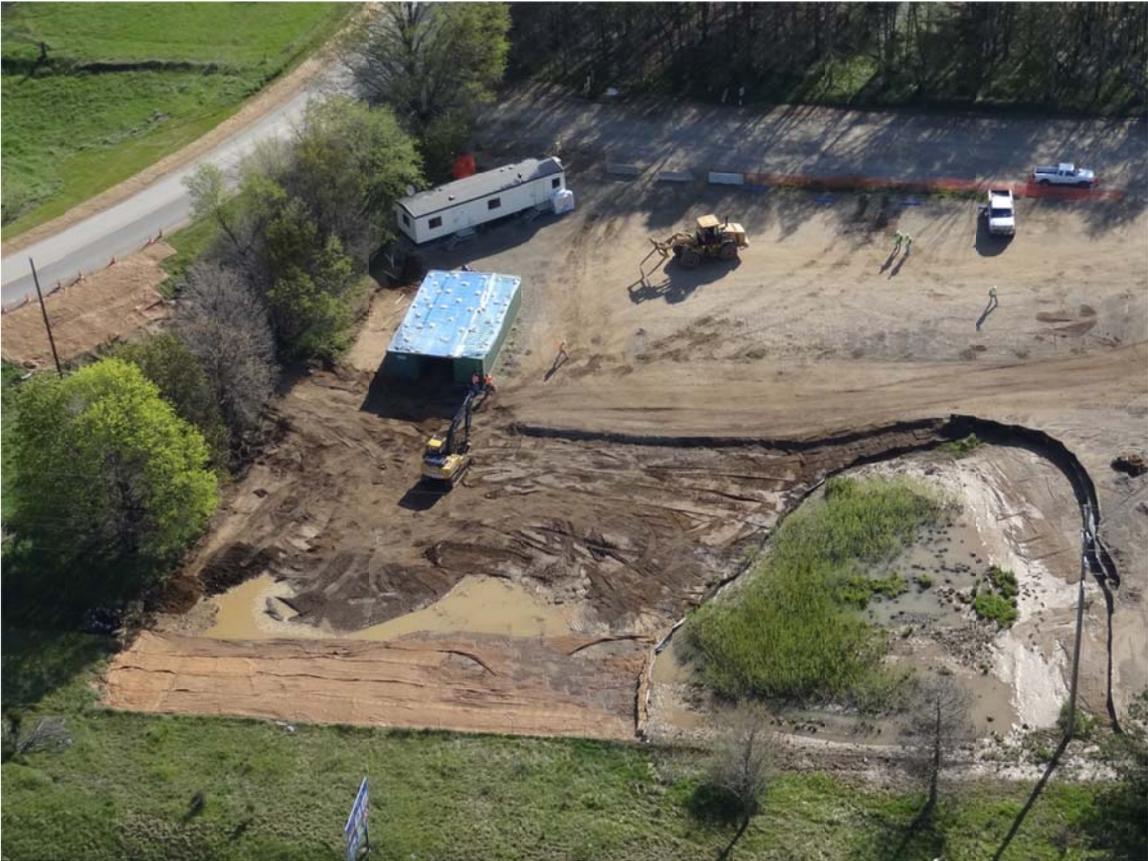
5. Frac-Tank City footprint reduction.

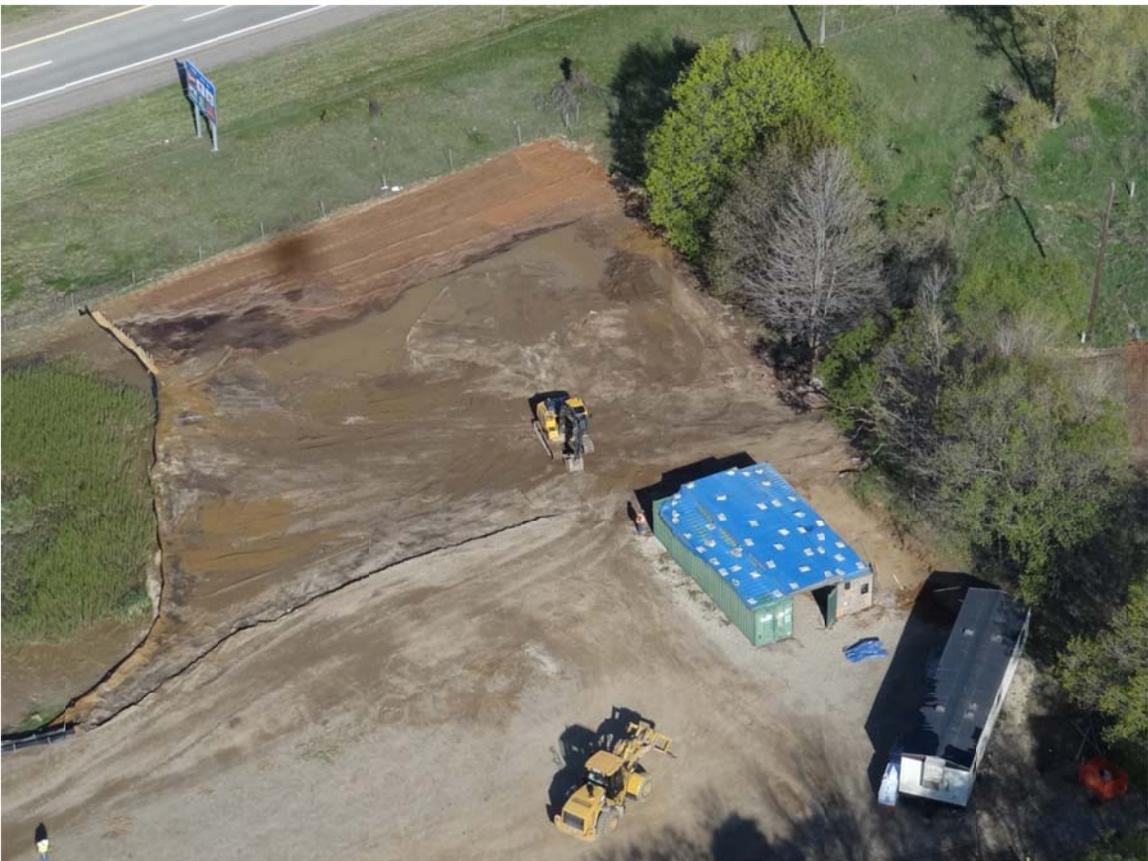
6. Frac-Tank City footprint reduction.

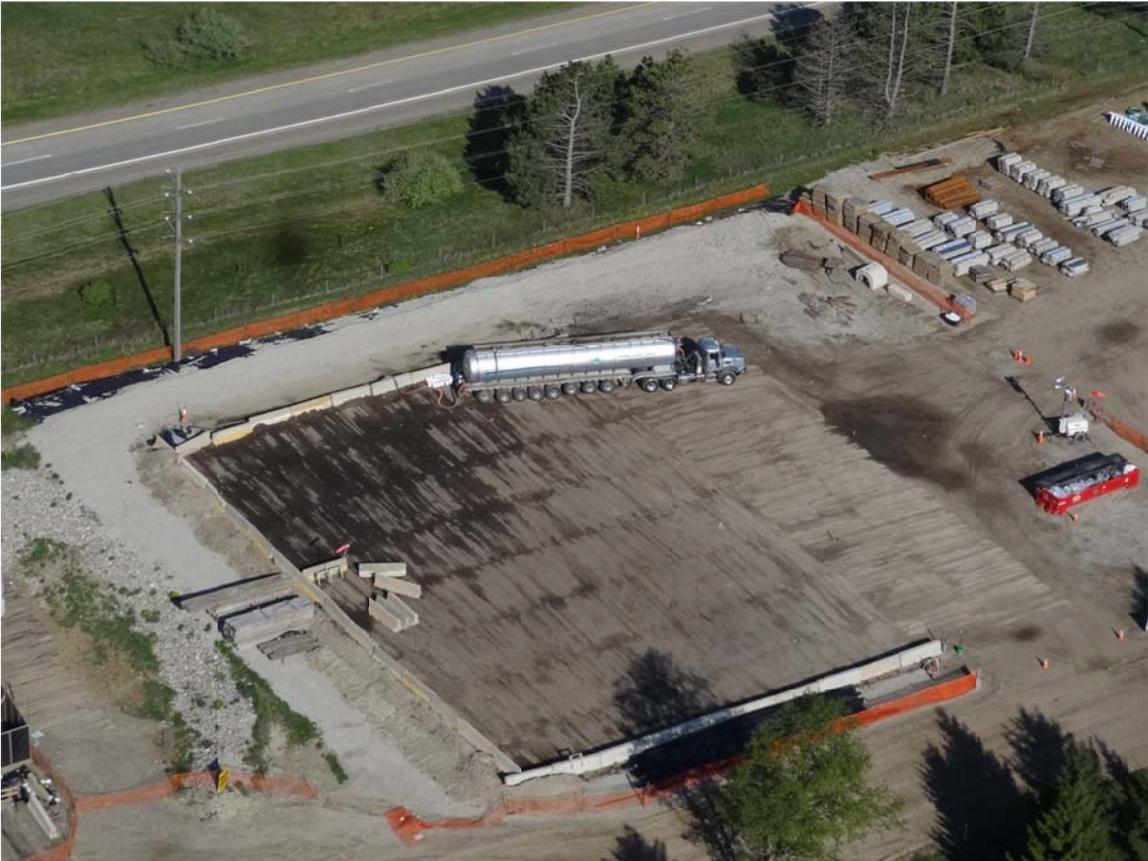
7. Frac-Tank City truck observed emptying Soil Cells A & B sump.

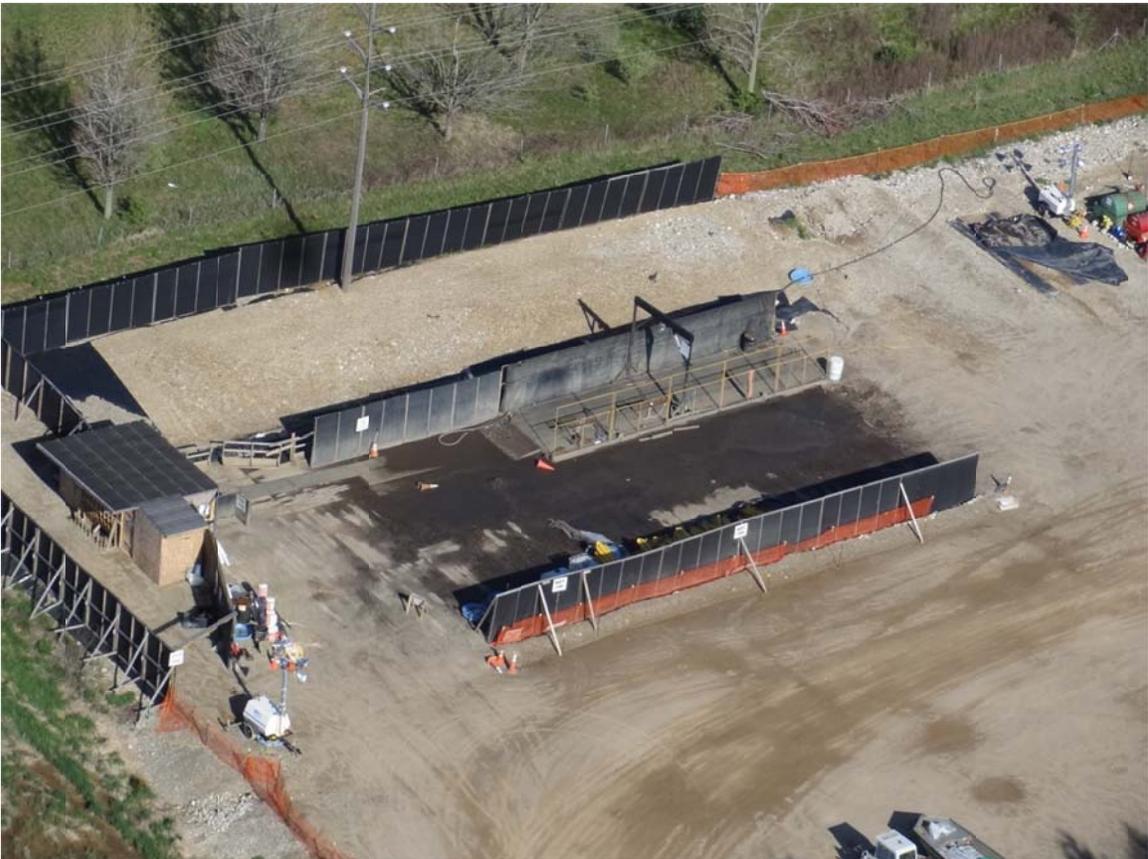
8. Frac-Tank City no decontamination activities observed.

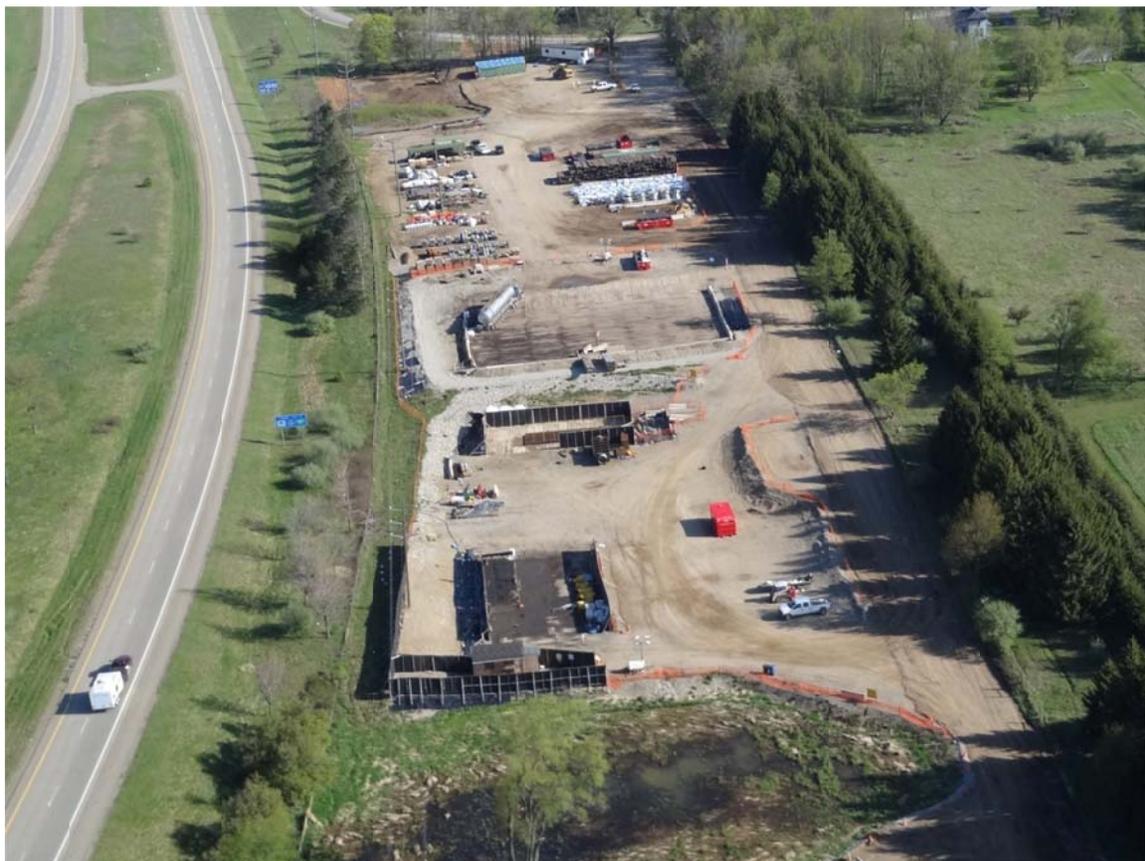
9. Frac-Tank City footprint reduction.

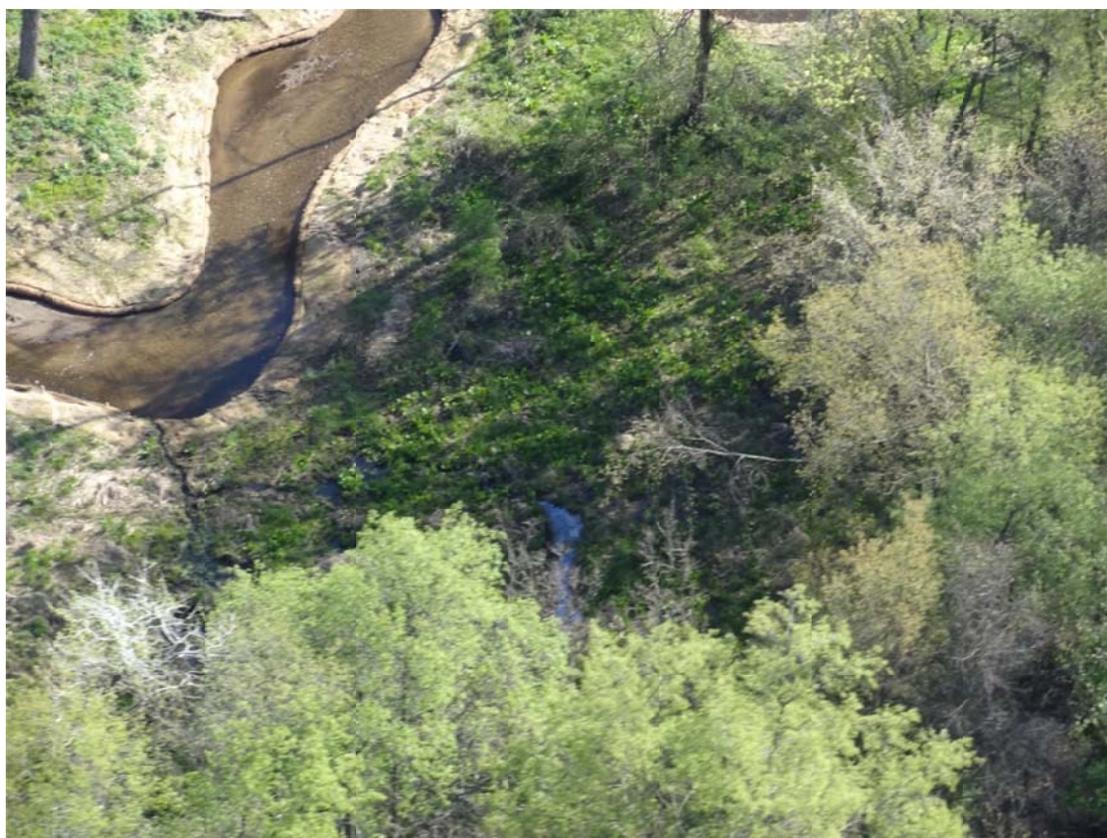
10. MP1.6 LDB Talmadge Creek sheen observed.

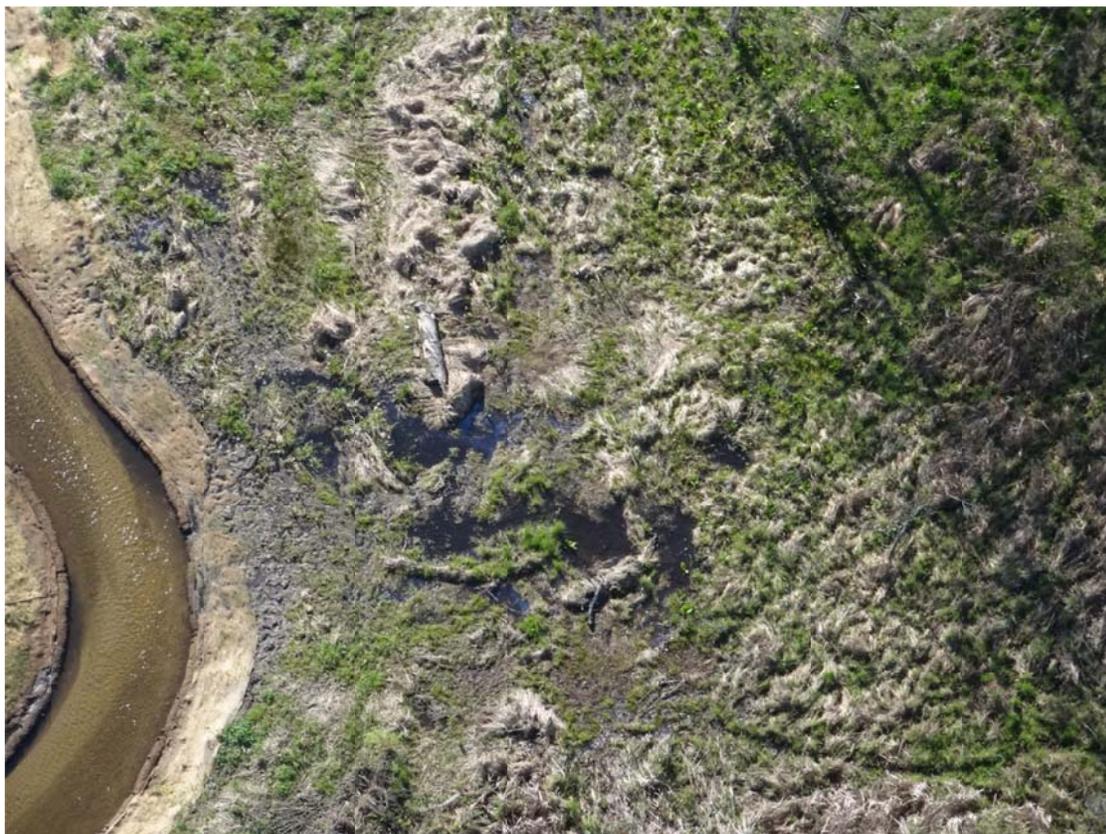
11. MP1.65 LDB Talmadge Creek sheen observed.

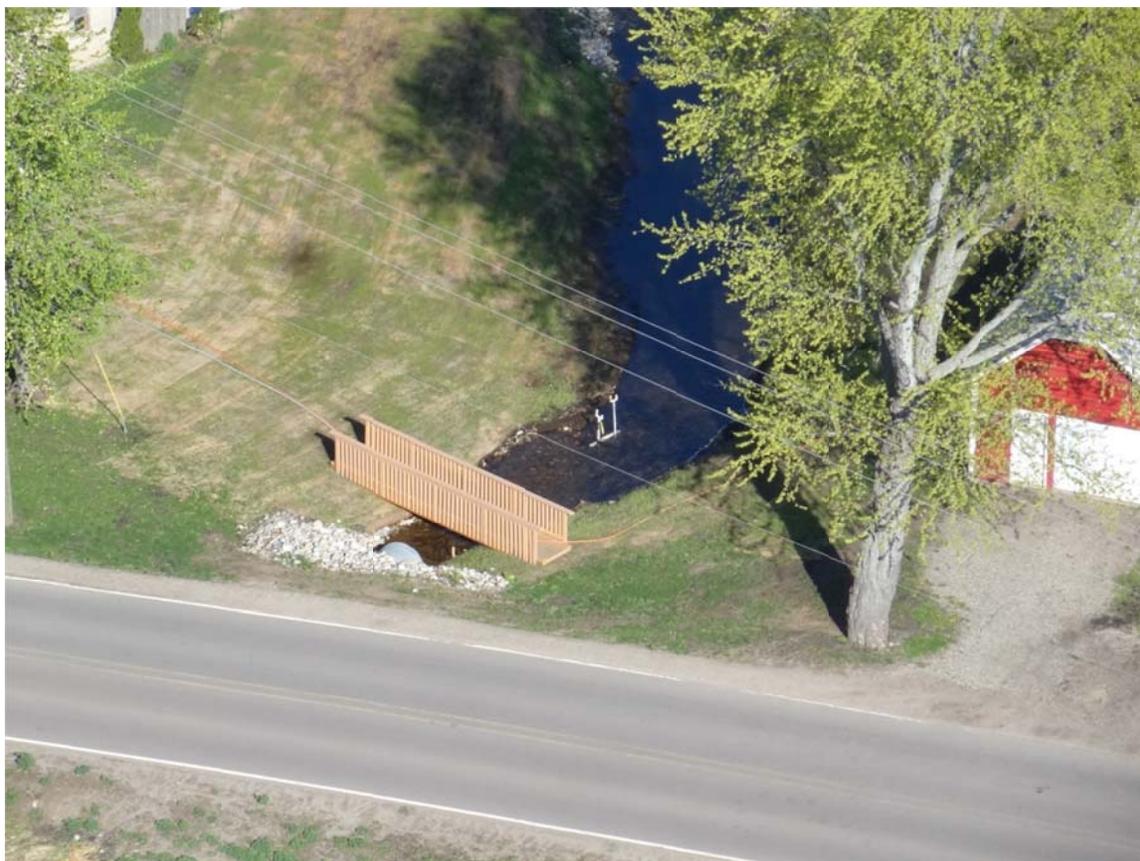
12. Walling tube installed within Talmadge Creek near the confluence.

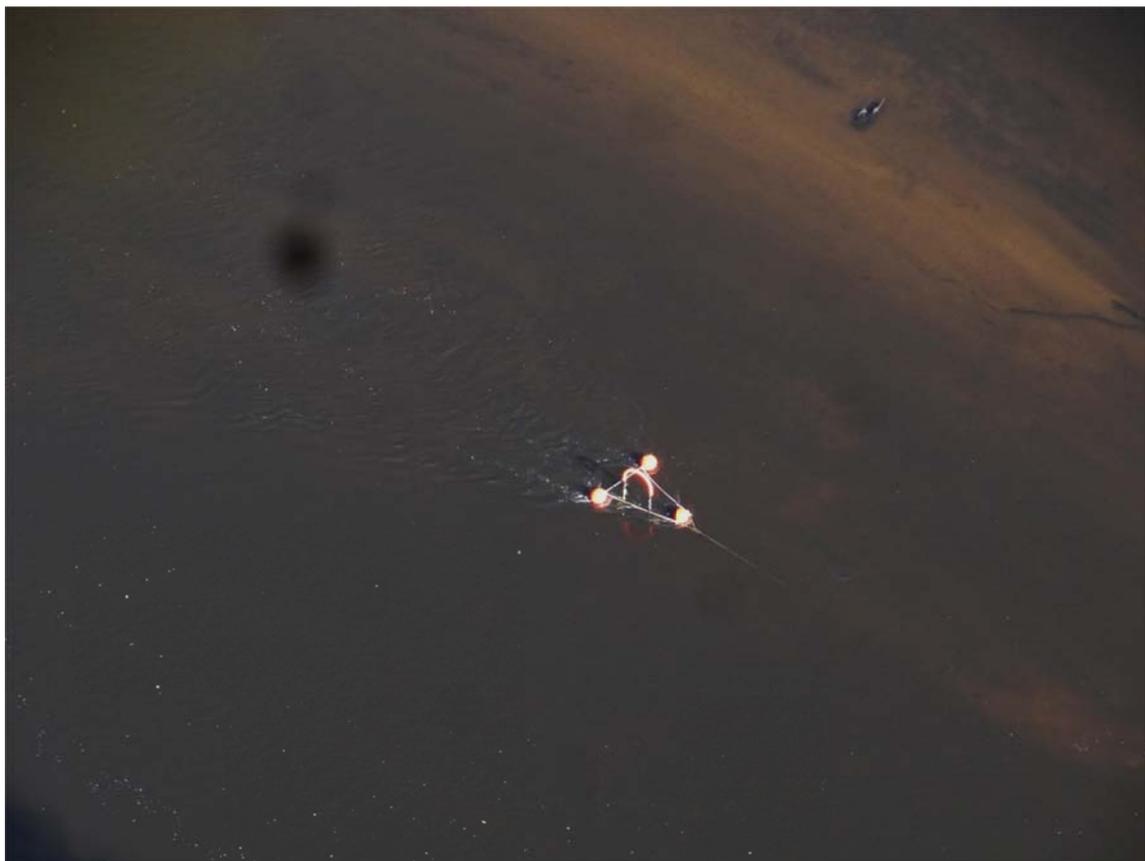
13. Walling tube buoy configuration up river from the confluence.

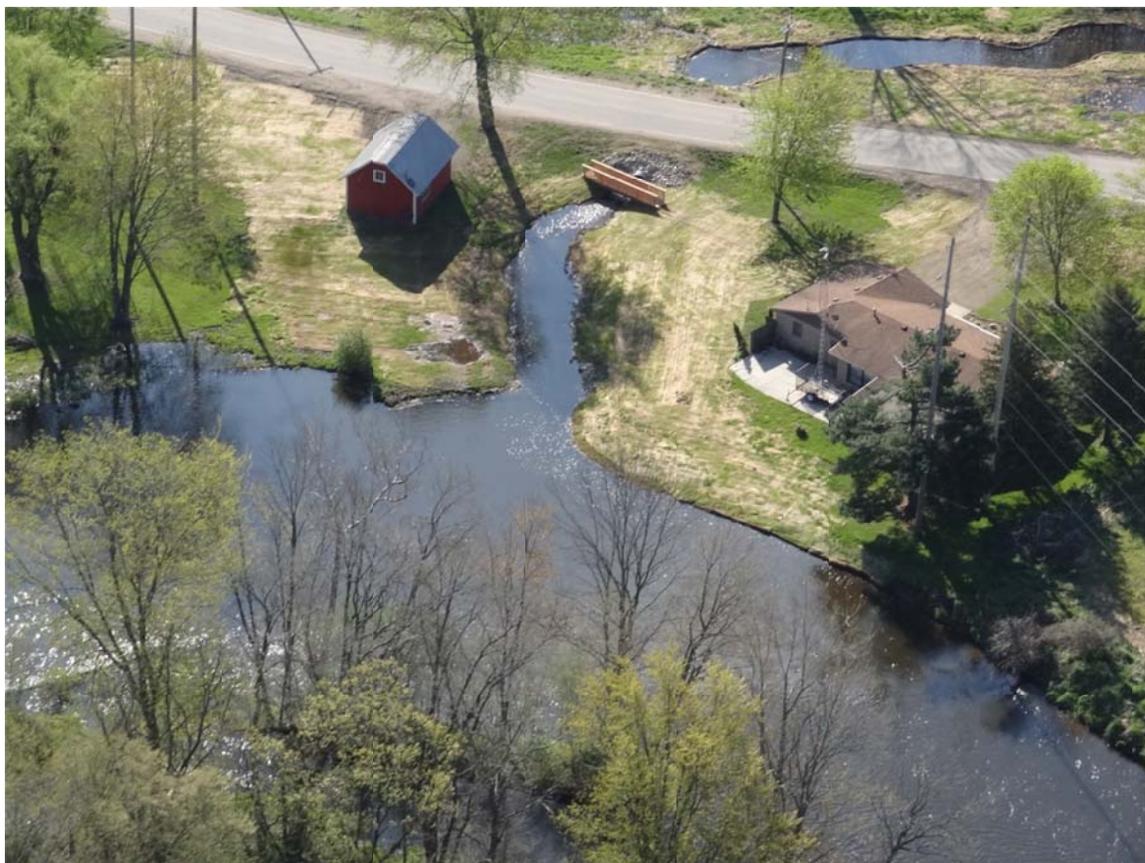
14. Confluence, buoys removed.

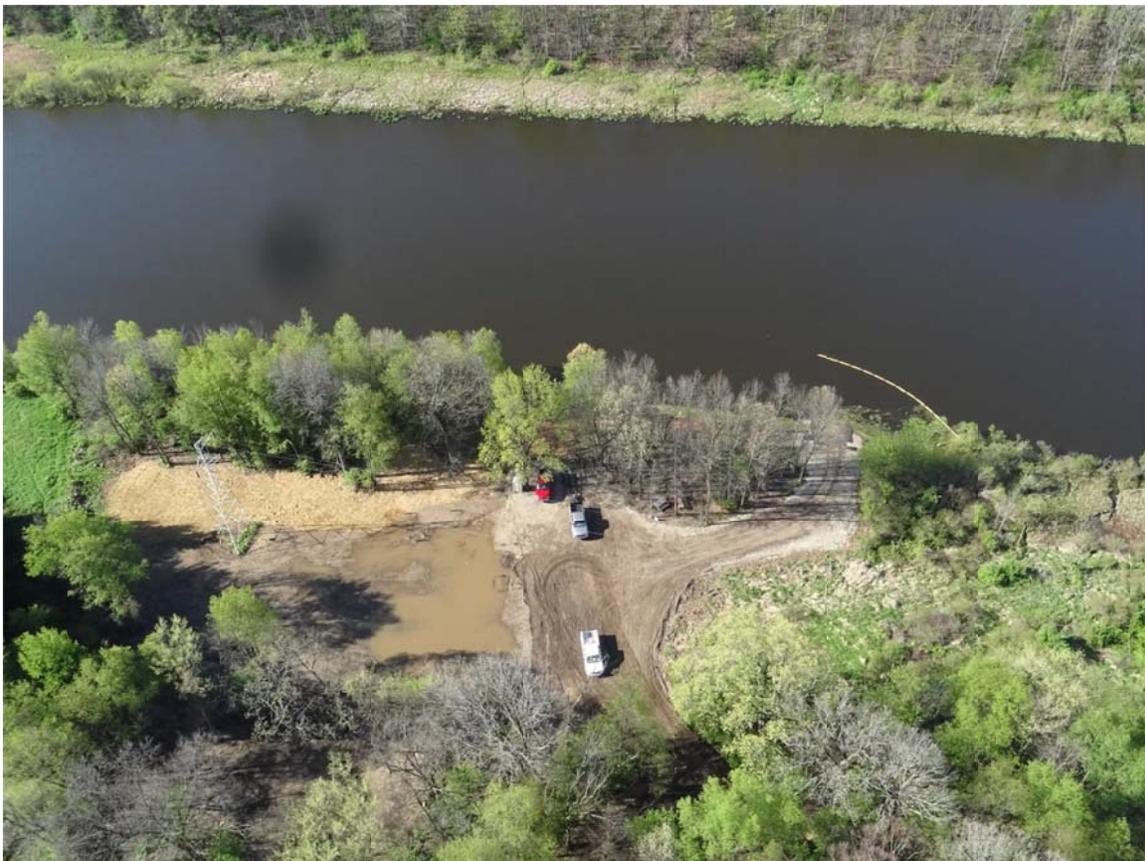
16. C0.4 Boat Launch footprint reduction.

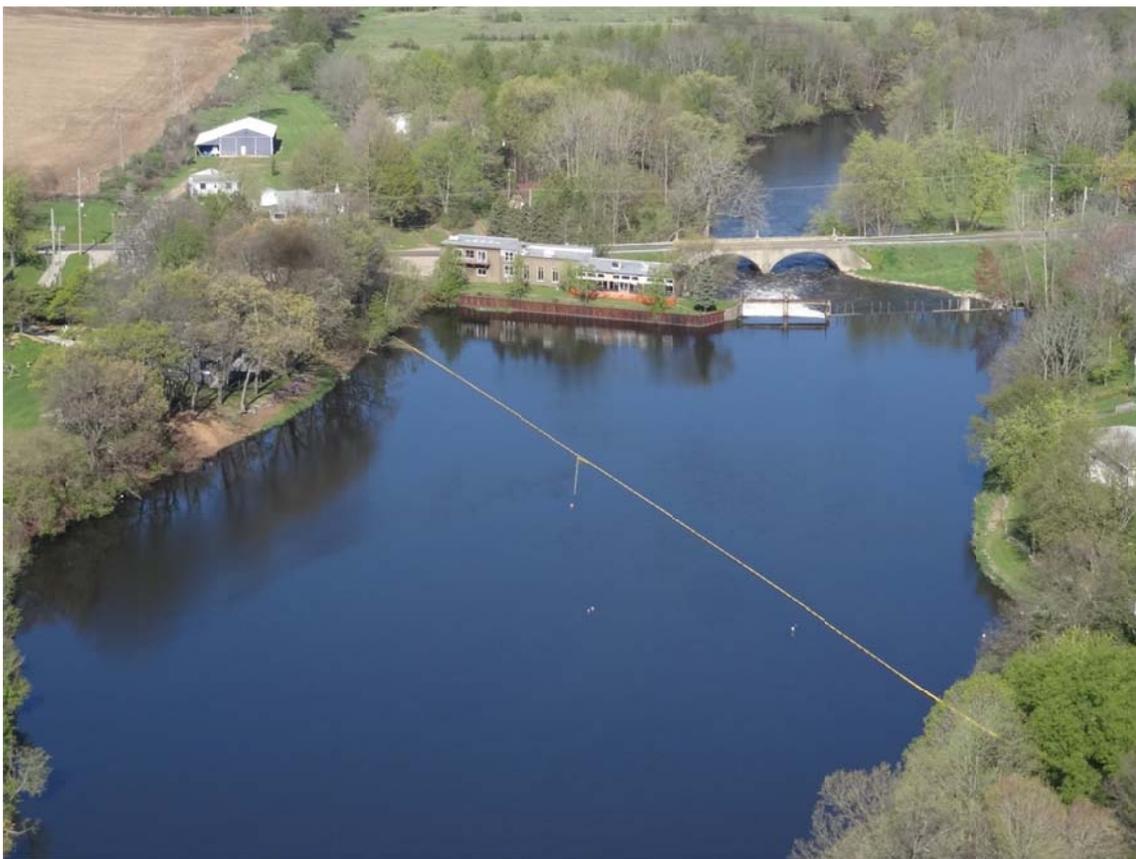
17. Ceresco Dam, no sheen observed.

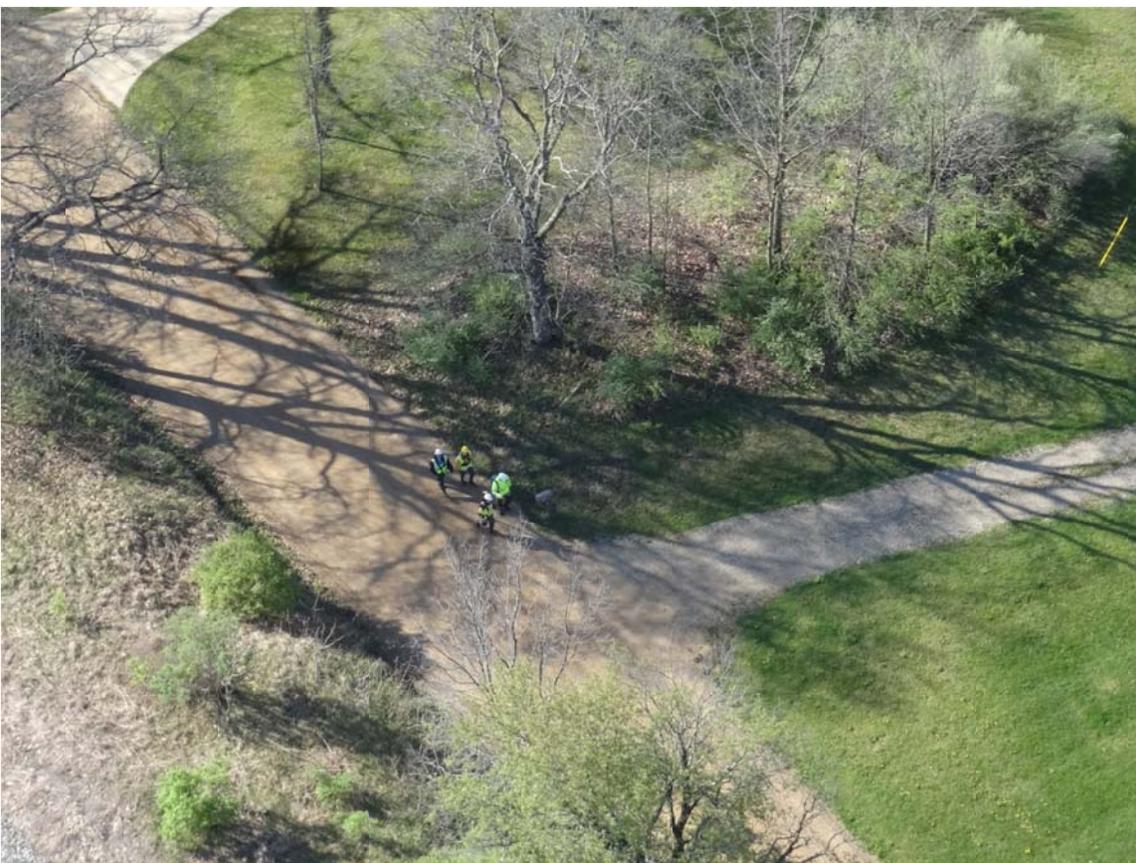
18. SORT Crew near MP6.0

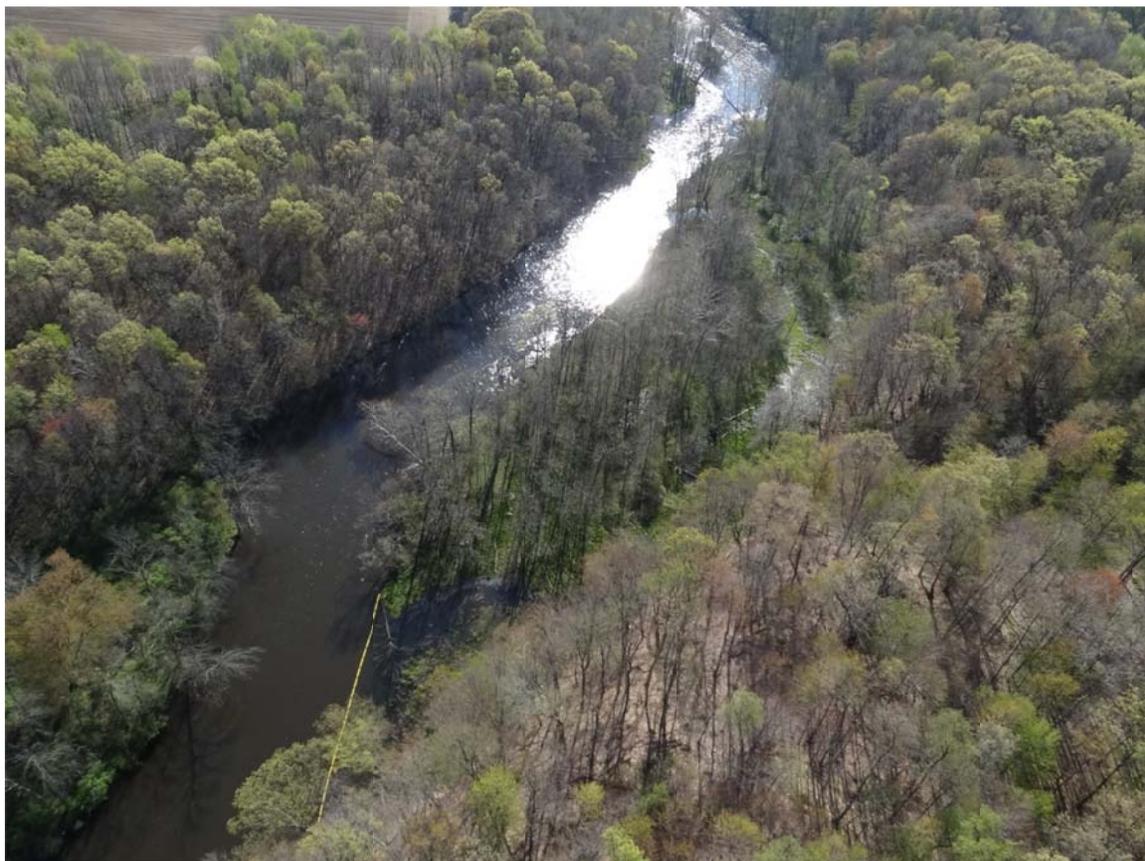
19. MP8.4 LDB, last remaining SORT location.

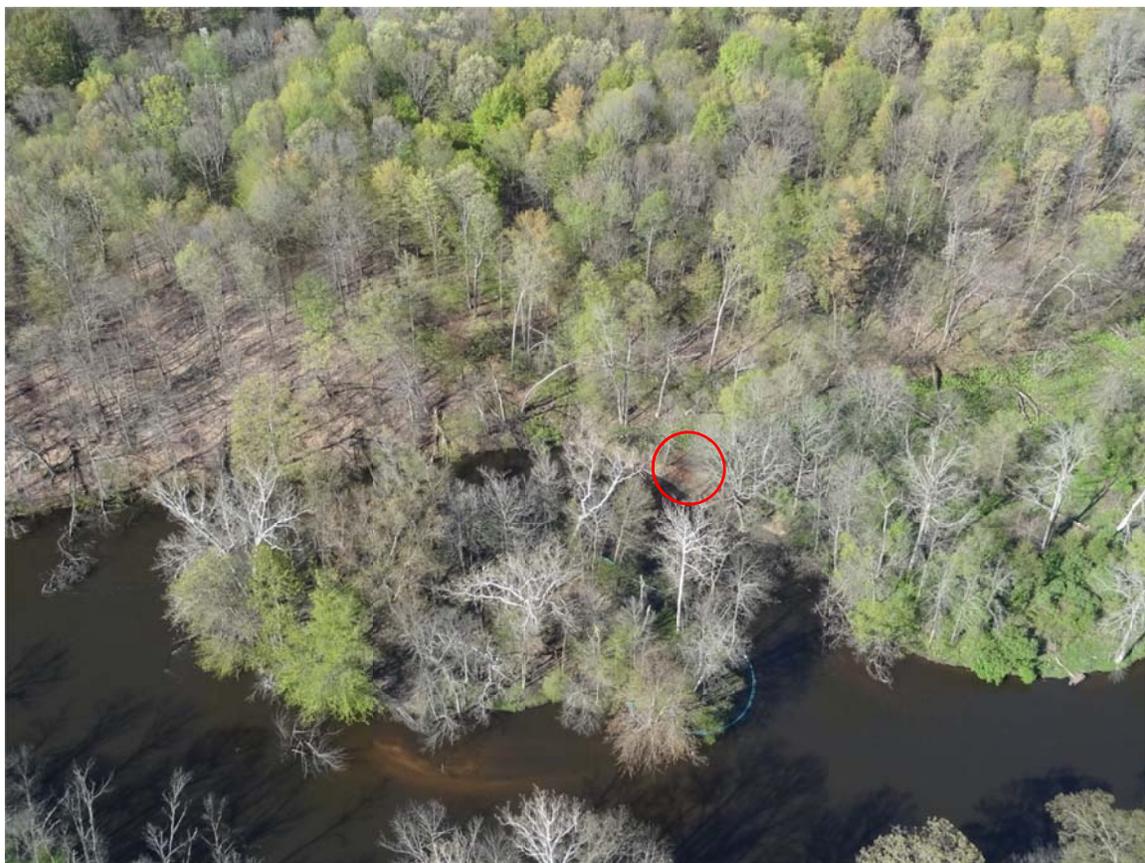
20. MP9.10 area newly restored.

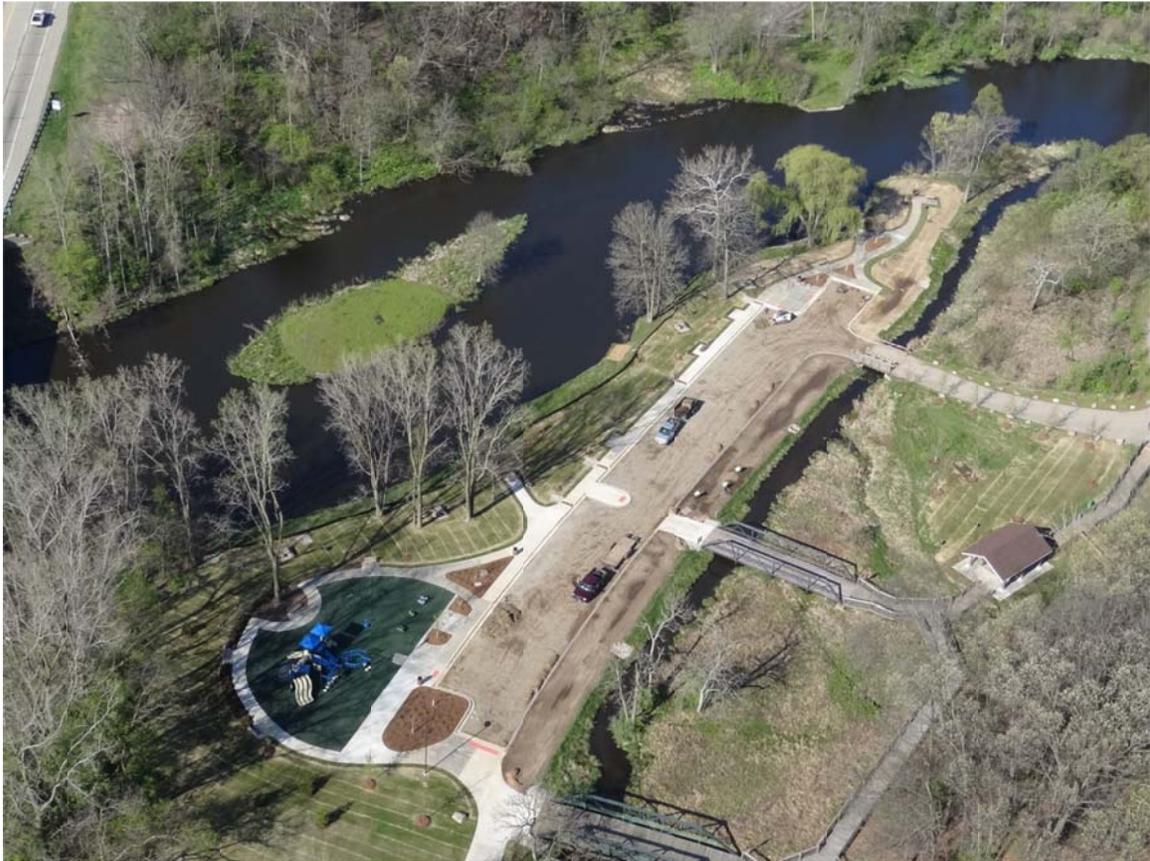
21. Work continuing at Historic Bridge Park.

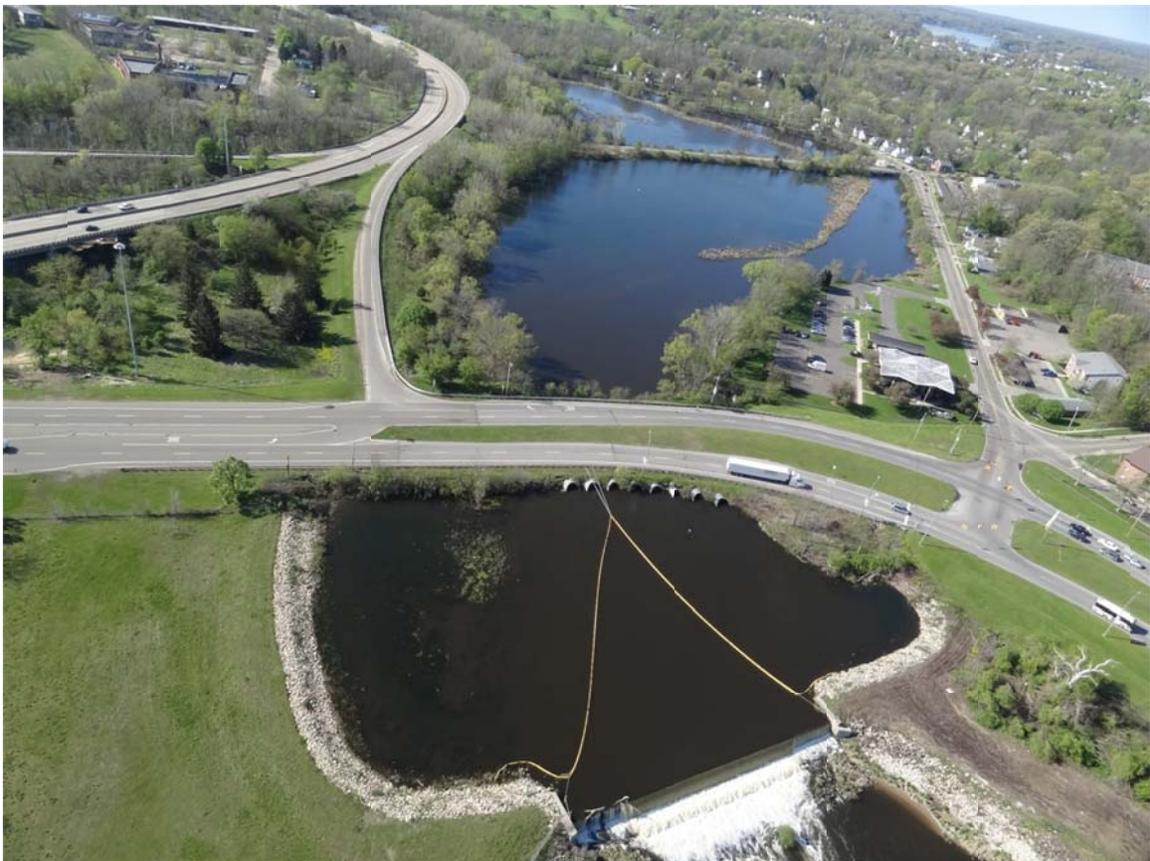
22. Overview of Mill Pond.

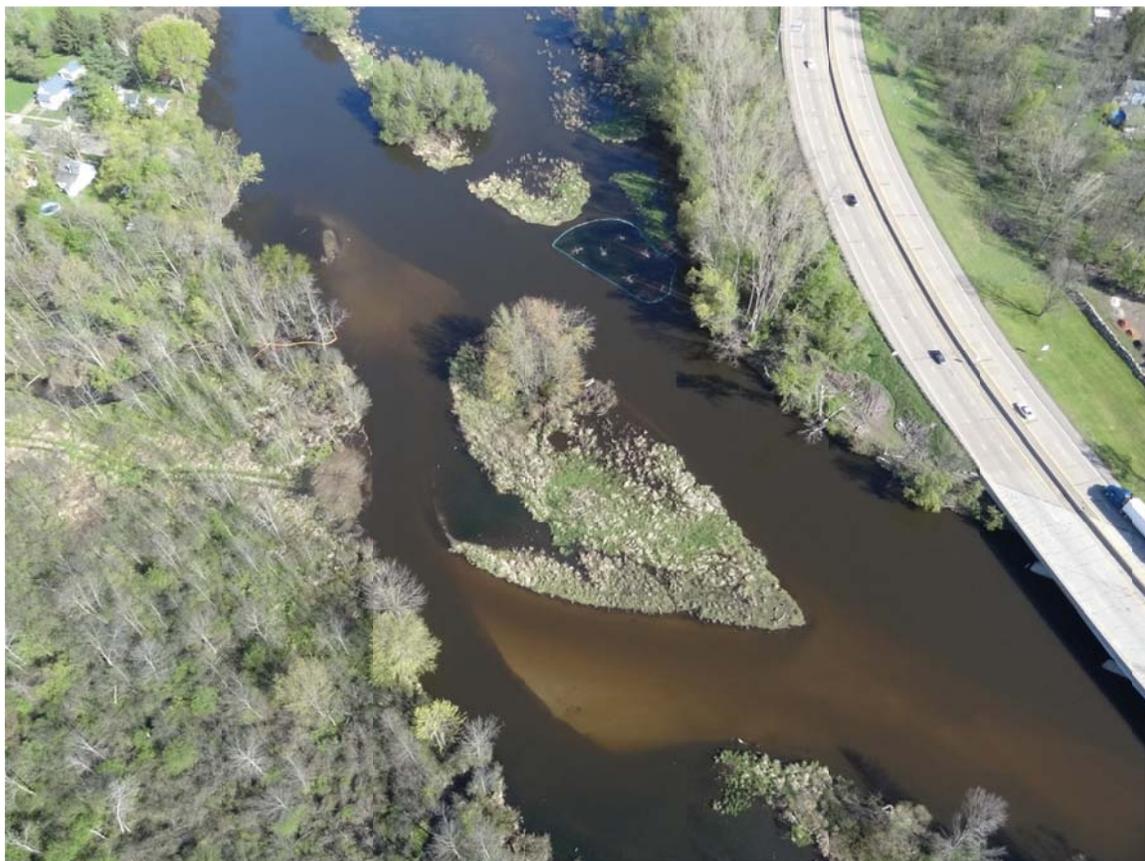
23. MP15.0 entering into Mill Pond.

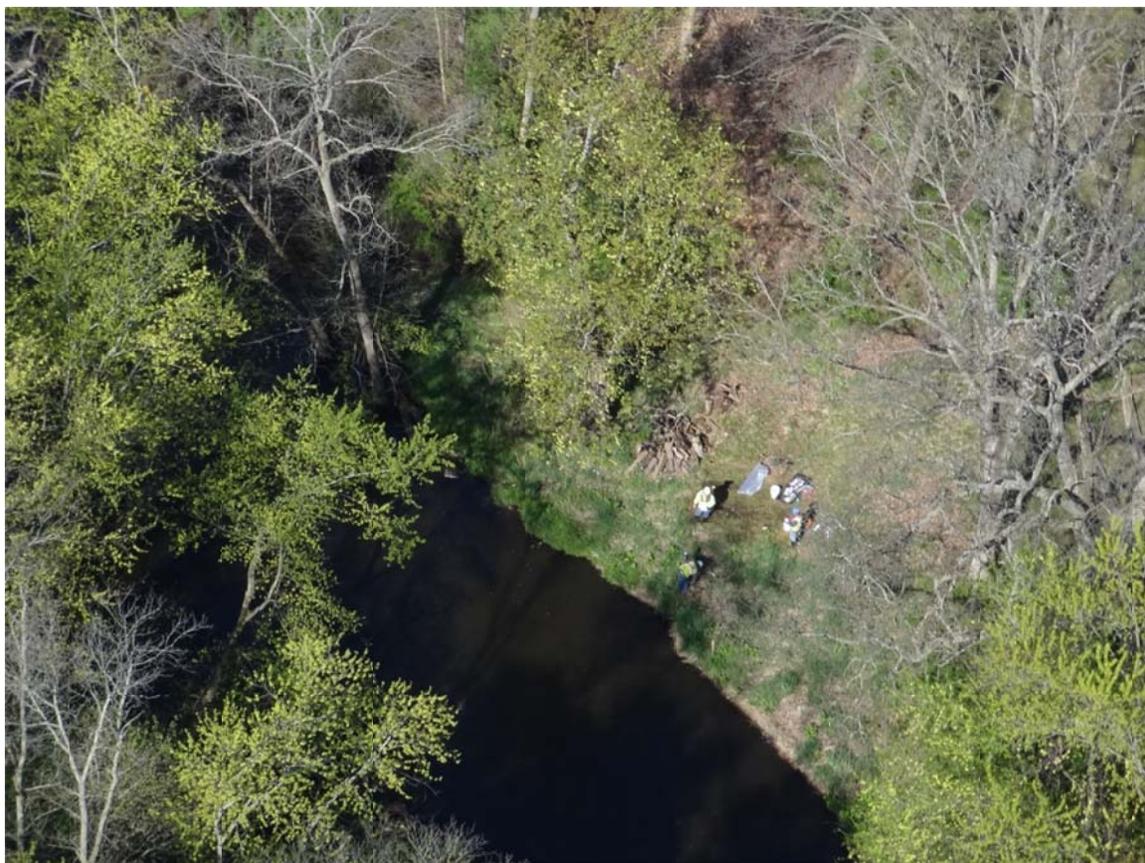
24. MP22.75 RDB RI crew observed.
