Situation Photo Log

Tuesday, April 17, 2012

Kalamazoo River / Enbridge Spill

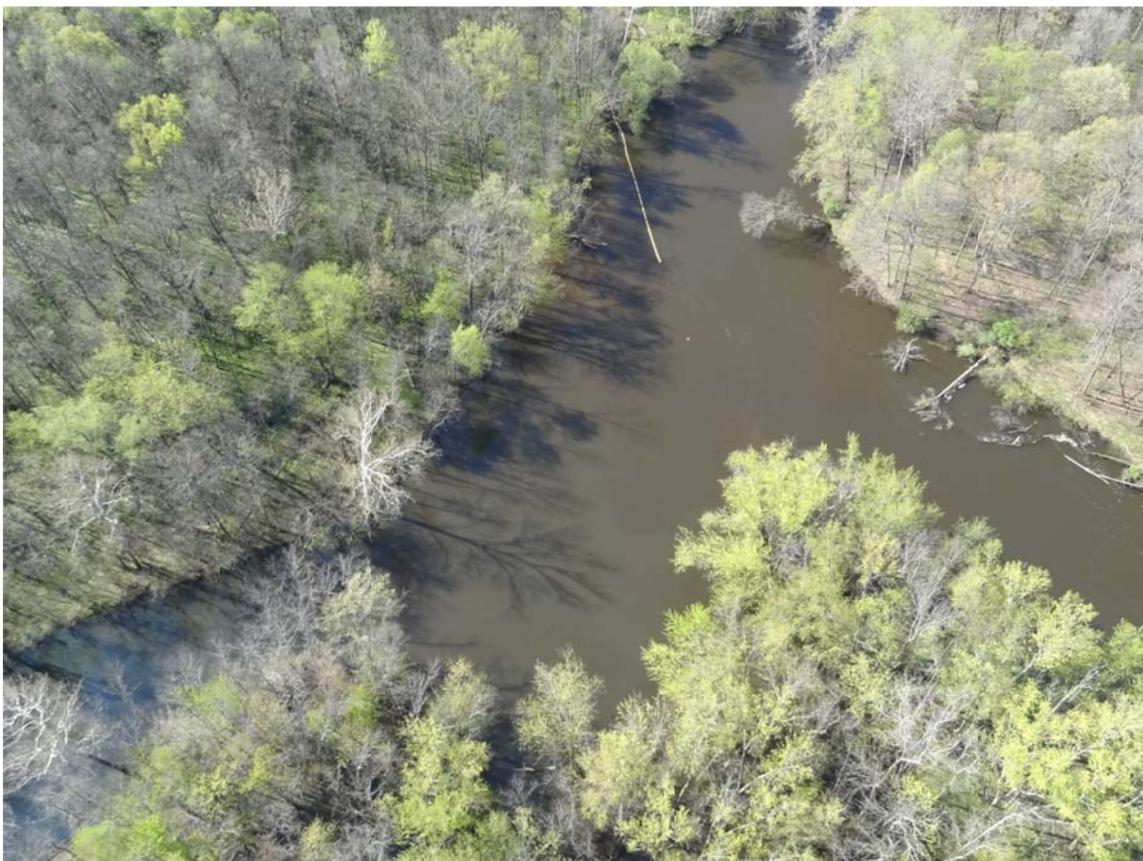
25. Boom located at MP30.8, no sheen observed.

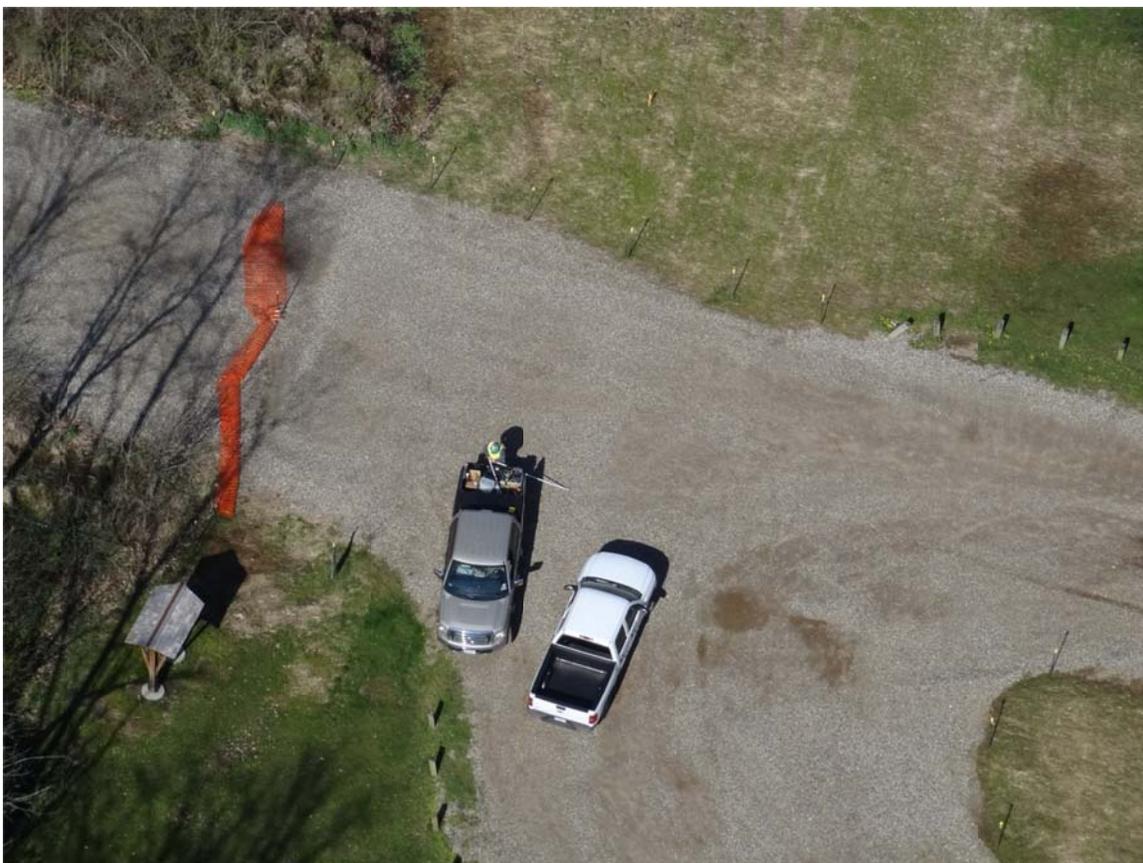
26. Boat launch E3 crew observed preparing to take water temperature readings.

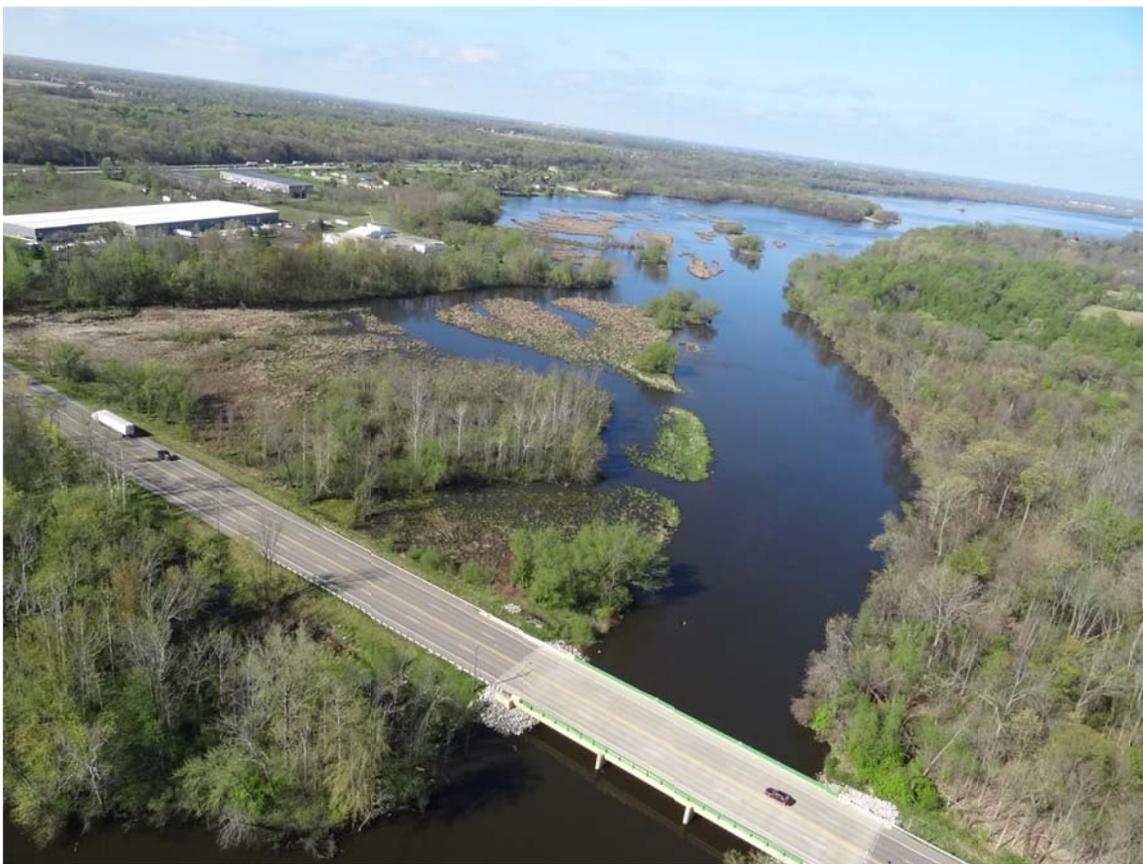
27. Morrow Lake Delta, no sheen observed.

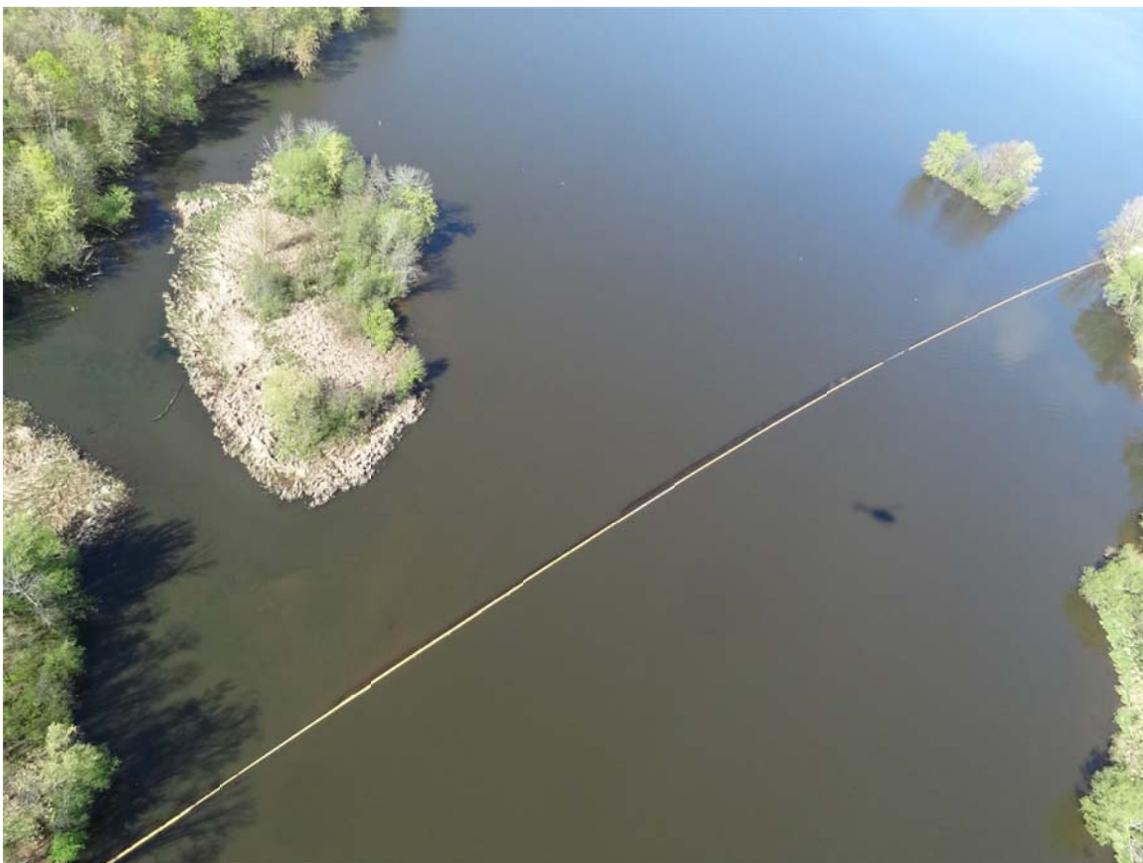
28. E4 Boom no sheen observed.

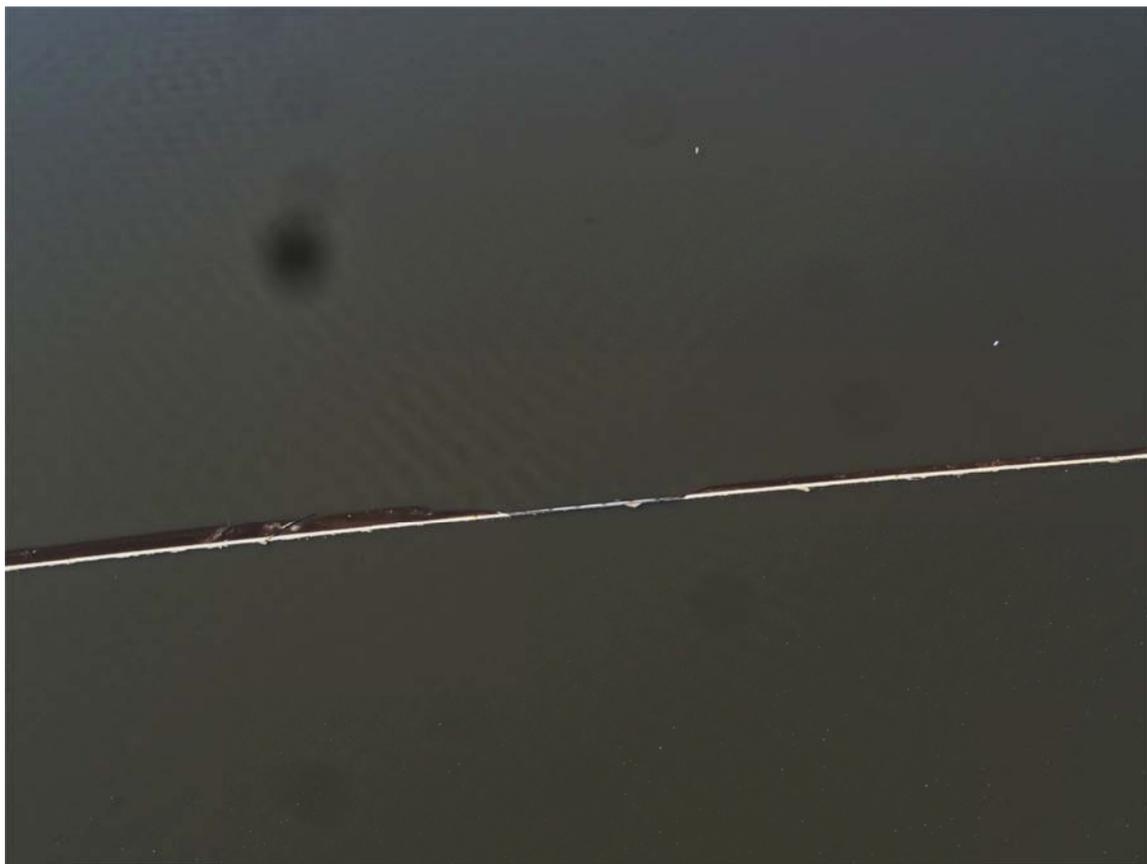
29. E4 Boom potential issue with sediment curtain.

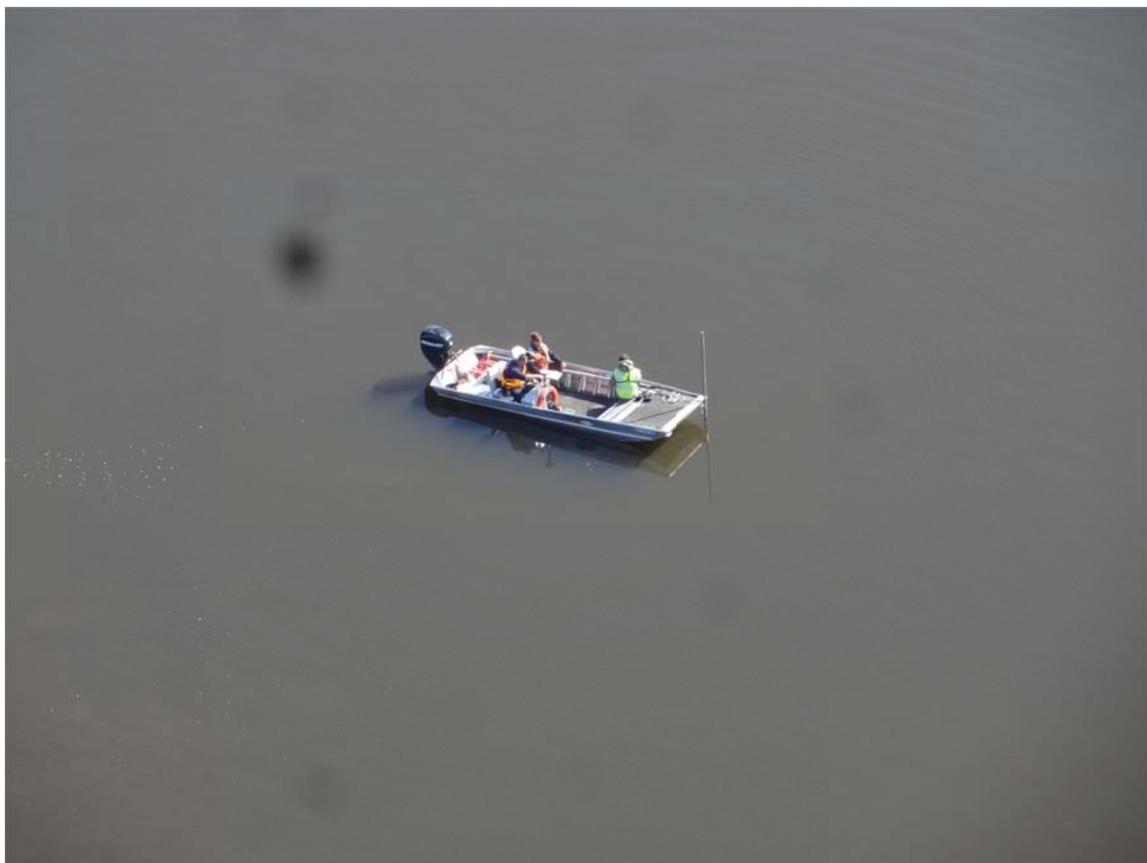
30. Morrow Lake poling crew.

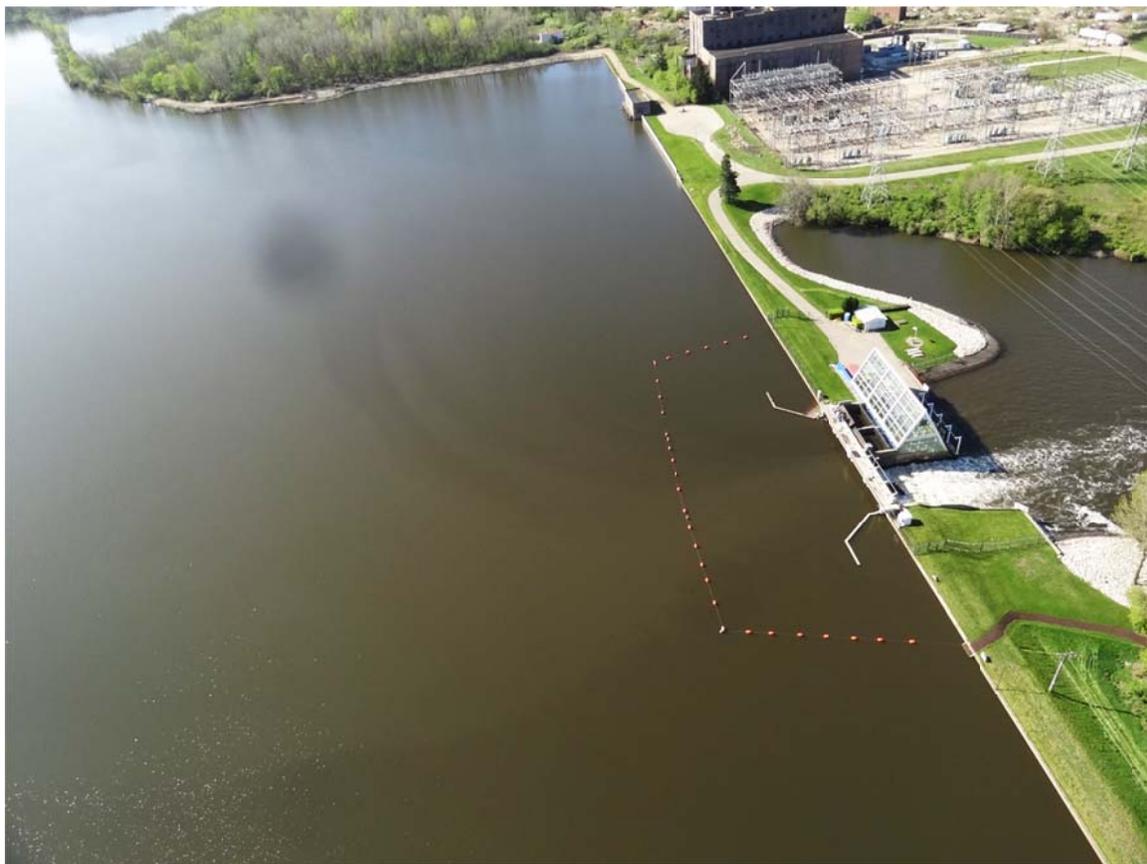
31. Morrow Lake Dam, sediment moving over dam.

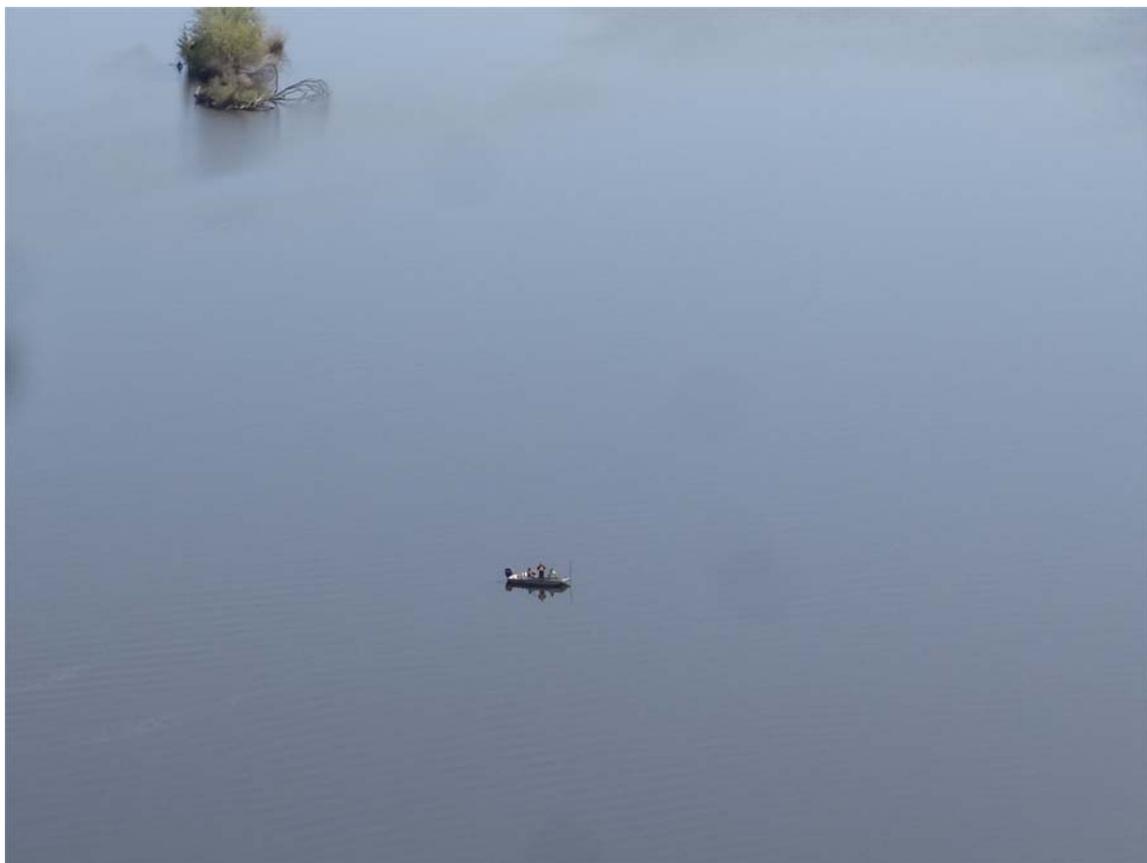
32. Morrow Lake poling crew.
