Situation Photo Log

Wednesday, April 18, 2012

Kalamazoo River / Enbridge Spill

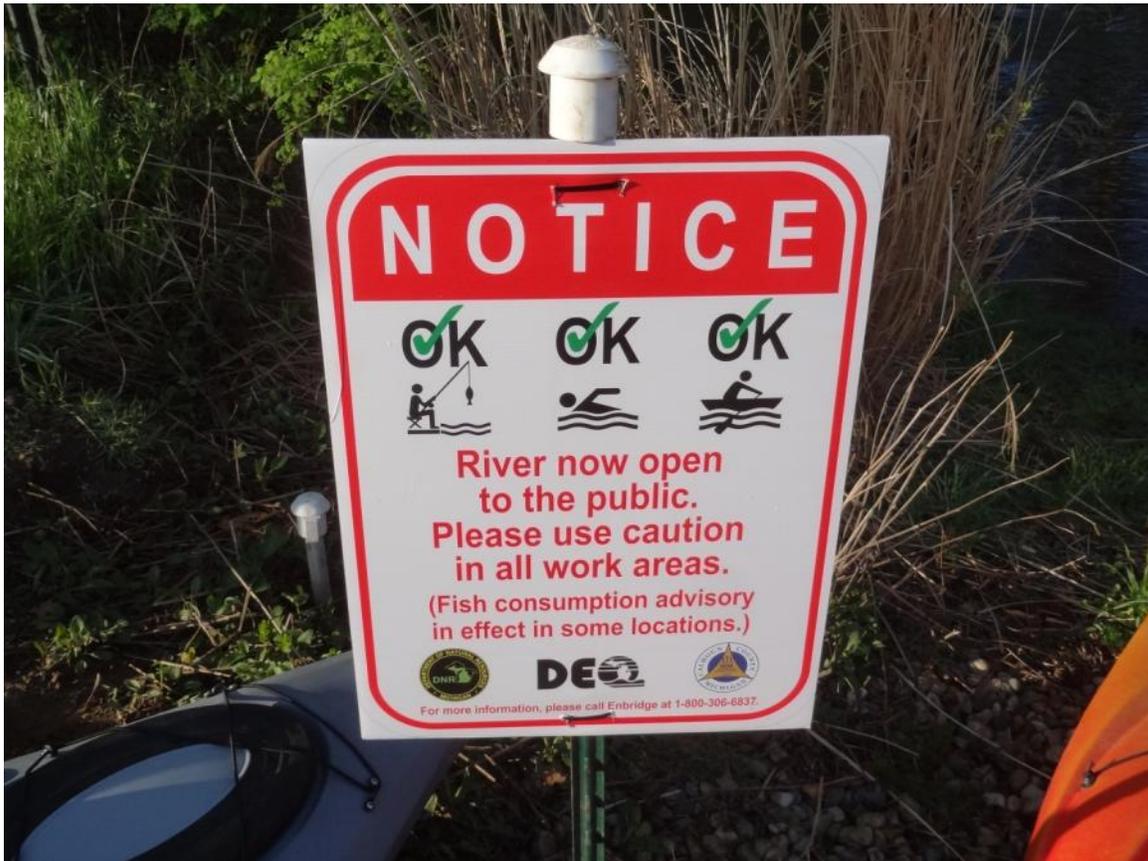
1. Segment 1 open.

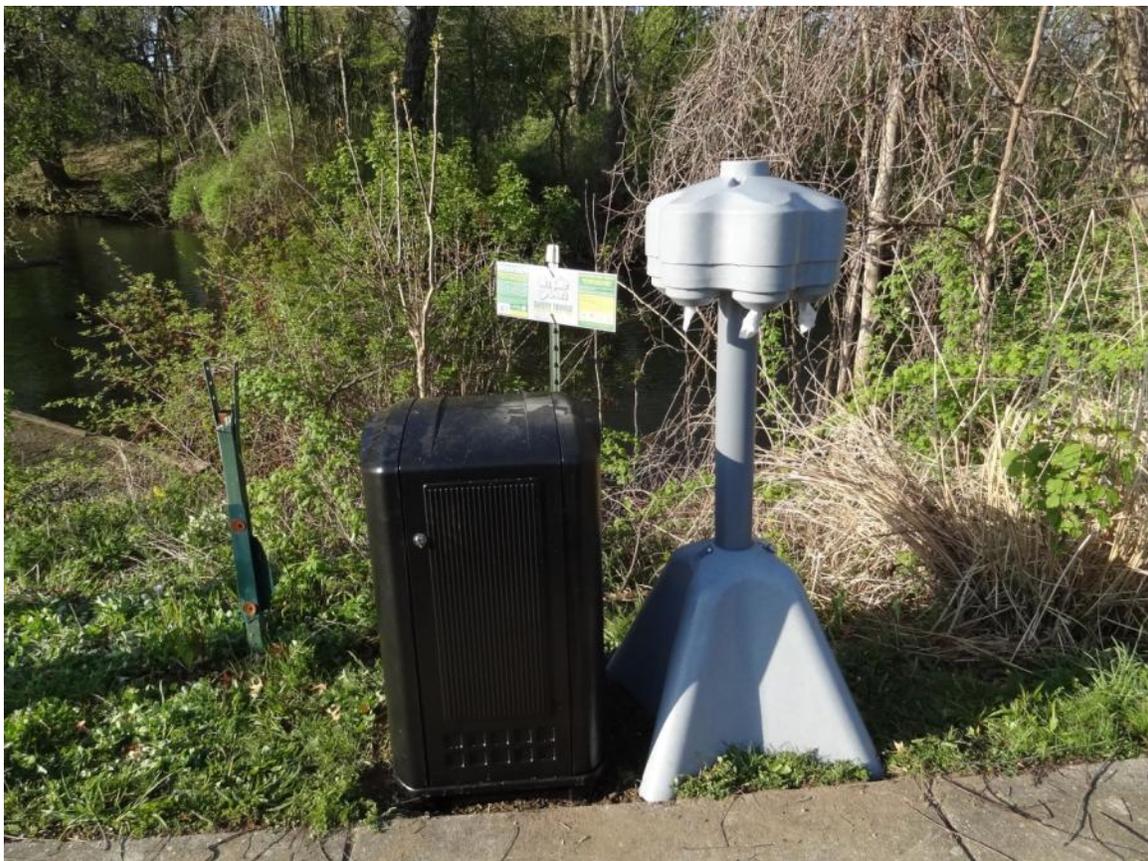
2. Cleaning station at Perrin Dam launch site.

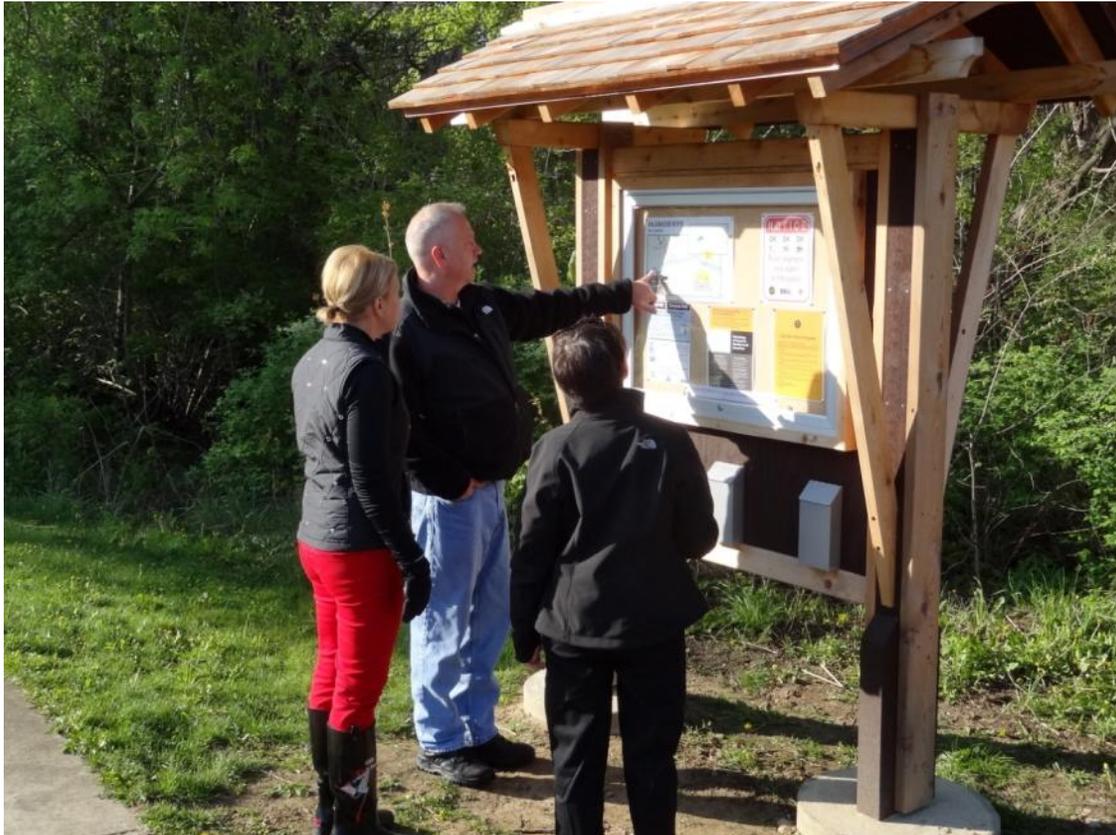
3. Kiosk material placed at Perrin Dam launch site.

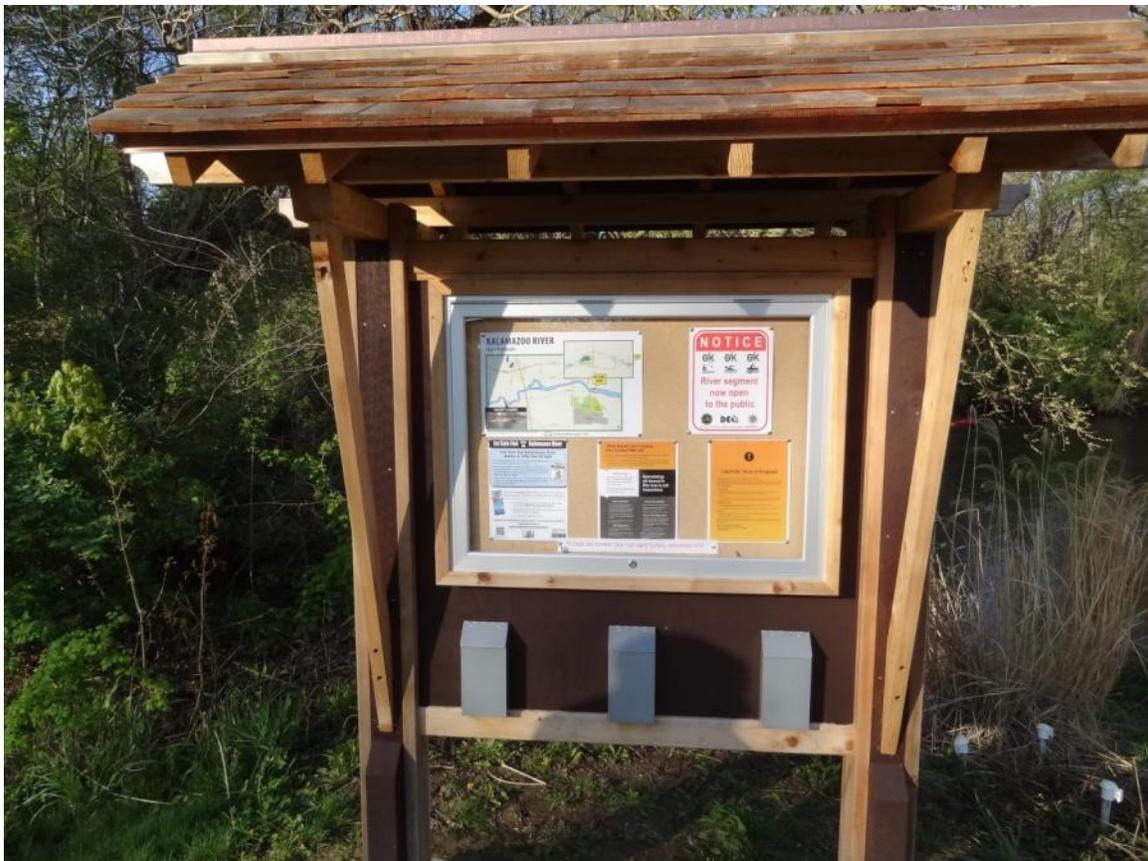
4. Kiosk material placed at Perrin Dam launch site.

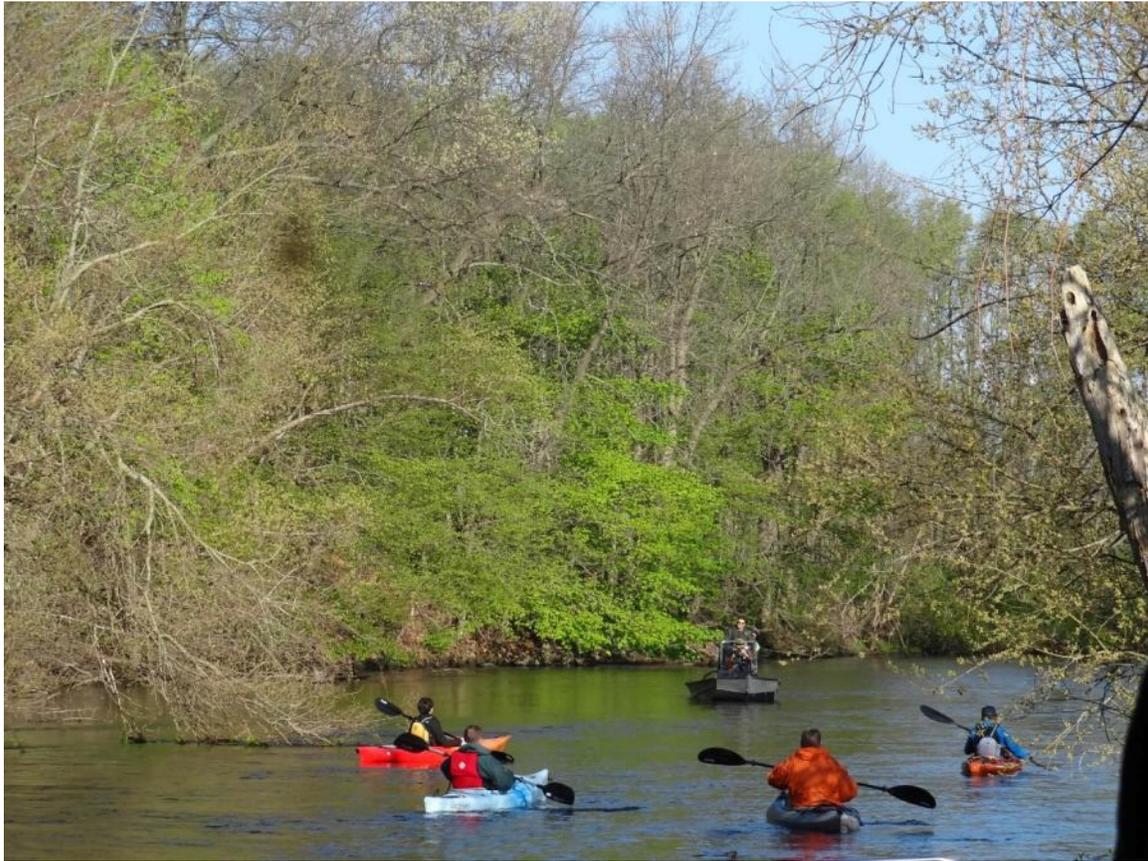
5. Kayak trip down open Segment 1.

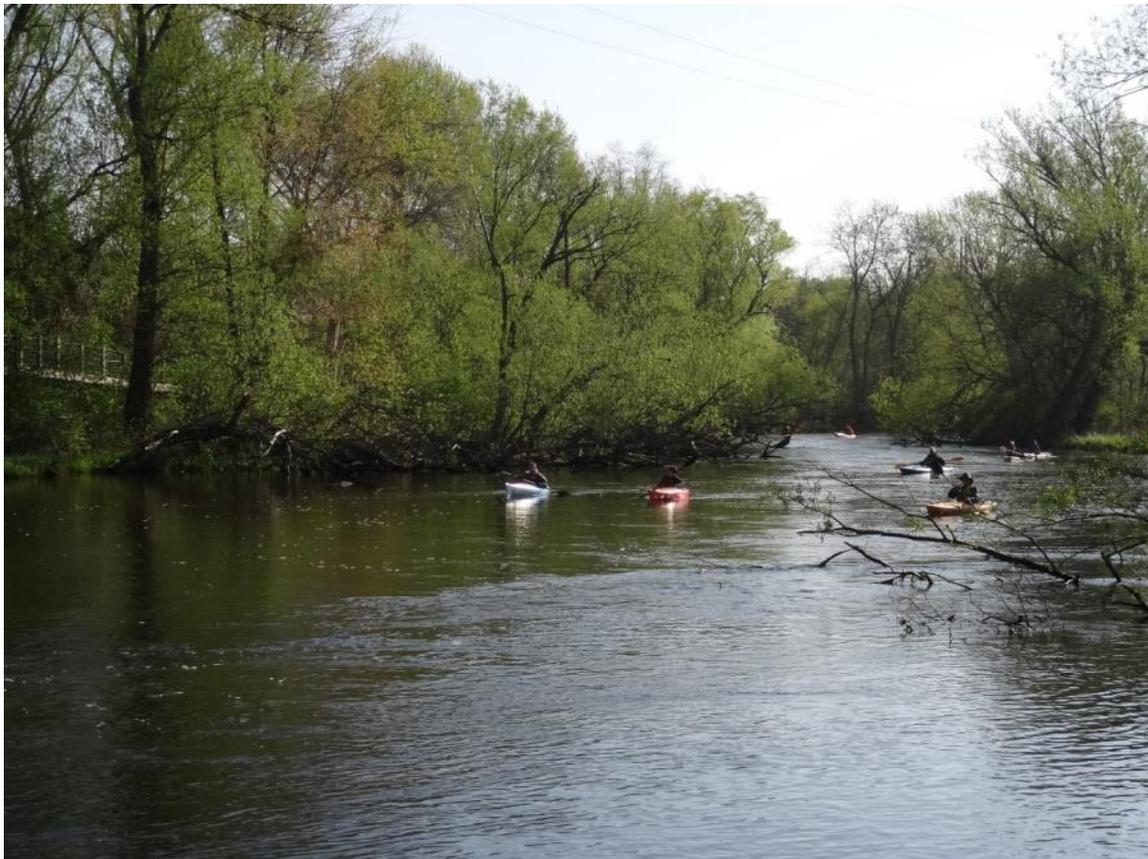
6. Kayak trip down open Segment 1.

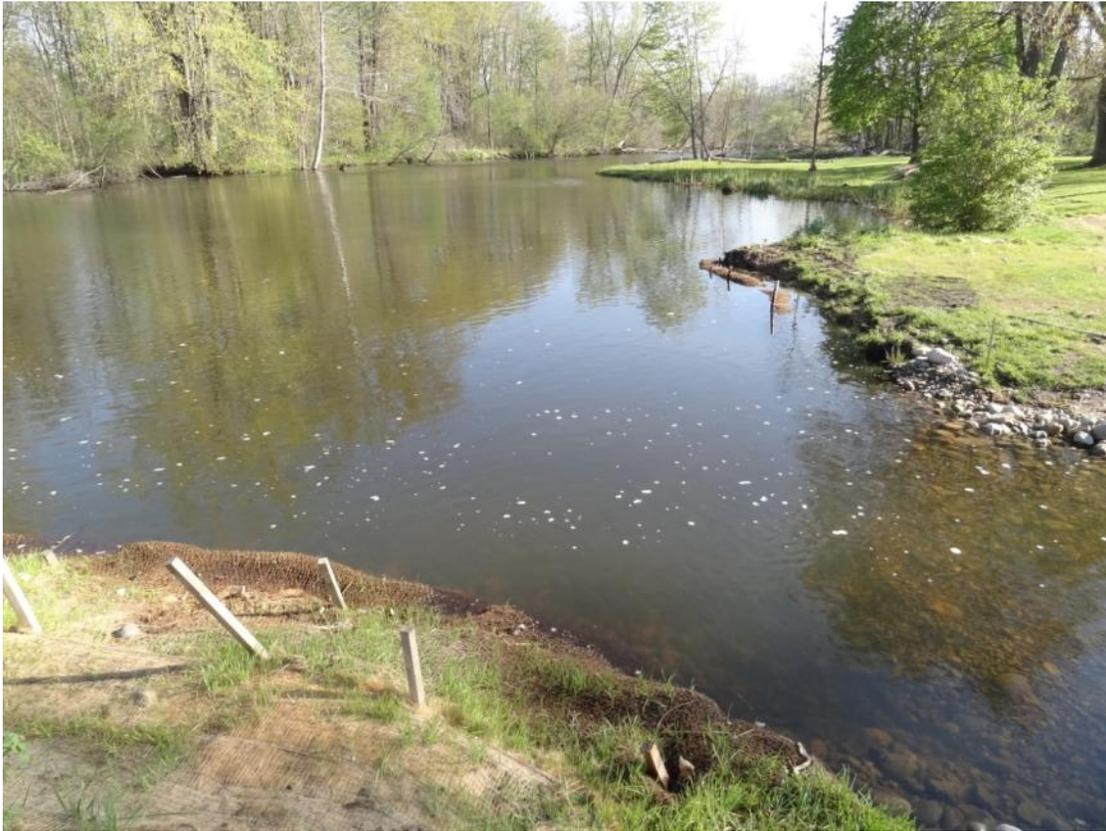
7. Buoys removed from the confluence.

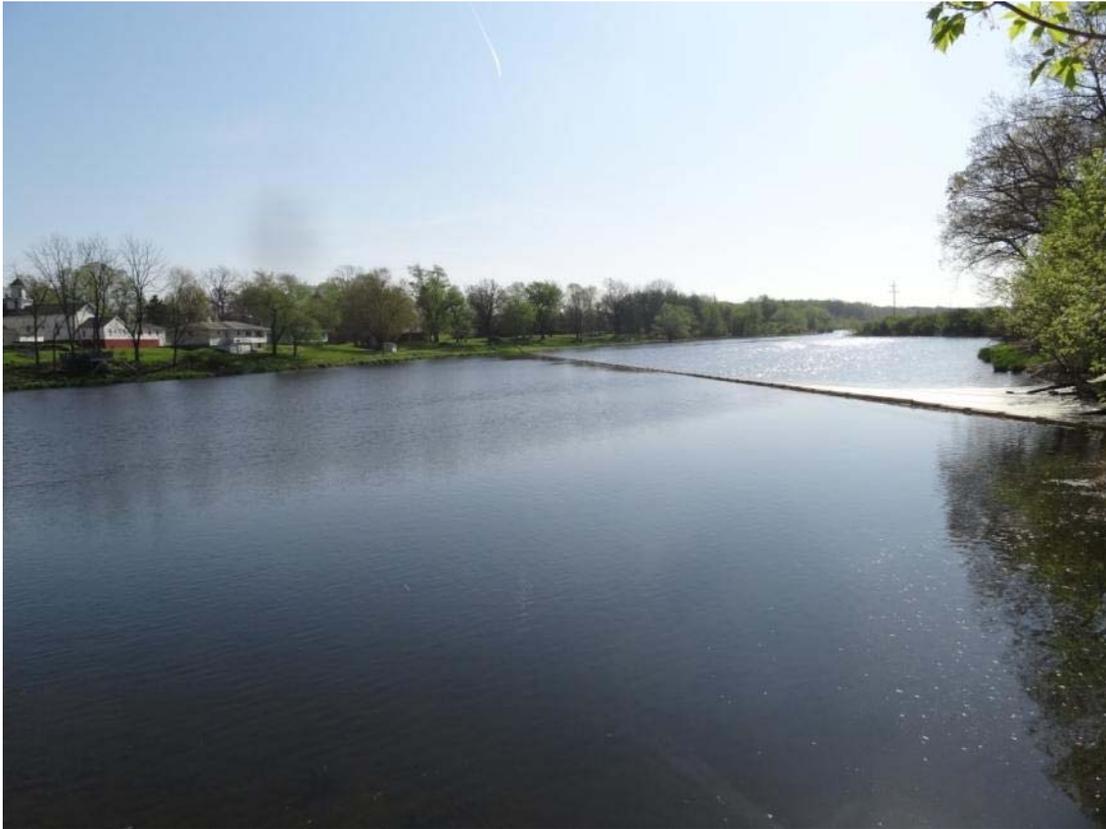
9. Ceresco Dam boom.
