Situation Photo Log

Monday, April 23, 2012

Kalamazoo River / Enbridge Spill

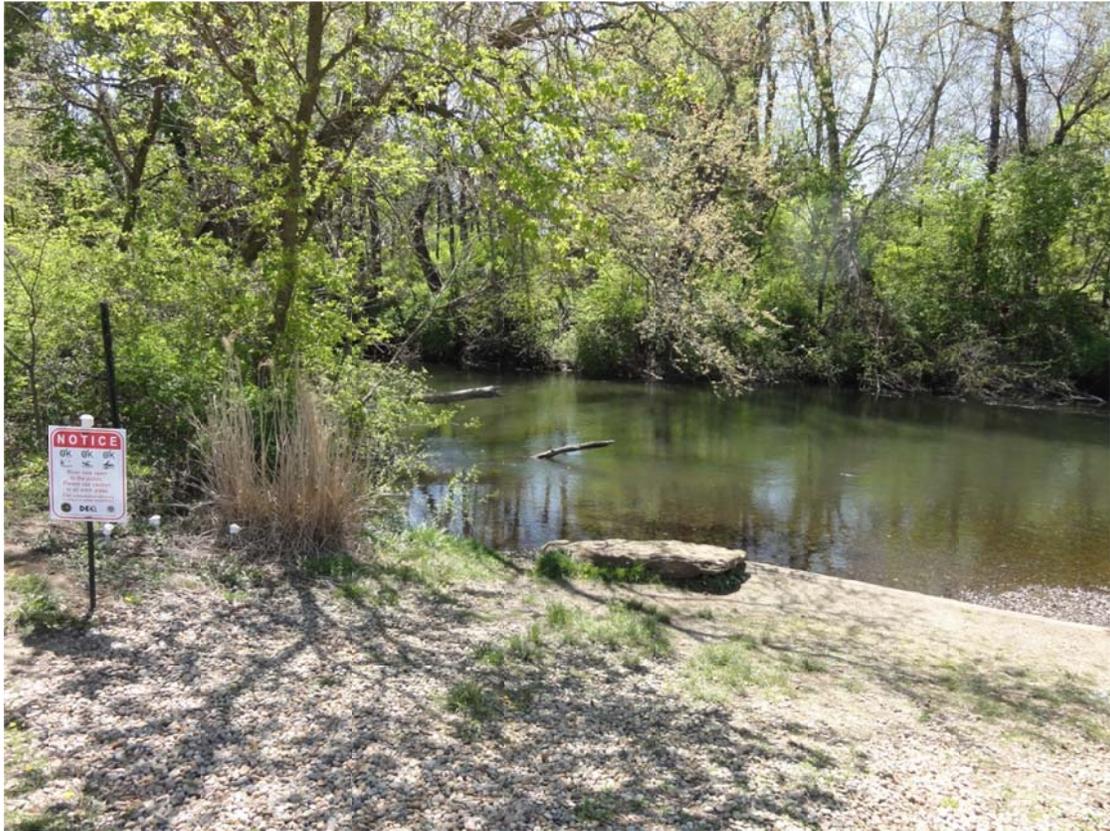
1. Launch point for open river section. River level has dropped since Friday.

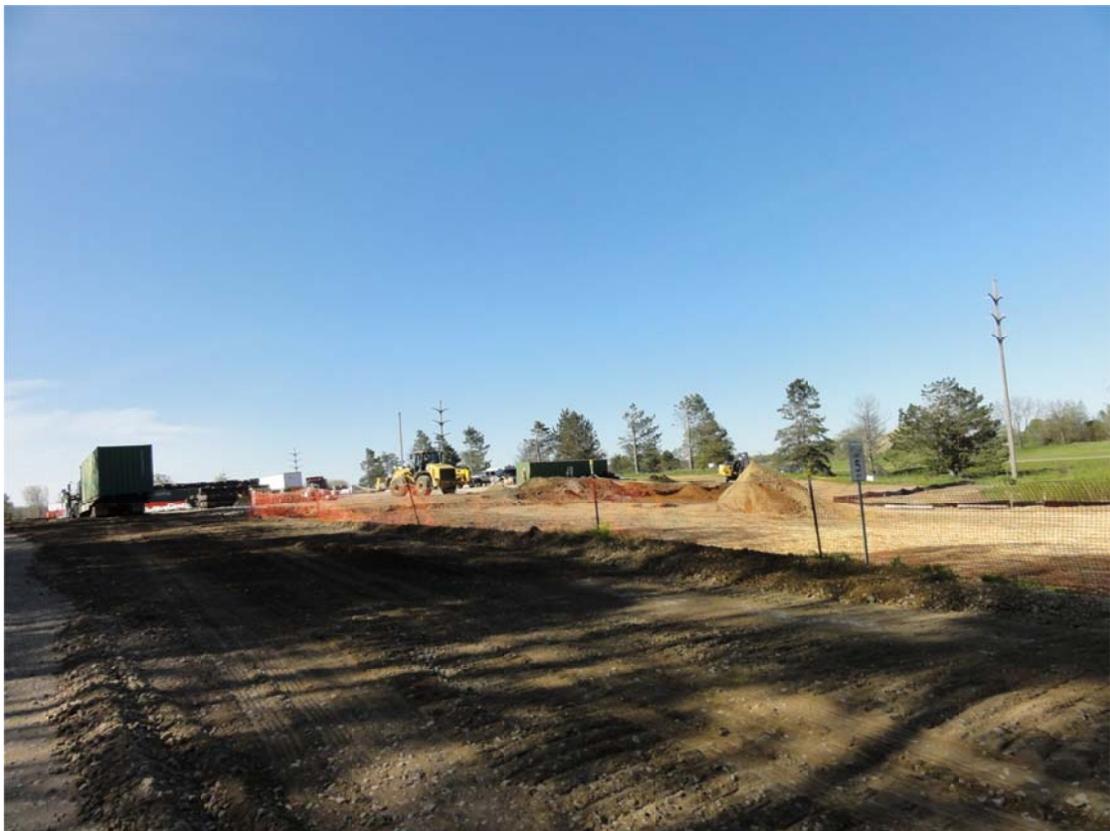
2. Frac Tank City, crews continue to reduce footprint in northern end of area.

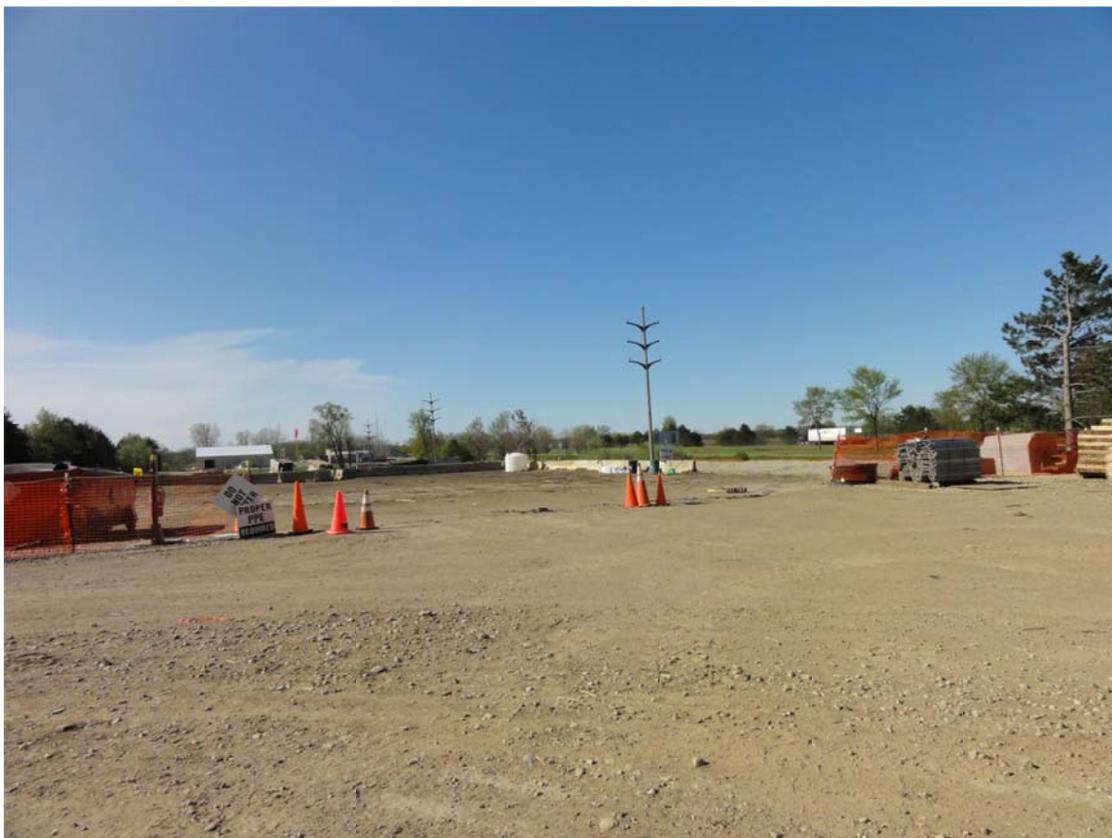
3. Frac Tank City soil cells A and B, no materials staged in cells.

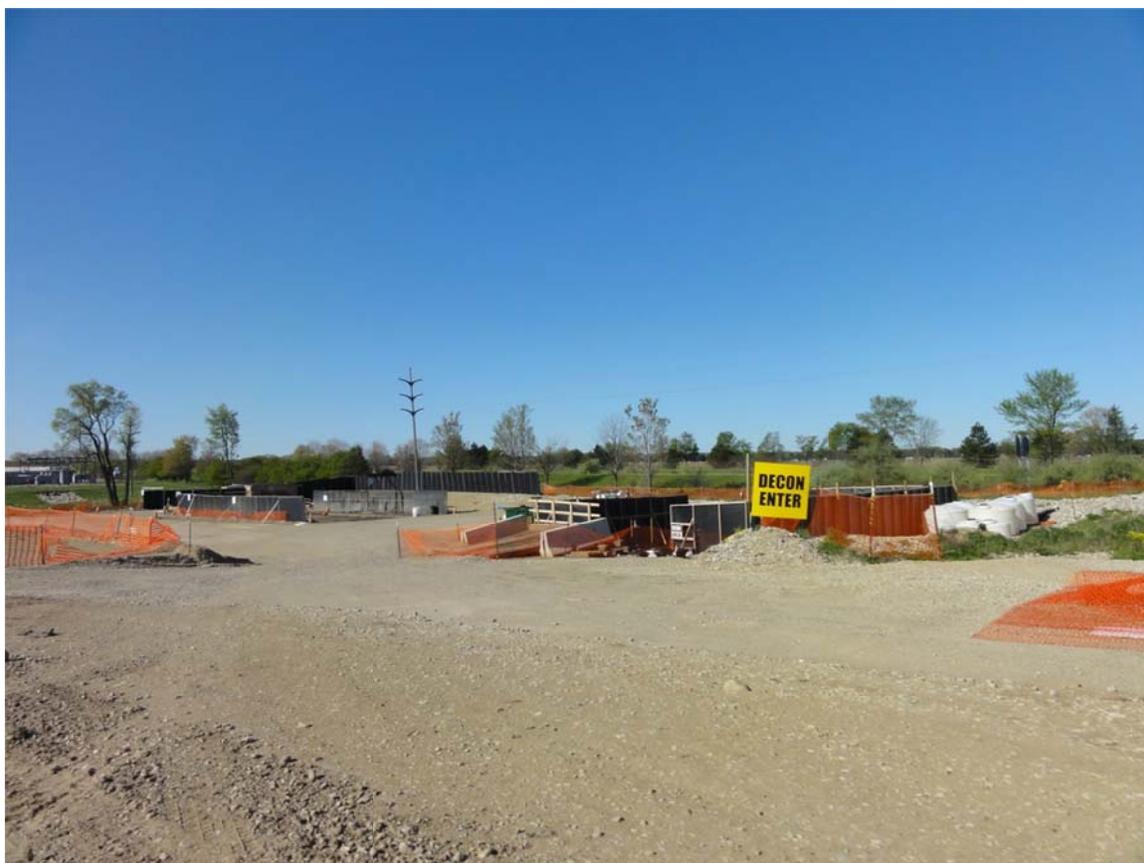
4. Frac Tank City decon area. No activity observed.

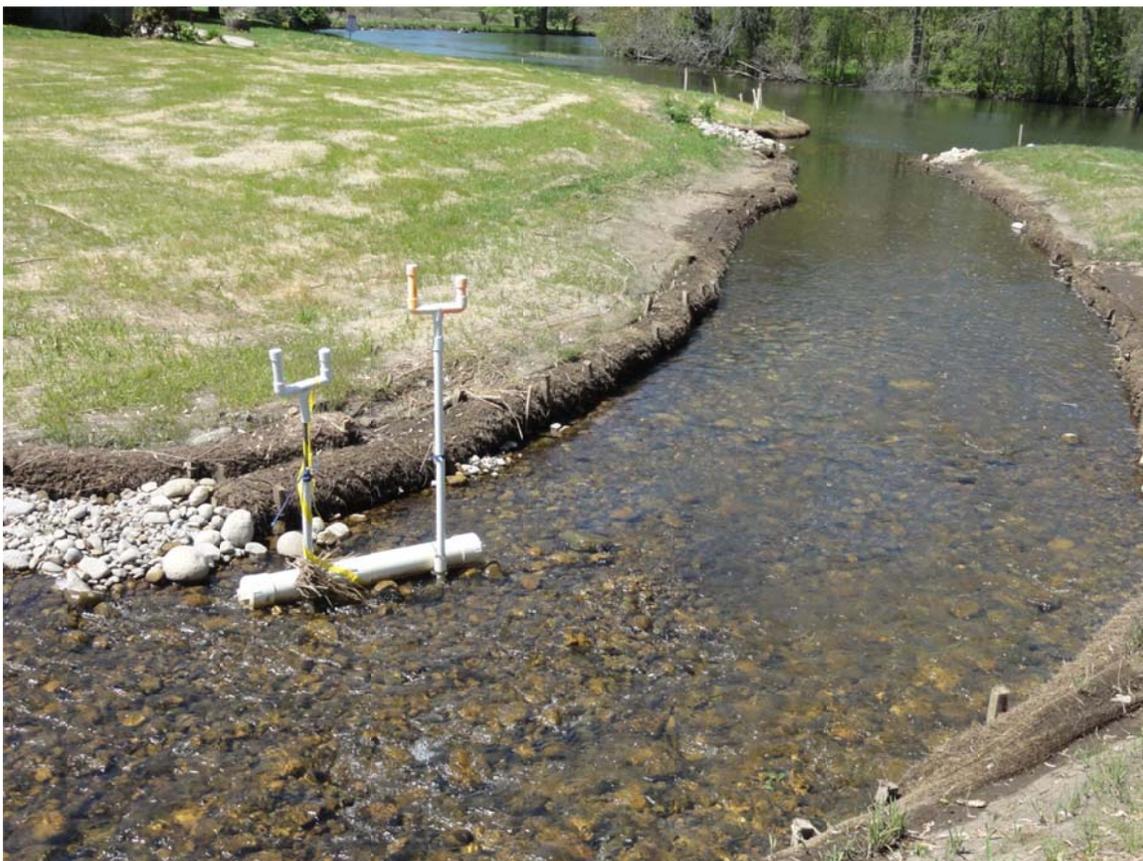
5. Walling tube at Confluence. Creek water level has dropped since Friday.

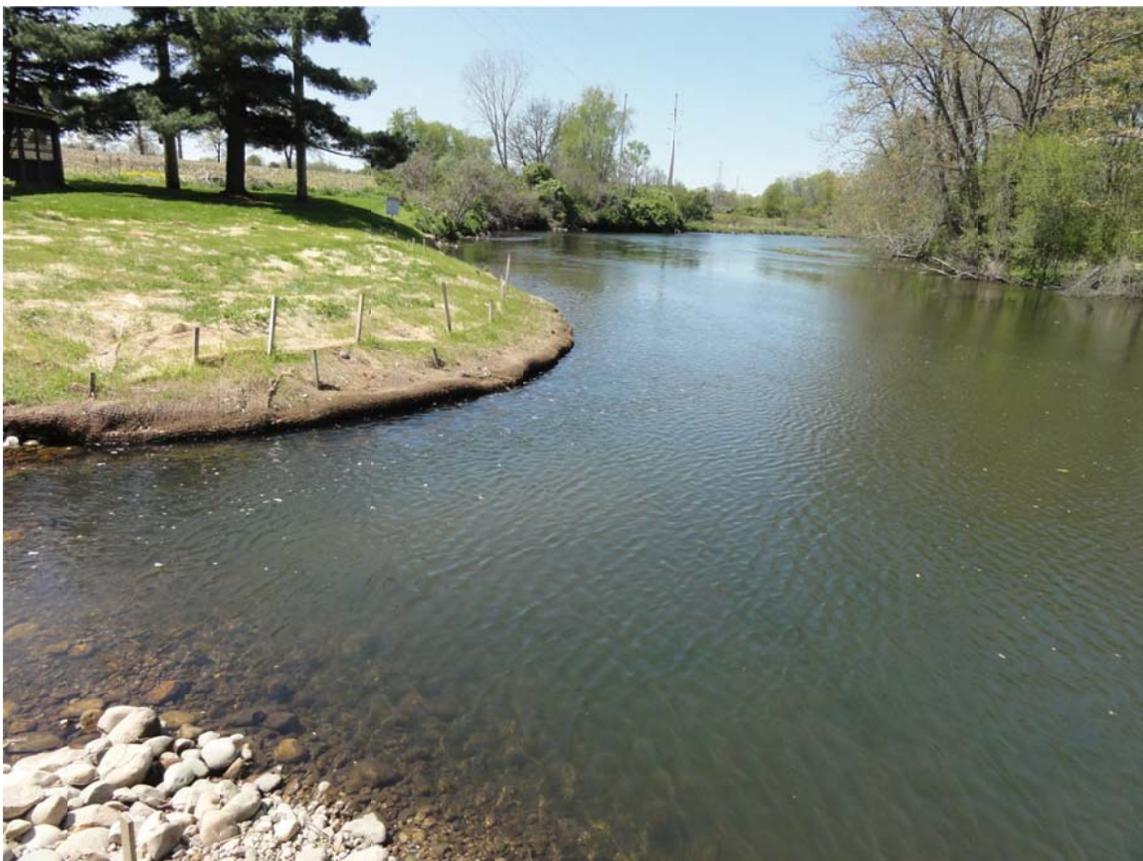
6. Confluence. No turbidity or sheen observed. Creek and river levels have dropped since Friday.

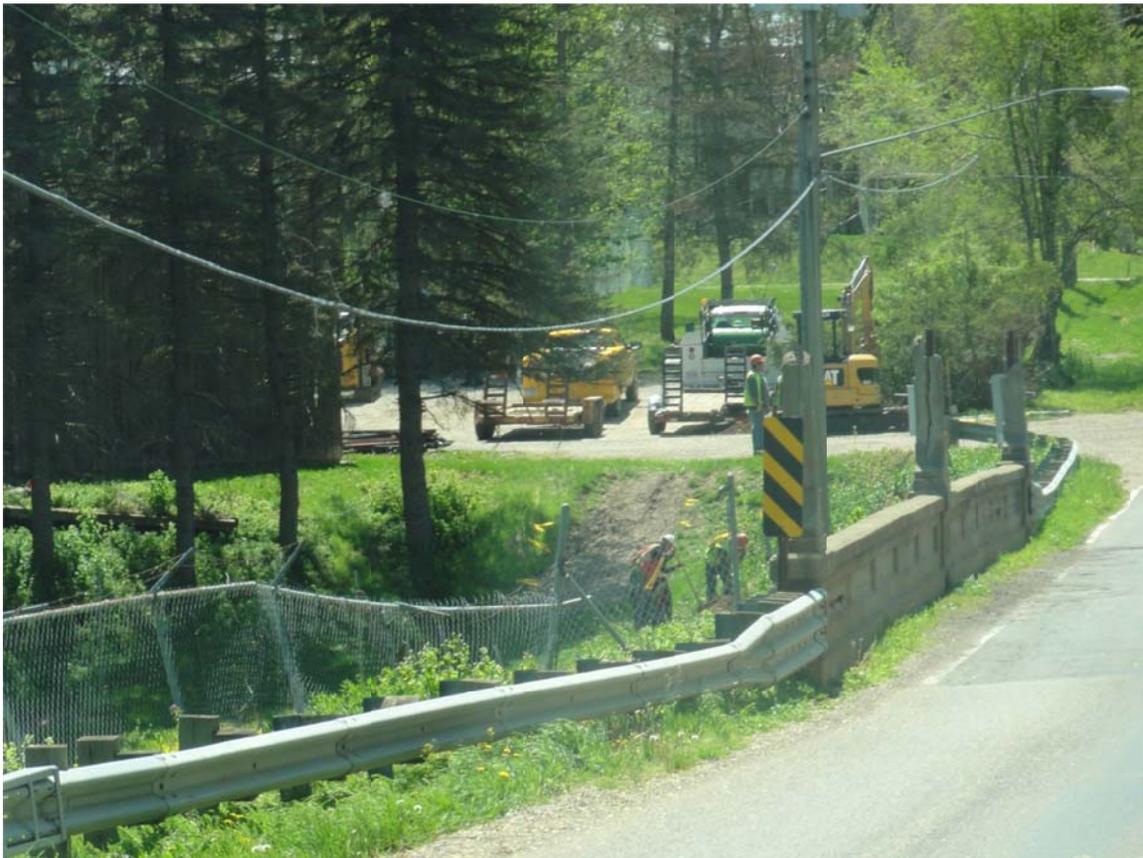
7. Ceresco Dam. Crews staging equipment and beginning utility location for construction of access point below dam.

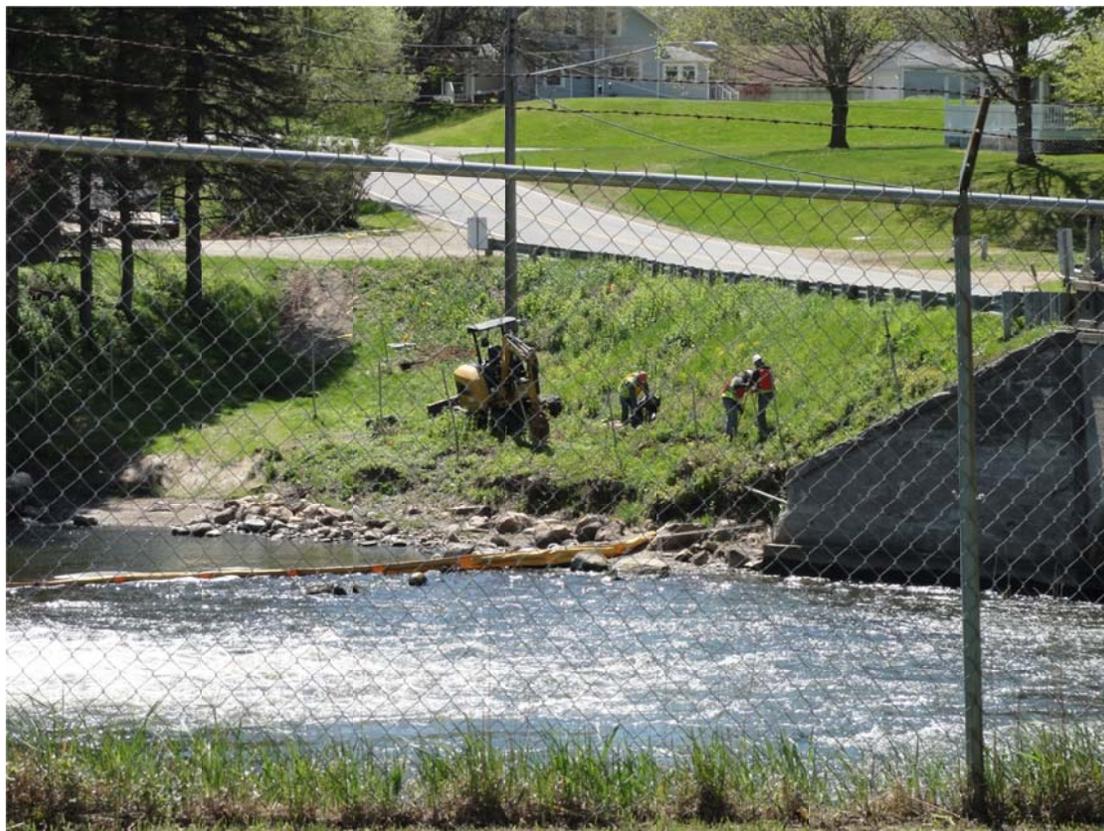
8. Ceresco Dam. Crews beginning activities associated with construction of public access point.

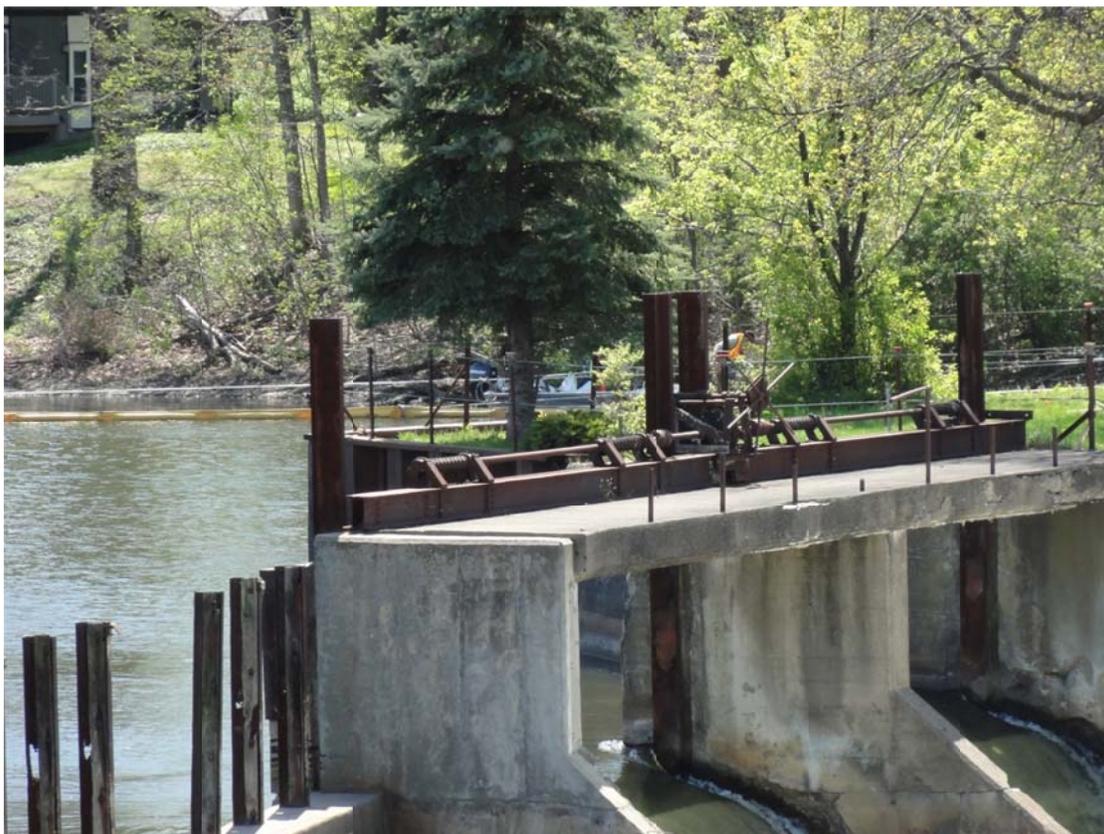
9. Boat crews removing debris from containment boom above Ceresco Dam.

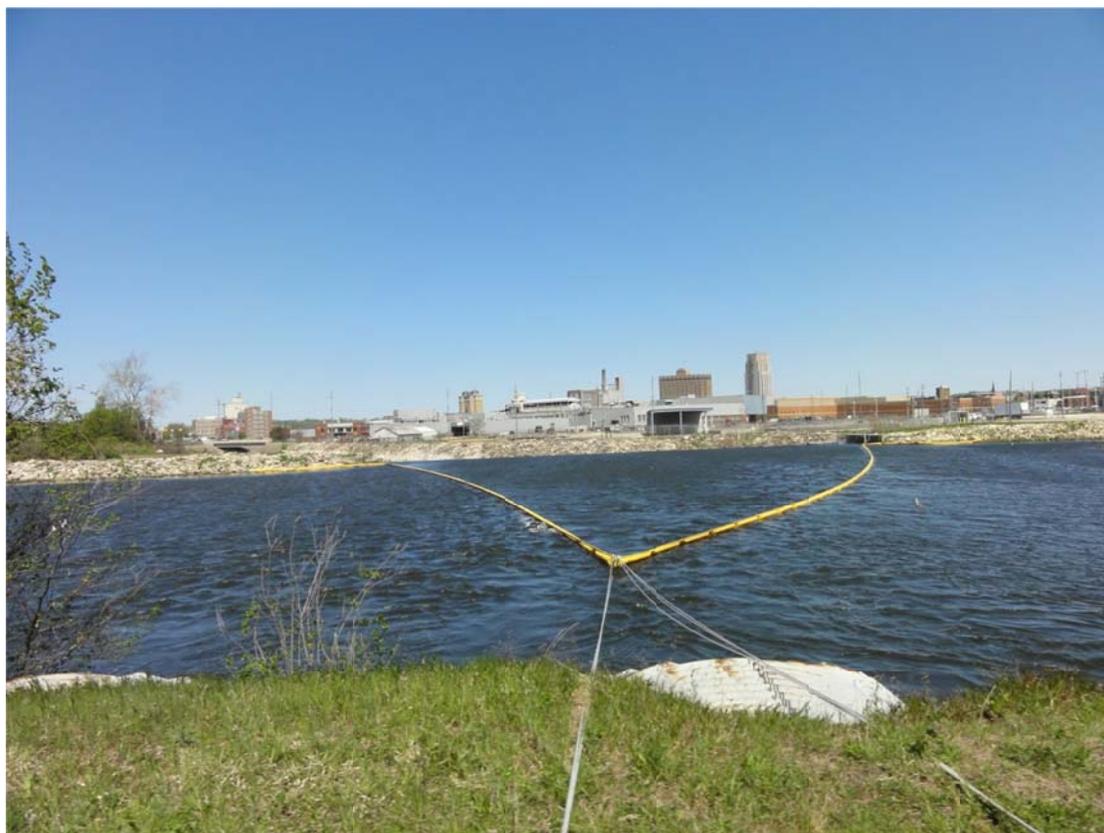
10. Chevron Boom at Battle Creek spillway. No sheen or debris observed.

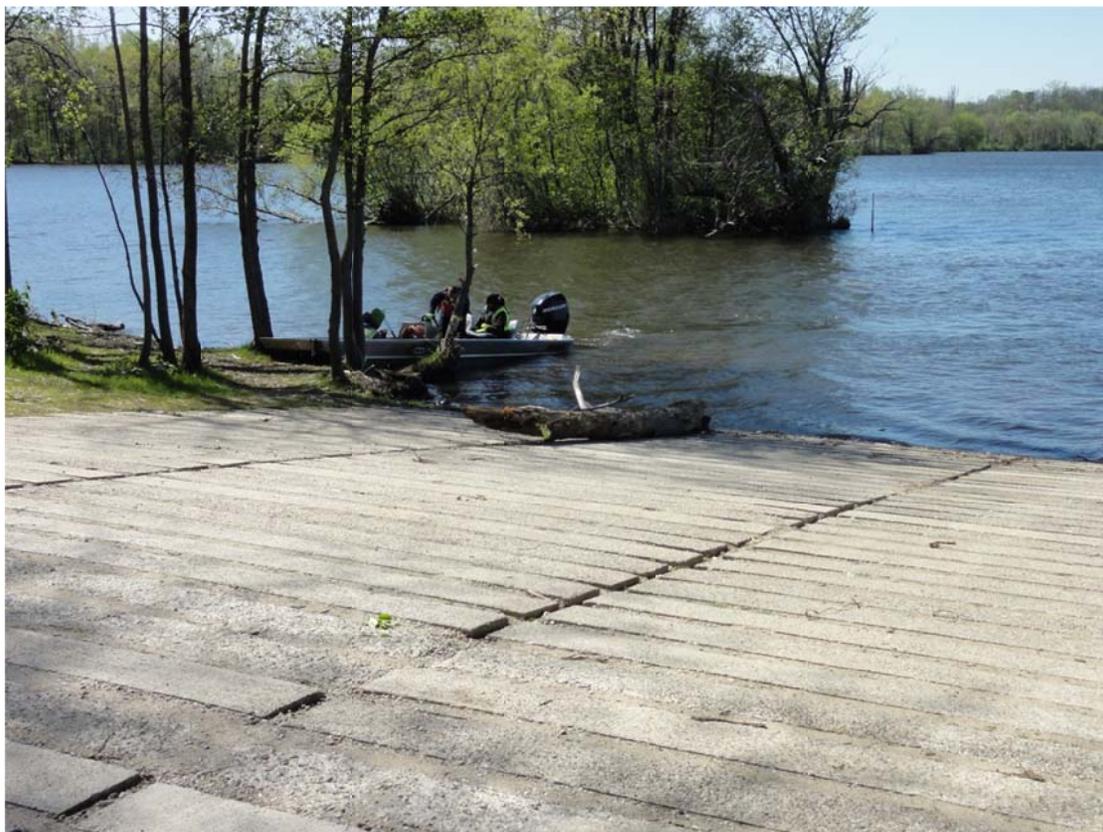
11. Morrow Lake. Poling crews shut down boat operations due to high winds on lake.

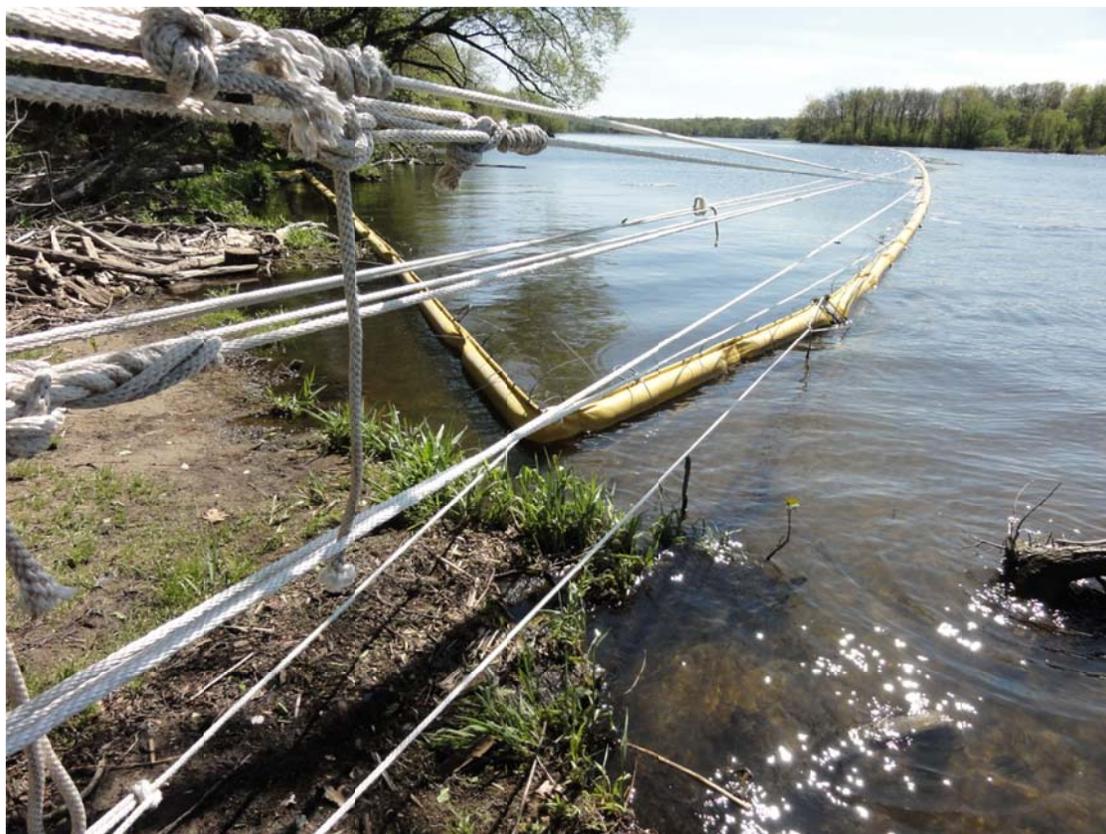
12. Control point at E4 boat launch. No sheen or debris observed.
