# Situation Photo Log

Friday, April 27, 2012

Kalamazoo River / Enbridge Spill

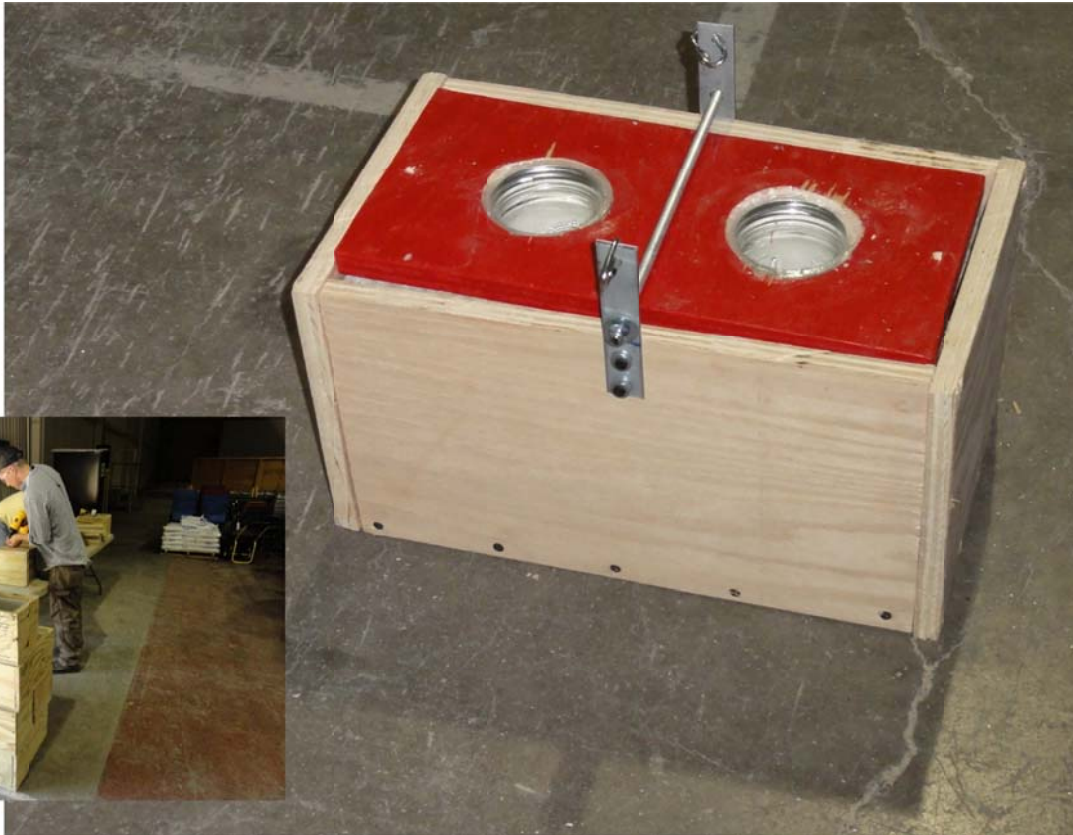
1. Crews building sediment collection devices for installation with sediment traps.

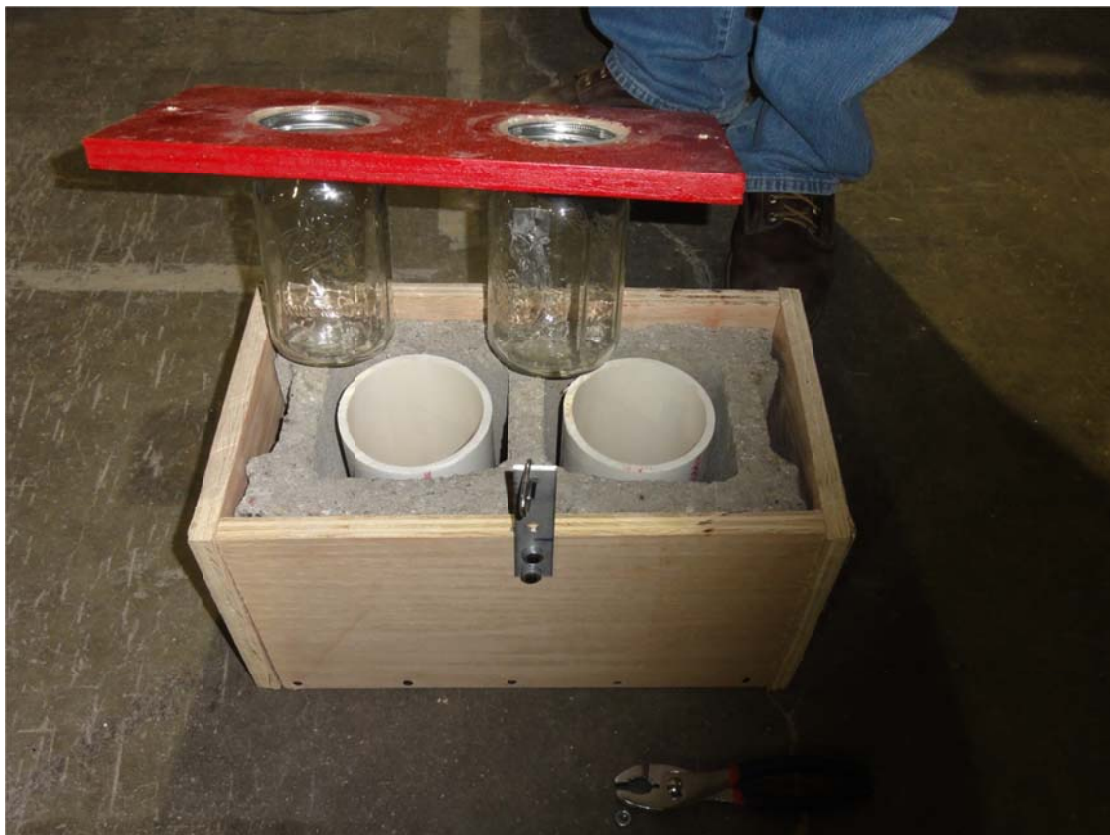
2. Close up of sediment collection device interior.

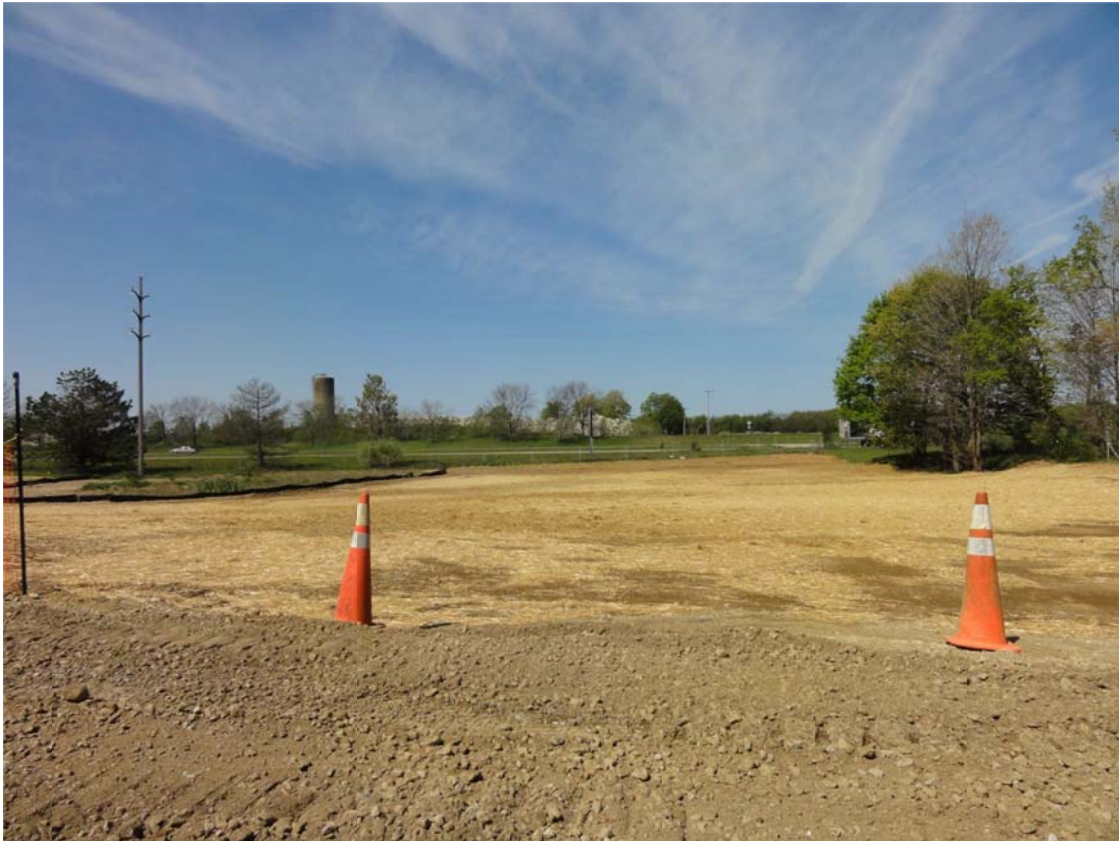
**3. Crews continue footprint reduction at Frac Tank City.**

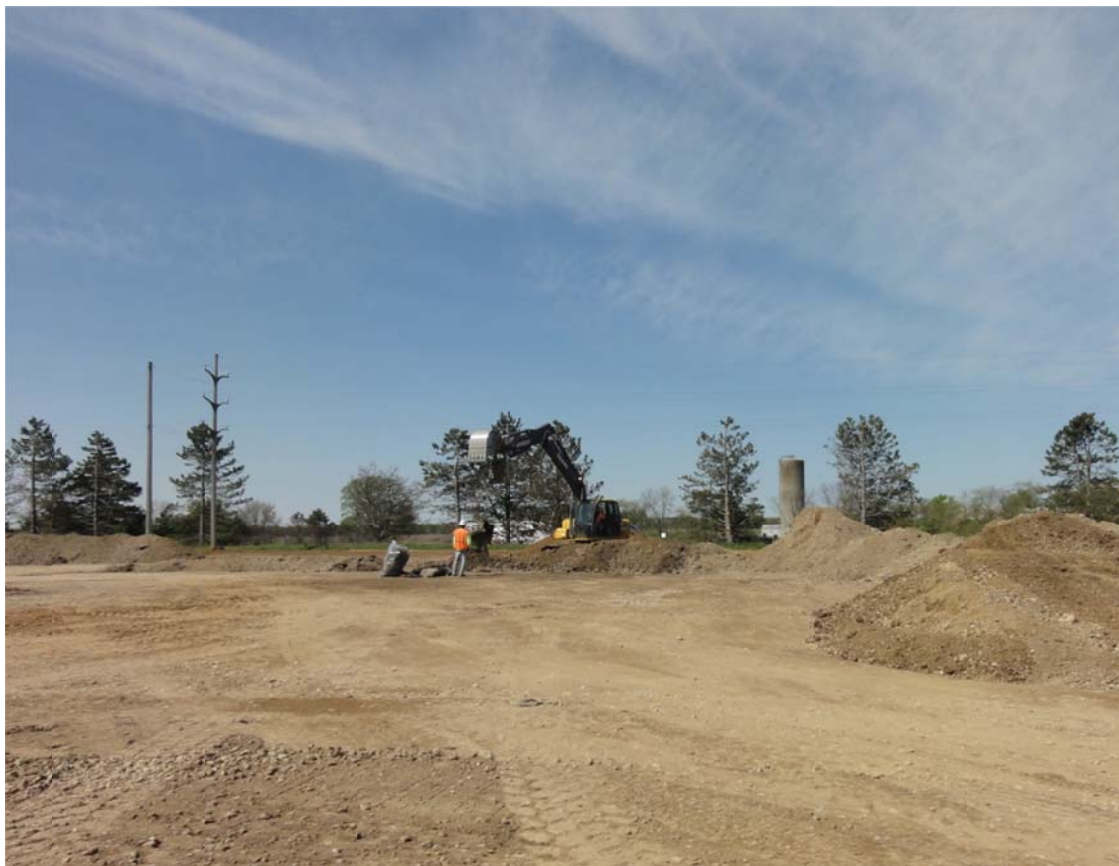
**4. Gravel removal in northern end of Frac Tank City.**

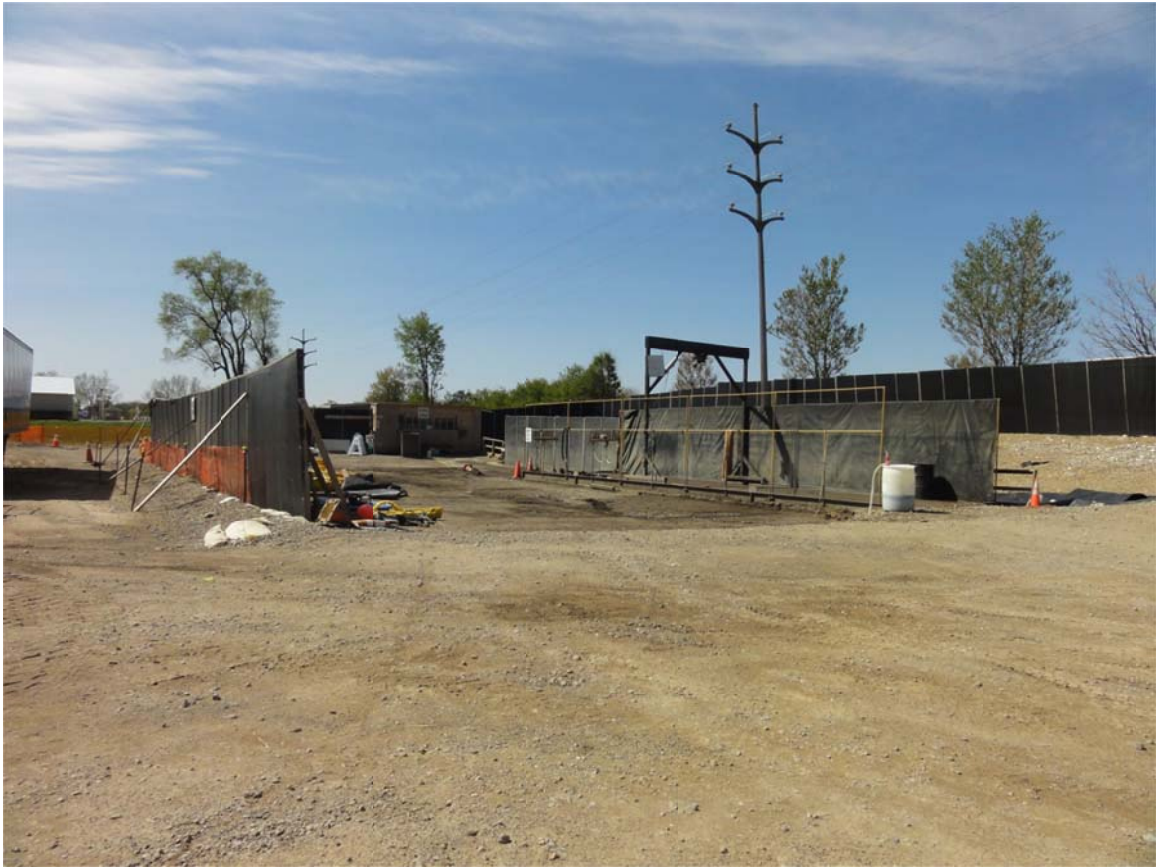
5. Southern decon pad at Frac Tank City. Boom and materials staged in pad.

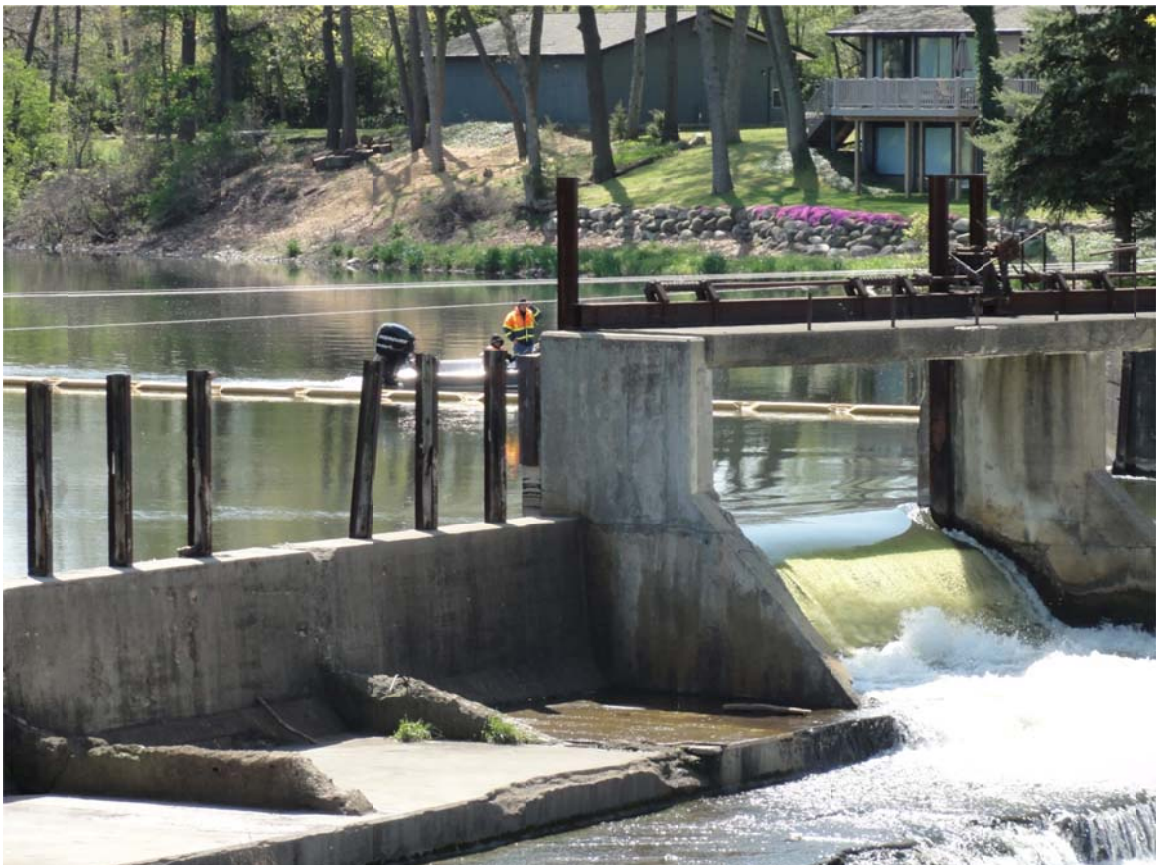
6. Crews conducting boom inspection and maintenance above Ceresco Dam.

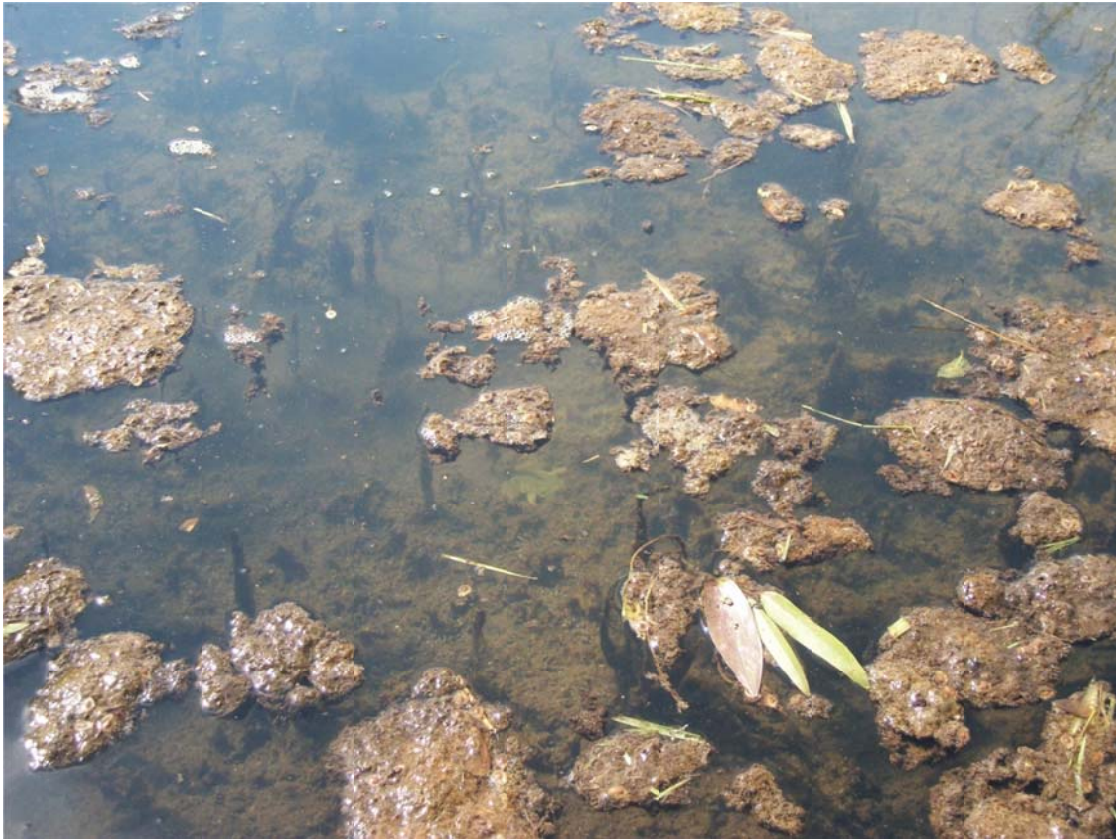
7. Pond at former OB 5.92 RDB excavation location. Area inspected by Operations today.

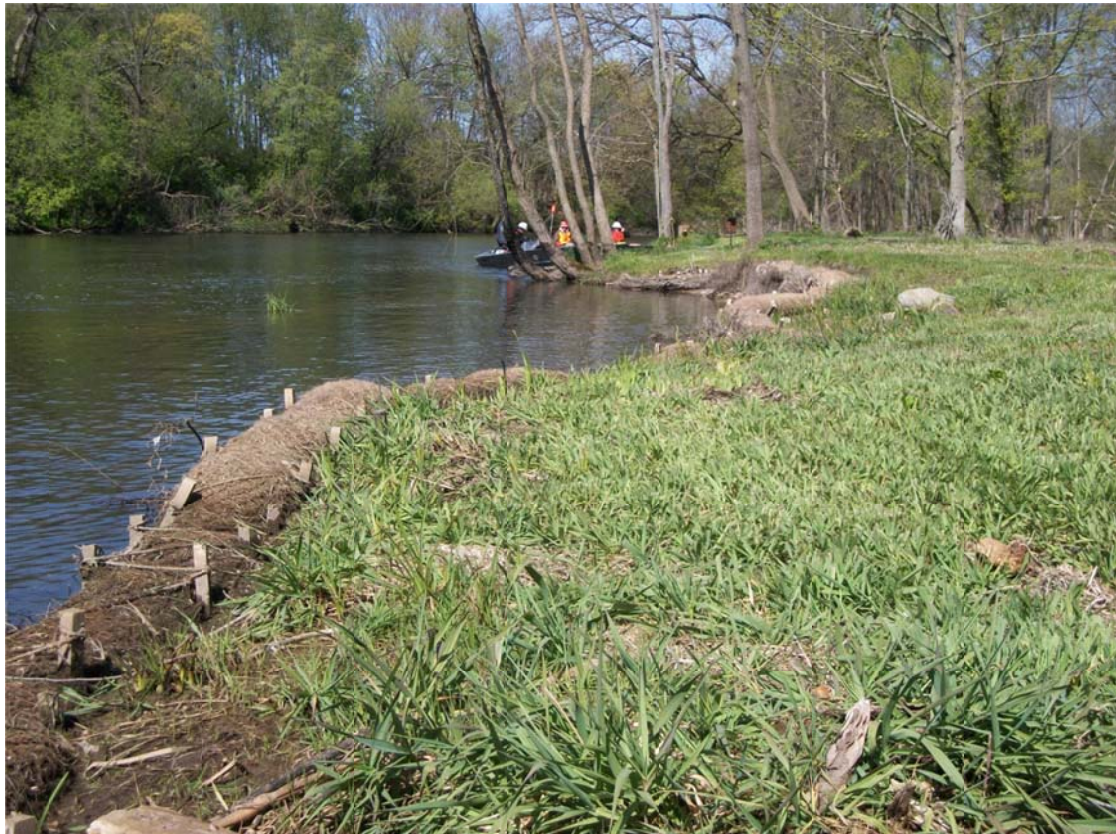
8. Operations crews inspecting shoreline at MP5.92 LDB.

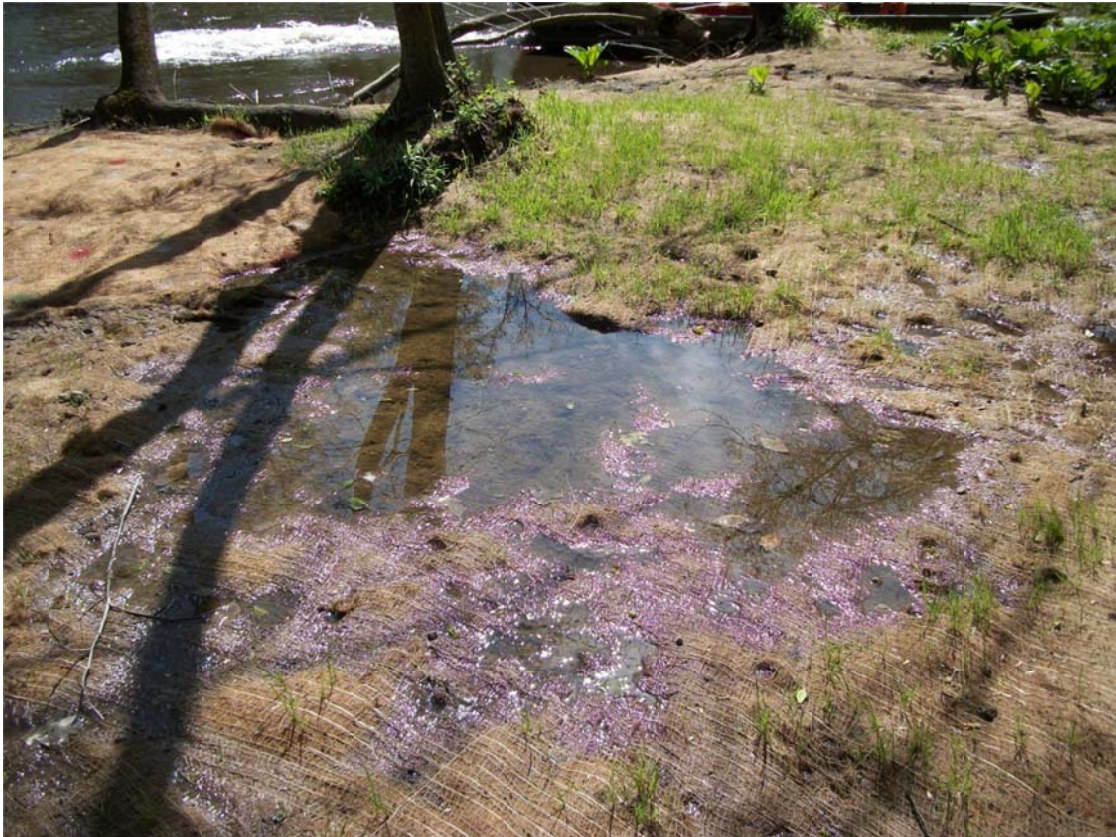
**9. Former excavation site at MP 9.10. Area inspected by Operations today.**

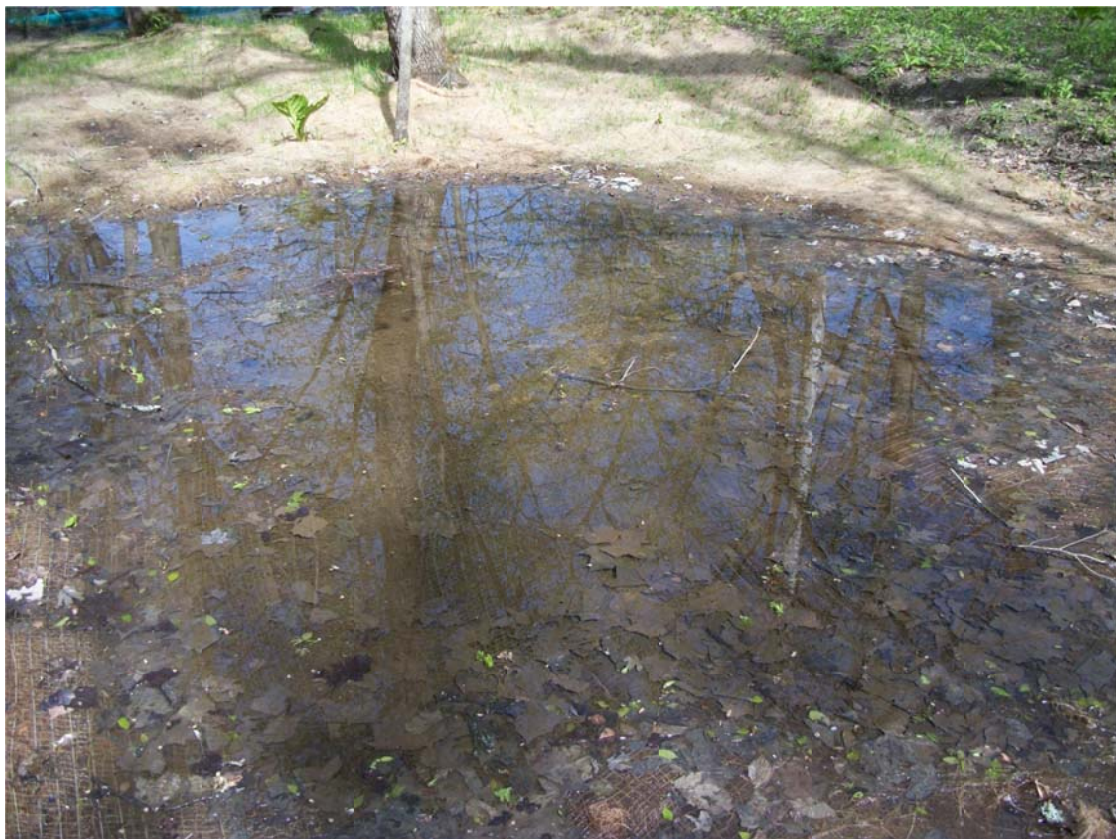
**10. Former excavation location at MP 8.97. Area inspected by Operations crews today.**

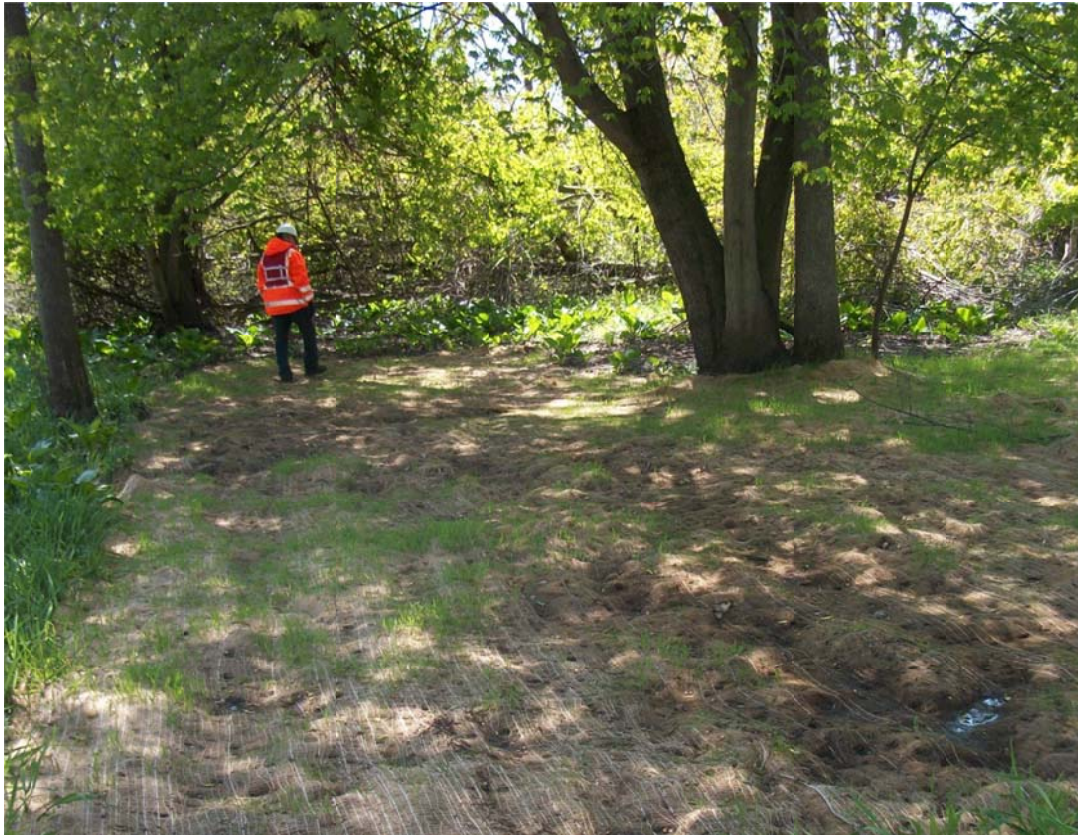
**11. Operations crew inspecting former 10.37 excavation area.**

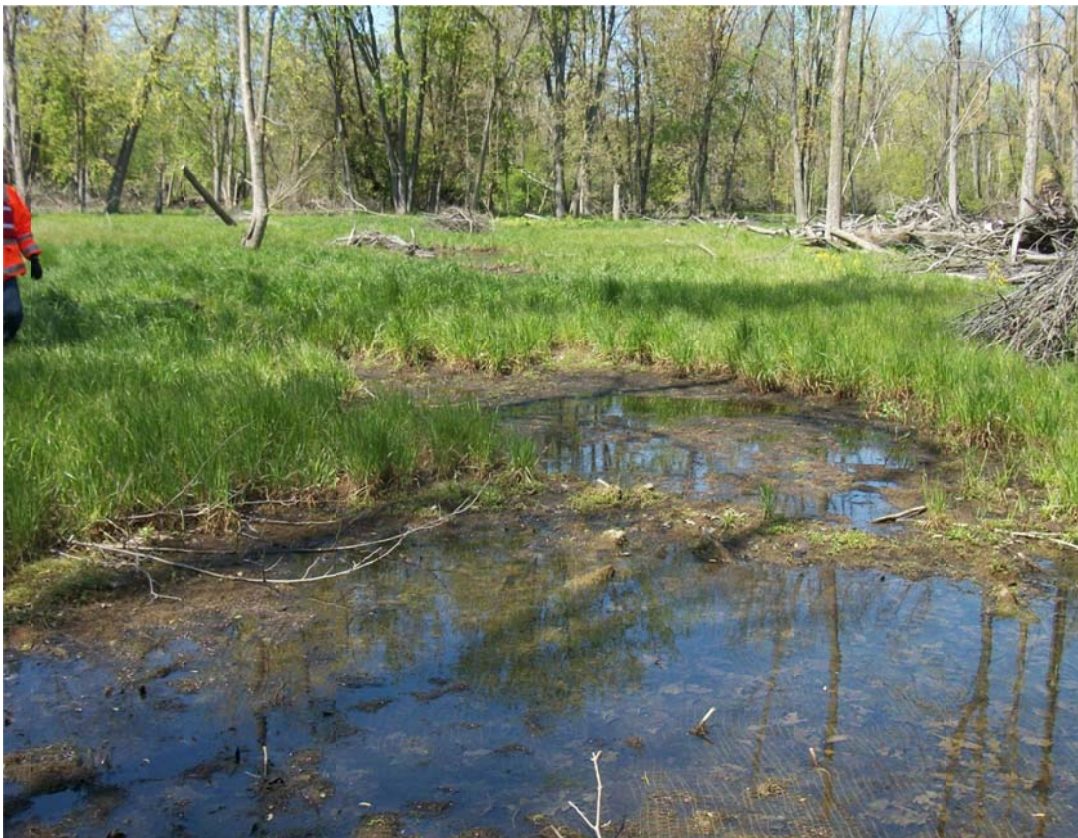
**12. Operations personnel inspecting former excavation area at MP 11.25.**

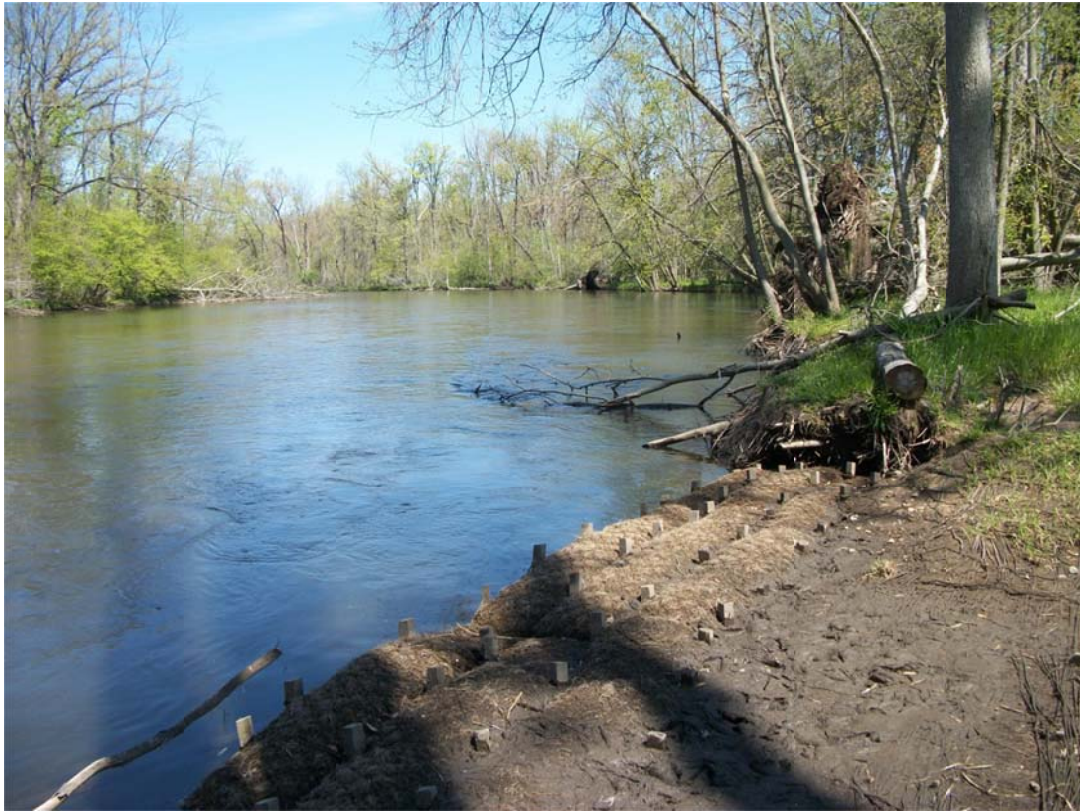
**13. Restoration at former excavation area at MP 11.25 R2. Operations personnel inspected this location today.**

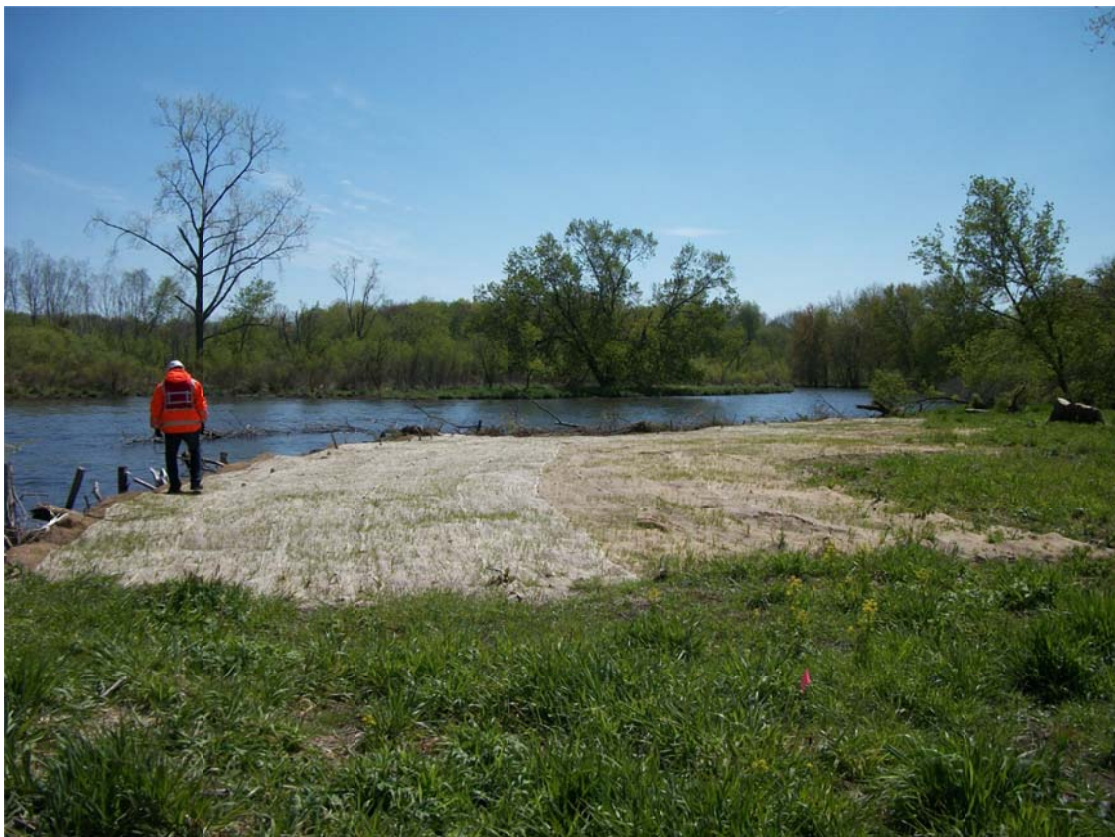
**14. Operations personnel inspecting former excavation location at OB 13.40 RDB.**

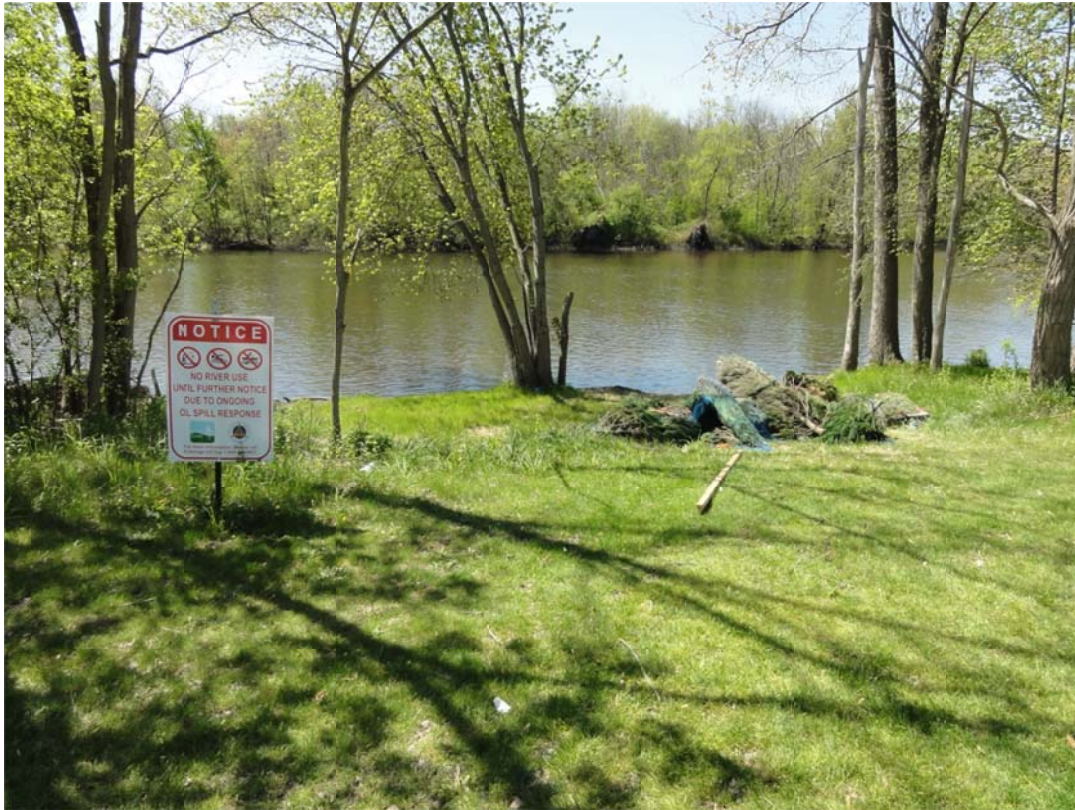
**15. Sediment trap materials staged at former D2 boat launch, across the river from MP 19.25 LDB sediment trap location.**

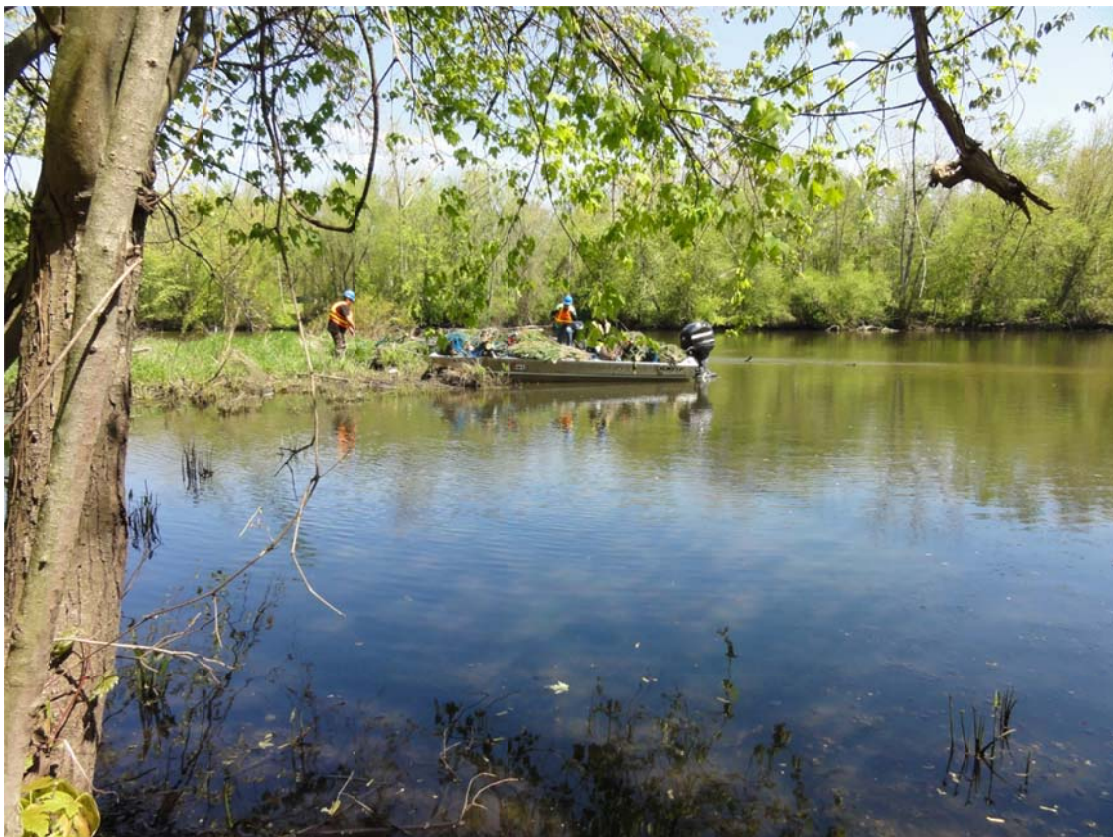
**16. Crews off-loading materials for sediment trap installation at MP 19.25 LDB.**

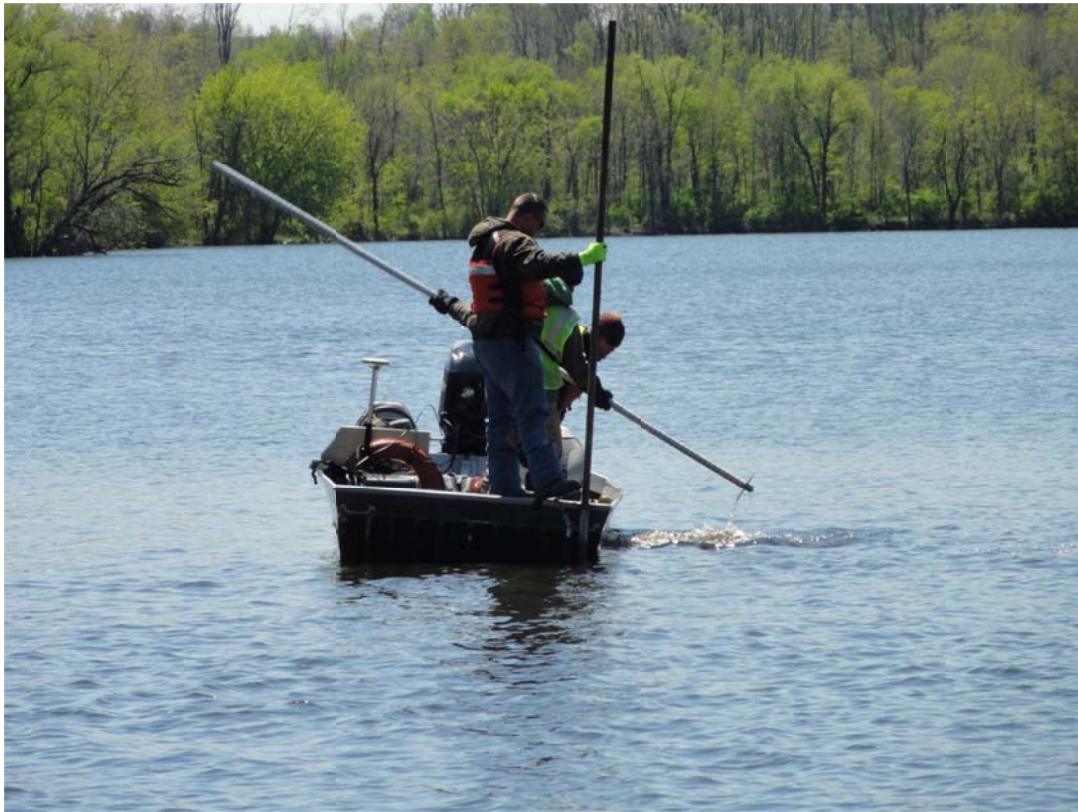
17. Crews continue poling activities in northeastern portion of Morrow Lake.

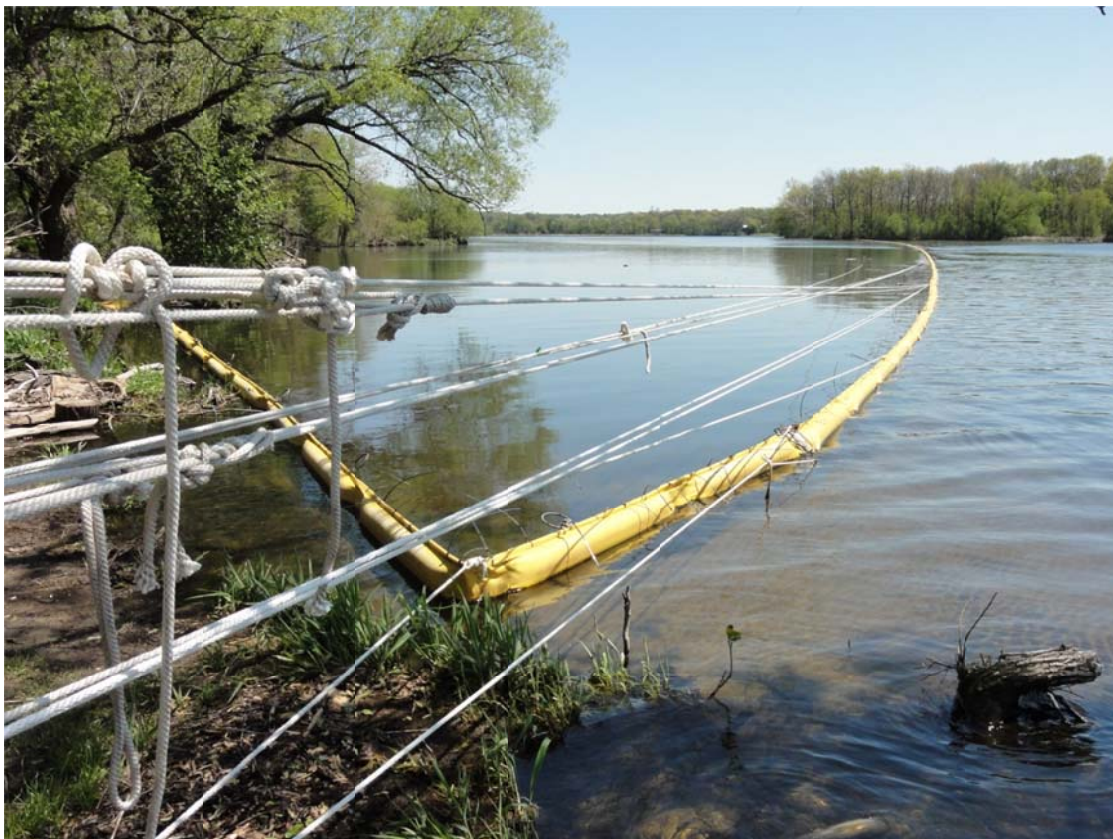
18. Control Point E4, no sheen observed.
