Situation Photo Log

Friday, May 4, 2012

Kalamazoo River / Enbridge Spill

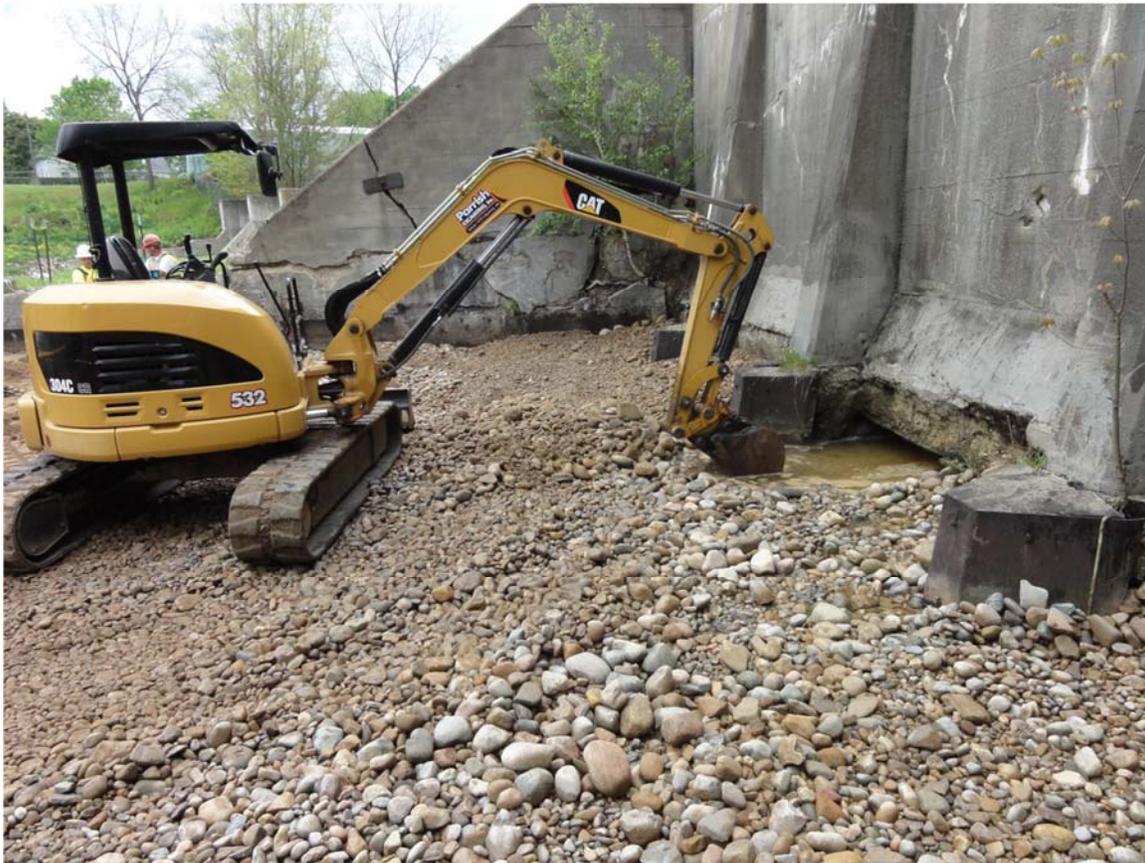
1. Ceresco Dam legacy work.

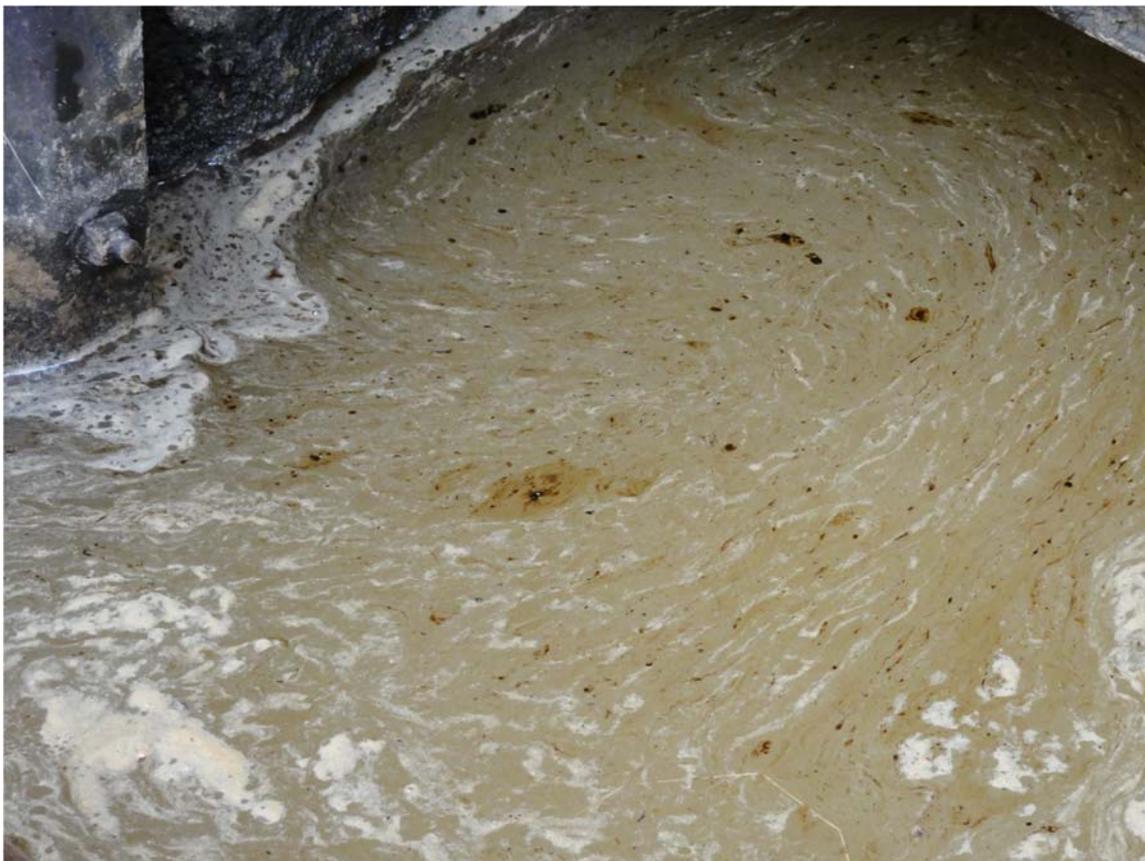
2. Oil globs and sheen observed during legacy work.

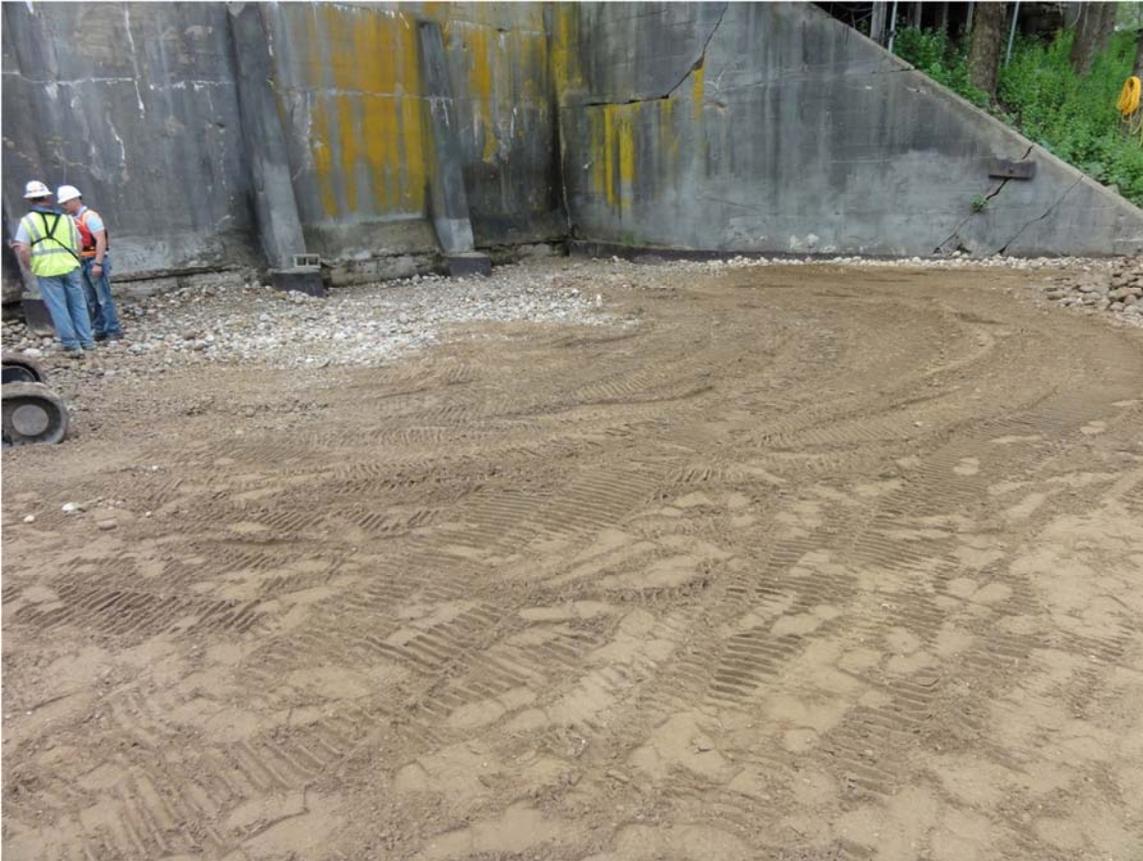
3. Ceresco Dam legacy work.

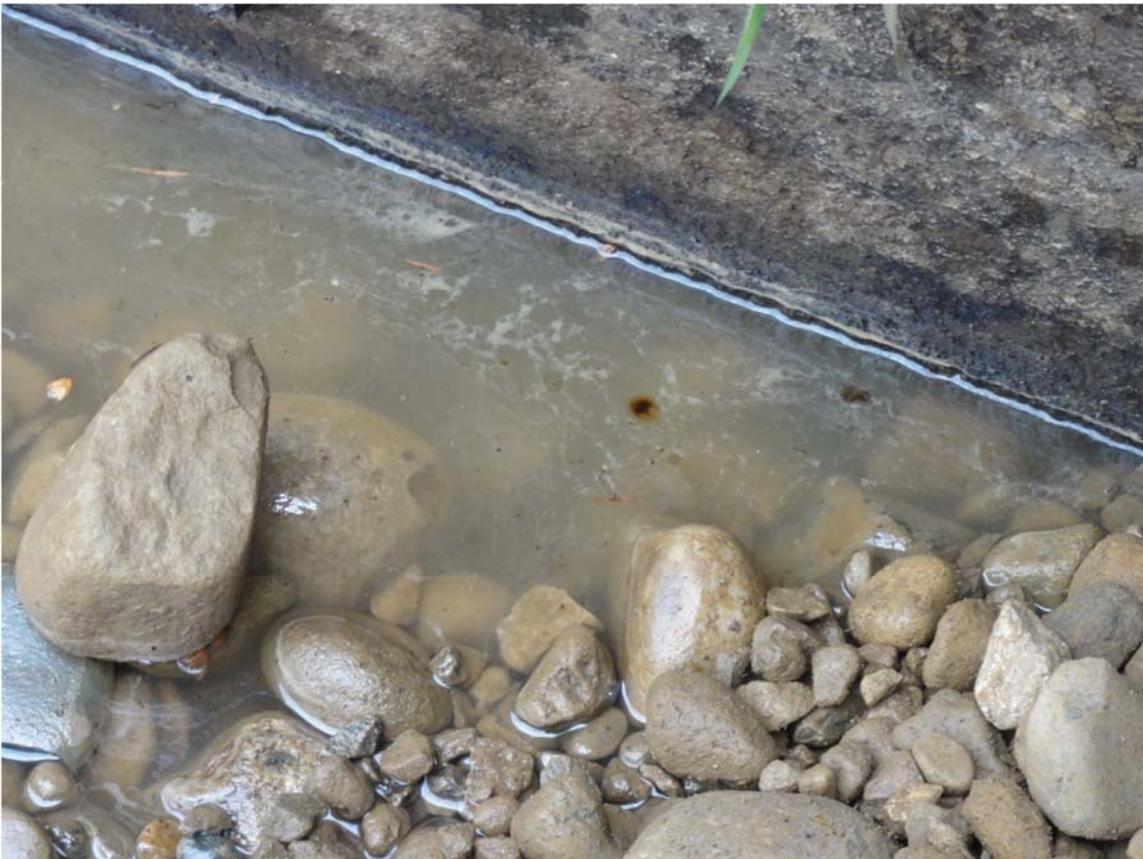
4. Oil globs and sheen observed during legacy work.

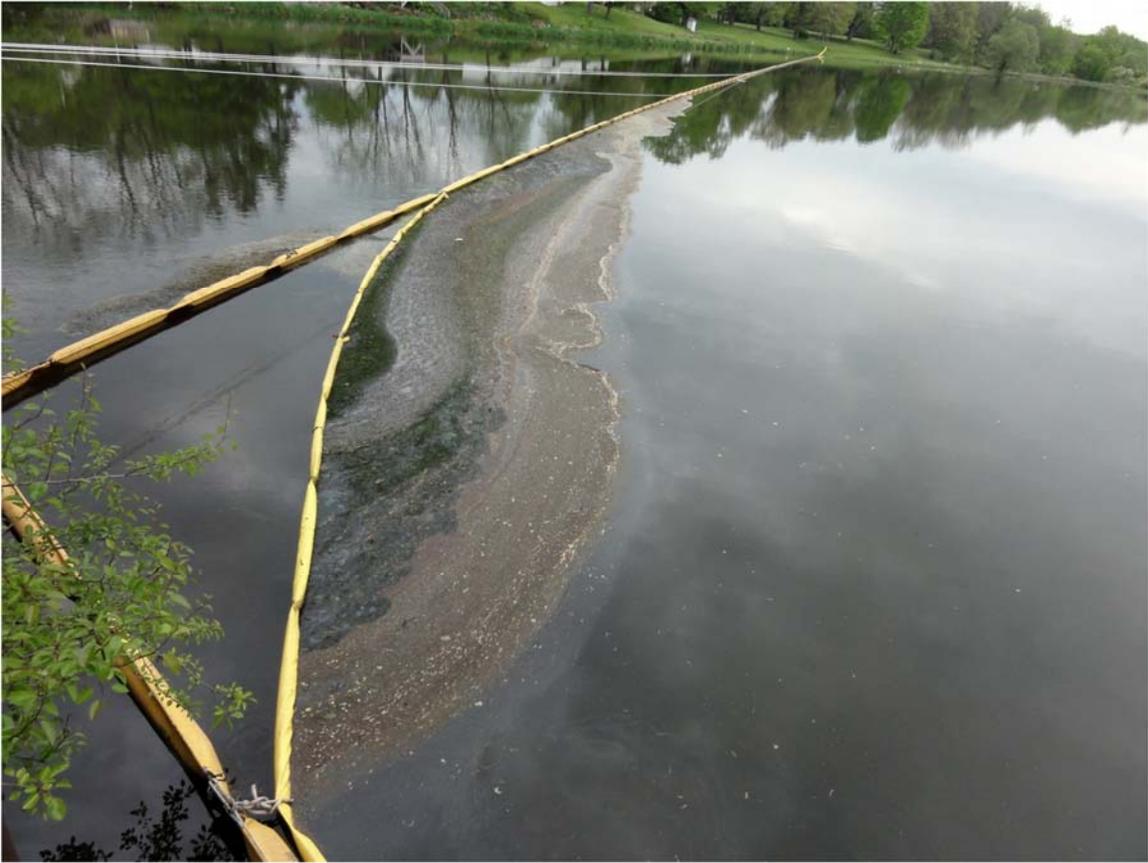
5. Ceresco Dam control point, sheen observed.

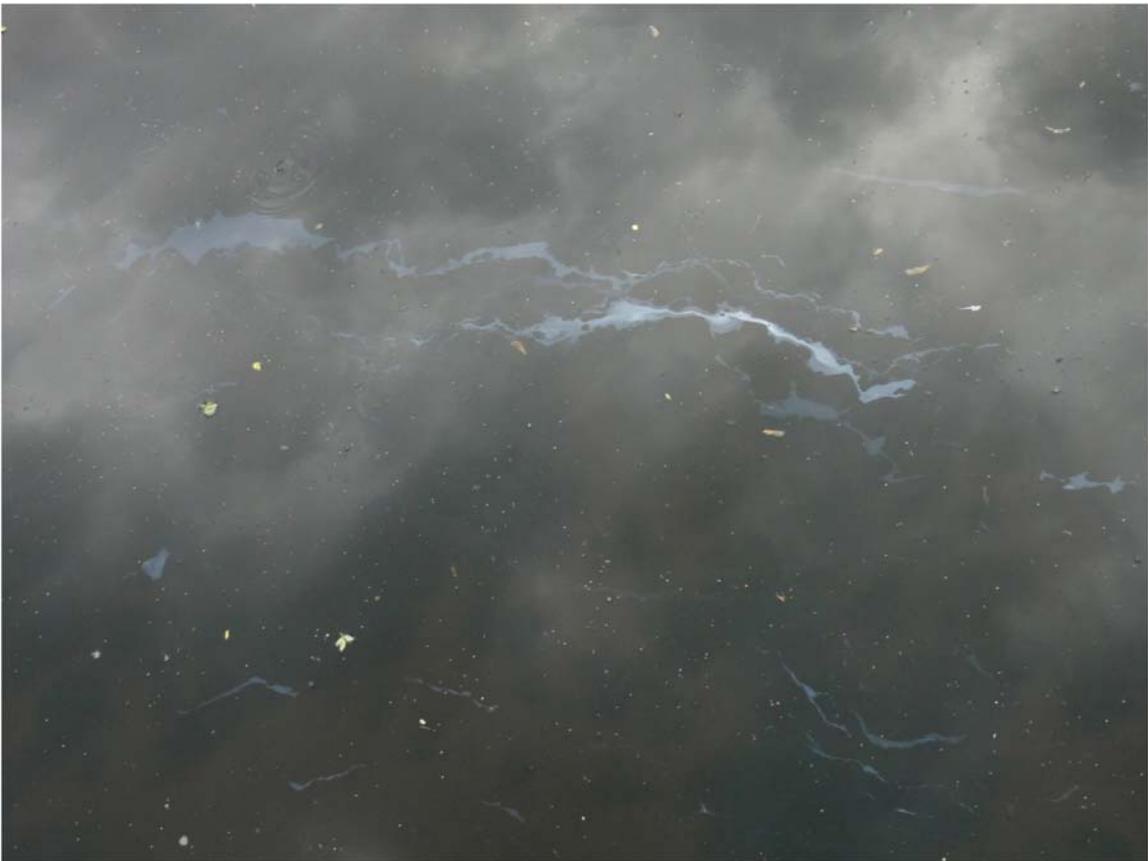
6. Ceresco Dam sheen observed.

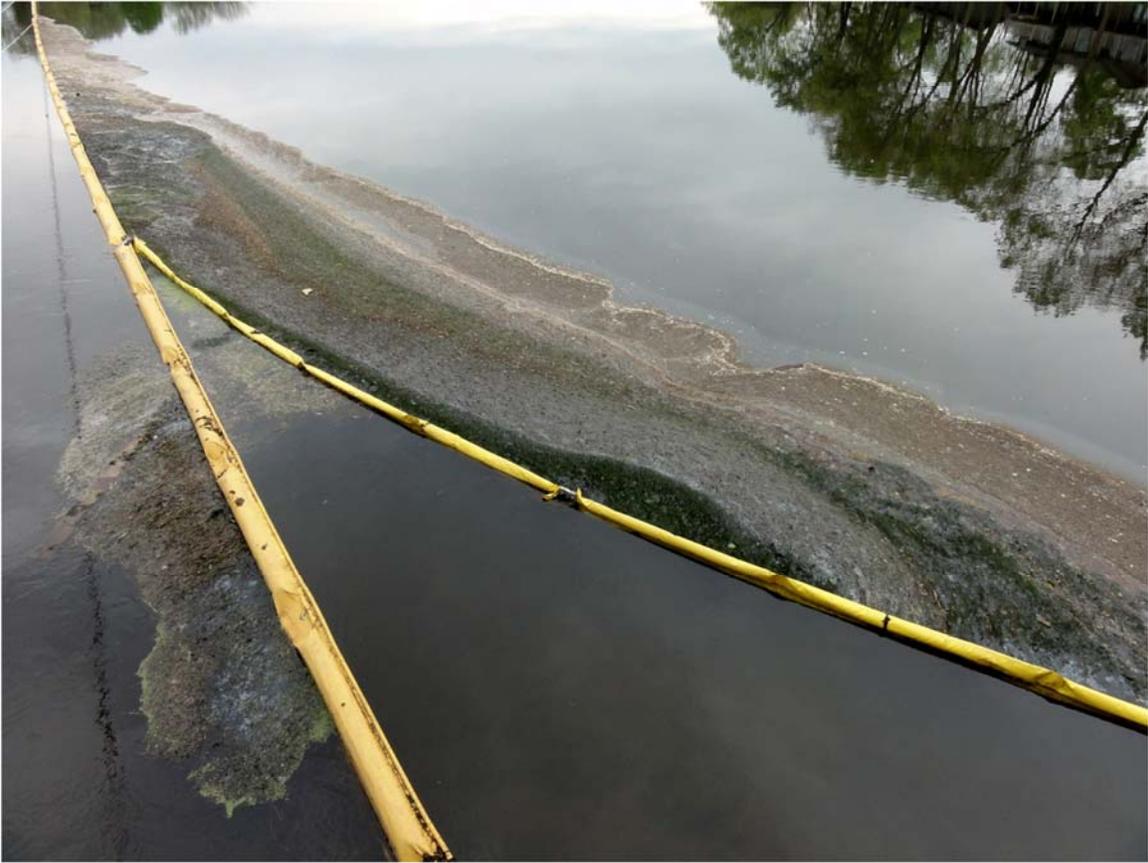
7. Ceresco Dam control point, sheen observed.

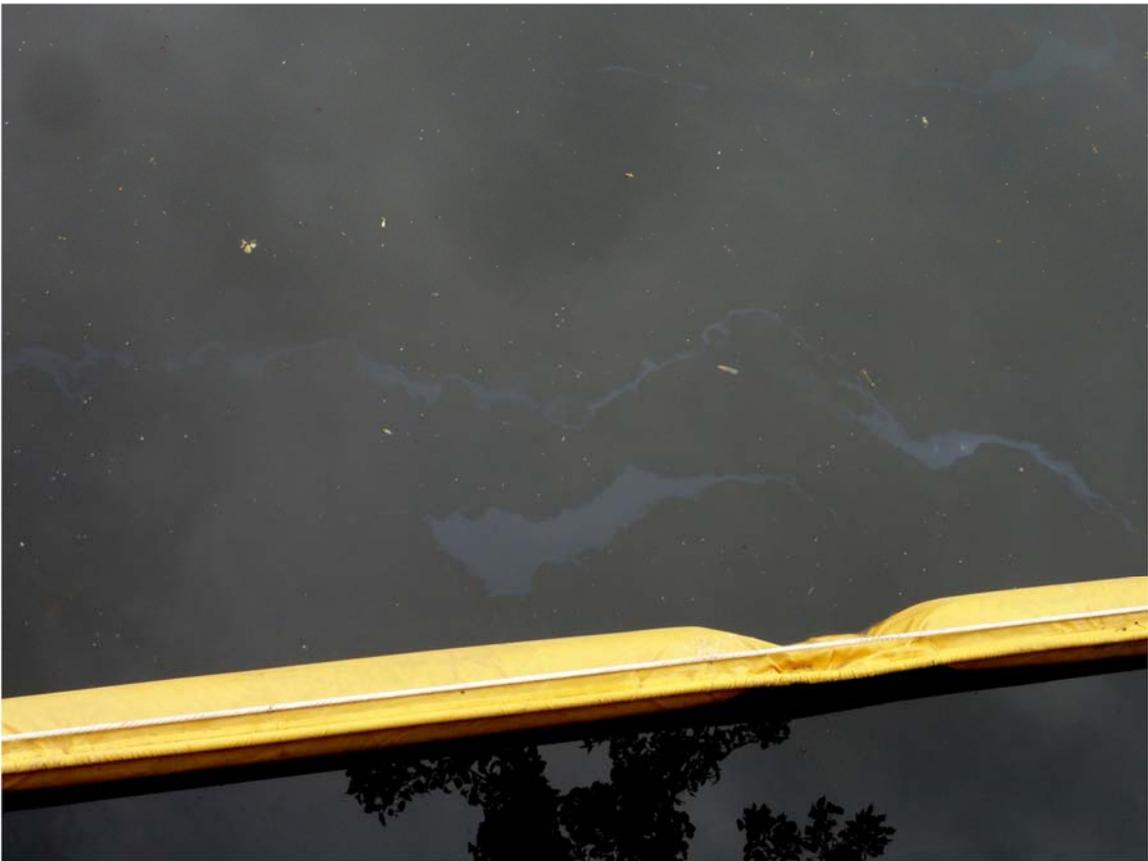
8. Ceresco sheen observed.

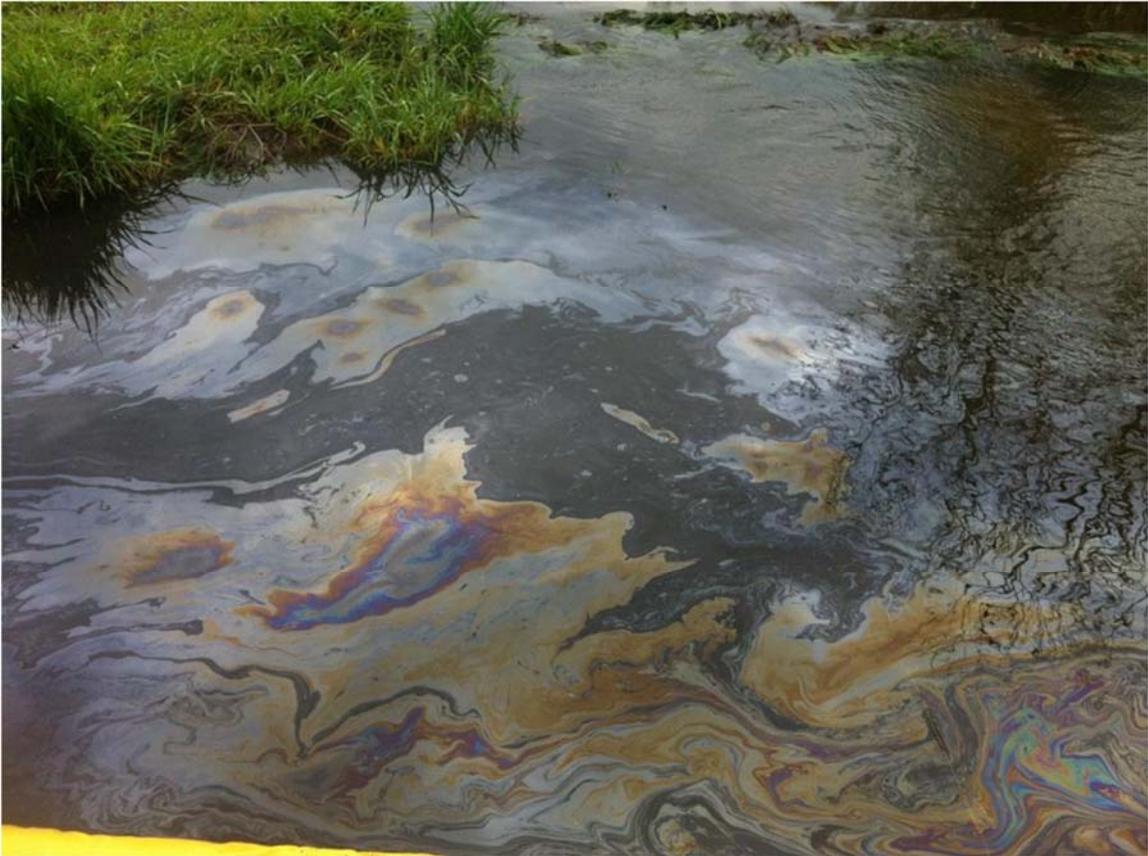
9. MP10.75 sheen observed.

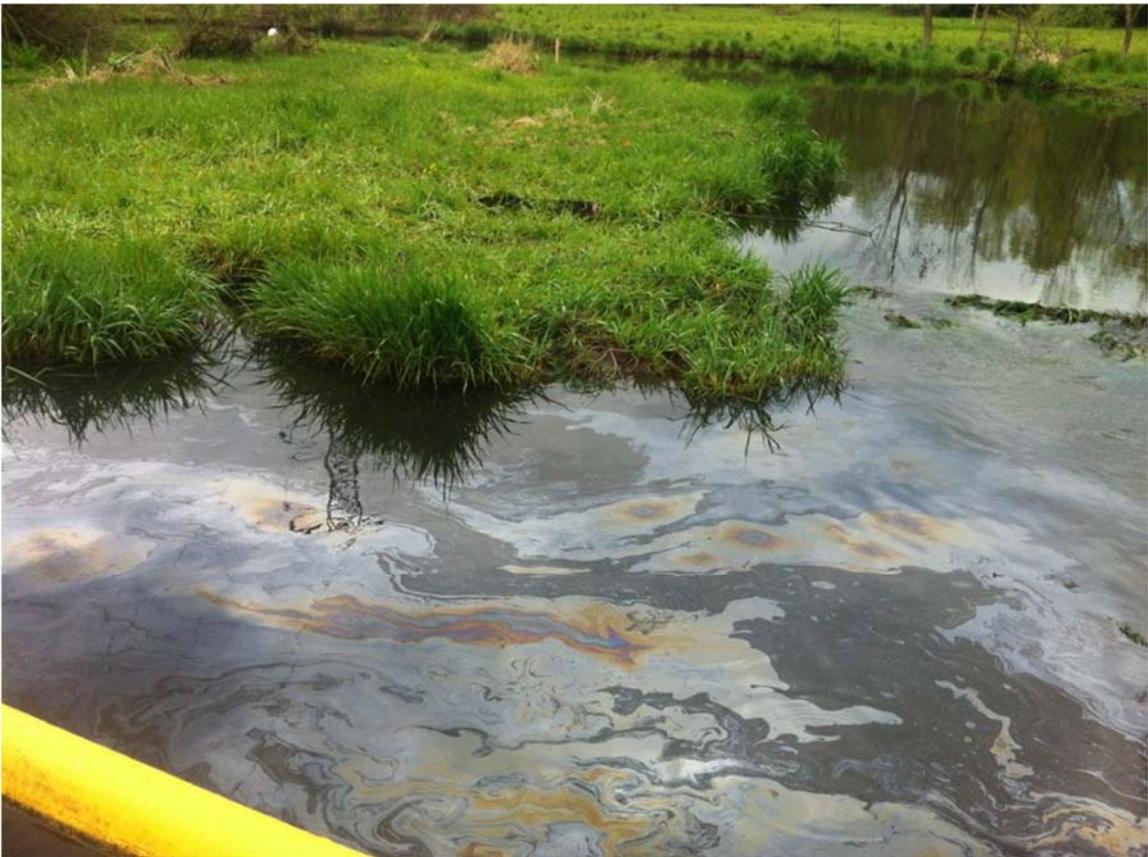
10. MP10.75 sheen observed.

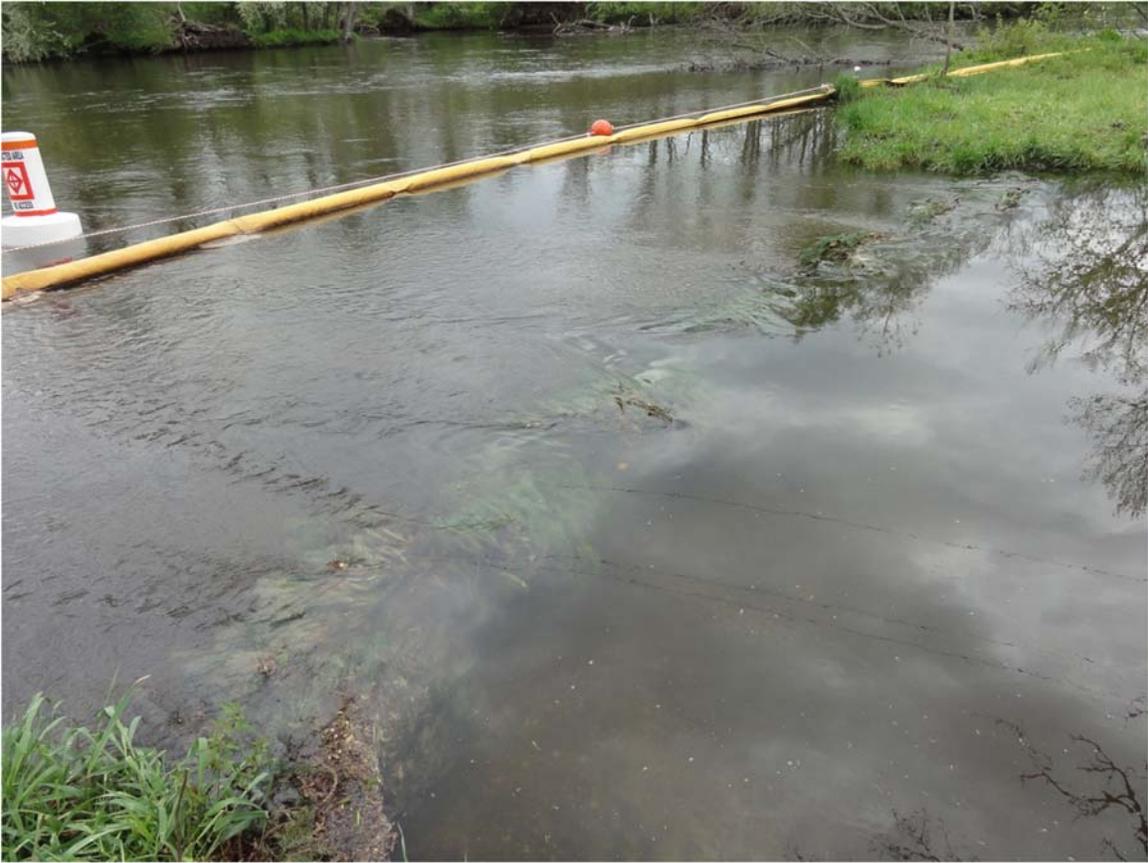
11. Buoy installed at 10.75 sediment trap location.

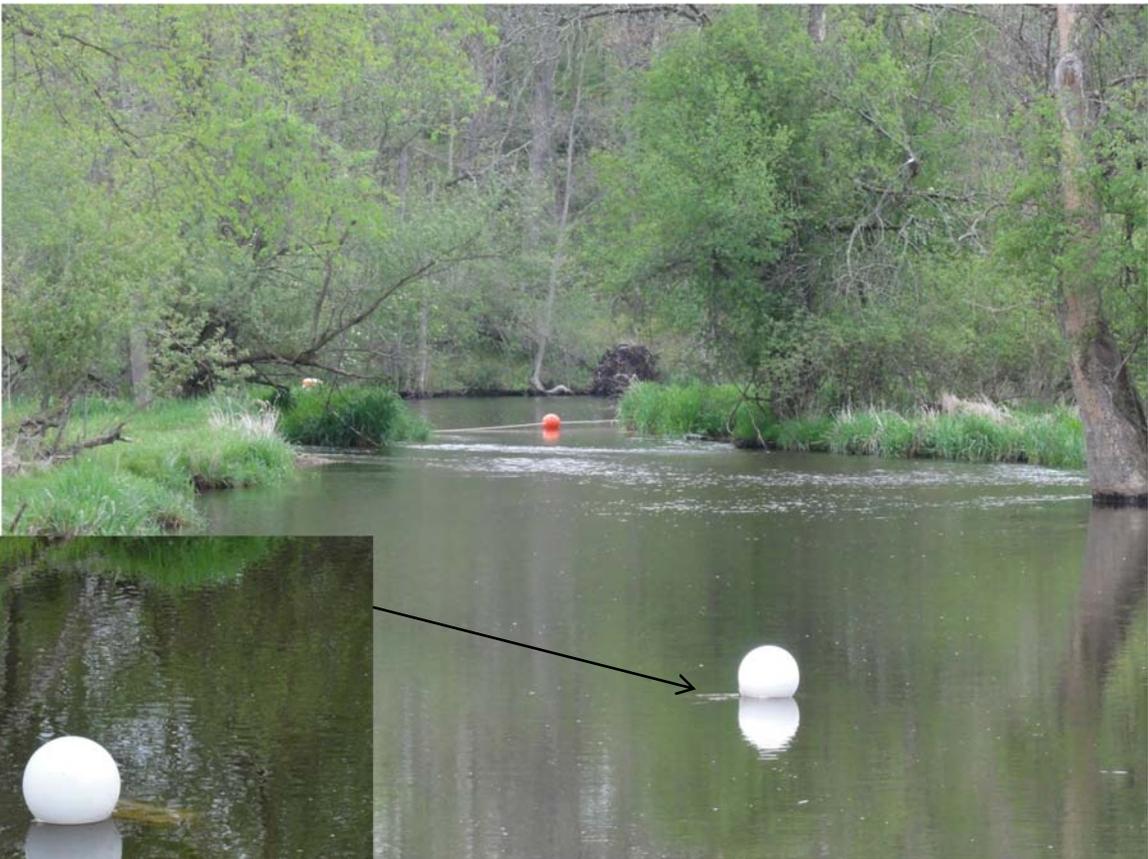
12. Buoys installed at MP10.75.

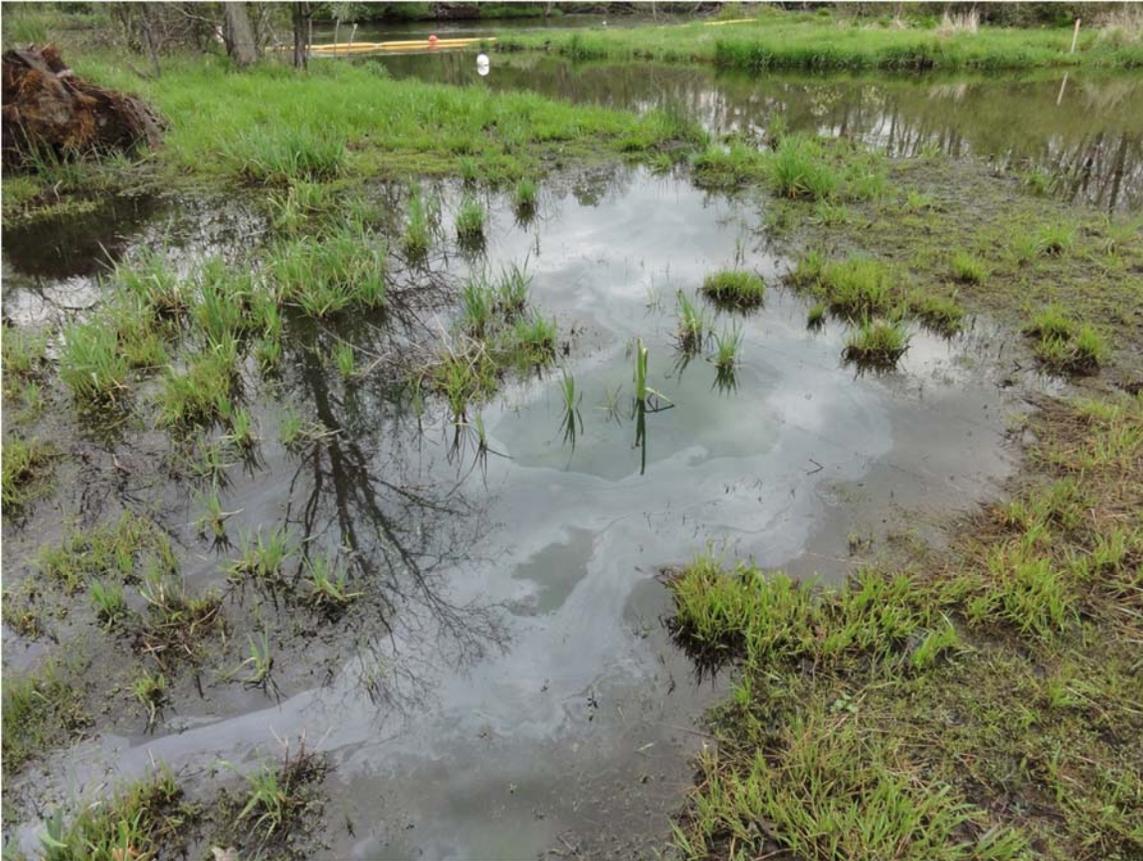
13. MP10.75, sheen observed.

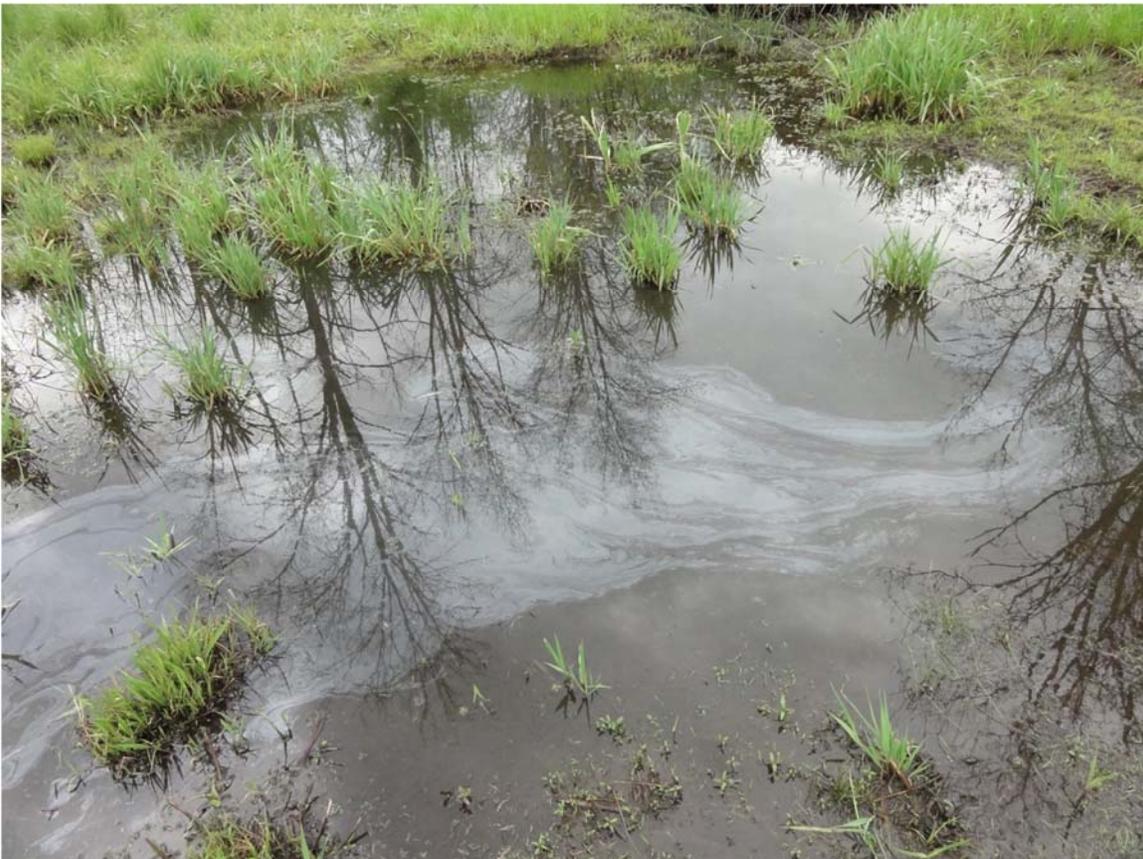
14. MP10.75 sheen observed.

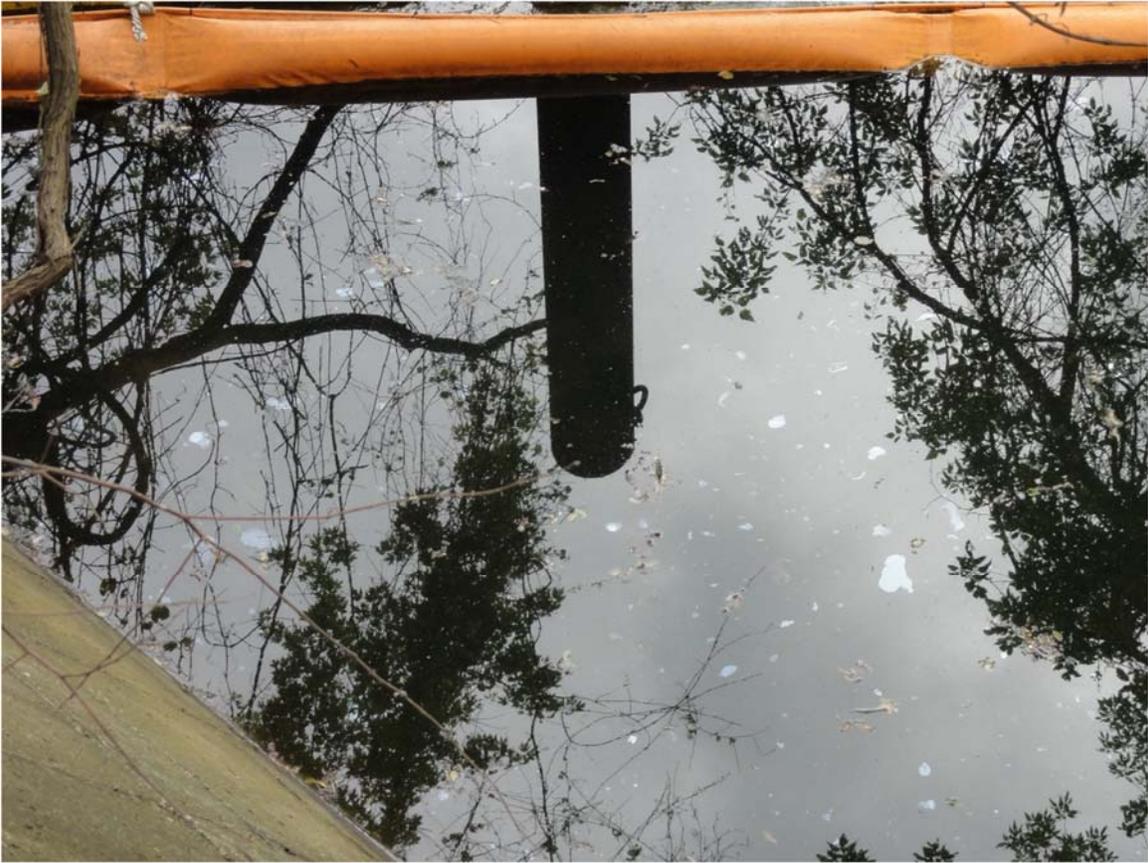
17. Rock Tenn sheen observed.

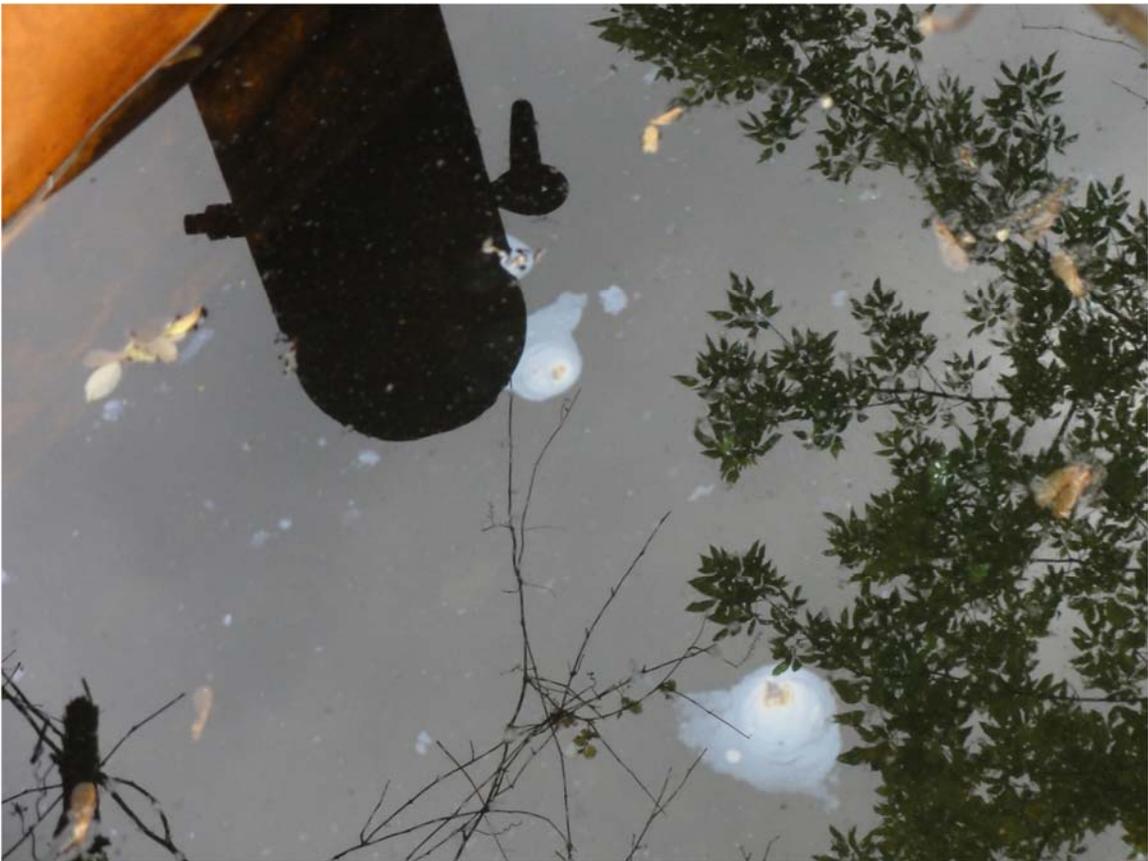
18. Rock Tenn sheen observed.

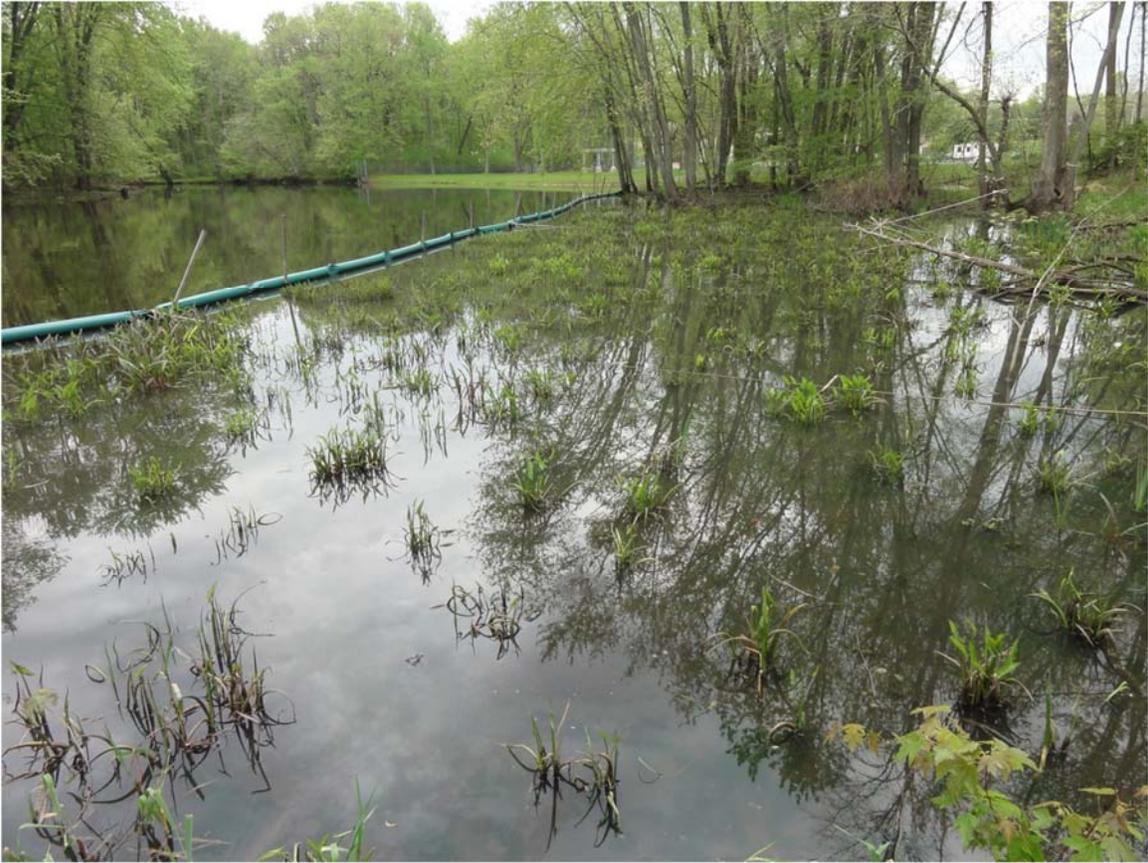
19. MP21.5 sheen observed throughout boomed area.

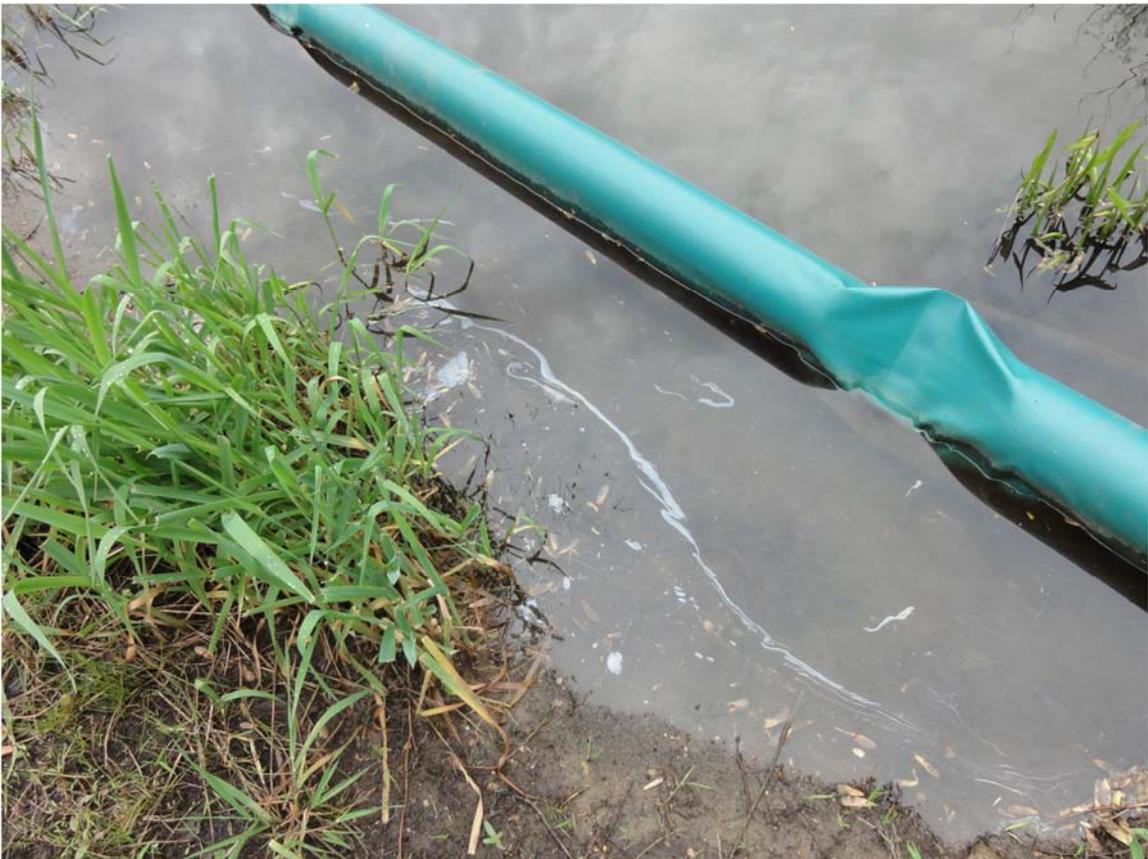
20. MP21.5 sheen observed.

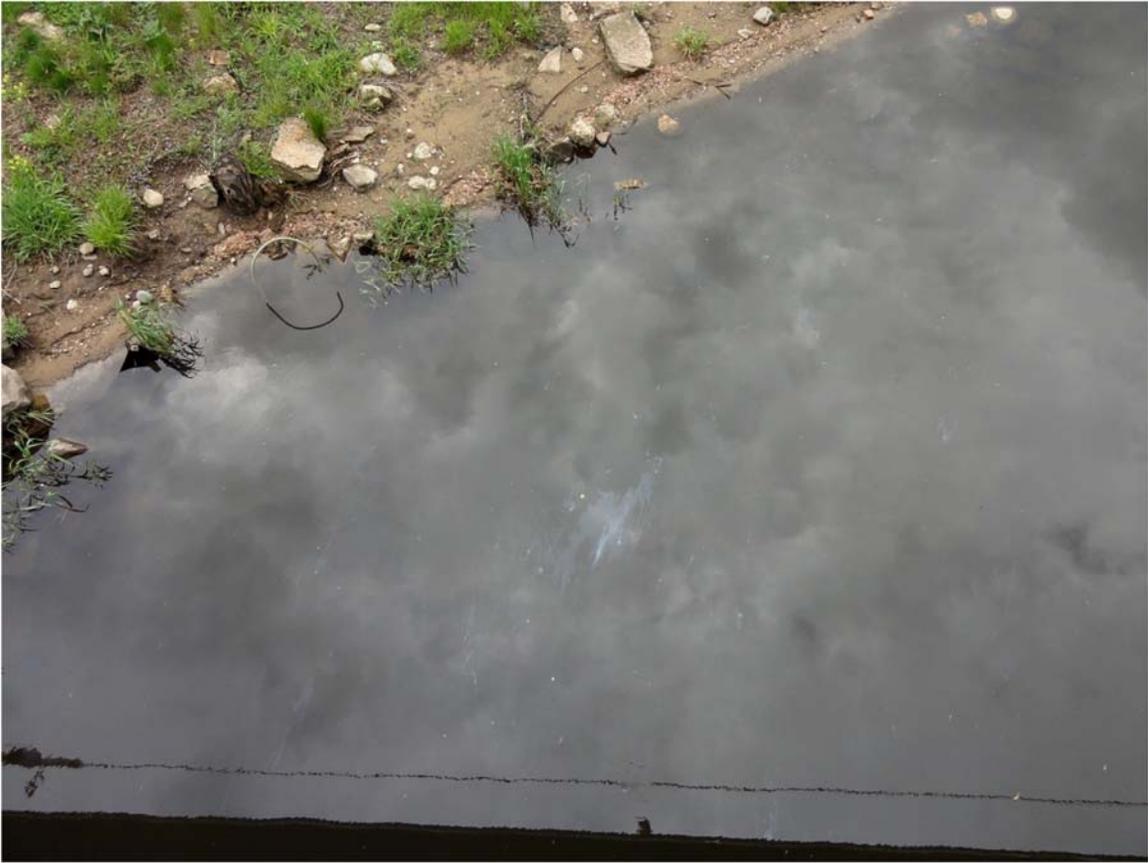
21. MP21.5 RDB just prior to Custer Drive bridge sheen observed.

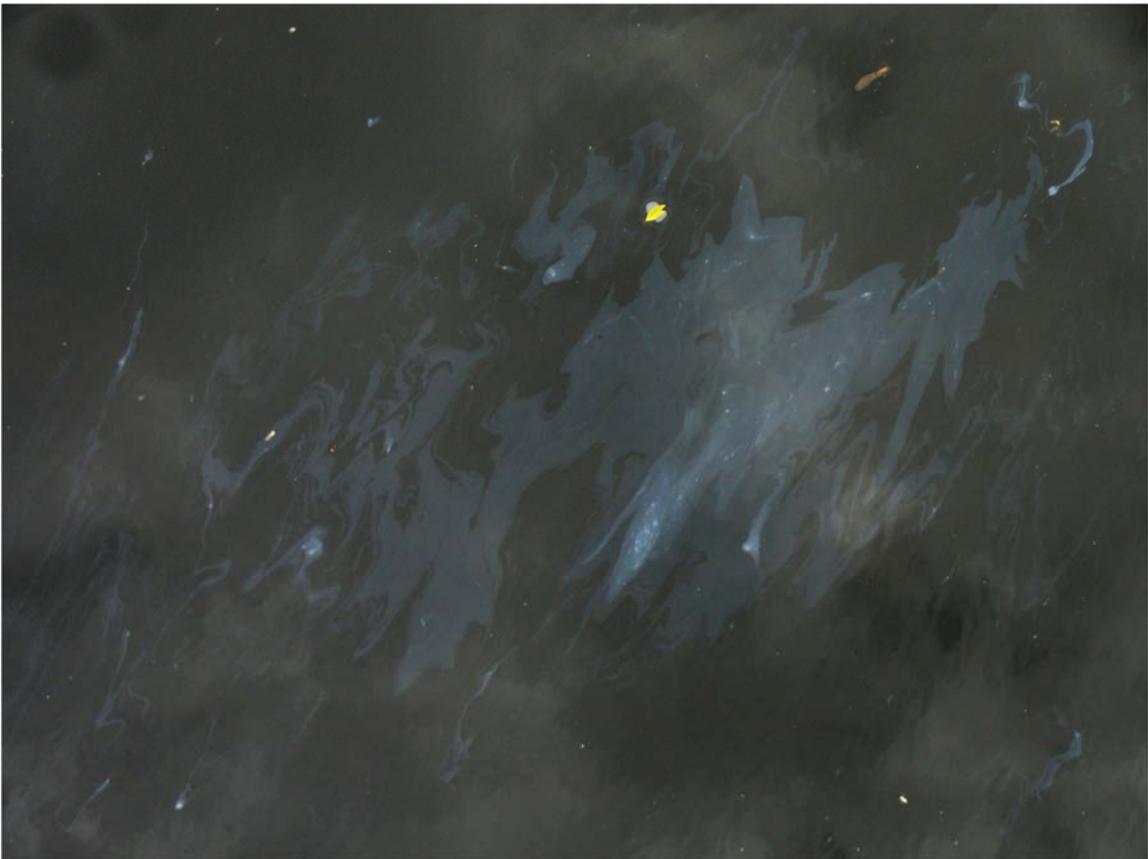
22. MP21.5 RDB just prior to Custer Drive bridge sheen observed.

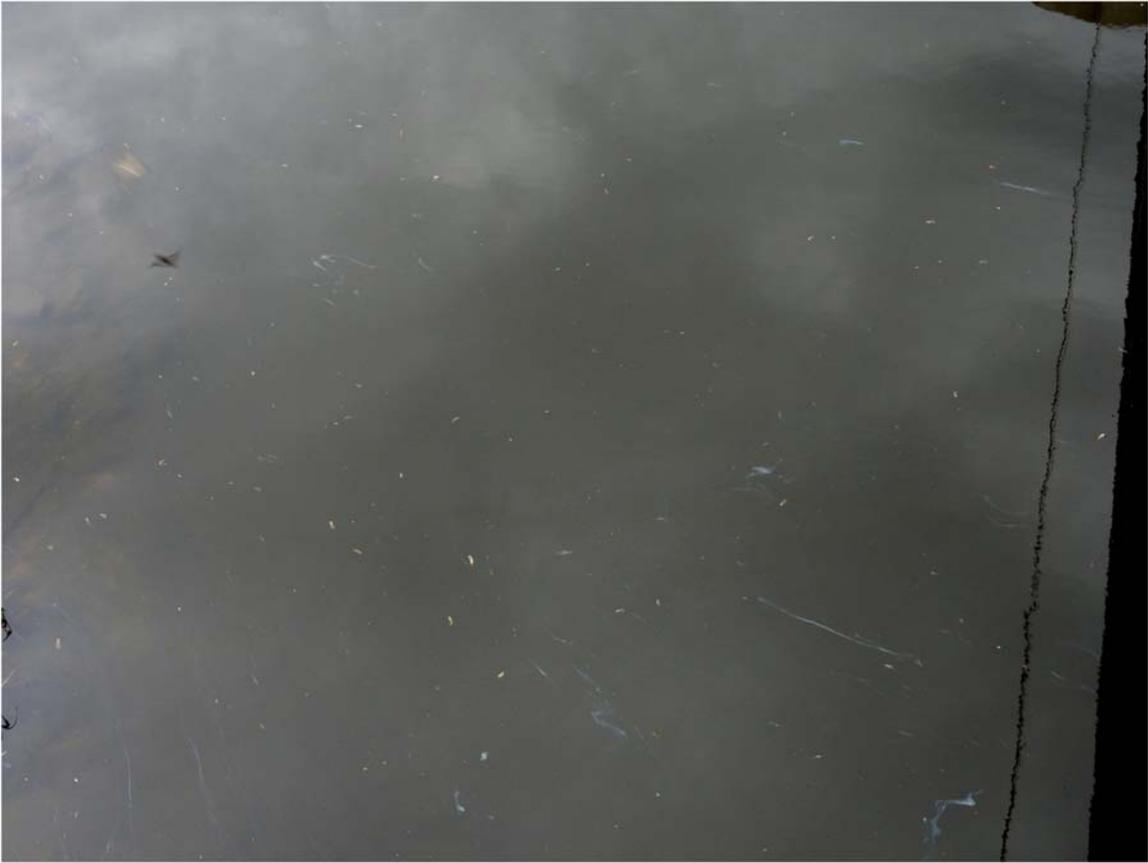
23. MP21.5 RDB just prior to Custer Drive bridge sheen observed.
