Situation Photo Log

Saturday, May 5, 2012

Kalamazoo River / Enbridge Spill

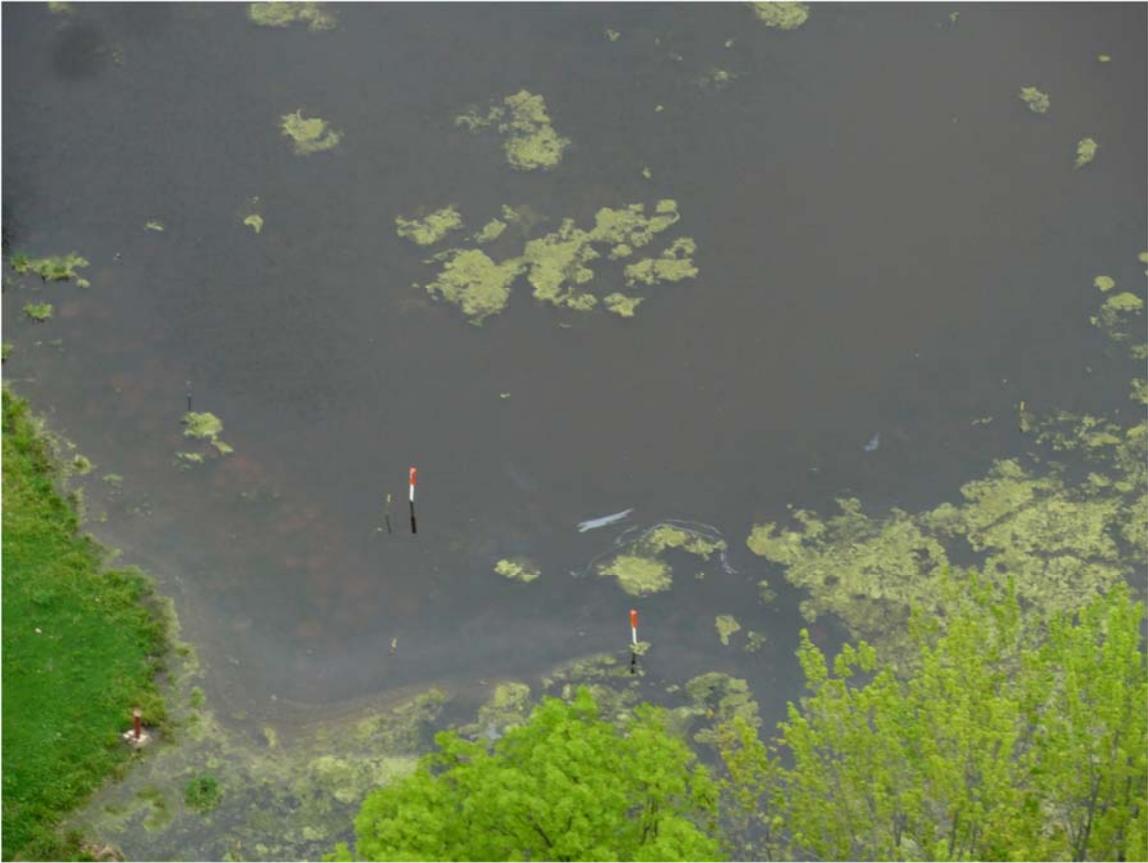
1. Source Area pond sheen observed.

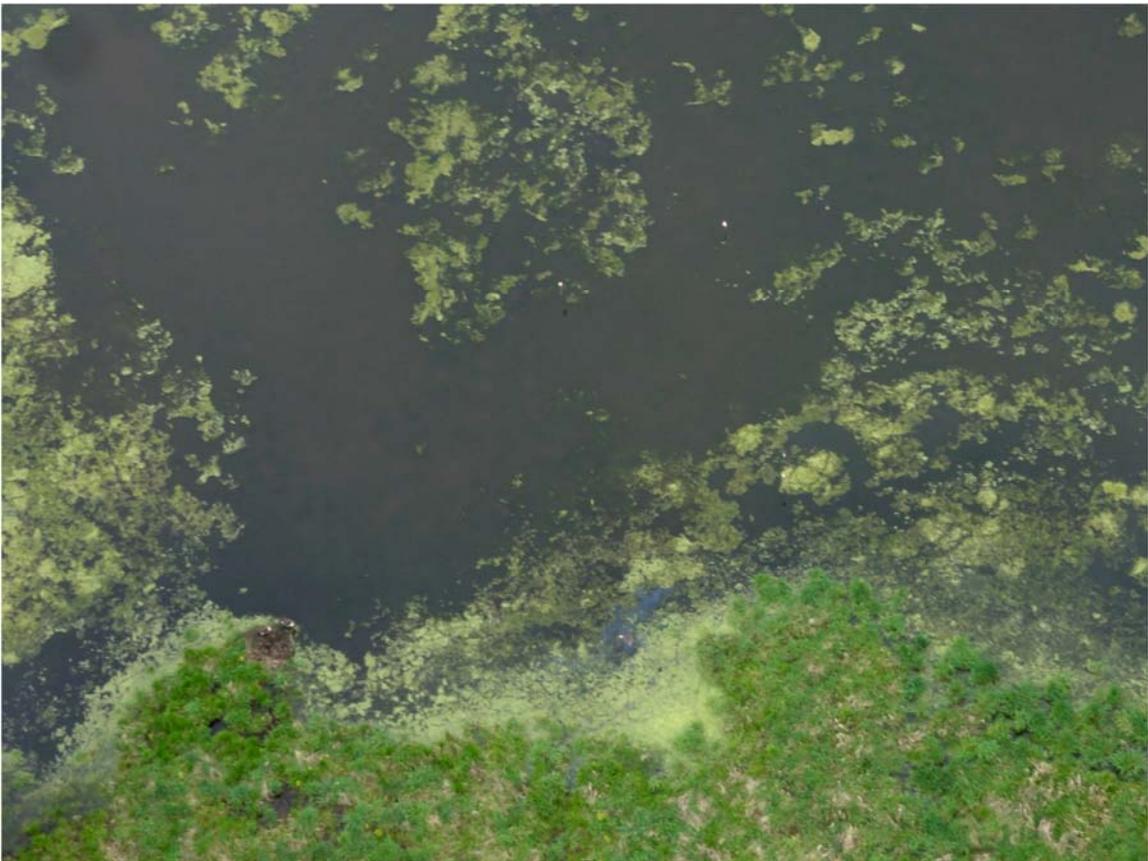
2. Source Area pond sheen observed.

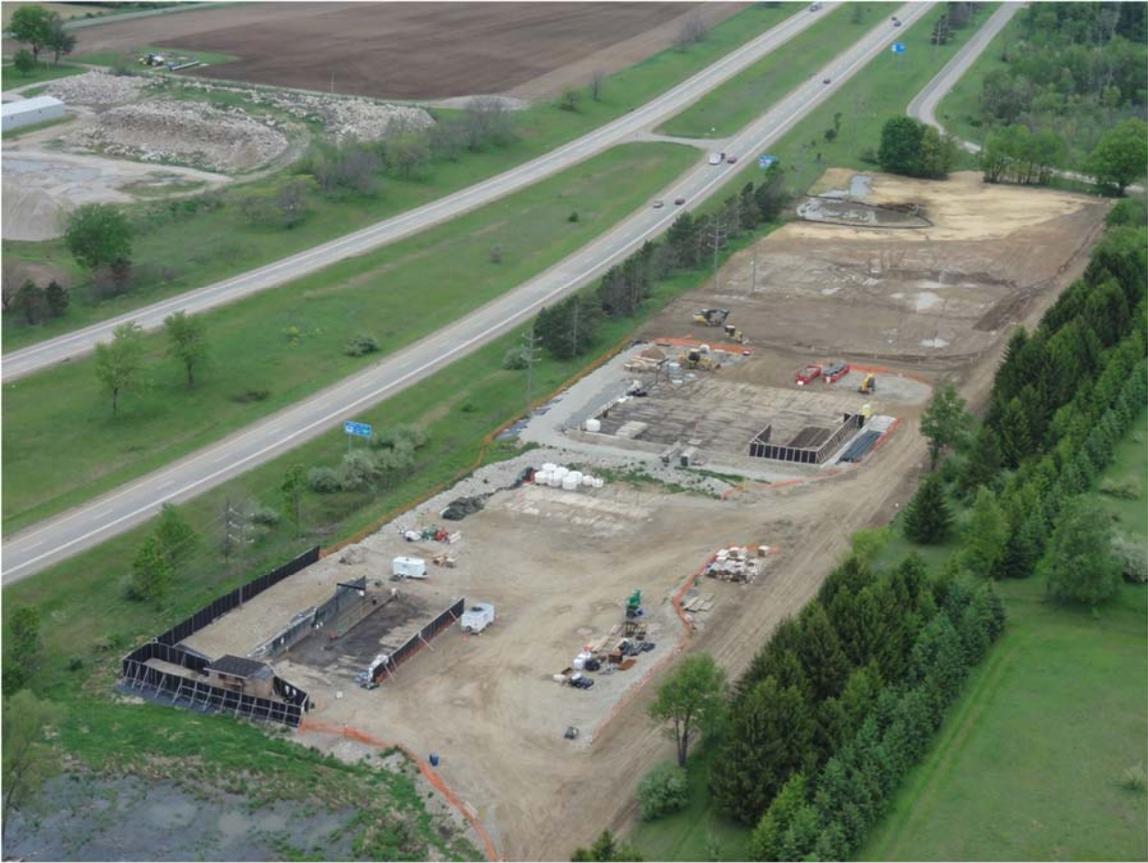
3. Frac Tank City footprint reduction work continued.

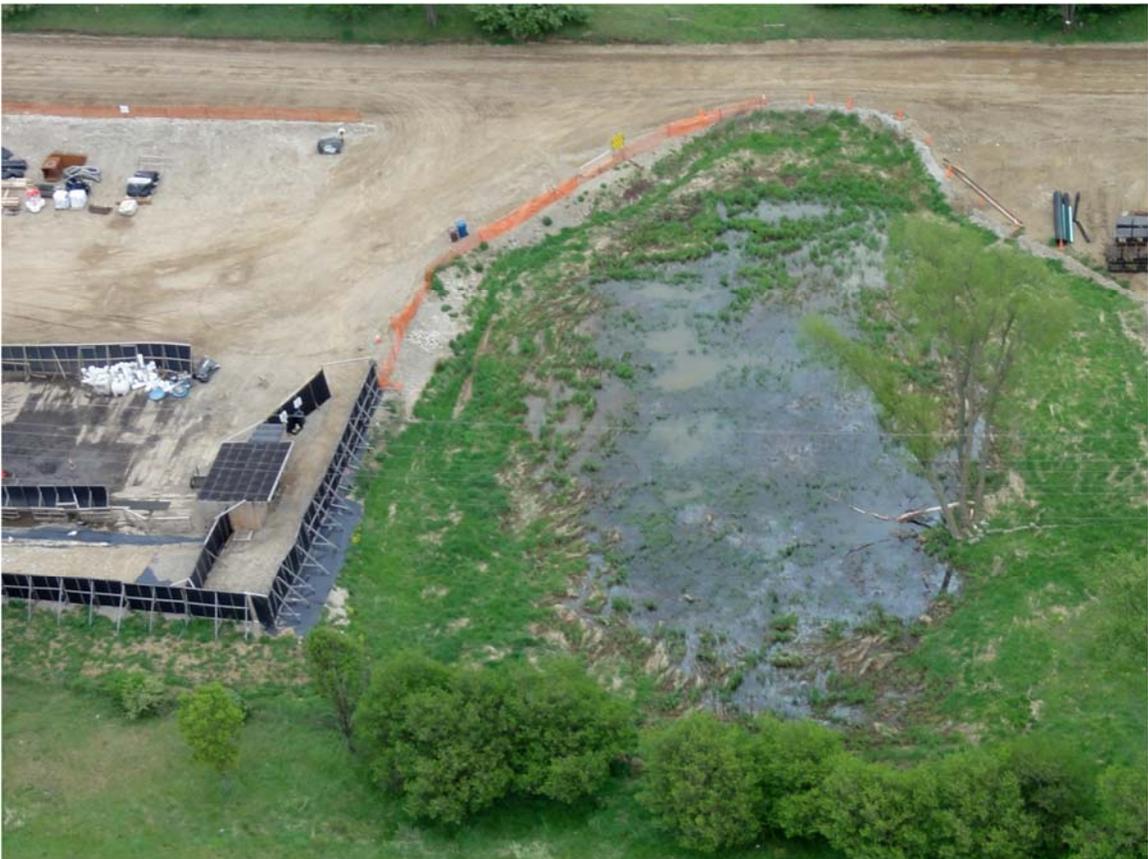
4. Frac Tank City sheen observed in pond.

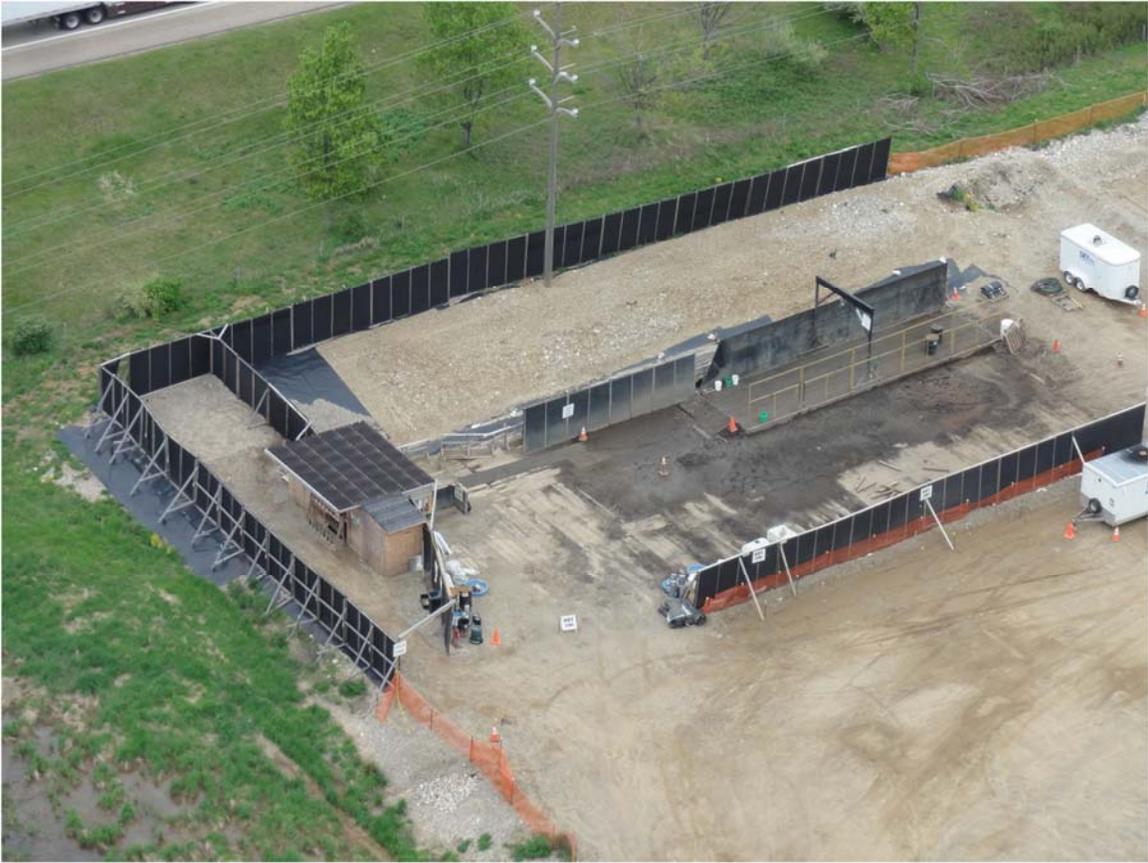
5. Frac Tank City decon pad no activity observed.

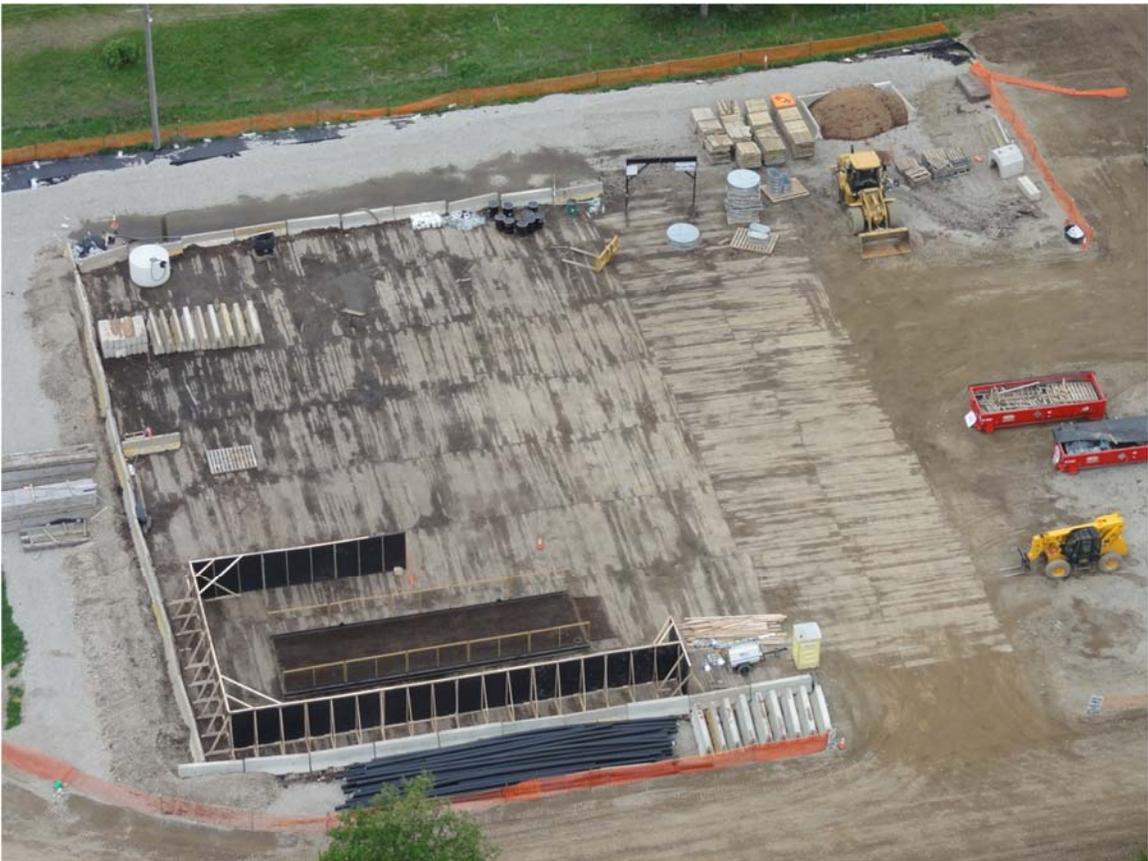
6. Frac Tank City relocated decon pad.

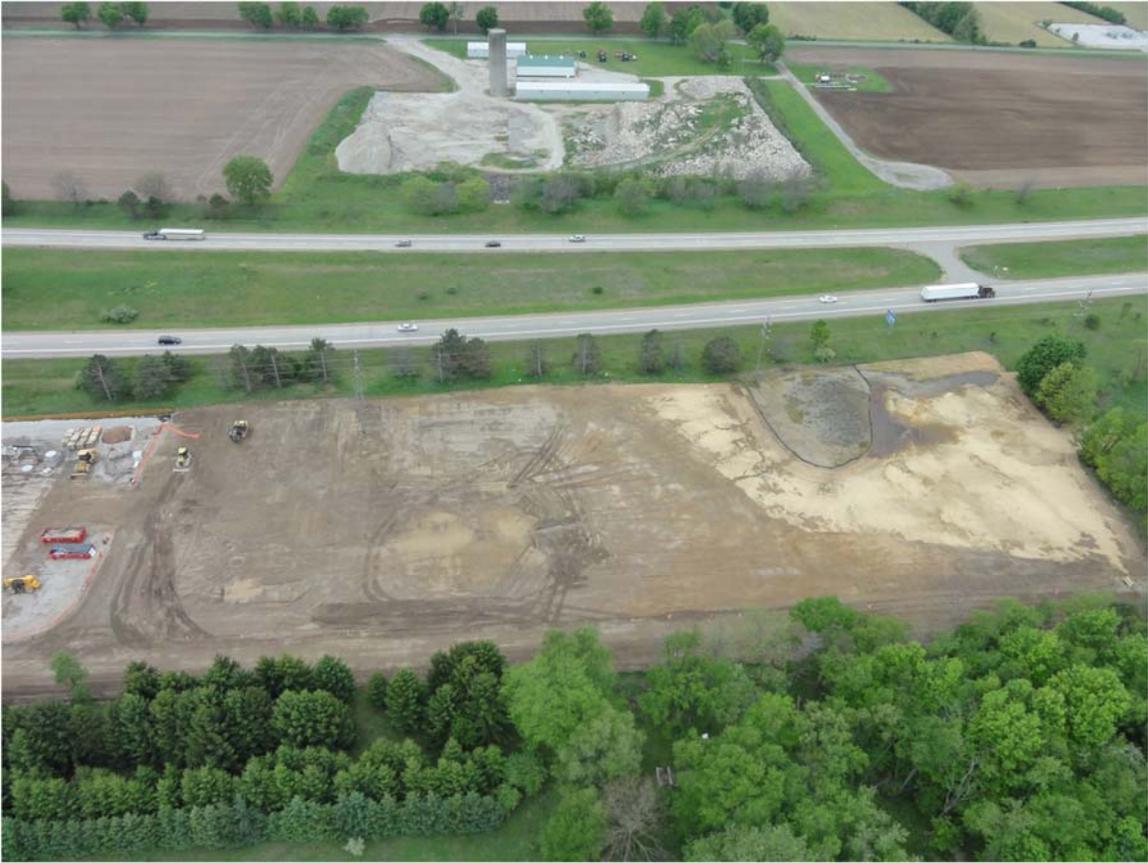
7. Frac Tank City footprint reduction work continued.

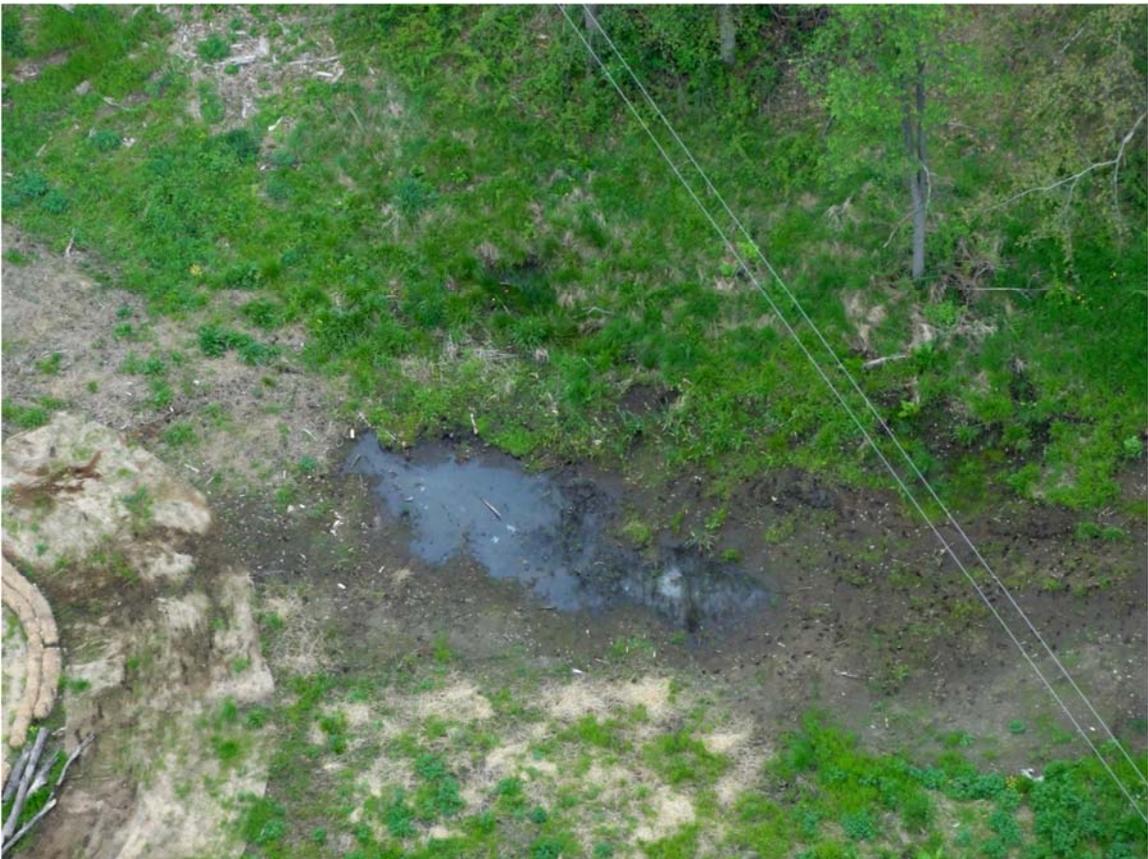
8. Talmadge Creek MP1.35 west of 15 1/2 Mile Rd. sheen observed.

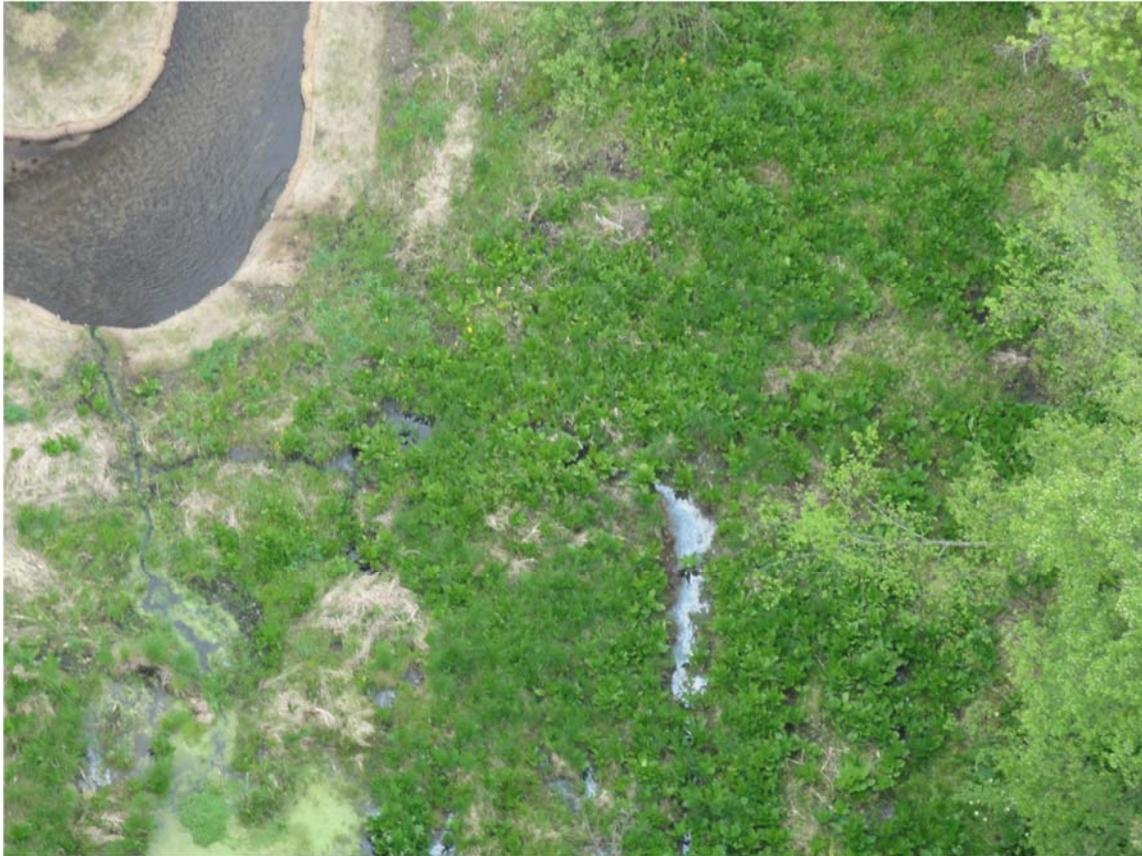
9. Talmadge Creek MP1.65 LDB sheen observed.

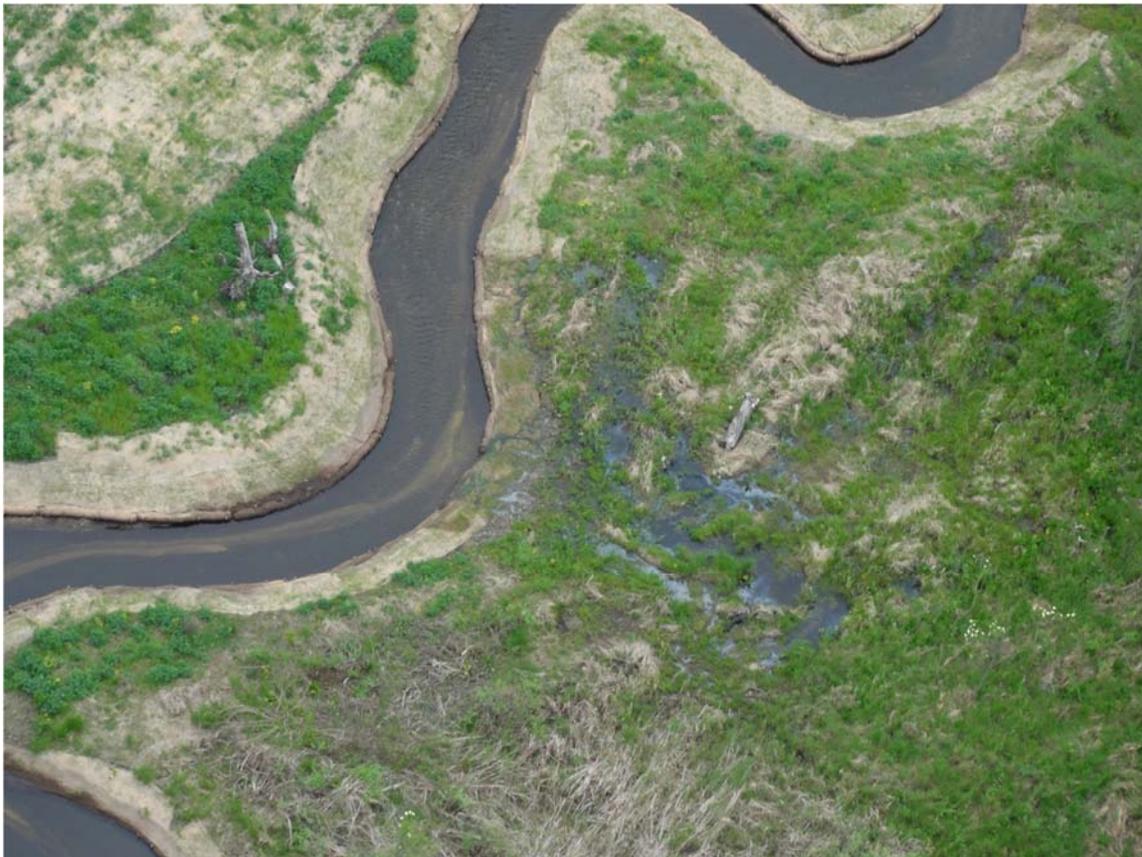
10. Talmadge Creek MP1.70 LDB sheen observed.

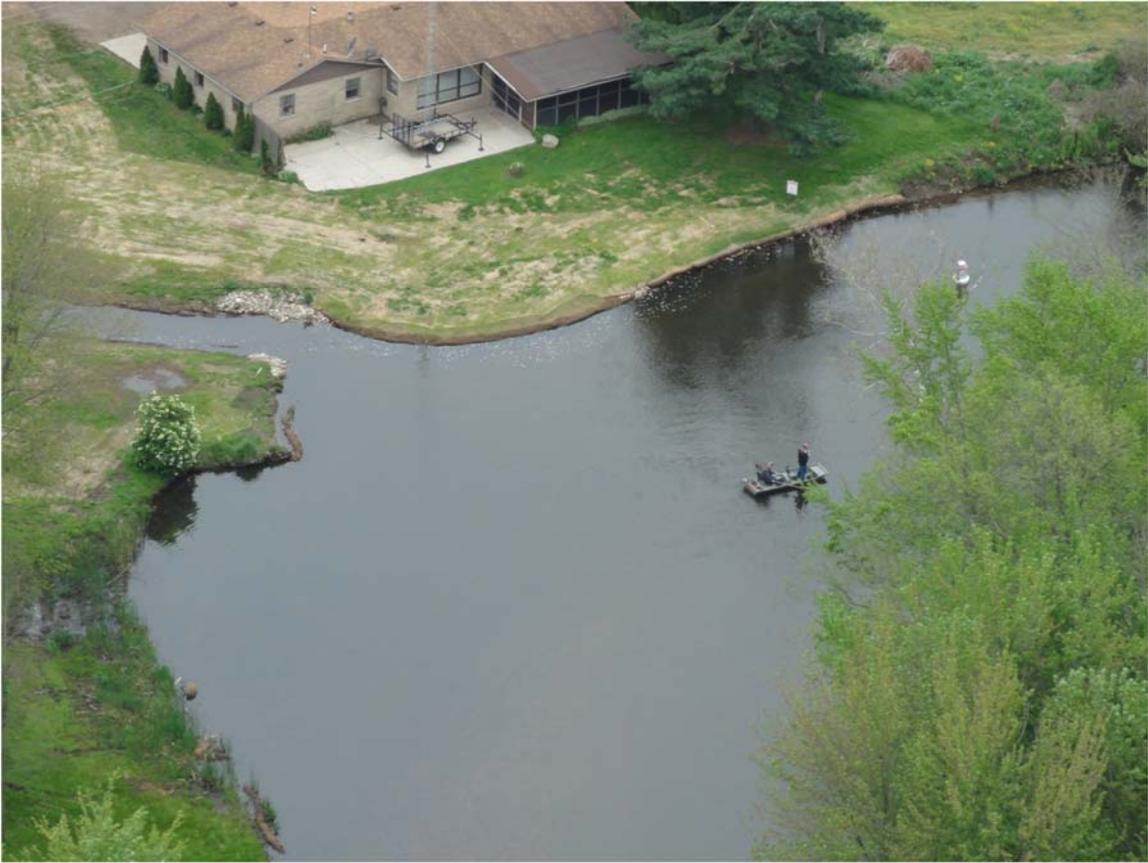
11. Confluence, observed public utilizing the river.

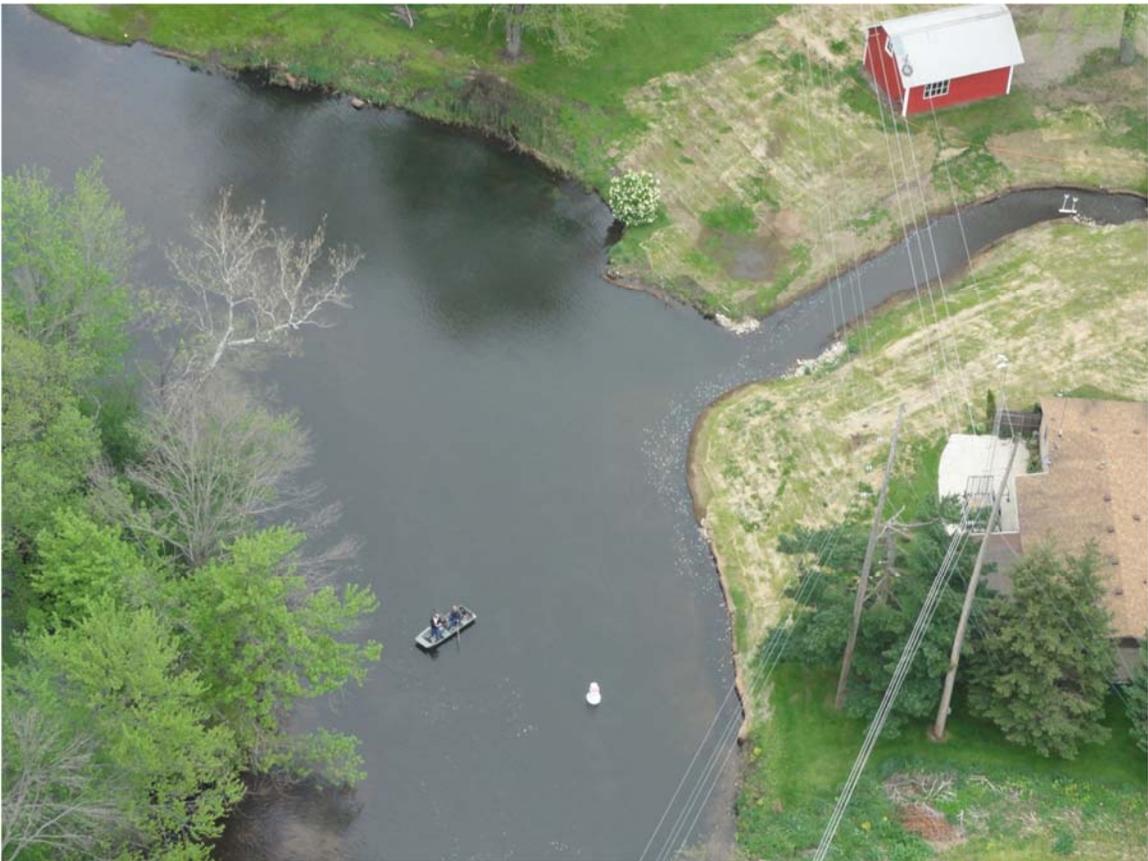
12. Confluence, observed public utilizing the river.

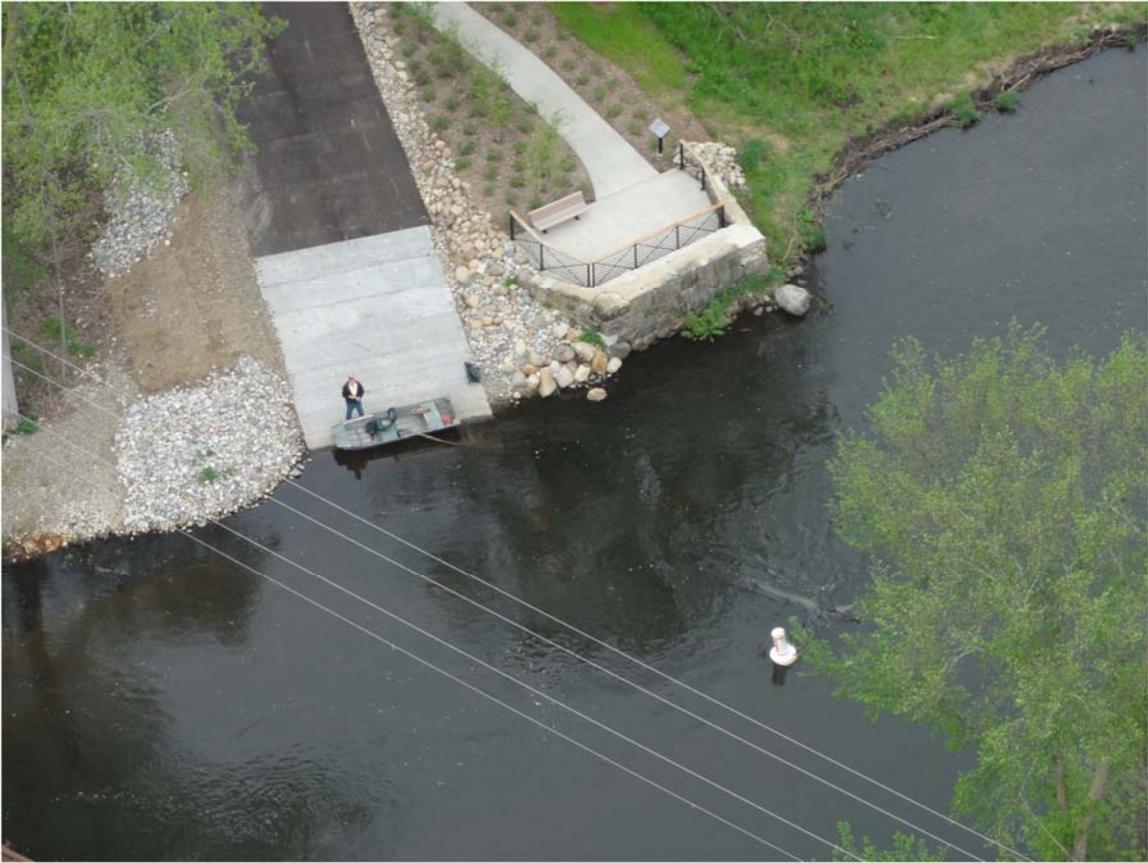
13. Saylor's Landing observed the public utilizing the boat launch.

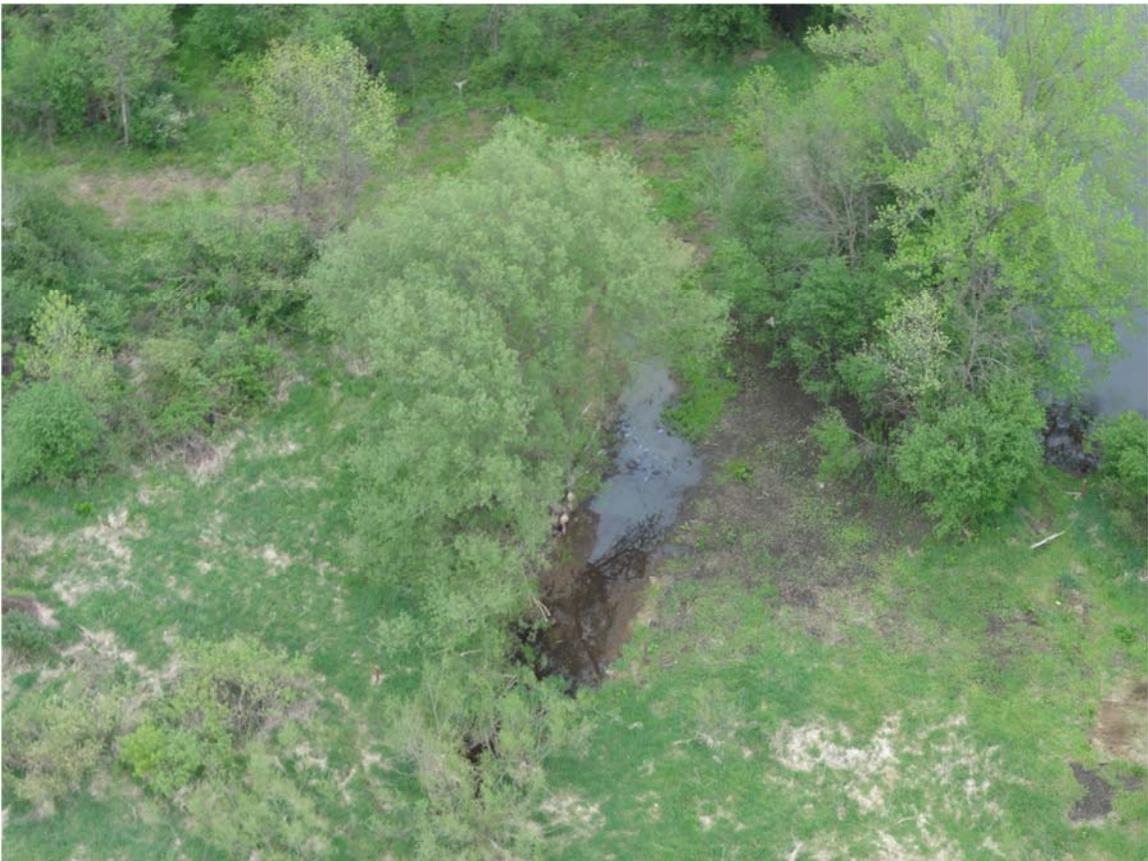
14. OB2.75 RDB sheen observed.

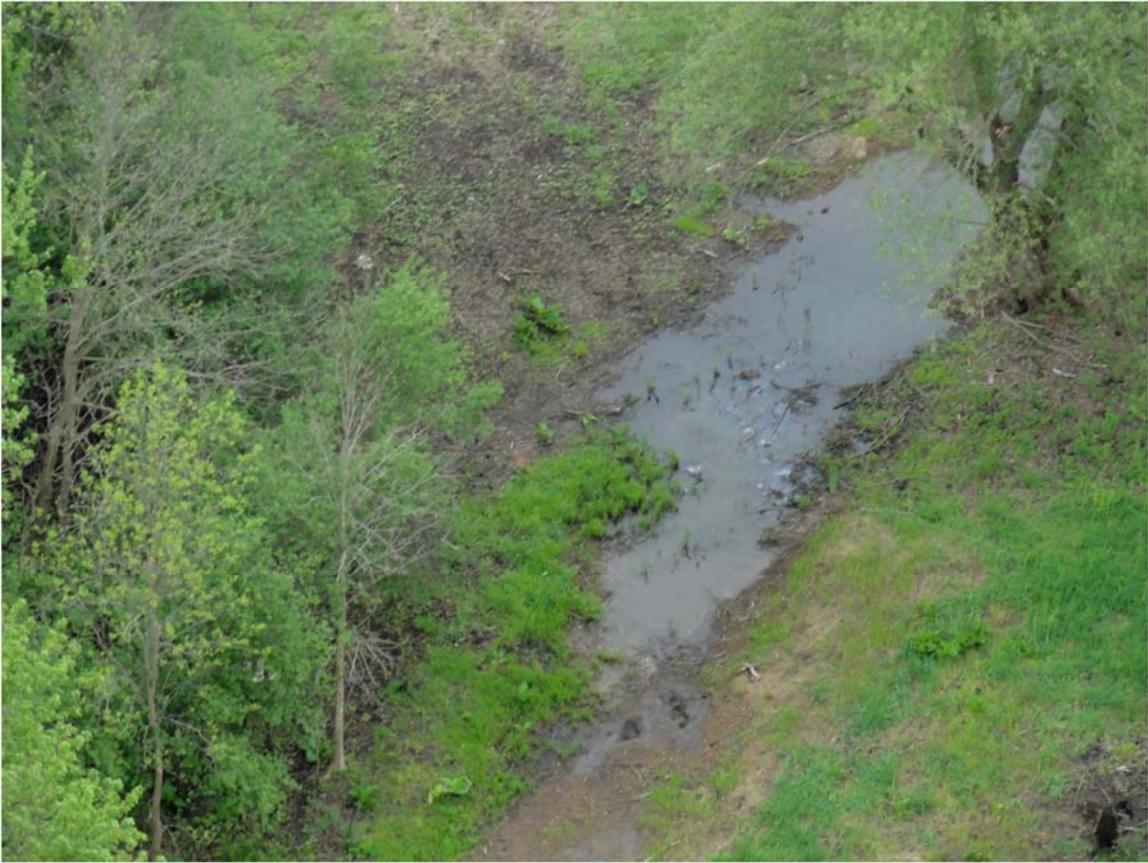
15. OB2.75 RDB sheen observed.

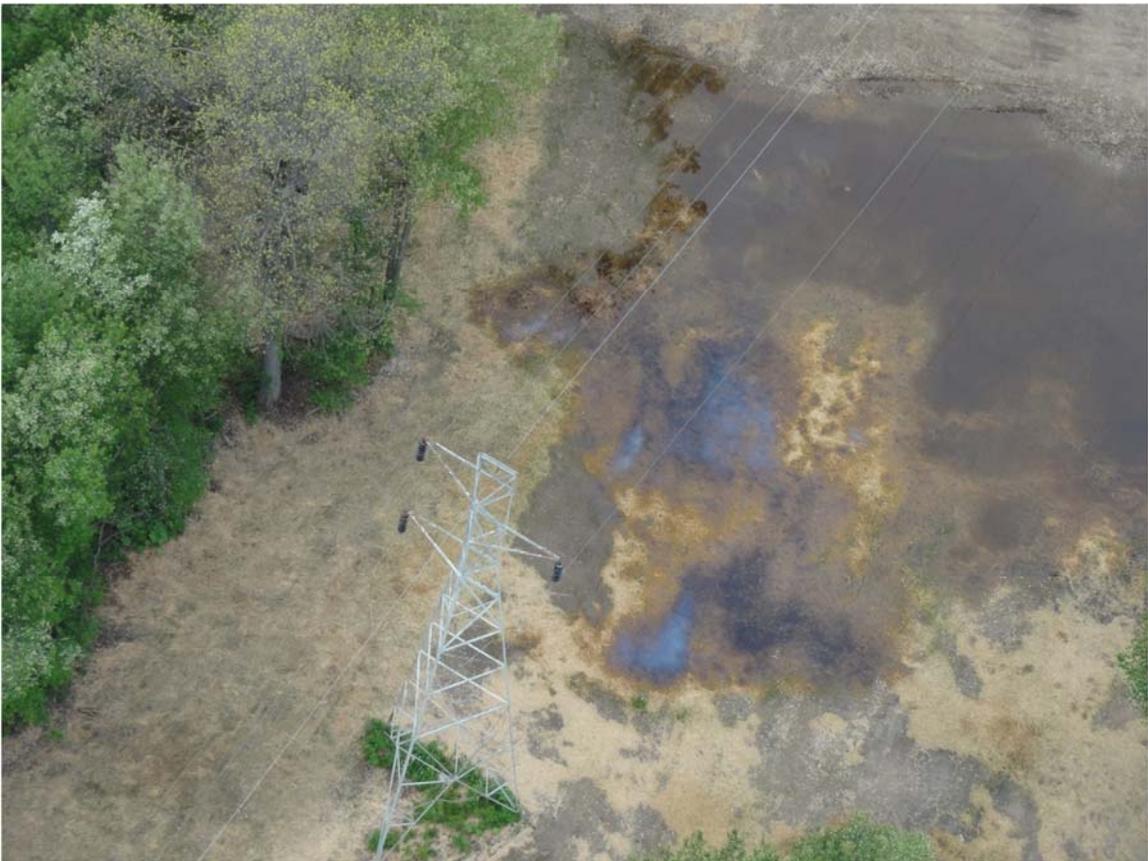
16. C0.5 Boat launch restored area sheen observed.

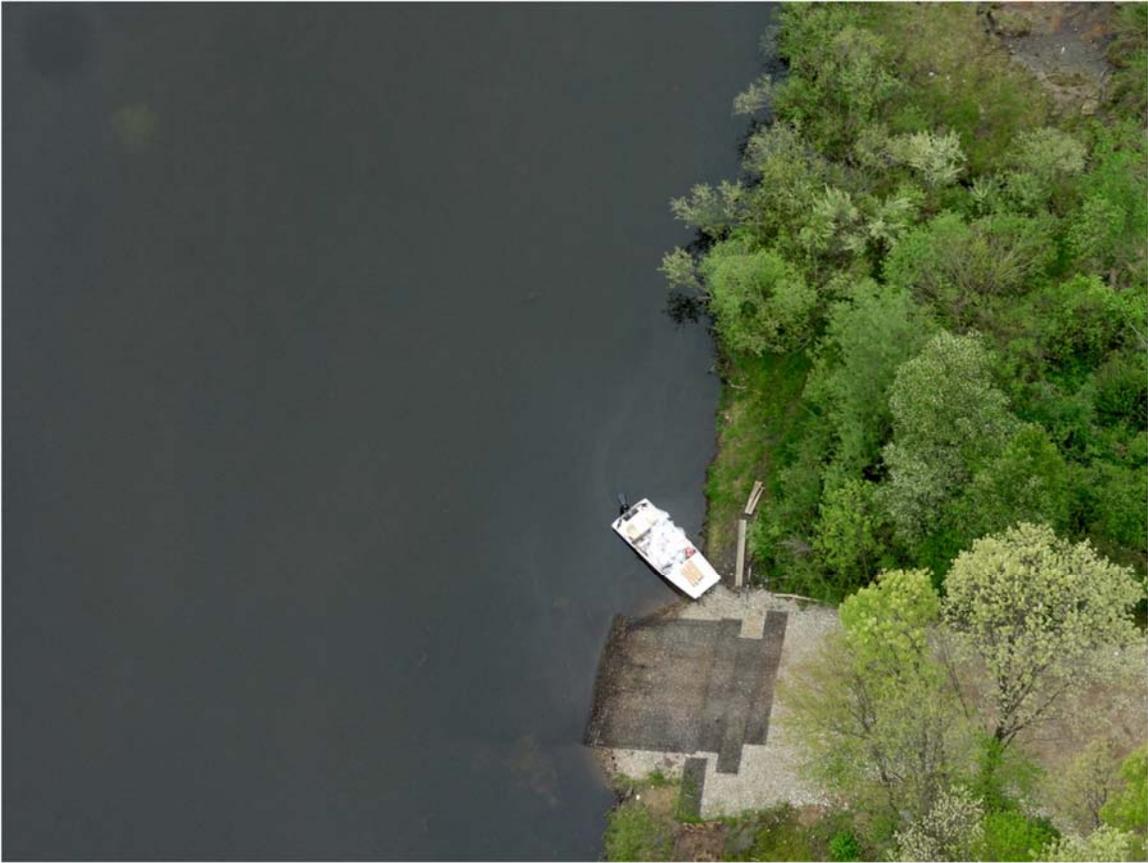
17. SWAT boat observed at C0.5 boat launch.

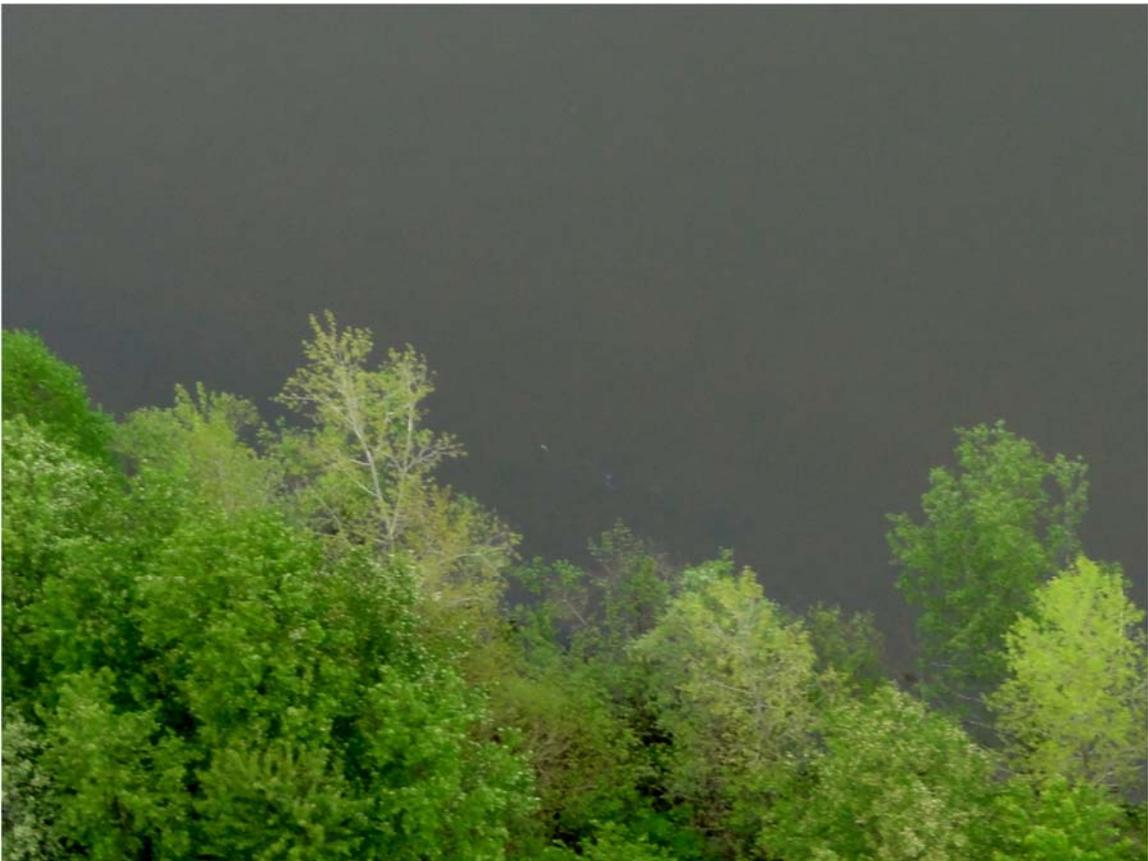
18. MP5.5 LDB sheen observed.

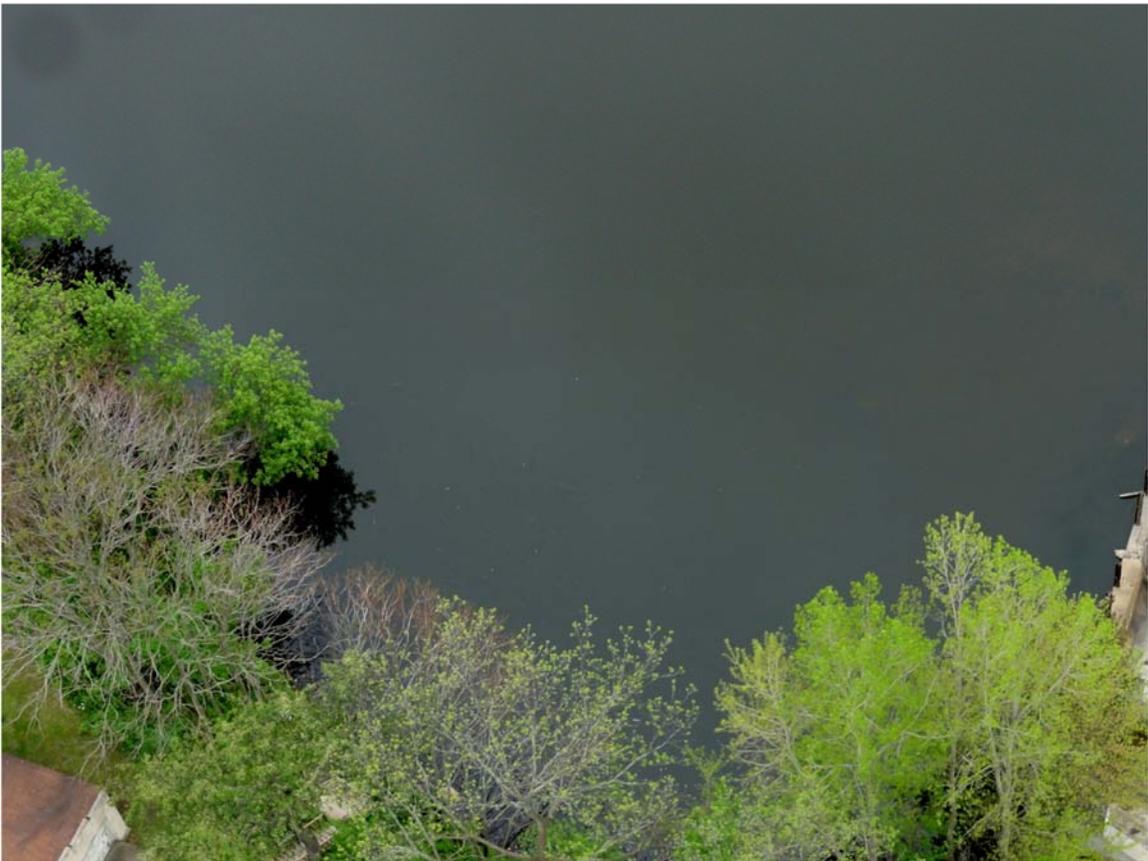
20. MP5.9 RDB above Ceresco Dam sheen observed.

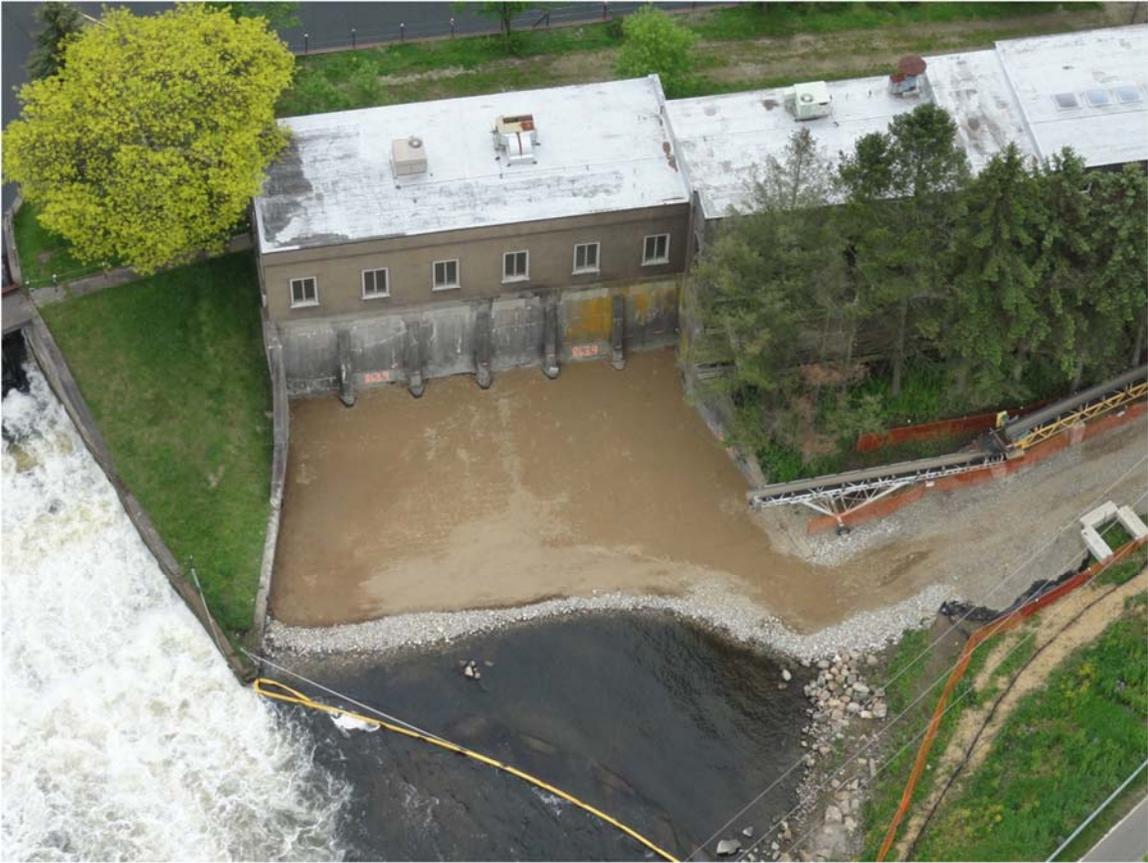
21. Legacy project located below Ceresco Dam.

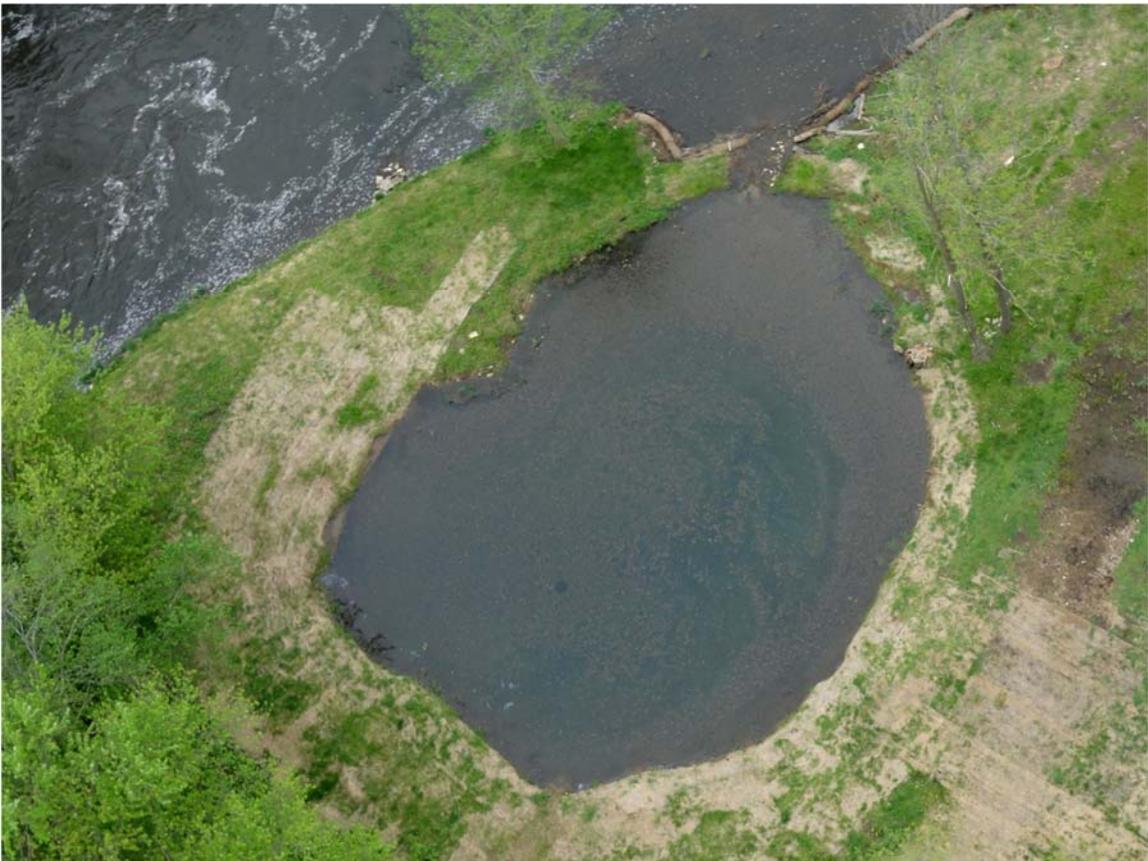
22. OB5.92 RDB sheen observed.

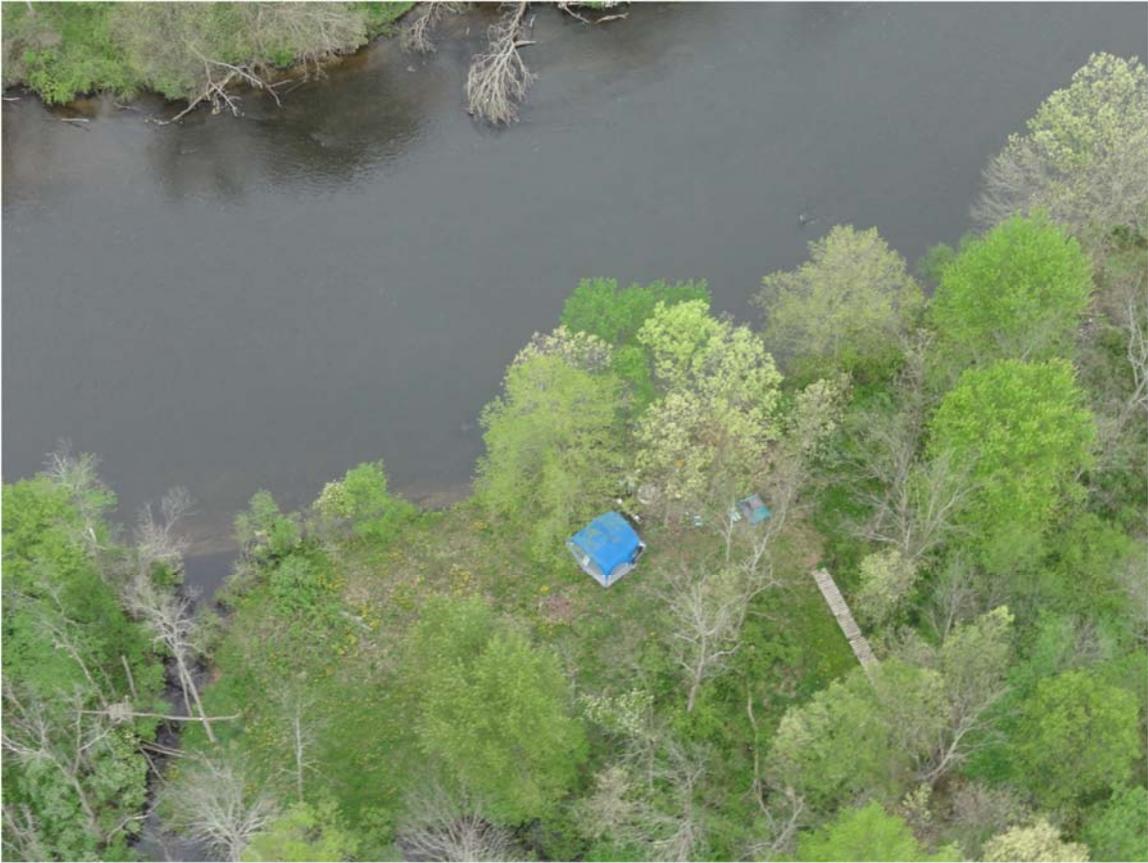
23. MP6.25 campers observed along river.

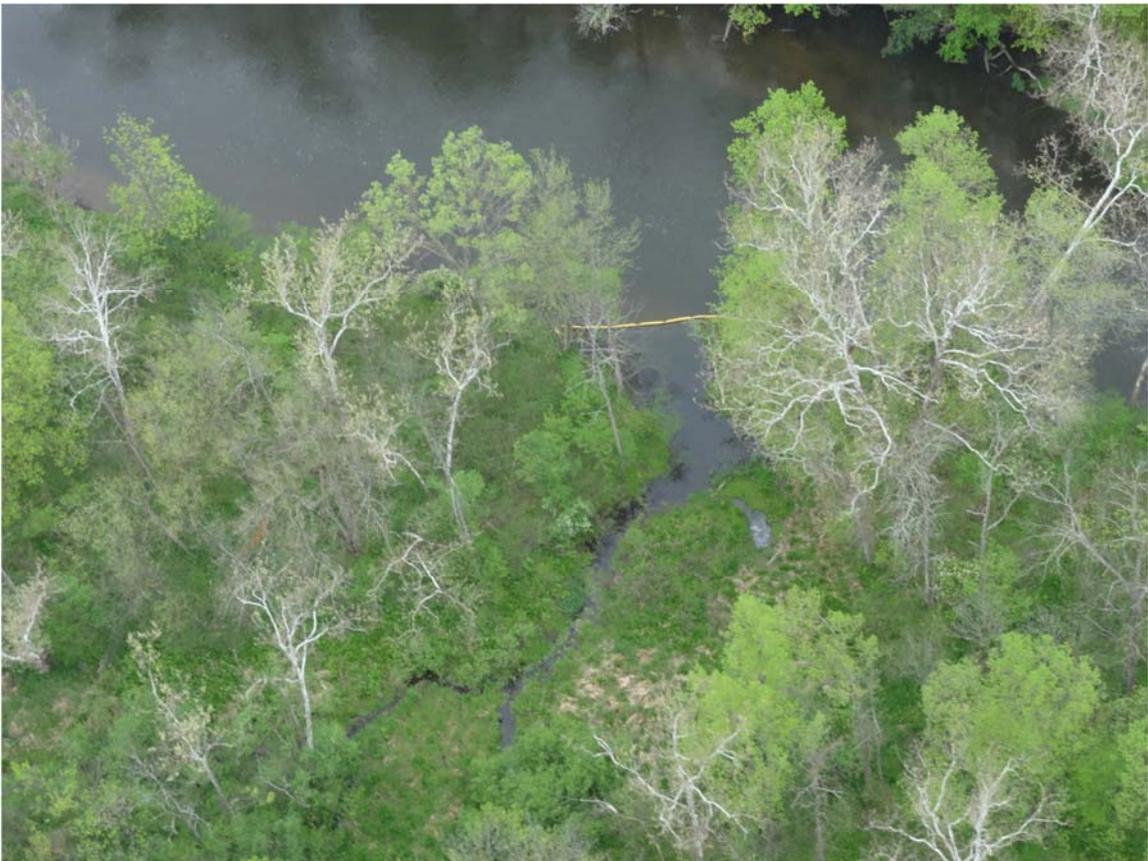
24. MP8.4 LDB sheen observed within boom.
