Situation Photo Log

Saturday, May 5, 2012

Kalamazoo River / Enbridge Spill

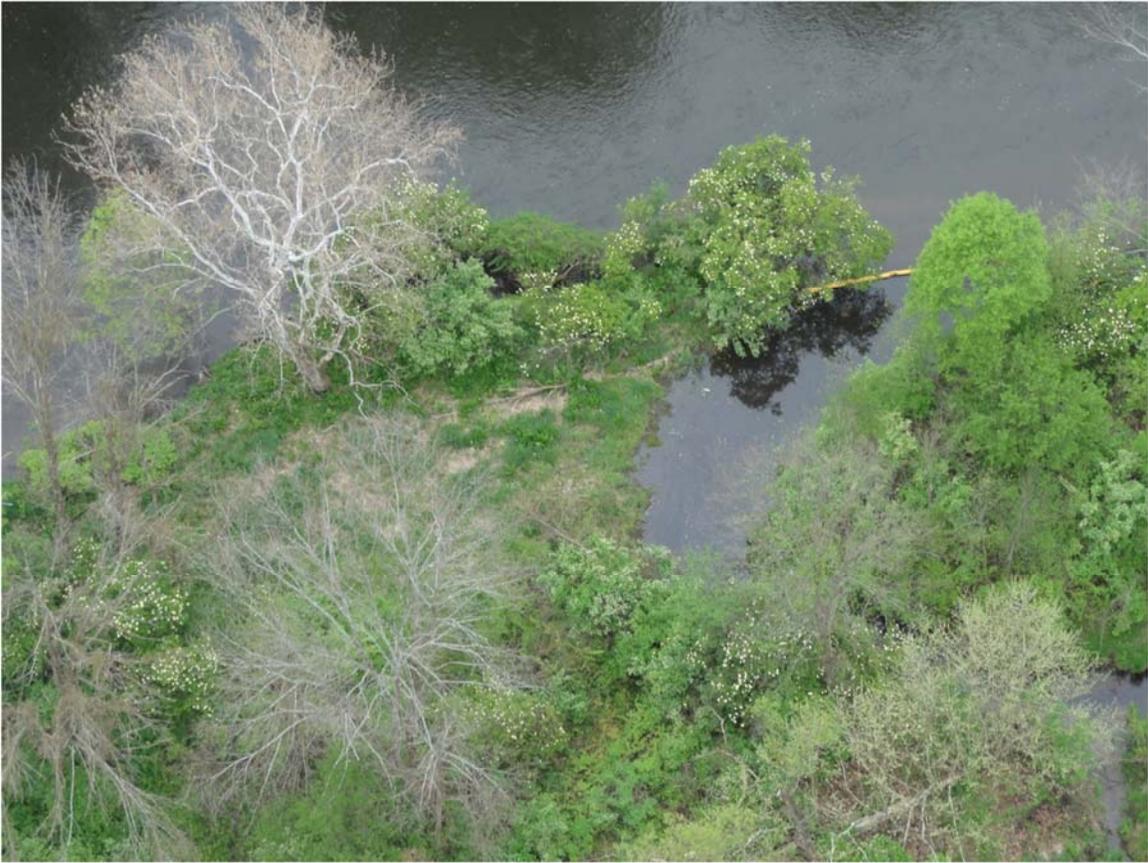
25. MP8.48 RDB sheen observed within boom.

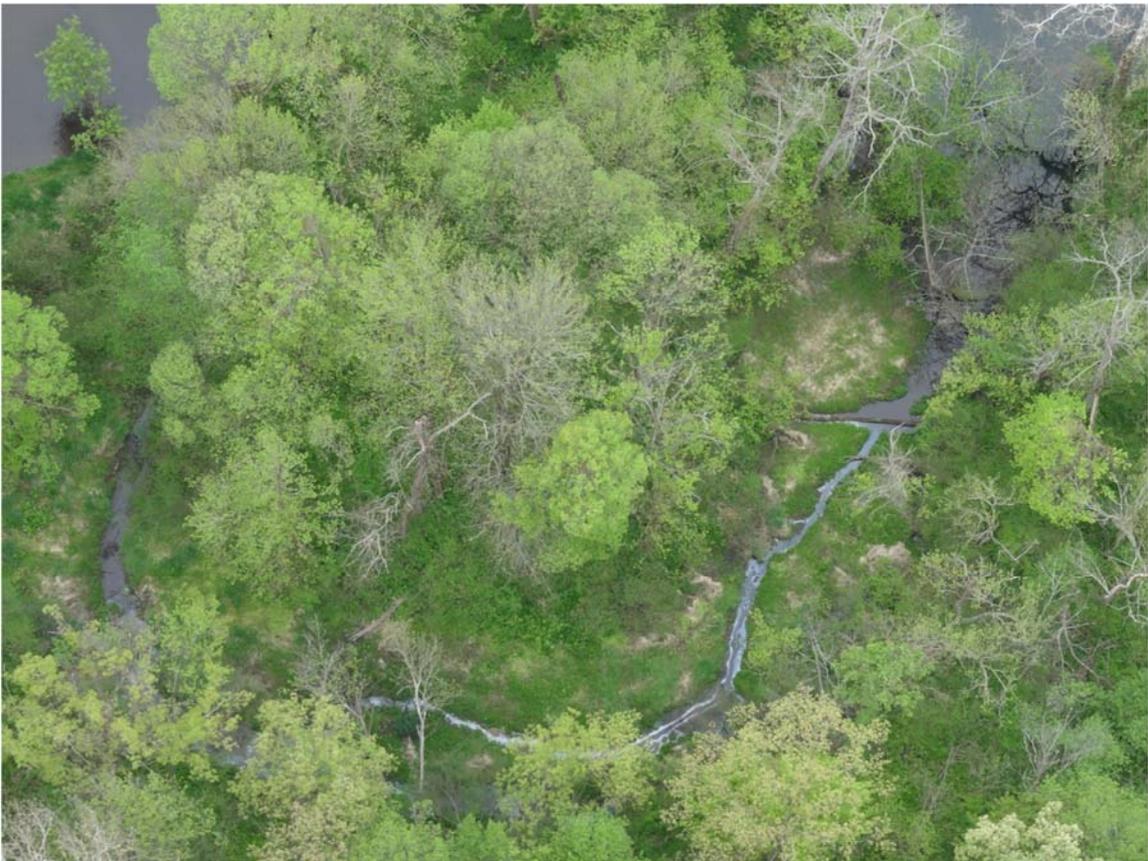
26. MP8.91 R1 sheen observed.

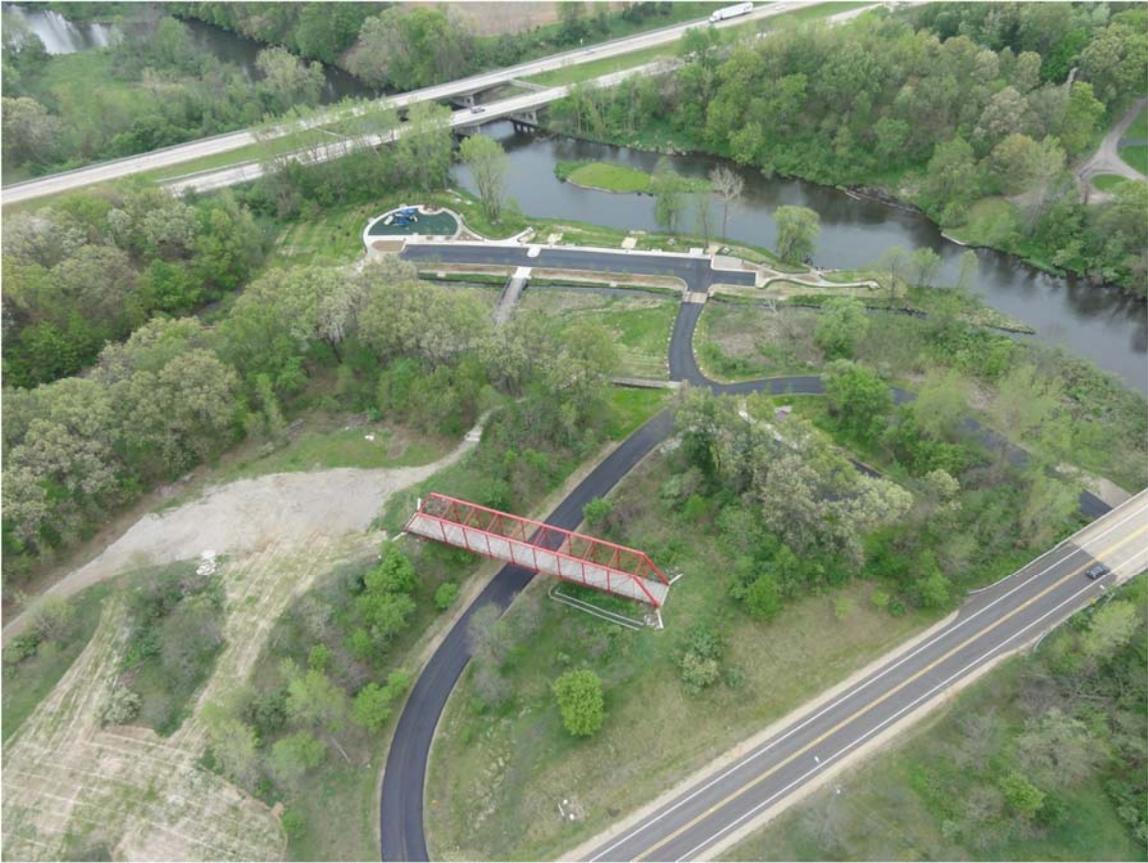
27. Historic Bridge Park paving work completed.

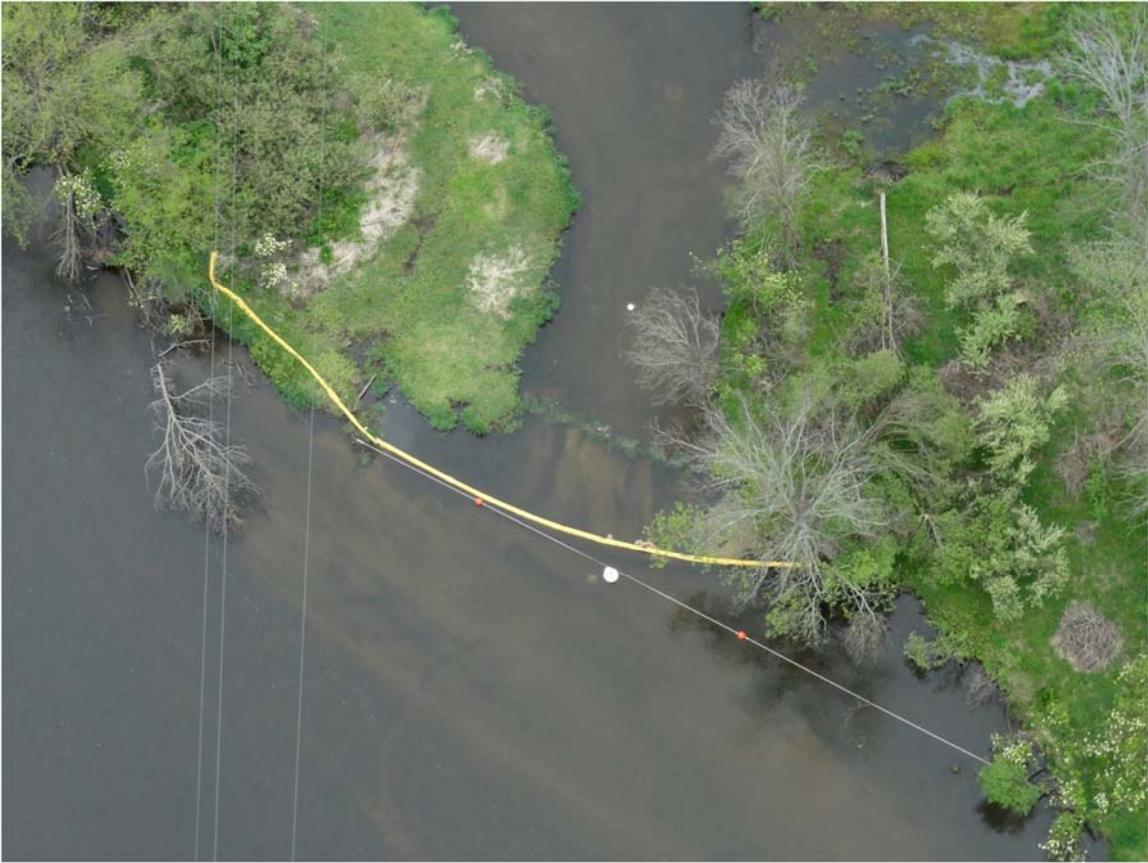
29. MP10.75 sediment trap, buoys installed.

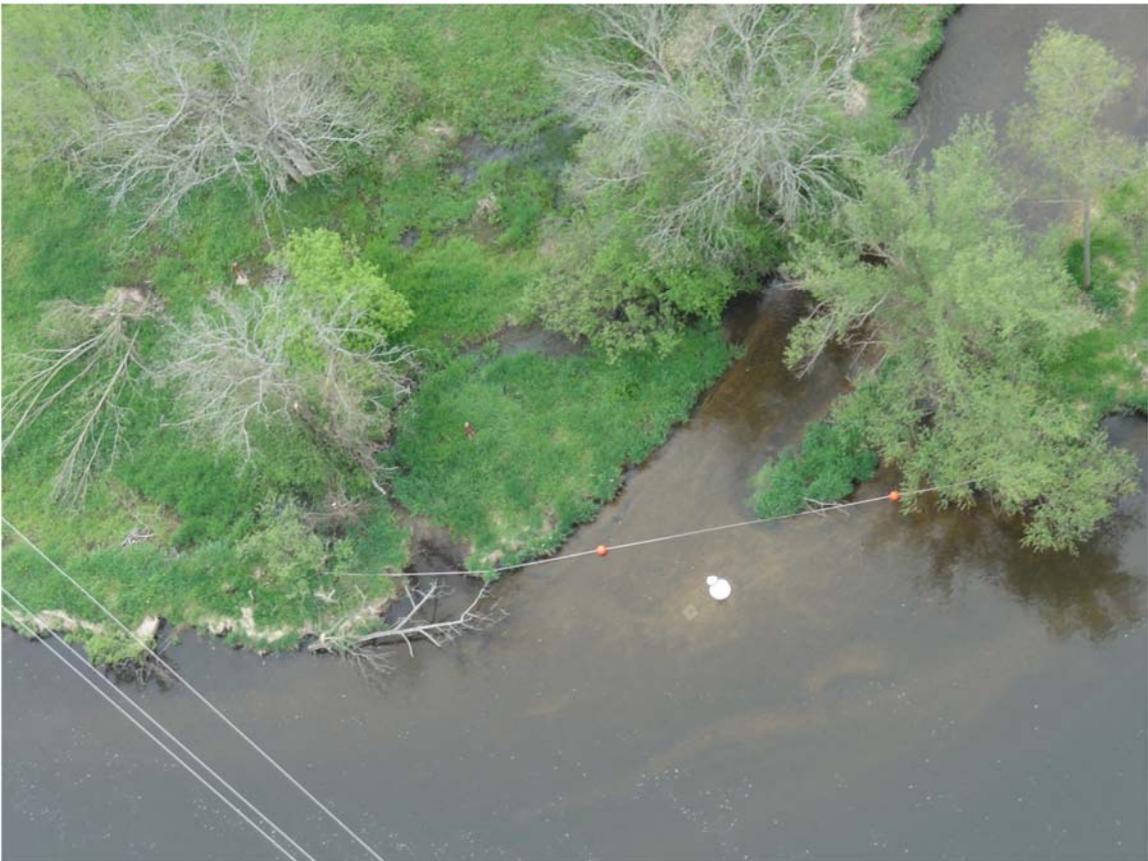
30. MP10.75 buoys deployed on upstream end of channel.

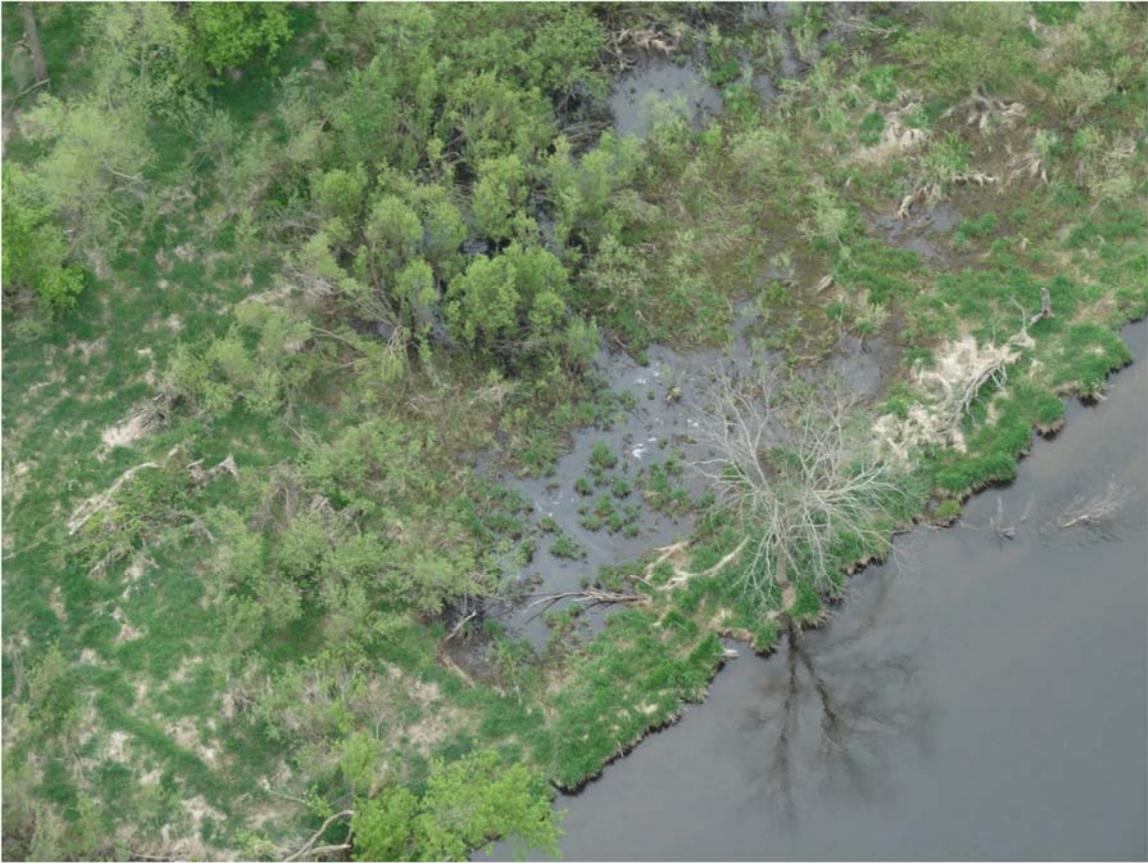
31. MP13.4 LDB sheen observed.

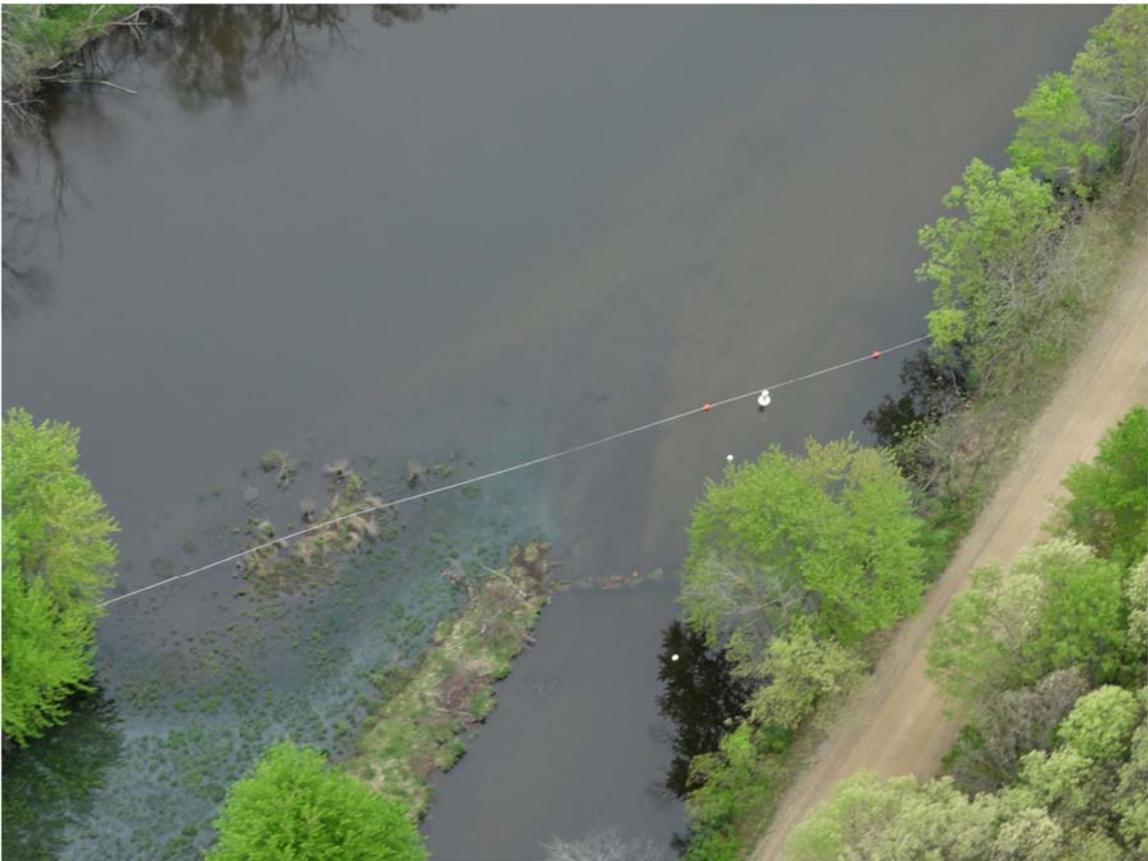
32. MP14.75 sediment trap, buoys deployed.

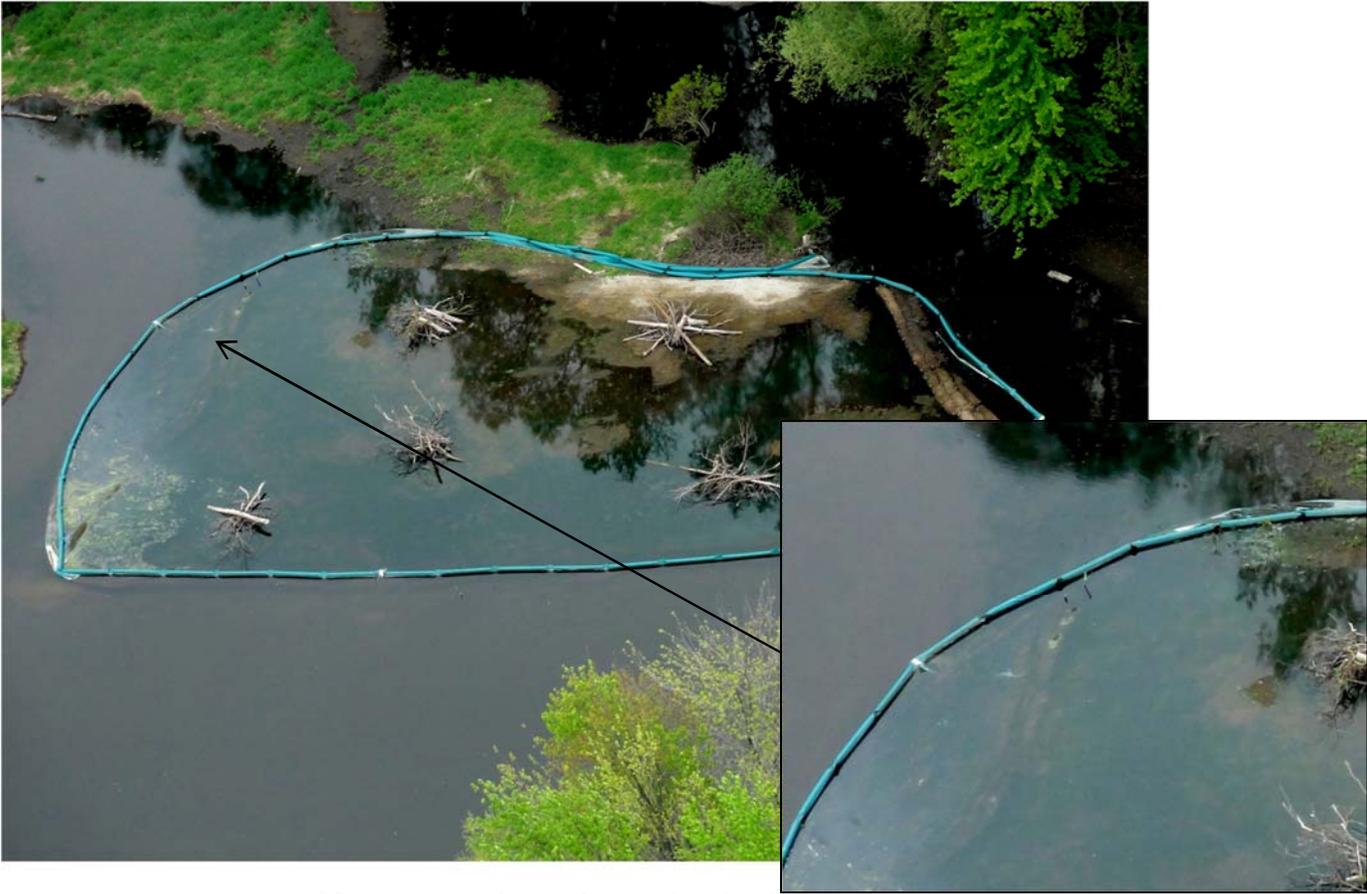
33. OB14.97 I sheen observed within boom.

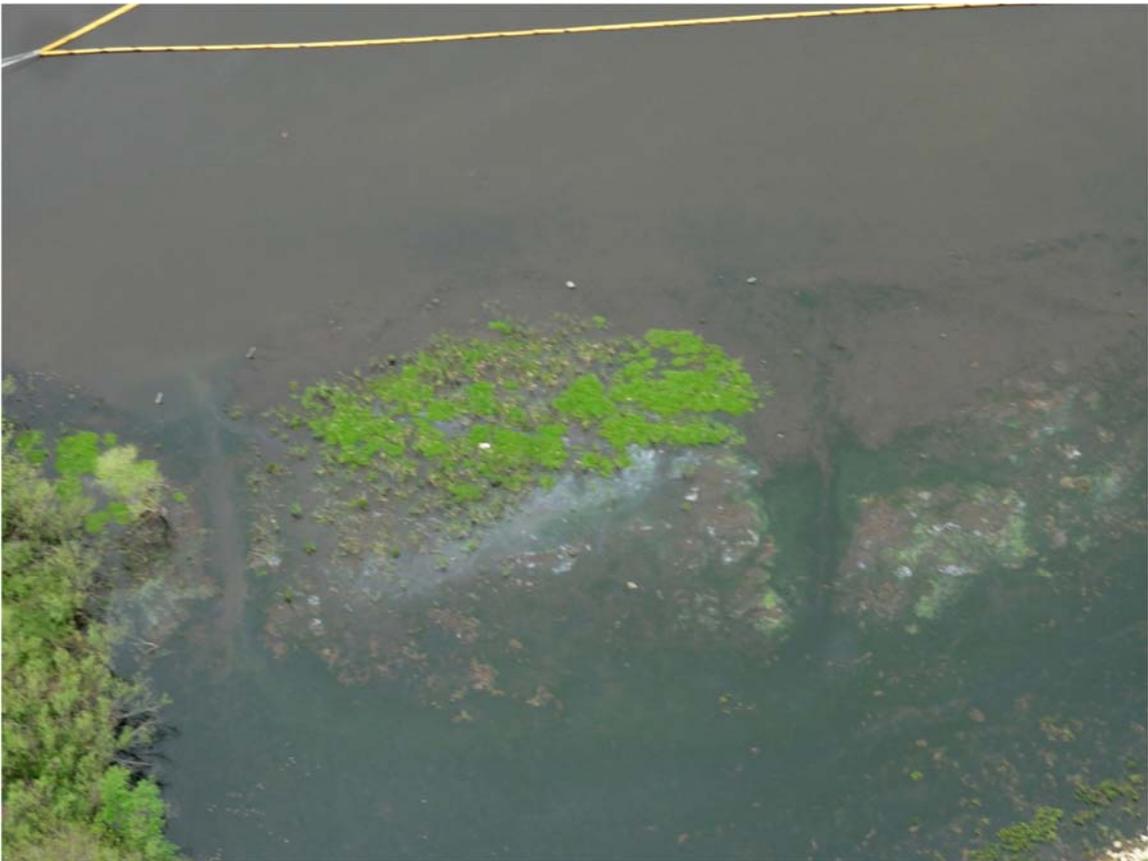
34. MP15.75 RDB sheen observed.

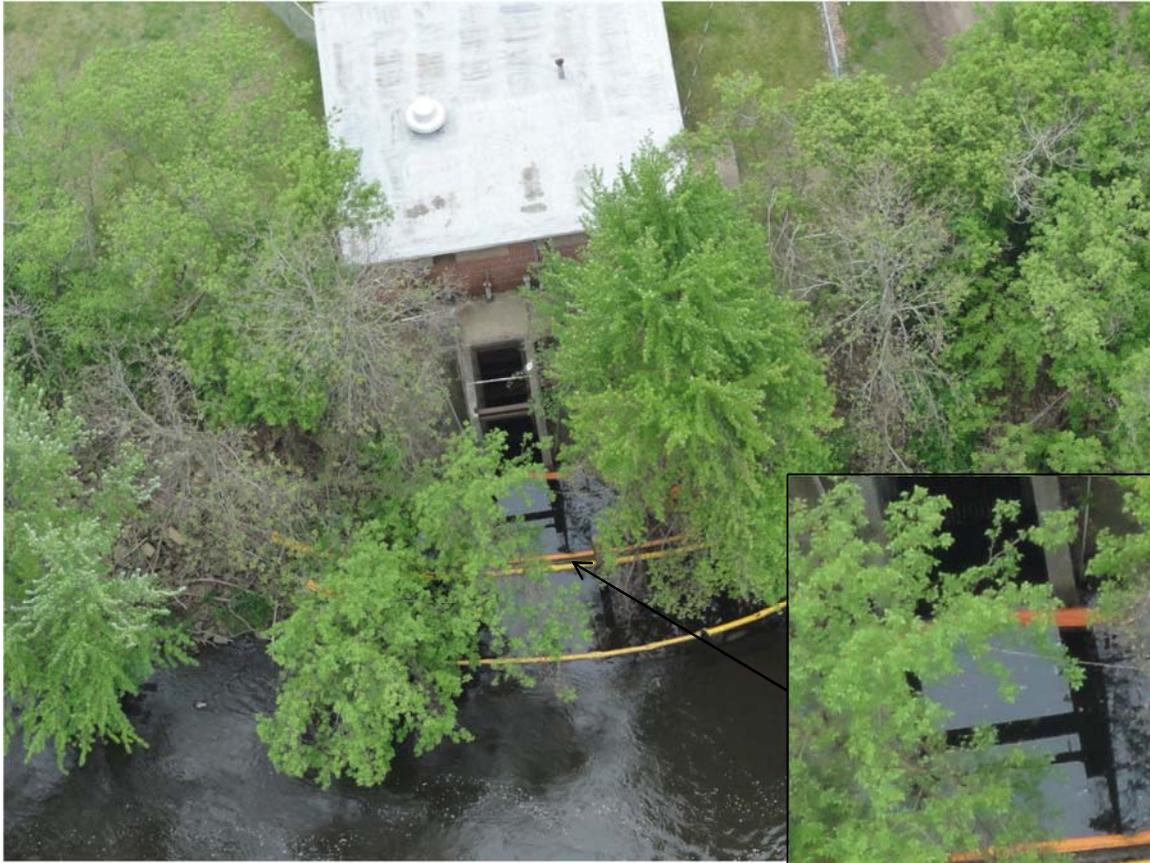
35. Rock Tenn sheen observed.

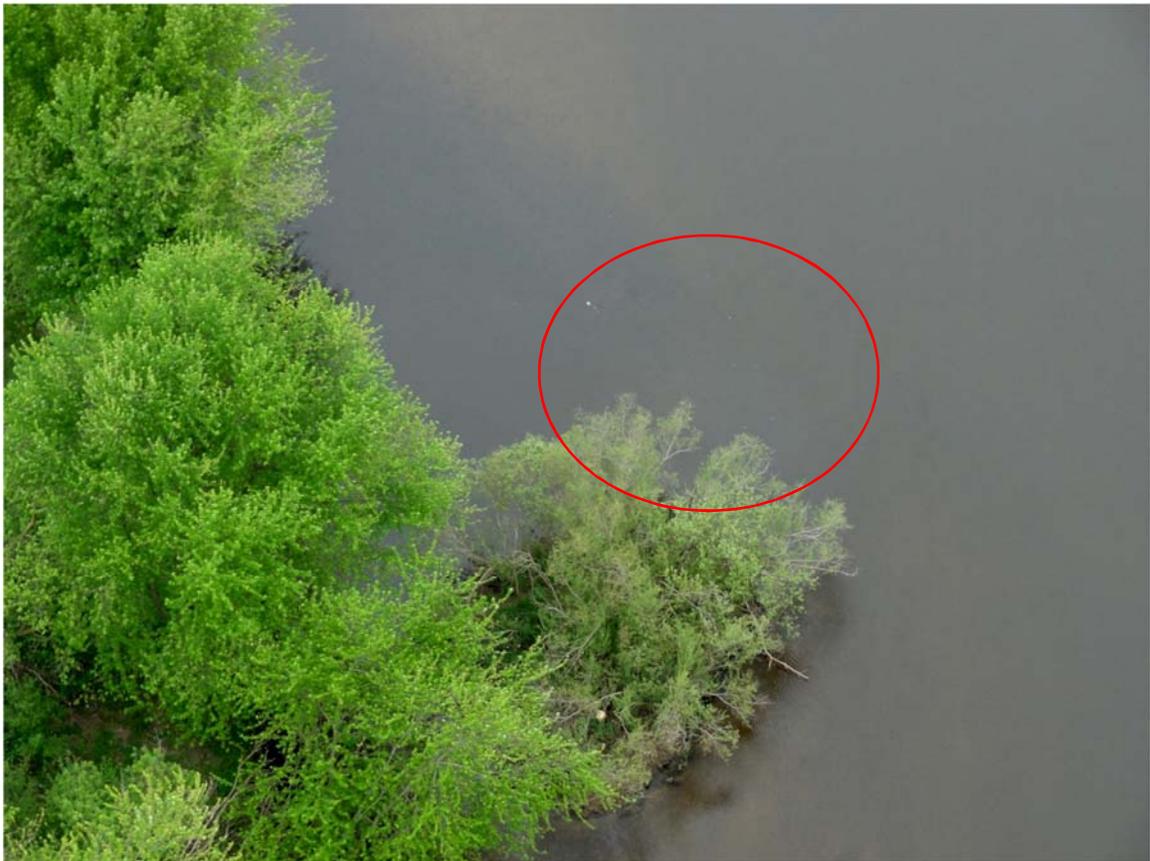
36. MP18.5 LDB sheen observed.

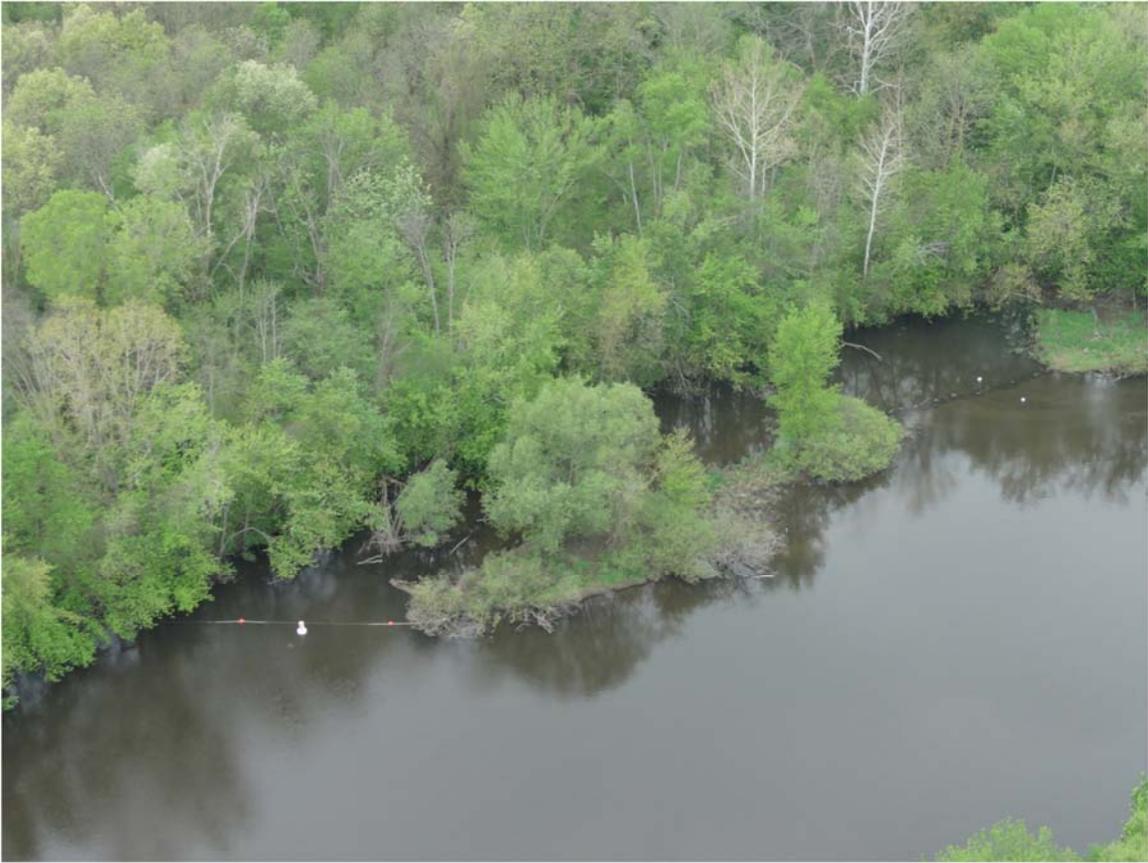
37. MP19.25 sediment trap, buoys deployed.

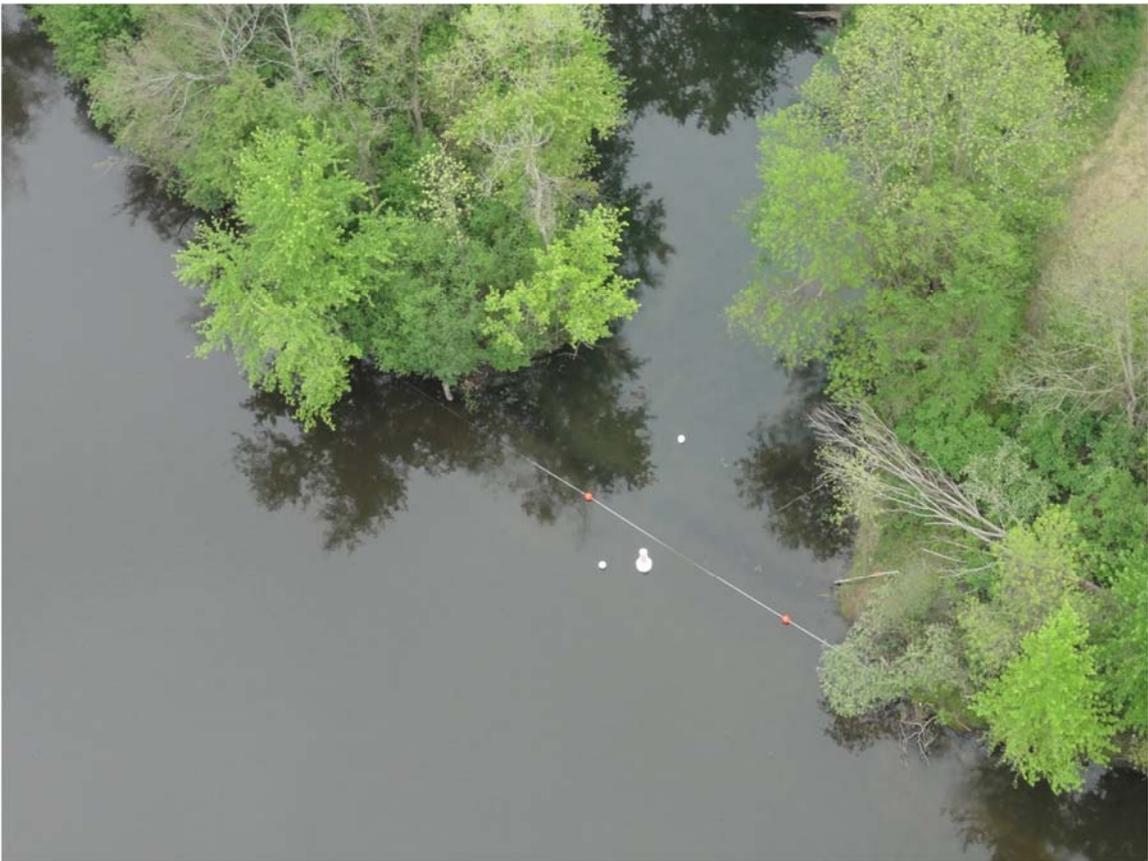
38. MP19.25 sediment trap, buoys deployed.

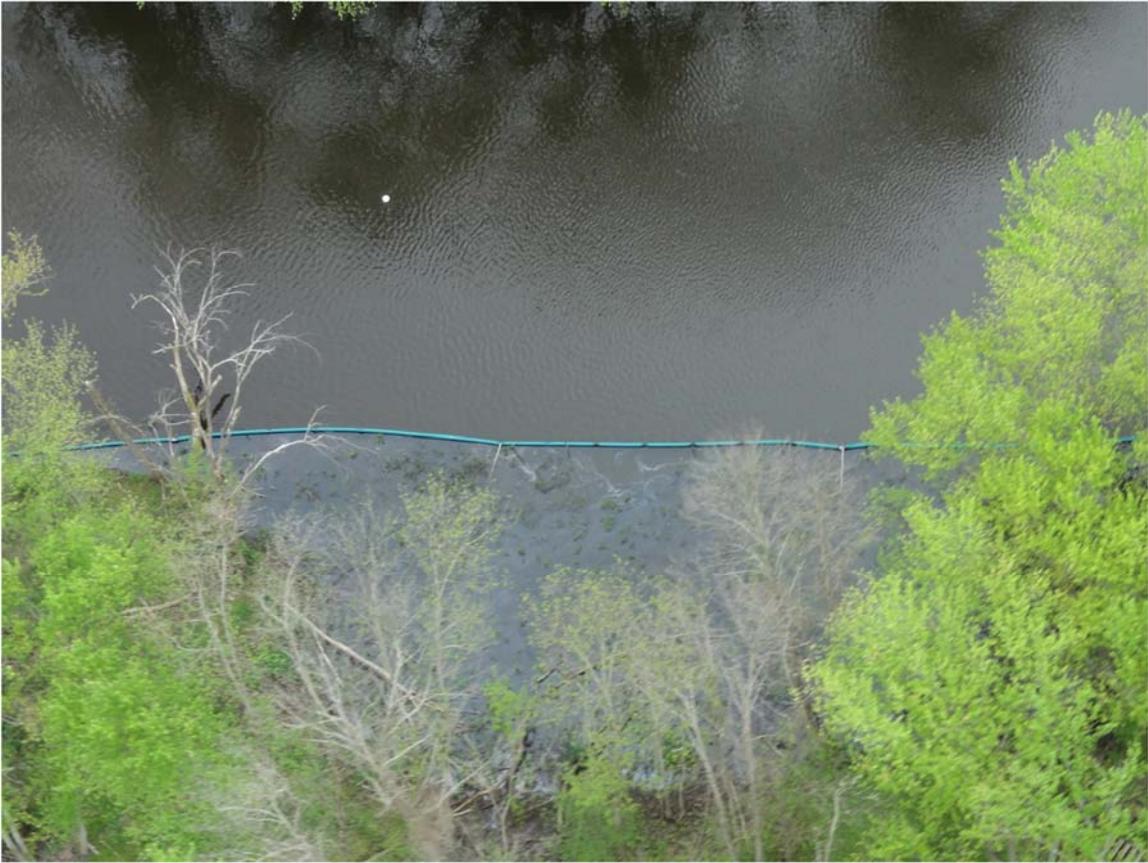
39. MP21.5 Oxbow sheen observed within the boom.

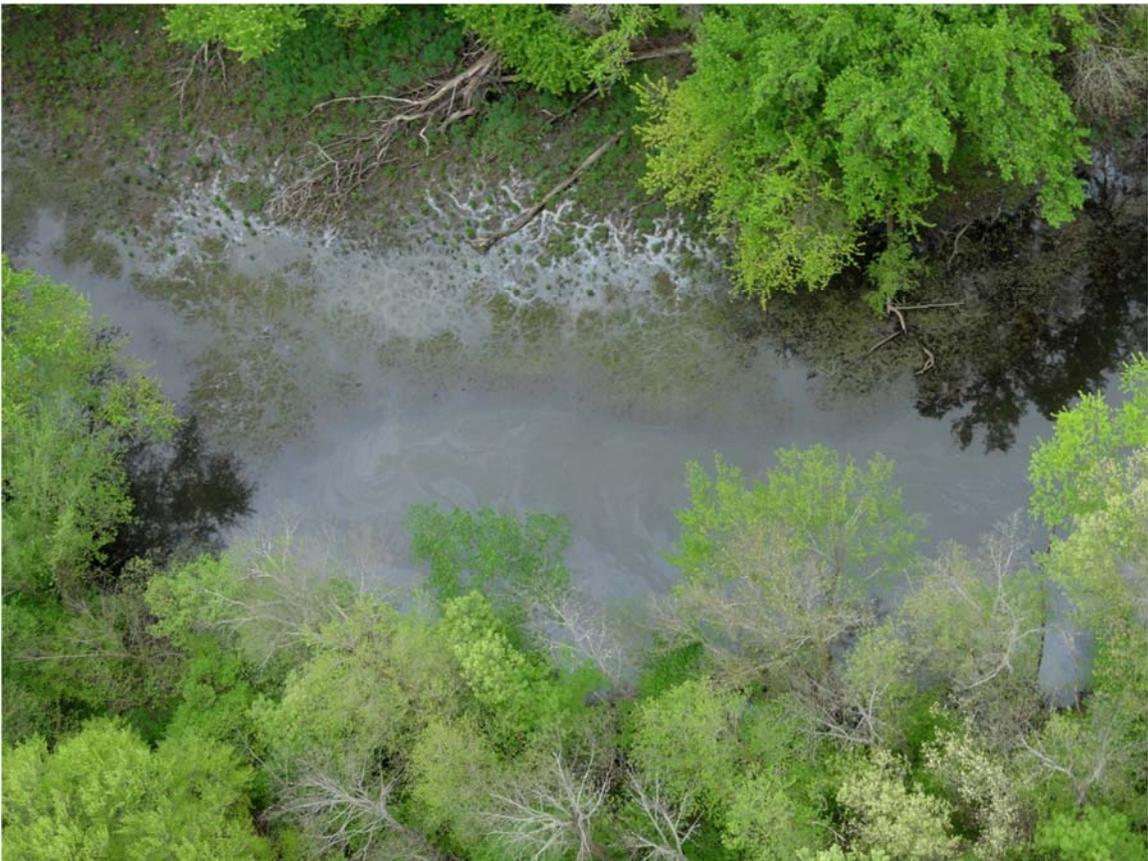
40. MP22.25 sheen observed.

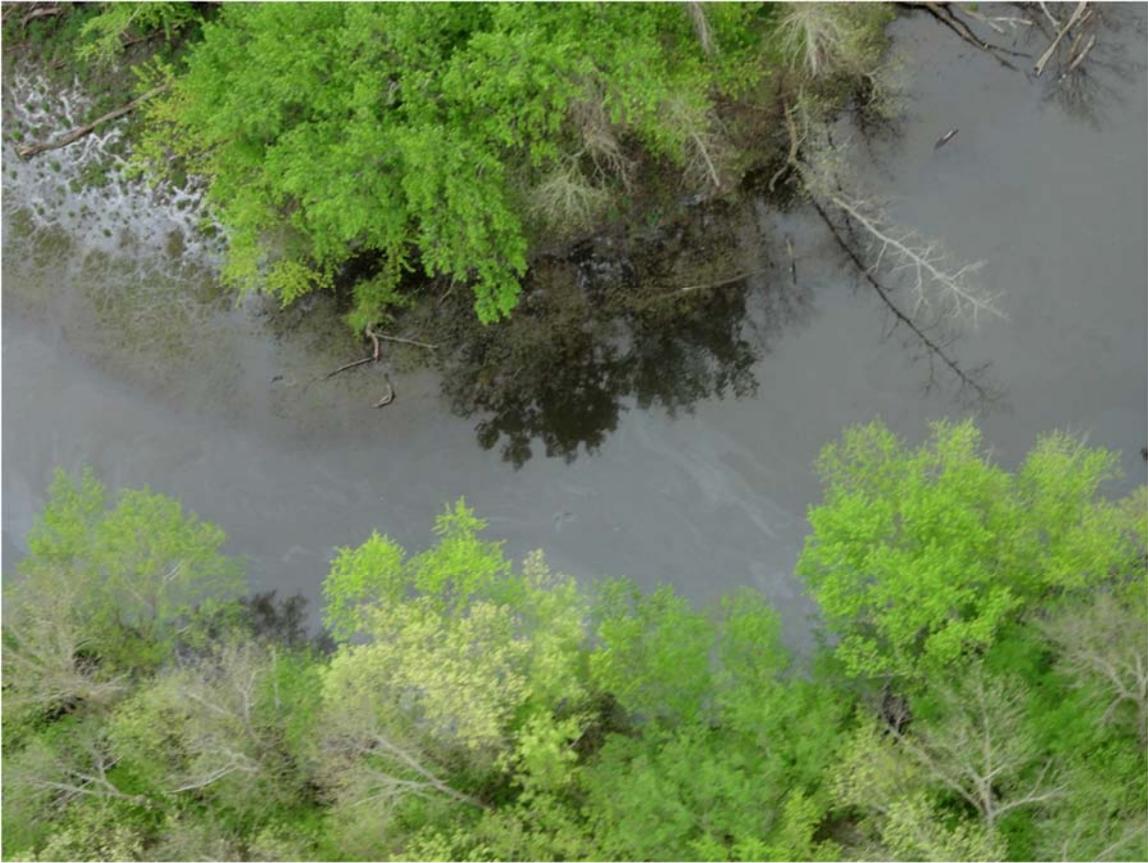
41. MP22.25 sheen observed.

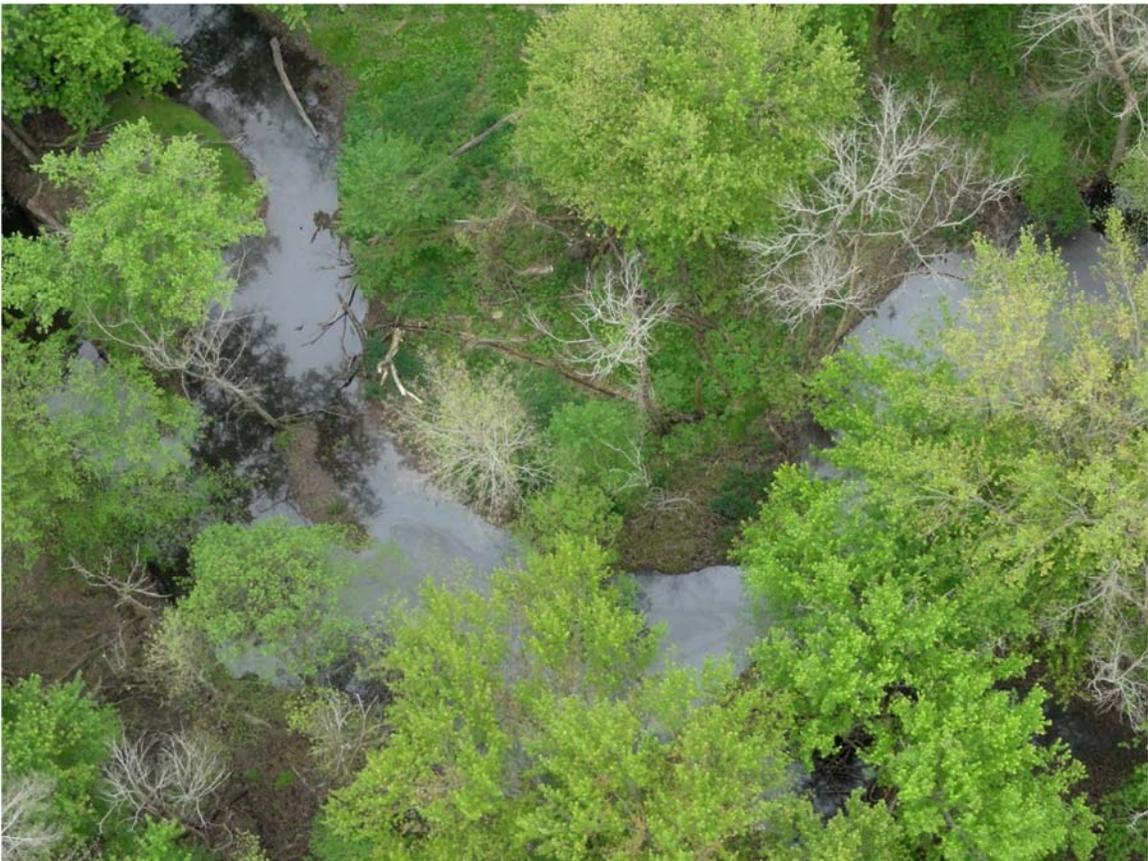
42. MP22.25 sheen observed.

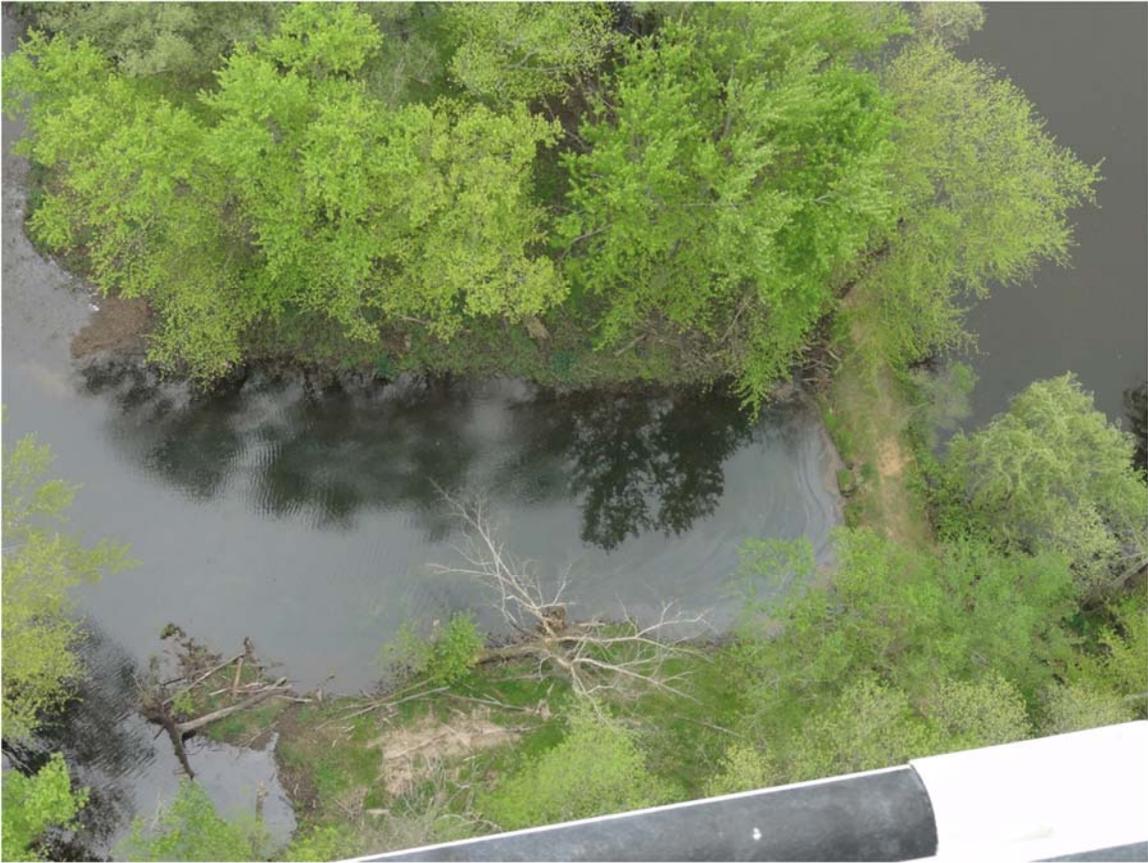
43. MP 26.25 sheen observed RDB.

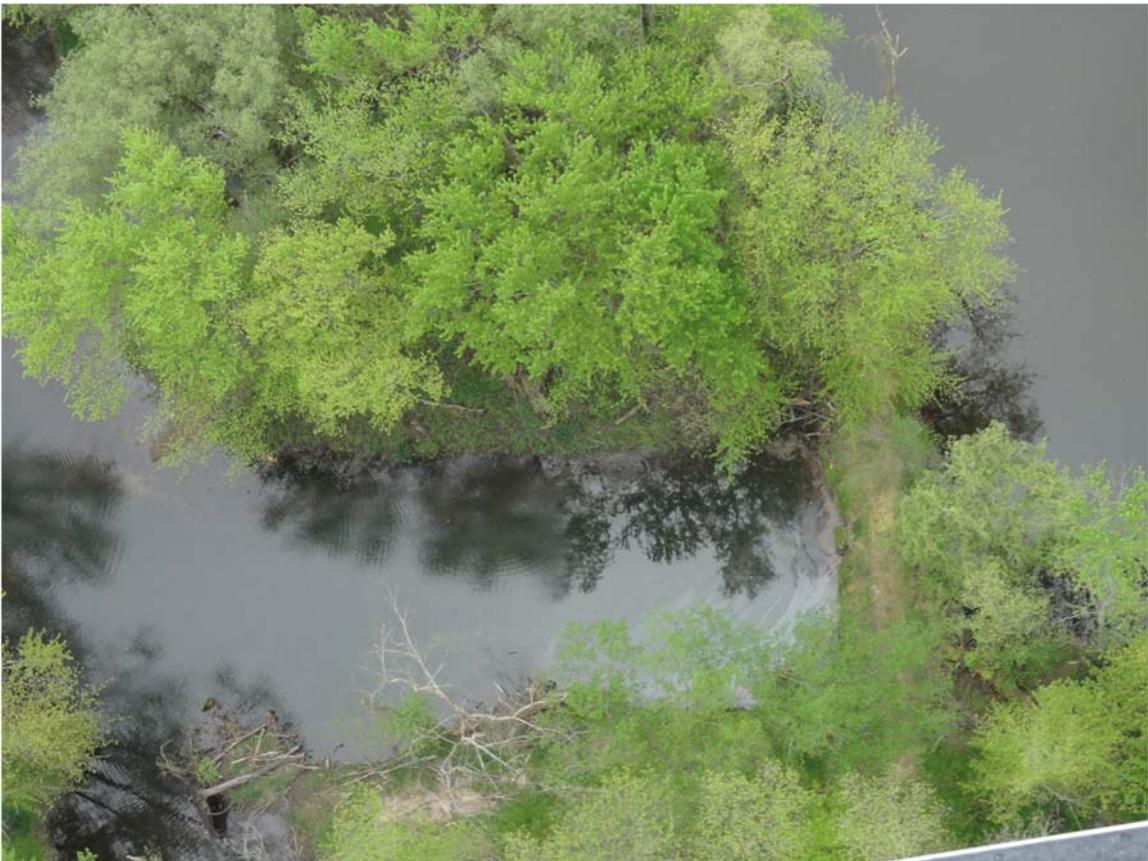
44. 26.25 sheen observed RDB.

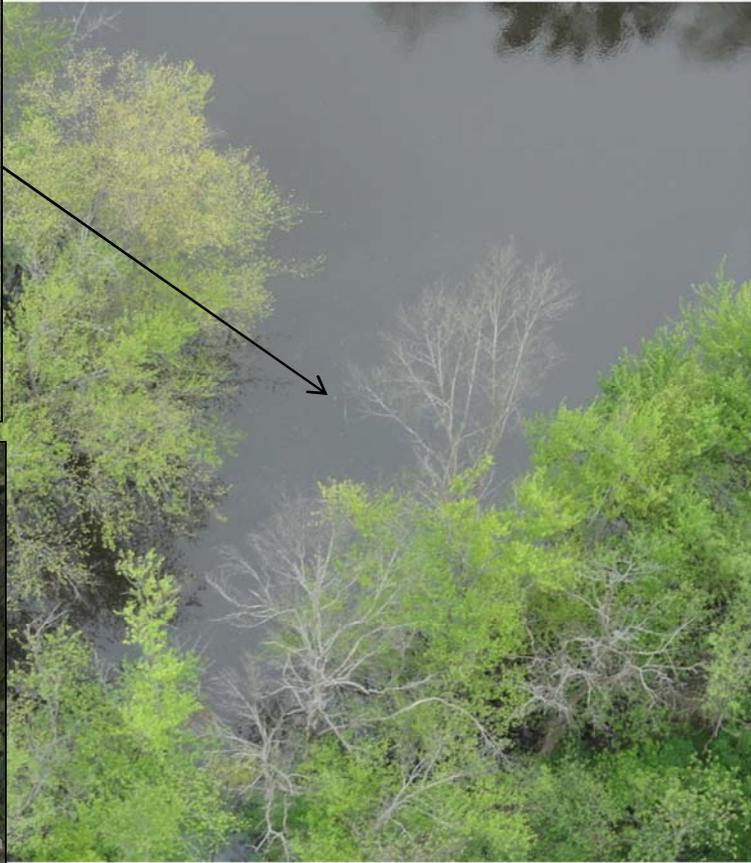
45. 27.75 sheen observed RDB.

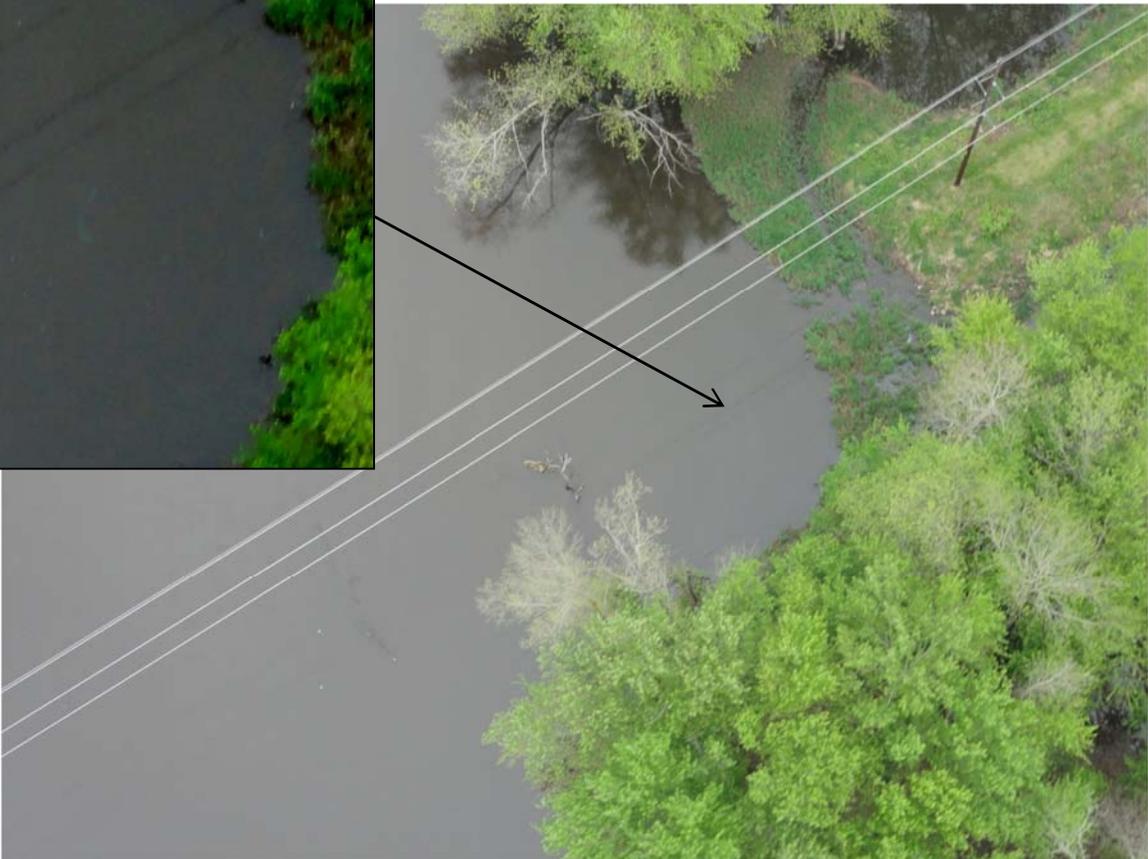
46. 27.75 sheen observed RDB.

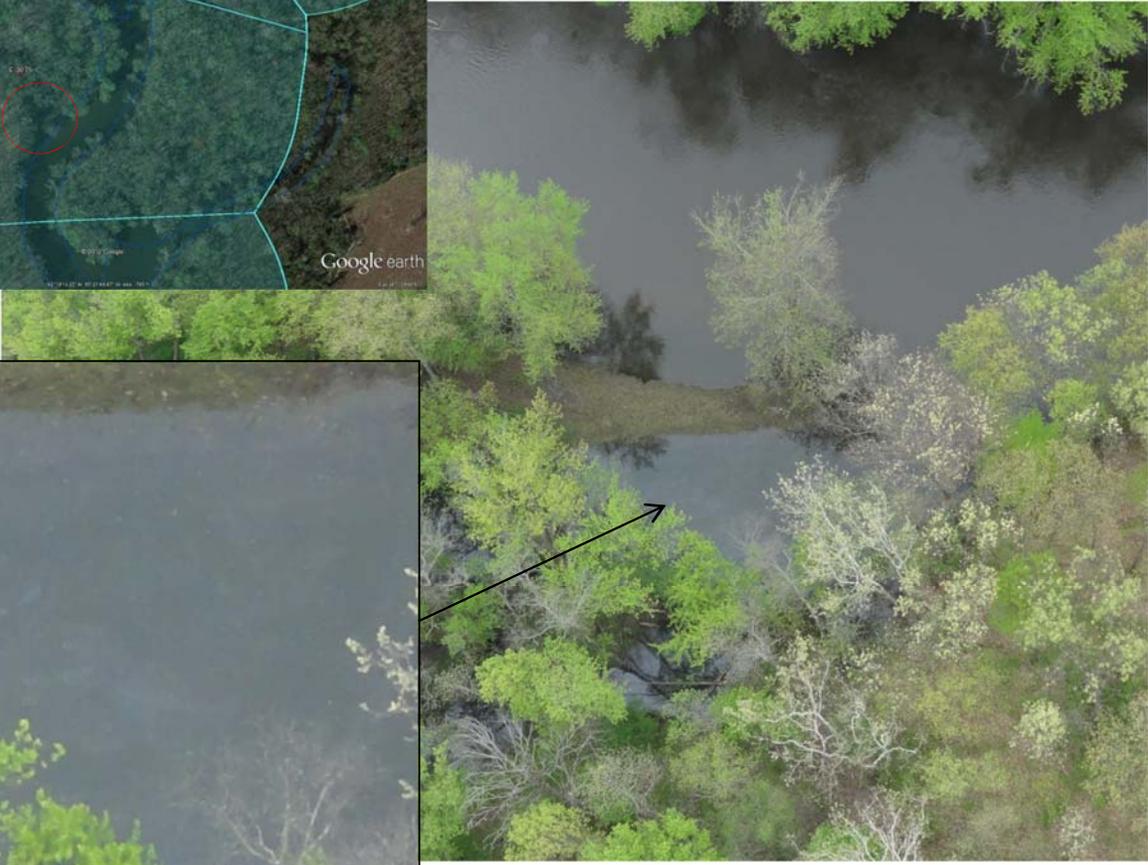
47. MP30.75 sheen observed RDB.

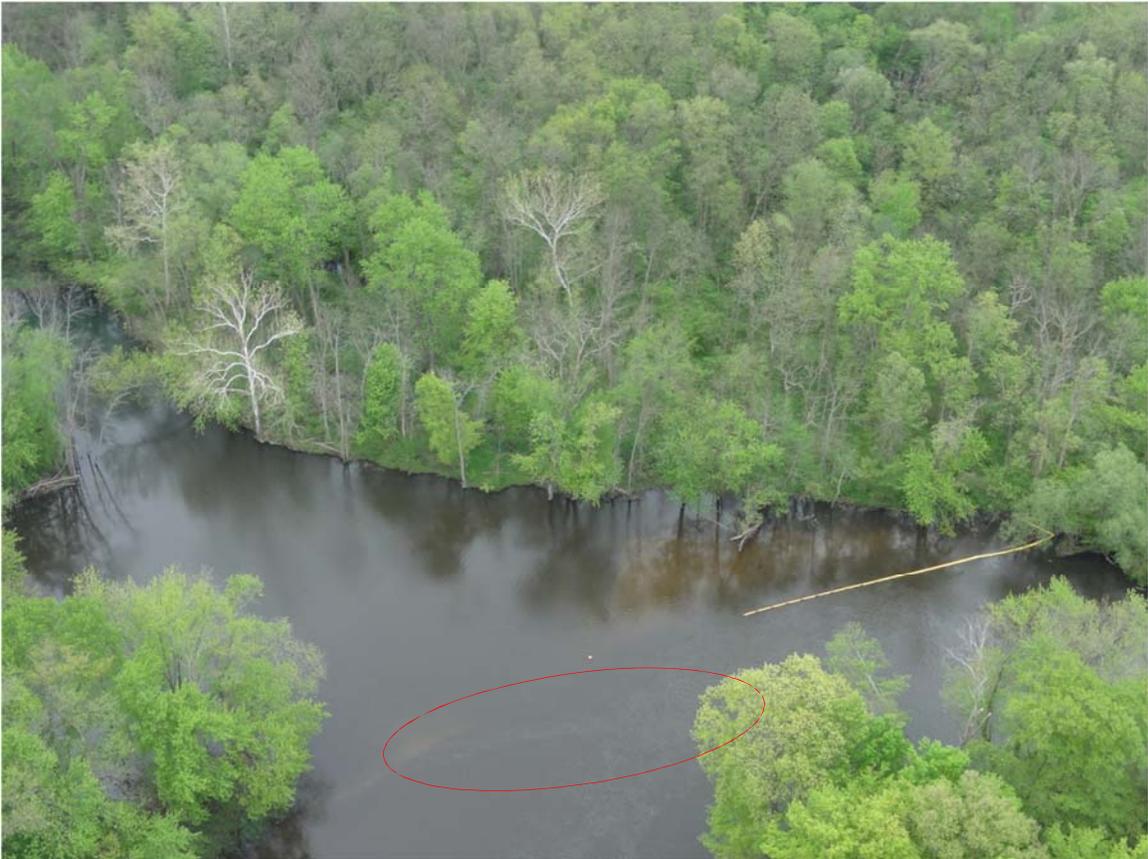
48. MP30.8 sheen observed.
