Situation Photo Log

Saturday, May 5, 2012

Kalamazoo River / Enbridge Spill

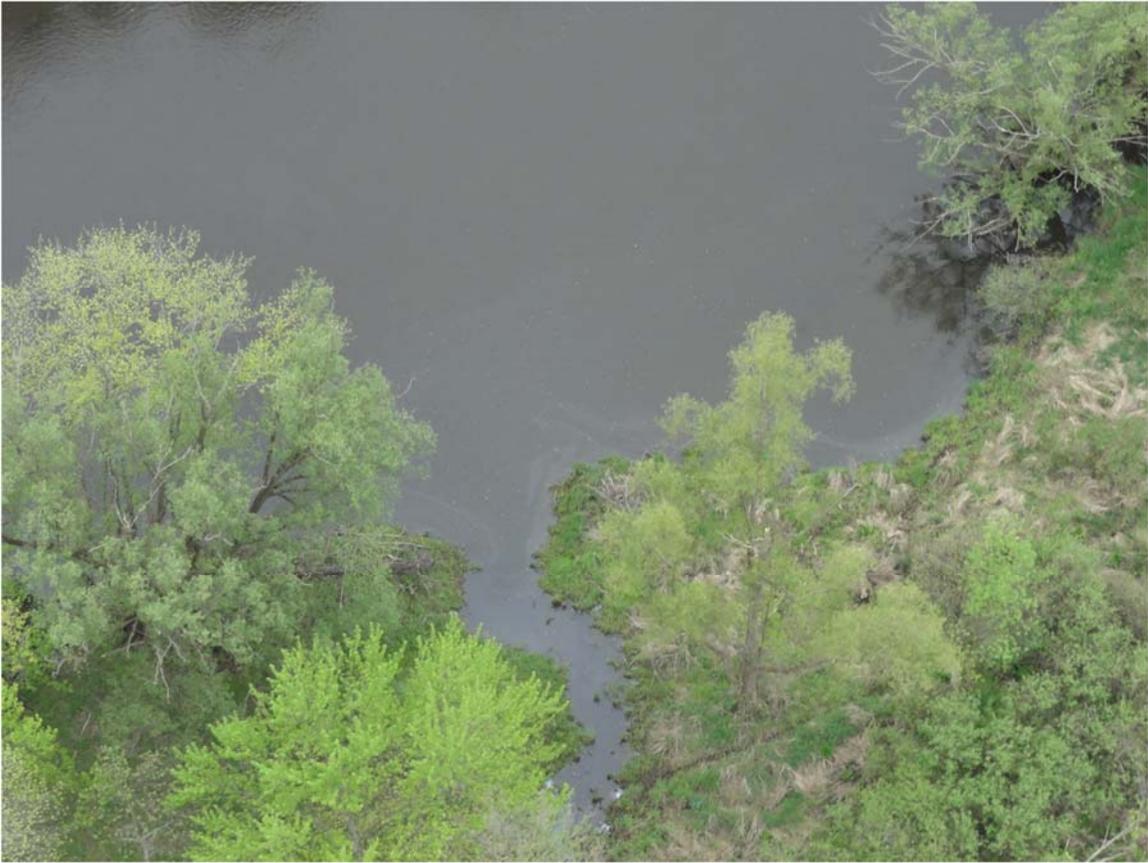
49. MP33.0 sheen observed RDB.

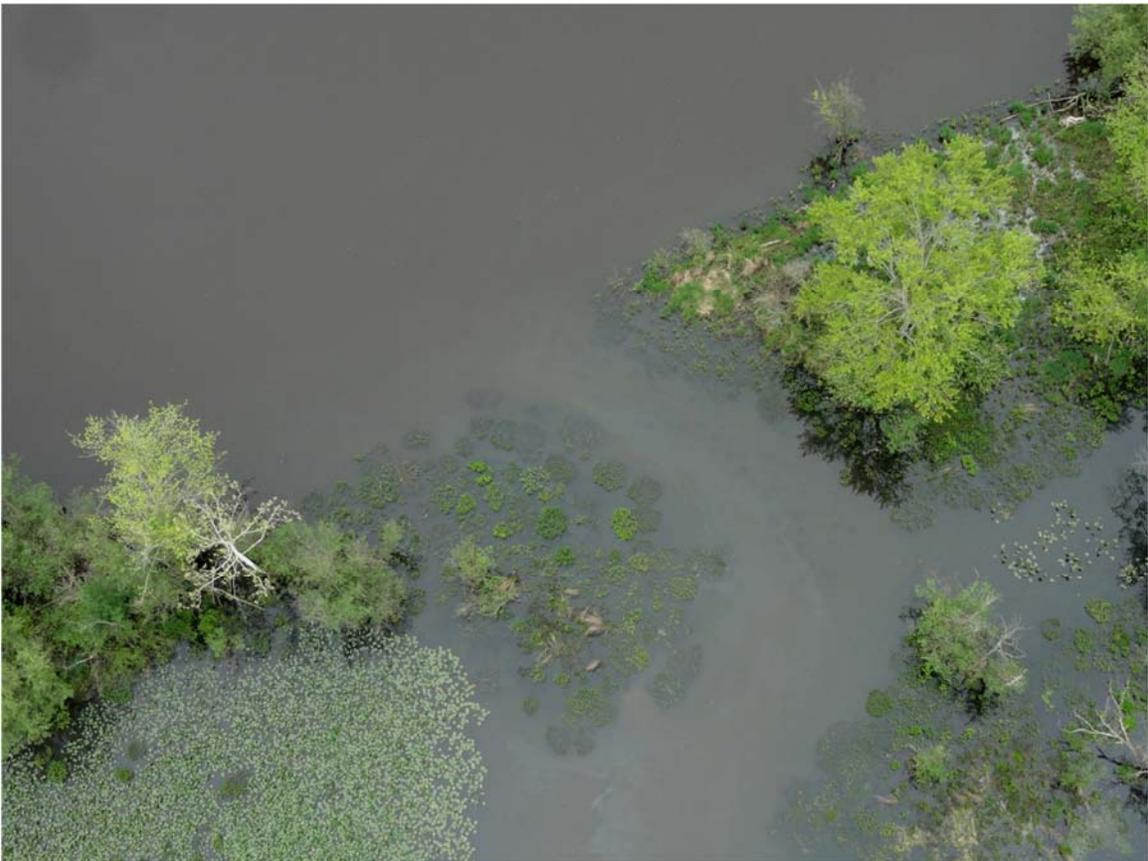
50. 36.01 sheen observed RDB.

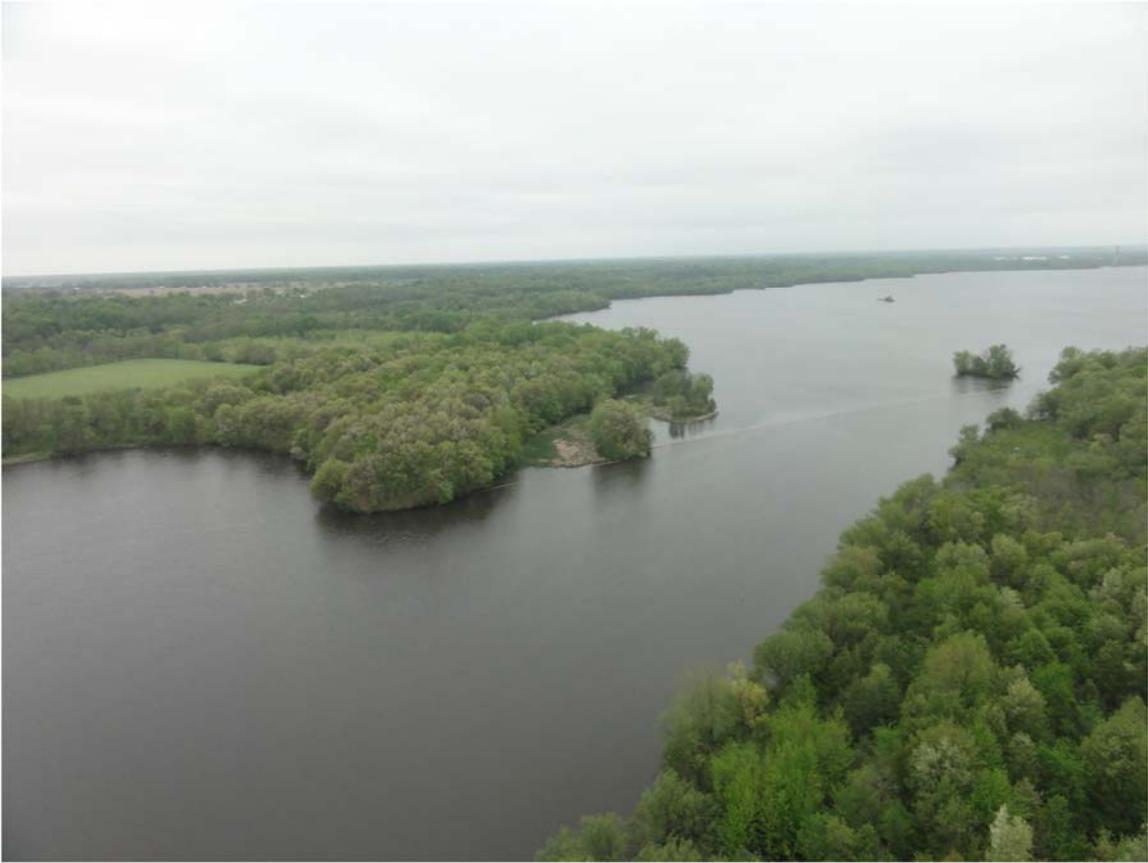
51. MP37.75 control point no sheen observed.

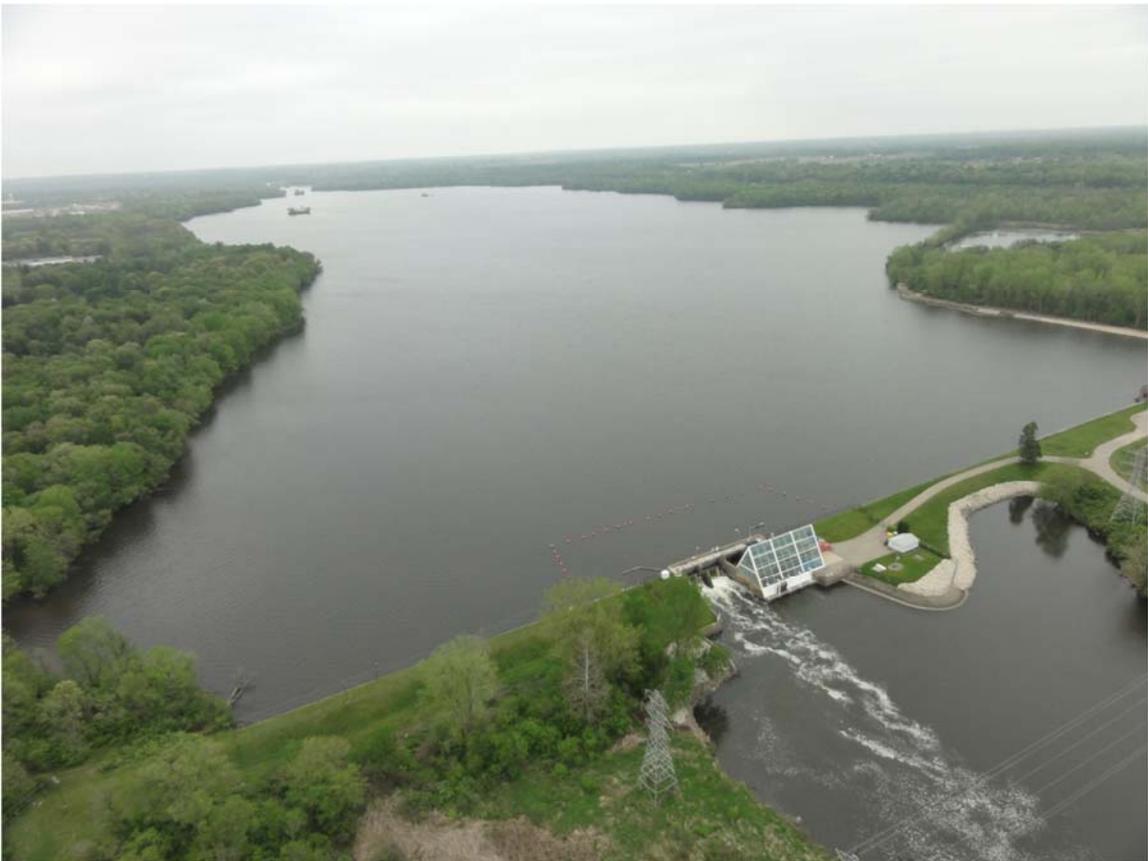
52. Lake Morrow no sheen observed.
