# Situation Photo Log

Tuesday, May 8, 2012

Kalamazoo River / Enbridge Spill

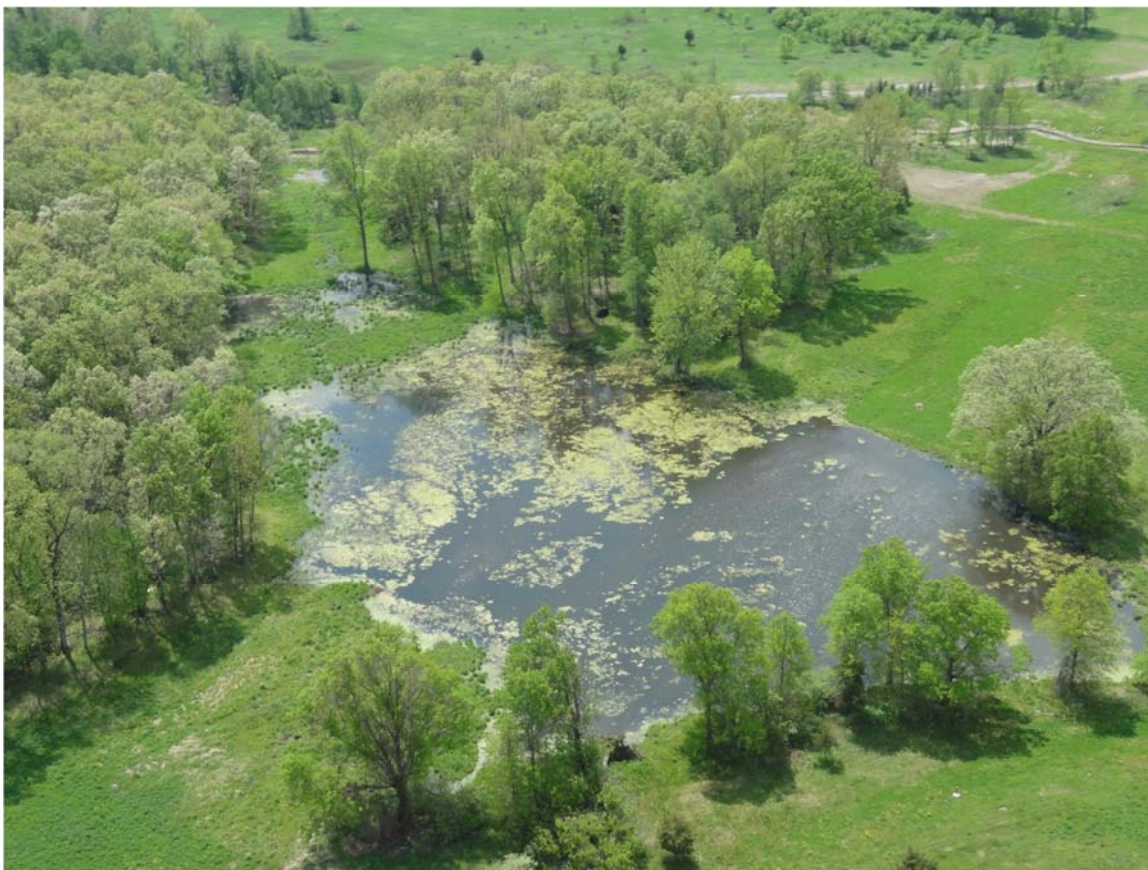
1. Source area pond, no sheen observed.

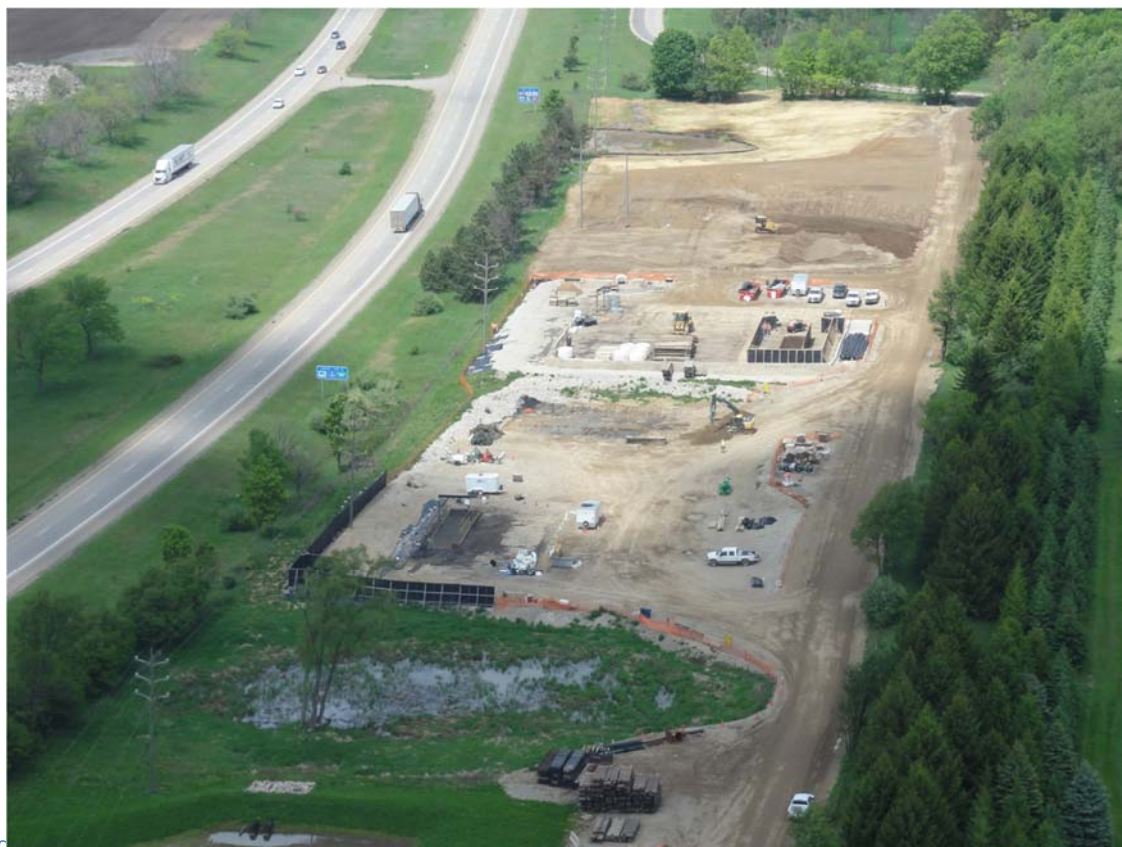
2. Frac-Tank City footprint reduction continued.

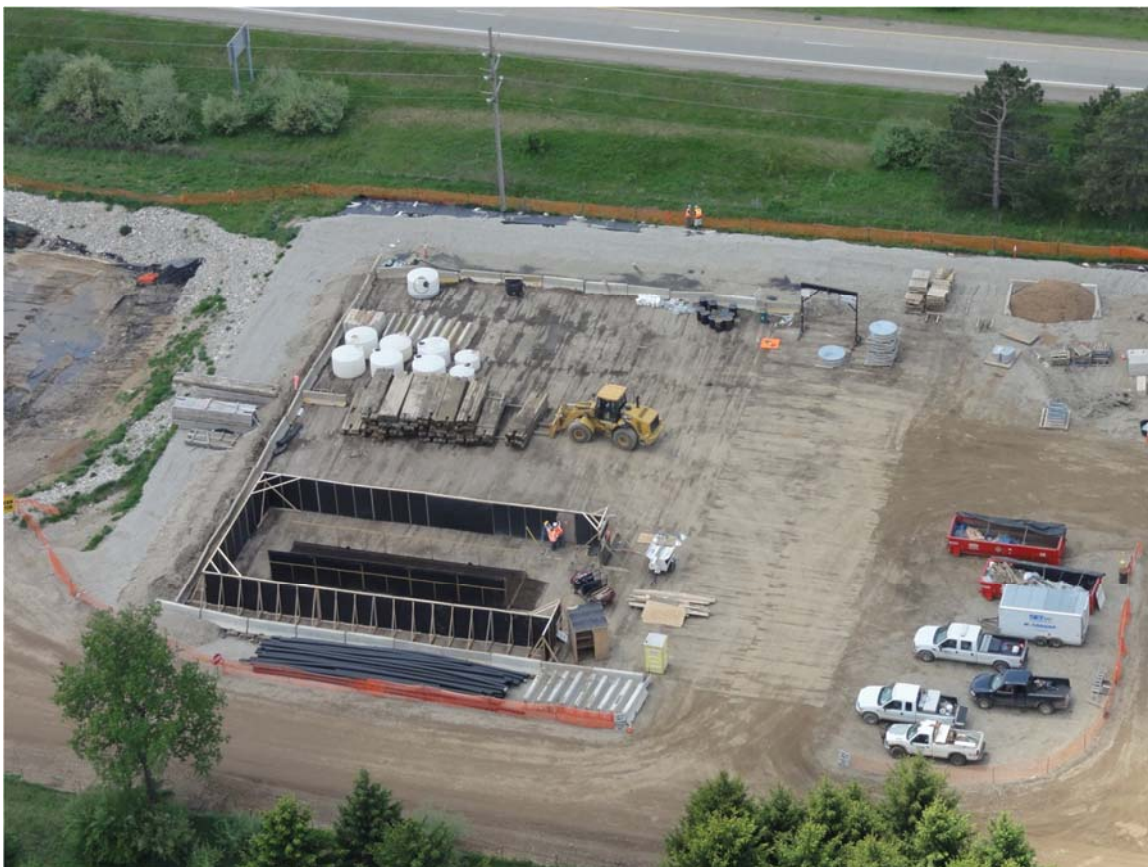
3. Frac-Tank City construction of the new decon pad.

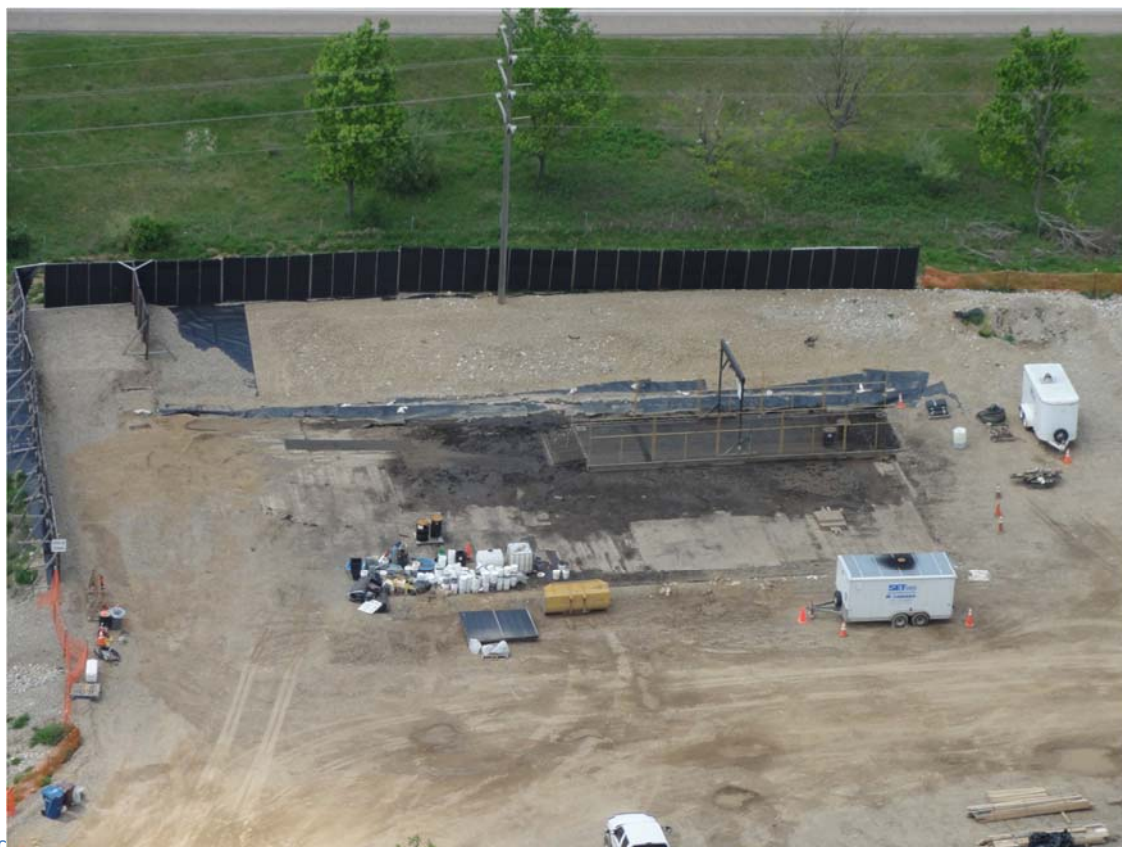
4. Frac-Tank City footprint reduction work continued.

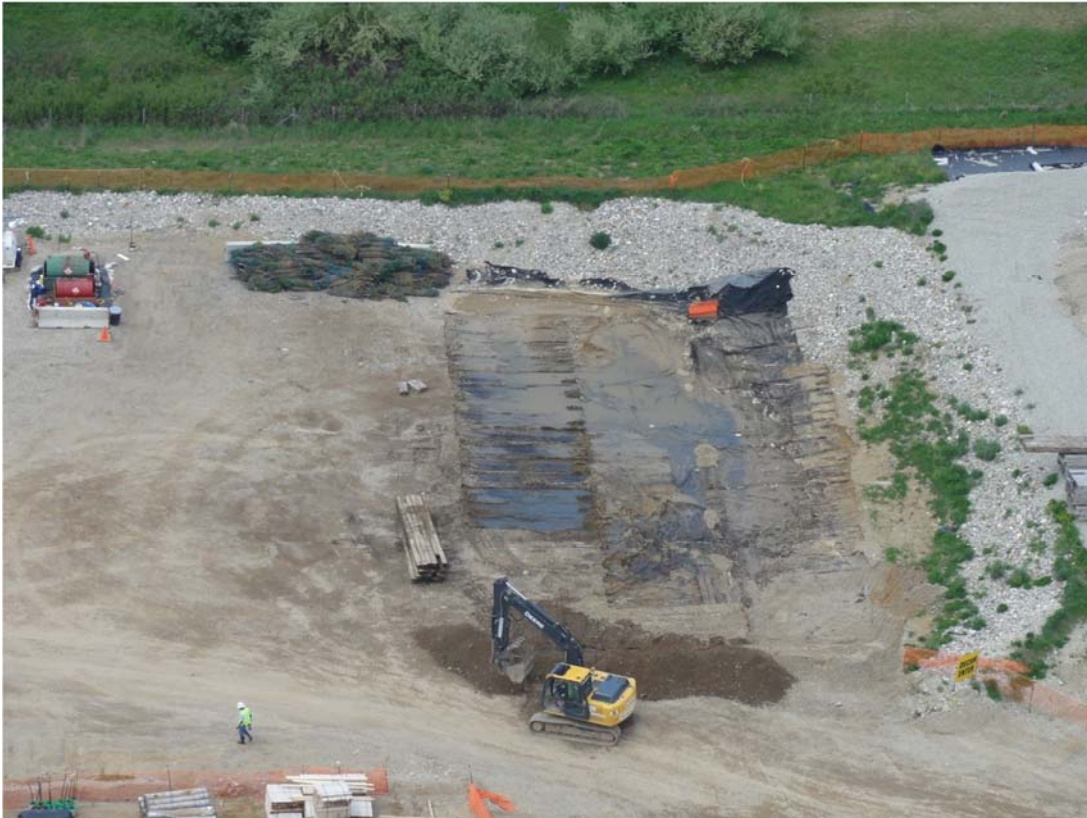
5. Frac-Tank City footprint reduction work continued.

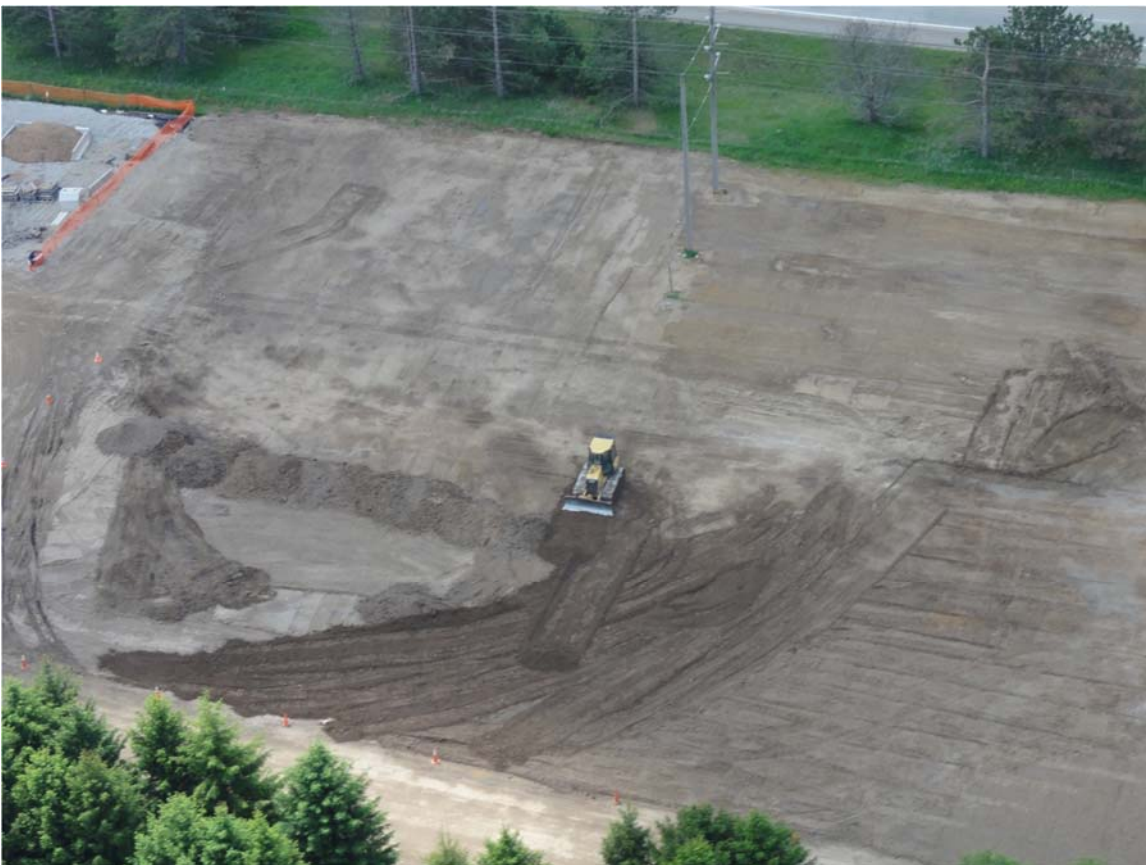
6. Frac-Tank City footprint reduction work continued.

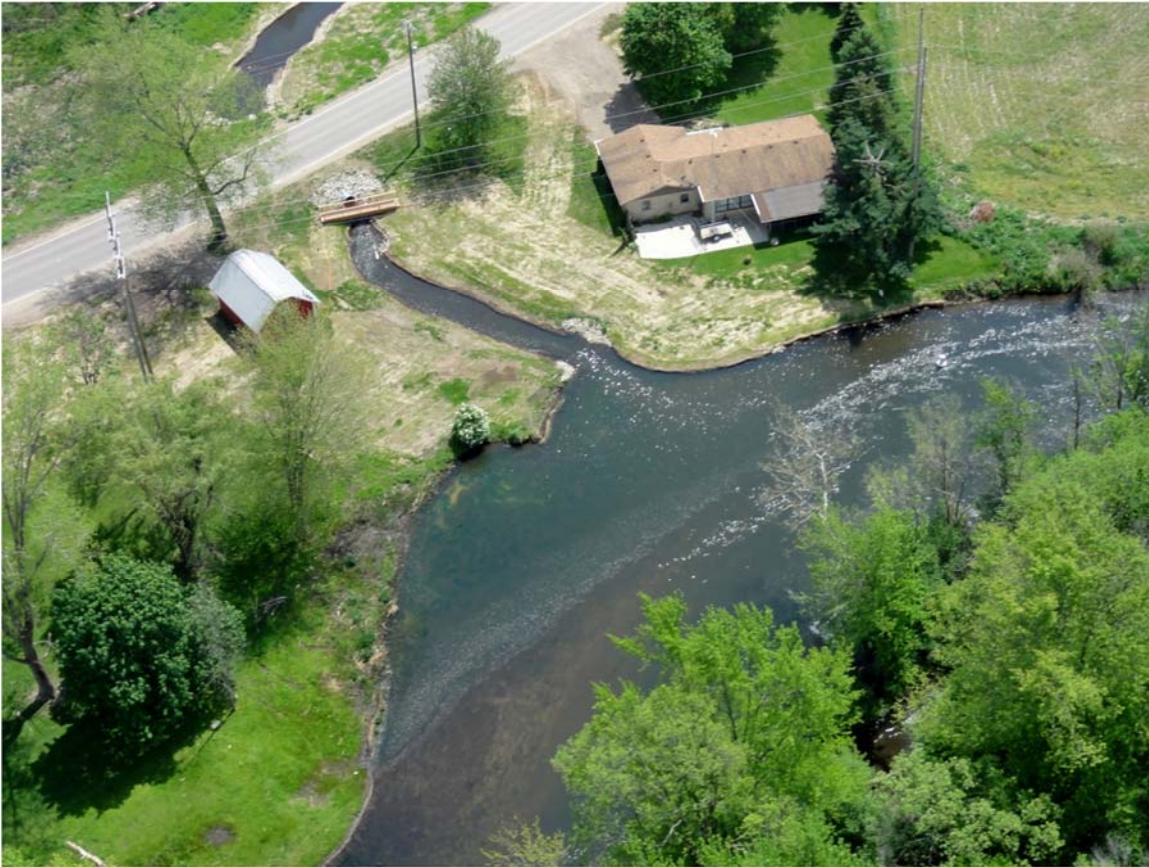
7. Confluence, no turbidity or sheen observed.

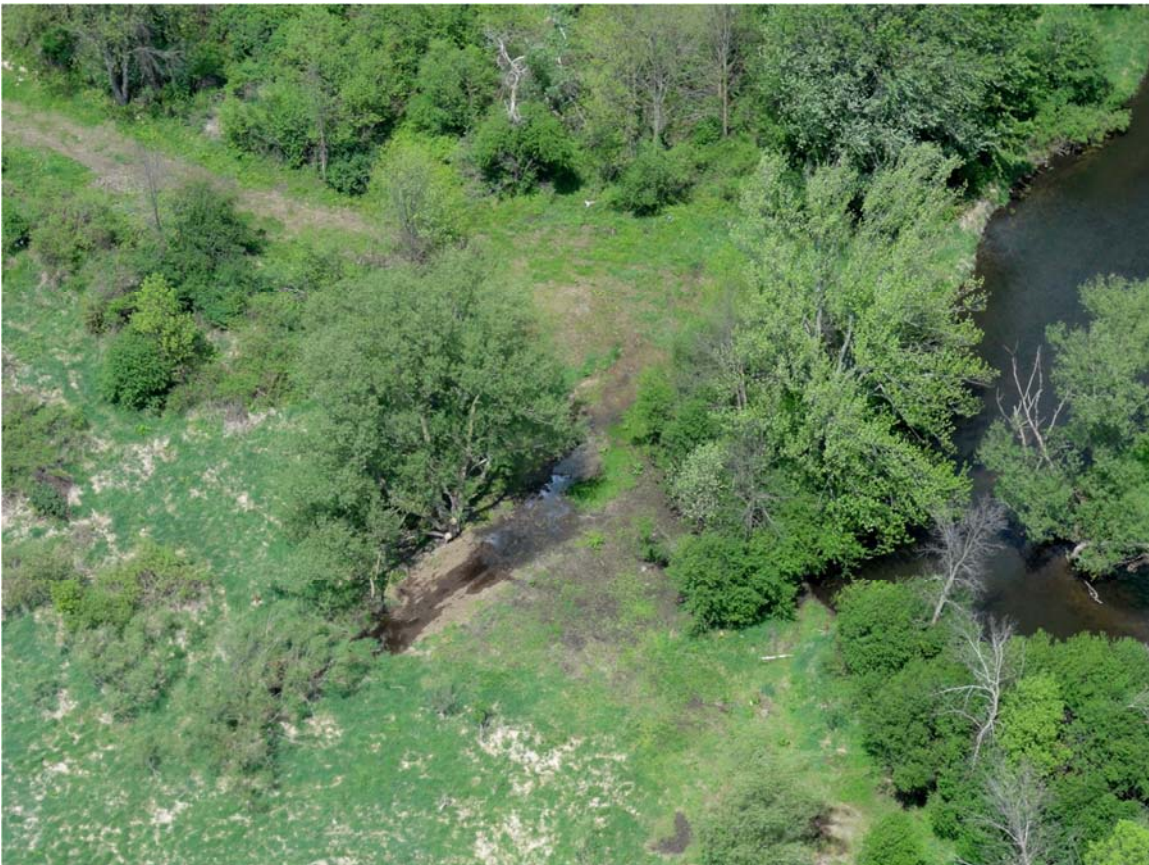
8. OB2.75 RDB, sheen observed beneath tree.

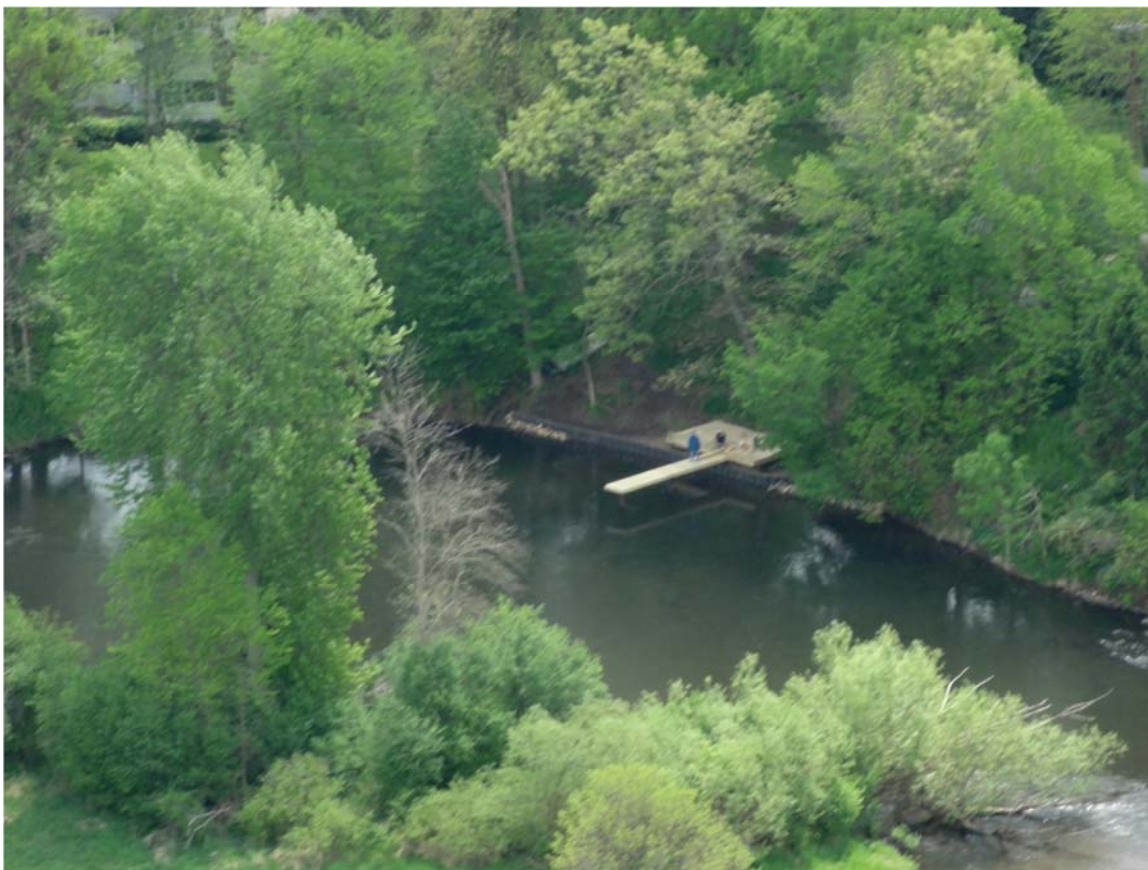
9. MP2.75 LDB new dock installed extending into the river.

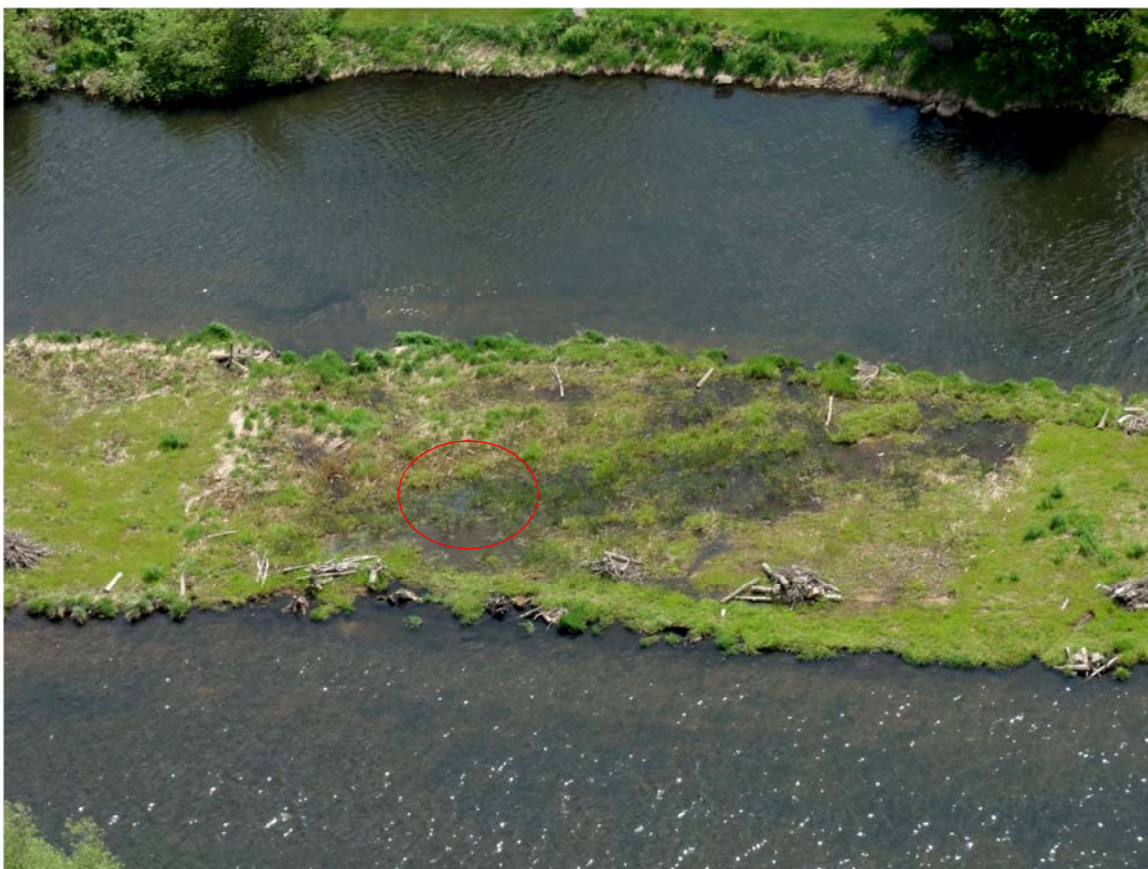
10. Island A sheen observed.

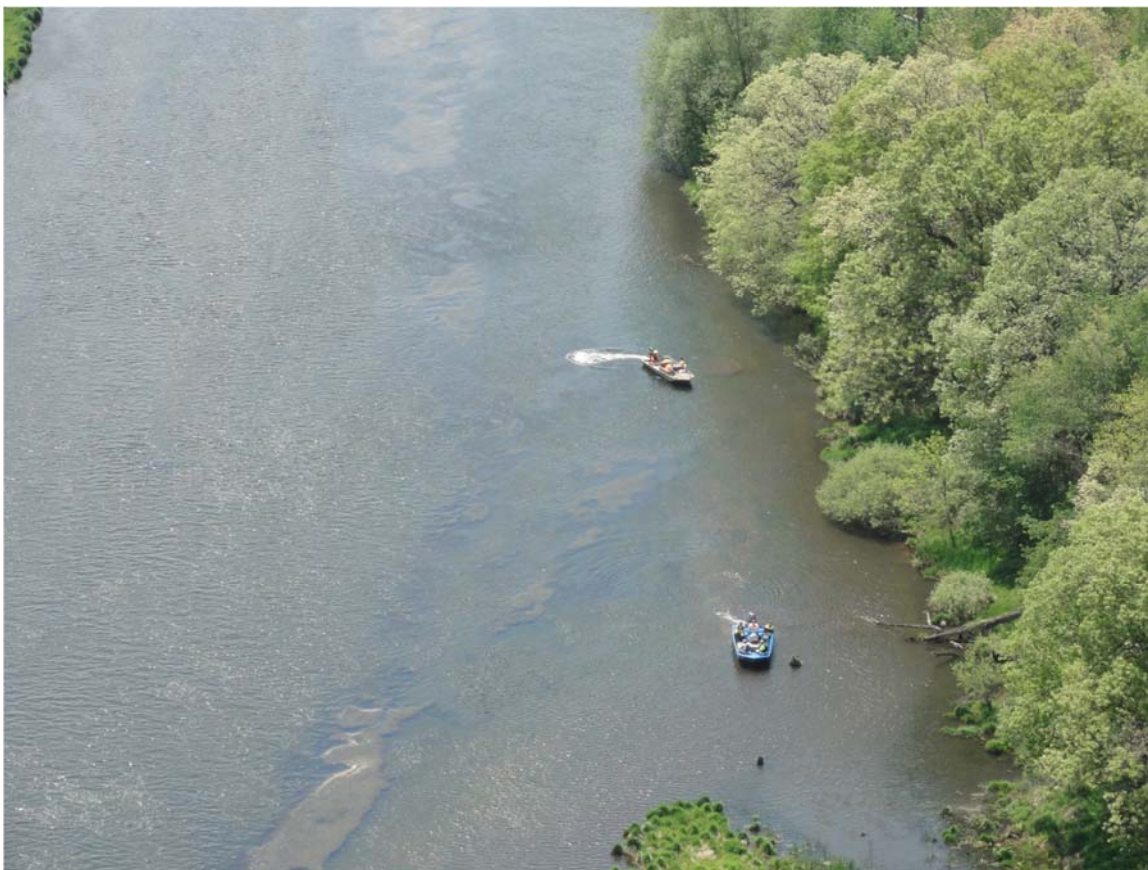
11. MP3.25 observed poling crew training.

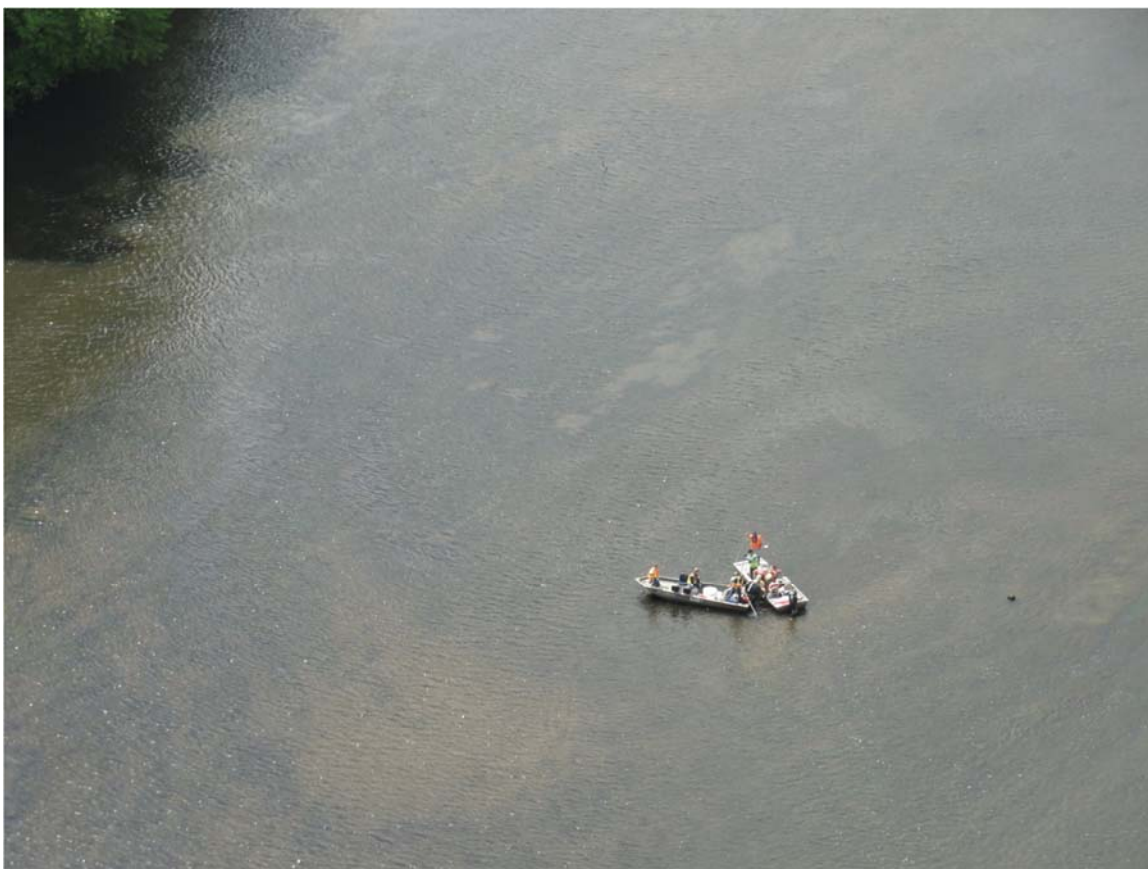
12. MP4.5 observed poling crew training.

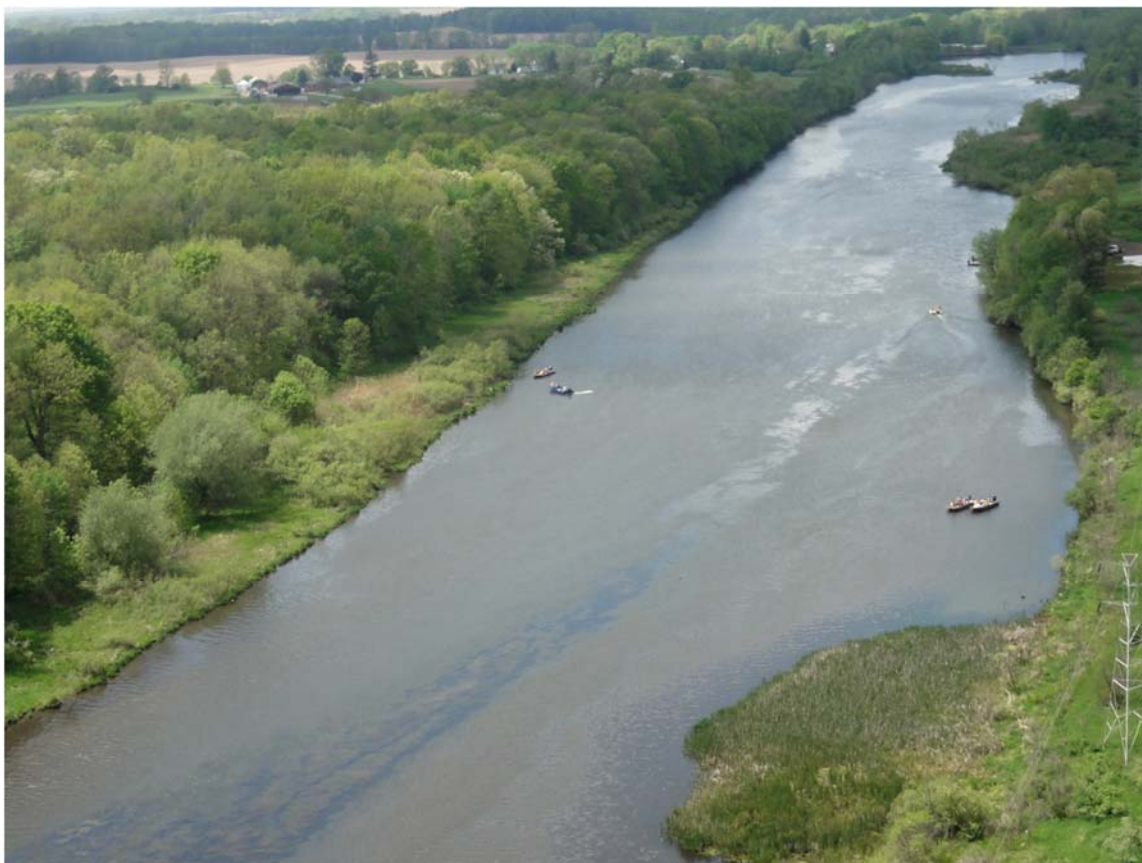
13. MP5.25 observed poling crew training.

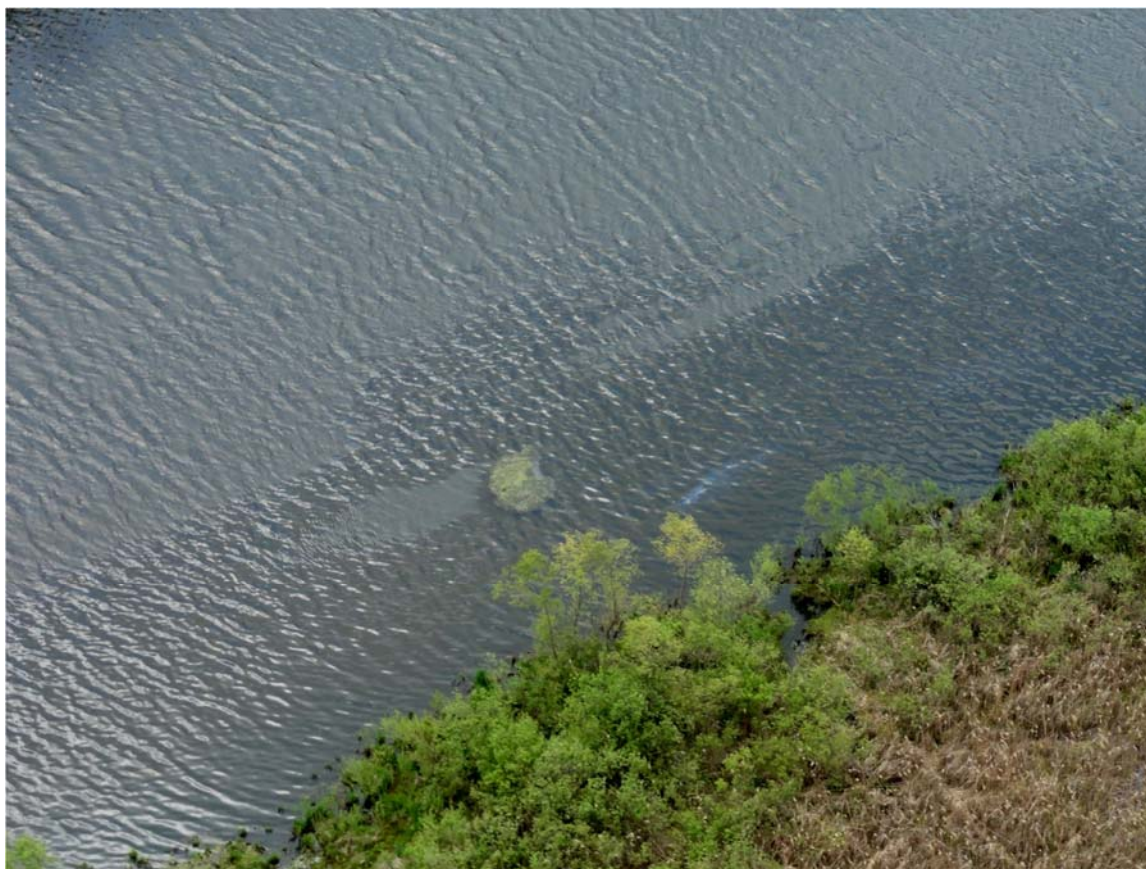
14. MP5.5 RDB sheen observed.

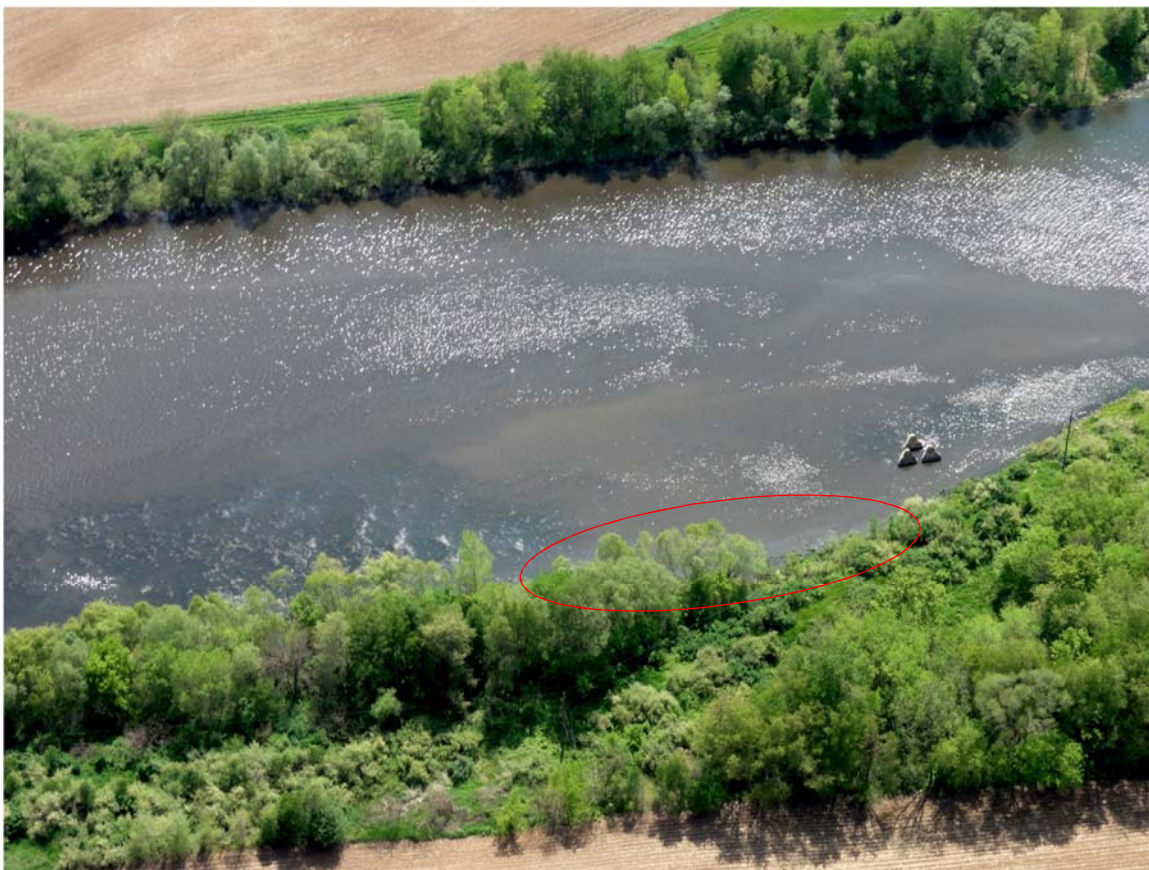
15. MP5.75 RDB sheen observed.

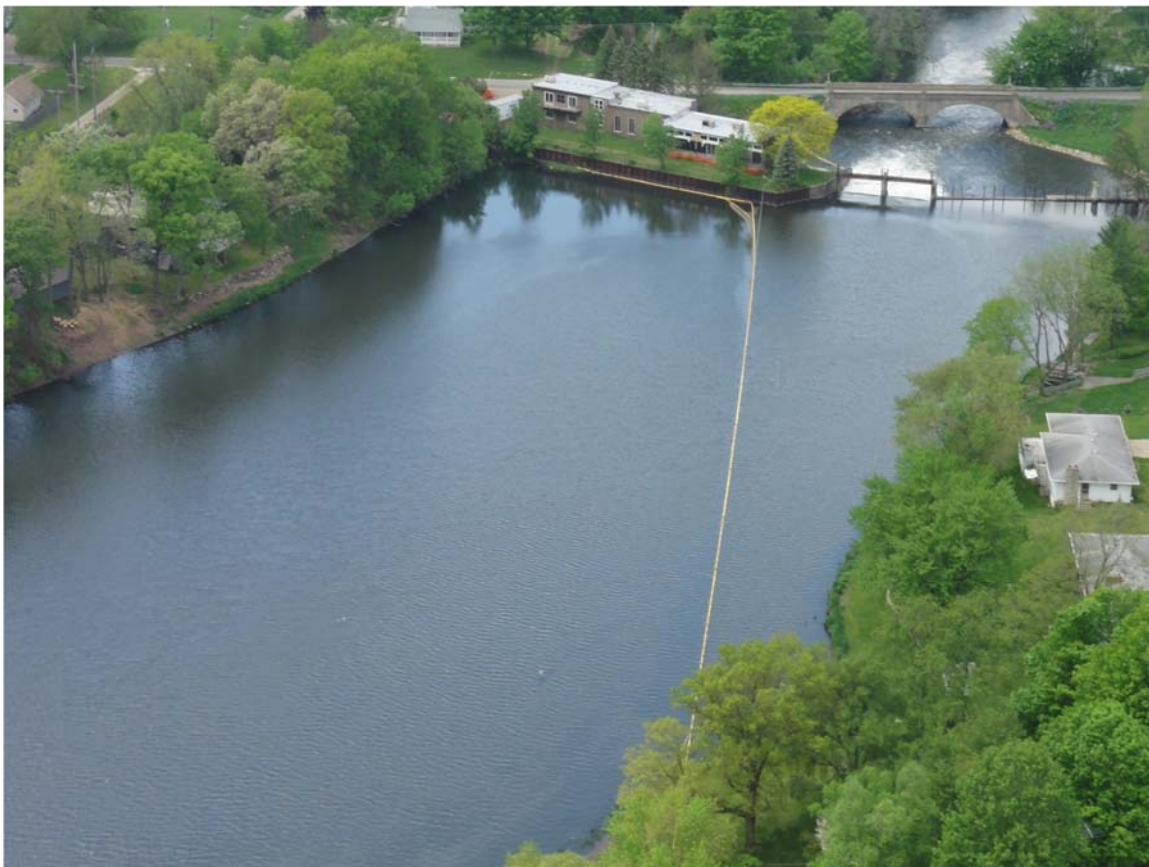
16. Ceresco Dam control point no sheen observed.

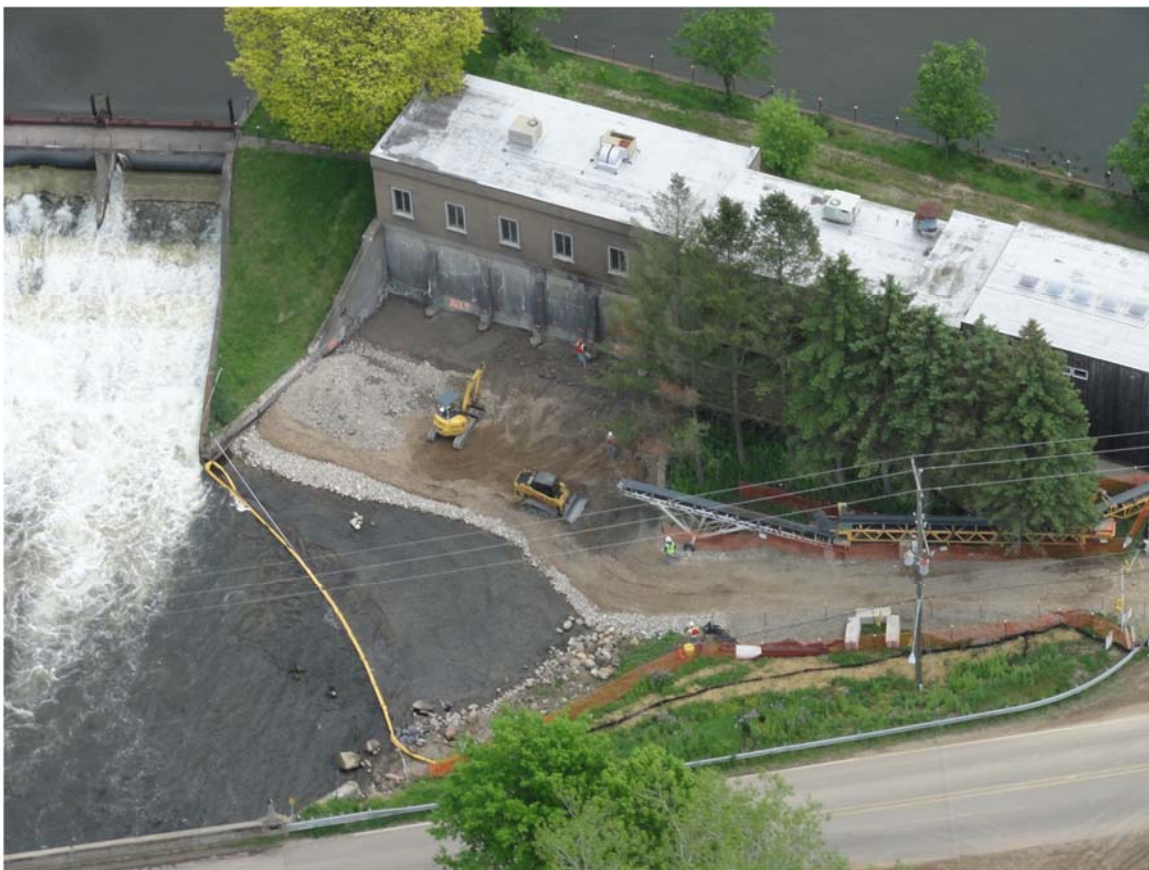
17. Ceresco Dam legacy work continued.

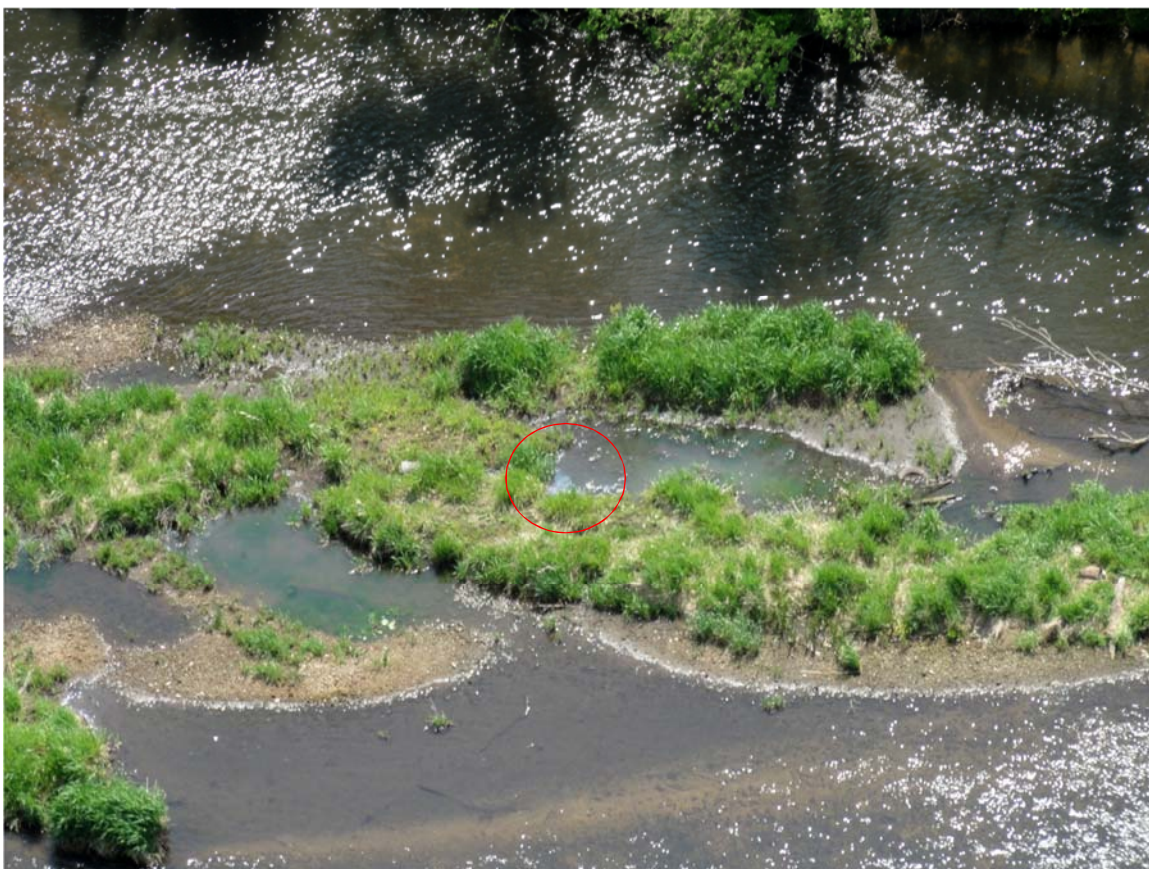
18. MP7.5 sheen observed in the middle of the island.

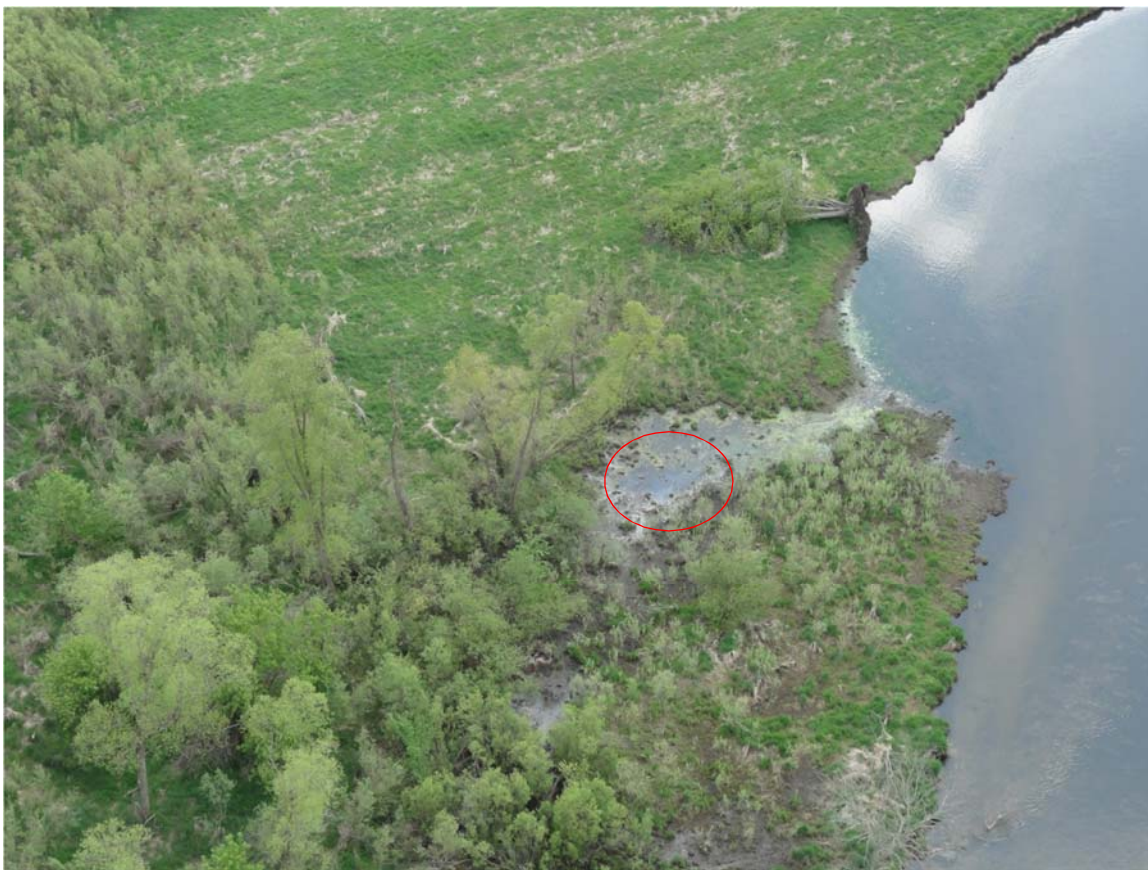
21. MP13.5 LDB sheen observed.

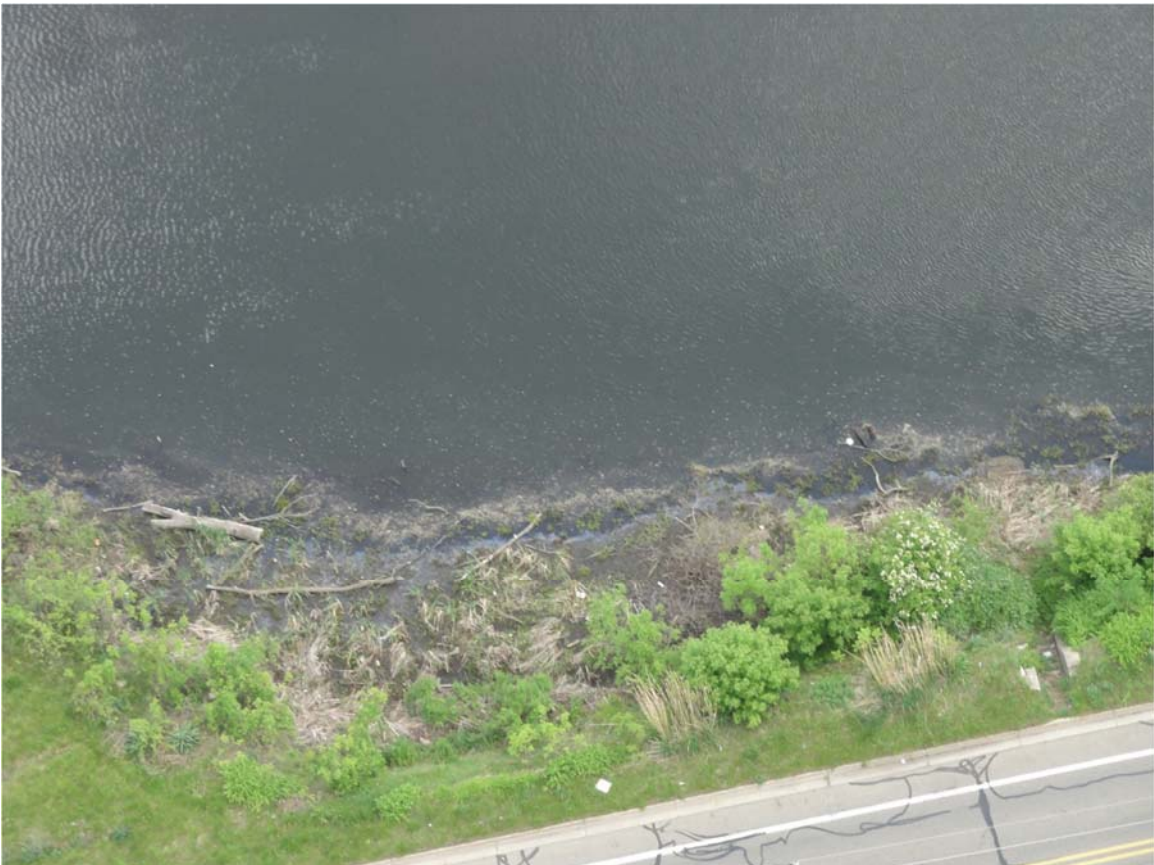
24. MP15.25 LDB sheen observed.

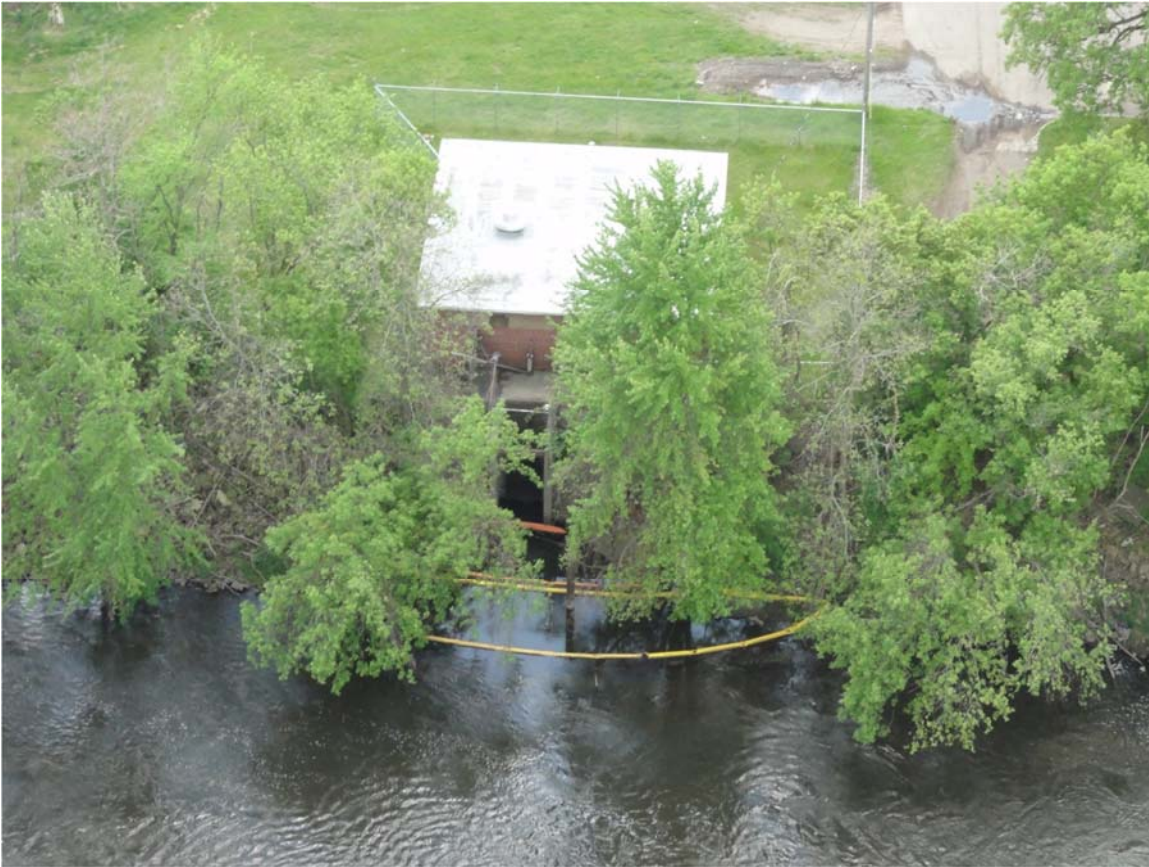
25. Rock Tenn sheen observed.

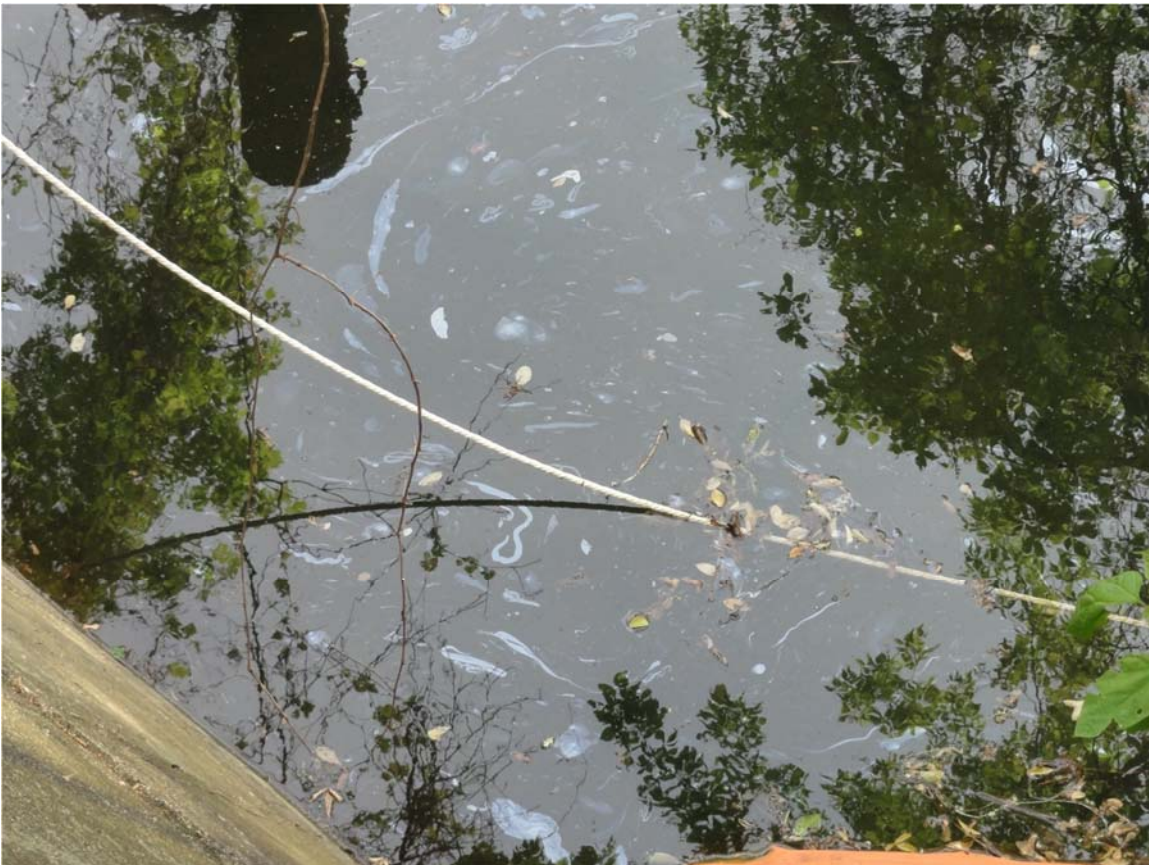
26. Rock Tenn sheen observed.

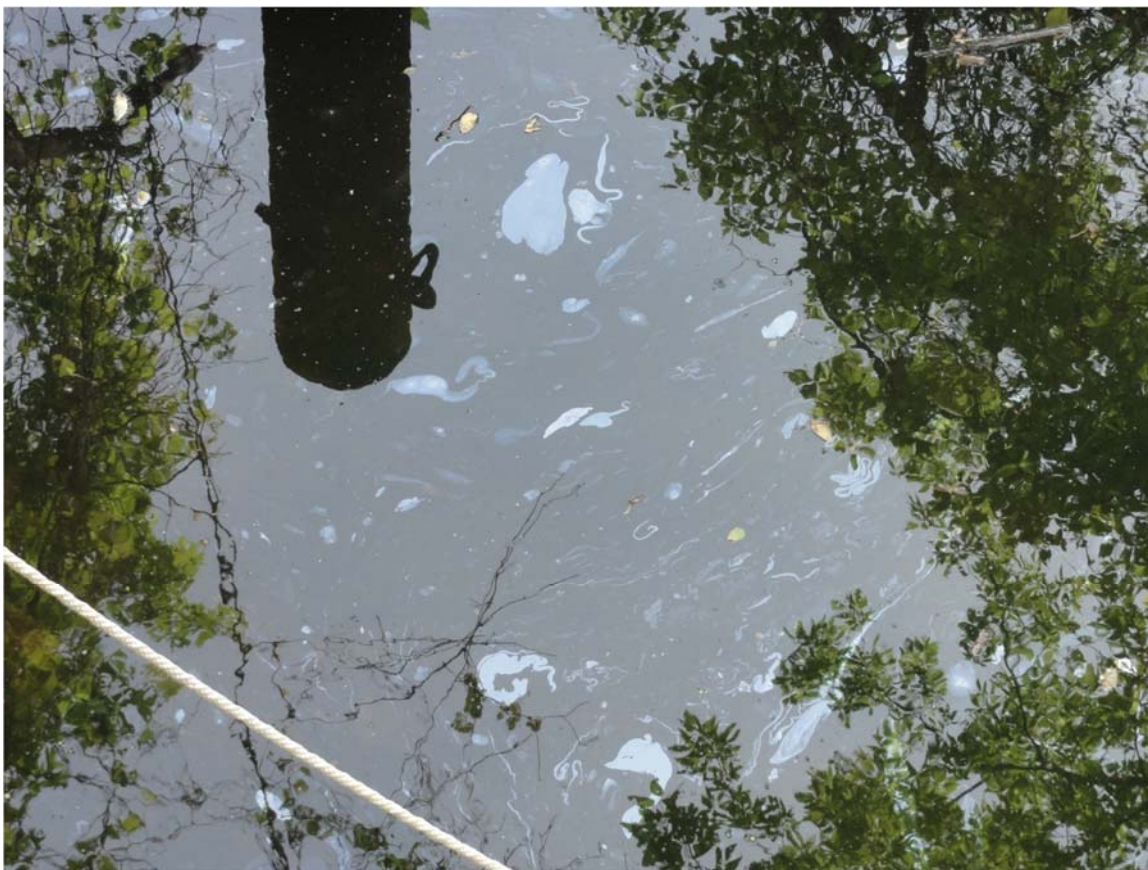
27. Rock Tenn sheen observed.
