# Situation Photo Log

Tuesday, May 8, 2012

Kalamazoo River / Enbridge Spill

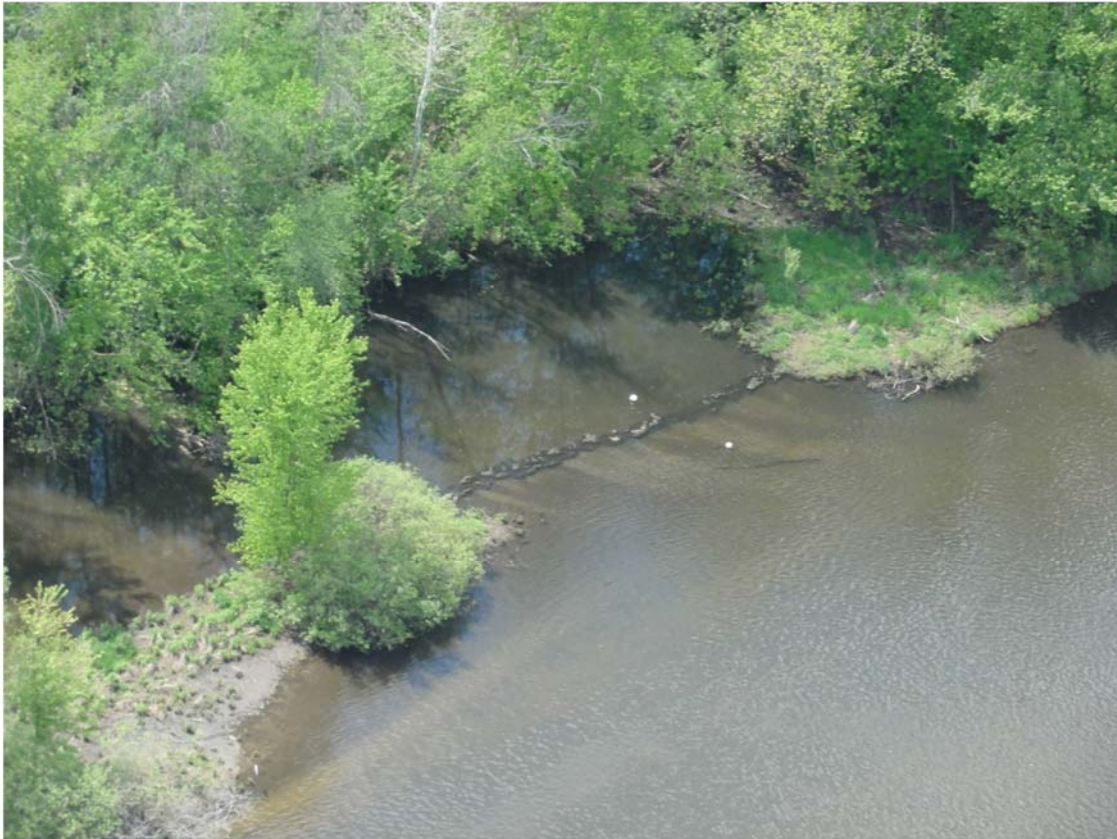
29. MP19.25 sediment control structure #1.

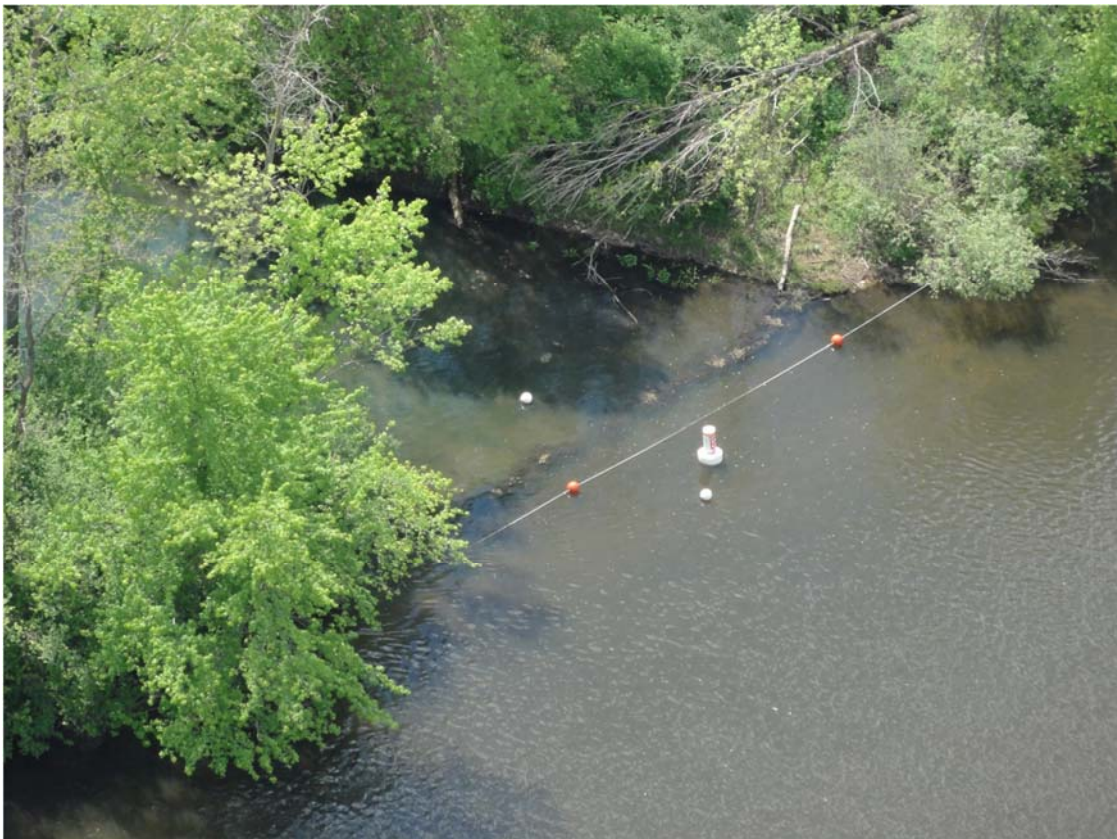
30. MP19.25 sediment control structure #2.

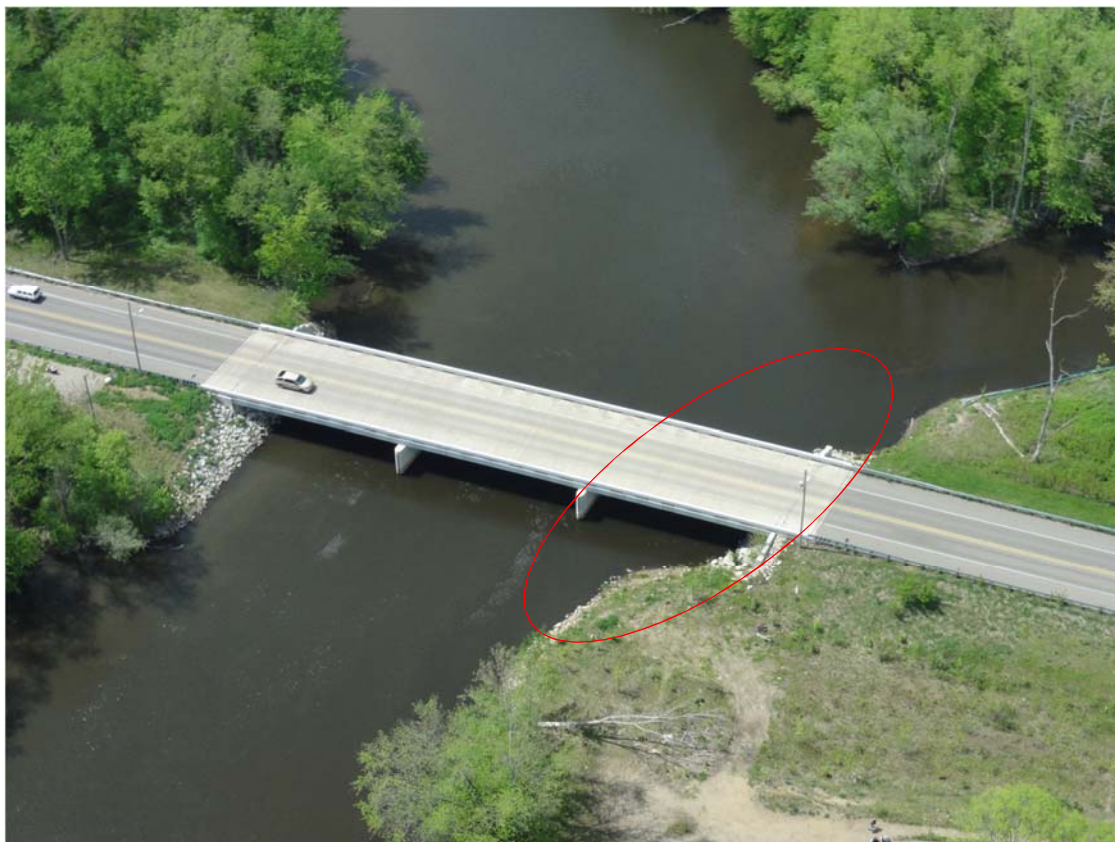
31. MP21.5 Custer Dr. RDB sheen observed.

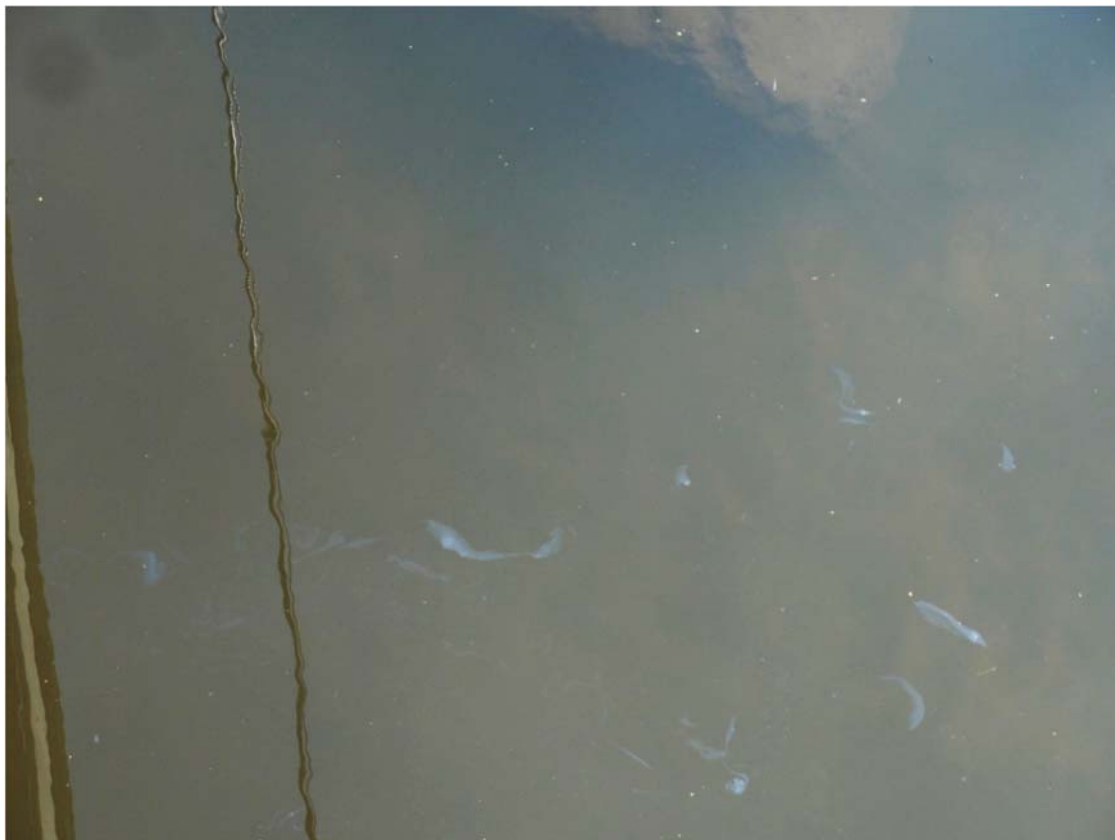
32. MP21.5 Custer Dr. RDB sheen observed.

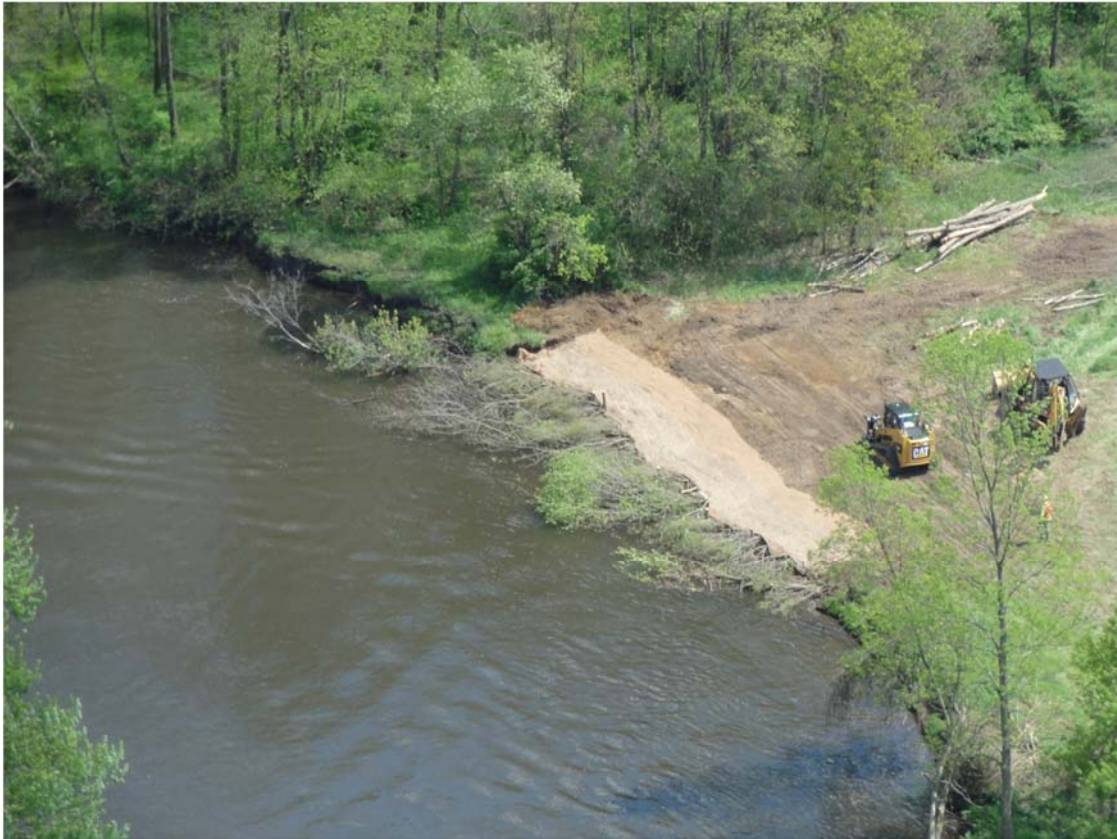
33. MP23.4 shoreline restoration work.

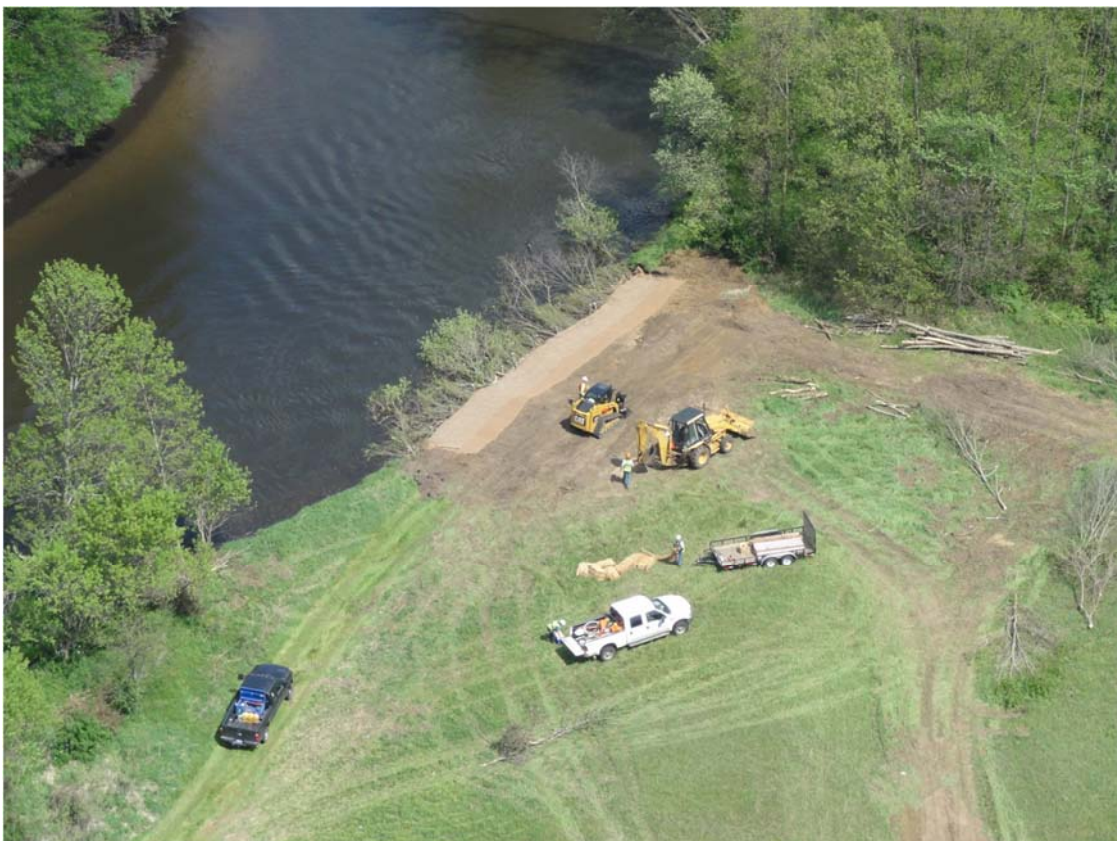
34. MP23.4 shoreline restoration work.

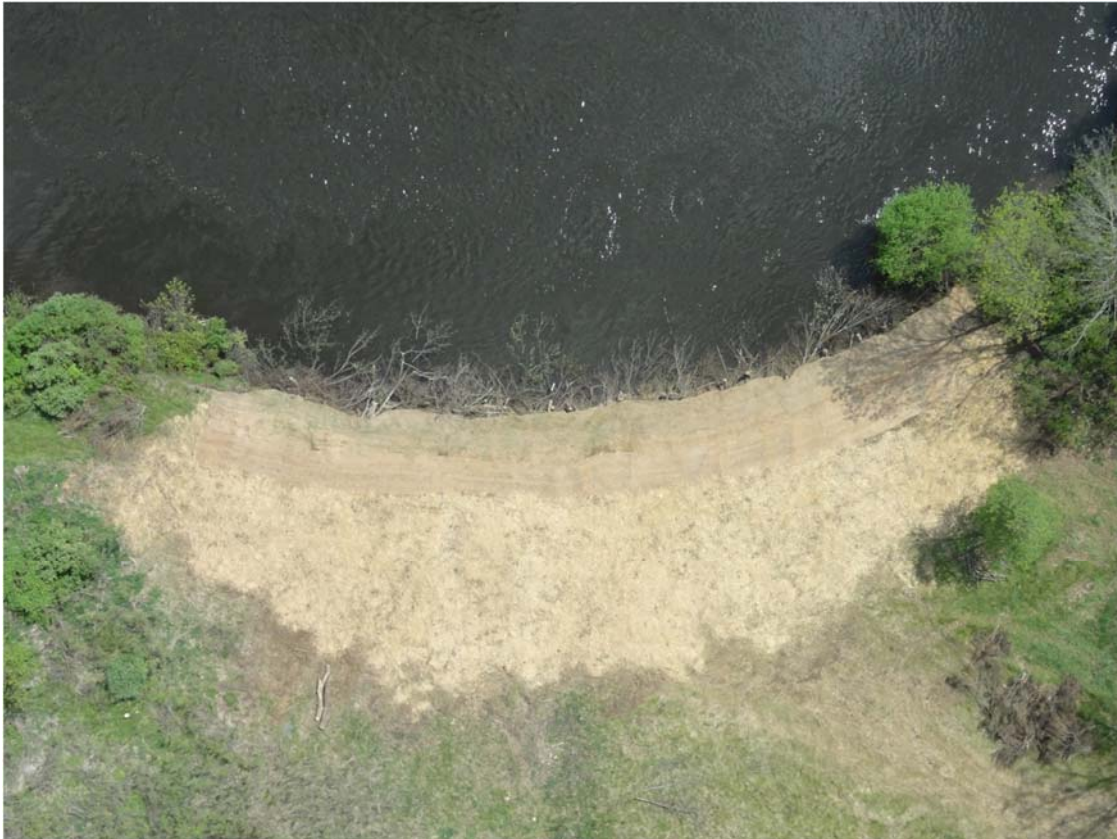
35. MP24.0 shoreline restoration work.

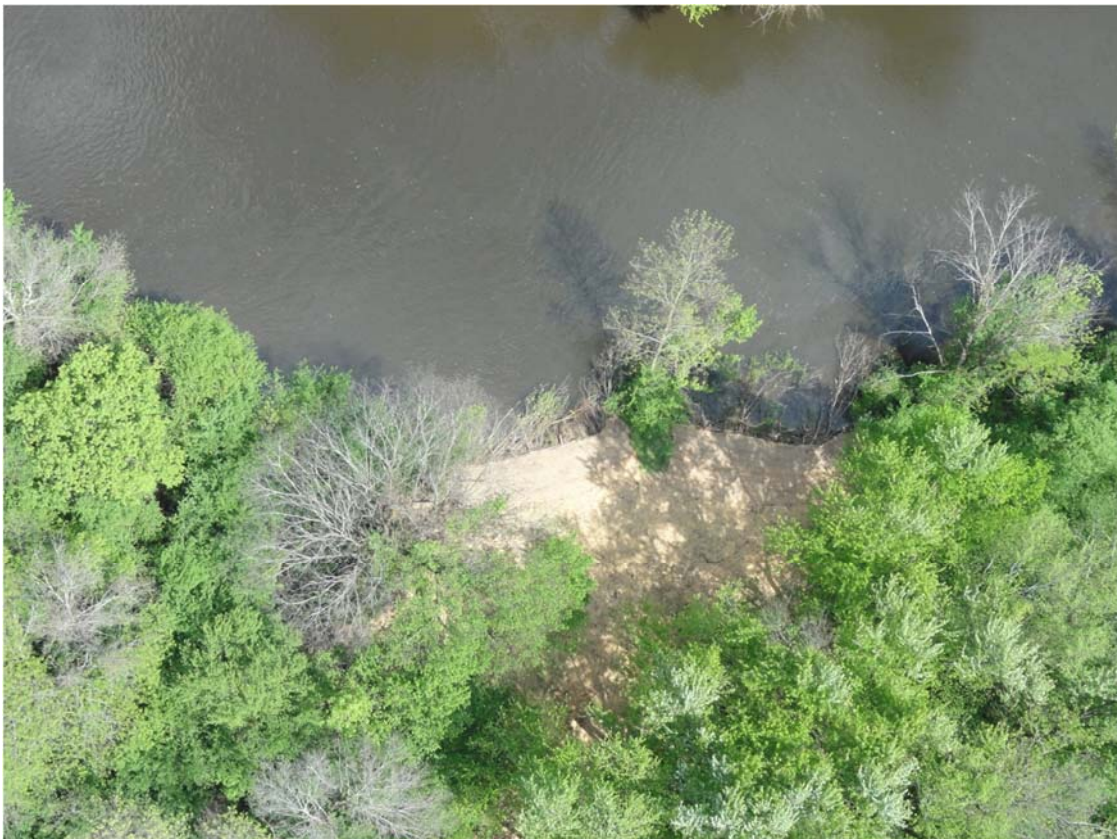
36. MP24.0 shoreline restoration work.

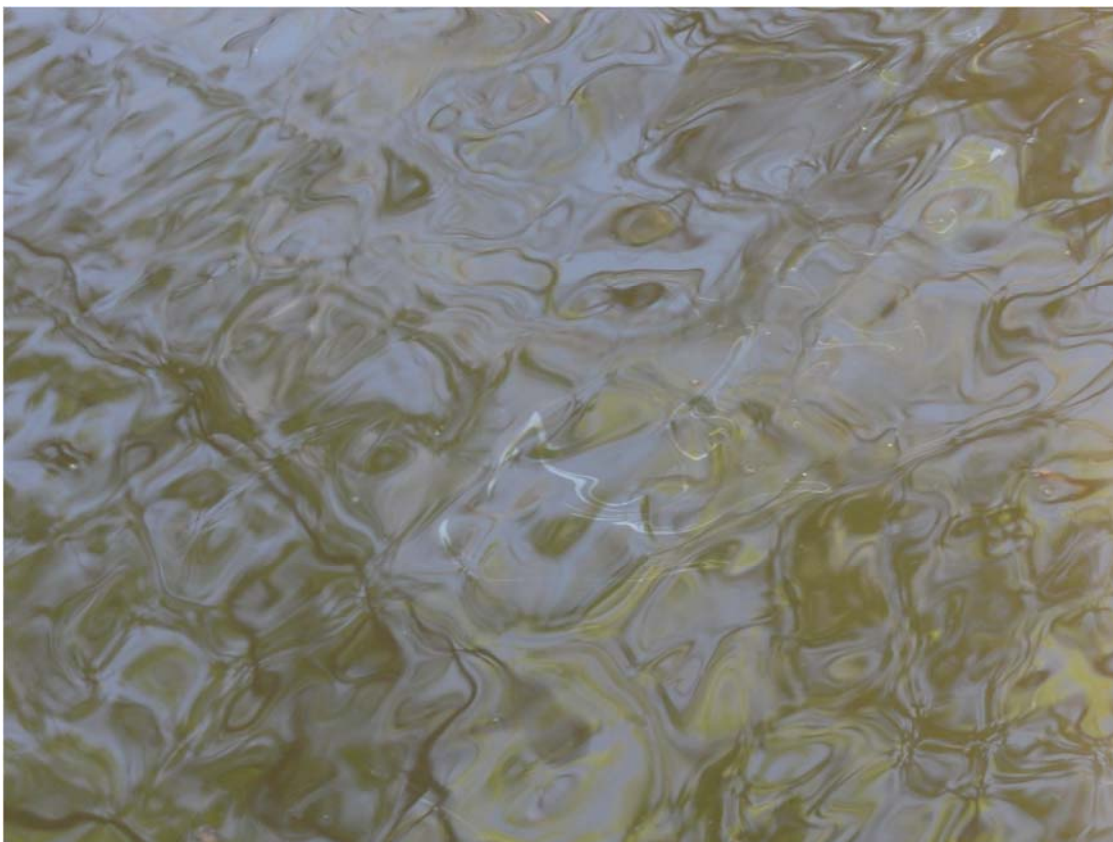
37. MP30.0 sheen observed at E2 boat launch.

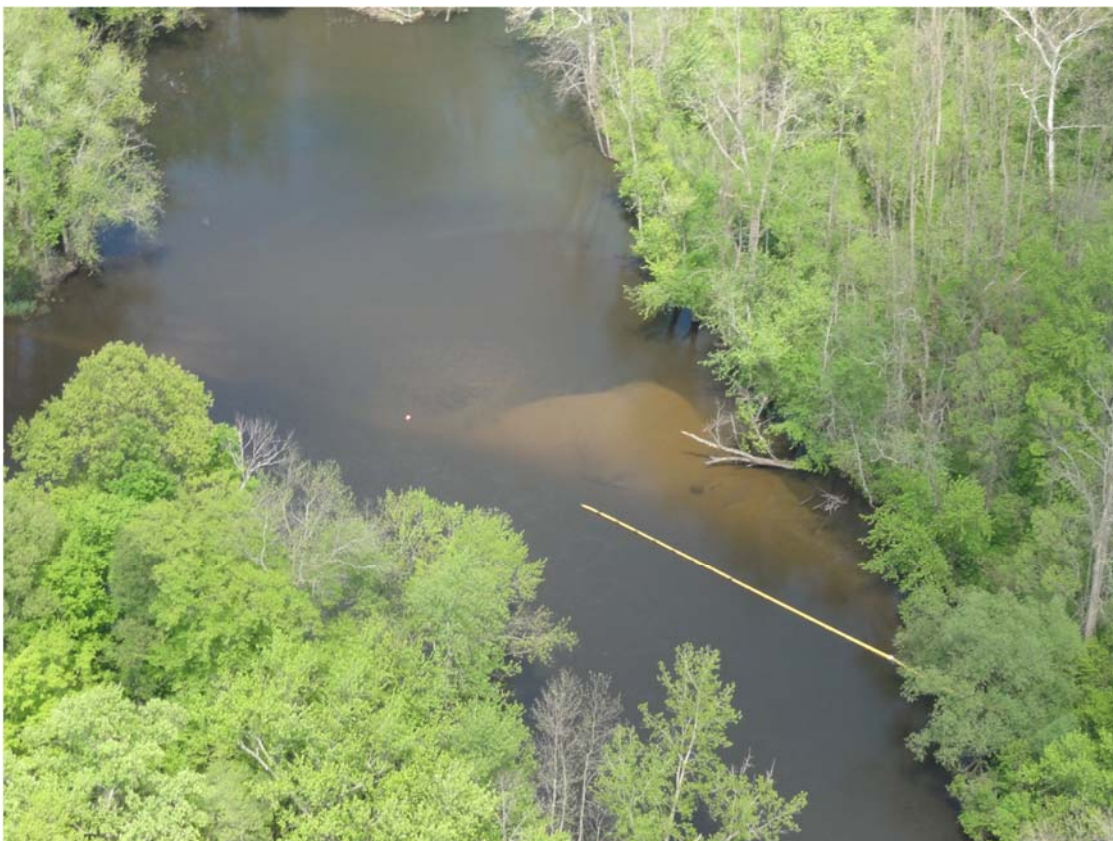
38. MP30.8 containment boom no sheen observed.

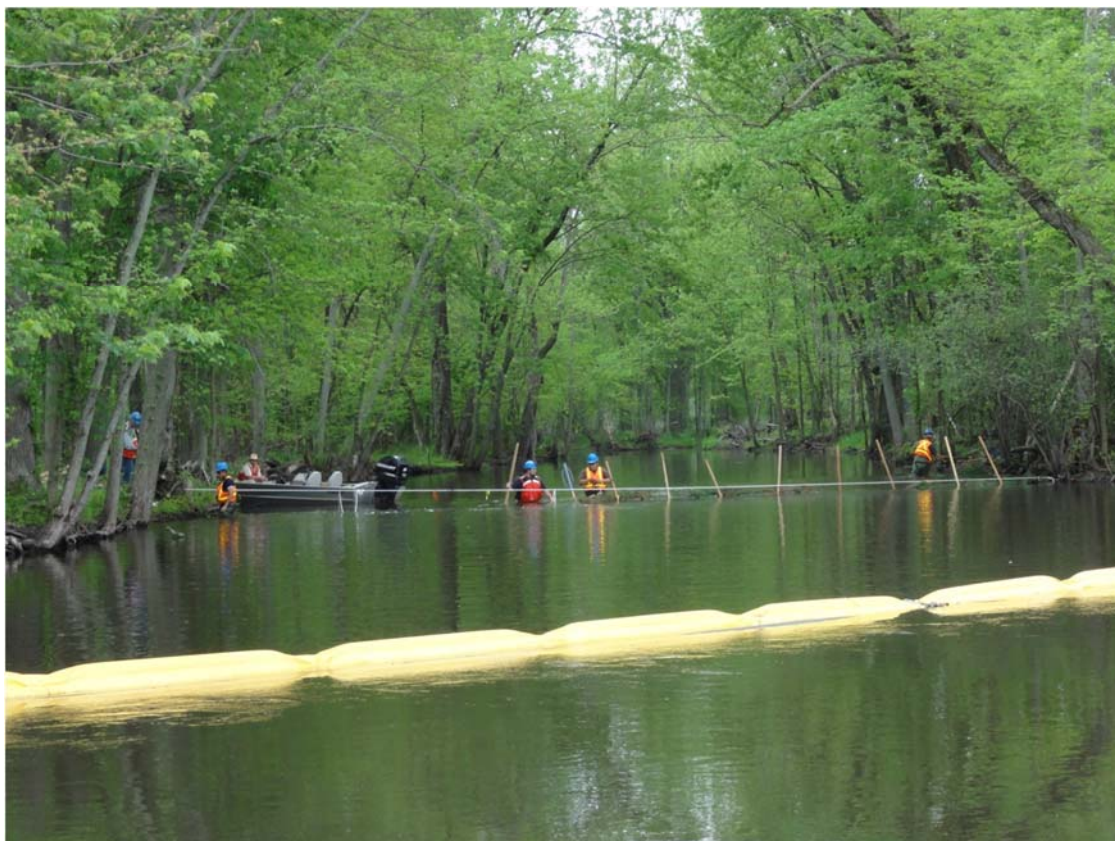
40. MP36.10 sediment trap installation.

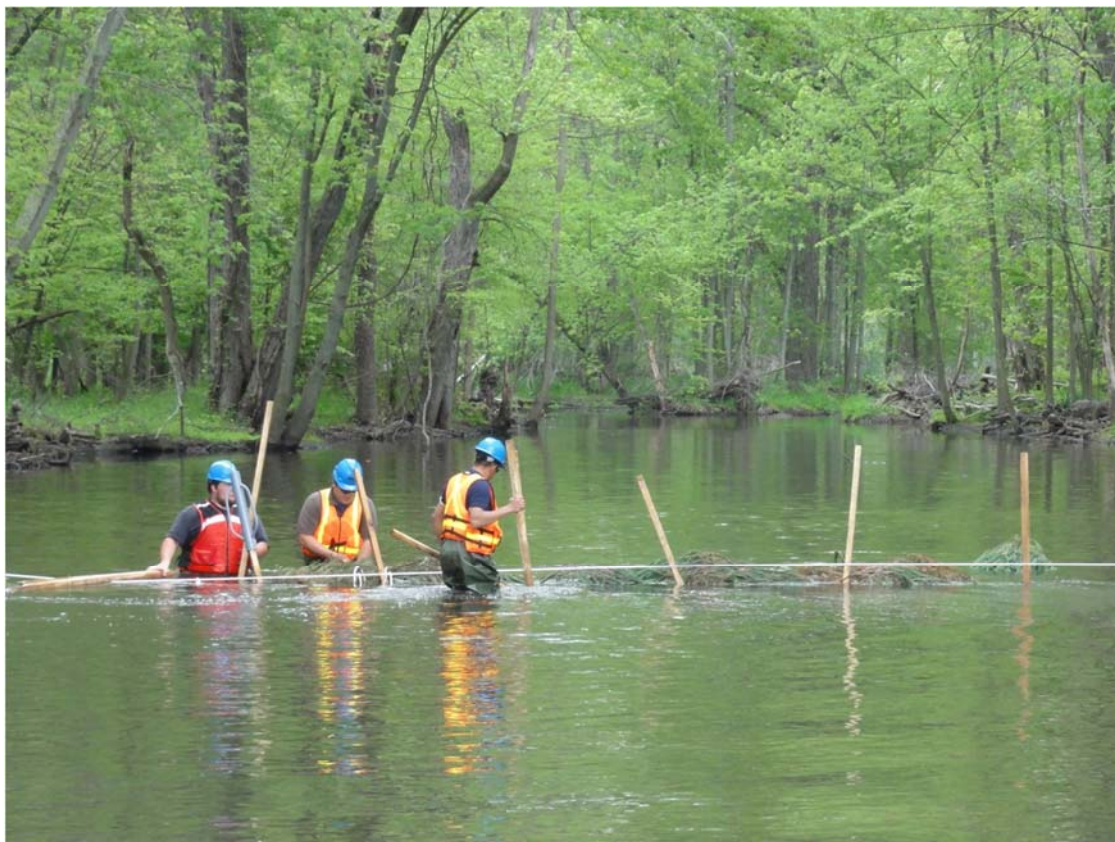
41. MP36.10 sediment trap installation.

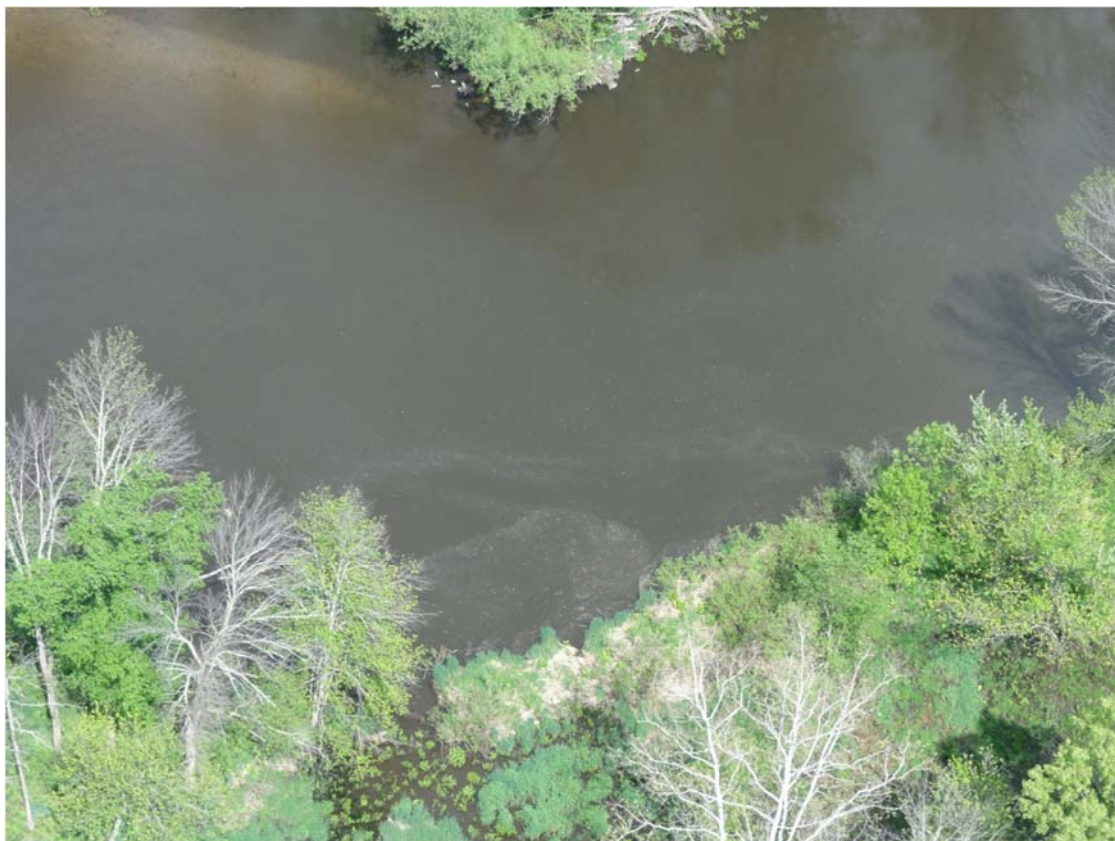
42. MP36.5 LDB sheen observed.

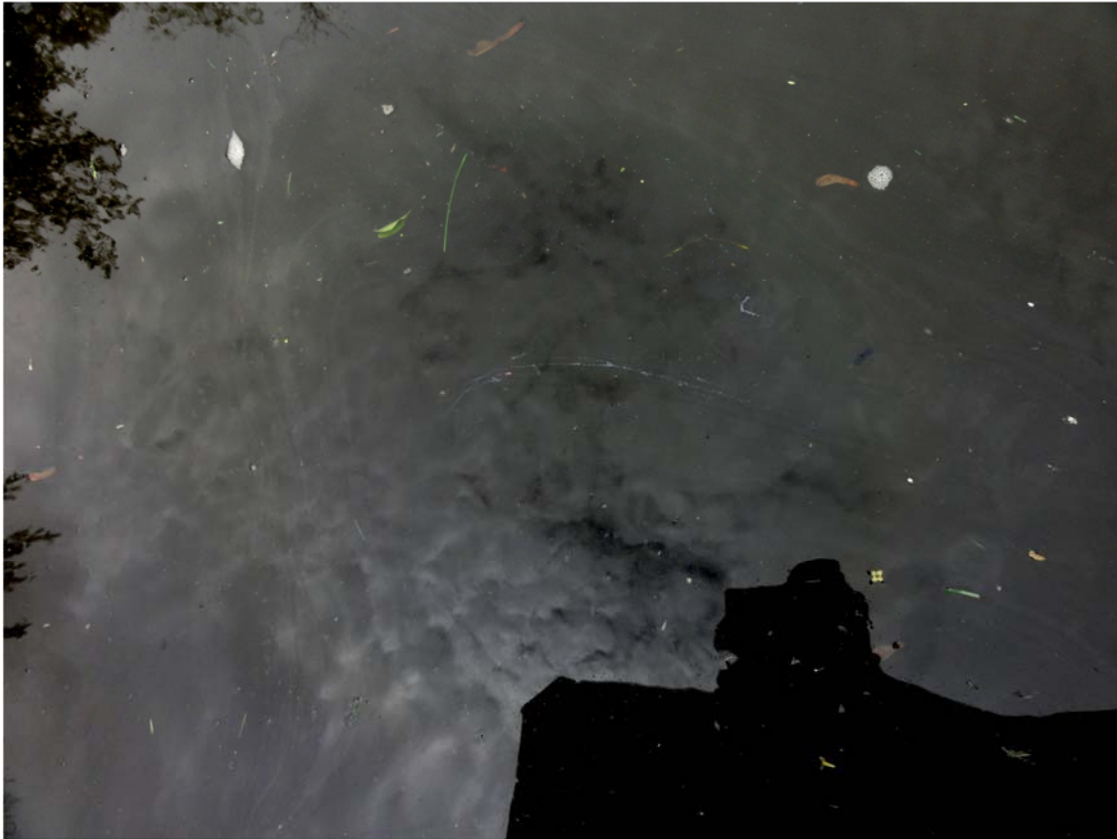
43. MP36.5 LDB sheen observed.

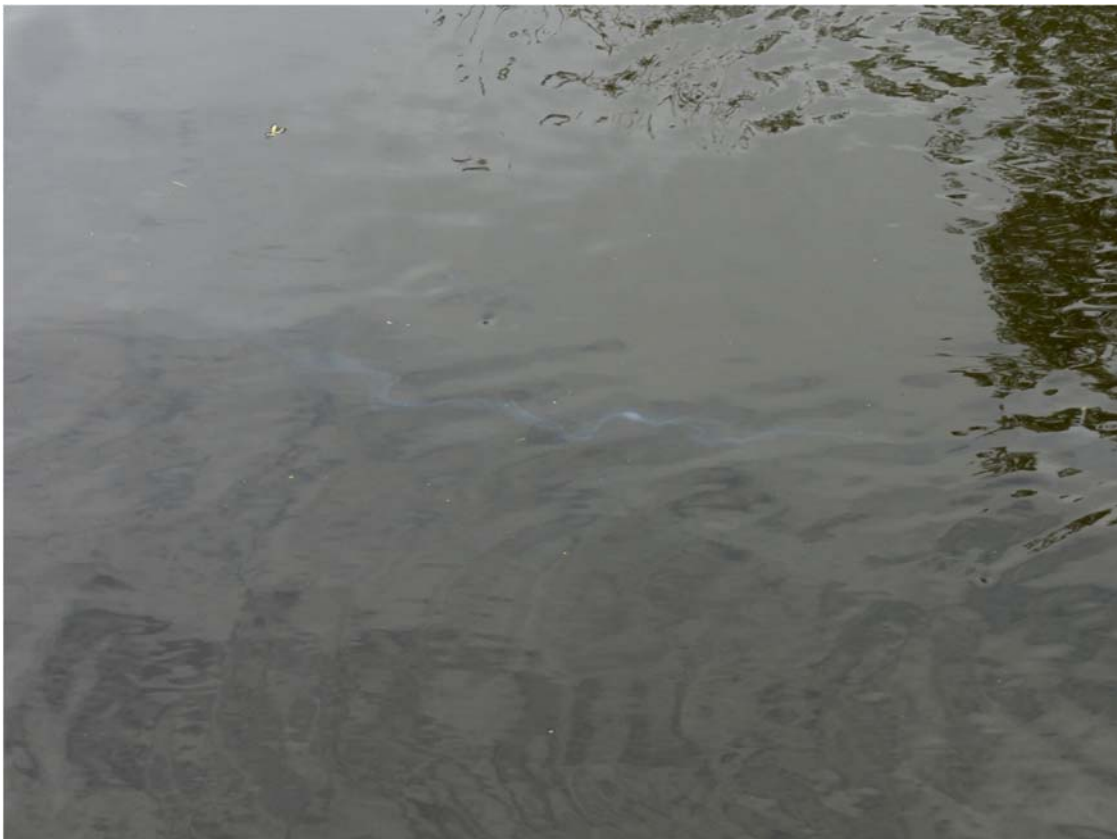
44. MP36.5 sheen observed prior to 35<sup>th</sup> Street Bridge.

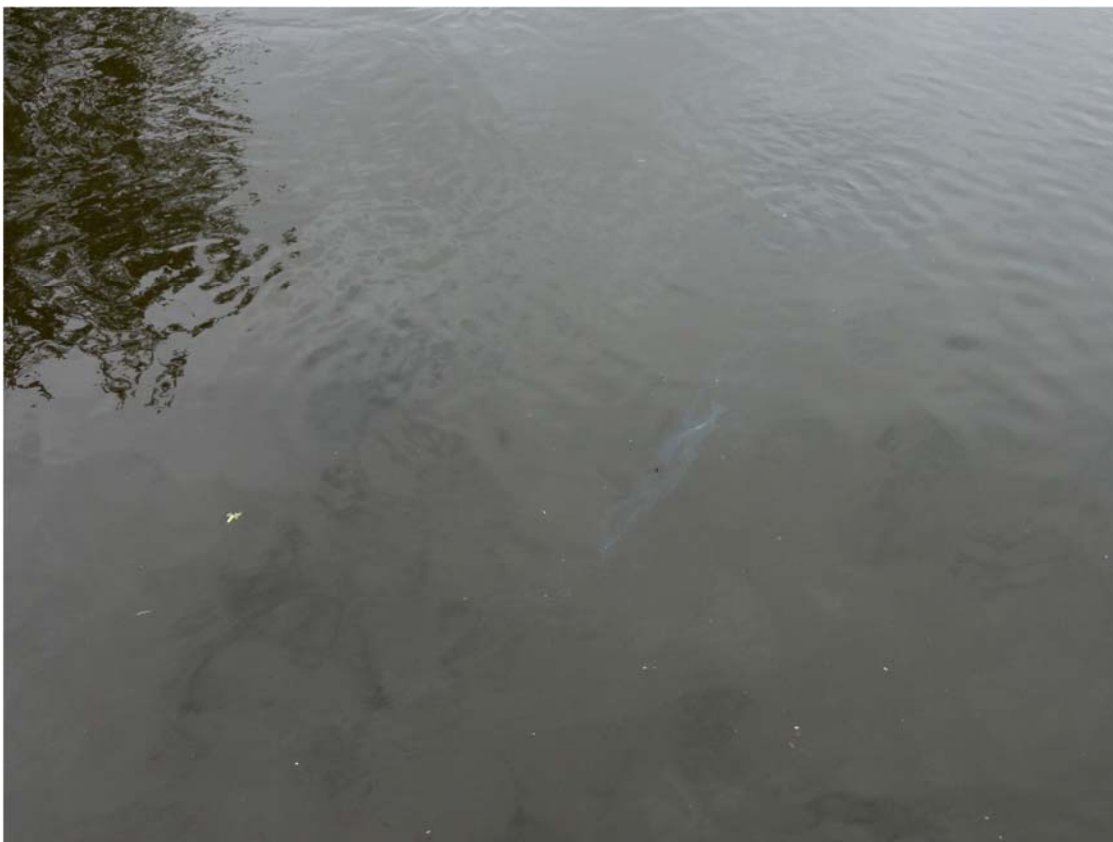
45. MP36.5 sheen observed prior to 35<sup>th</sup> Street Bridge.

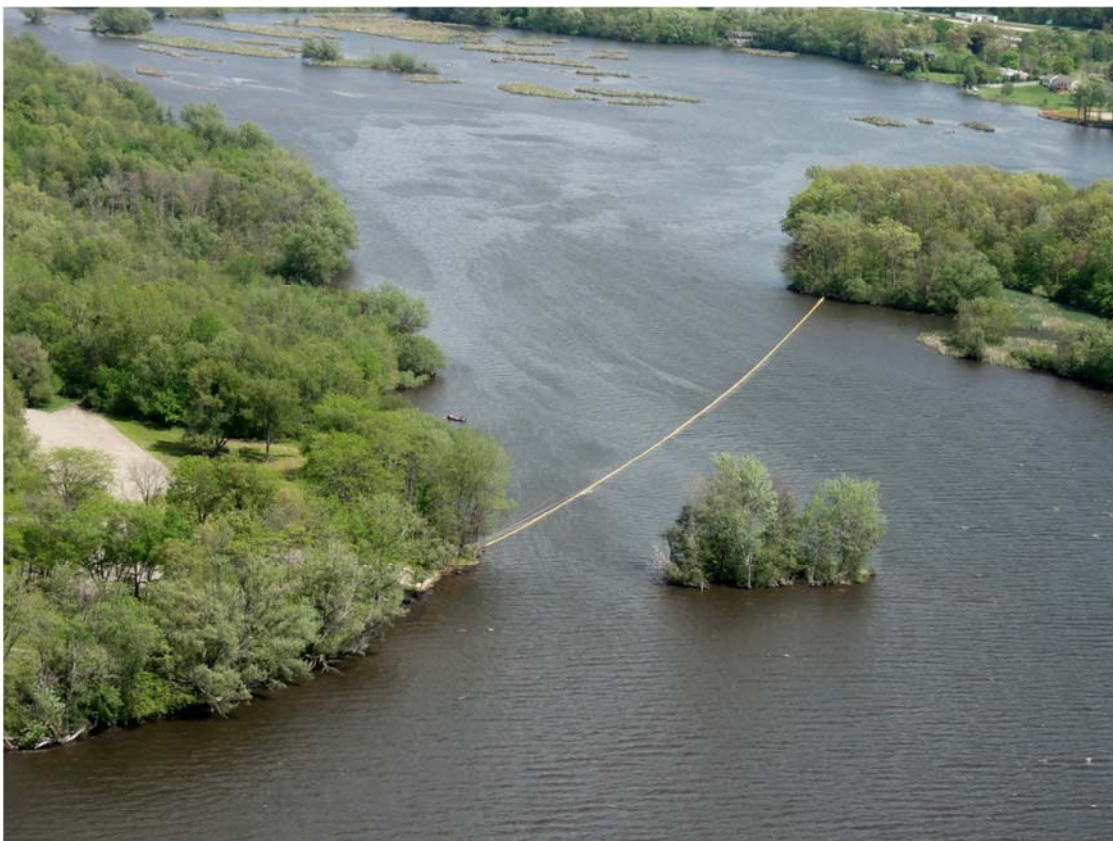
46. MP37.75 sheen observed along control point.

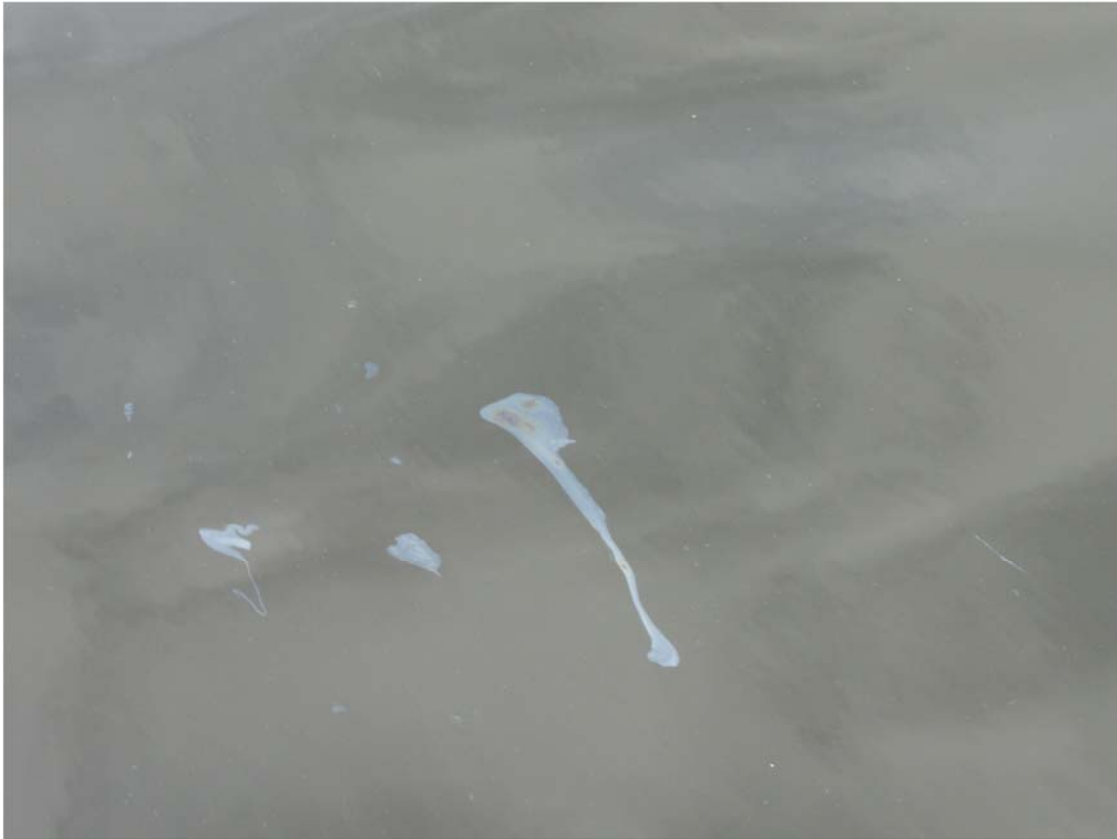
47. MP37.75 sheen observed along control point.

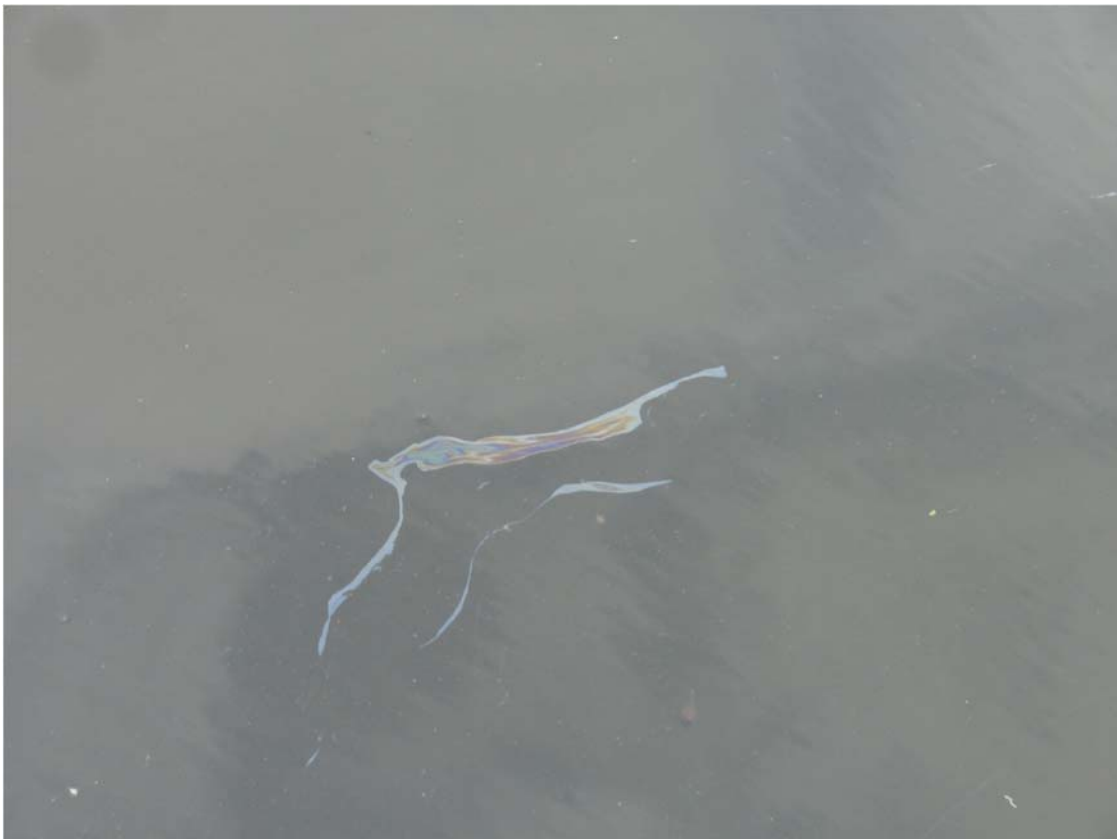
48. MP37.75 sheen observed along control point.

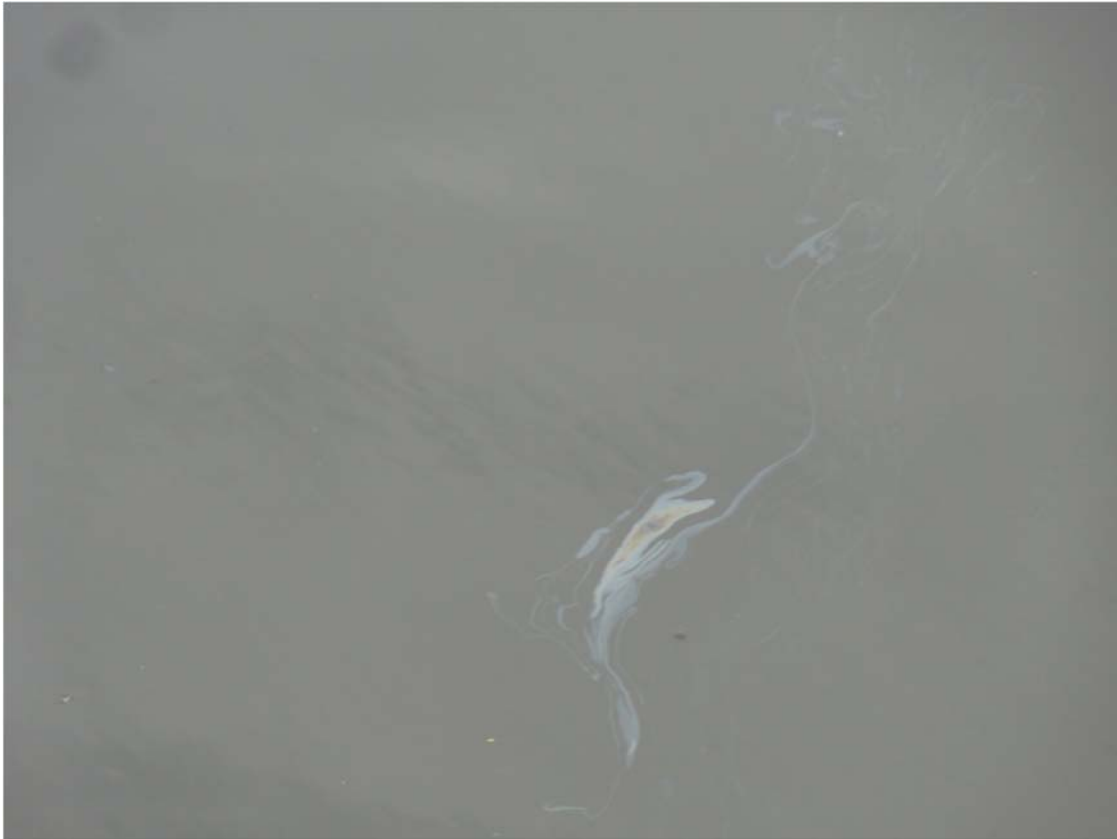
**49. MP37.75 sheen observed along control point.**

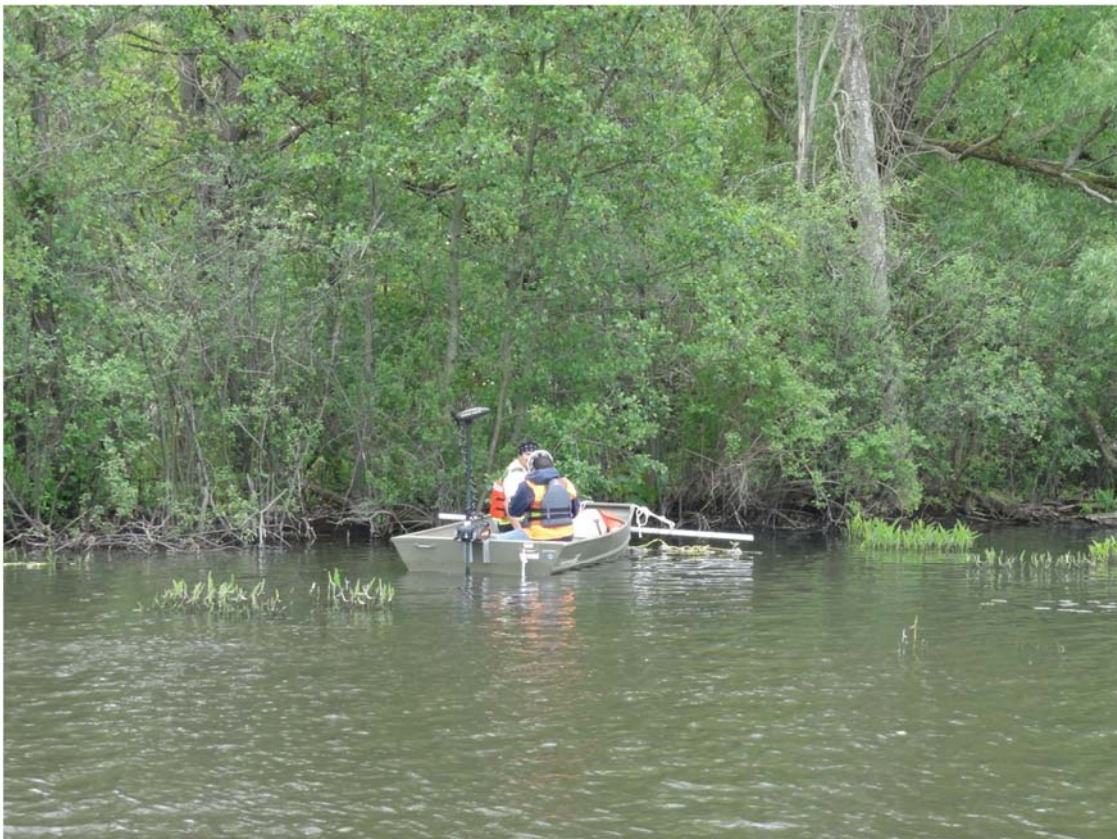
**50. MP37.75 sheen sweep boat sweeping around island on lake side of boom.**

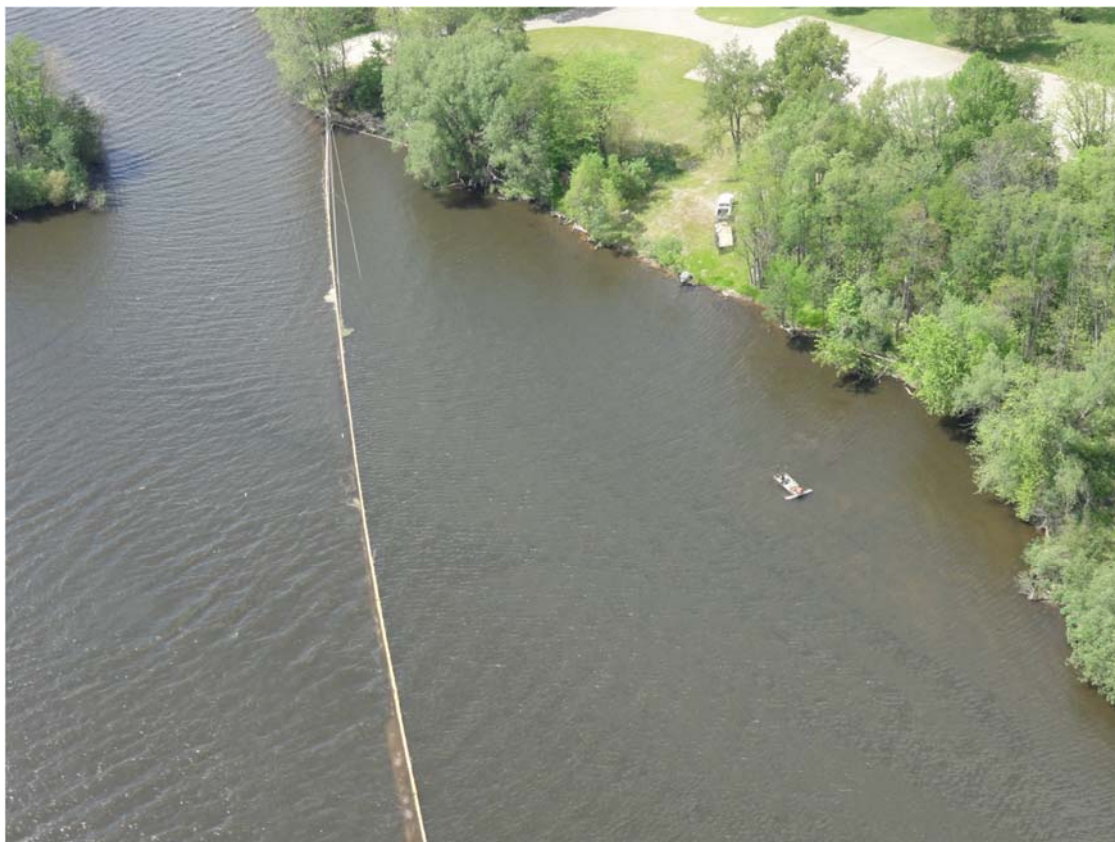
51. MP37.75 sheen sweep.

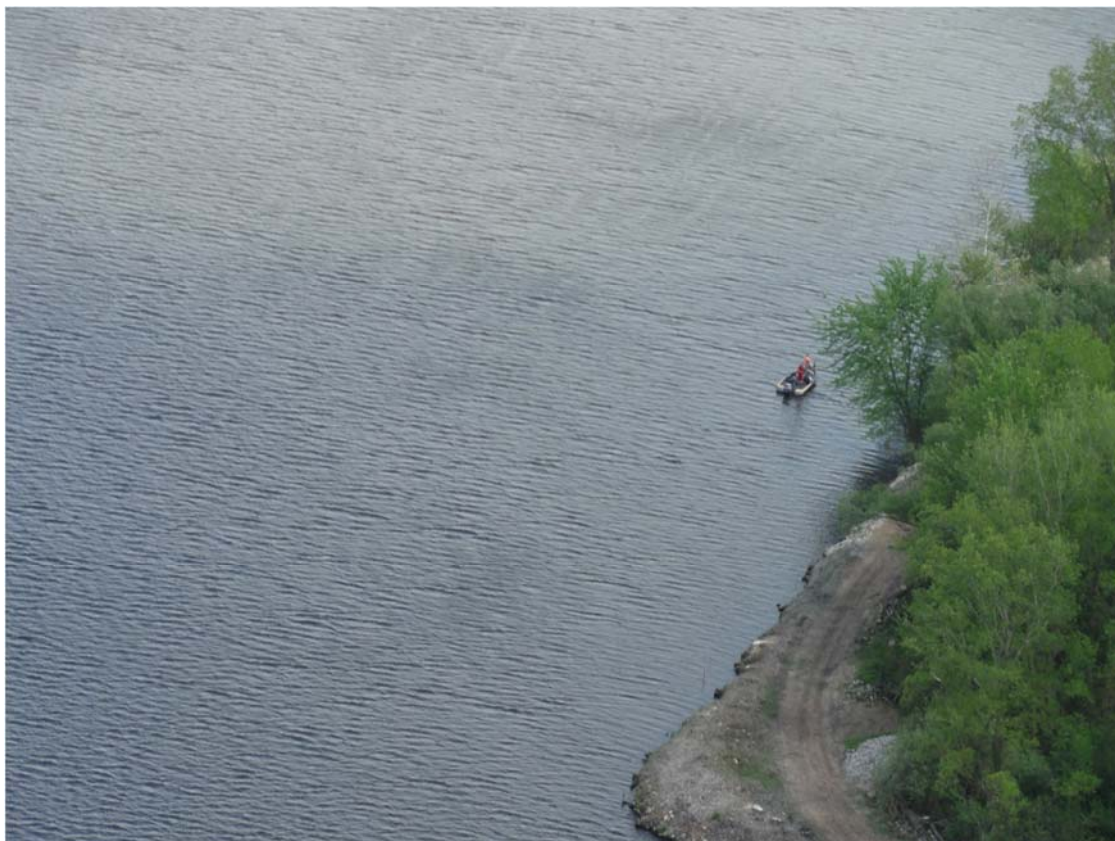
52. Morrow Lake public fishing near dam.
