Situation Photo Log

Saturday, May 12, 2012

Kalamazoo River / Enbridge Spill

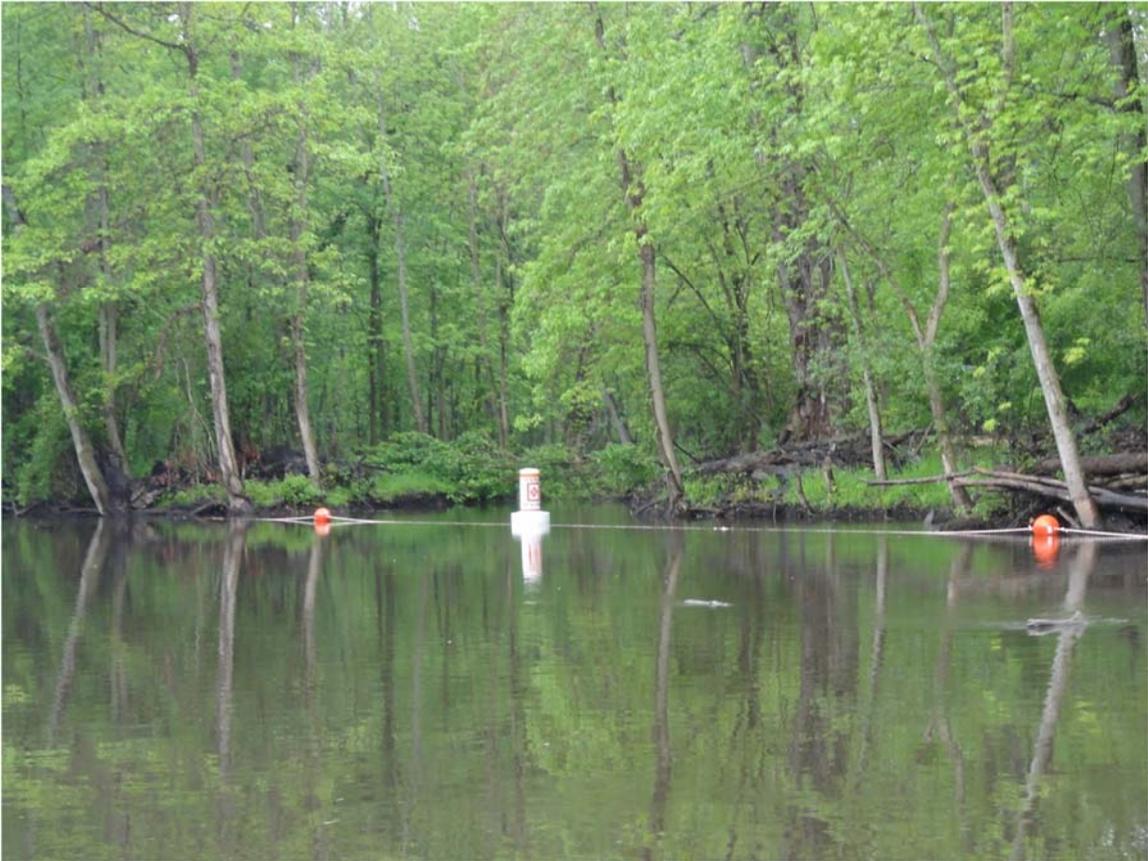
1. MP36.10 buoys deployed at upstream end of sediment trap location.

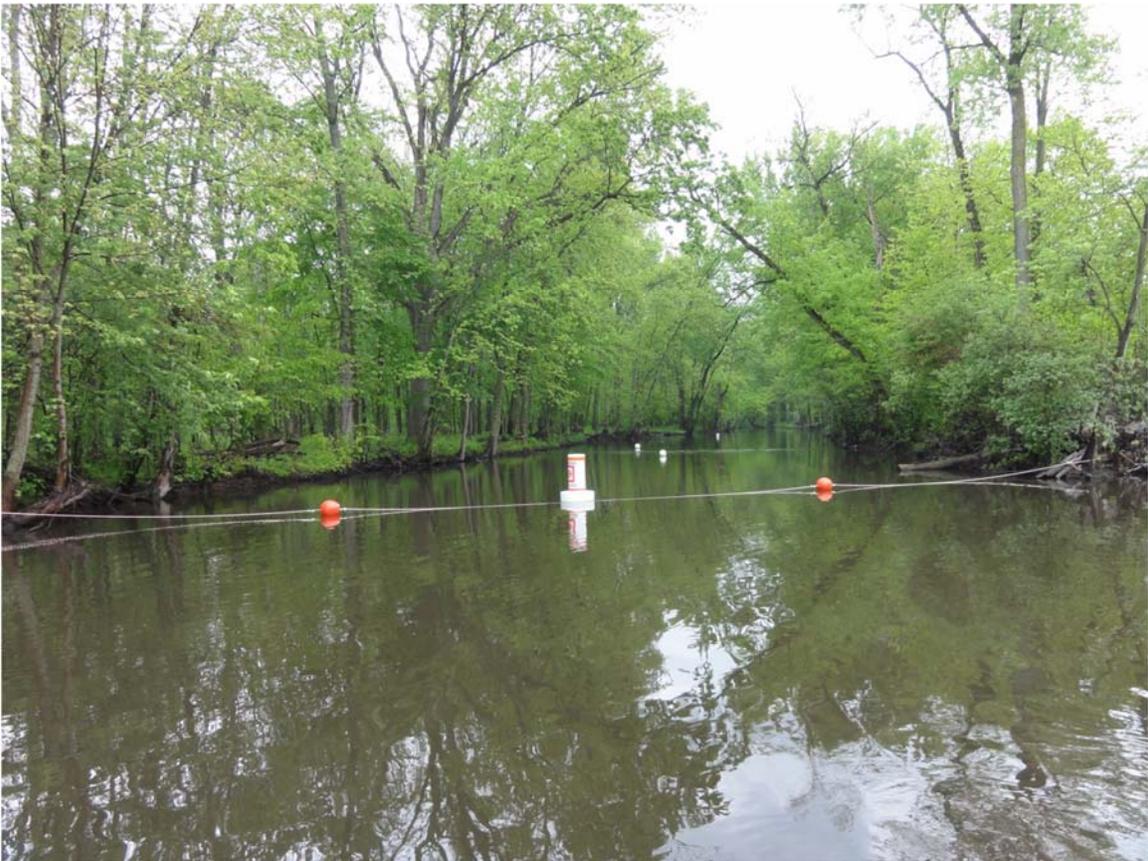
2. MP36.10 buoys deployed at the sediment trap location.

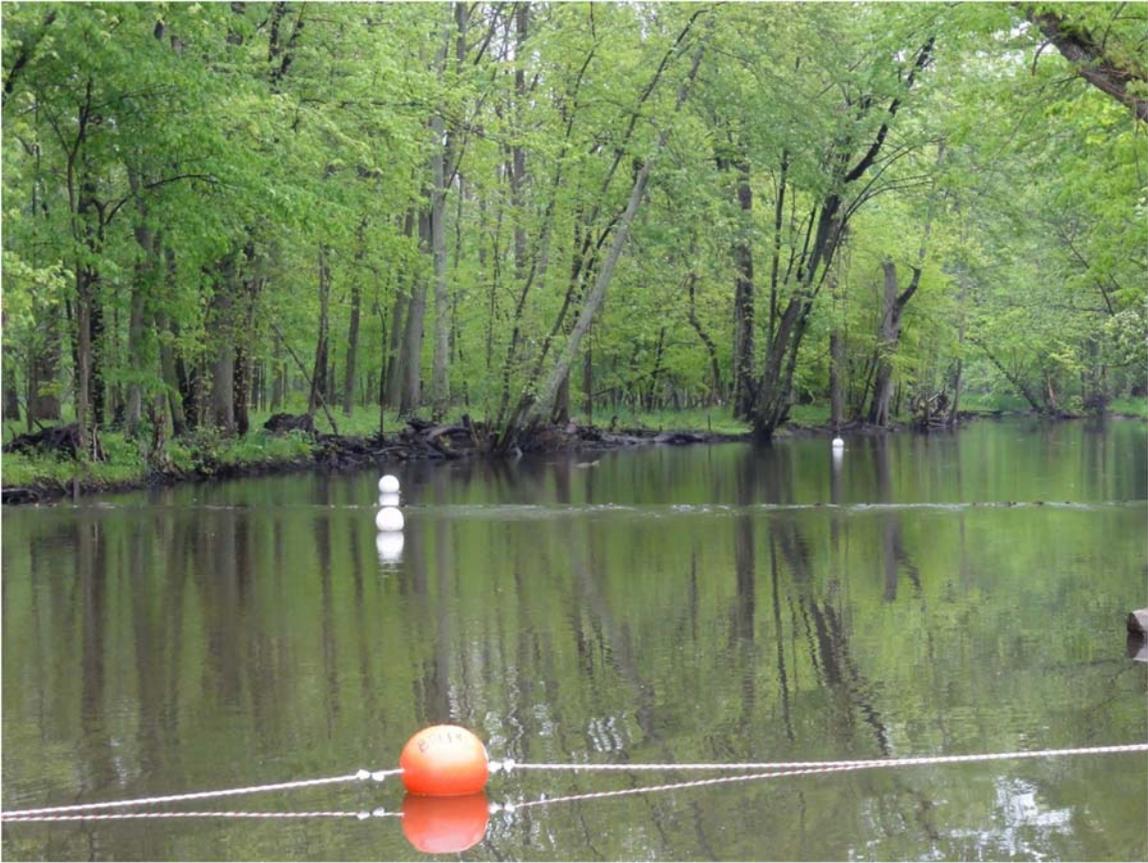
3. MP36.10 buoys deployed at the sediment trap location.

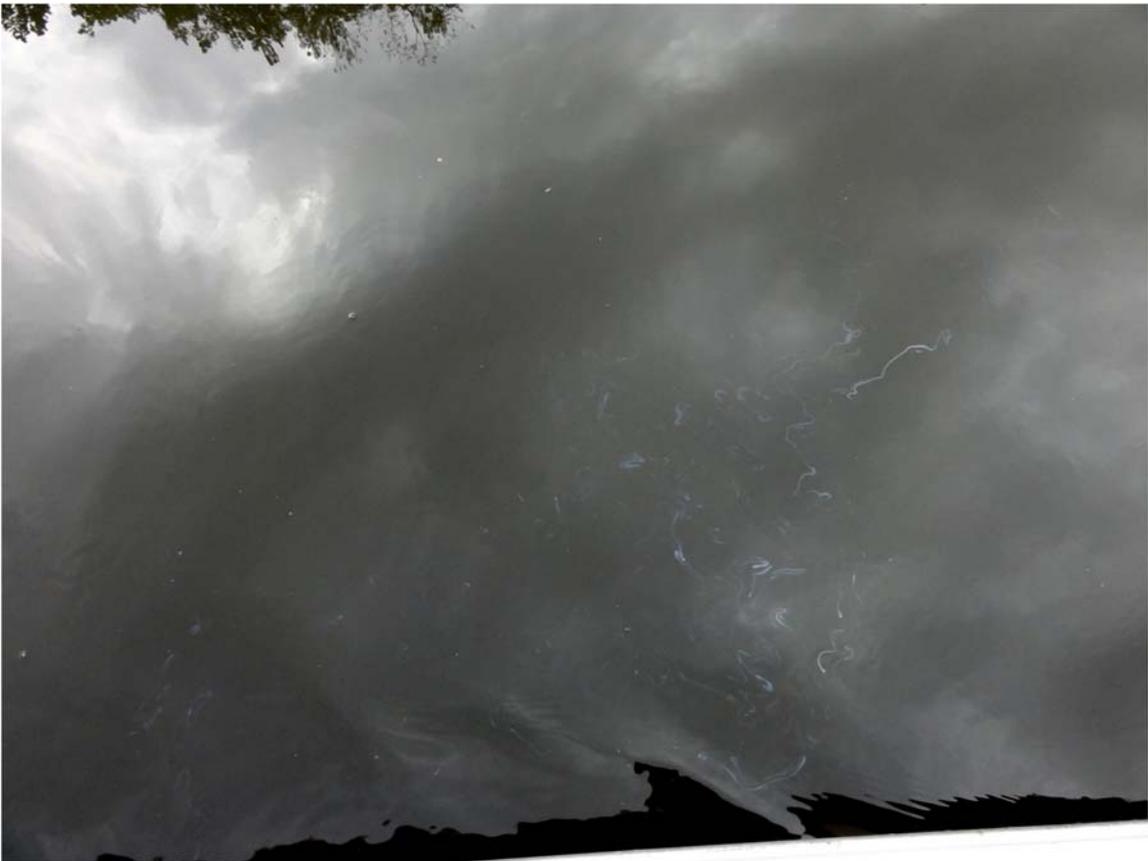
4. MP36.10 sheen observed in river channel.

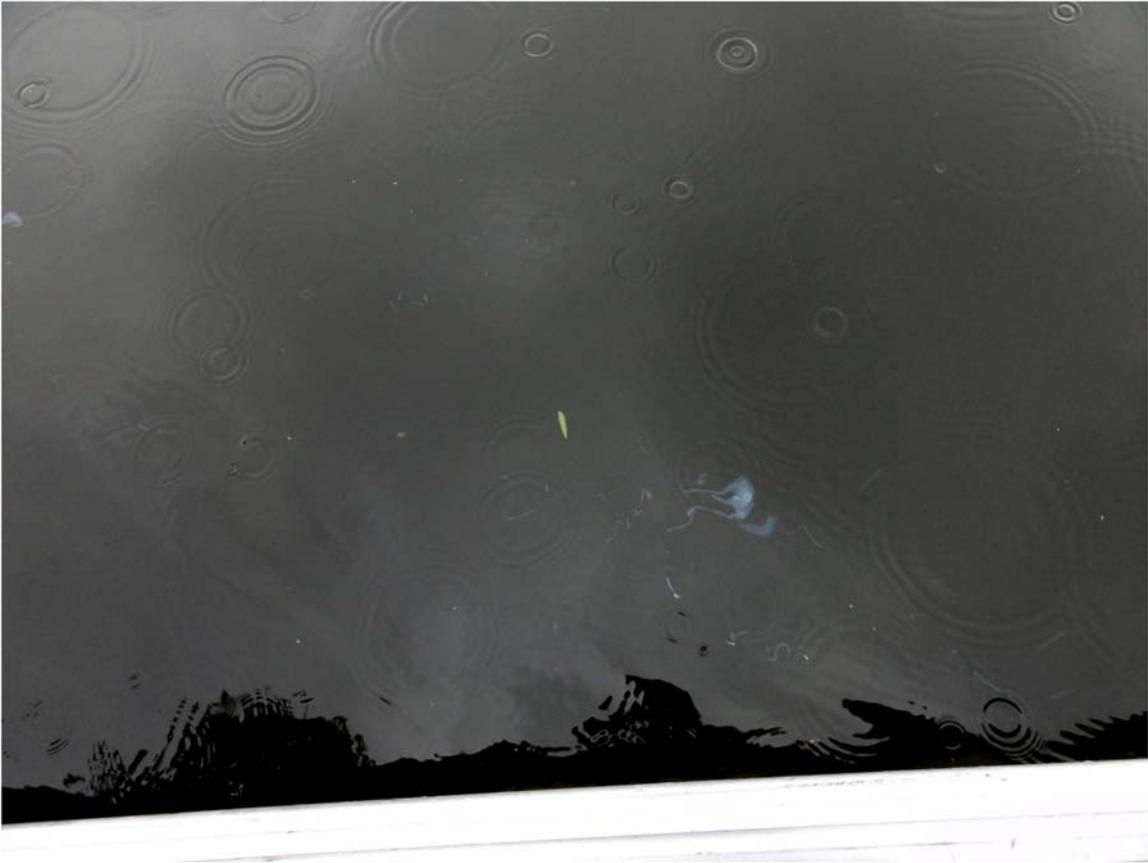
5. MP36.5 RDB sheen observed in river channel.

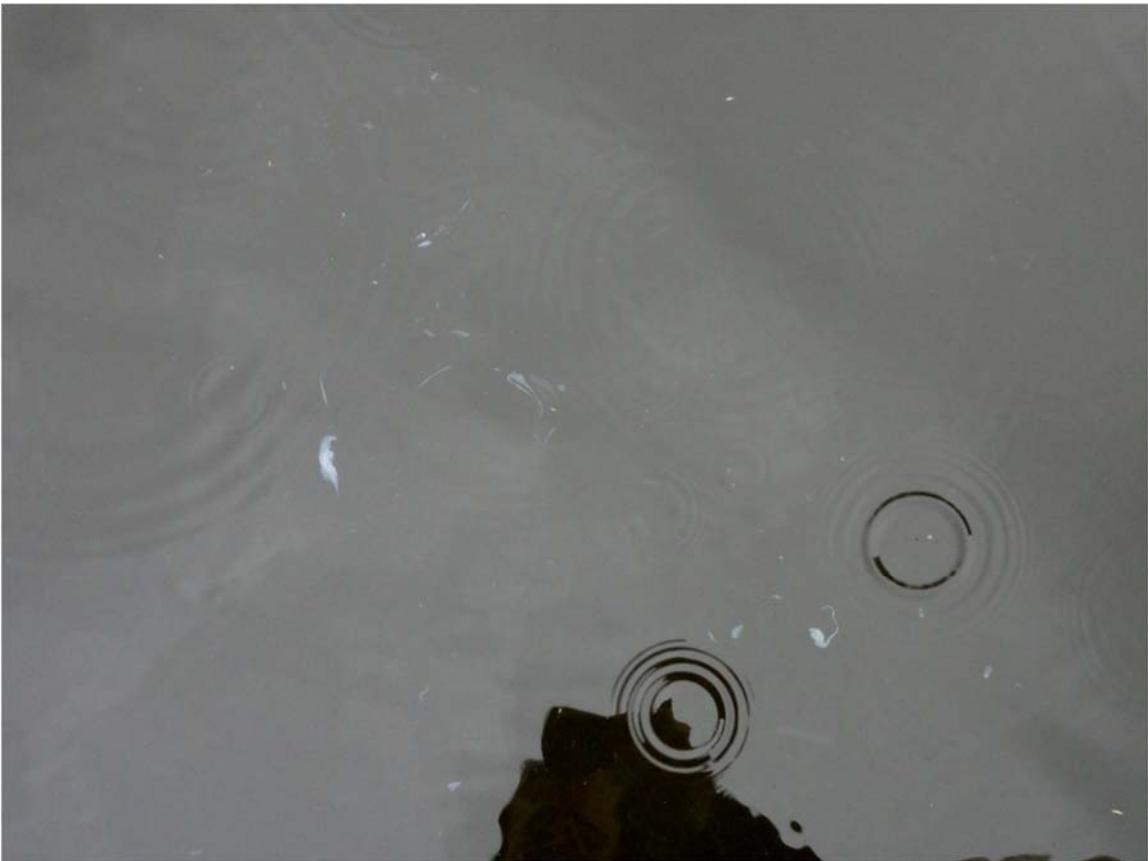
6. MP36.5 RDB sheen observed in river channel.

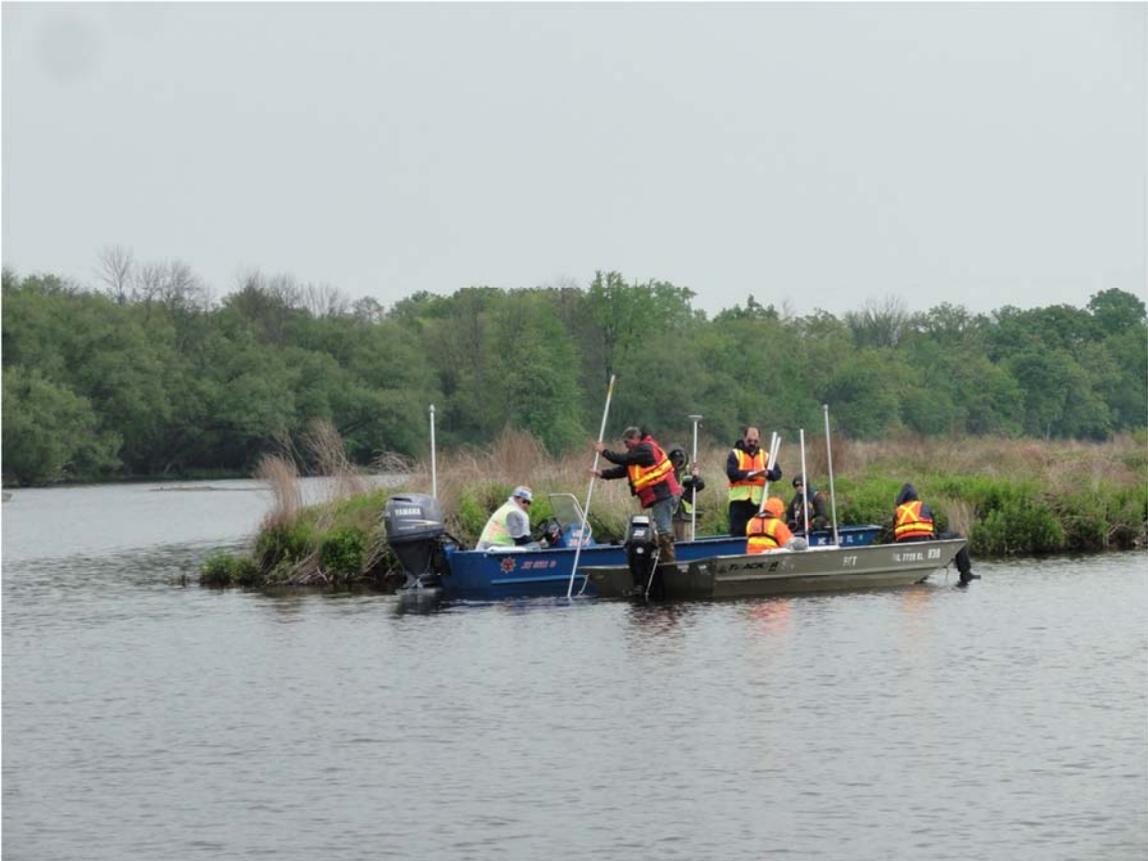
7. Morrow Lake Delta poling crew.

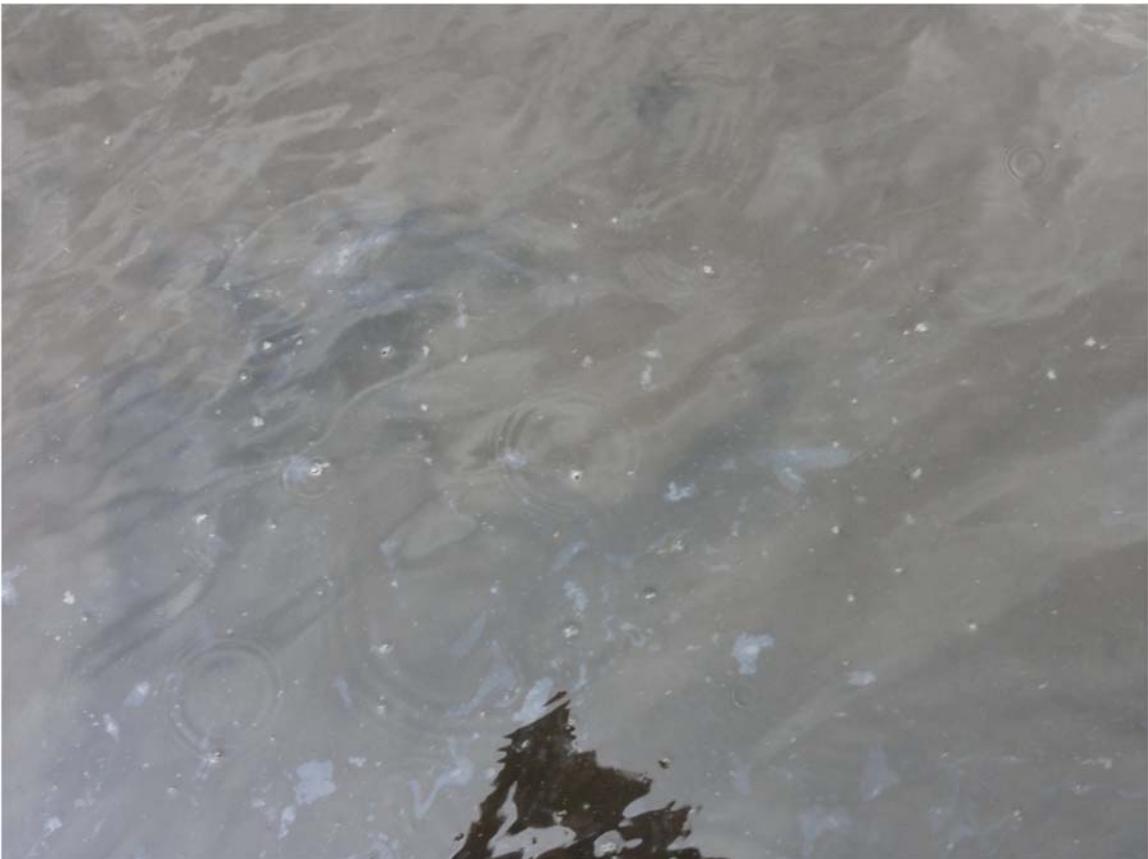
8. Morrow Lake Delta sheen observed around poling boats.

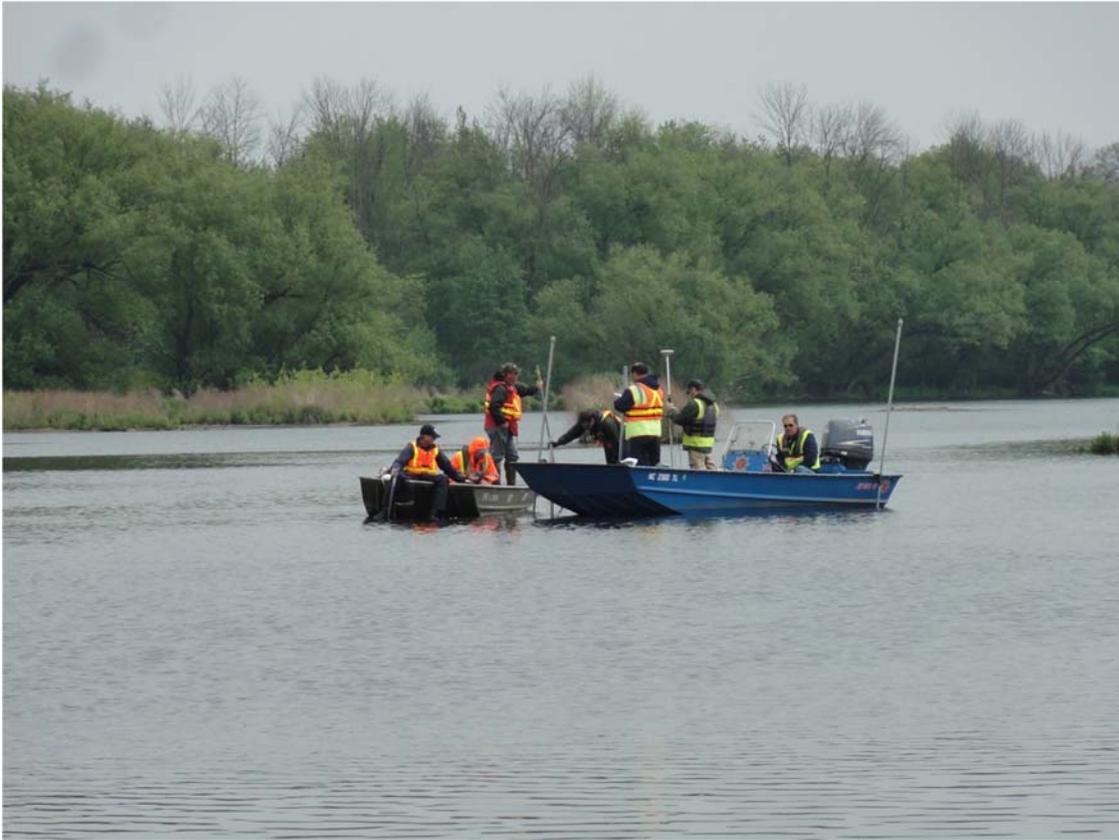
9. Morrow Lake Delta poling.

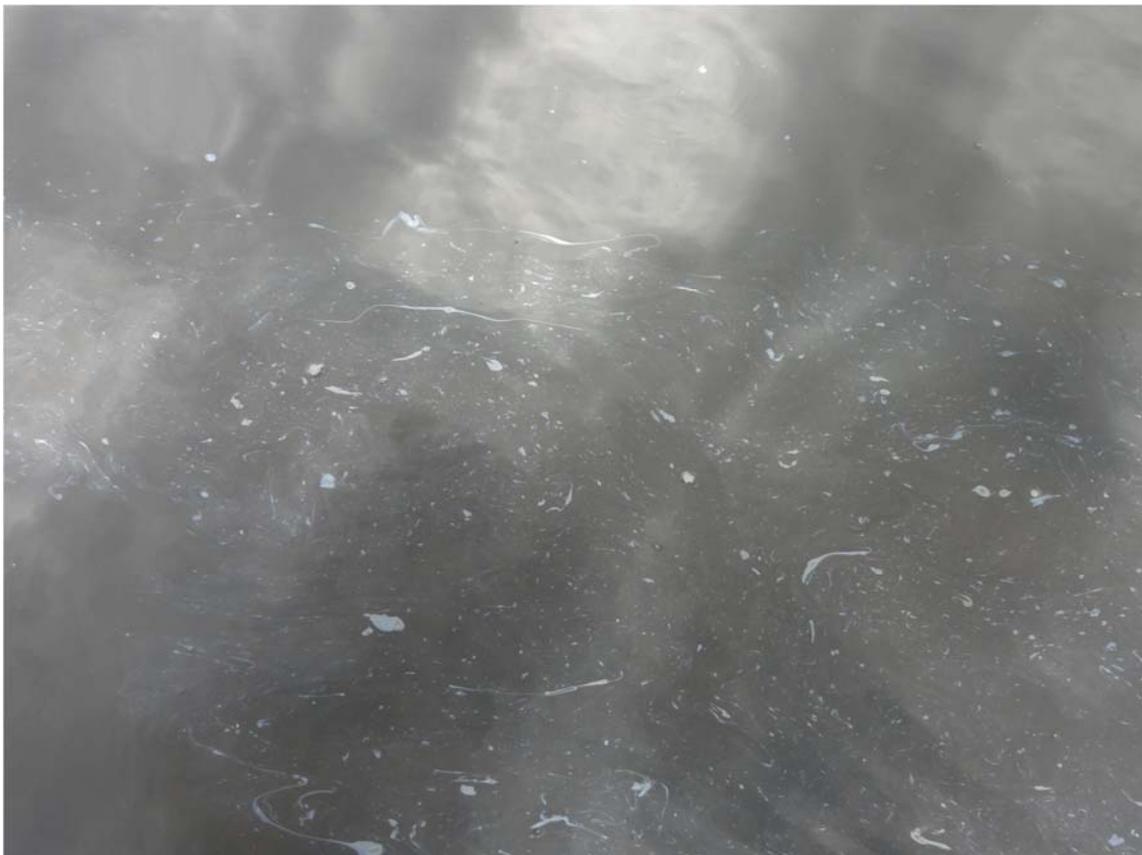
10. Morrow Lake Delta sheen observed as sediment was disturbed by our boat.

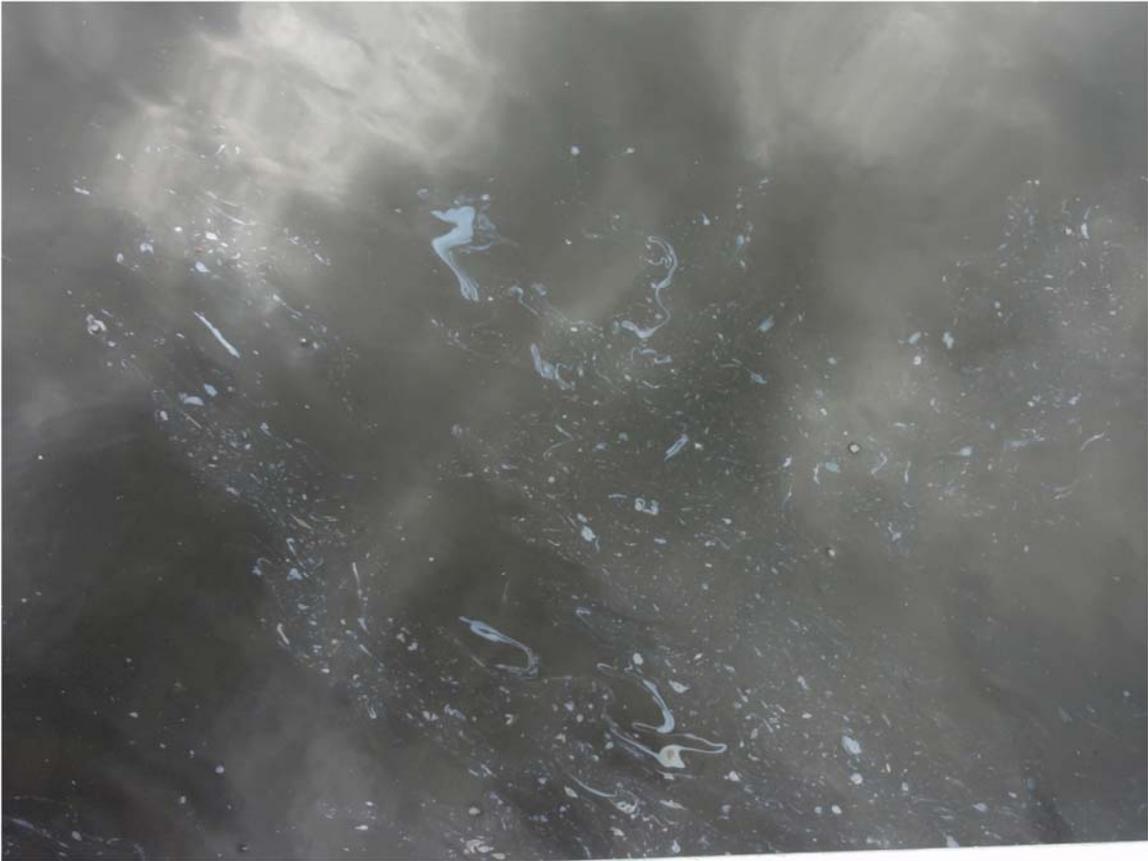
11. Morrow Lake Delta sheen observed as sediment was disturbed by our boat.

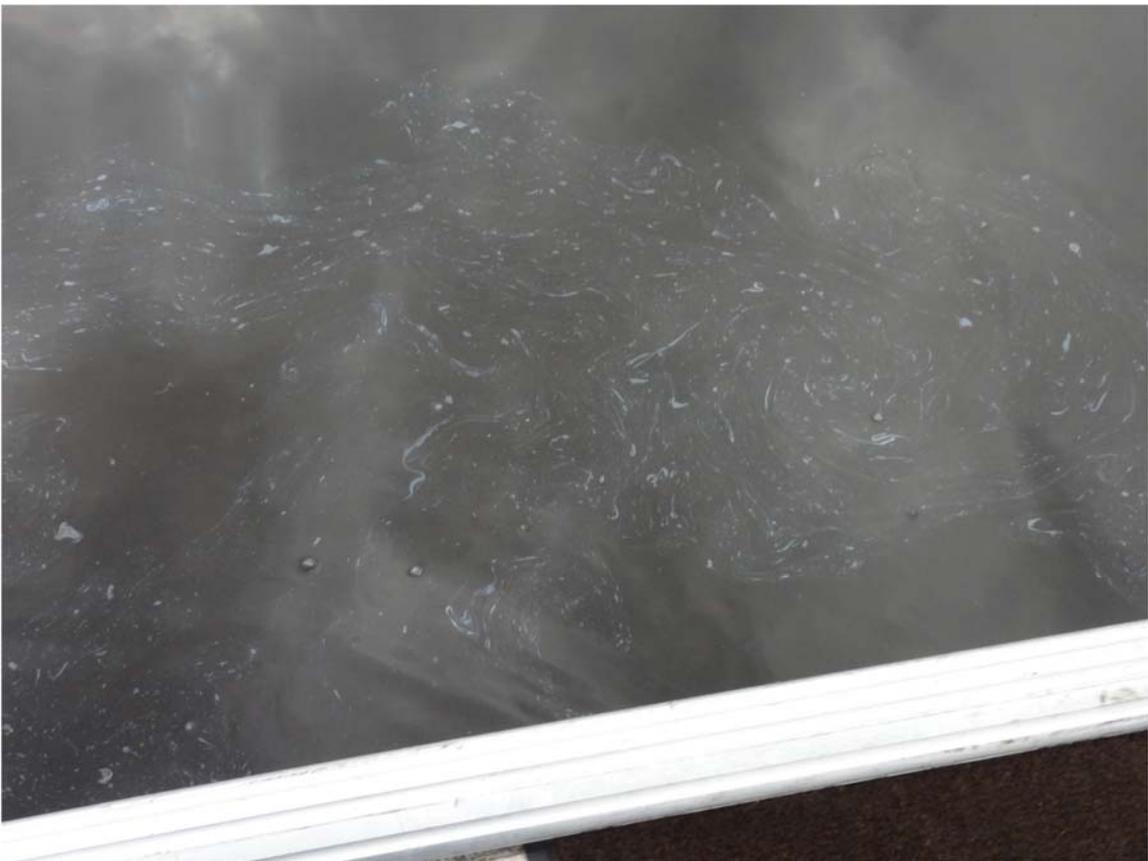
12. Morrow Lake Delta sheen observed as sediment was disturbed by our boat.

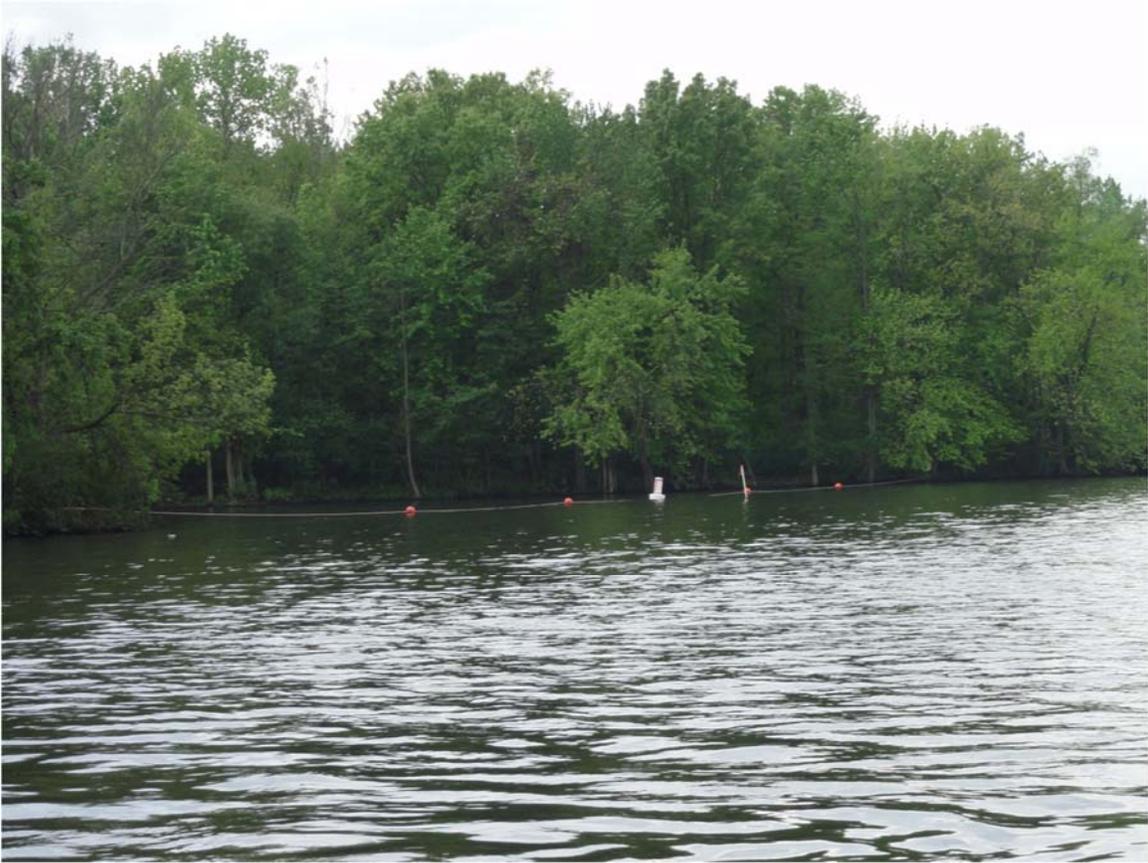
13. Morrow Lake E4 buoys deployed.

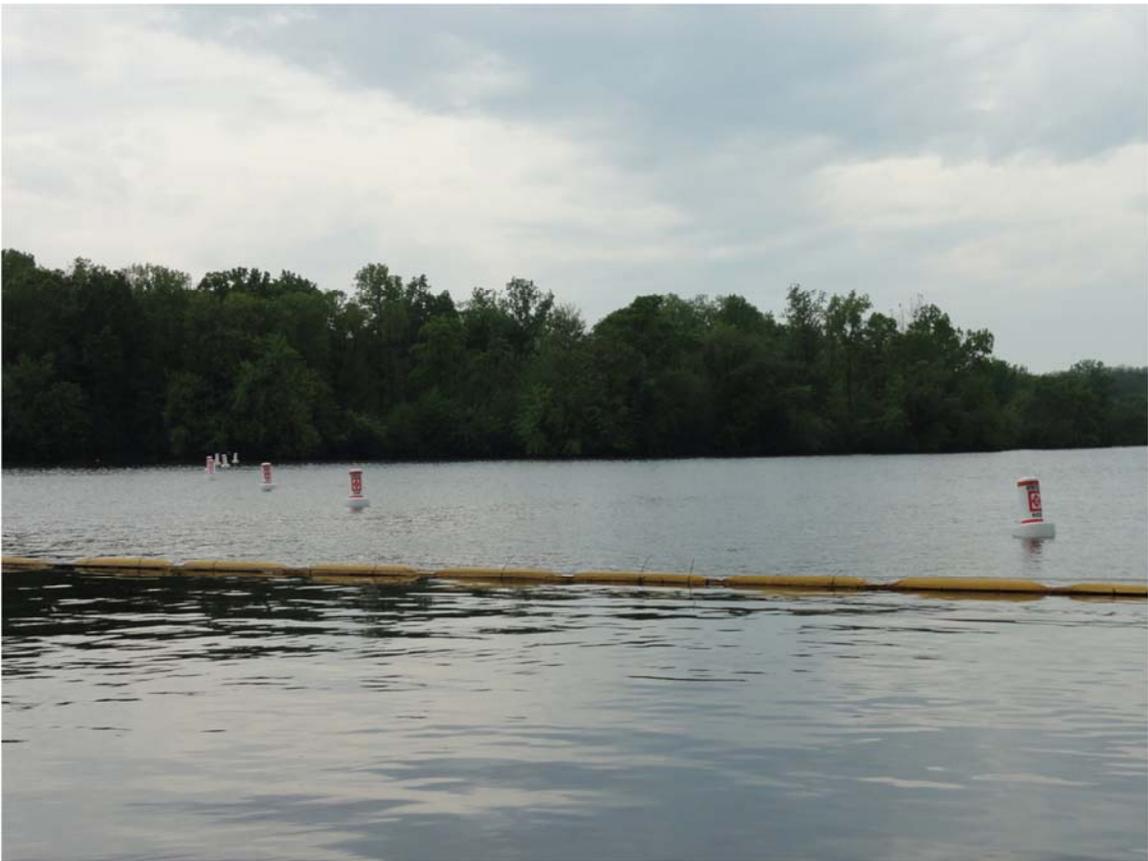
14. Morrow Lake E4 buoys deployed.

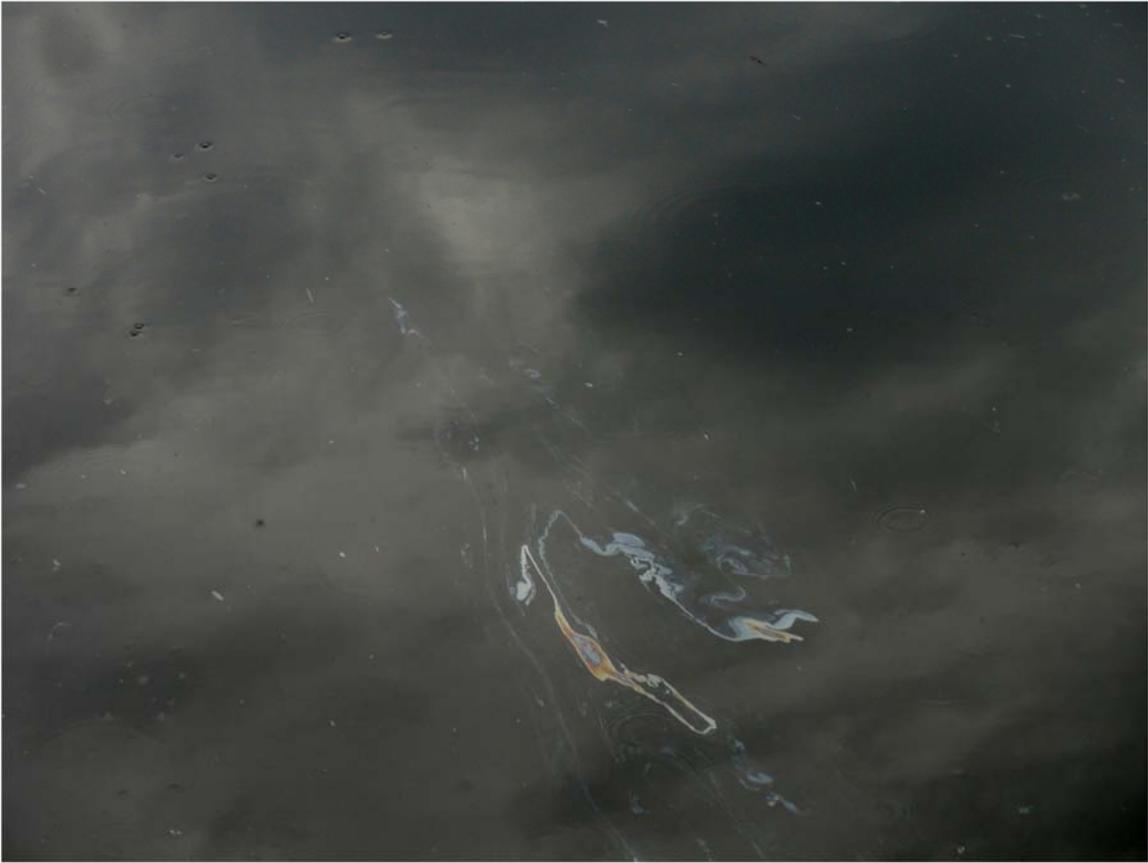
15. Morrow Lake Delta sheen observed between MP37.35 – MP37.75.

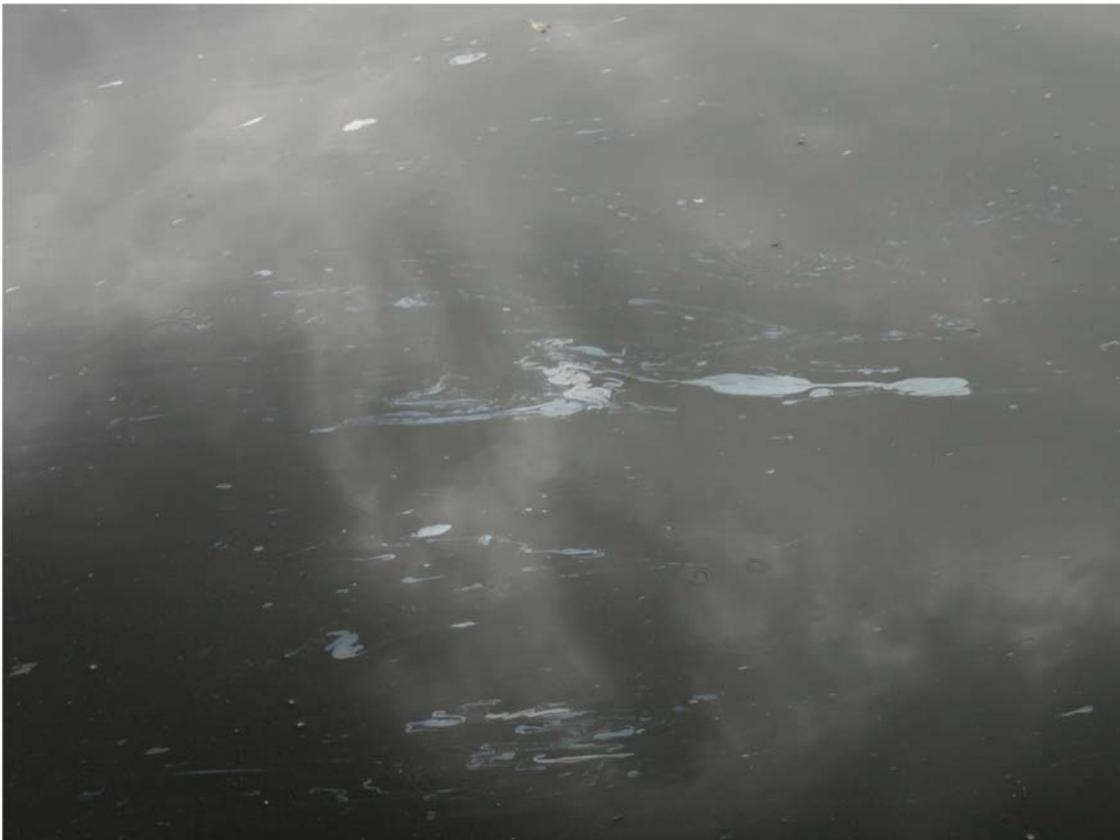
16. Morrow Lake Delta sheen observed between MP37.35 – MP37.75.

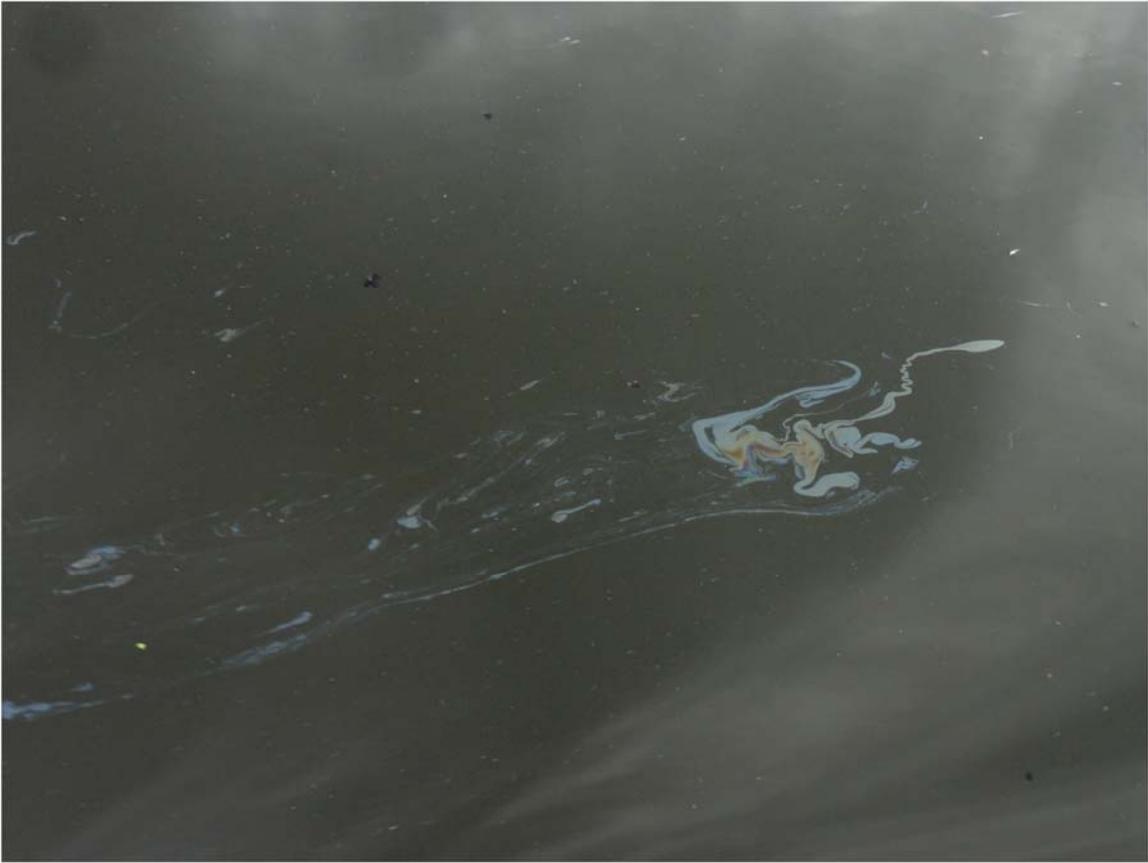
17. Morrow Lake Delta sheen observed between MP37.35 – MP37.75.

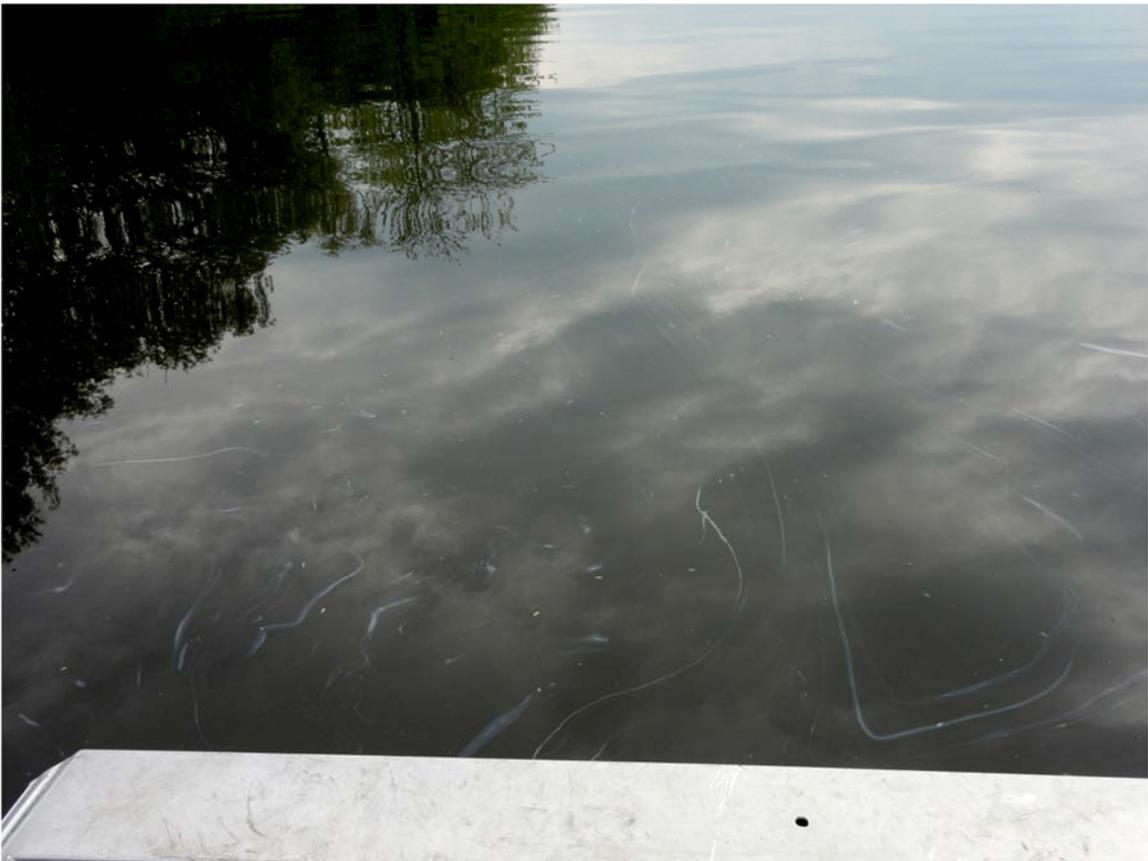
18. Morrow Lake Delta sheen observed between MP37.35 – MP37.75.

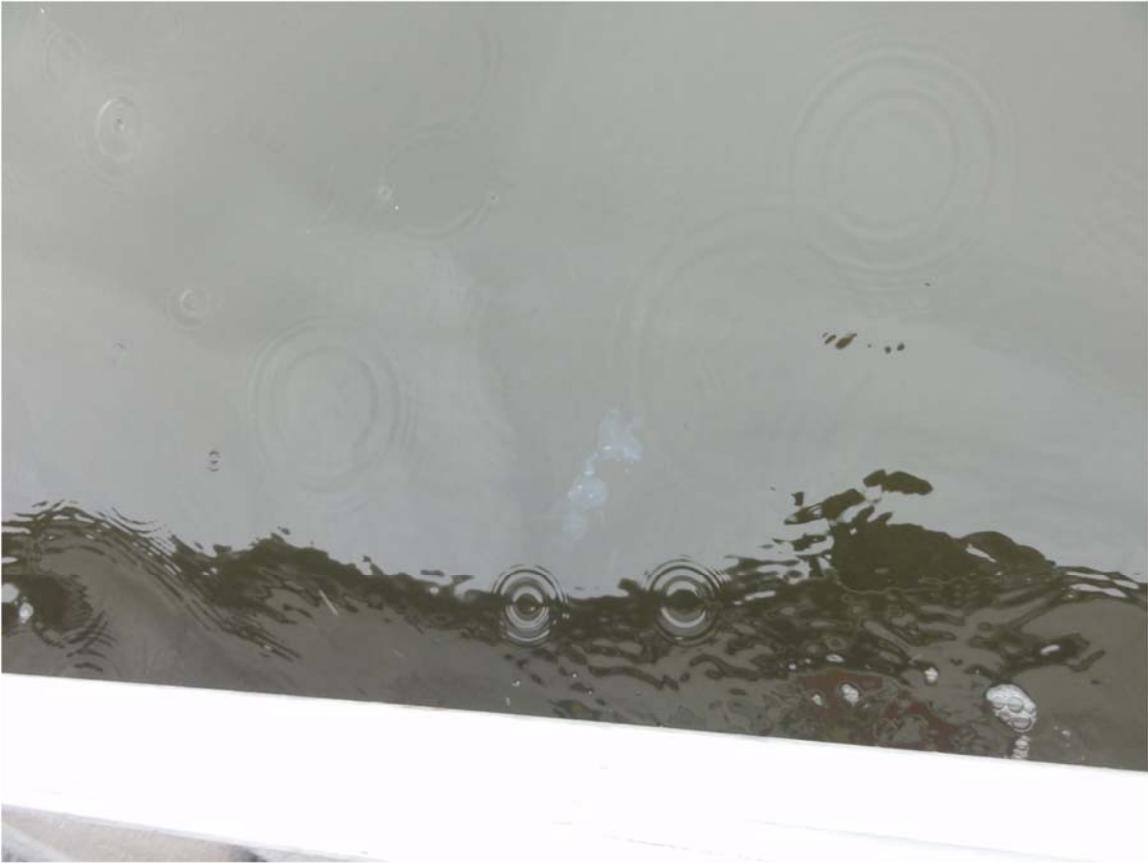
19. Morrow Lake north cove sheen observed.

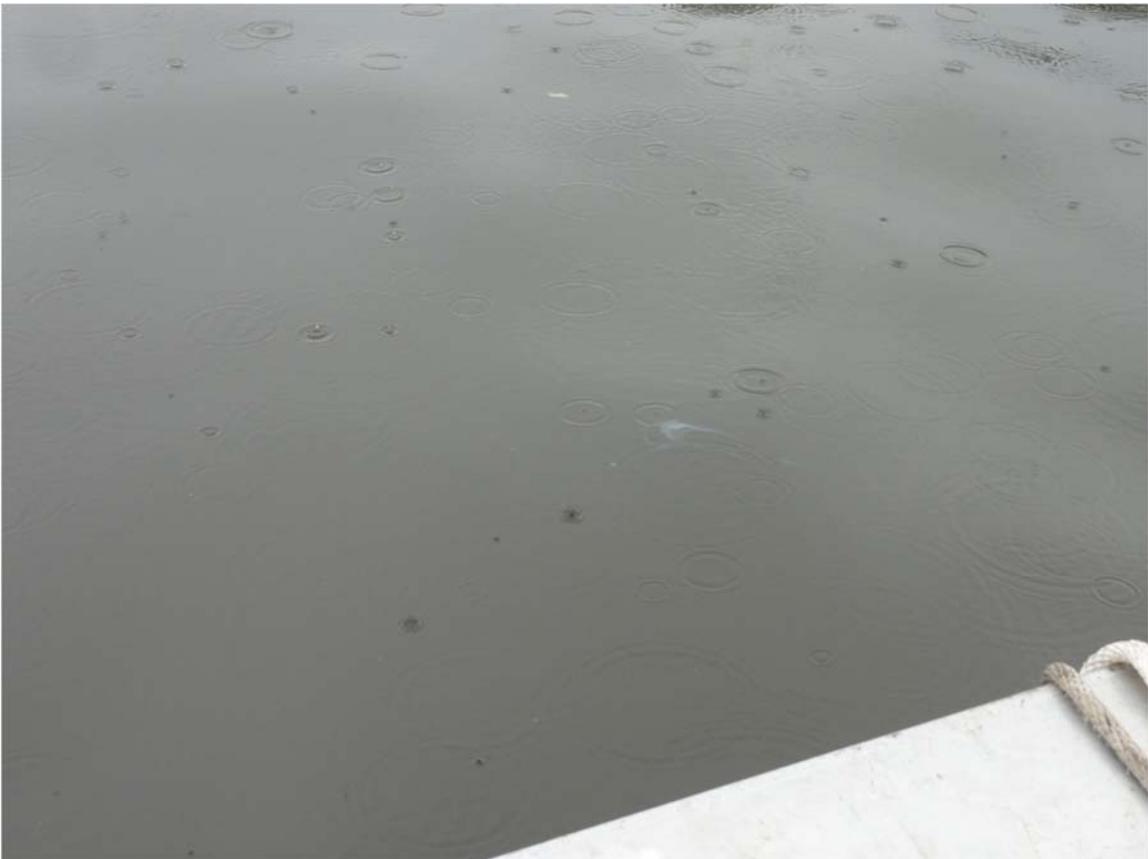
20. Morrow Lake north cove sheen observed.
