# Situation Photo Log

Thursday, May 17, 2012

Kalamazoo River / Enbridge Spill

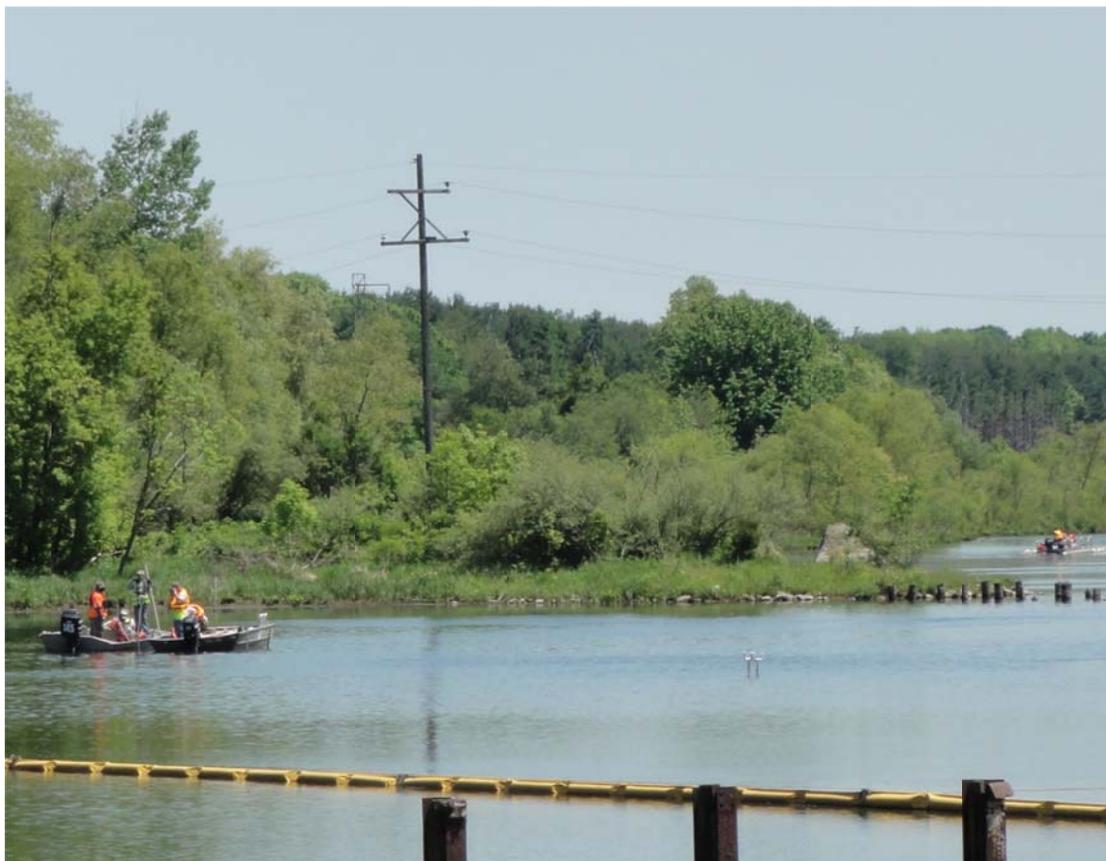
1. Poling crews and sheen sweep boat working upstream of Ceresco Dam.

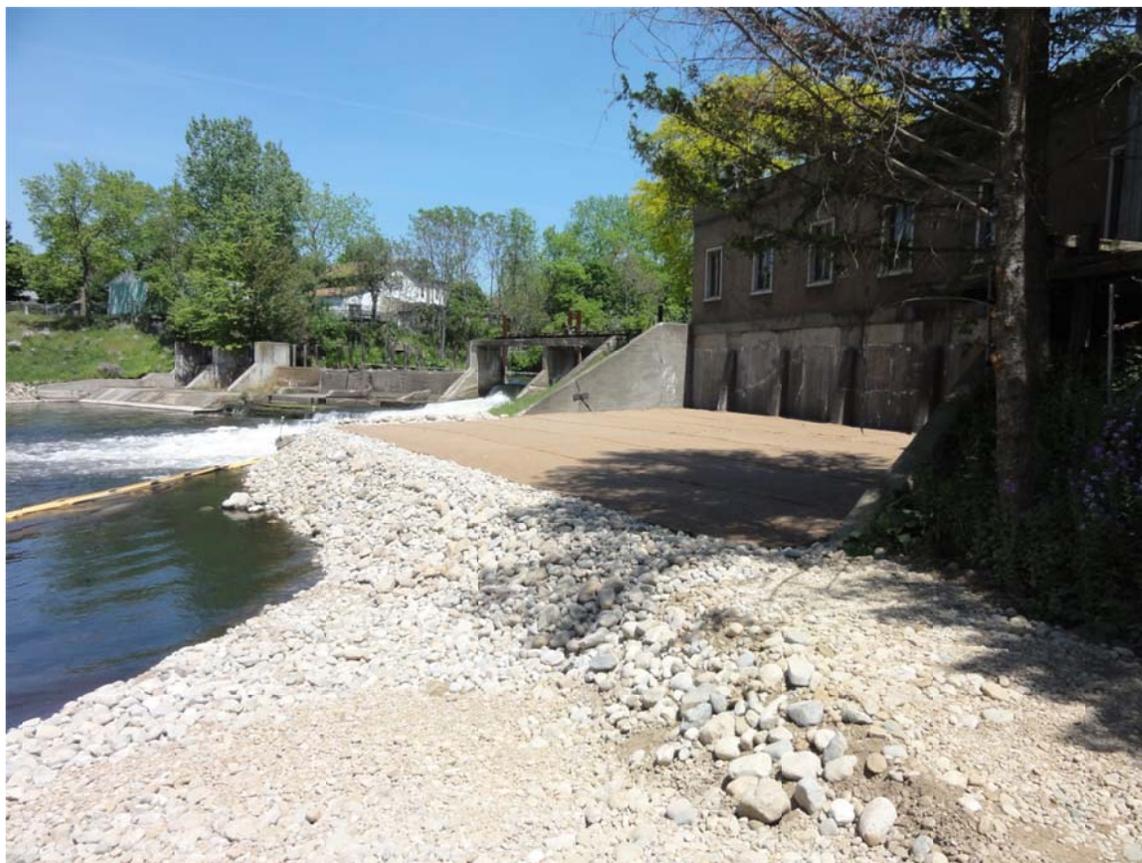
2. Work completed at legacy site below Ceresco Dam. Crews observed demobilizing equipment from here today.

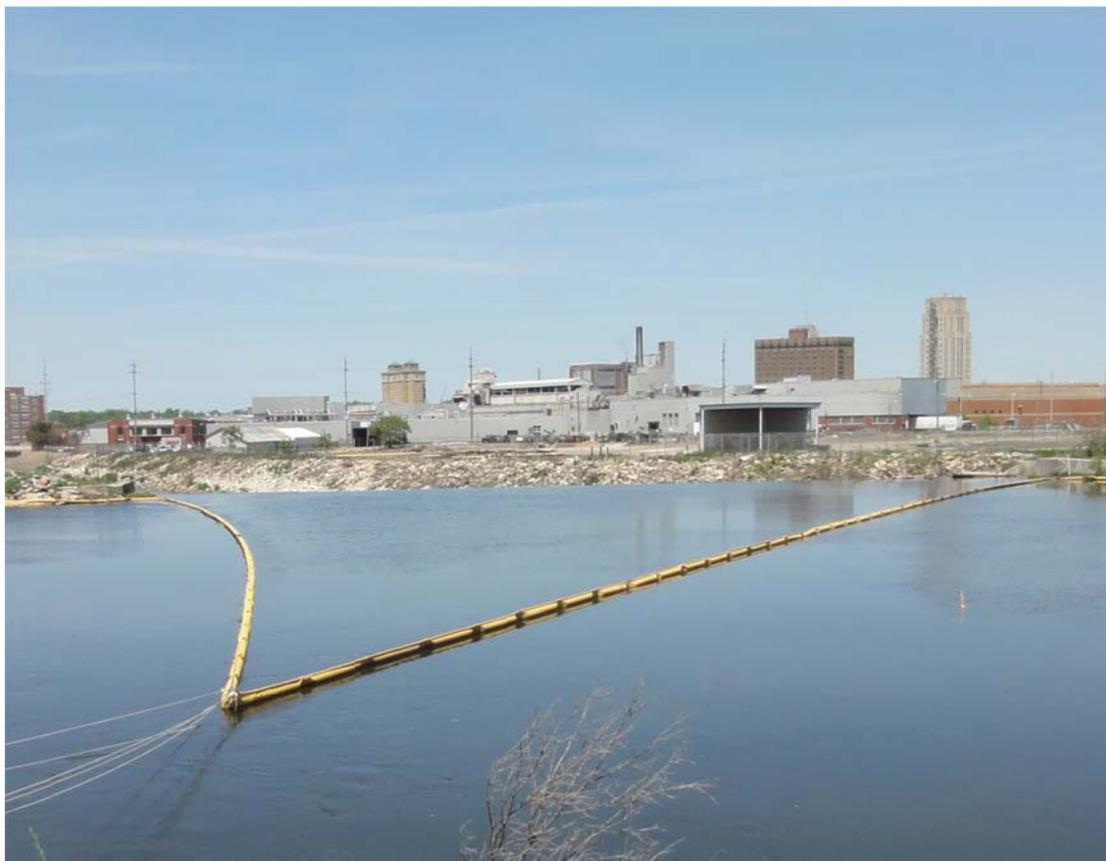
3. Control Point at Battle Creek spillway, no sheen or debris observed.

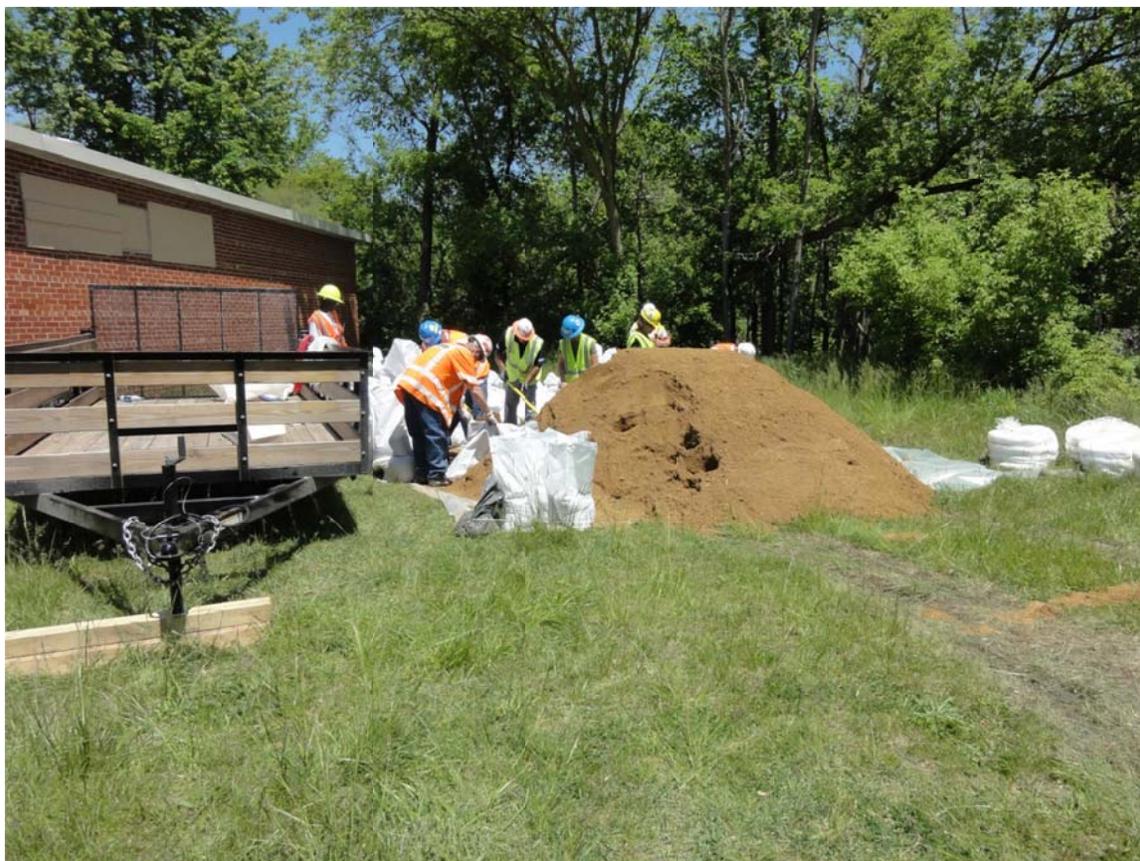
4. Crews filling sand bags at Rock Tenn inlet for planned inlet cleaning work.

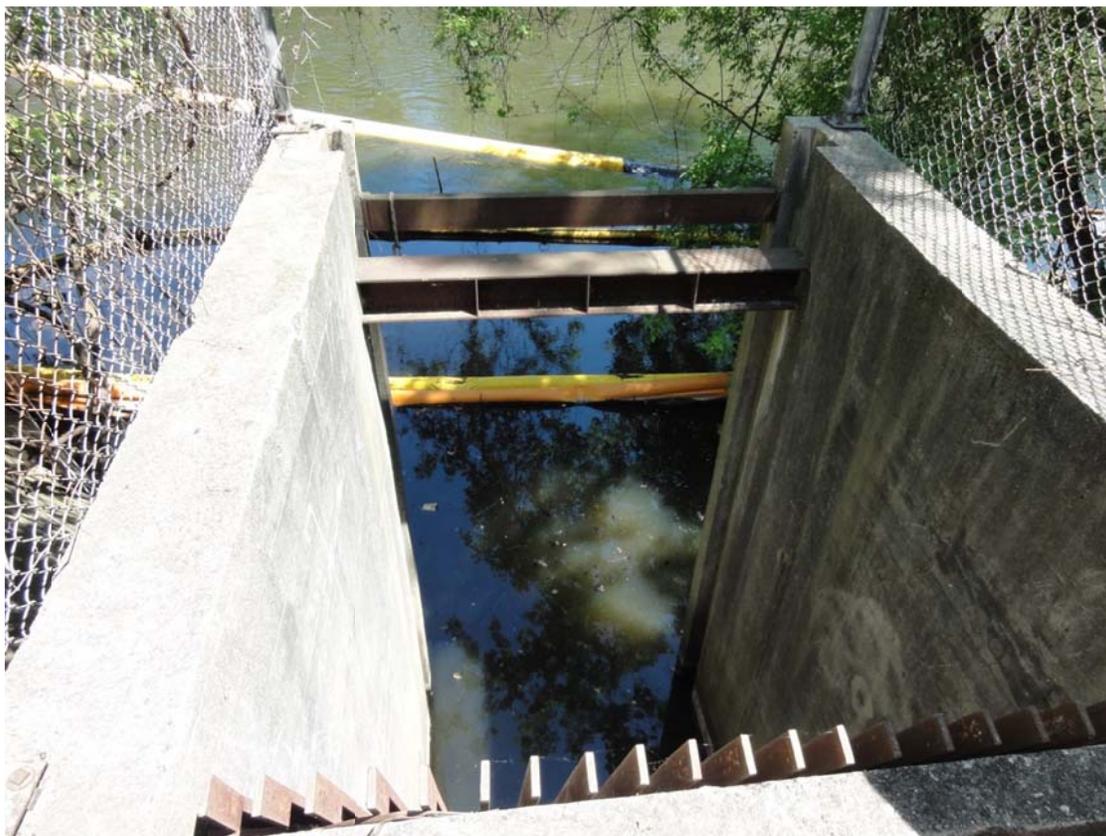
5. Rock Tenn inlet. Sheen observed within containment.

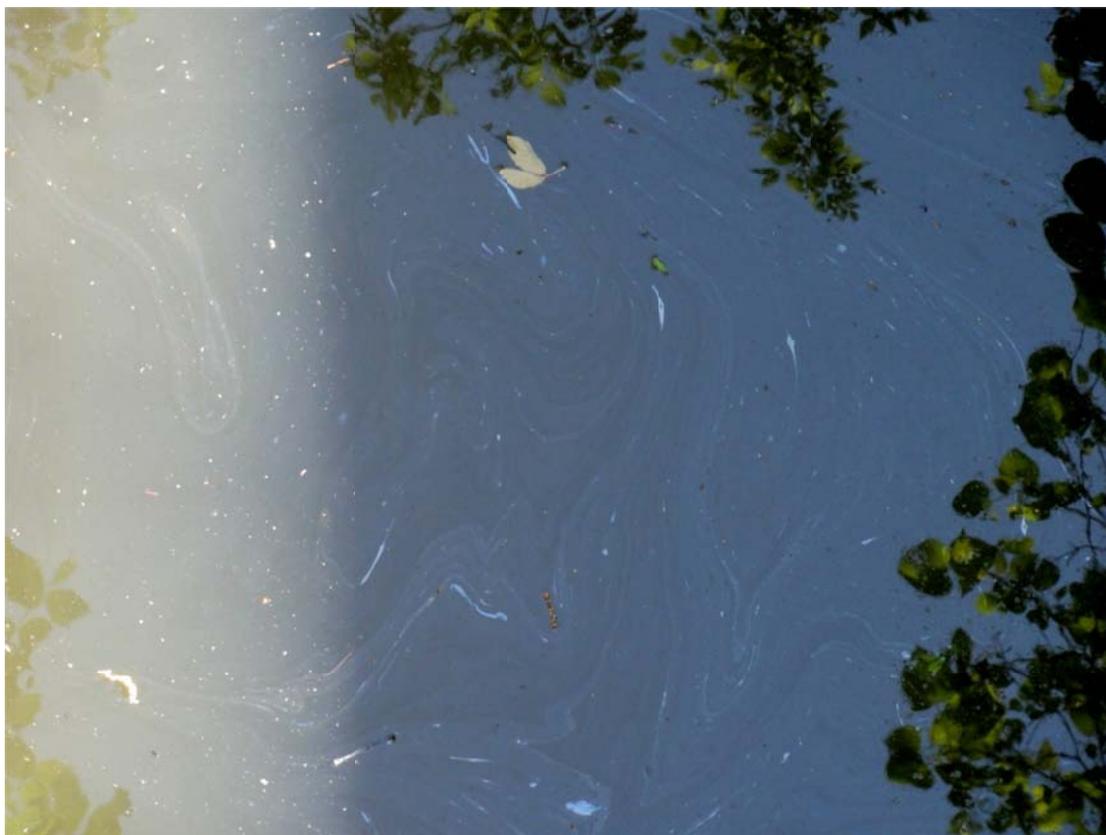
6. Sheen observed within containment at Rock Tenn.

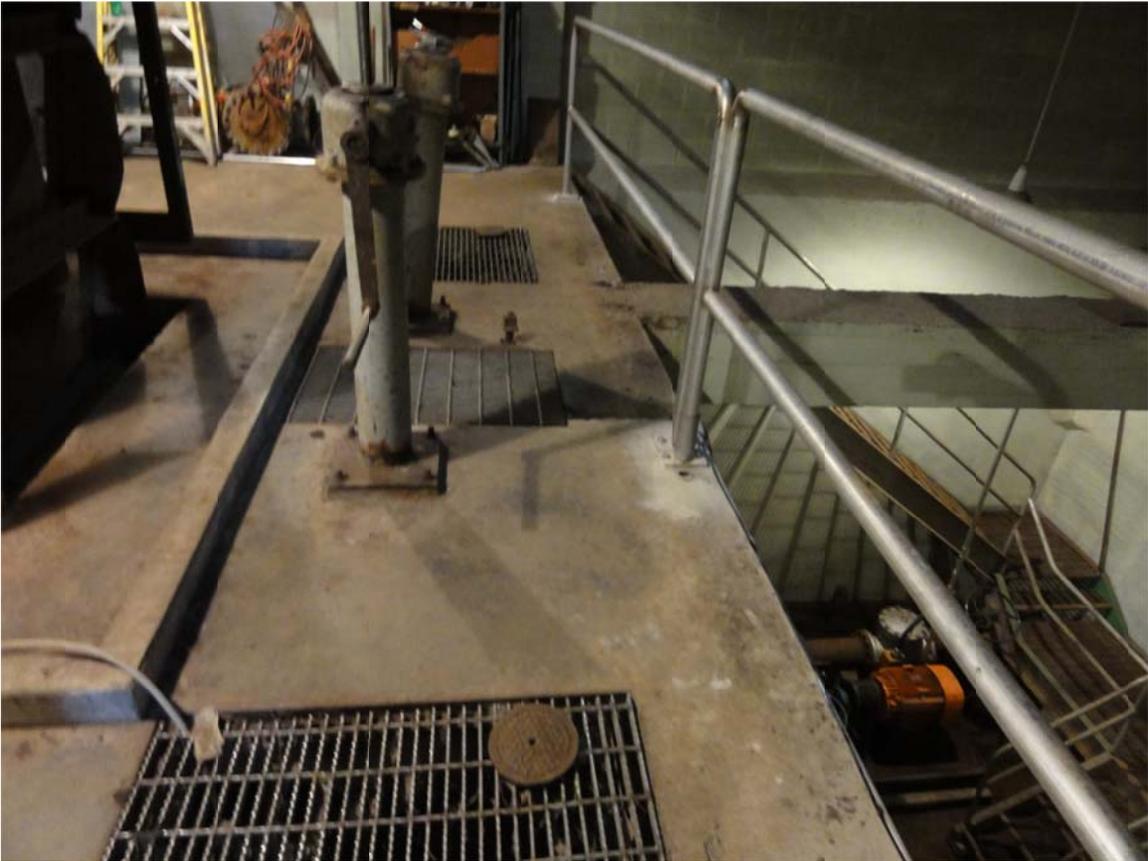
7. Mechanical area inside Rock Tenn inlet building. Location of planned confined space work.

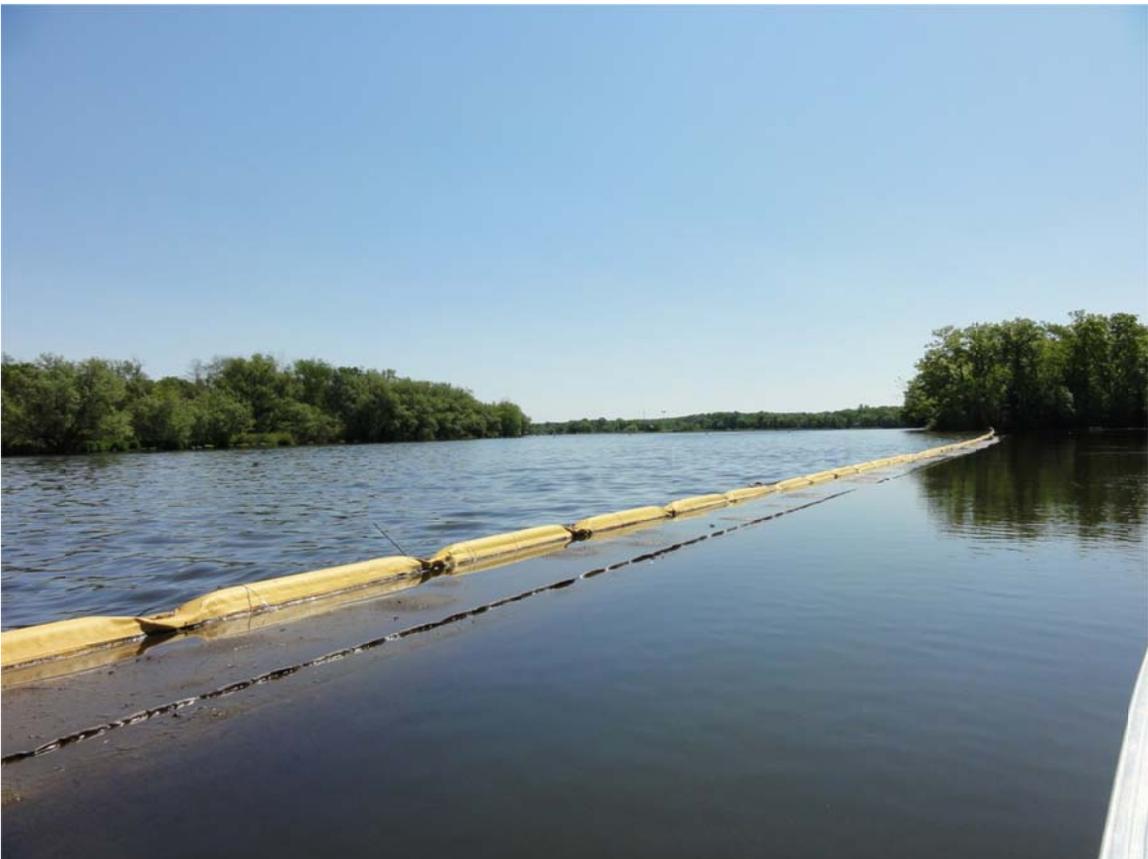
8. Control Point E4, looking east into Morrow Lake Delta. No sheen observed.

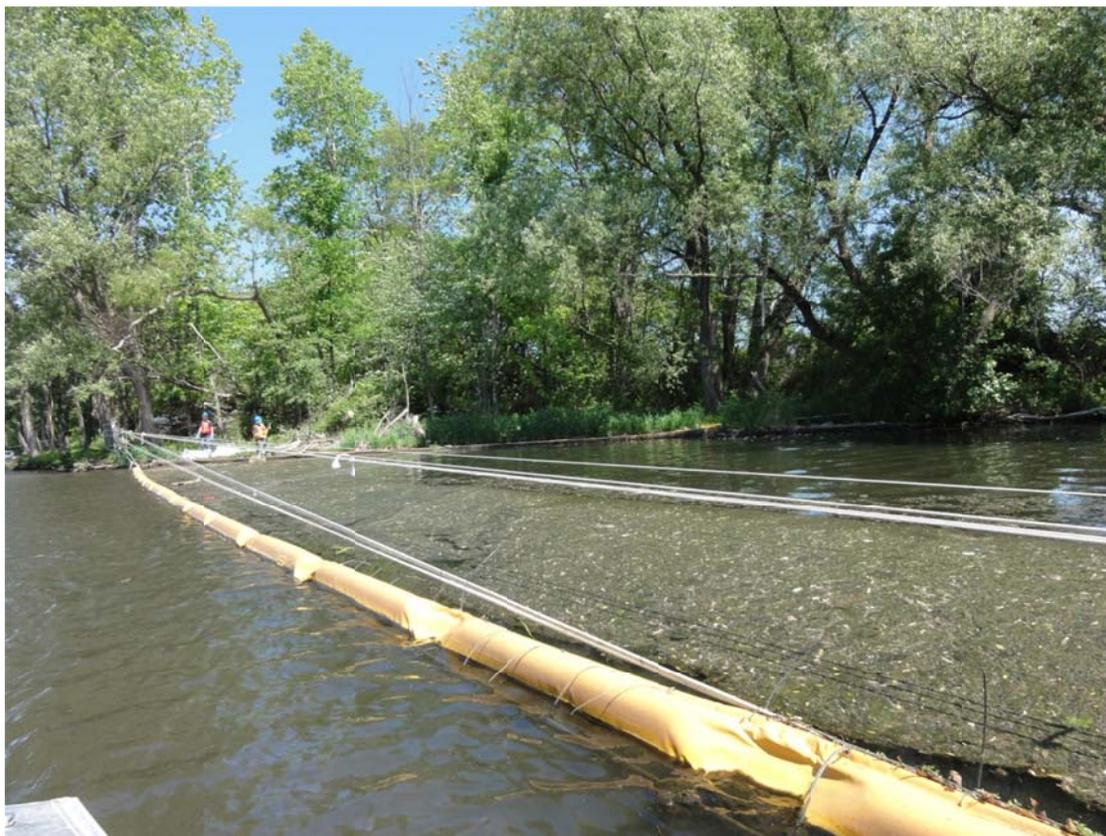
9. Control Point E4 debris.

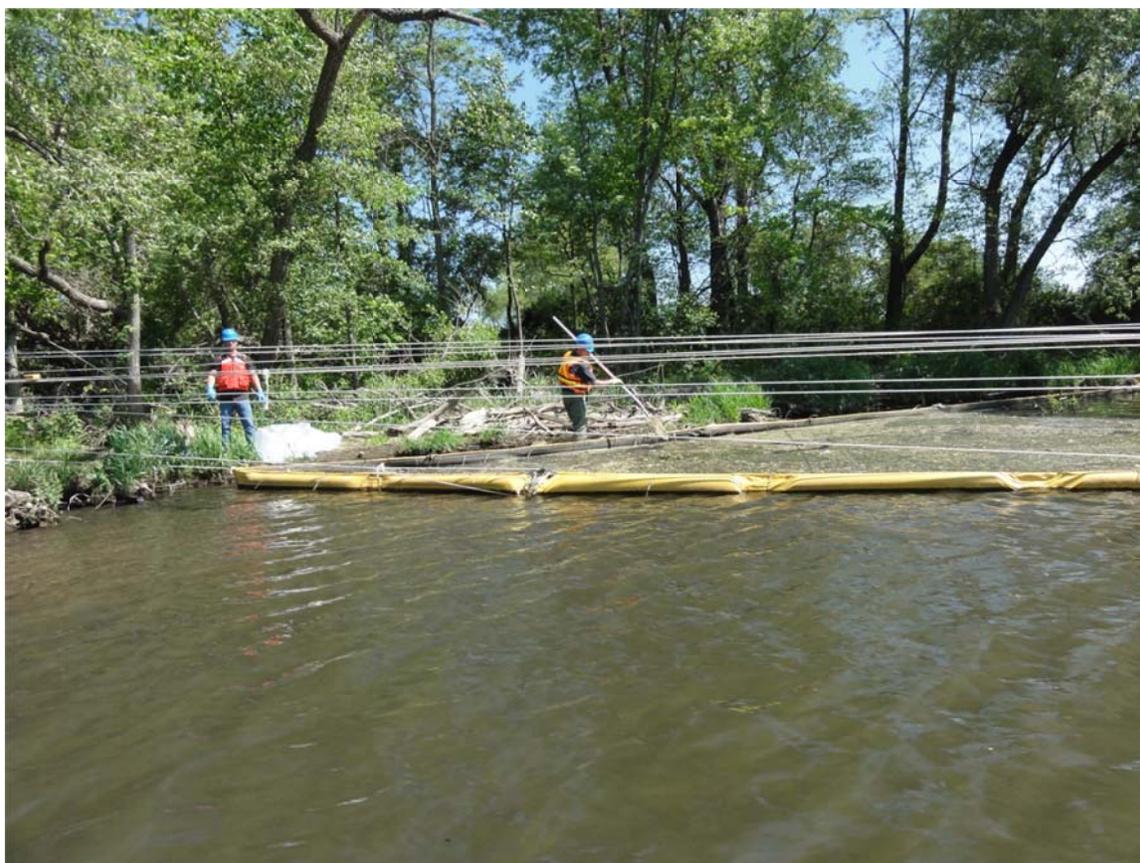
10. Crews cleaning debris from E4 control point.

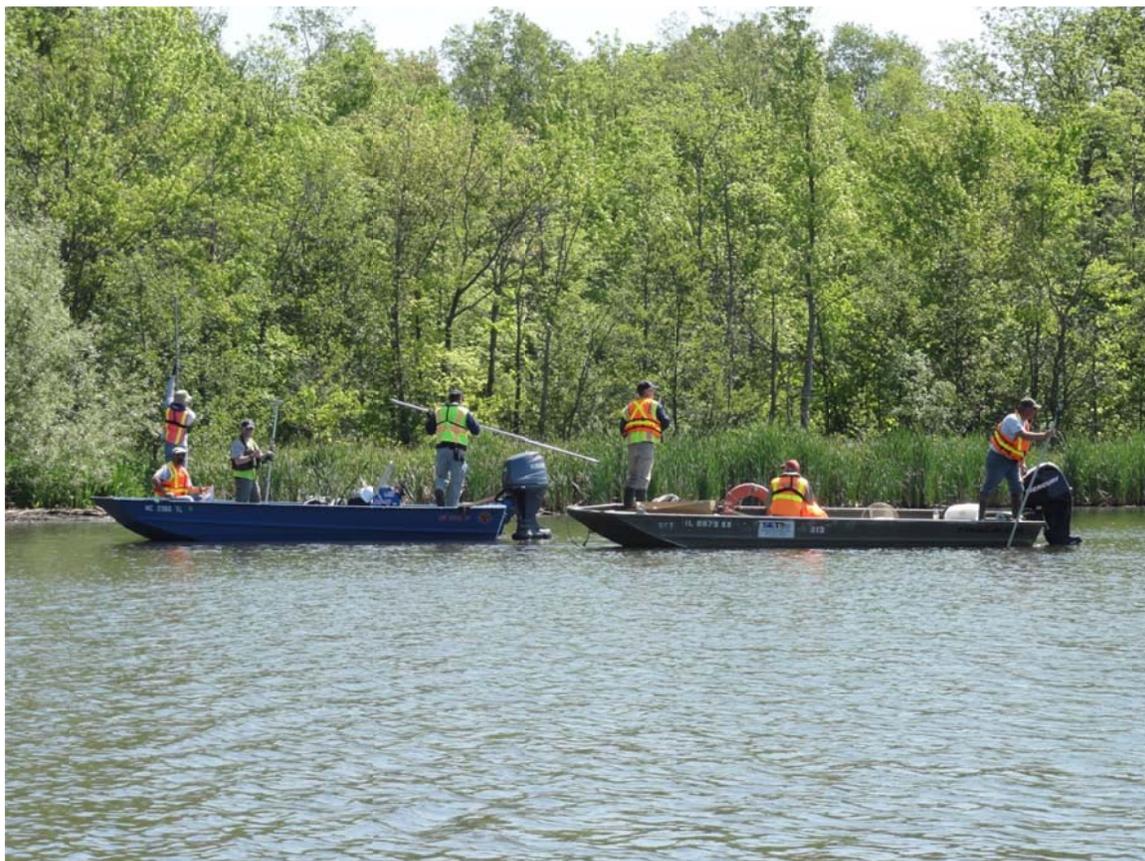
11. Poling crews observed along northern shore of Morrow Lake.

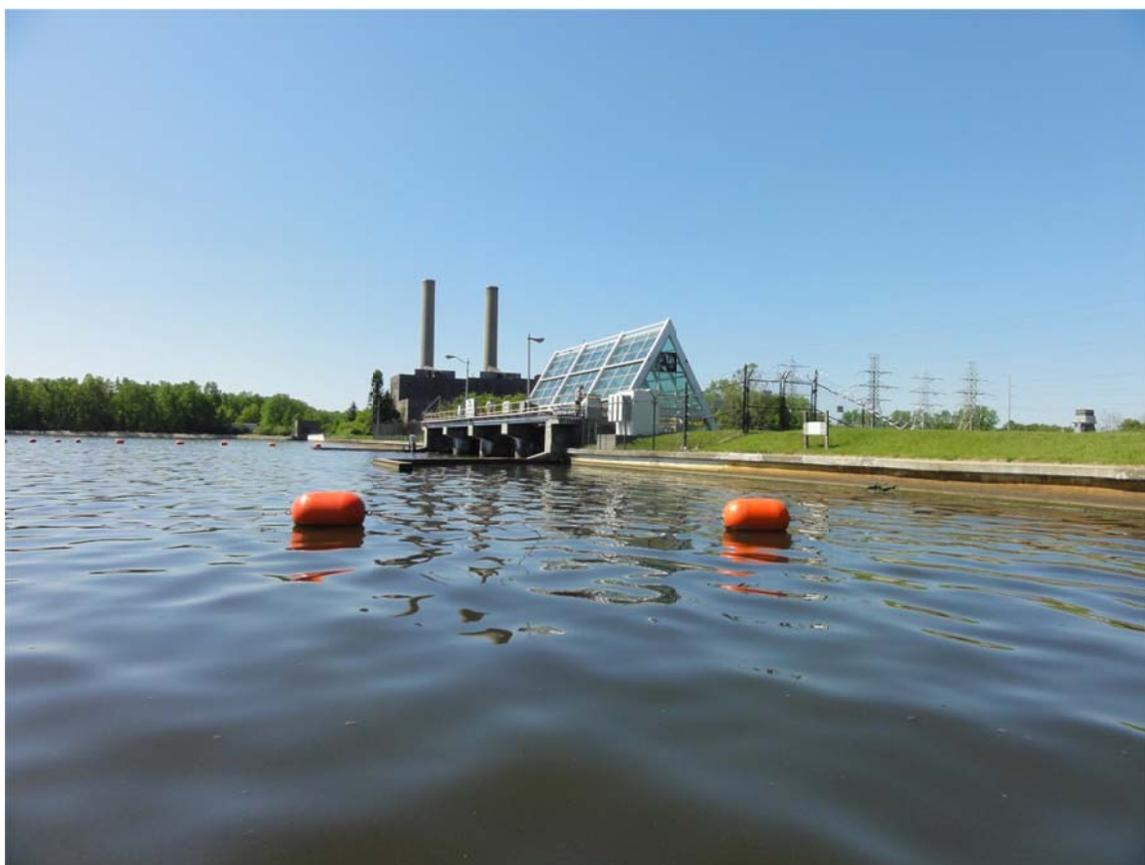
12. Morrow Lake Dam, no sheen observed.

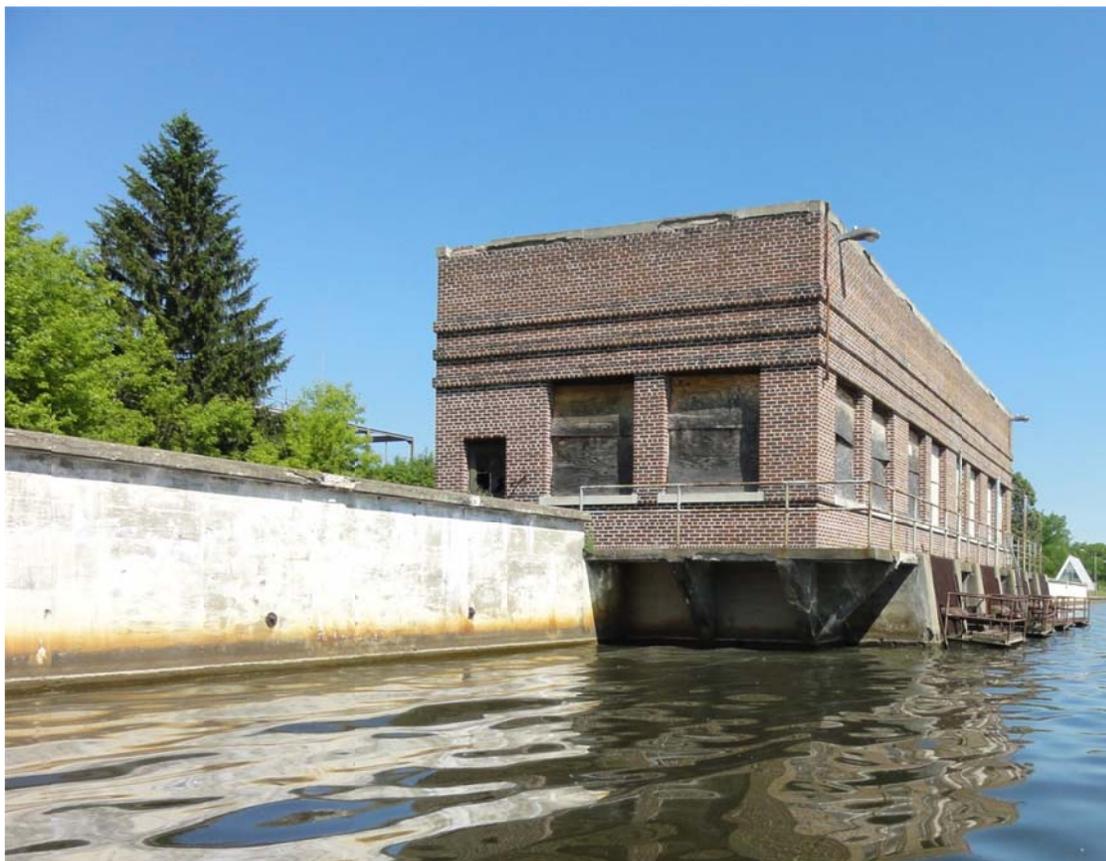
13. South side of Morrow Lake Dam, no sheen observed.

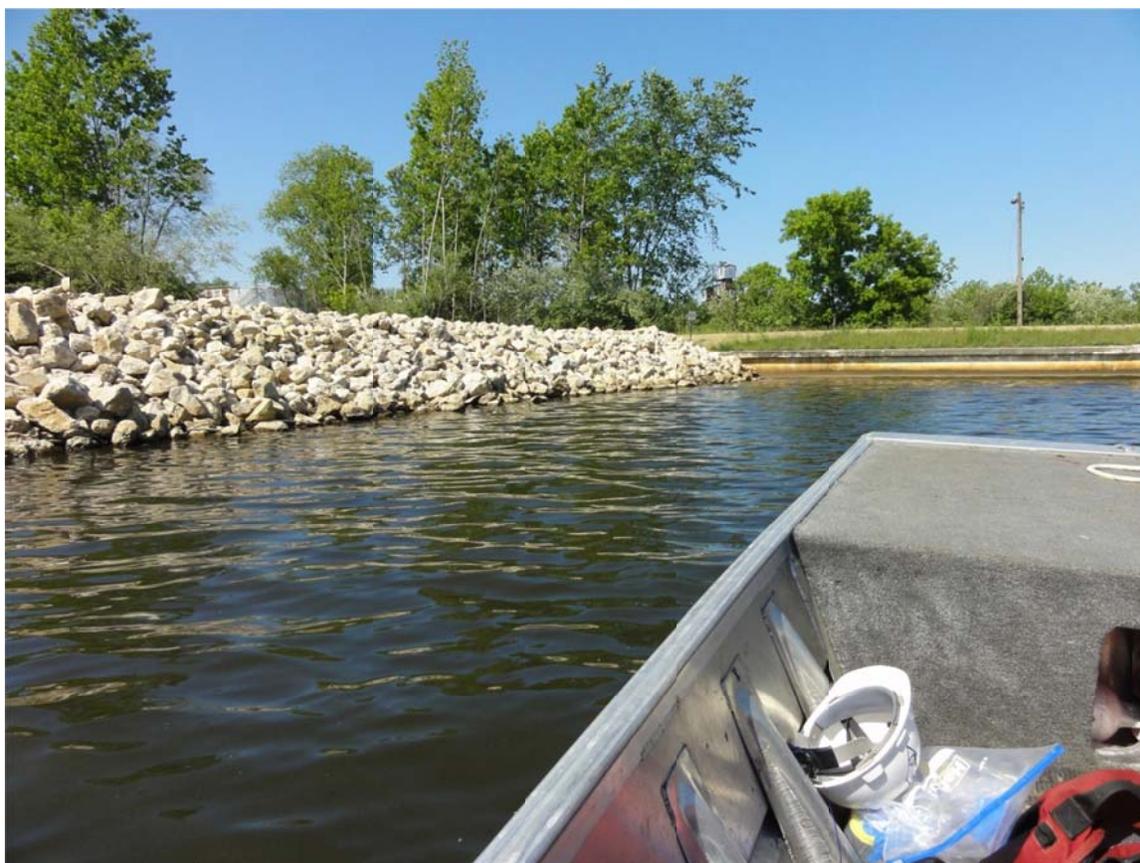
14. Southwest corner of Morrow Lake. No sheen observed.
