# Situation Photo Log

Friday, May 18, 2012

Kalamazoo River / Enbridge Spill

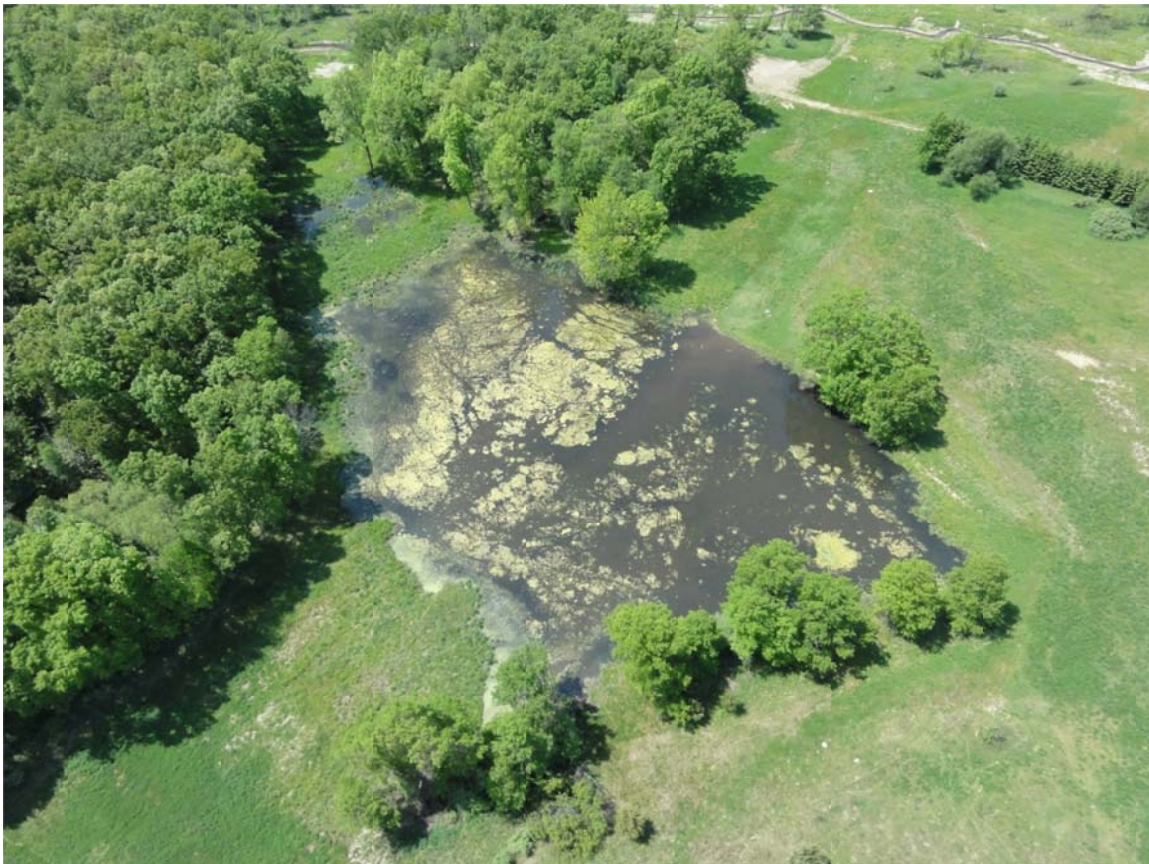
1. Source area pond, no sheen observed.

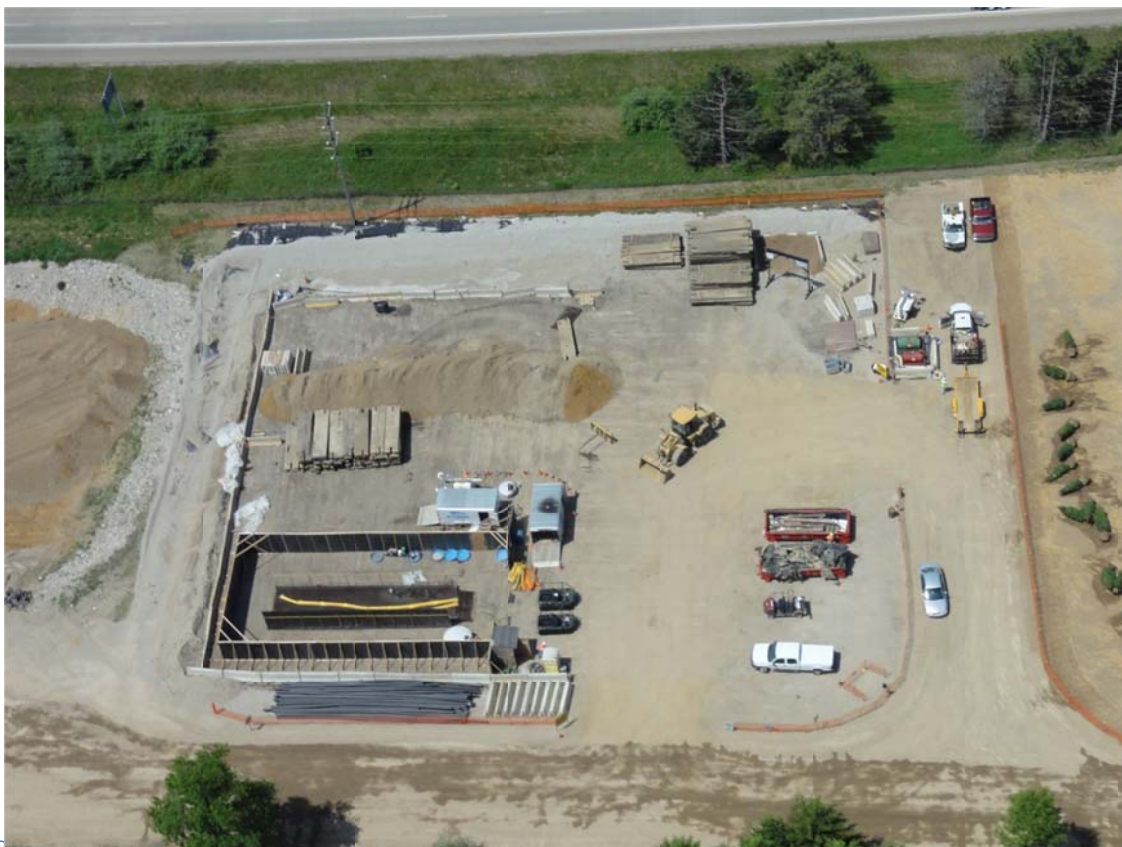
2. Frac-Tank City decon pad and soil cells. Boom observed in decon area.

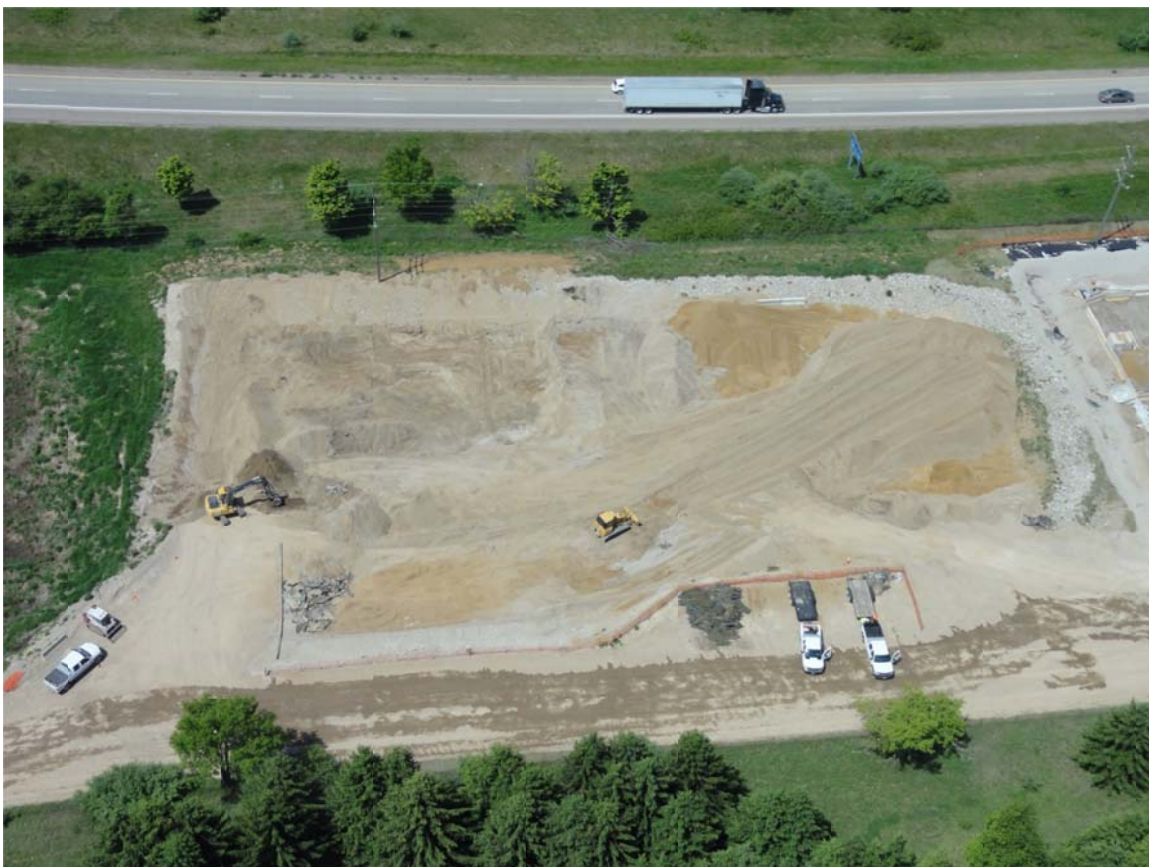
**3. Frac-Tank City, footprint reduction continues.**

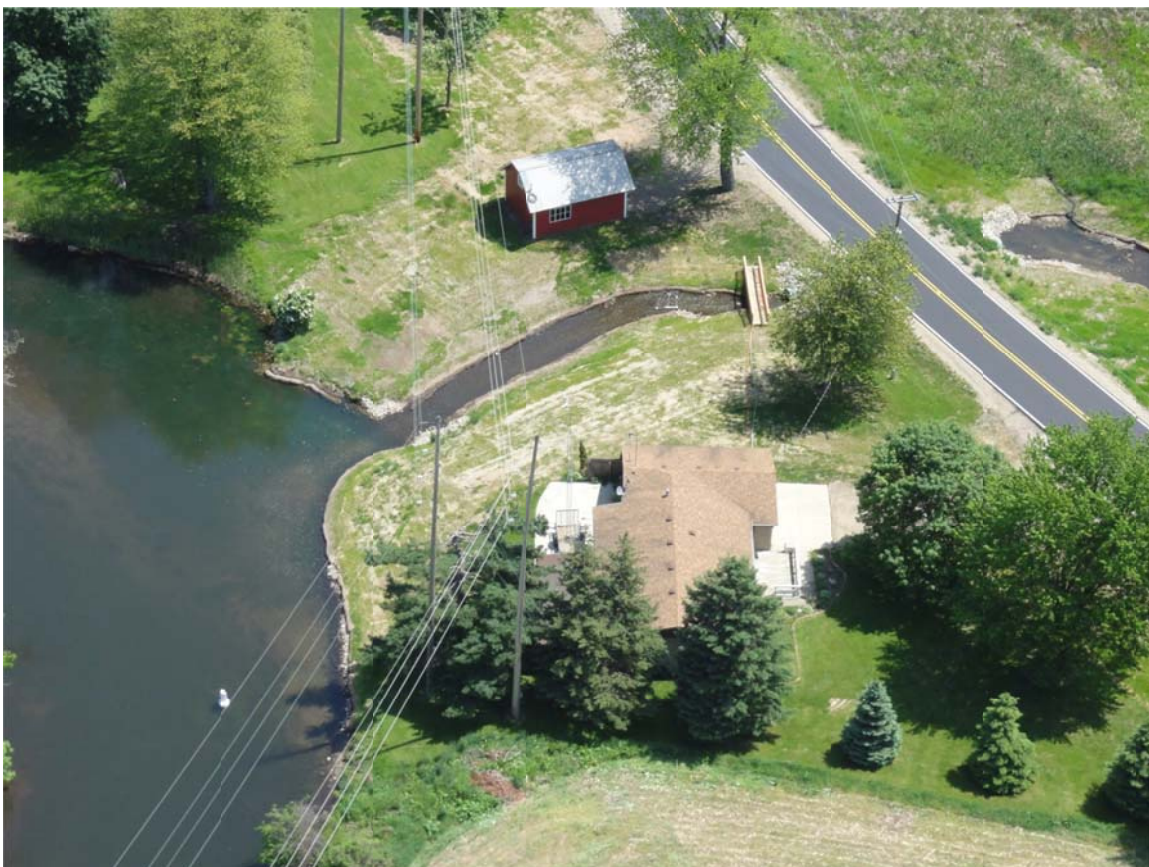
**4. Confluence, no turbidity or sheen observed.**

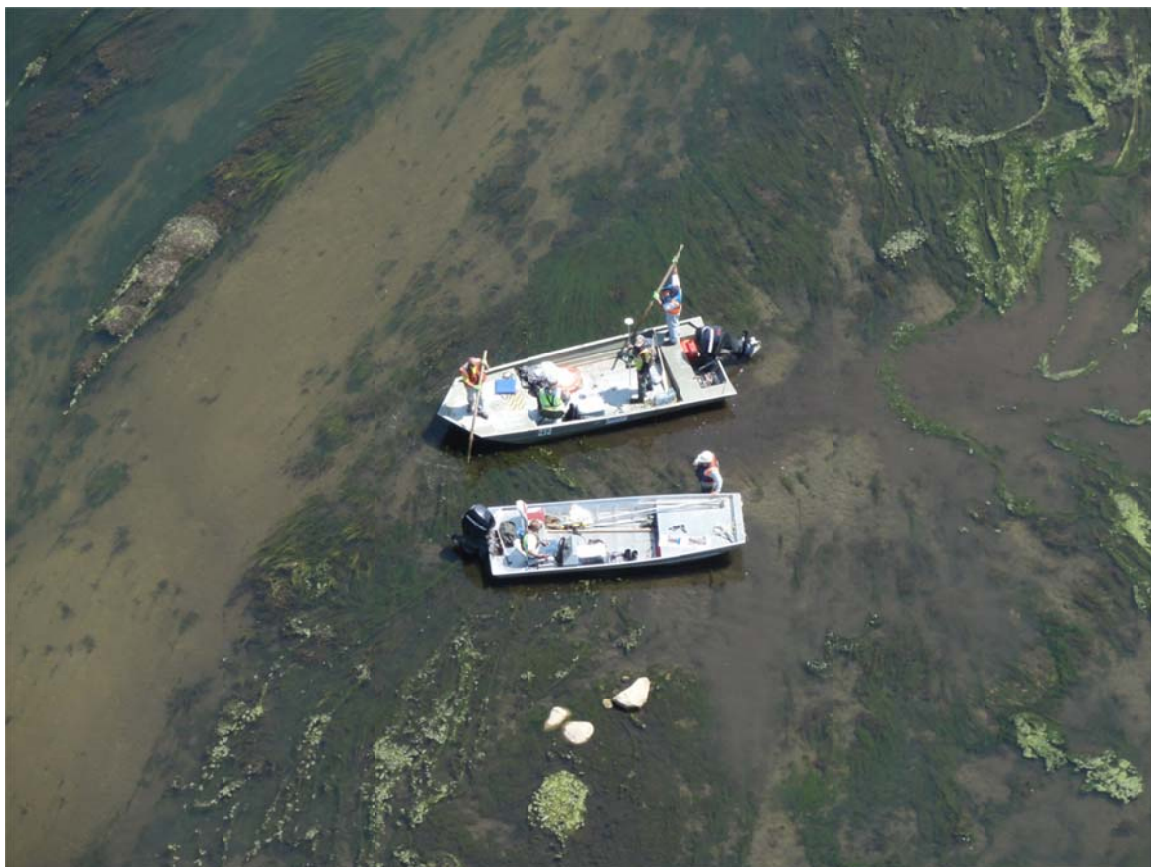
5. Former Island E location, poling crew observed.

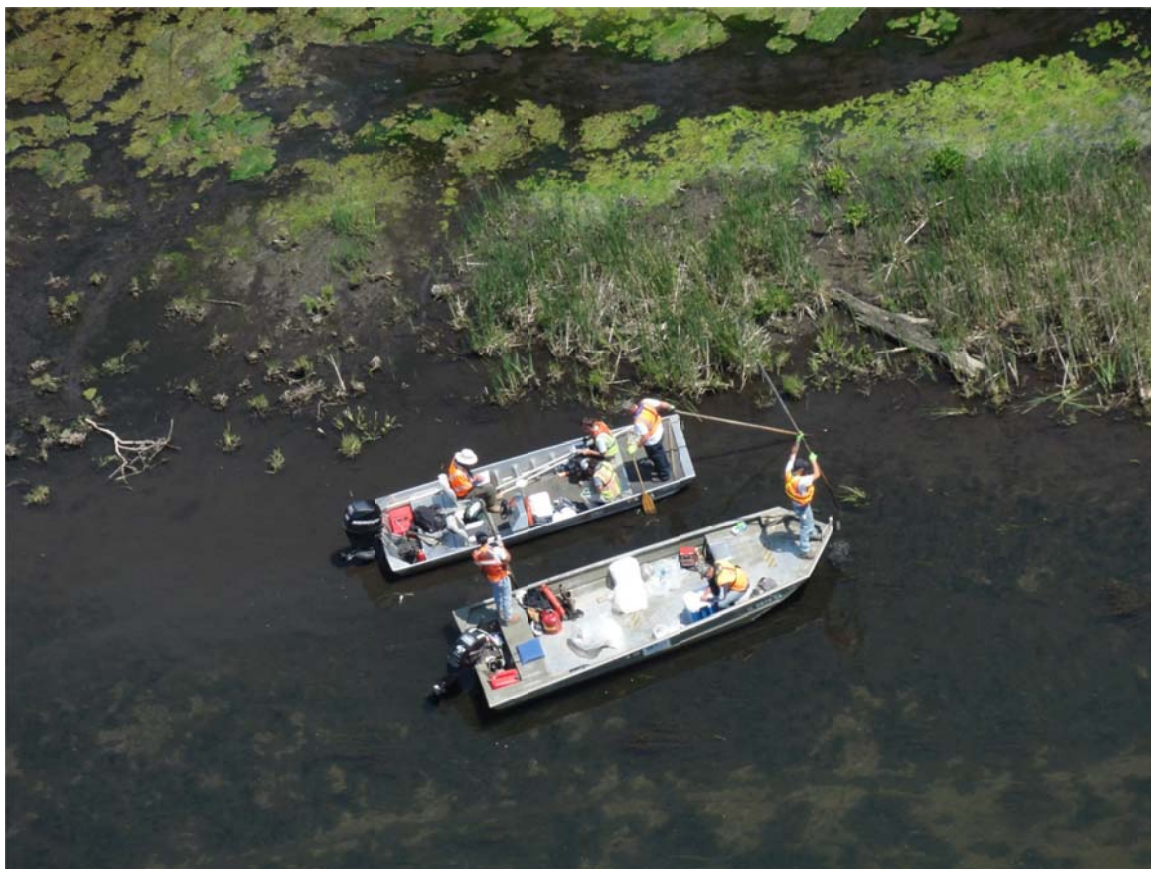
6. MP4.8 LDB, observed poling crews.

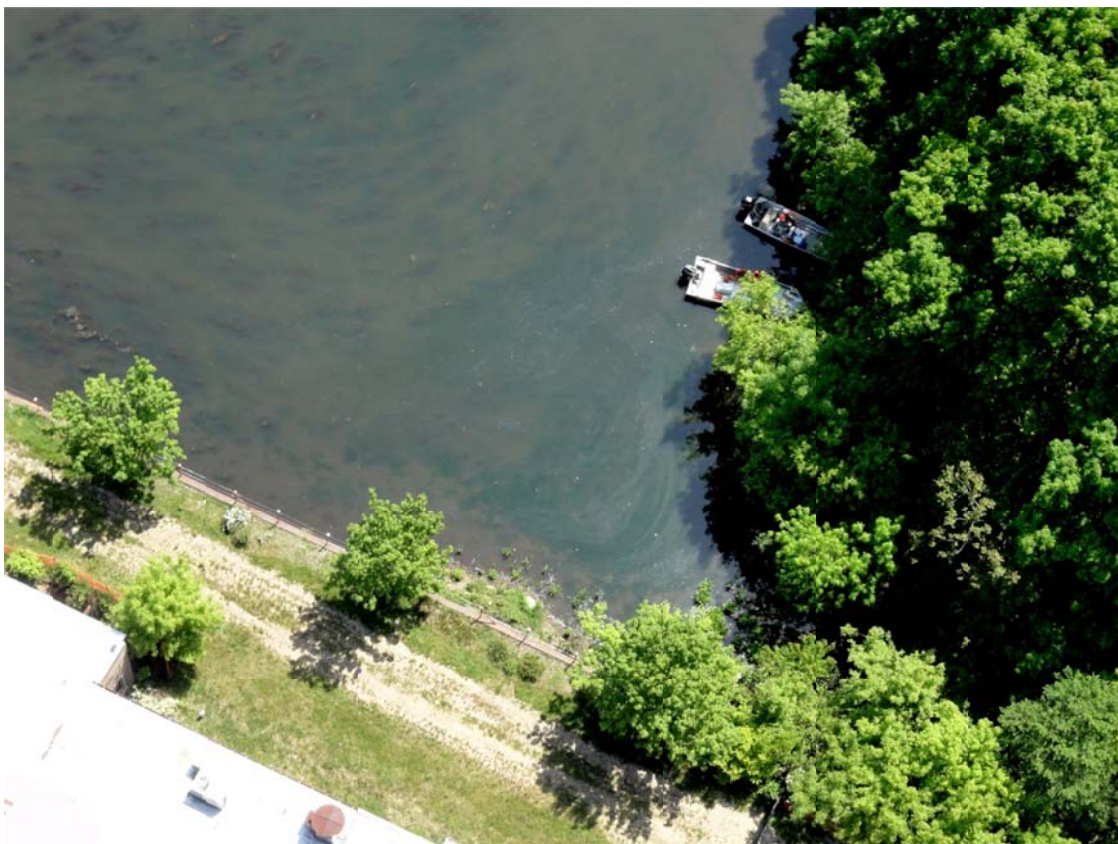
7. Southwest corner of river above Ceresco Dam, poling crews and sheen observed.

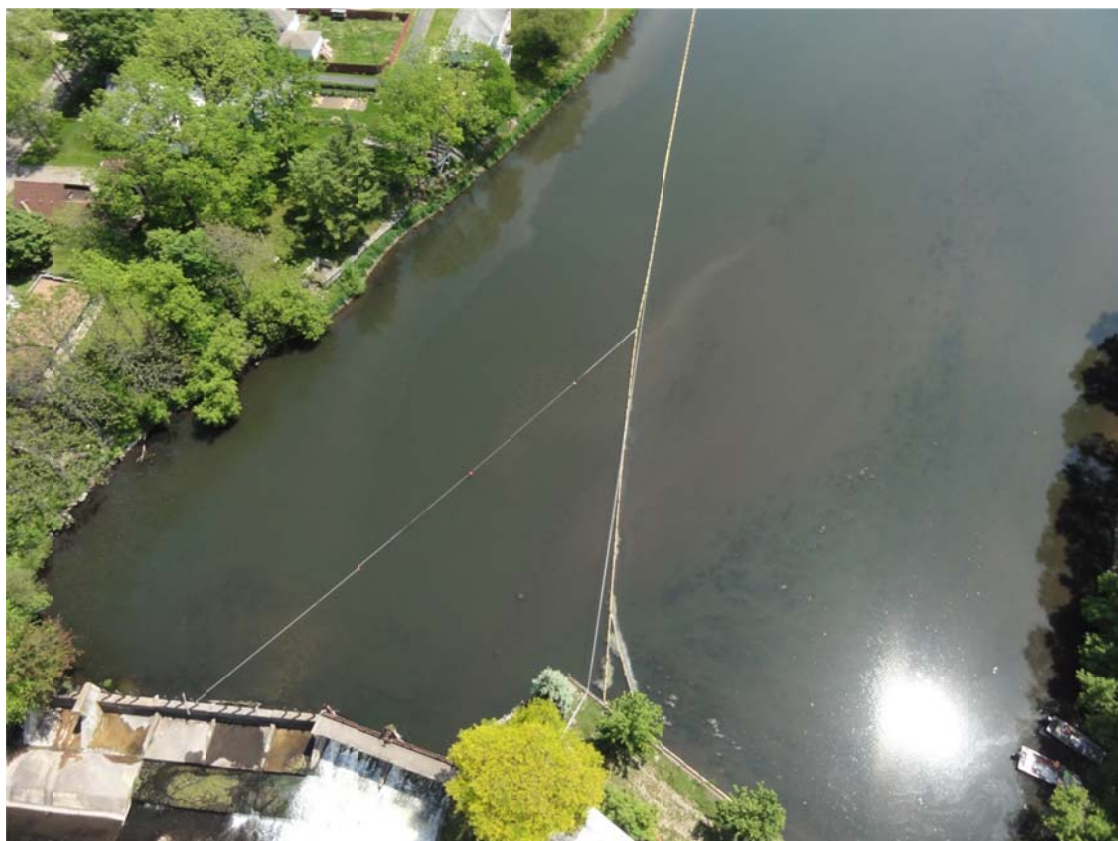
8. Control point above Ceresco Dam, sheen and some debris observed within containment.

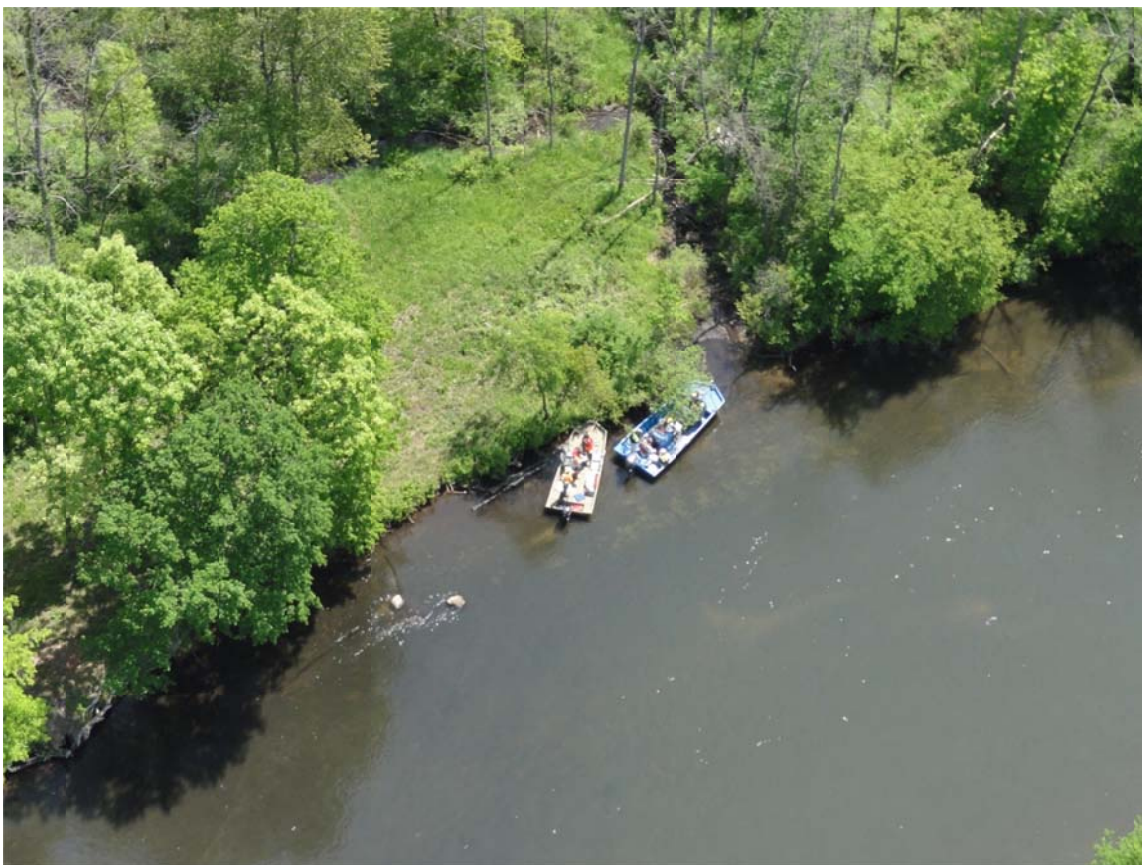
9. Poling crew observed near MP 6.5 RDB.

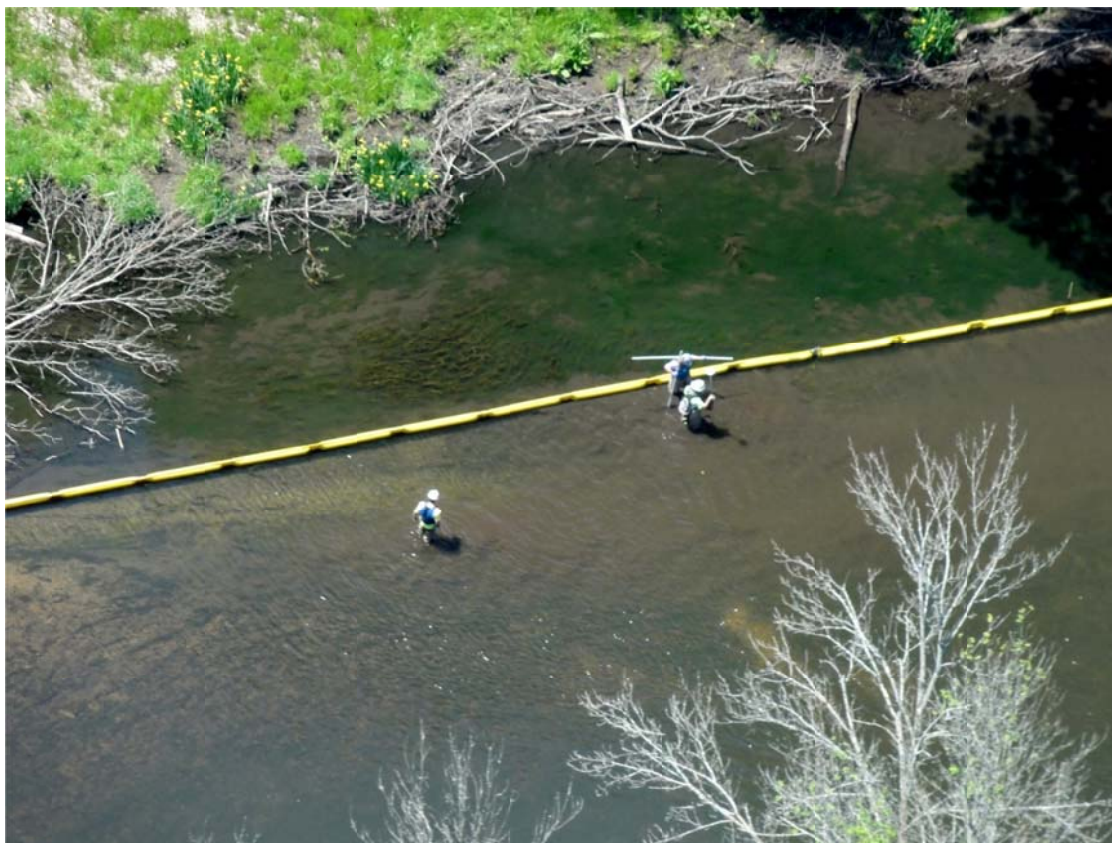
10. MP8.5 LDB, poling crew observed.

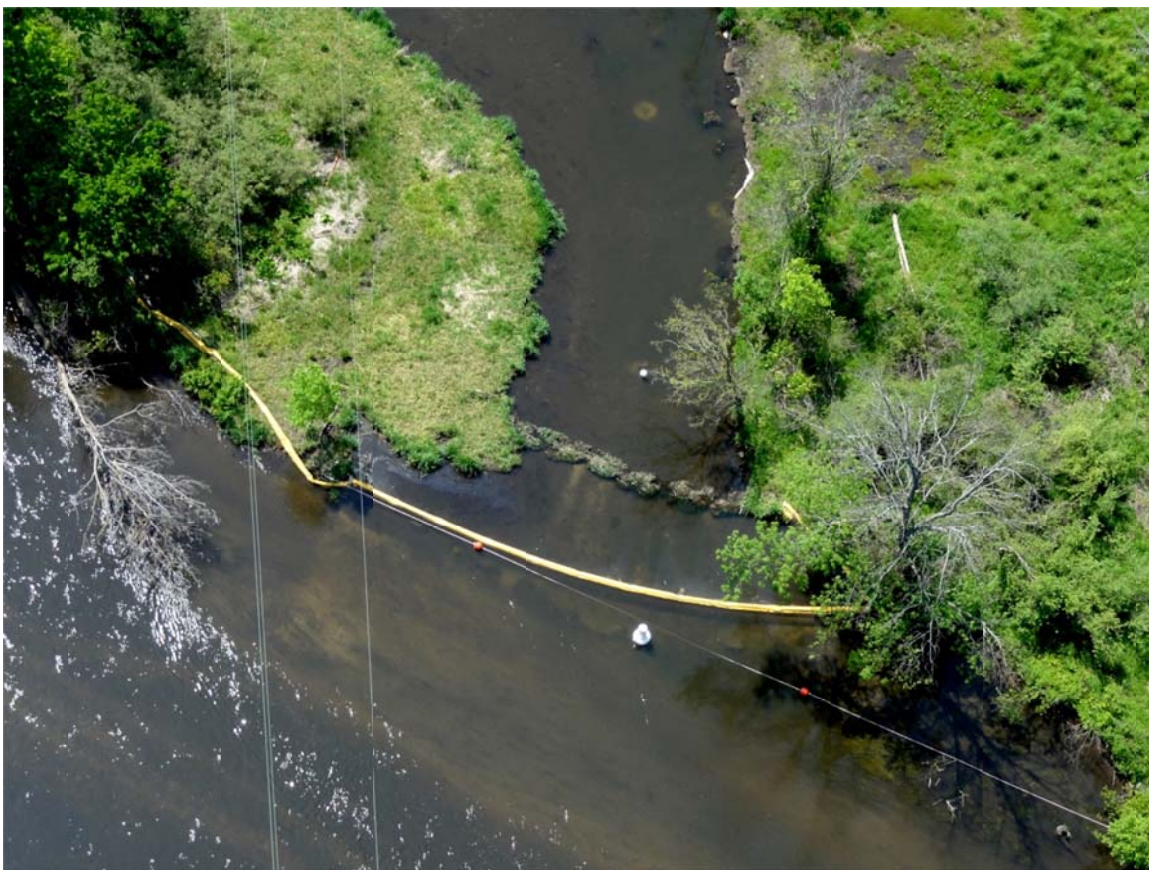
11. MP 10.75 LDB sediment trap, sheen observed within containment.

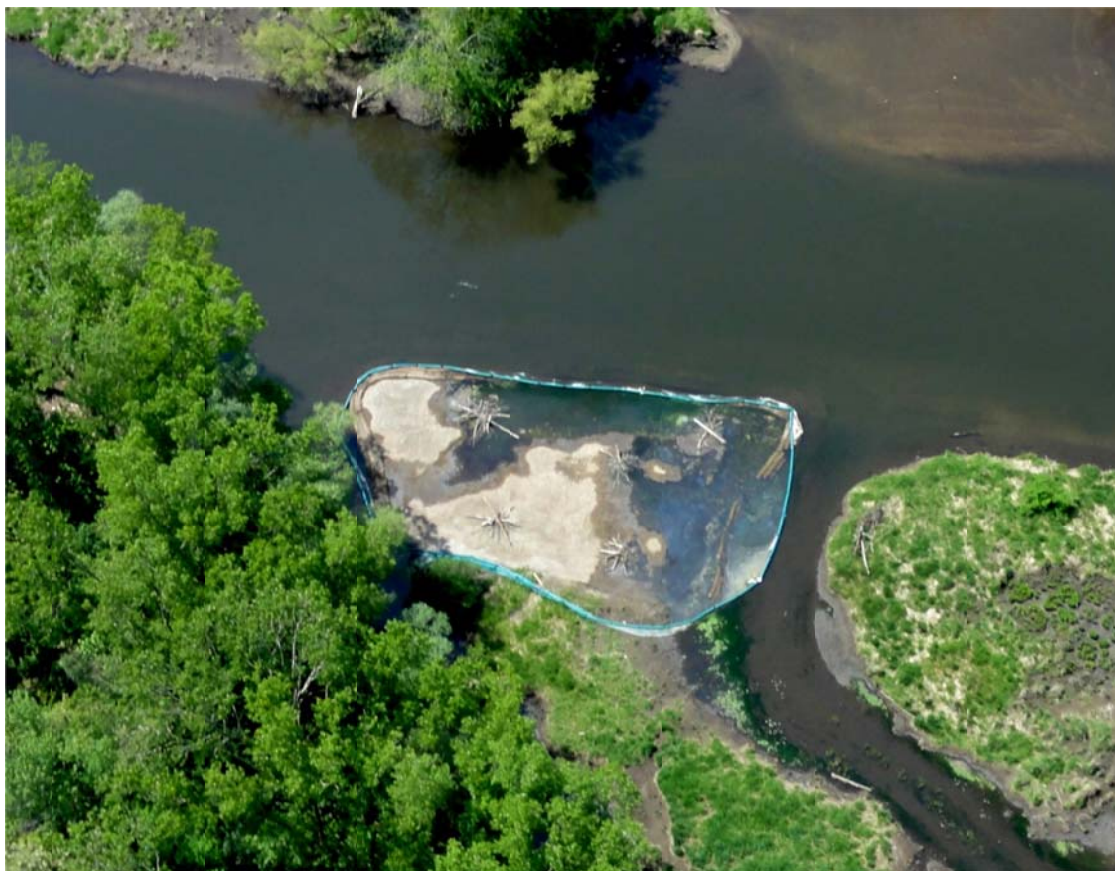
12. MP 14.98 Island, sheen observed. Sheen testing indicated that the material was biogenic.

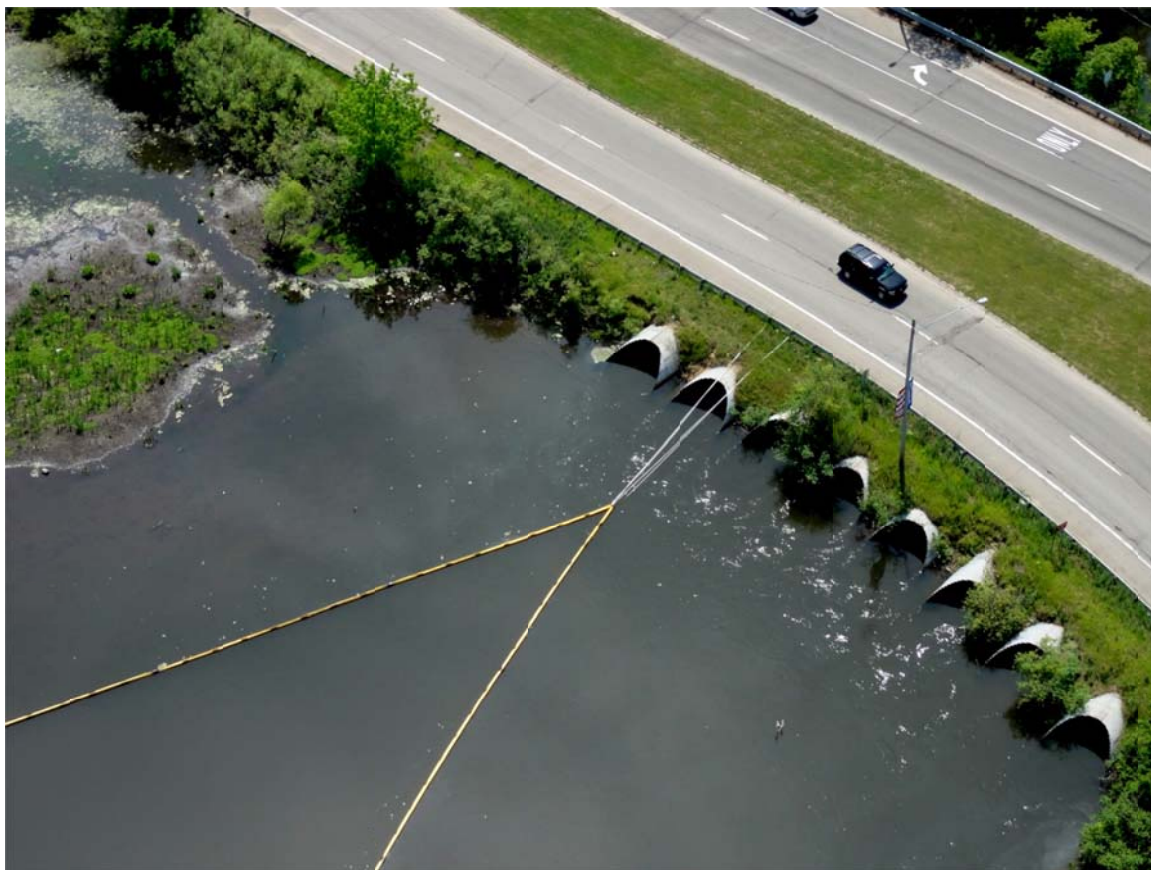
13. Control point at Battle Creek spillway. Sheen observed at culverts.

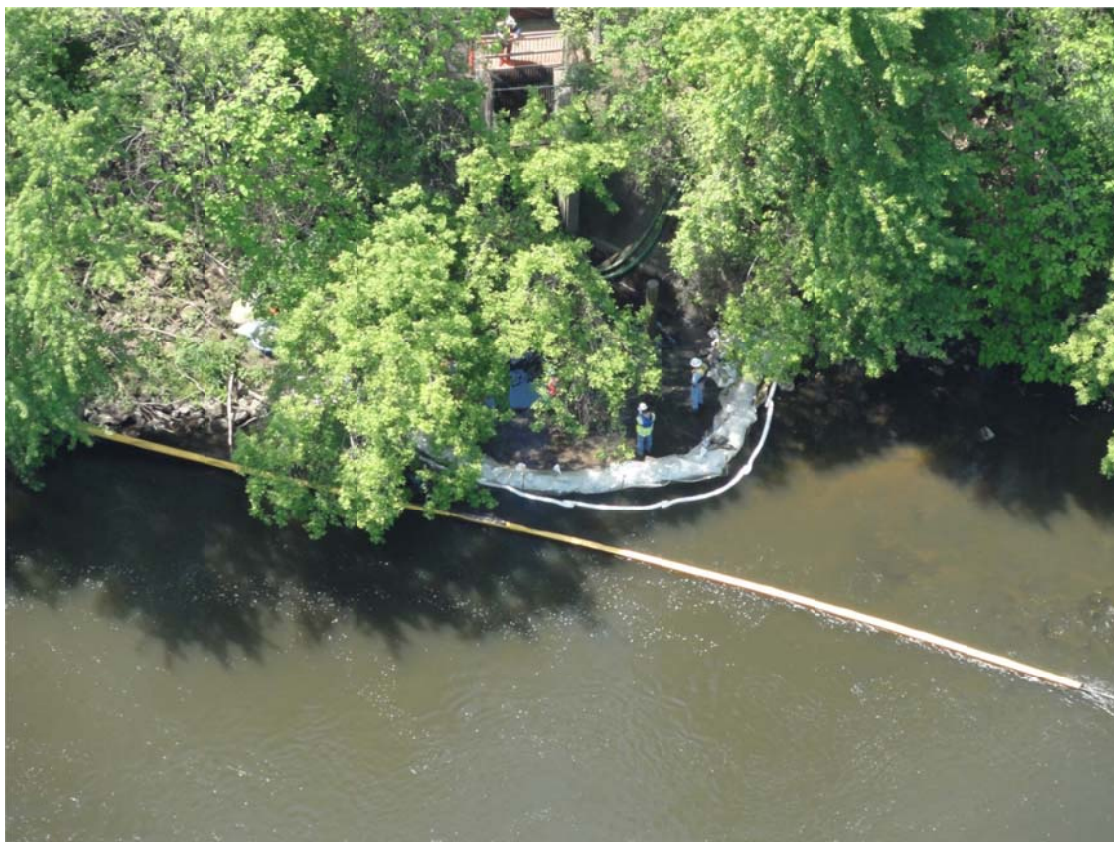
14. Rock Tenn inlet, crews observed cleaning inlet inside containment.

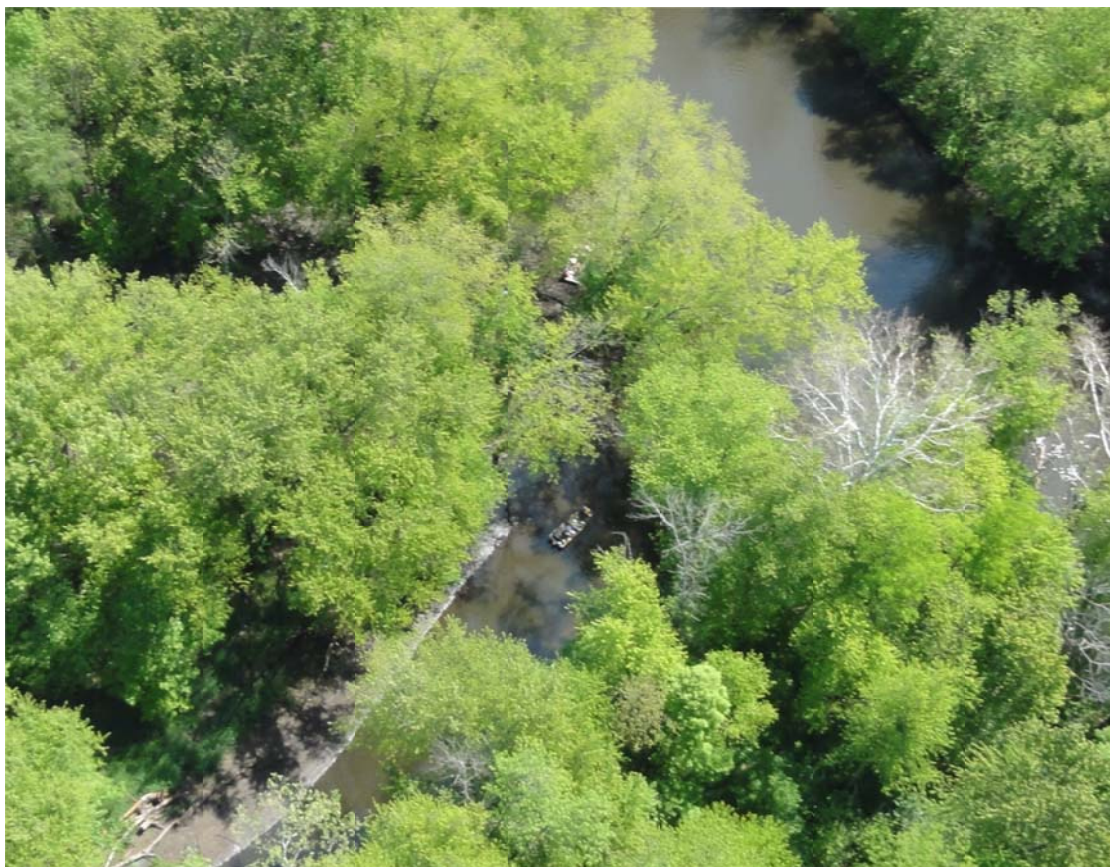
15. MP 28.25 oxbow, poling crews observed within oxbow.

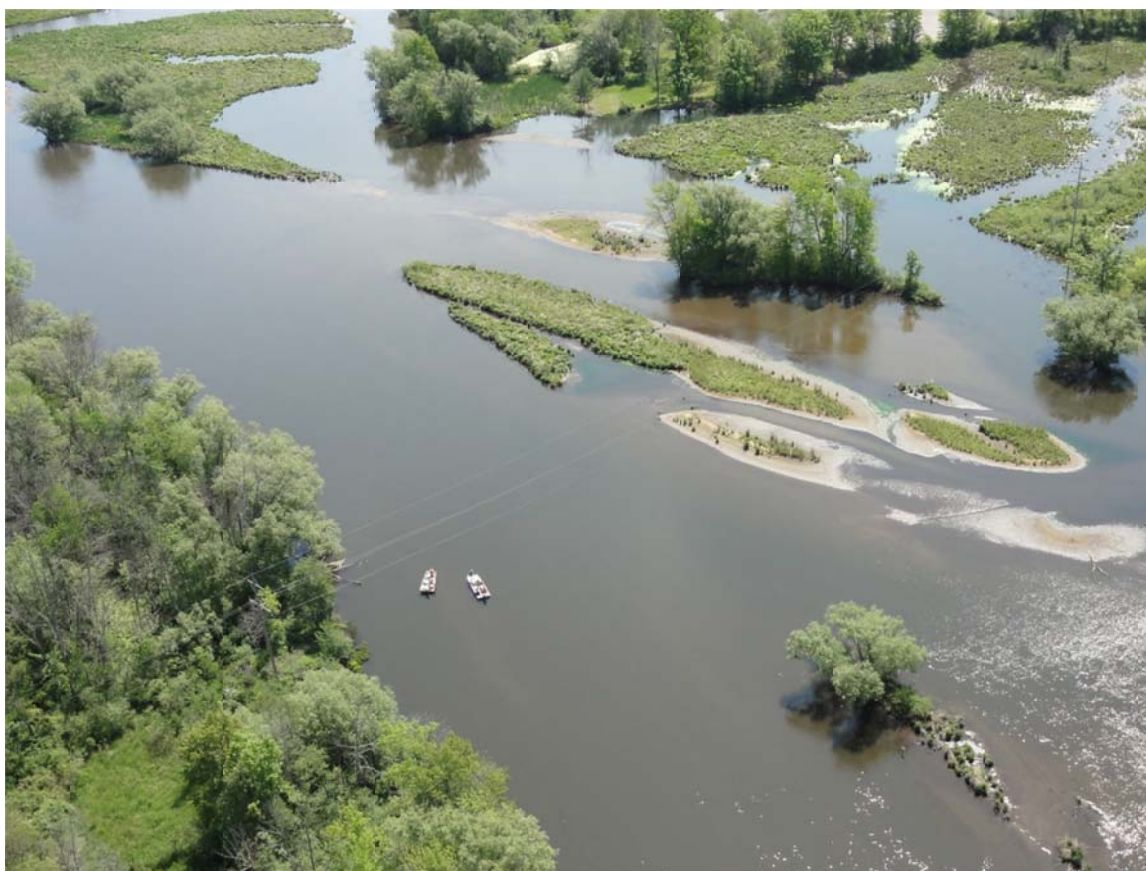
16. Morrow Lake Delta, one poling crew observed.

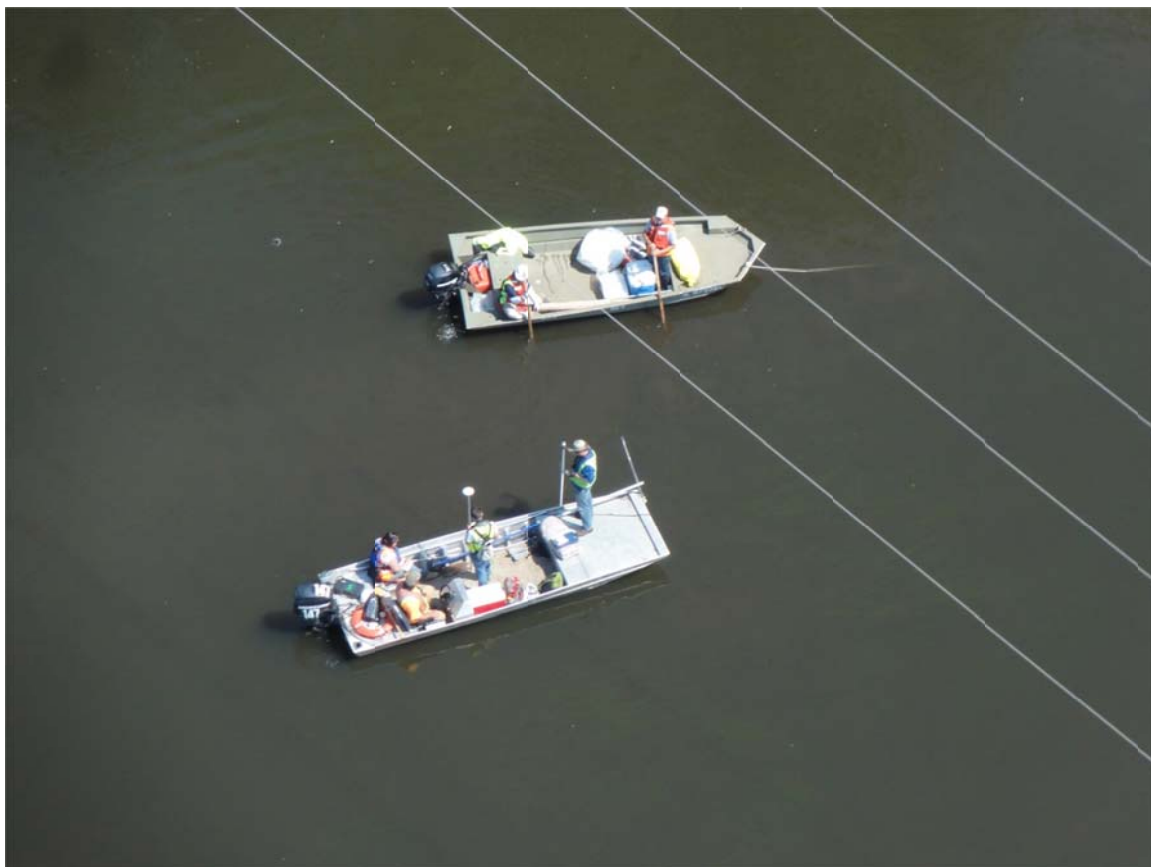
17. Poling crew in Morrow Lake Delta, no sheen observed.

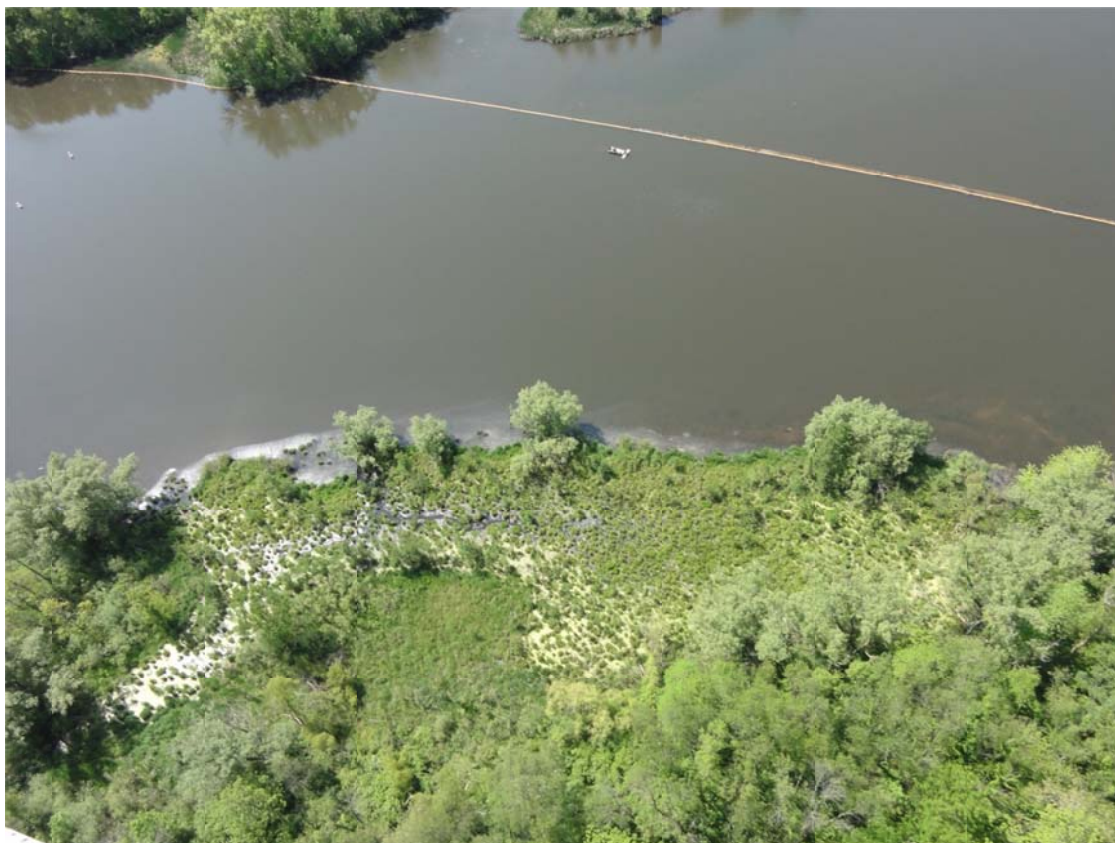
18. Control Point E4, sheen observed along northern shore.

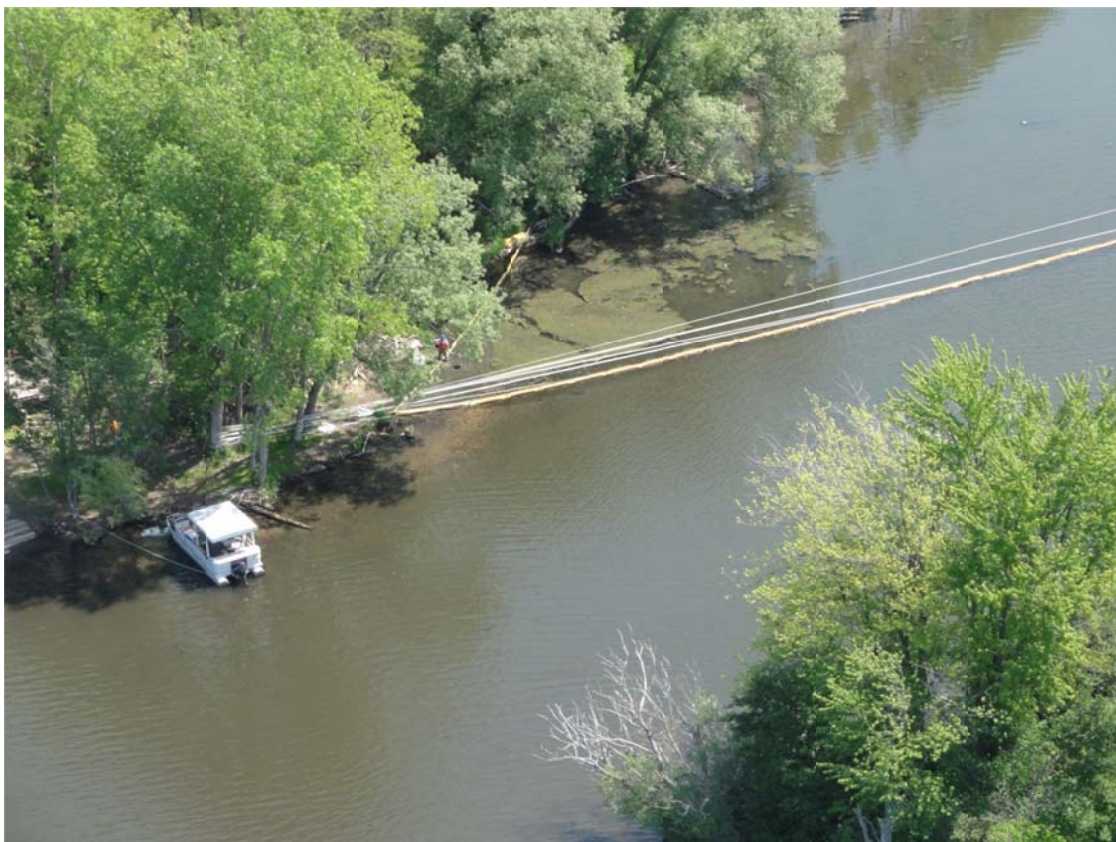
**19. Crews removing debris from Control Point E4.**

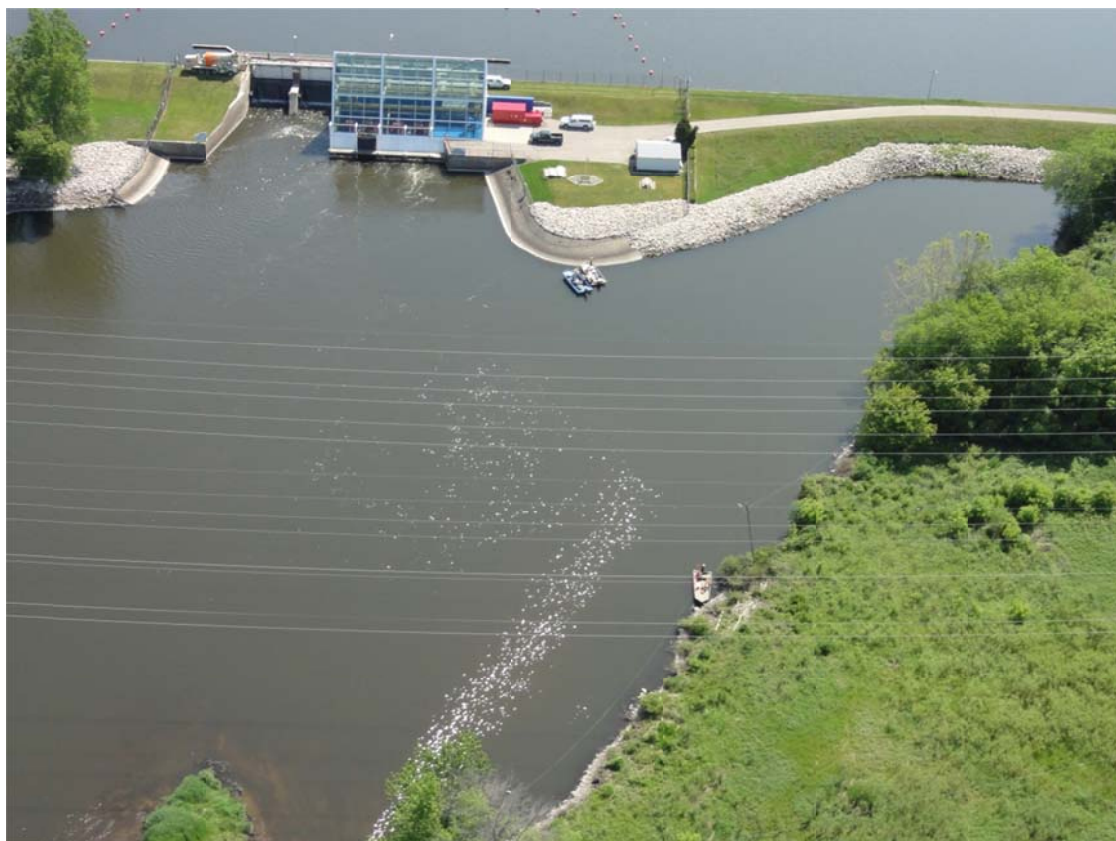
**20. Poling crew operating below Morrow Lake Dam.**

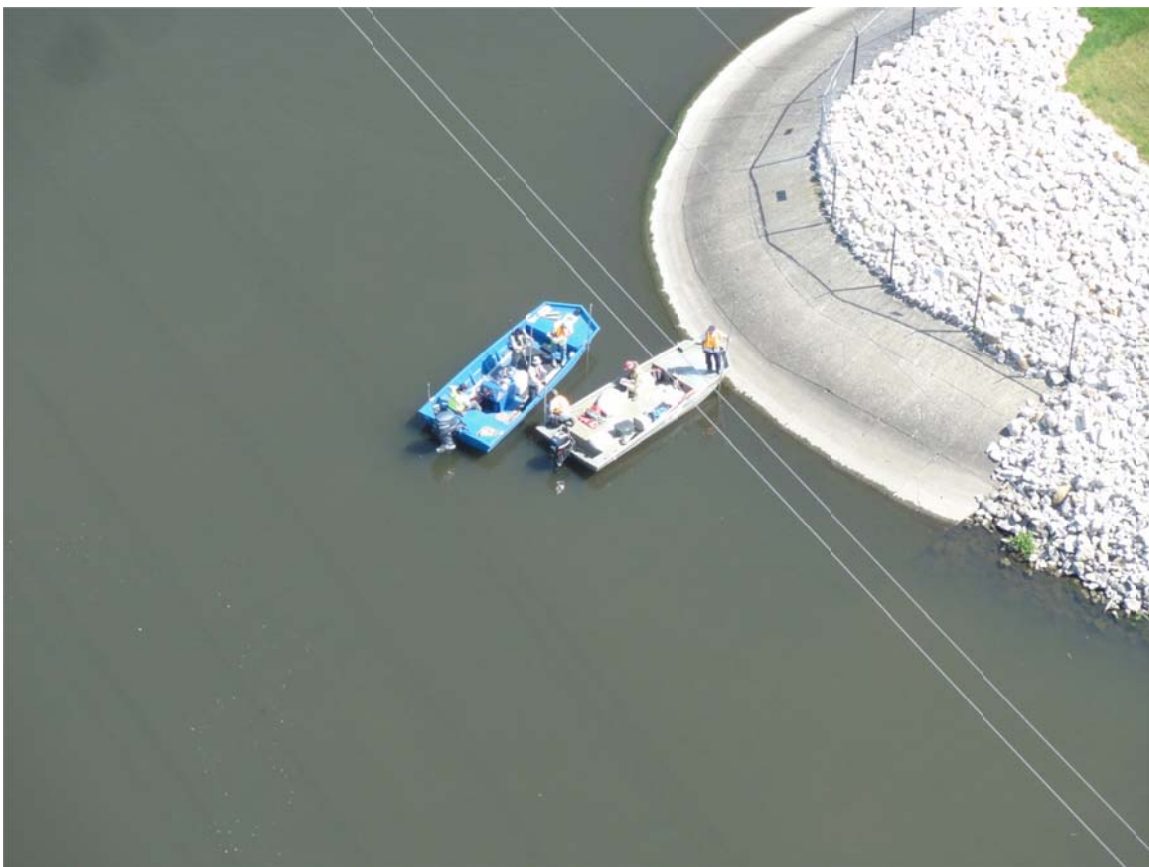
21. Poling crew below Morrow Lake Dam.

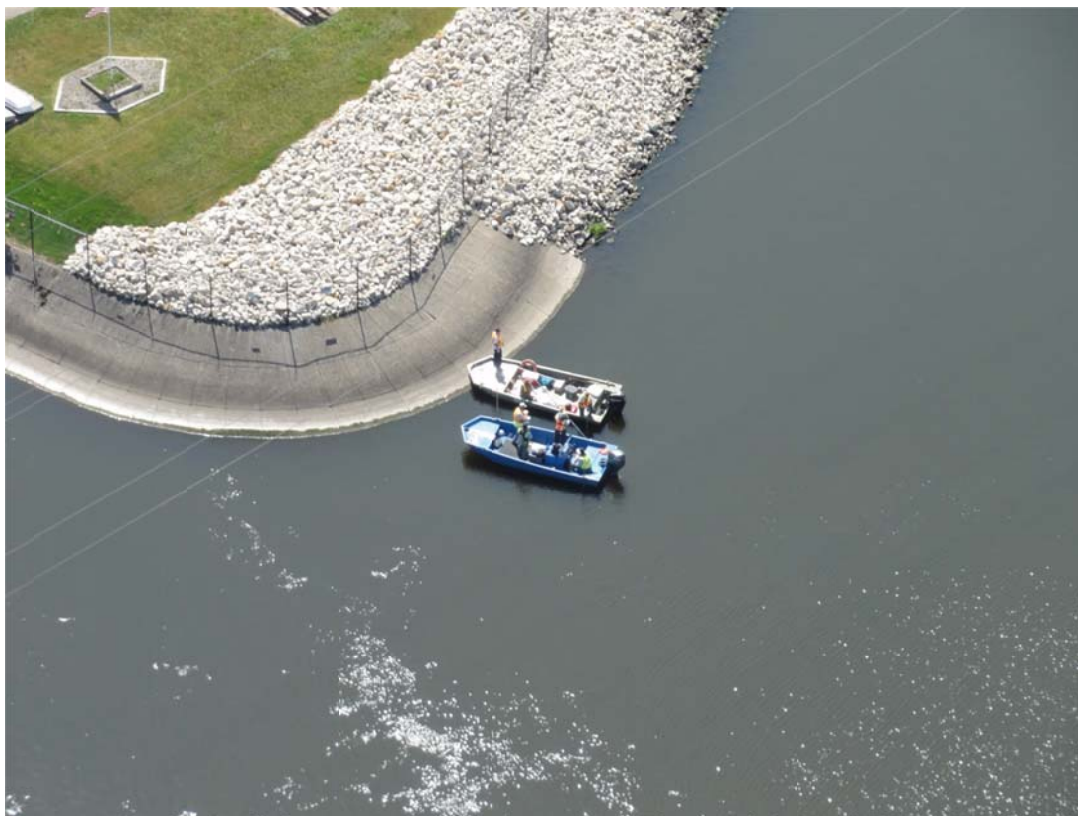
22. Poling crew below Morrow Lake Dam.
