# Situation Photo Log

Saturday, May 19, 2012

Kalamazoo River / Enbridge Spill

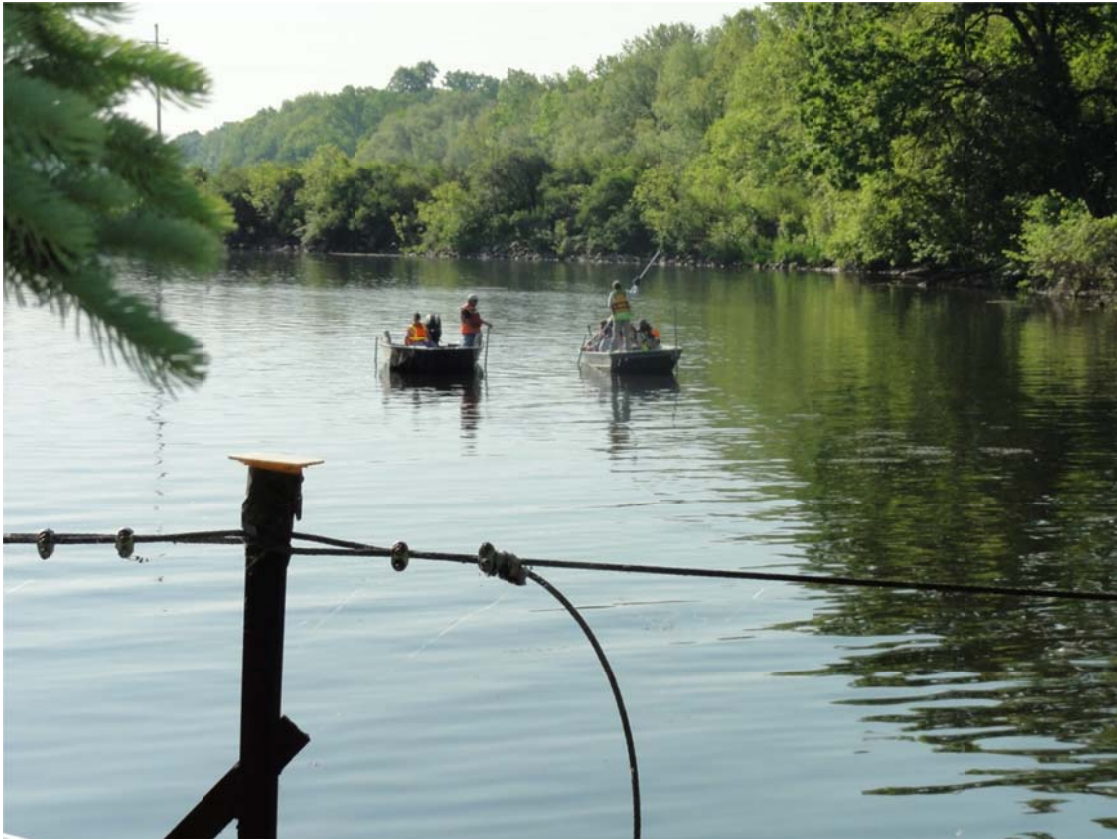
1. Poling crews working upstream of Ceresco Dam.

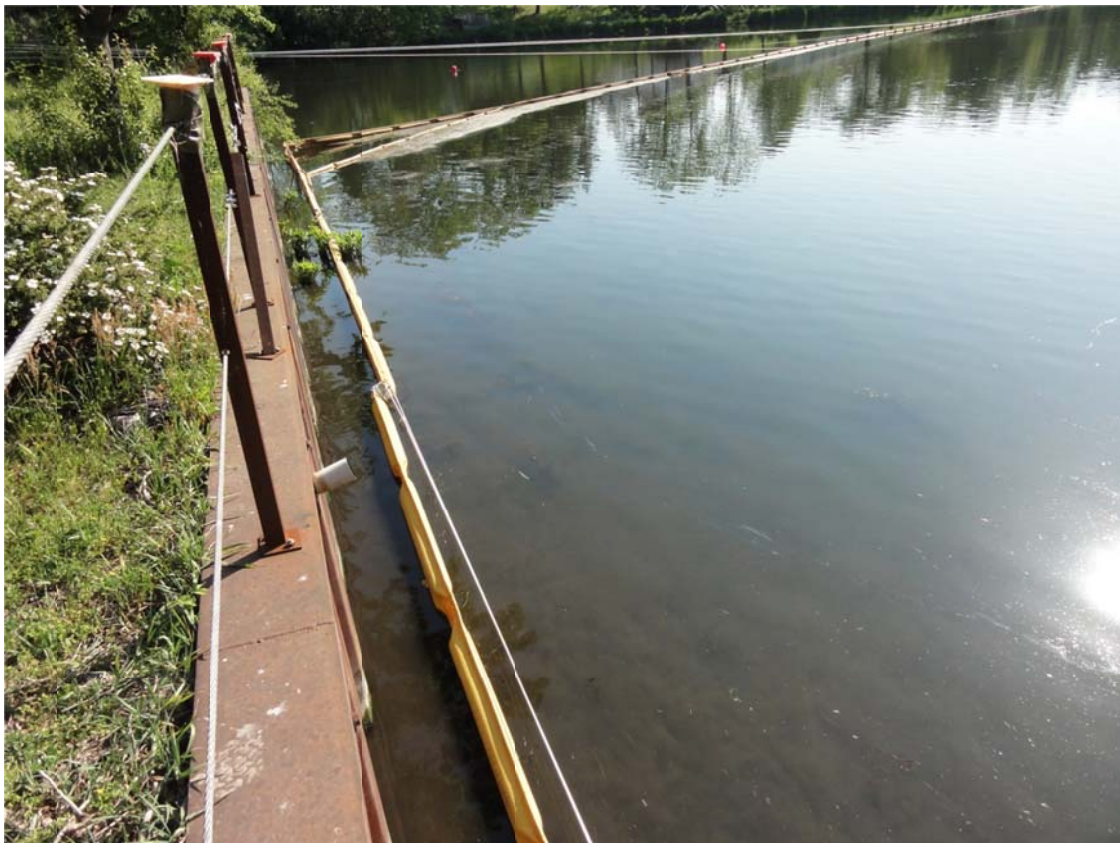
2. Sheen observed above Ceresco Dam within containment.

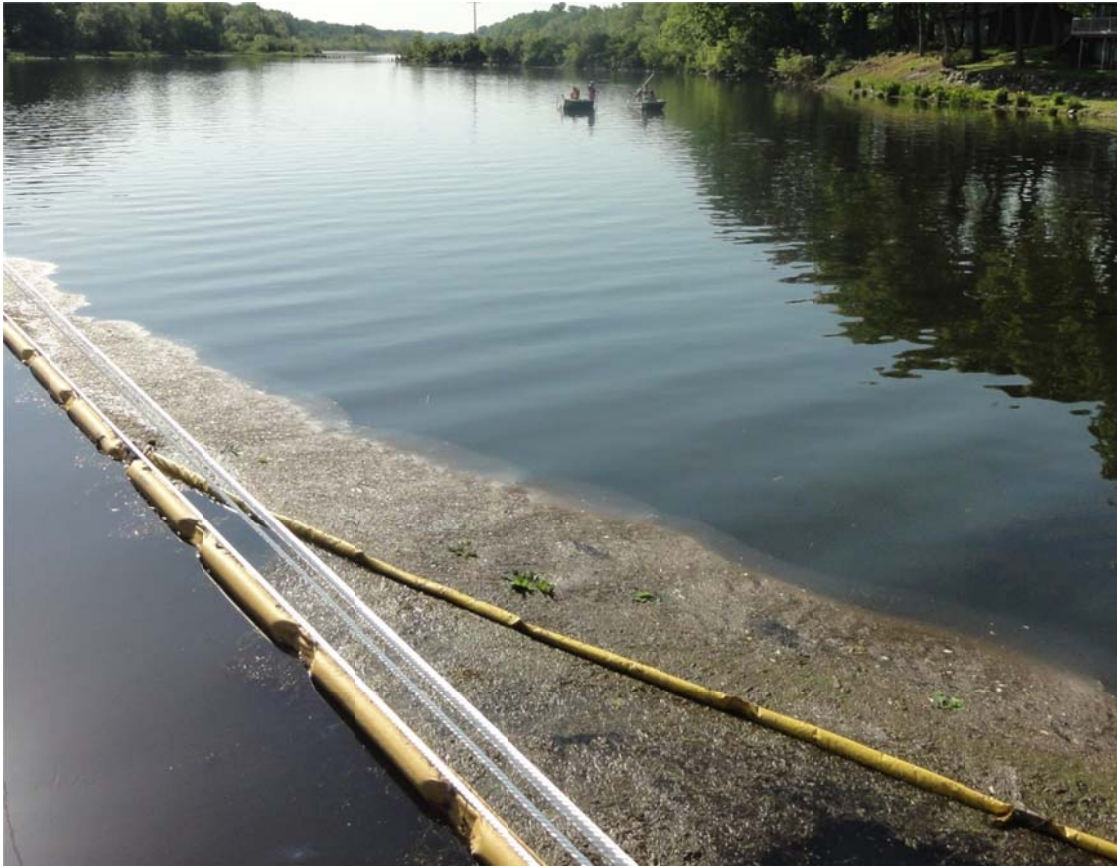
3. Control Point at Ceresco Dam, sheen and debris observed in containment.

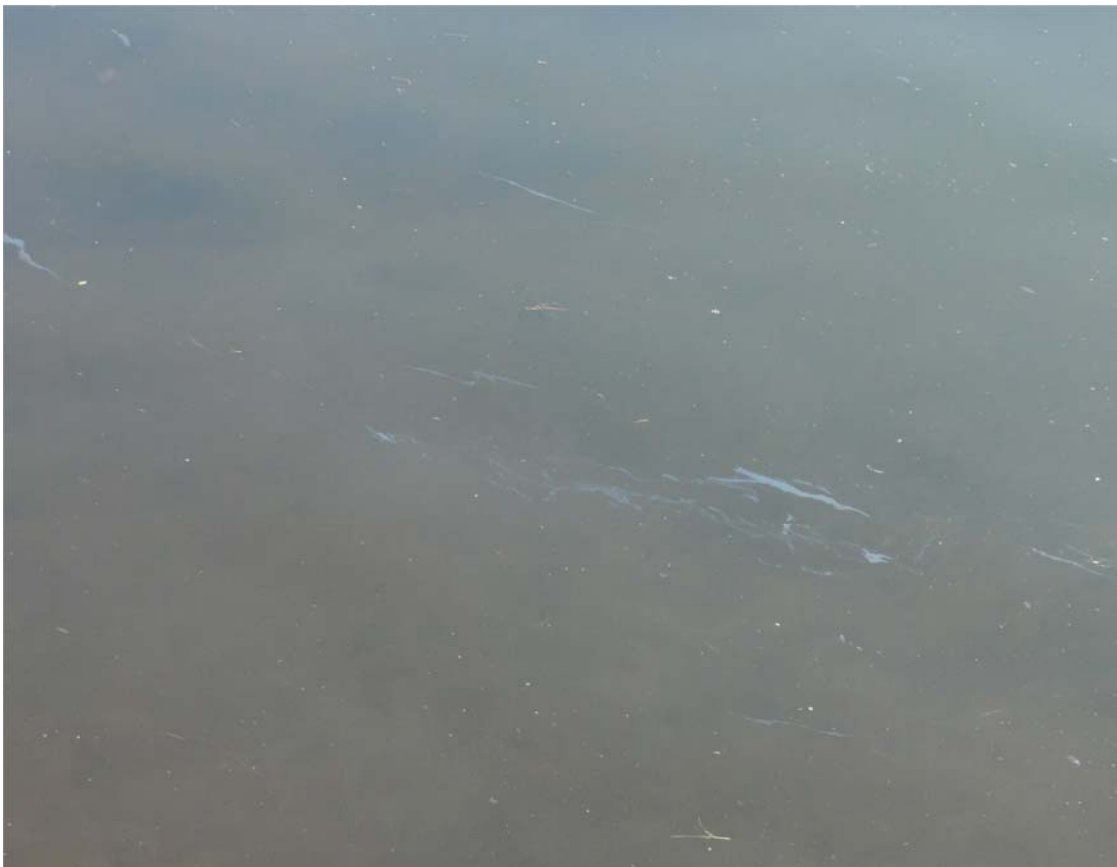
4. Sheen ribbons observed within containment above Ceresco Dam.

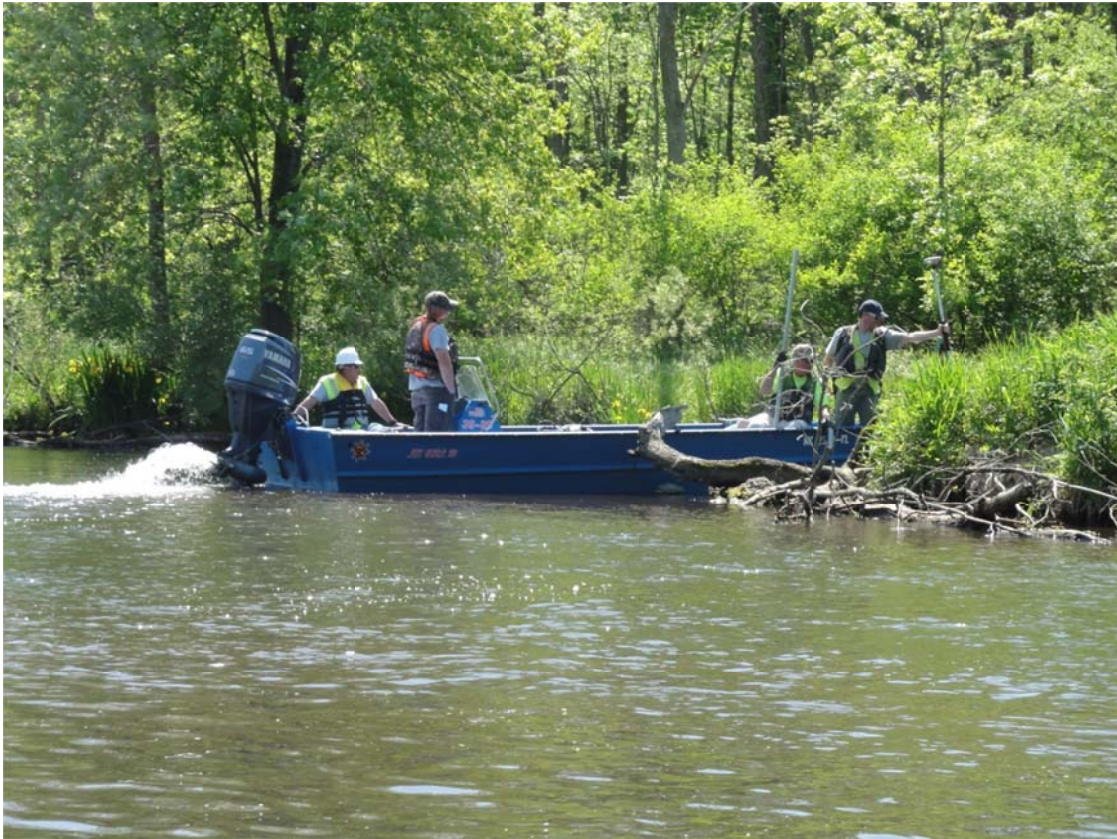
5. Poling crews near MP 6.75.

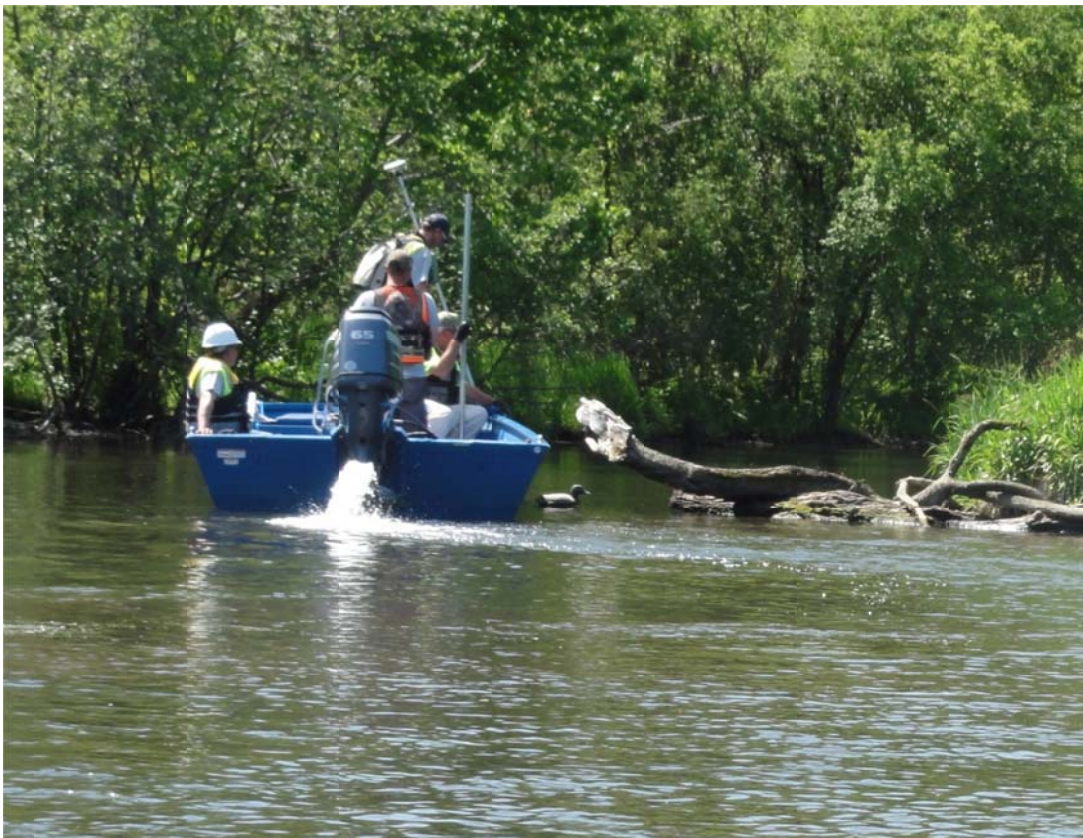
6. Poling crews near MP 6.75.

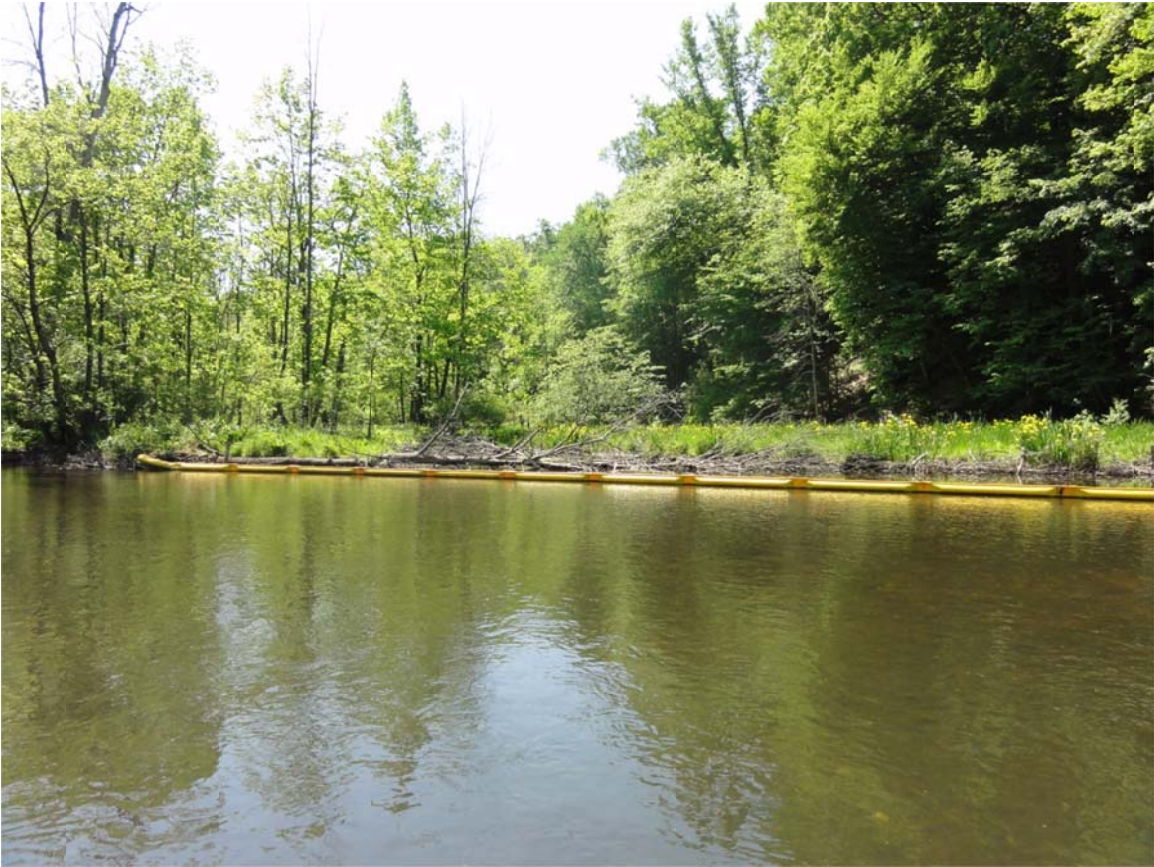
7. MP 8.48 containment boom.

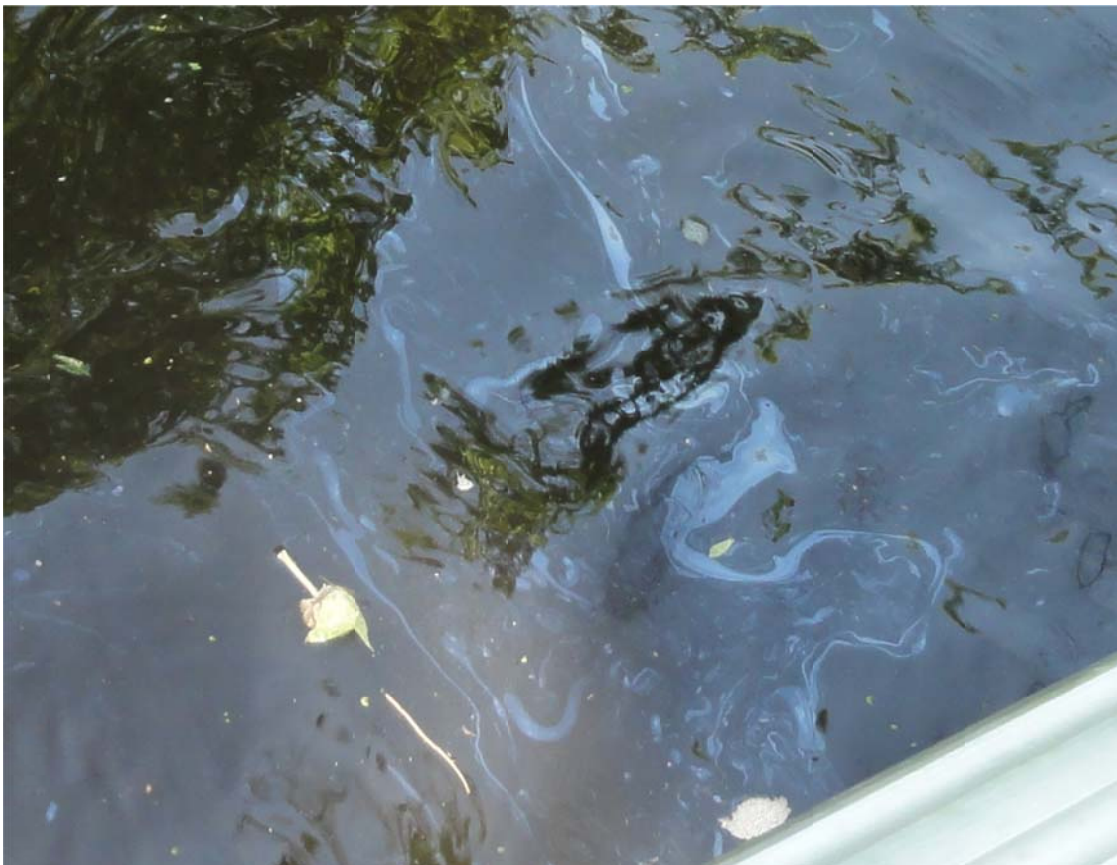
8. Sheen observed within containment at MP 8.48 LDB.

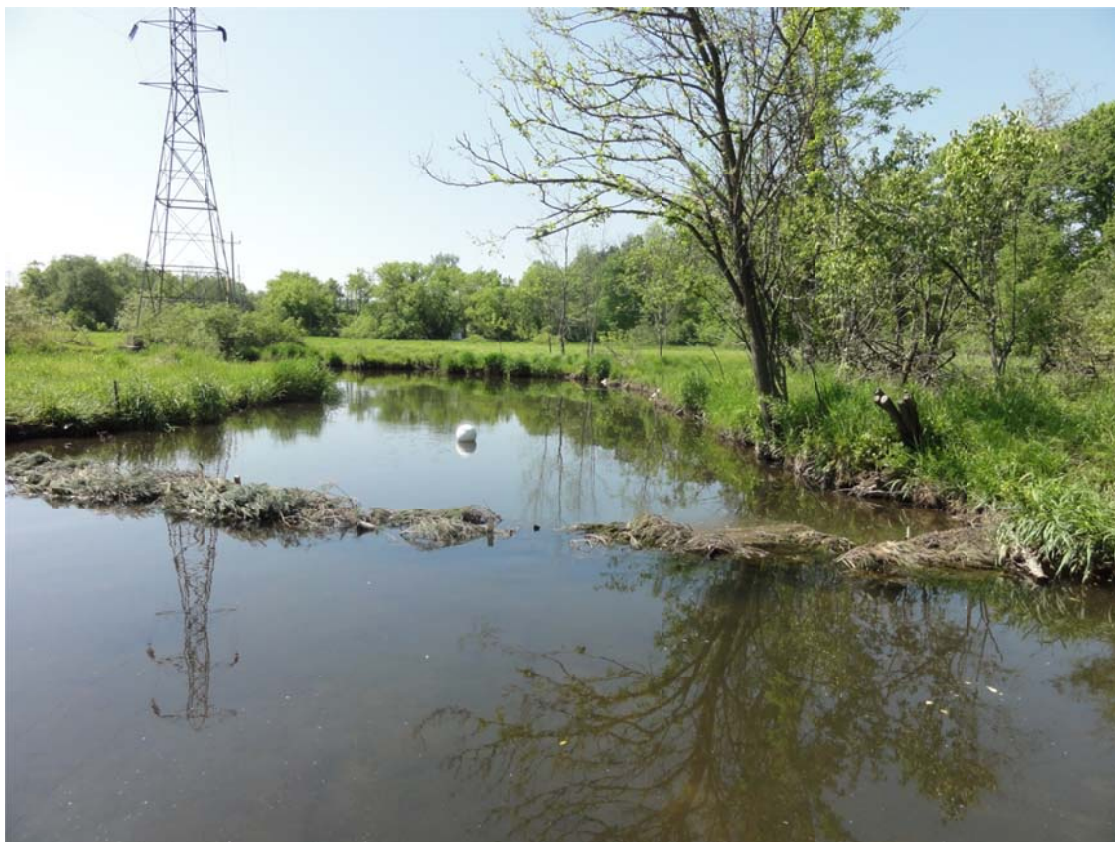
9. Sediment trap at MP 10.75 LDB. Sheen observed within containment.

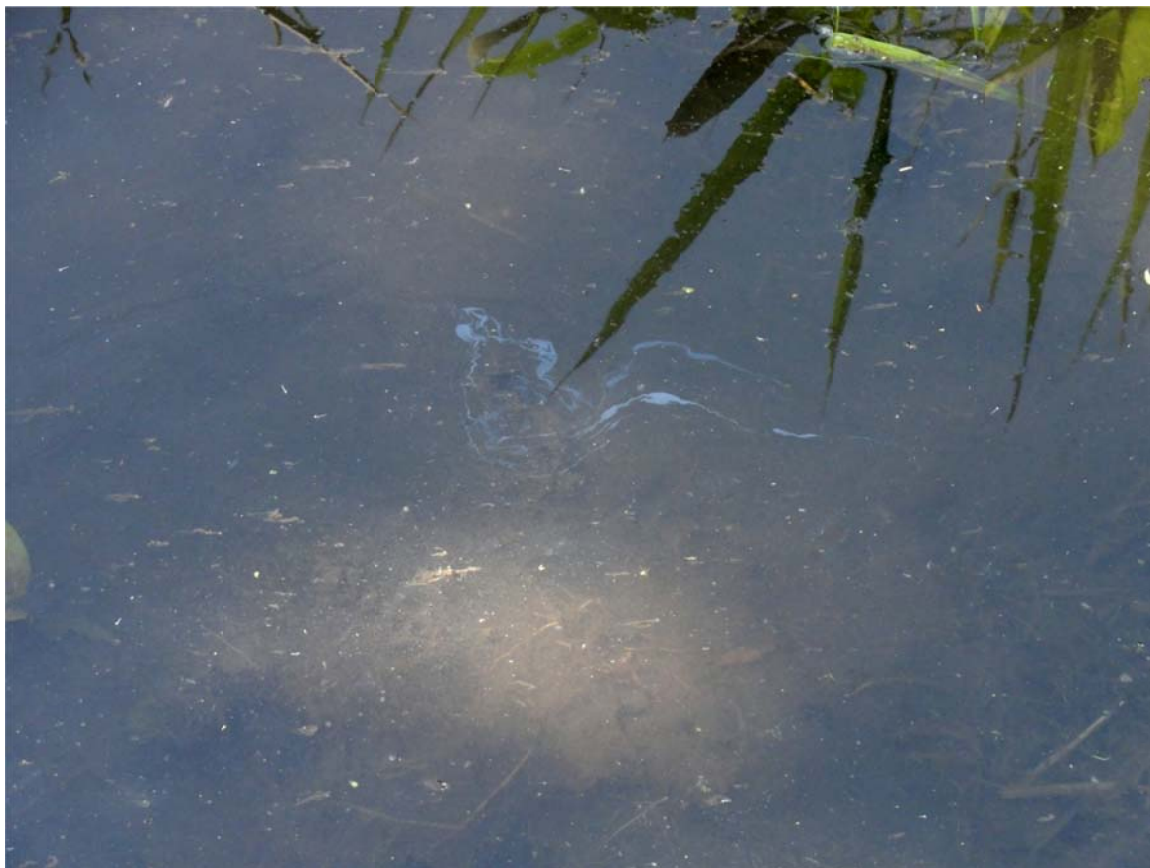
10. Sheen observed within containment at MP 10.75.

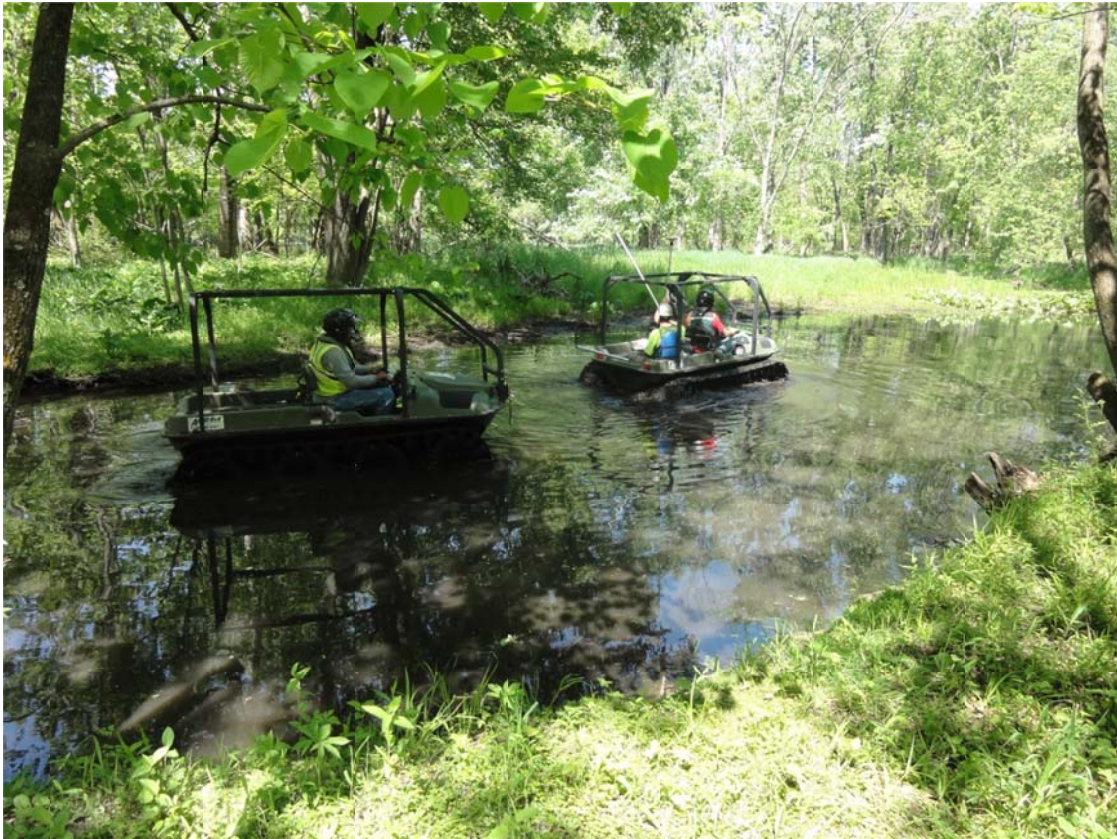
**11. Poling crews using ARGO all-terrain vehicles in backchannel near MP 11.25 LDB.**

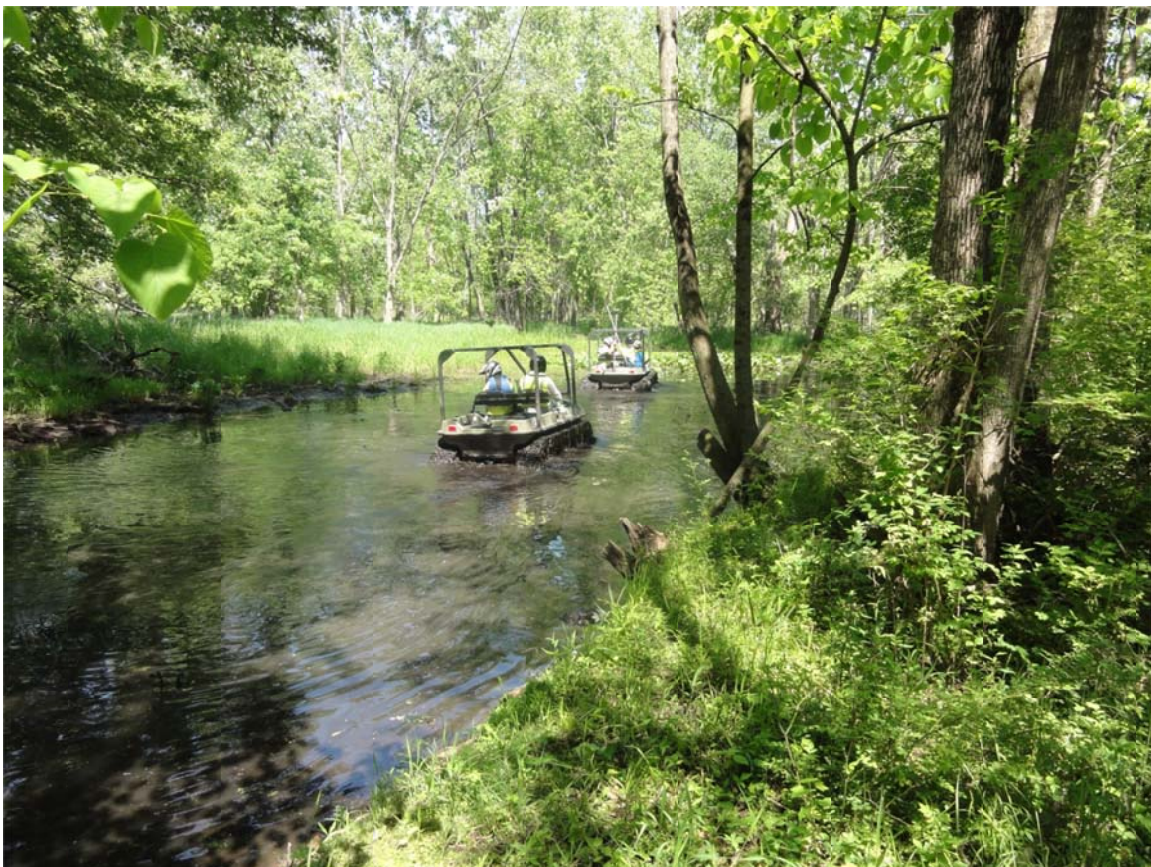
**12. Poling crews using ARGO all-terrain vehicles in backchannel near MP 11.25 LDB.**

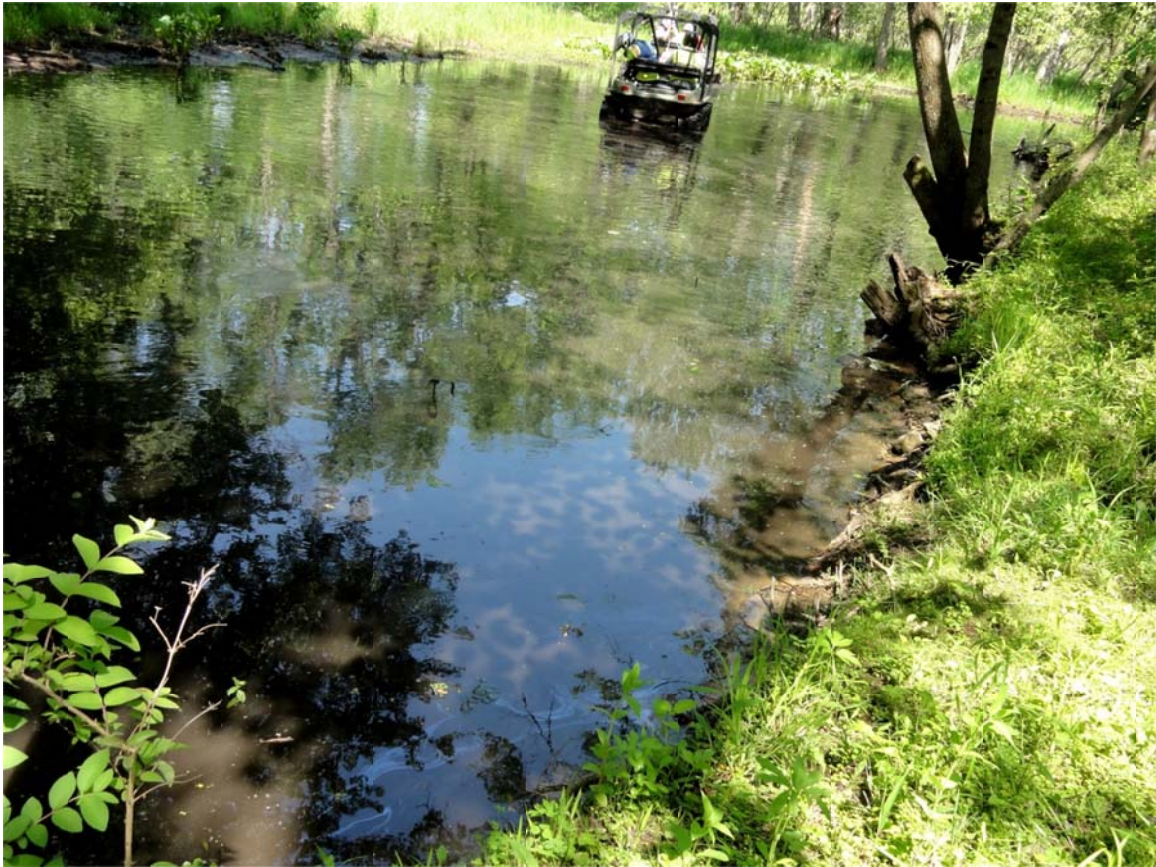
13. Sheen along backchannel shoreline at MP 11.25 LDB.

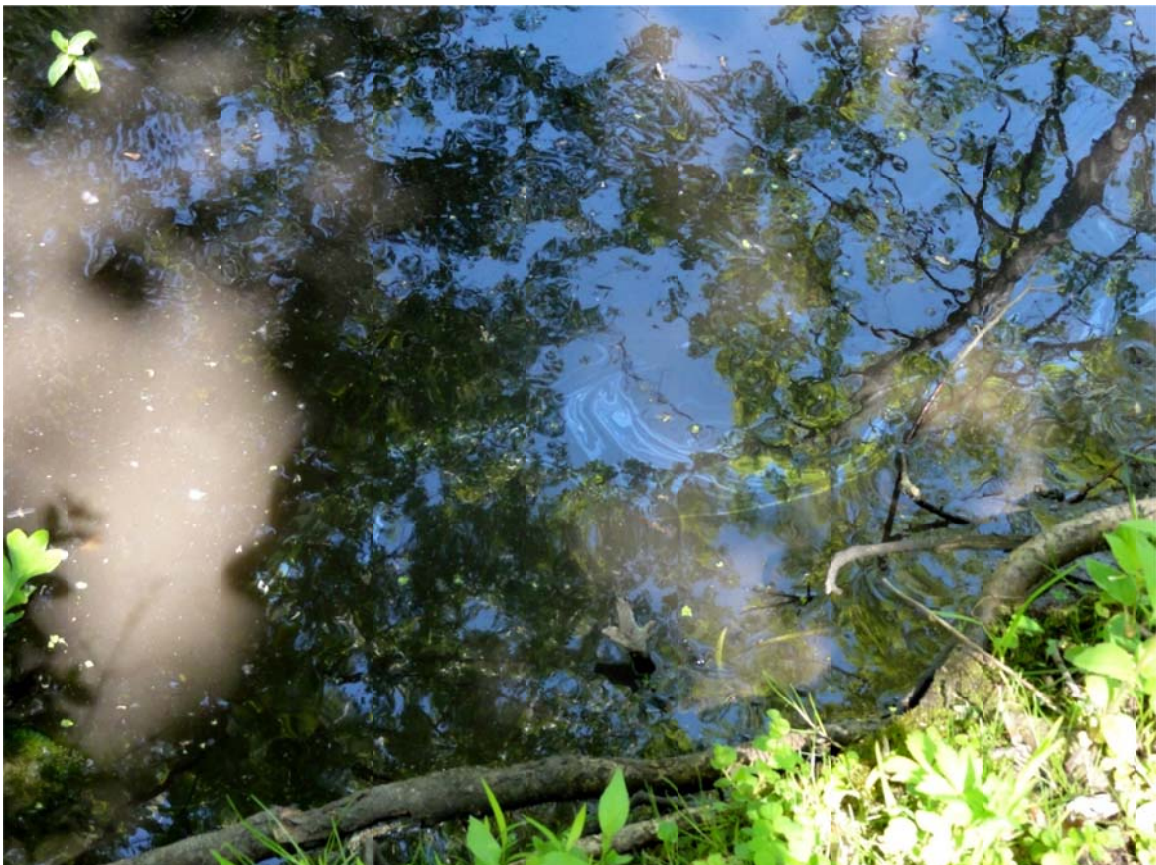
14. Sheen along backchannel shoreline at MP 11.25 LDB. Support boat present to collect sheen.

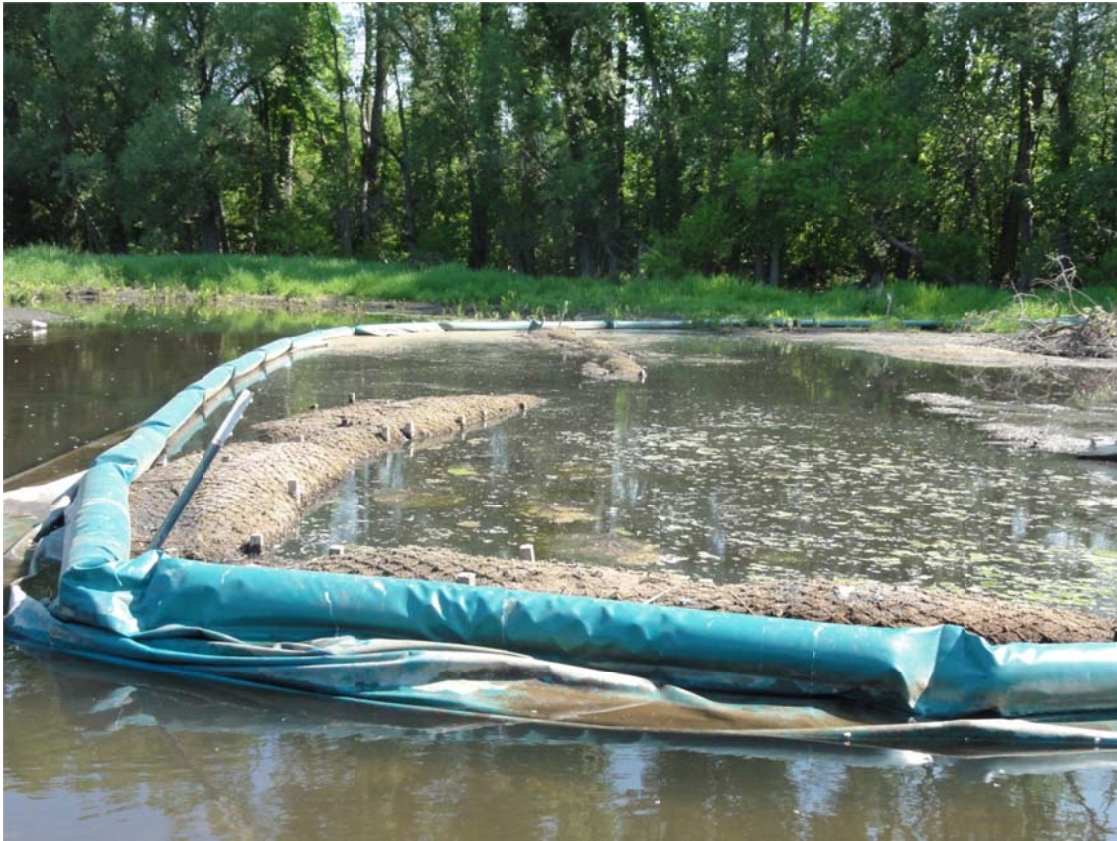
15. MP 14.98 Island. Containment boom remains in place around island.

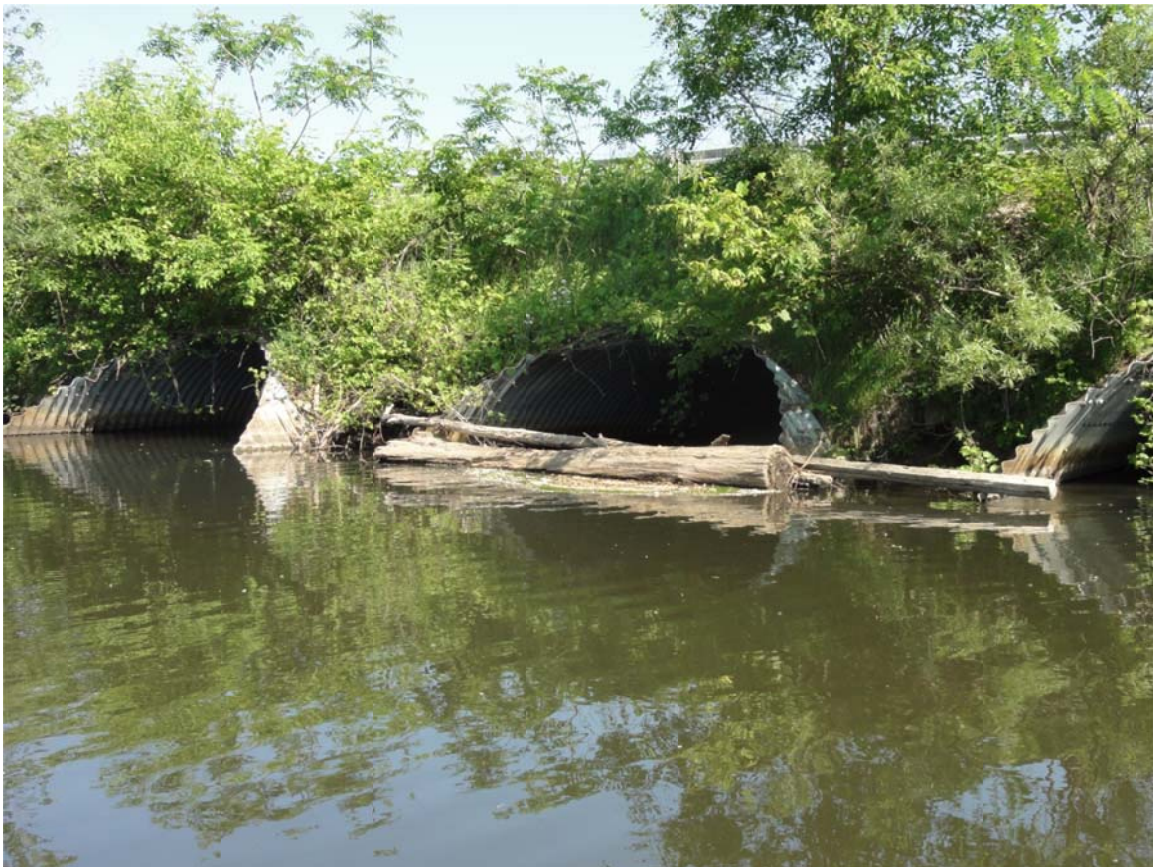
16. Culverts at MP 15.75, north end of Mill Ponds, no sheen observed.

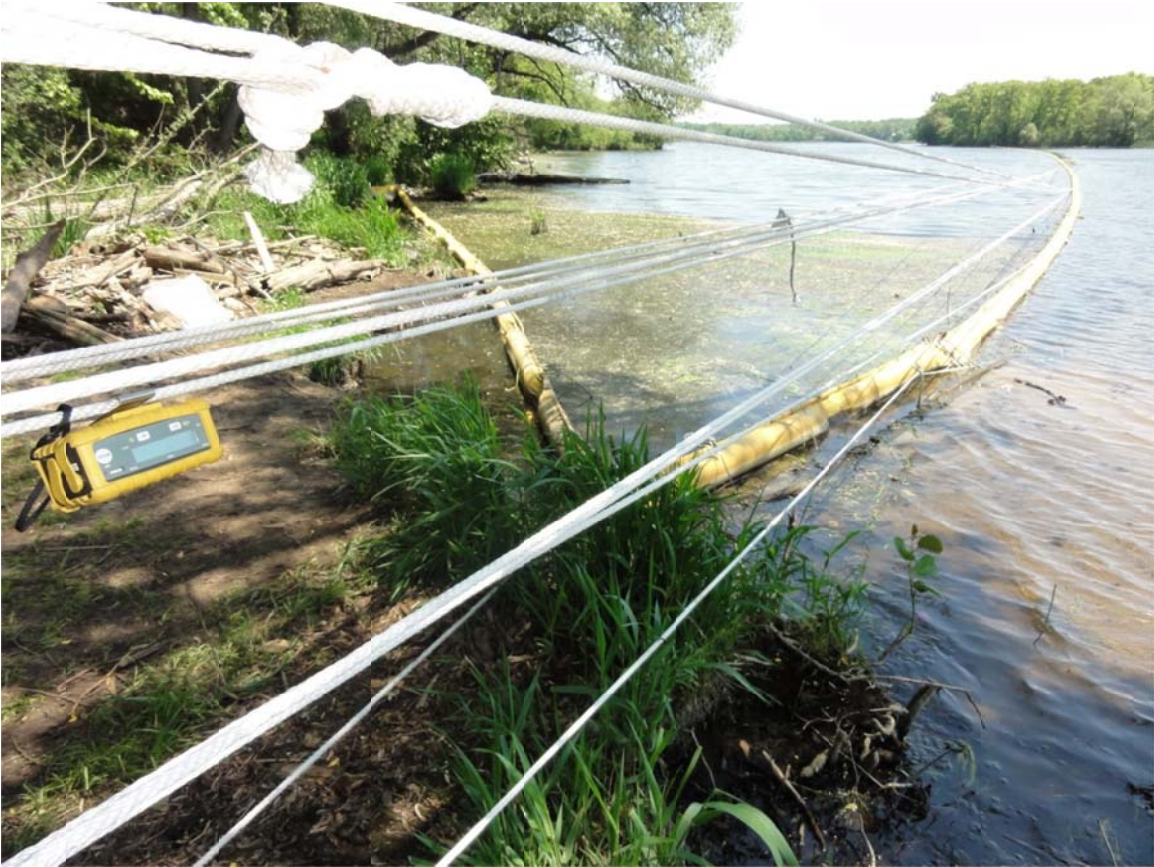
17. Control Point E4, crews observed removing debris within containment.

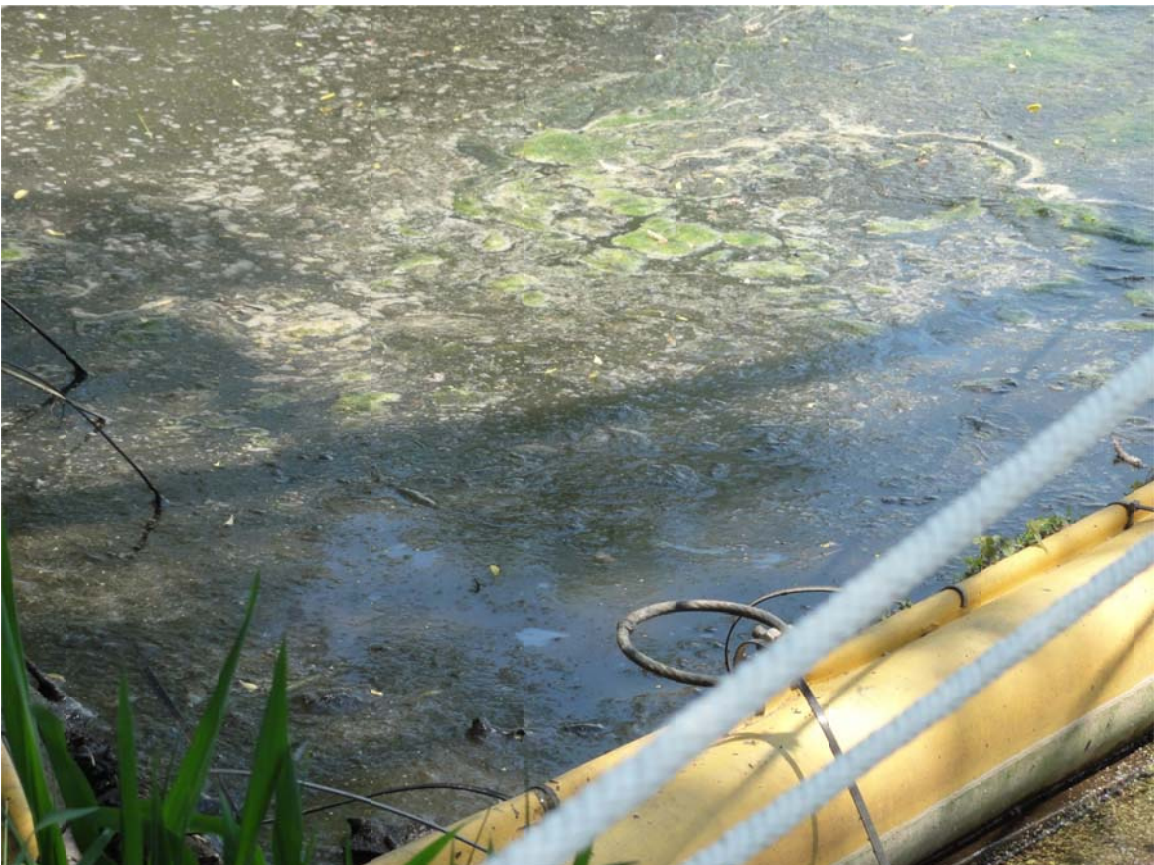
18. Sheen and debris within containment at Control Point E4.

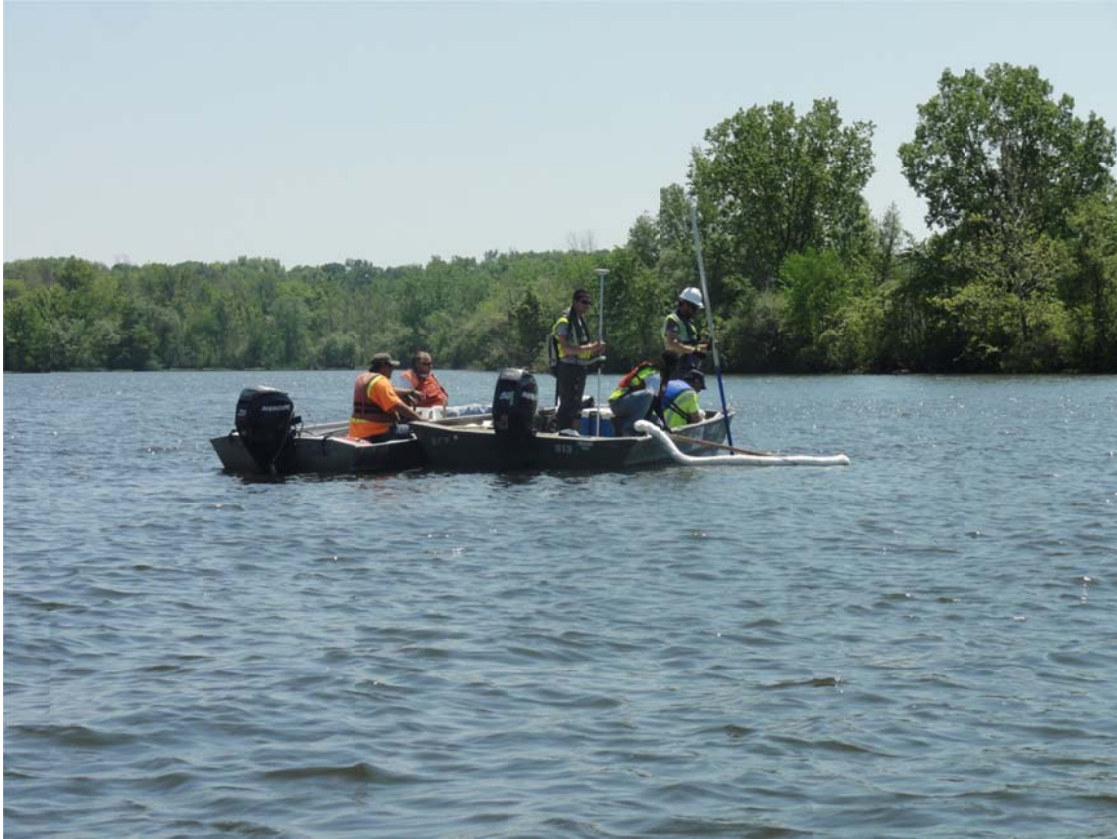
**19. Poling crews in southwestern portion of Morrow Lake.**

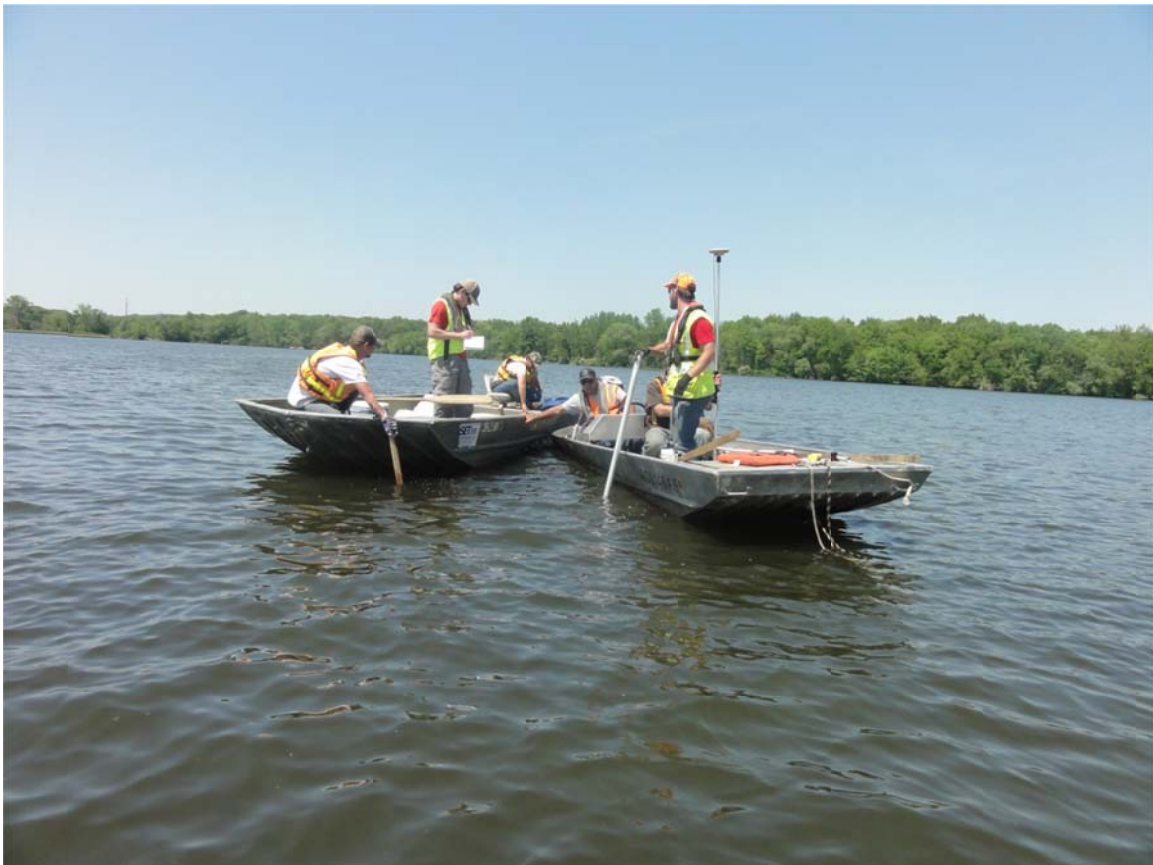
**20. Poling crews in west central portion of Morrow Lake.**

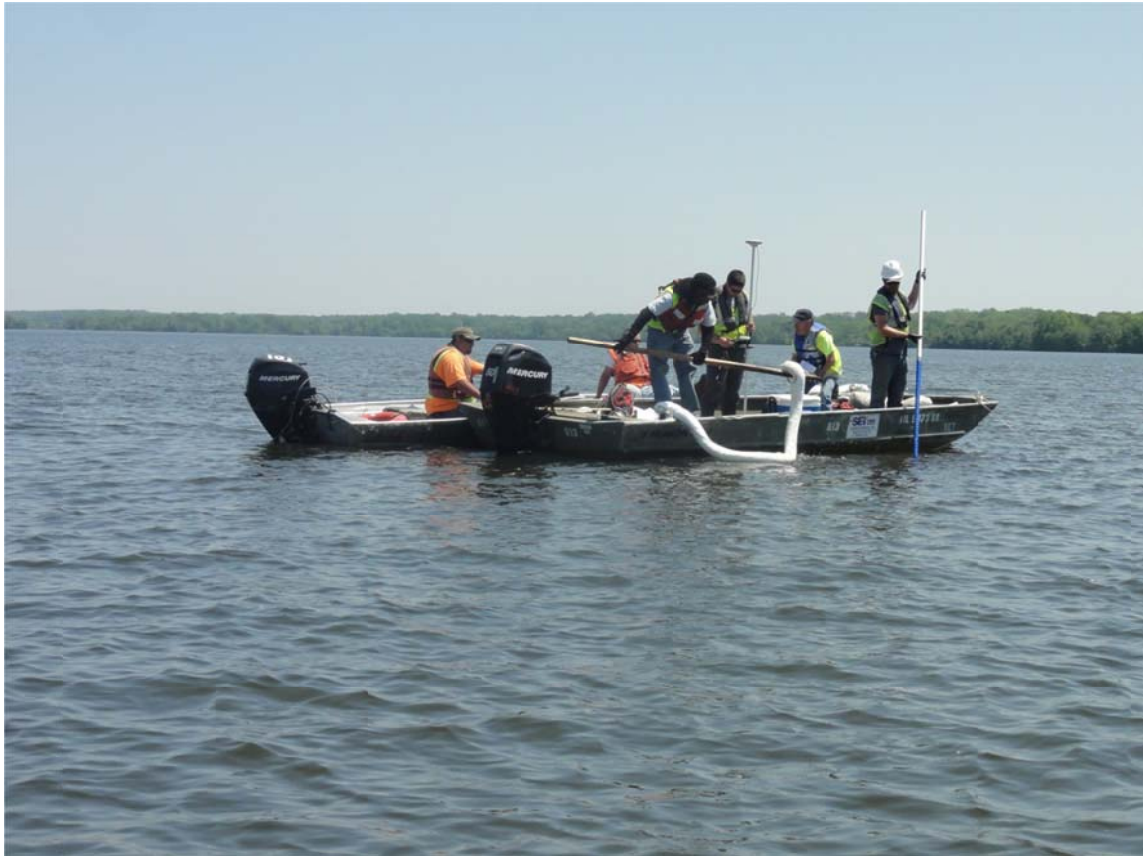
21. Poling crew in southwestern portion of Morrow Lake.

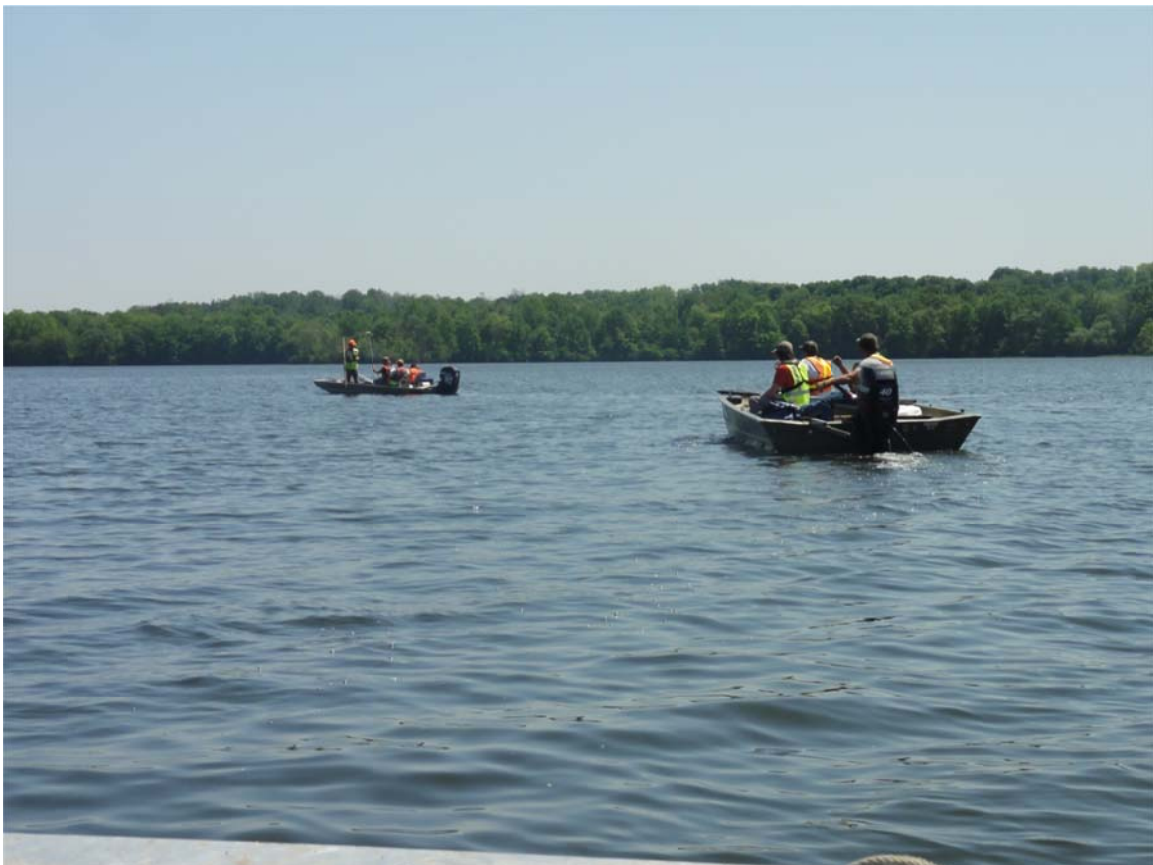
22. Poling crews on Morrow Lake mobilizing to next poling location.

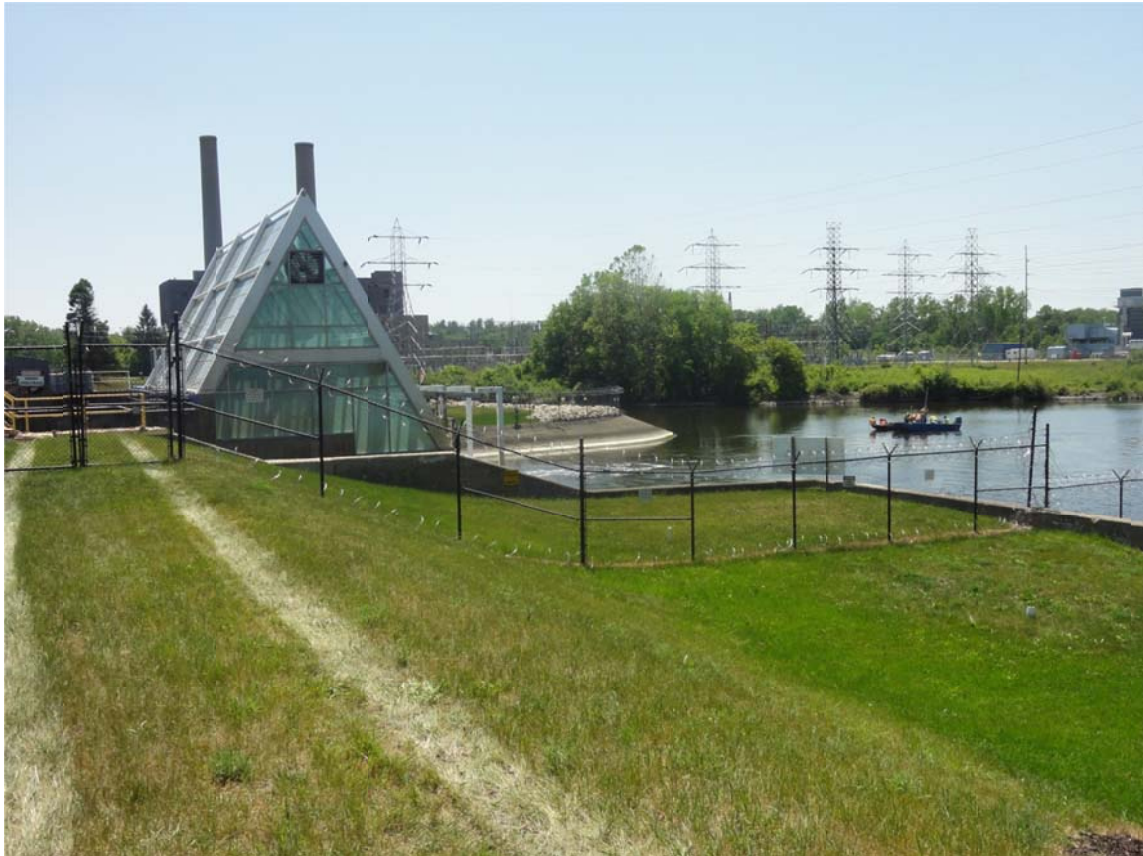
23. Poling crew observed downstream of Morrow Lake Dam.
