# Situation Photo Log

Saturday, May 19, 2012

Kalamazoo River / Enbridge Spill

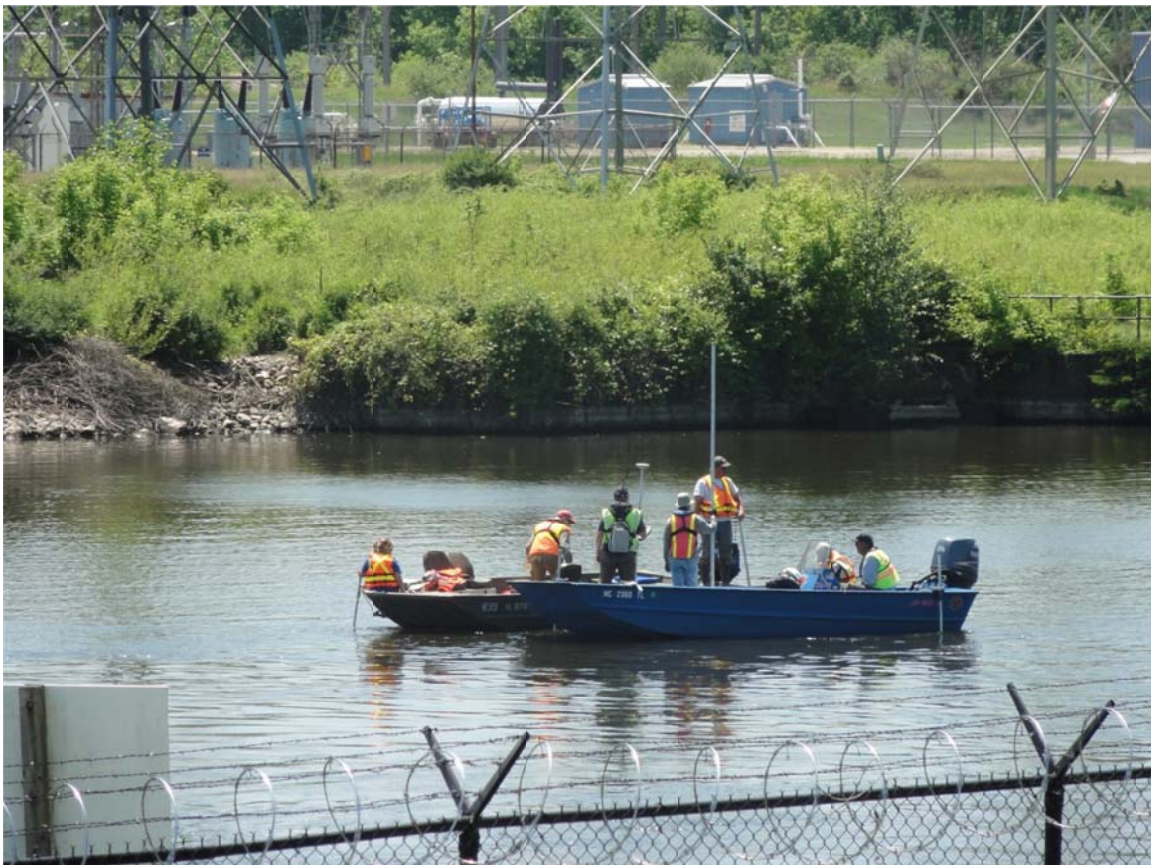
24. Poling crew below spillway of Morrow Lake Dam.
