# Situation Photo Log

Wednesday, May 23, 2012

Kalamazoo River / Enbridge Spill

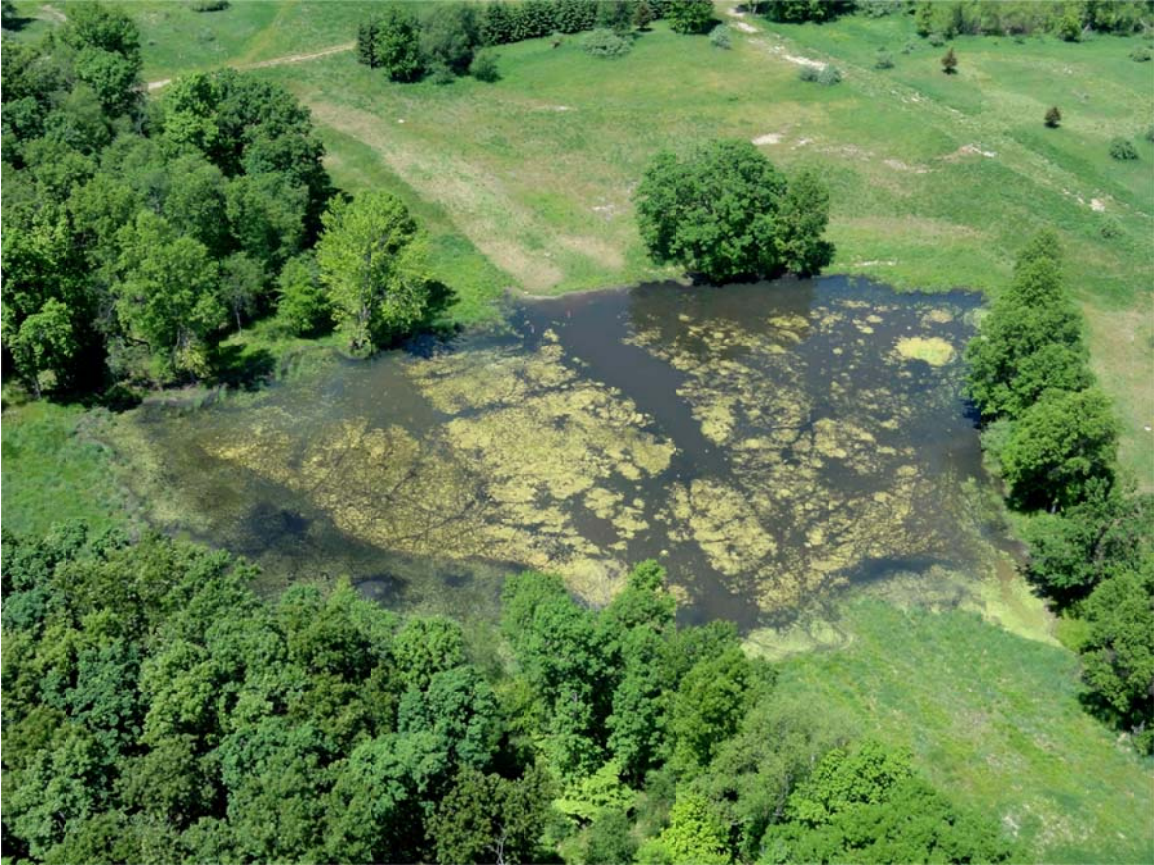
1. Source area pond, no sheen observed.

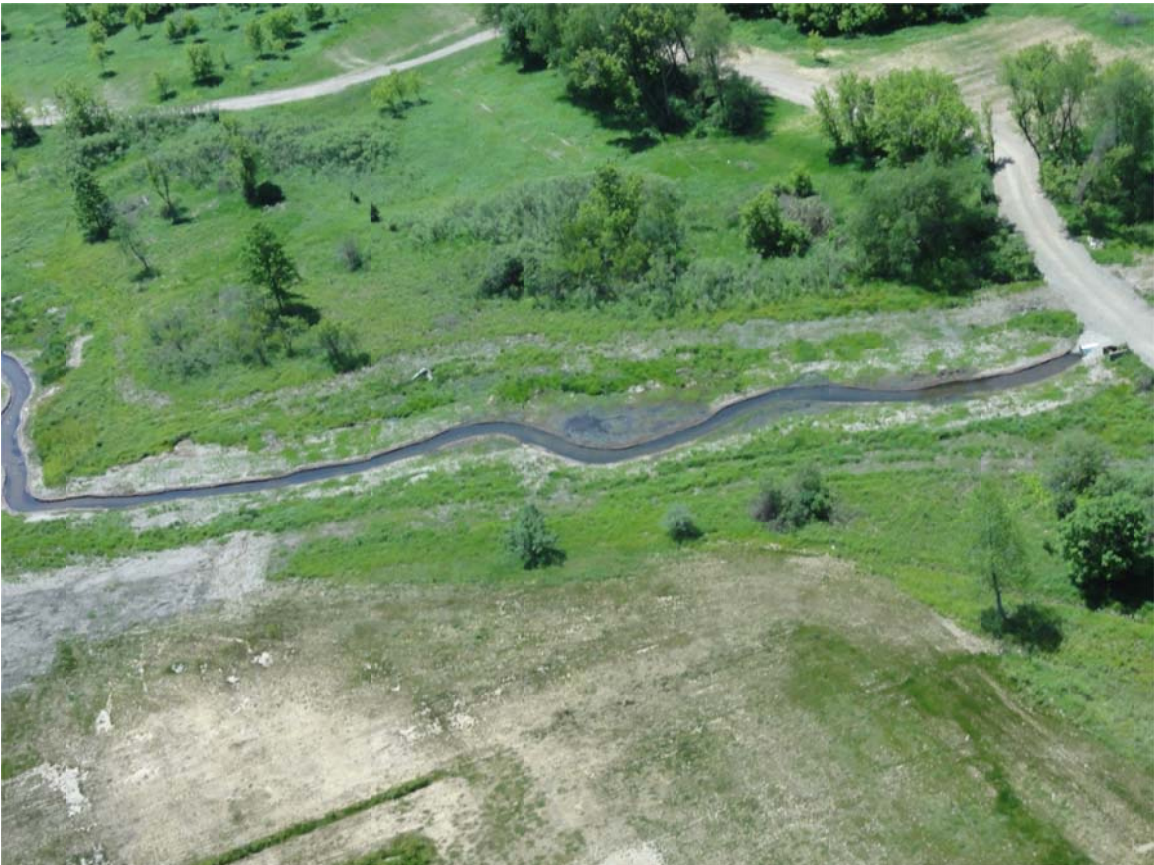
2. Sheen observed on LDB of Talmadge Creek, east of gravel road near MP0.2.

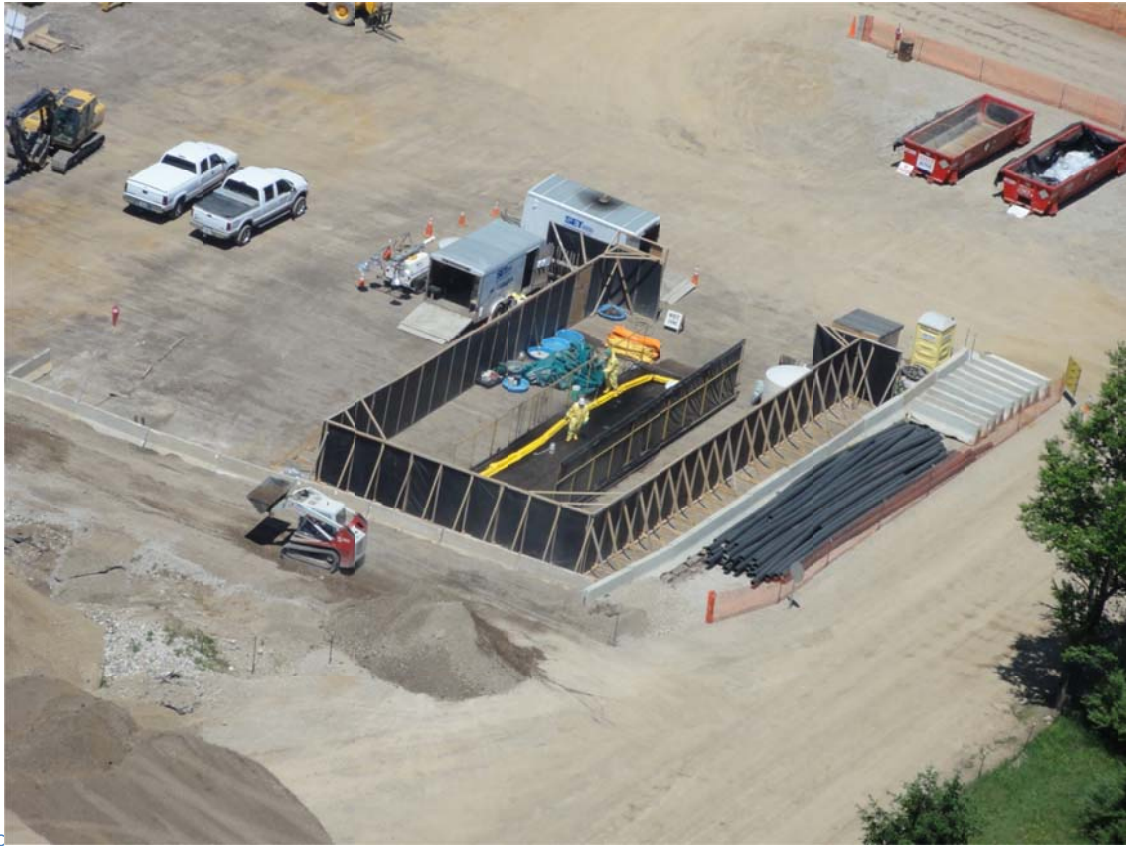
3. Frac-Tank City decon pad. Crews observed cleaning boom.

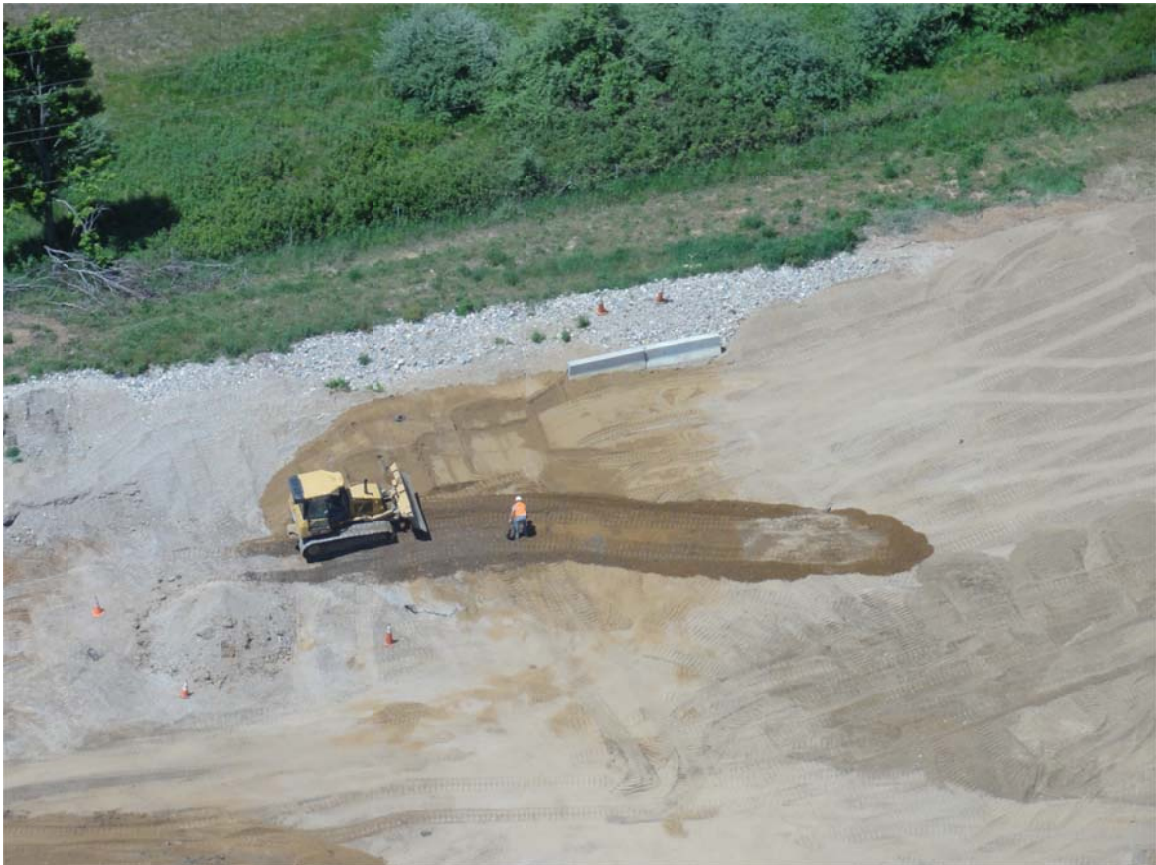
4. Frac-Tank City, footprint reduction continues.

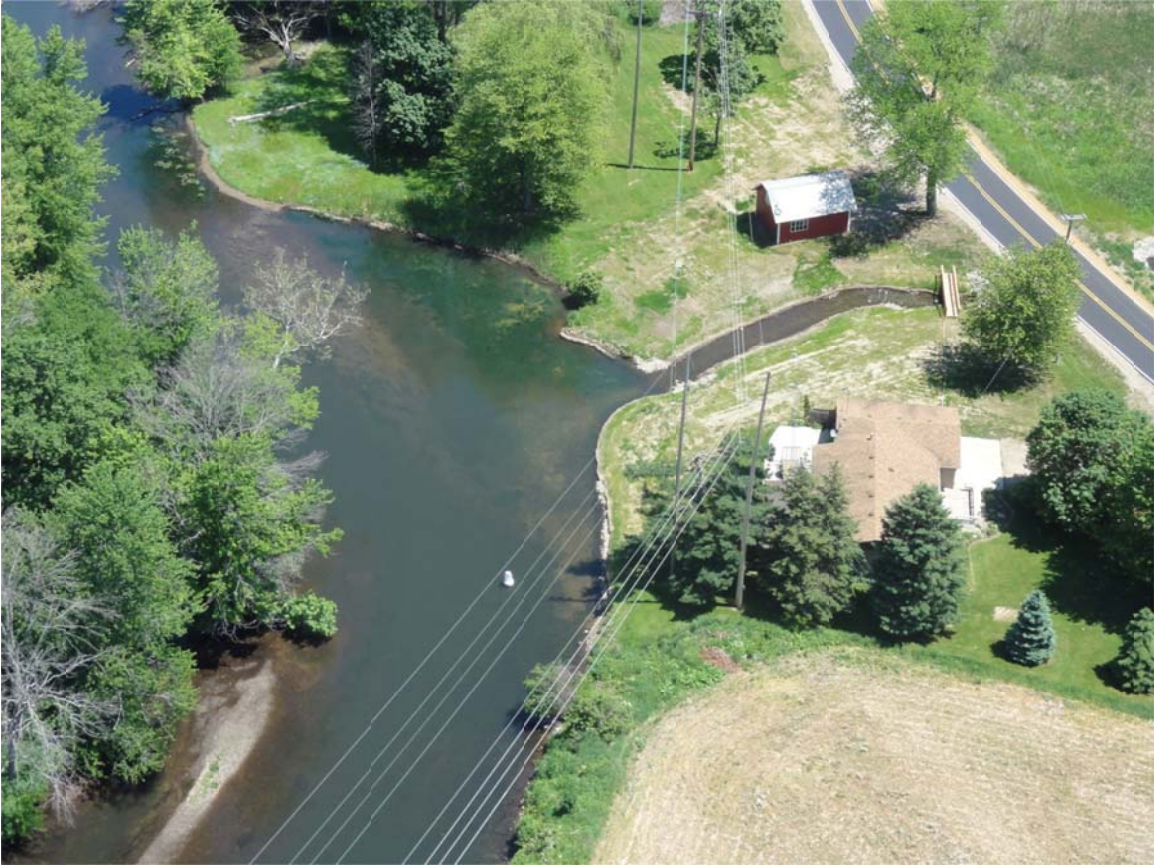
5. Confluence, no sheen observed.

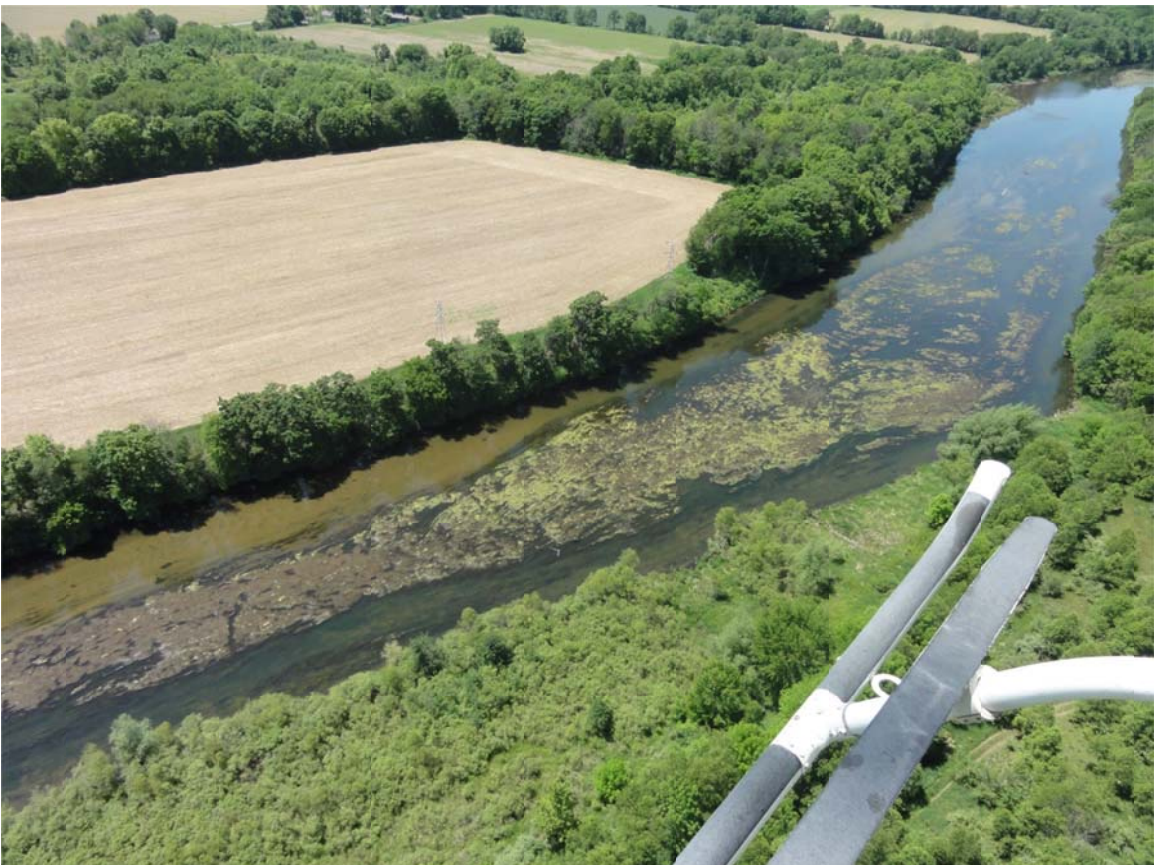
6. Emerging vegetation on Kalamazoo River near MP 3.0.

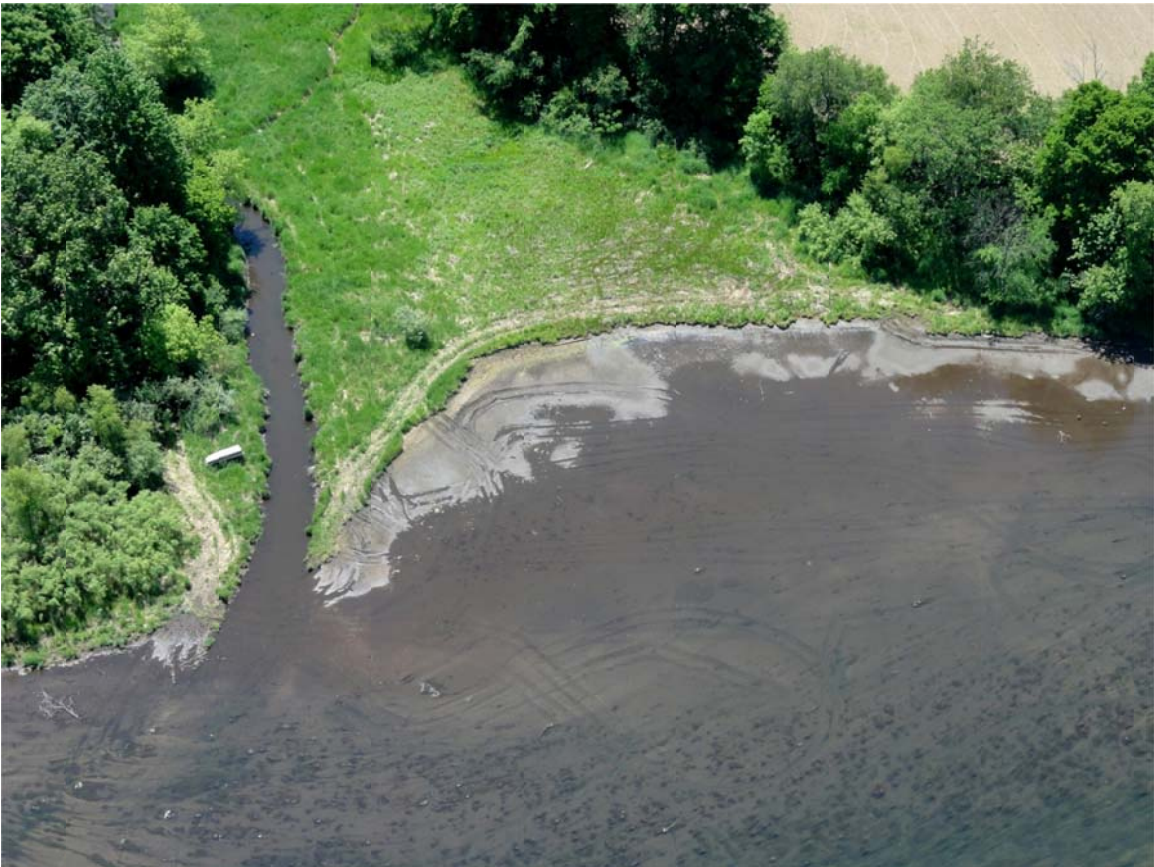
7. MP4.5 LDB, Former Lily Pad area, no sheen observed.

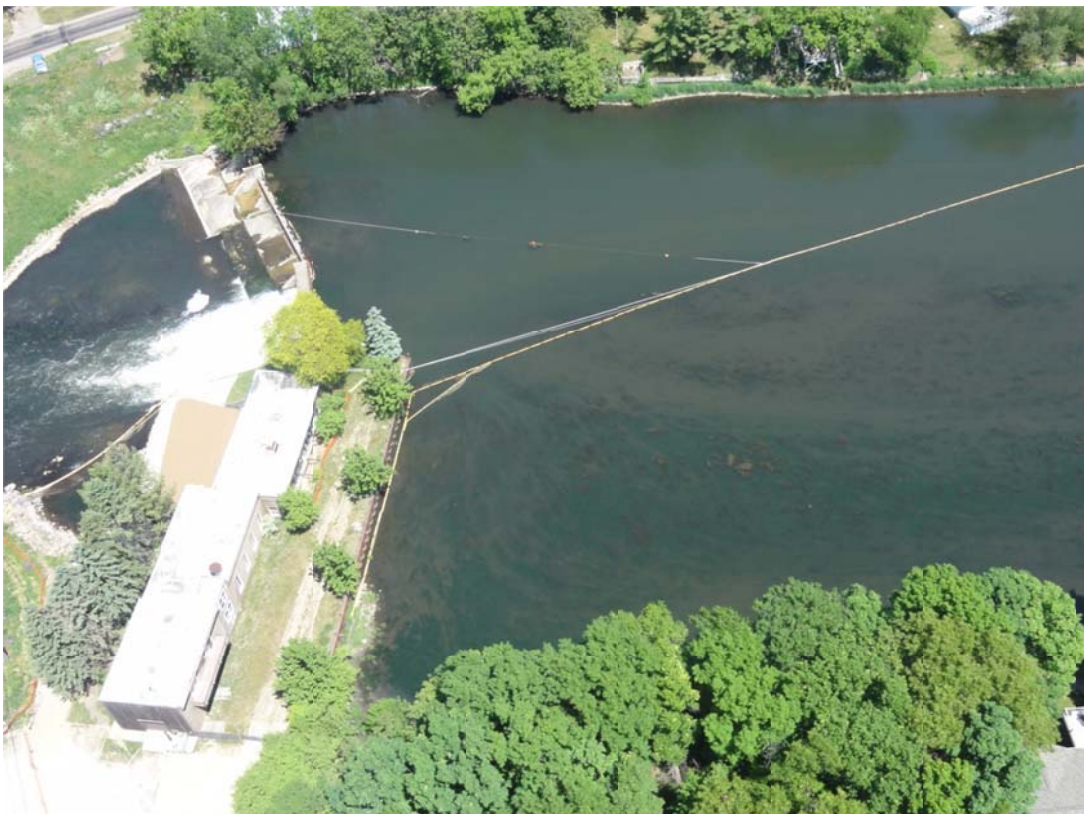
8. Ceresco Dam, no sheen observed.

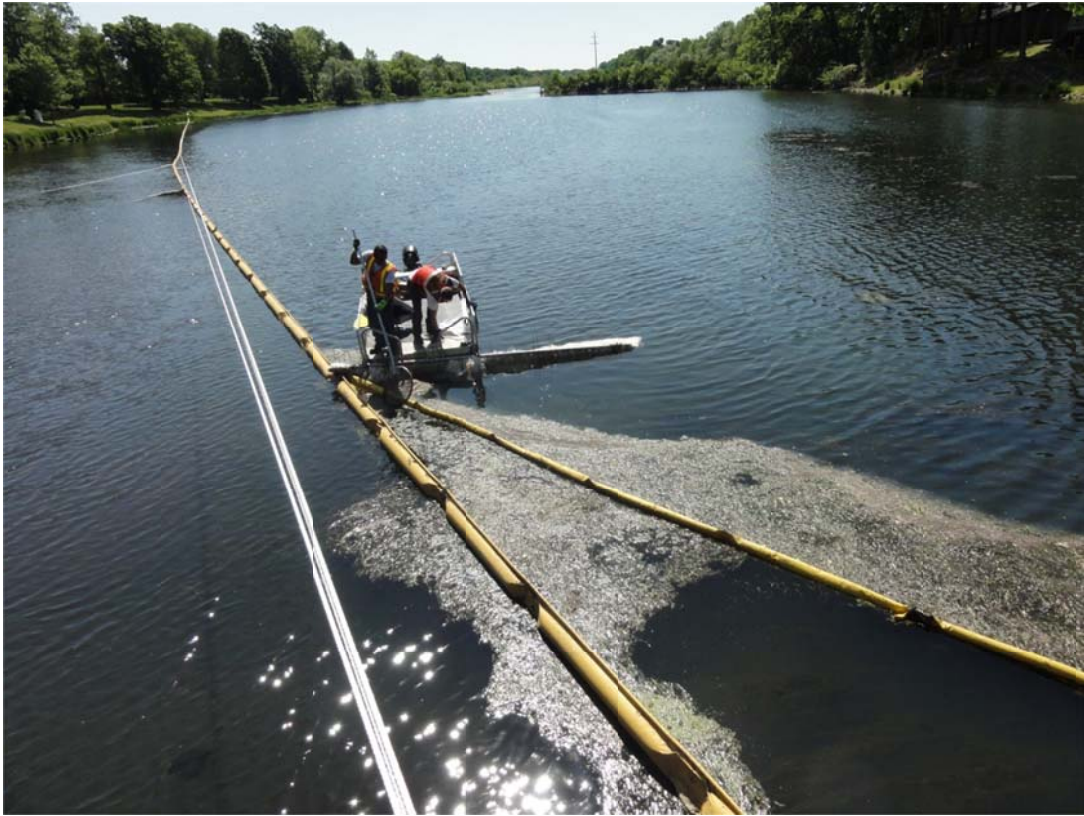
9. Ceresco Dam, crews removing debris from containment above dam.

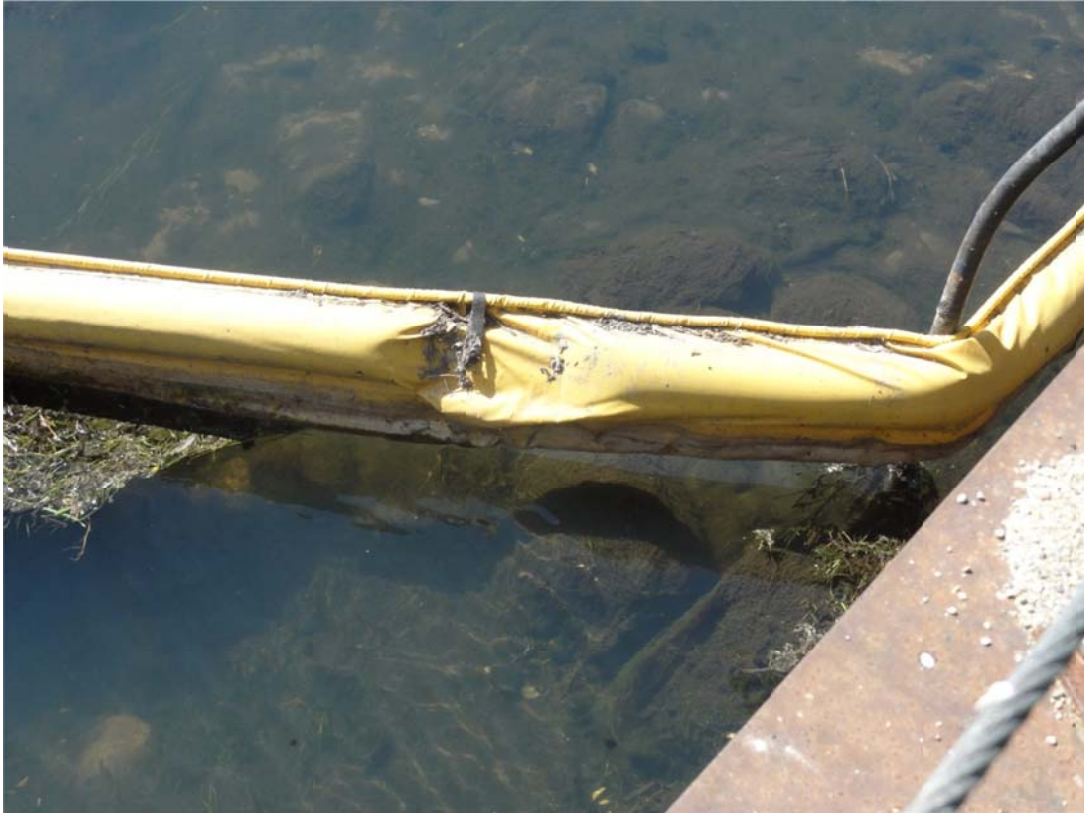
10. Ceresco Dam. Water level has dropped below containment boom, containment crews notified of need to adjust boom height.

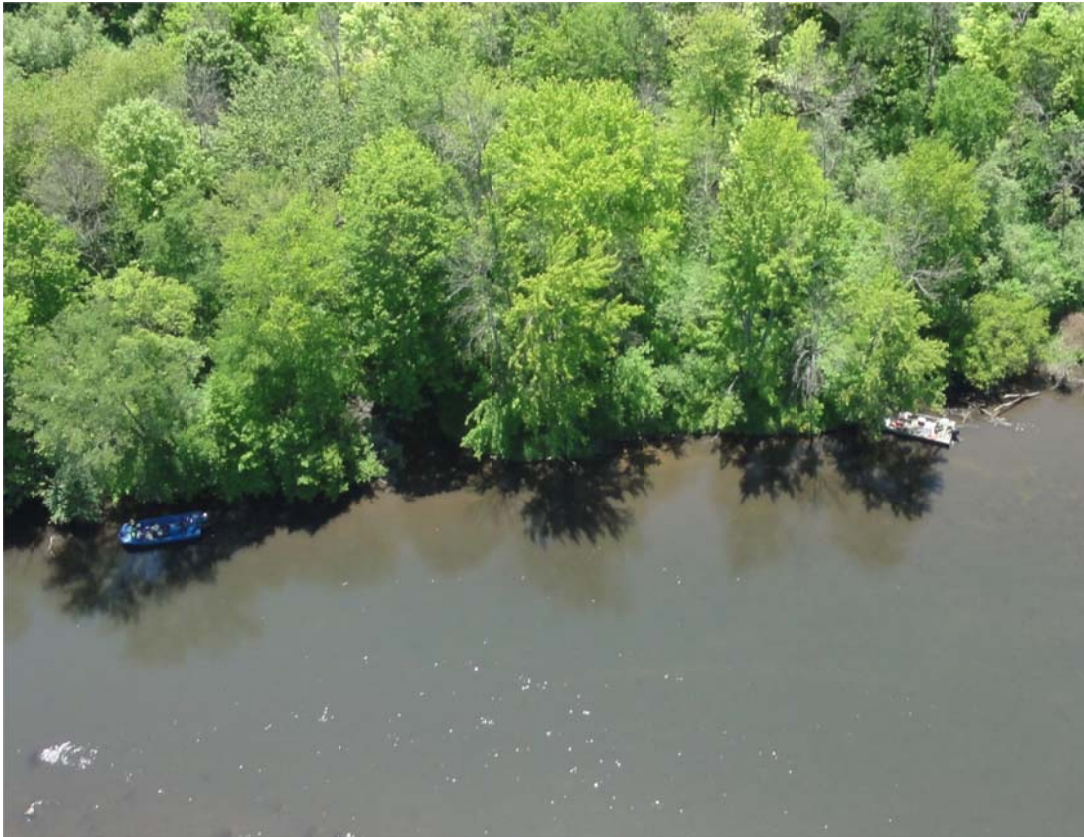
**11. Poling crews observed along LDB near MP 7.0.**

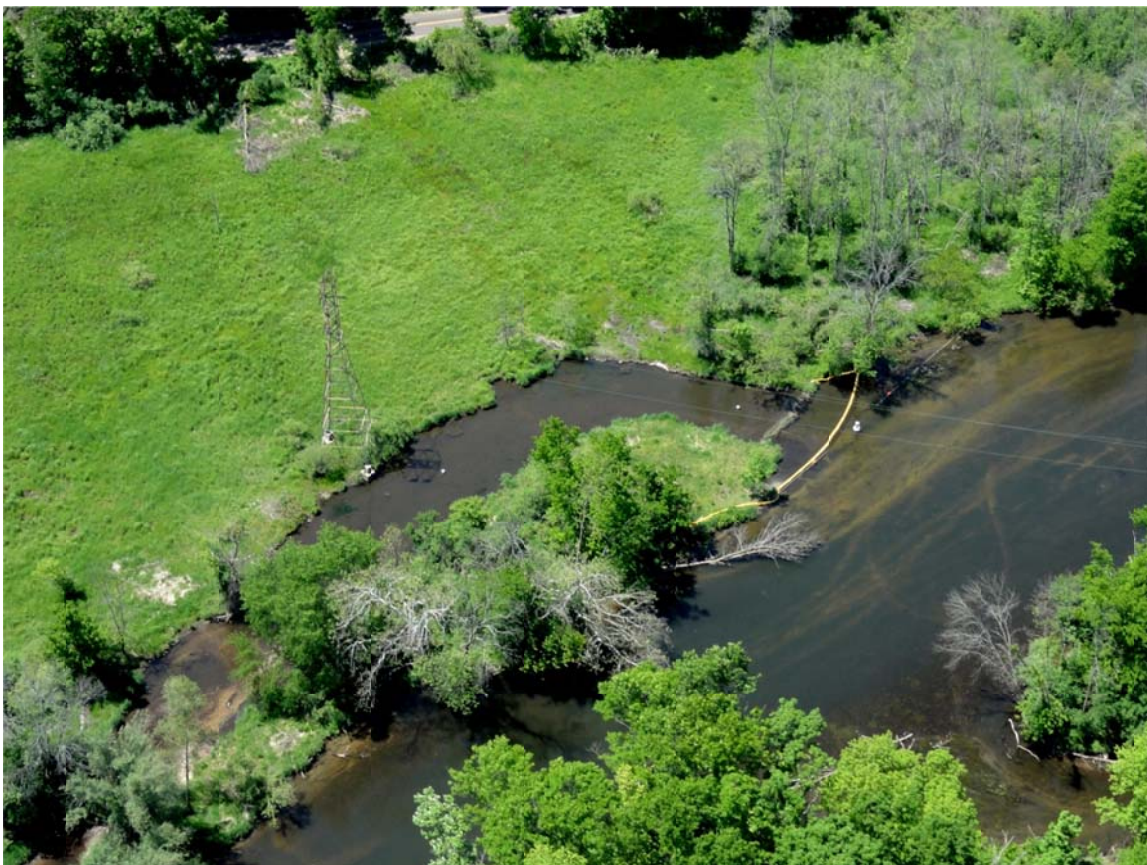
**12. MP 10.75 sediment trap, sheen observed within containment.**

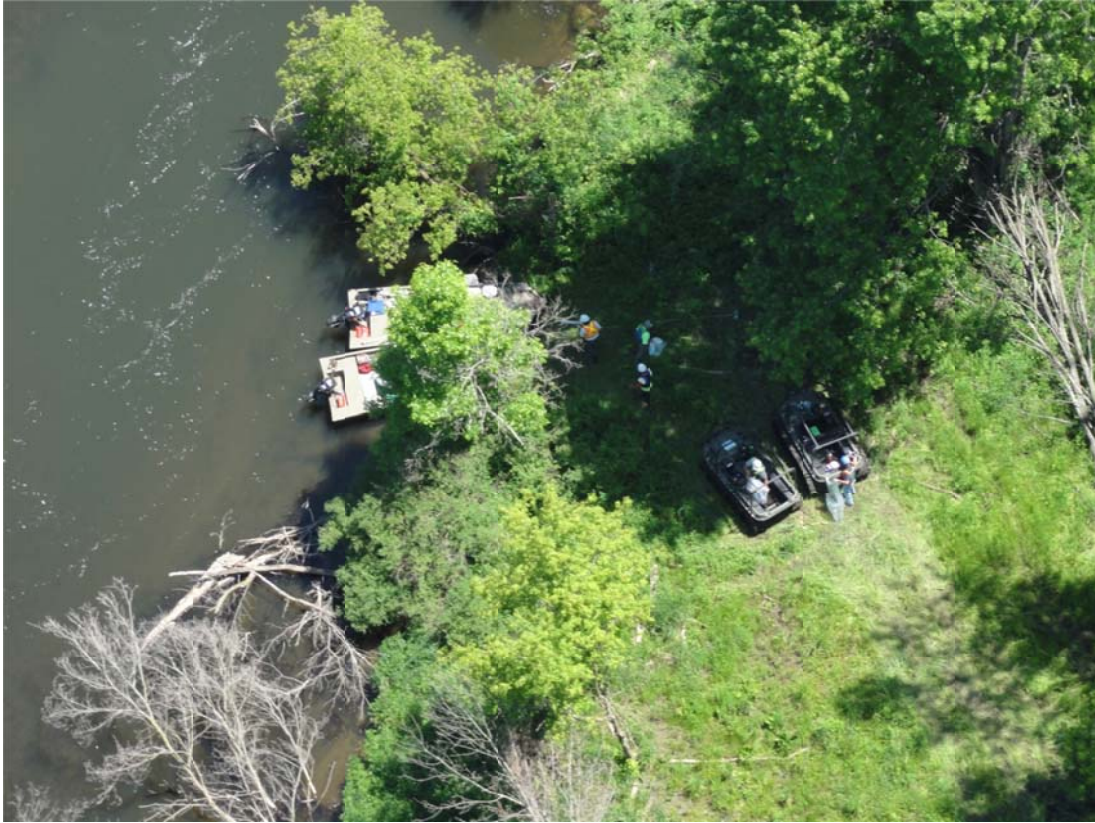
13. Argo poling crews observed near MP 11.79 south.

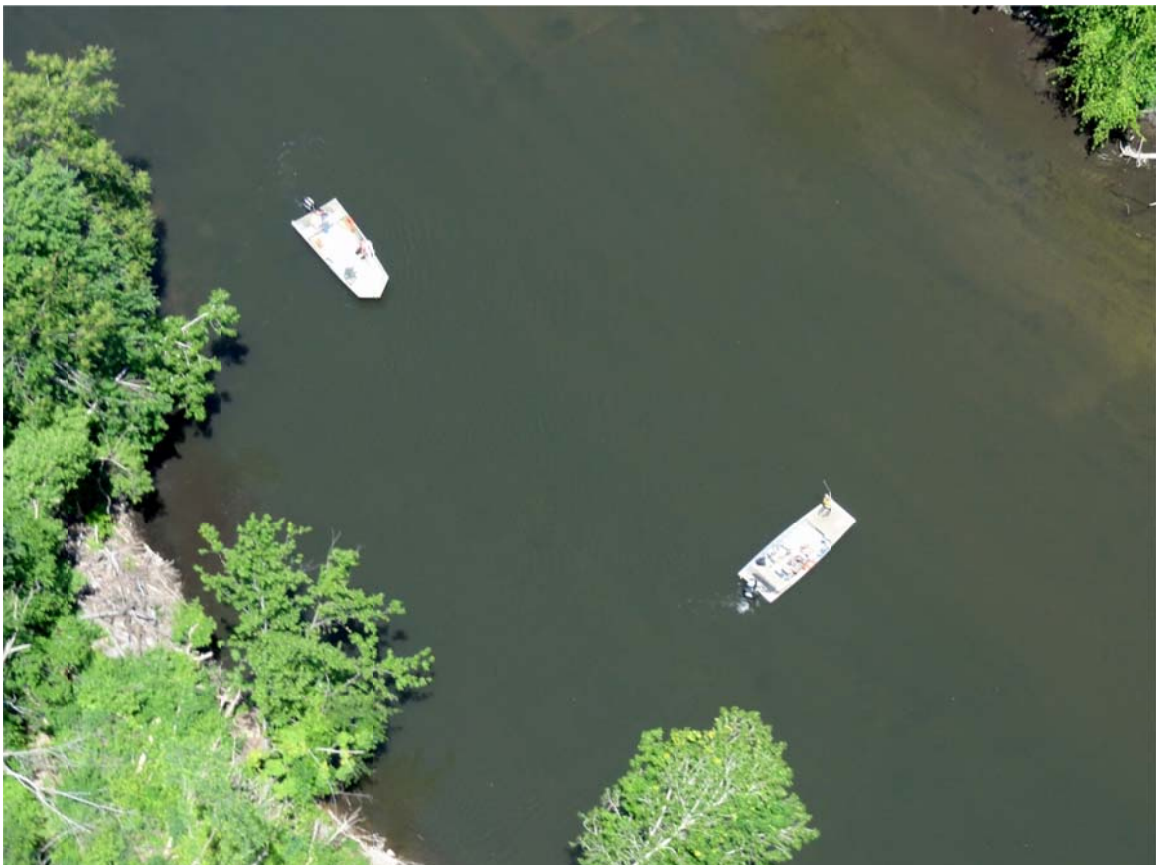
14. Poling crews observed near MP14.0.

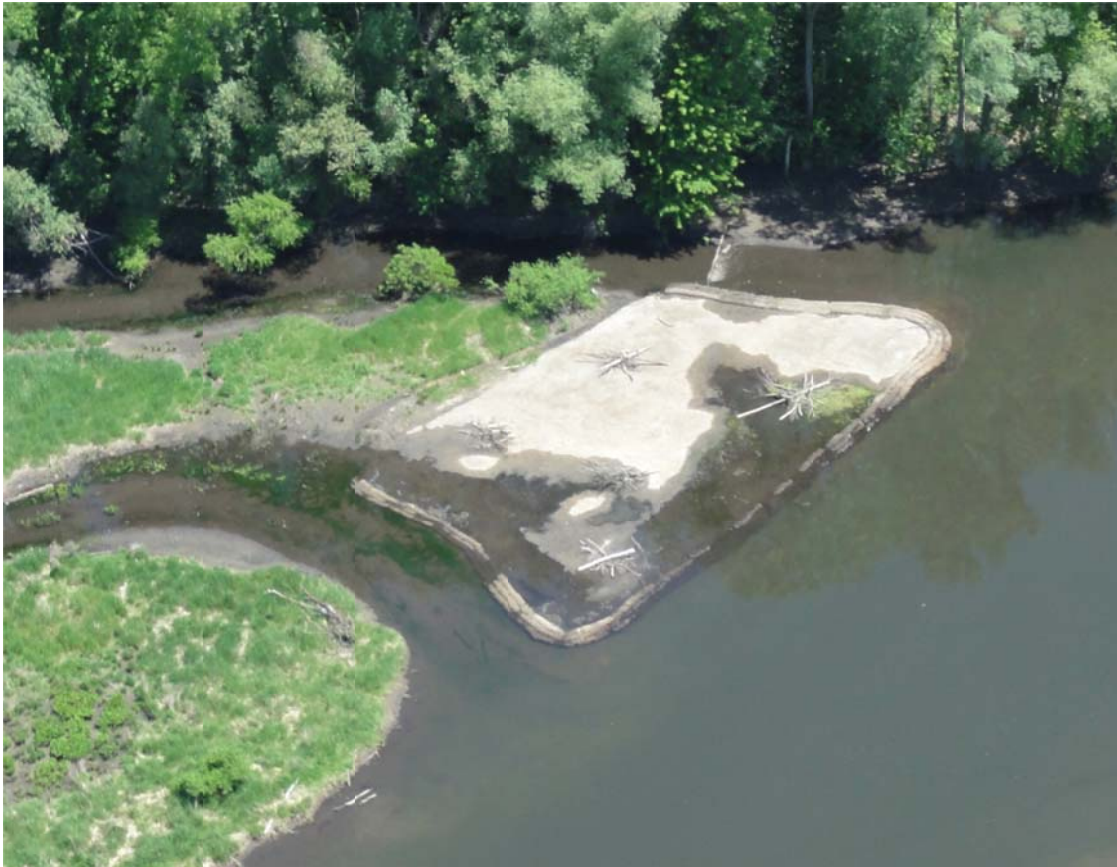
15. MP 14.98 island, containment around island was removed on Tuesday this week, no sheen observed.

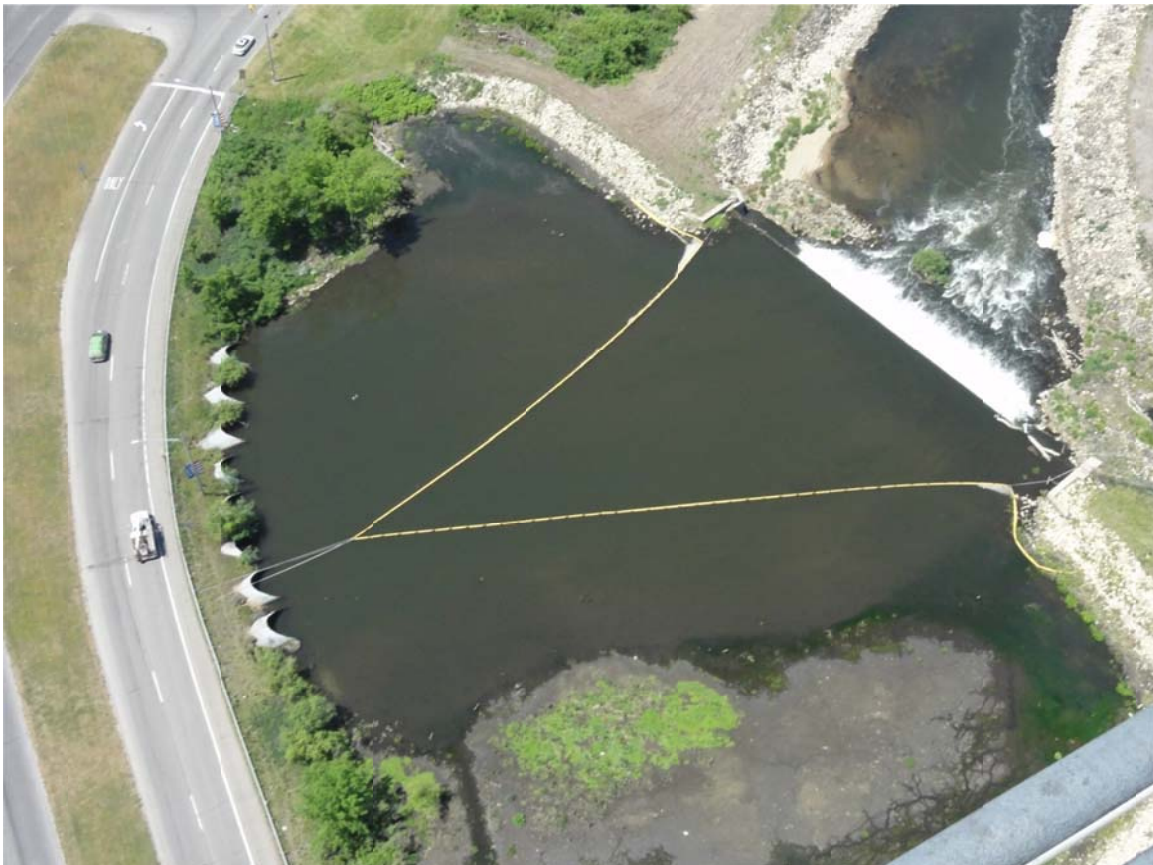
16. Control point at Battle Creek spillway. No sheen observed.

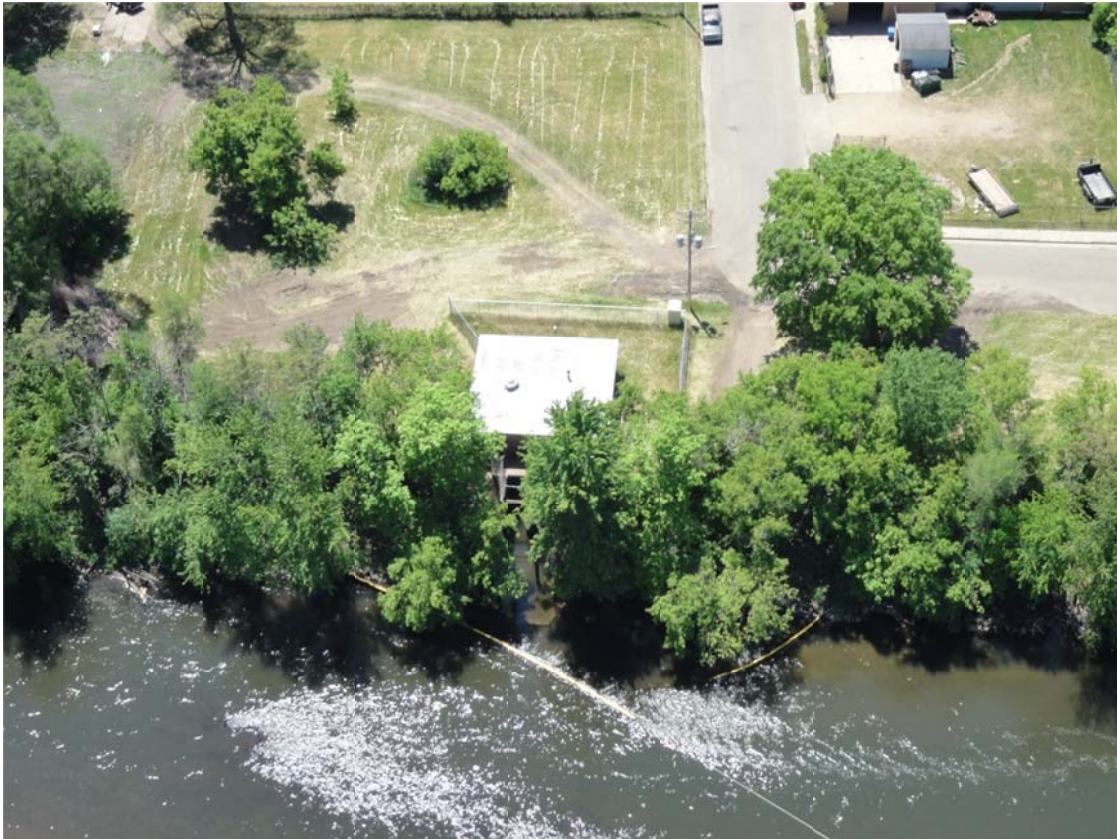
**17. Rock Tenn inlet, no activity observed.**

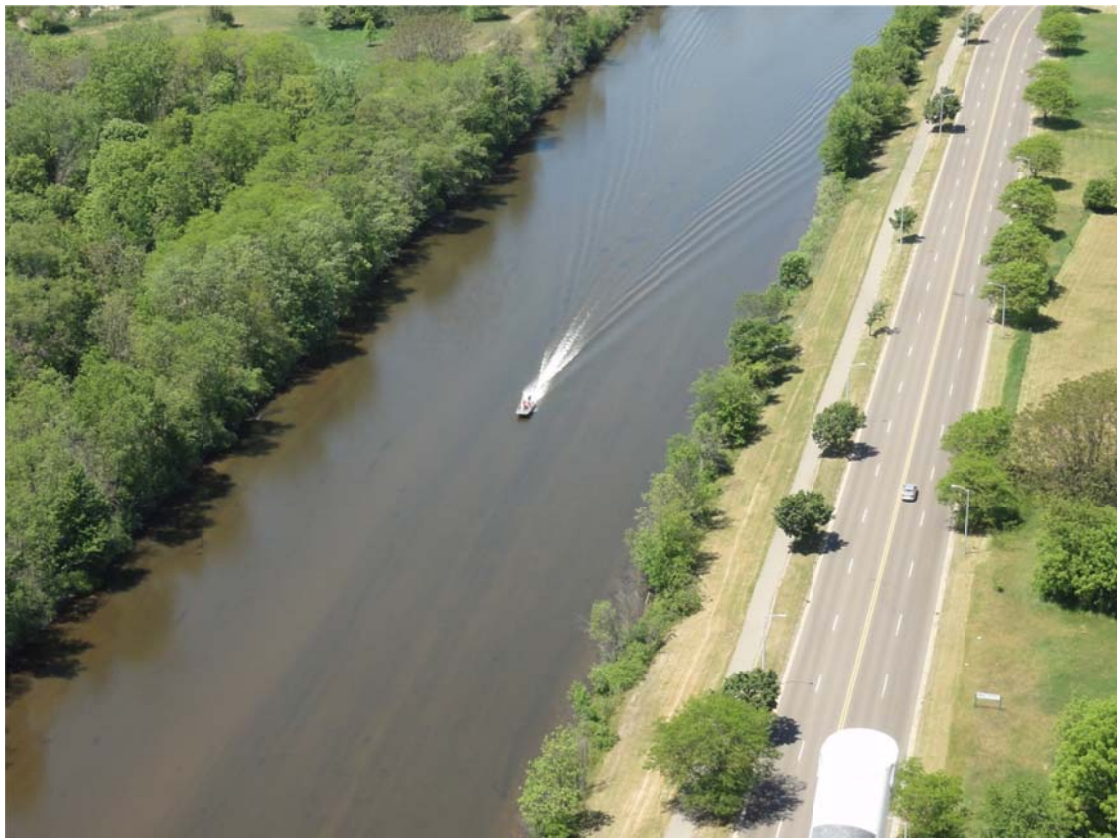
**18. Poling crew observed near MP 18.0.**

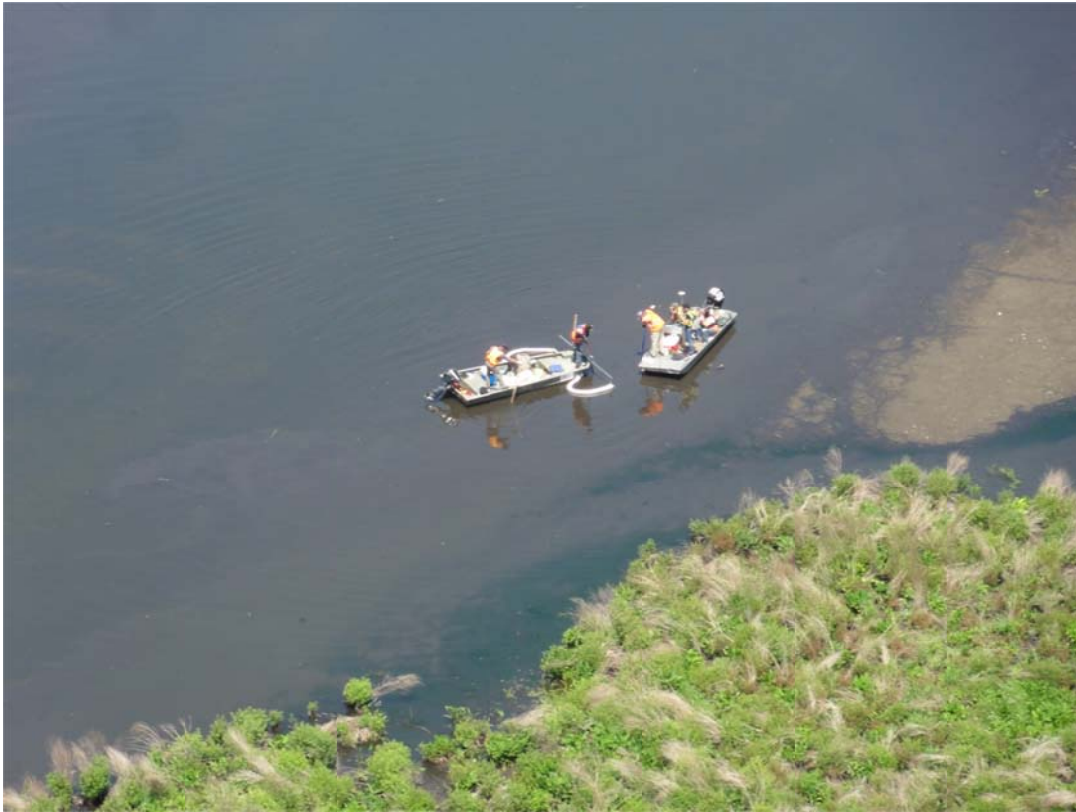
**19. Poling crew observed in eastern end of Morrow Lake Delta.**

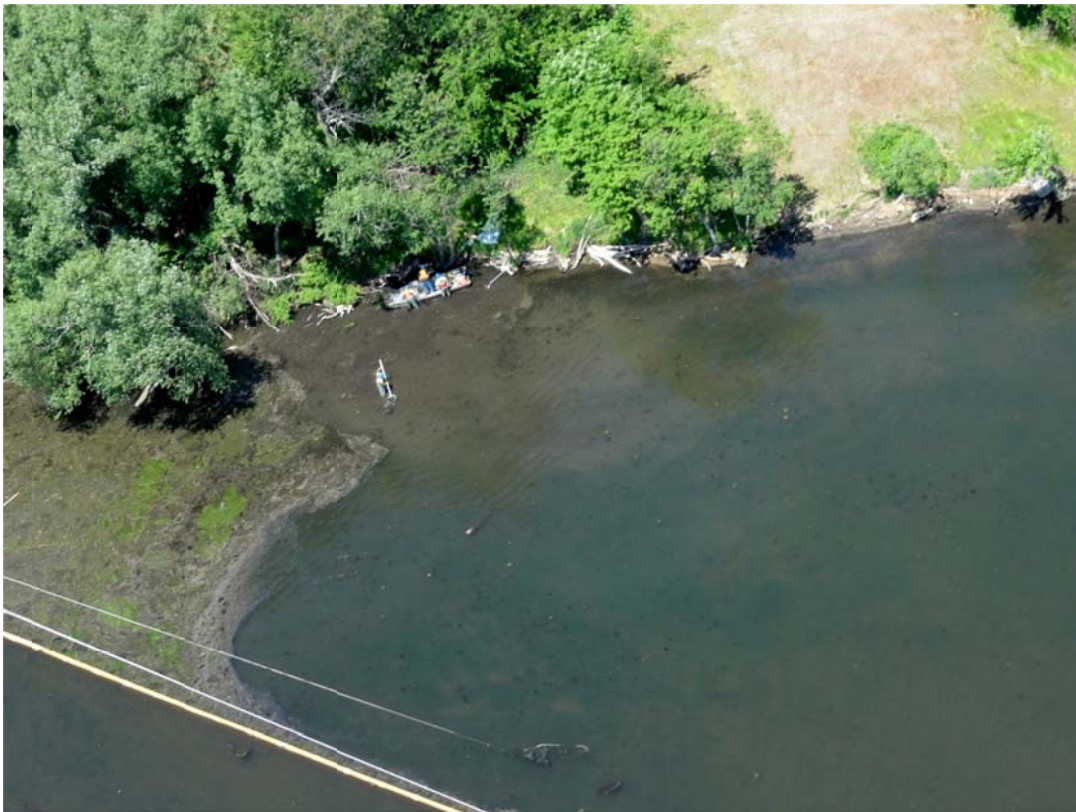
**20. Crews removing vegetation and debris from E4.0 control point.**

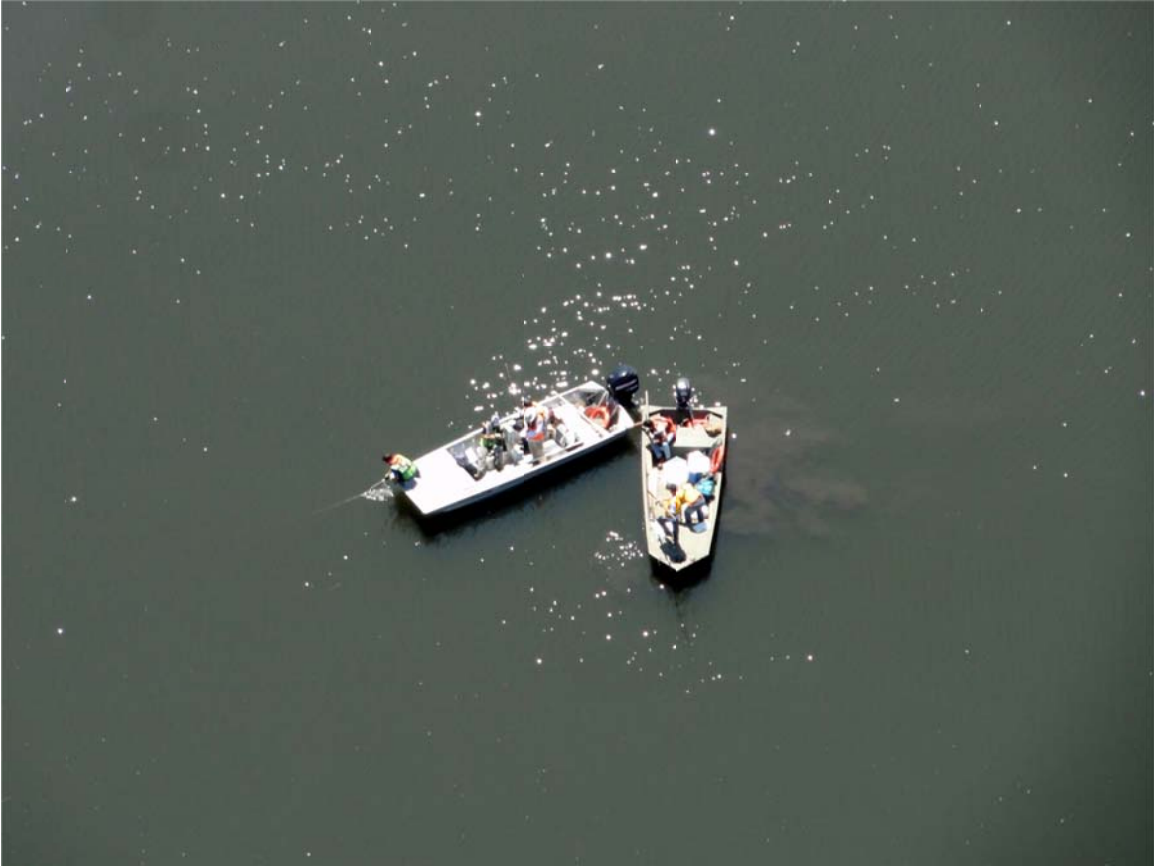
21. Morrow Lake, poling crew observed in eastern end of lake.

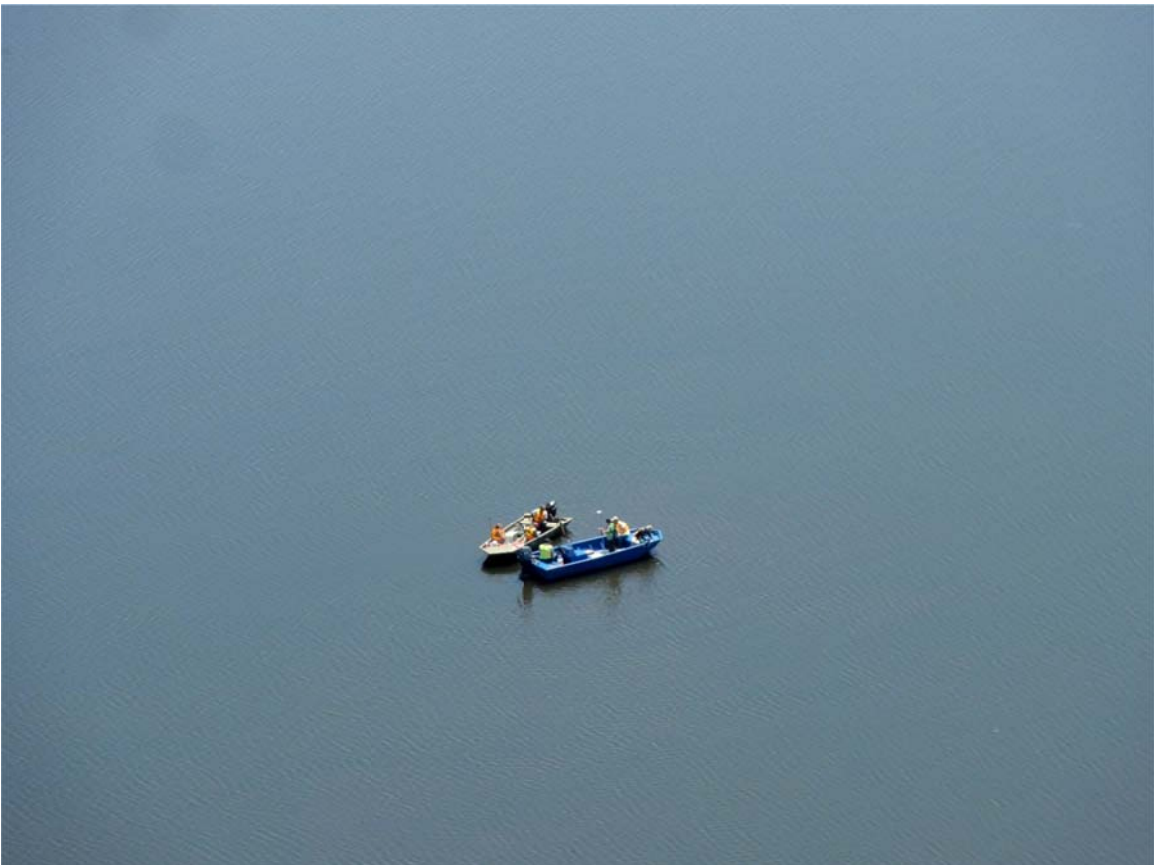
22. Poling crew observed in central portion of Morrow Lake.

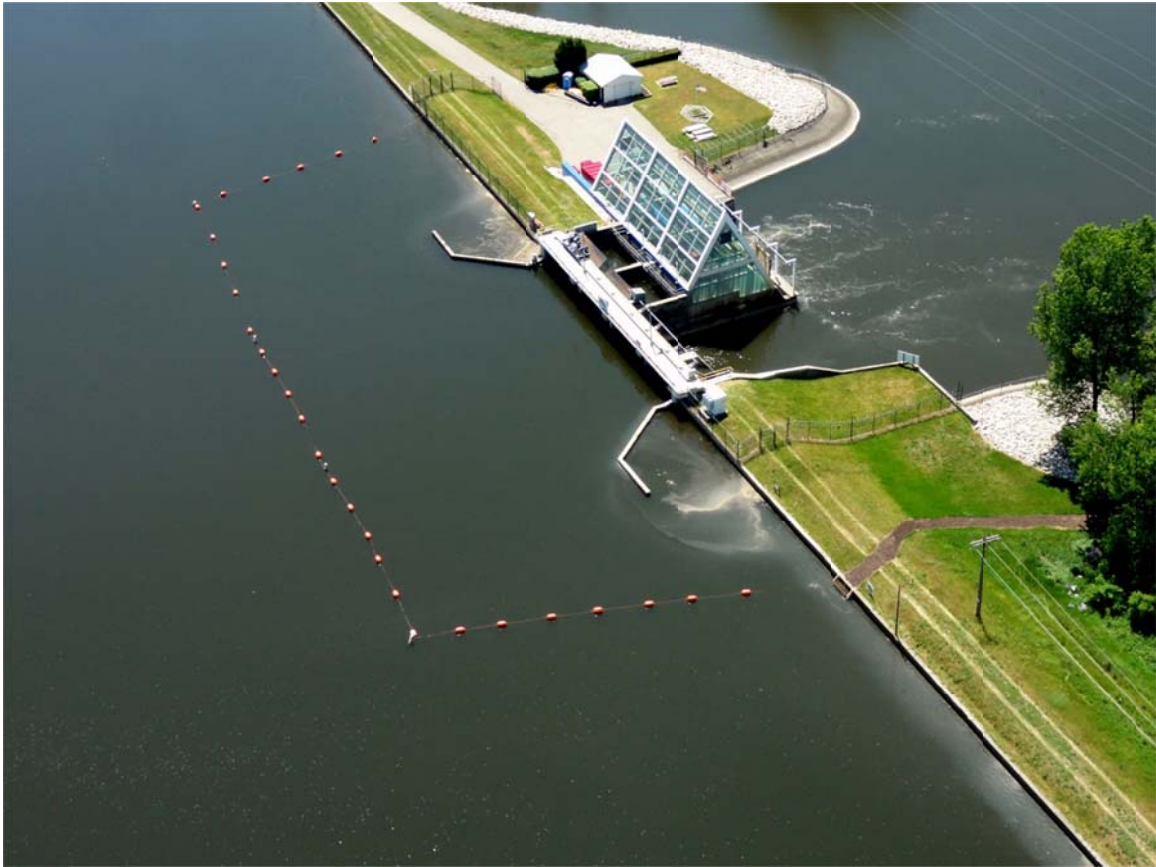
**23. Morrow Lake Dam. Sheen observed along shoreline north of spillway.  
Operations crew notified.**

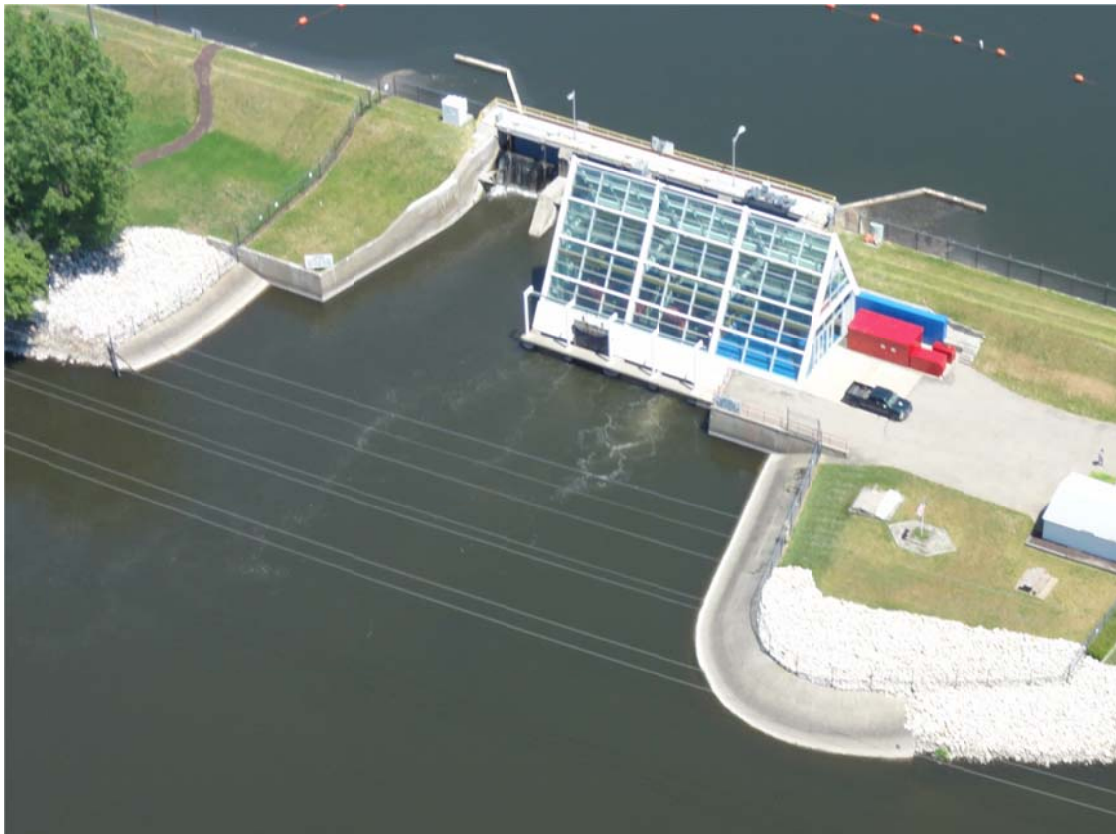
**24. Close up of Morrow Dam discharge.**
