Situation Photo Log

Thursday, May 24, 2012

Kalamazoo River / Enbridge Spill

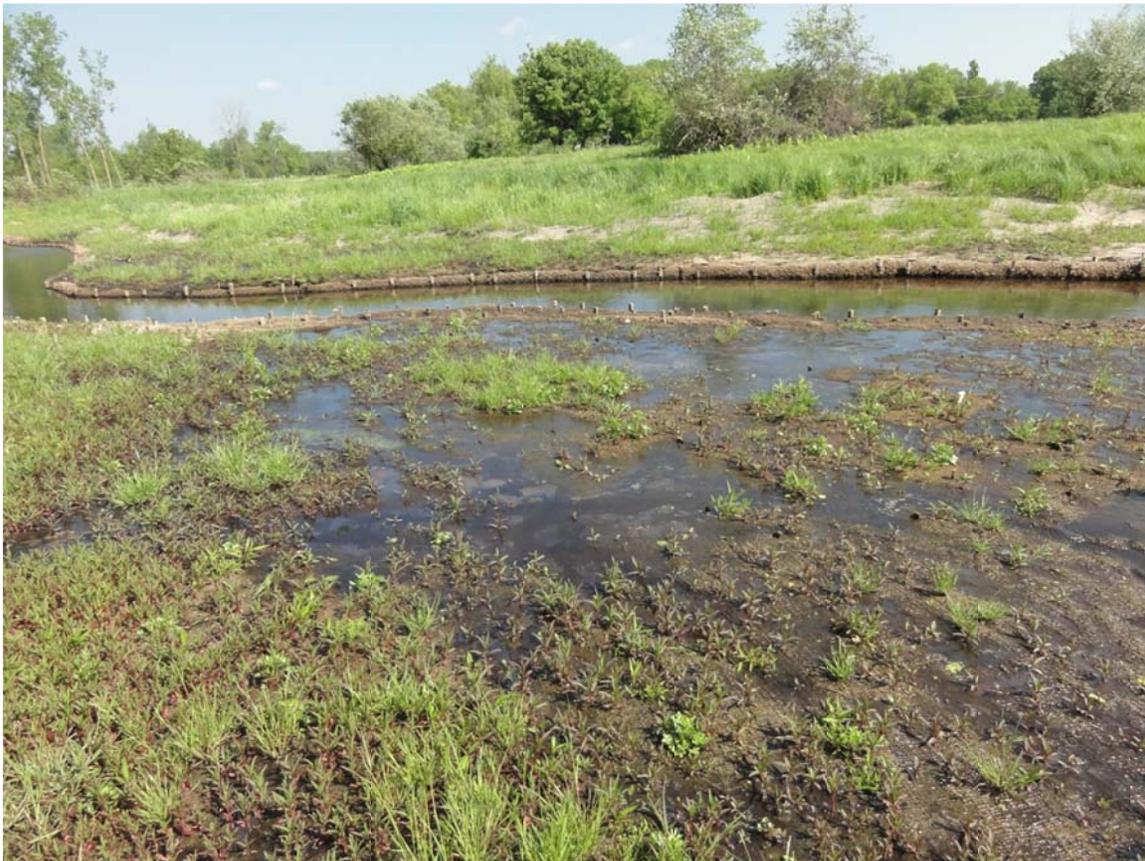
1. MP0.25 LDB on Talmadge Creek, location of sheen observed during yesterday's overflight.

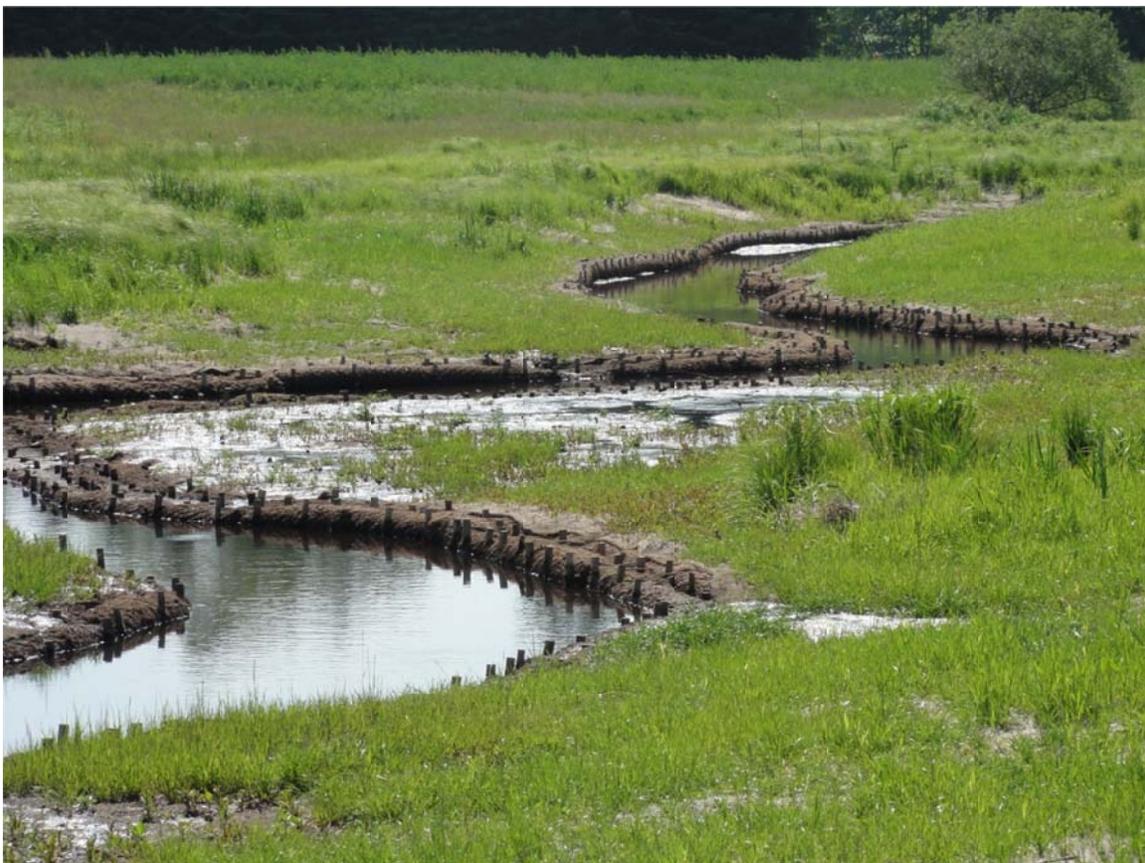
2. Talmadge Creek at MP 0.25 looking east.

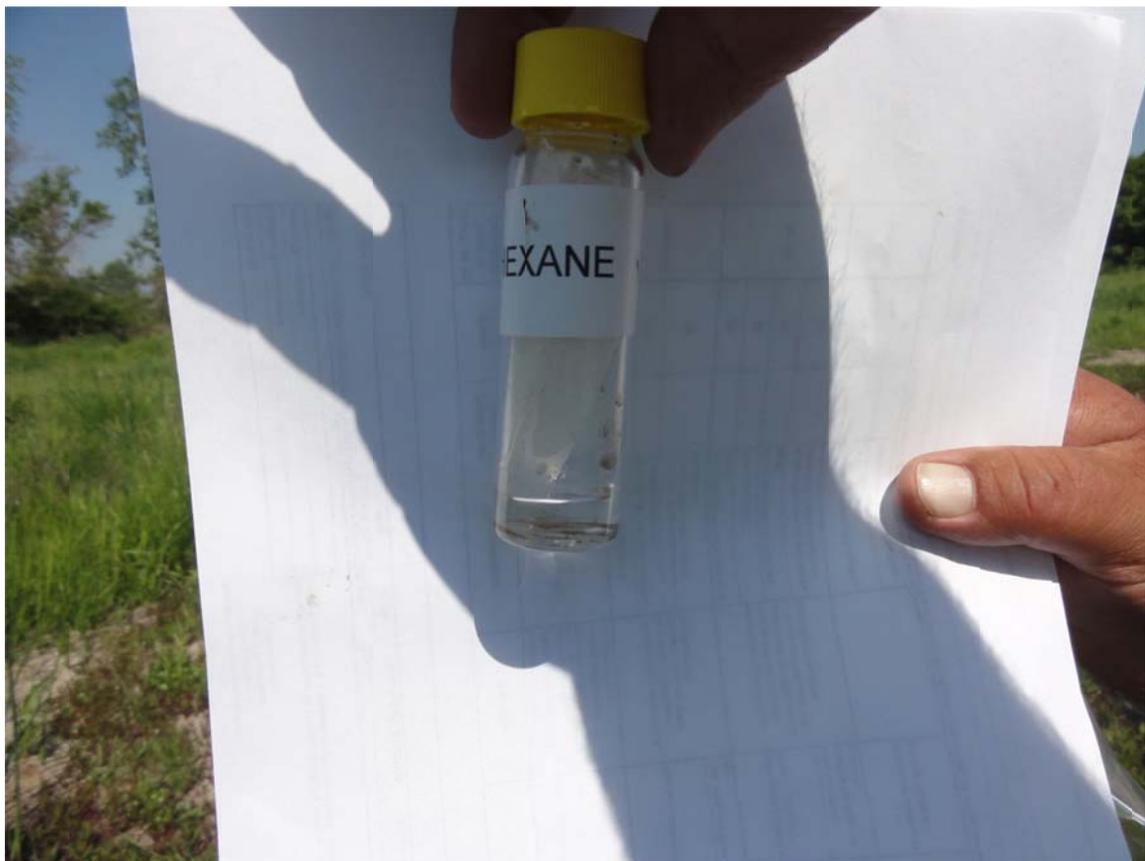
3. Hexane test at MP 0.25 location. Test showed no color change, indicating sheen is biogenic.

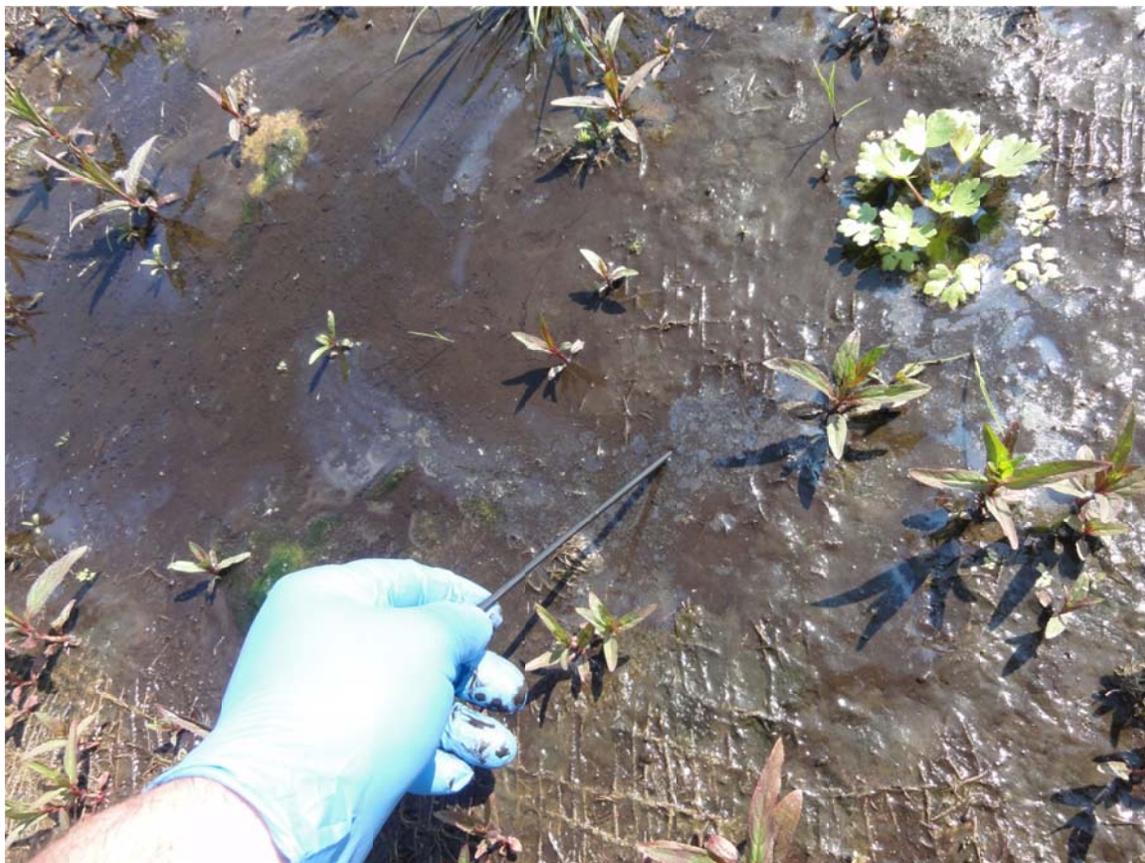
4. Stick test performed at MP 0.25. Test indicated biogenic sheen.

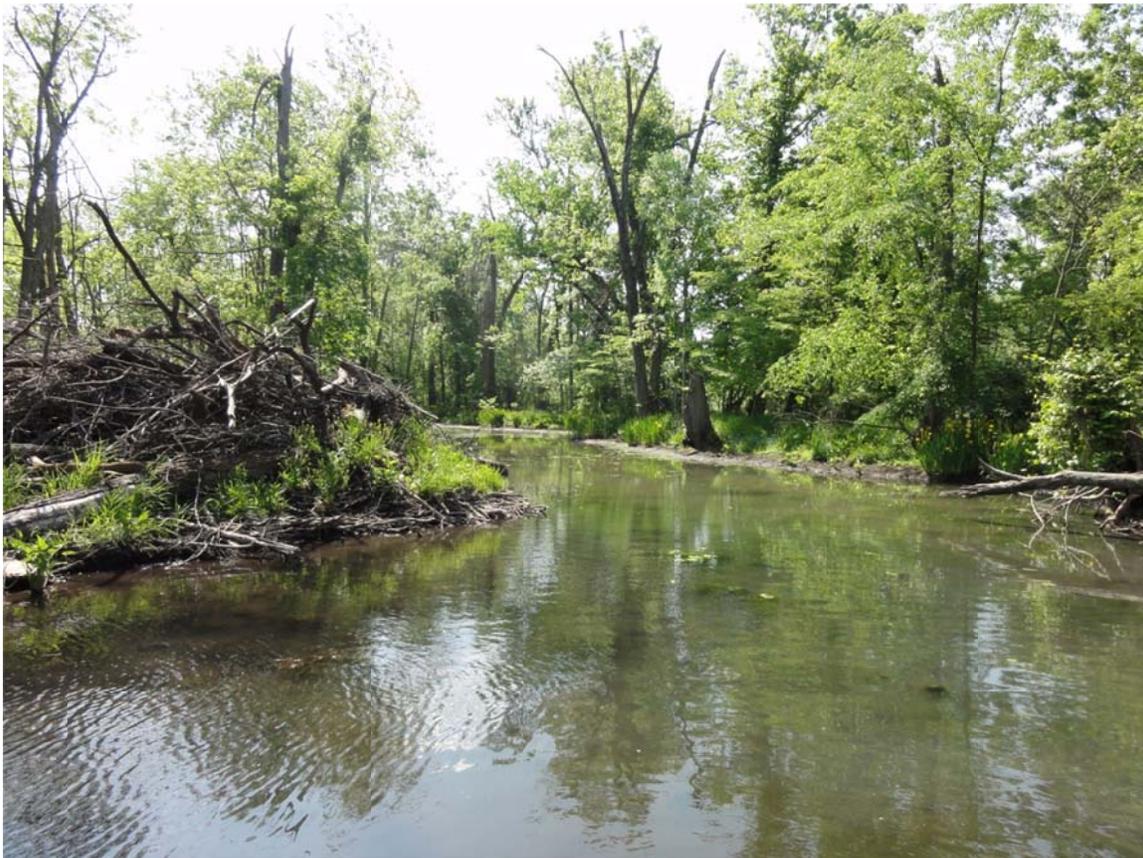
5. Back channel near MP 11.61 RDB, location of sheen observed during overflight yesterday. No sheen observed from ground today.

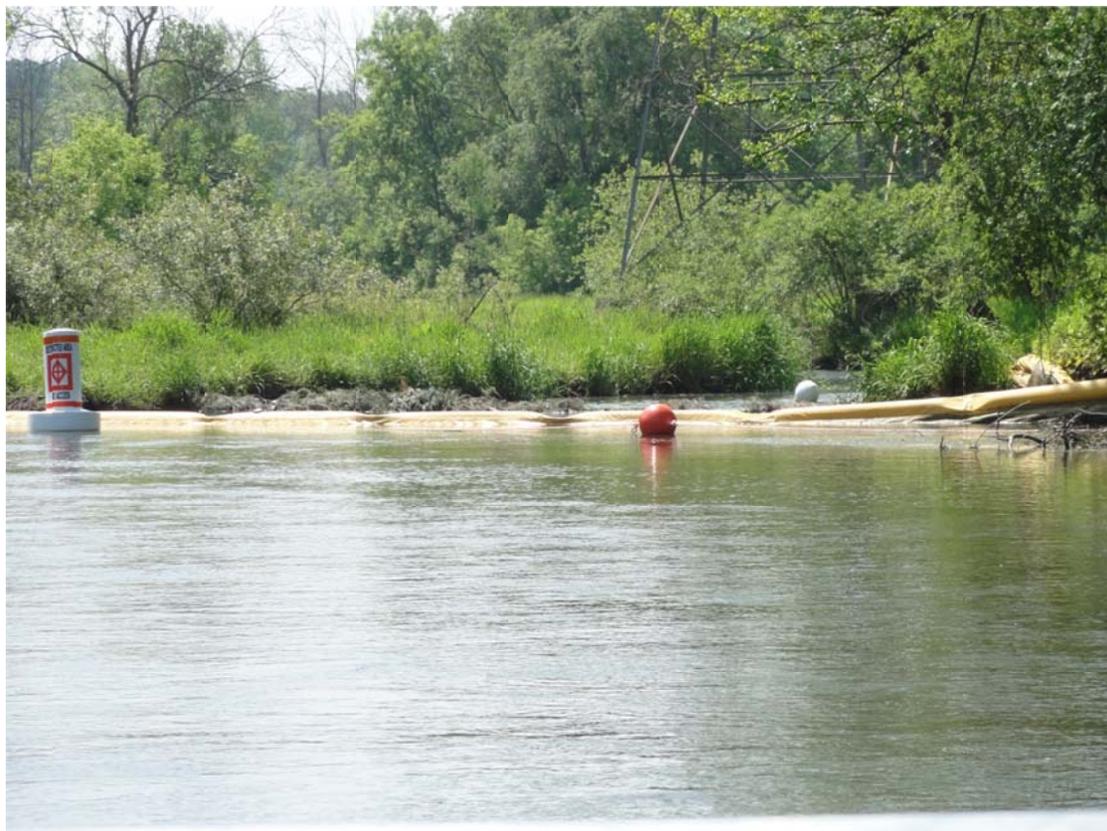
6. MP 10.75 sediment trap. Sheen observed within containment.

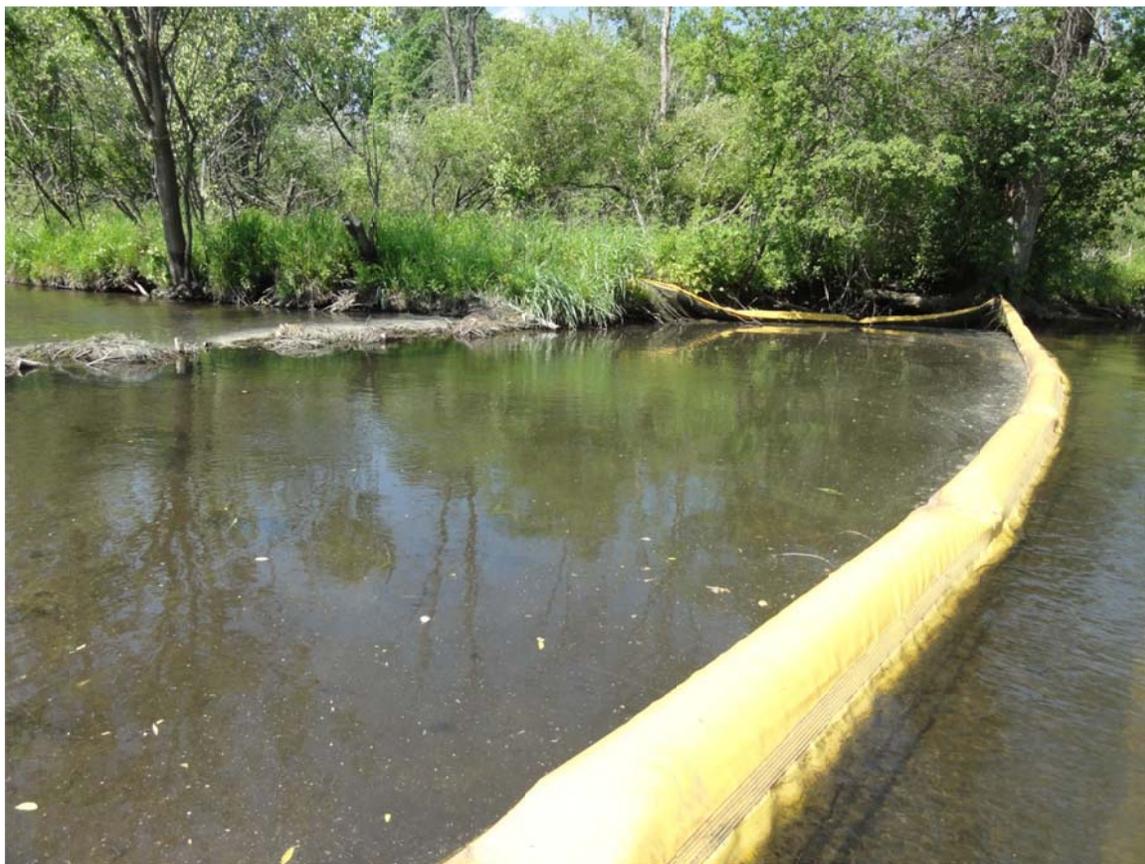
7. MP 10.75 control point, biogenic material observed in western corner of containment.

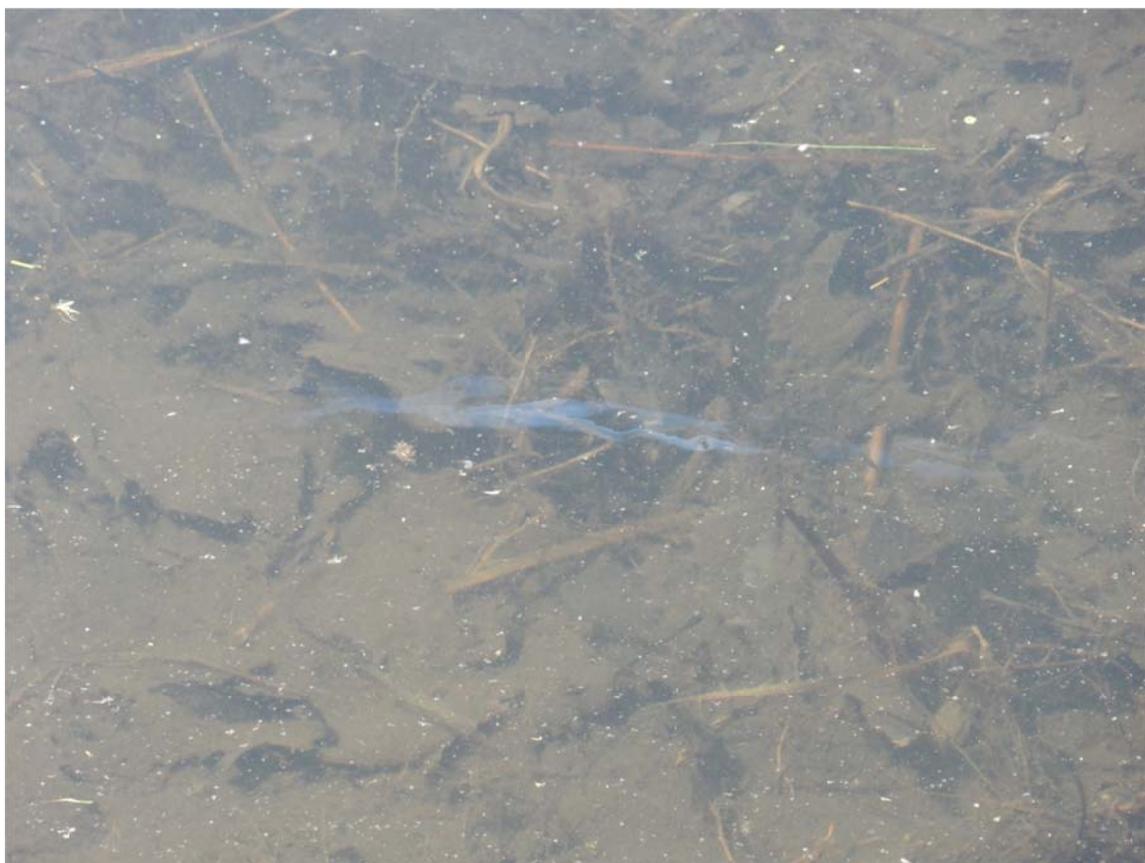
8. Tar globule and sheen observed within containment at MP 10.75 sediment trap.

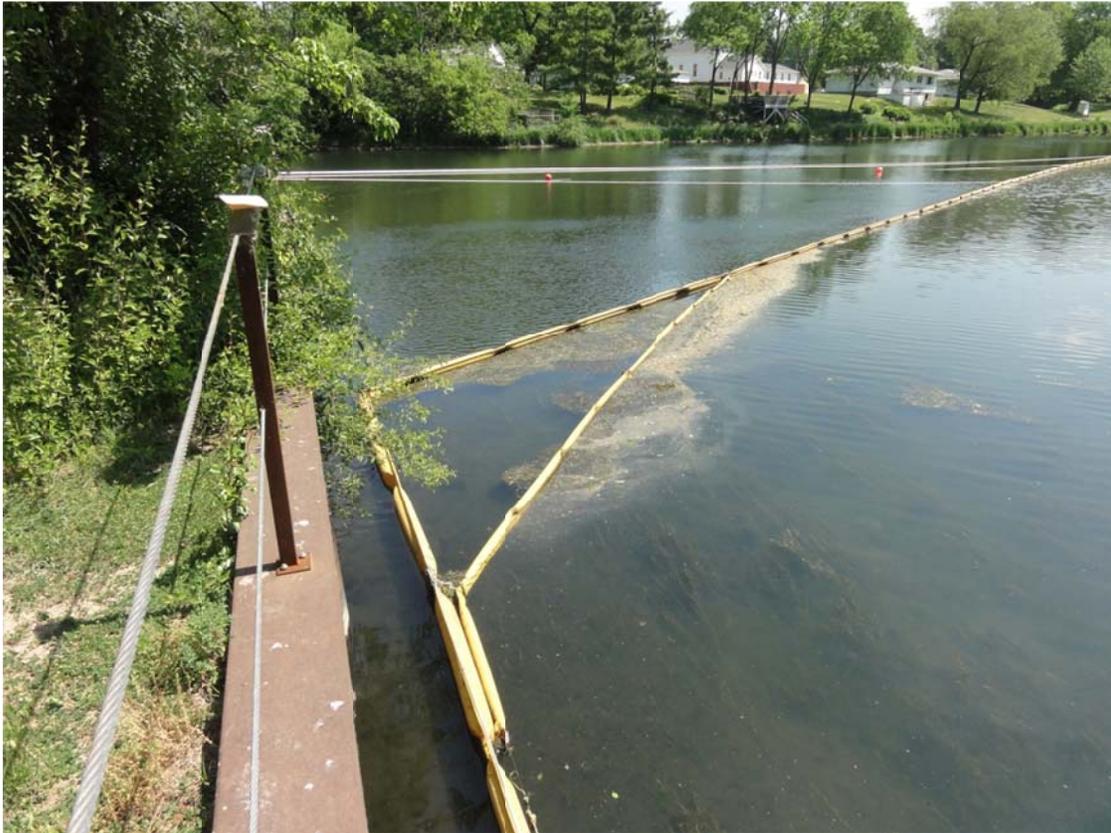
9. Ceresco Dam control point. Sheen and debris observed within containment.

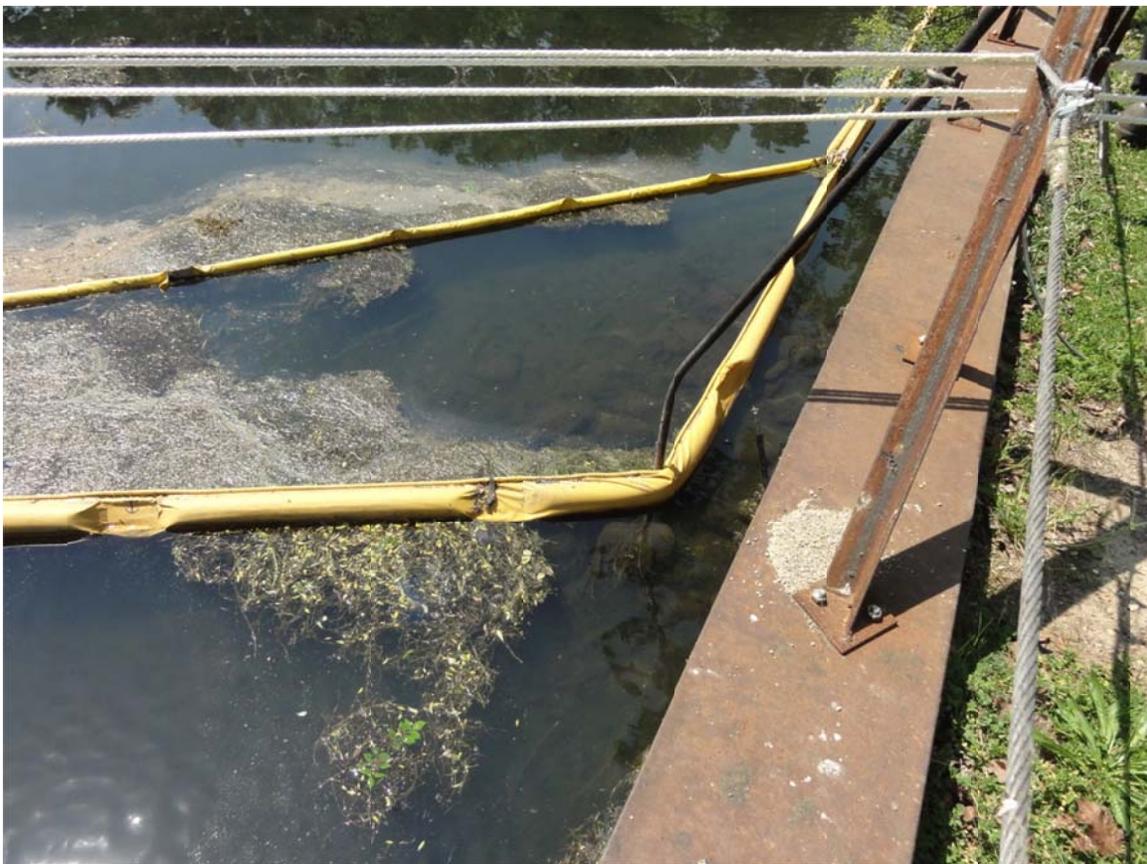
10. Ceresco Dam control point. Boom lowered from yesterday to adjust for dropping river level.
