# Situation Photo Log

Saturday, May 26, 2012

Kalamazoo River / Enbridge Spill

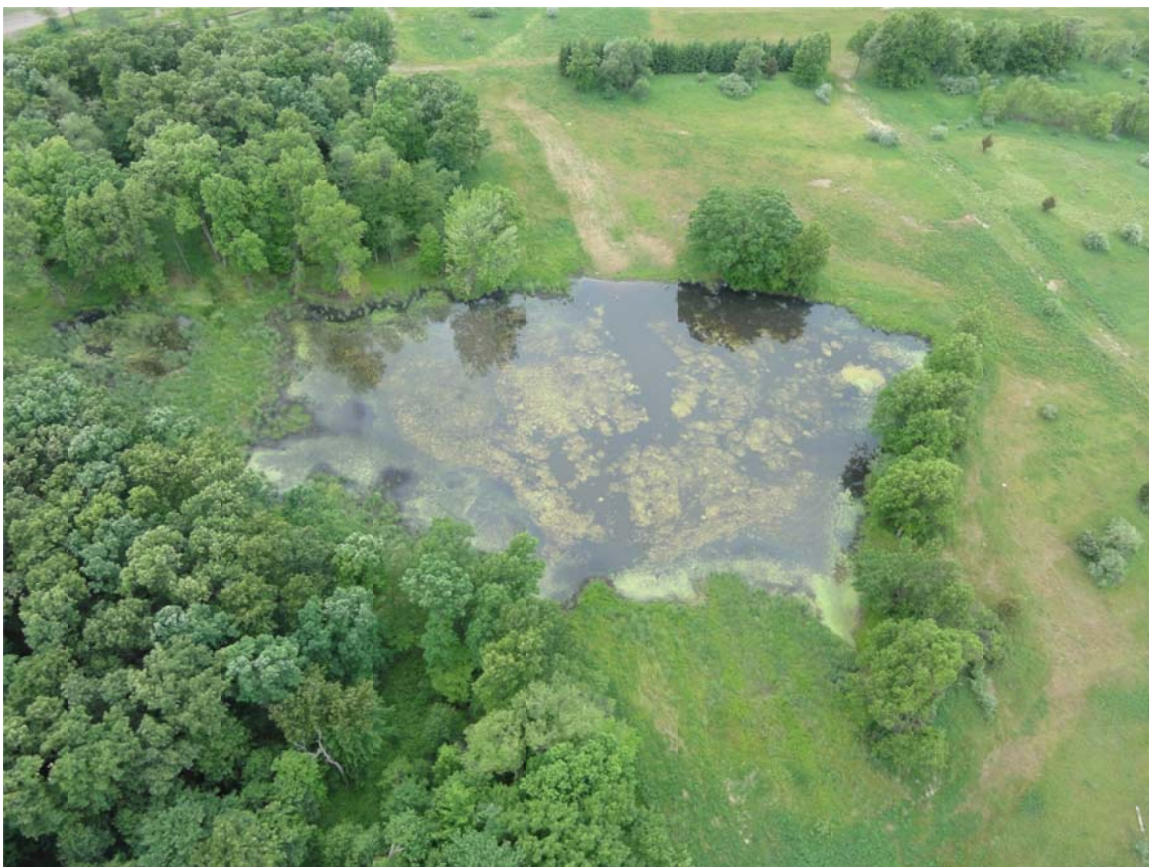
1. Source area pond, no sheen observed.

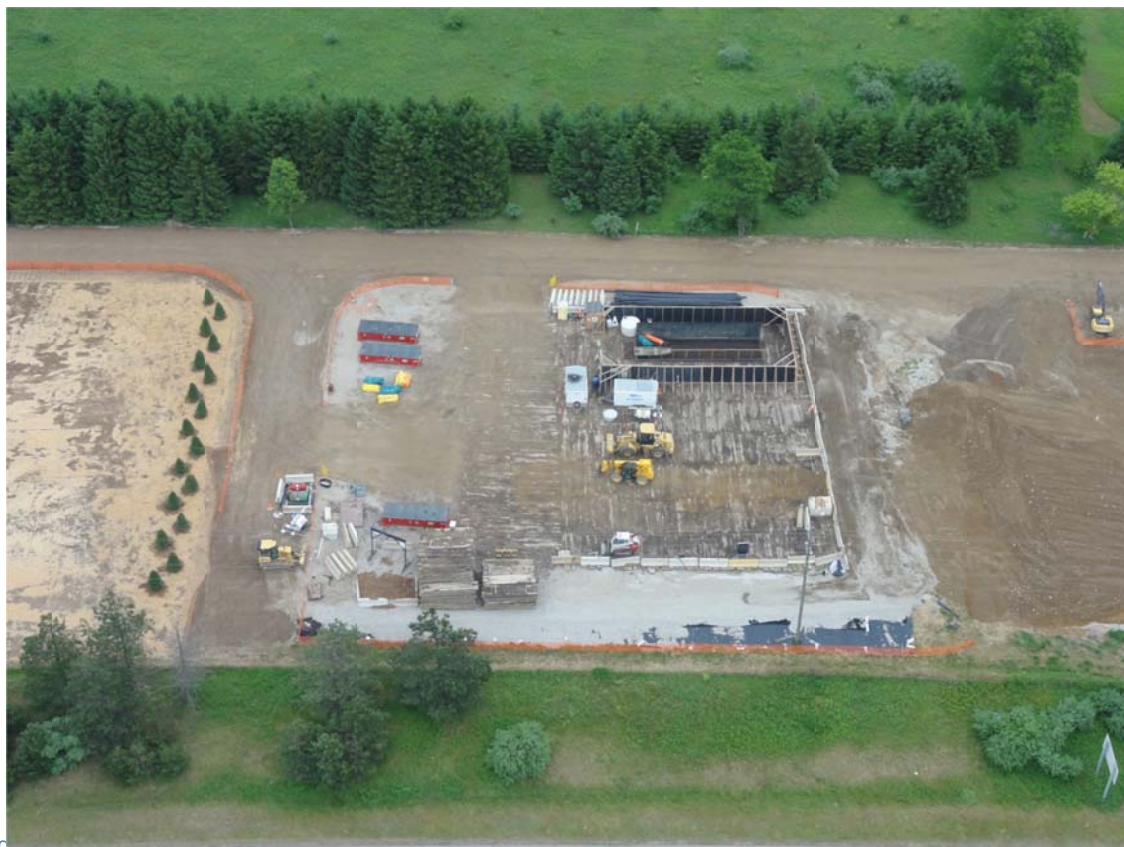
2. Frac-Tank City decon pad. No activity observed.

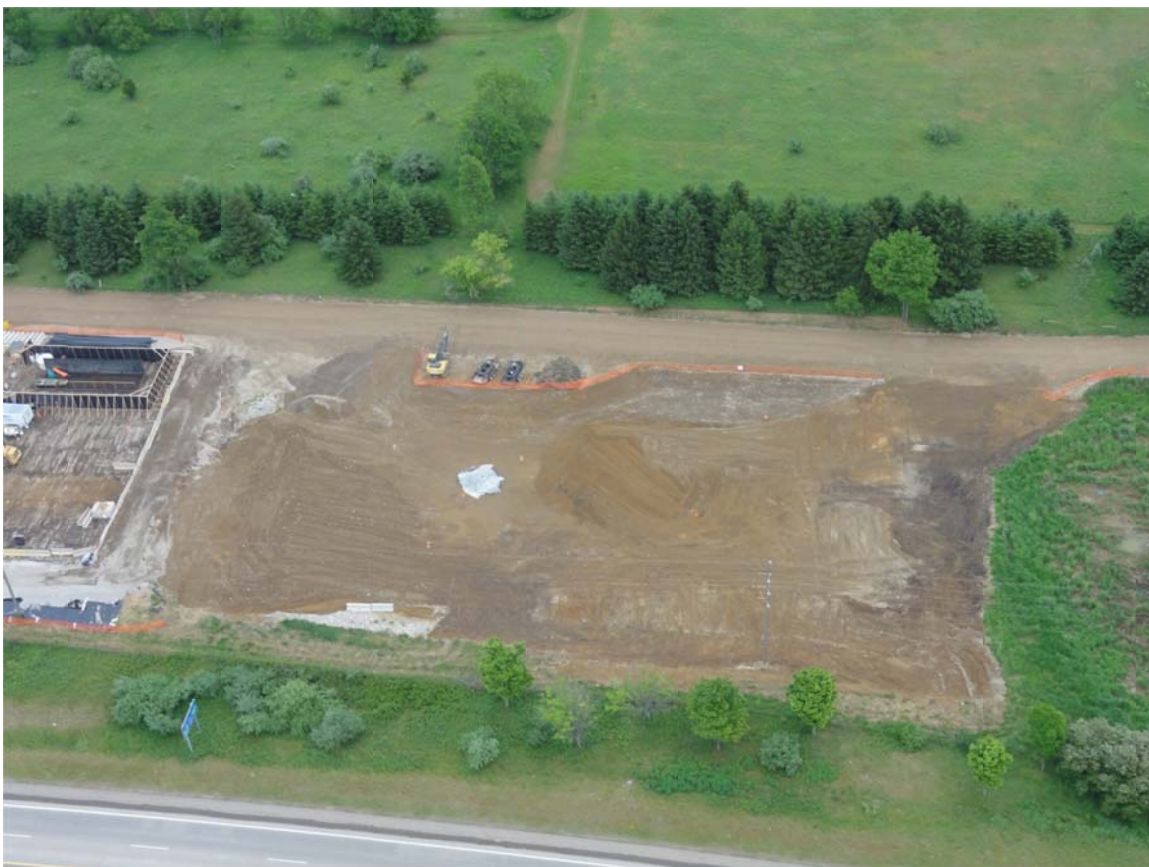
3. Frac-Tank City former southern decon pad. No activity observed.

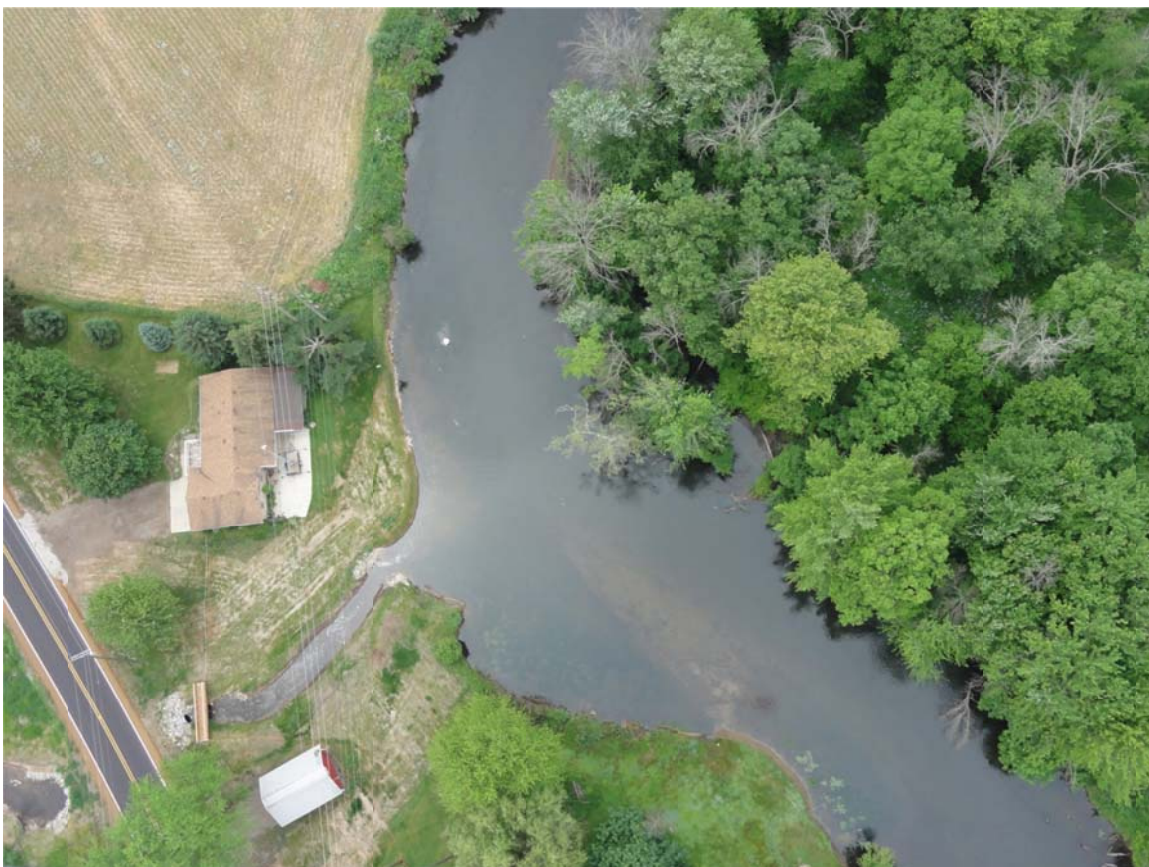
4. Confluence, no sheen observed.

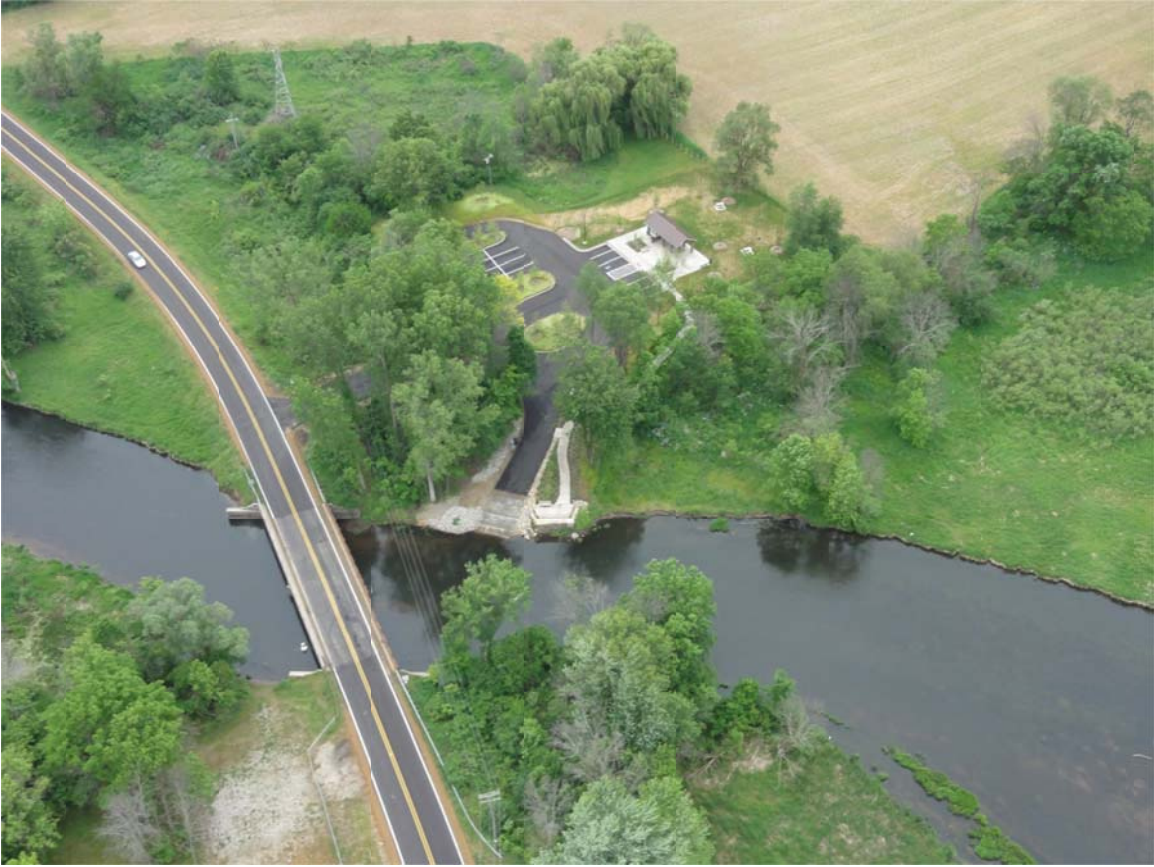
5. Saylor's Landing, no public activity observed.

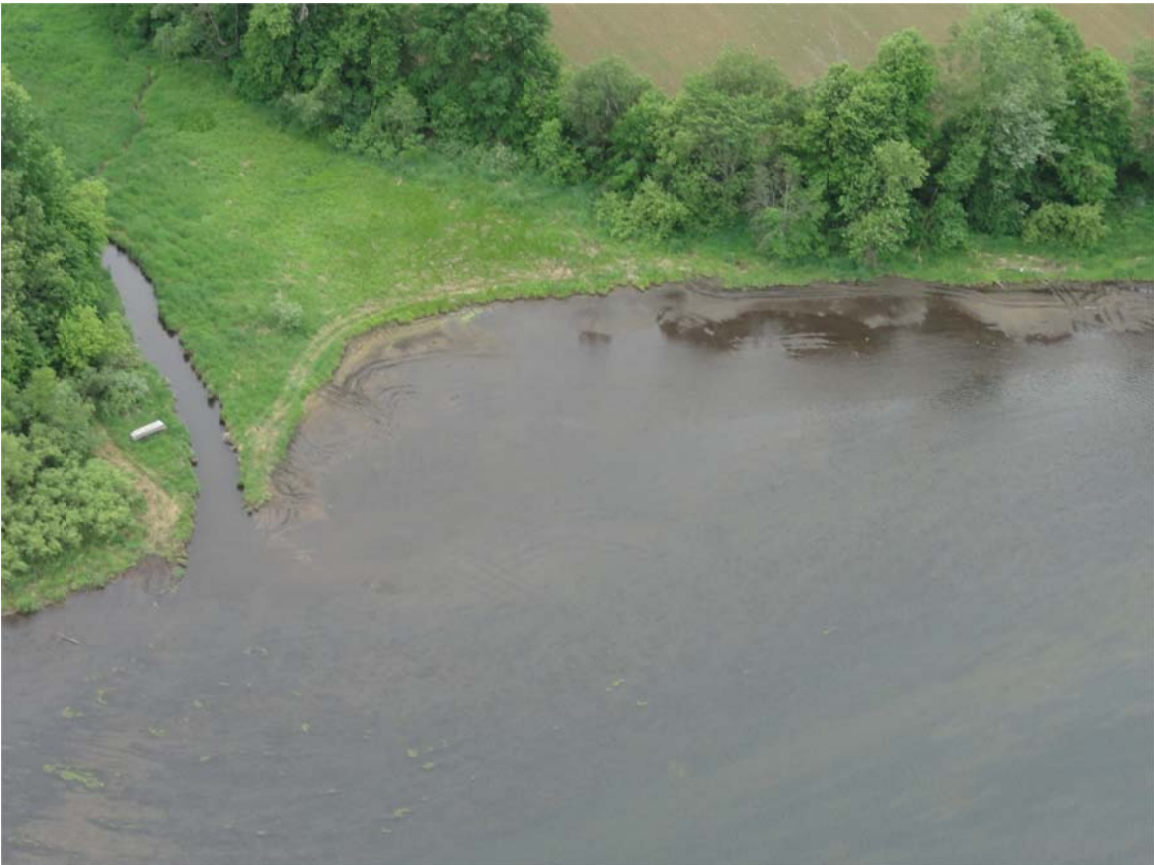
6. MP4.5 LDB, Former Lily Pad area, no sheen observed.

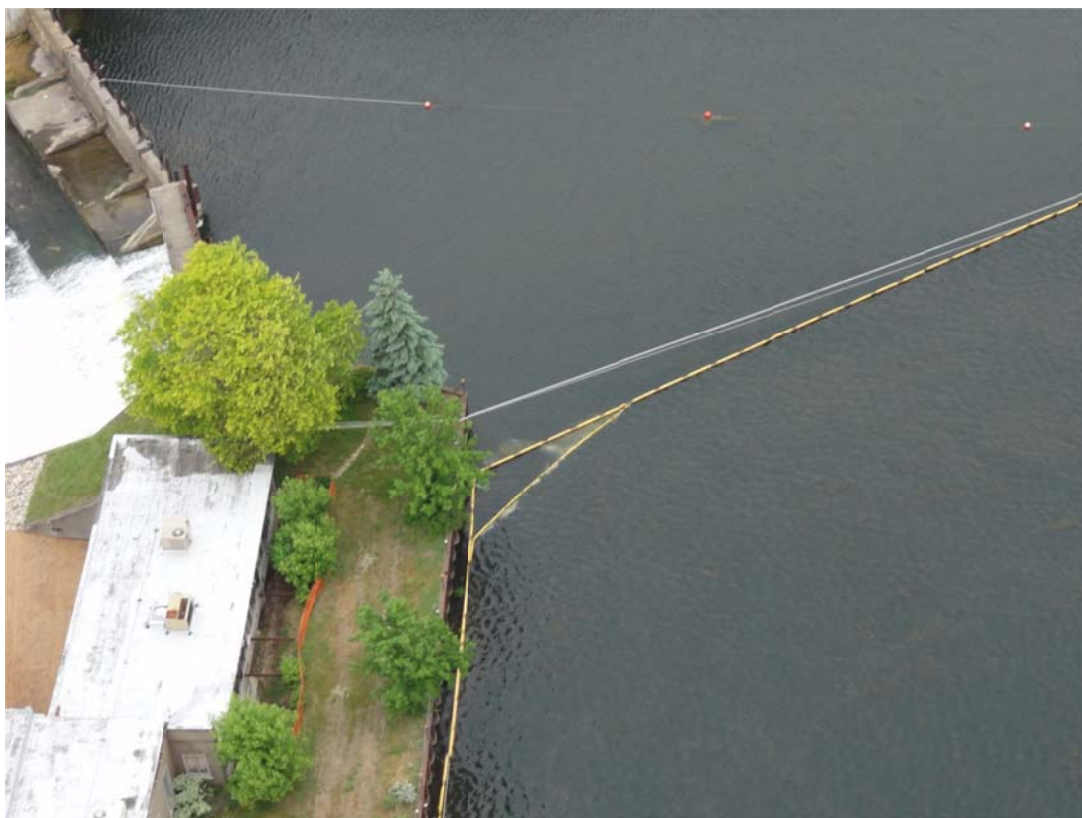
7. Ceresco Dam, no sheen observed.

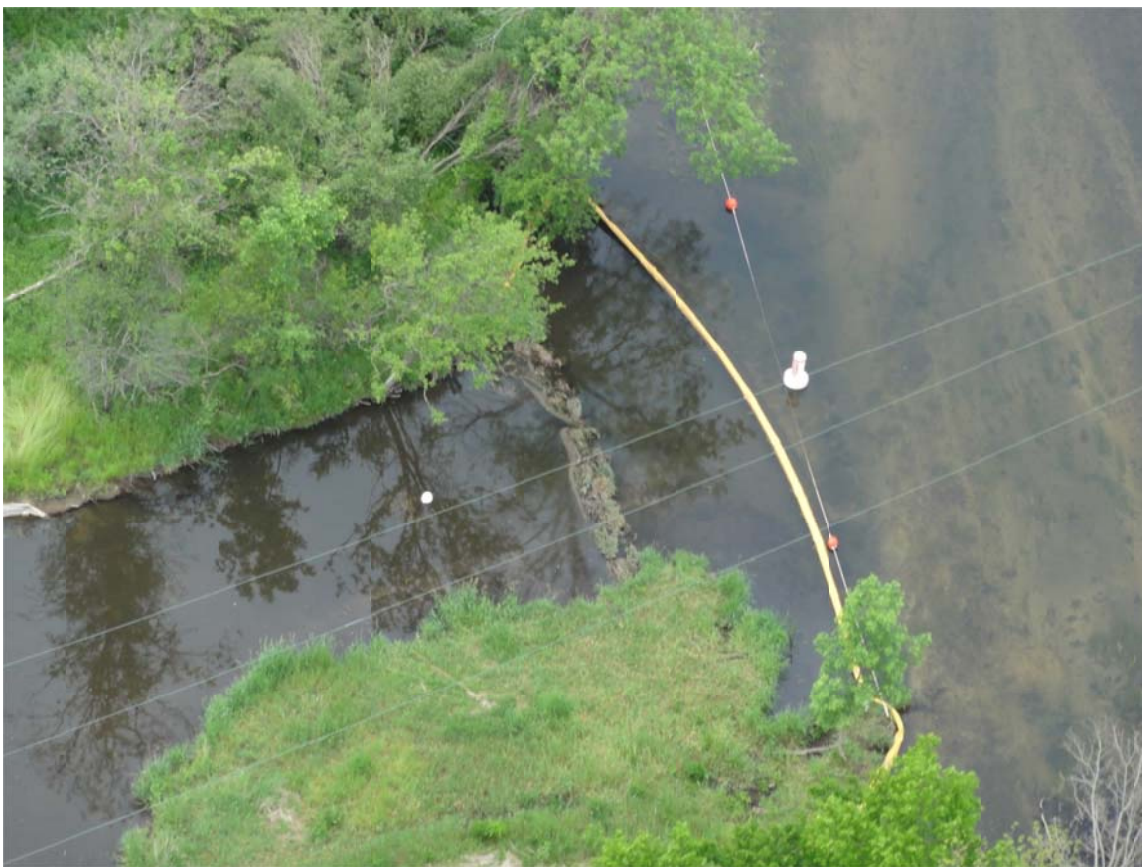
8. MP 10.75 sediment trap, sheen observed within containment.

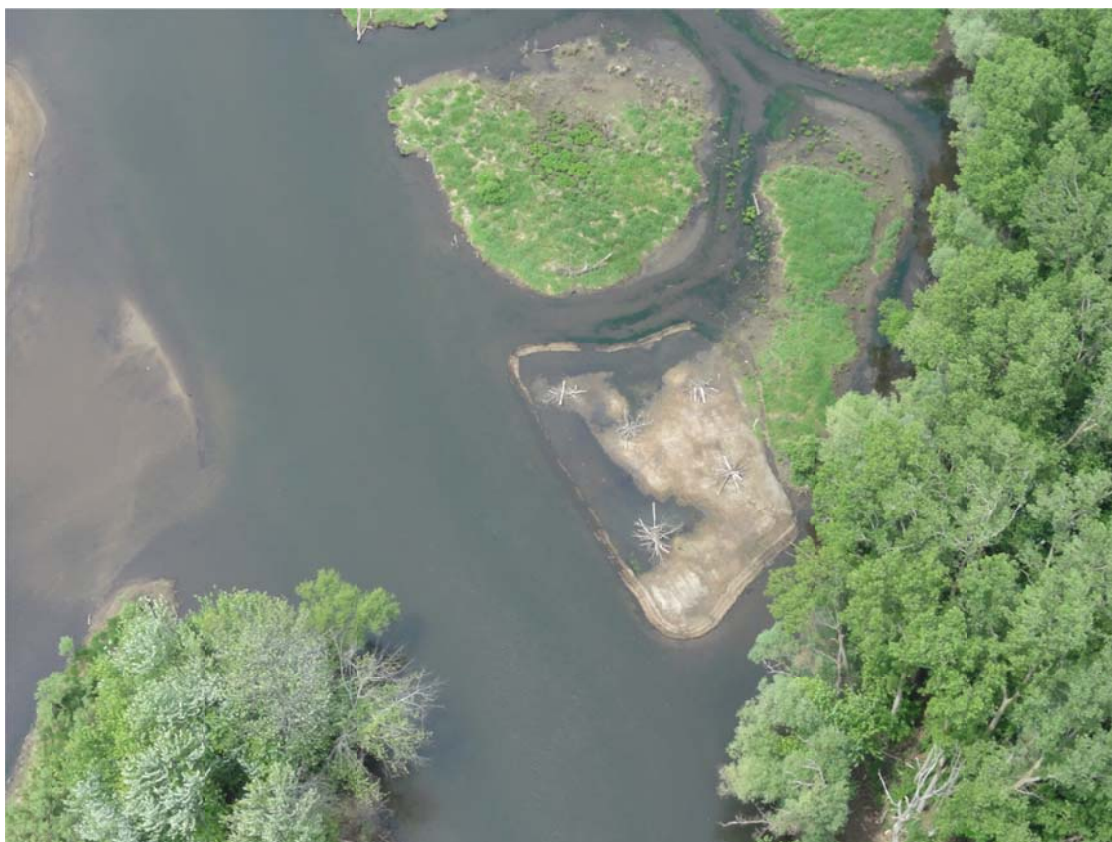
9. MP 14.98 island, containment around island was removed last week, no sheen observed.

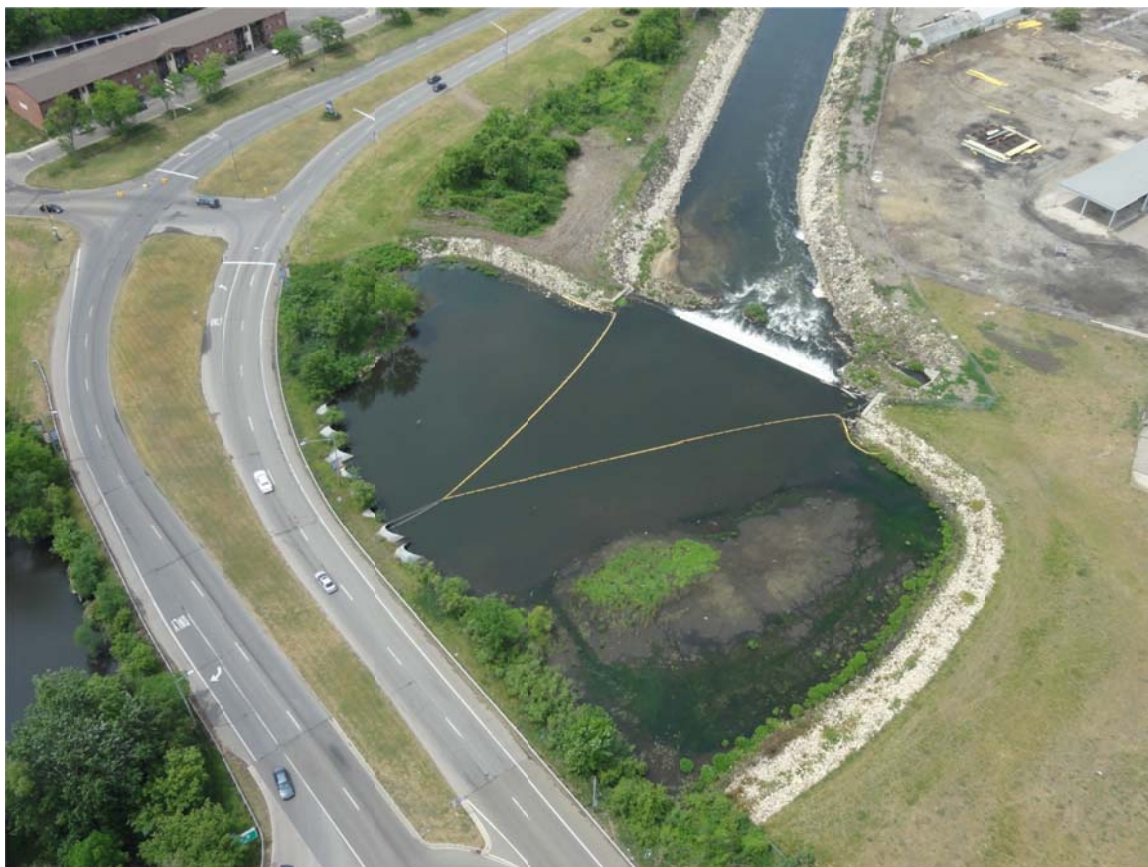
10. Control point at Battle Creek spillway. No sheen observed.

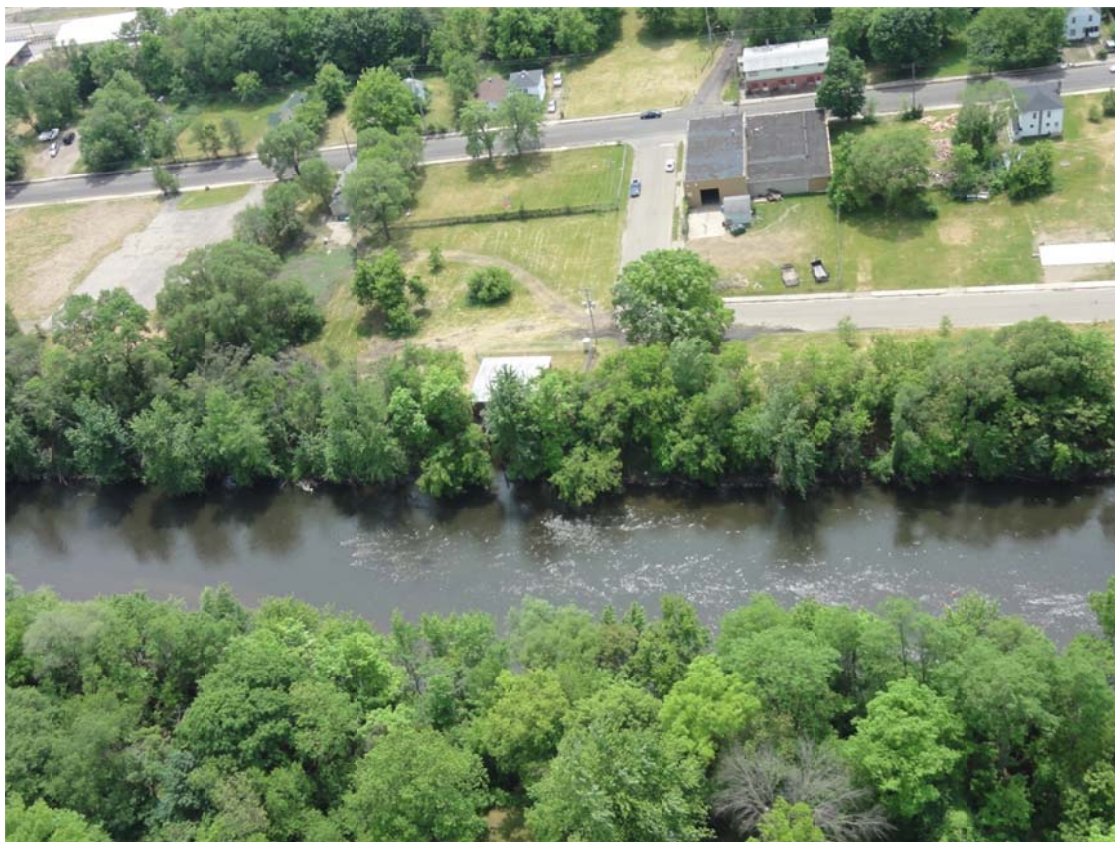
**11. Rock Tenn inlet, no activity observed.**

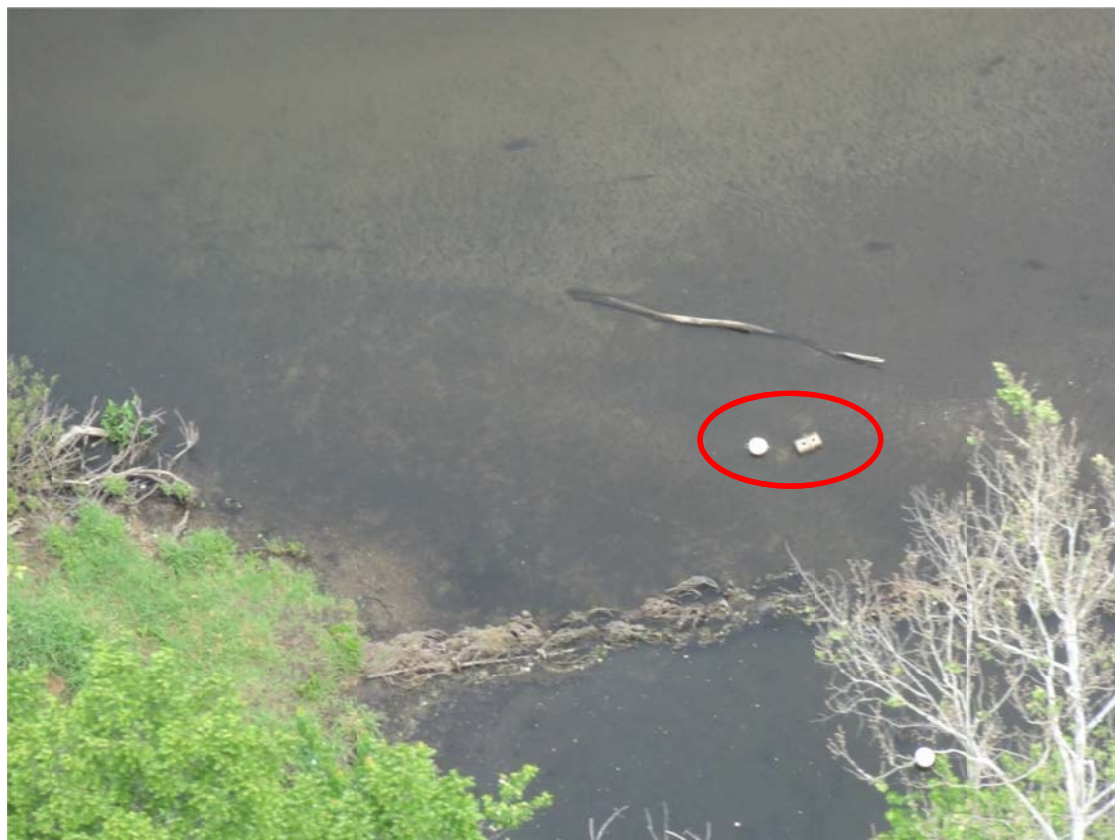
**12. MP 10.25 sediment trap. Sediment sampling device was observed to be out of water.**

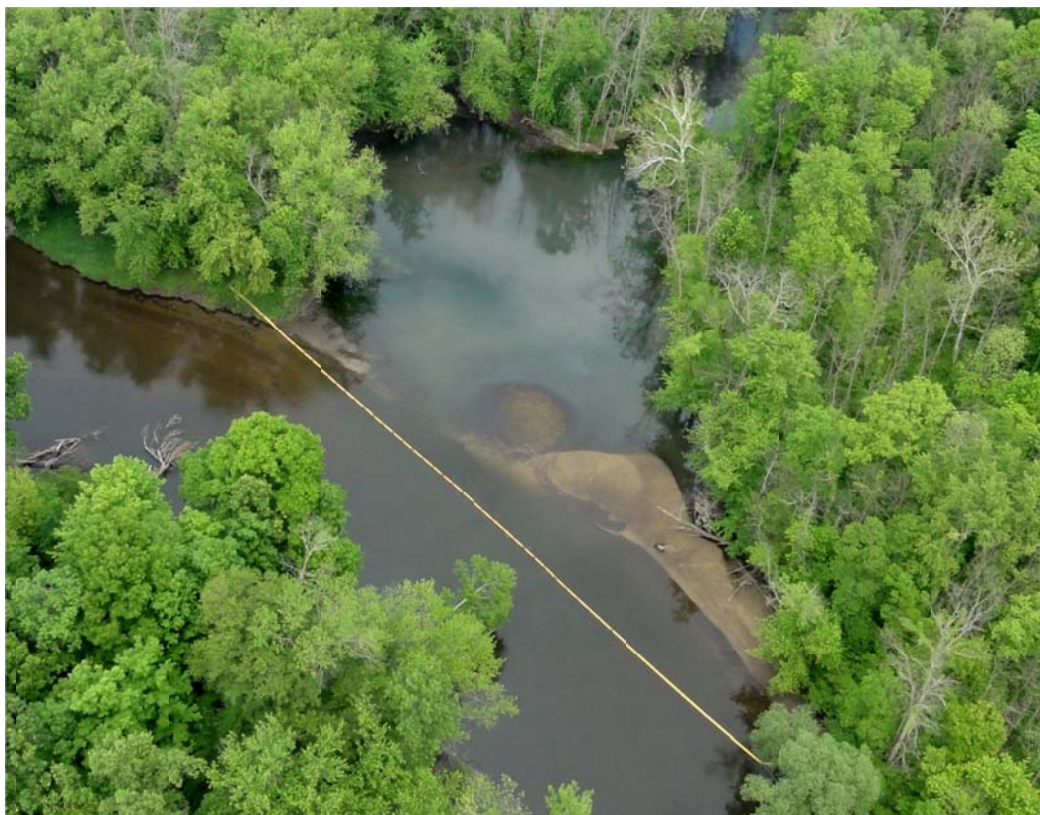
**13. MP 30.8 LDB containment. Sheen observed within containment. Operations crew notified to conduct inspection.**

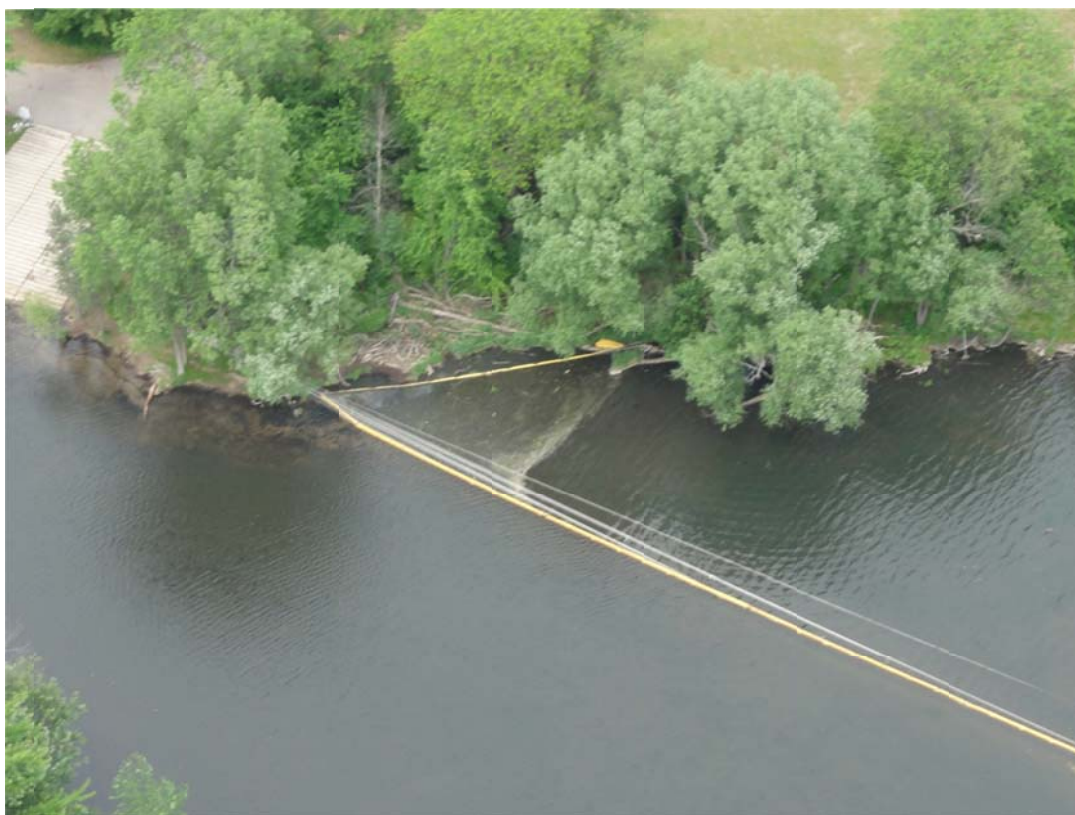
**14. E4.0 control point. Debris observed within containment. No sheen observed.**

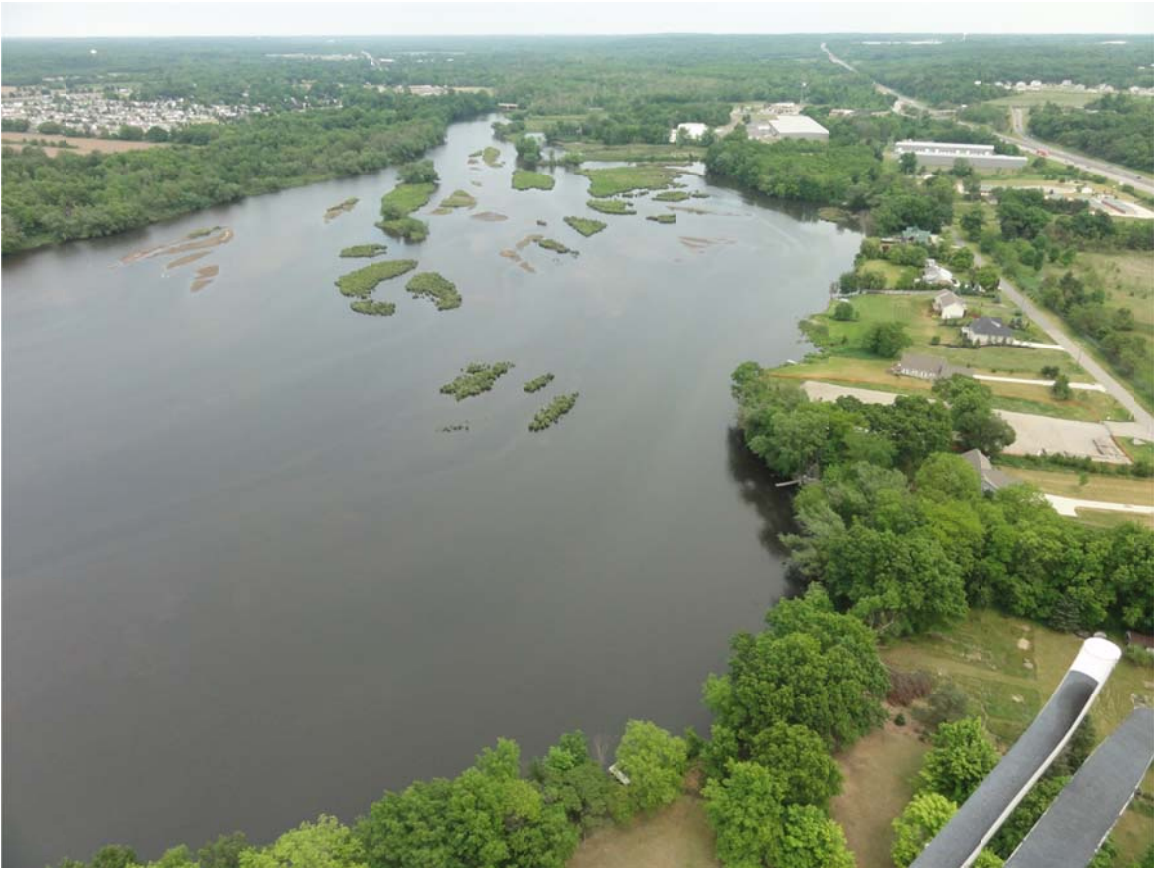
15. Morrow Lake Delta, looking east. No sheen observed in delta.

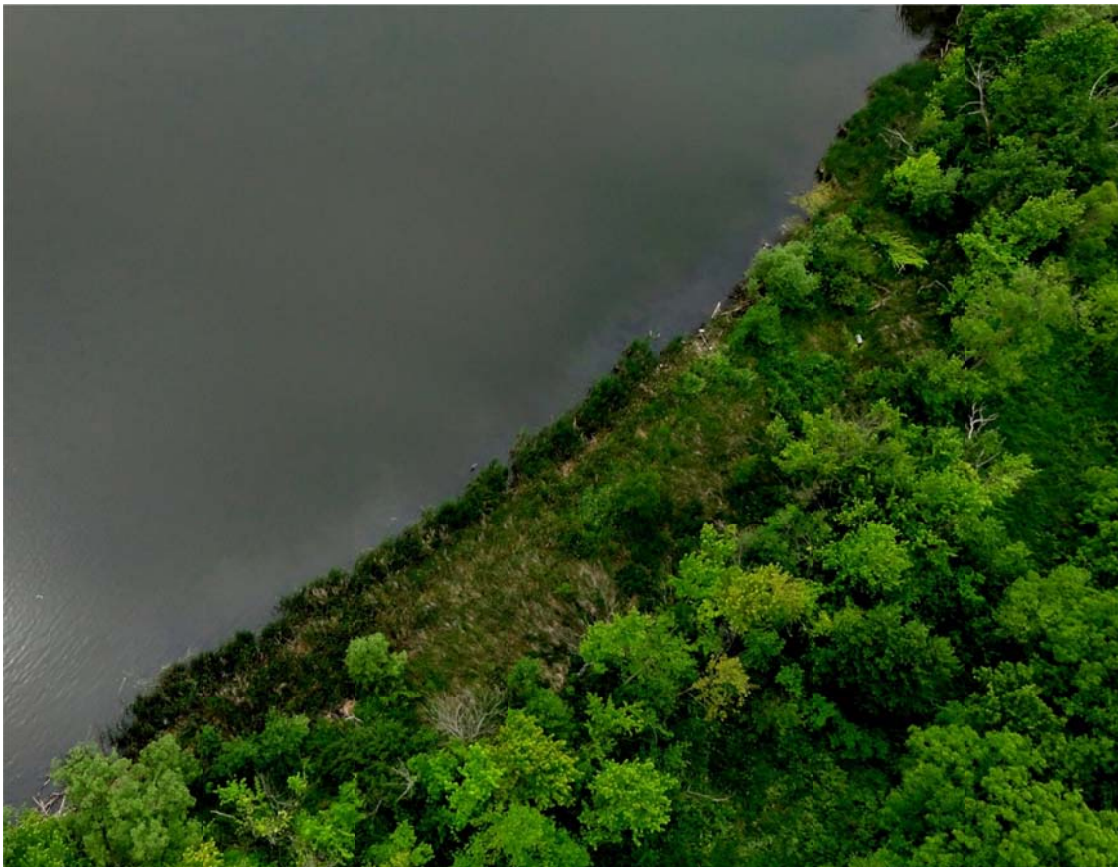
16. Sheen observed along shoreline in northern cove on Morrow Lake near MP38.25. Operations crew notified to conduct inspection.

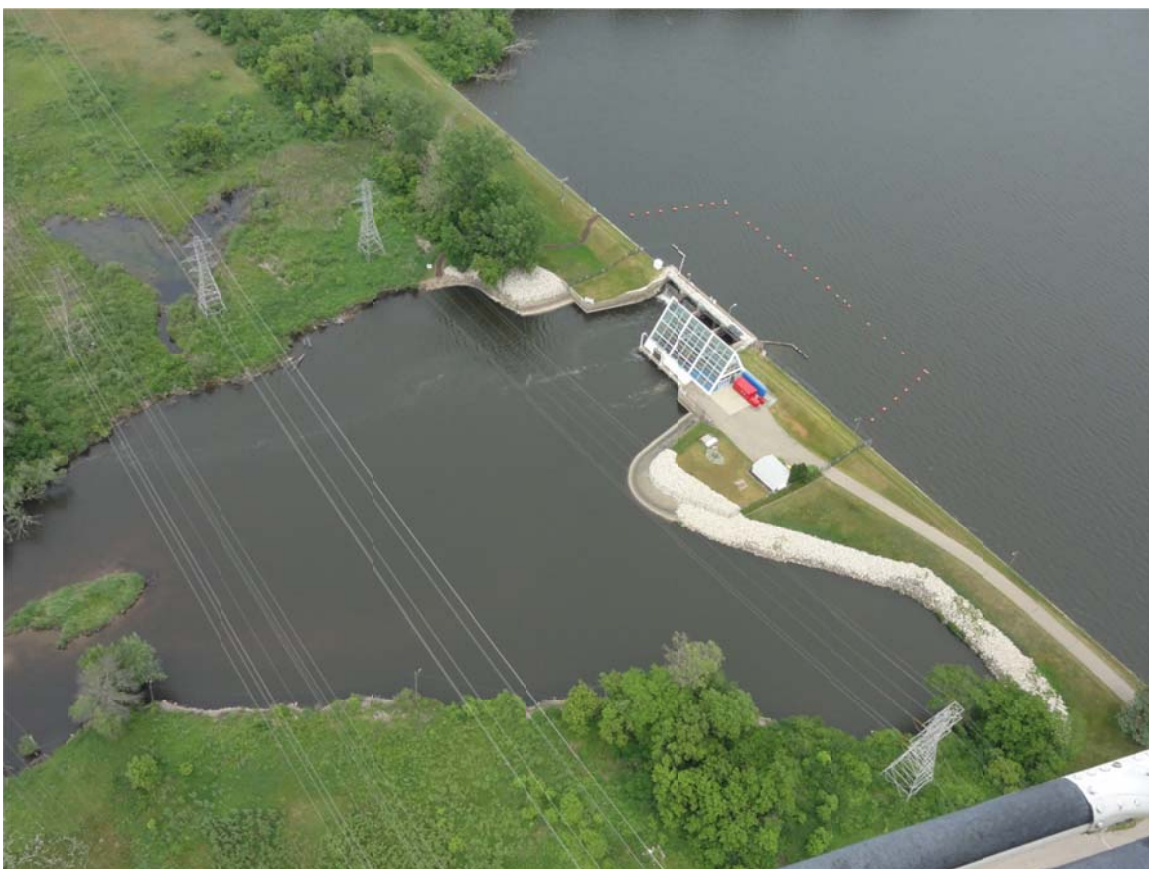
17. Morrow Lake Dam, no sheen or activity observed.

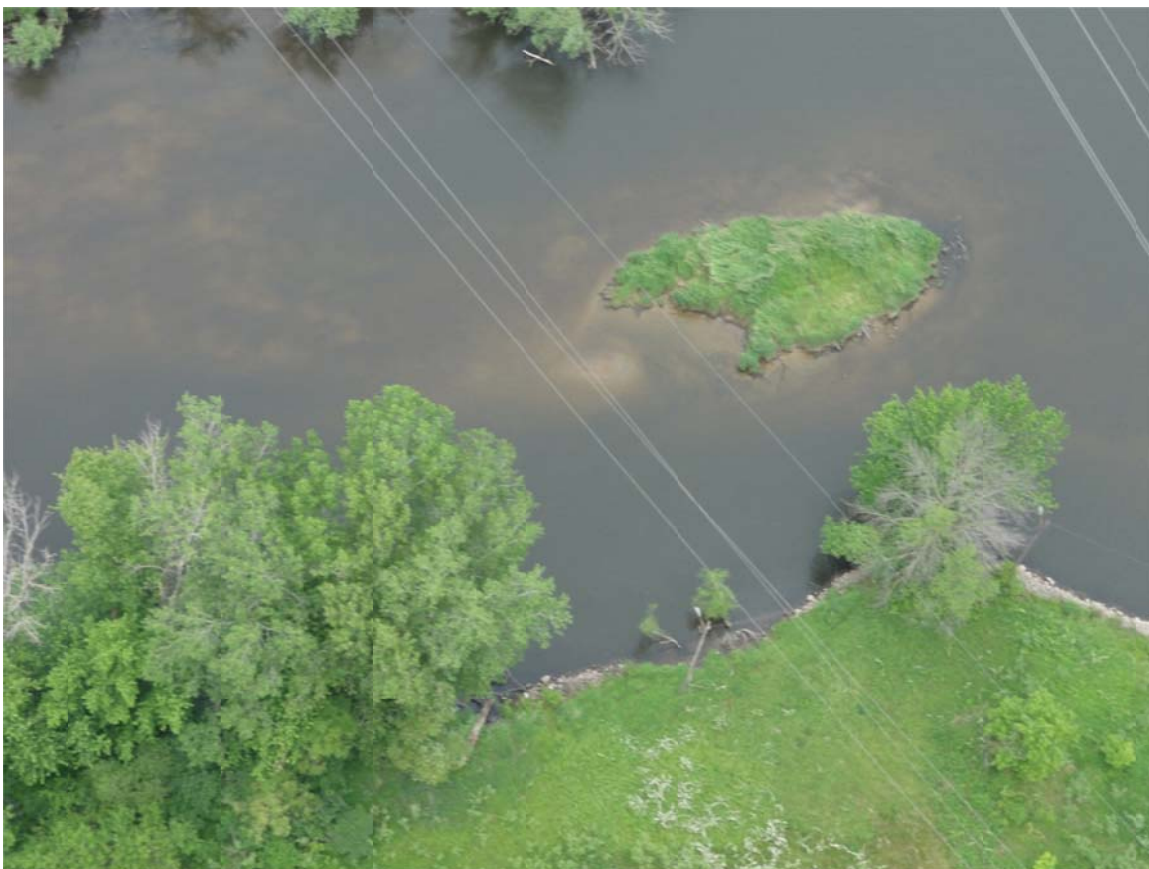
18. South bank of river below Morrow Lake Dam. No sheen observed.
