# Situation Photo Log

Tuesday, May 29, 2012

Kalamazoo River / Enbridge Spill

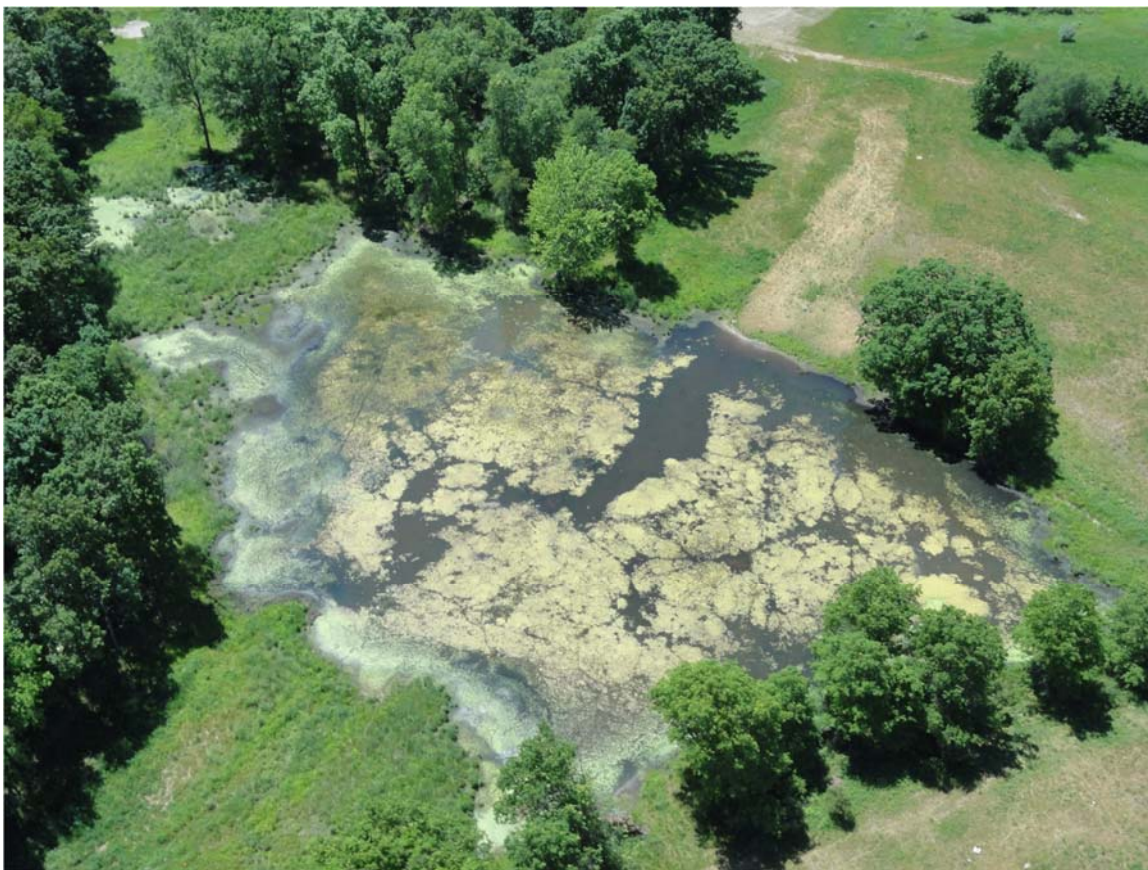
1. Source area pond, no sheen observed.

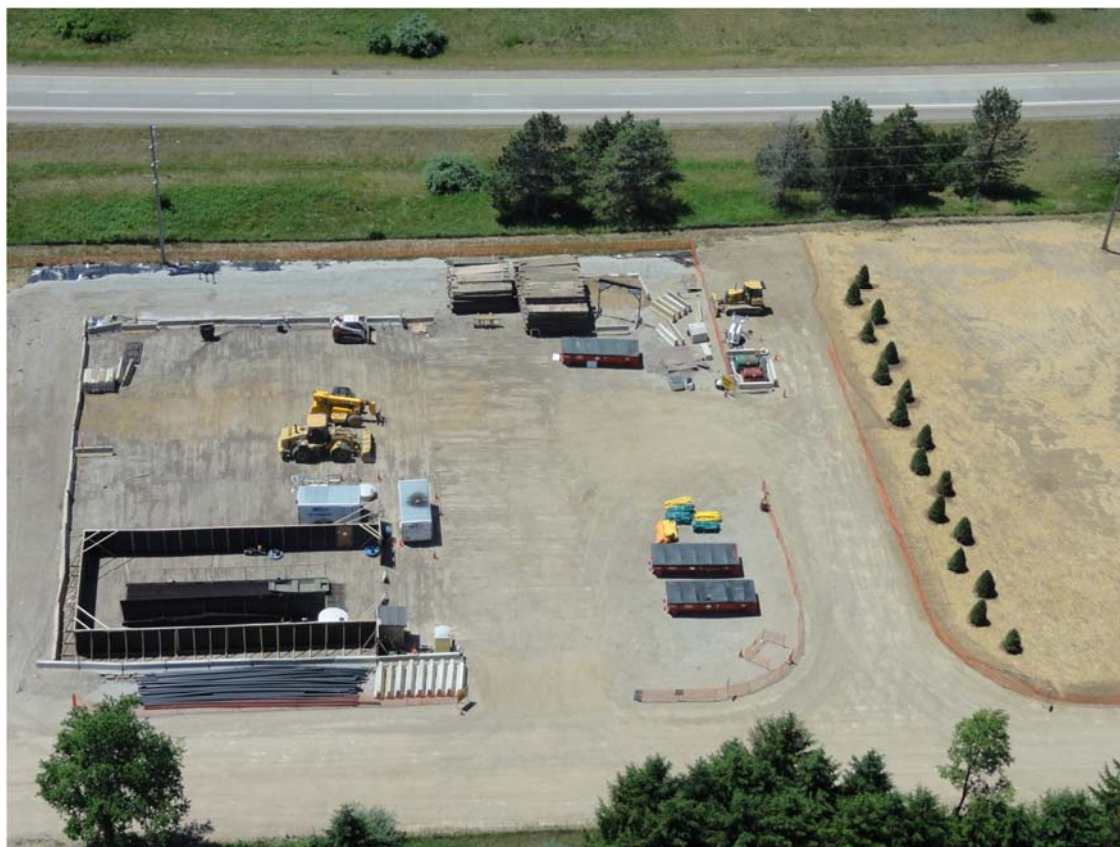
2. Frac-Tank City decon pad and soil cells. Boat observed in decon area.

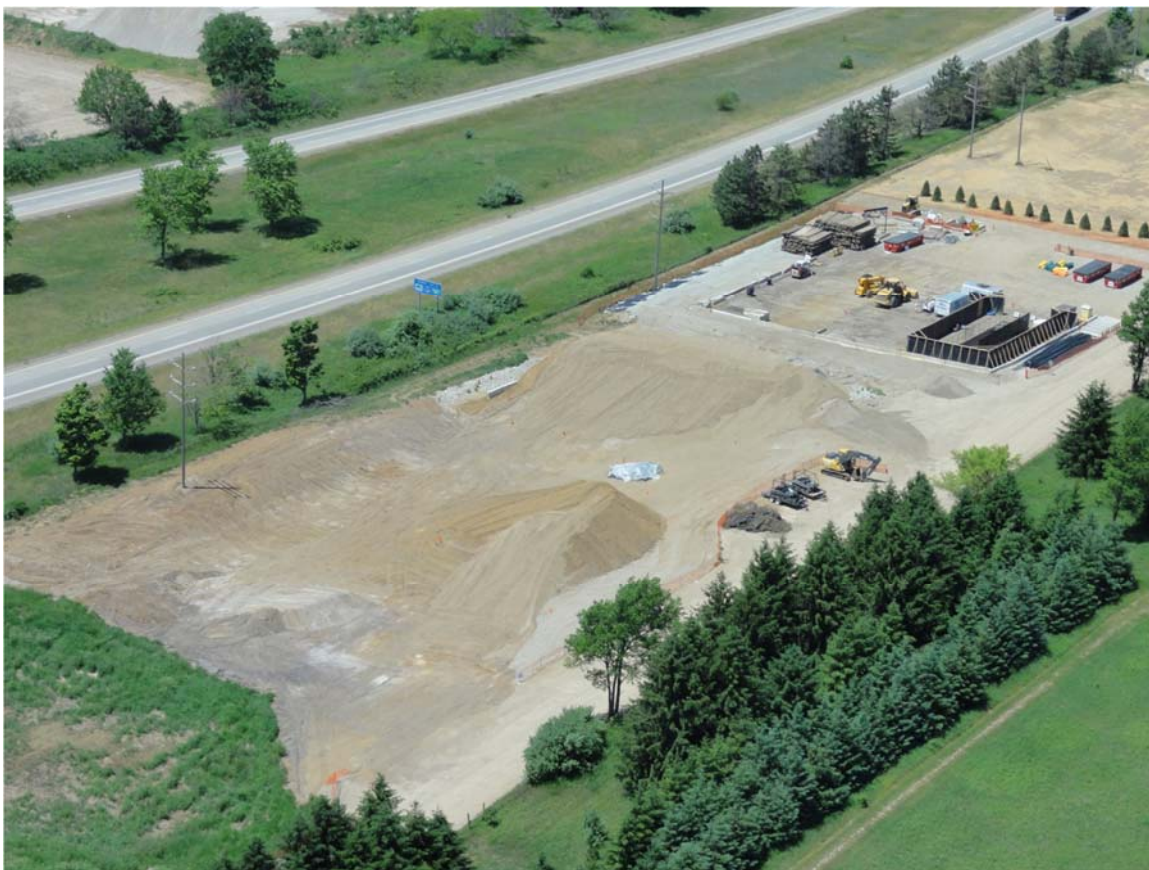
3. Frac-Tank City, footprint reduction continues.

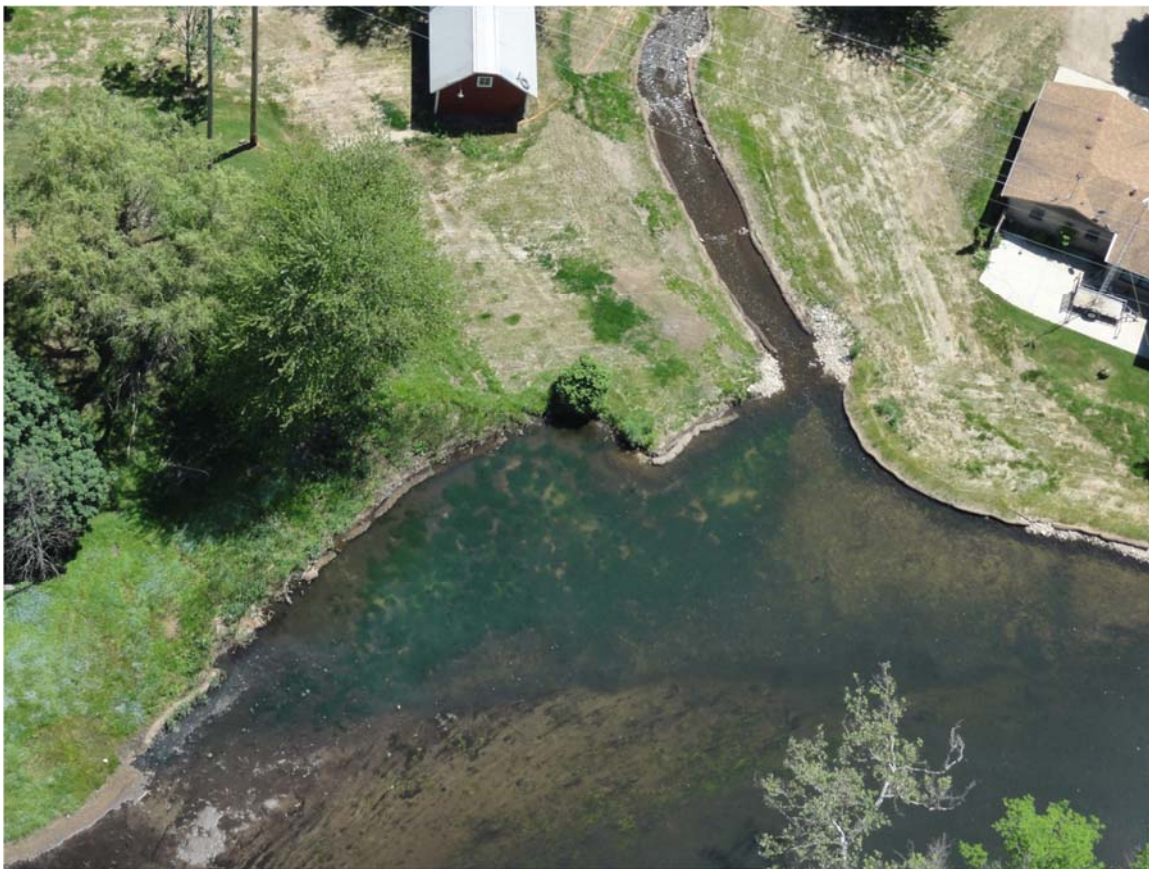
4. Confluence, no turbidity or sheen observed.

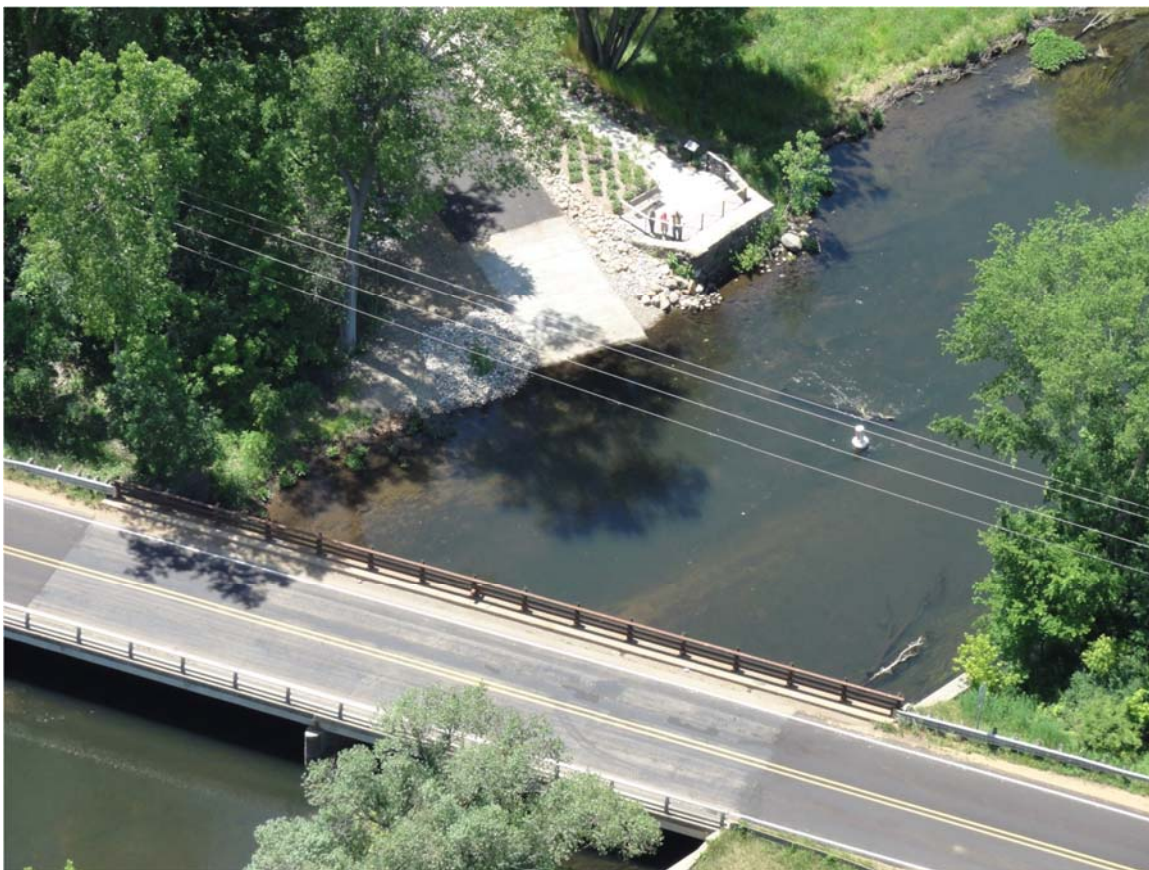
5. Observed public utilizing Saylor's Landing.

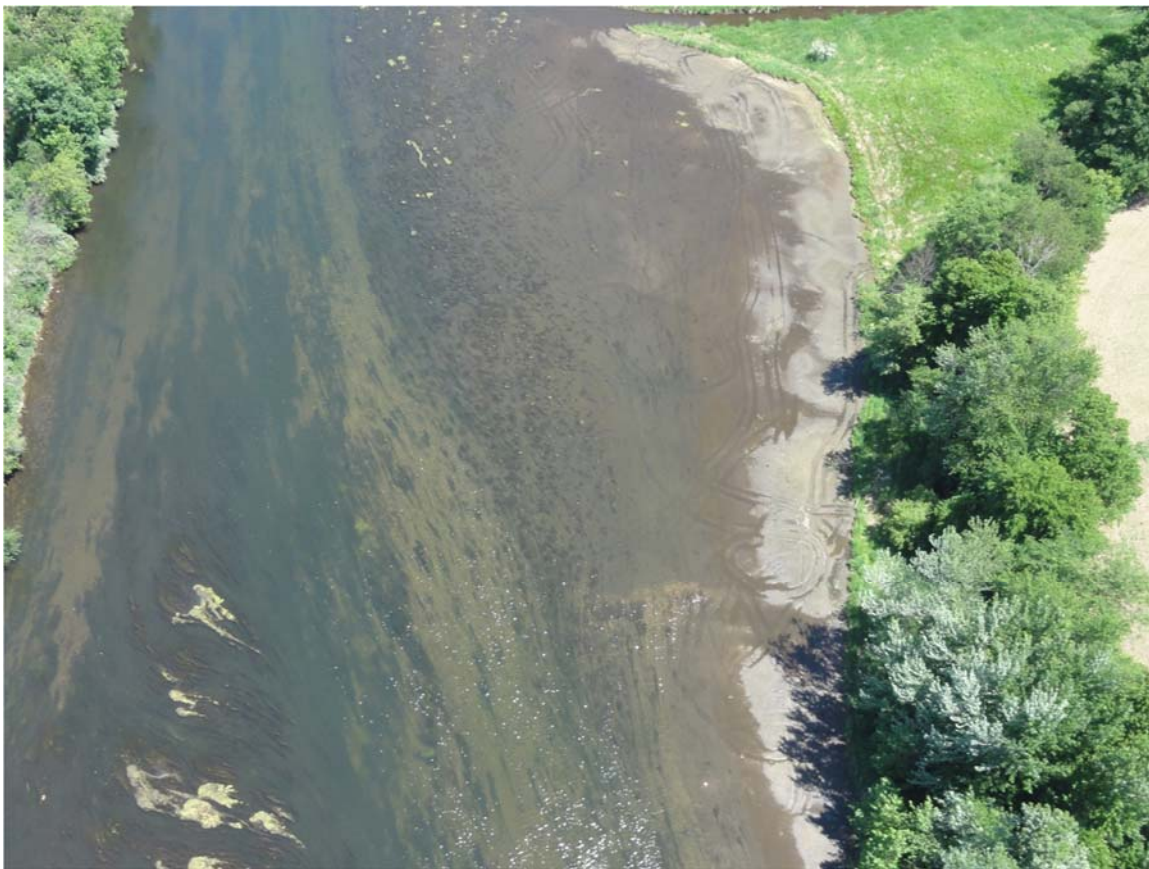
6. MP4.5 LDB, no sheen observed.

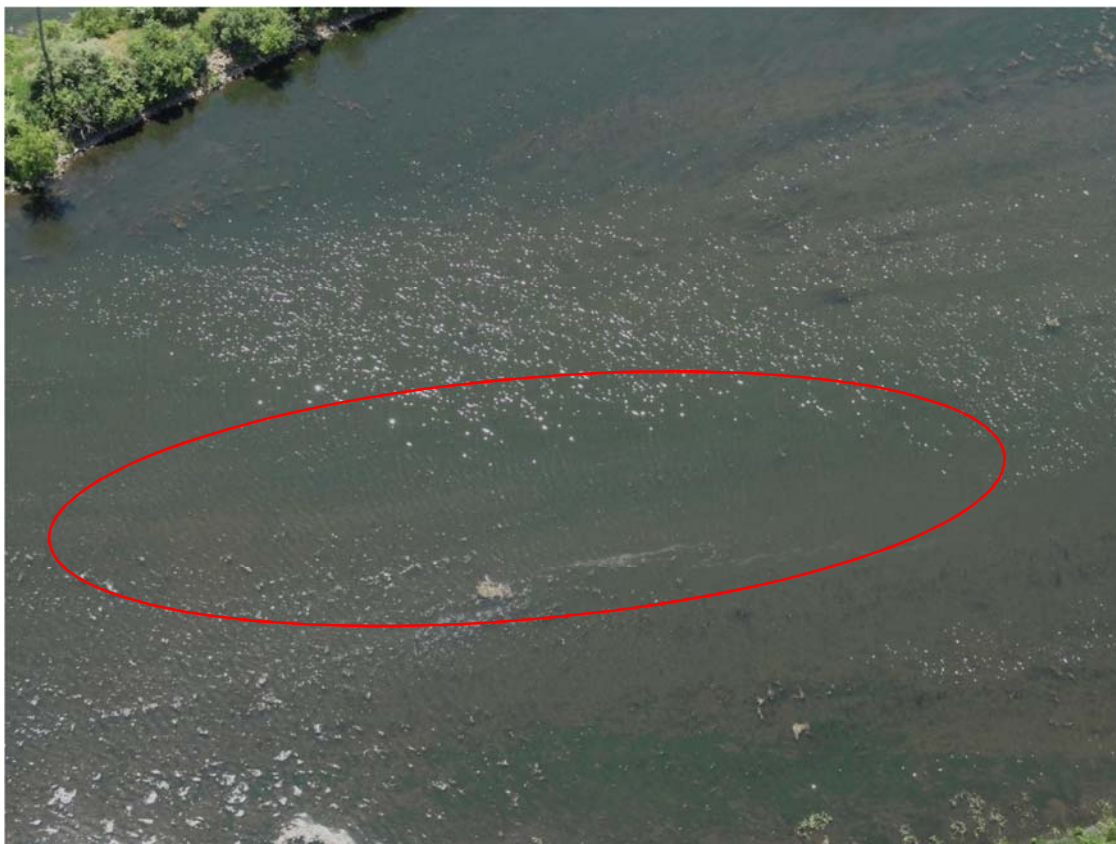
7. Above Ceresco Dam, sheen observed.

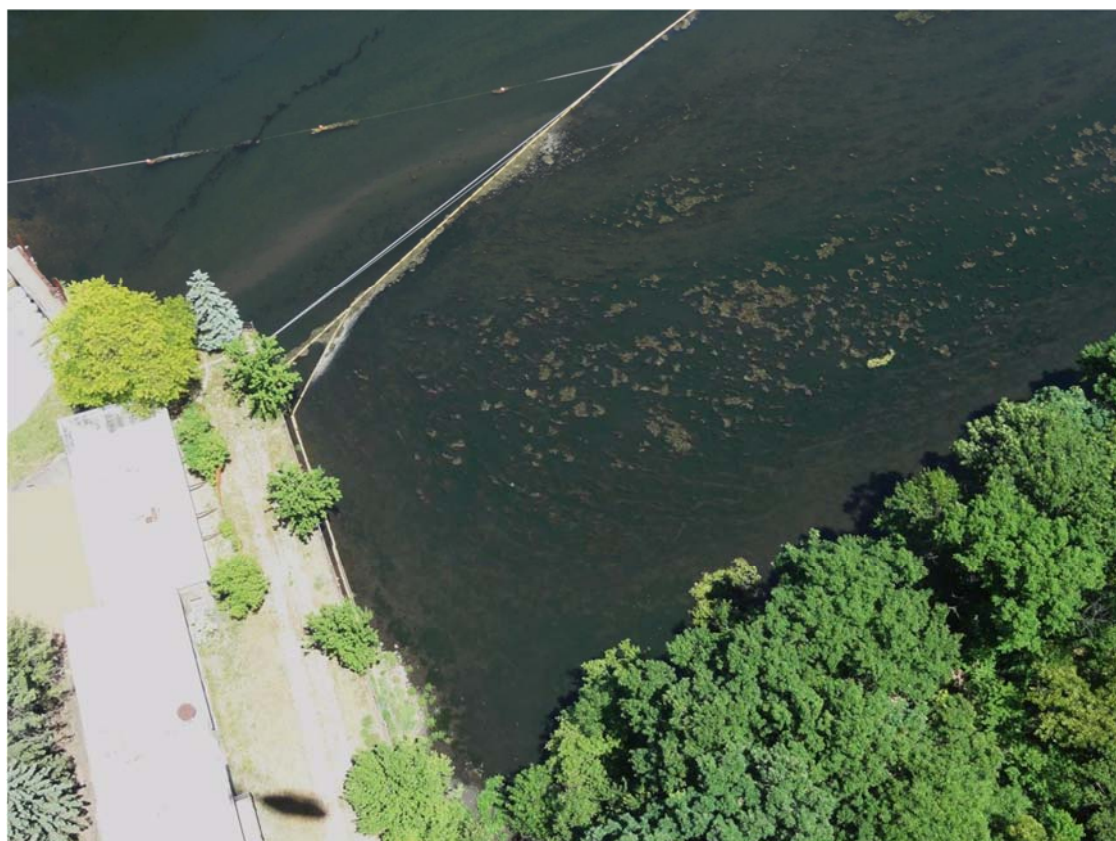
8. Control point above Ceresco Dam, some debris observed within containment.

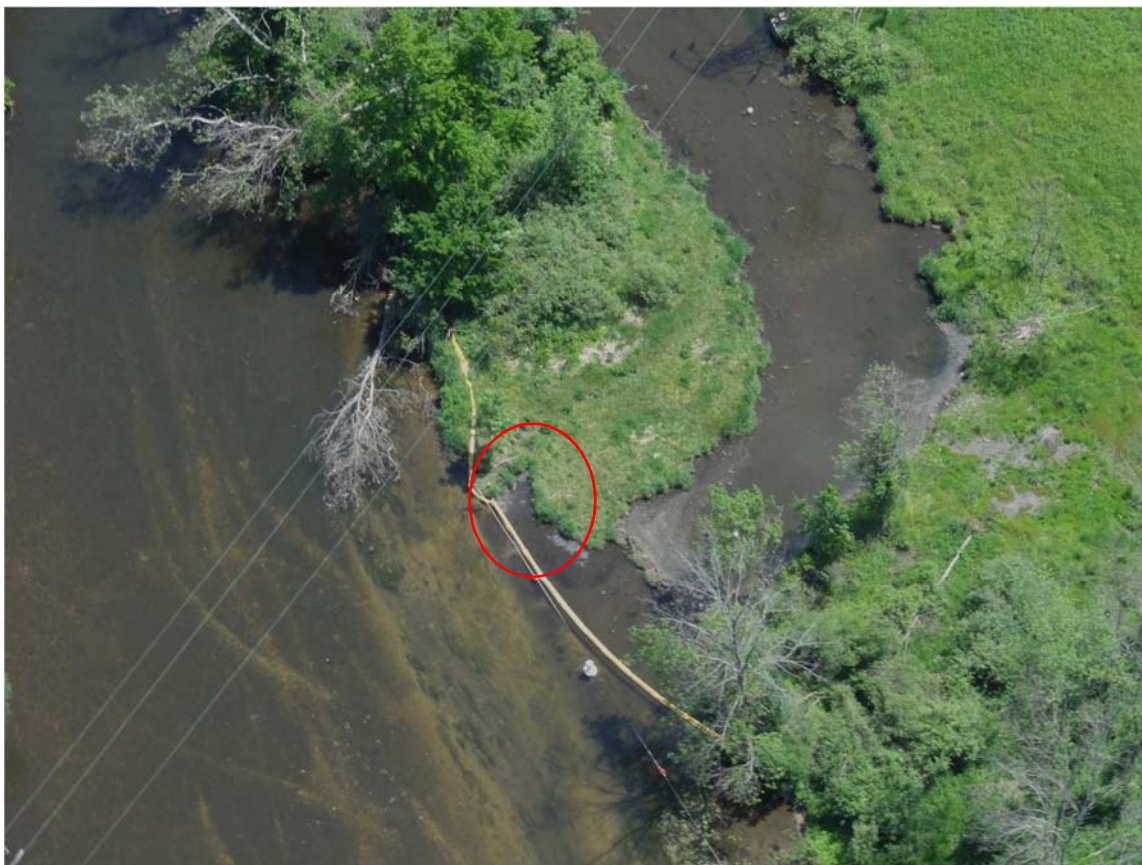
9. MP10.75 sheen observed within boom.

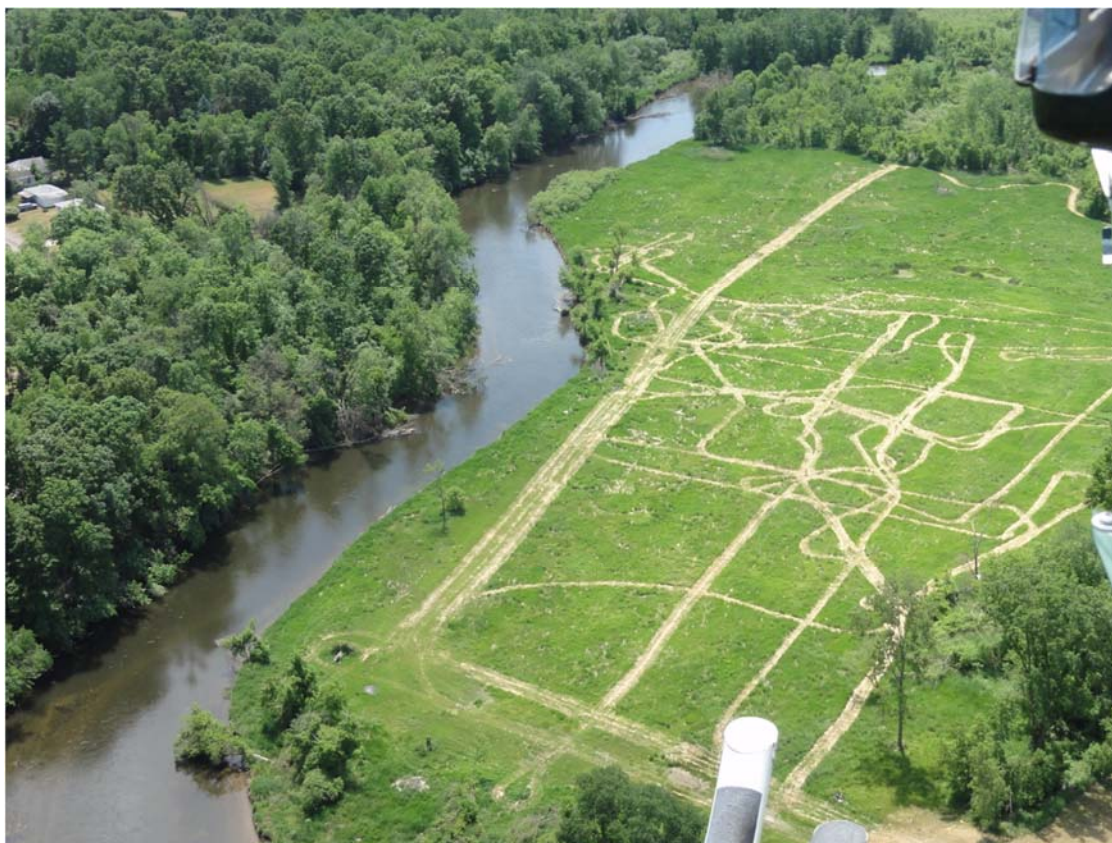
10. MP13.0 land owner mowed field.

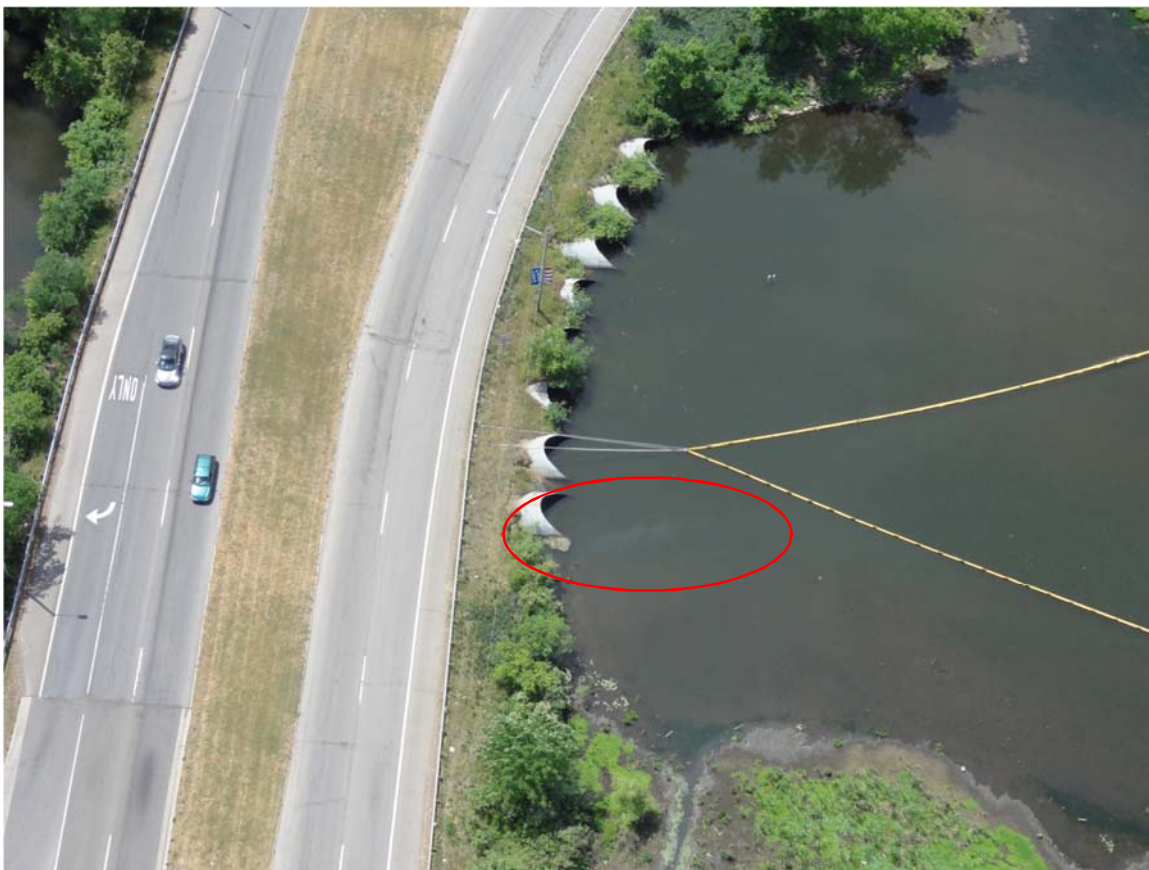
11. MP15.75 Mill Ponds culverts, sheen observed within containment.

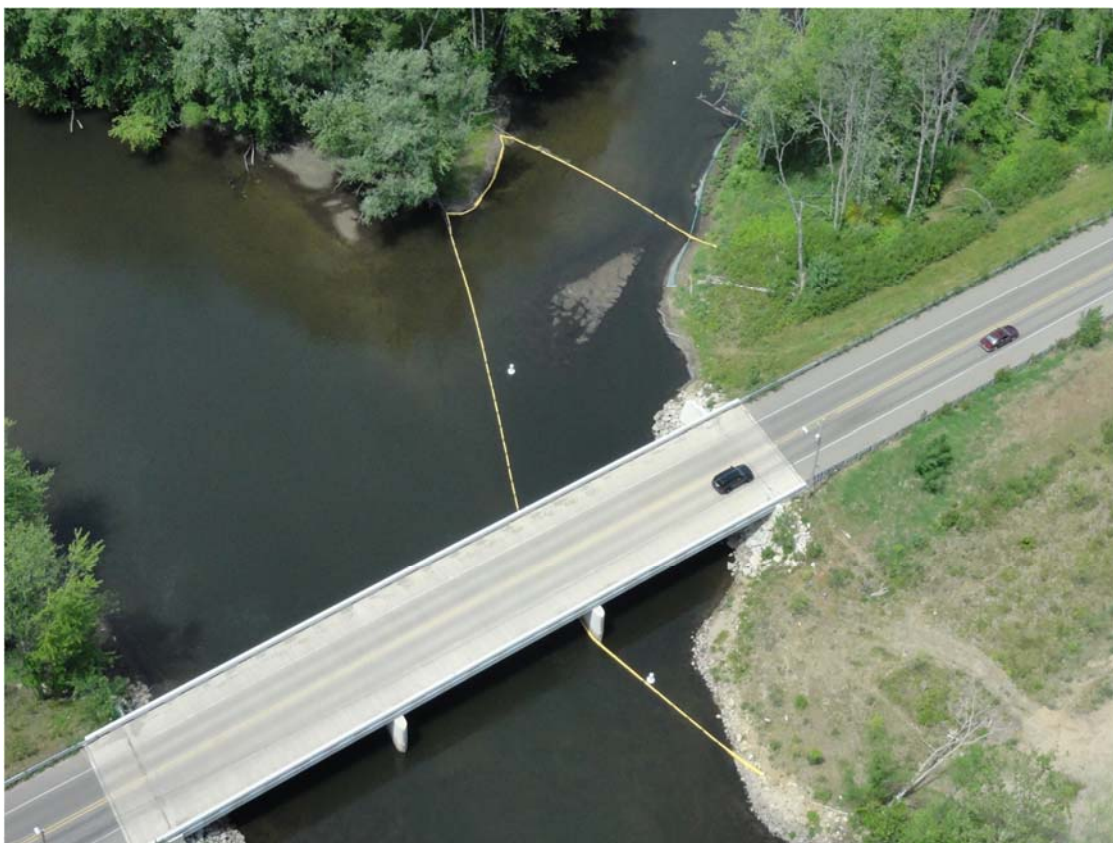
12. MP21.5, no sheen observed within boom.

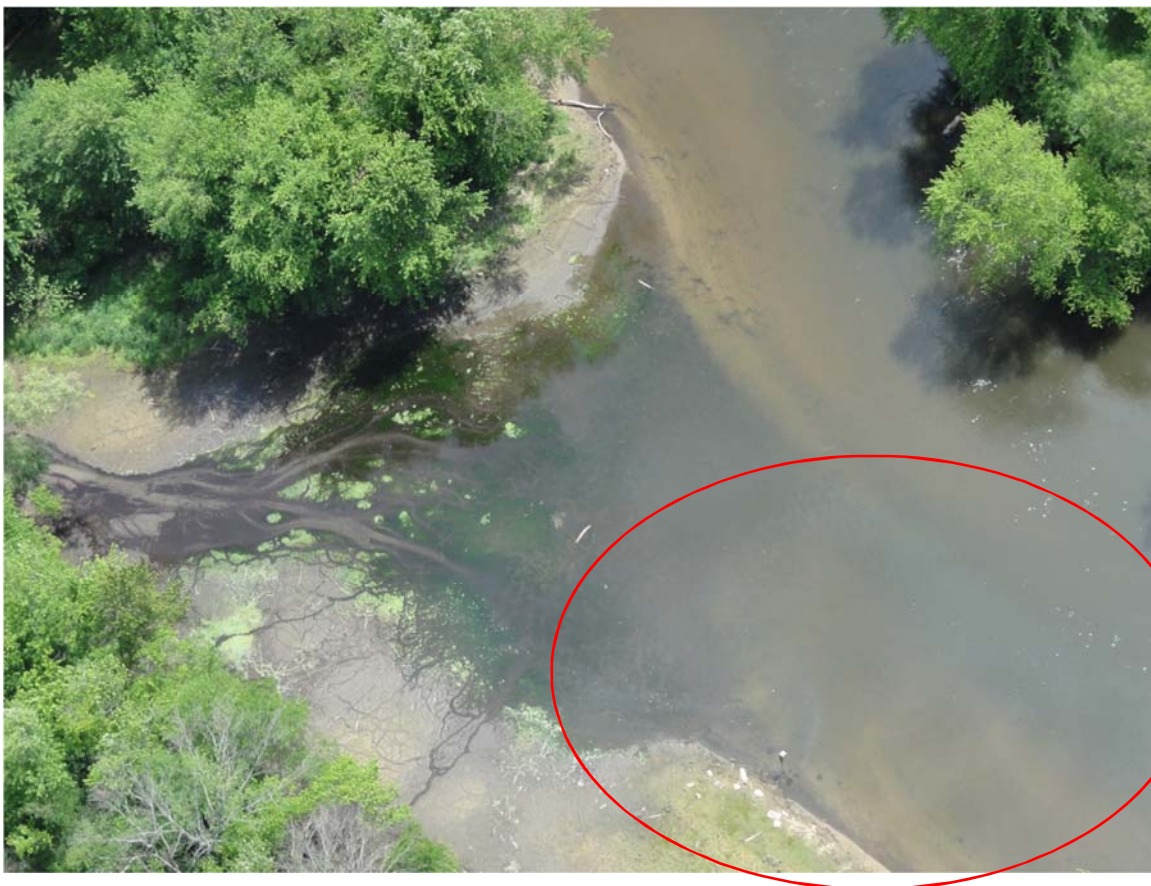
13. MP26.0 RDB sheen observed.

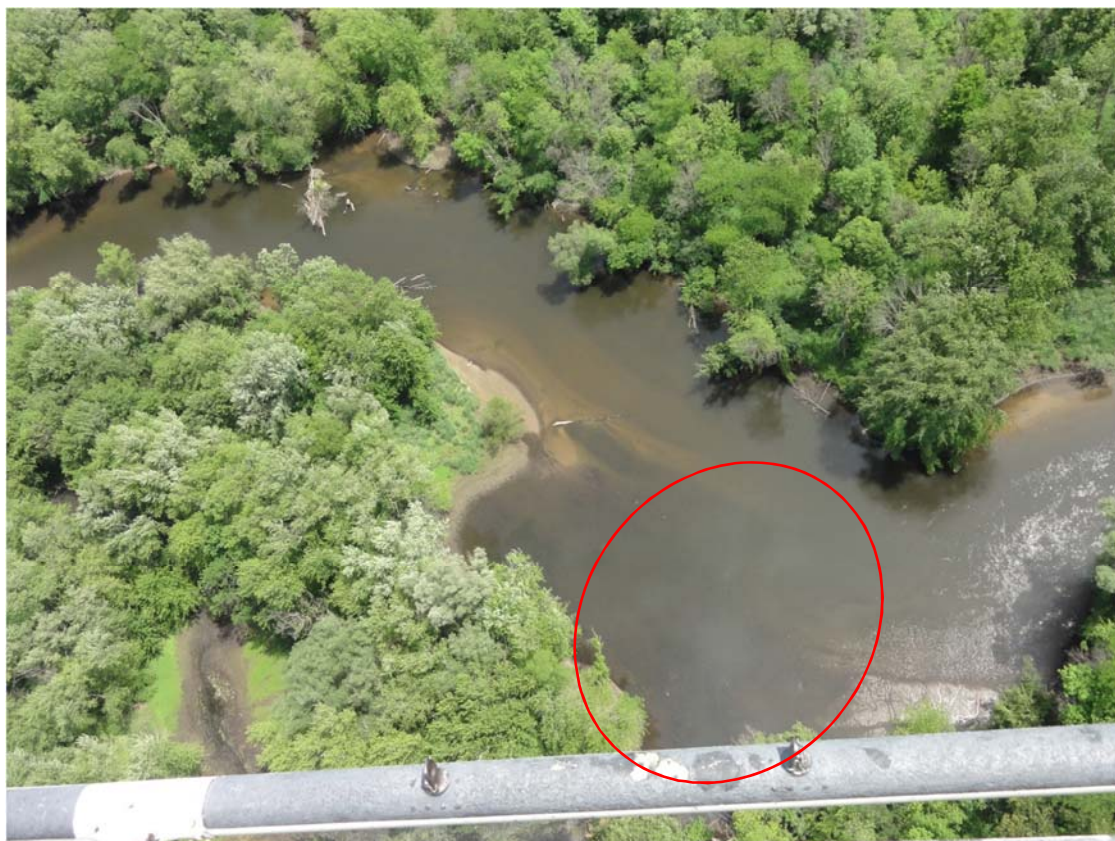
14. MP26.25 RDB sheen observed.

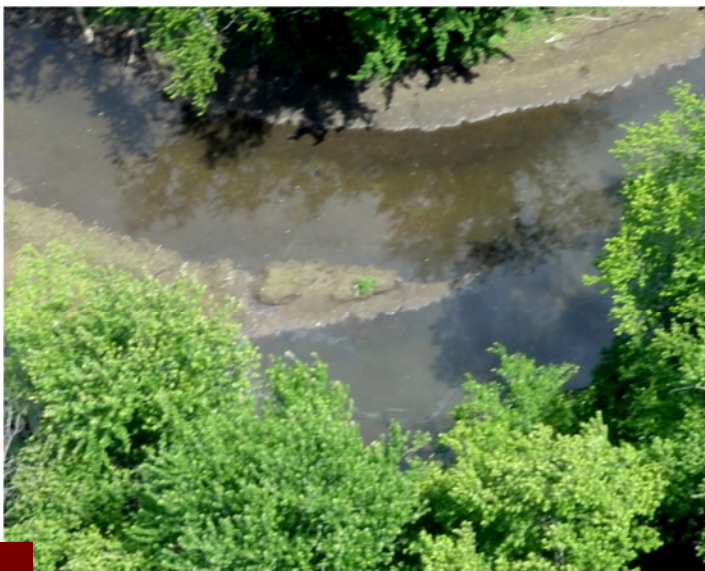
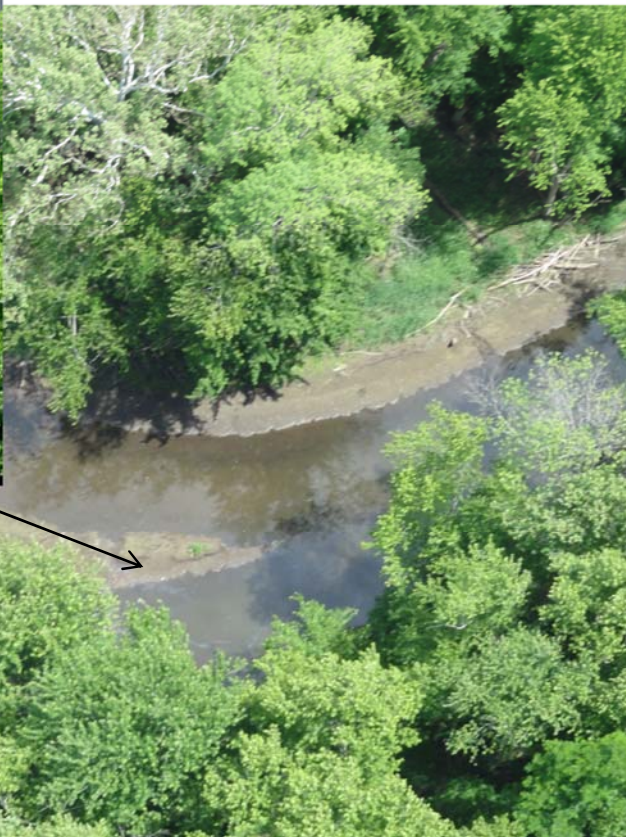
15. MP 28.25 oxbow, sheen observed within oxbow.

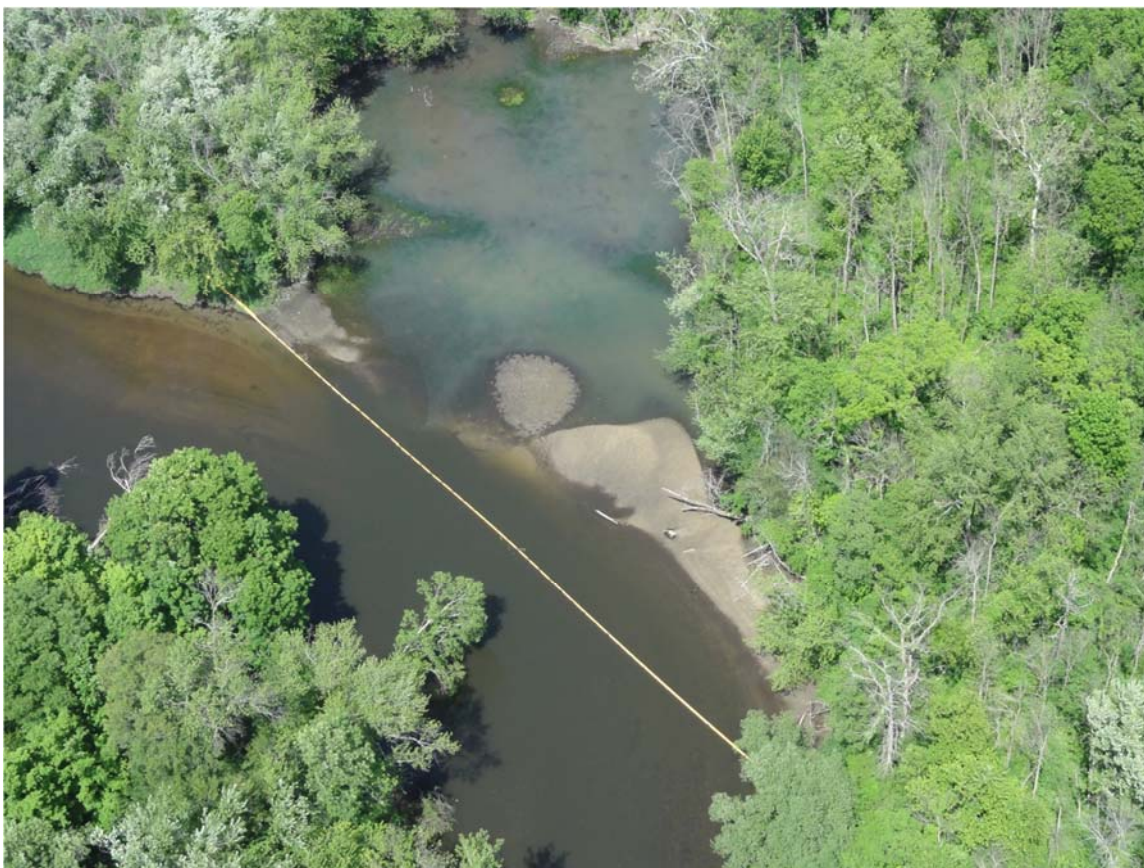
16. MP30.8 LDB no sheen observed.

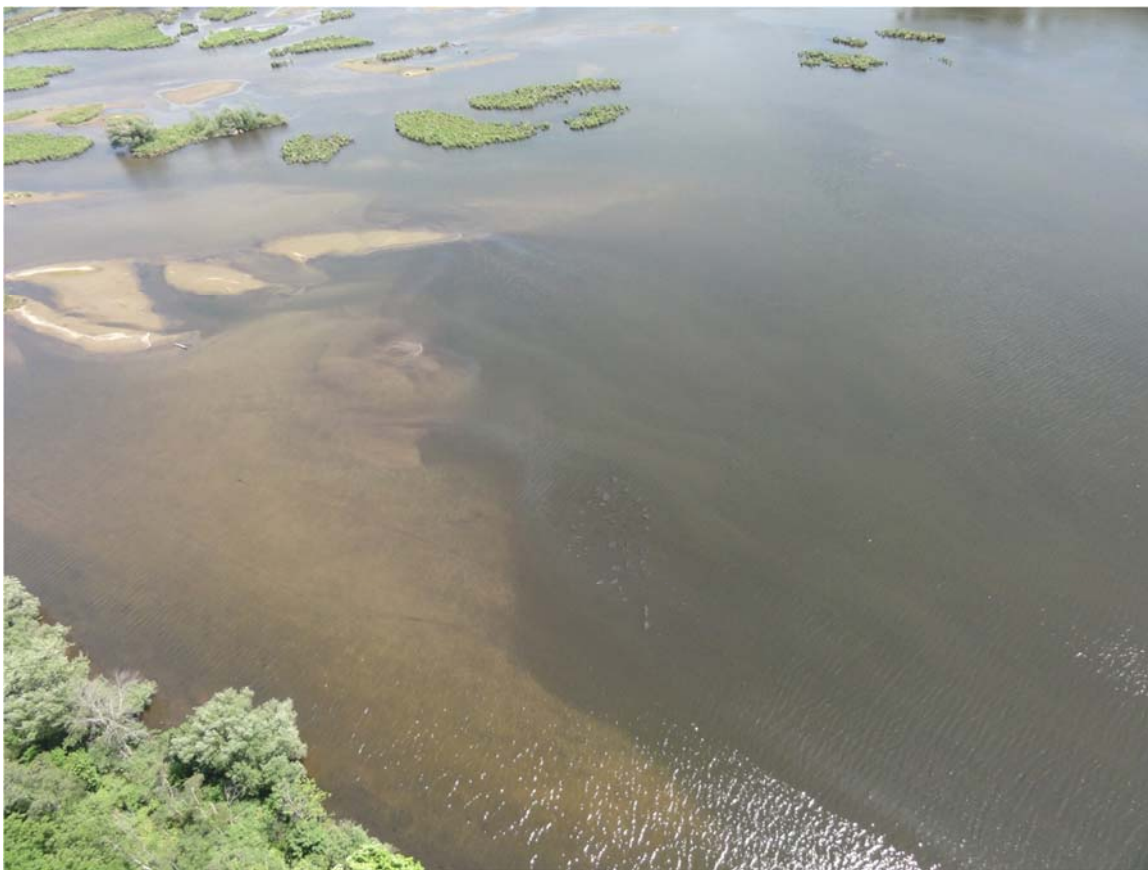
**17. Morrow Lake Delta sheen observed around sandbar.**

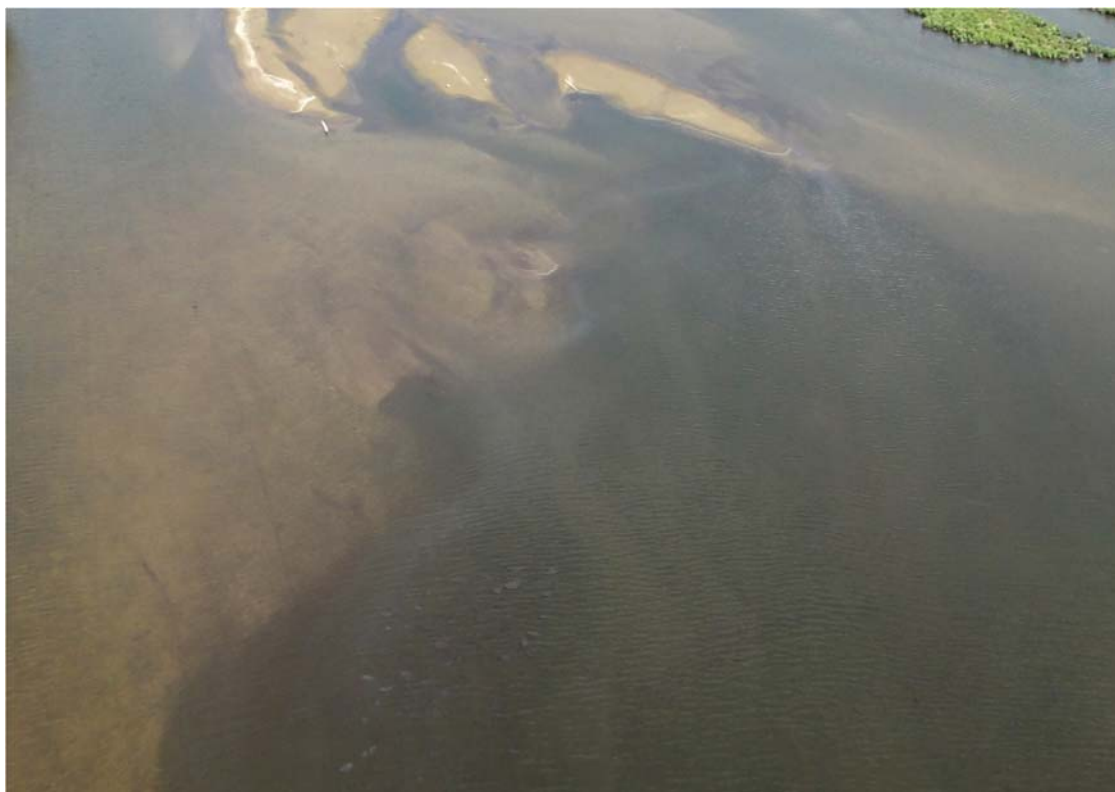
**18. Morrow Lake Delta sheen observed around sandbar.**

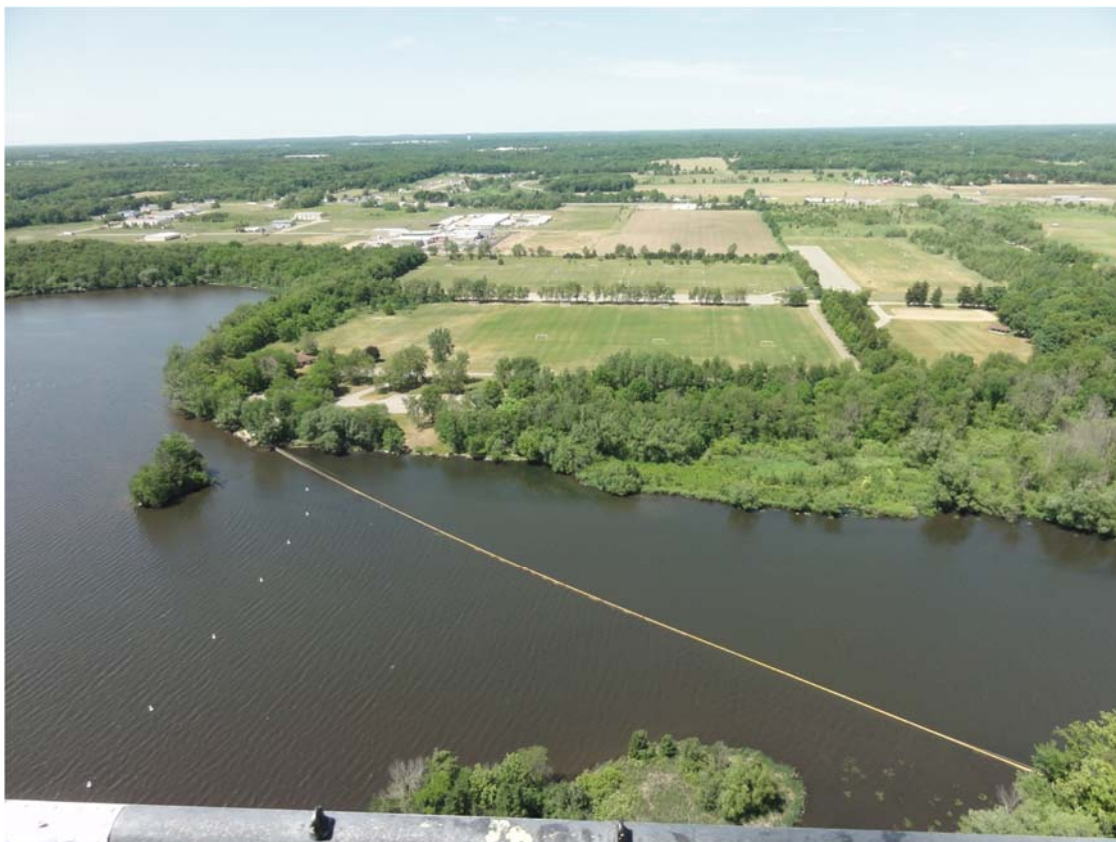
**19. Control Point E4 no sheen observed.**

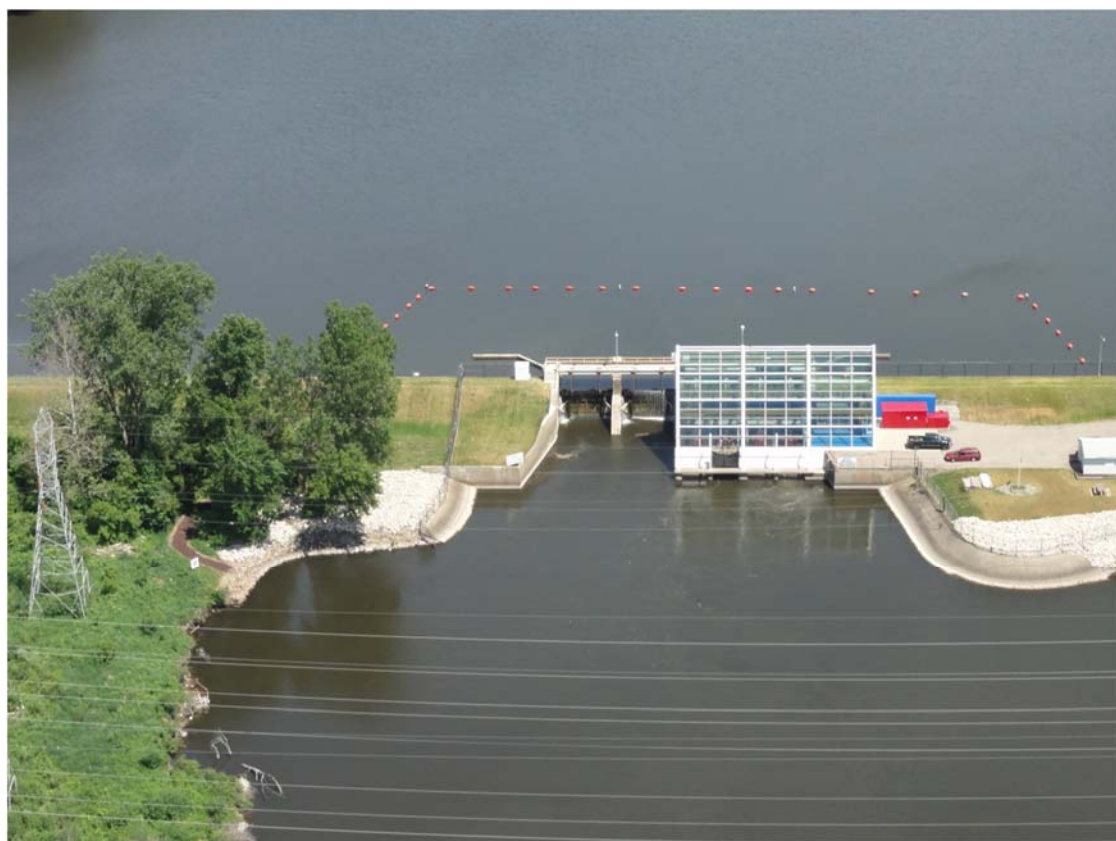
**20. No activity observed below Morrow Lake Dam.**
