# Situation Photo Log

Wednesday, May 30, 2012

Kalamazoo River / Enbridge Spill

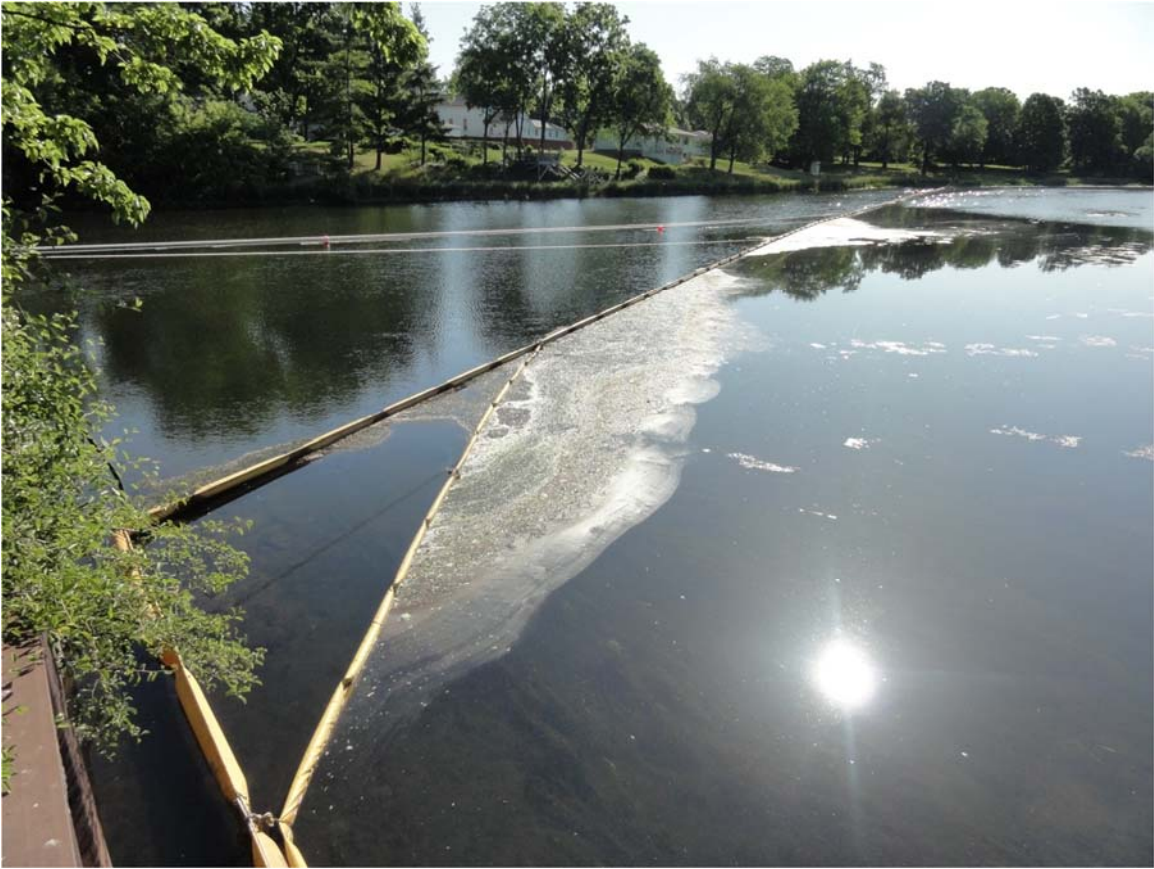
1. Ceresco Dam containment boom.

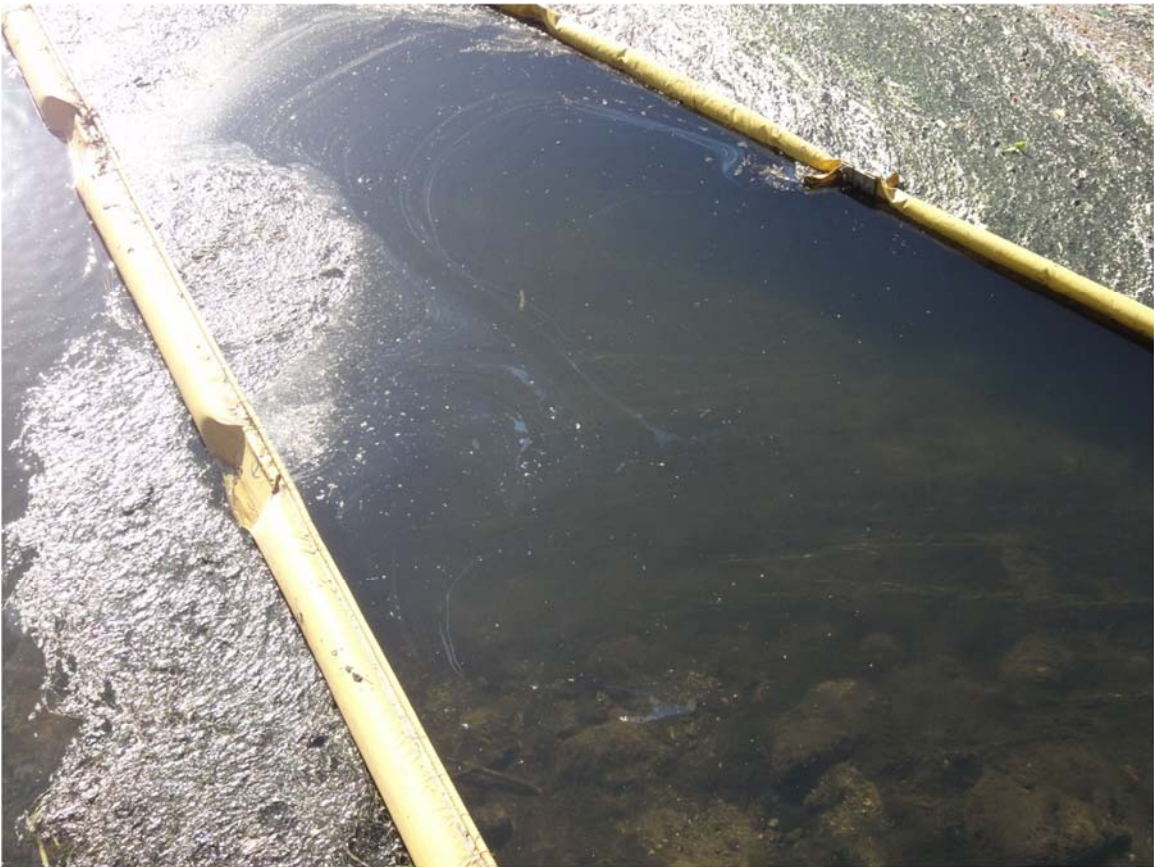
2. Sheen observed between booms at Ceresco Dam.

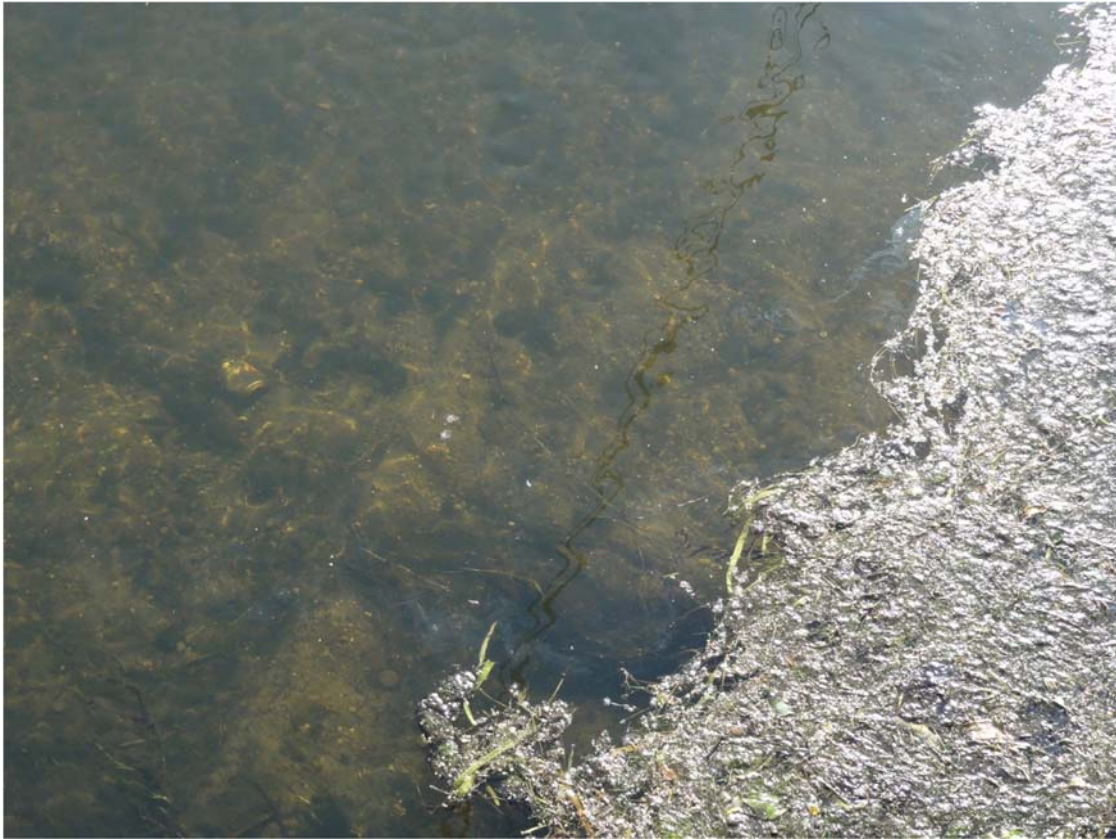
3. Sheen observed outside of boom at Ceresco Dam.

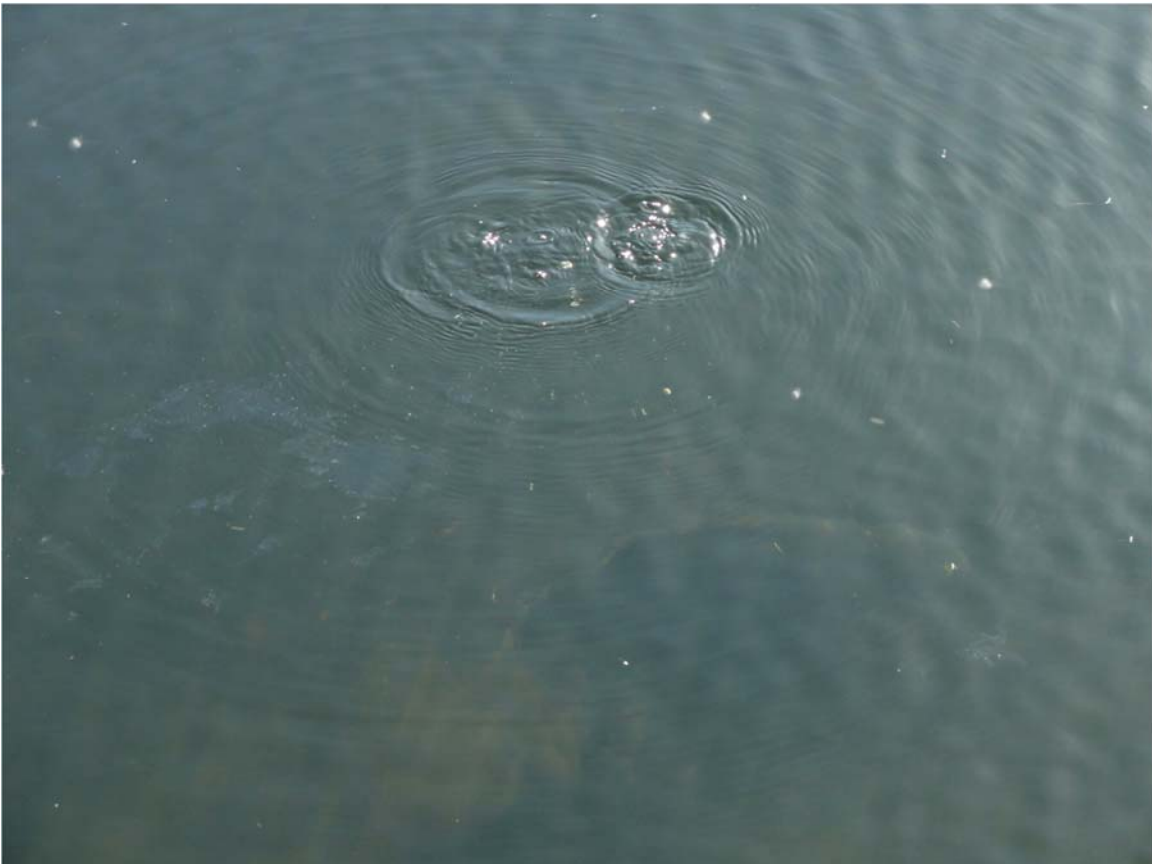
4. Sheen observed outside of boom at Ceresco Dam.

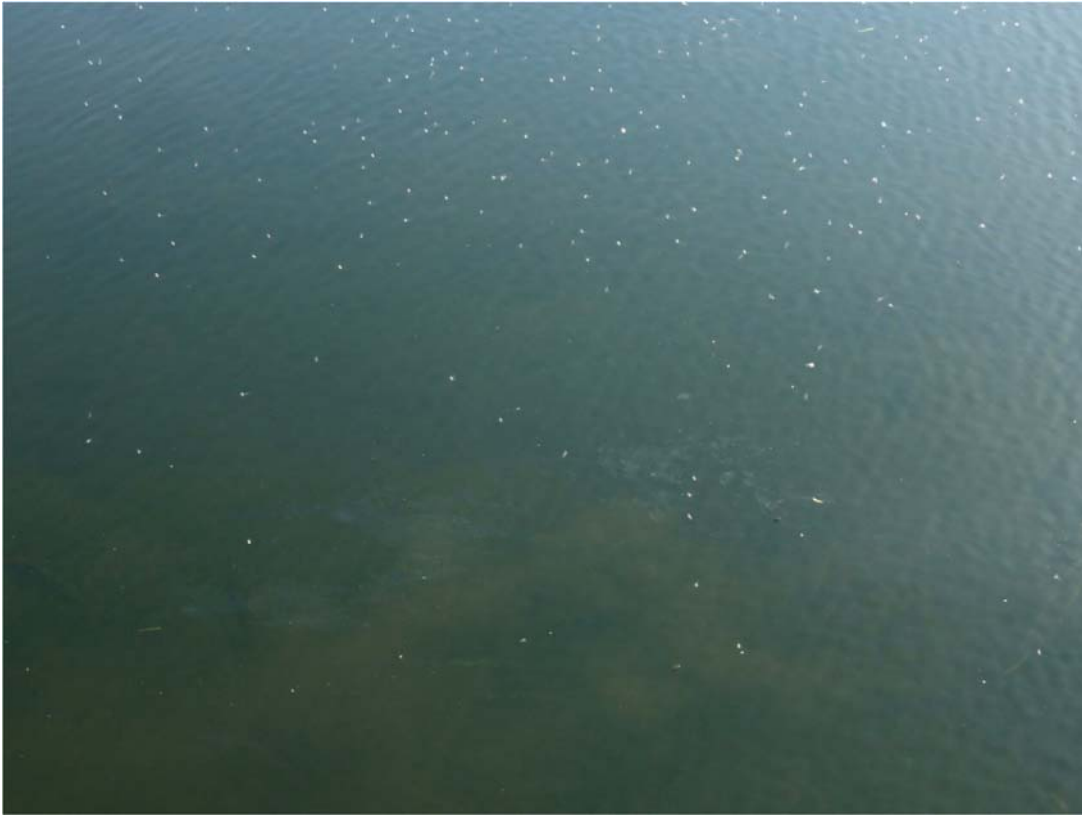
5. Sheen observed outside of boom at Ceresco Dam.

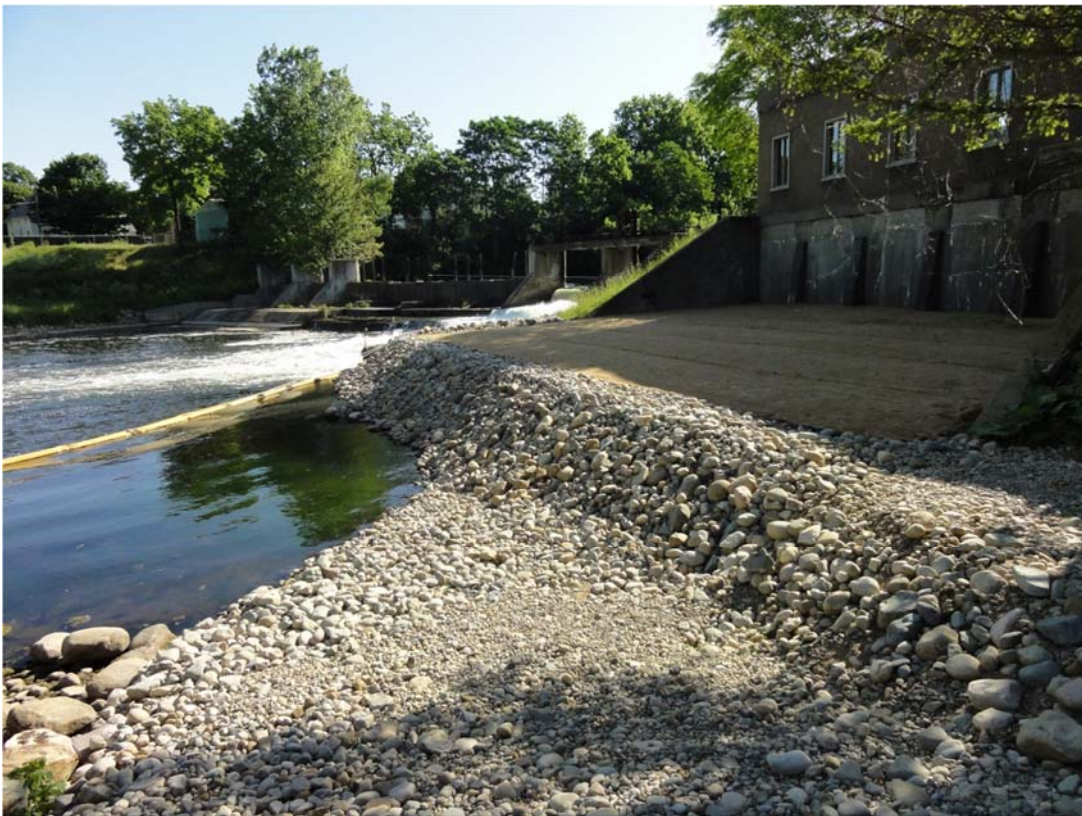
6. Legacy work below Ceresco Dam.

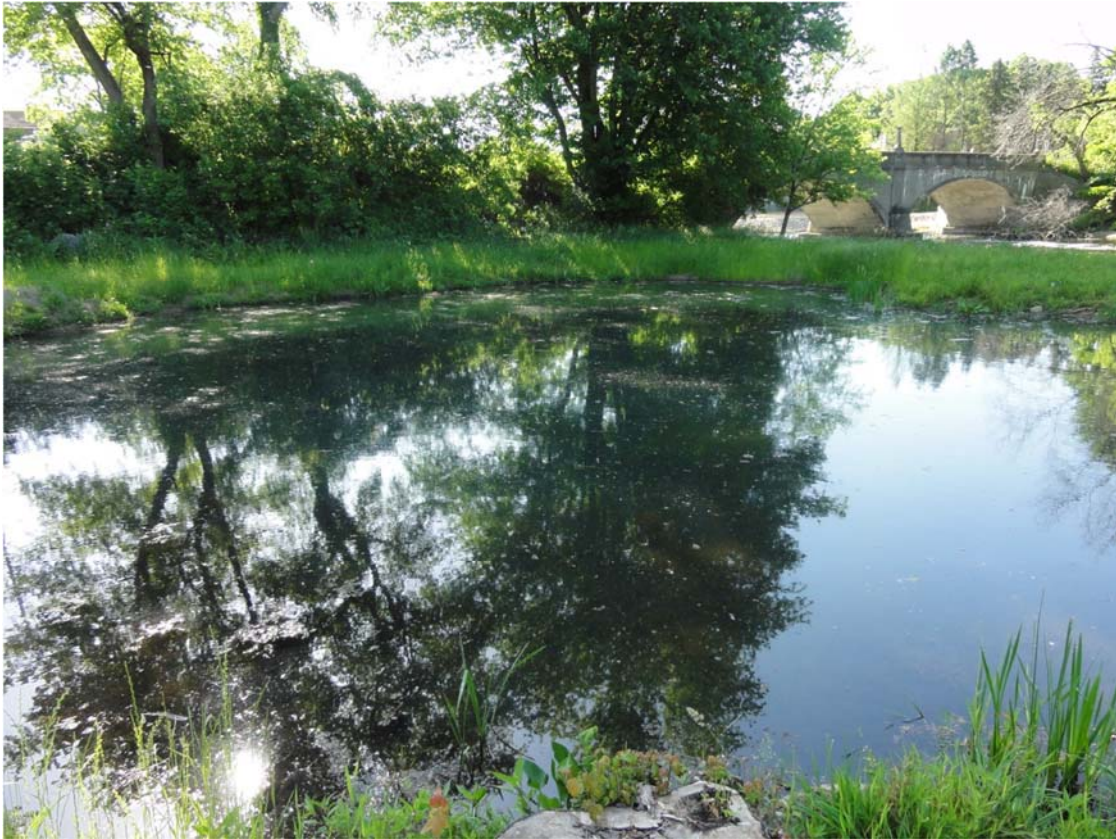
7. OB5.92 RDB sheen observed in pond.

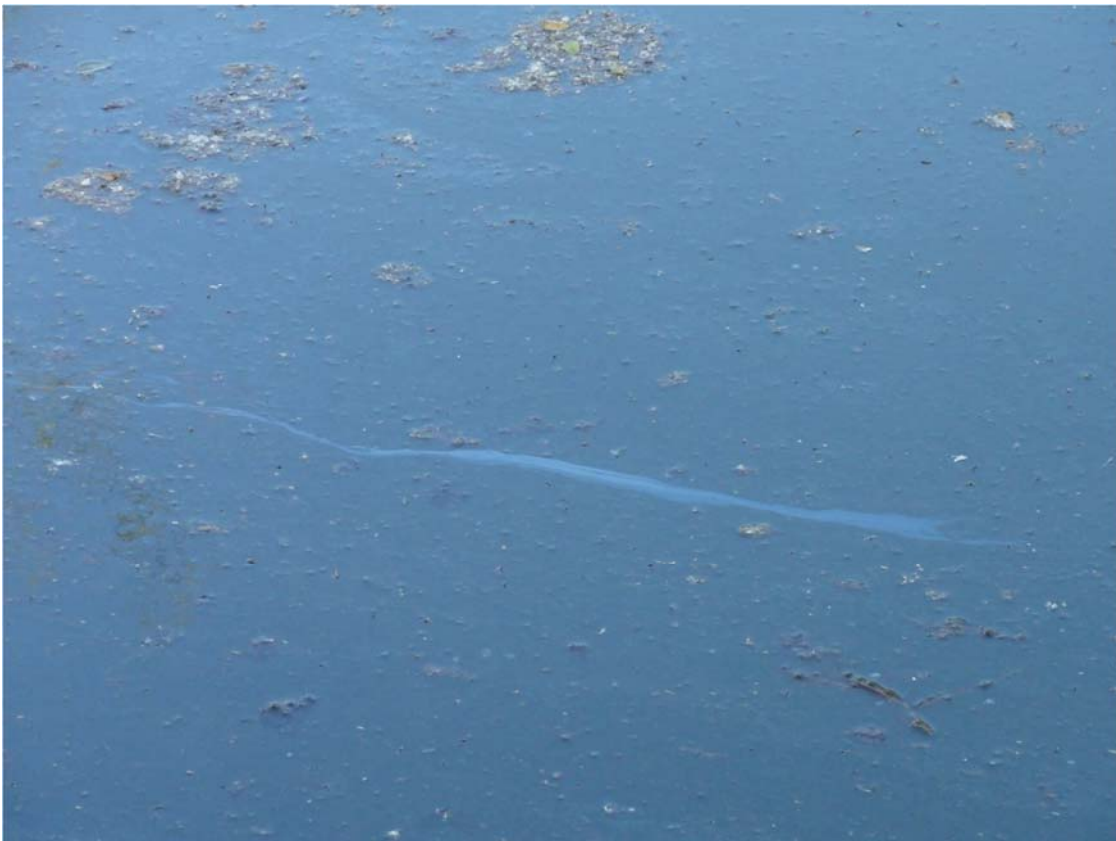
8. OB5.92 RDB sheen observed in pond.

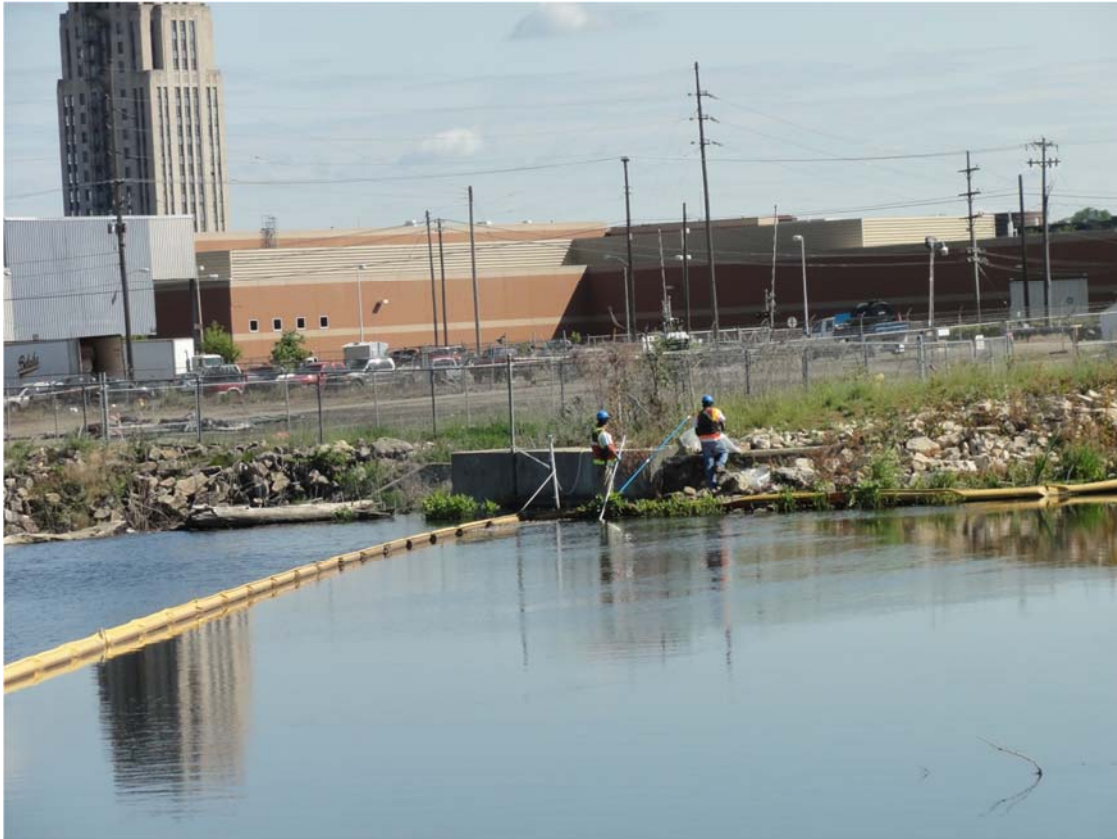
9. MP15.75 crew observed cleaning out control point.

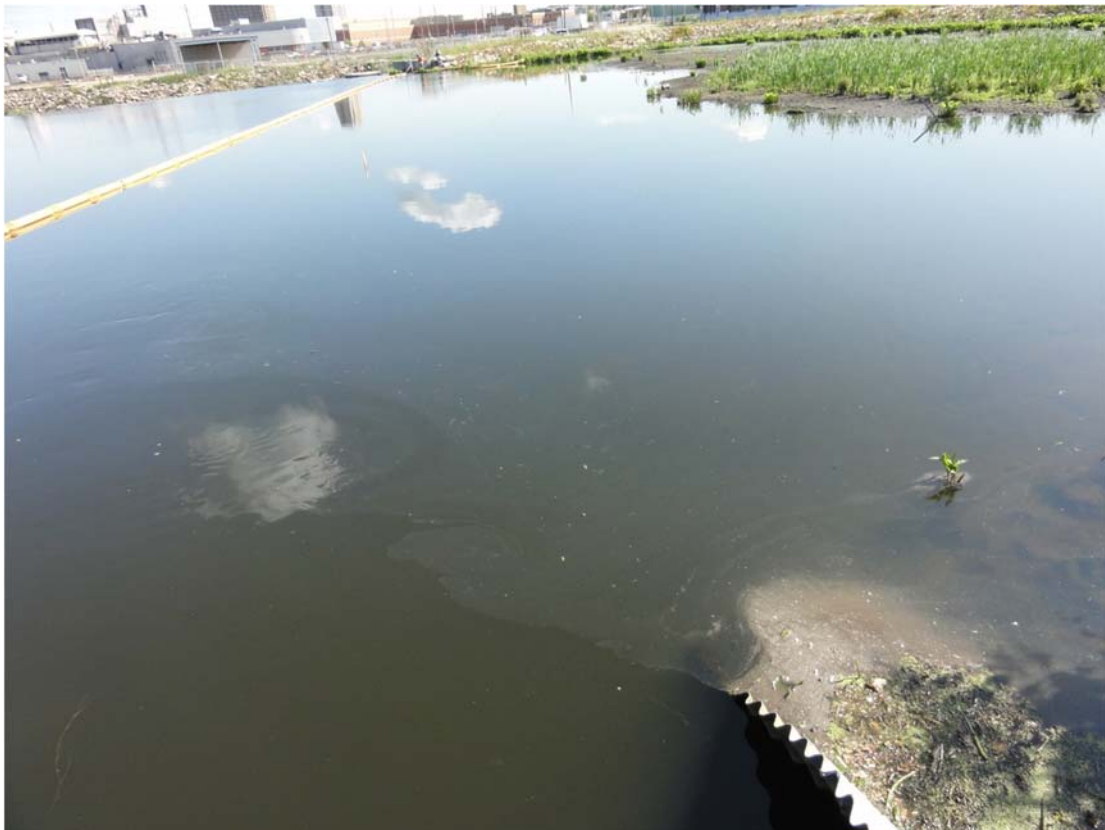
10. MP15.75 sheen and debris observed near culvert.

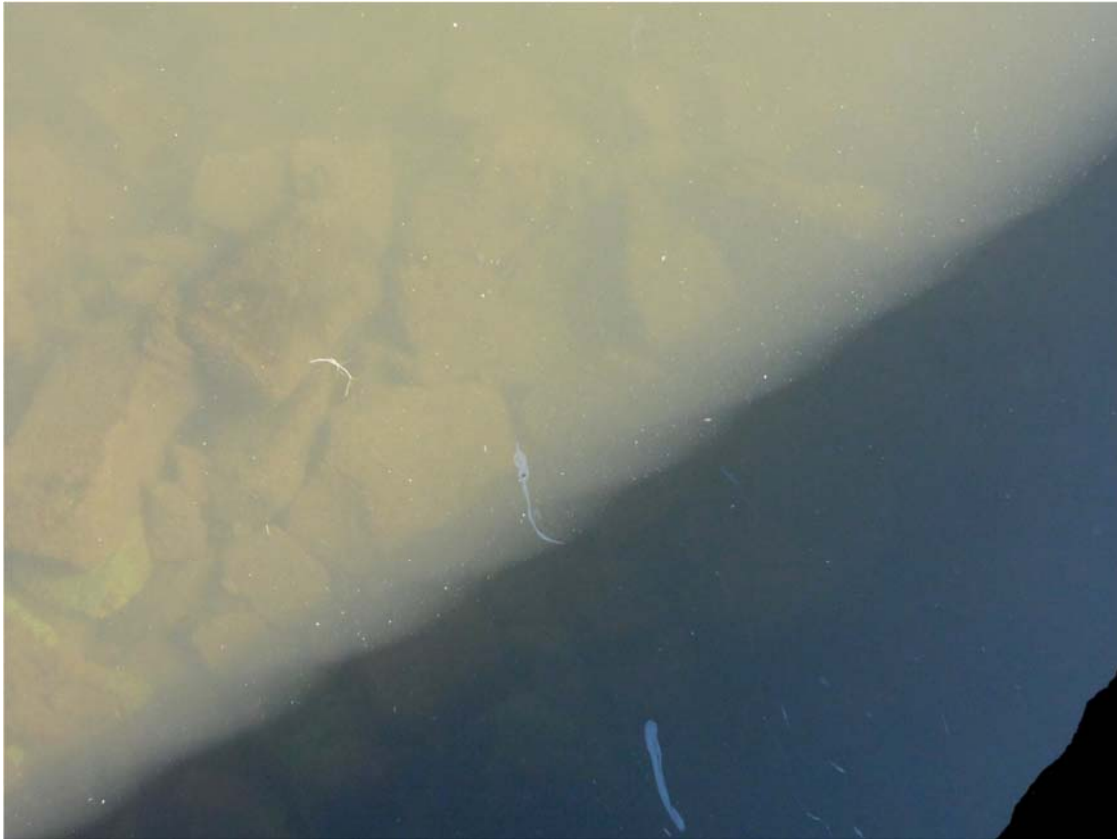
11. MP15.75 sheen observed flowing through culvert.

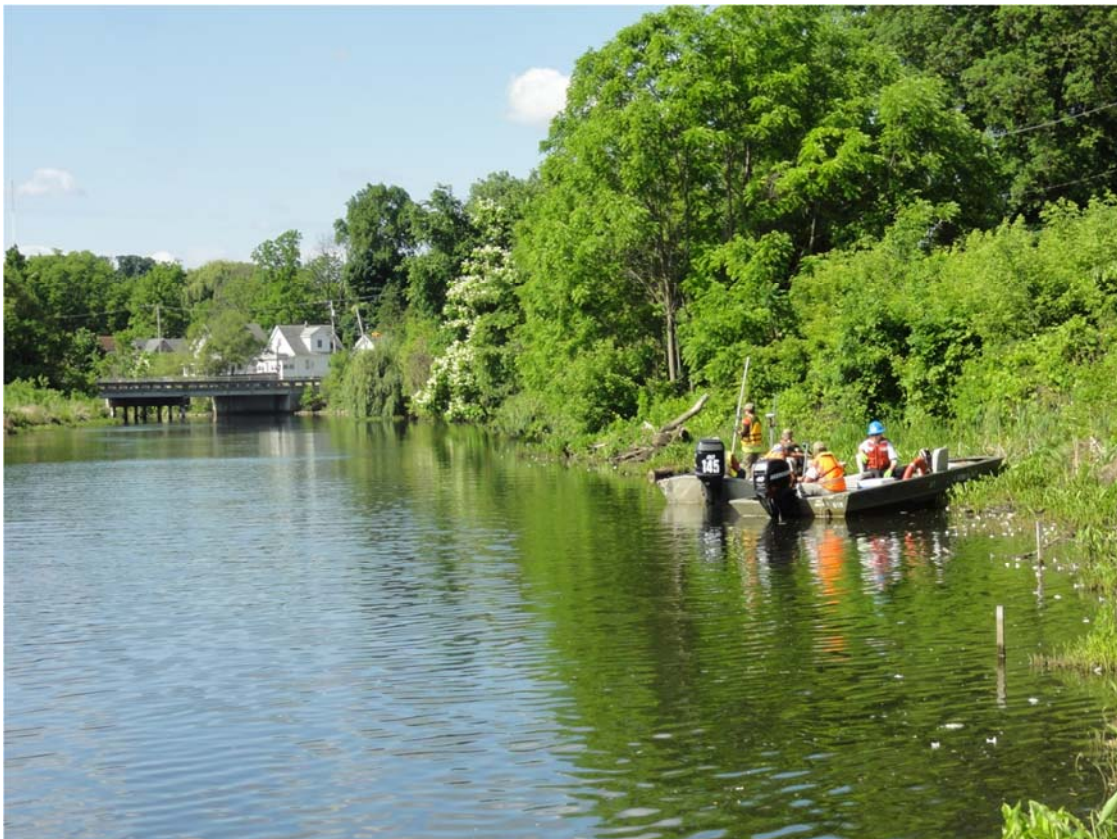
12. MP15.5 Mill Ponds poling crew observed.

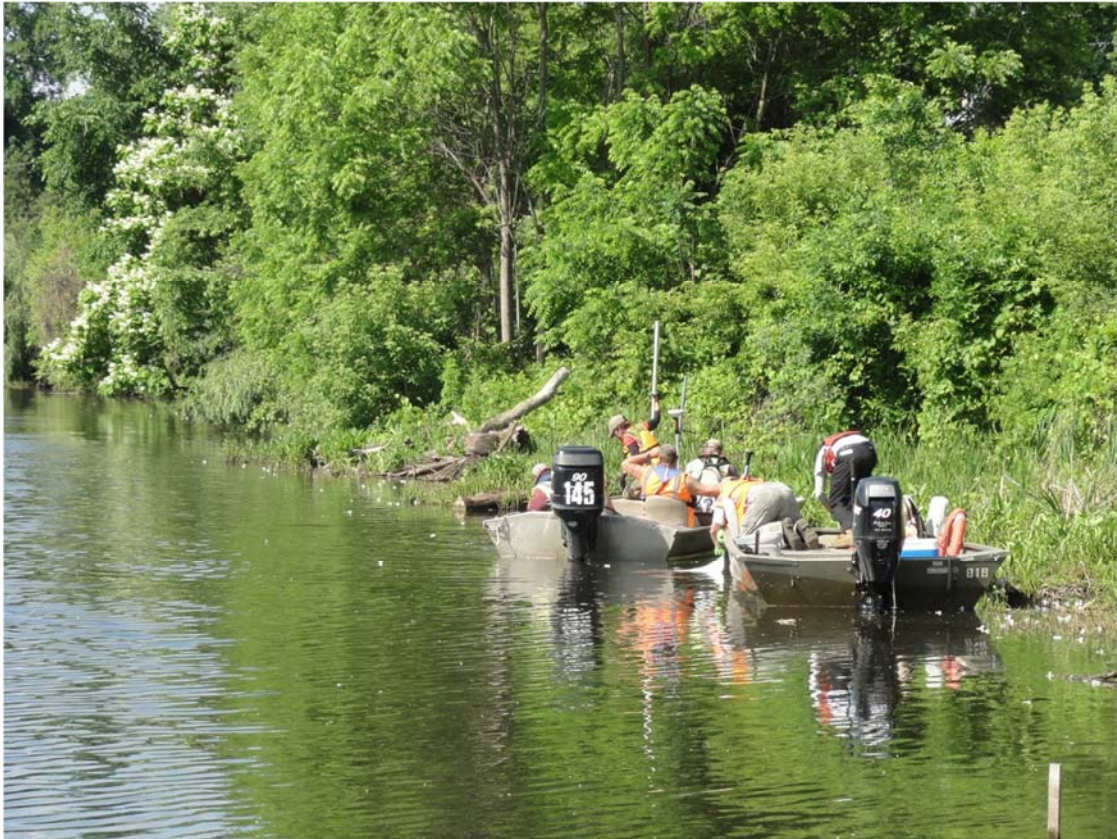
13. MP15.5 Mill Ponds poling crew observed.

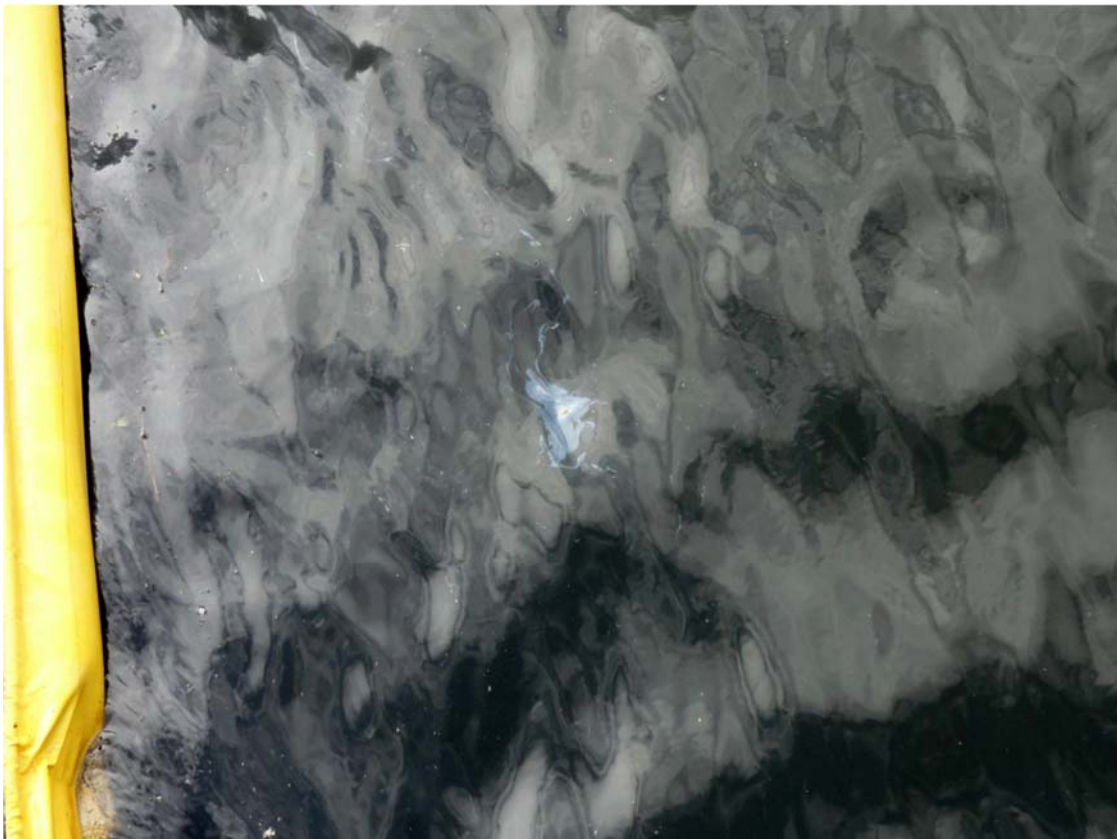
14. MP21.5 sheen observed within the river channel outside of containment.

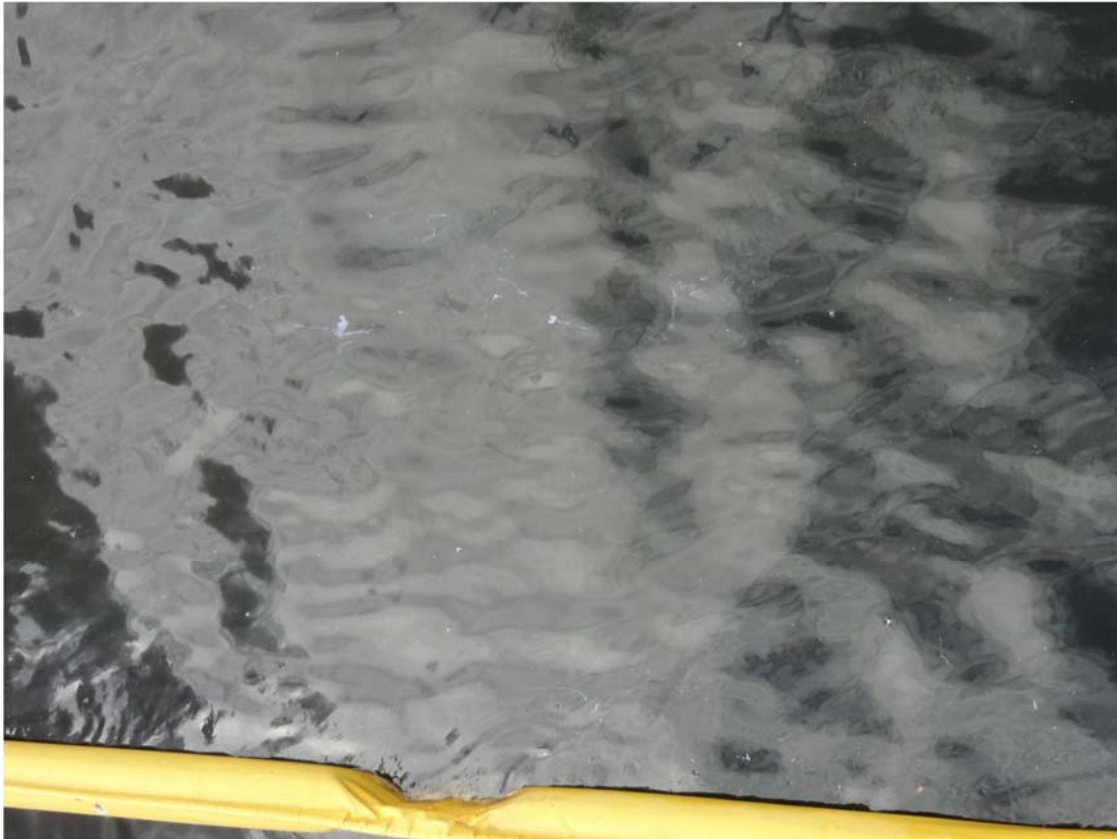
15. MP21.5 sheen observed within the river channel outside of containment.

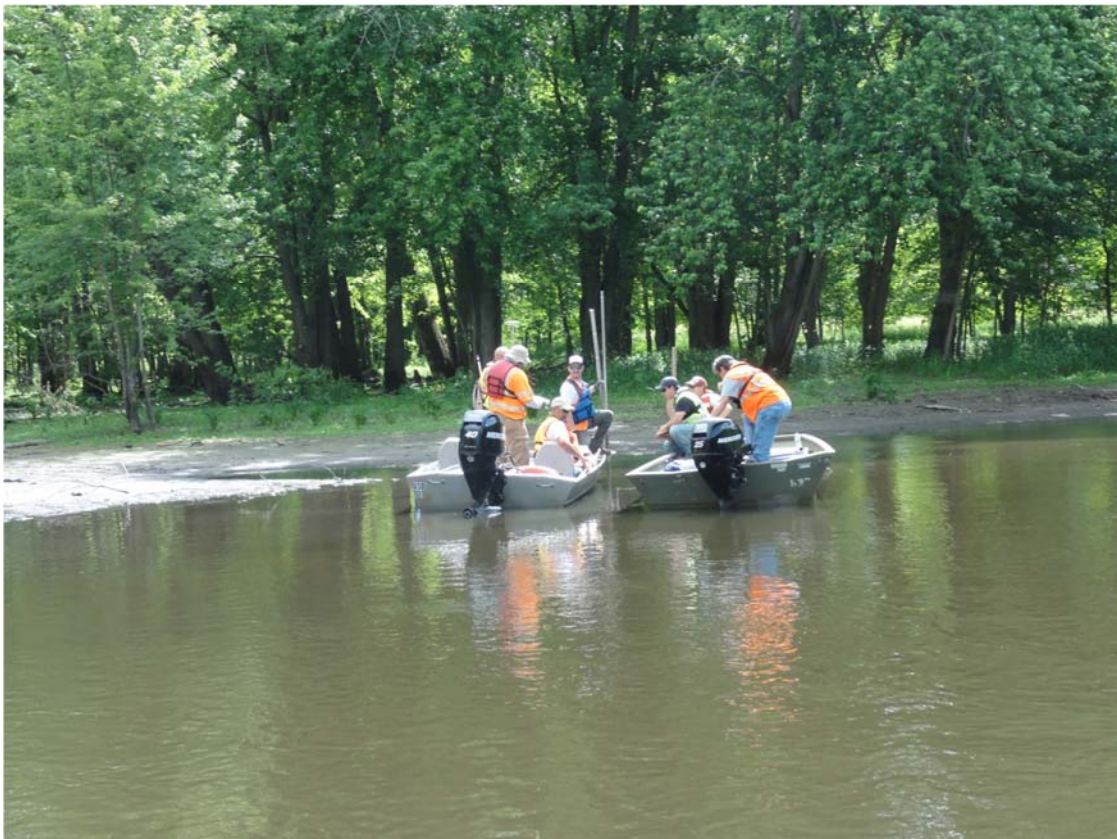
16. MP26.75 poling crew observed.

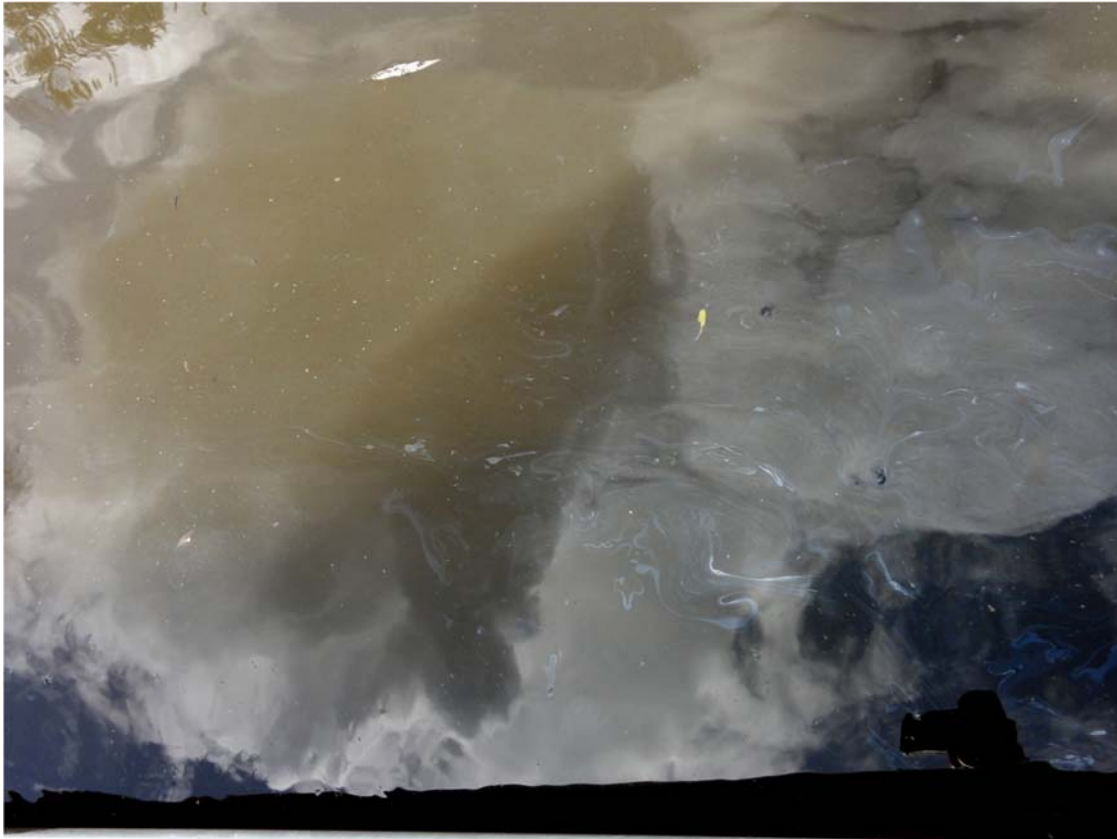
17. MP26.25 RDB sheen observed.

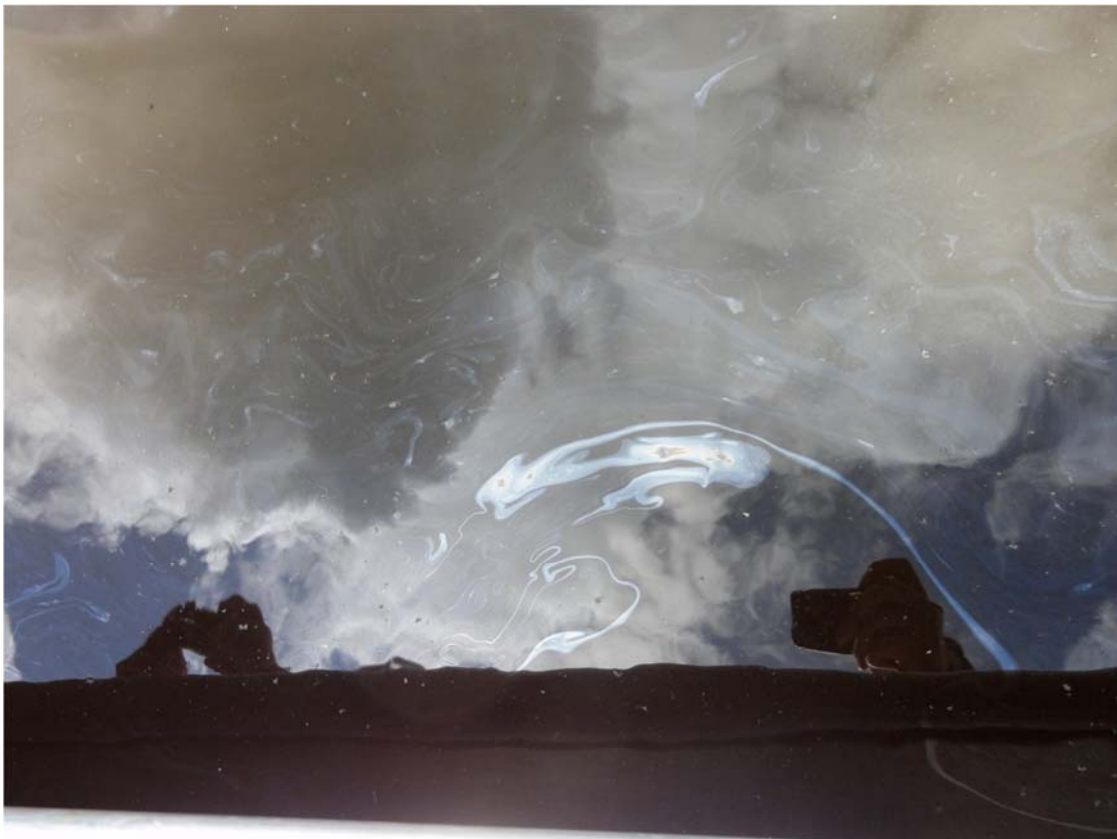
18. MP26.25 RDB sheen observed.

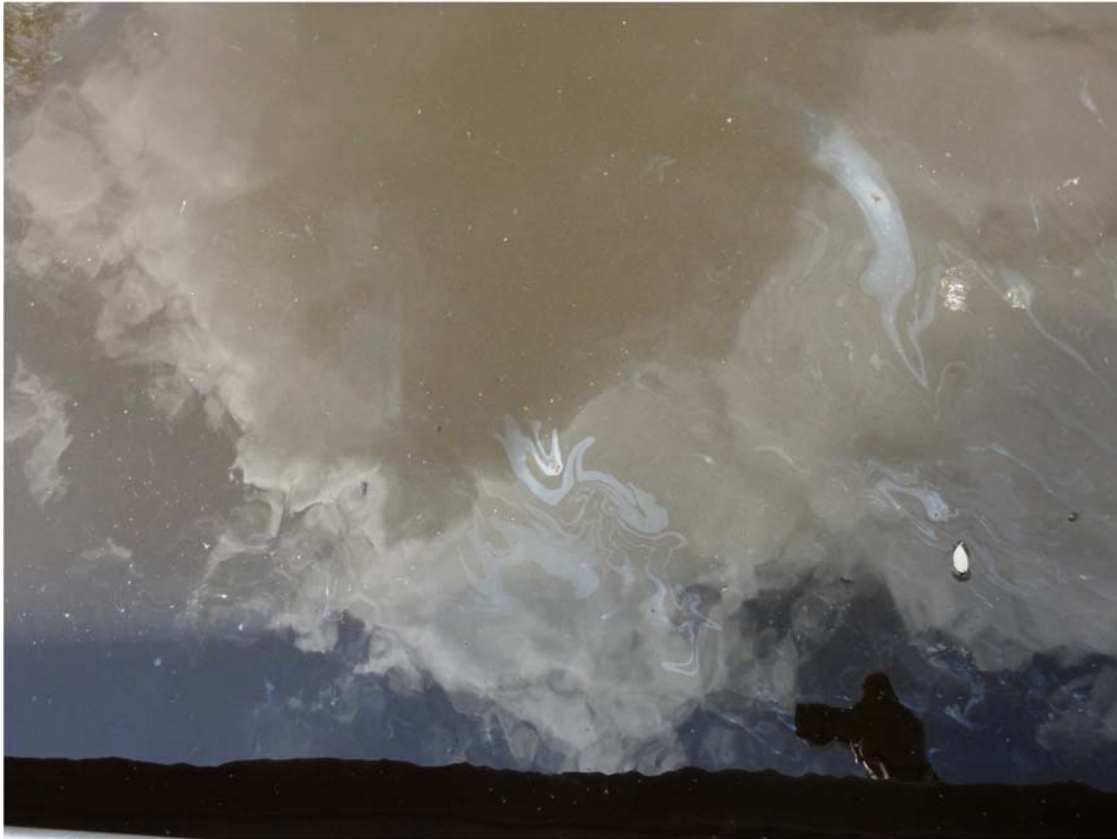
19. MP26.25 RDB sheen observed.

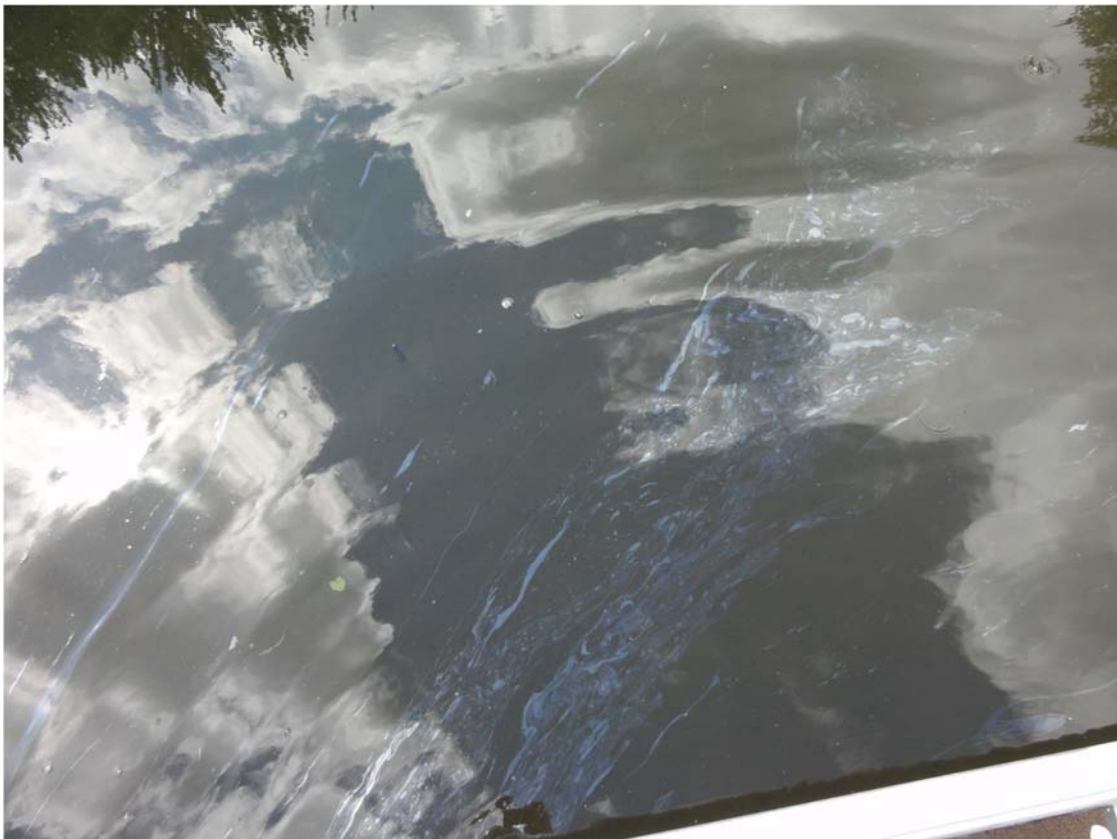
20. MP26.0 RDB sheen observed.

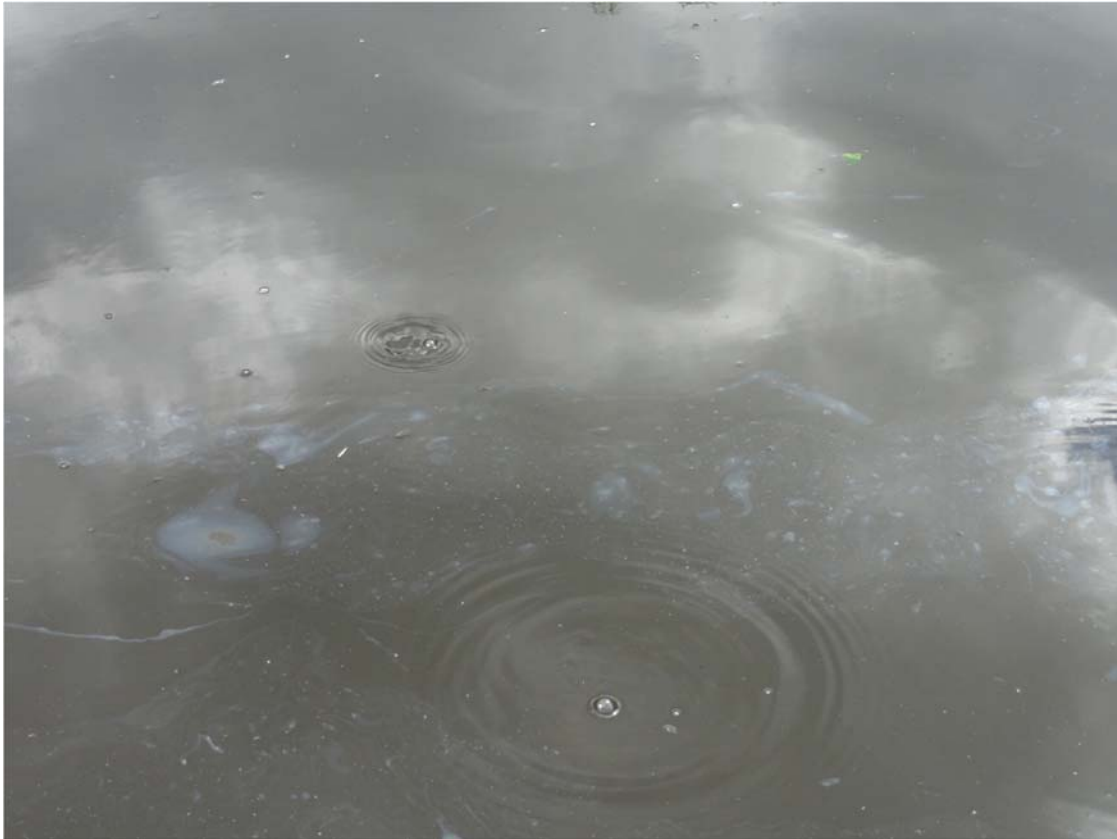
21. MP26.0 RDB sheen observed.

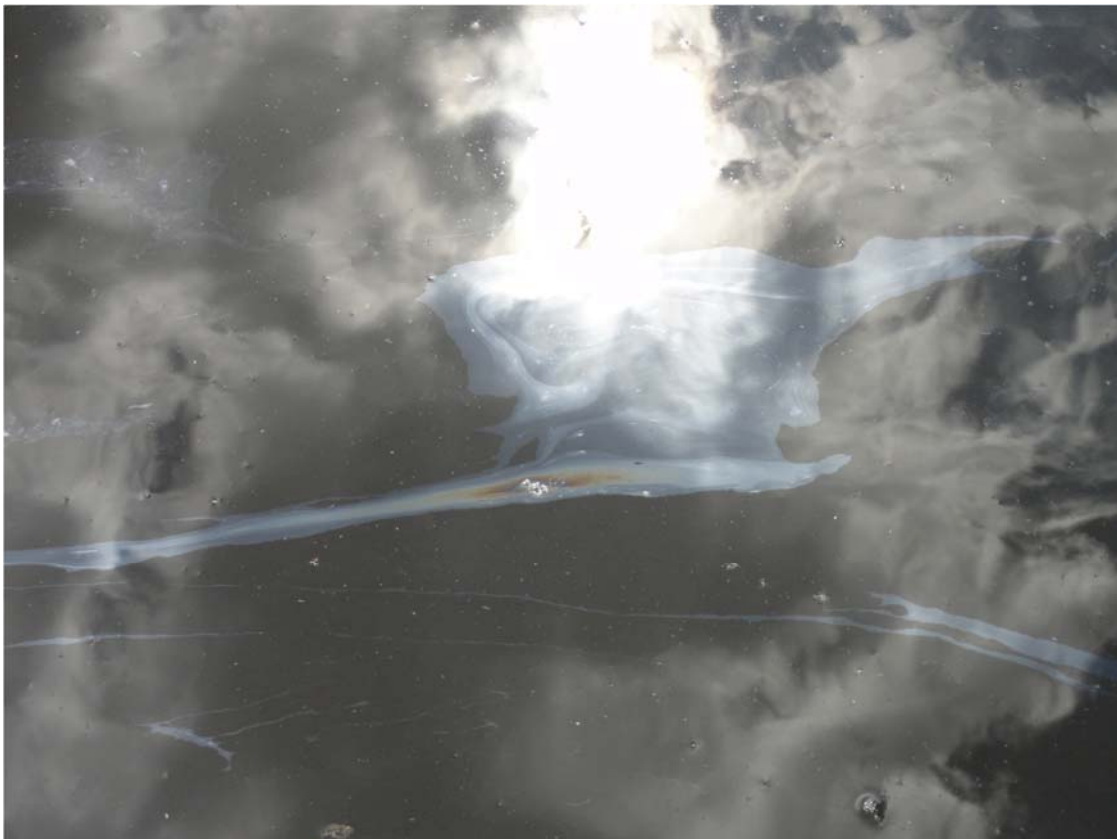
22. MP26.0 sheen observed.

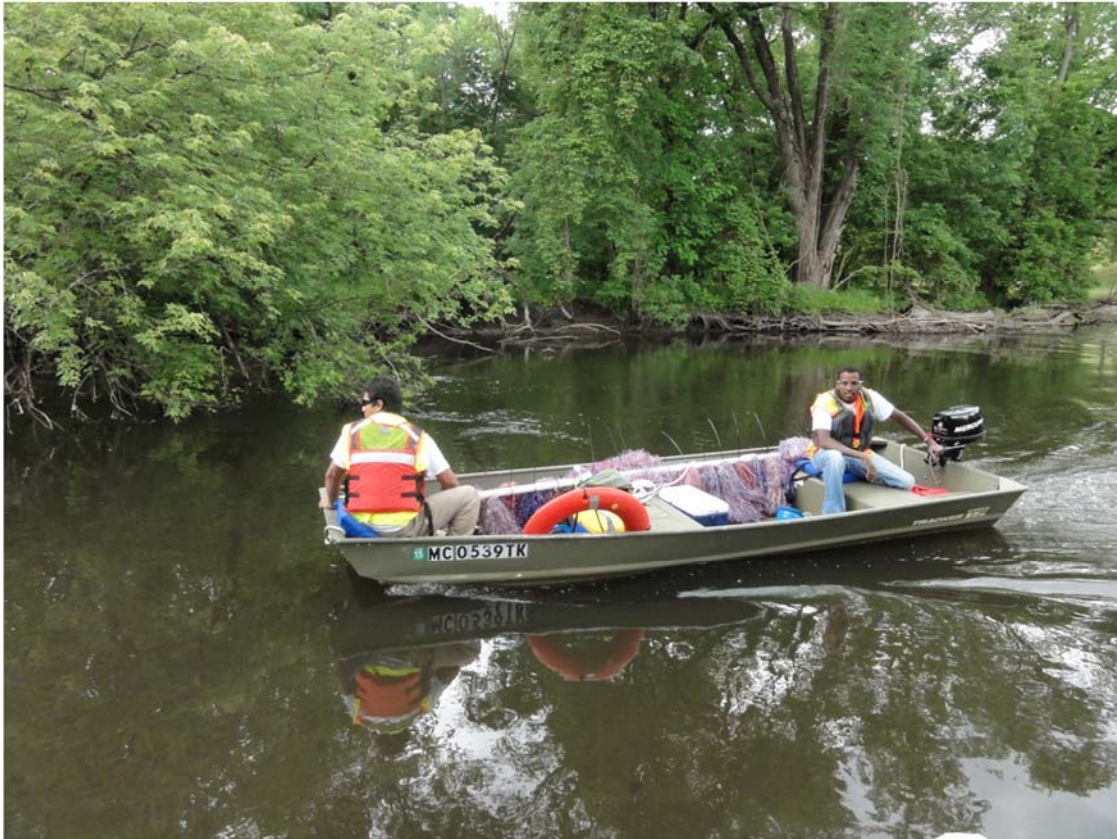
23. Sweep boat mobilizing to MP26.0 and MP26.25.

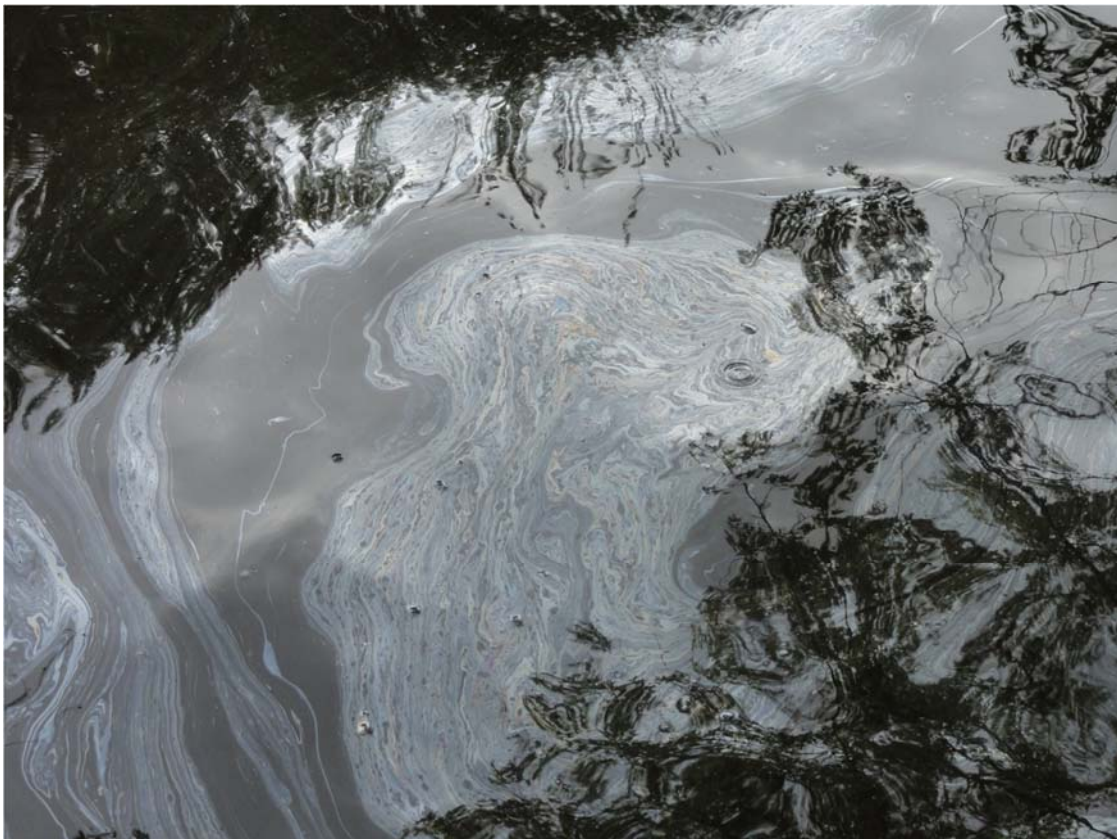
24. MP28.25 sheen observed after jet boat reverse thrust.
