# Situation Photo Log

Wednesday, May 30, 2012

Kalamazoo River / Enbridge Spill

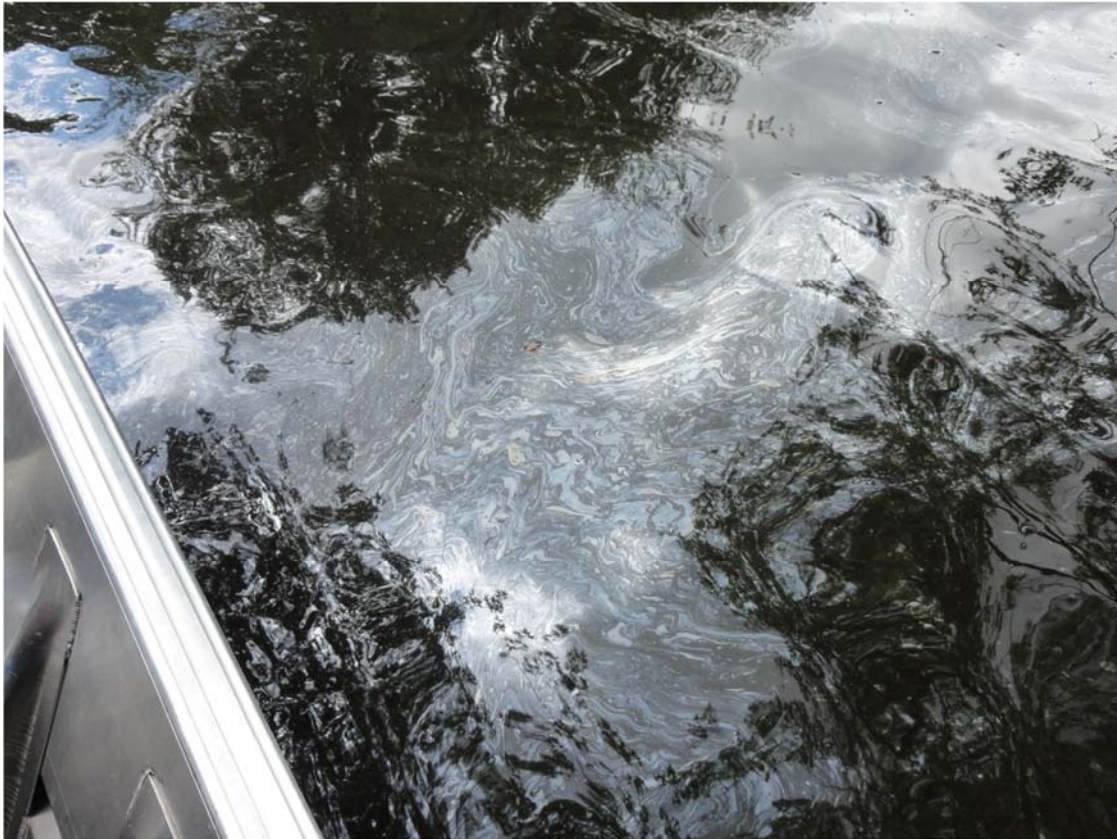
25. MP28.25 sheen observed after jet boat reverse thrust.

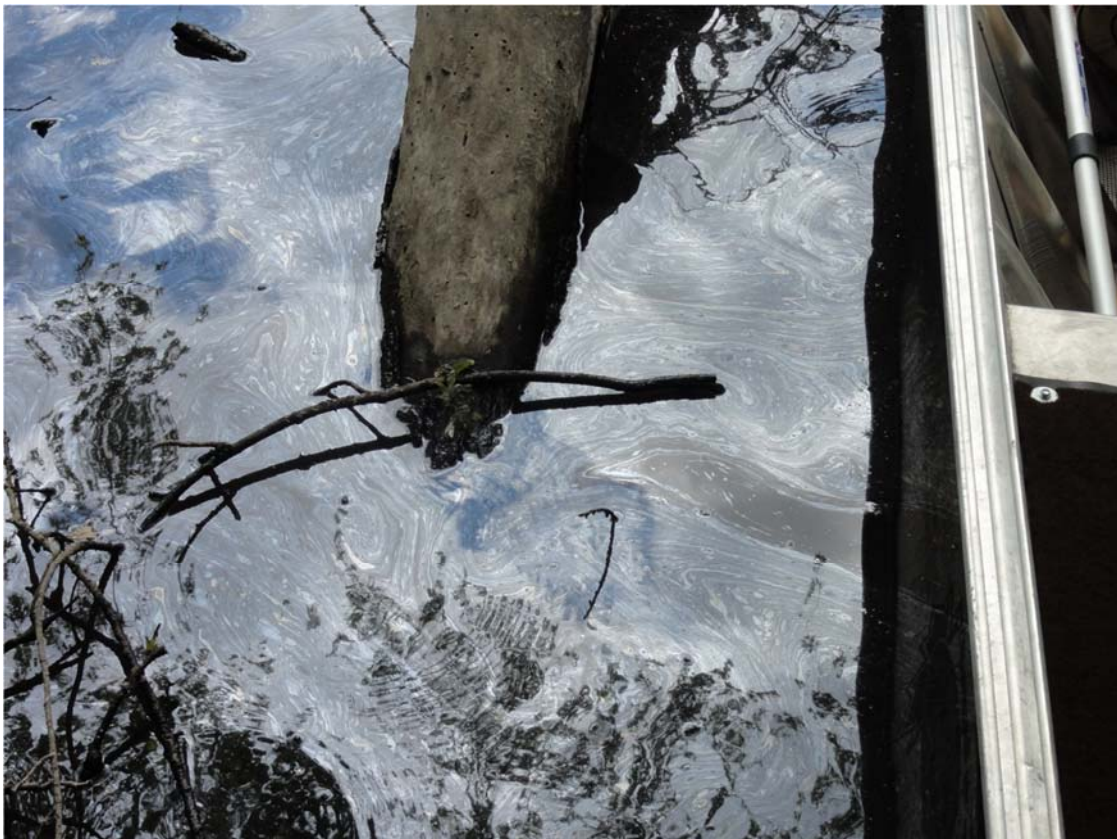
26. MP28.25 sheen observed after jet boat reverse thrust.

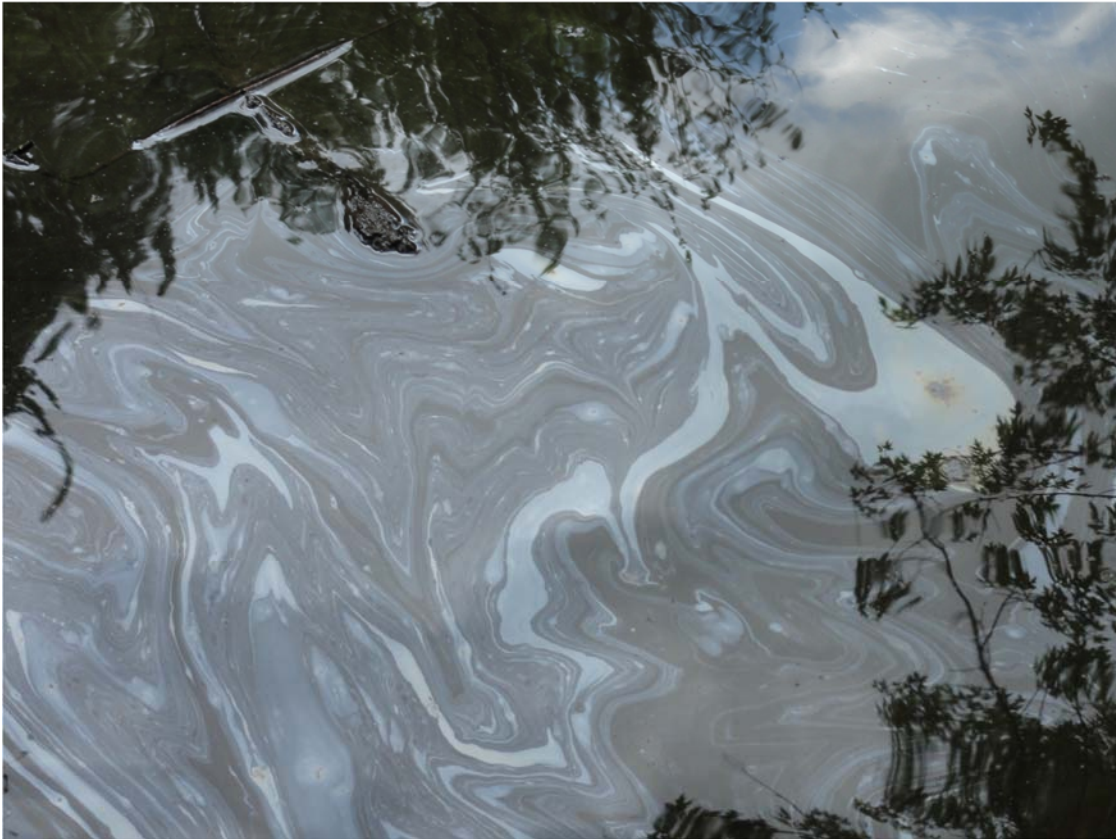
27. MP28.25 sheen observed after jet boat reverse thrust.

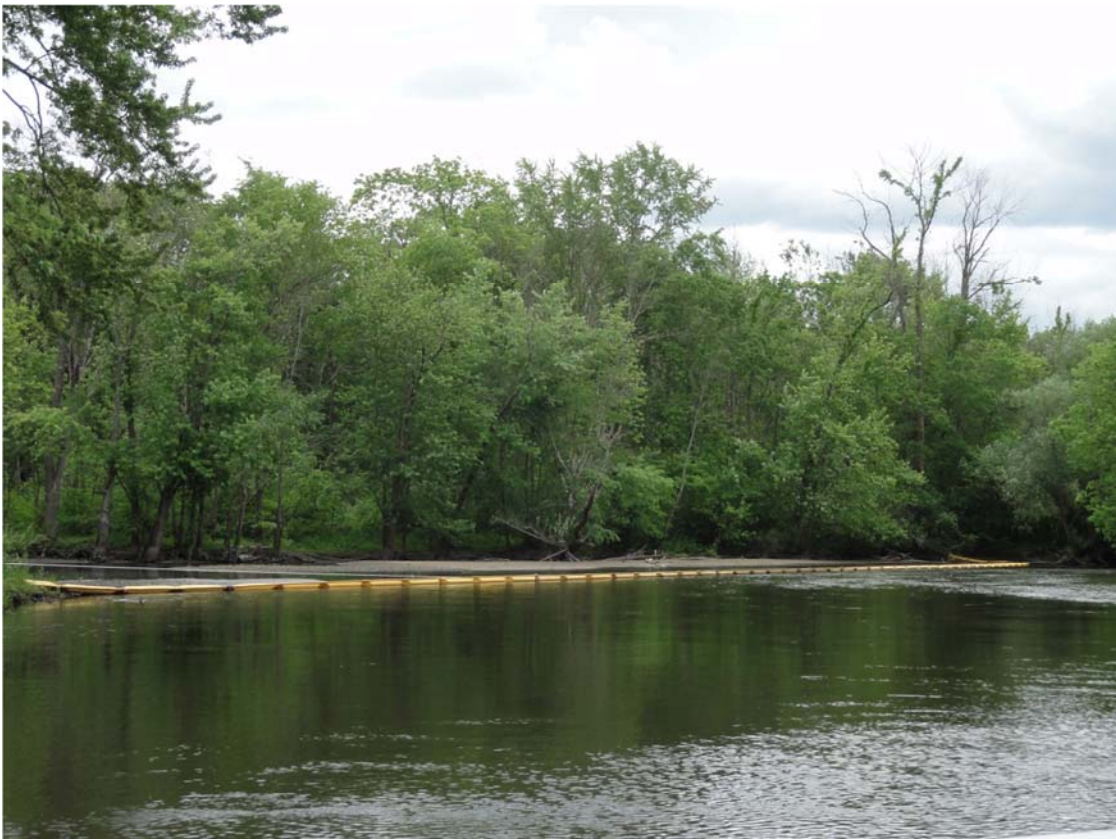
28. MP30.8 containment boom sheen observed within boom.

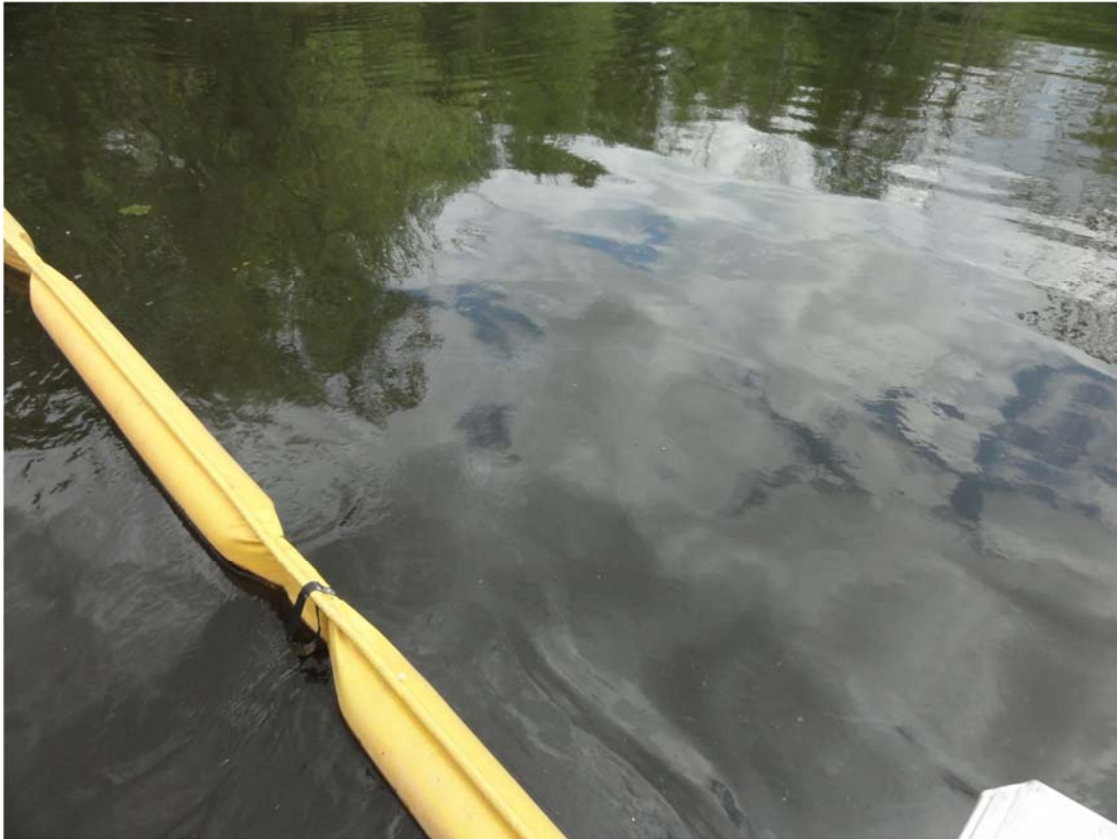
**29. MP30.8 sheen observed within boom.**

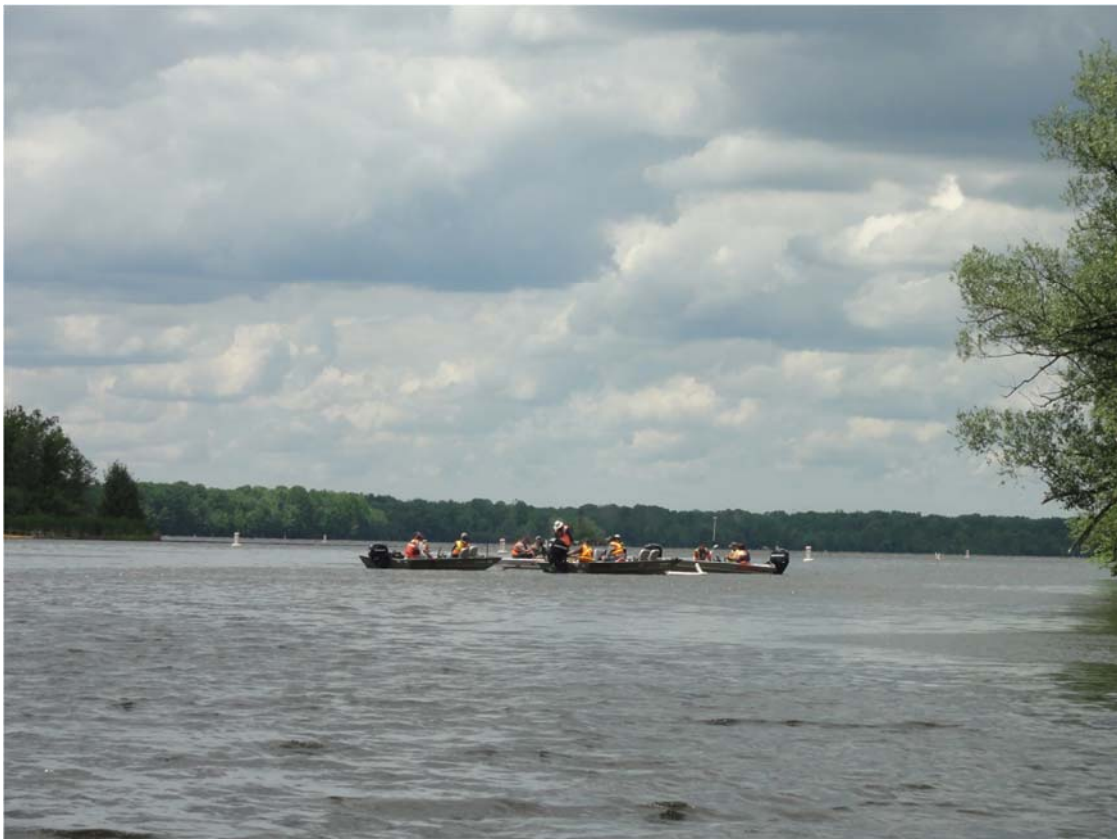
**30. Morrow Lake Delta poling crews.**

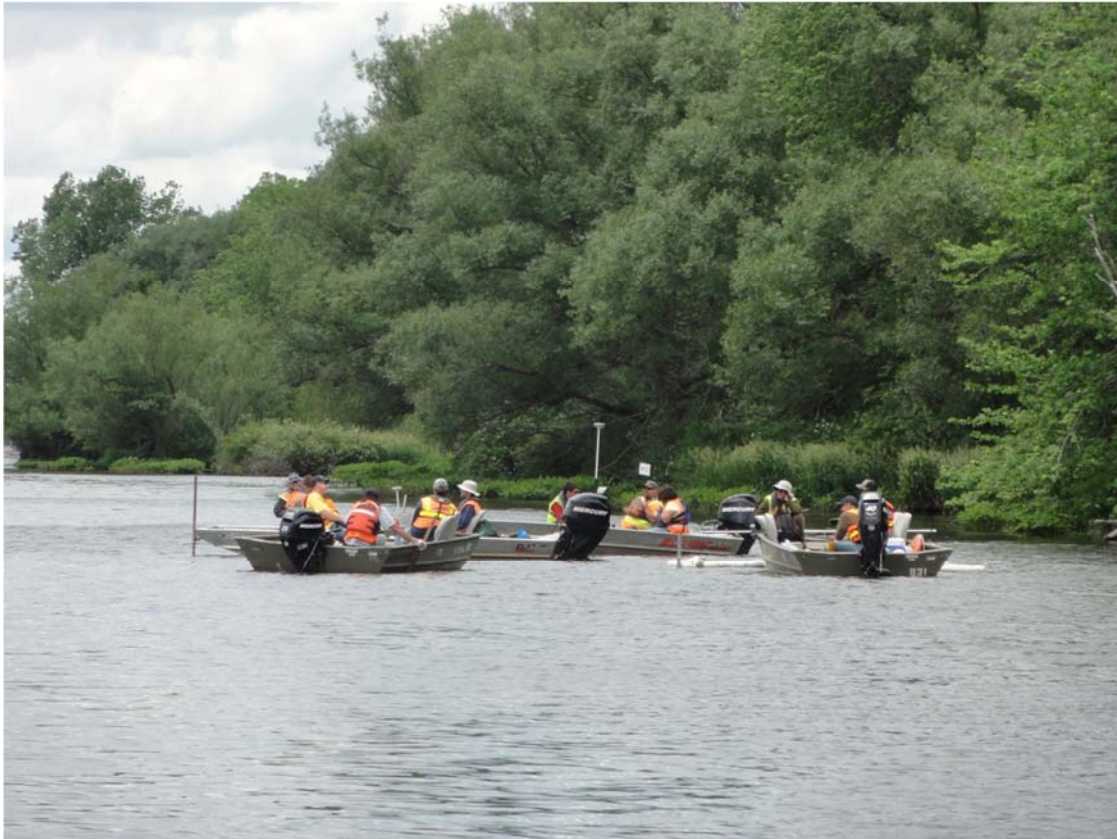
31. Morrow Lake Delta poling crews.

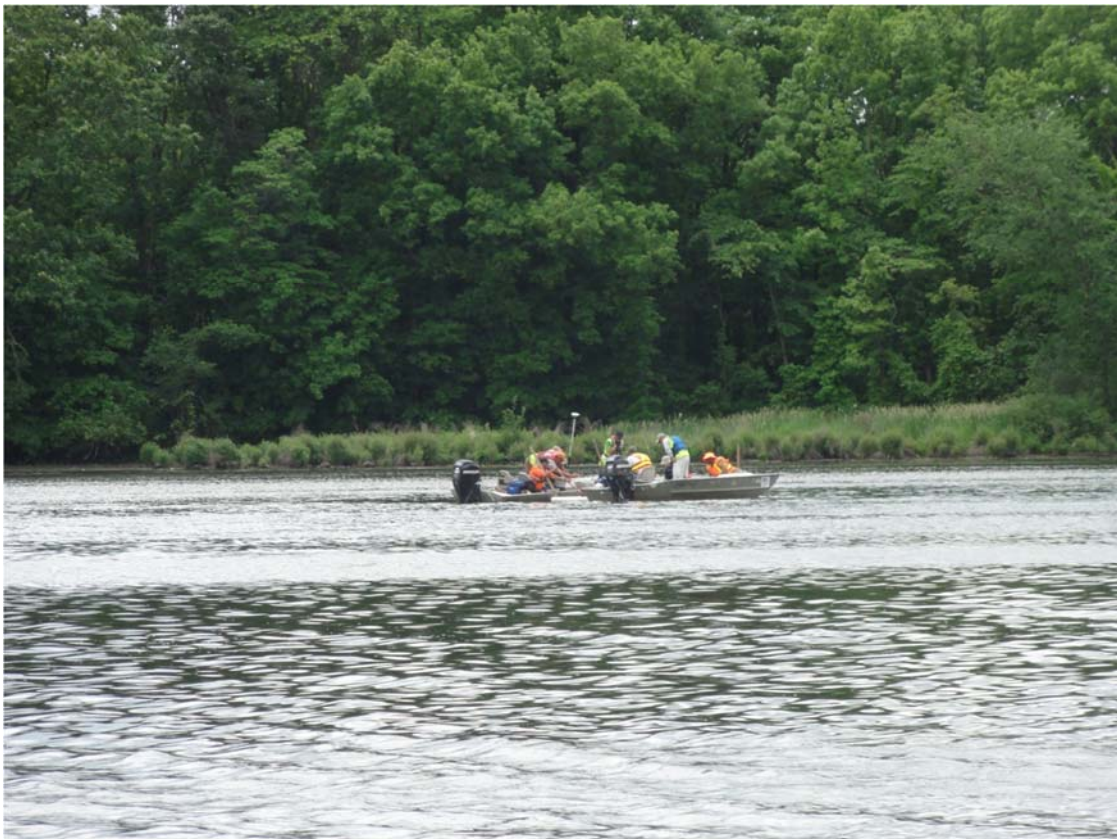
32. Morrow Lake Delta poling crews.

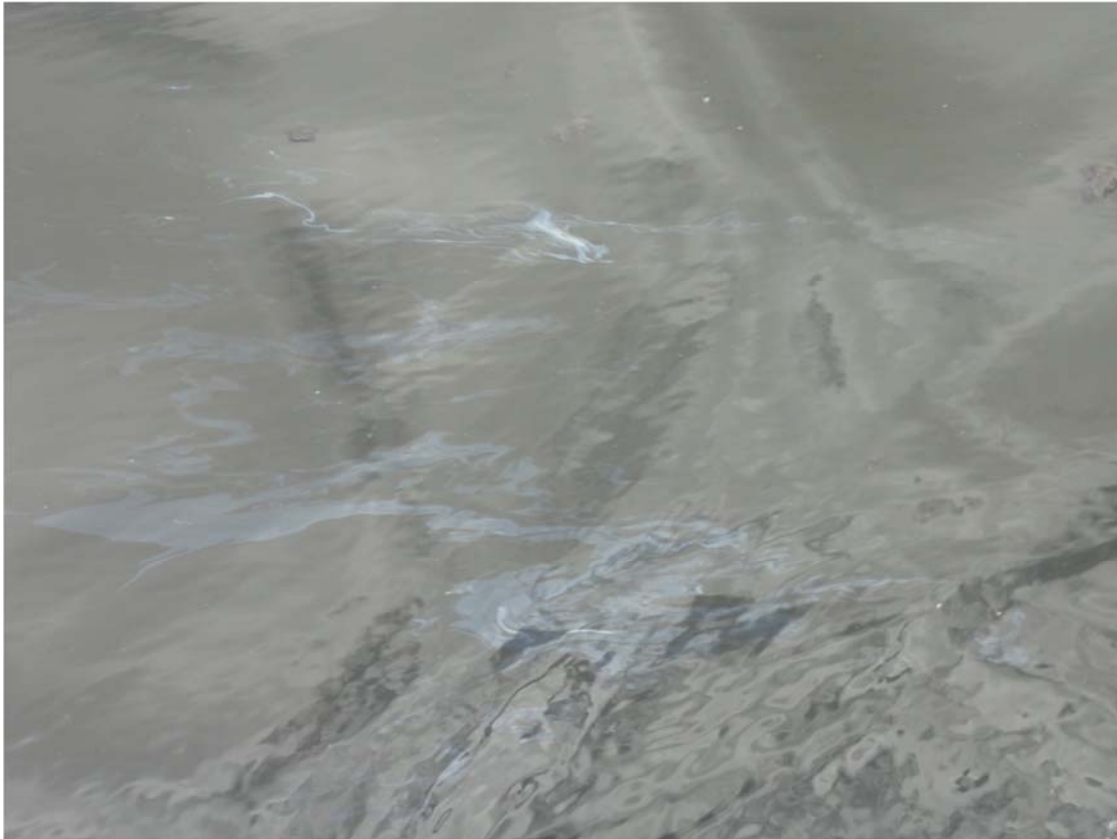
**33. Morrow Lake Delta sheen observed.**

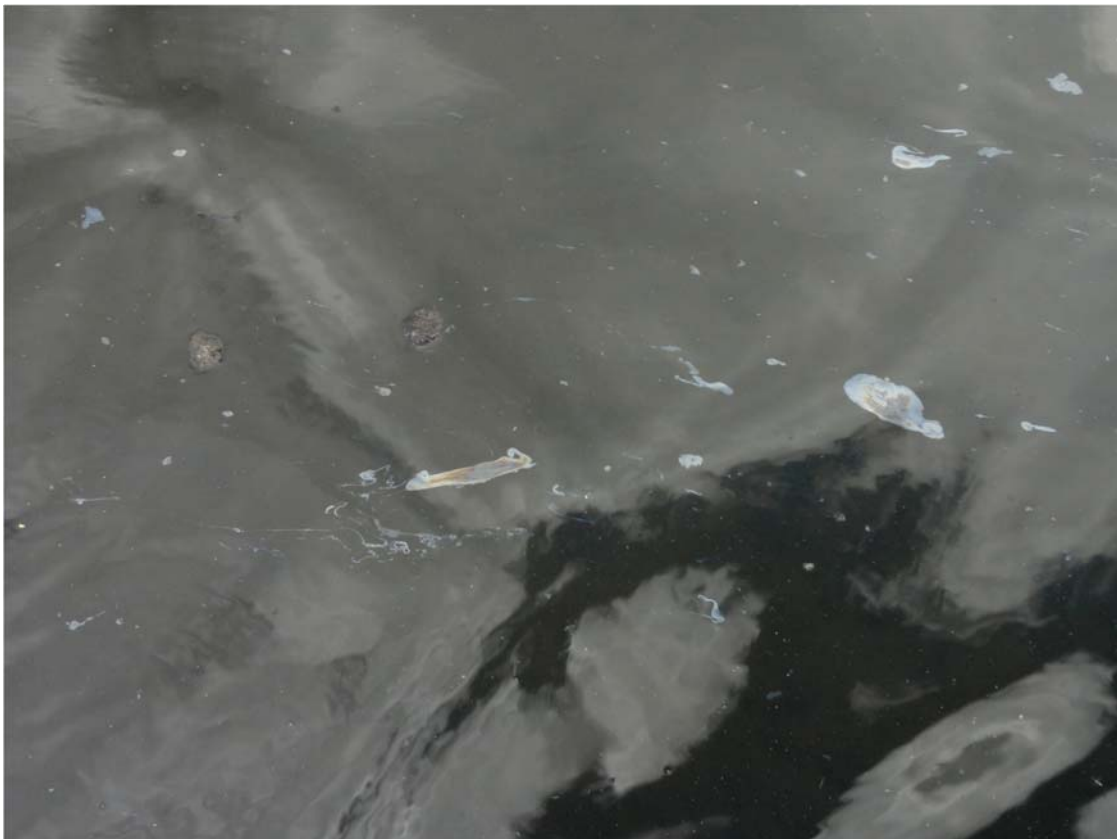
**34. Morrow Lake Delta sheen observed.**

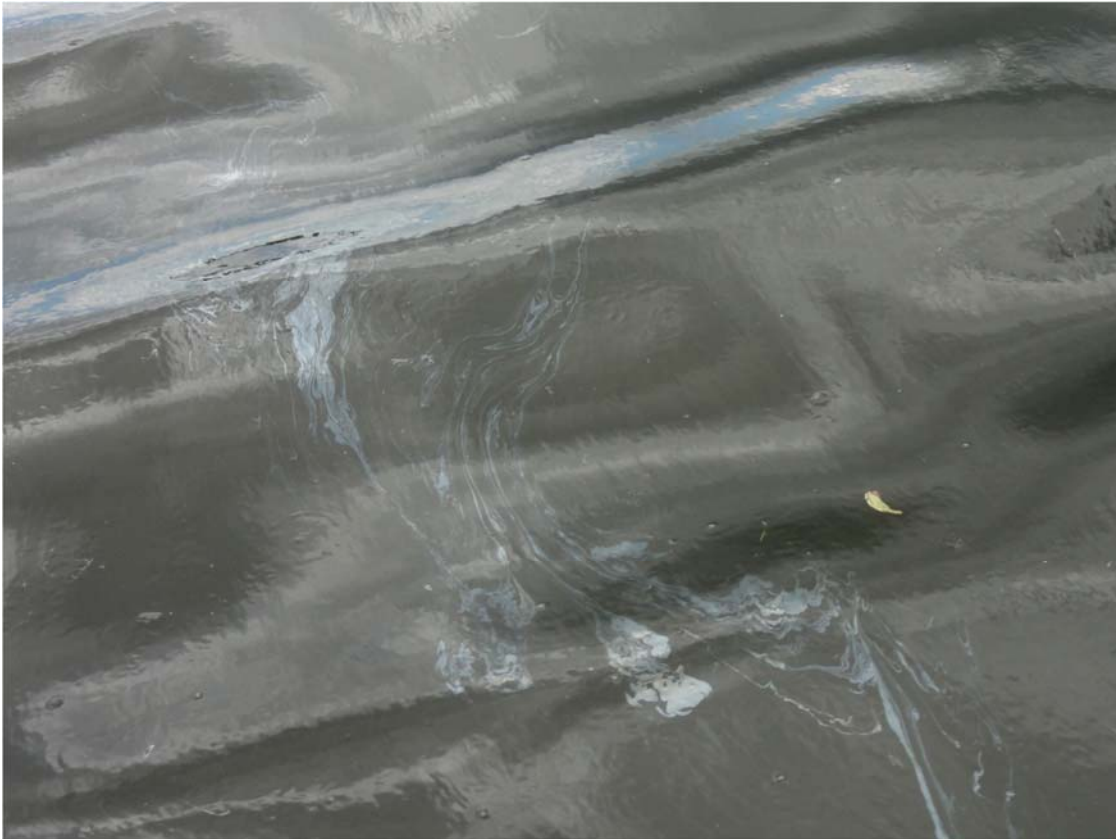
**35. Morrow Lake Delta sheen observed.**

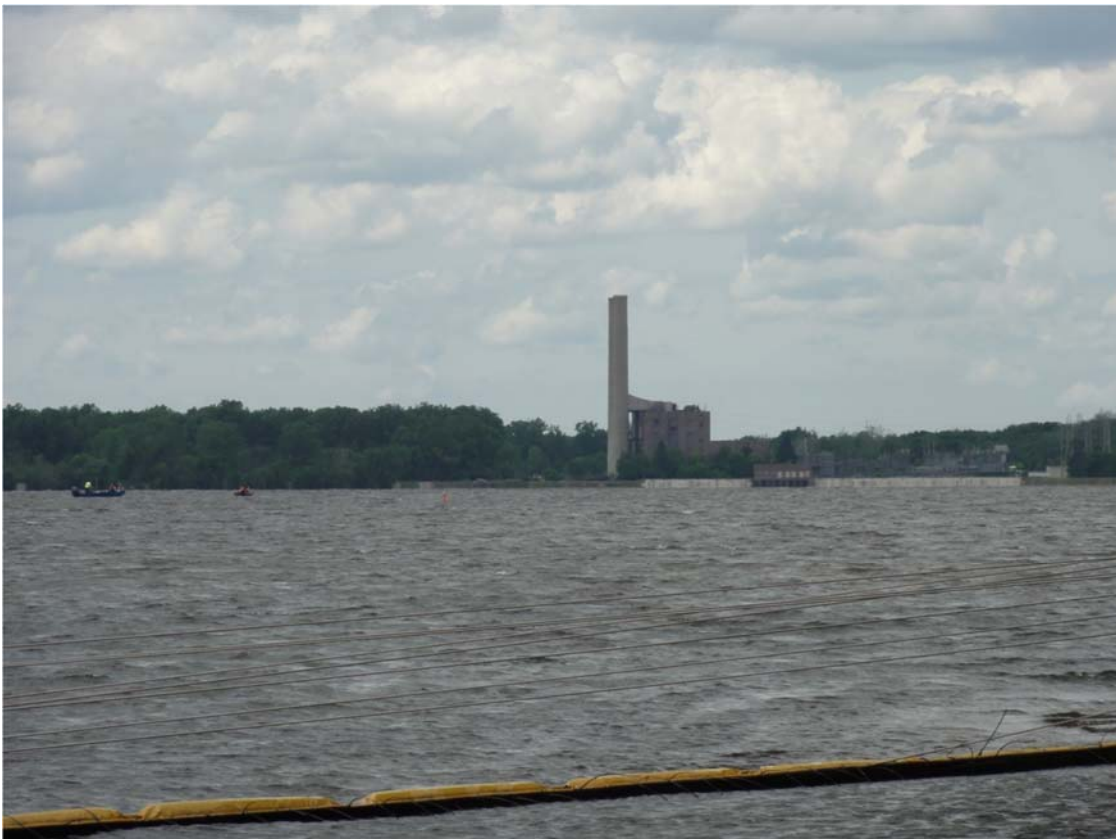
**36. Morrow Lake poling crew.**

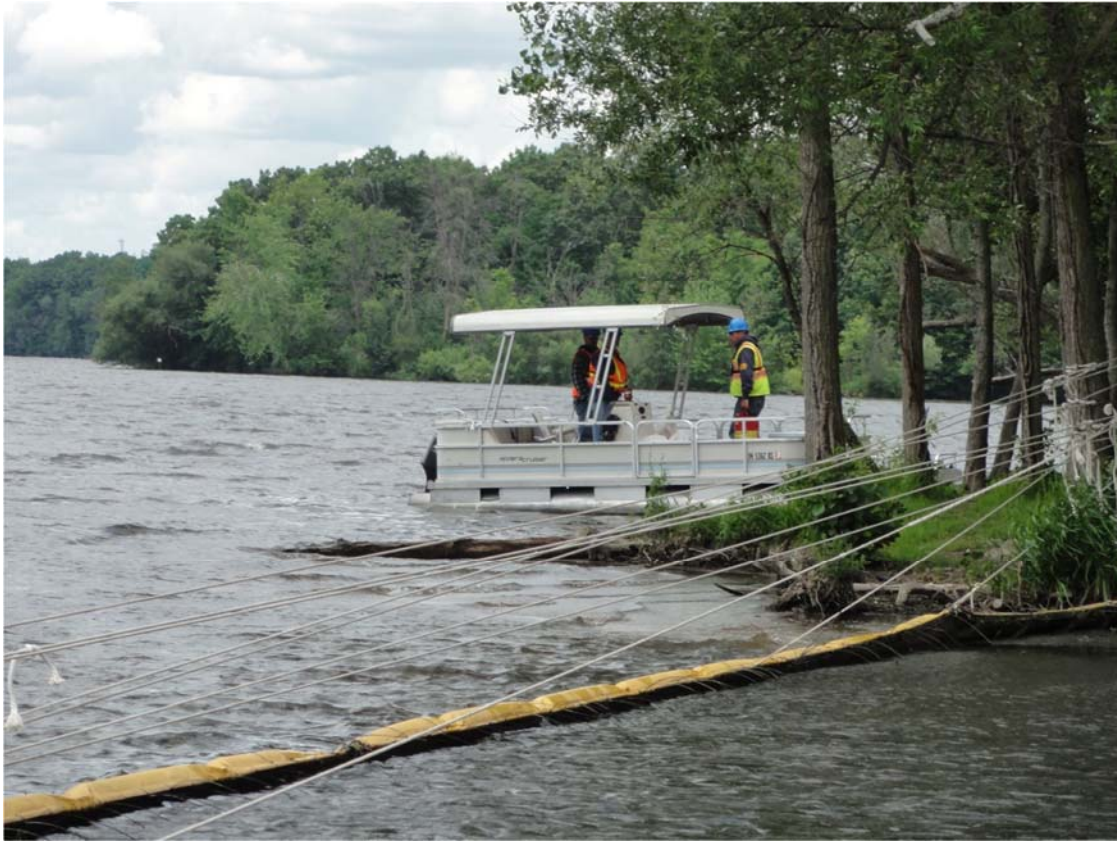
37. Morrow Lake sheen sweep boat.

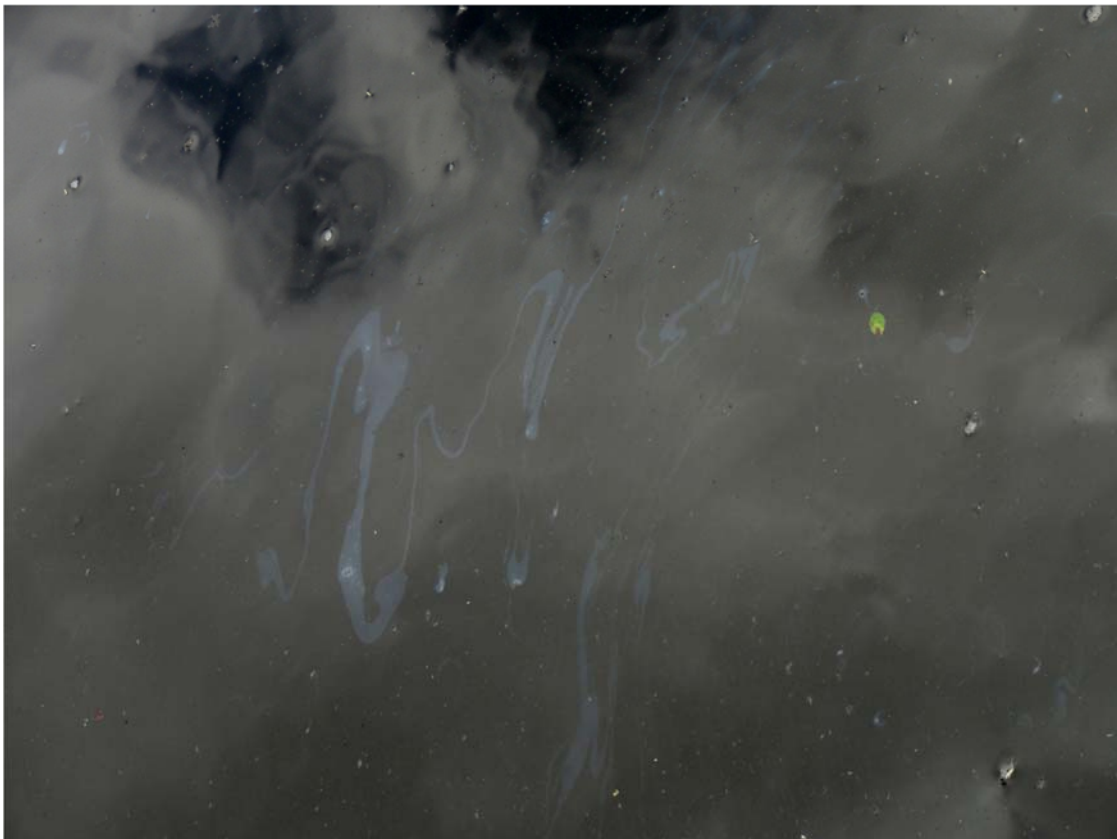
38. Sheen observed around boat after docking at Shady Bend Campground.
