# Situation Photo Log

Thursday, May 31, 2012

Kalamazoo River / Enbridge Spill

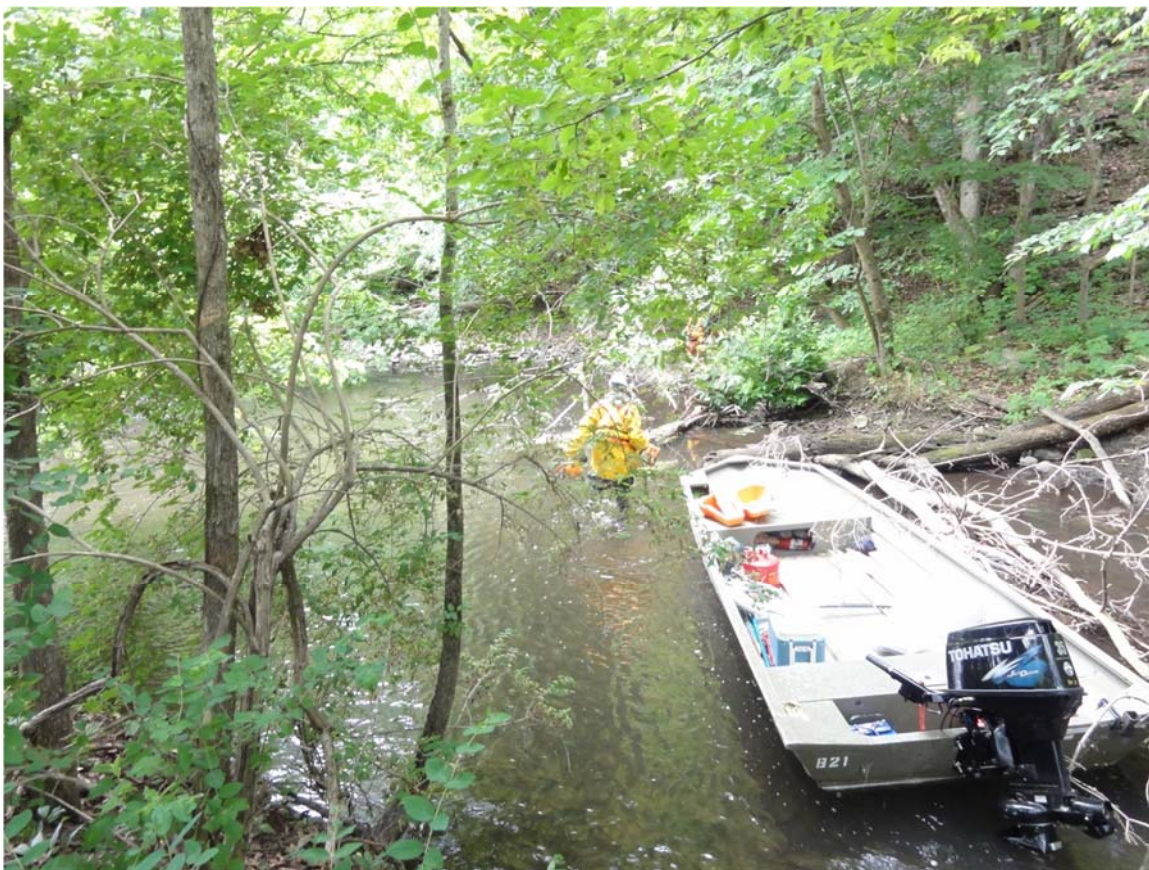
1. MP7.89 LDB woody debris removal crew.

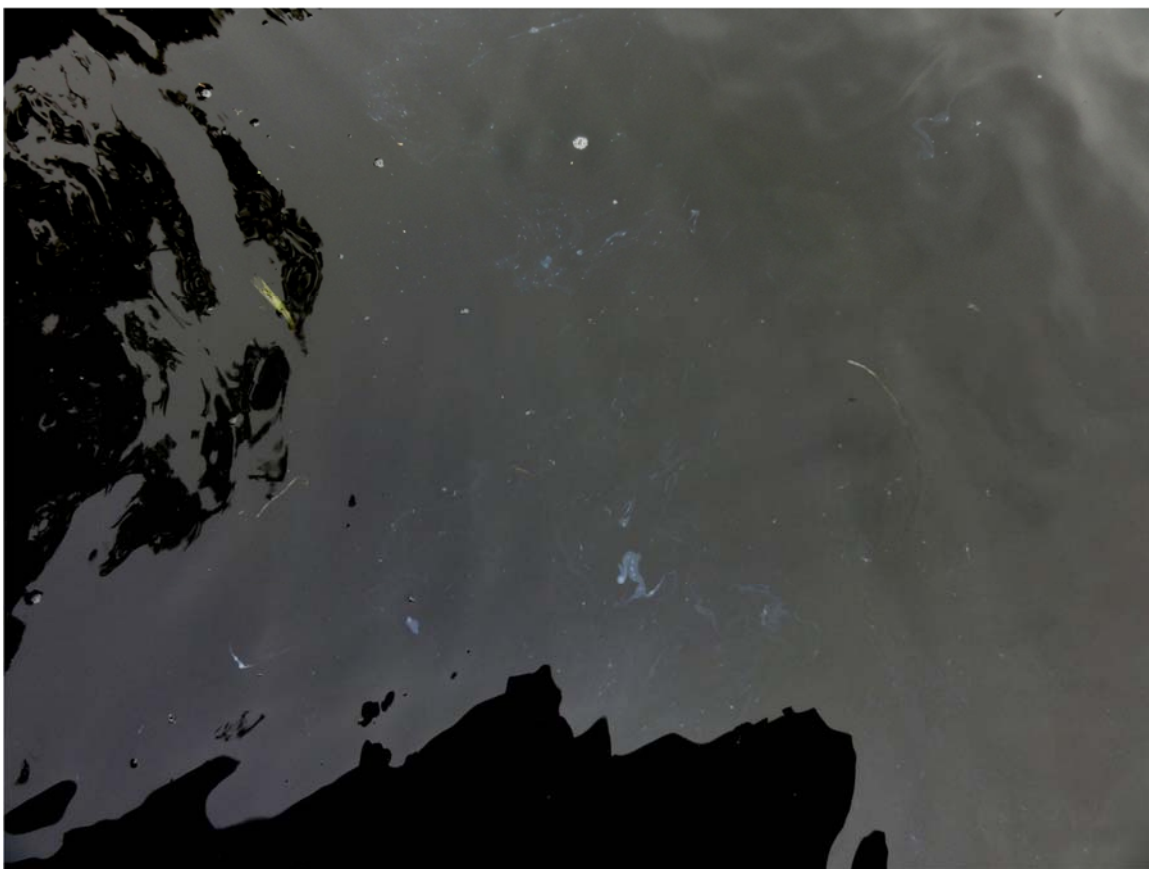
2. MP7.89 LDB sheen observed when the boat docked along the shoreline.

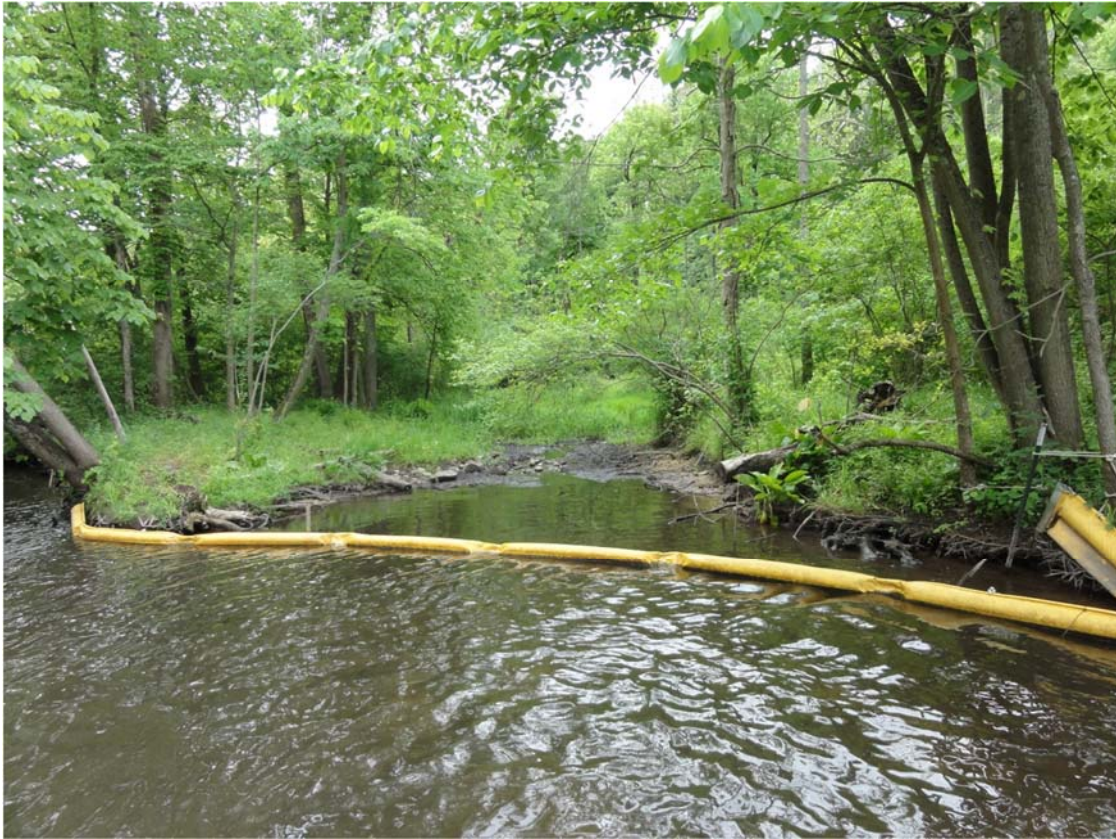
3. MP8.48 LDB boom.

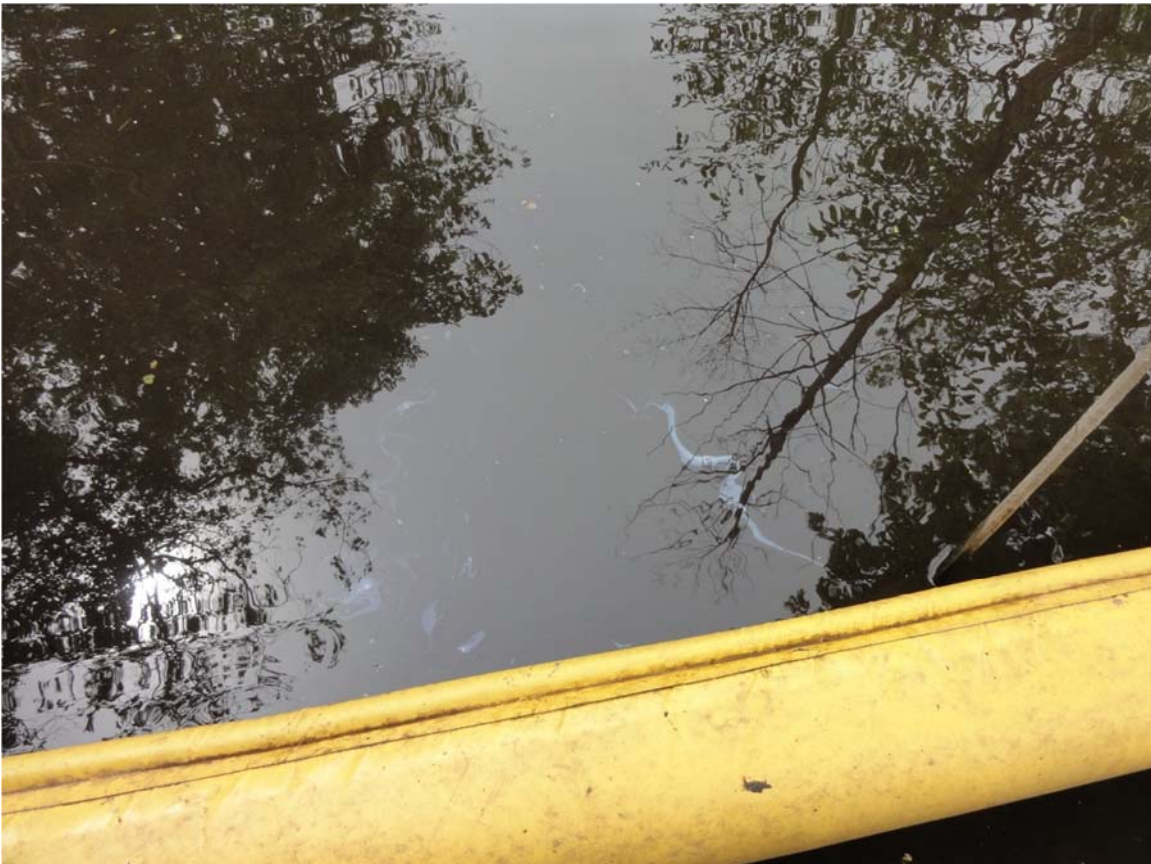
4. MP8.48 Sheen observed within boom.

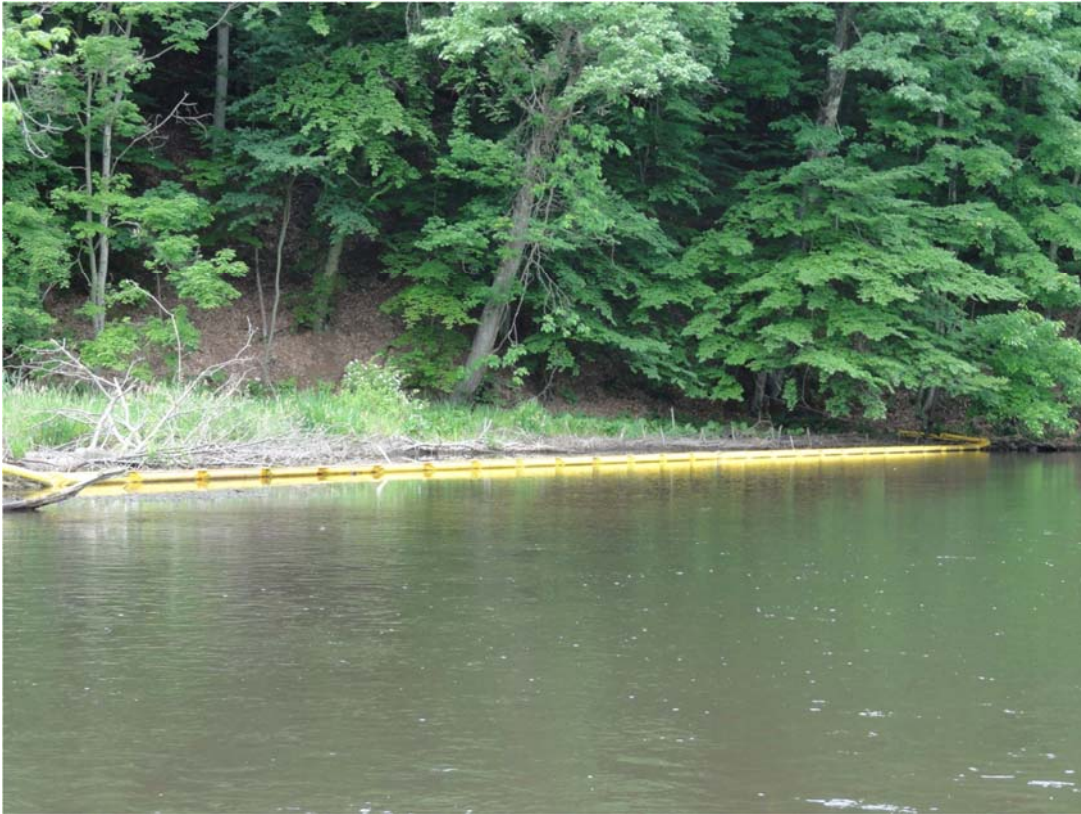
5. MP8.48 LDB boom no sheen observed.

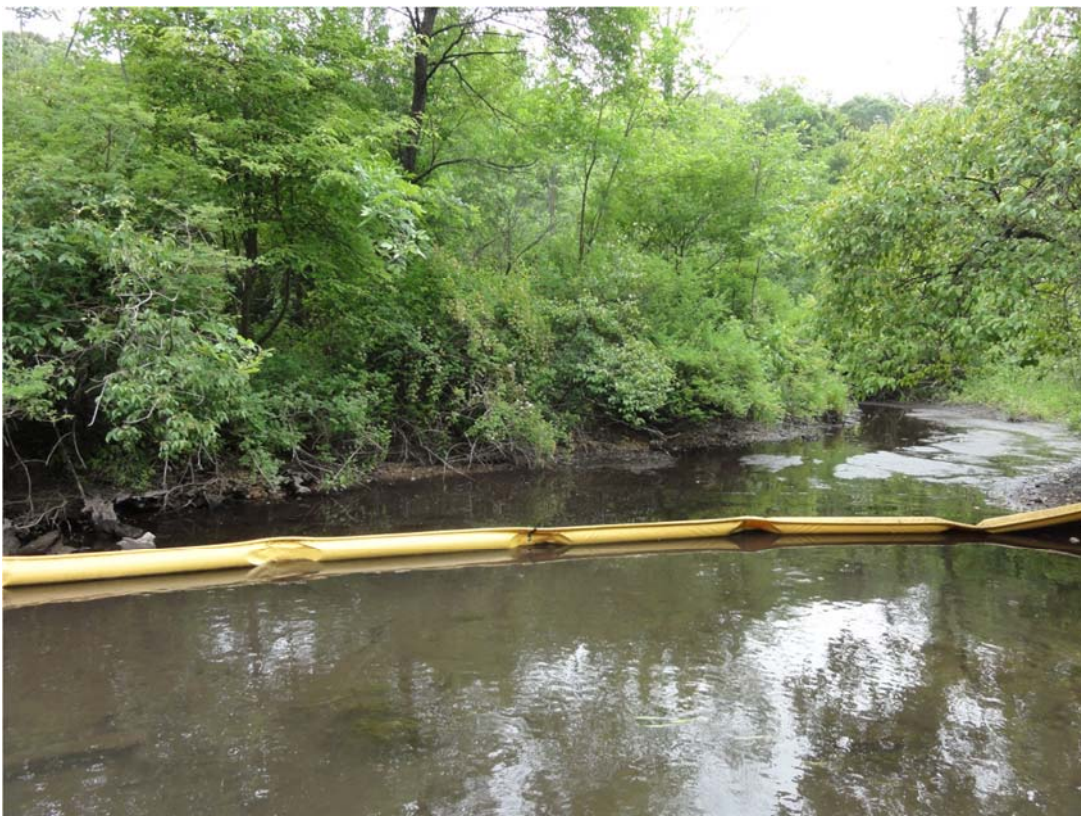
6. MP8.75 RDB boom no sheen observed.

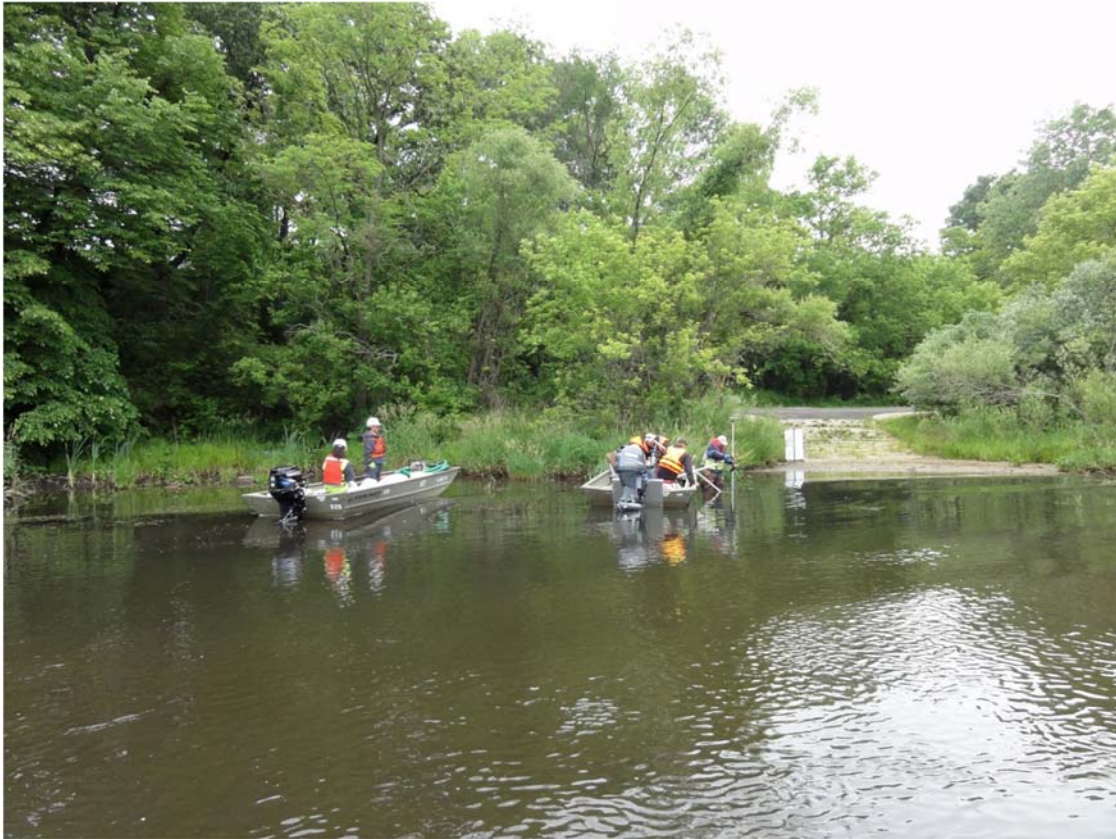
7. MP9.75 RDB poling crew observed.

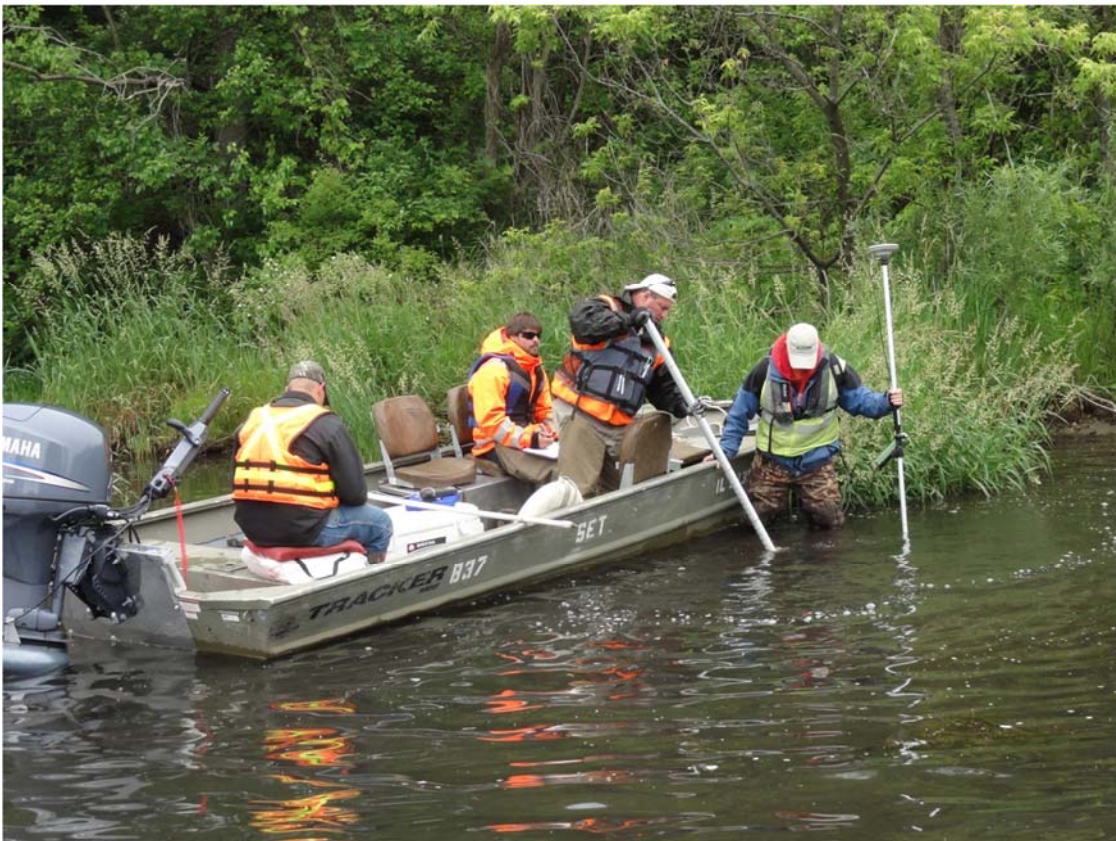
8. MP9.75 RDB poling crew observed.

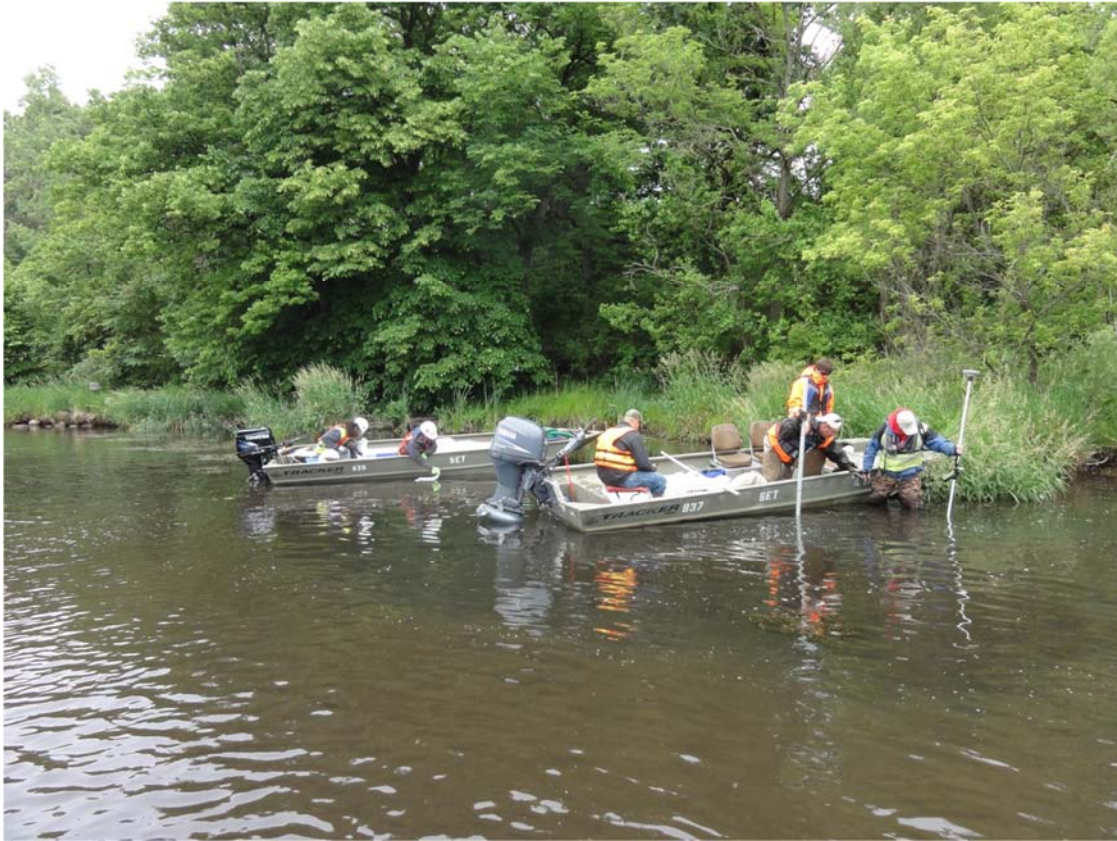
9. MP9.75 RDB poling crew observed.

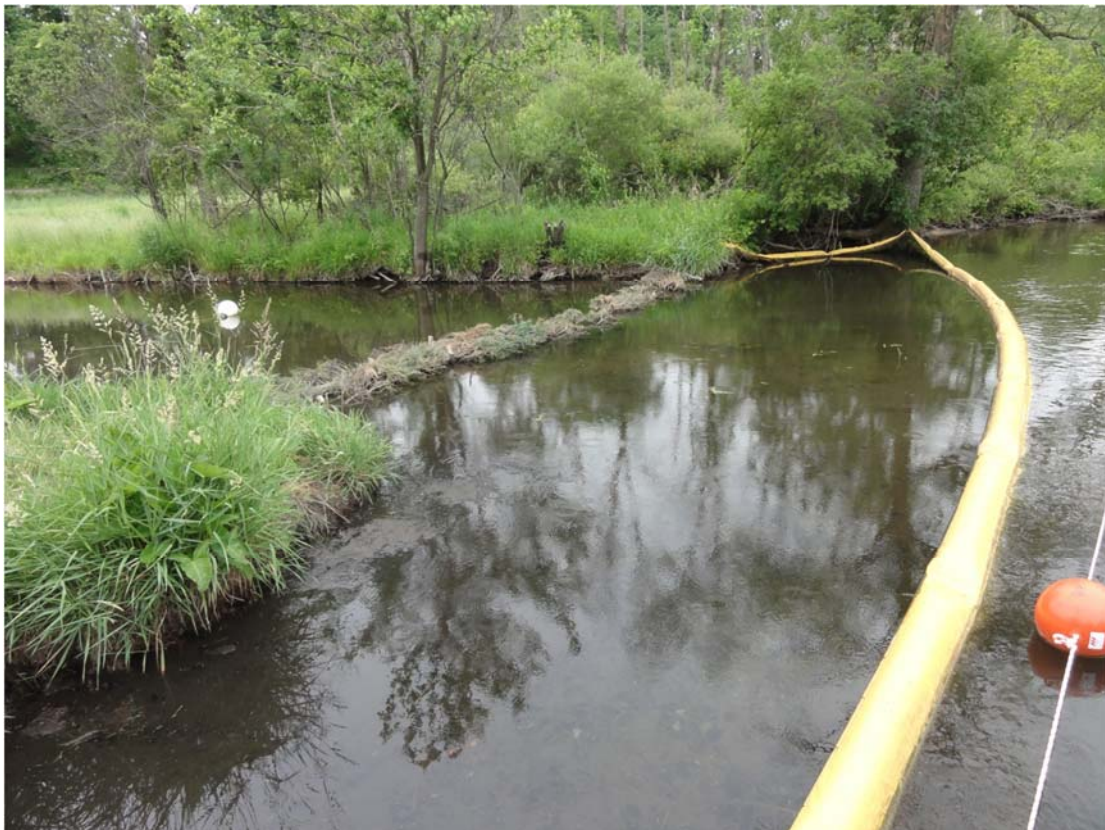
10. MP10.75 sediment control trap, water levels receding.

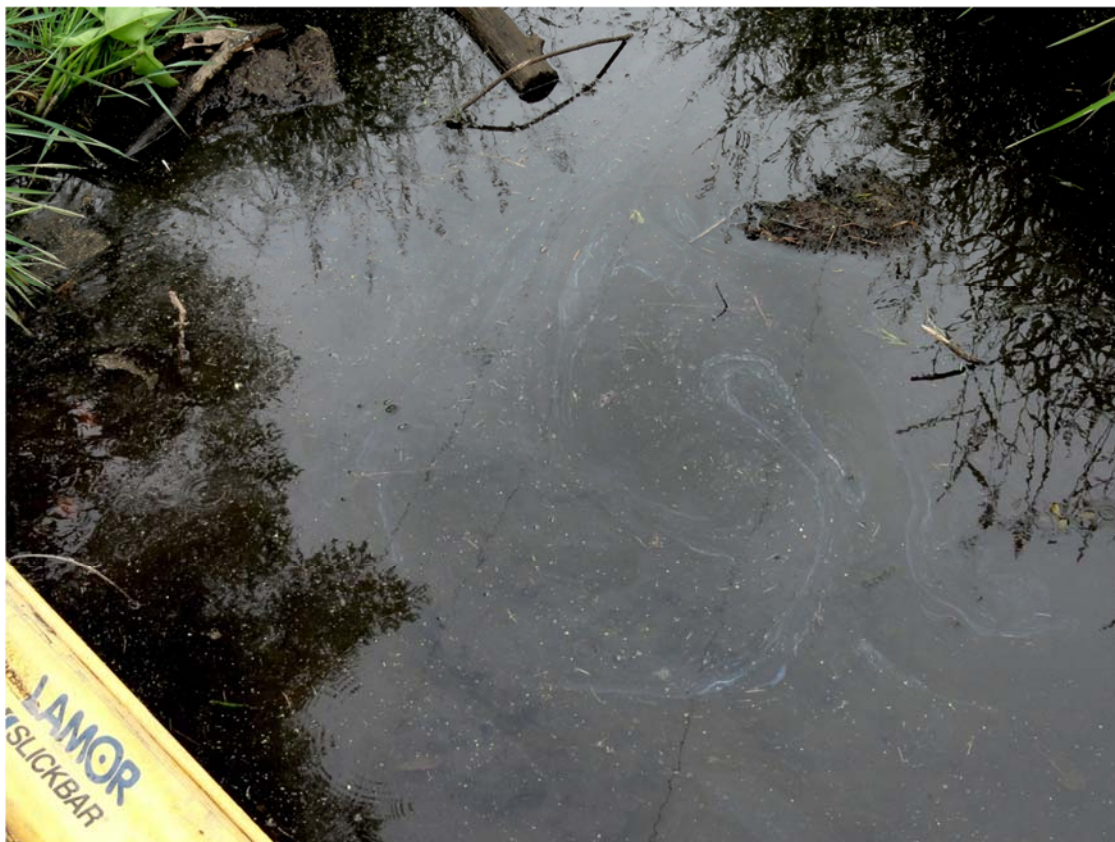
11. MP10.75 sheen observed within the boom.

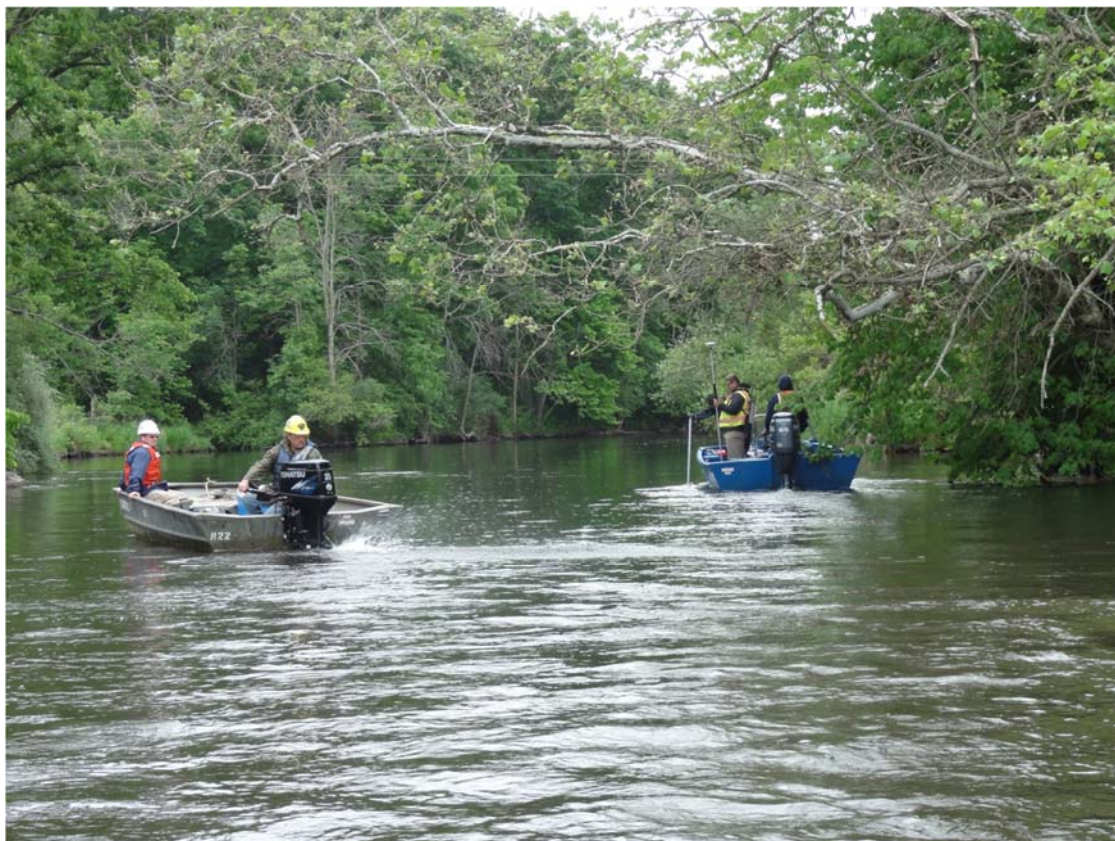
12. MP10.75 poling crew observed.

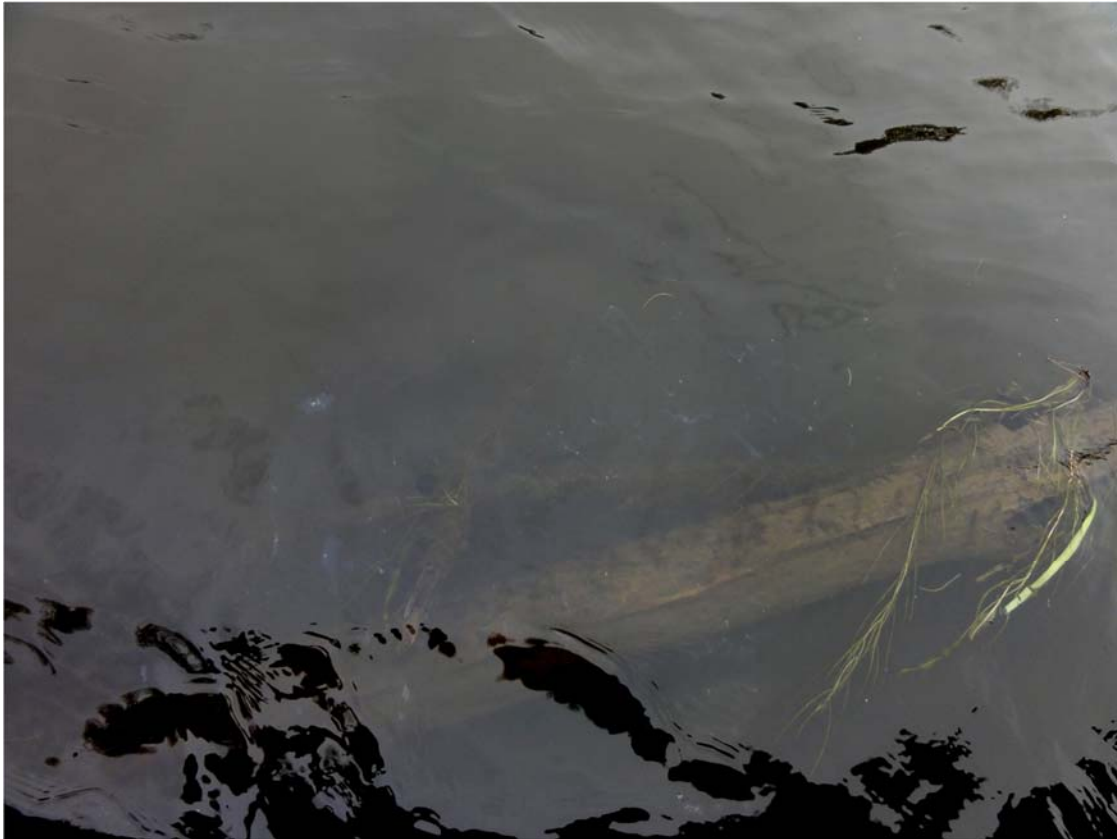
13. MP10.0 C3.2 boat launch sheen observed around docking boats.

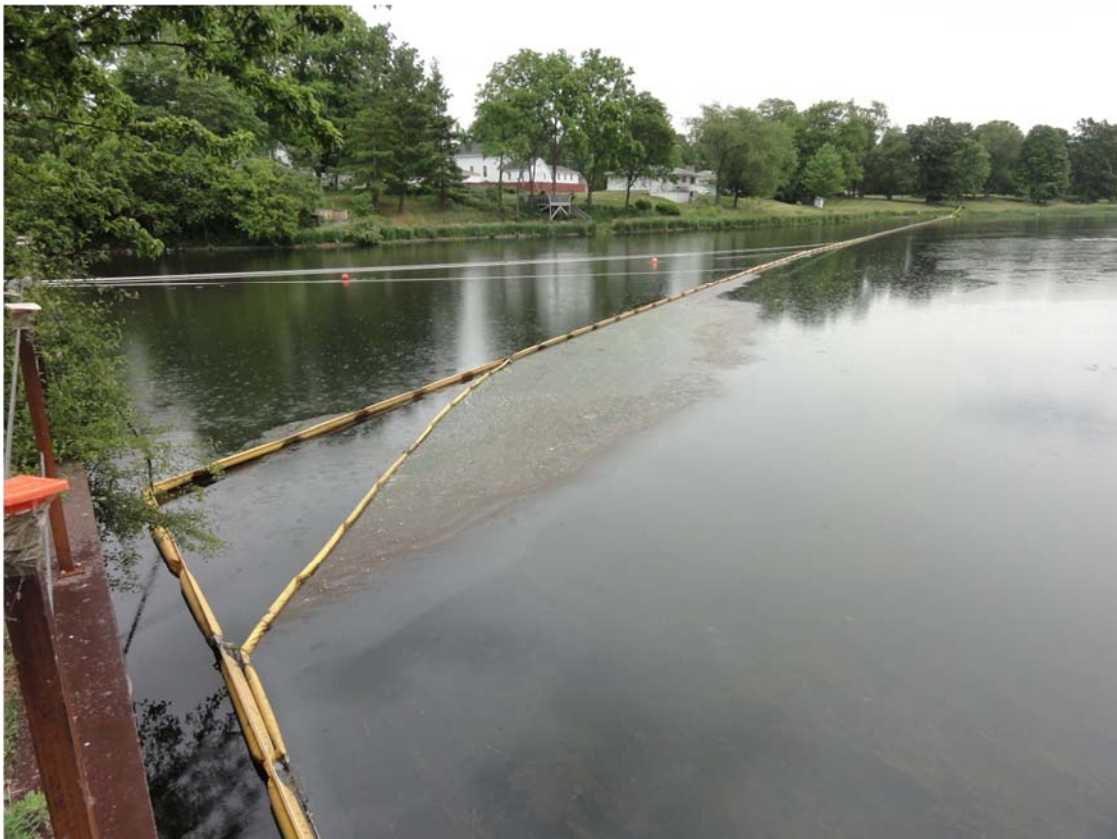
14. Ceresco Dam sheen and debris collecting at boom.

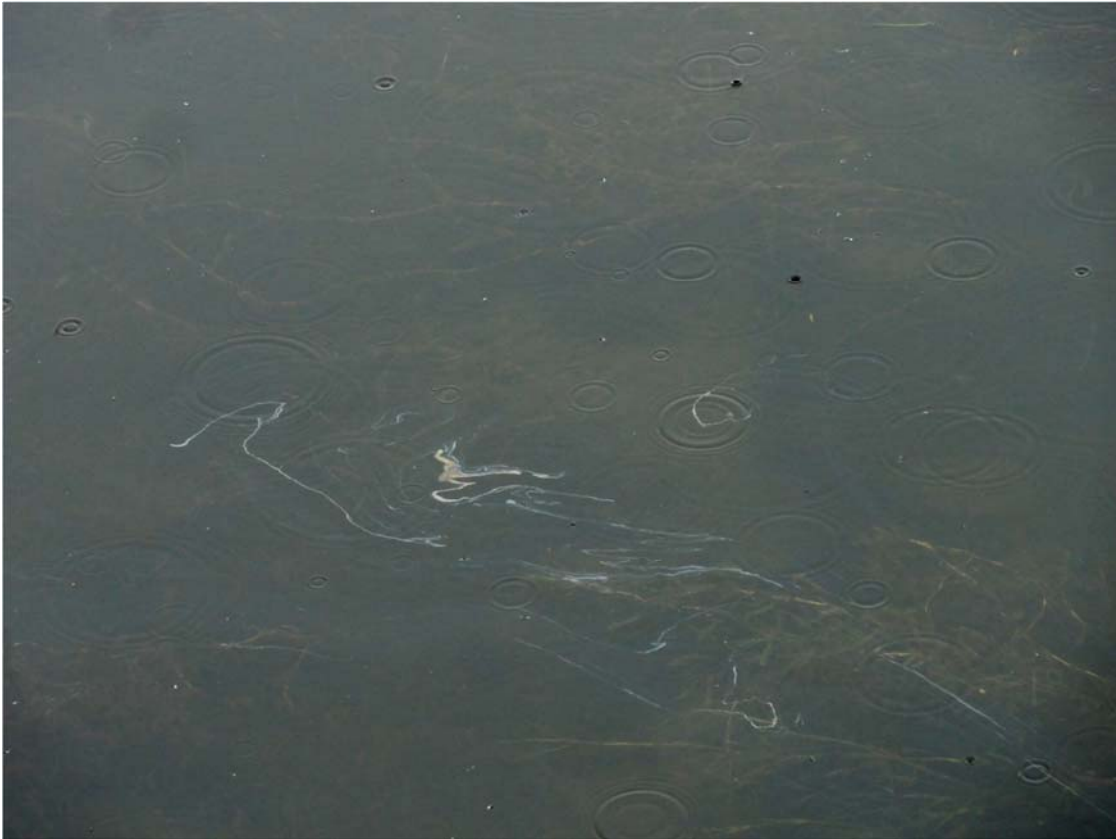
15. Ceresco Dam sheen observed.

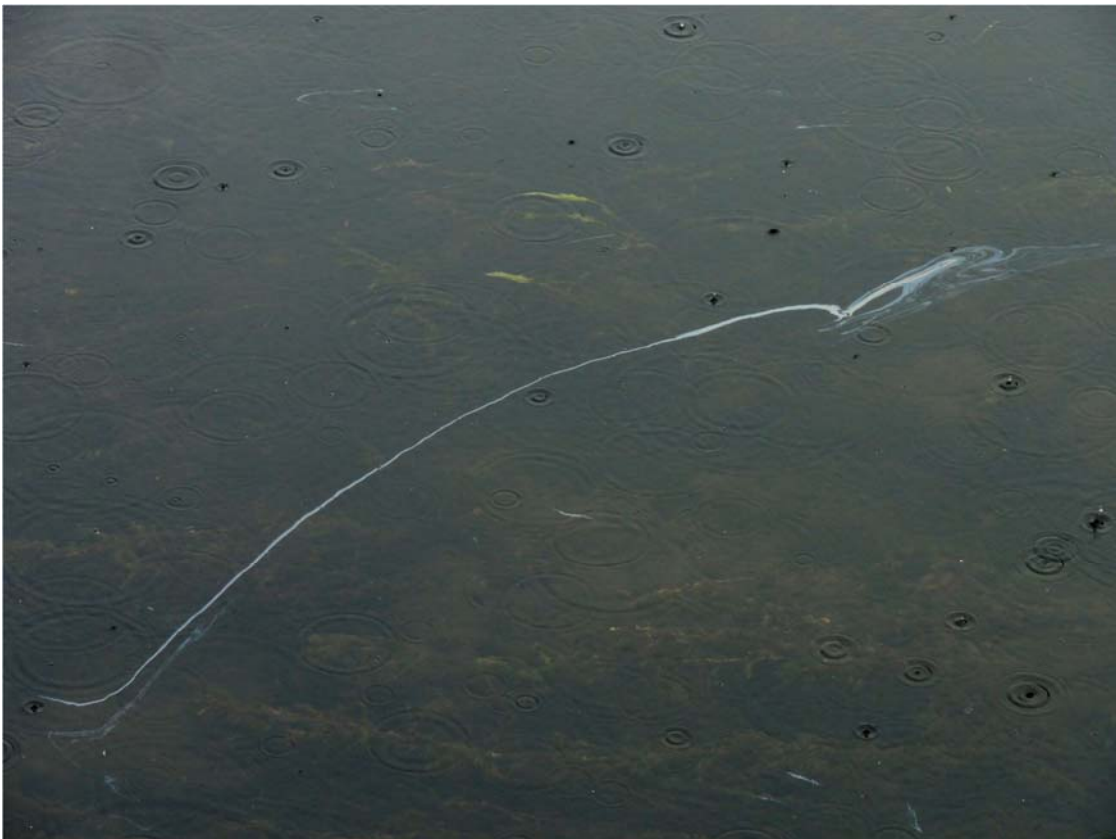
16. Ceresco Dam sheen observed.

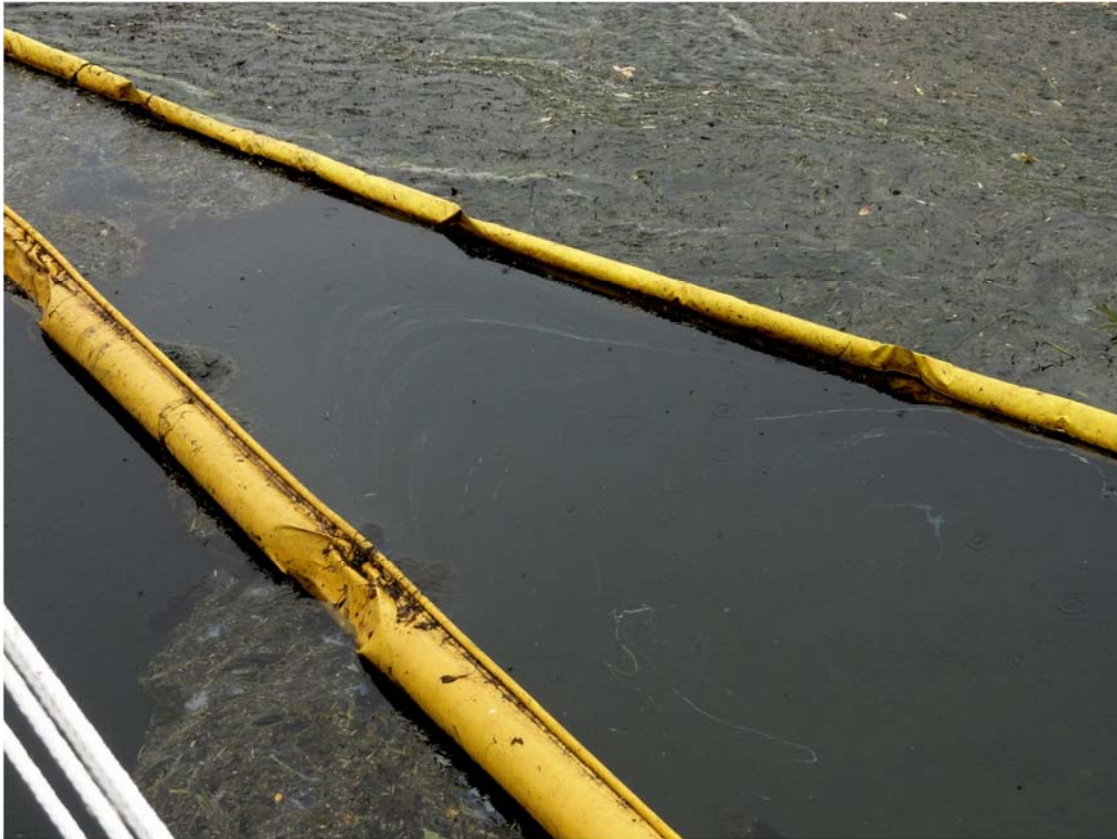
17. Ceresco Dam sheen observed between two booms.

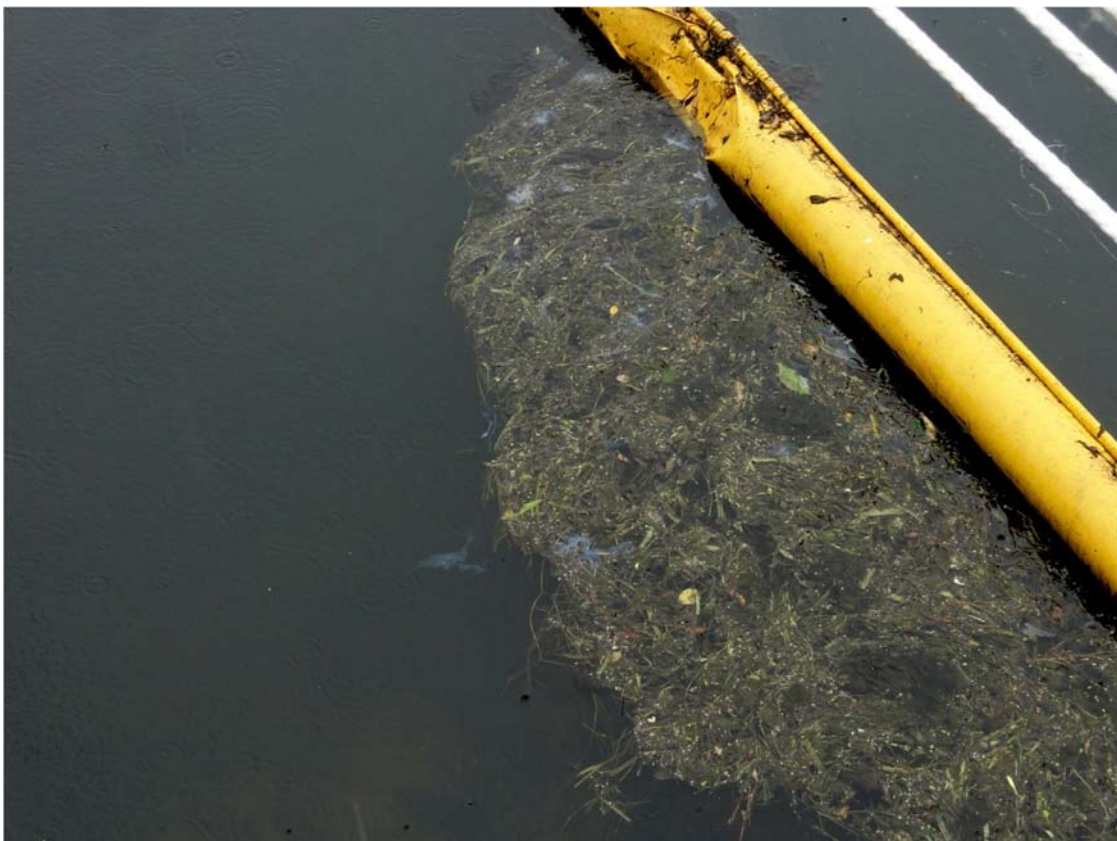
18. Ceresco Dam sheen observed down stream of boom.

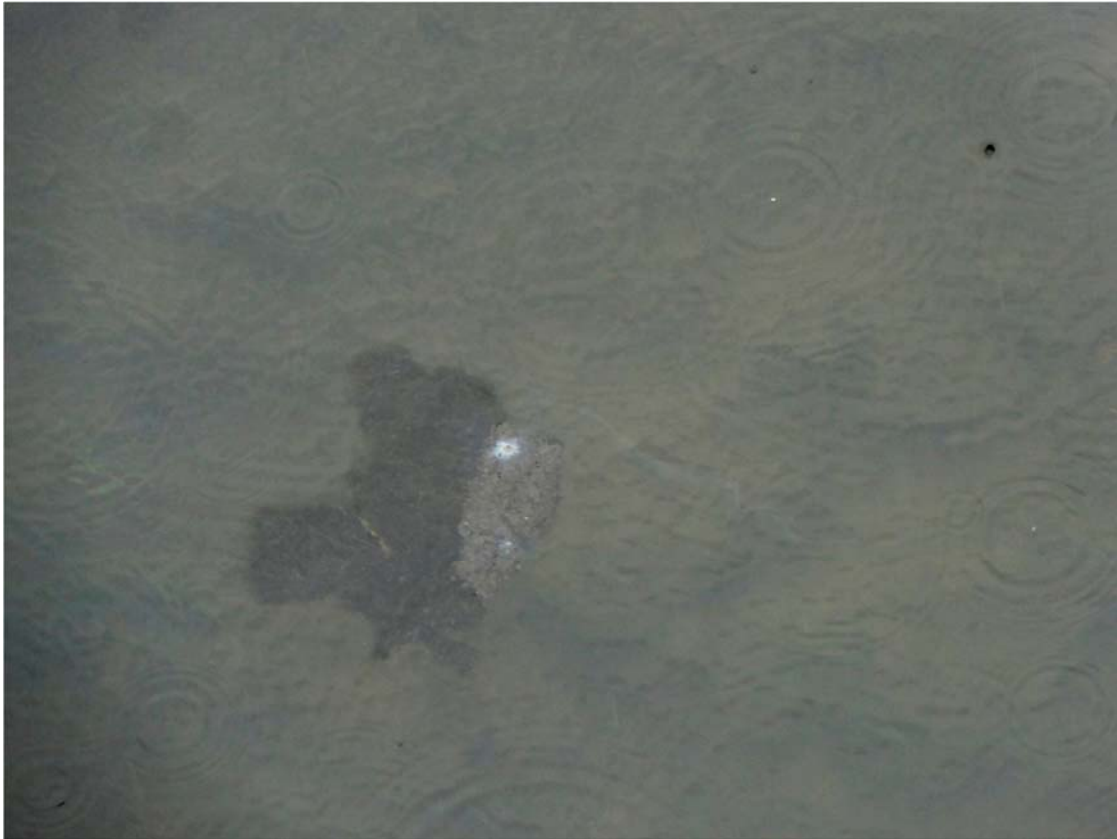
19. Ceresco Dam tar glob bound to vegetation flowing over dam.

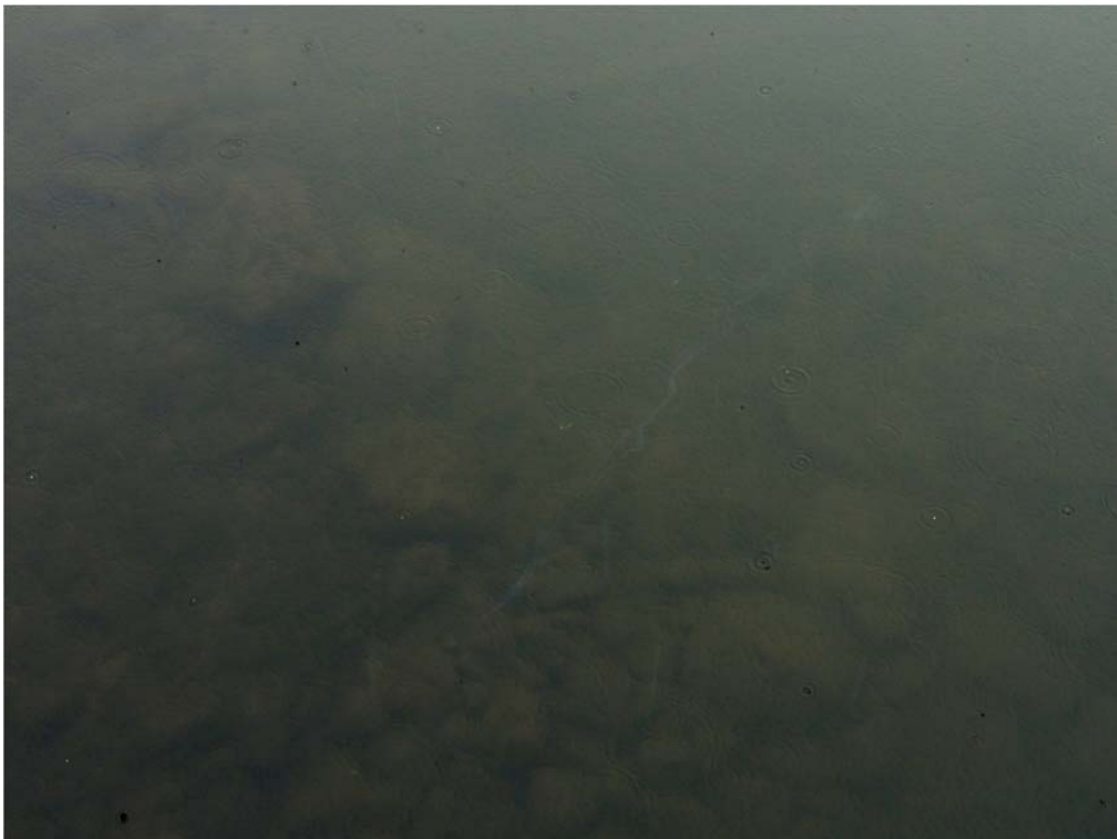
20. Ceresco Dam sheen observed flow over dam.

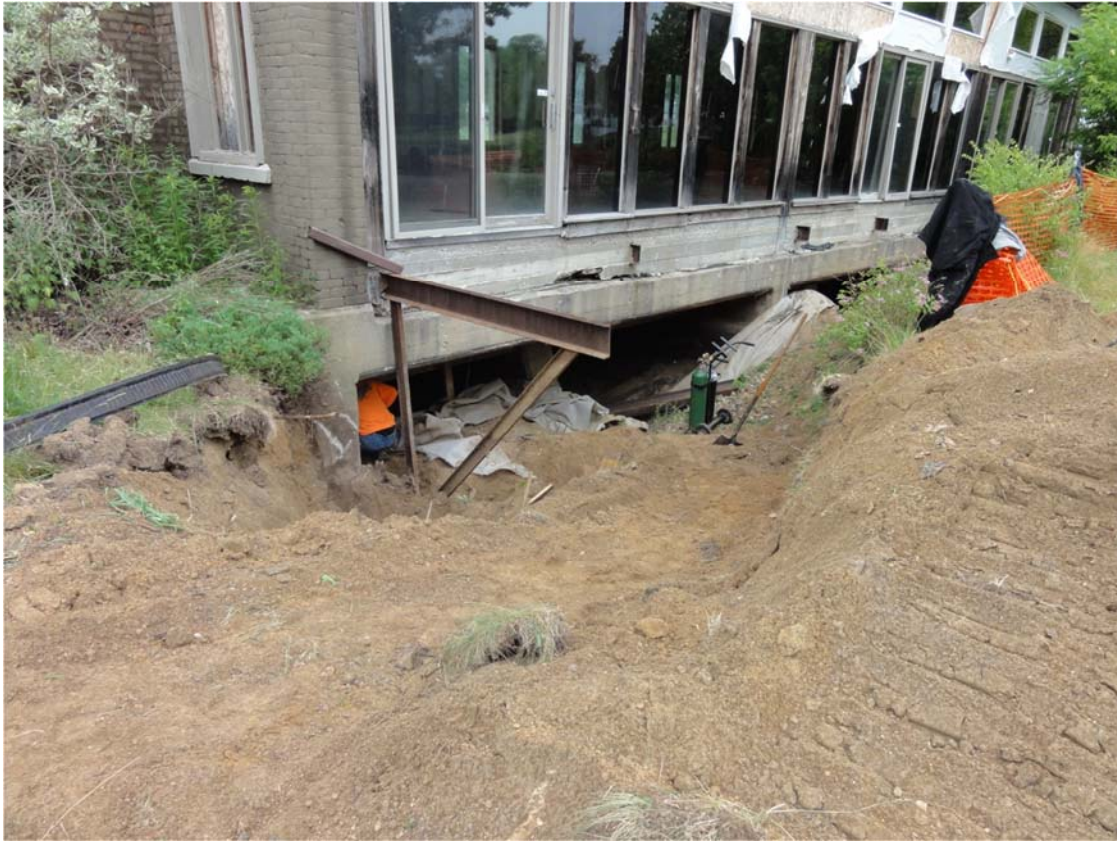
21. Ceresco Dam, owner is having turbines removed.

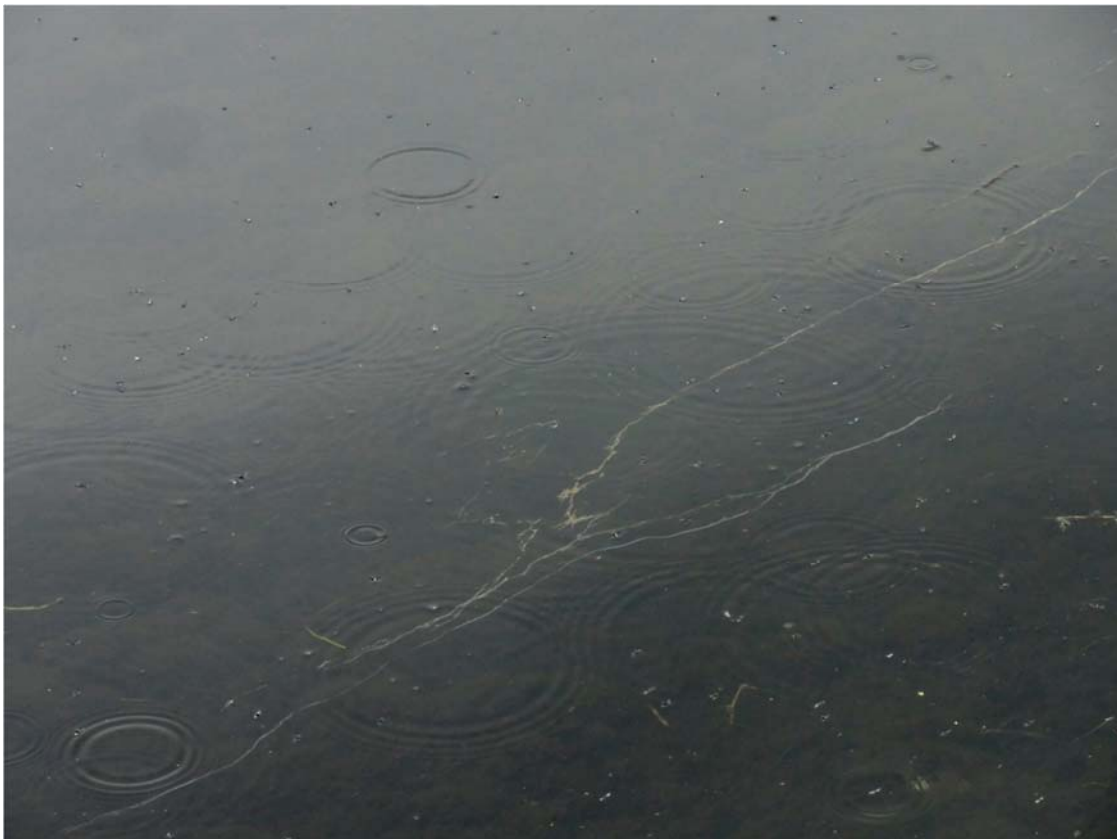
22. C0.4 Boat launch sheen observed.

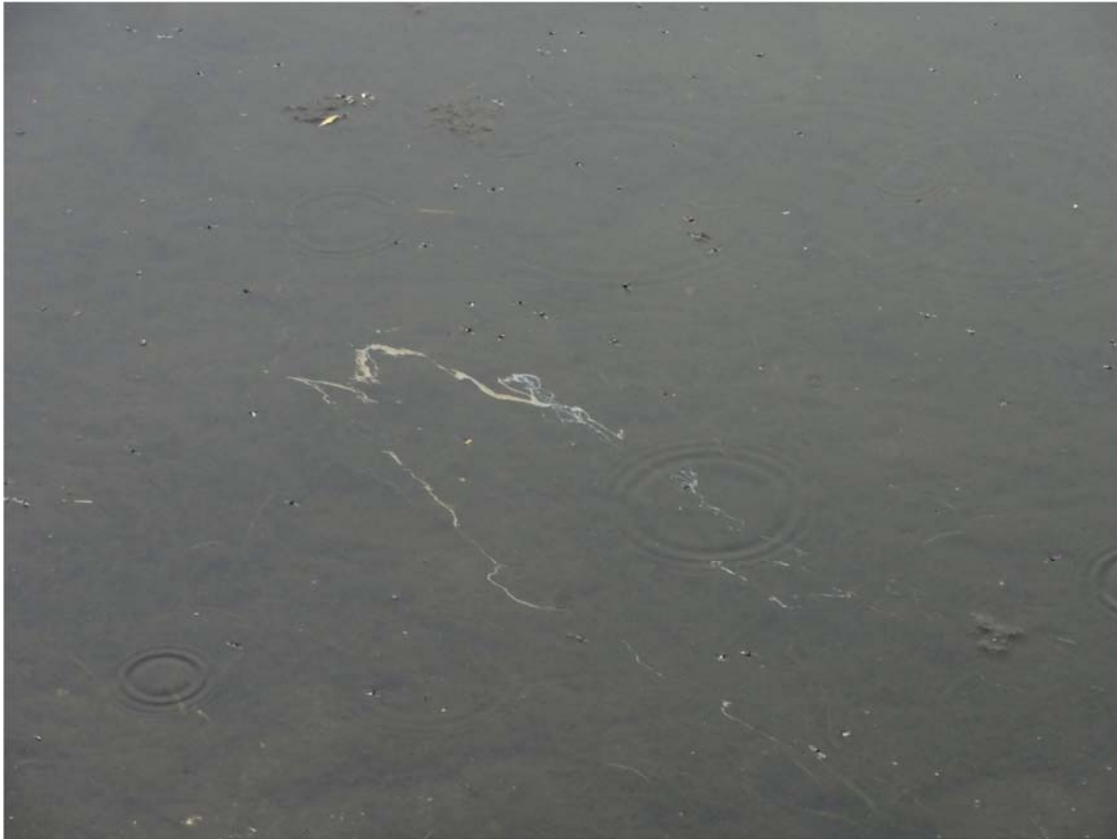
23. C0.4 Boat launch sheen observed.

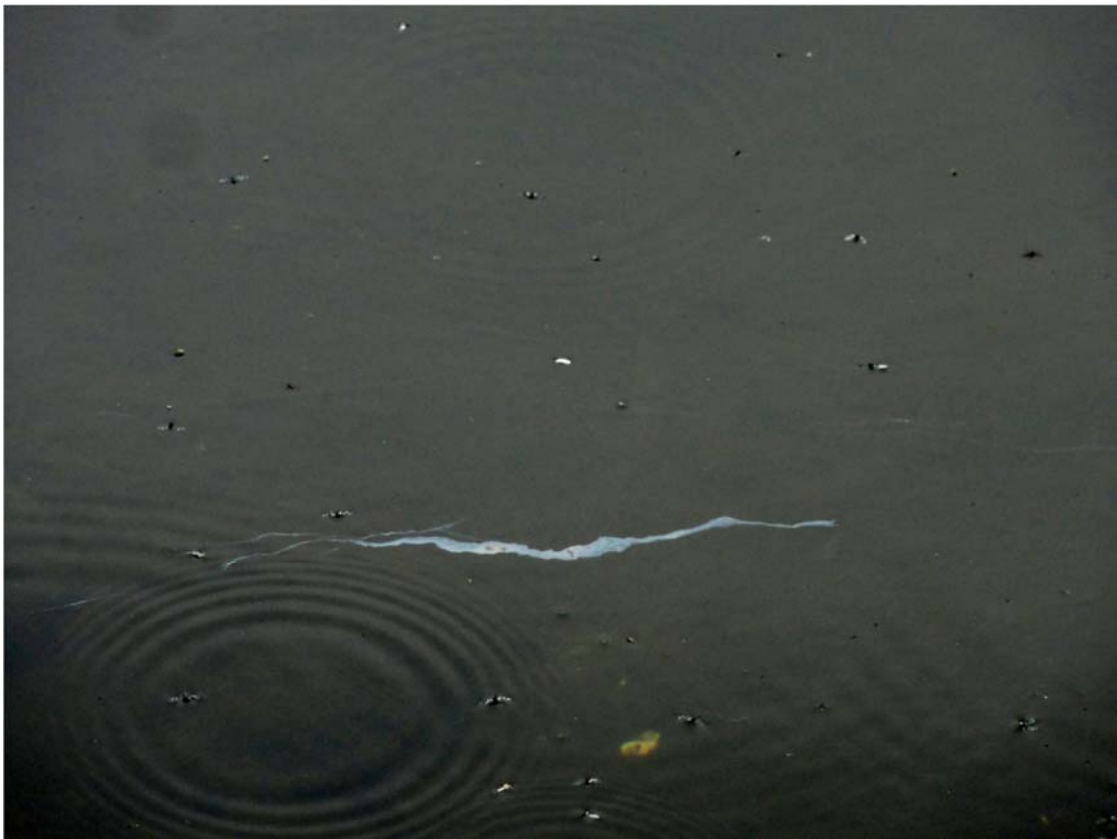
24. C0.4 Boat launch sheen observed.
