# Situation Photo Log

Thursday, May 31, 2012

Kalamazoo River / Enbridge Spill

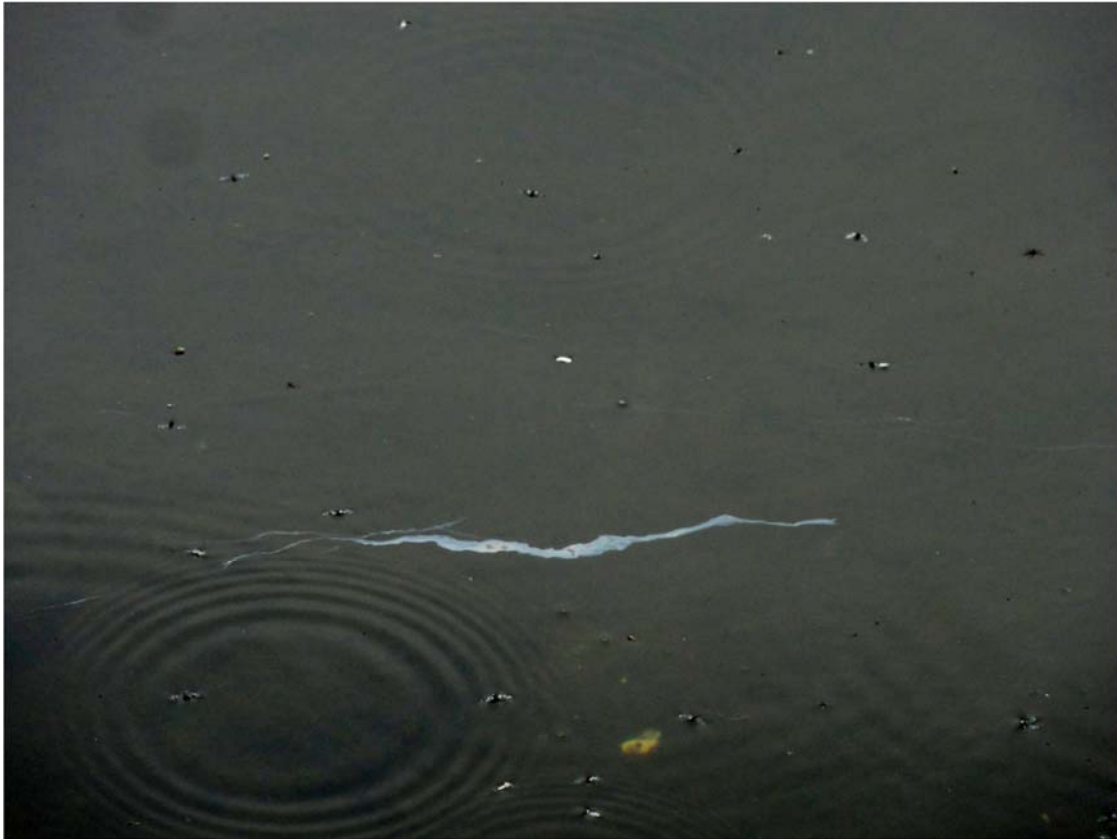
25. C0.4 Boat launch sheen observed.

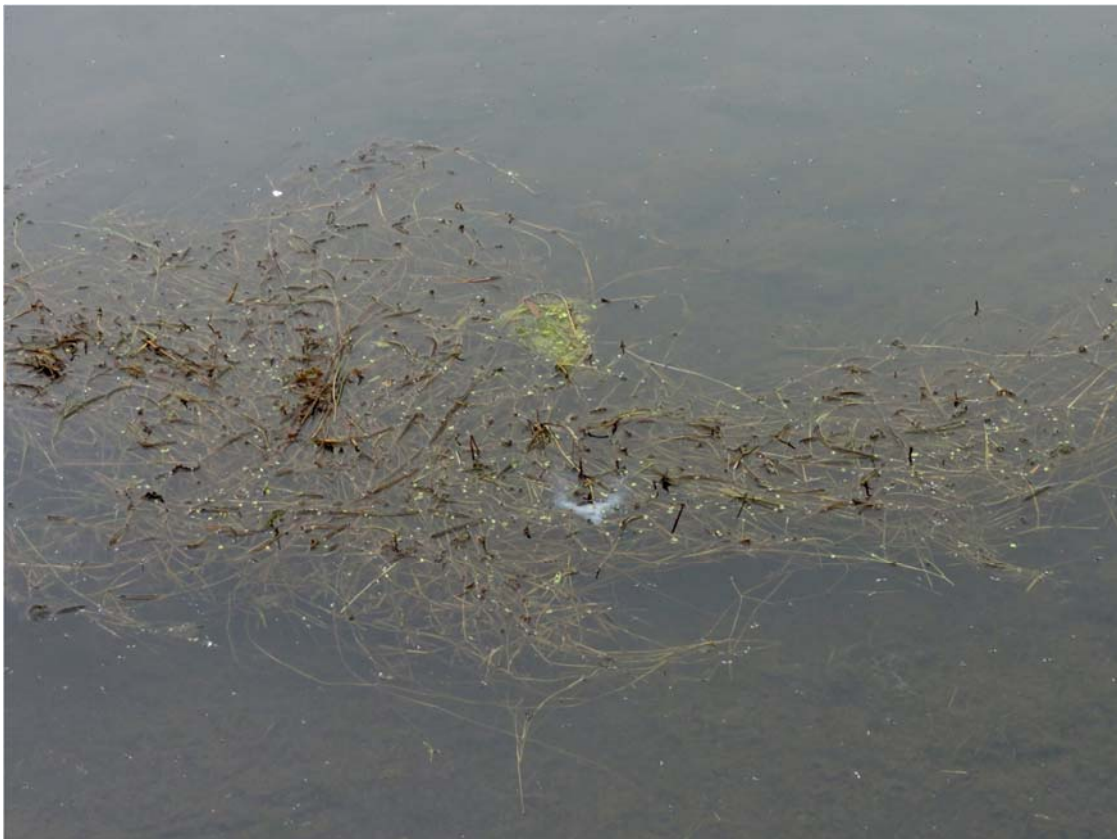
26. C0.4 Boat launch sheen observed bound in vegetation.

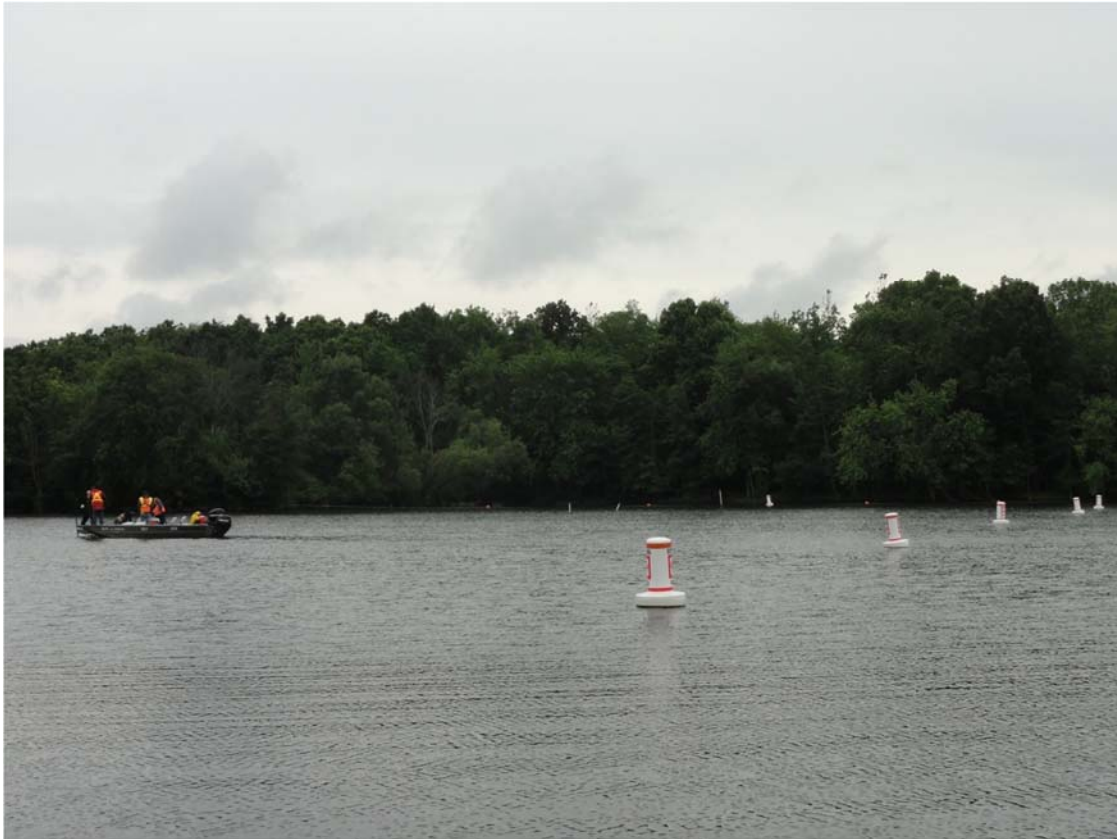
27. MP37.75 Poling crew observed just below E4 boom.

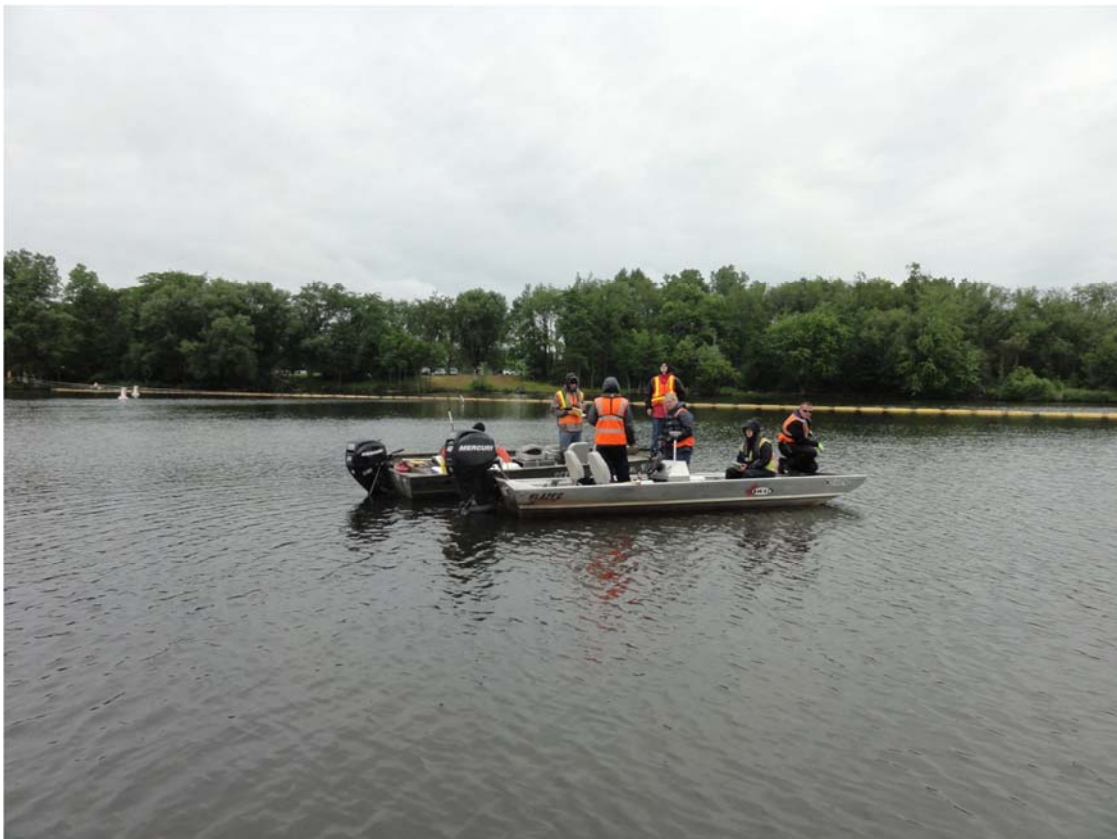
28. MP37.75 Poling crew observed just below E4 boom.

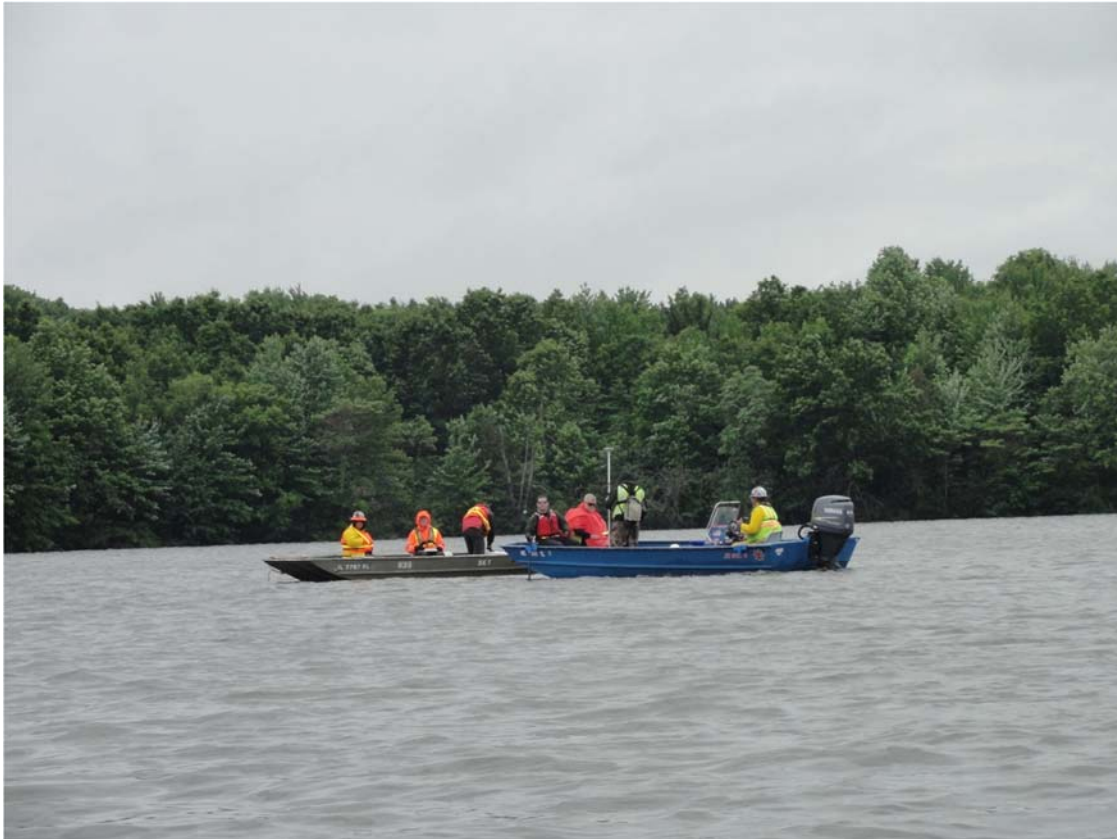
29. Morrow Lake poling crew.

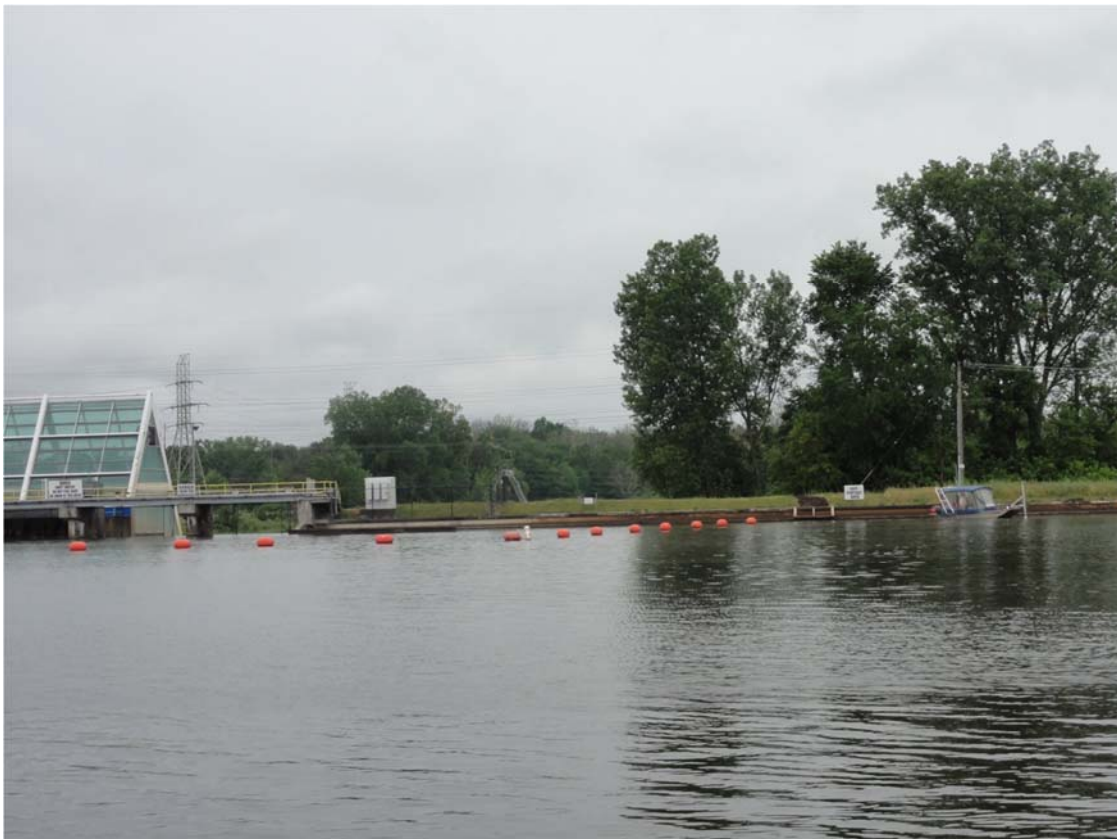
30. Morrow Lake Dam velocity study observed.

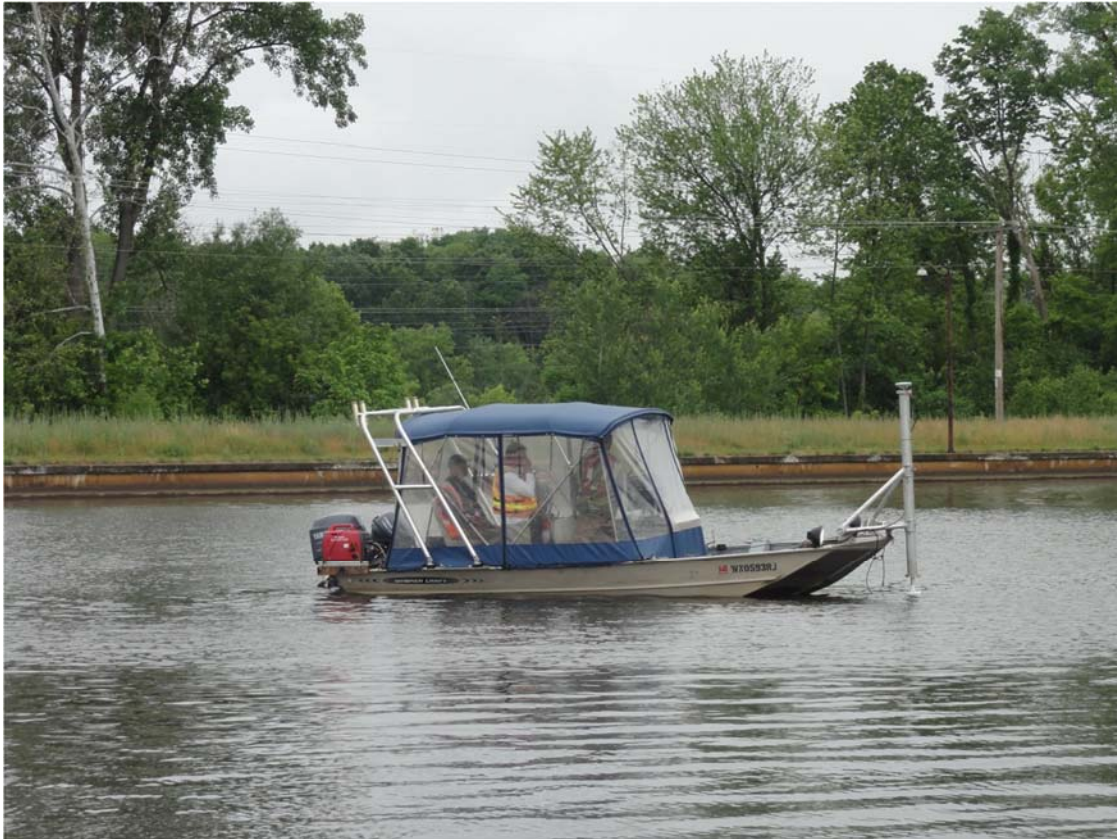
31. Morrow Lake Dam velocity study observed.

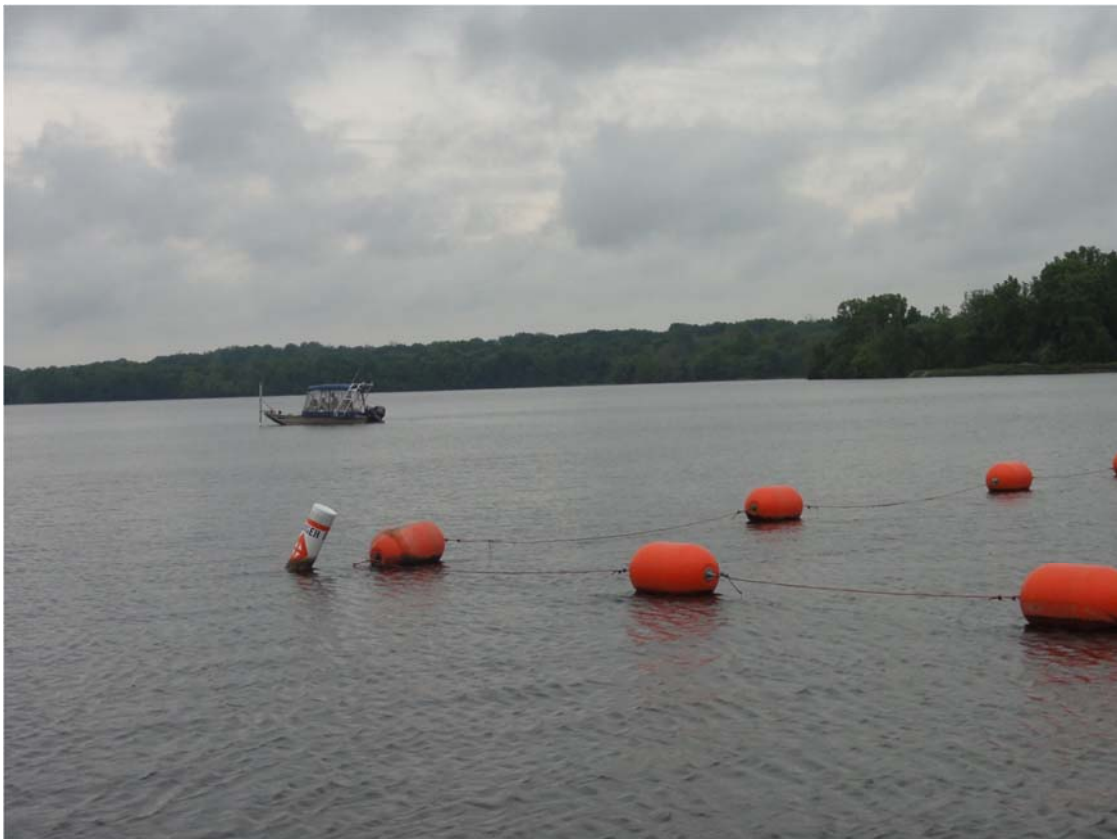
32. Morrow Lake Dam velocity study observed.

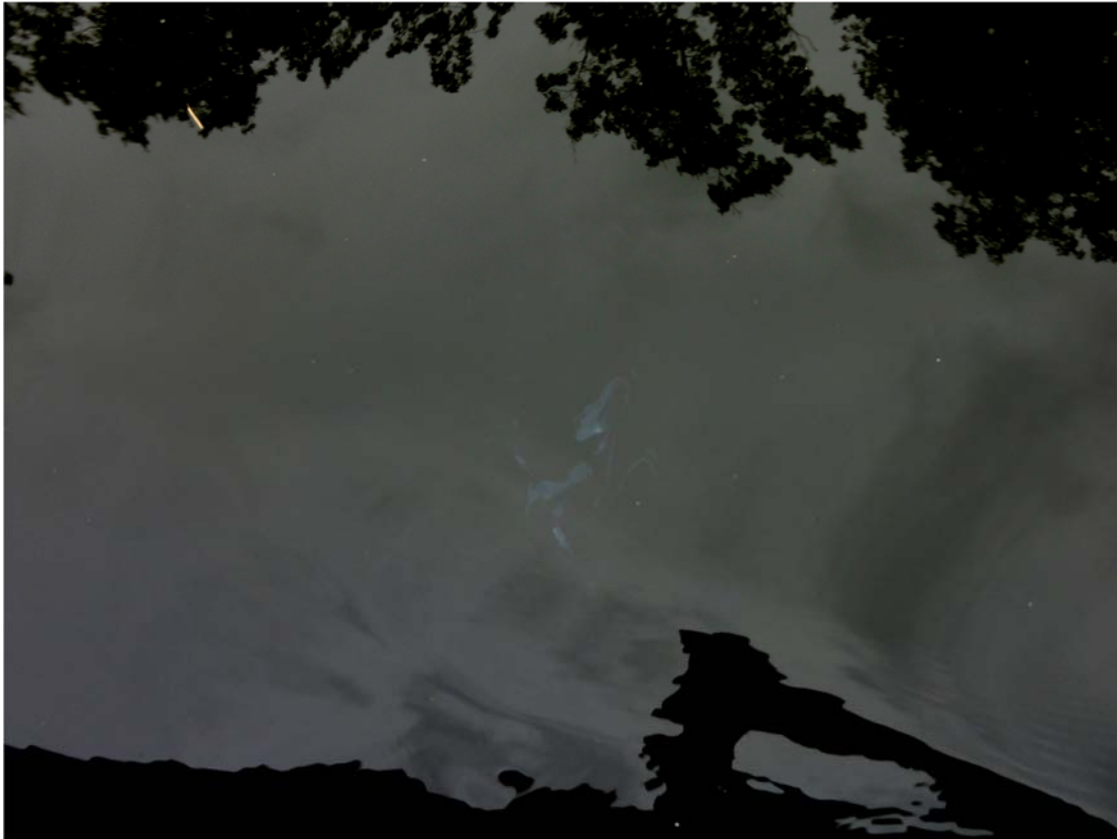
33. MP38.75 north shore Morrow Lake sheen observed.

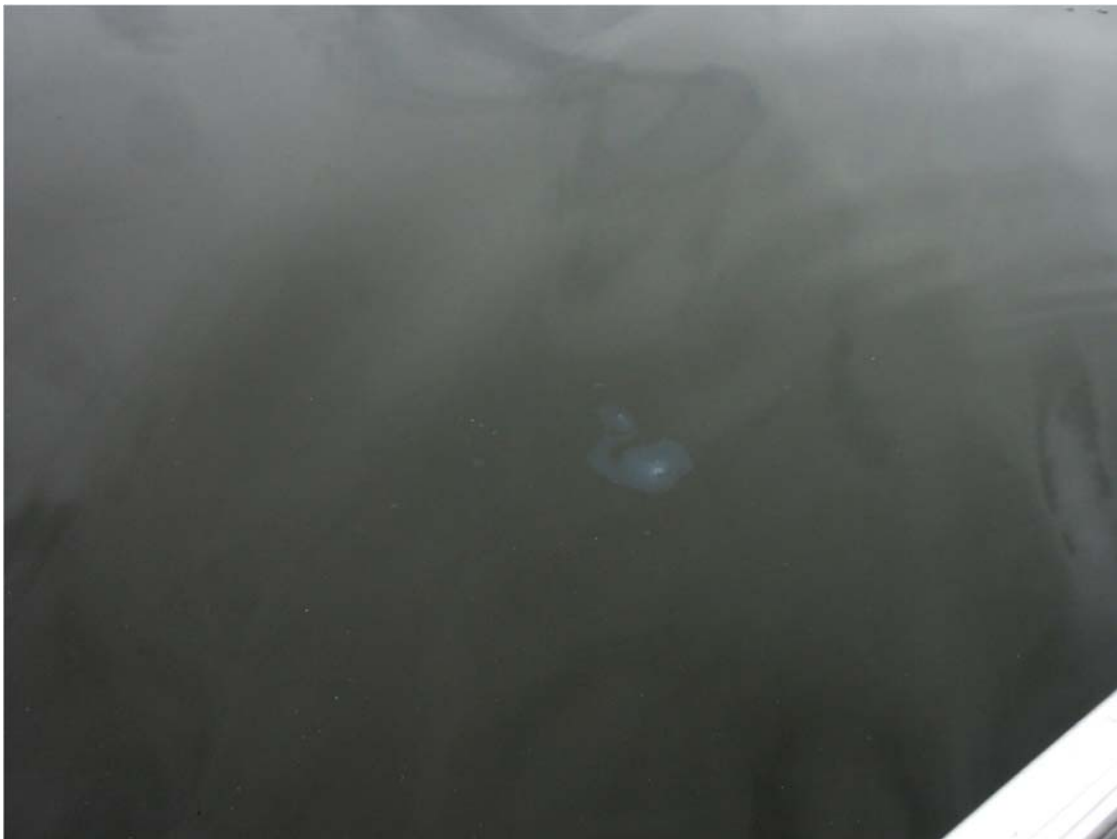
34. MP38.75 north shore Morrow Lake sheen observed.

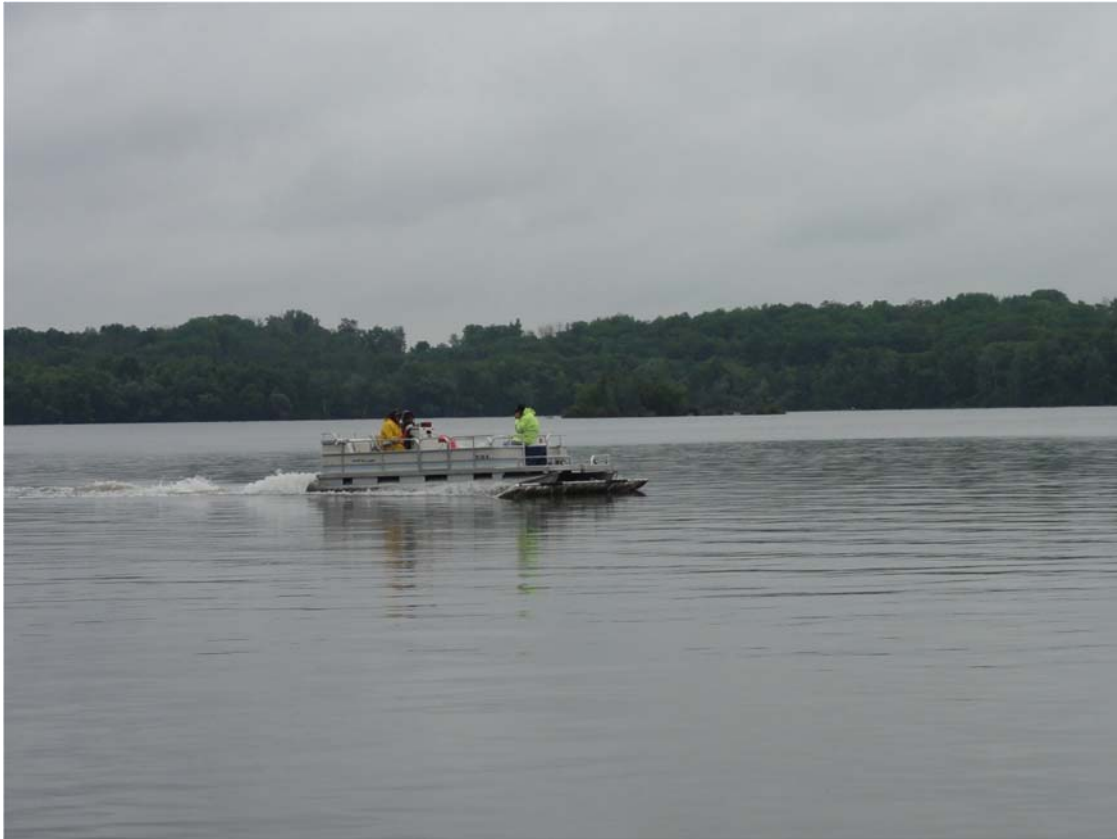
35. Morrow Lake sweep boat responding to sheen observed.

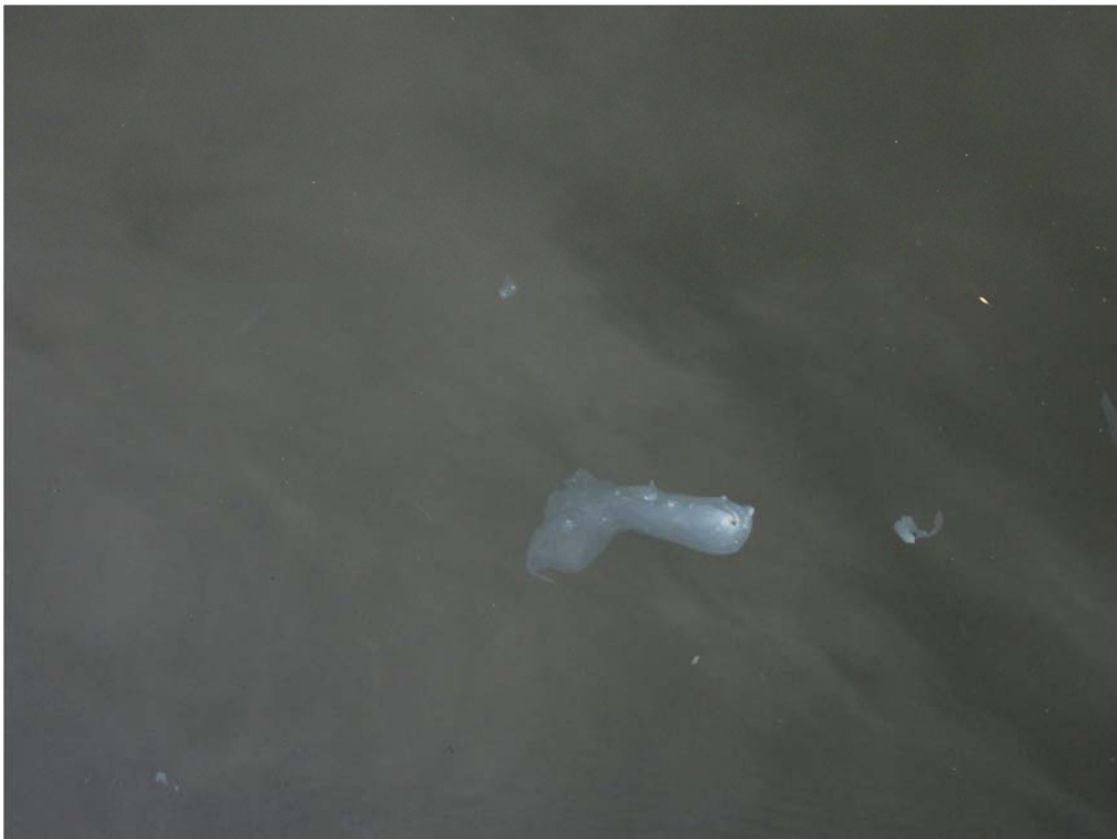
36. MP38.25 Morrow Lake sheen observed.

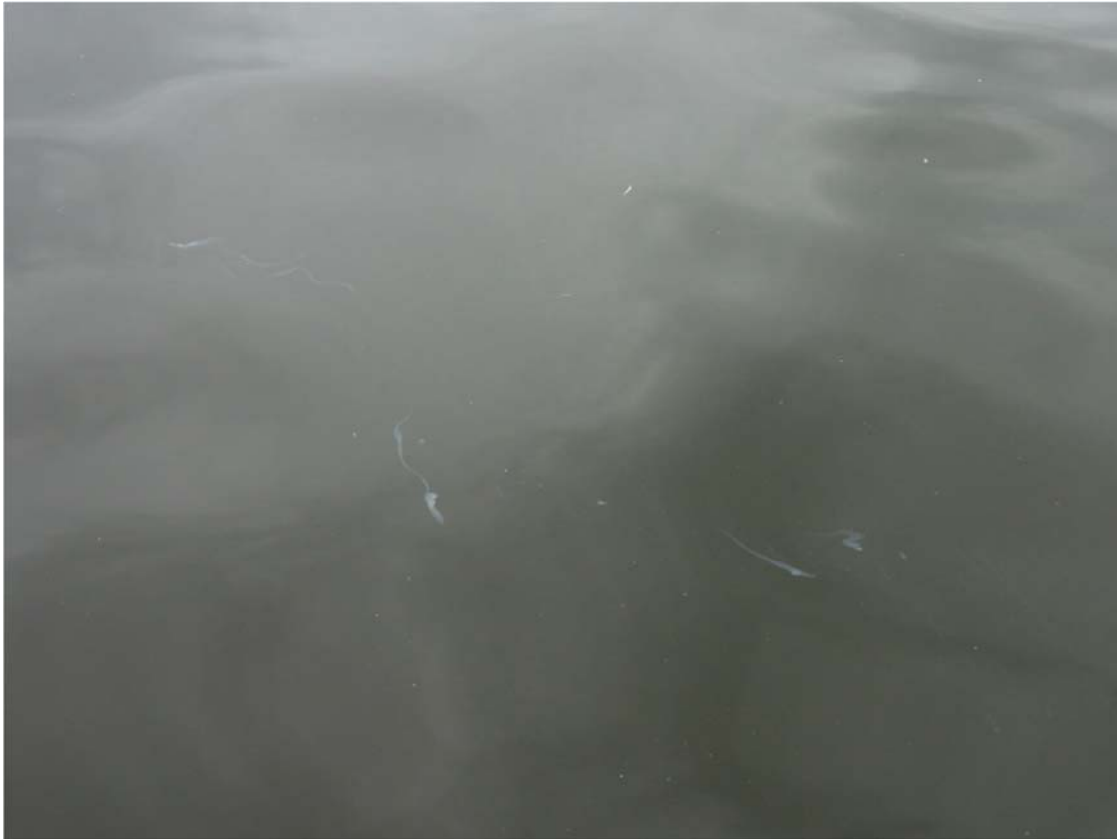
37. MP38.25 Morrow Lake sheen observed.

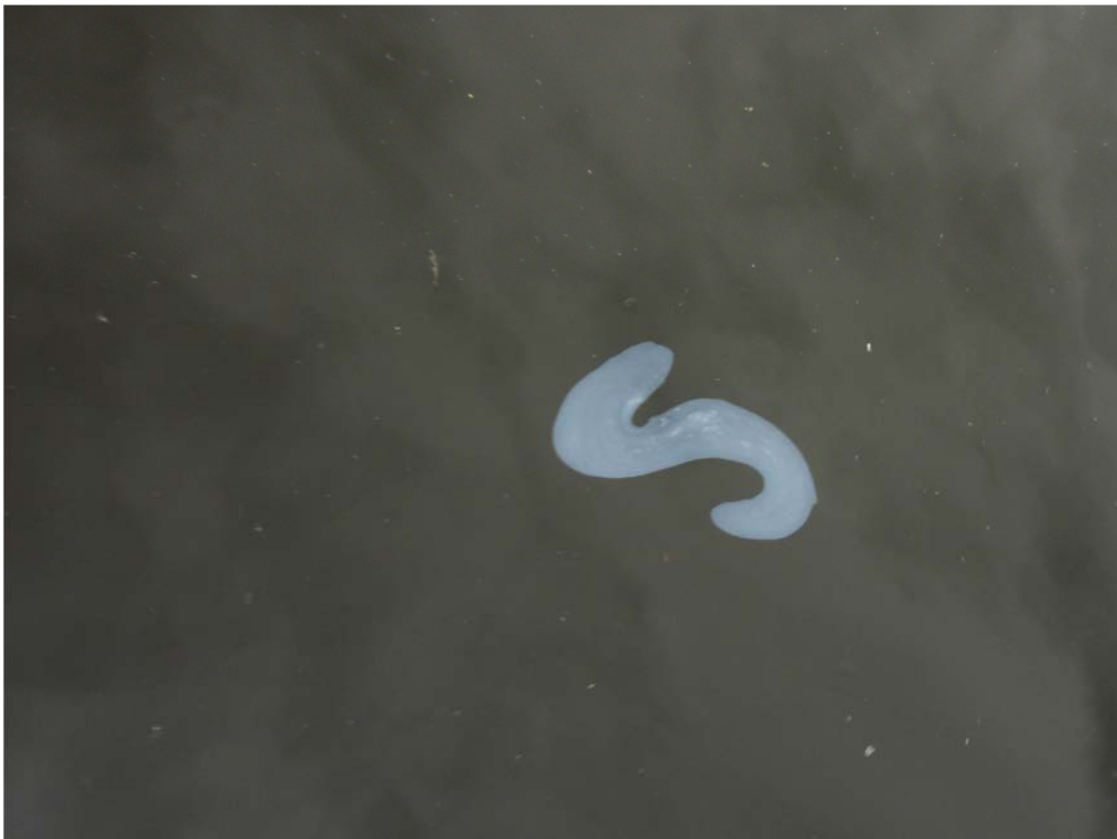
38. MP38.25 Morrow Lake sheen observed.

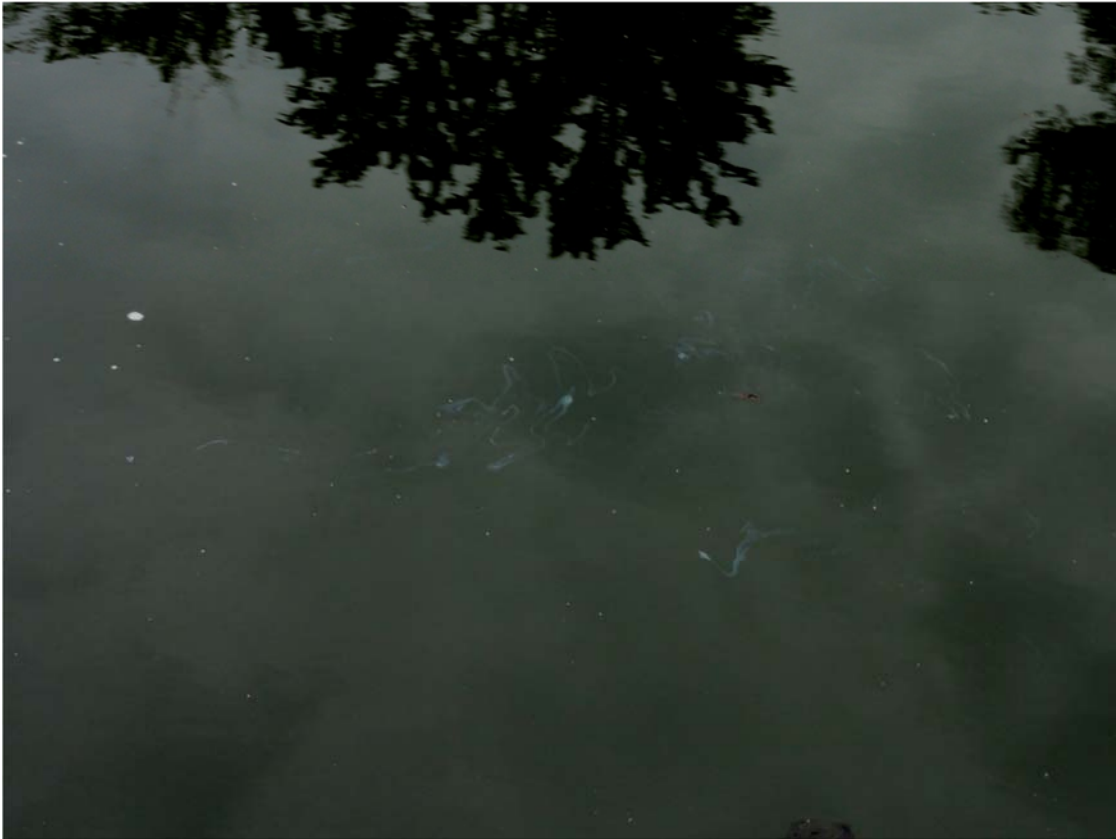
39. MP38.00 Morrow Lake north cove sheen observed.

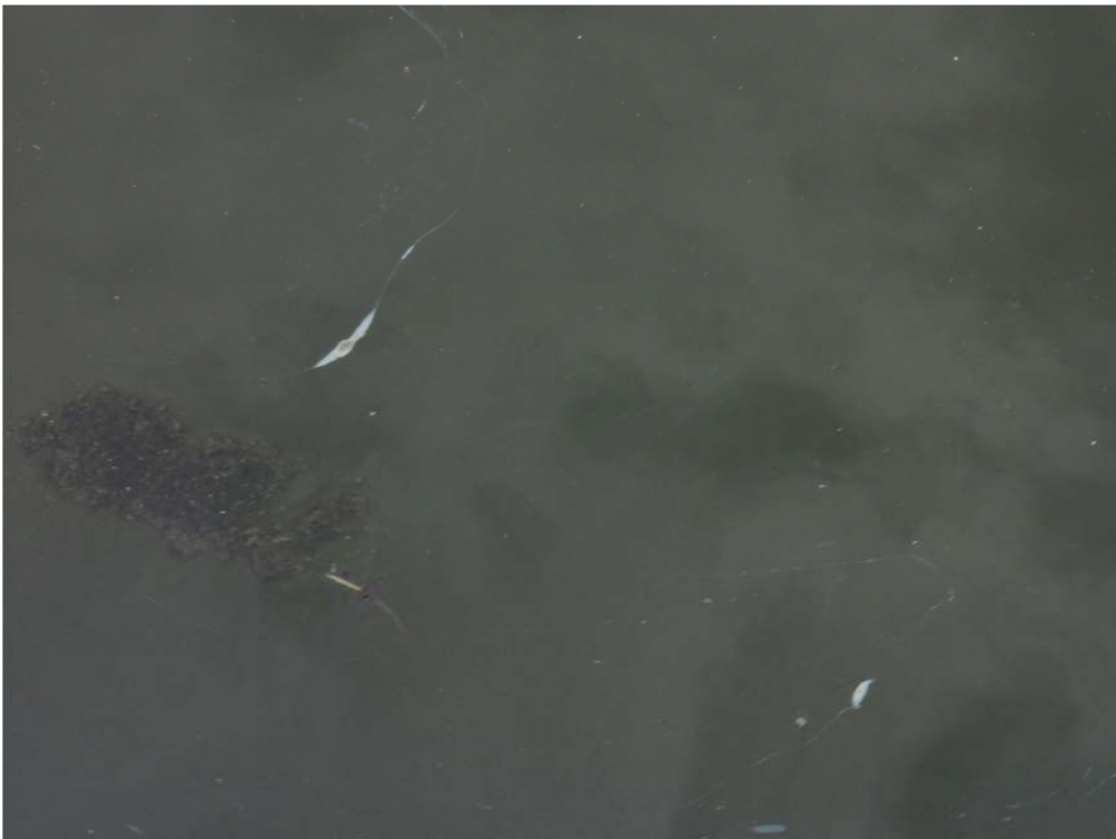
40. MP38.00 Morrow Lake north cove sheen observed.
