Situation Photo Log

Saturday, June 2, 2012

Kalamazoo River / Enbridge Spill

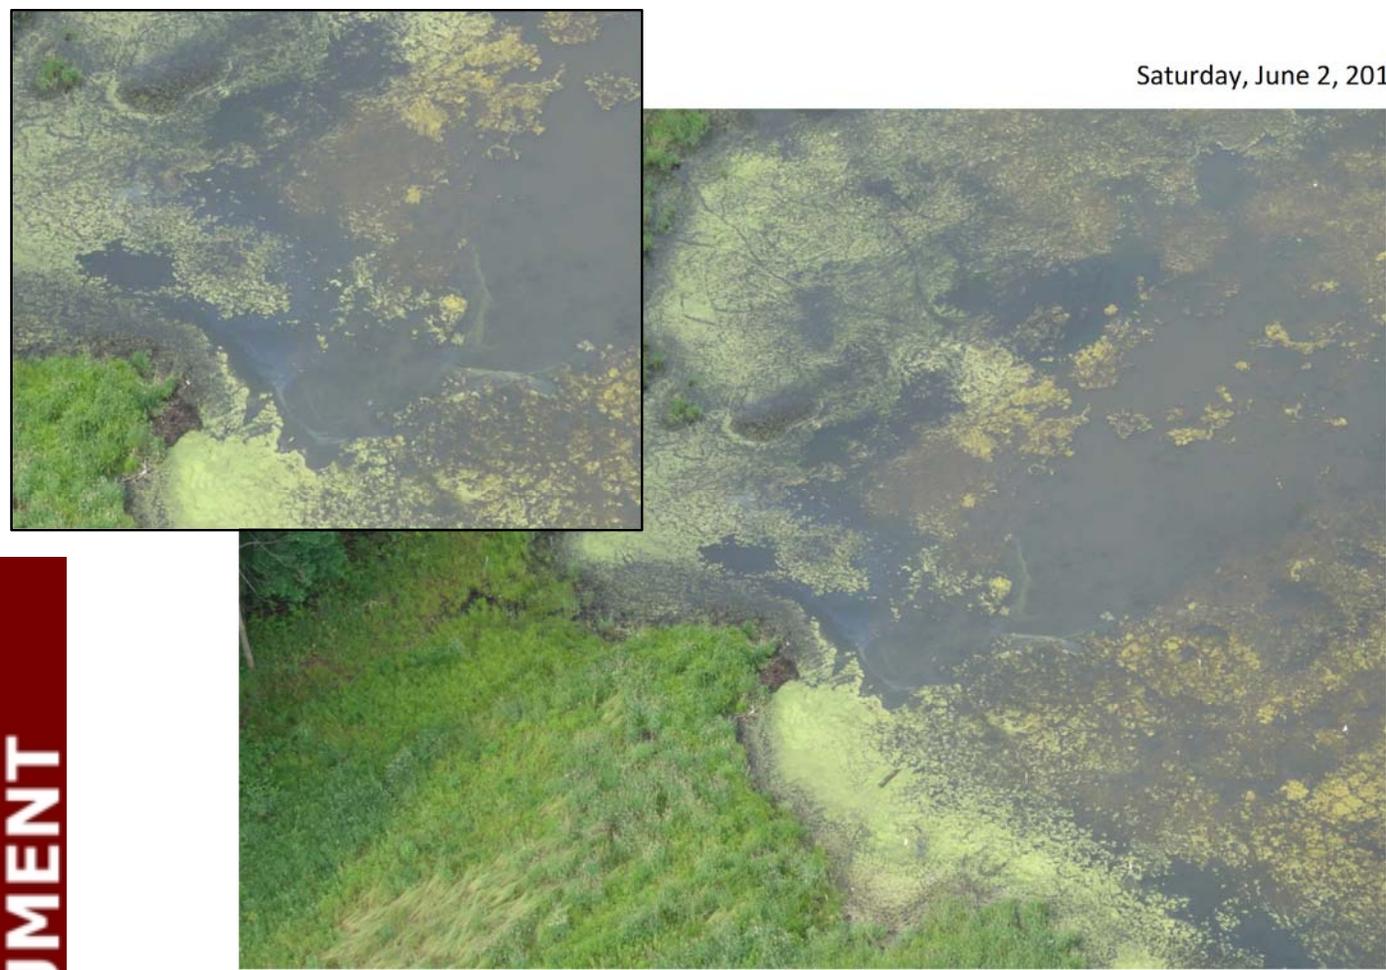
1. Source area pond, sheen observed.

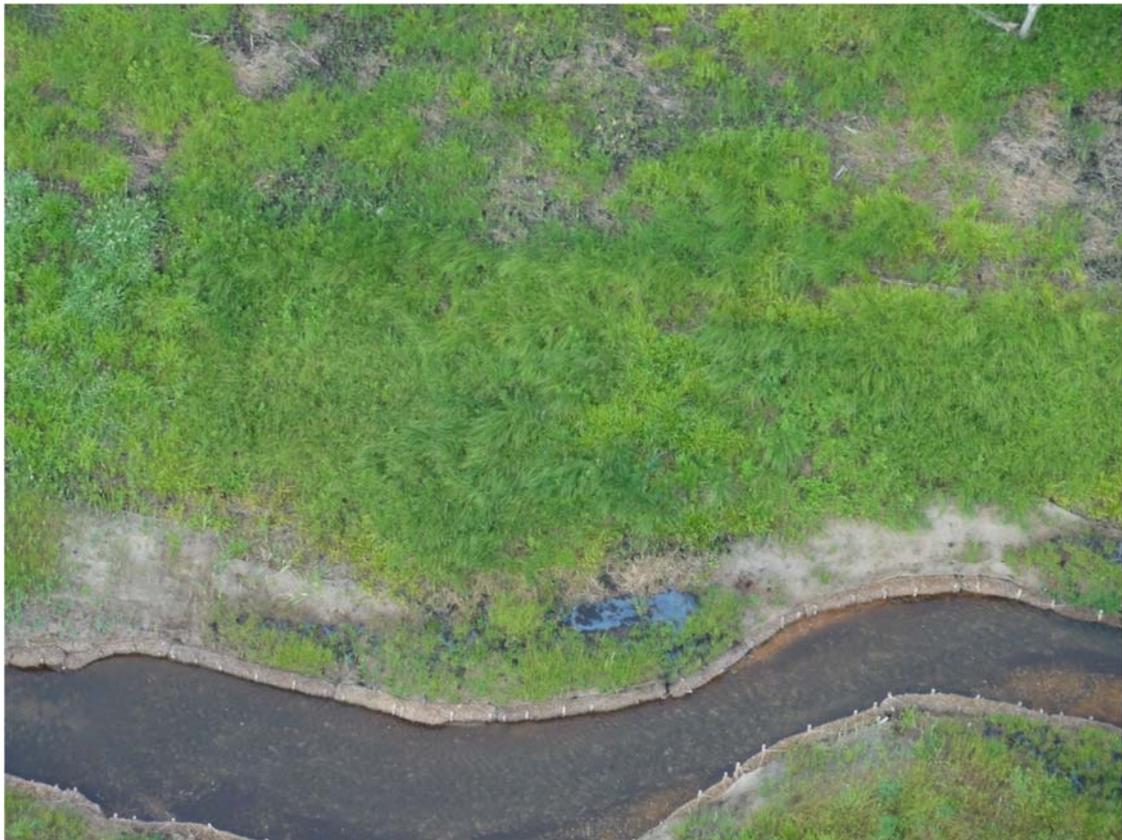
2. MP0.6 LDB Talmadge Creek sheen observed.

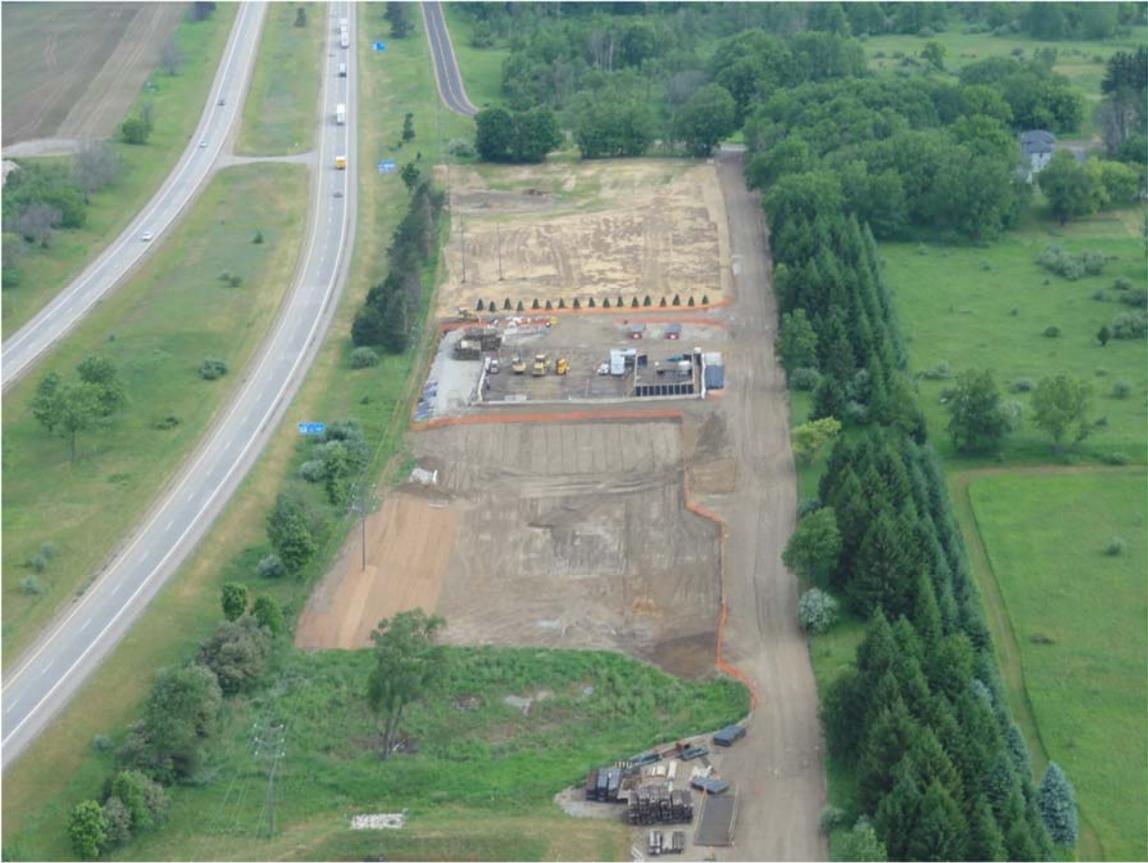
3. Frac-Tank City, footprint reduction continues.

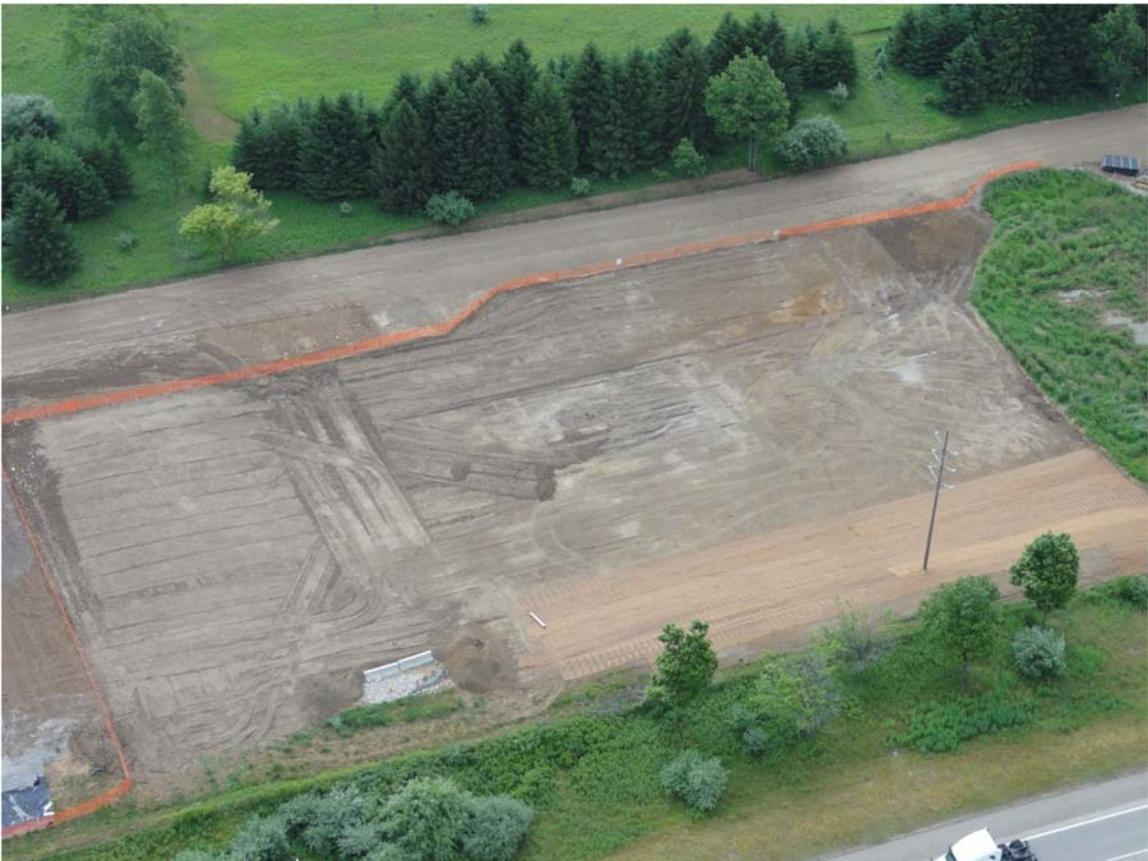
4. Frac-Tank City, footprint reduction continues.

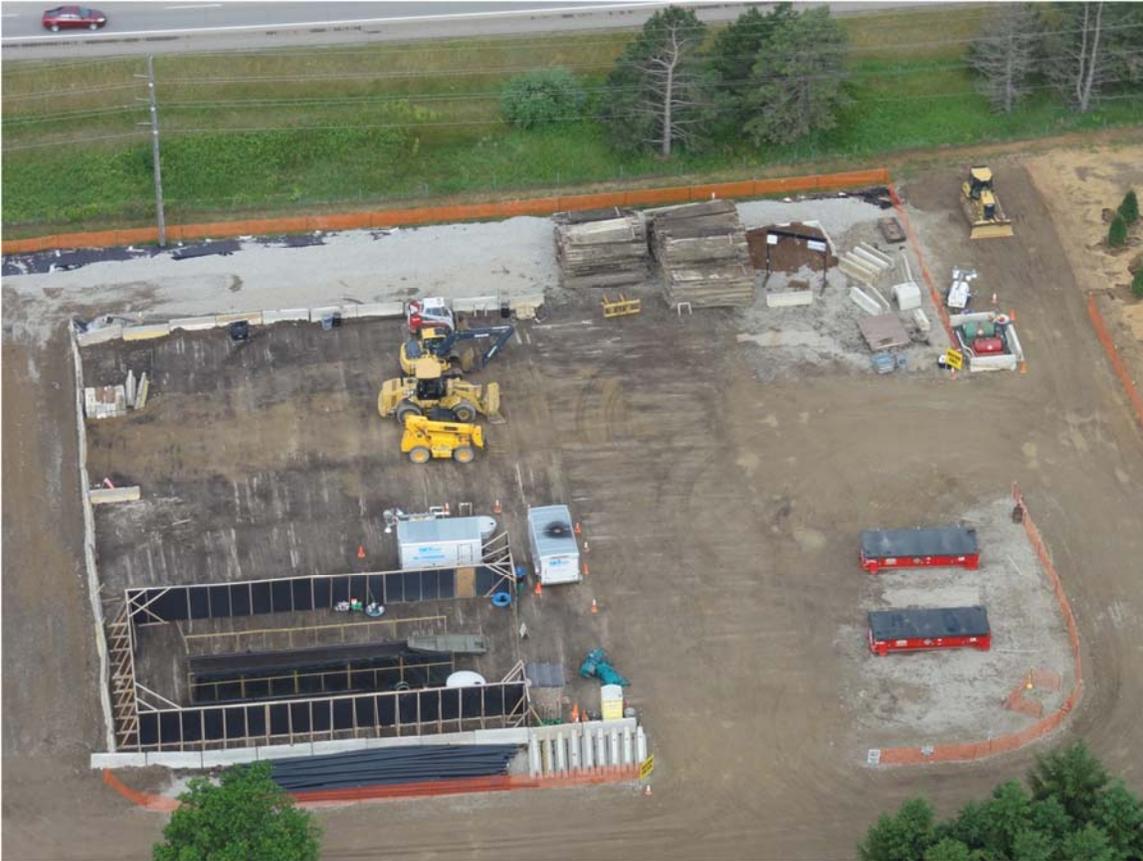
5. Frac-Tank City, decon pad no activity observed.

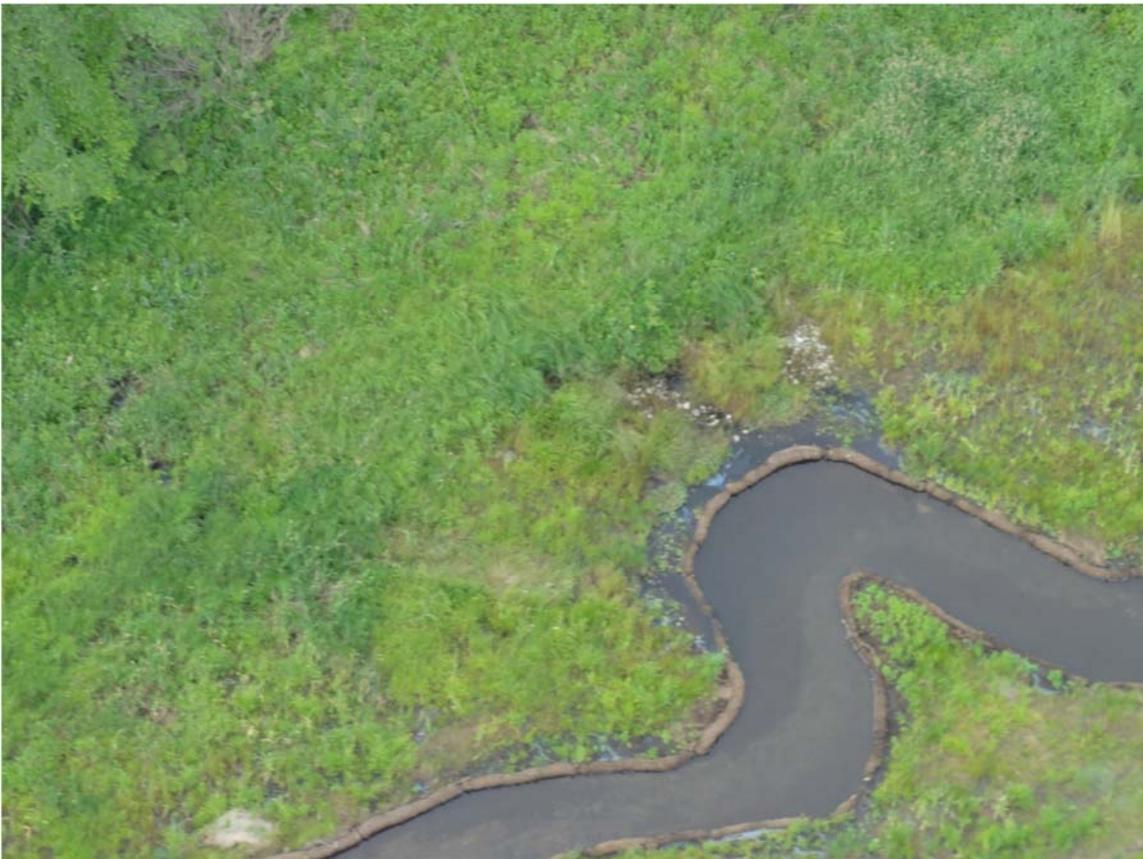
6. MP1.1 Just west of I-69 Talmadge Creek LDB sheen observed.

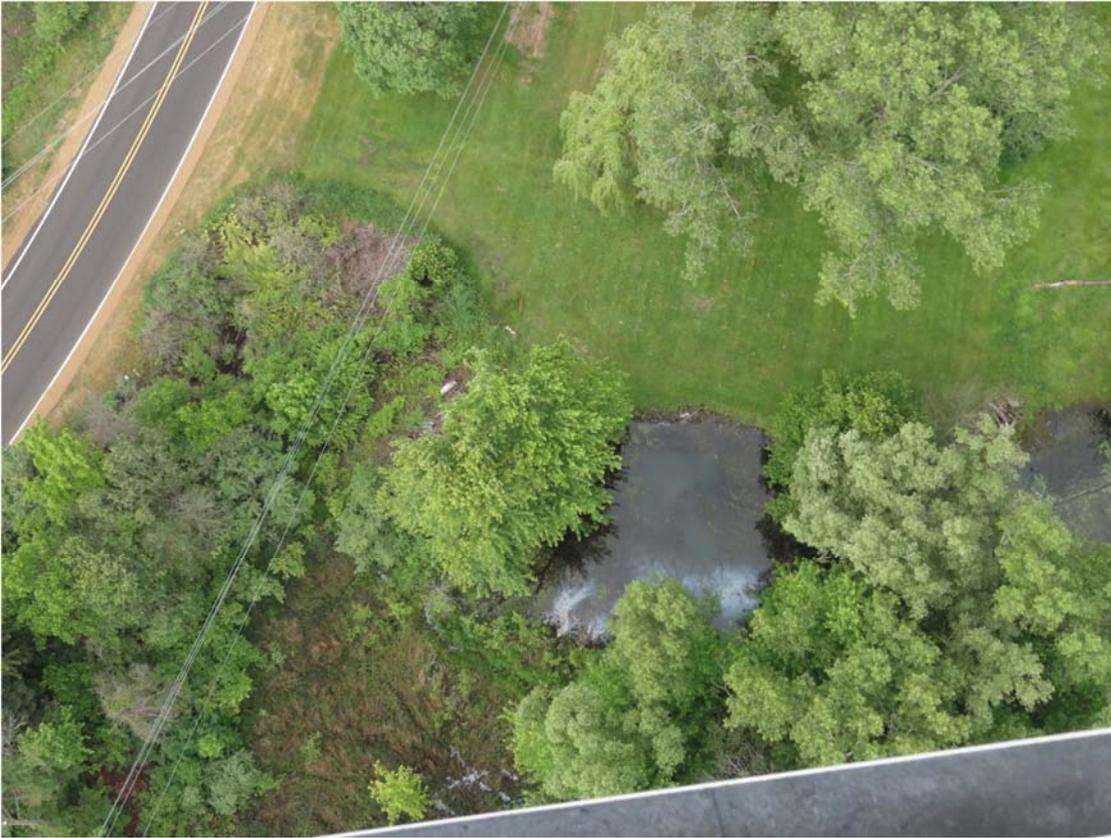
7. Pond east of confluence sheen observed.

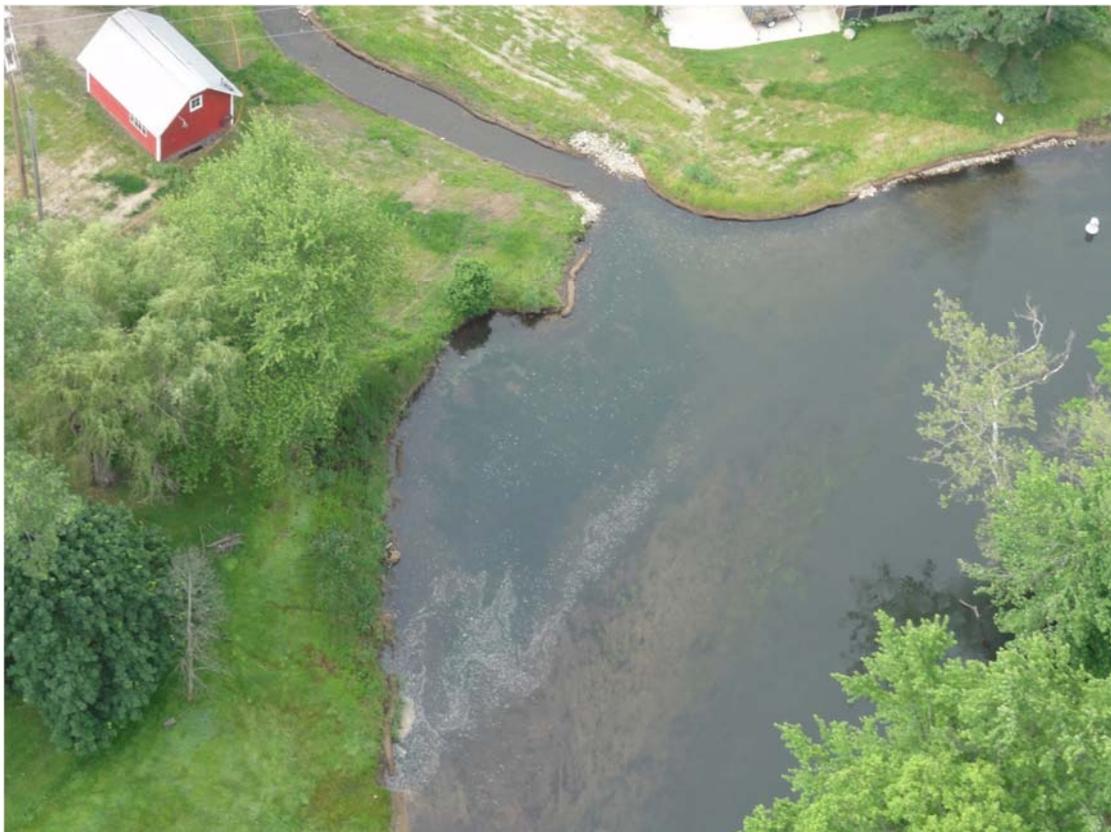
8. Confluence, no sheen observed.

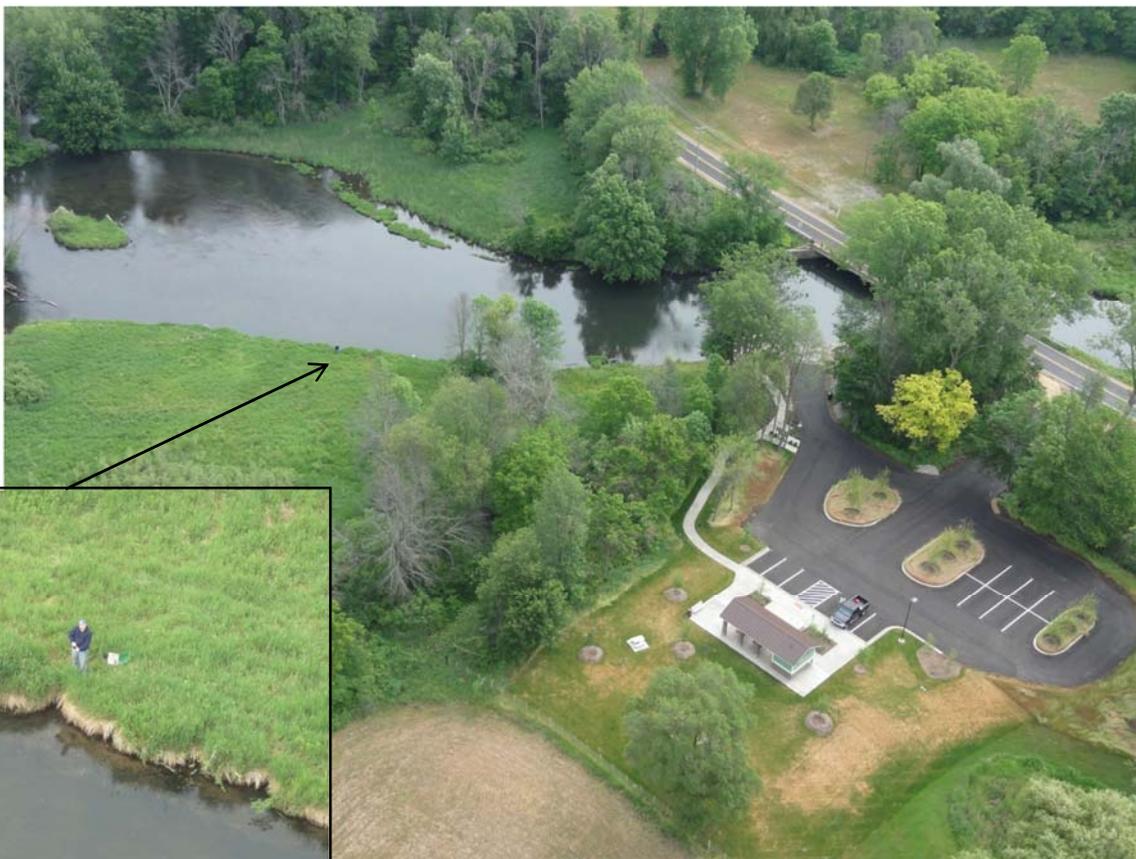
9. Saylor's Landing observed public fishing.

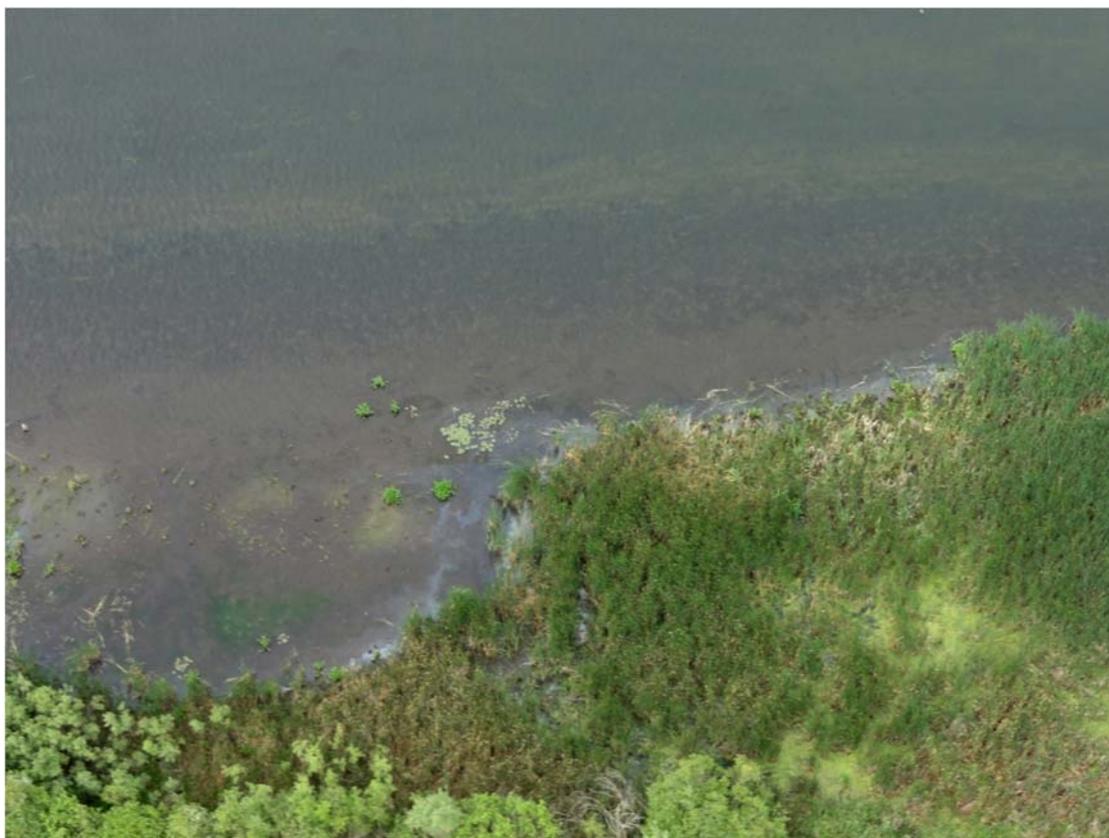
10. MP5.0 RDB sheen observed.

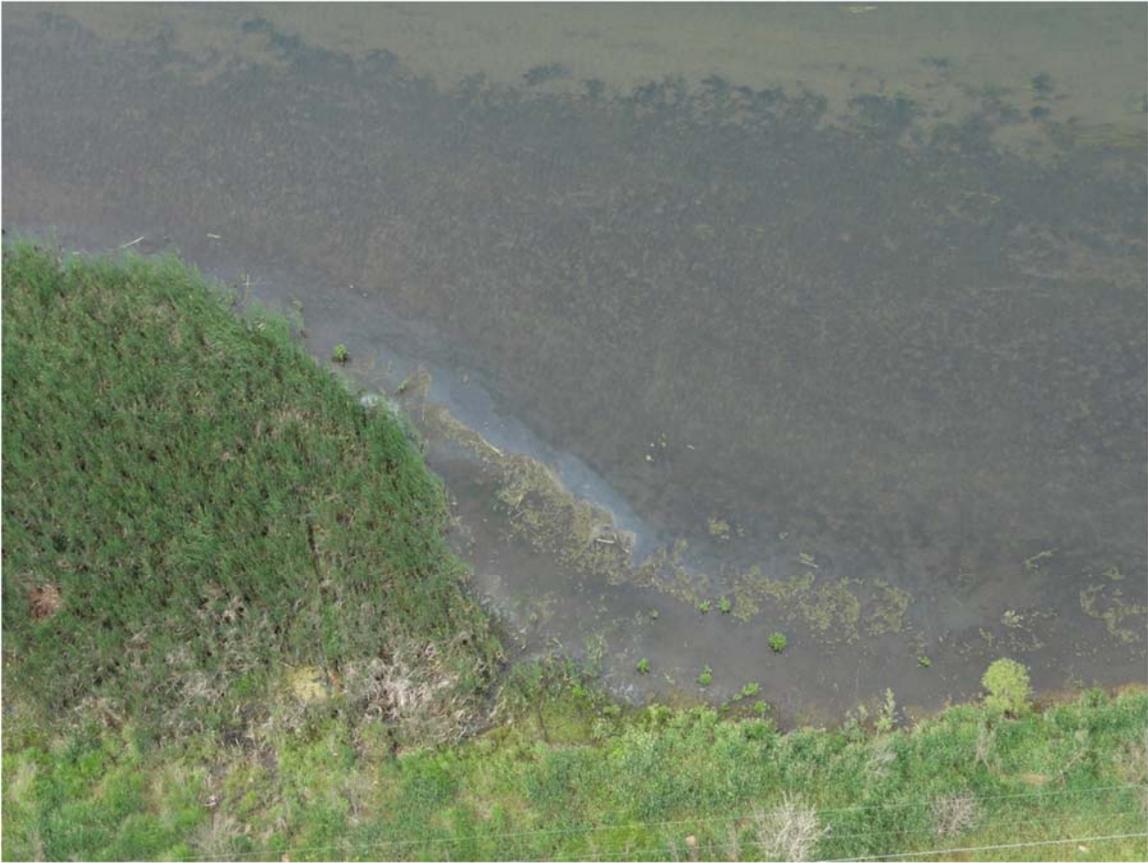
11. MP5.0 RDB sheen observed.

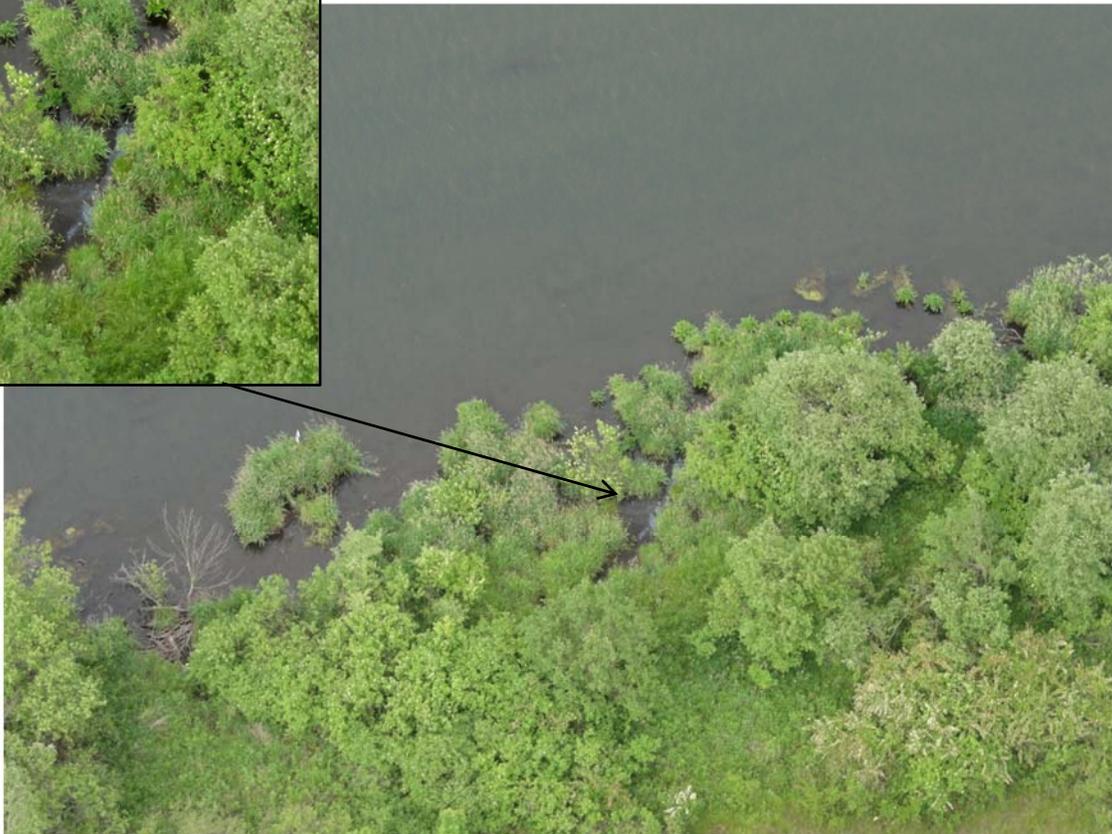
12. MP5.25 RDB sheen observed.

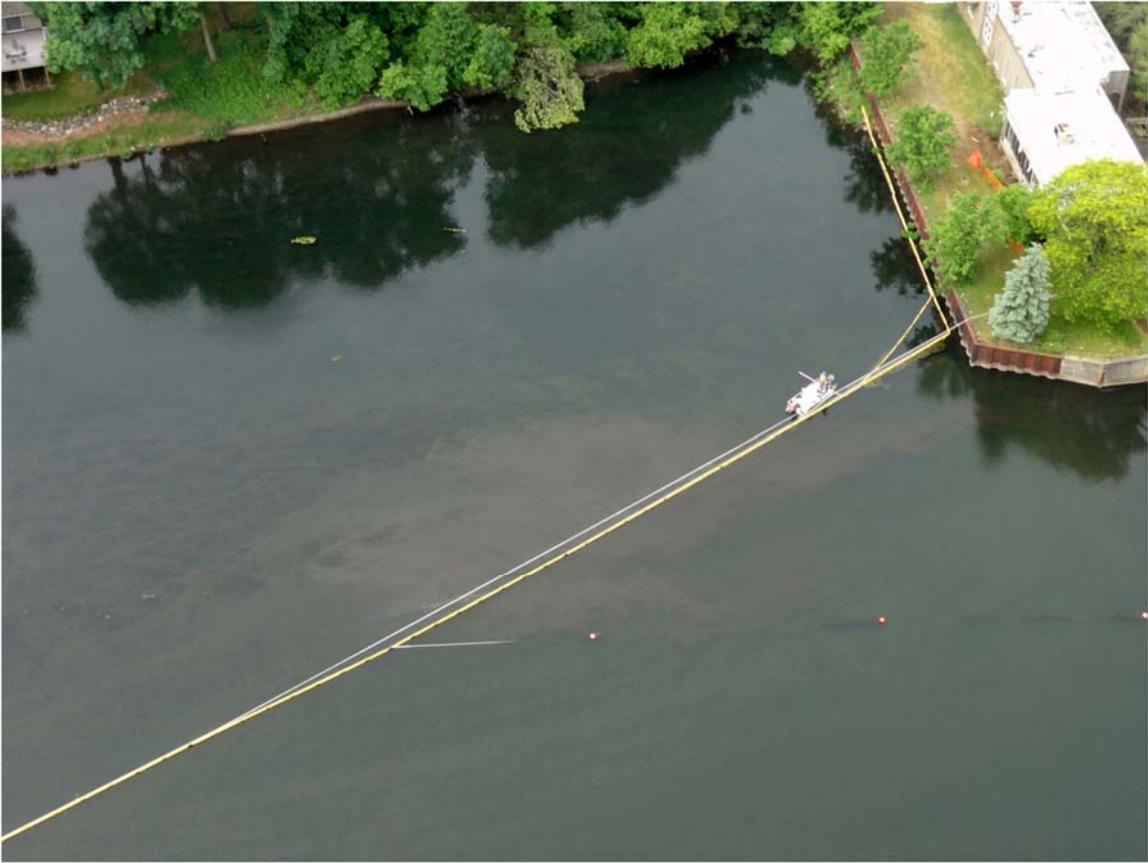
13. Ceresco Dam observed crew performing boom maintenance.

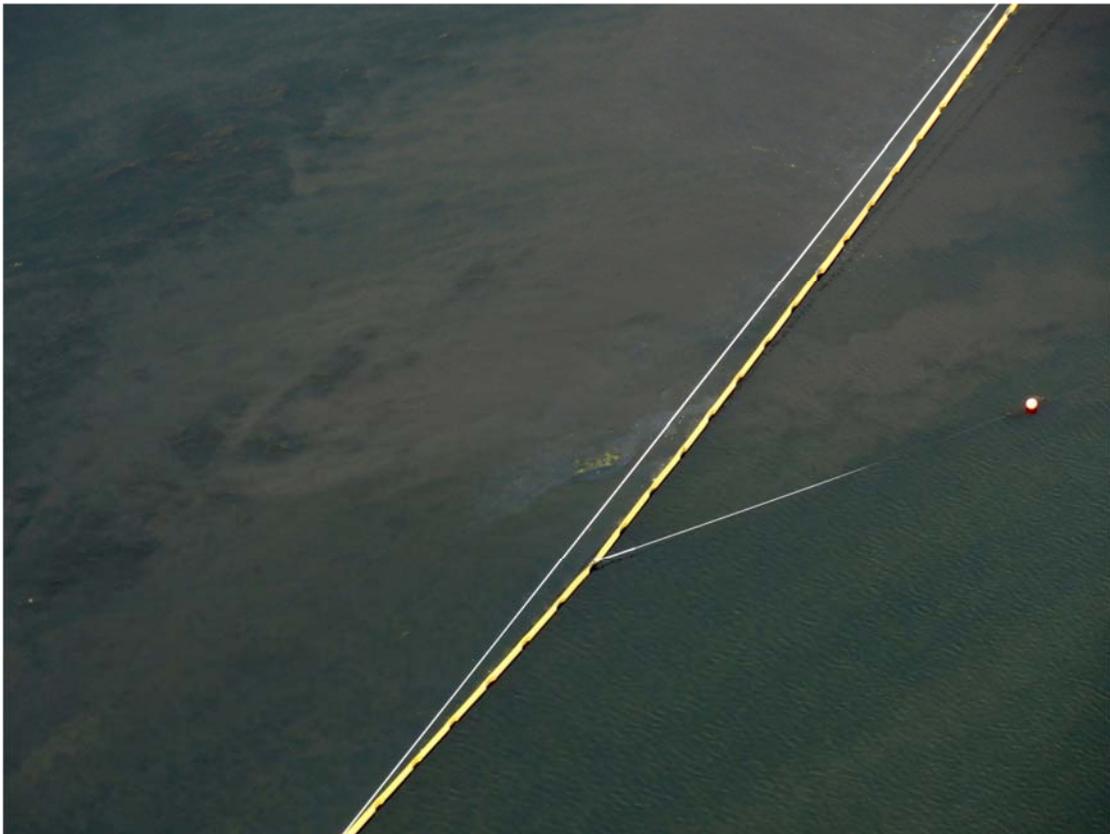
14. Ceresco Dam sheen observed.

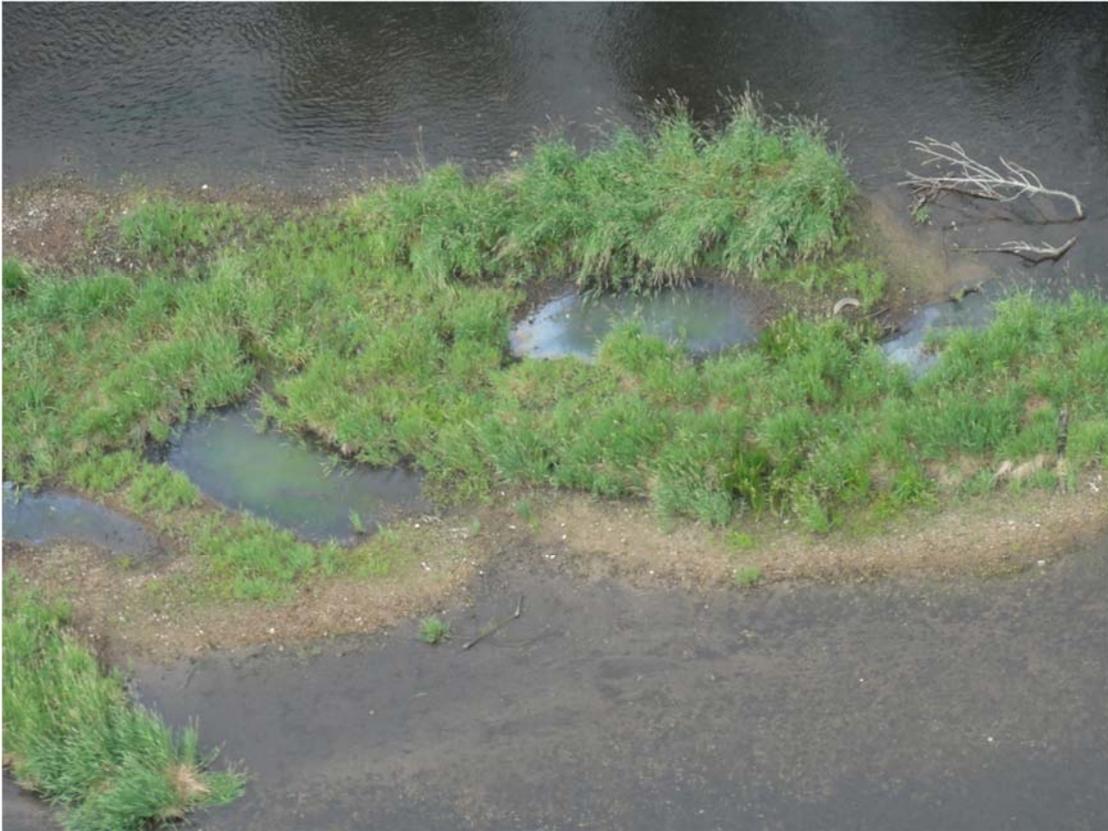
15. MP7.5 Island sheen observed.

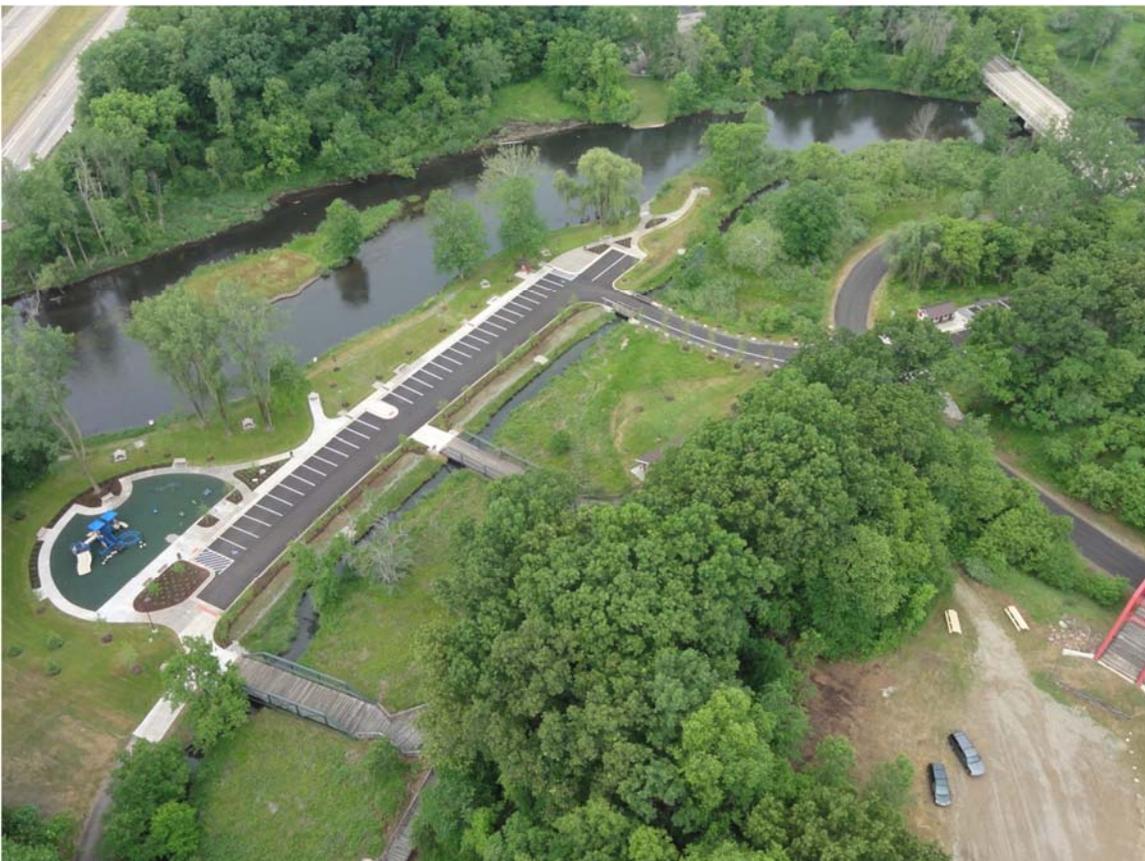
16. Historic Bridge Park opened to the public.

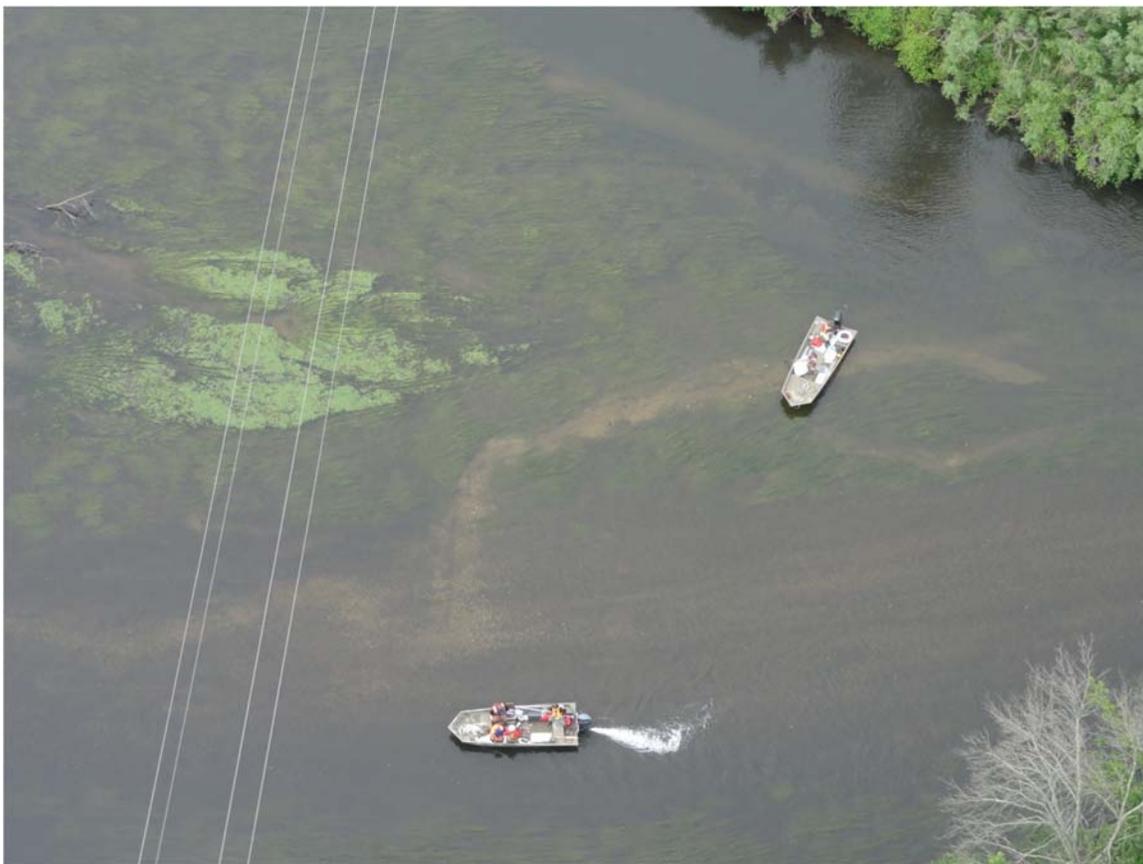
17. MP10.0 Poling crew observed.

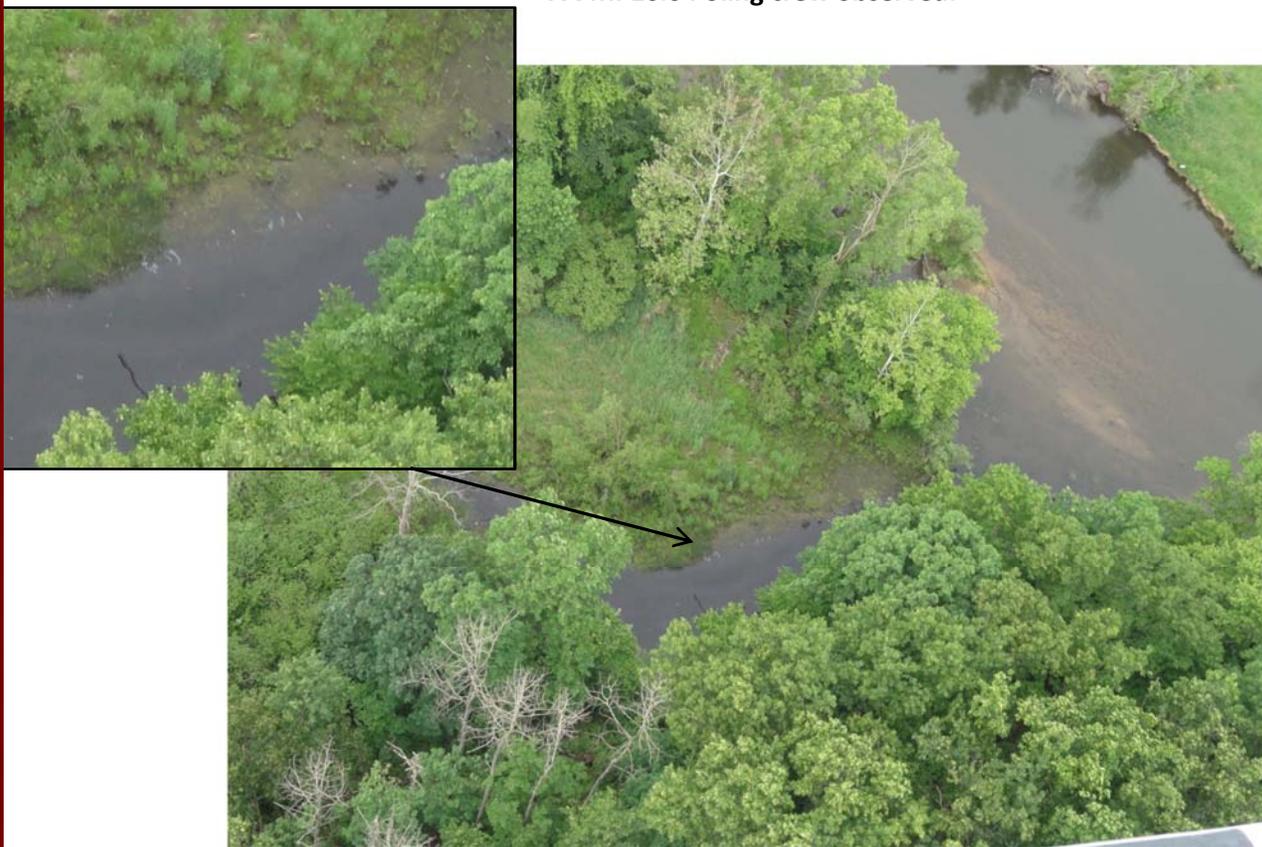
18. MP10.75RDB sheen observed.

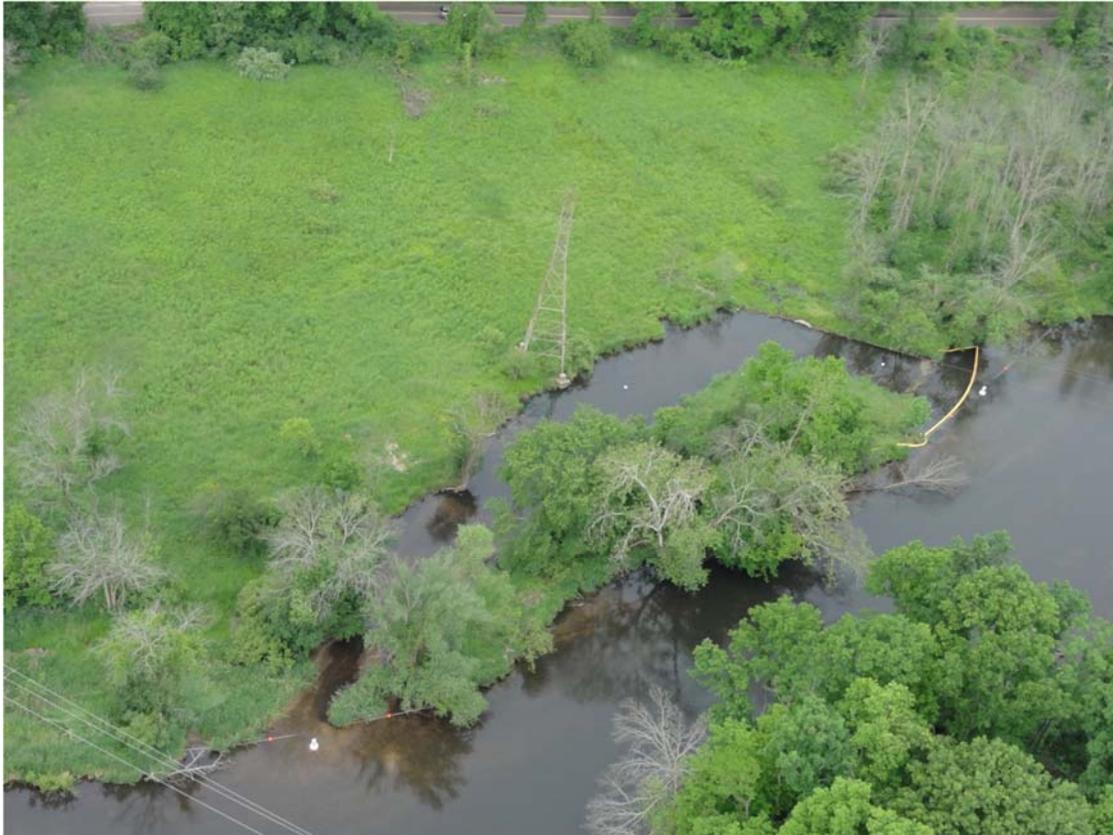
19. MP10.75 Sediment Control Structure.

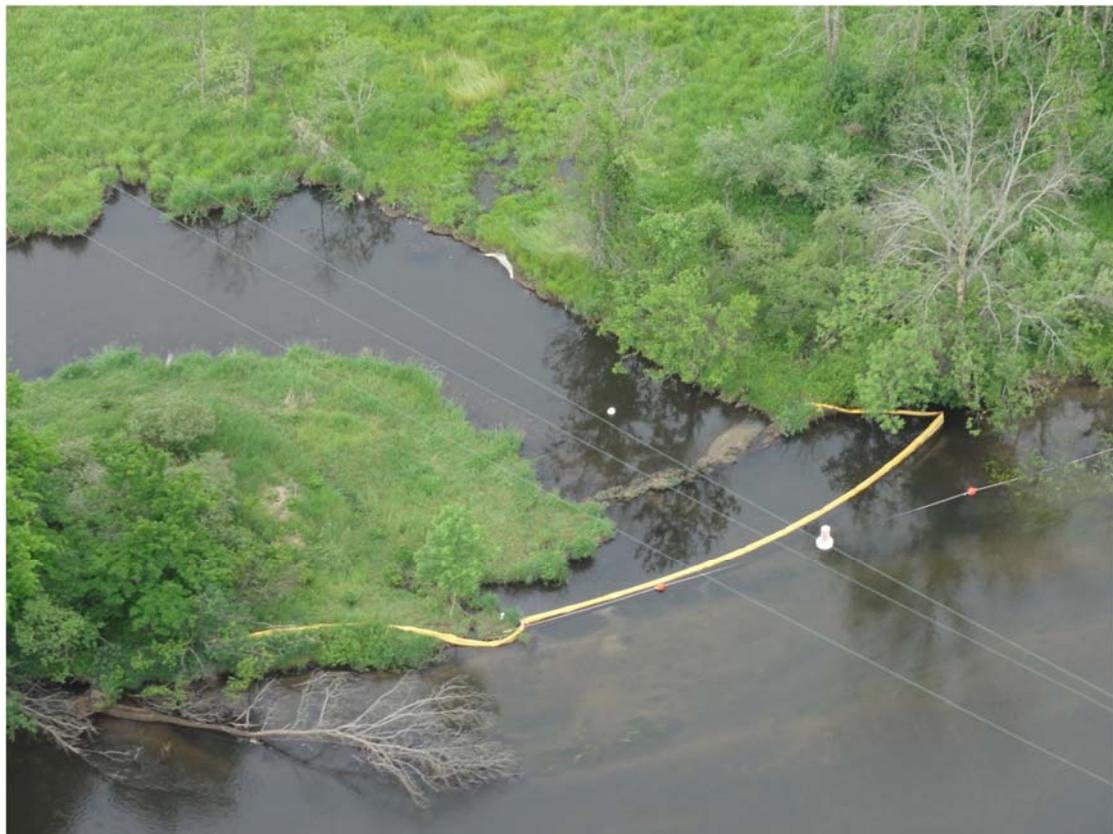
20. MP10.75 Sediment Control Structure.

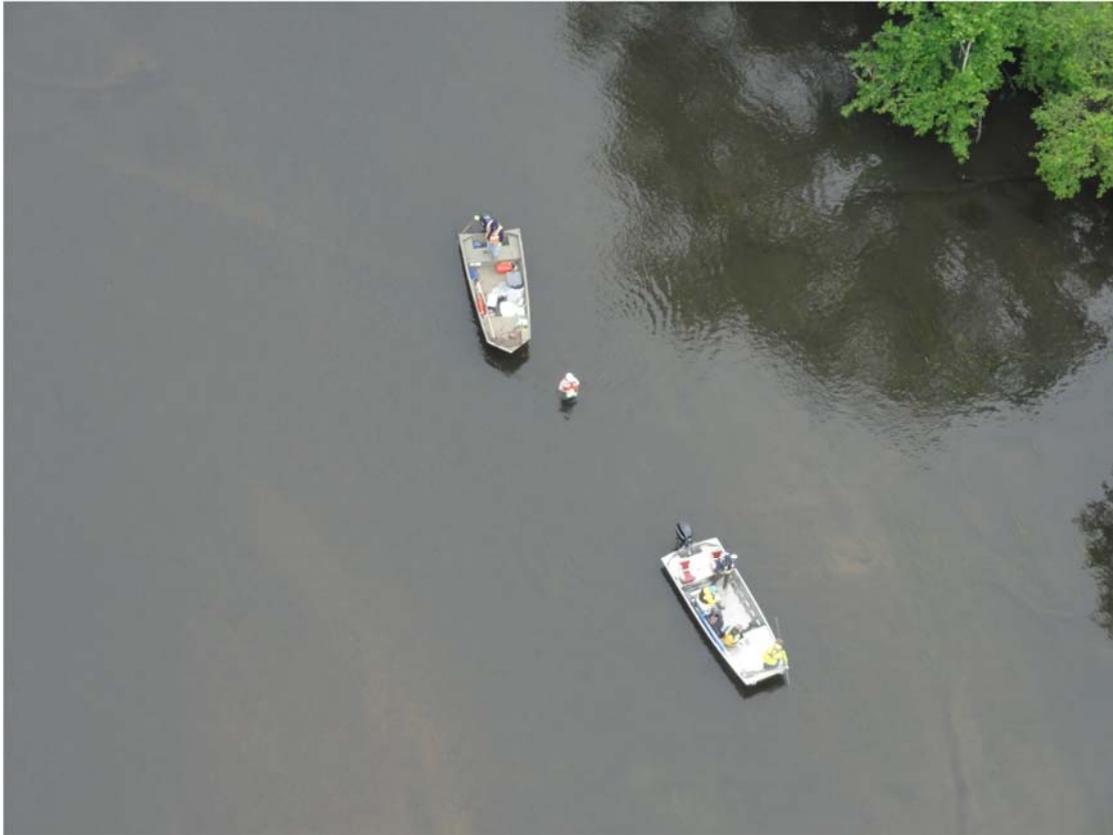
21. MP11.25 Poling crew observed.

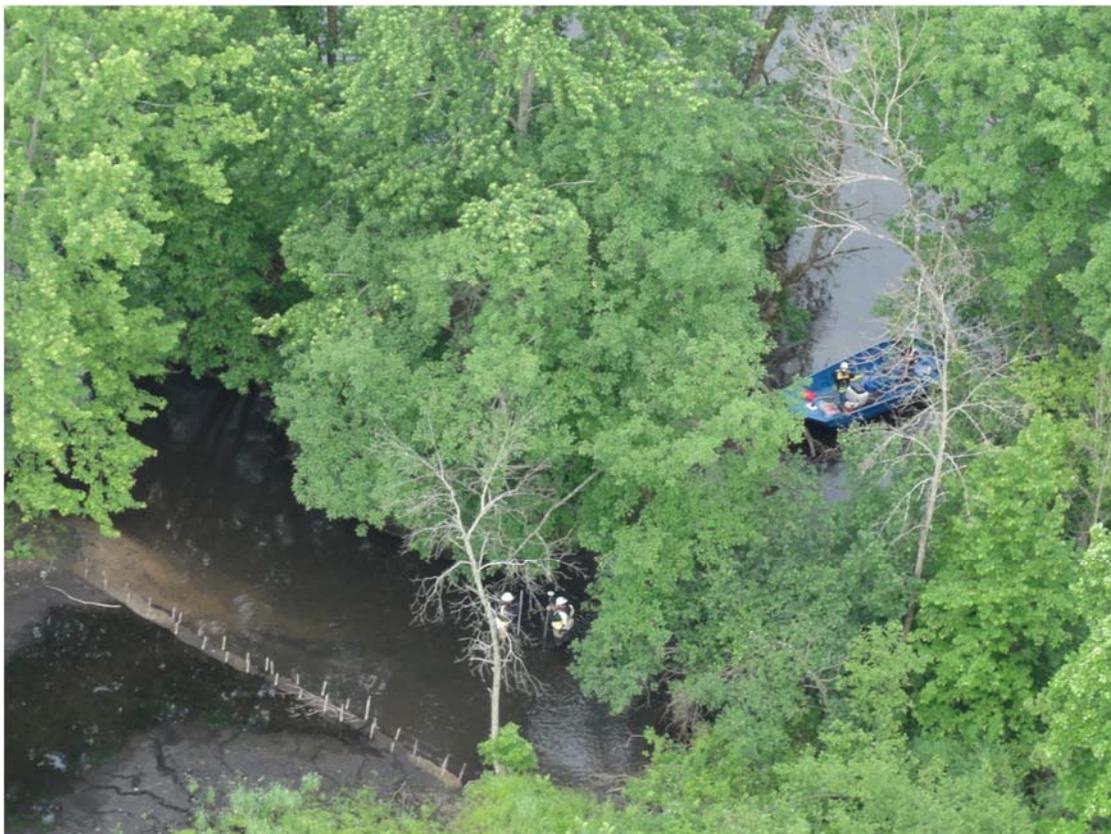
22. MP11.25 Poling crew observed.

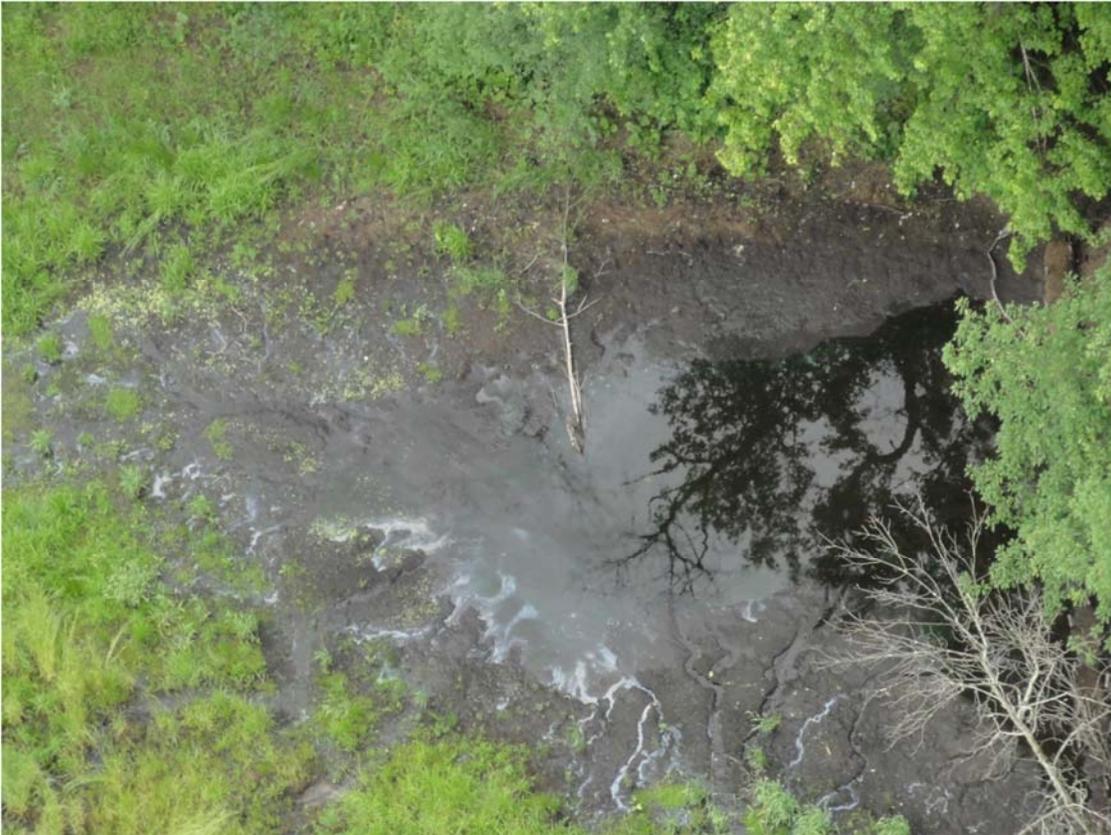
23. MP11.25R1 sheen observed.
