Situation Photo Log

Saturday, June 2, 2012

Kalamazoo River / Enbridge Spill

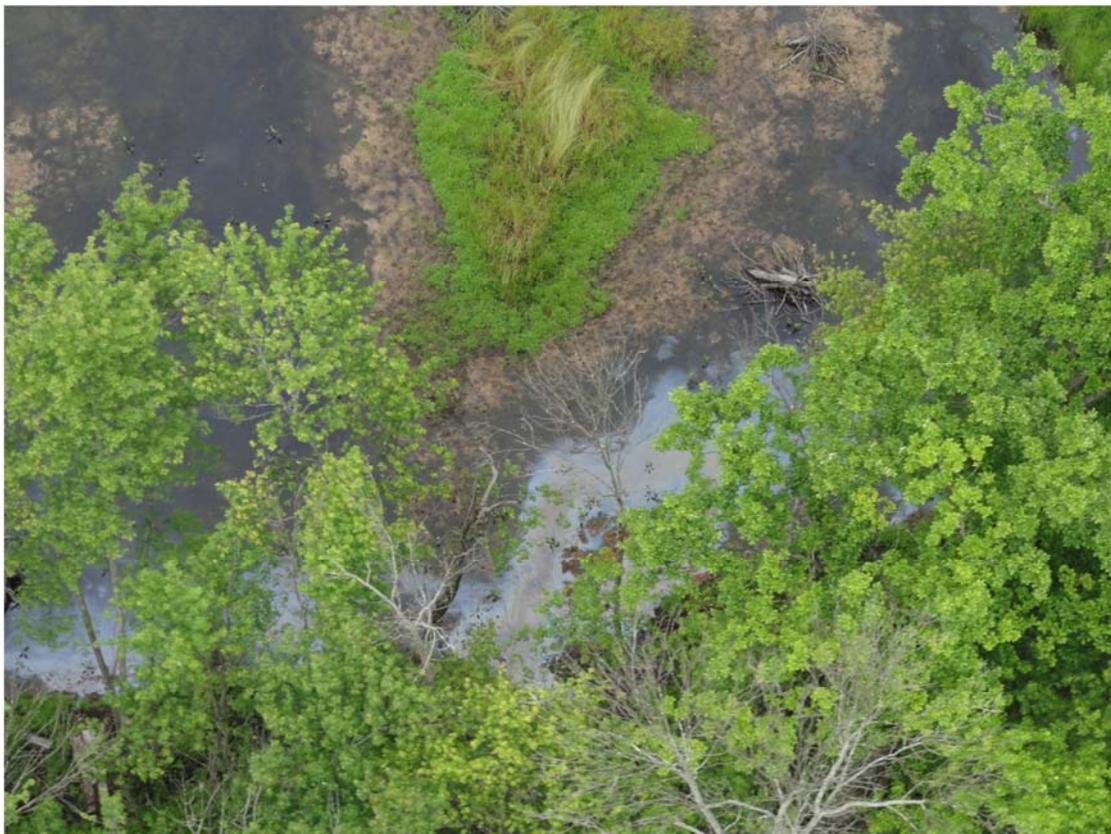
24. MP11.25R2 sheen observed.

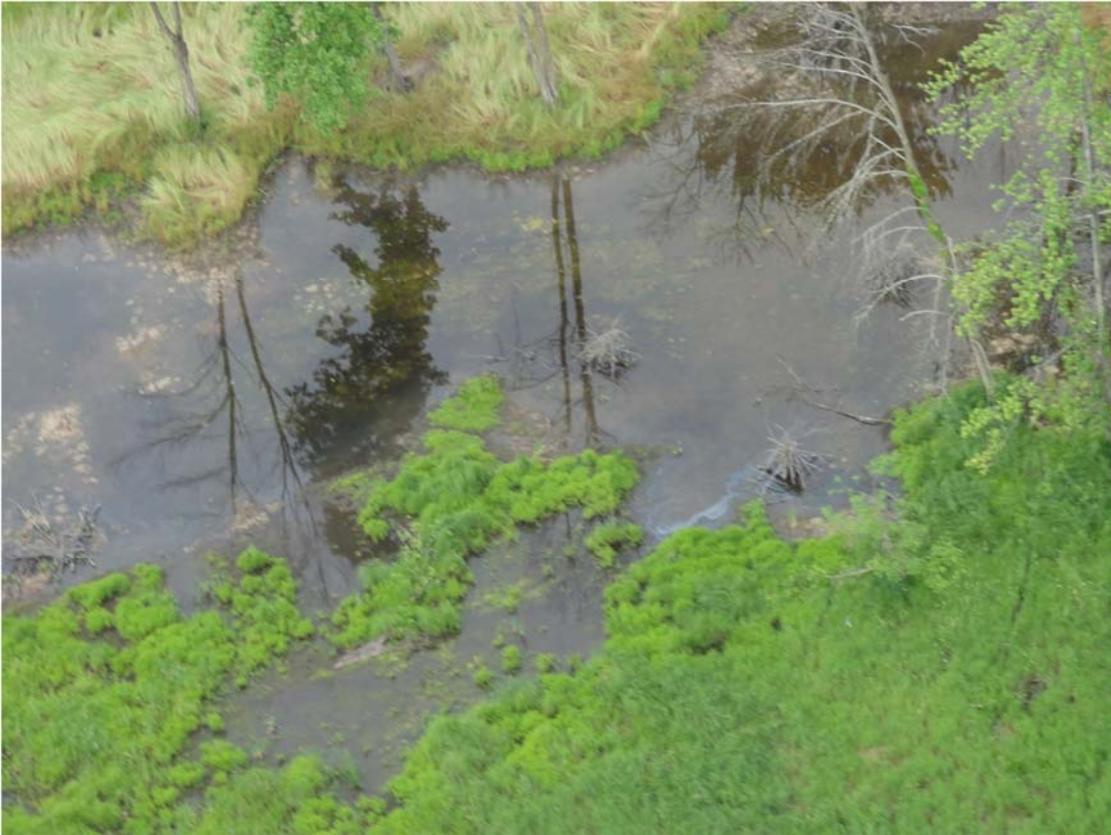
25. MP11.25 sheen observed.

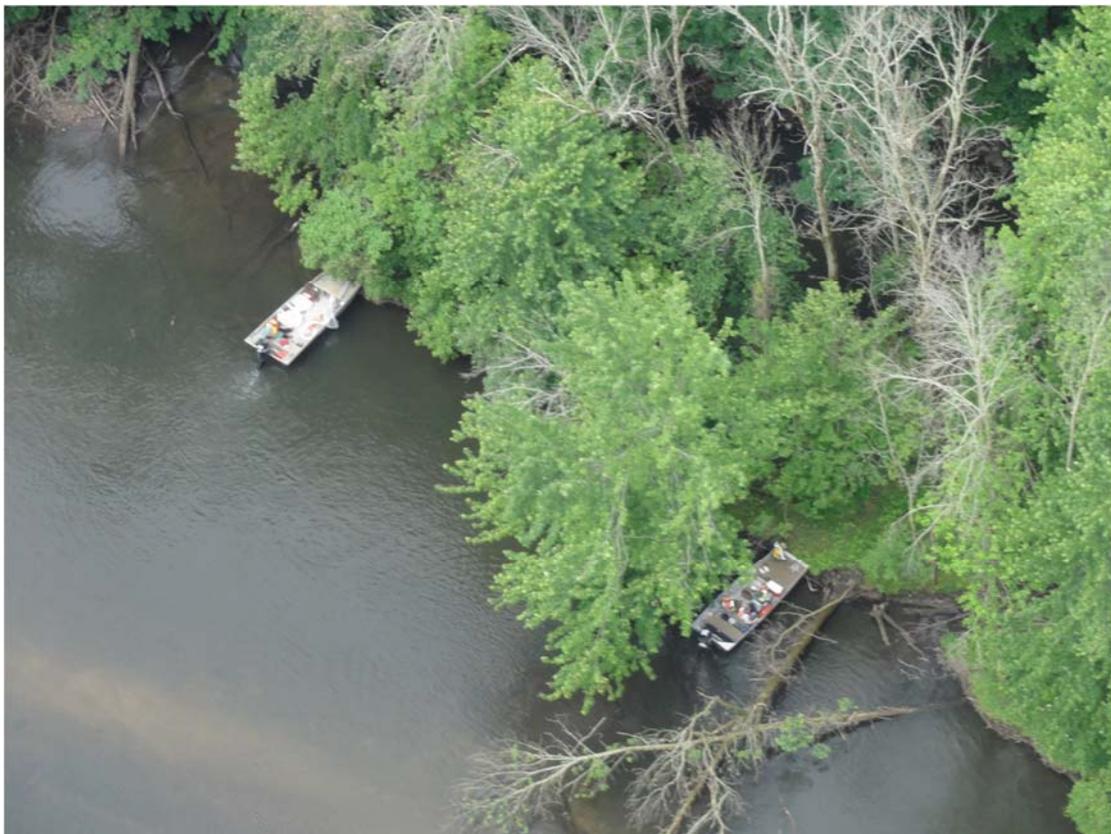
26. MP13.75 Poling crew observed.

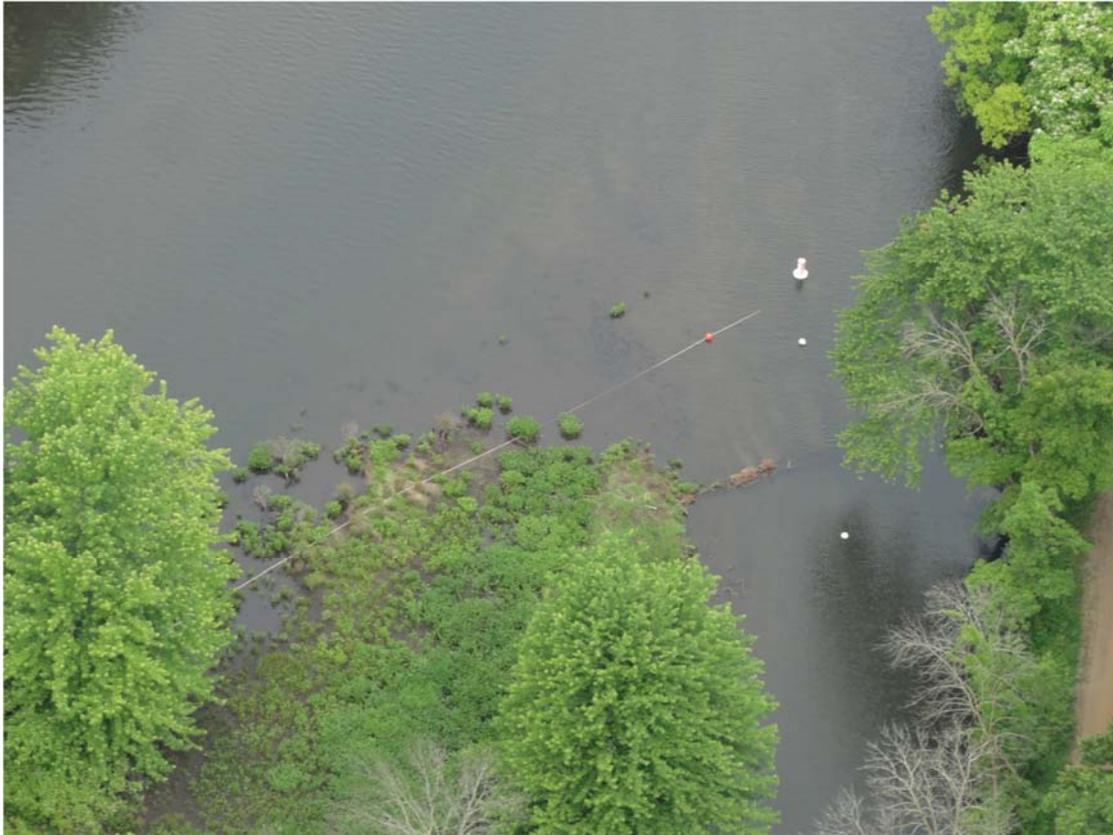
27. MP14.75 Sediment Control Structure.

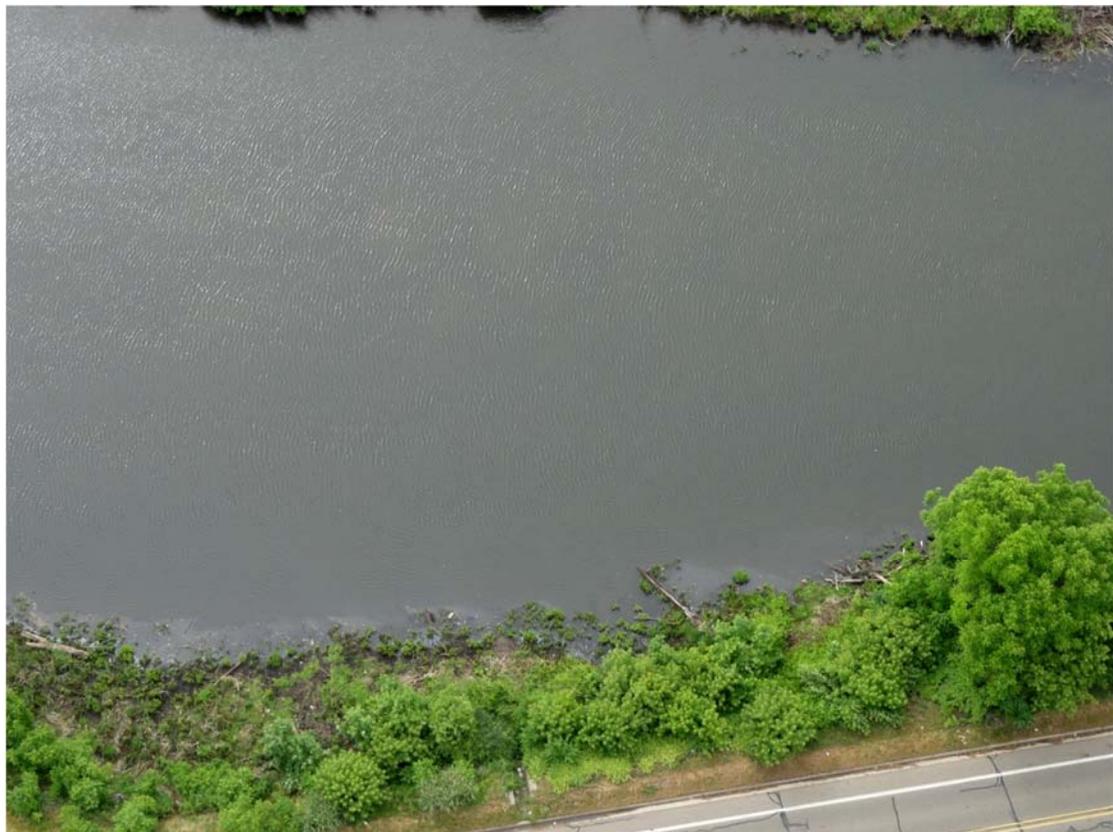
28. MP15.5 LDB sheen observed.

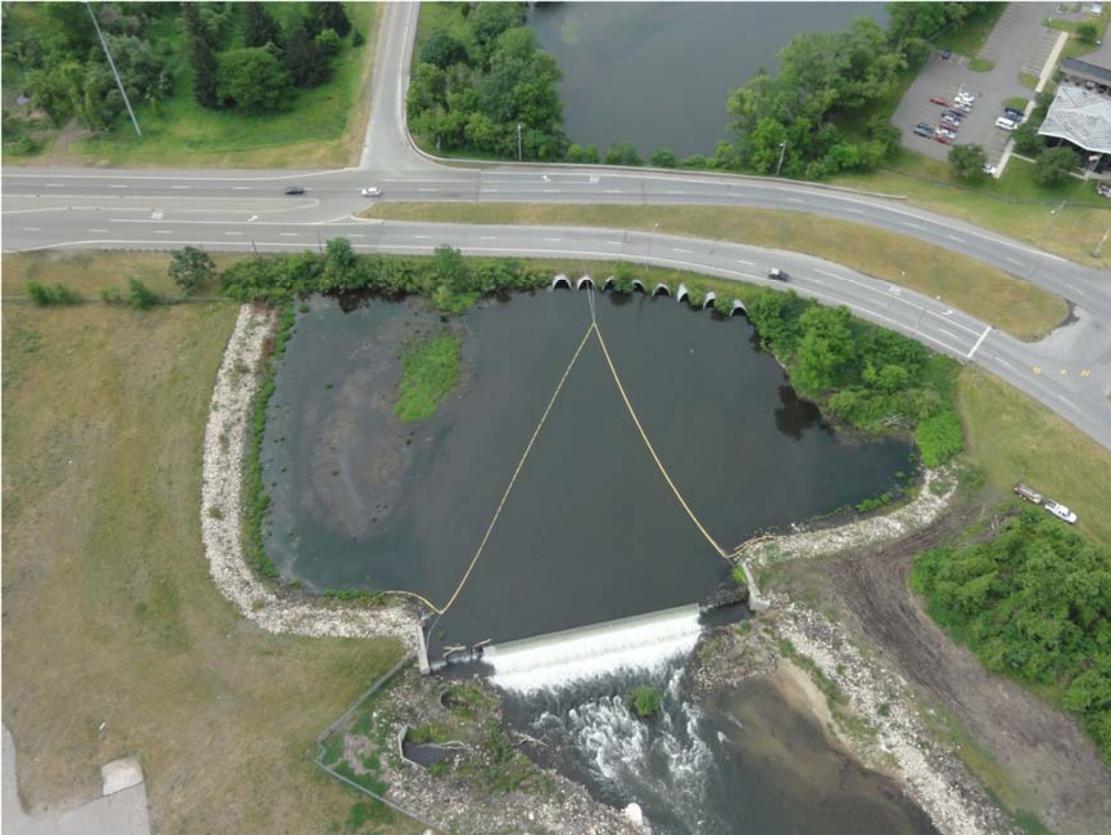
29. MP15.75 boom.

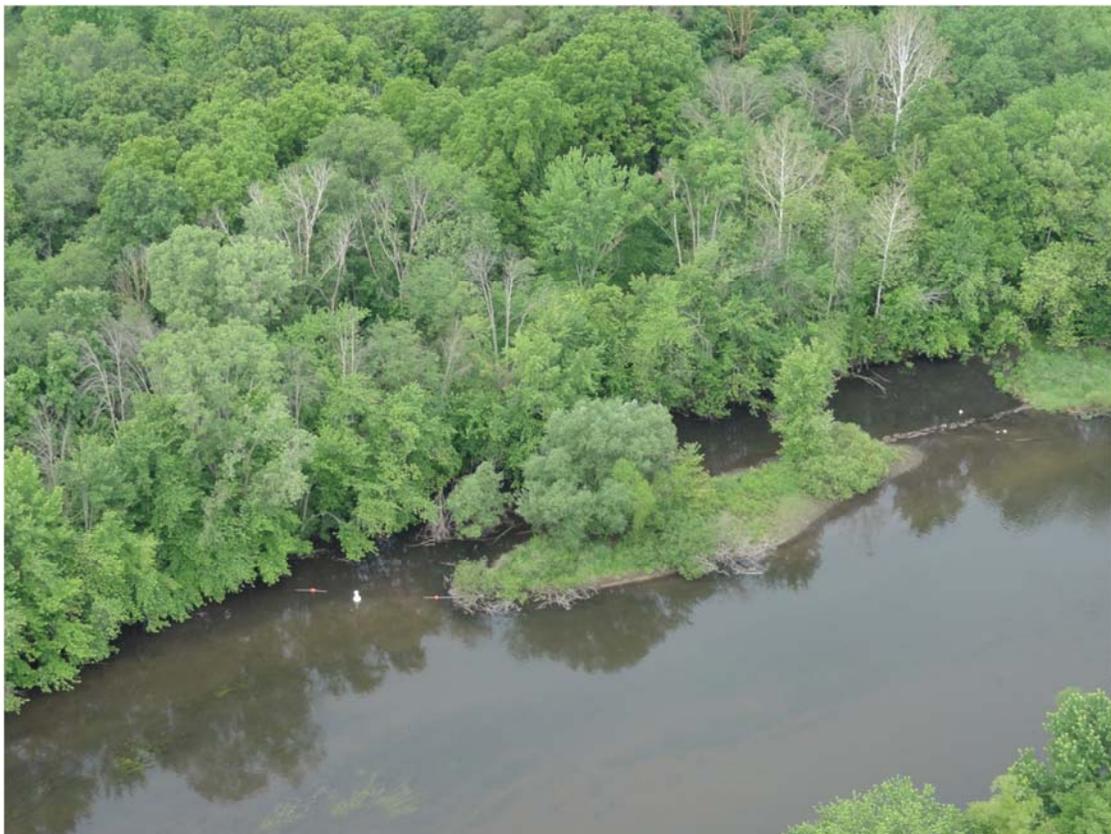
30. MP19.25 Sediment Control Structure.

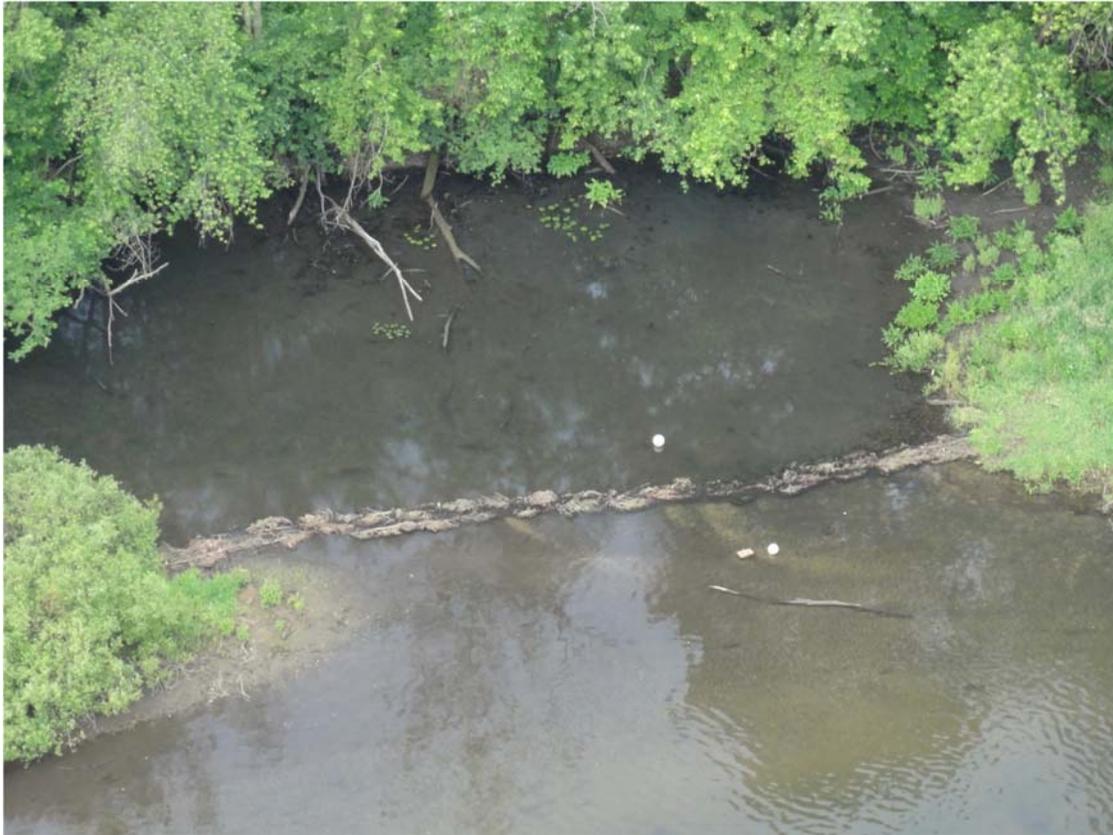
31. MP19.25 Sediment Control Structure.

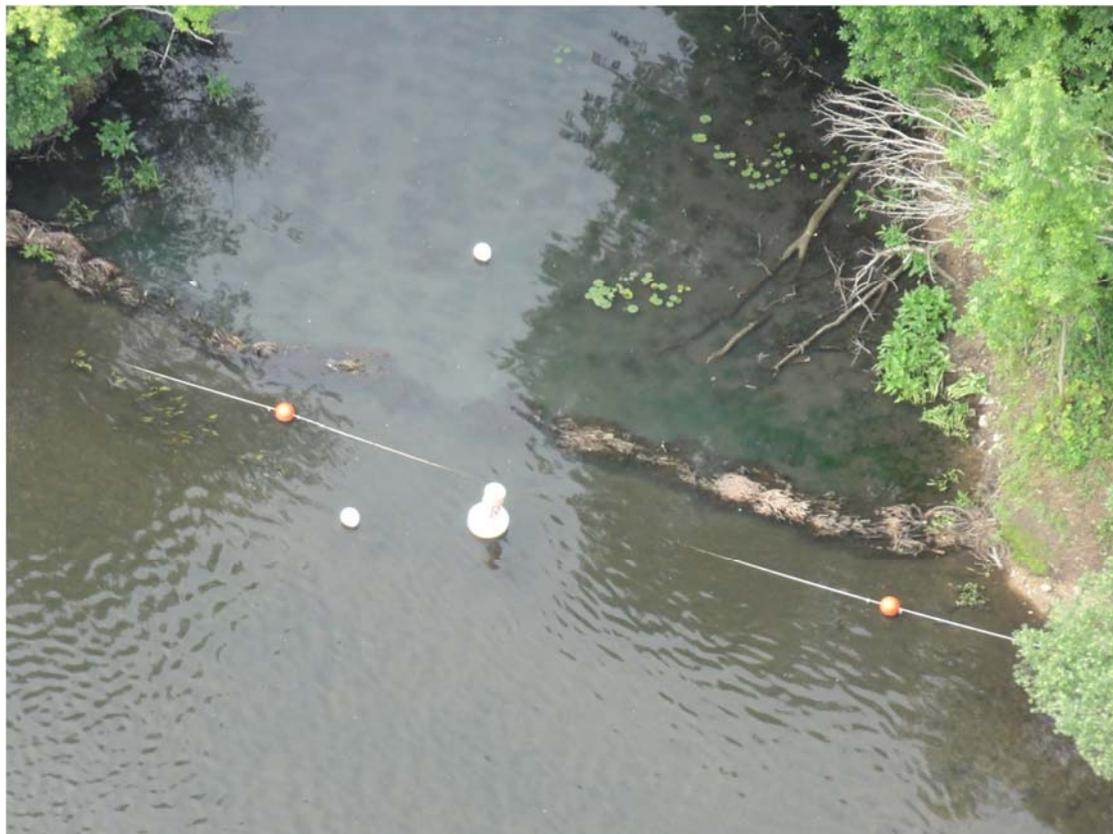
32. MP19.25 Sediment Control Structure.

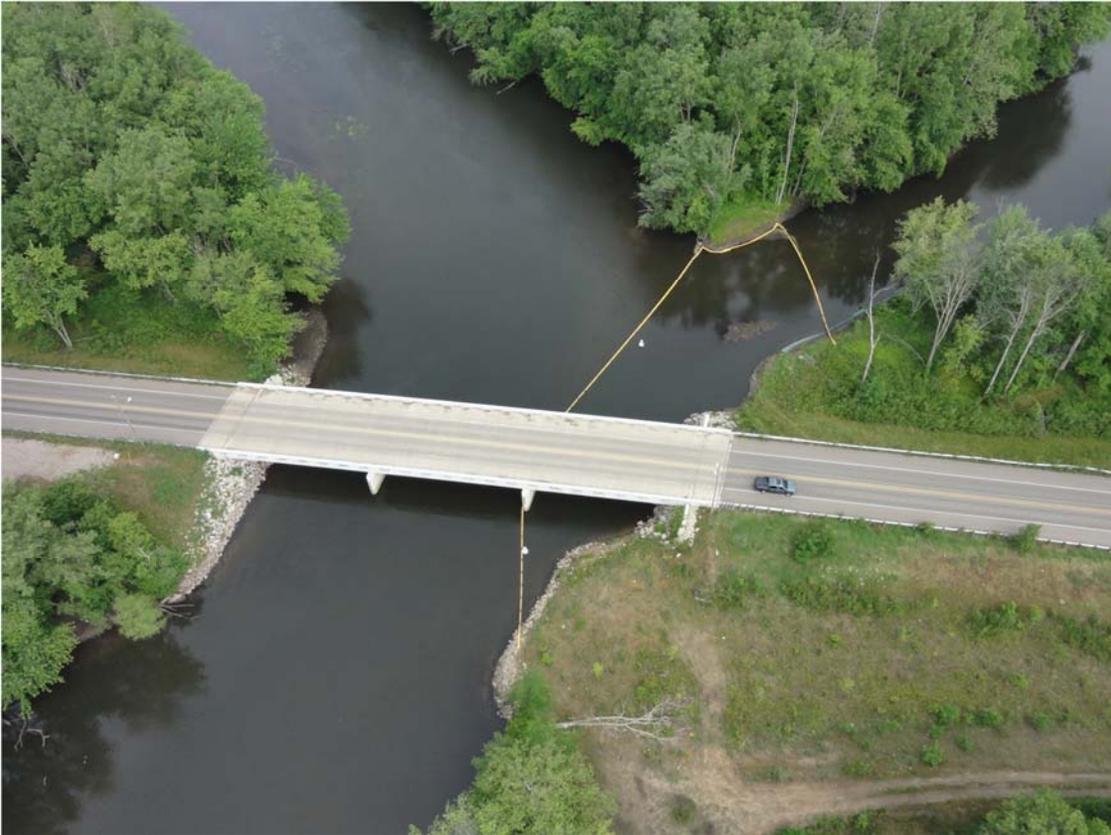
33. MP21.5 no sheen observed.

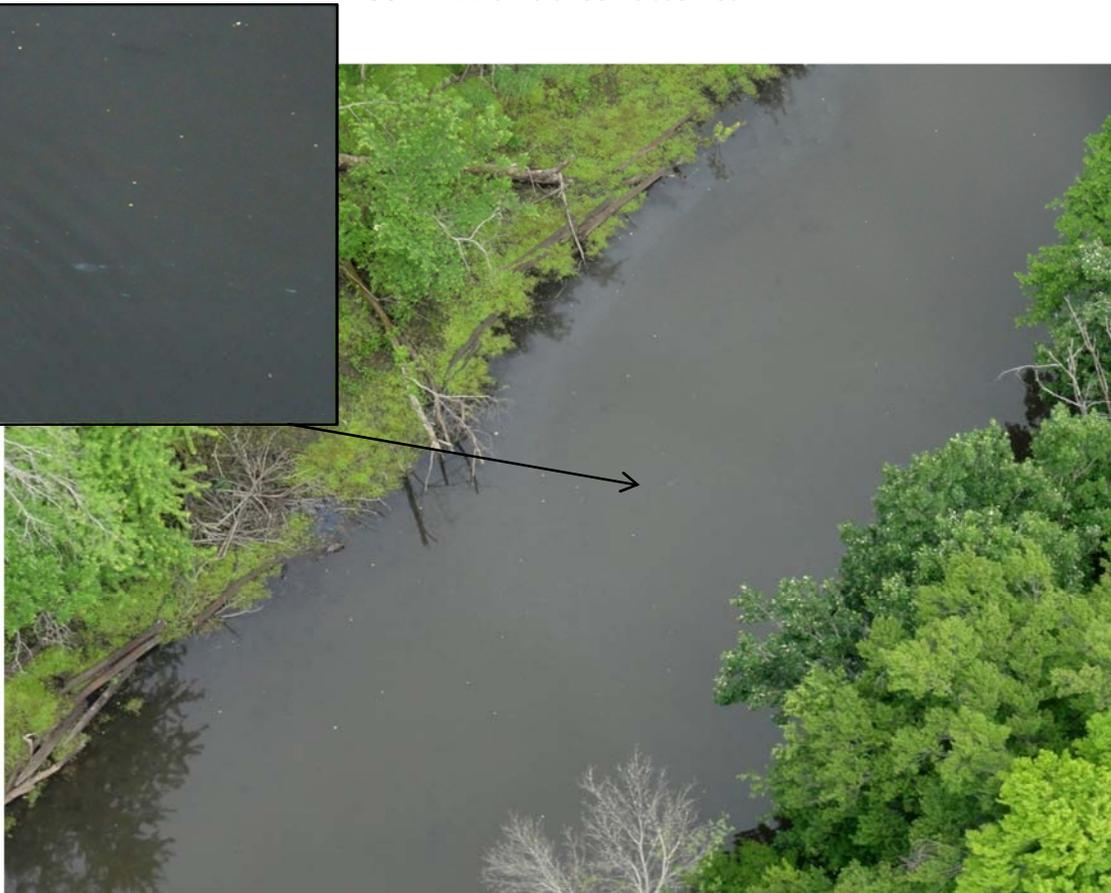
34. MP22.1 back water area sheen observed.

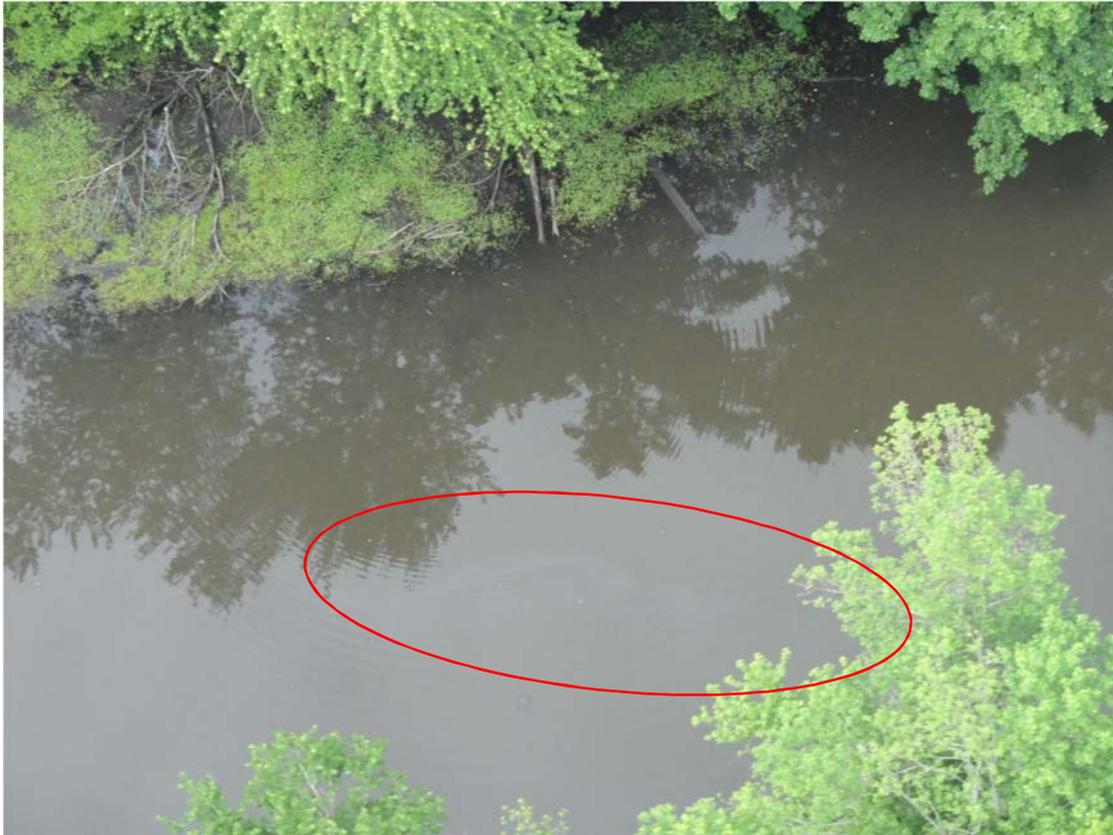
35. MP22.1 back water area sheen observed.

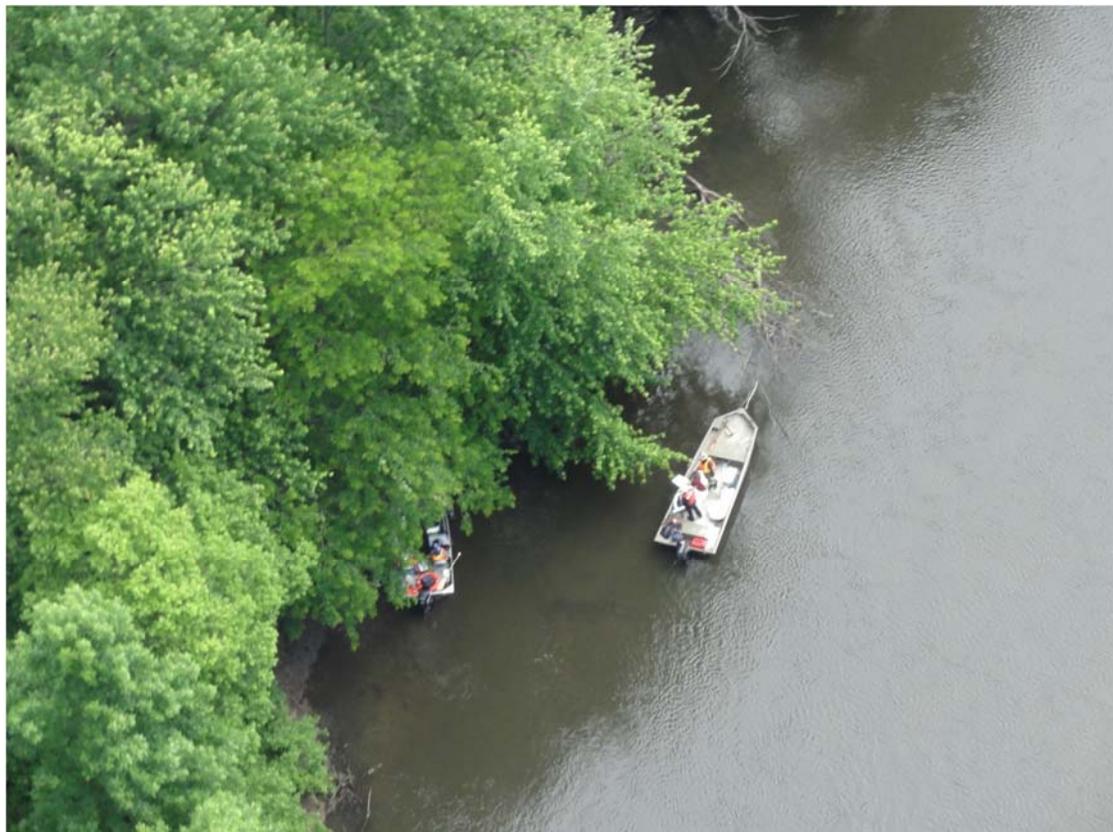
36. MP24.0 Poling crew observed.

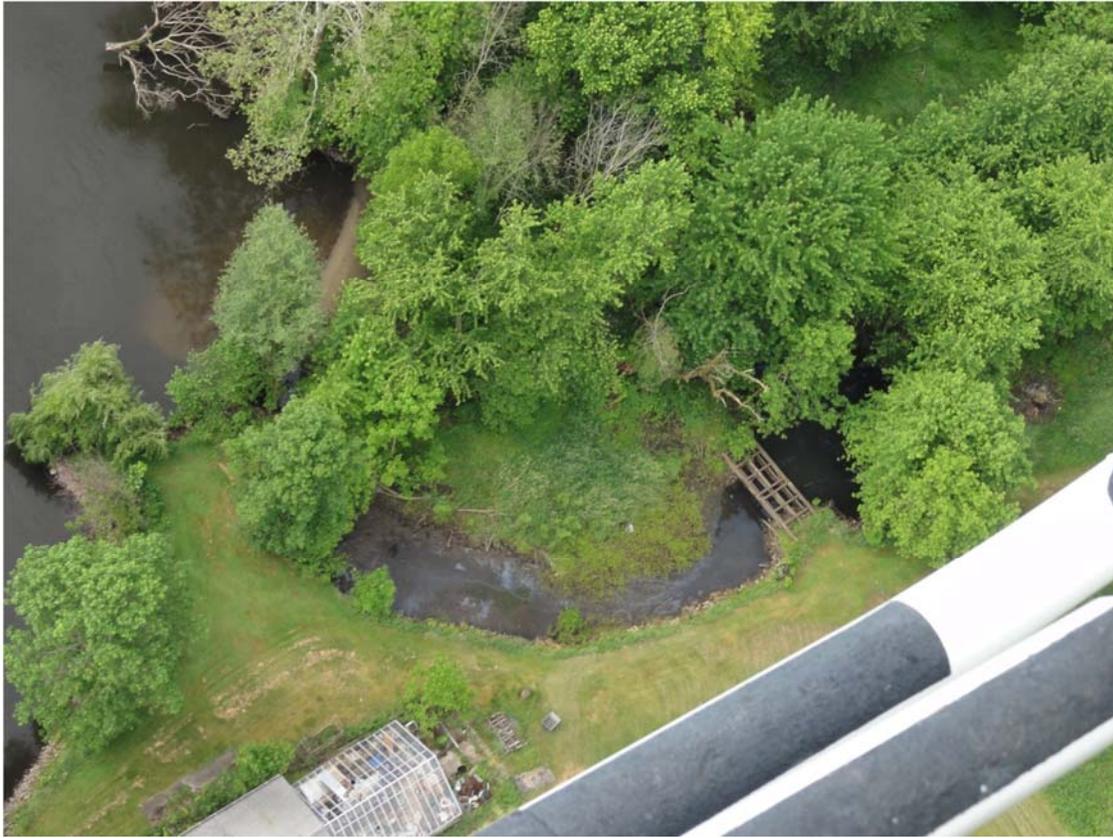
37. MP26.0 Pond sheen observed.

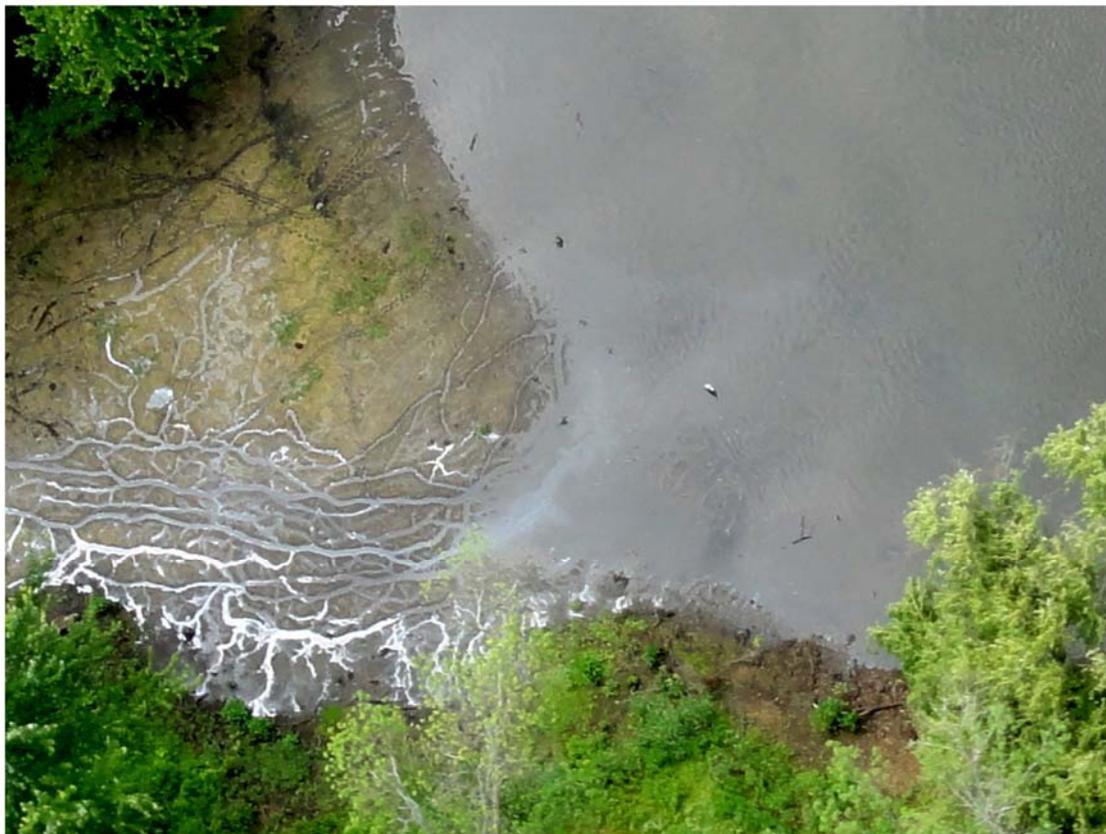
38. MP27.0 RDB sheen observed.

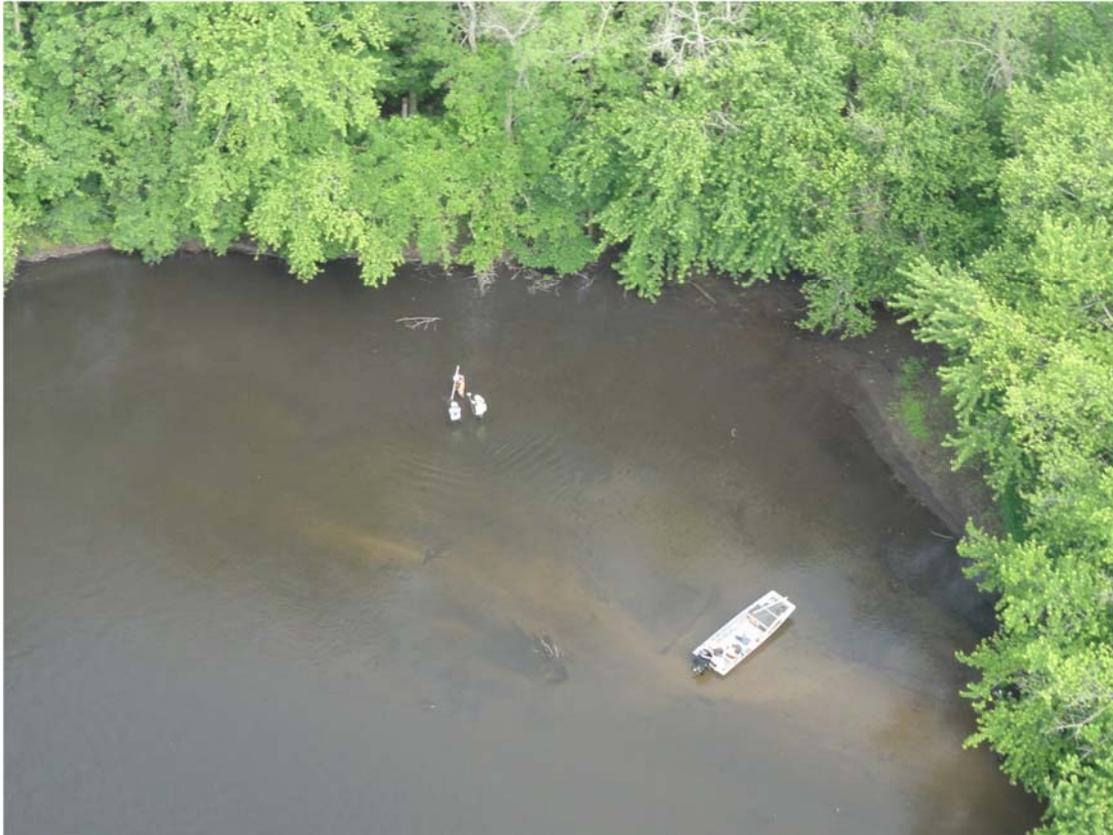
39. MP27.75 Poling crew observed.

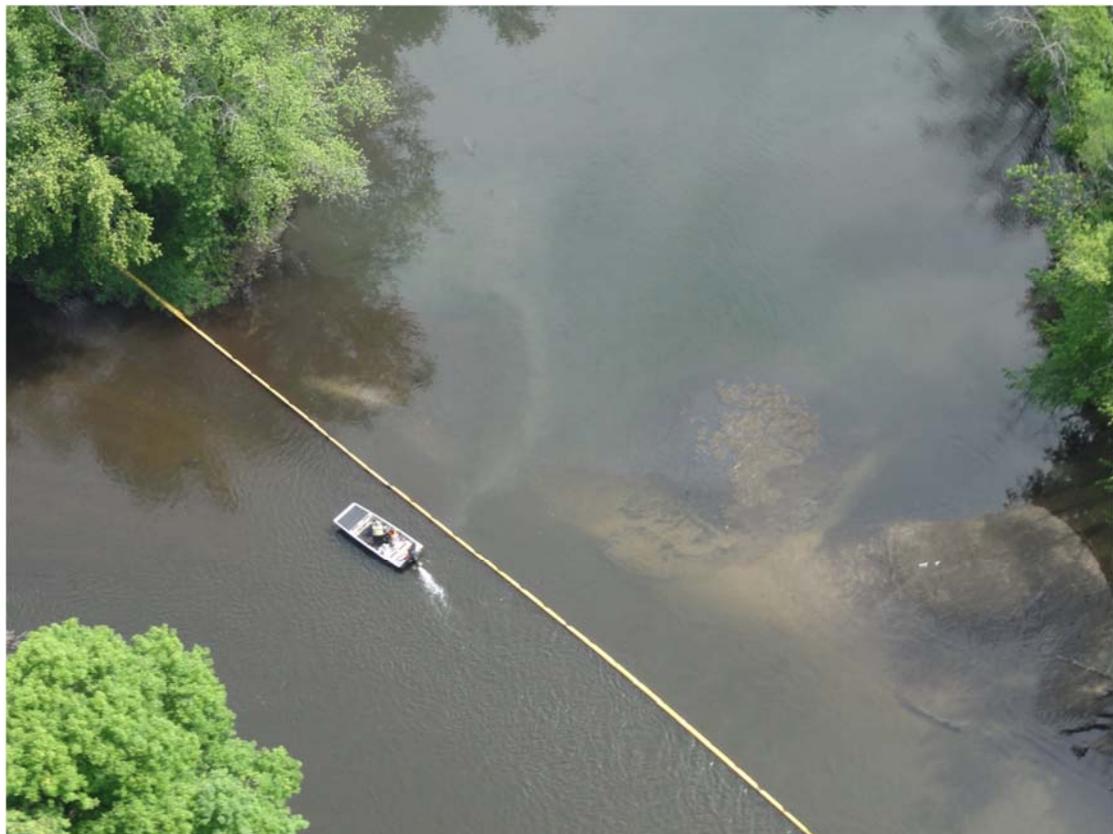
40. MP30.8 containment branch crew observed, sheen observed within boom.

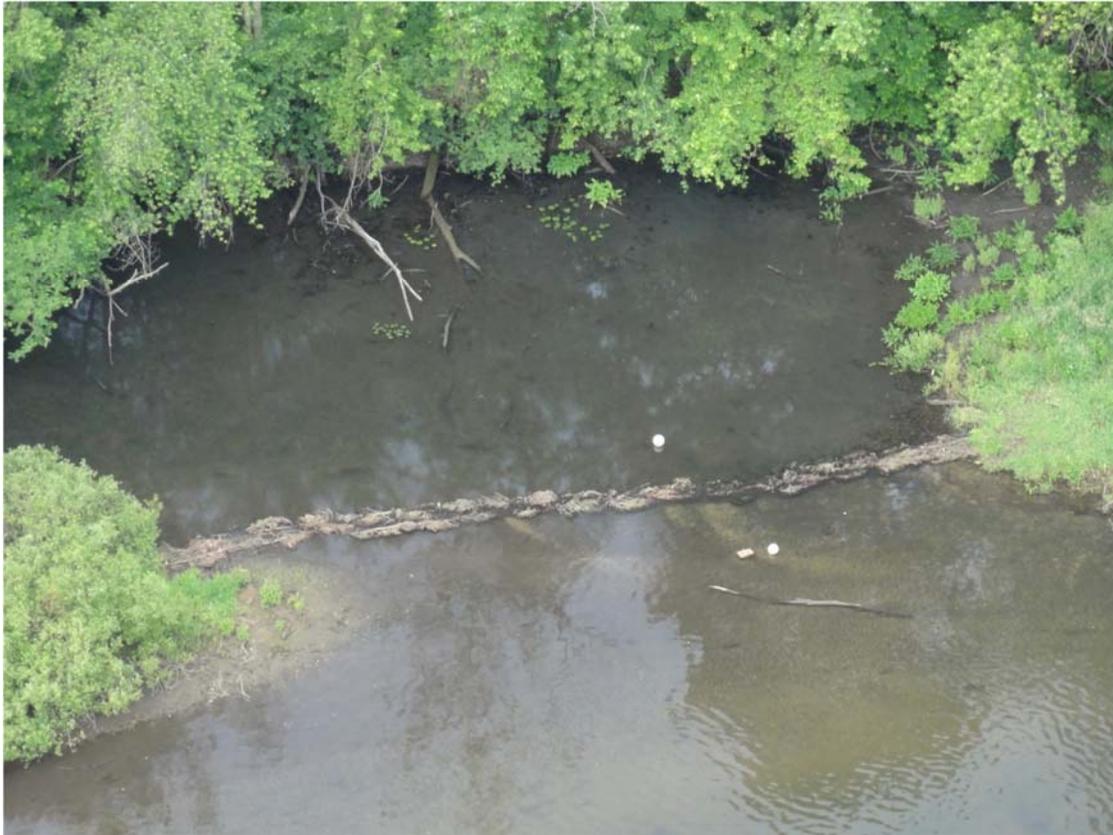
41. MP19.25 Sediment Control Structure.

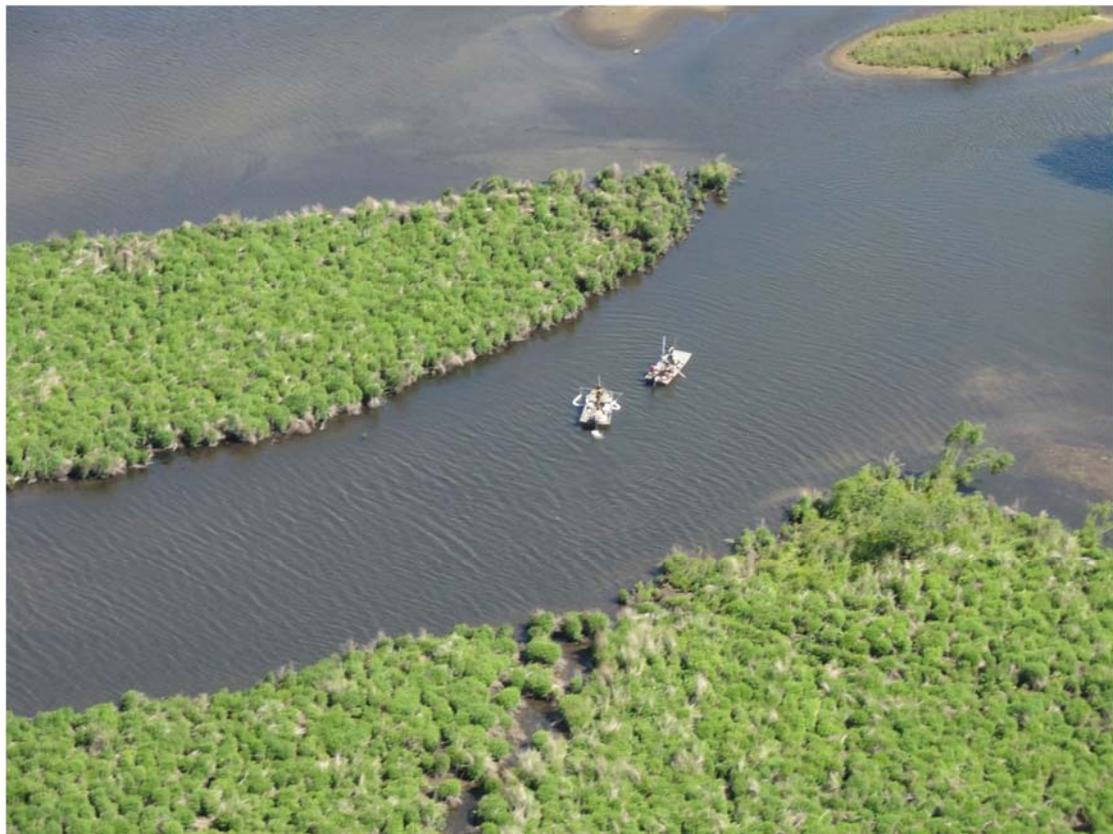
42. Morrow Lake Delta Poling Crew.

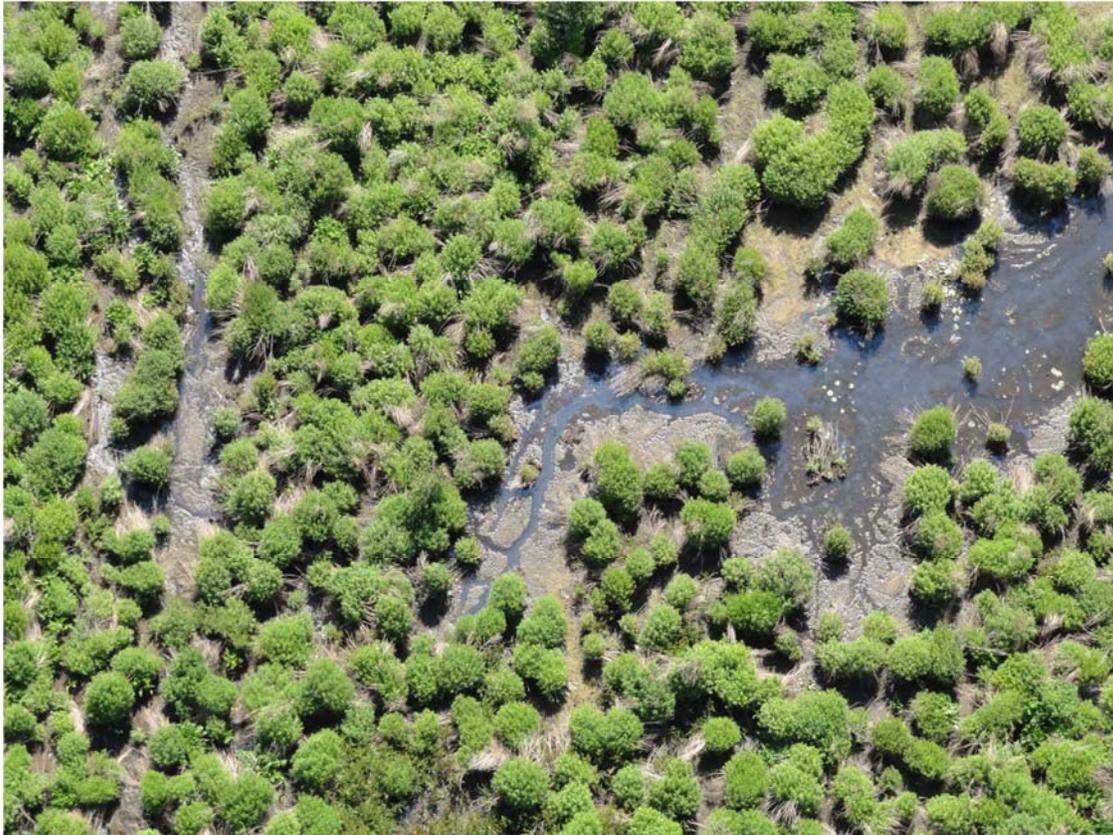
43. Morrow Lake Delta sheen observed within island vegetation.

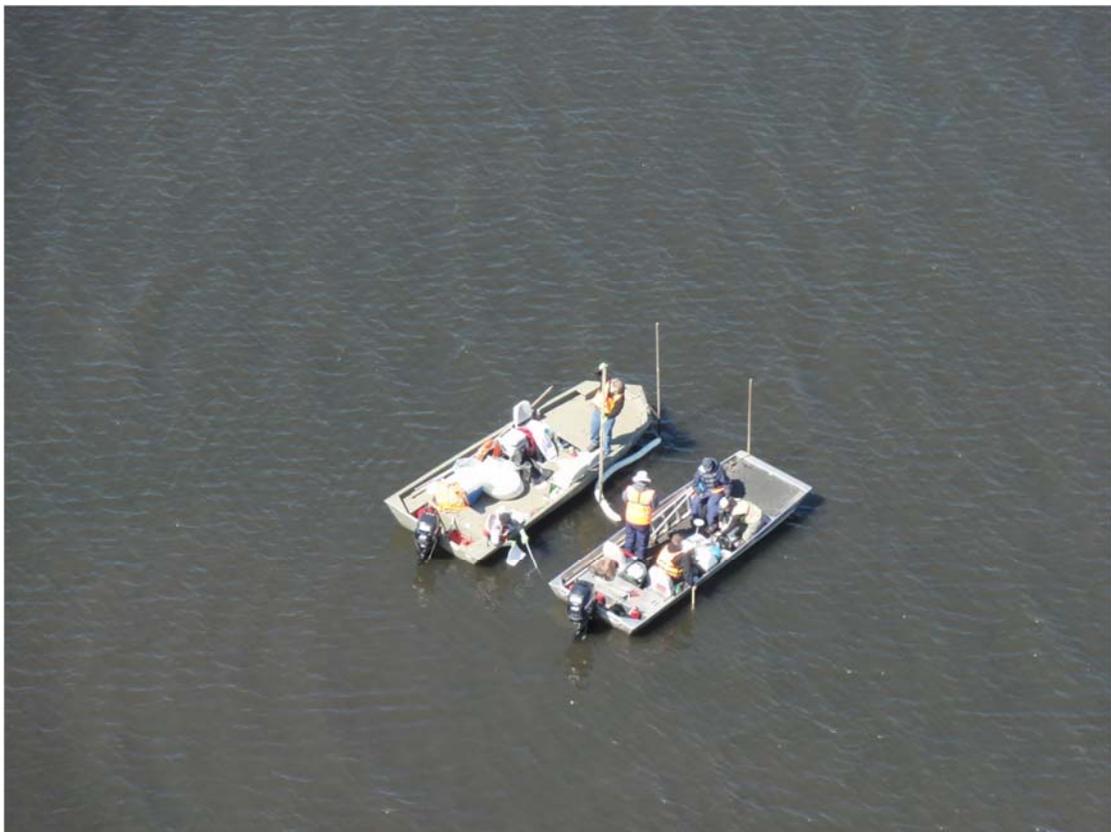
44. Morrow Lake Delta poling crew.

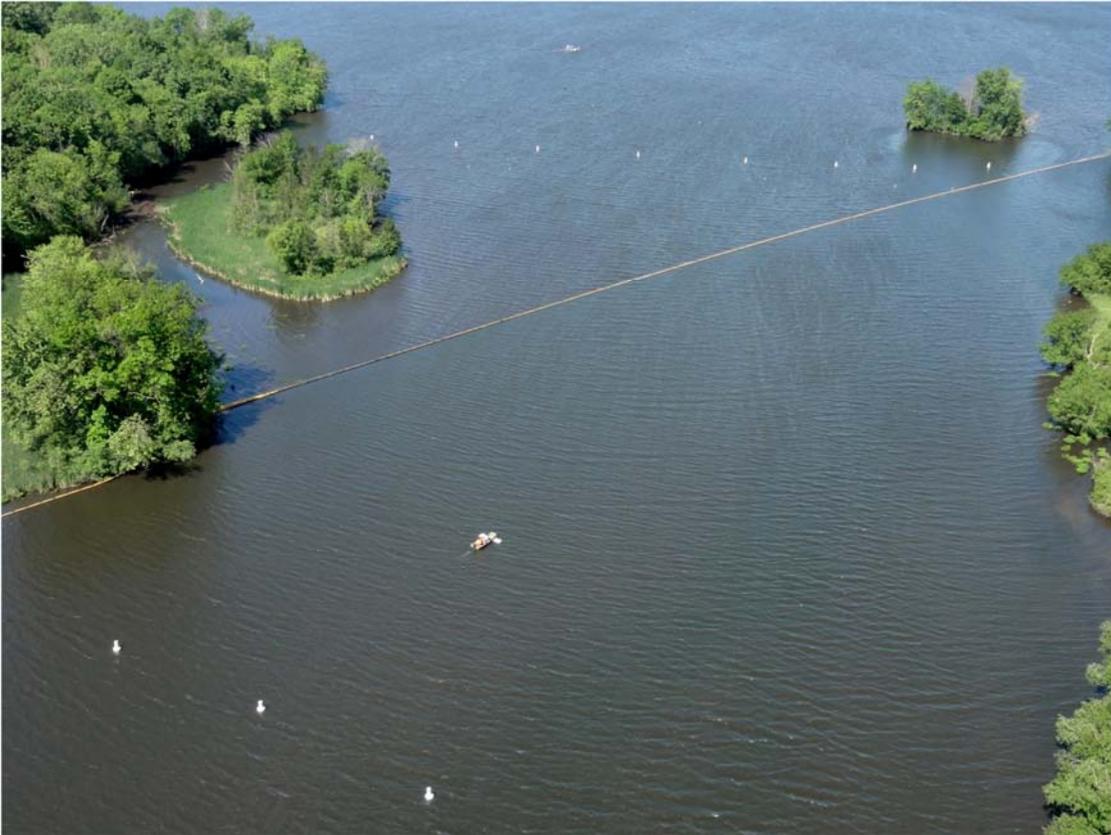
45. Sweep boat observed operating above E4 boom.

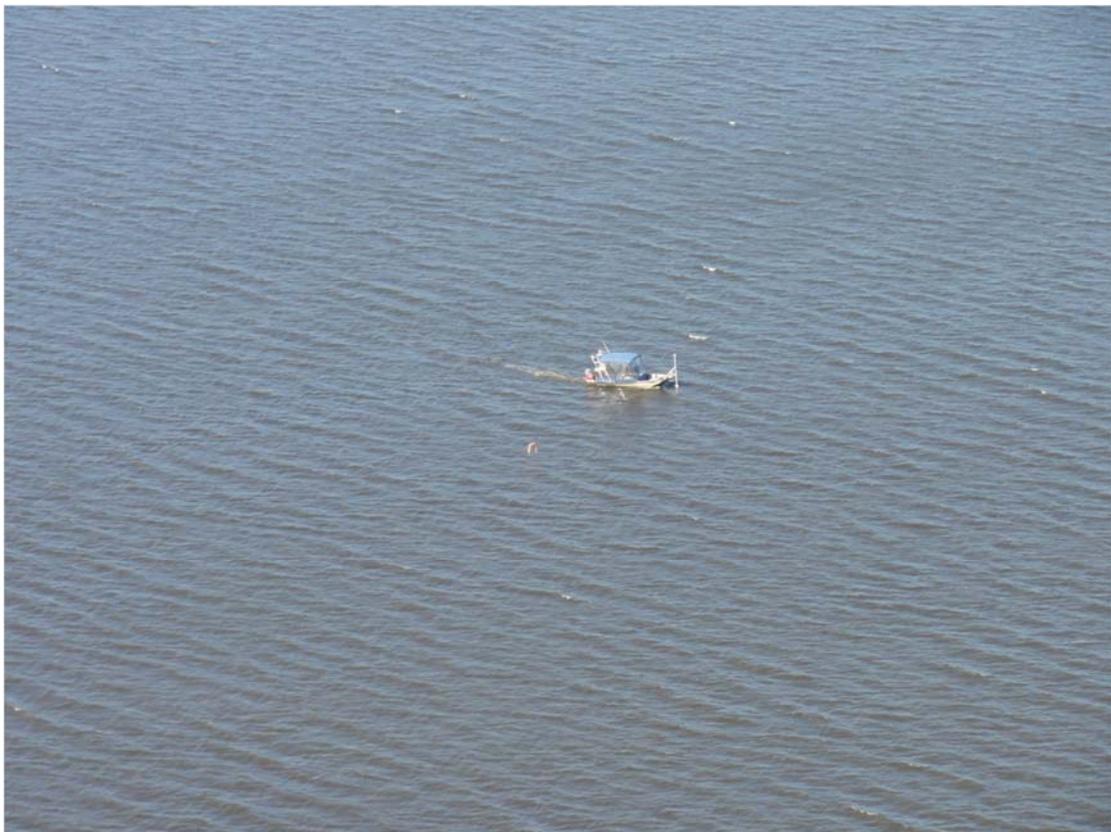
46. Velocity measurements being taken in Lake Morrow.

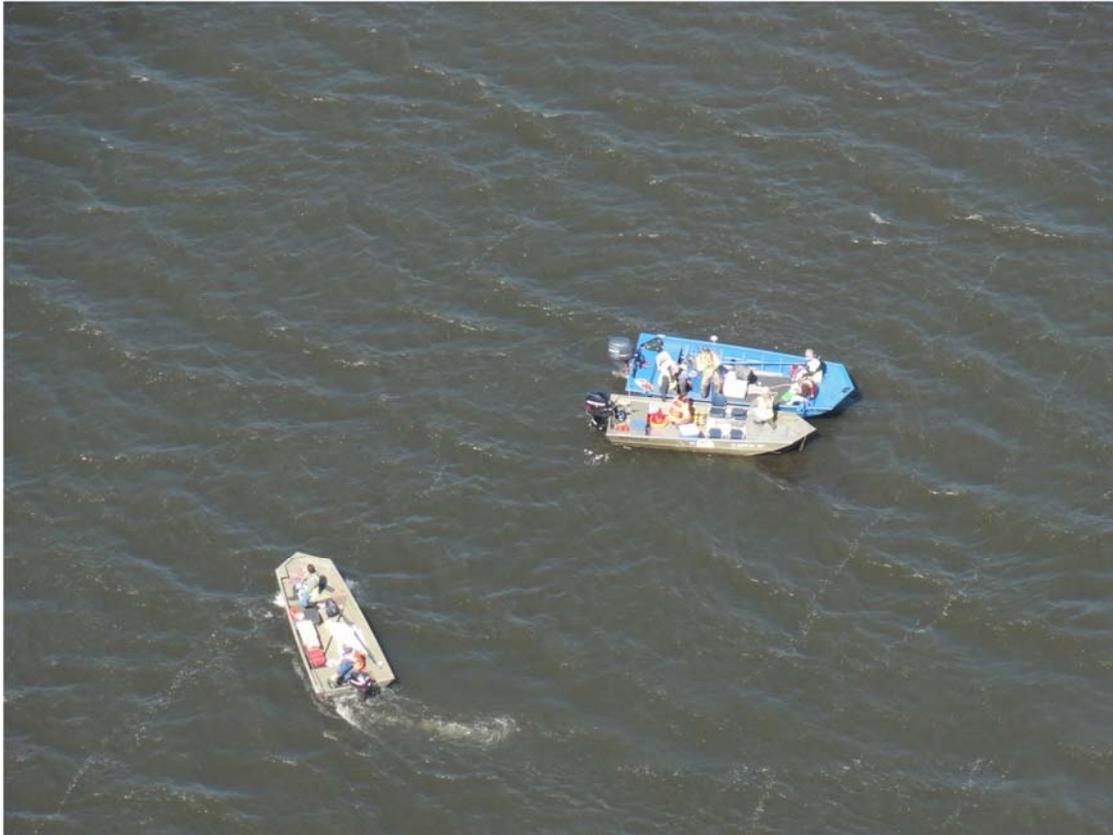
47. Morrow Lake Poling crew.
