Situation Photo Log

Saturday, June 2, 2012

Kalamazoo River / Enbridge Spill

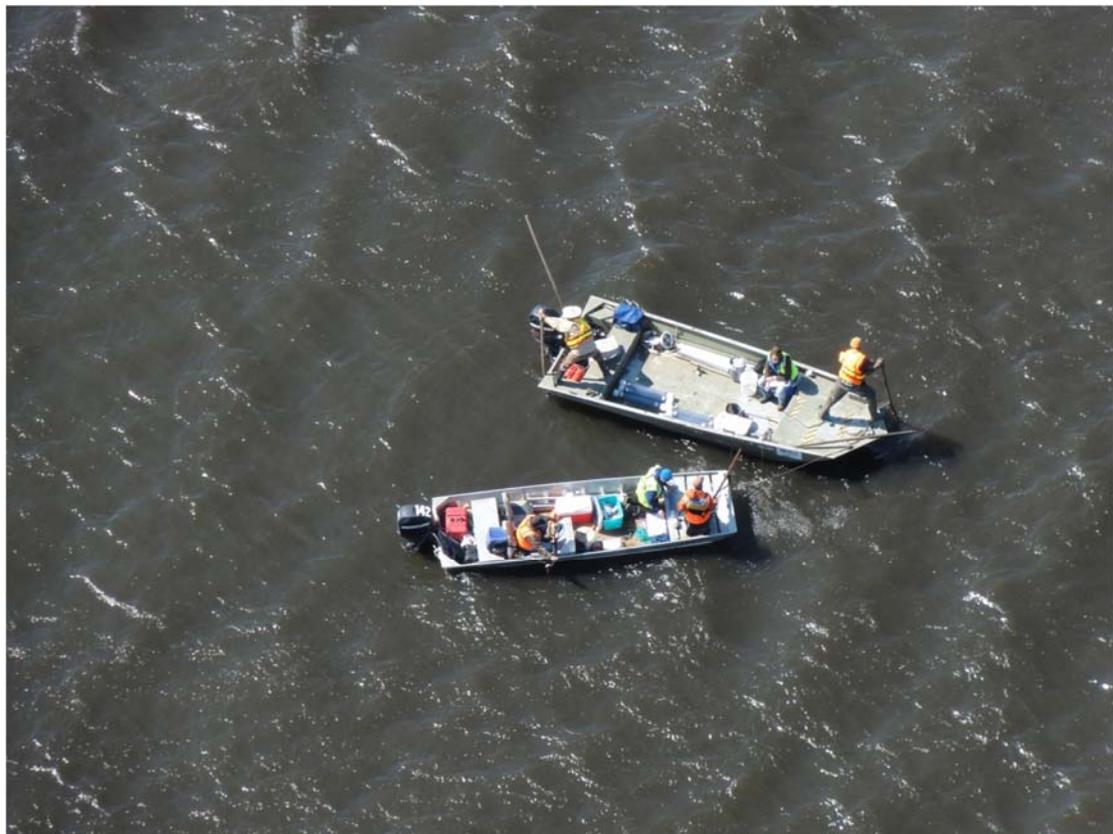
48. Morrow Lake Walling Tube installation.

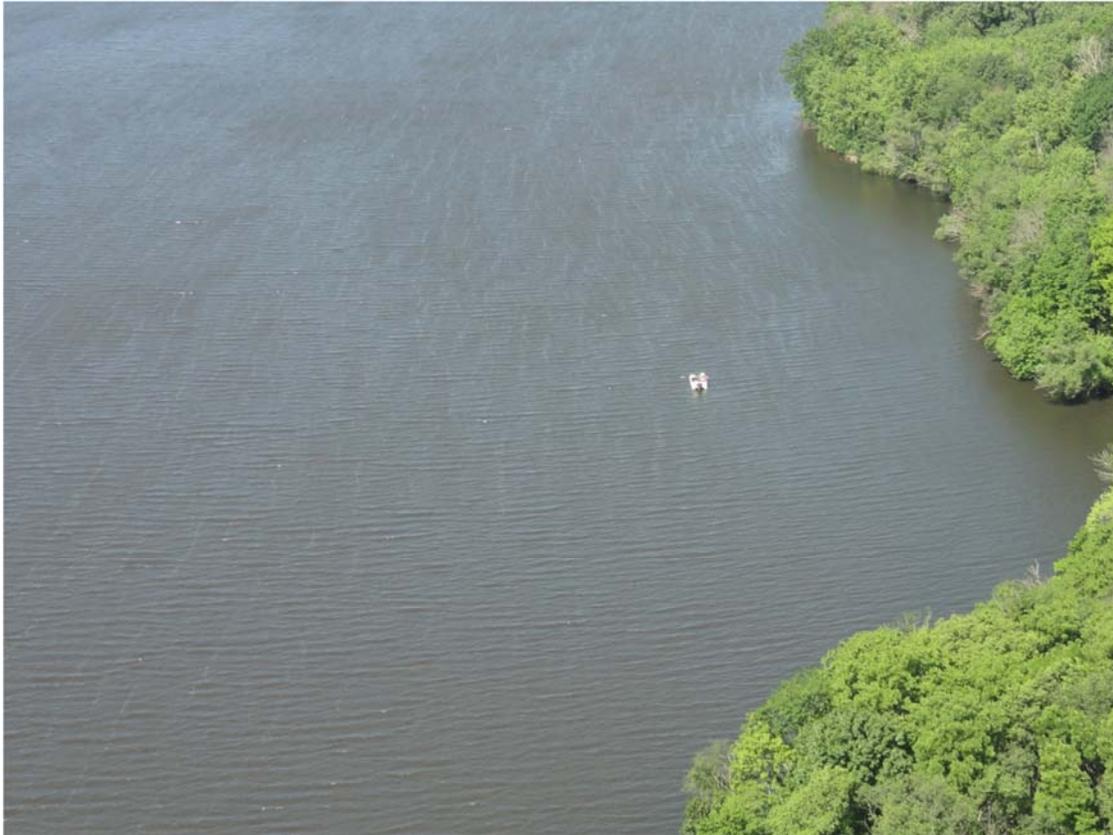
49. Morrow Lake sweep boat operating along the north shore line.

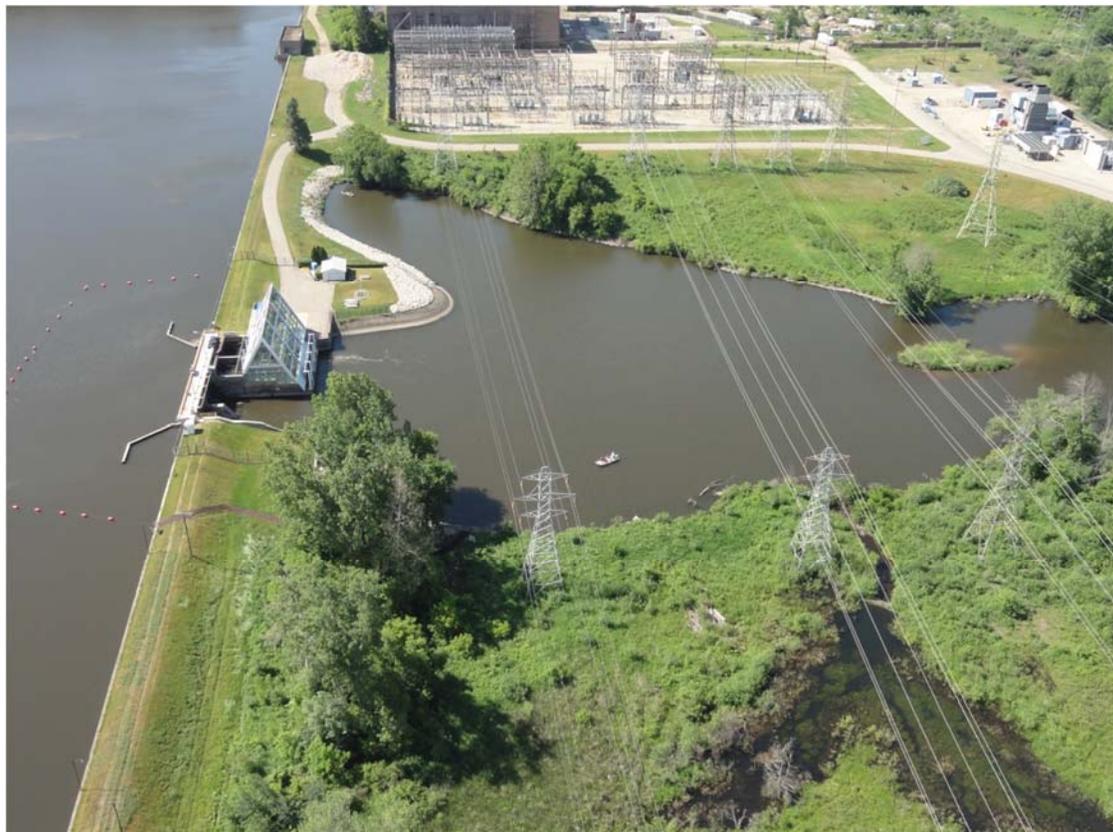
50. Morrow Lake Dam, observed two fishing boats below the dam.
