# Situation Photo Log

Tuesday, June 12, 2012

Kalamazoo River / Enbridge Spill

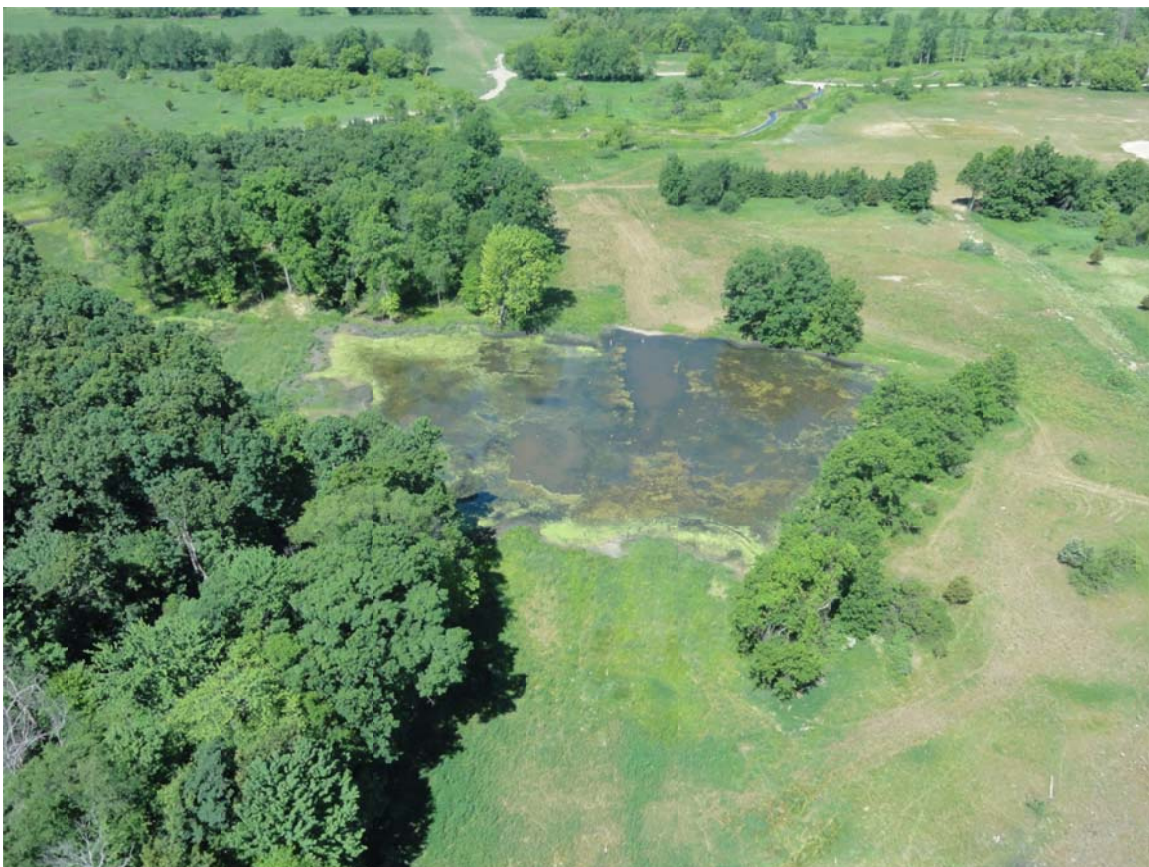
1. Source area pond. No sheen observed.

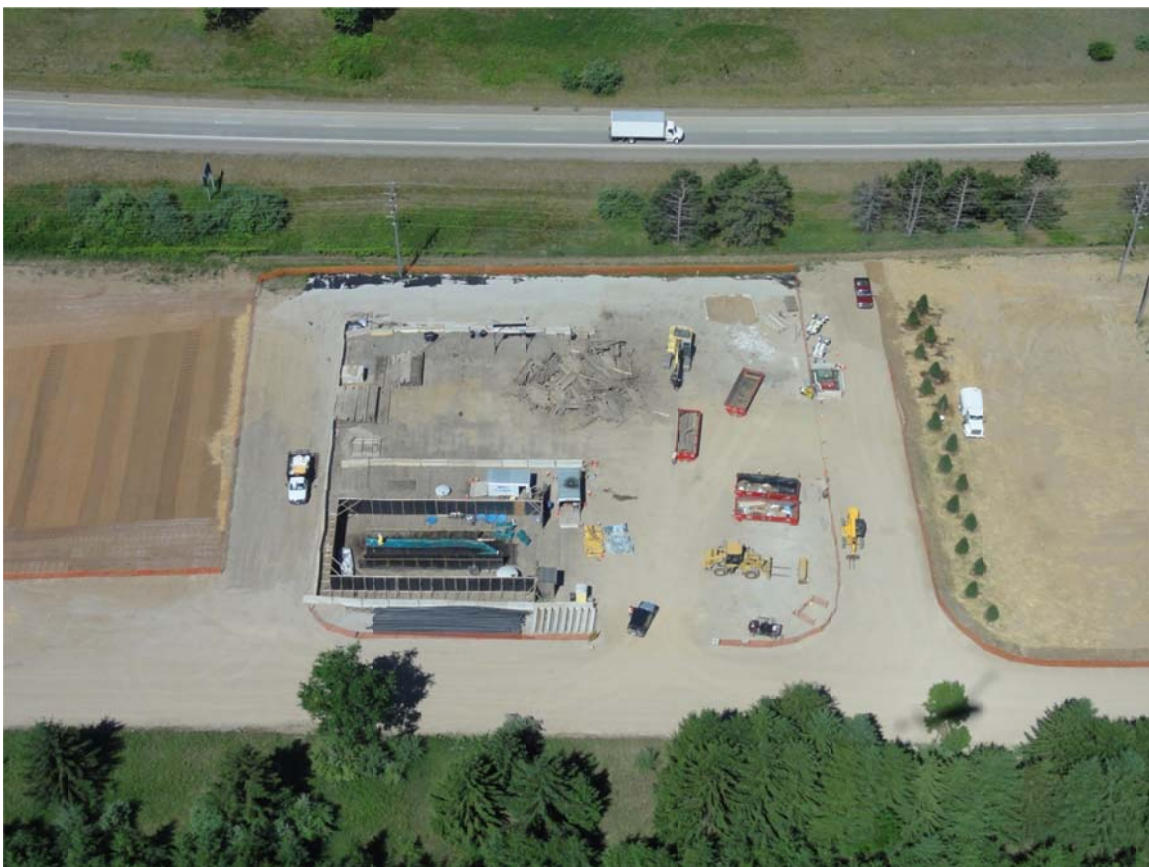
2. Frac-Tank City, observed the timber mats being disposed of.

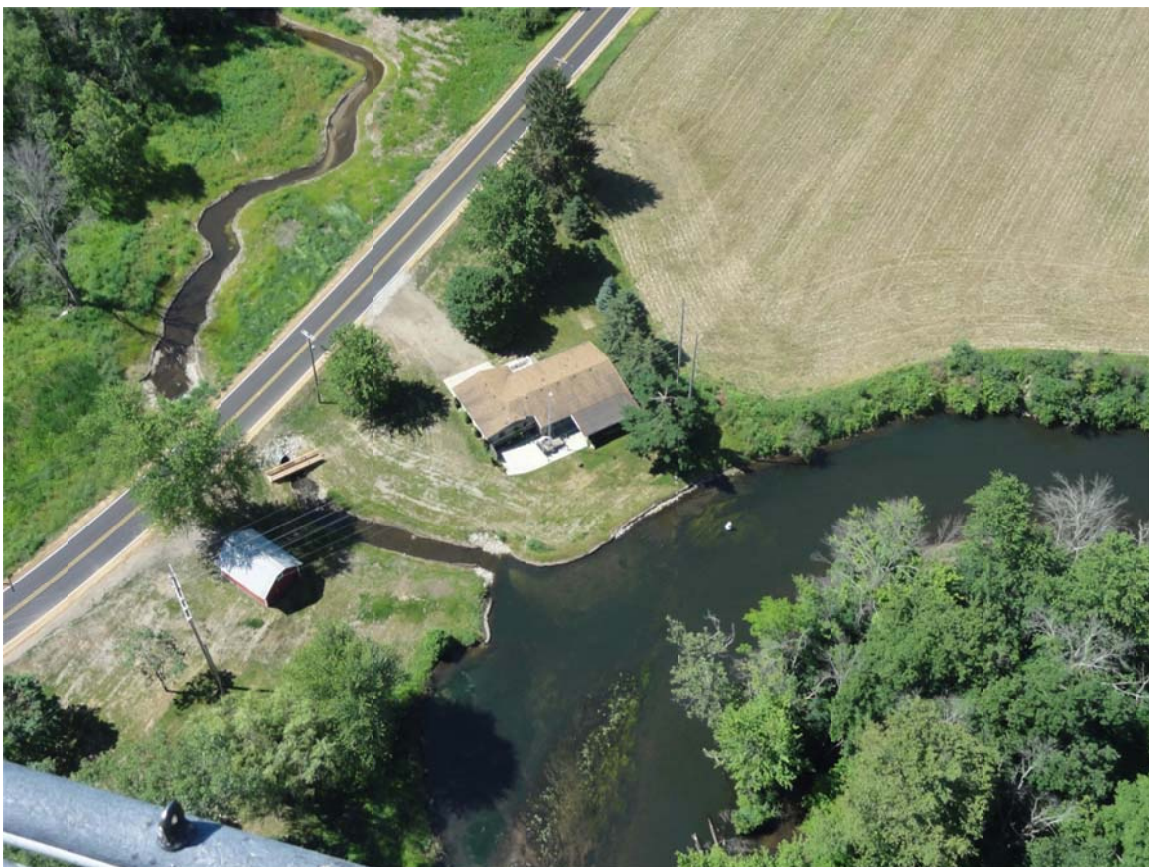
3. Confluence, no sheen or turbidity observed.

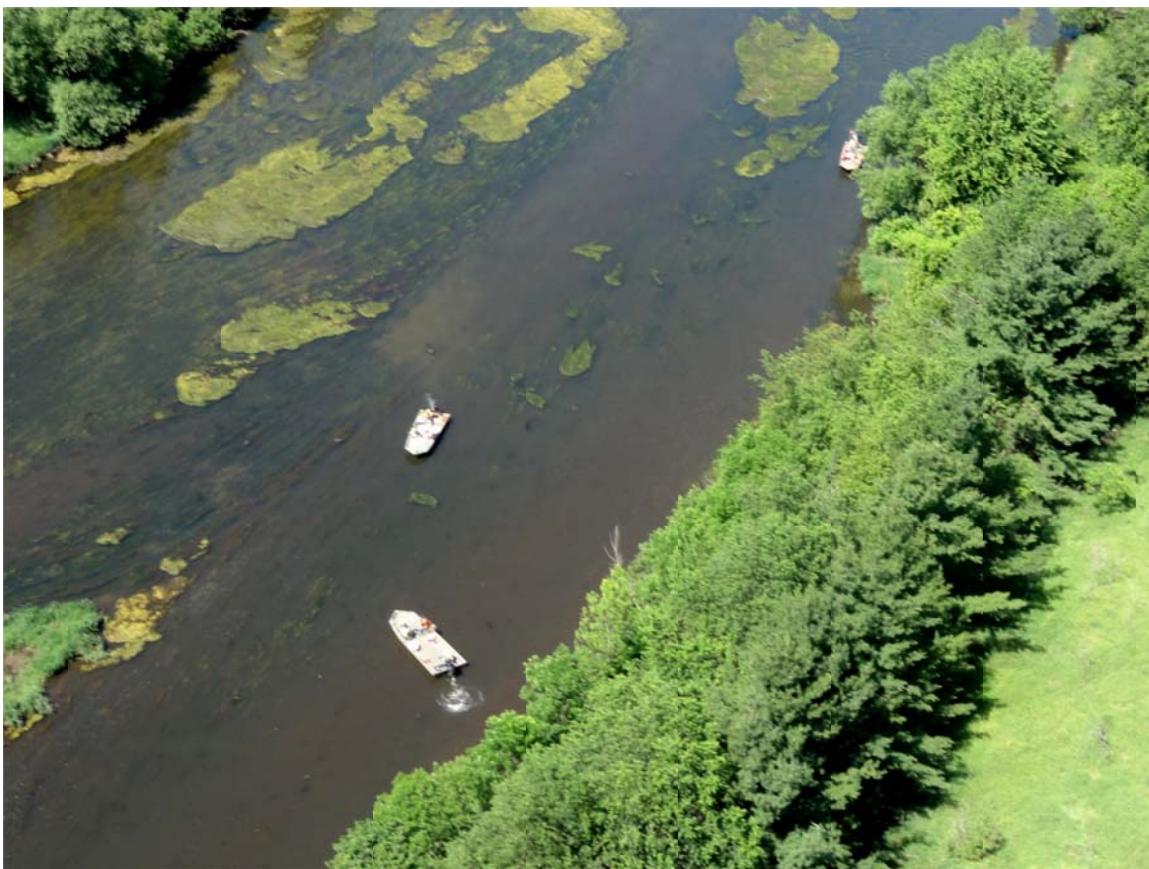
4. Poling crew observed along RDB adjacent to Island A.

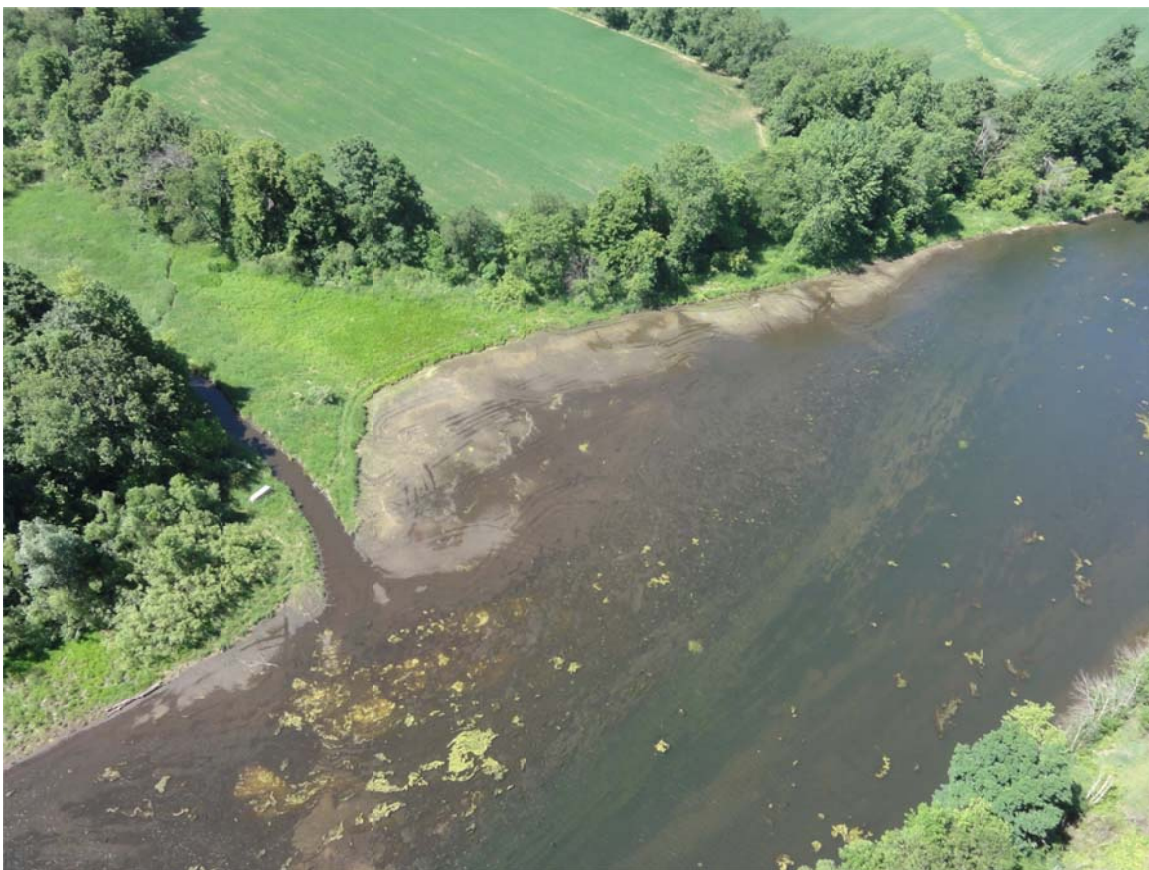
5. MP5.25 LDB Lily Pad area, no sheen observed.

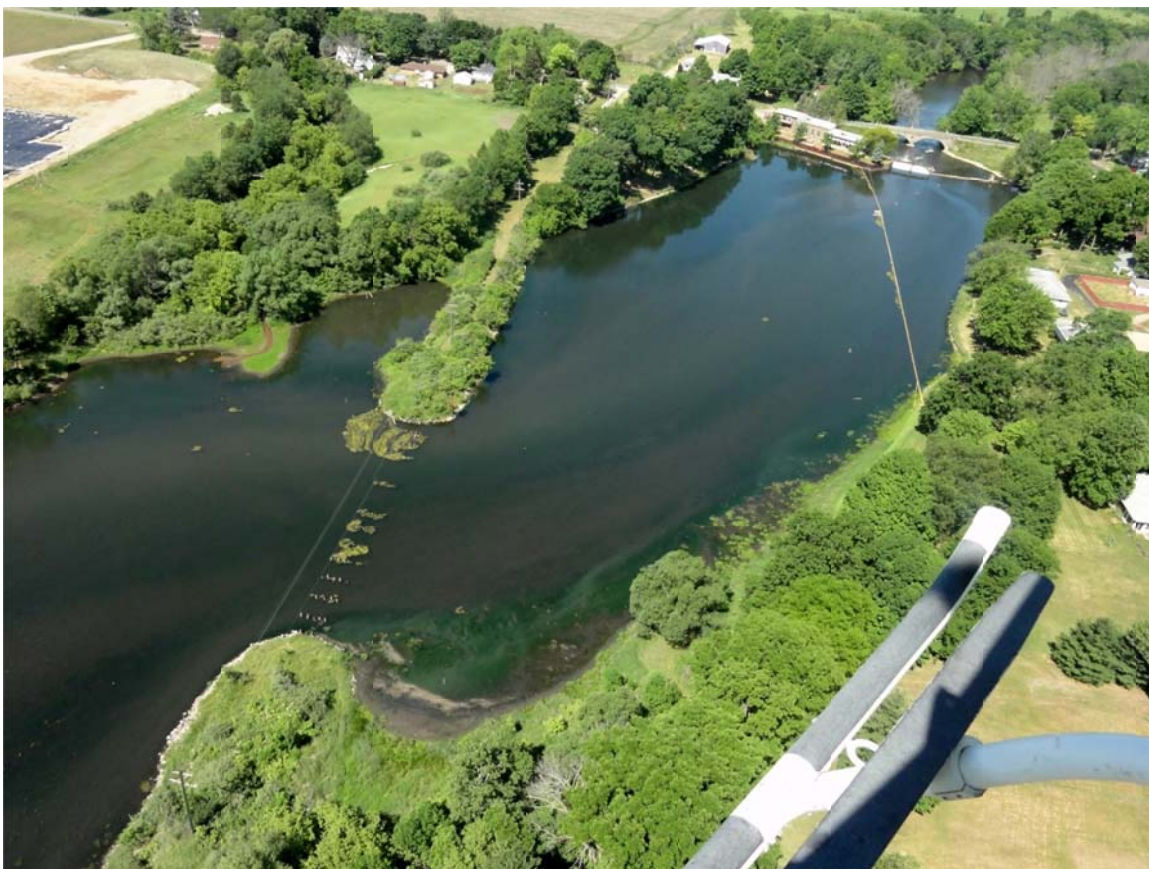
6. Ceresco Dam, boom maintenance crew observed.

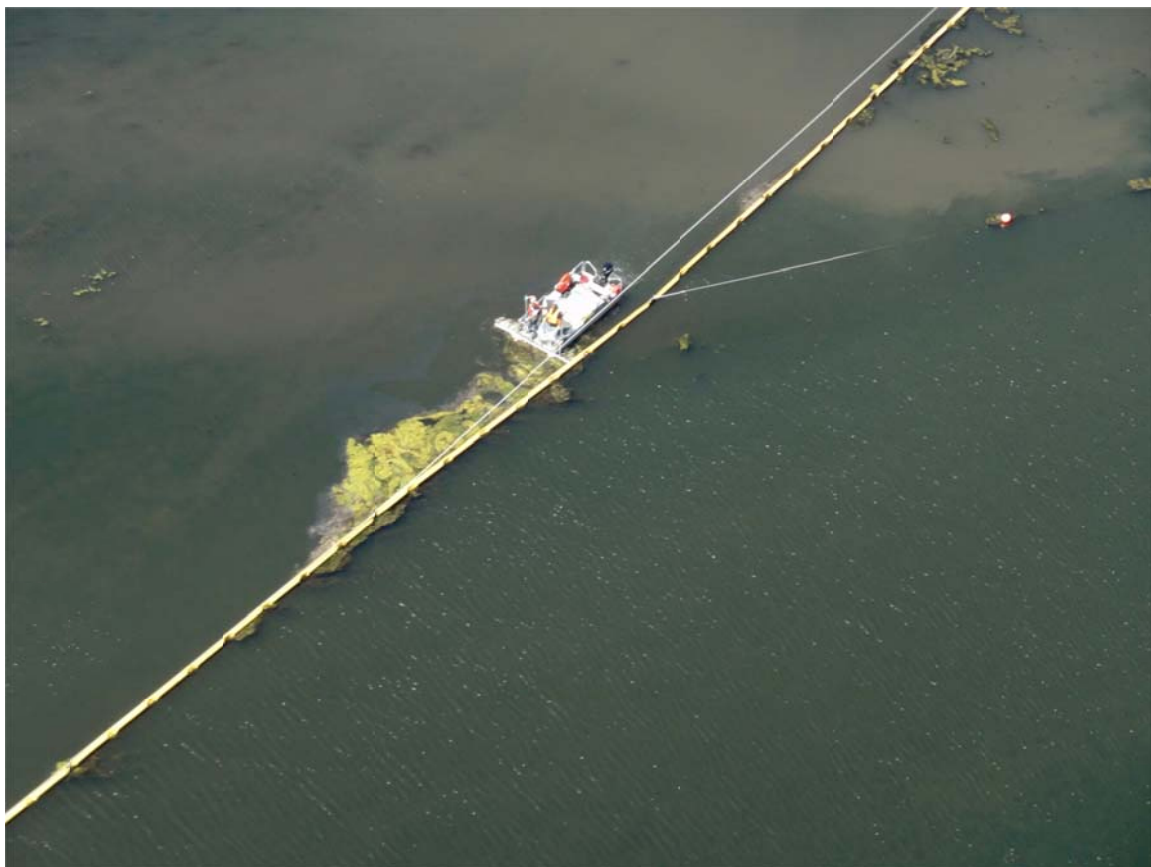
7. Ceresco Dam, boom maintenance crew removing debris from control point.  
Sheen and turbidity observed.

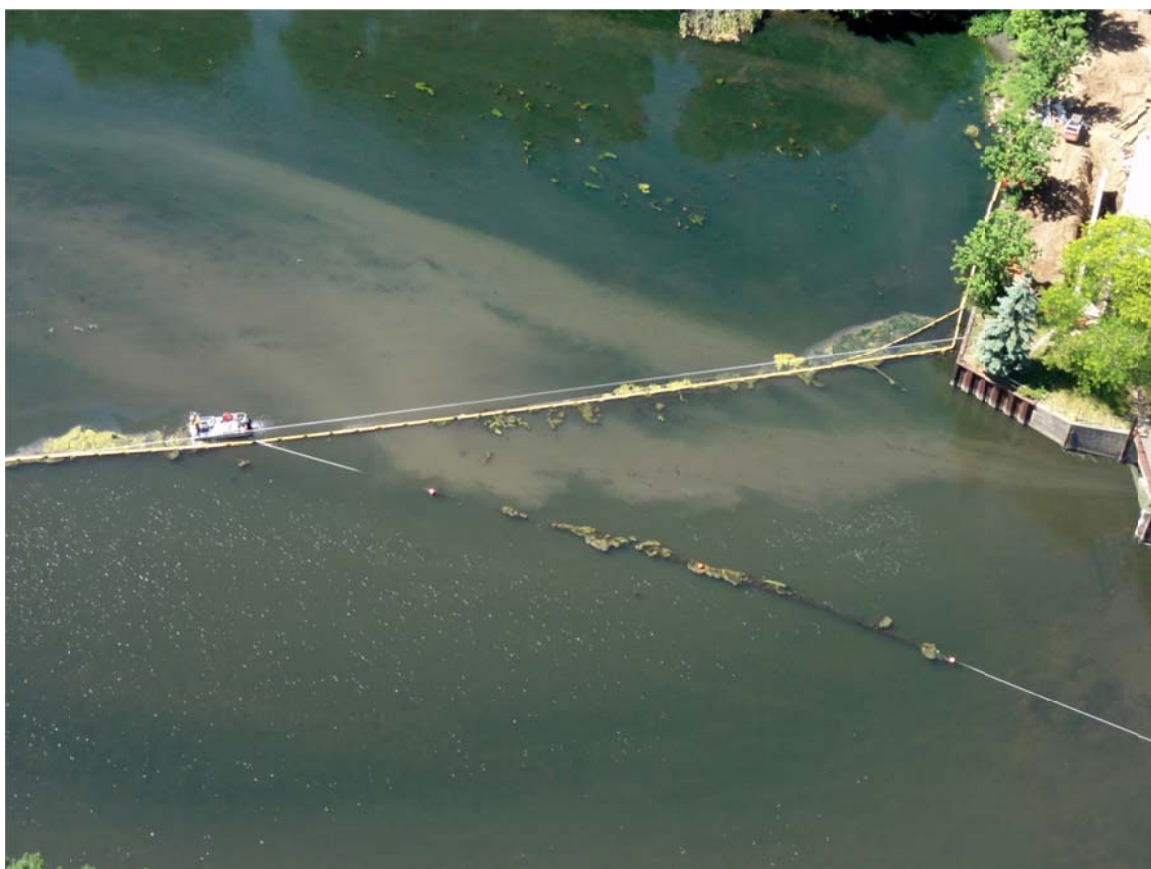
8. Turbidity plume observed above Ceresco Dam.

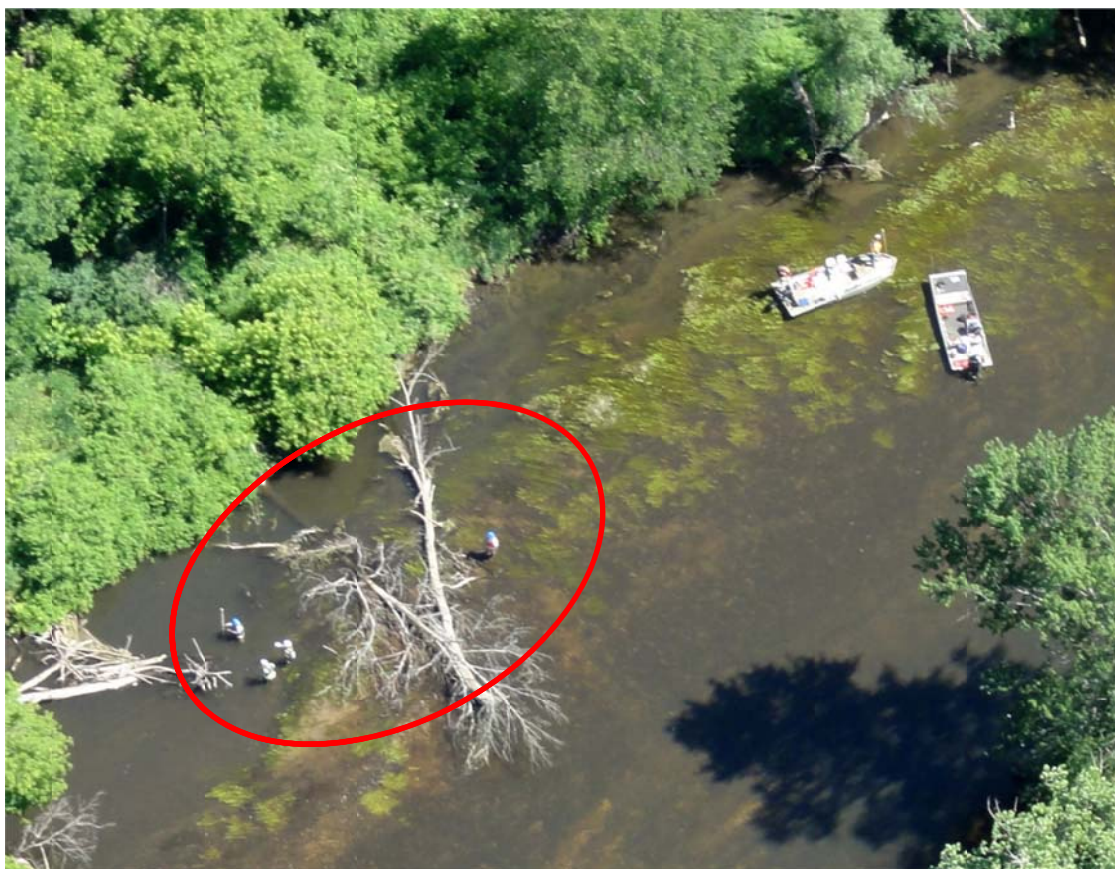
9. Poling crew observed in water near MP 10.25 RDB.

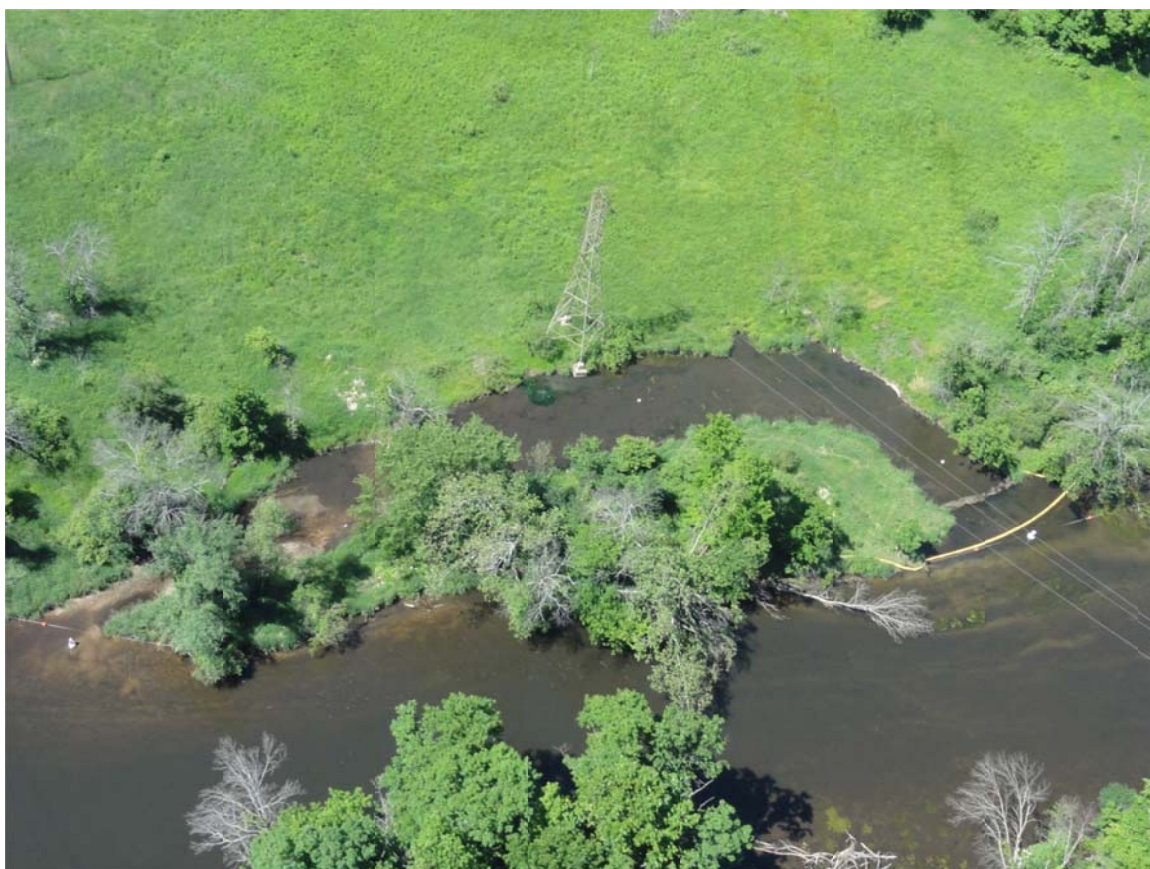
10. MP10.75 Sediment trap. No sheen observed.

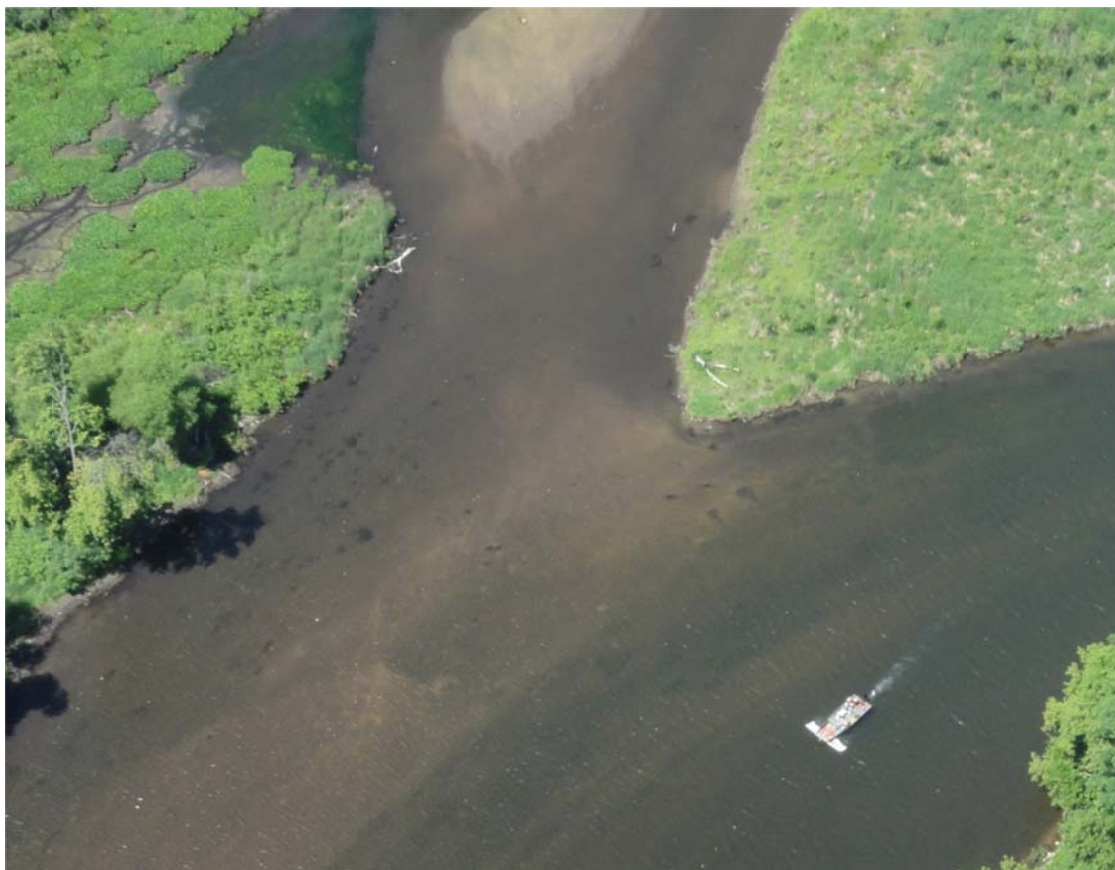
11. Sweeper boat observed at south end of Mill Ponds.

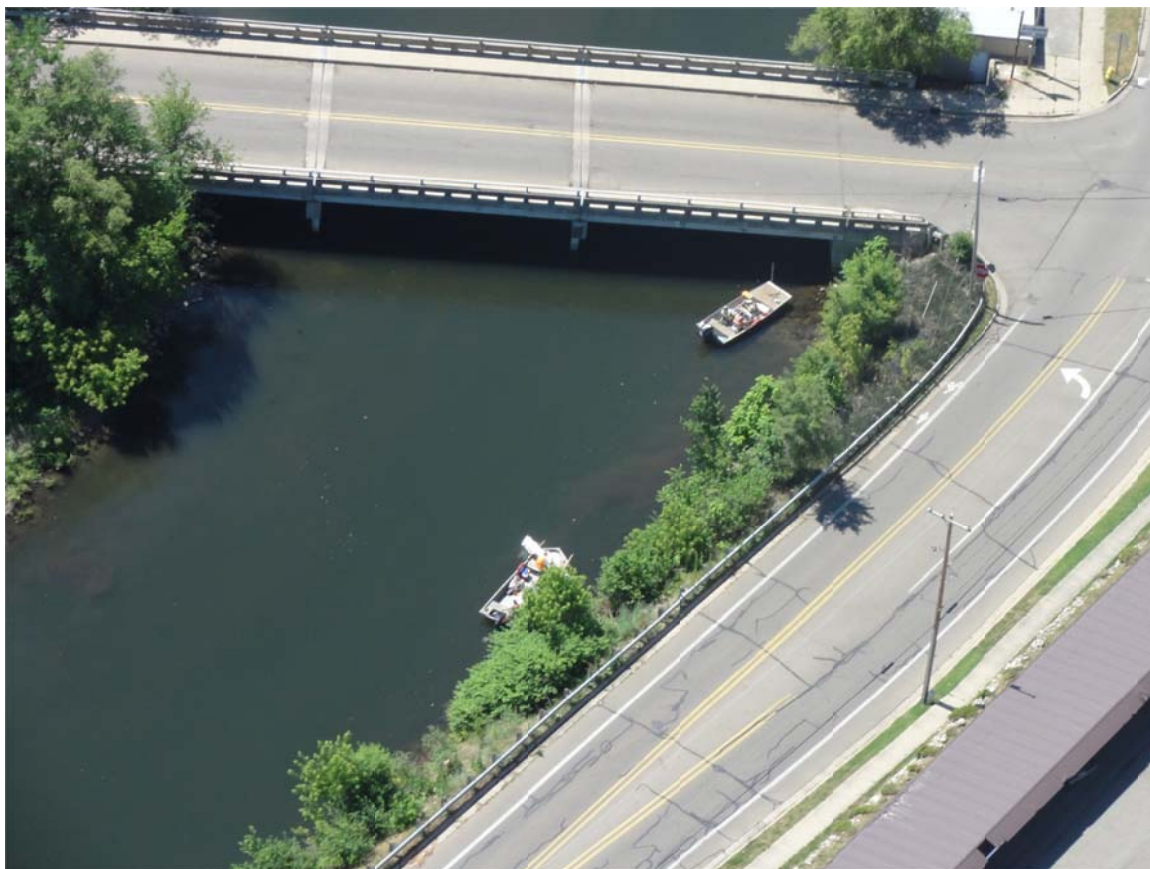
12. Poling Crew and sweeper boat at Burnham Street bridge in Mill Ponds.

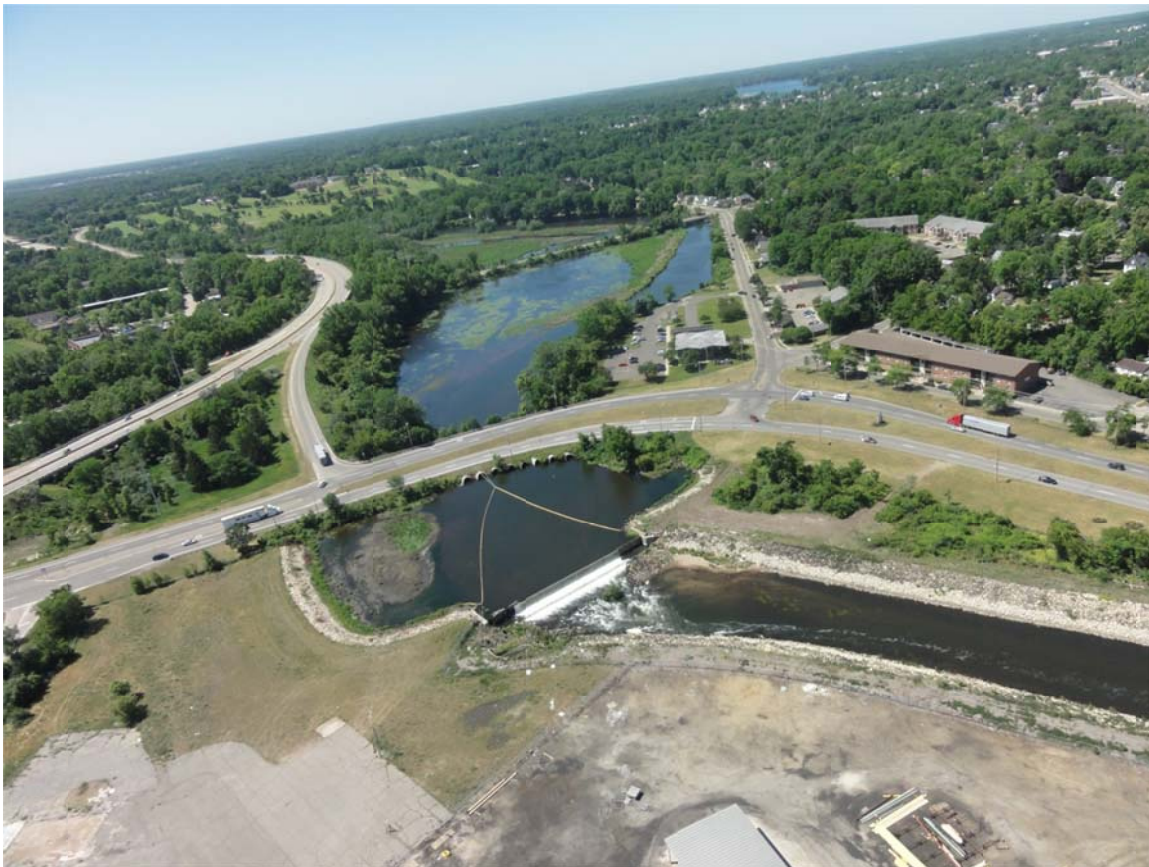
**13. Battle Creek Spillway and Mill Ponds. No sheen observed.**

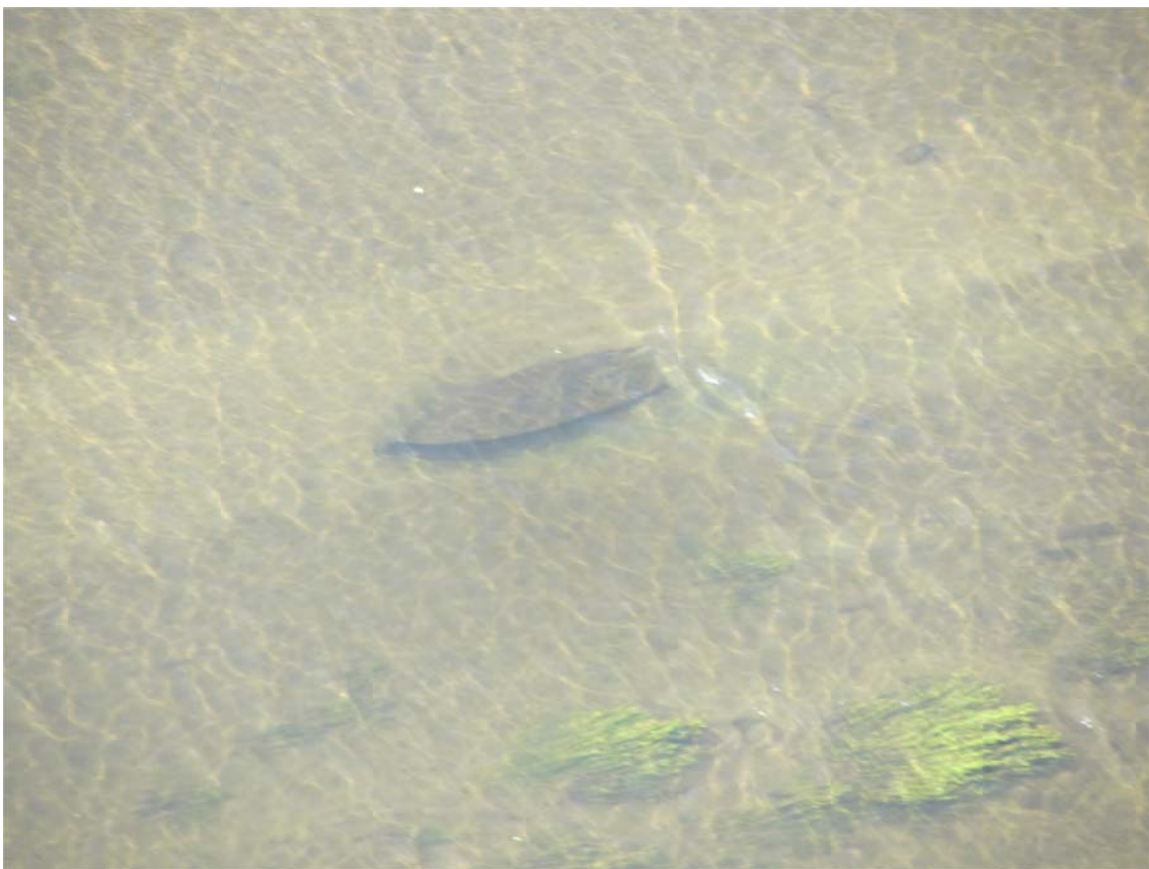
**14. Possible submerged boat observed in river near MP 19.0.**

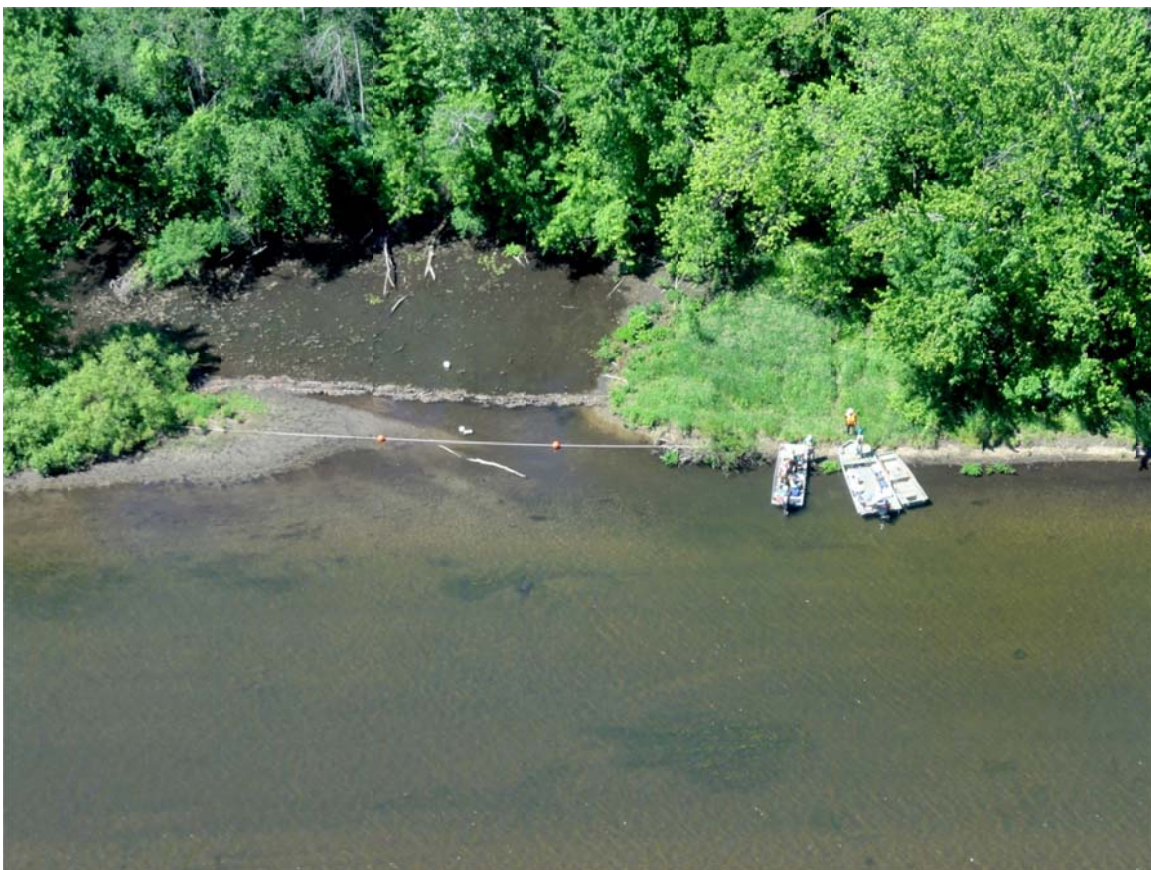
15. Poling crew observed at MP19.25 sediment trap.

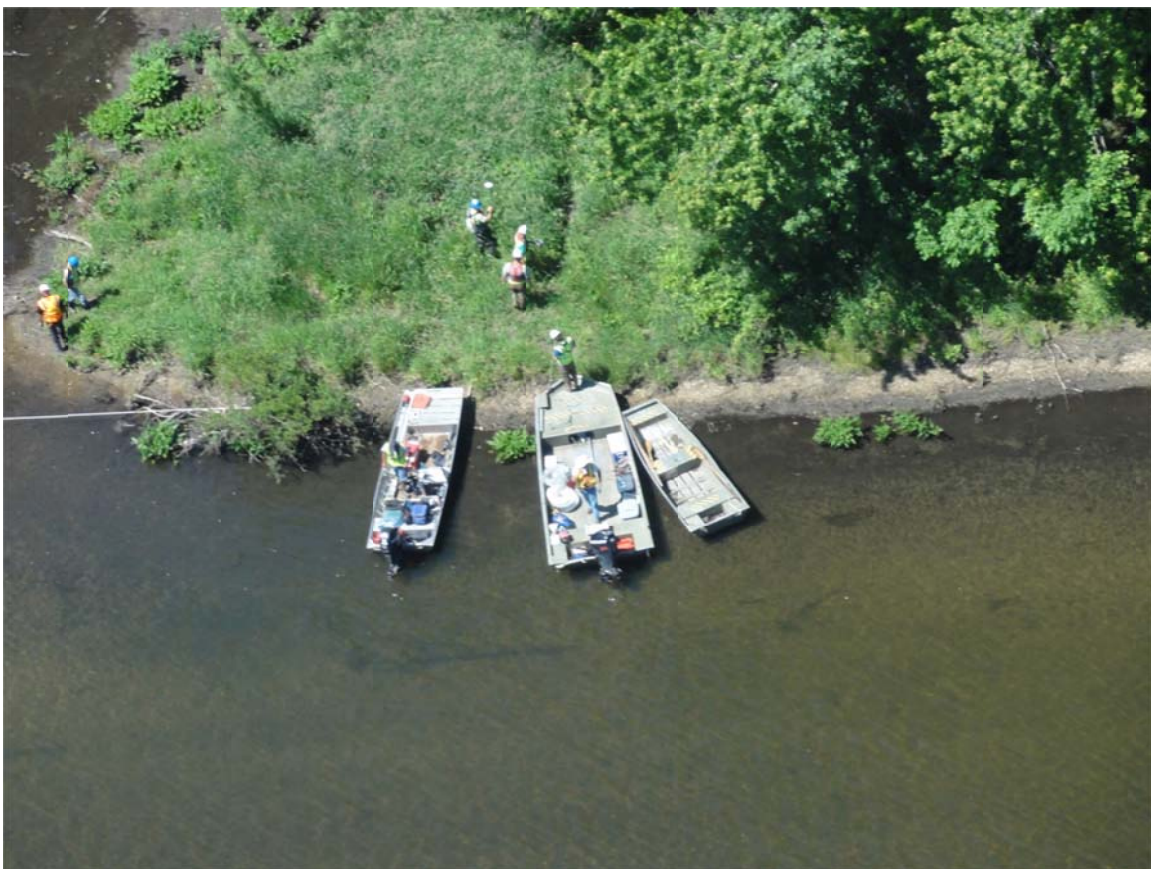
16. Poling crew at MP 19.25 sediment trap.

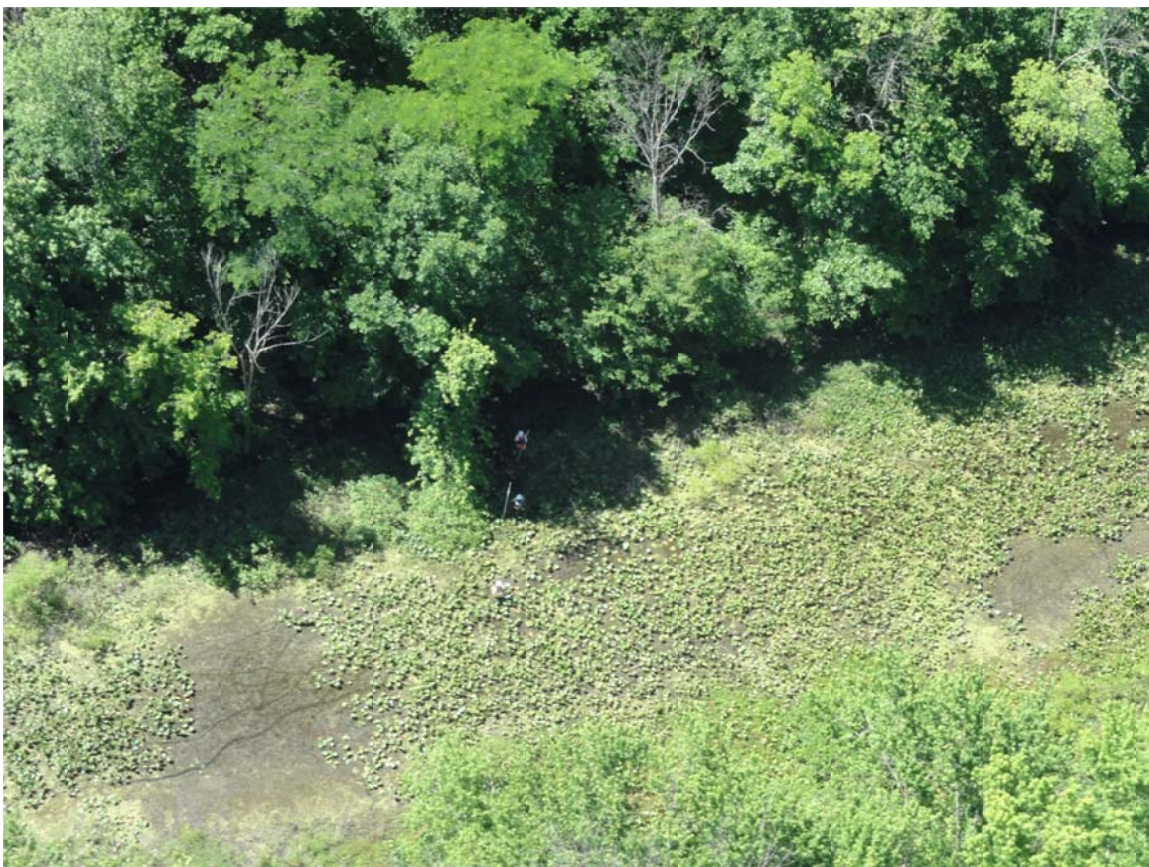
17. MP24.5 RDB, poling crew observed in backchannel.

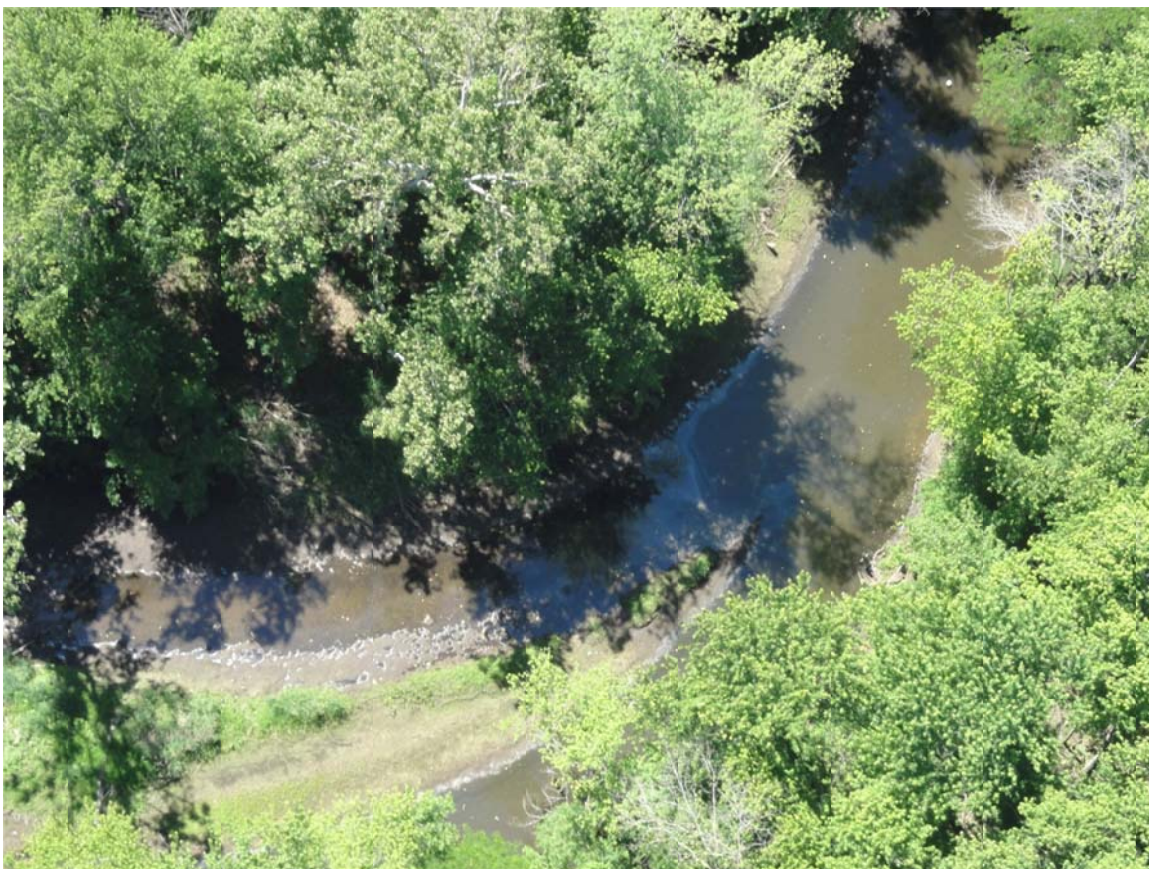
18. MP28.25 back channel, sheen observed. Operations observed.

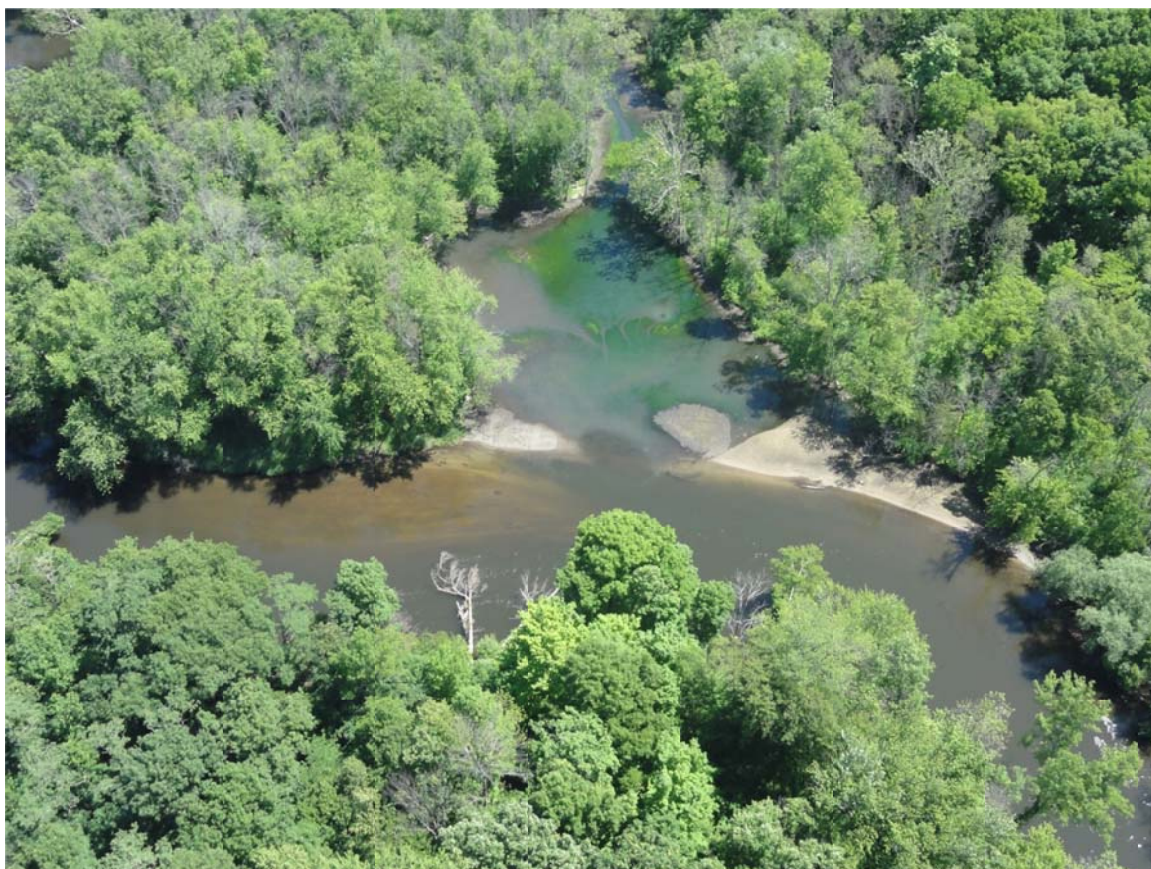
19. MP30.8, no sheen observed within the boom.

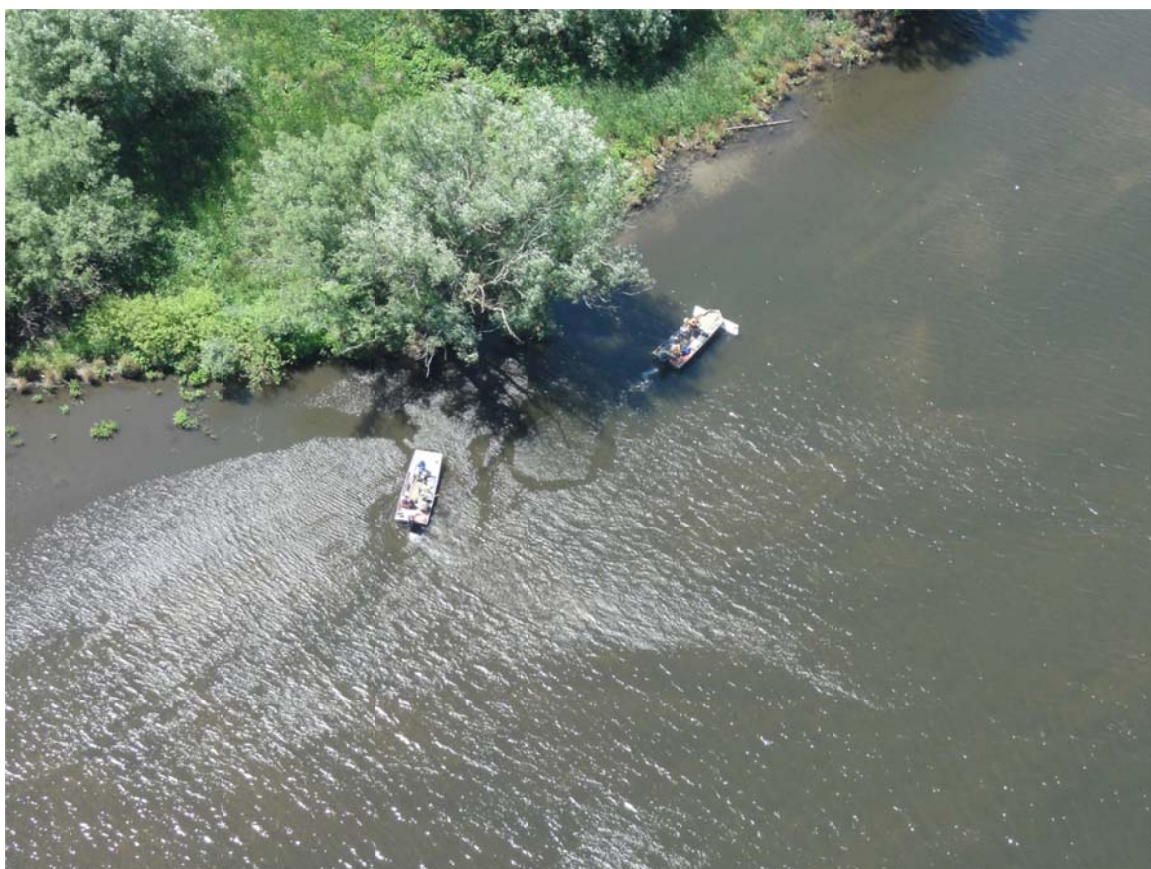
20. Poling crew observed at east end of Morrow Lake Delta.

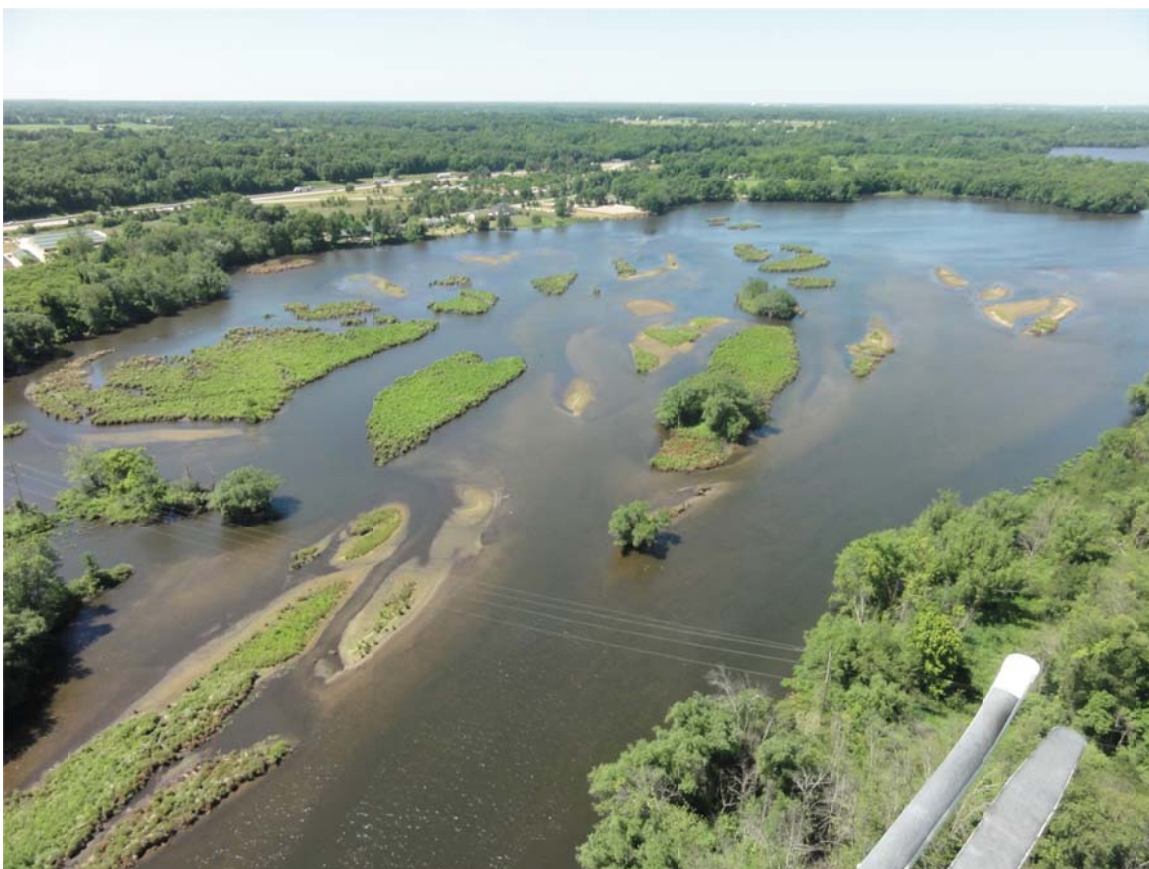
21. Overview of Morrow Lake Delta.
