Situation Photo Log

Wednesday, June 13, 2012

Kalamazoo River / Enbridge Spill

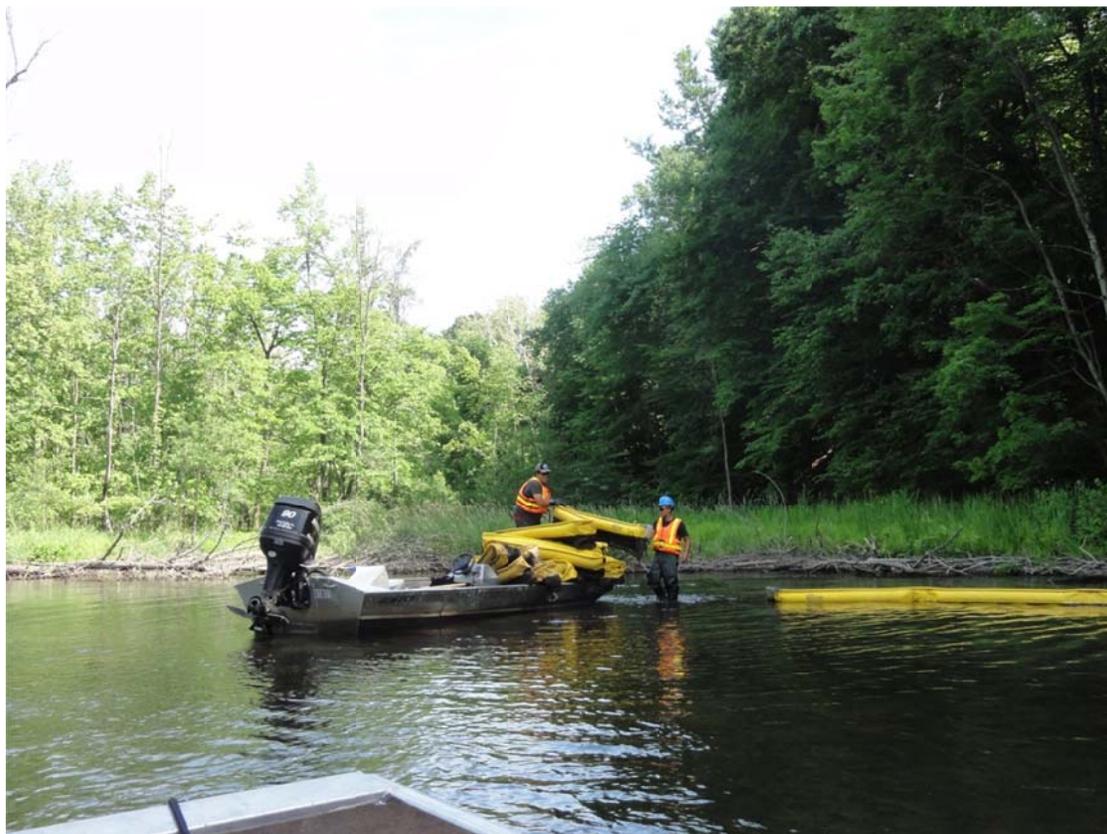
1. Containment crews removing boom from MP 8.5 L3 location.

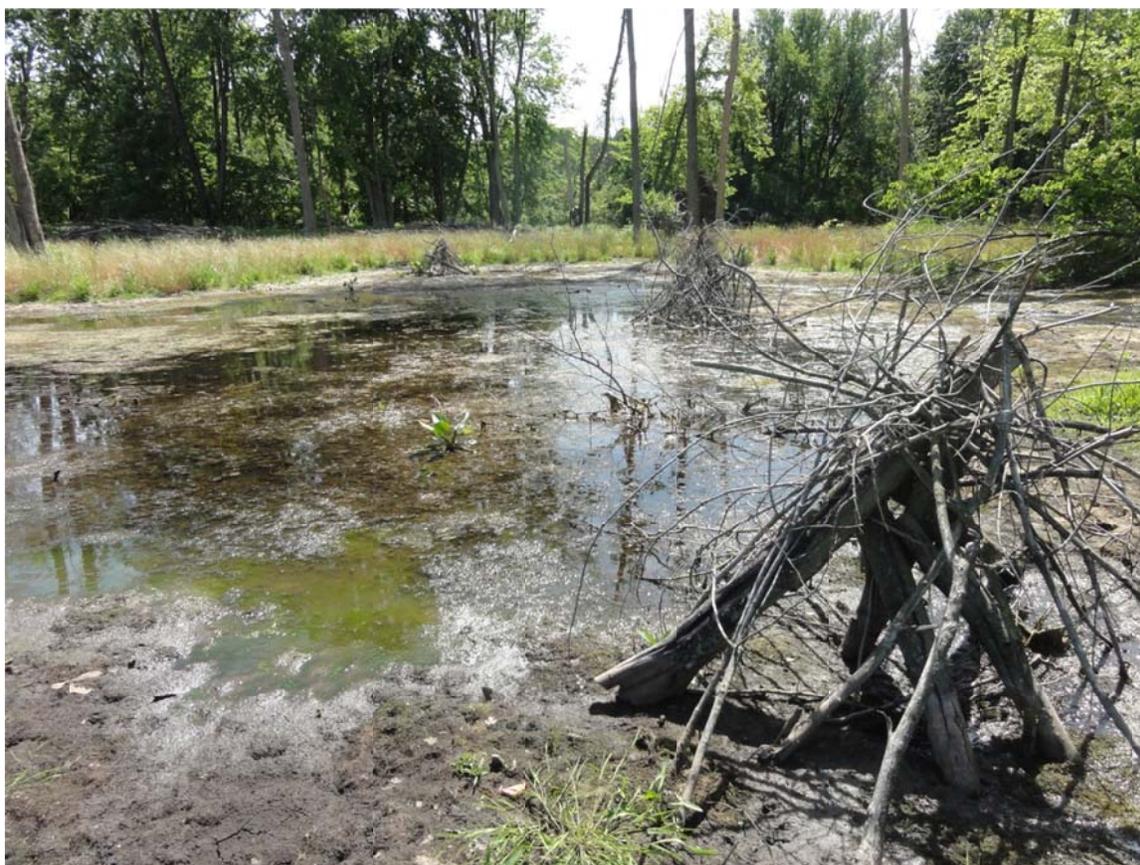
2. North side of former excavation area at MP 11.25 R2 LDB. No sheen observed.

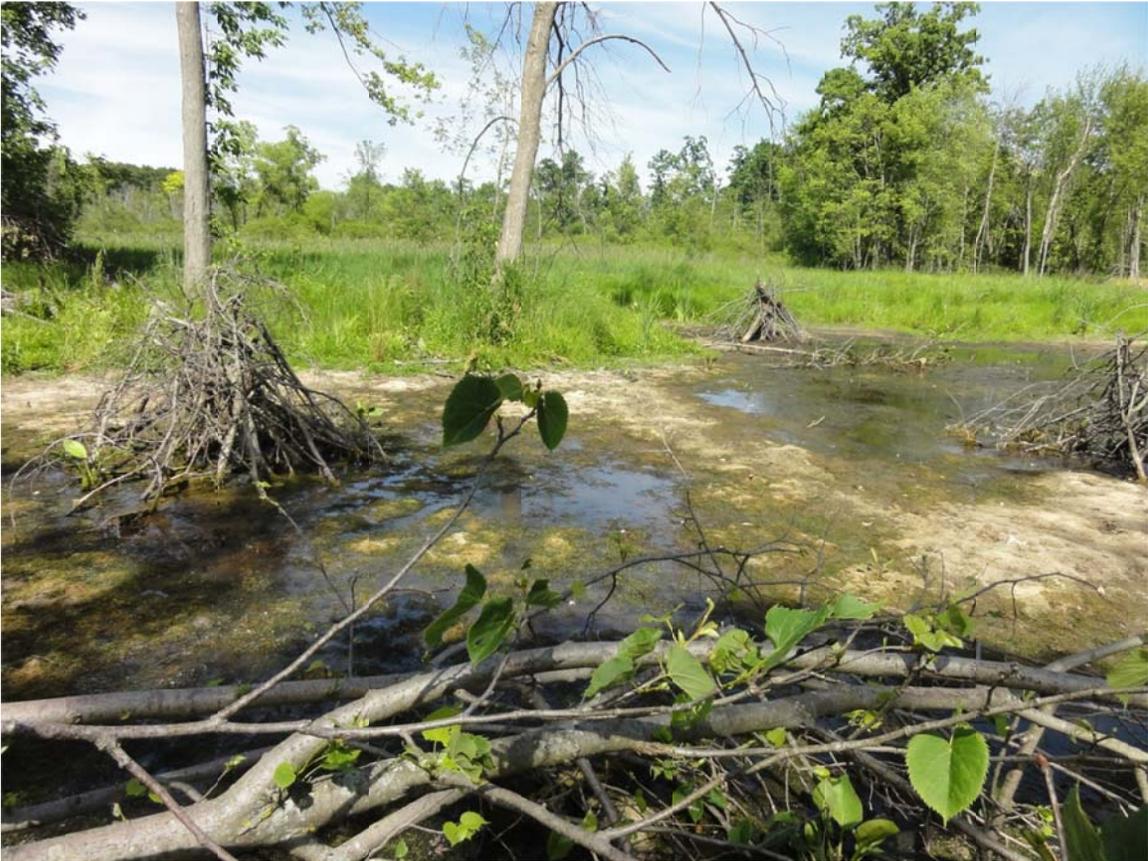
3. South side of former excavation area at MP 11.25 R2 LDB. No sheen observed.

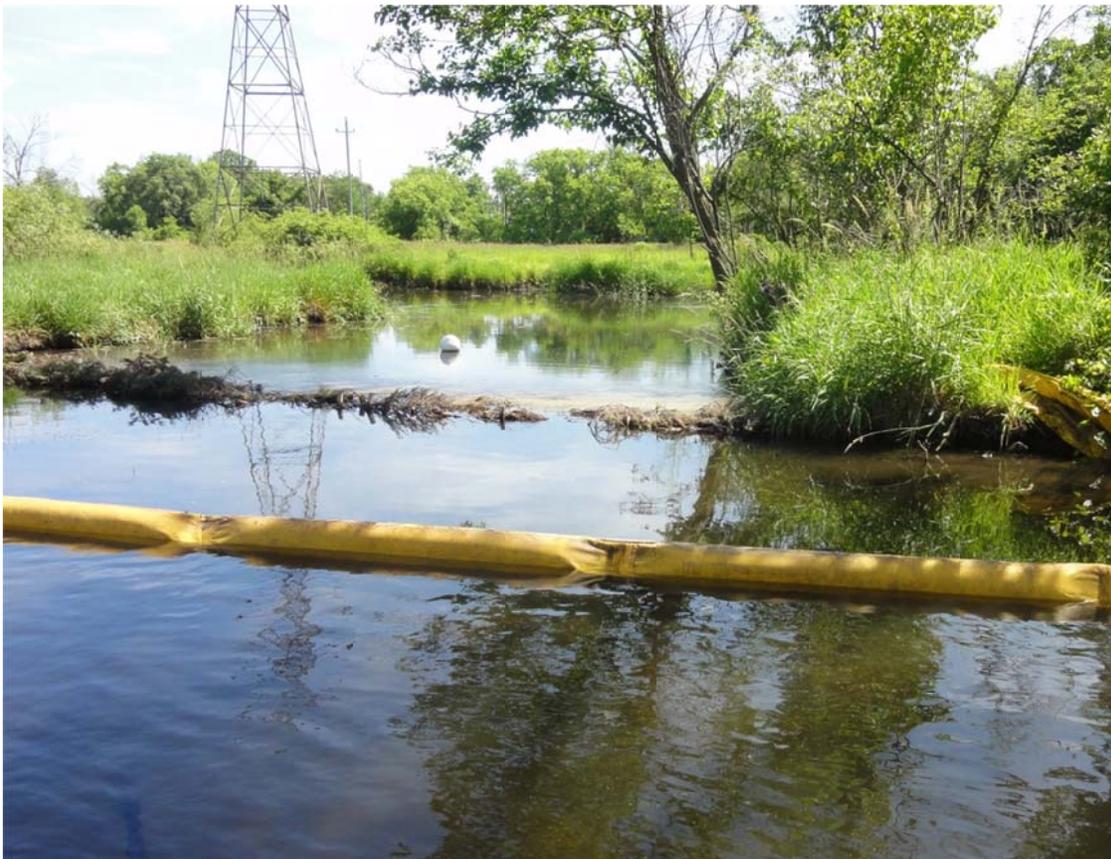
4. Sediment trap at MP 10.75 LDB. Sheen observed within containment.

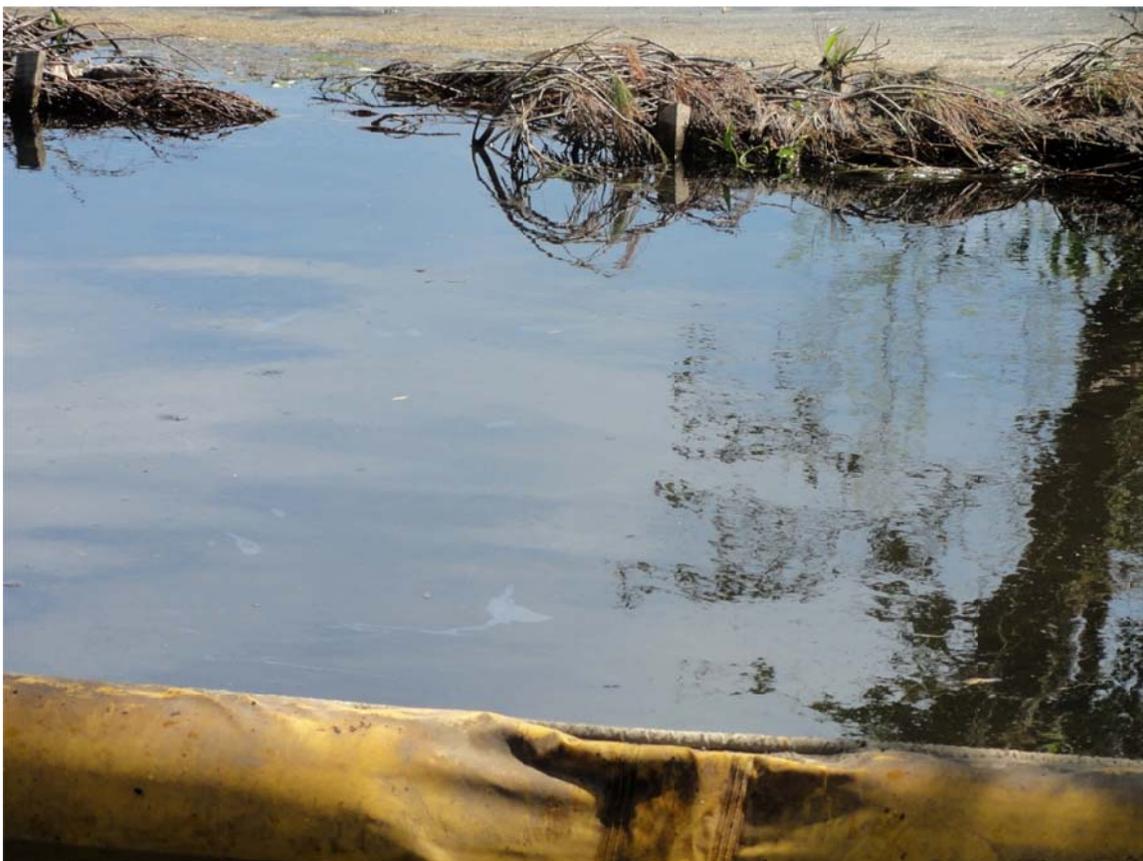
5. Sheen within containment at the MP 10.75 sediment trap.

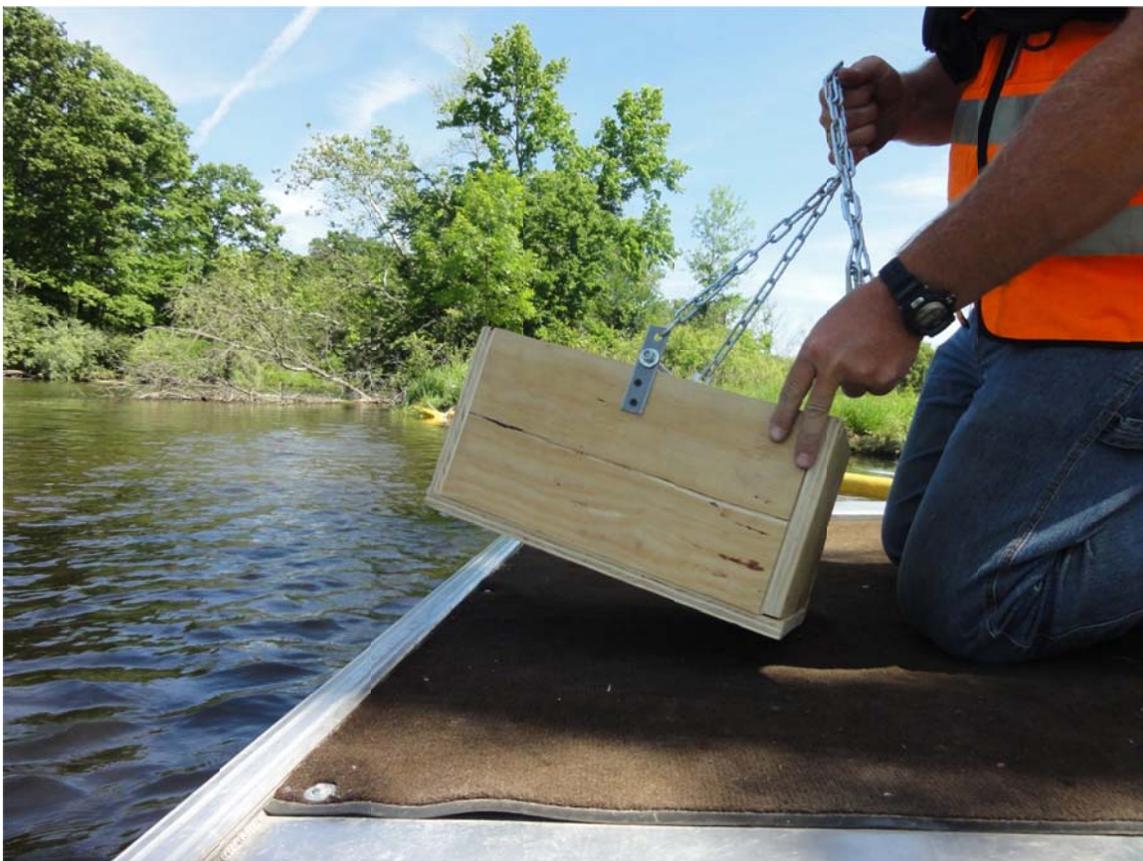
6. Containment crew deploying a new sediment sampler on the downstream side of the MP 10.75 LDB sediment trap.

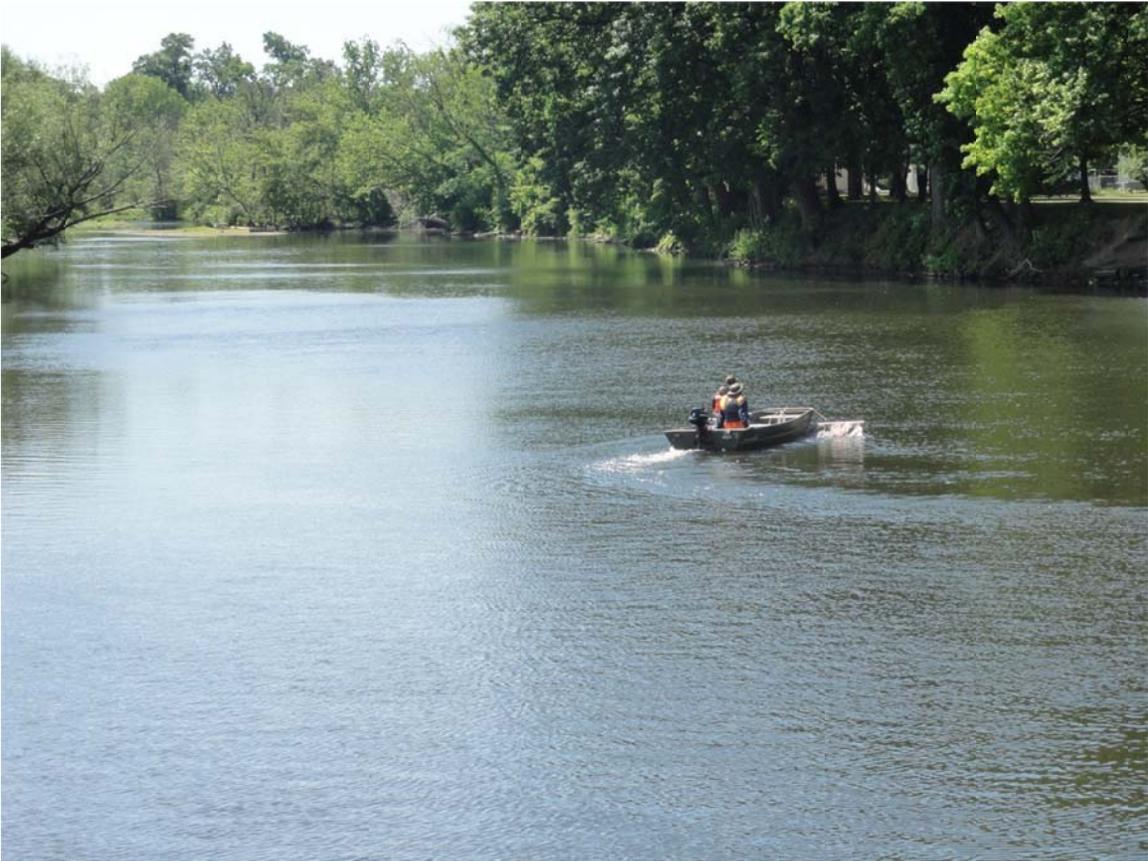
7. Sheen sweeper crew operating at the Mill Ponds just south of the Burnham Street Bridge.

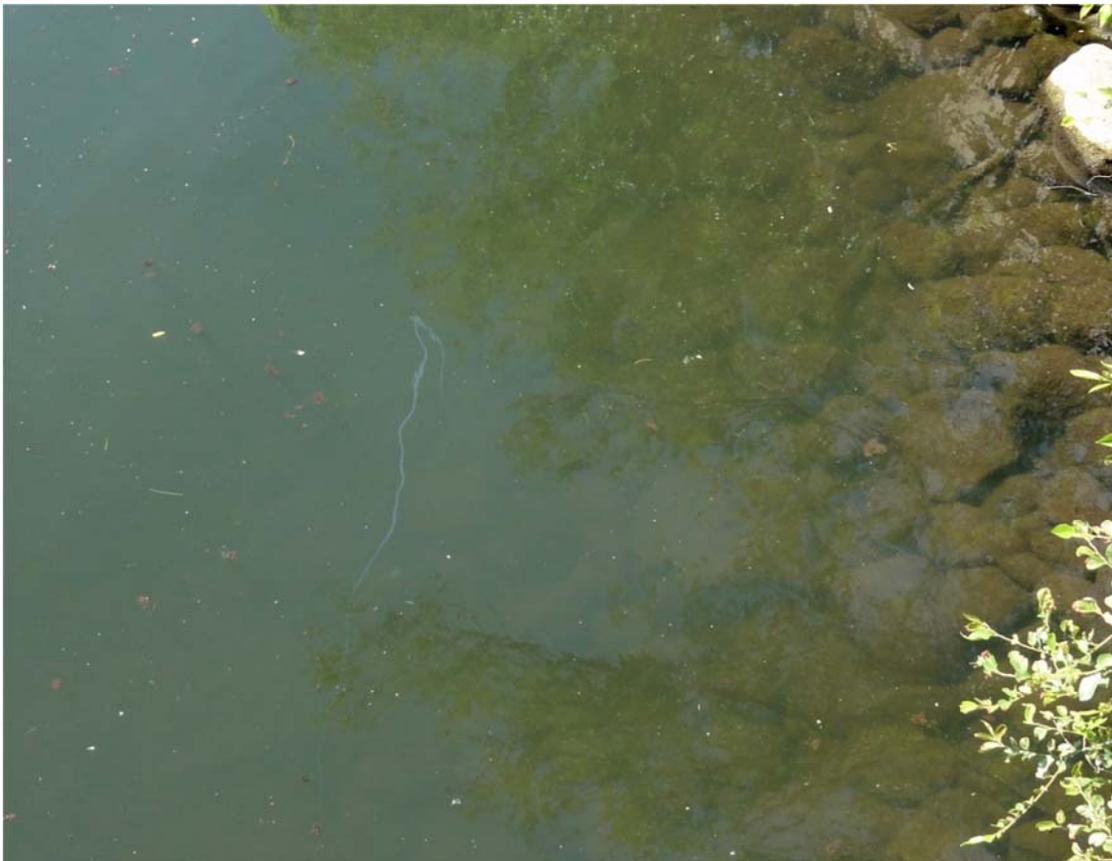
8. Sheen observed in the river channel at the Mill Pond upstream from the Battle Creek Spillway control point.

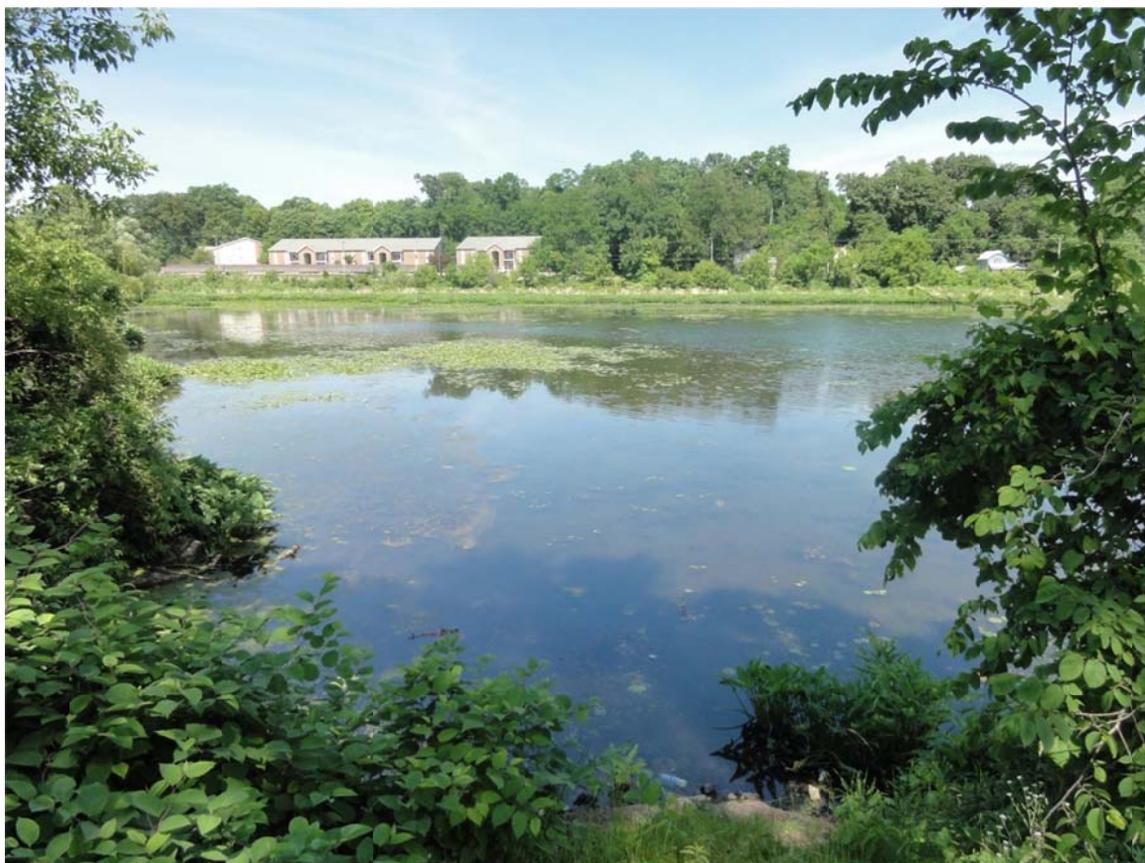
9. Northern end of the Mill Pond looking west. No sheen observed.

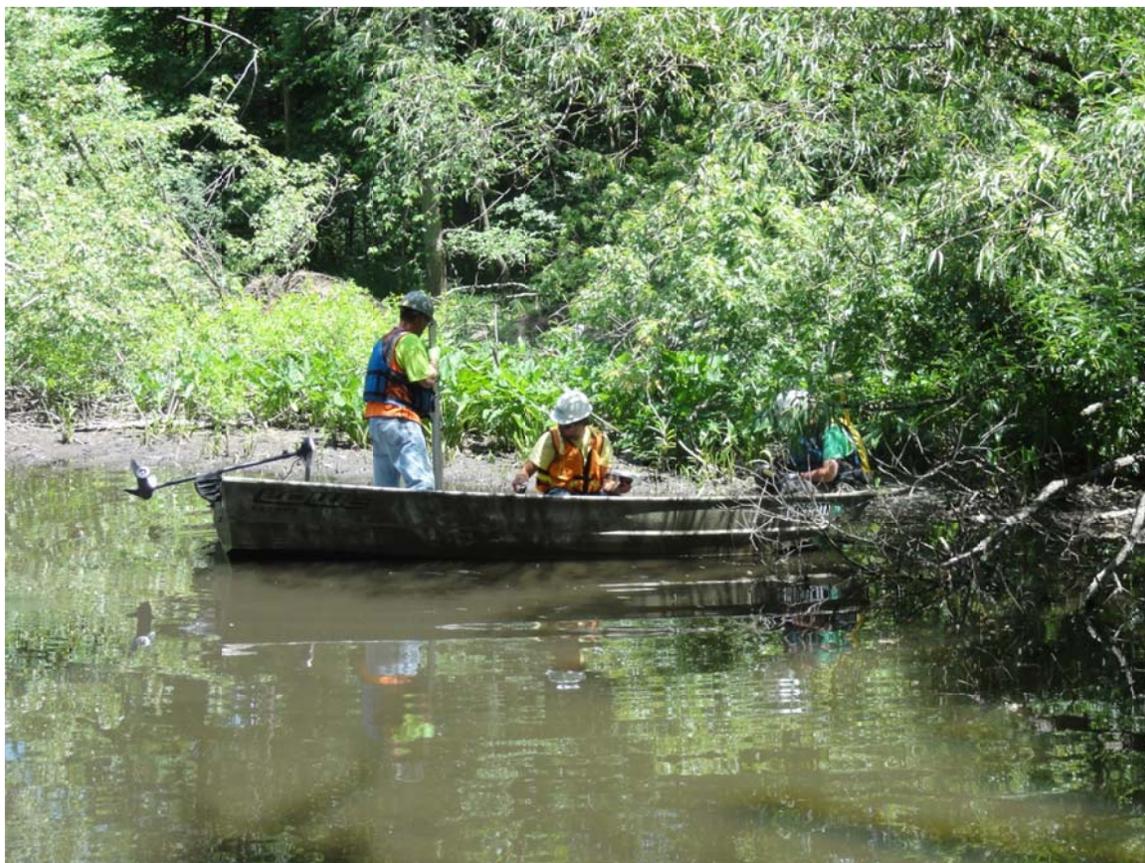
10. Poling crew operating in overbank channel near MP 24.6 LDB.

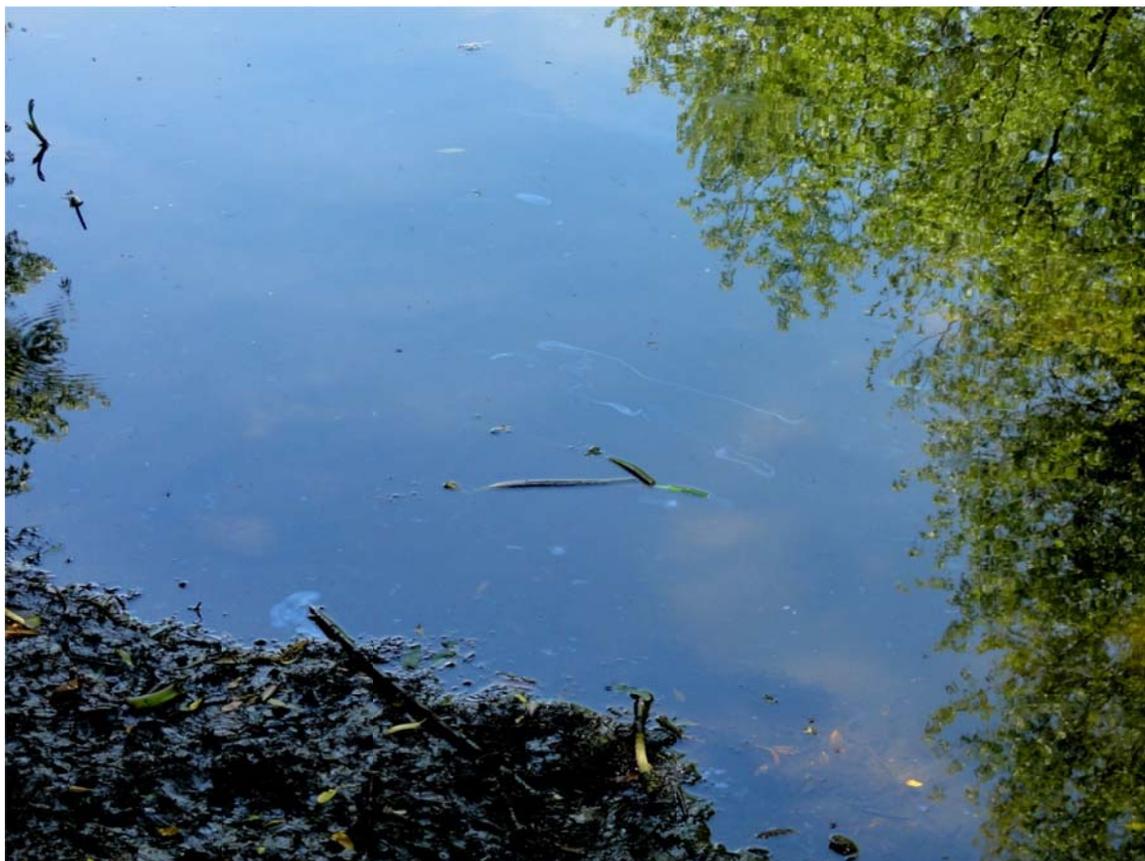
11. Sheen generated and cleaned up by poling crews in overbank channel near MP 24.6 LDB.

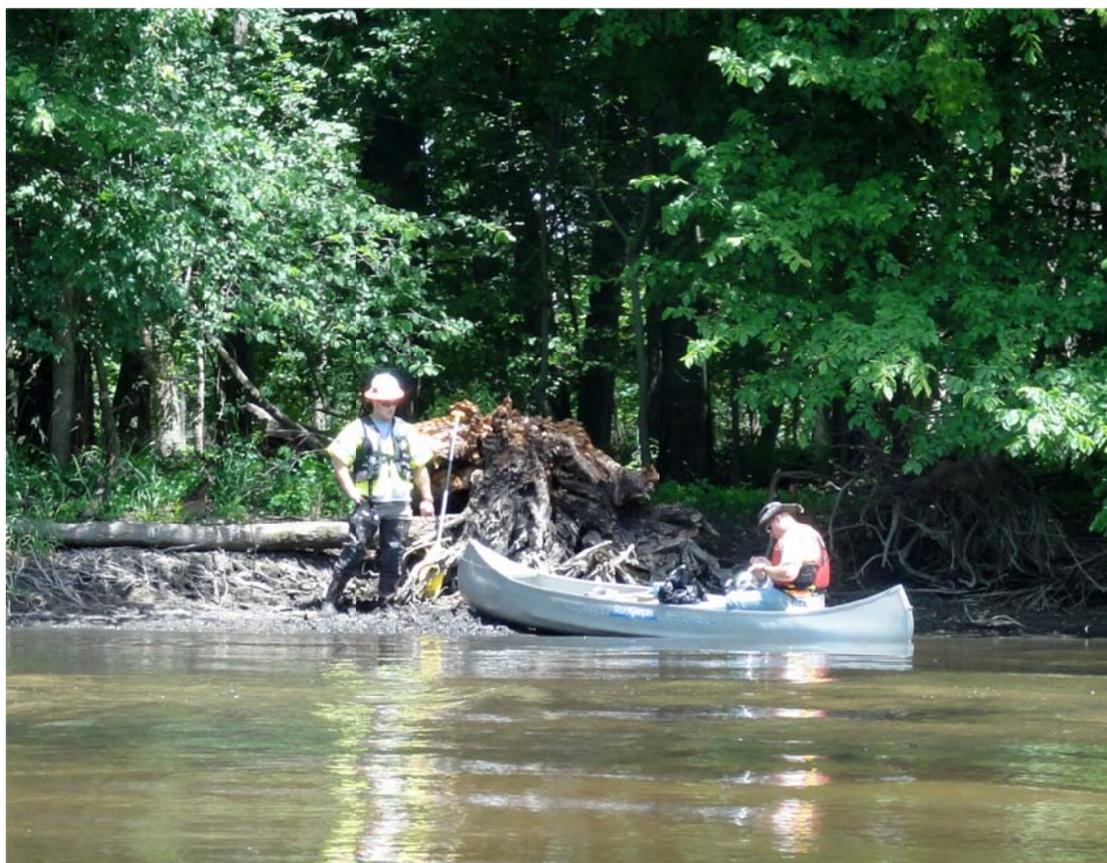
12. Air monitoring crew collecting air samples near MP 27.00 LDB.

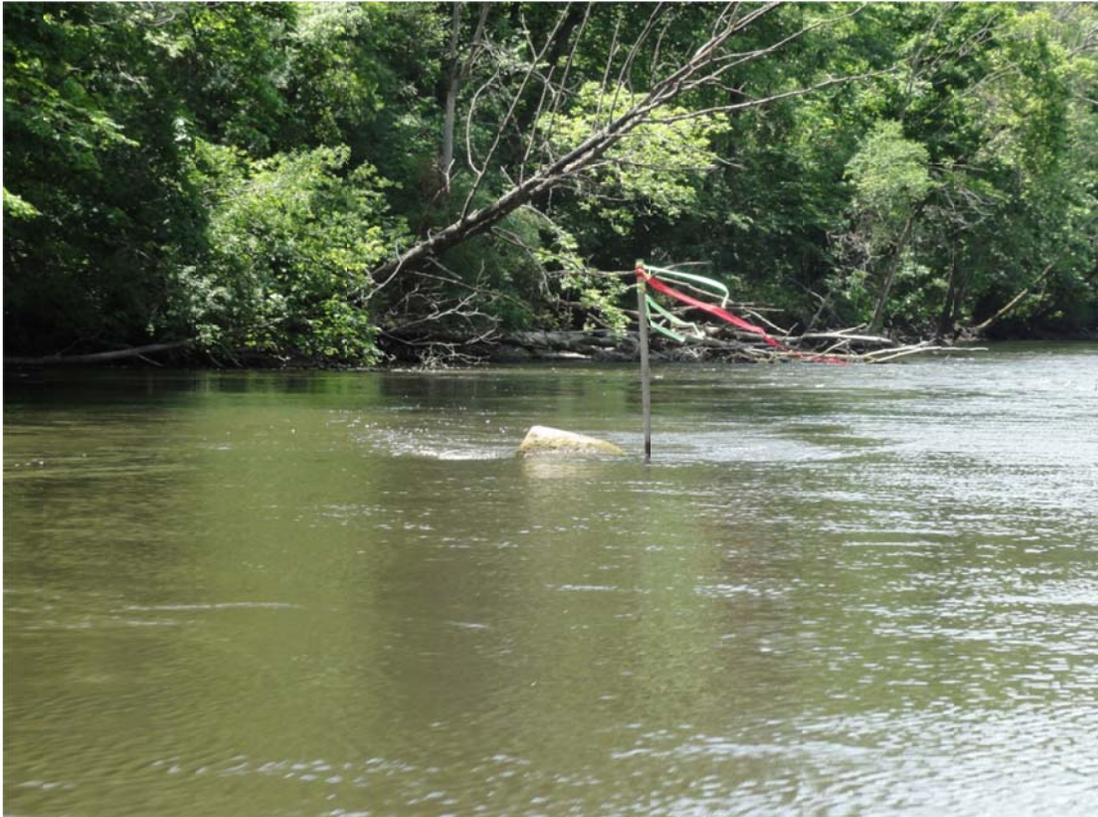
13. Shallow rocks and river hazards flagged by boat crews due to low river levels.

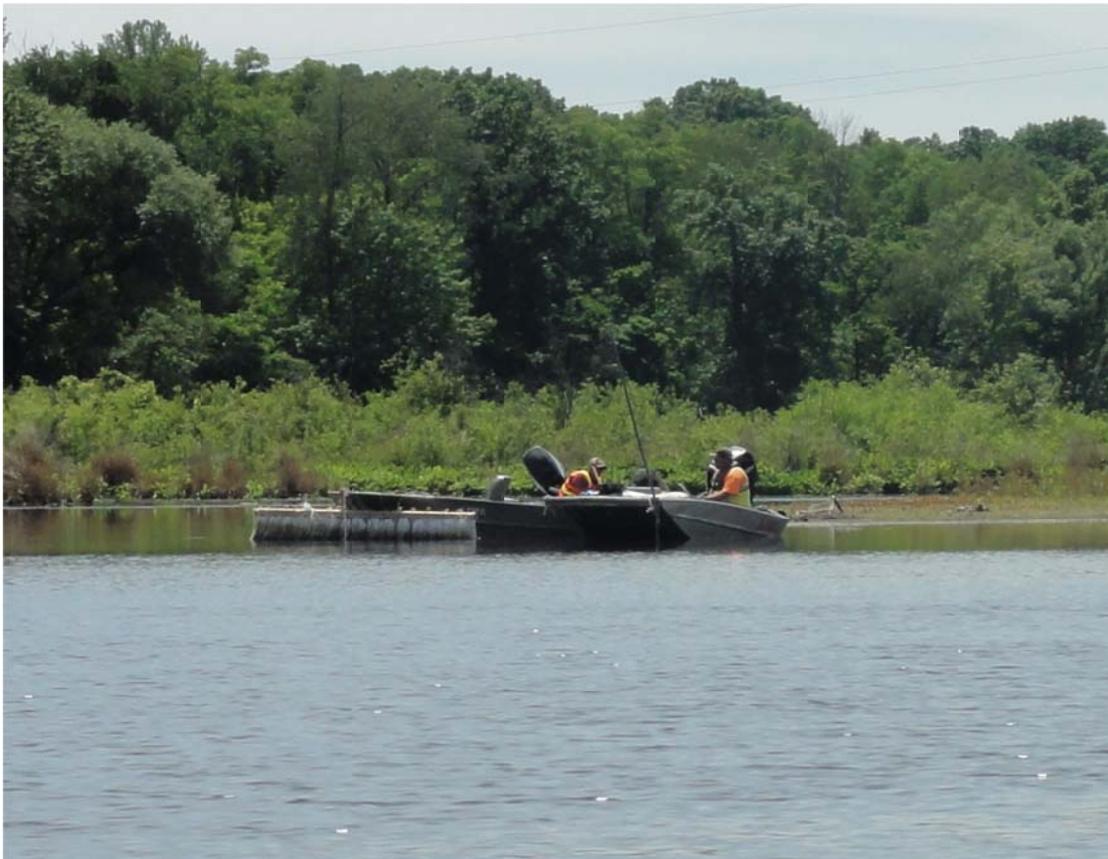
14. Poling crew and sheen sweep boat operating in southeastern portion of Morrow Lake Delta.

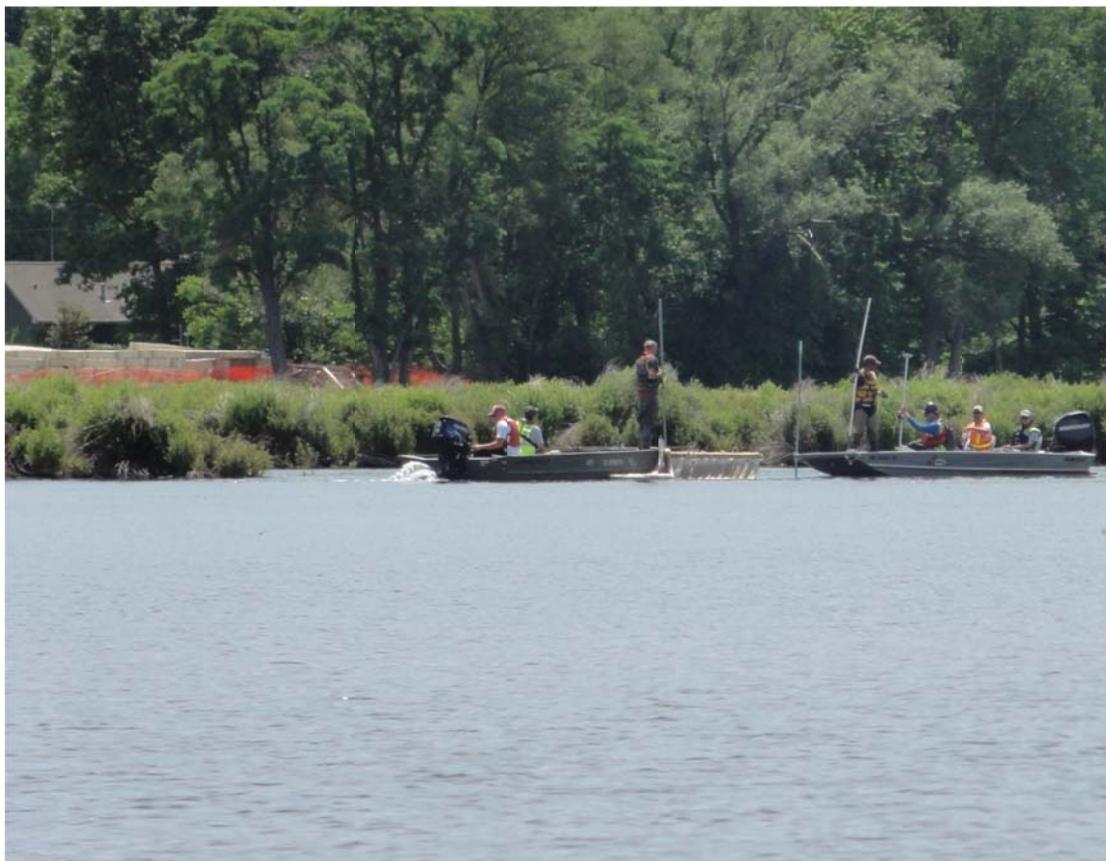
15. Poling crew and sweeper boat operating near southern shore of Morrow Lake Delta.

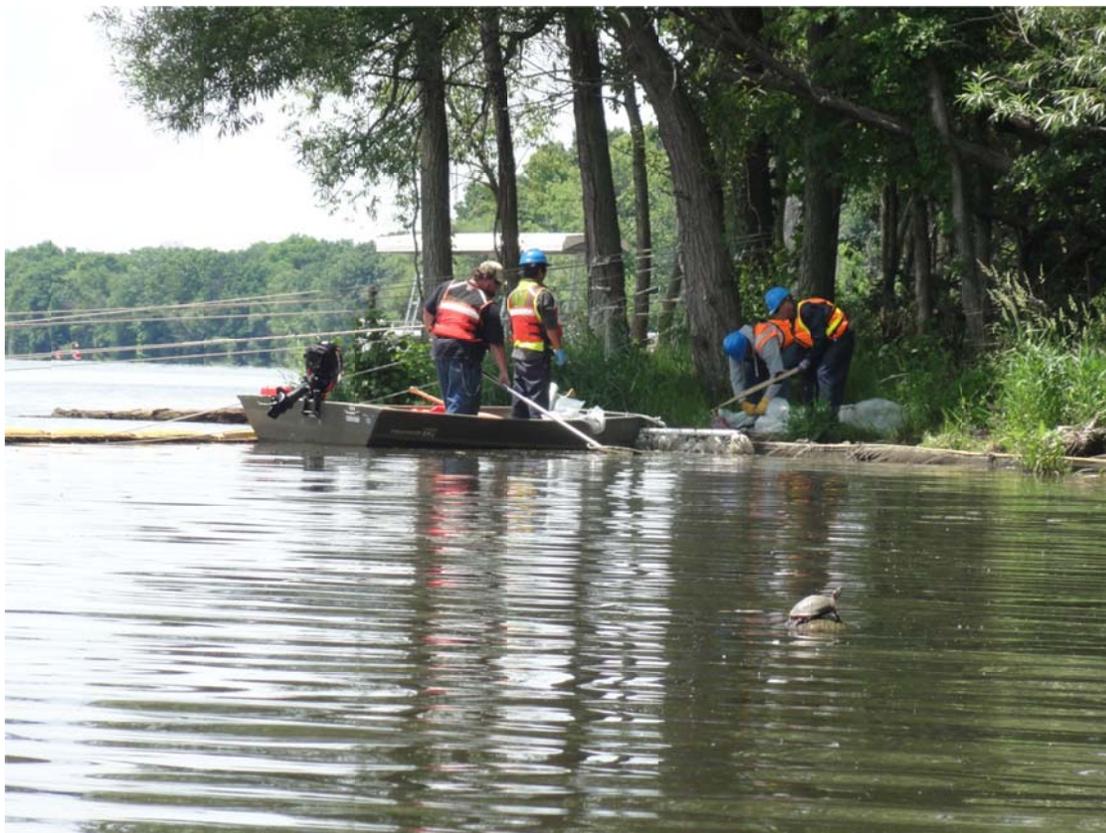
16. Containment crews removing debris from E 4.0 control point.

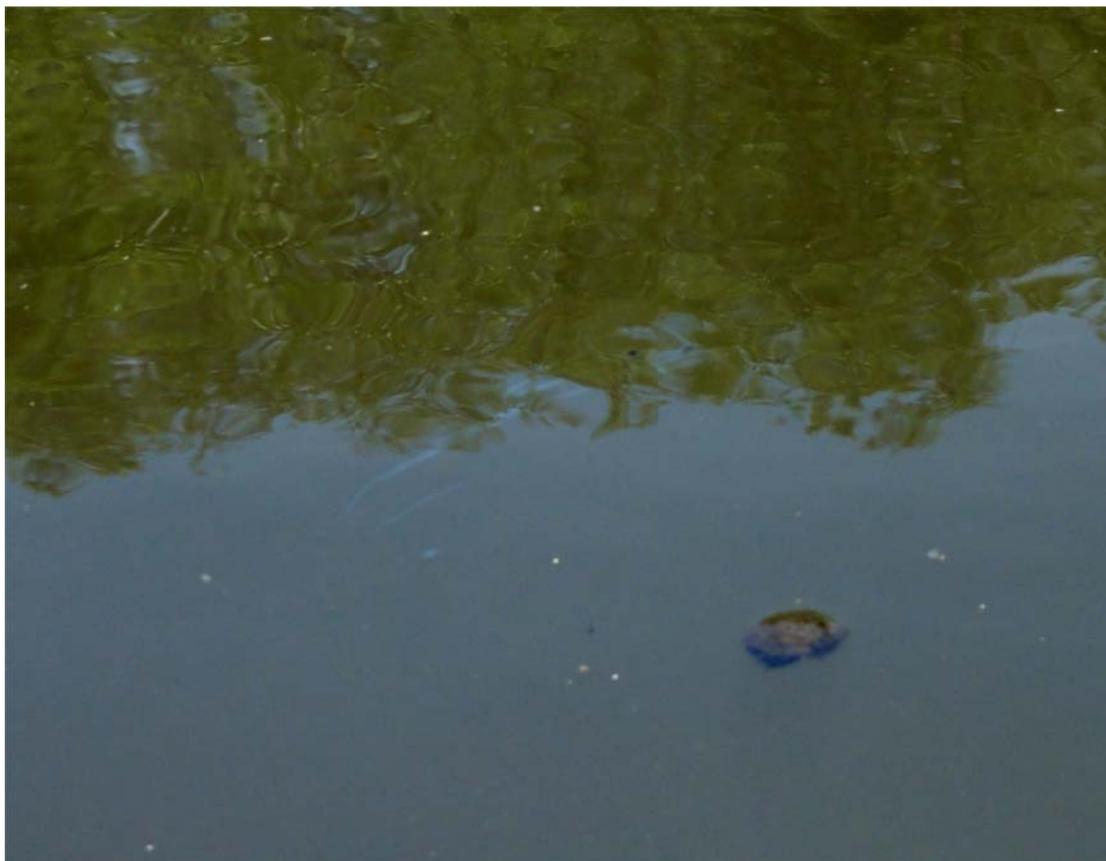
17. Sheen and tar globules observed along upstream side of E 4.0 control point.

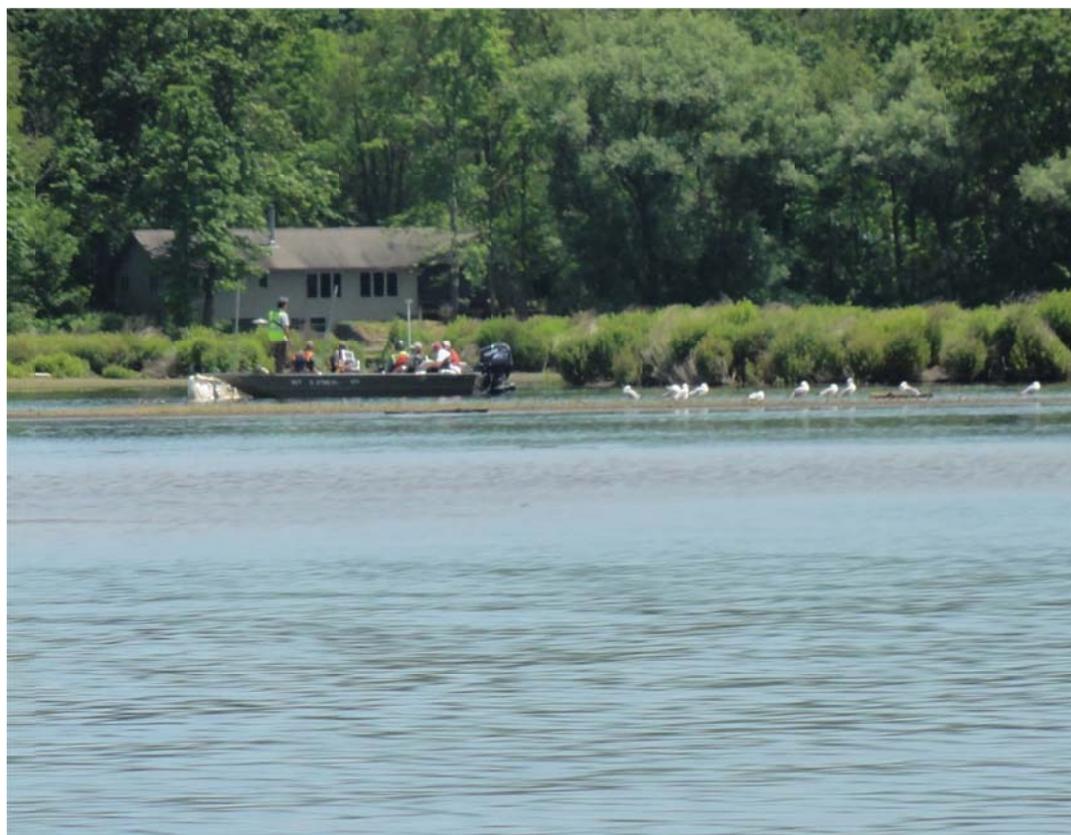
18. Poling crew surveying in the southwestern corner of Morrow Lake Delta.
