# Situation Photo Log

Tuesday, June 19, 2012

Kalamazoo River / Enbridge Spill

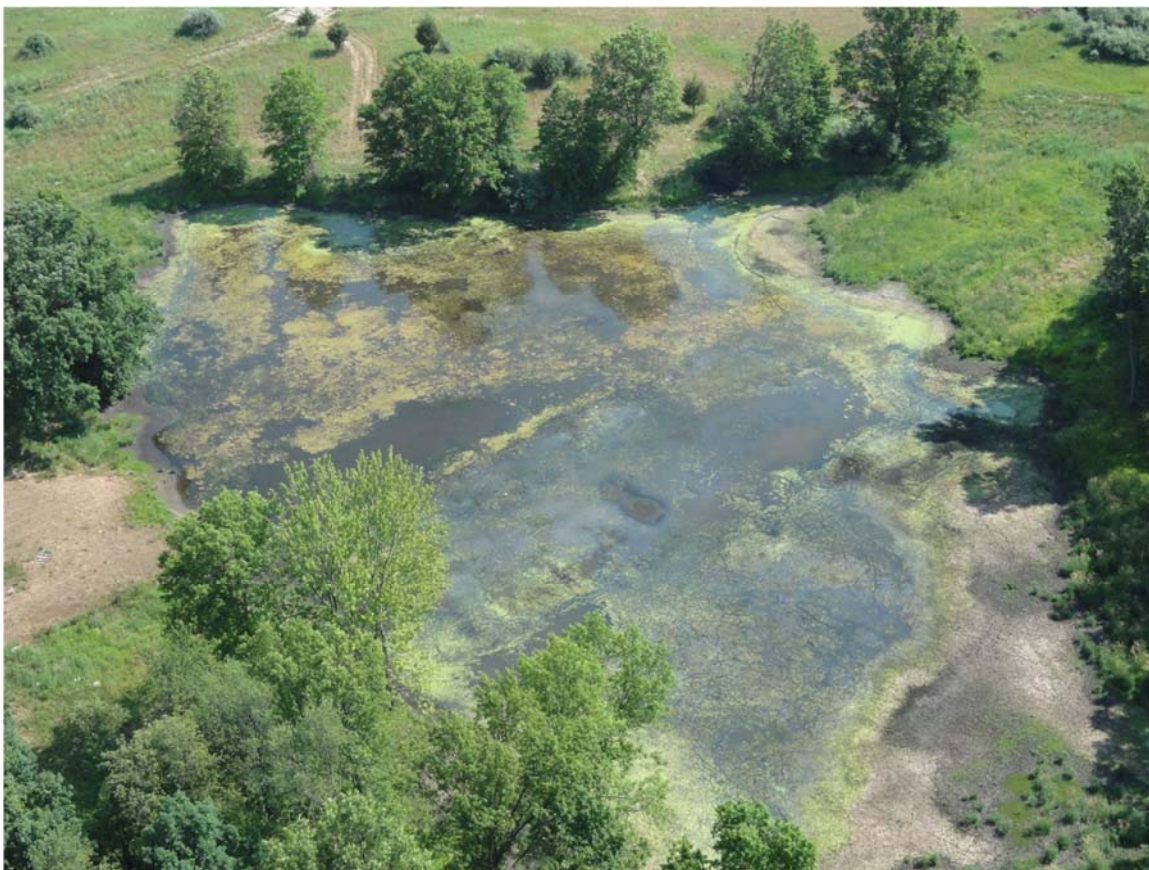
1. Source area pond.

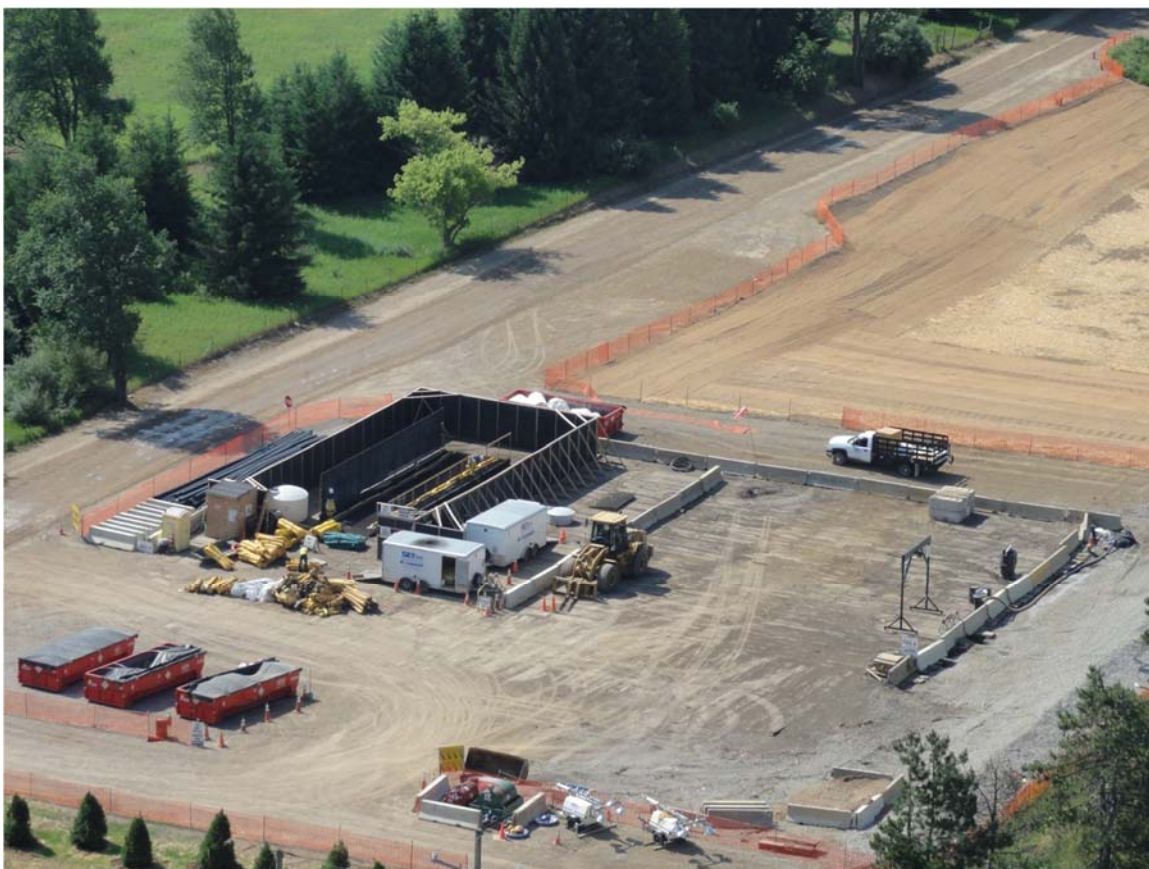
2. Frac-City observed boom being decontaminated.

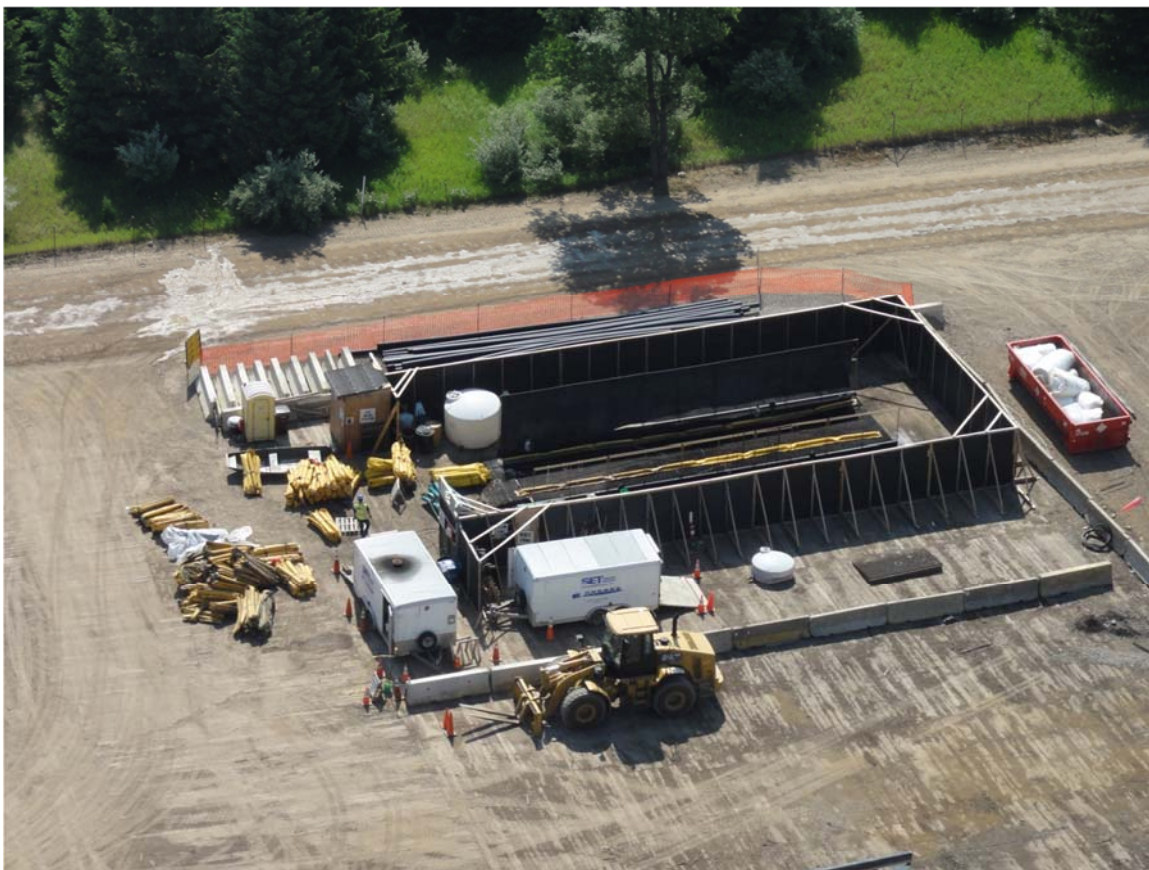
3. Frac-City observed boom being decontaminated.

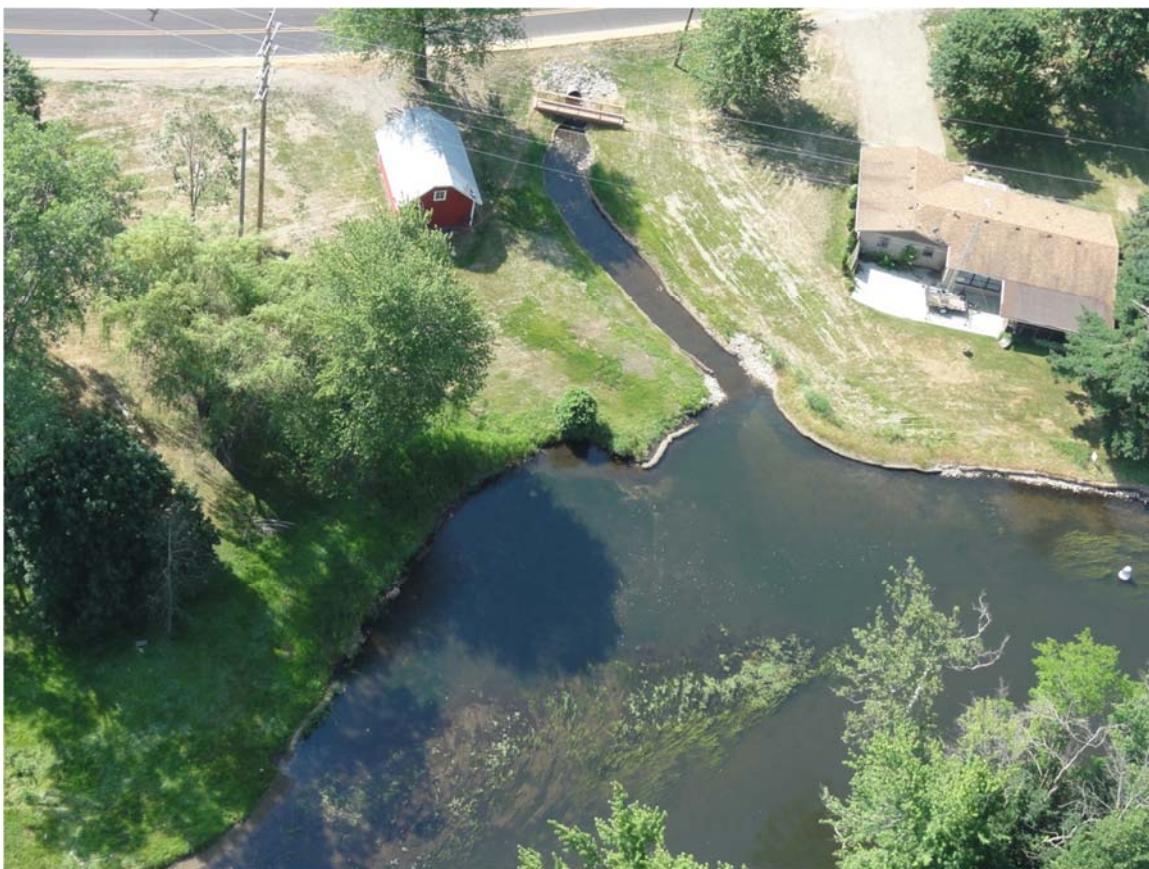
4. Confluence, no sediment or sheen observed.

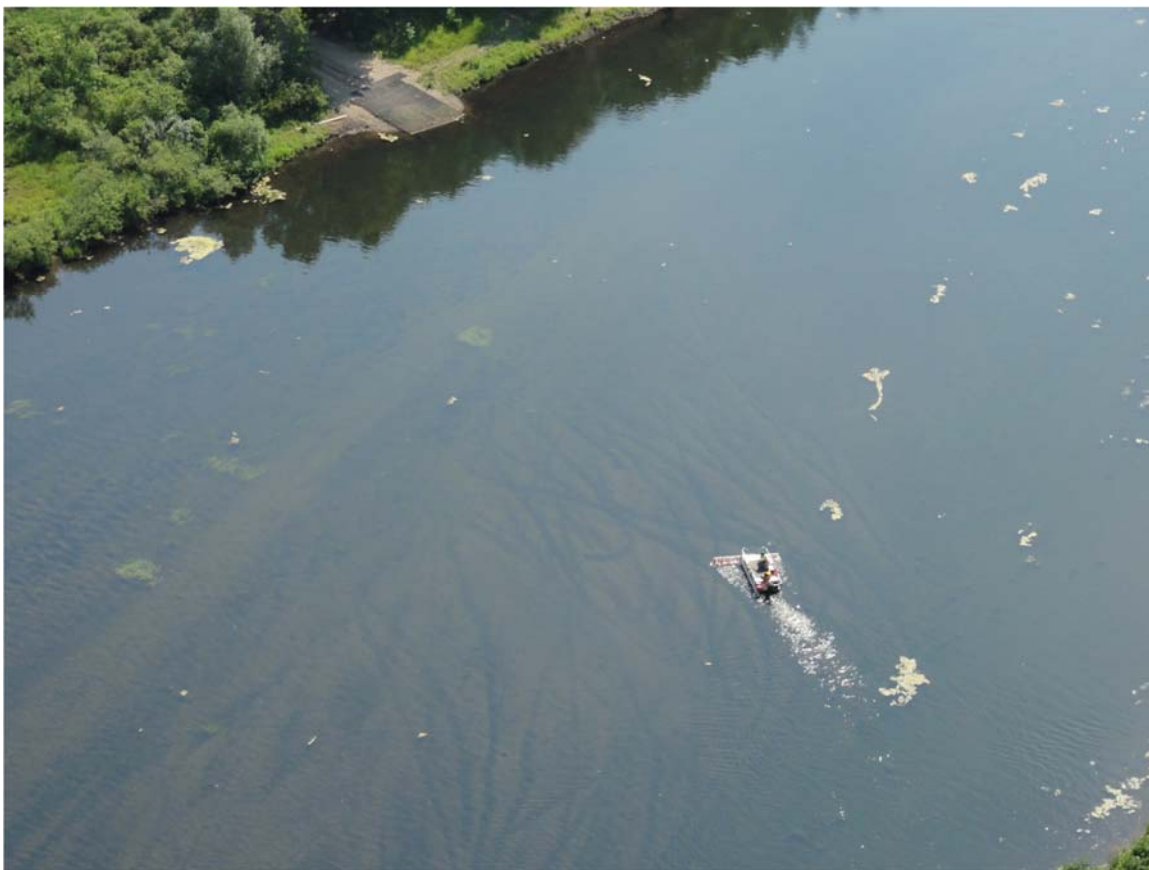
5. MP5.0 Sweep boat observed.

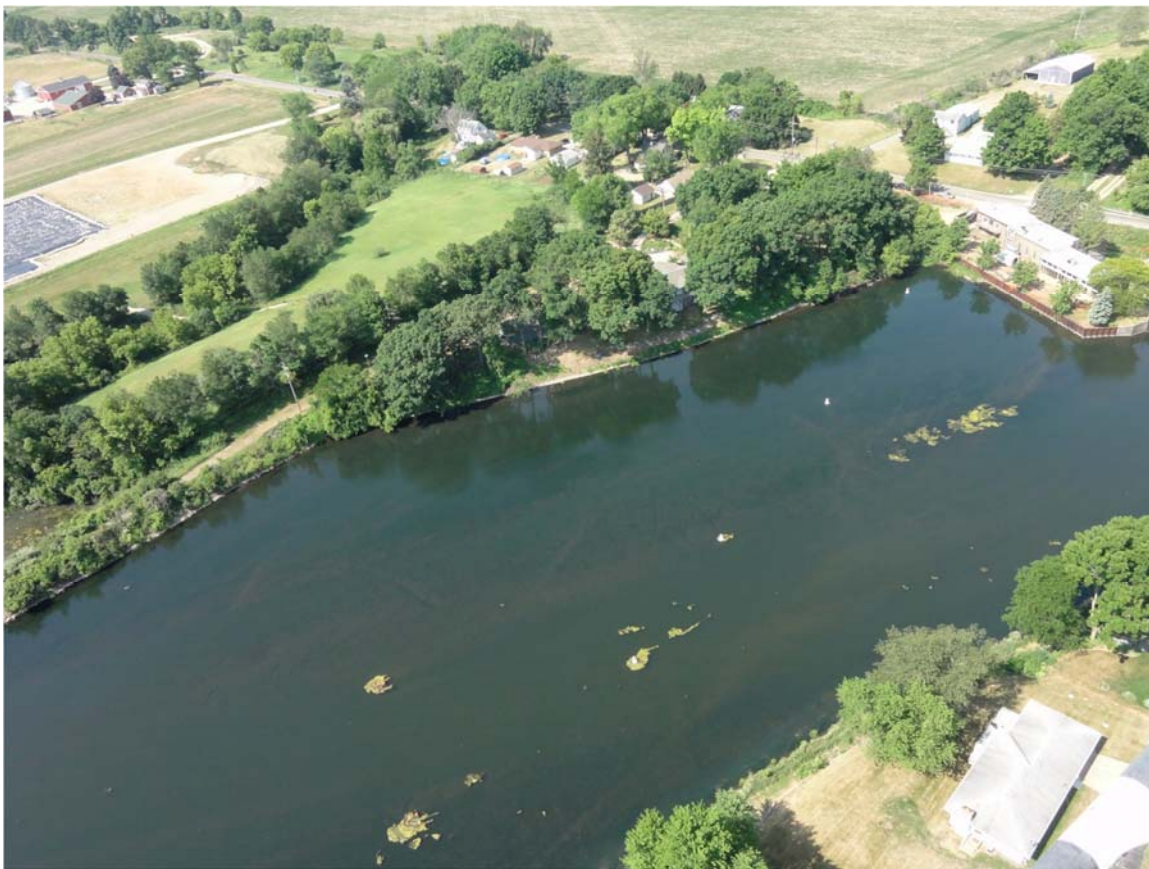
6. Ceresco Dam boom has been removed.

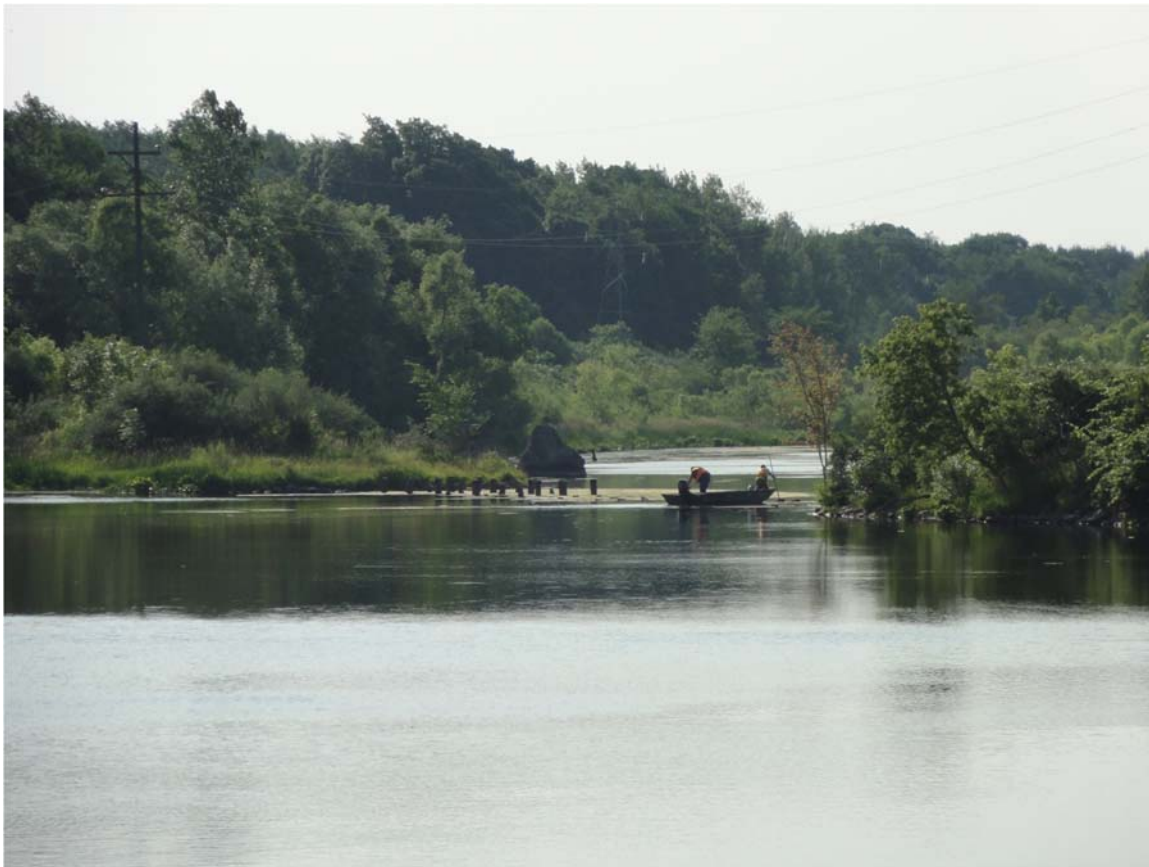
7. MP5.63 Observed crew removing vegetation.

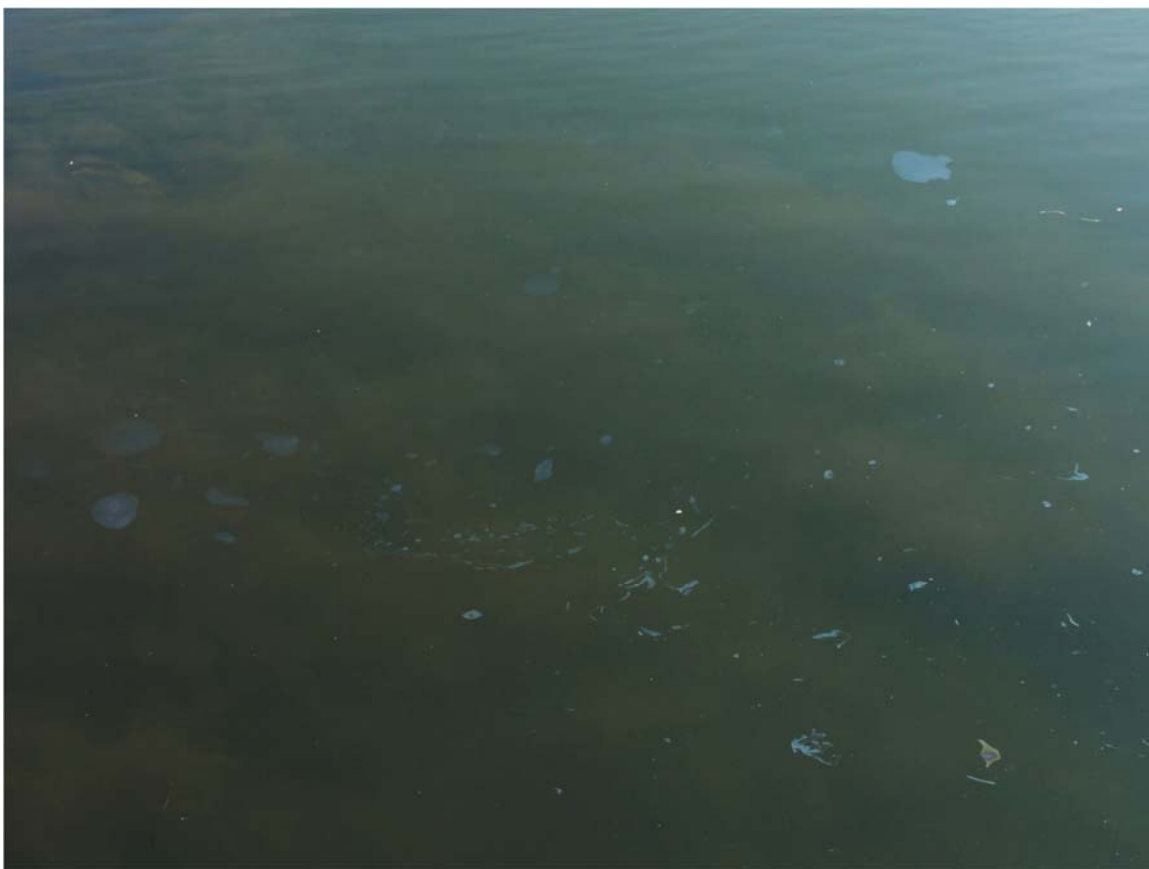
8. Ceresco Dam sheen observed.

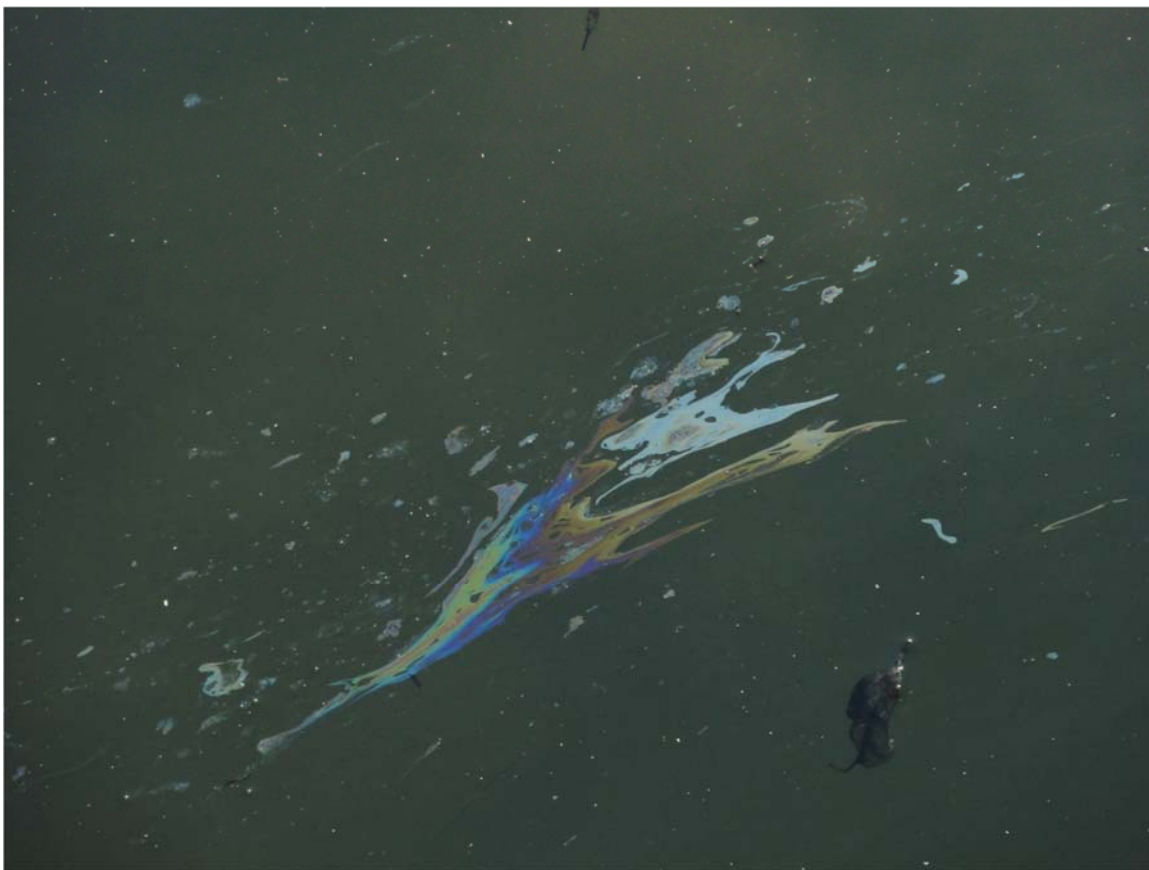
9. Ceresco Dam sheen observed.

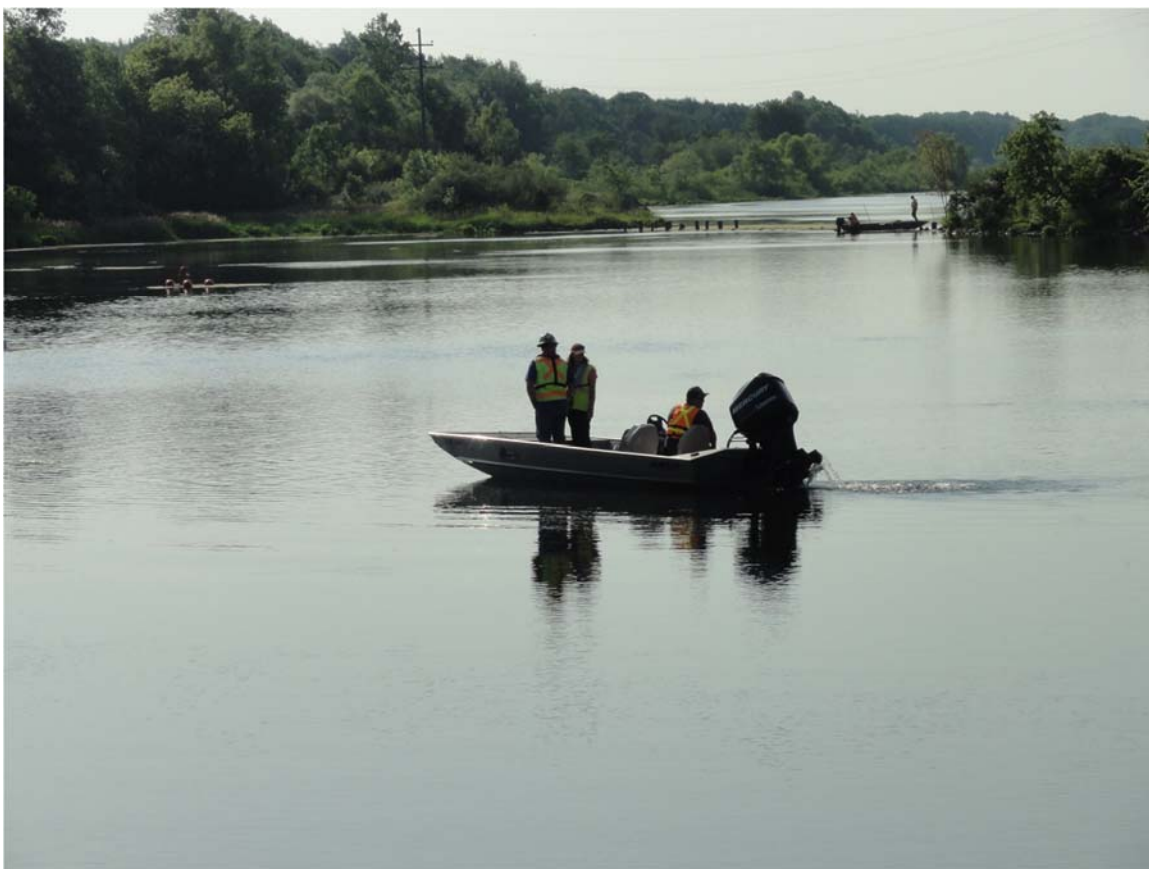
10. Ceresco Dam containment branch crew observed.

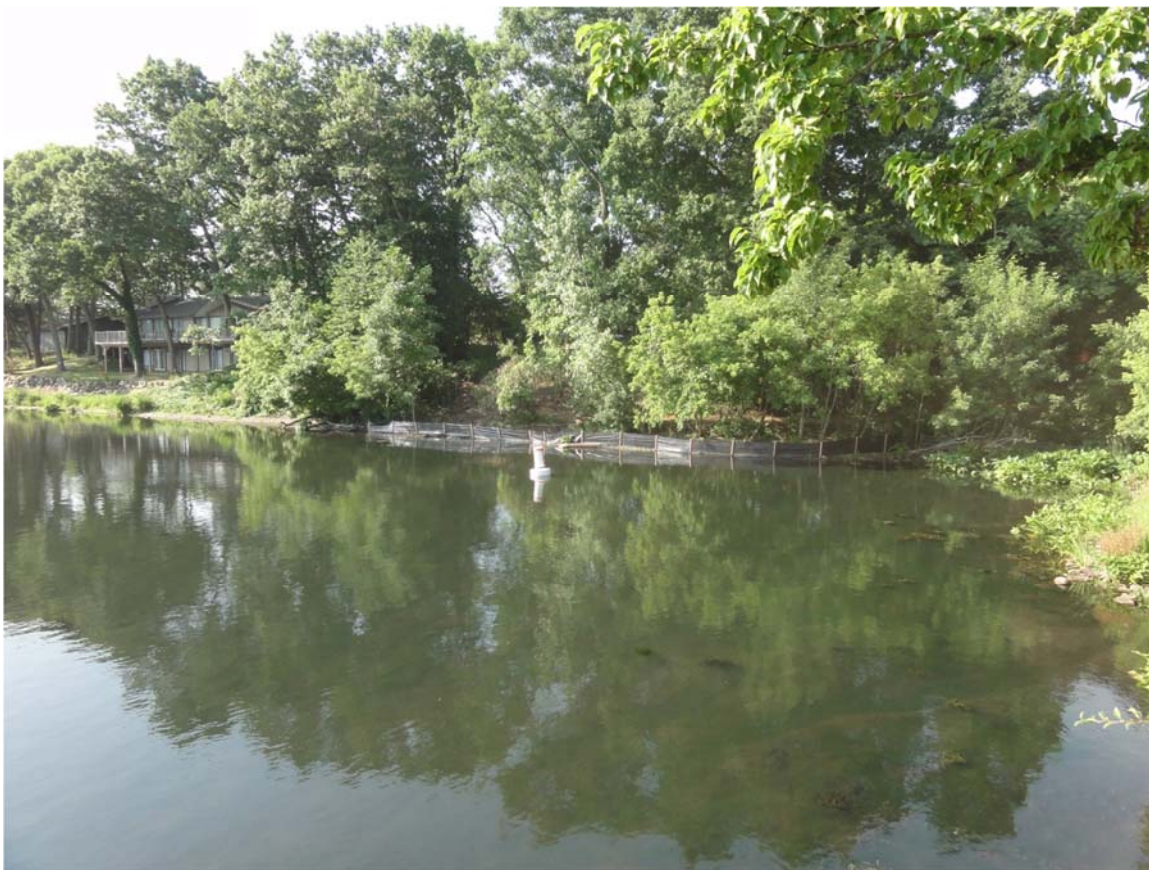
11. Ceresco Dam portage work continued.

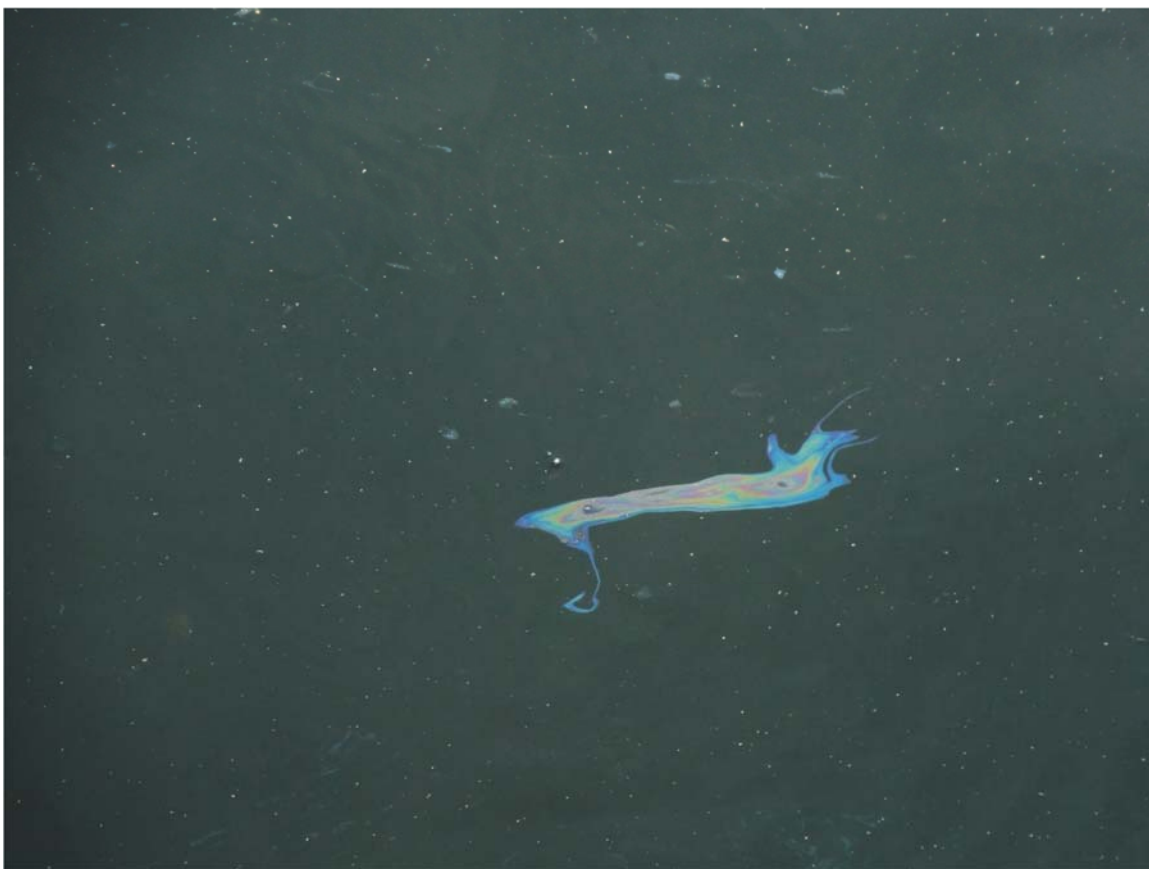
12. Ceresco Dam sheen observed.

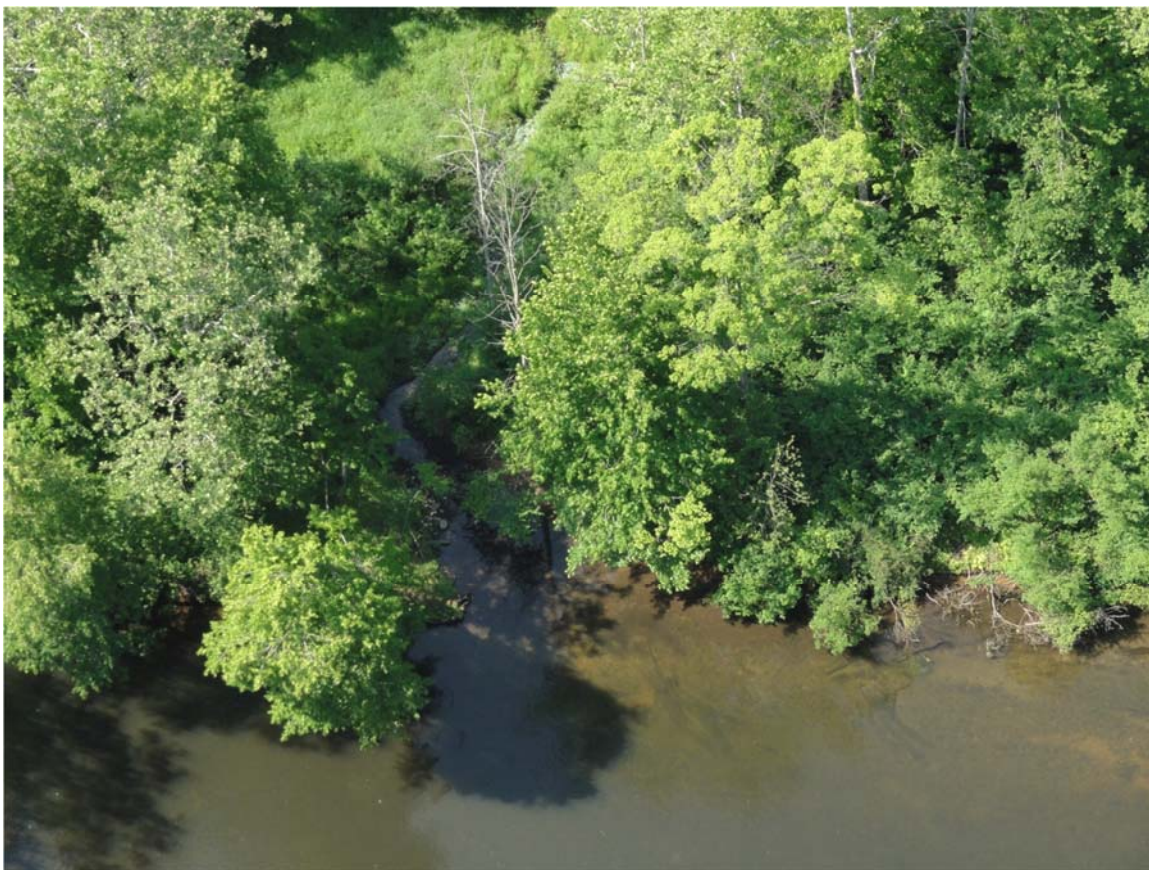
**13. MP8.4 Boom removed.**

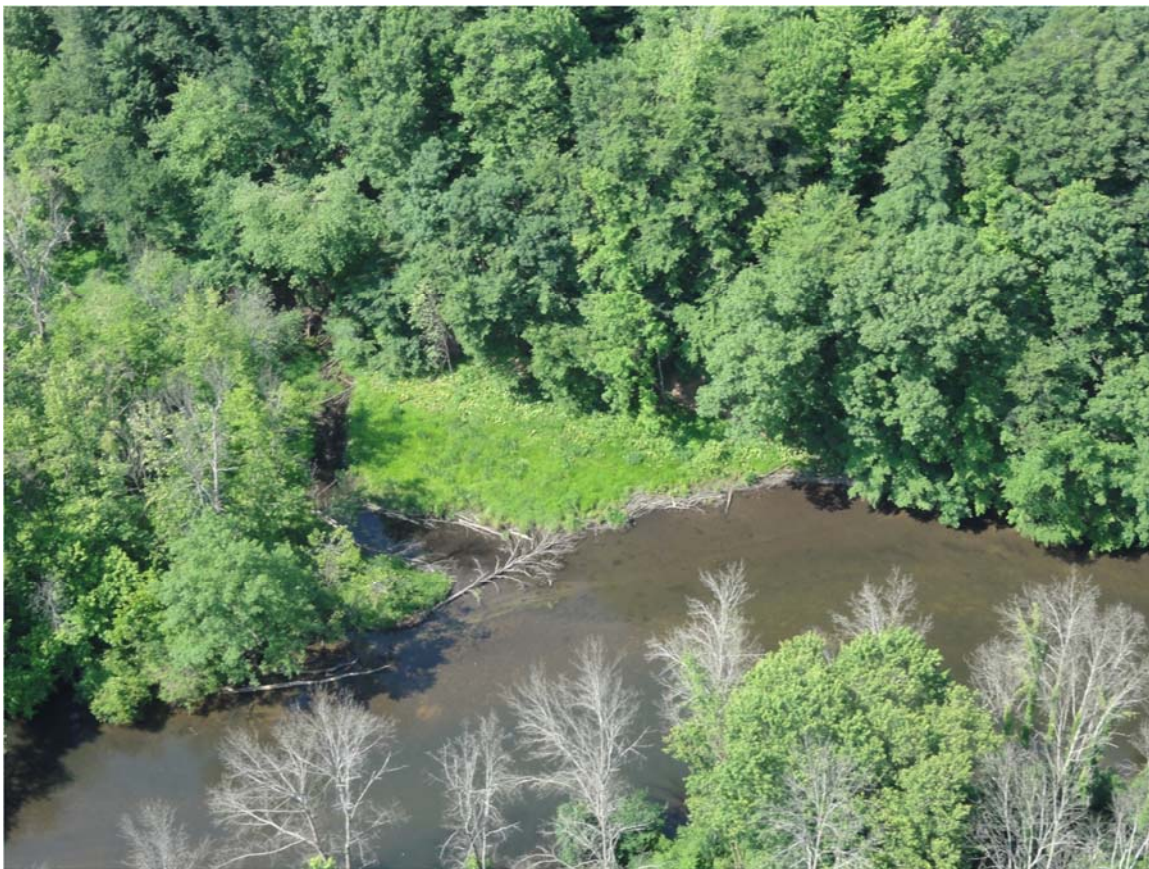
**14. MP8.45 Boom removed.**

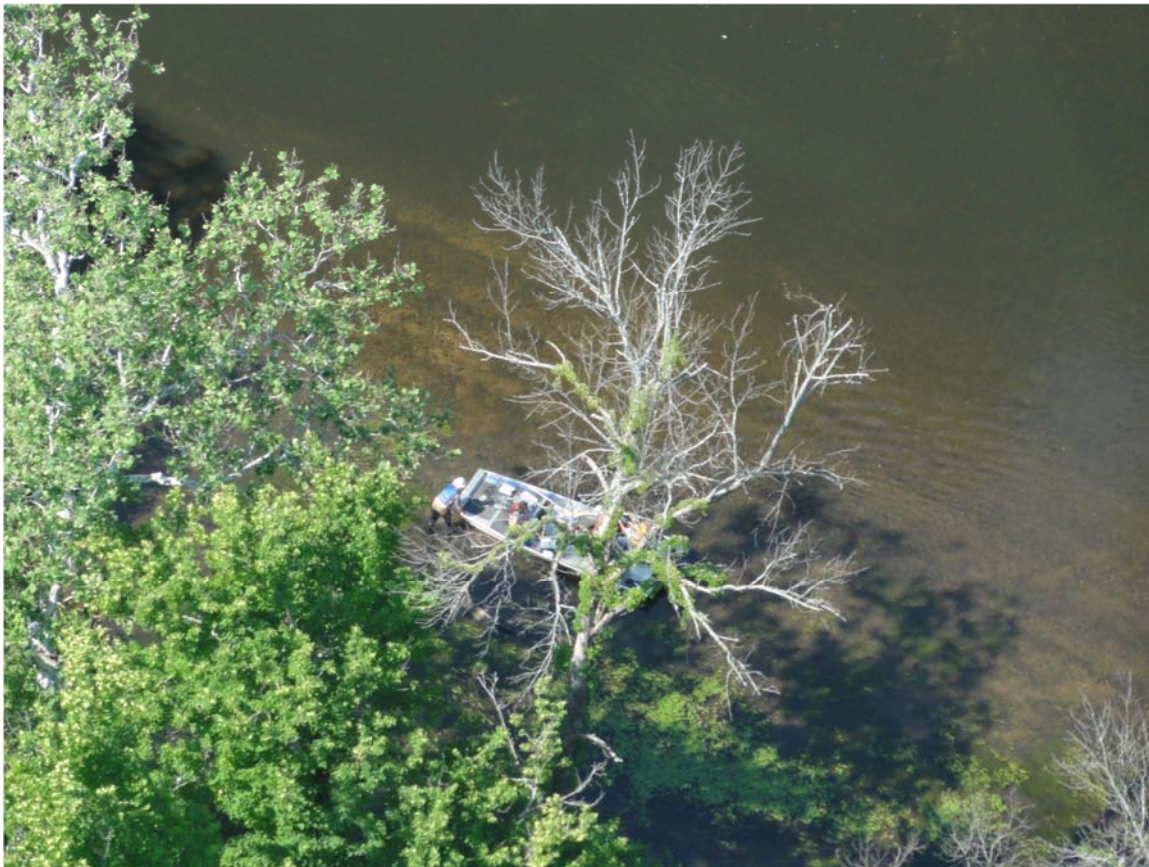
15. MP8.75 Reassessment crew observed.

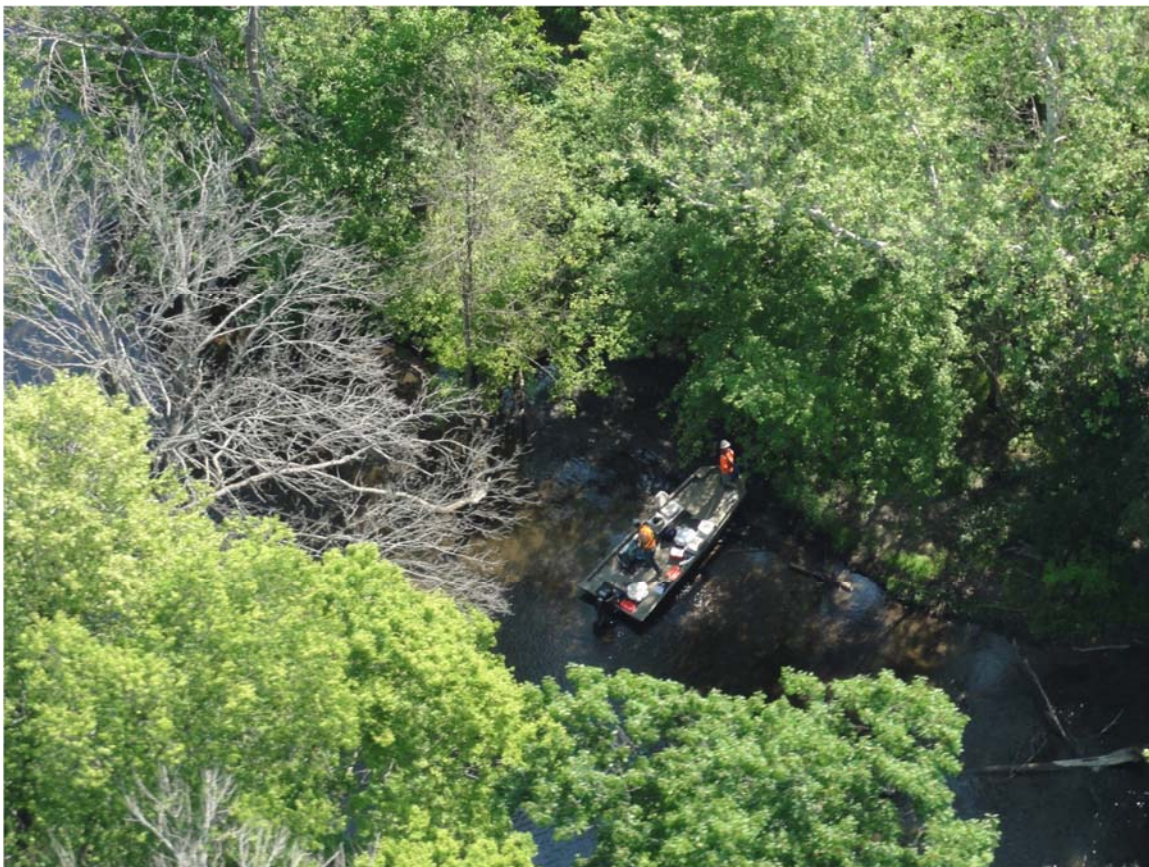
16. MP8.9I Reassessment crew observed.

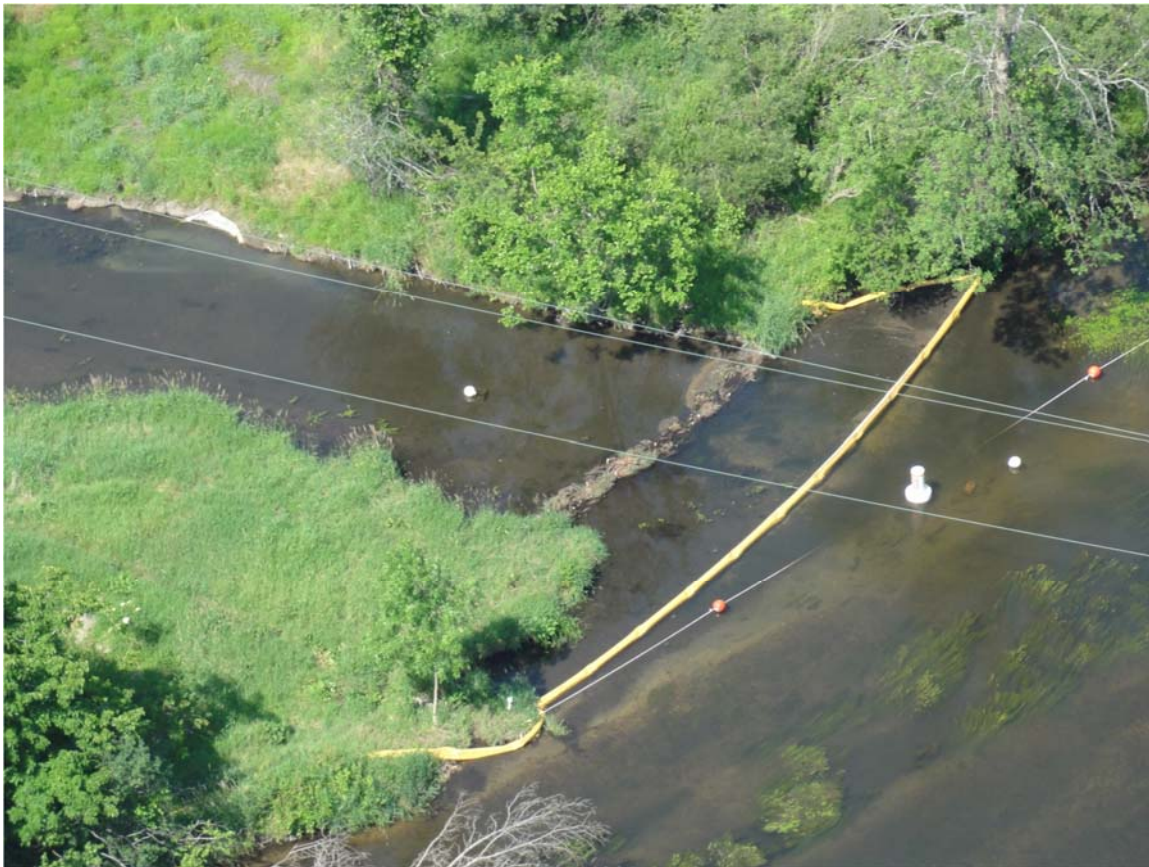
**17. MP10.75 Sediment trap.**

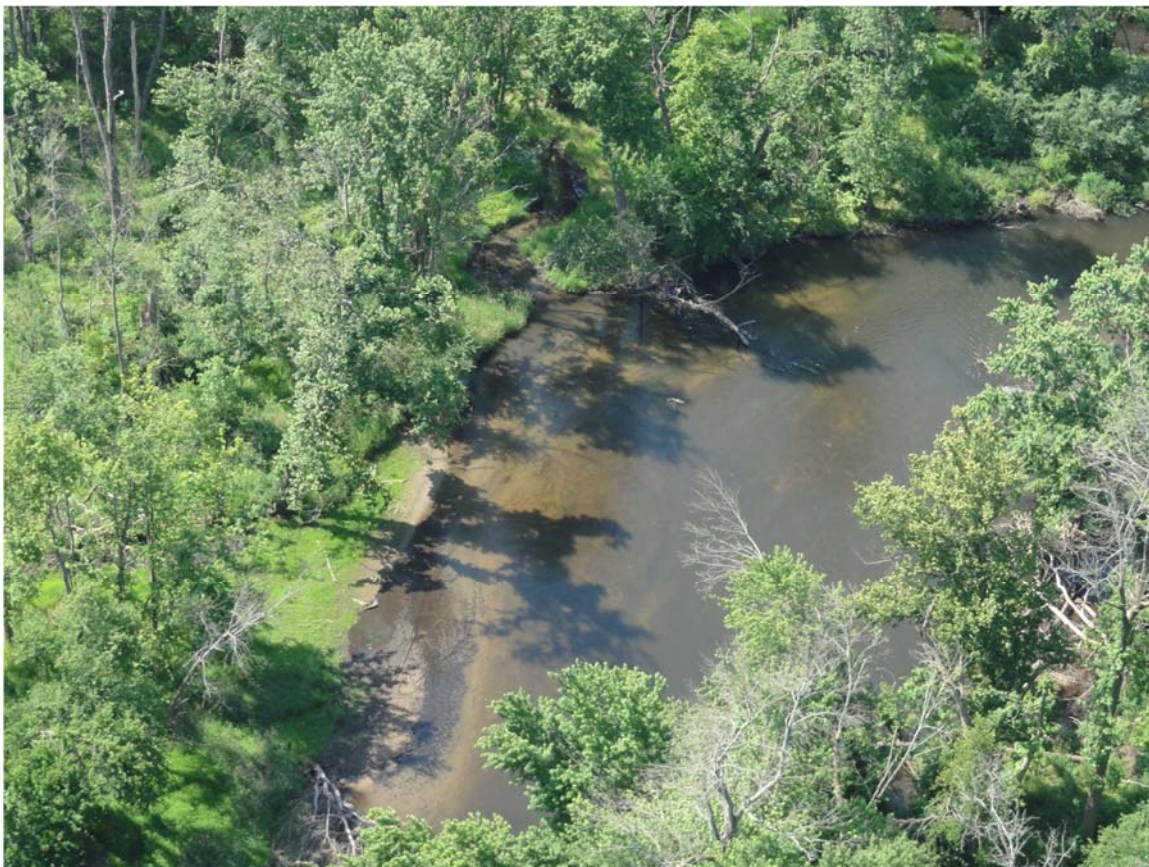
**18. MP11.75 Boom removed.**

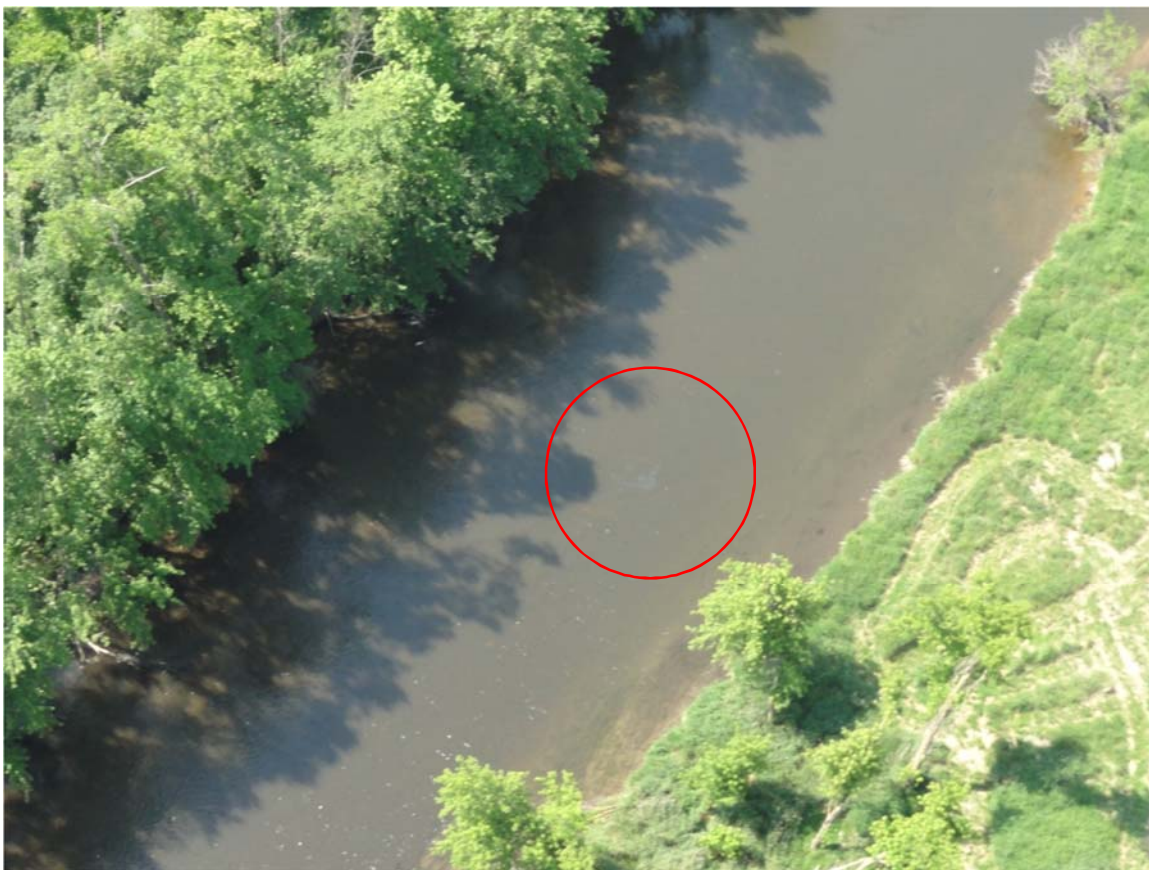
19. MP13.0 Sheen observed in river channel.

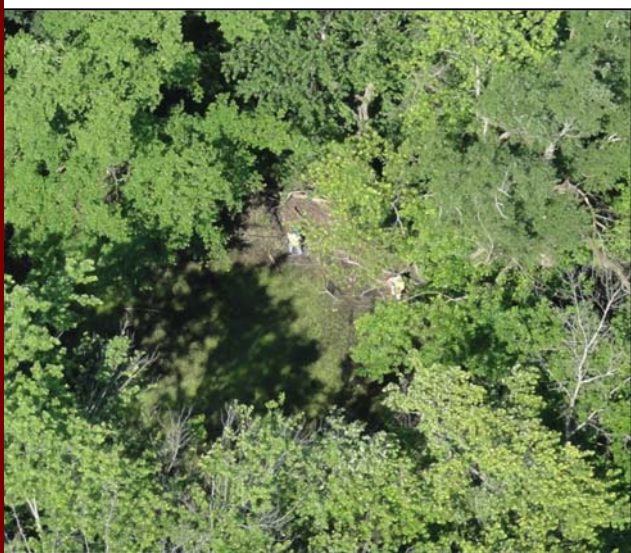
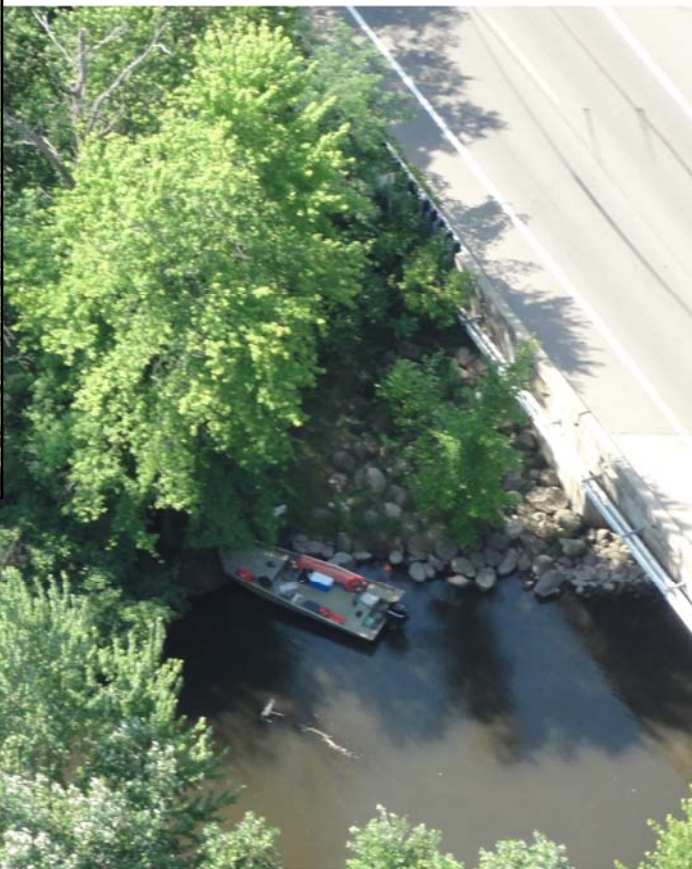
20. MP13.75 Reassessment crew observed in overbank area.

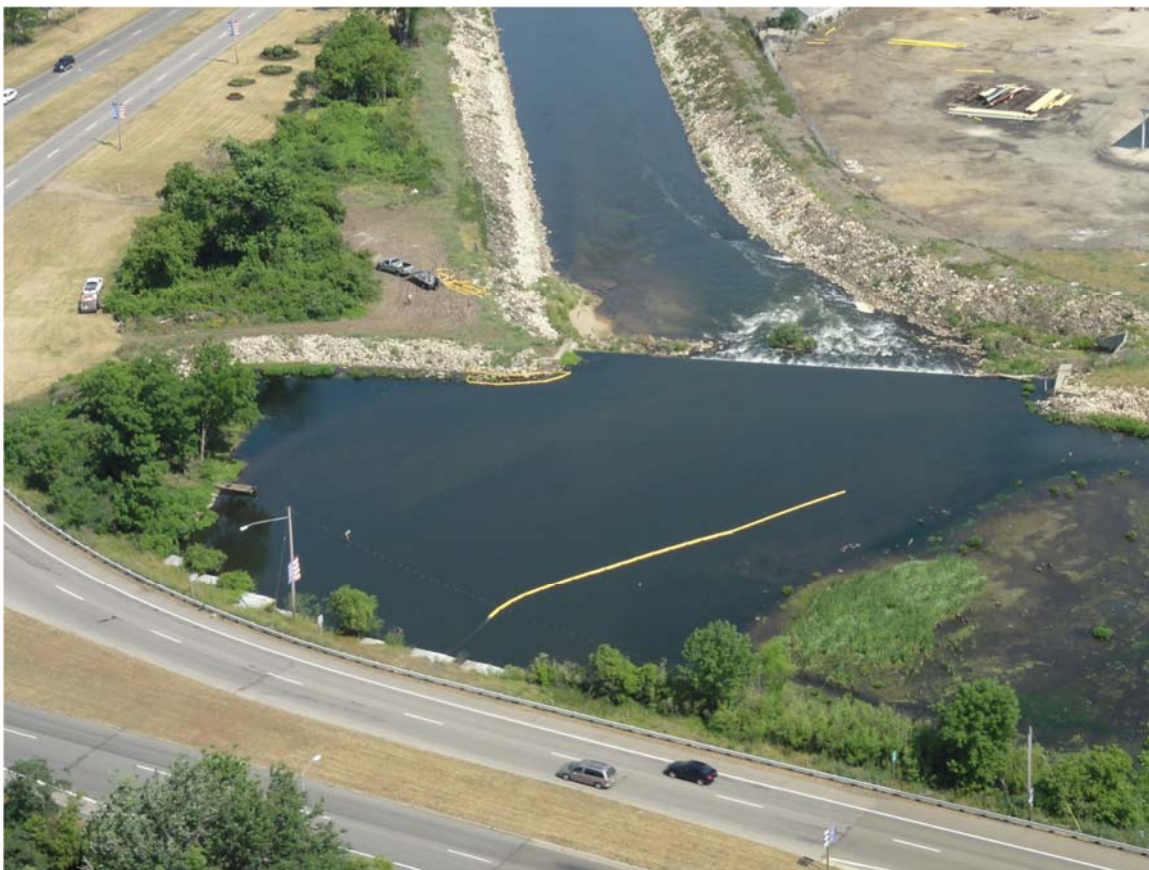
21. MP15.75 Boom observed being removed.

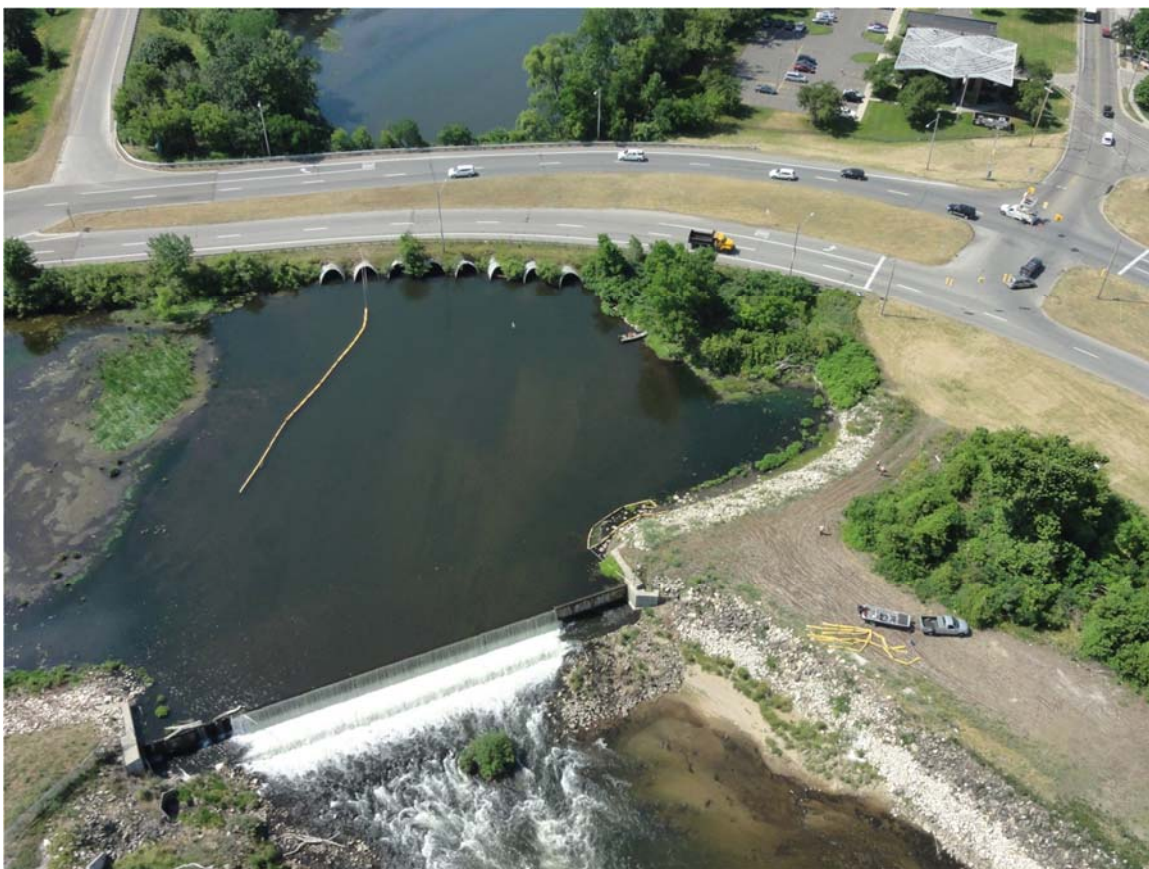
22. MP15.75 Boom observed being removed.

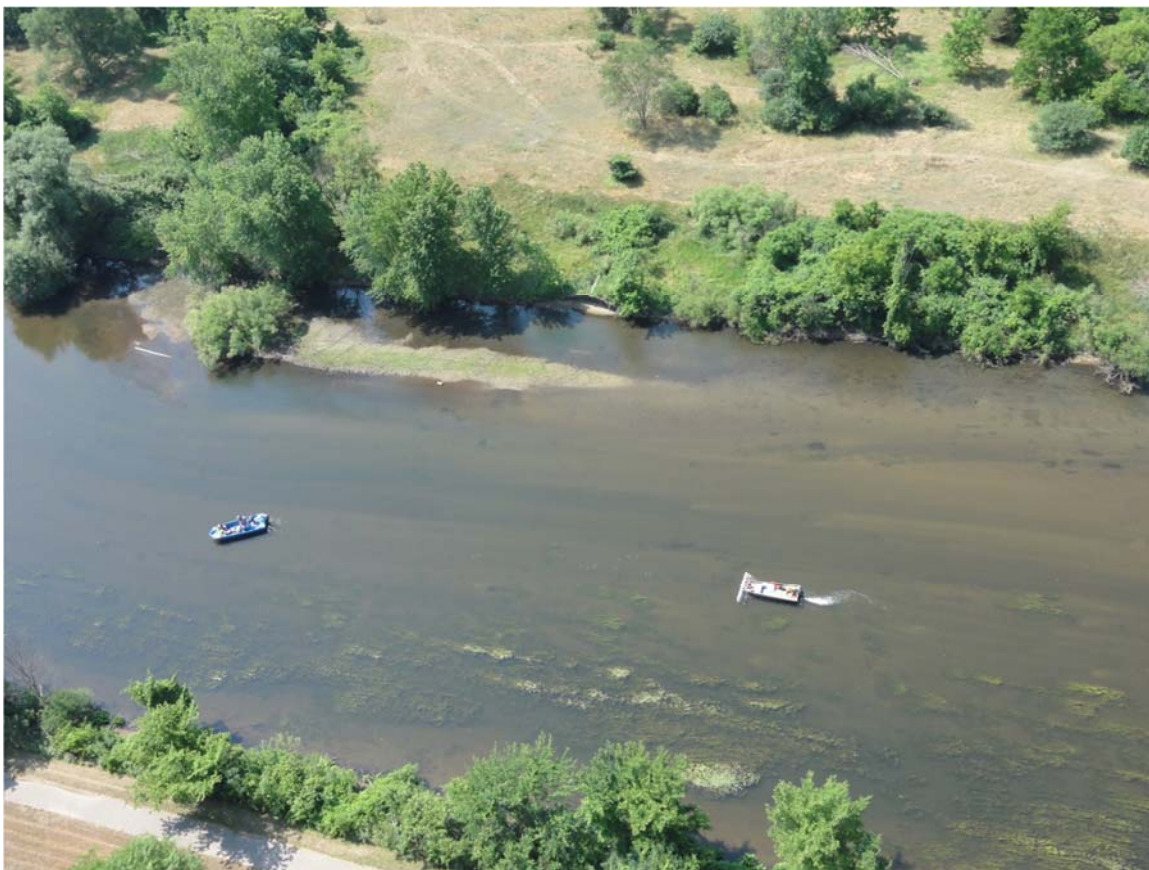
23. MP17.5 Poling crew observed.
