# Situation Photo Log

Tuesday, June 19, 2012

Kalamazoo River / Enbridge Spill

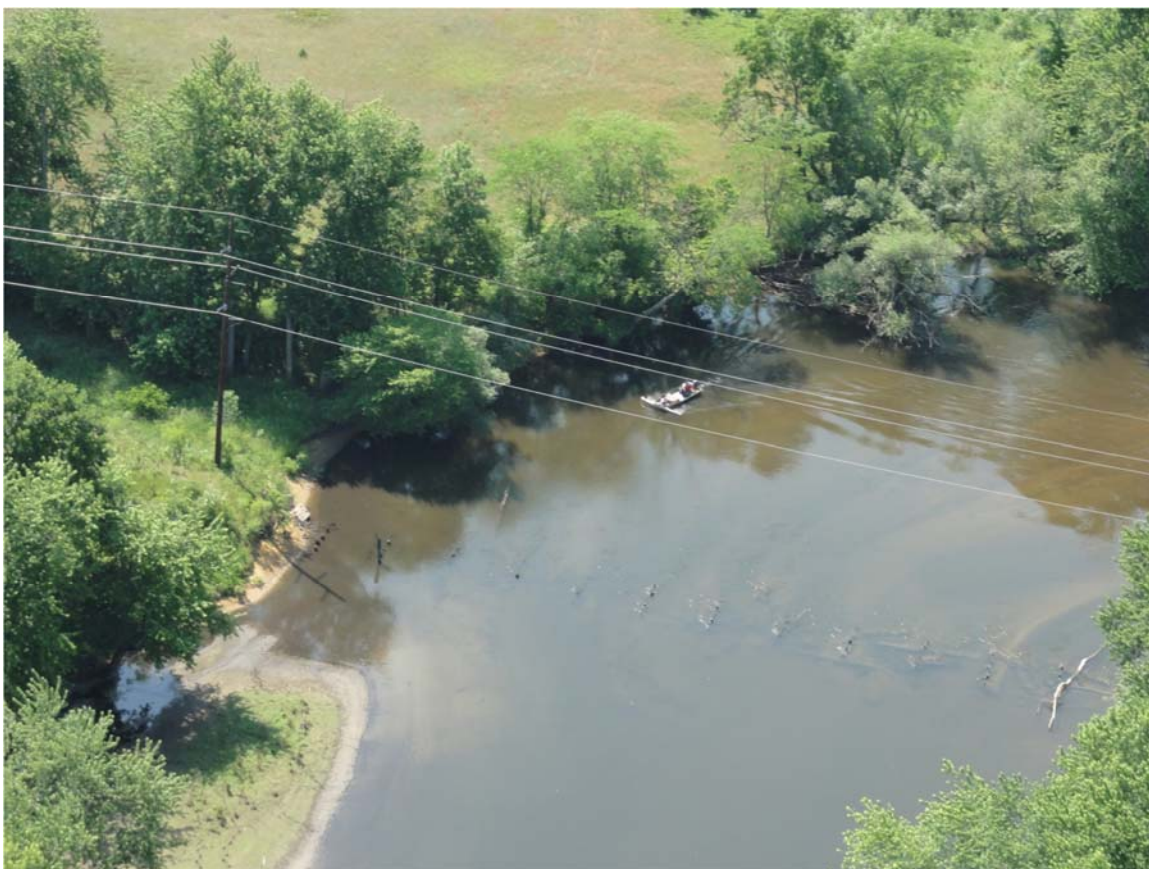
24. MP27.75 sheen sweep boat observed.

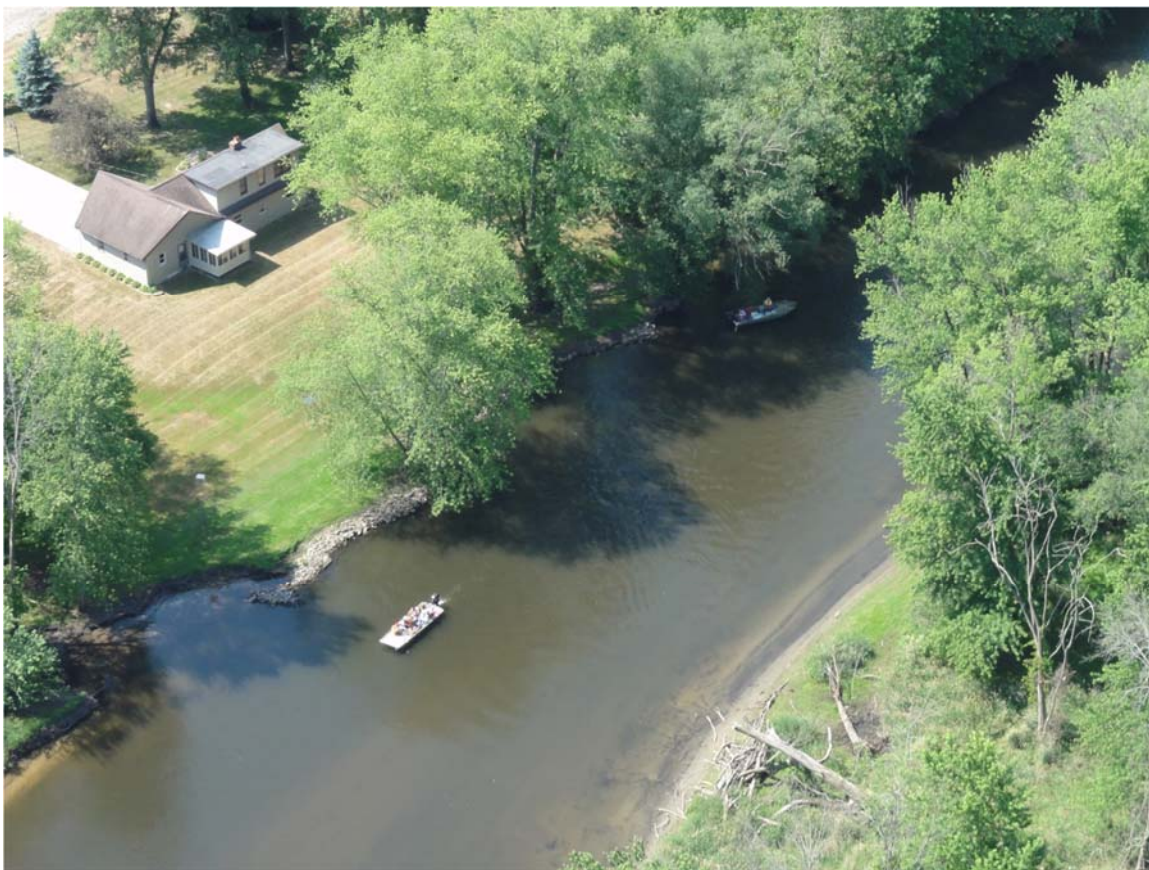
25. MP28.25 Poling crew observed.

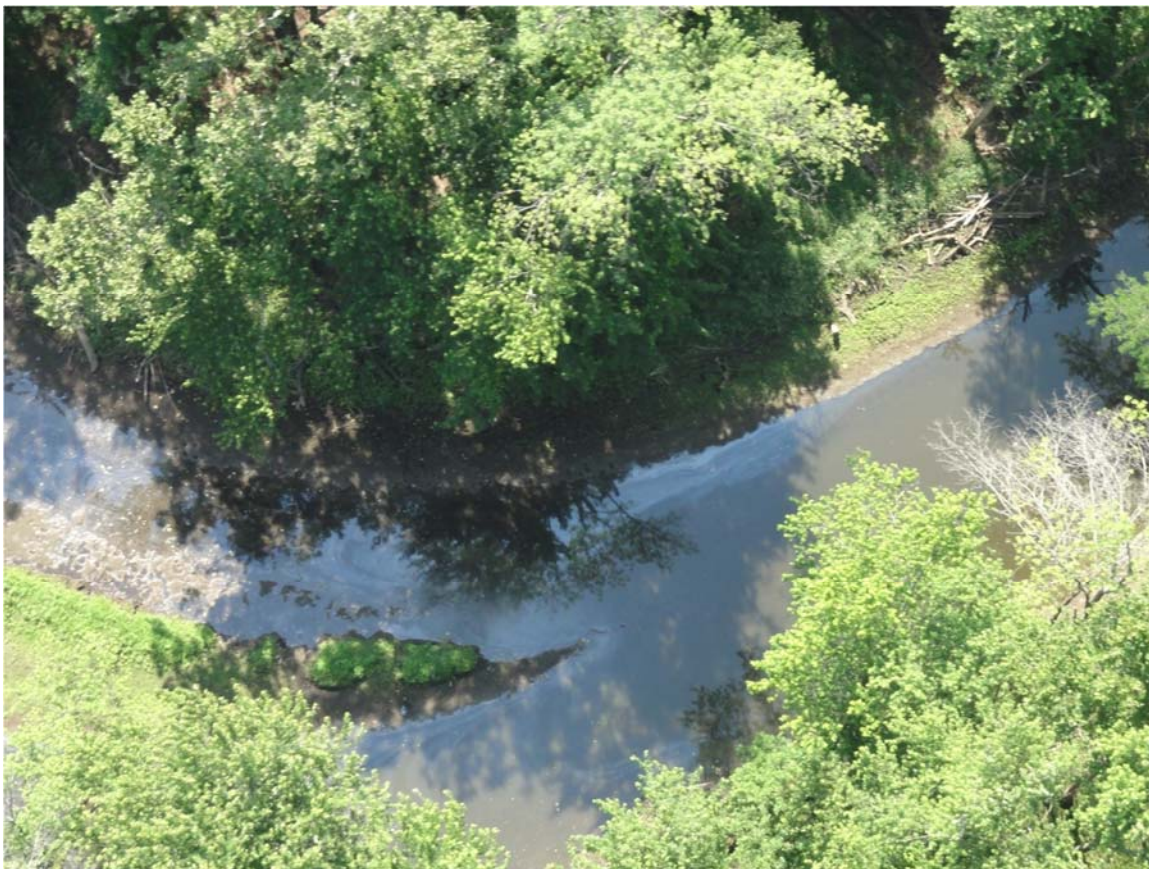
26. MP28.25 Oxbow sheen observed.

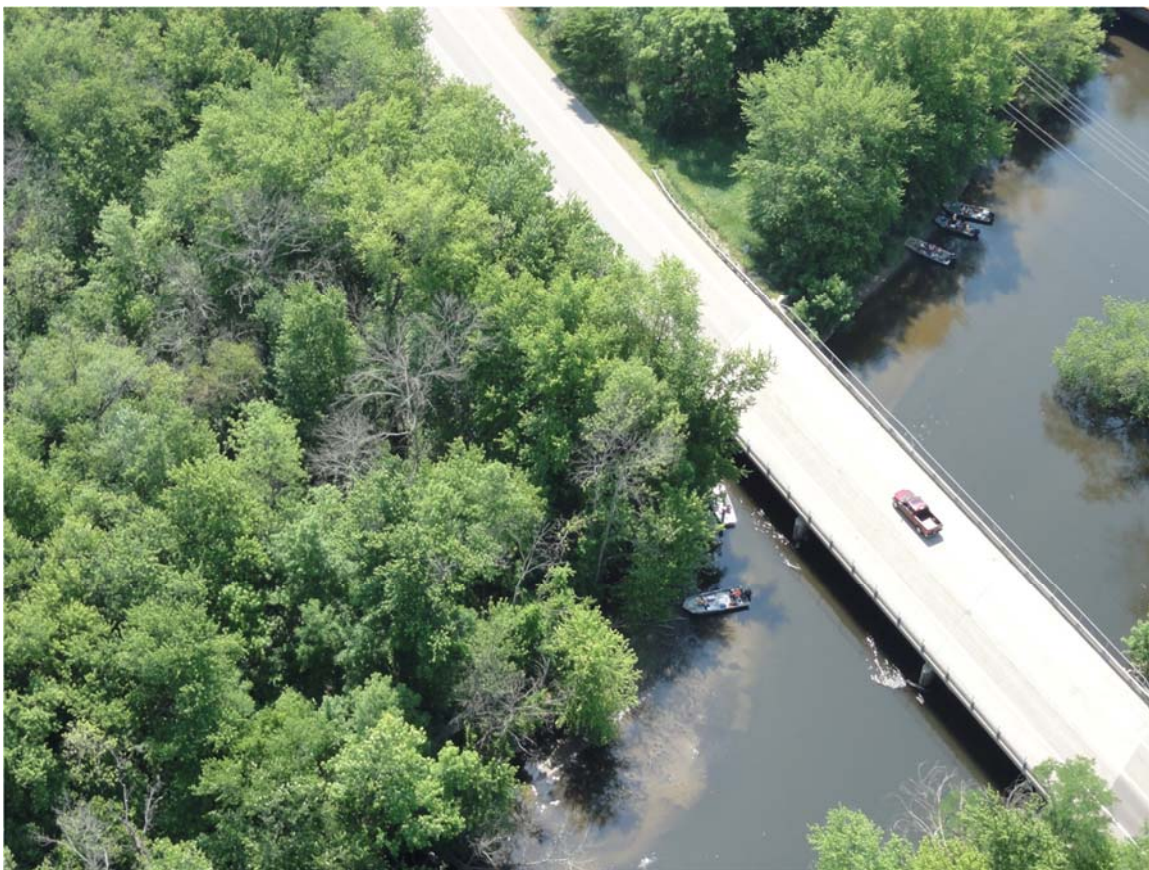
27. MP29.0 Reassessment crews observed.

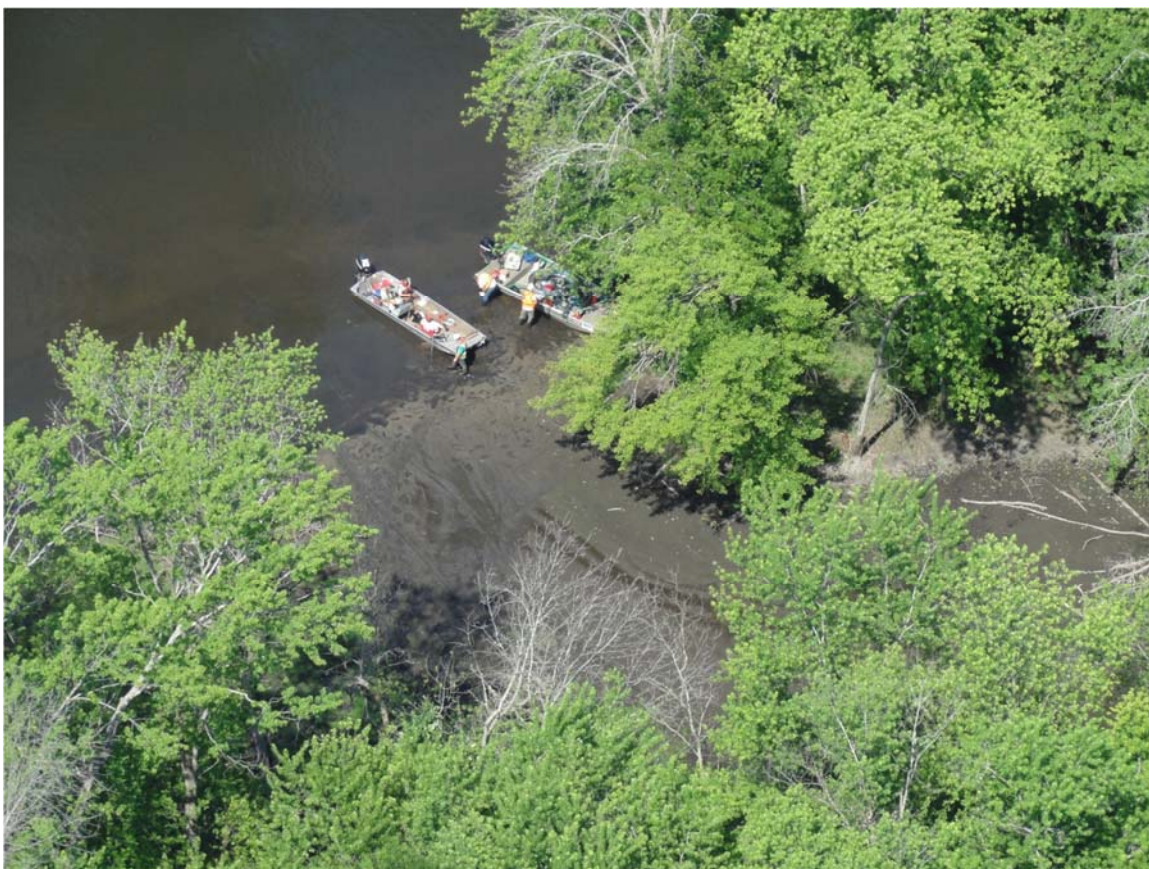
28. MP33.0 Reassessment crew observed.

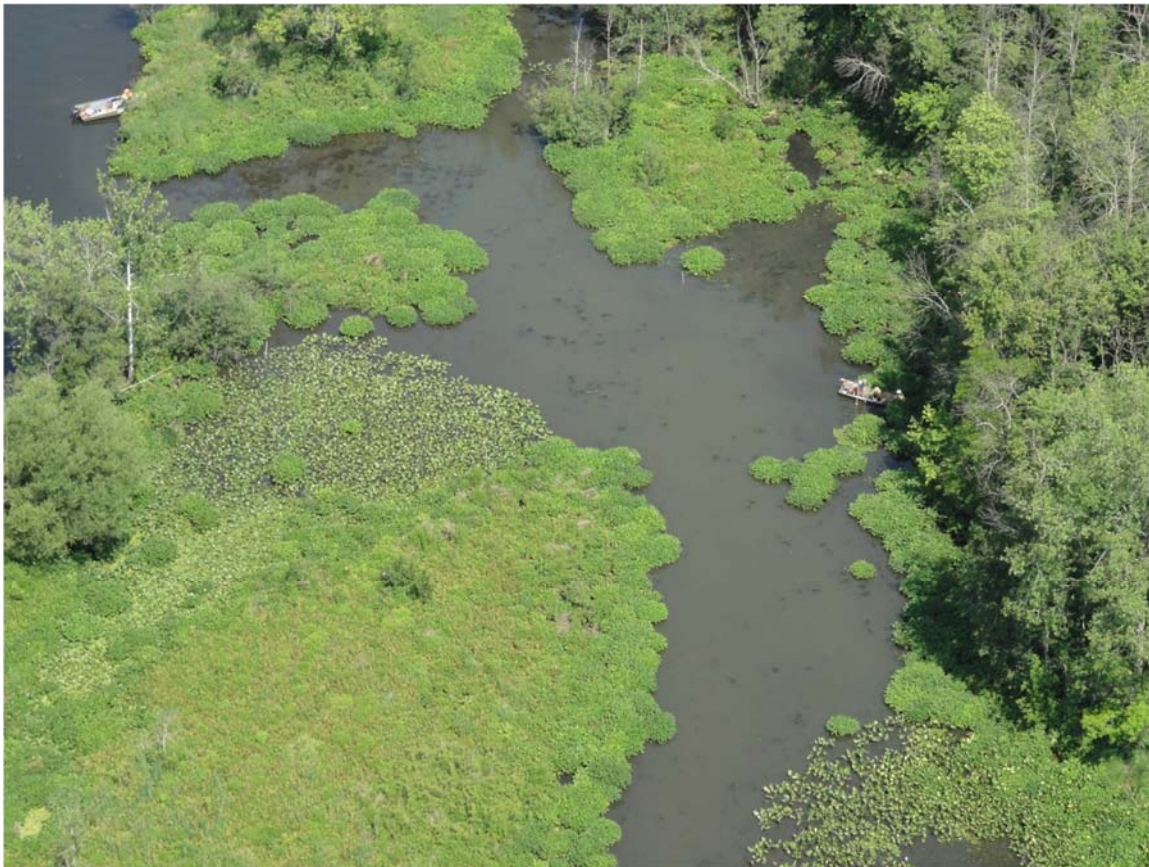
**29. MP36.5 Reassessment team observed.**

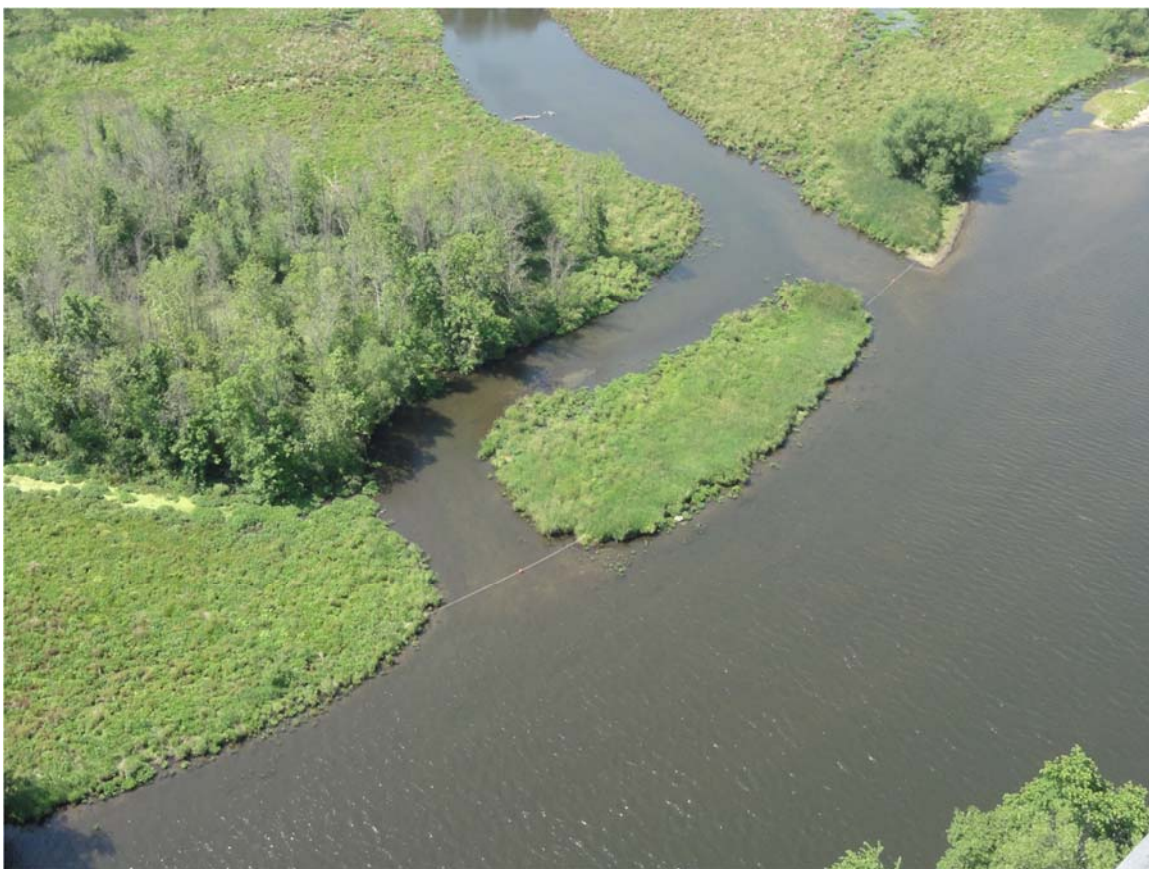
**30. Morrow Lake Delta buoys deployed.**

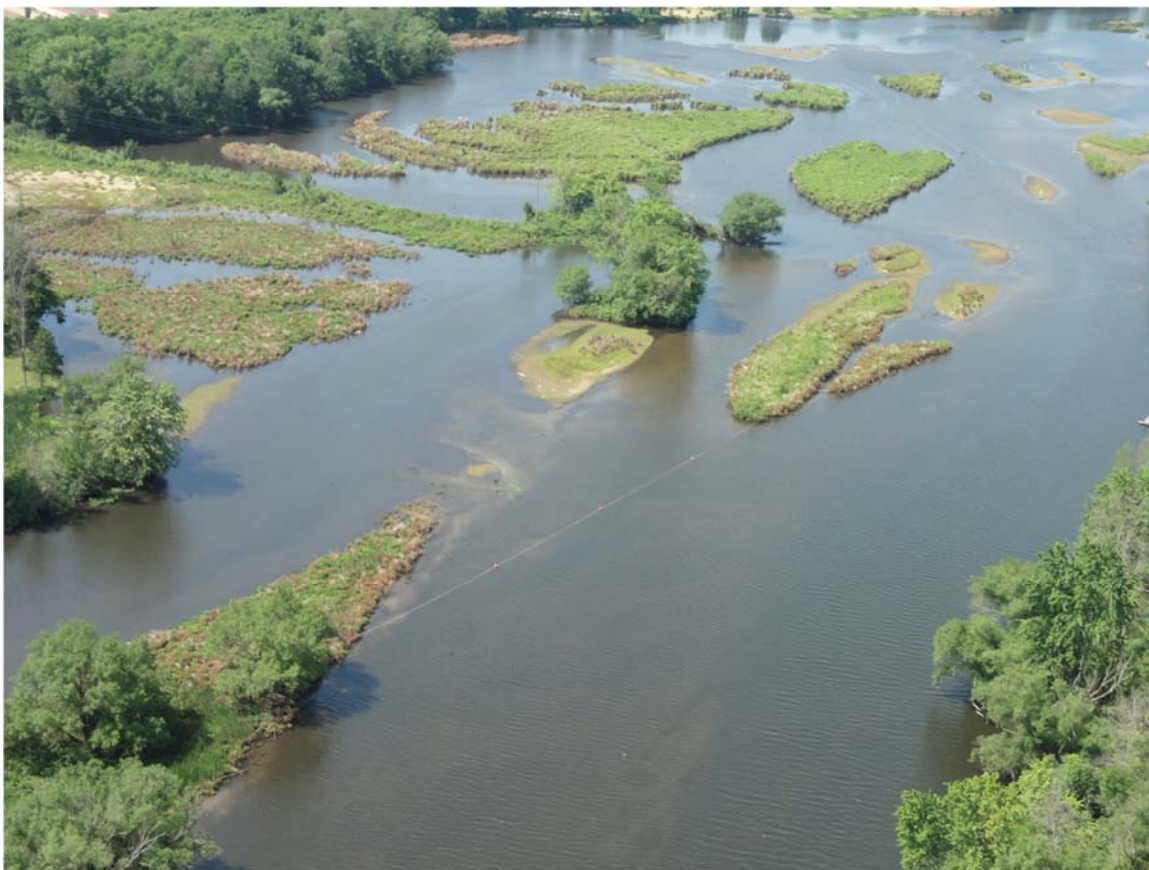
31. Morrow Lake Delta buoys deployed.

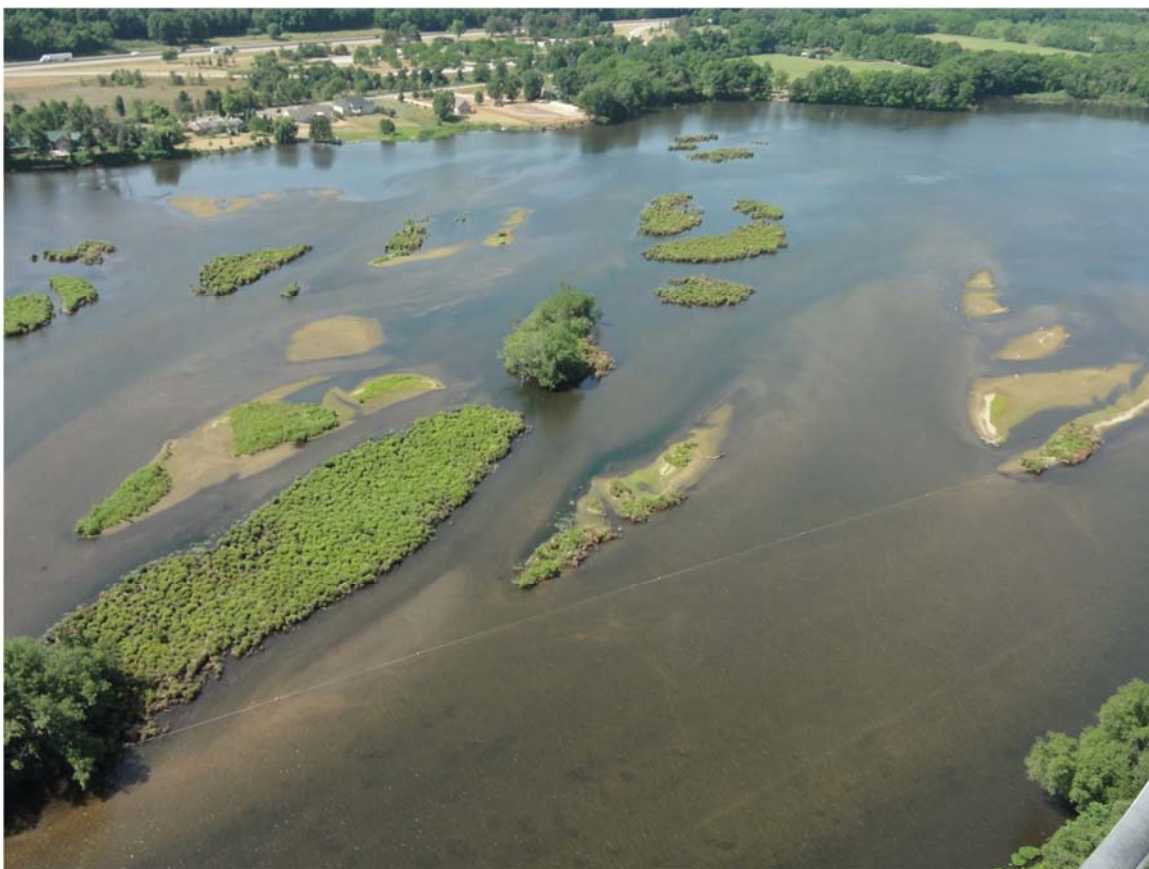
32. Morrow Lake Delta buoys deployed.

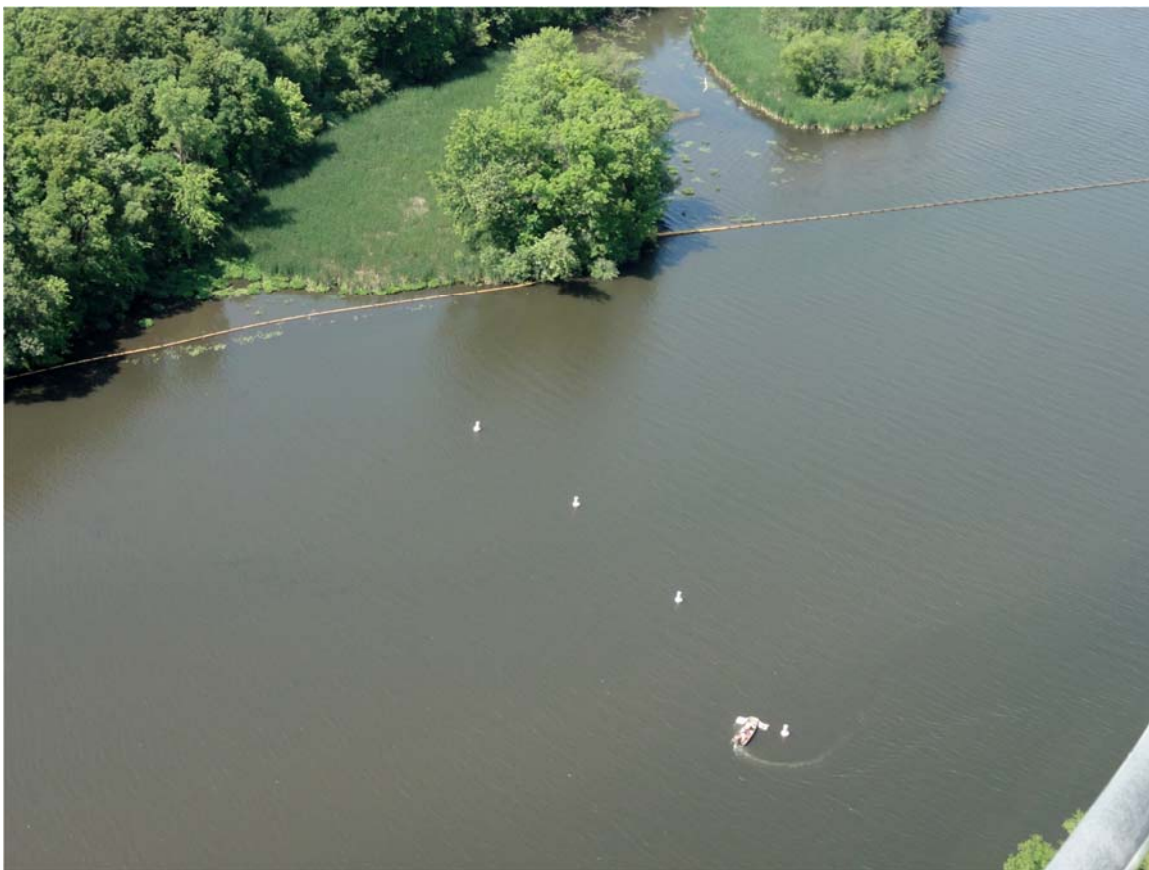
33. Morrow Lake Delta sheen sweep observed at E4 boom.

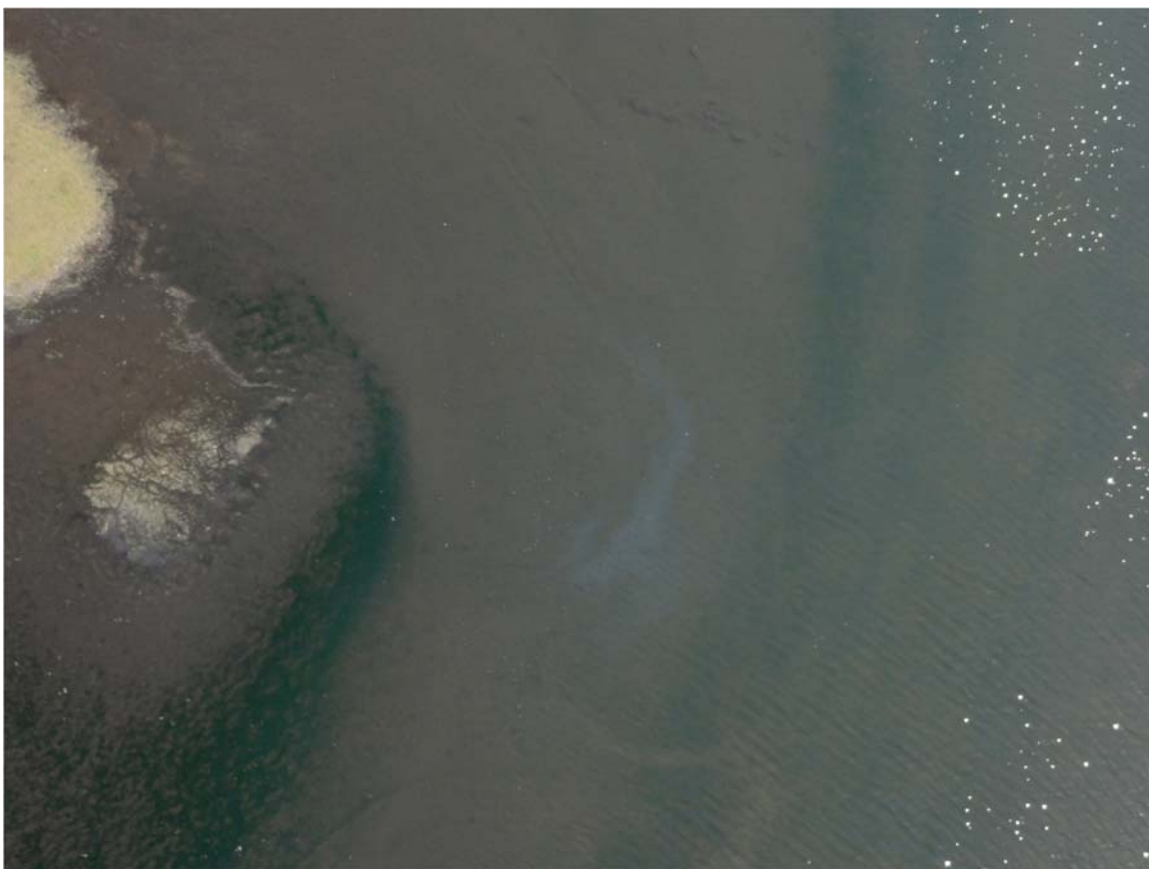
34. Morrow Lake Delta sheen observed.

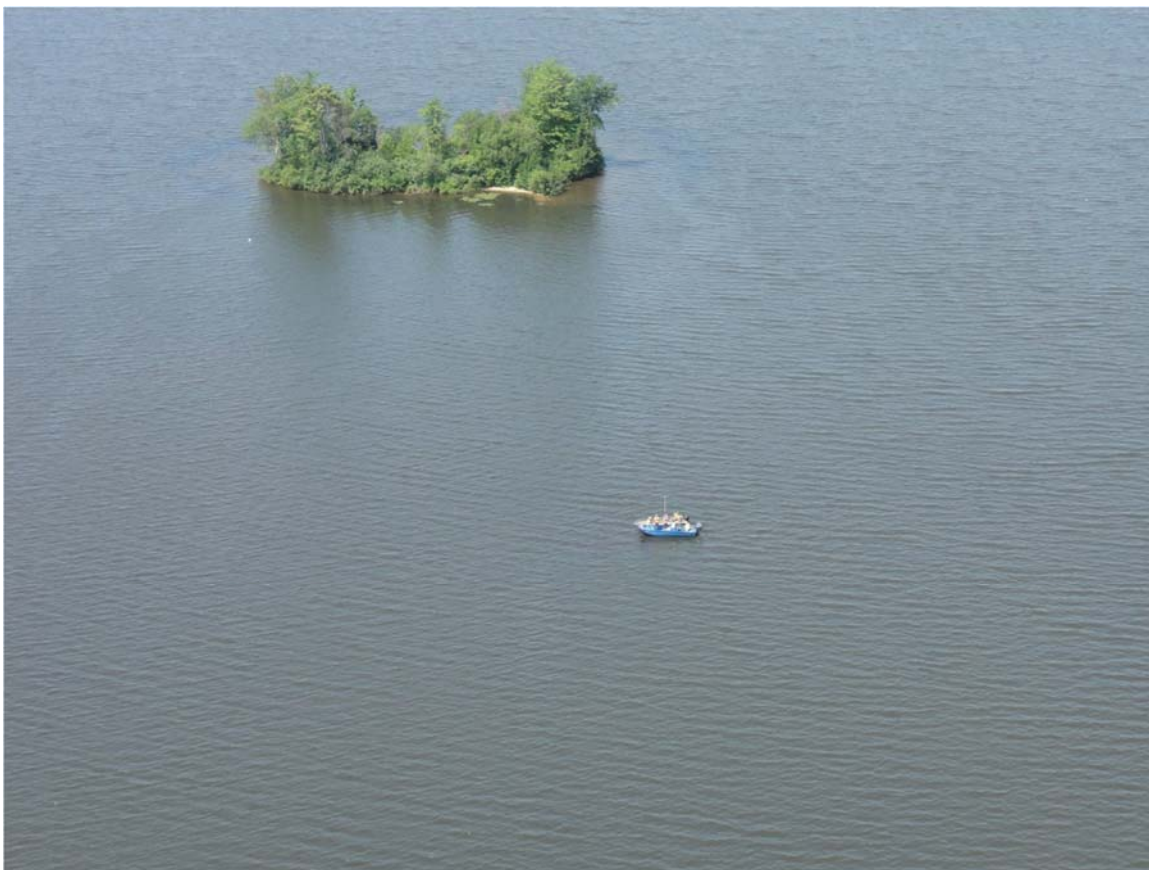
35. Morrow Lake poling crew.

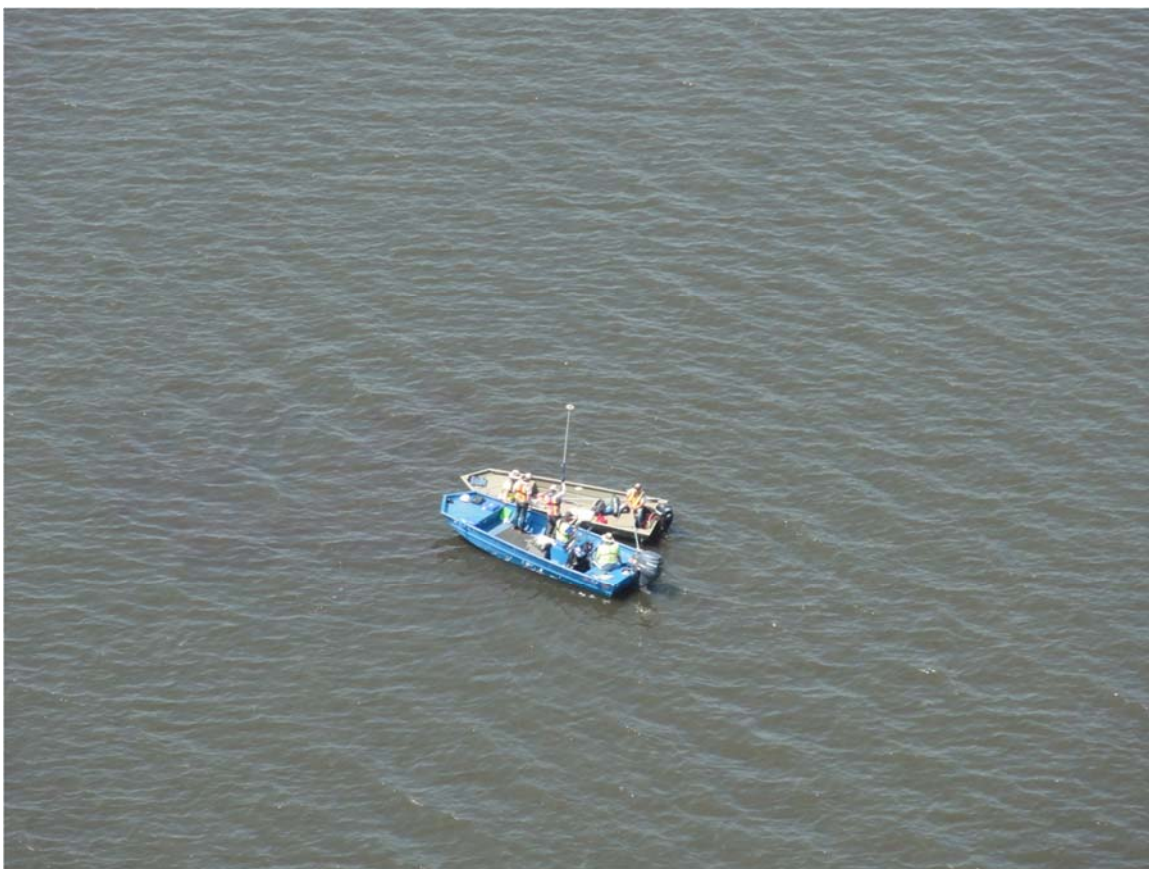
36. Morrow Lake poling crew.

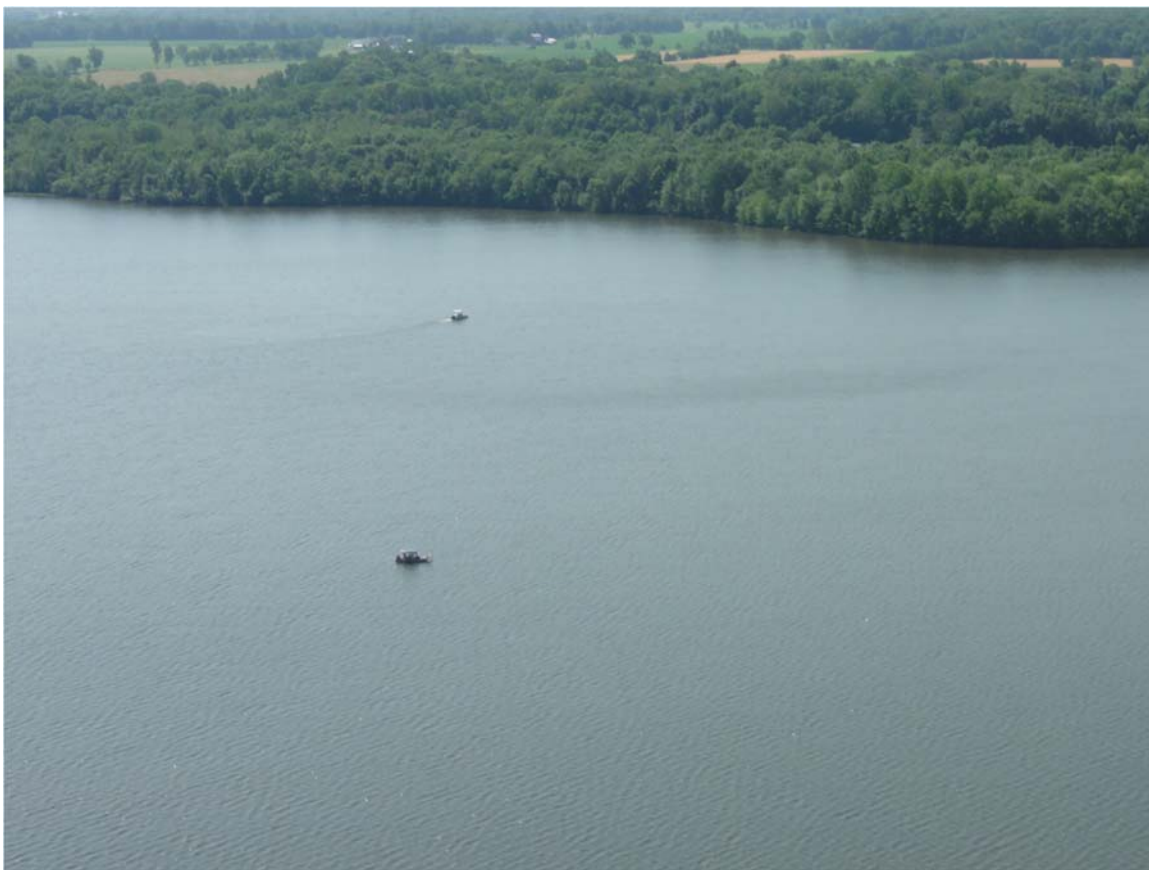
37. Morrow Lake velocity boat and sheen sweep boat observed.
