# Situation Photo Log

Saturday, June 23, 2012

Kalamazoo River / Enbridge Spill

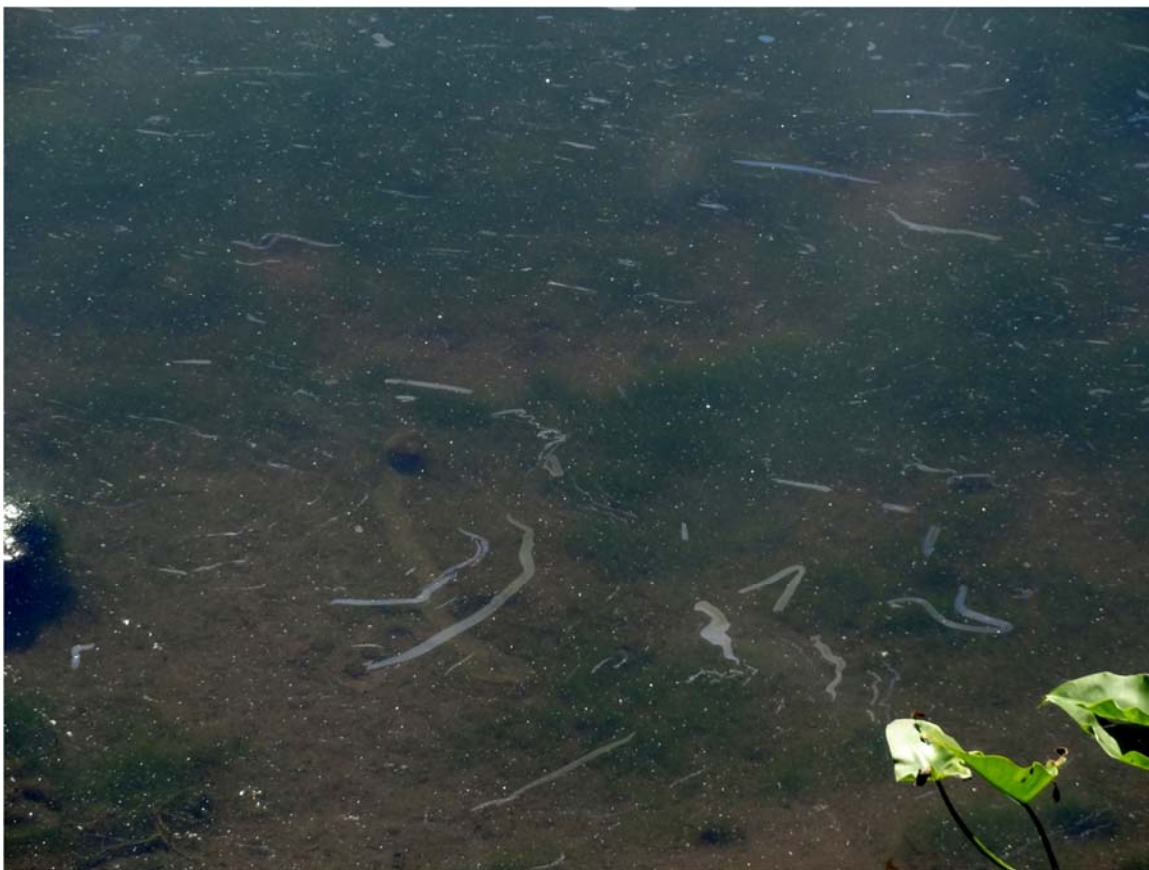
1. Sheen observed at Ceresco Dam.

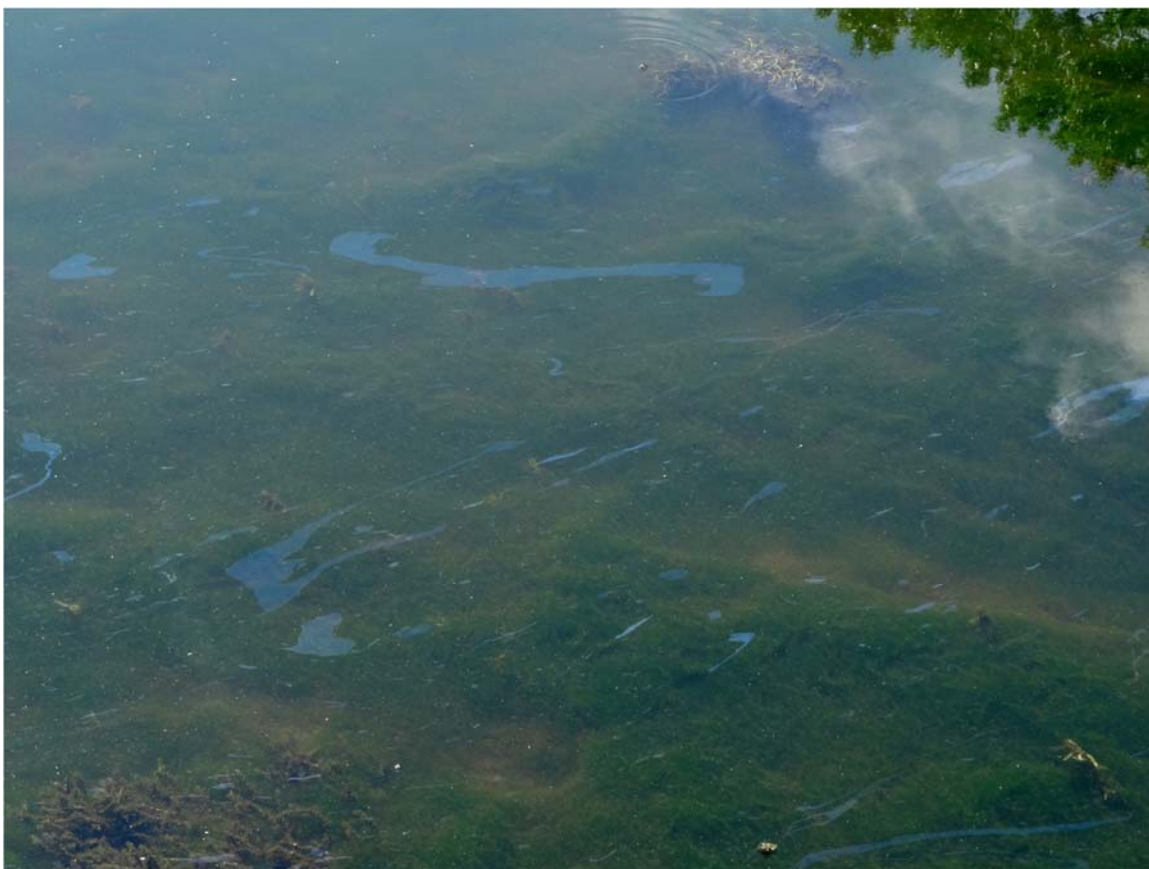
2. Sheen observed at Ceresco Dam.

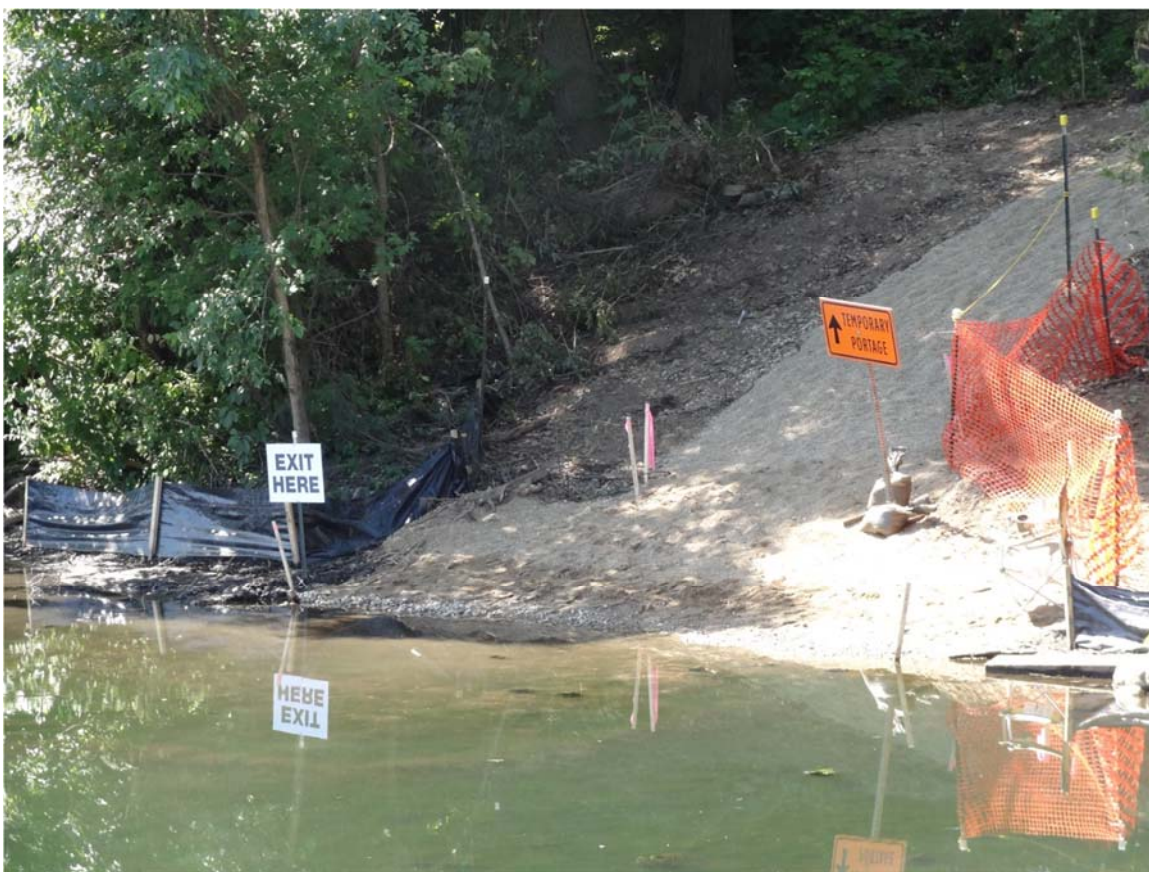
3. Ceresco Dam temporary portage.

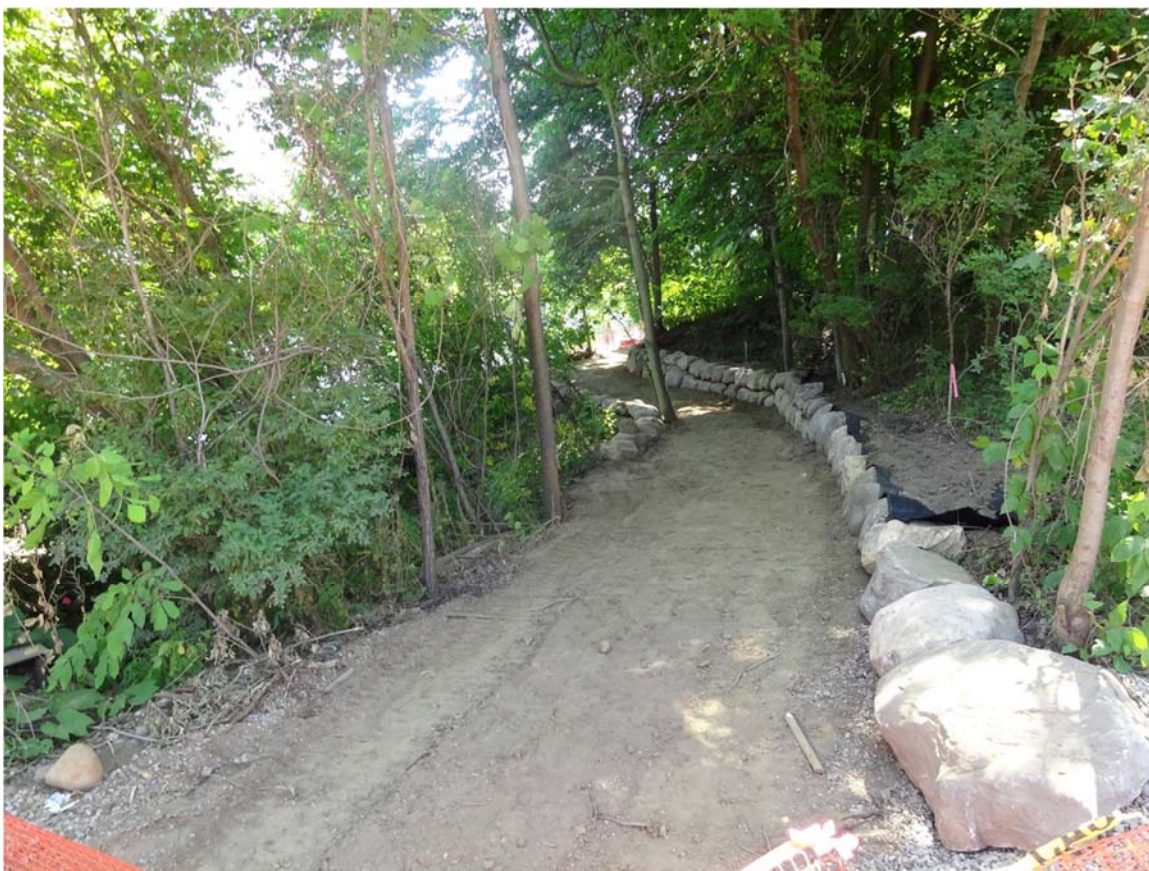
4. Ceresco Dam Portage under construction.

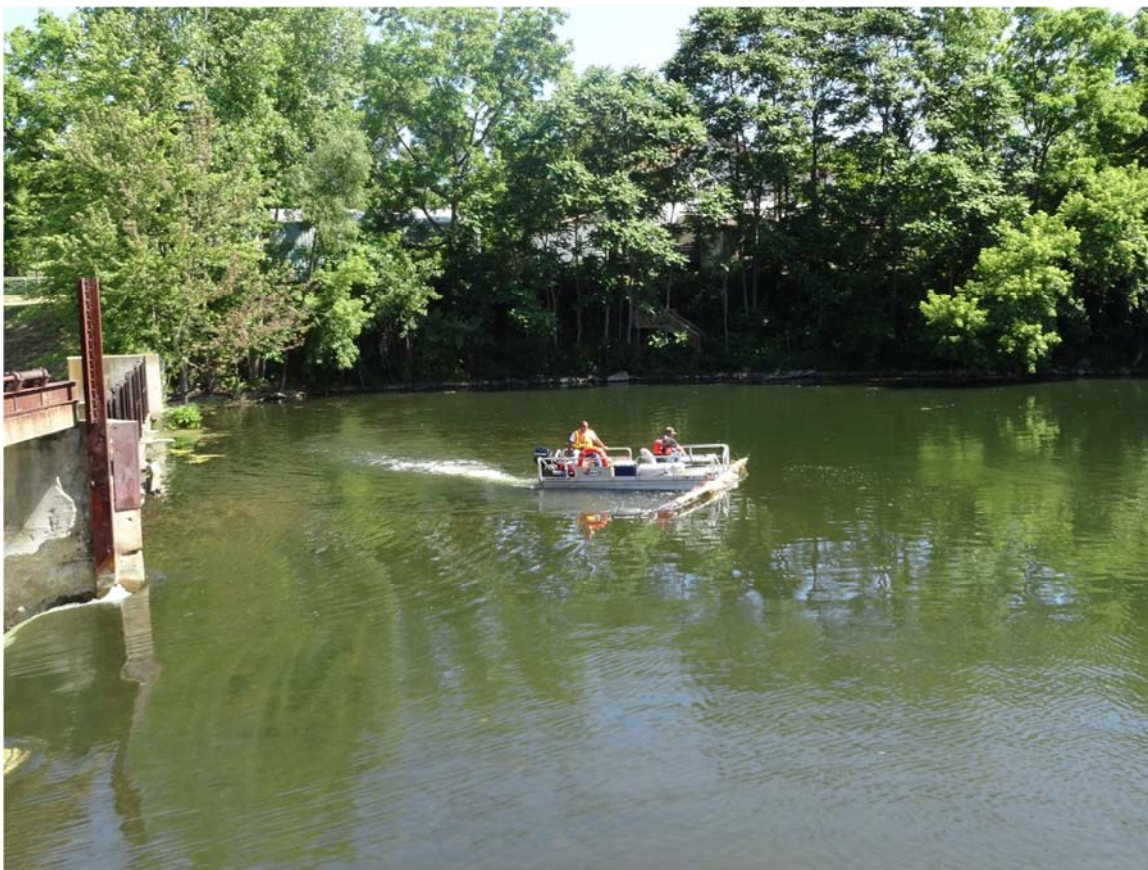
5. Ceresco Dam sweep boat.

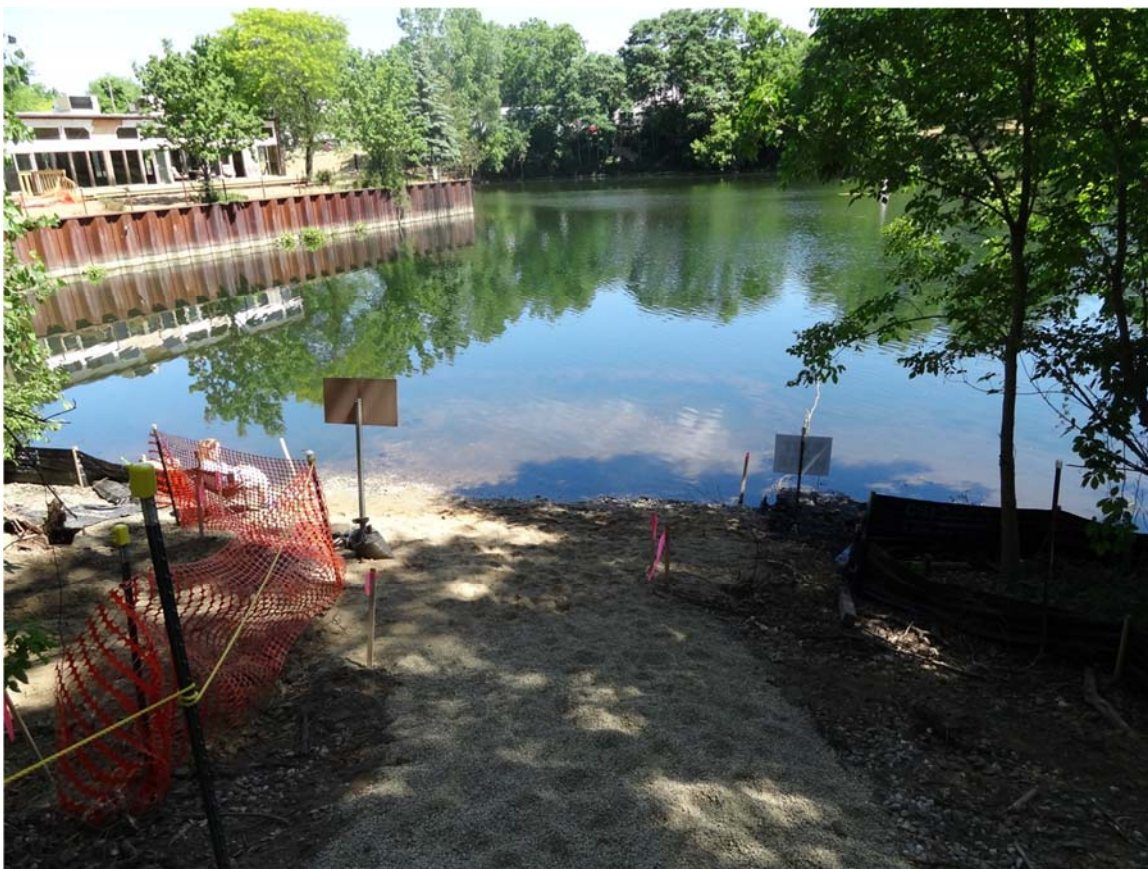
6. Ceresco Dam temporary portage.

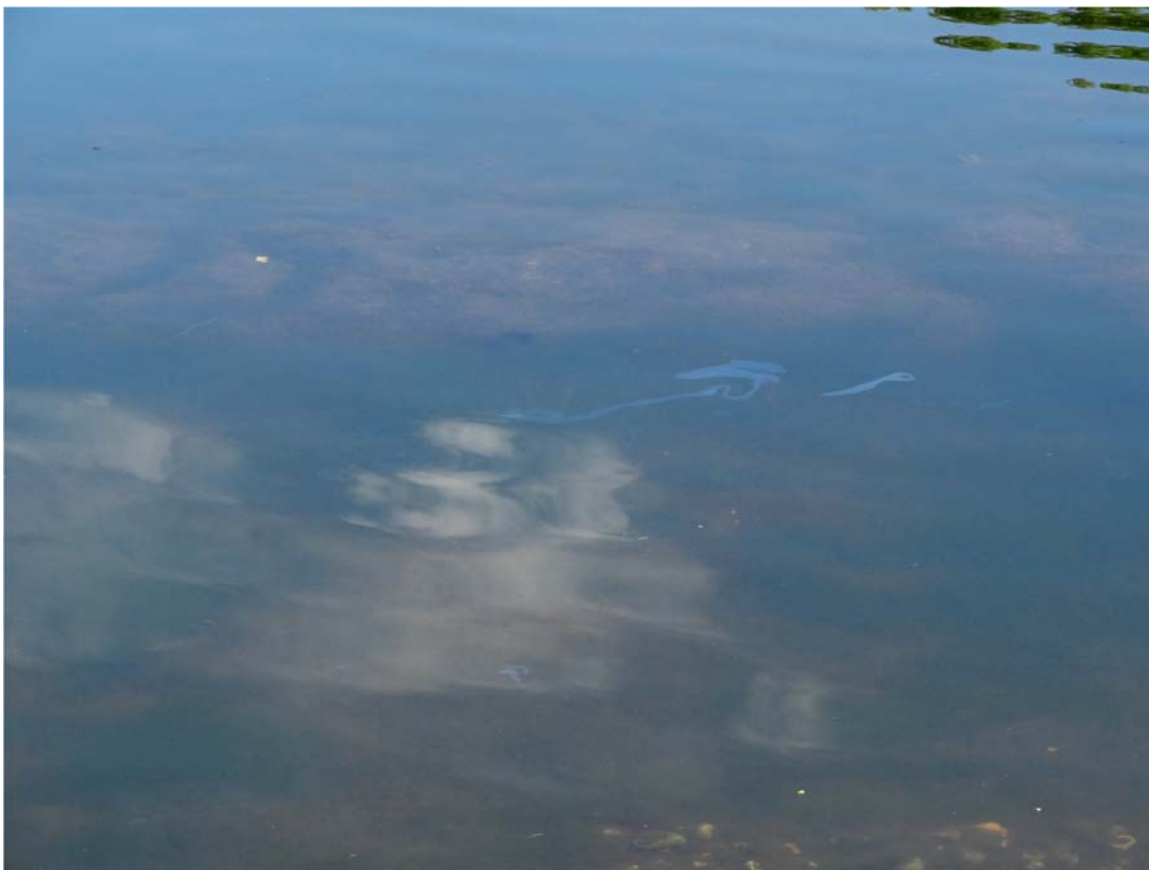
7. Ceresco Dam sheen observed portage.

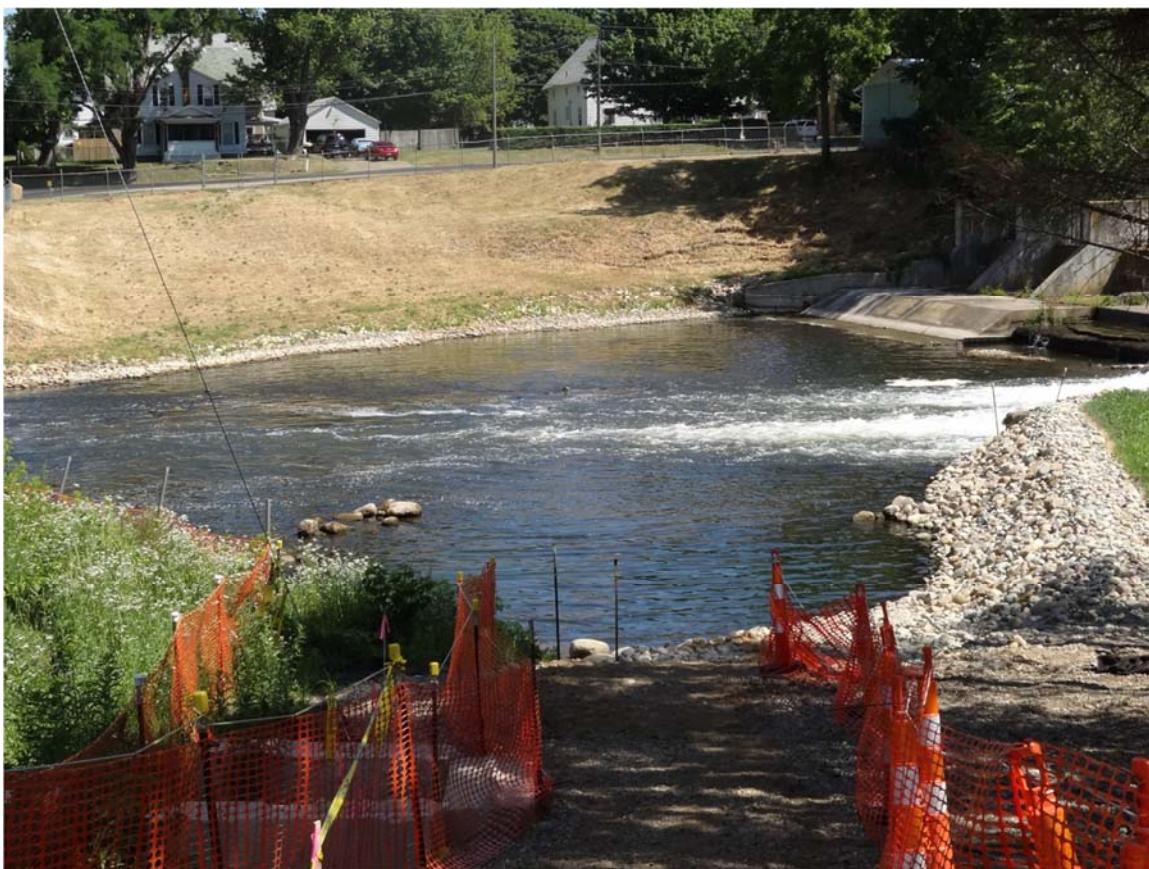
8. Ceresco Dam downstream put in.

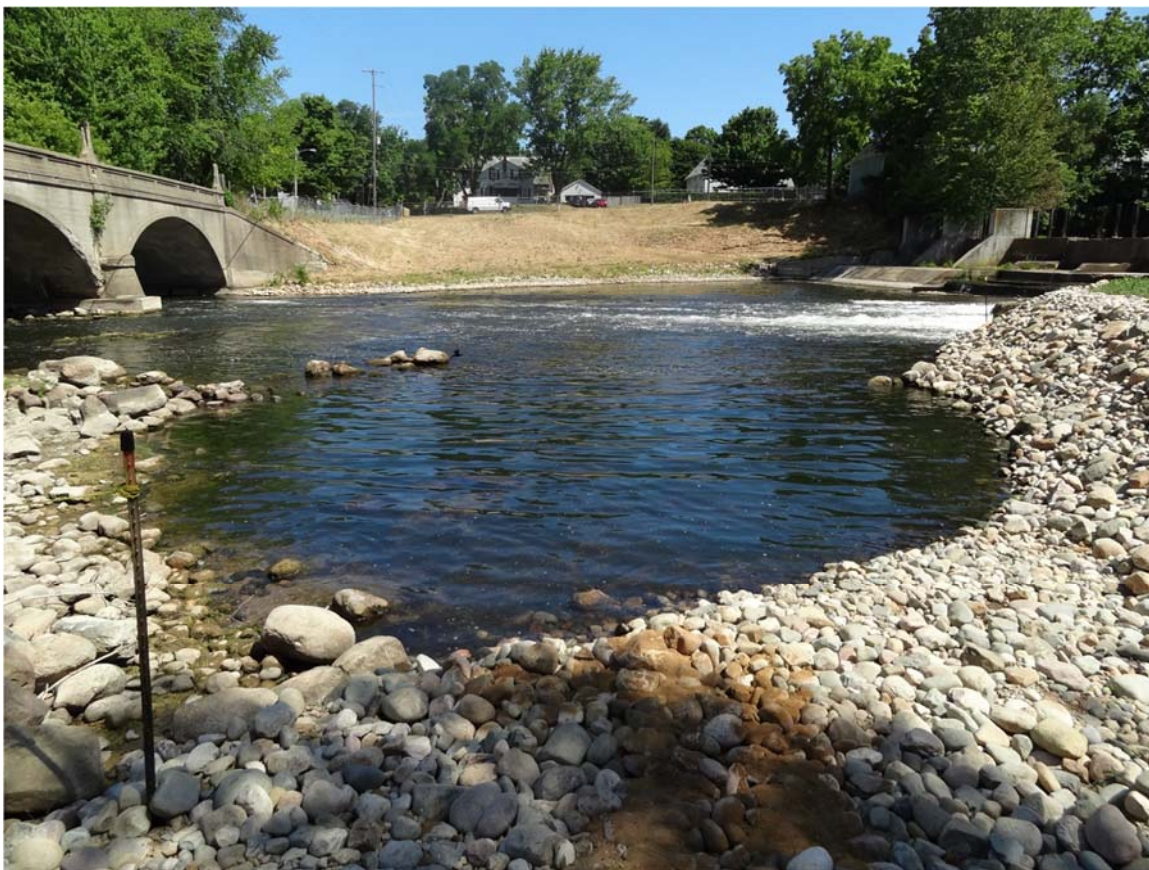
9. Boom removed from below Ceresco Dam.

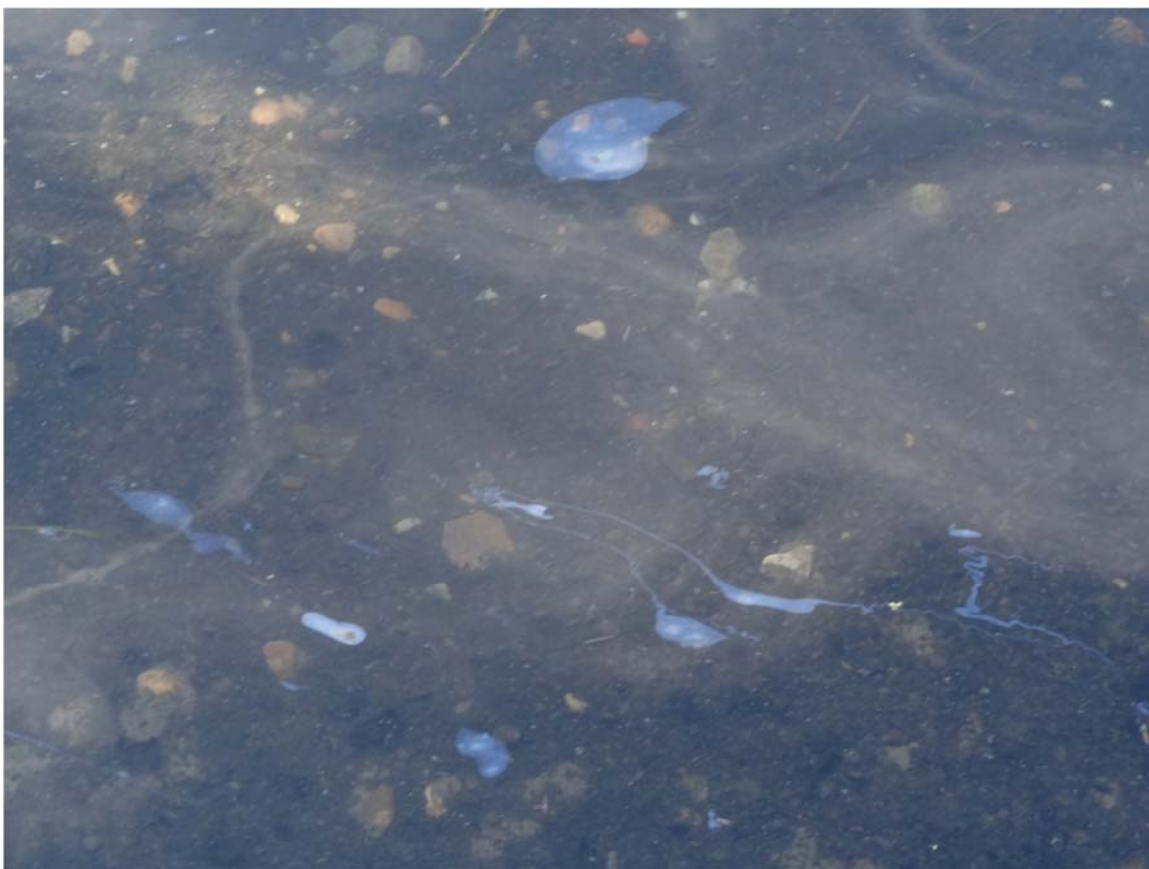
10. Sheen observed at E4 boat launch.

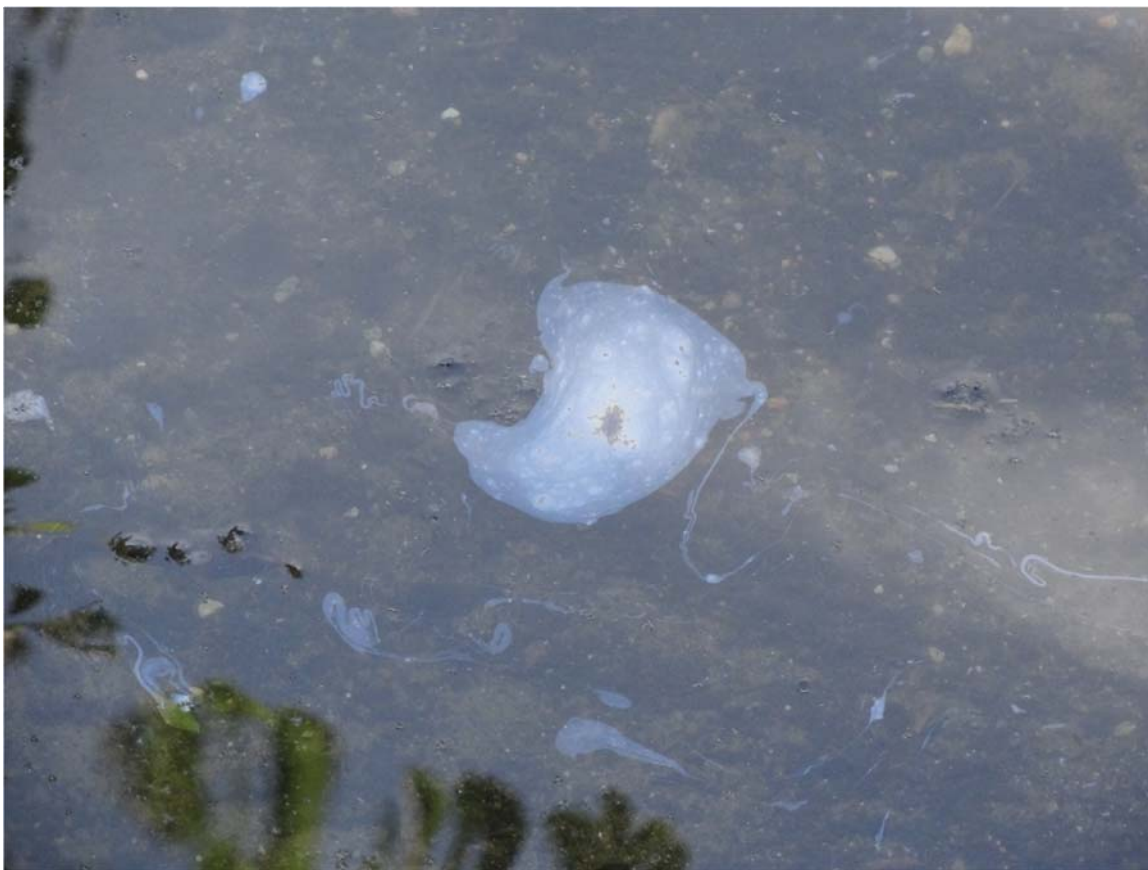
11. Sheen observed at E4 boat launch.

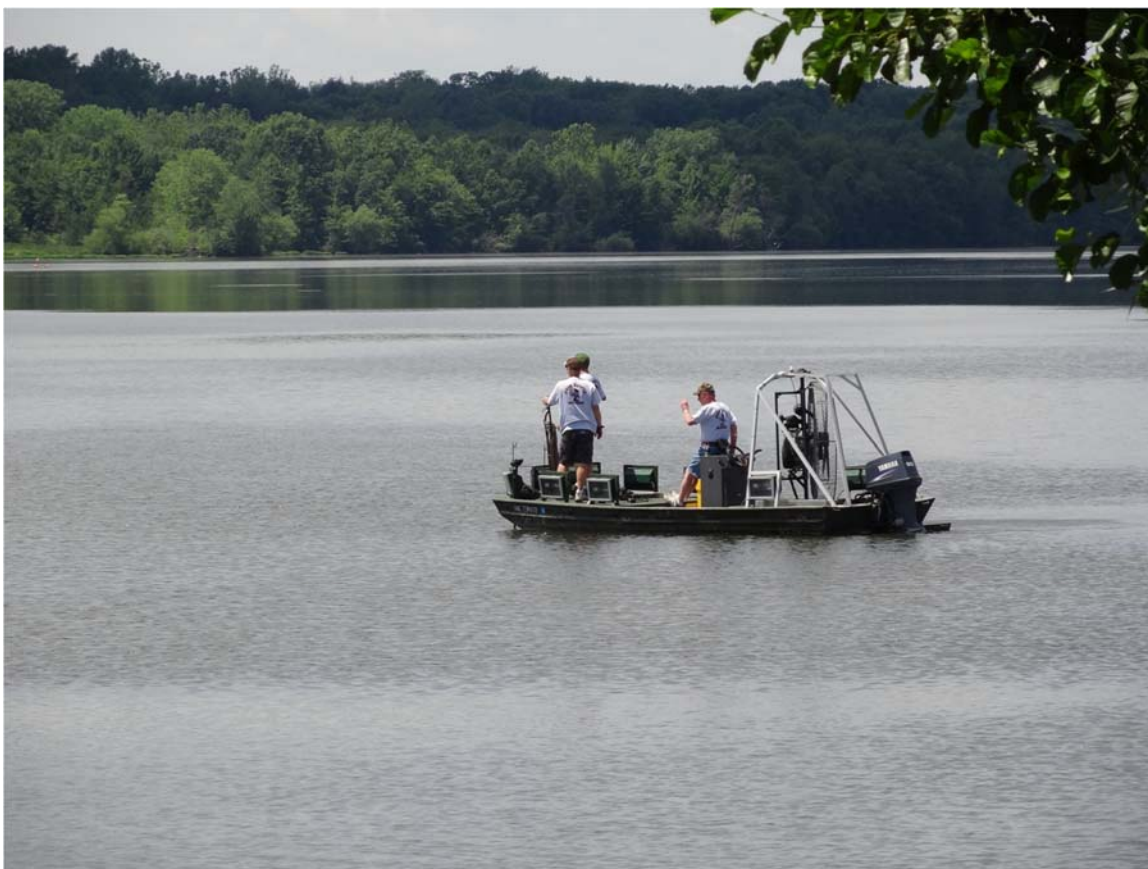
12. Morrow Lake observed public utilizing the lake.

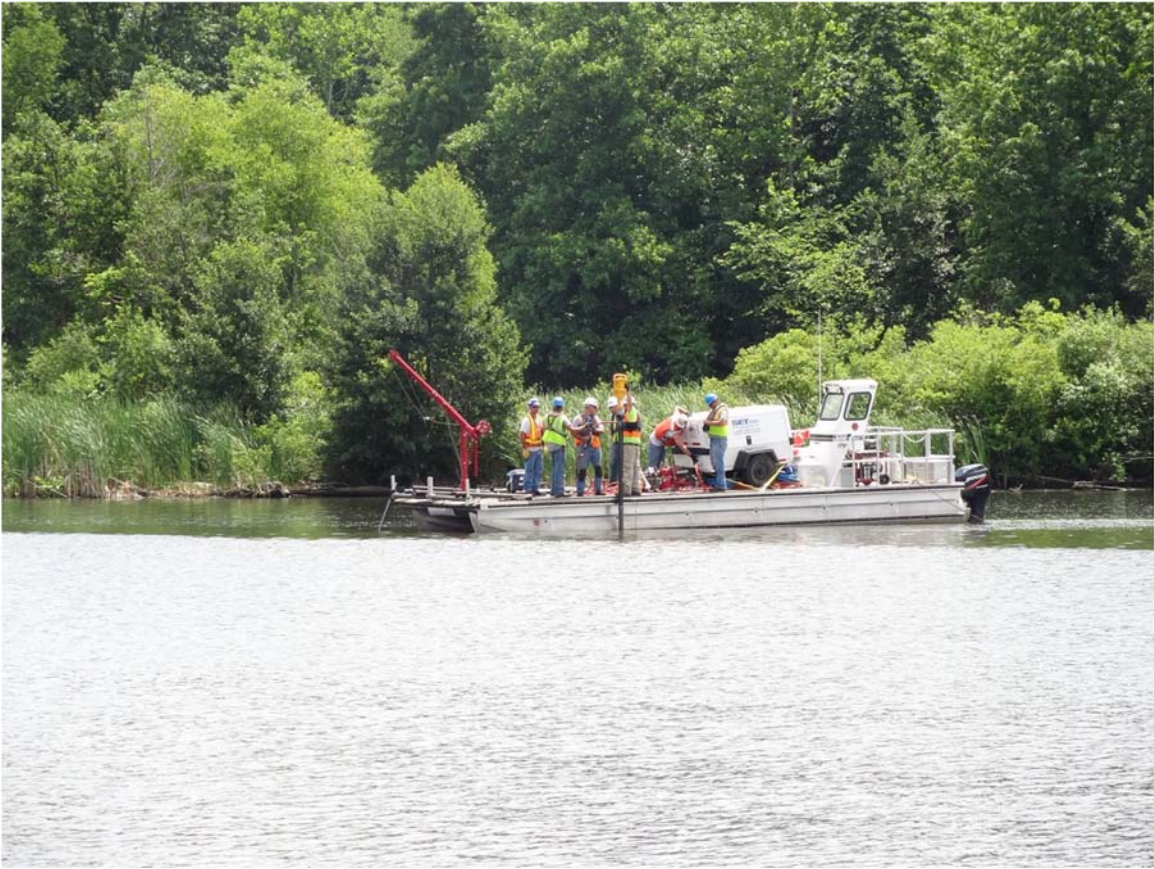
13. Morrow Lake Delta observed crew installing boom anchors.

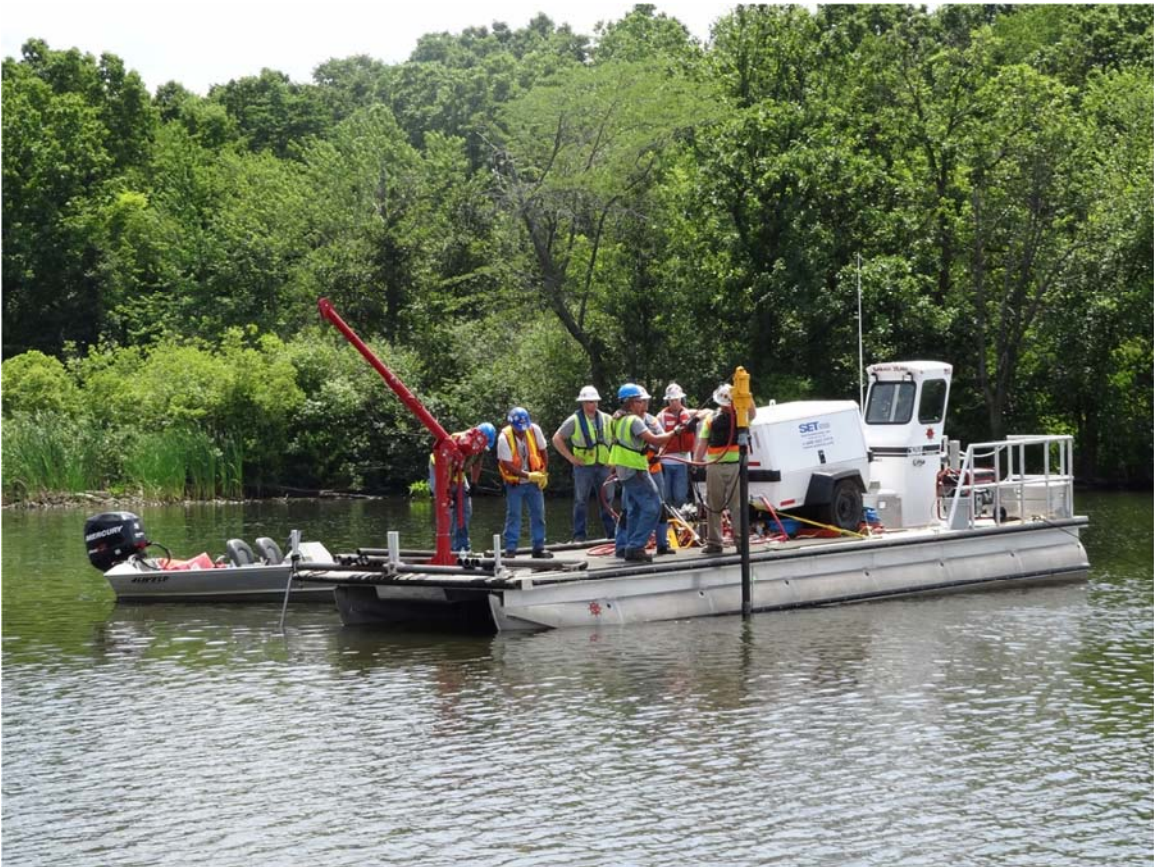
14. Morrow Lake Delta observed crew installing boom anchors.

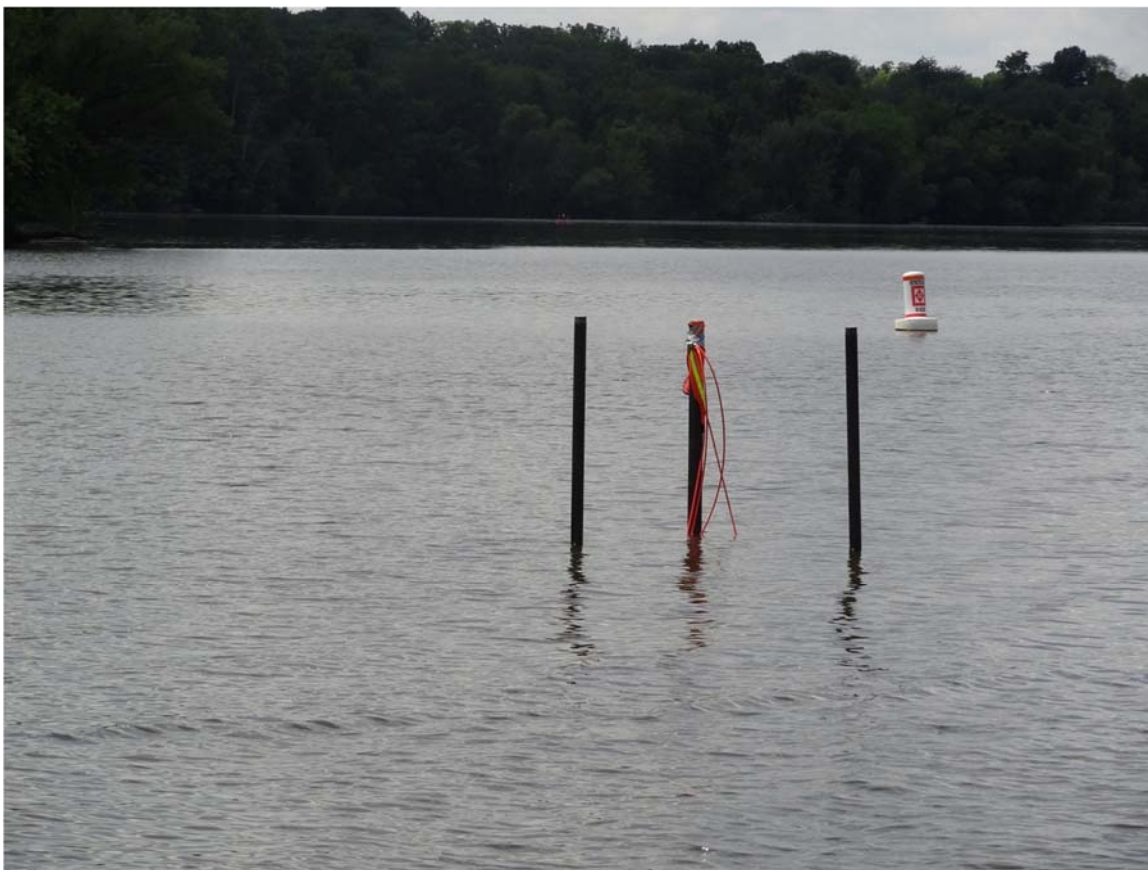
15. Morrow Lake Delta observed installed boom anchors.

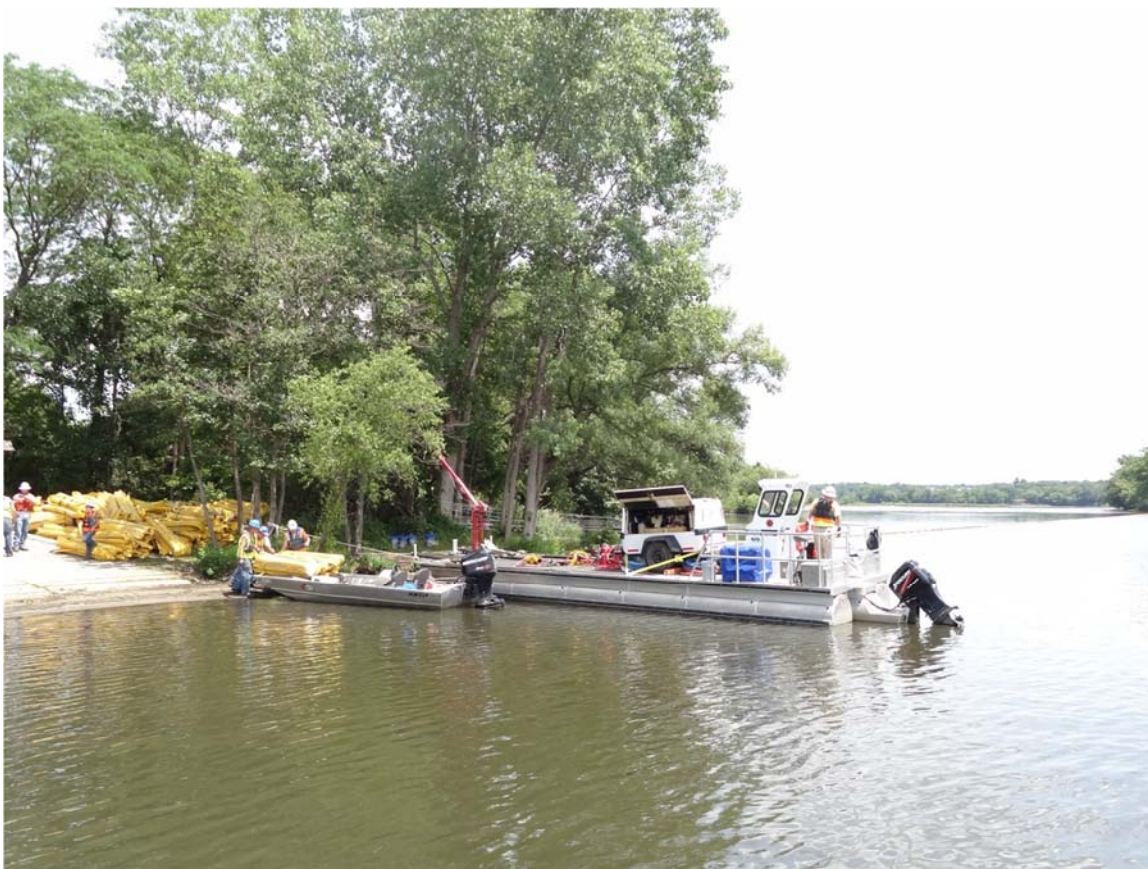
16. E4 Boat Launch crew loading boom to be deployed.

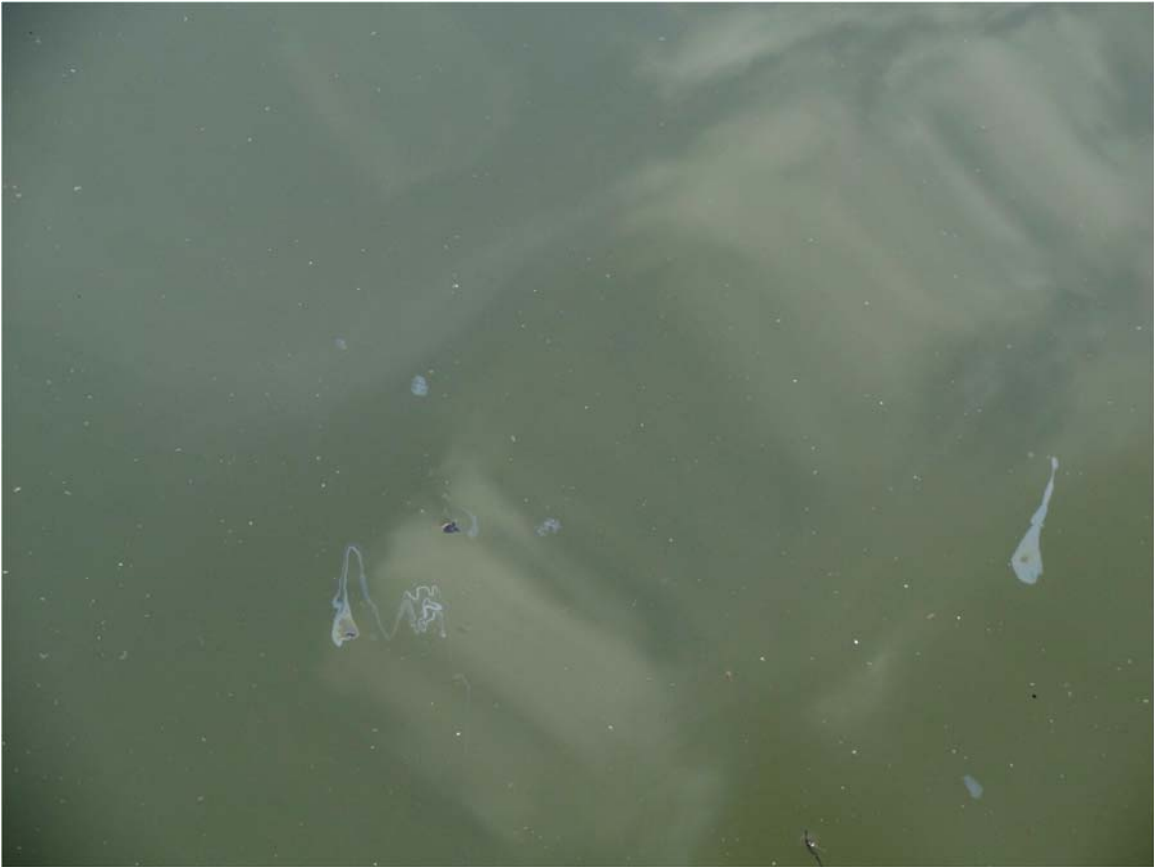
17. Morrow Lake Fan sheen observed.

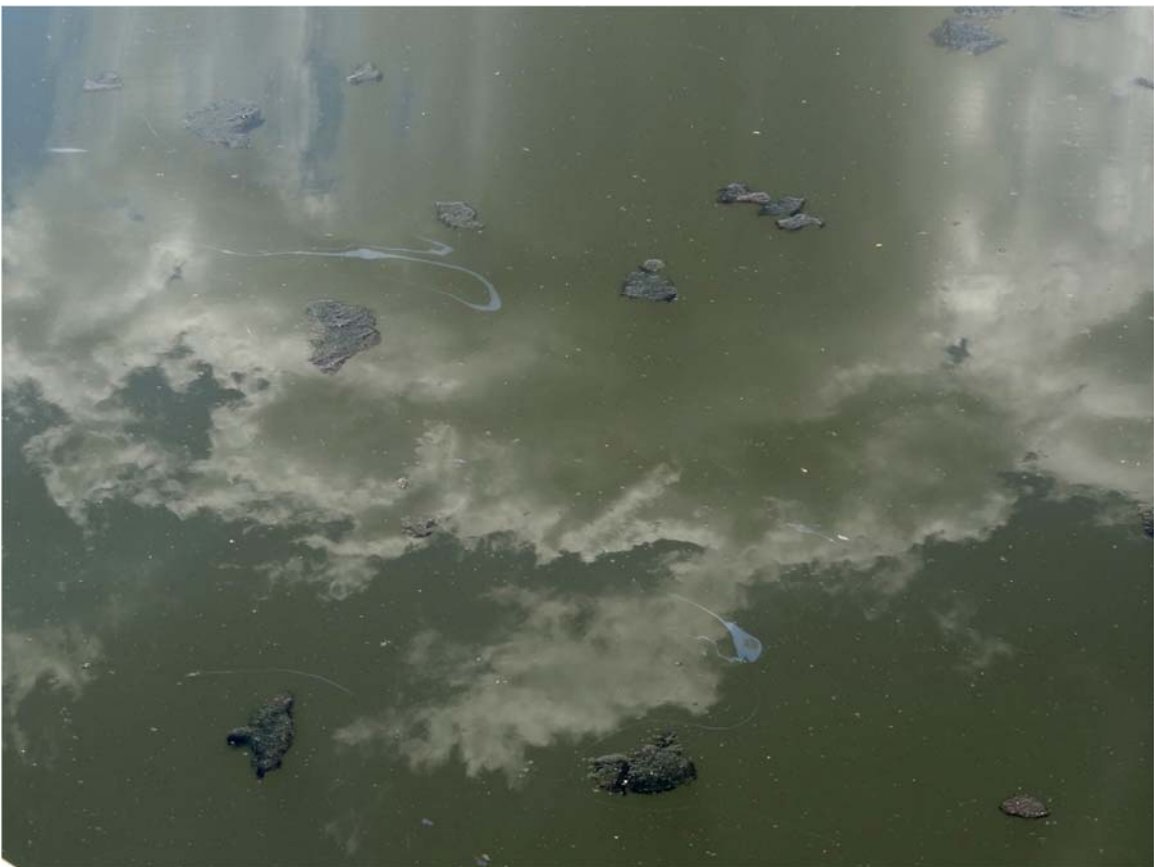
18. Morrow Lake Fan sheen observed.
