Situation Photo Log

Tuesday, June 26, 2012

Kalamazoo River / Enbridge Spill

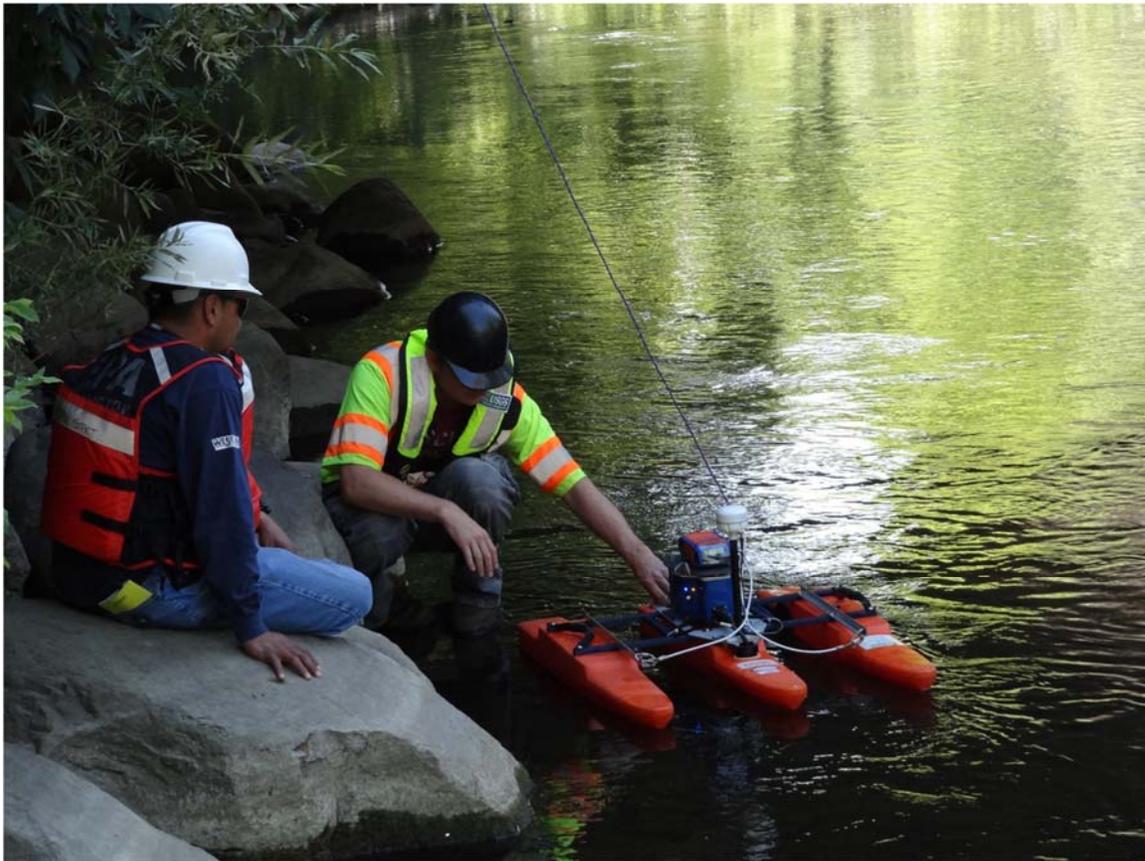
1. Beedle Lake Bridge USGS observed performing discharge measurements.

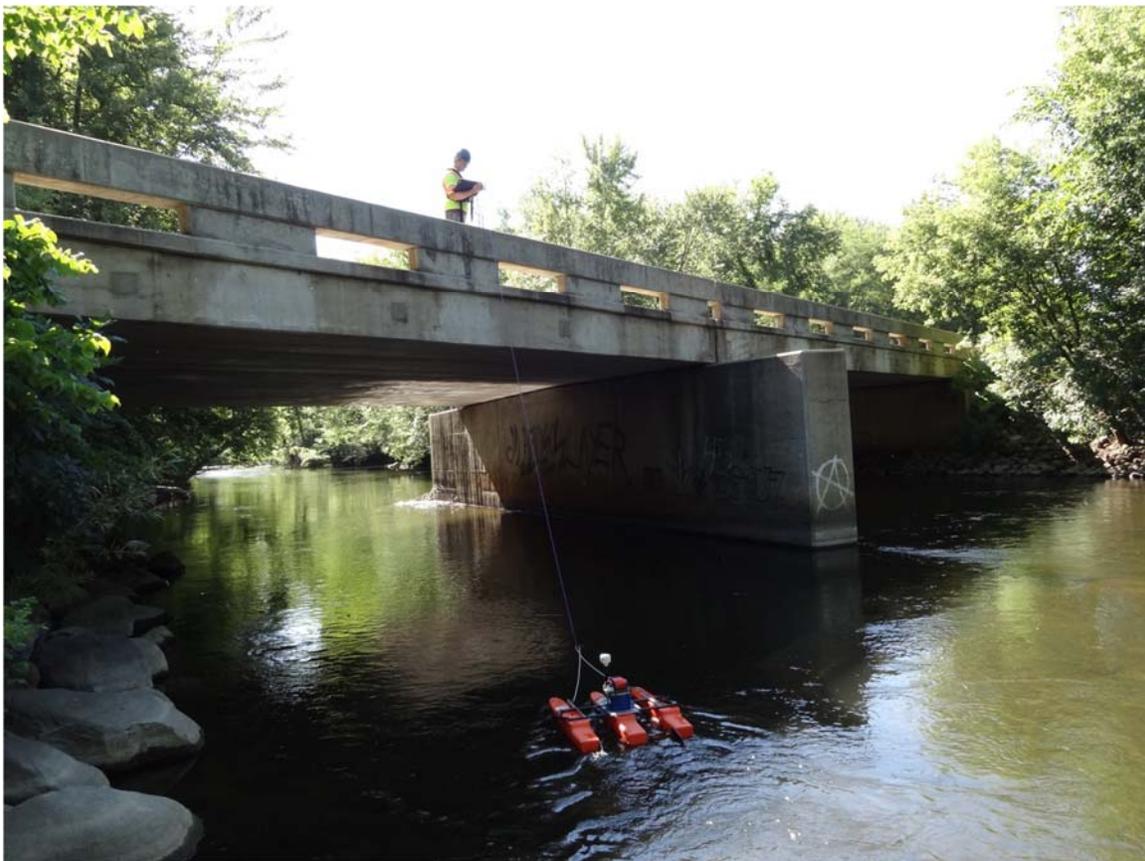
2. Beedle Lake Bridge USGS observed performing discharge measurements.

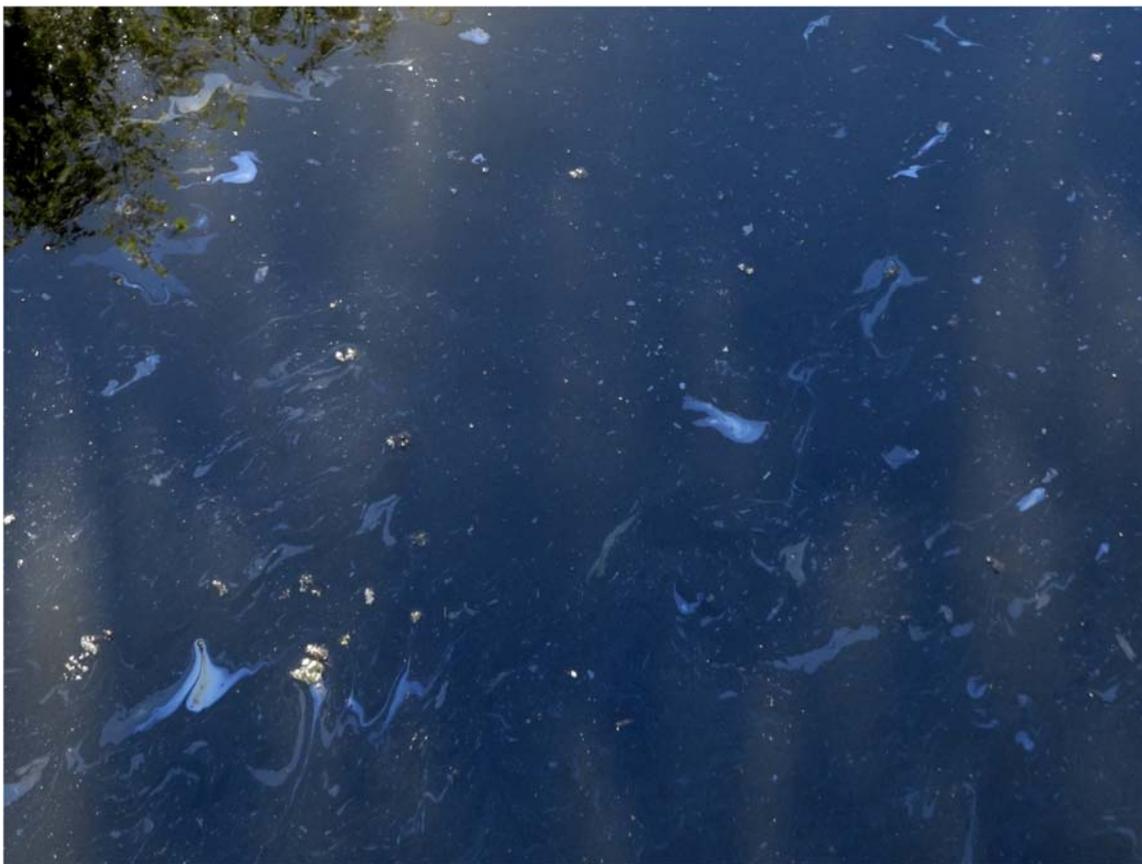
3. MP15.5 South Mill Pond north corner observed sheen flowing out of Mill Pond into river. Operations was notified and sweep boat was observed in the area.

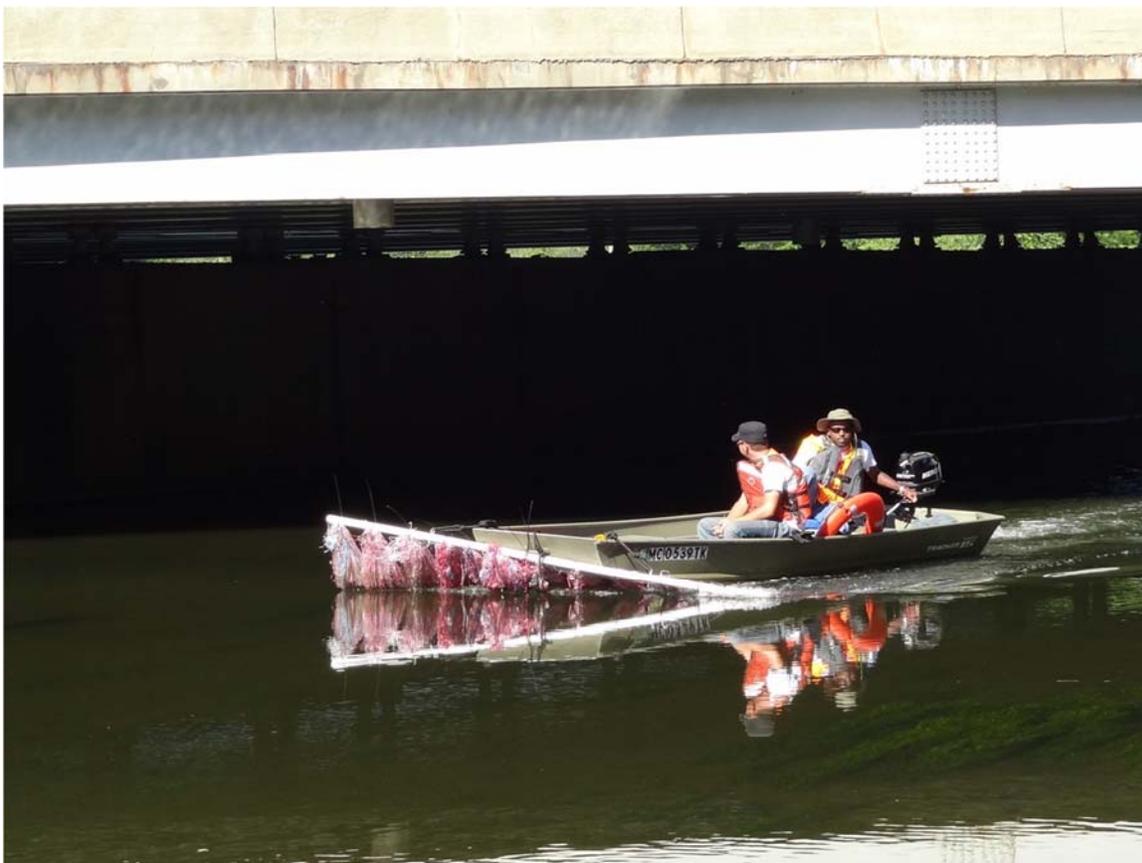
4. Observed sheen sweep boat operating near C5 boat launch.

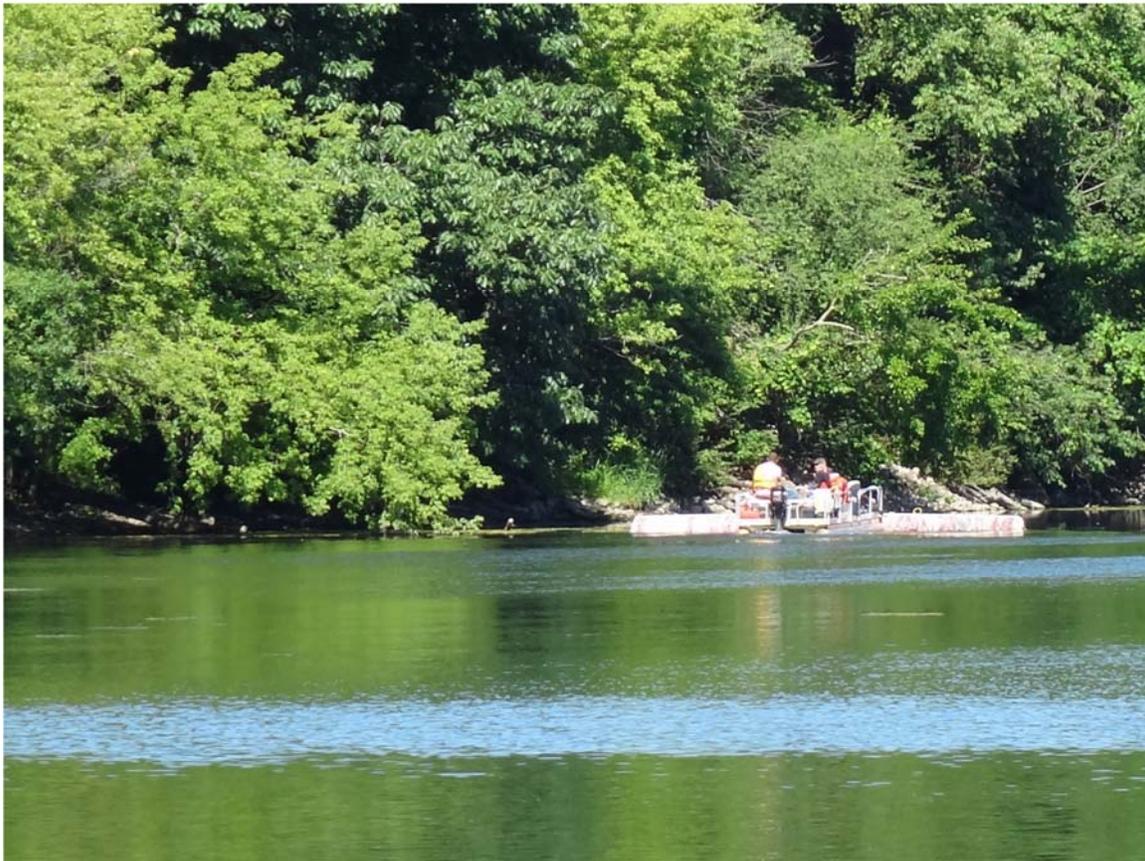
5. Observed sheen sweep boat operating near MP5.5 LDB.

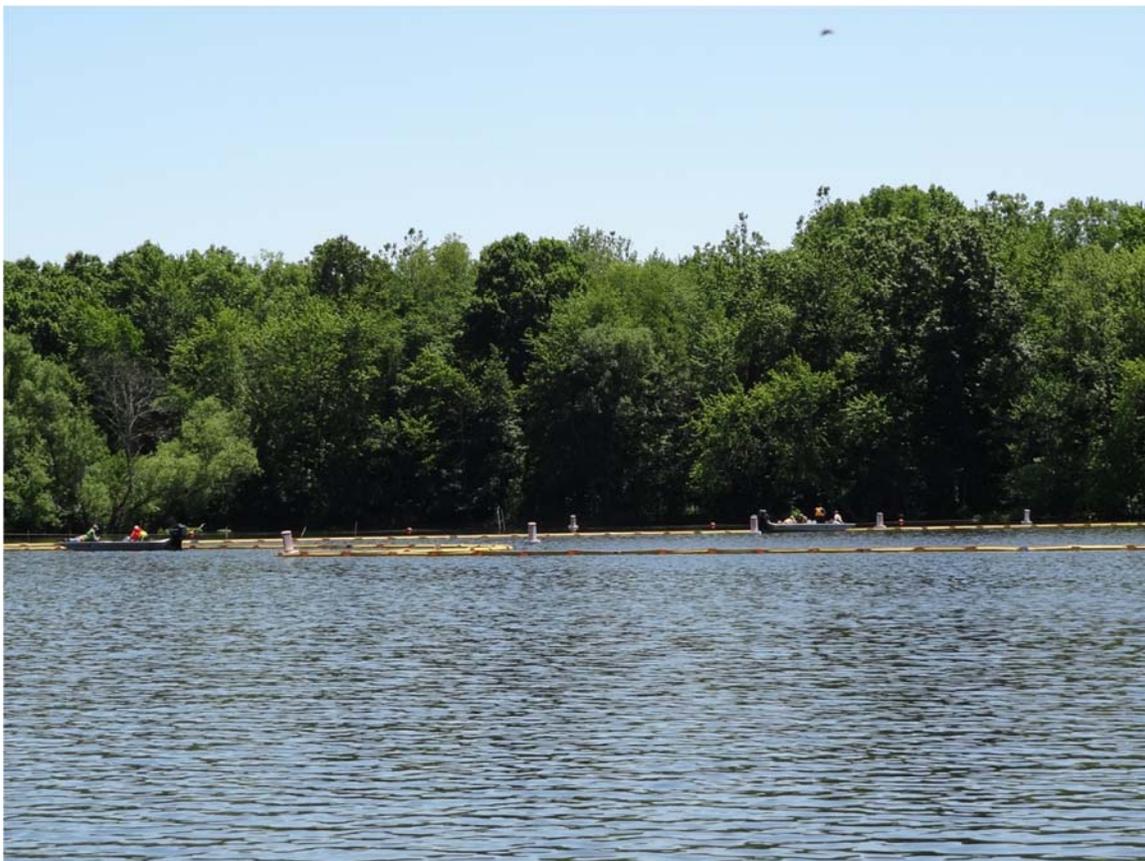
6. MP37.75 Observed crews deploying boom.

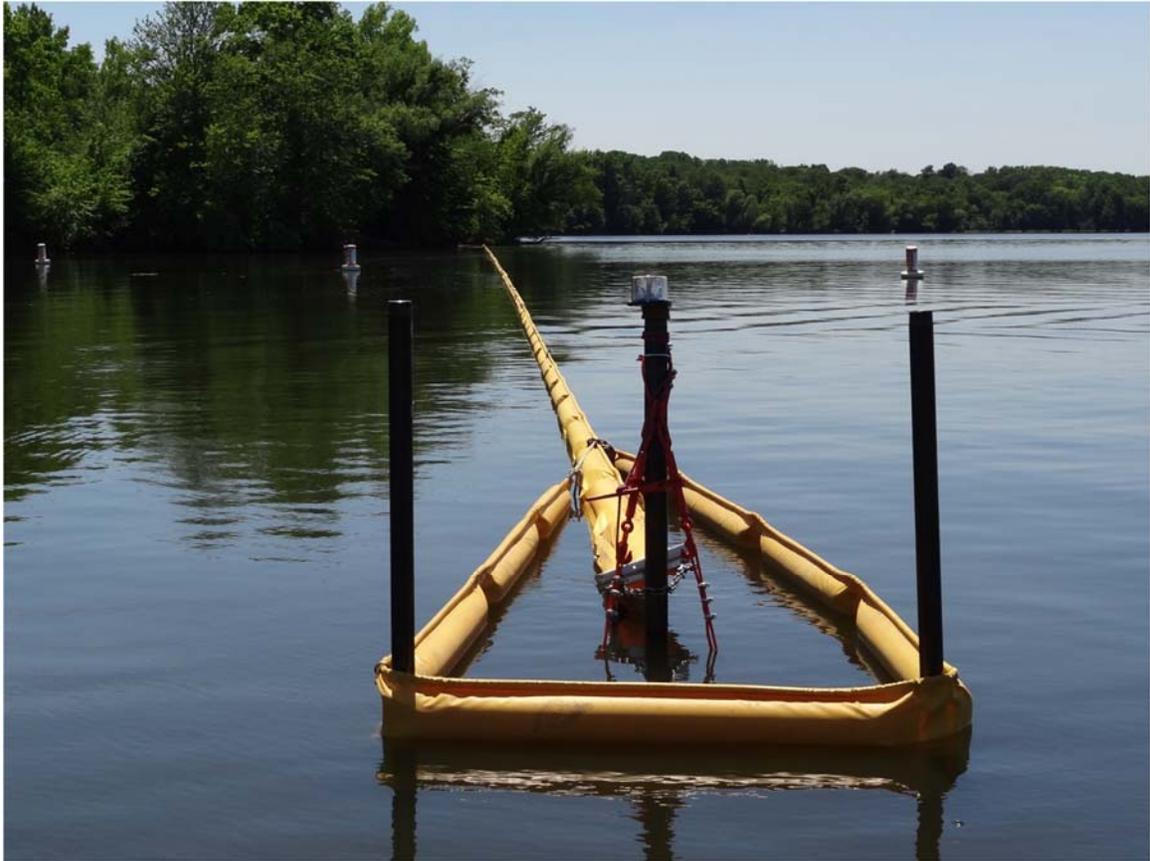
7. MP37.75 Newly installed boom.

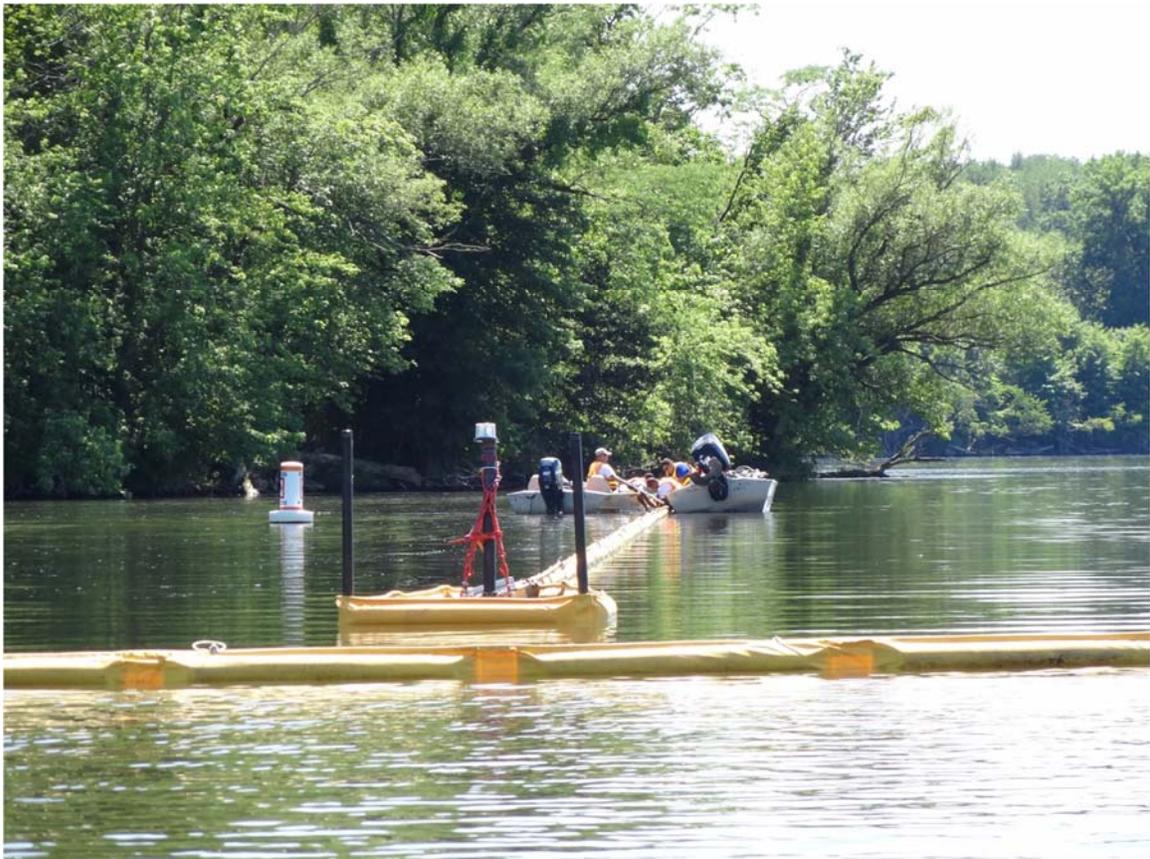
8. Observed crew installing curtain onto boom.

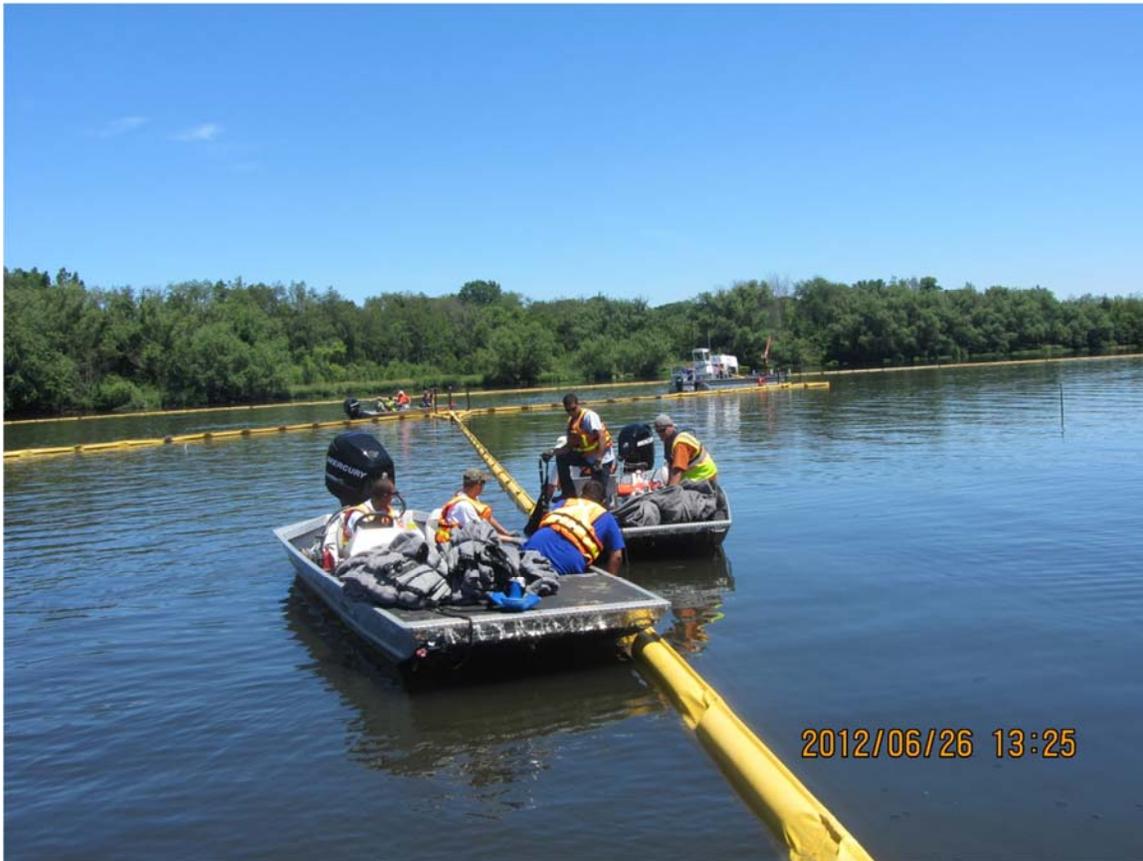
9. Observed crew installing curtain onto boom.

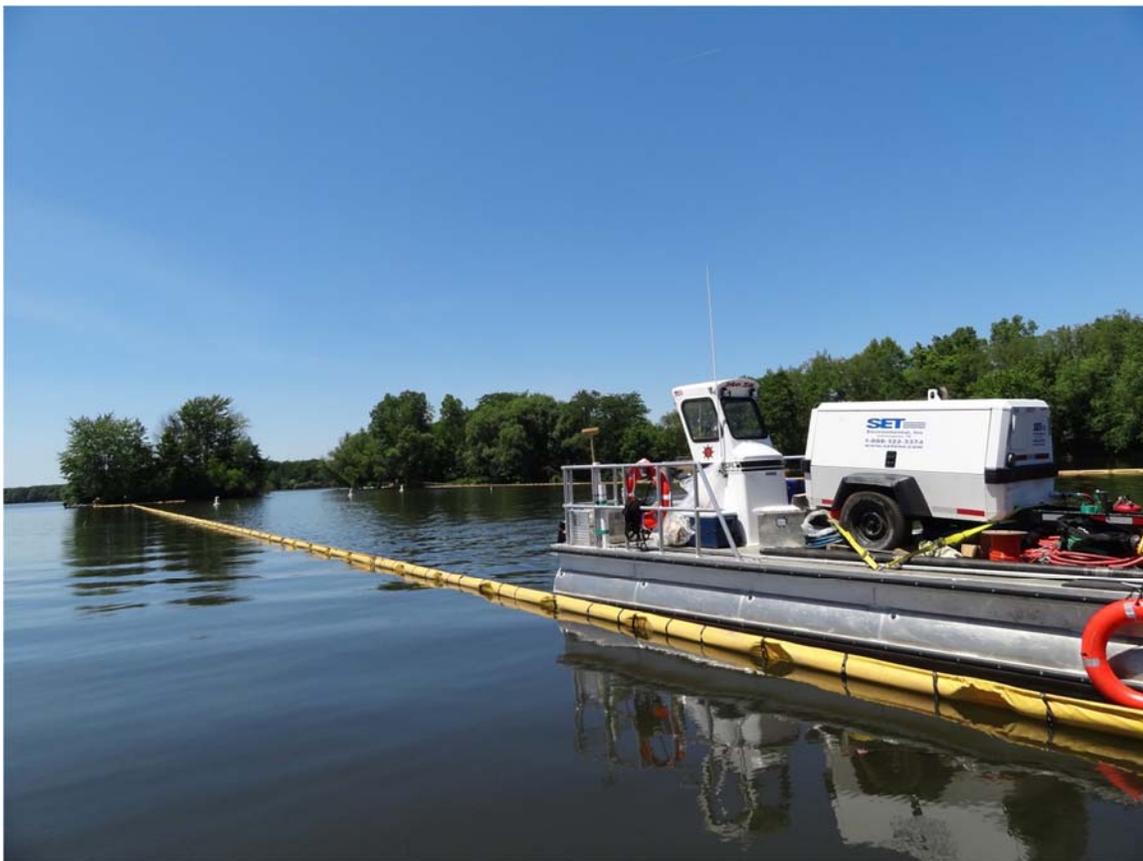
10. MP37.75 Newly installed booms.

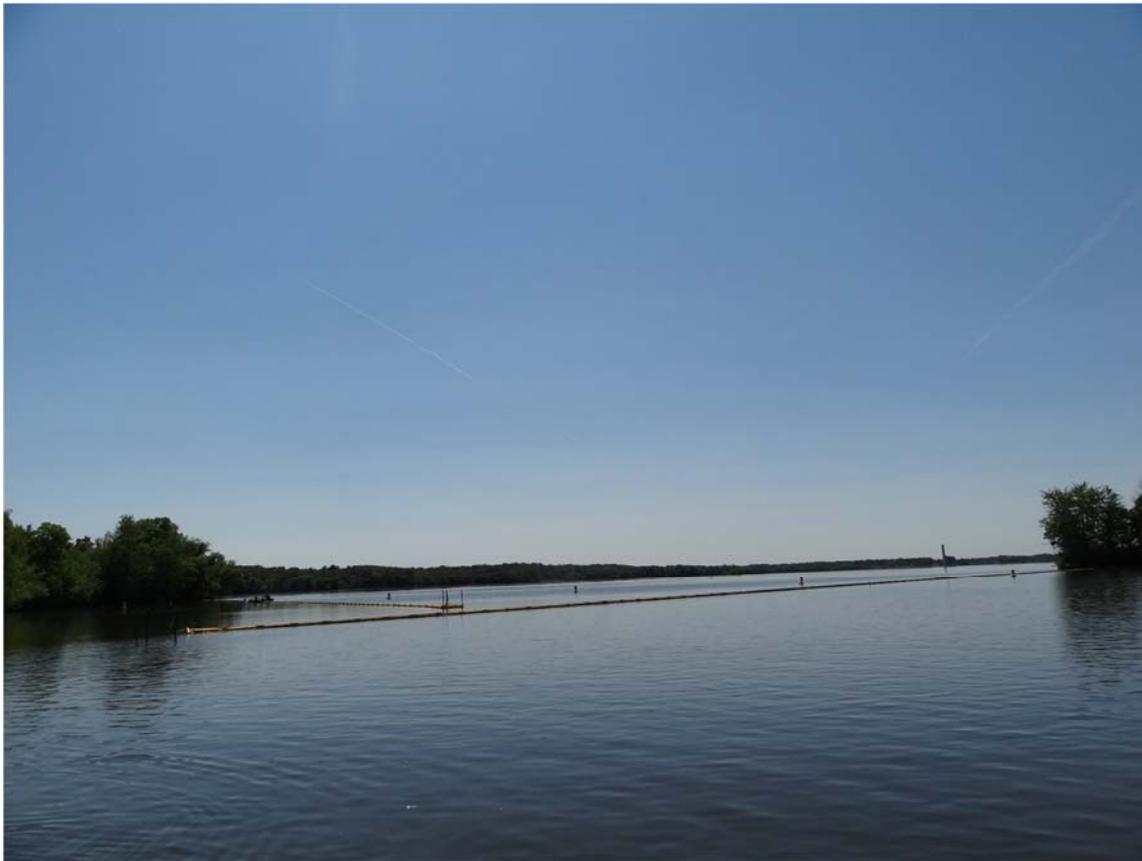
11. MP37.75 Newly installed booms.

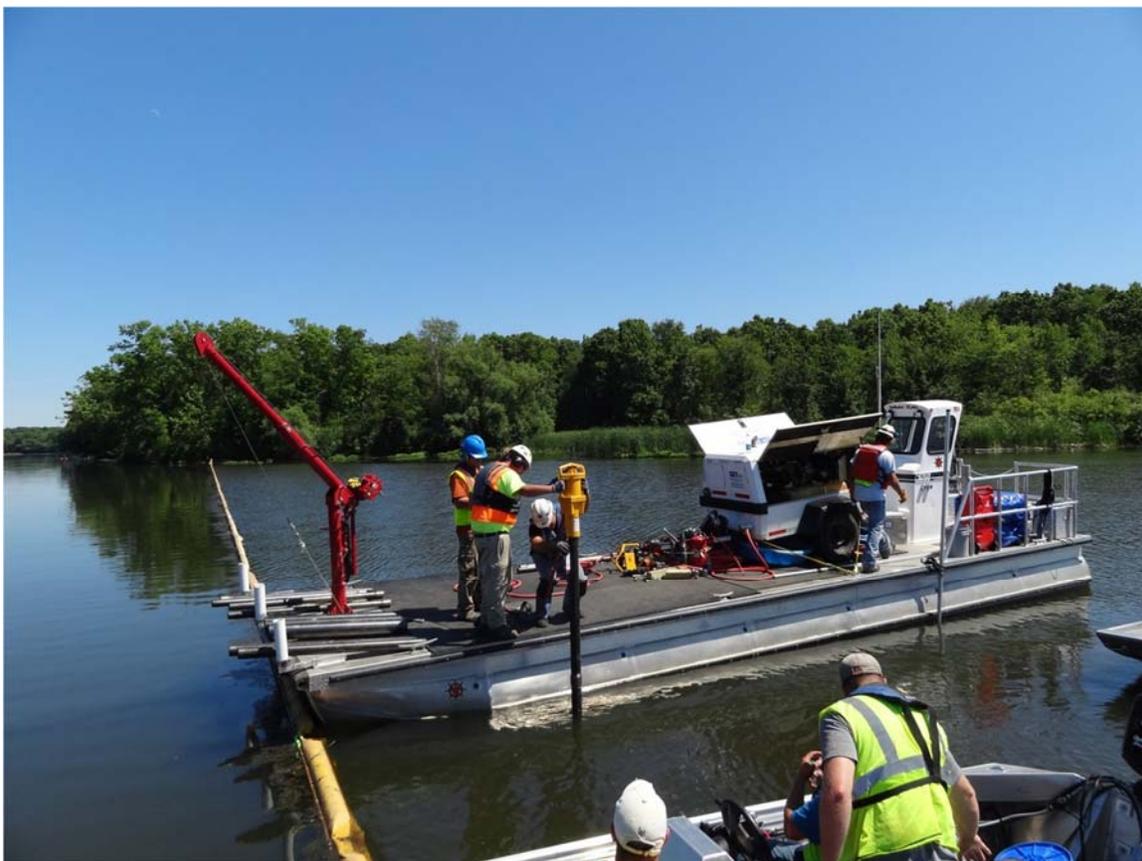
12. MP37.75 Observed crews installing additional anchor point.

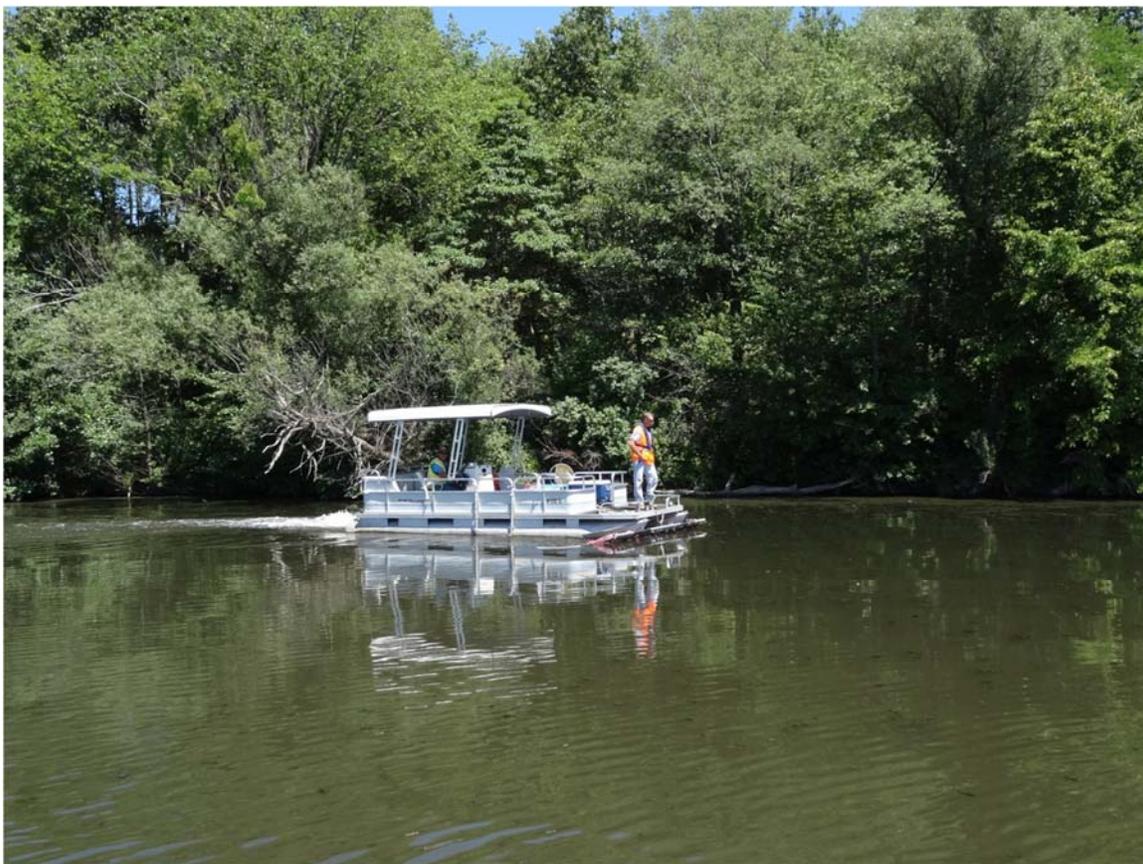
13. Observed sheen sweep boat operating in the north cove of Morrow Lake.

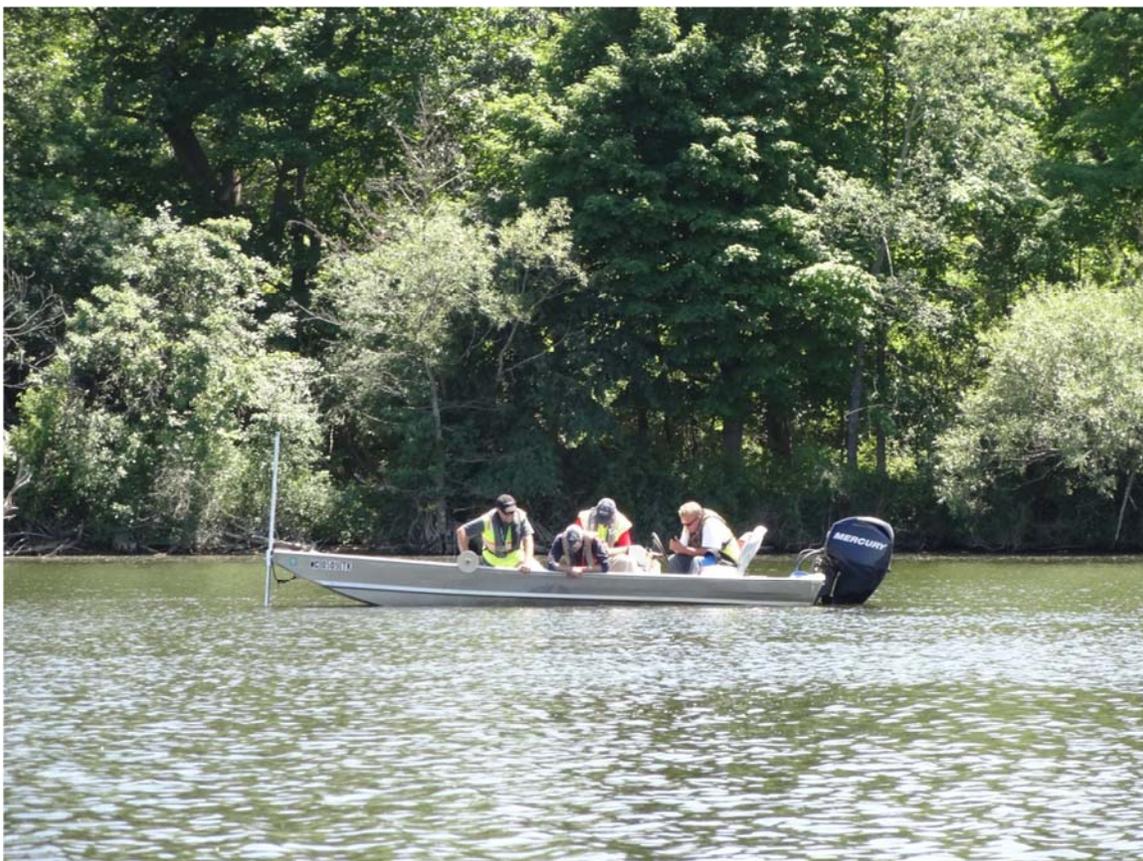
14. Morrow Lake poling crew observed.

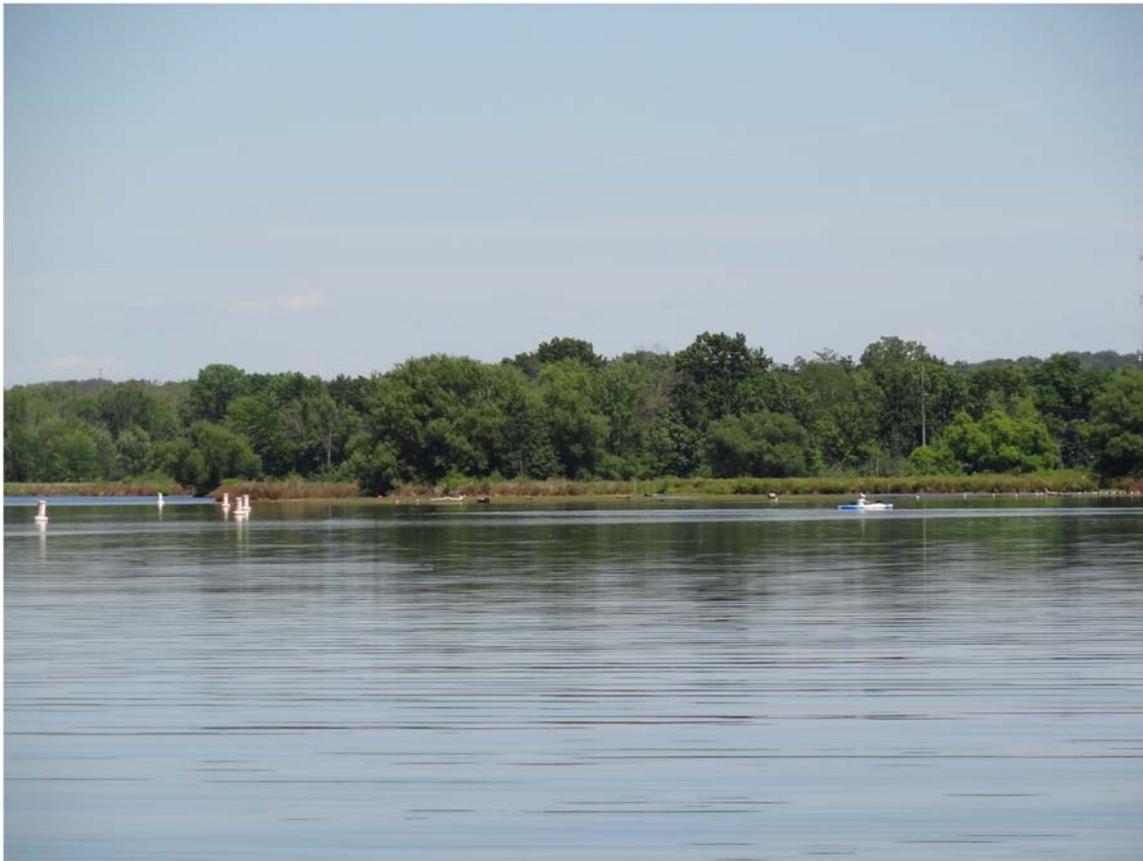
15. Observed person kayaking into closed section of Morrow Lake Delta.

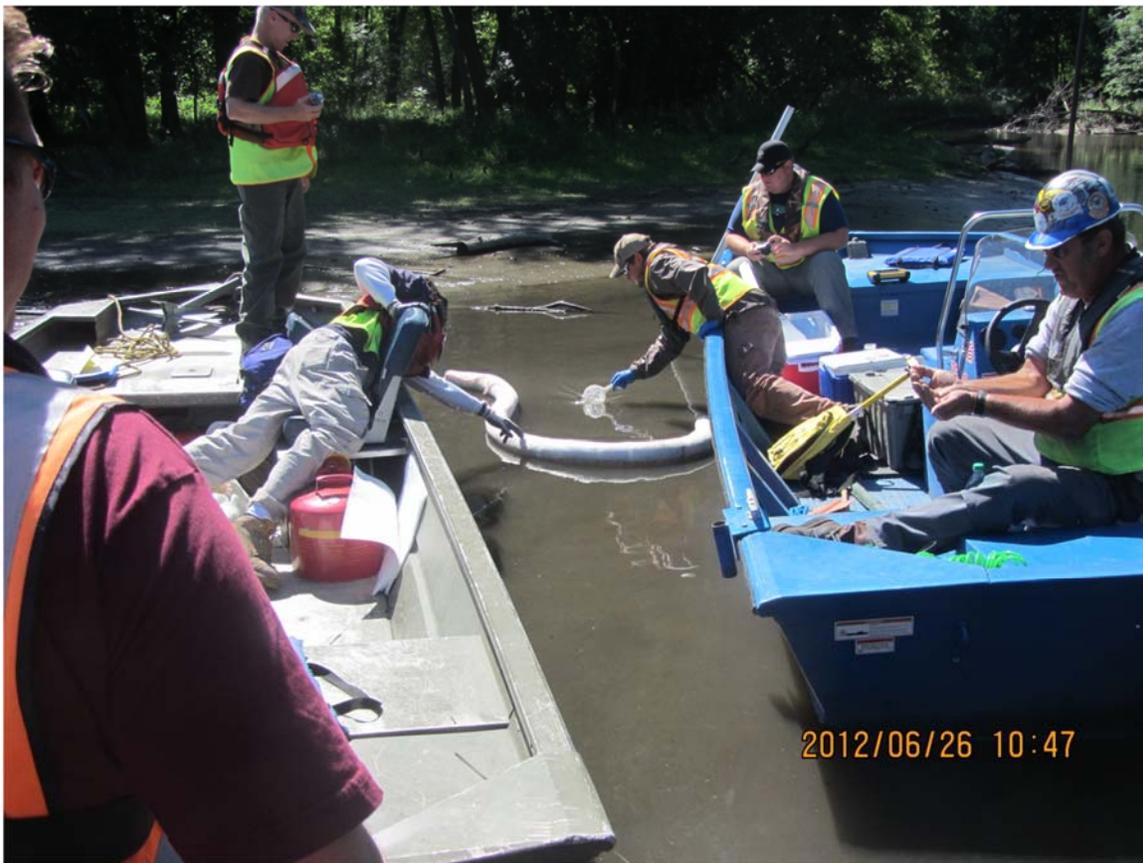
16. Observed sheen/glob samples being collected at MP30.8LDB.

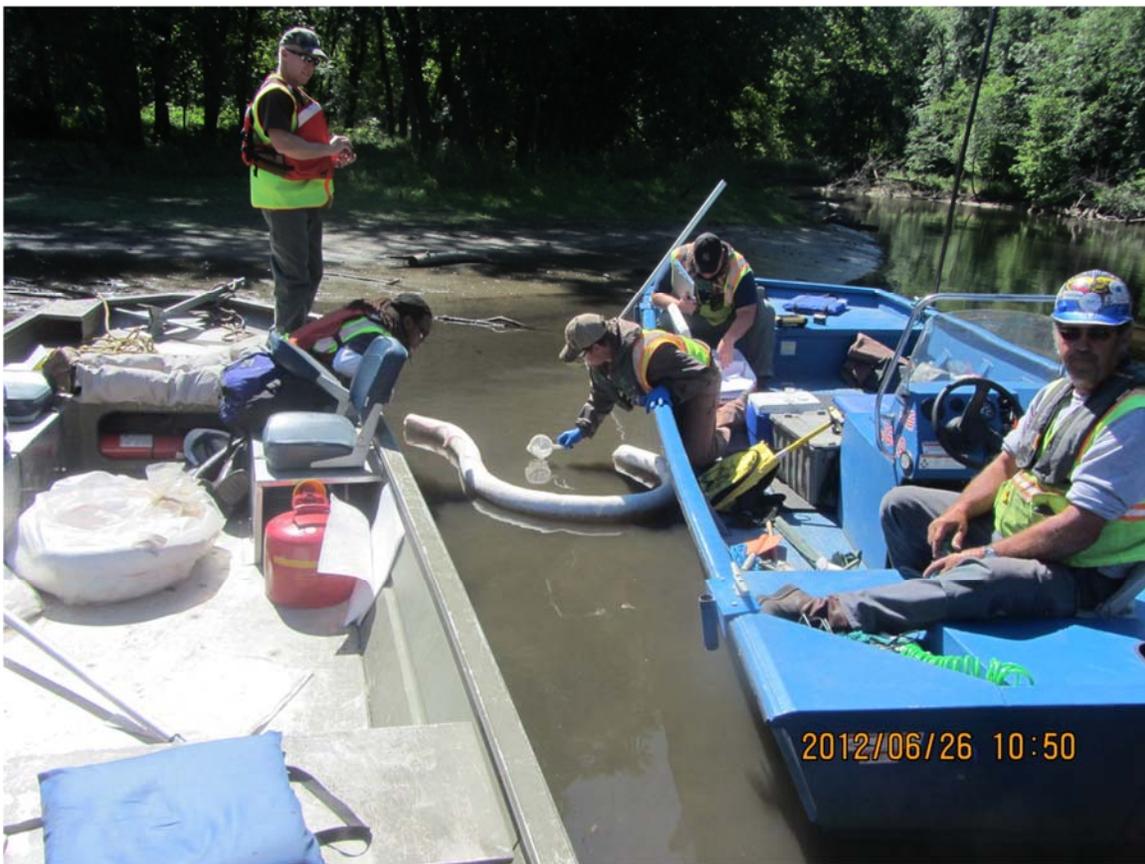
17. Observed sheen/glob samples being collected at MP30.8LDB.

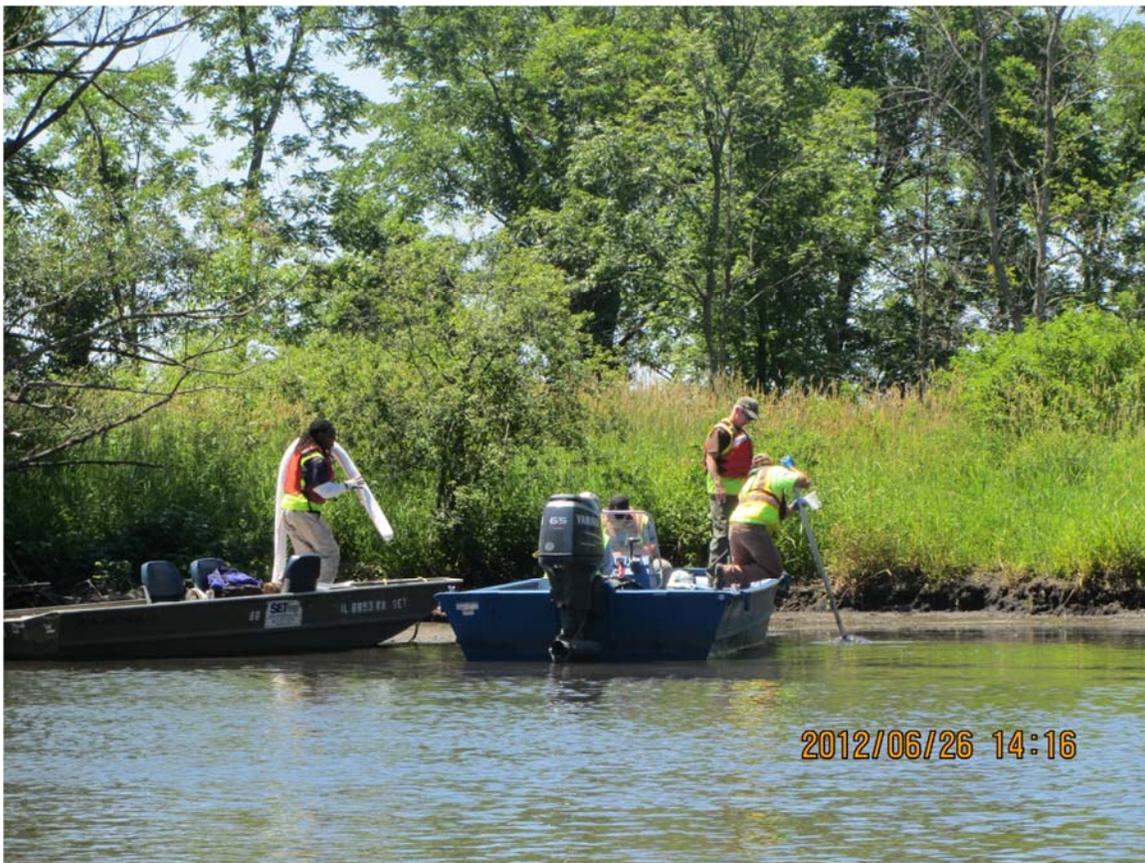
18. Observed sheen/glob samples being collected at MP33.0 A.

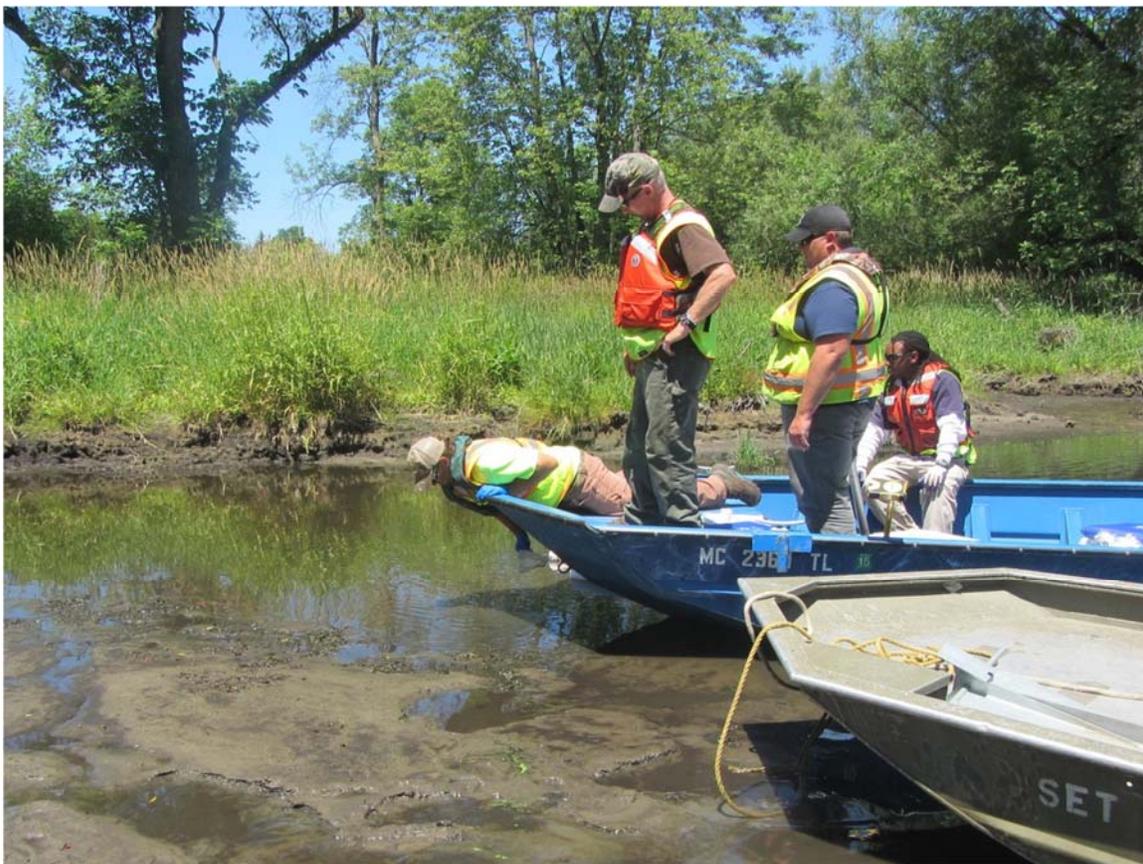
19. Observed sheen/glob samples being collected at MP33.0 A.

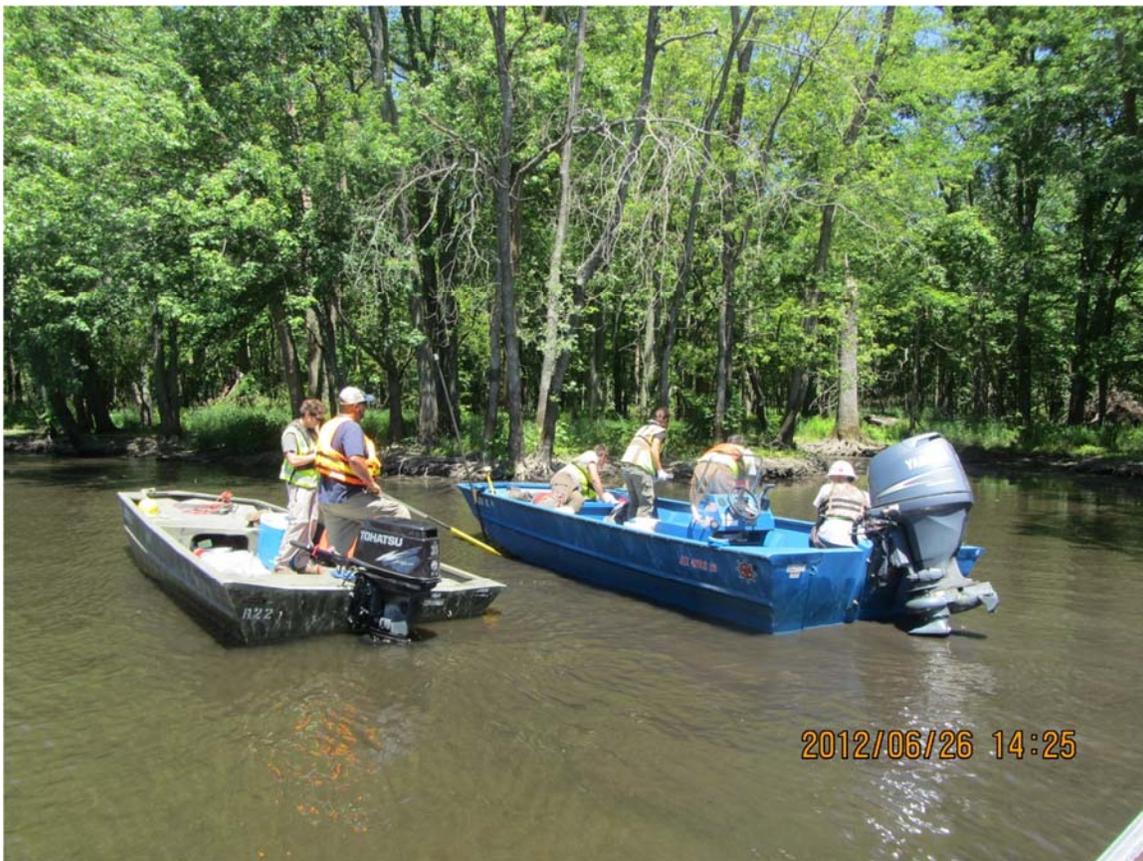
20. Observed sheen/glob samples being collected at MP33.0 B.
