Situation Photo Log

Wednesday, June 27, 2012

Kalamazoo River / Enbridge Spill

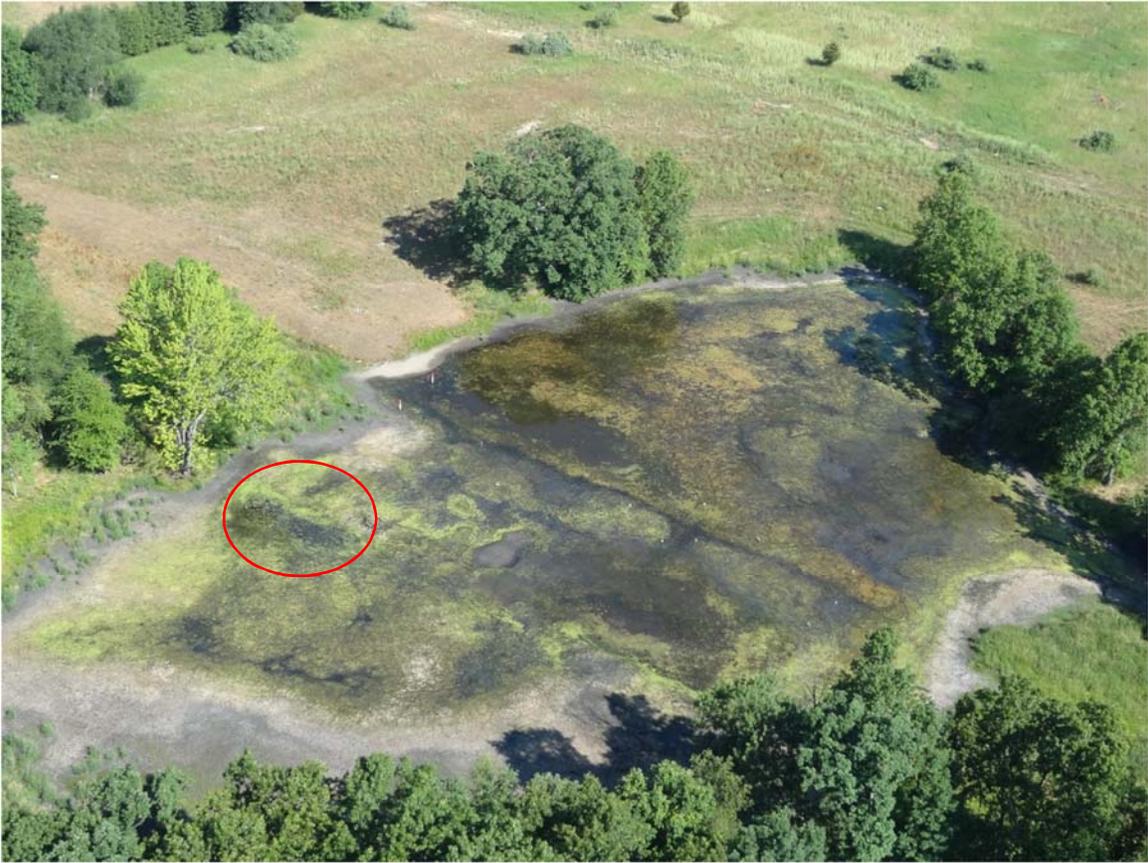
1. Source area pond sheen observed south of pipeline easement.

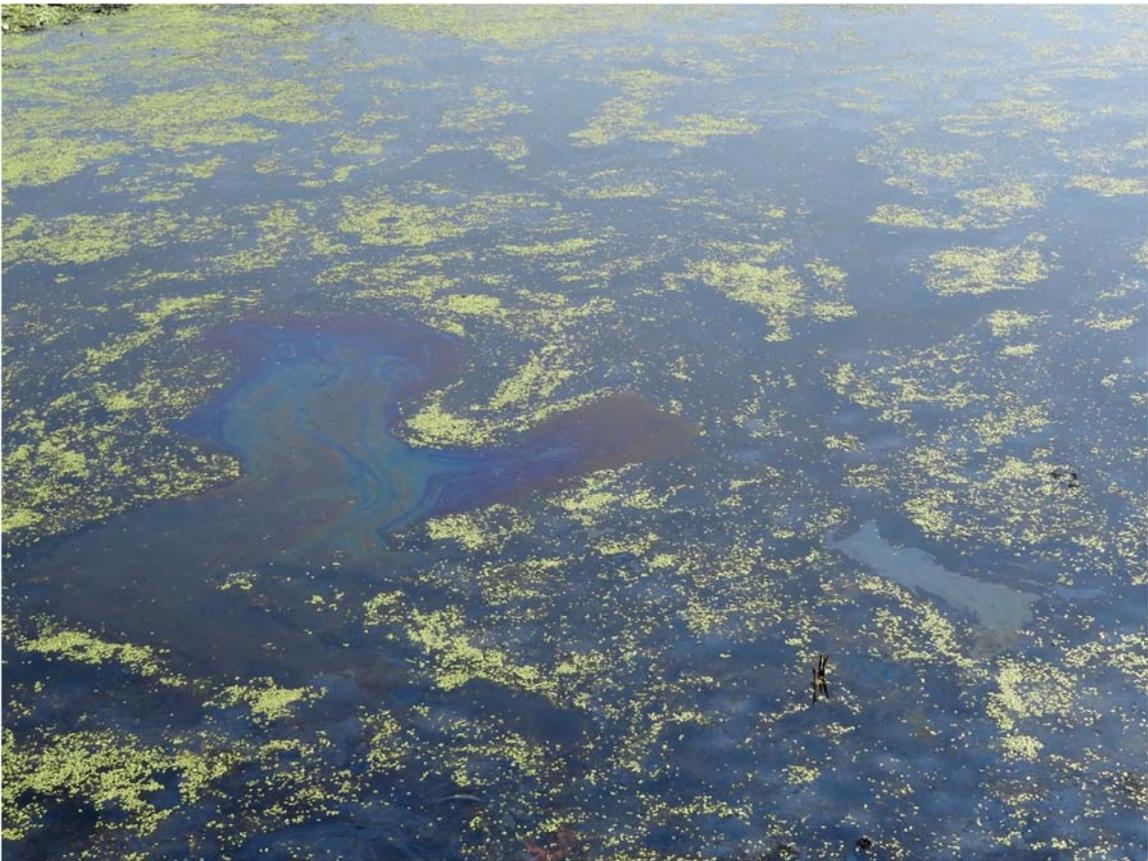
2. Source area pond sheen observed south of pipeline easement.

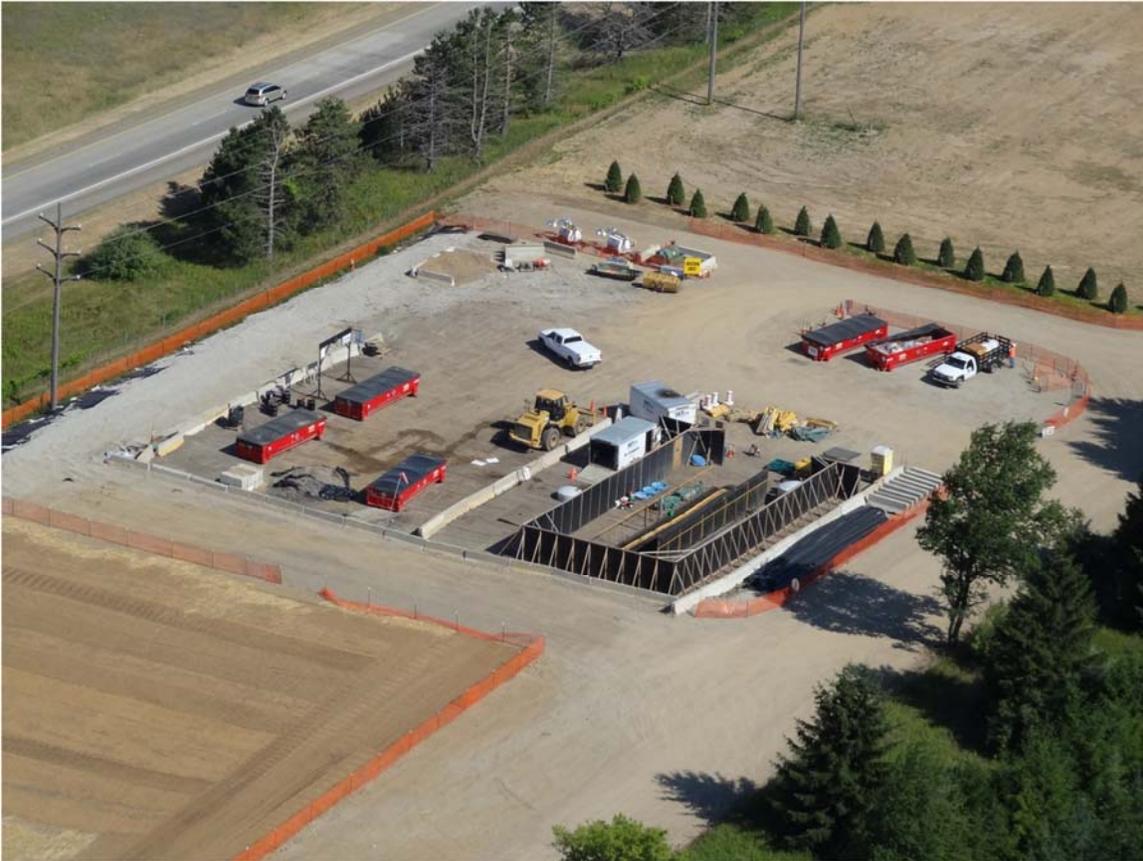
3. Frac-City observed soils staged in soil cell and boom being decontaminated.

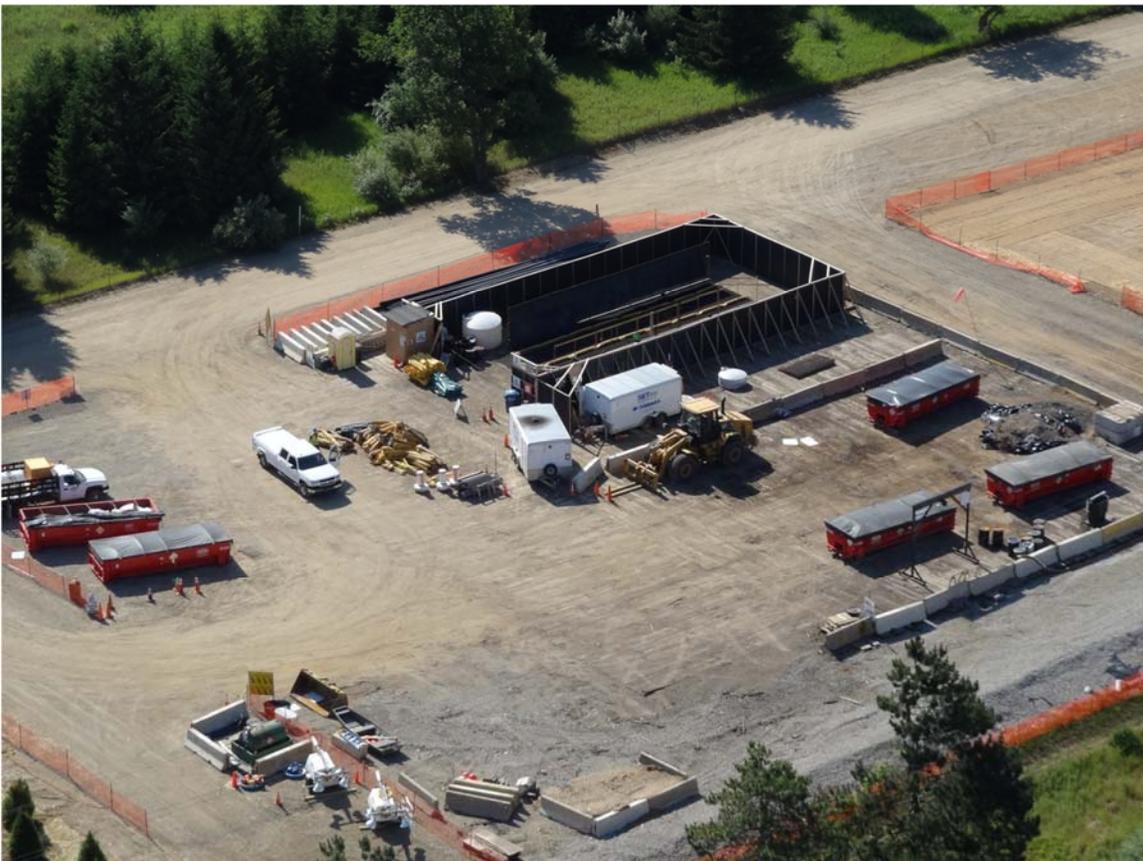
4. Frac-City observed soils staged in soil cell and boom being decontaminated.

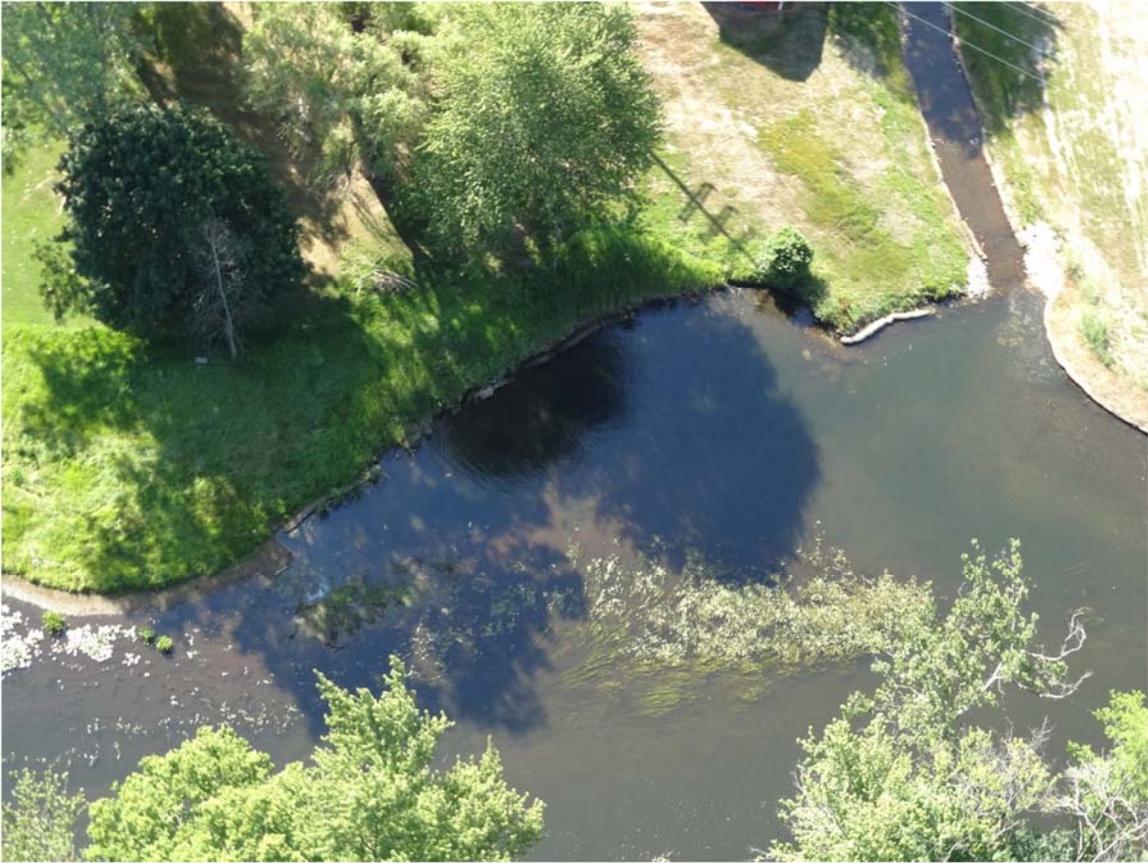
5. Confluence sheen observed. Area was called in from the helicopter to operations for a sheen differentiation test to be performed.

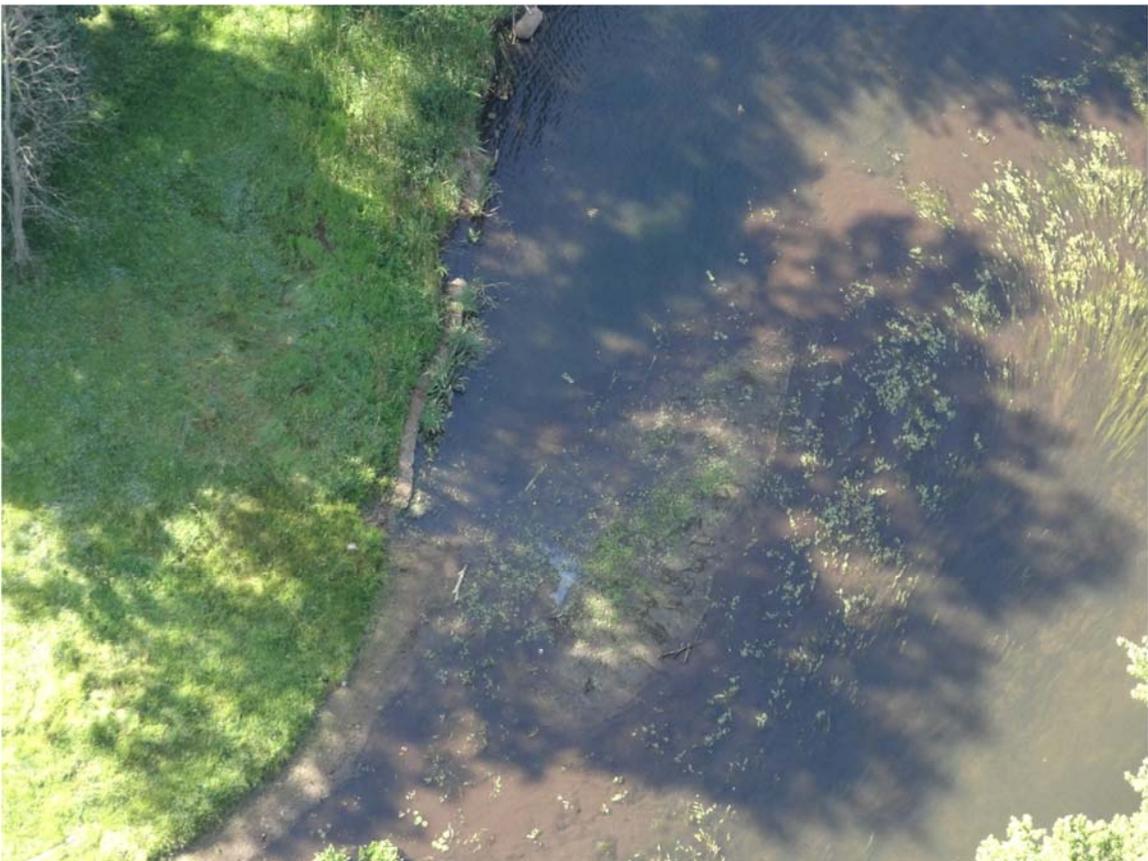
6. Confluence sheen observed. Area was called in from the helicopter to operations for a sheen differentiation test to be performed.

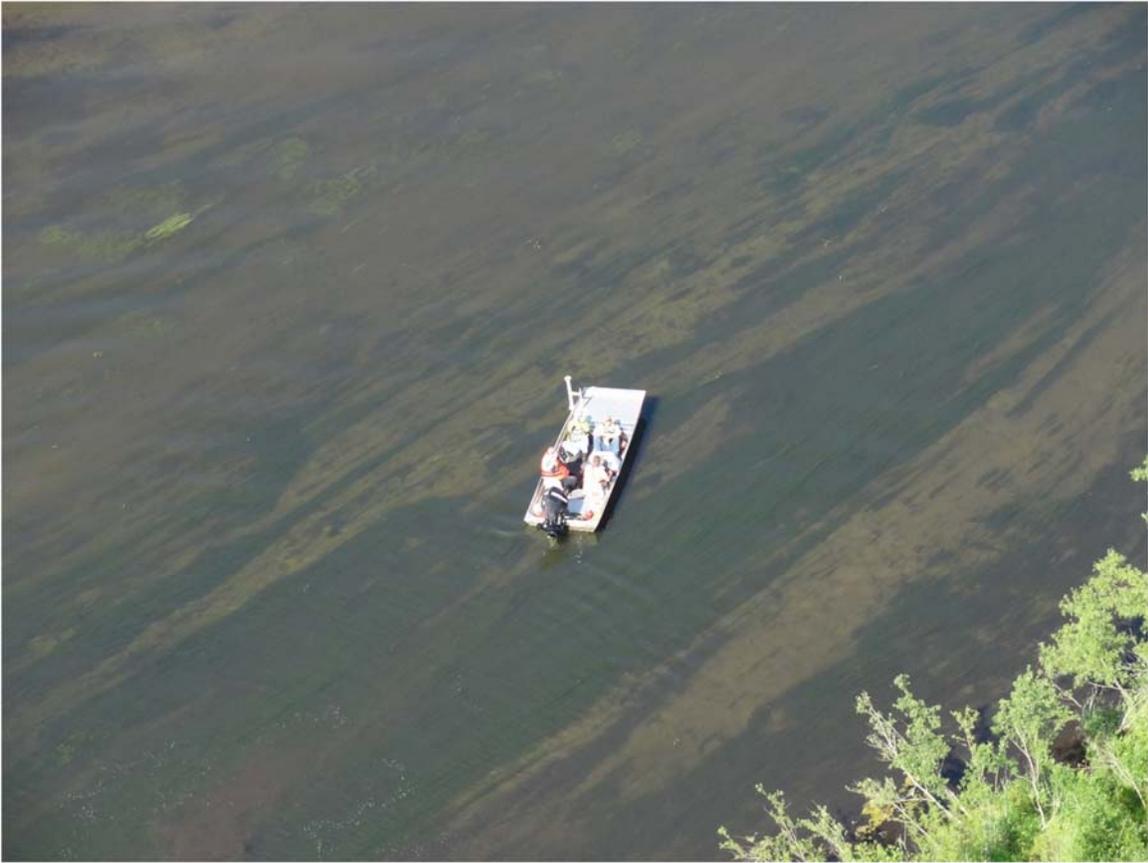
7. MP4.0 Containment branch crew observed.

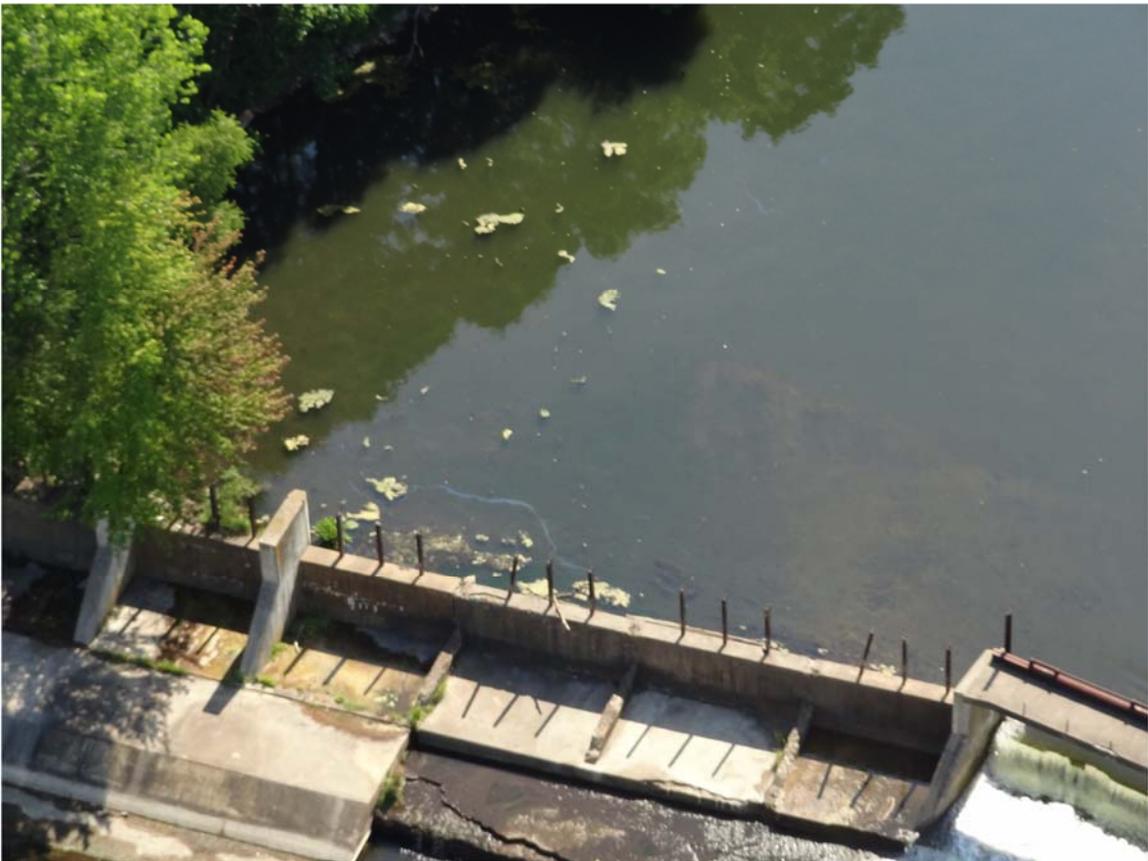
8. Ceresco Dam sheen observed along north side of dam.

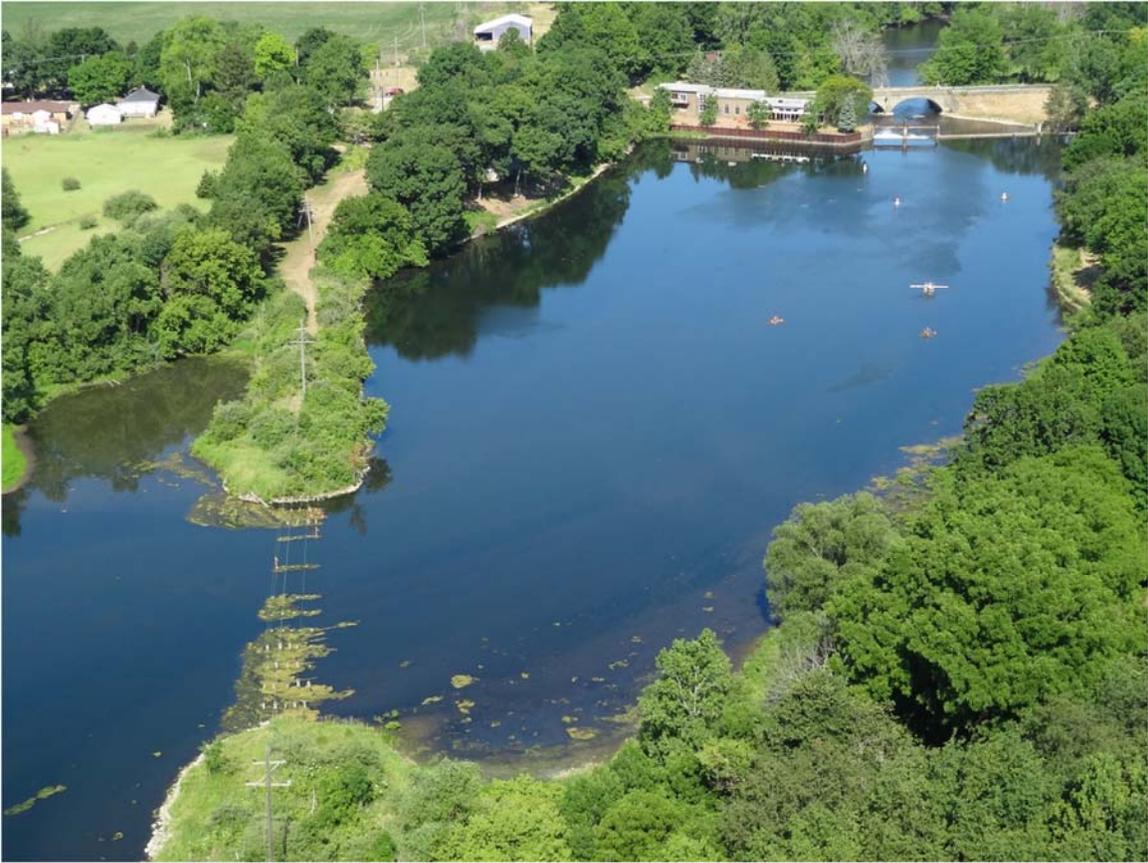
9. Ceresco Dam sheen sweep boat observed.

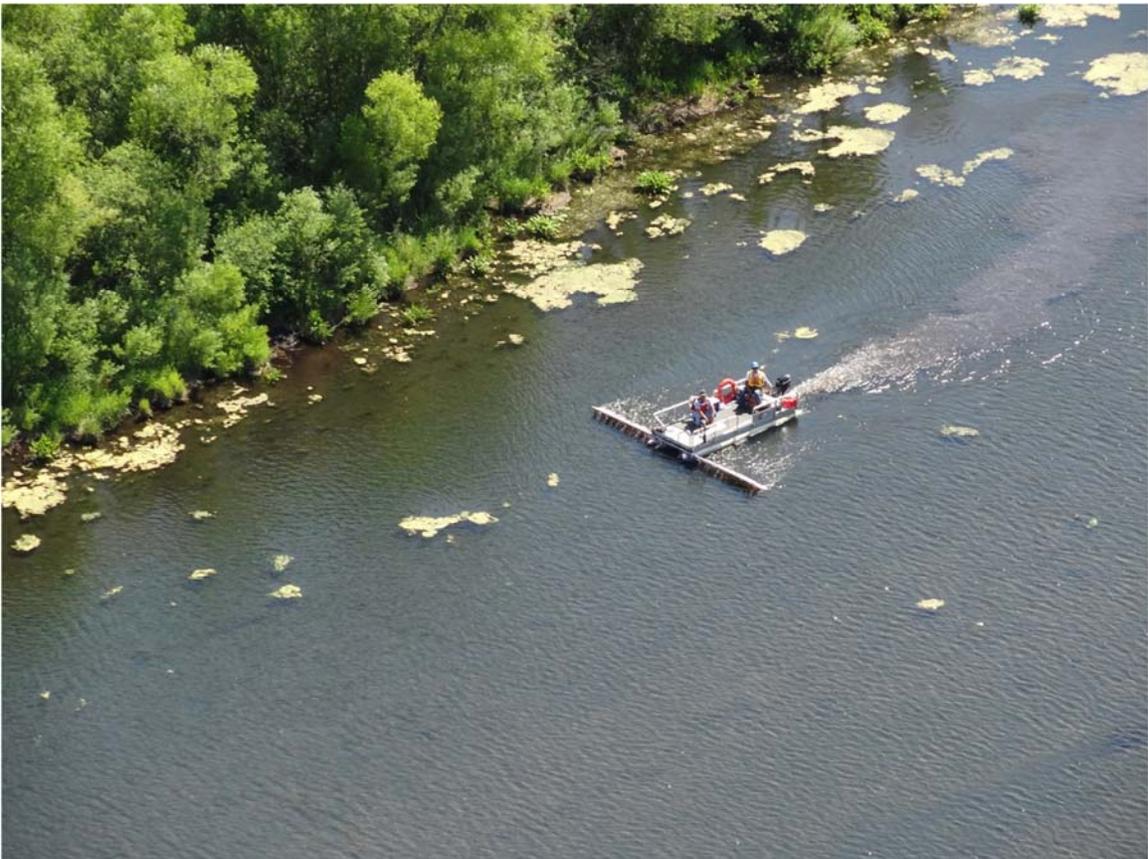
10. Ceresco Dam sheen sweep boat observed along the RDB.

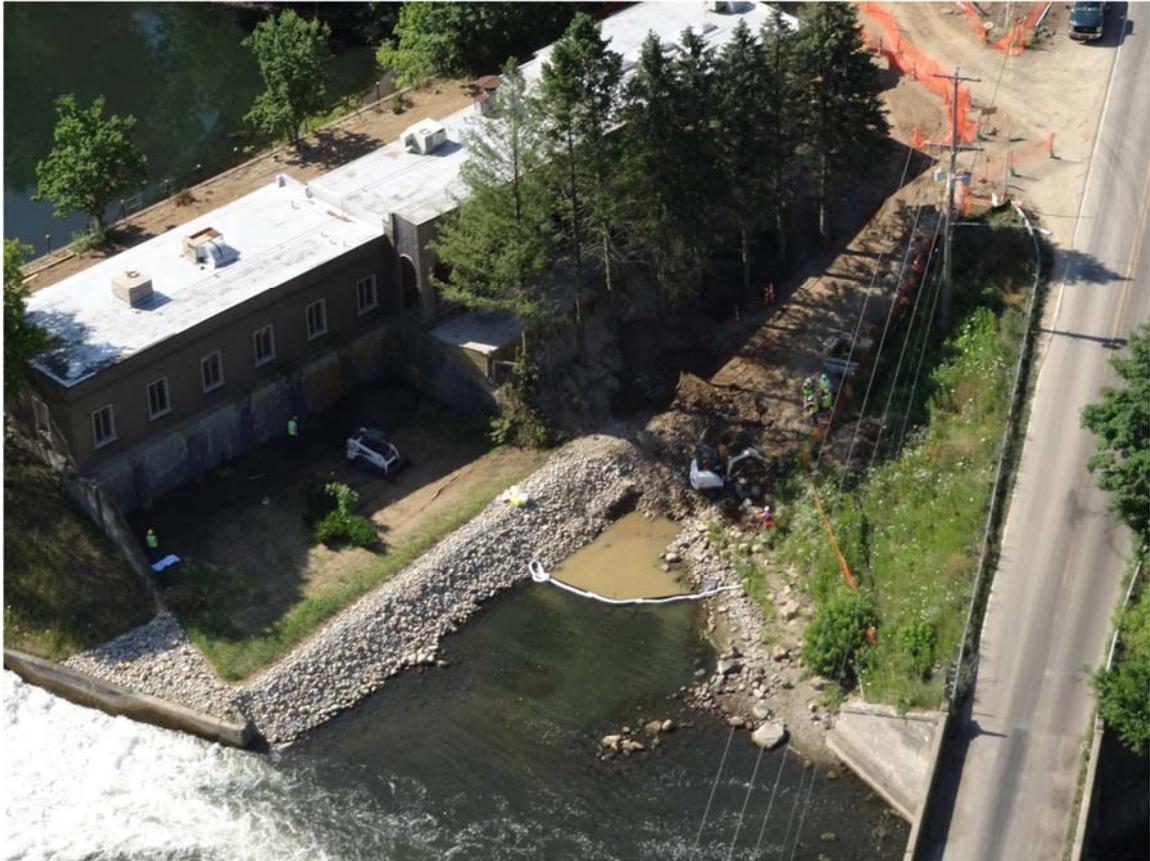
11. Ceresco Dam portage work observed below the dam.

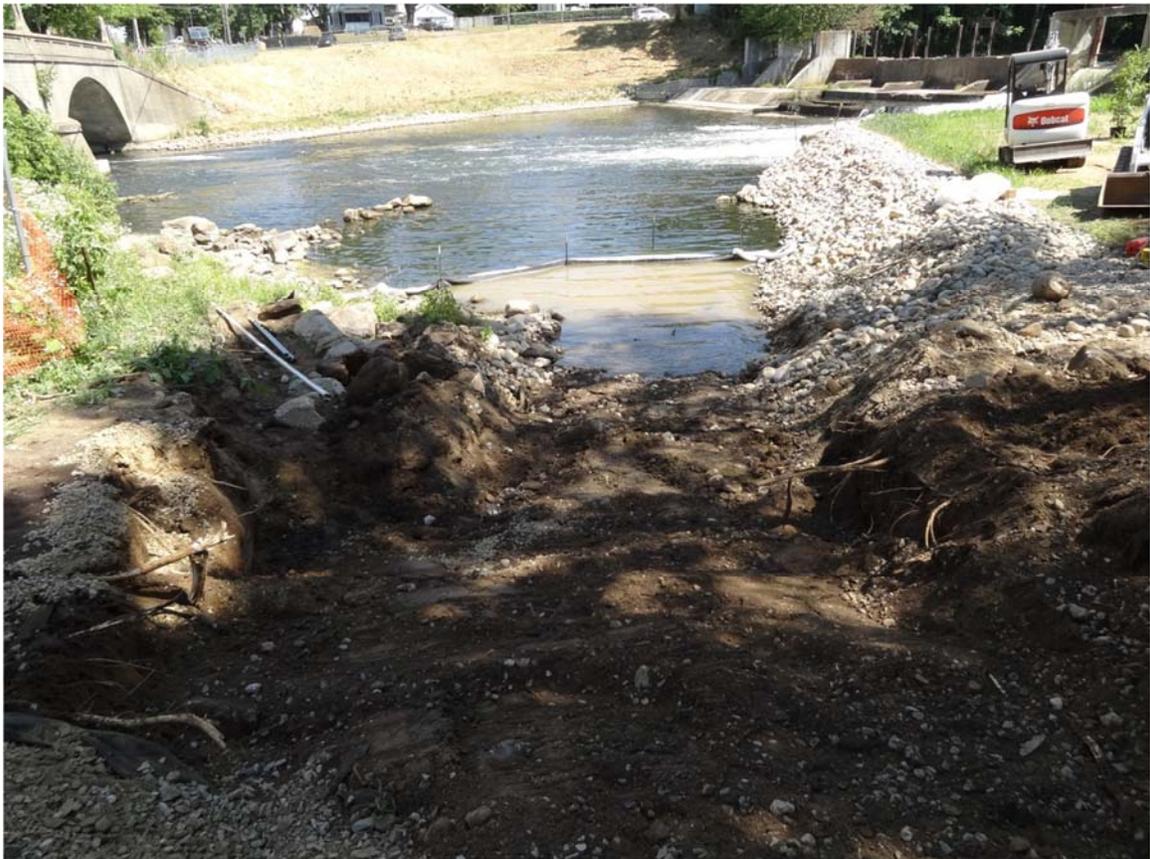
12. Ceresco Dam portage work observed below the dam.

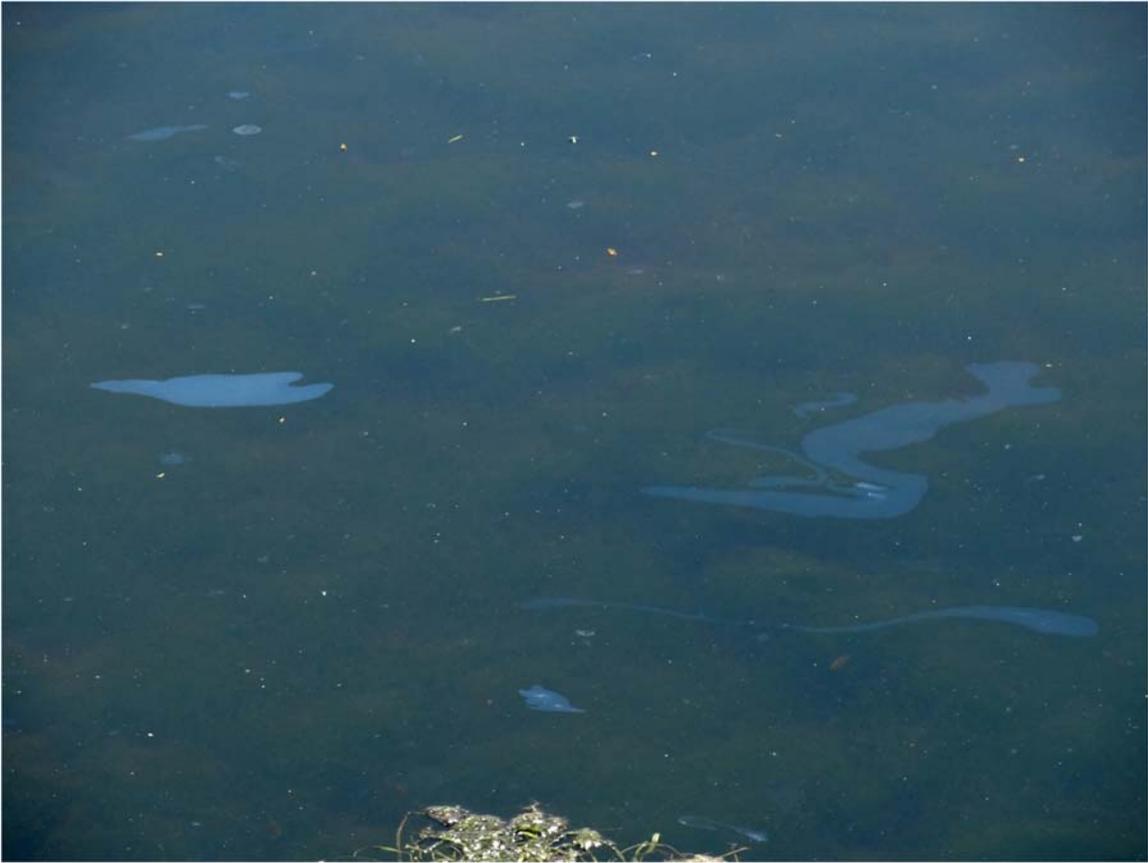
13. Ceresco Dam sheen observed along south side of dam.

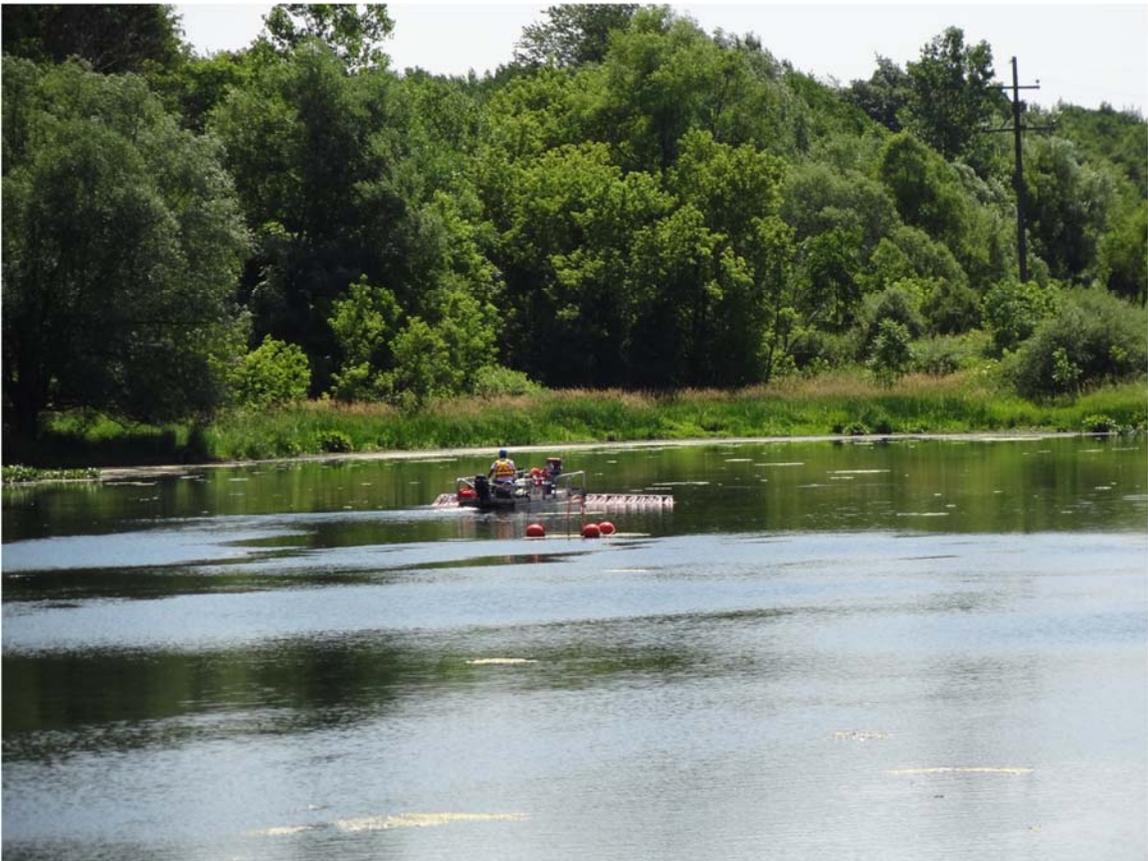
14. Ceresco Dam sheen sweep boat observed.

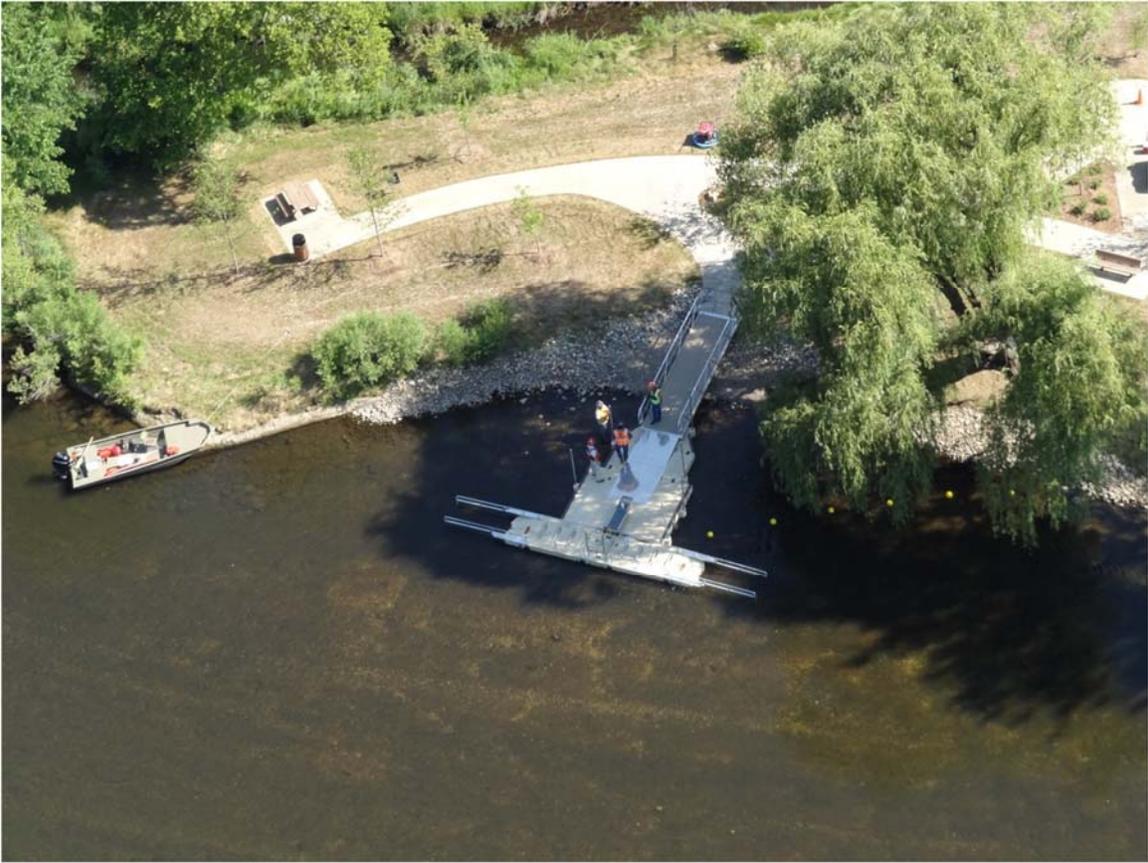
15. Historic Bridge Park handicap boat launch.

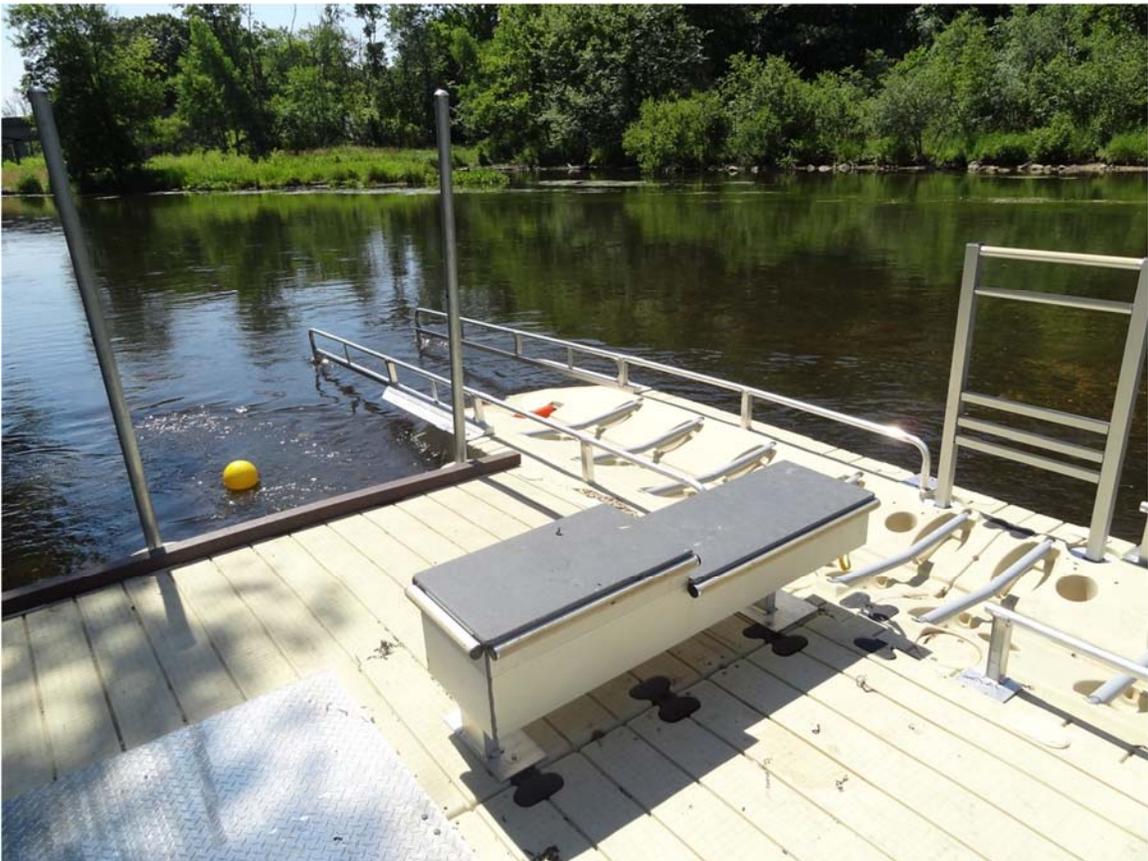
16. Historic Bridge Park handicap boat launch.

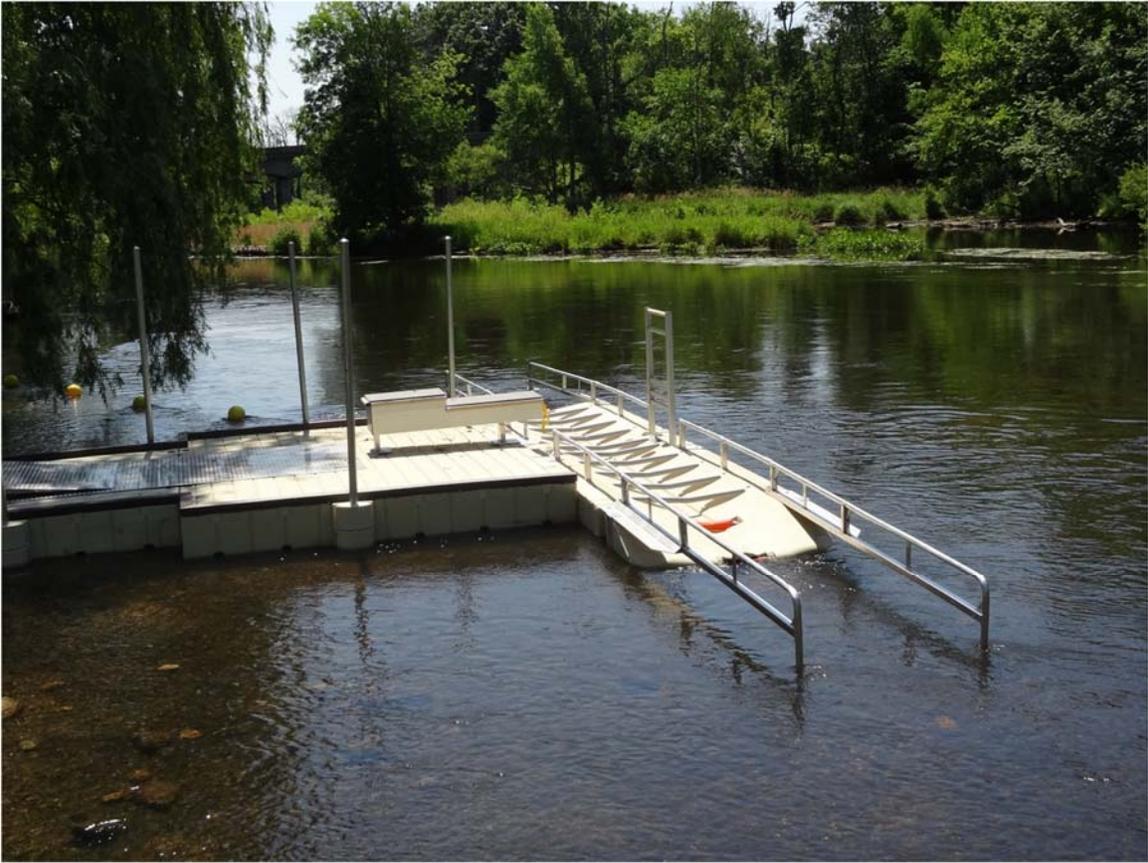
17. Historic Bridge Park handicap boat launch.

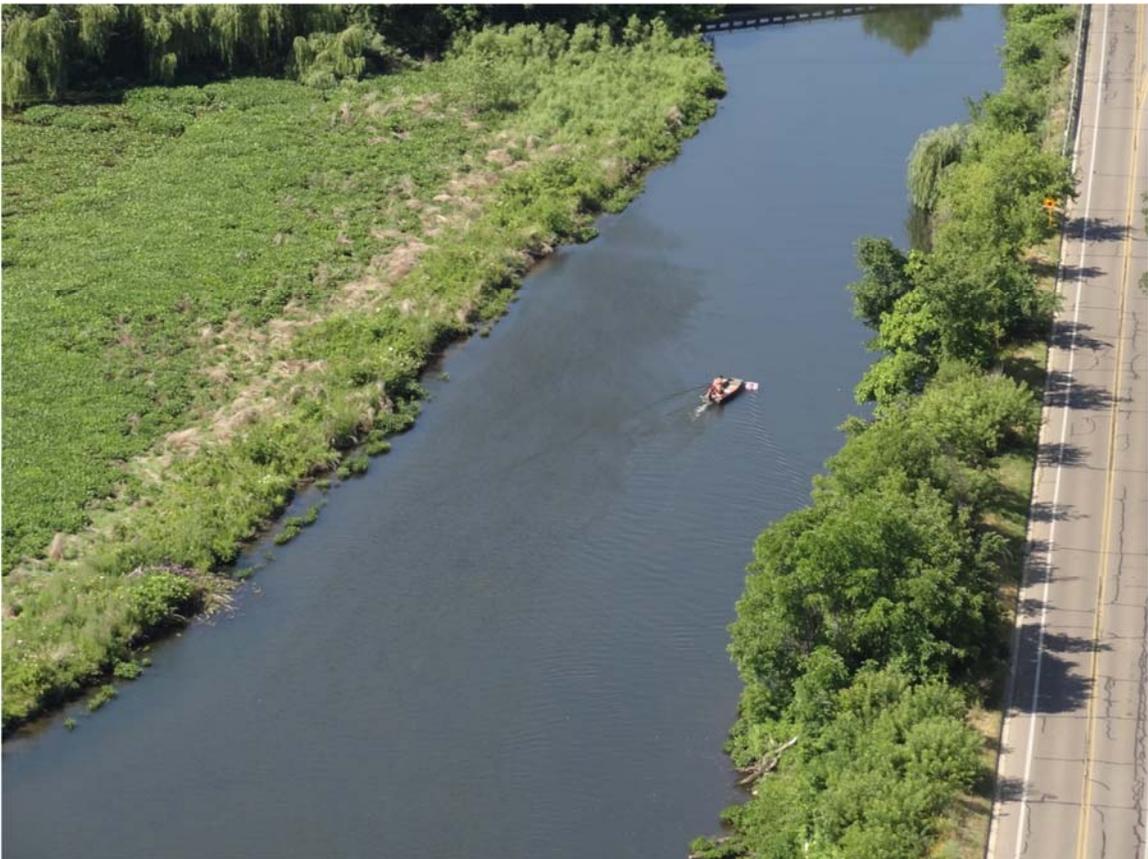
18. MP15.5 Mill Ponds sheen sweep boat observed.

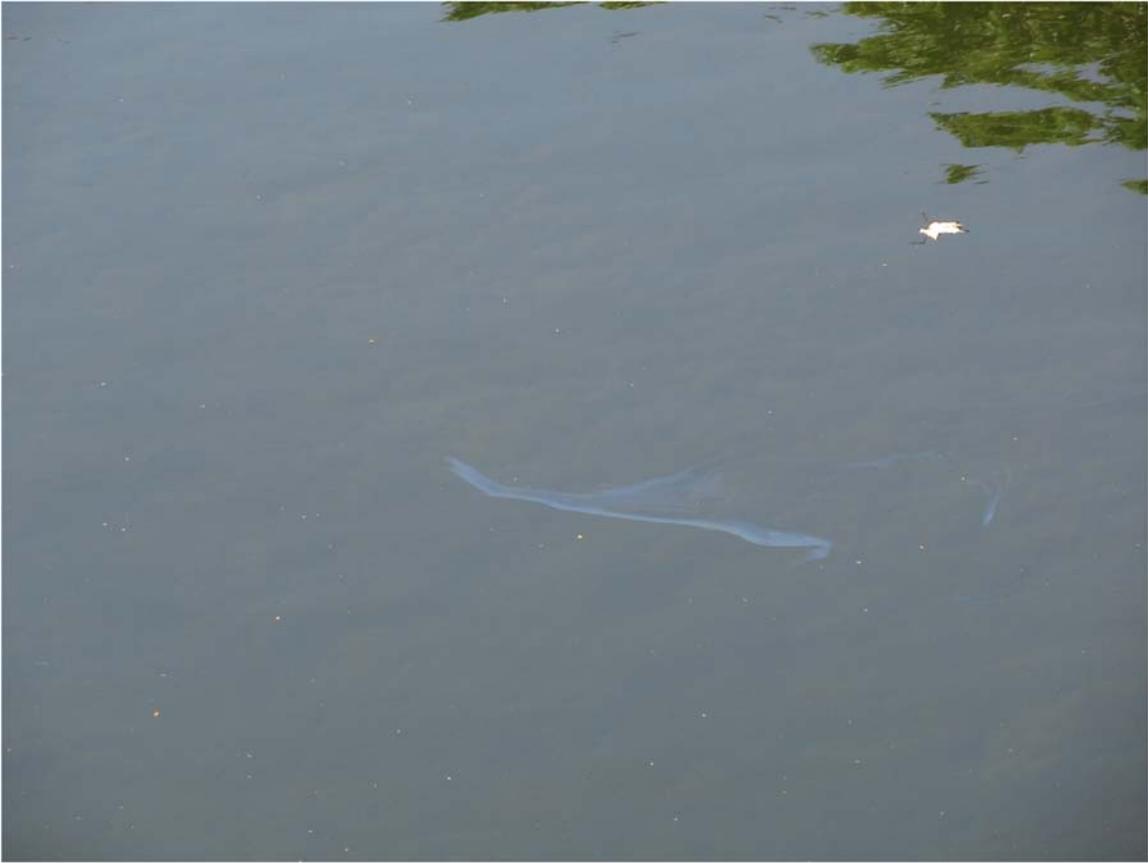
19. MP15.5 Sheen observed in river channel.

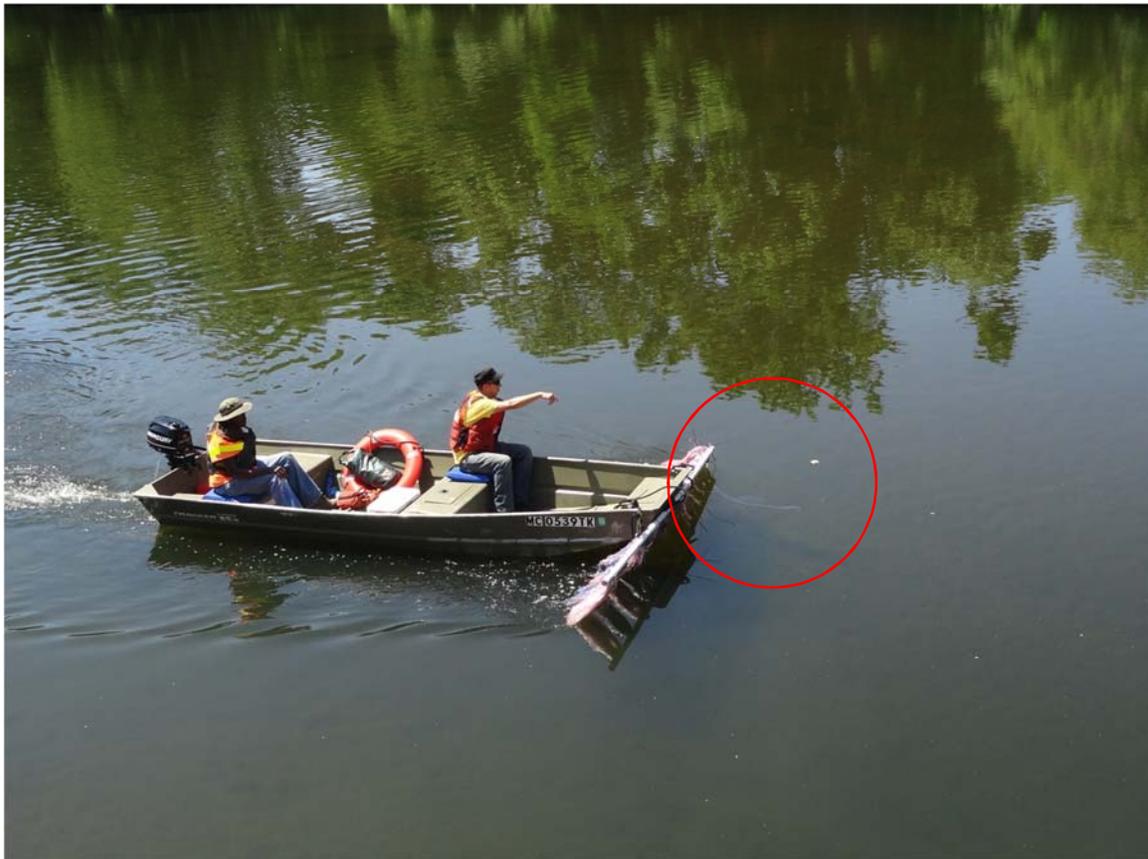
20. MP15.5 observed sheen sweep boat sweeping sheen.

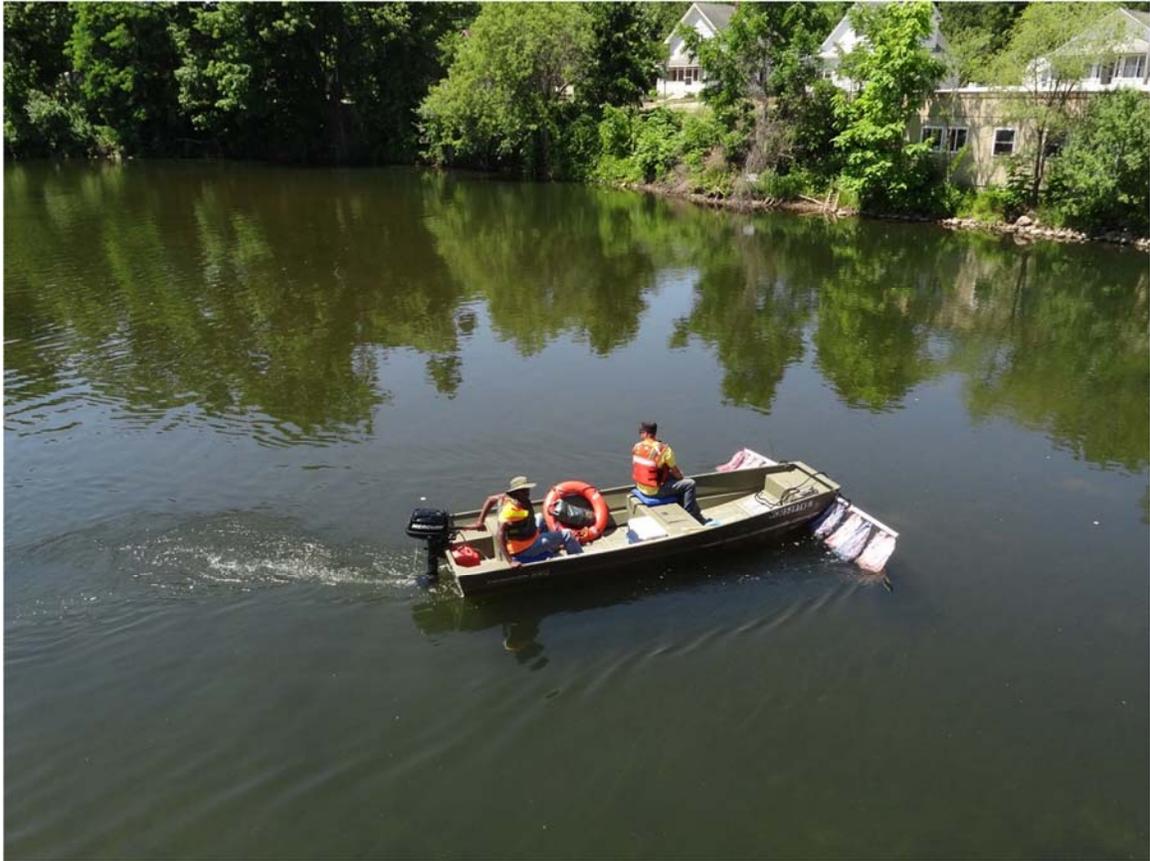
21. MP15.5 Sheen sweep boat removed sheen from river channel.

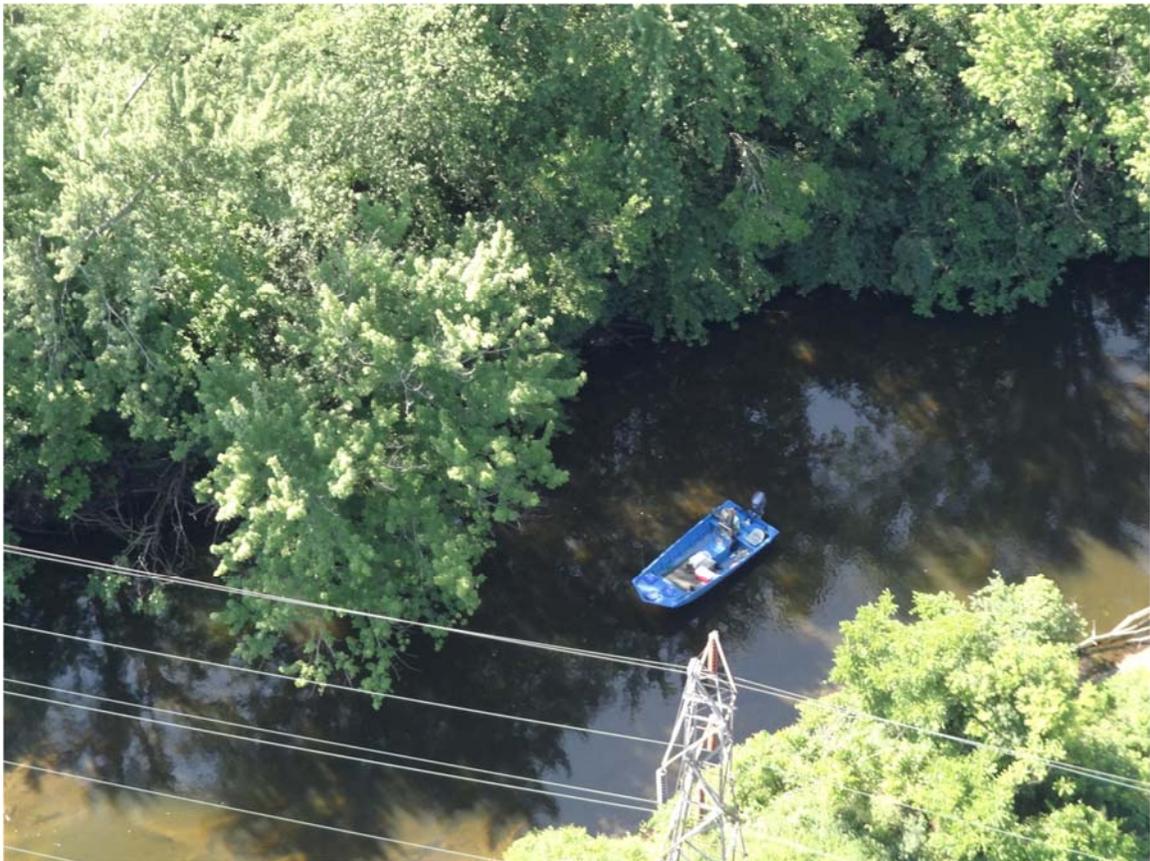
22. Battle Creek River sheen and glob samples observed being collected.

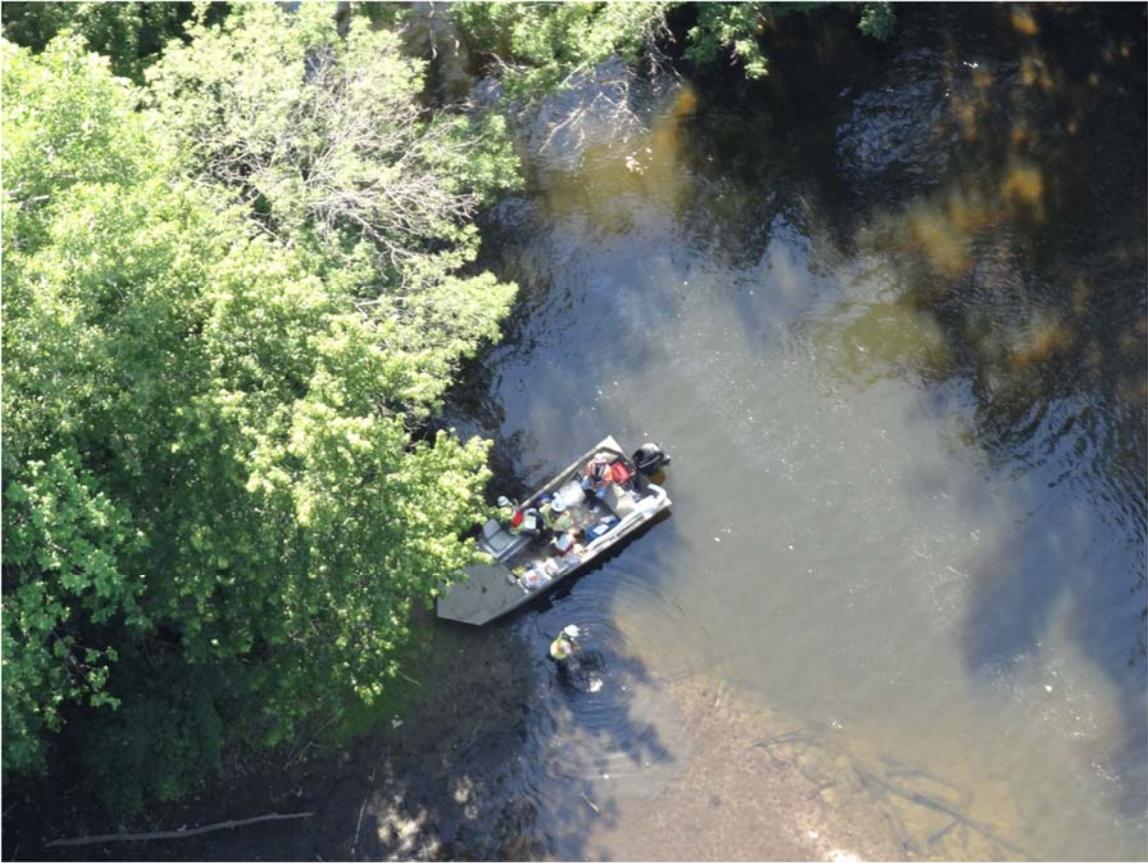
23. Battle Creek River sheen and glob samples observed being collected.
