Situation Photo Log

Wednesday, June 27, 2012

Kalamazoo River / Enbridge Spill

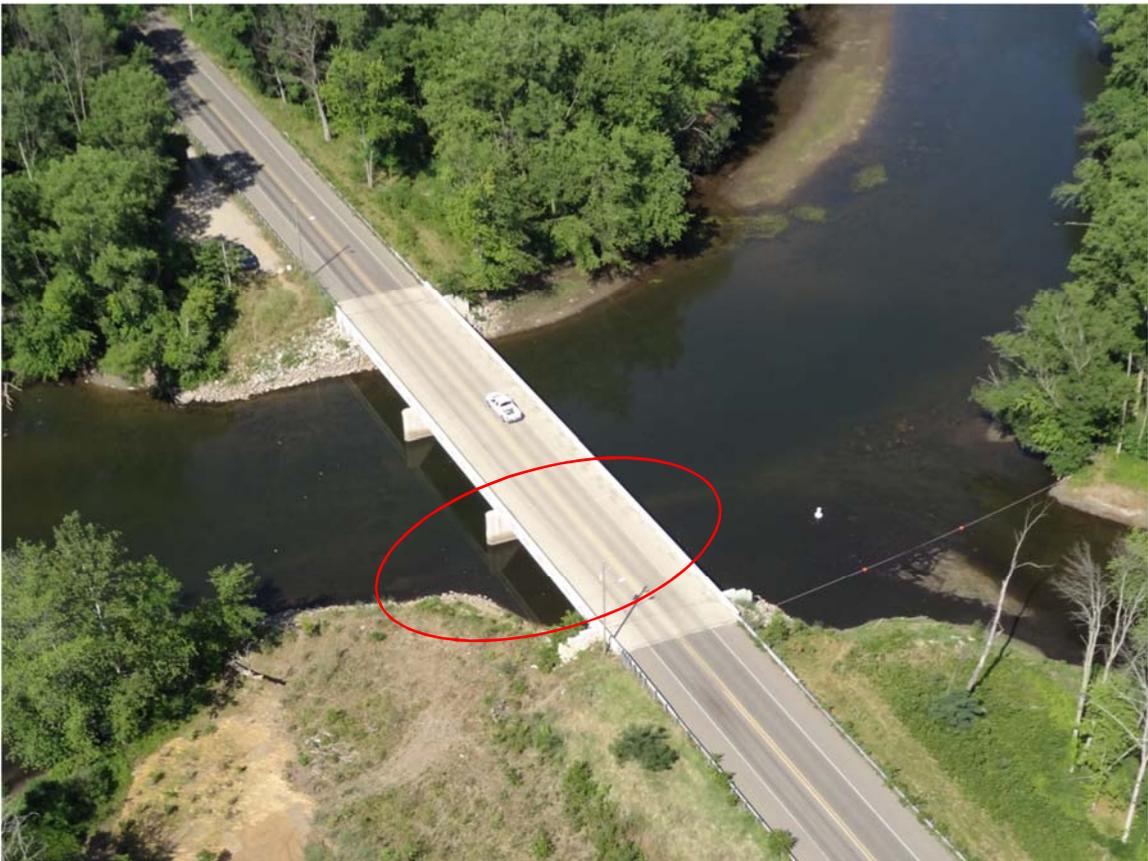
24. MP21.5 Custer bridge sheen observed.

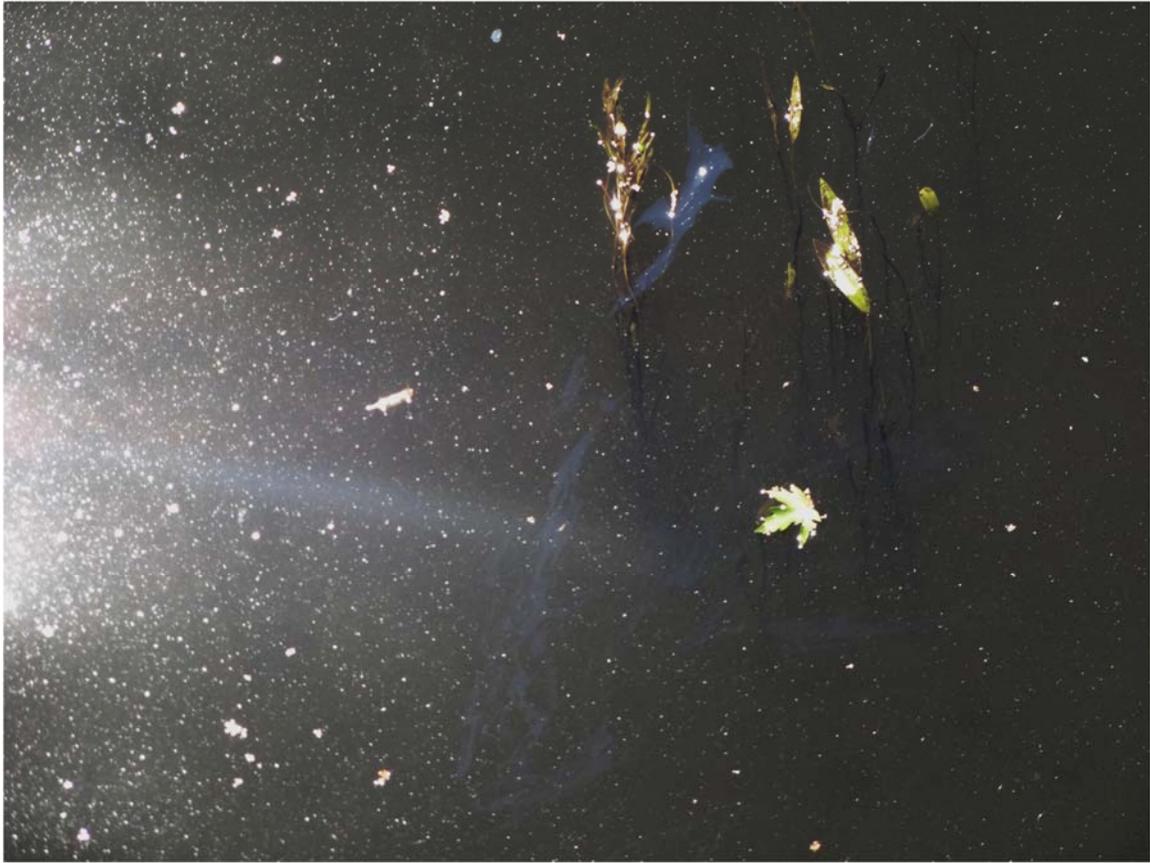
25. MP21.5 Custer bridge sheen observed. Operations was notified and a sheen sweep boat was deployed.

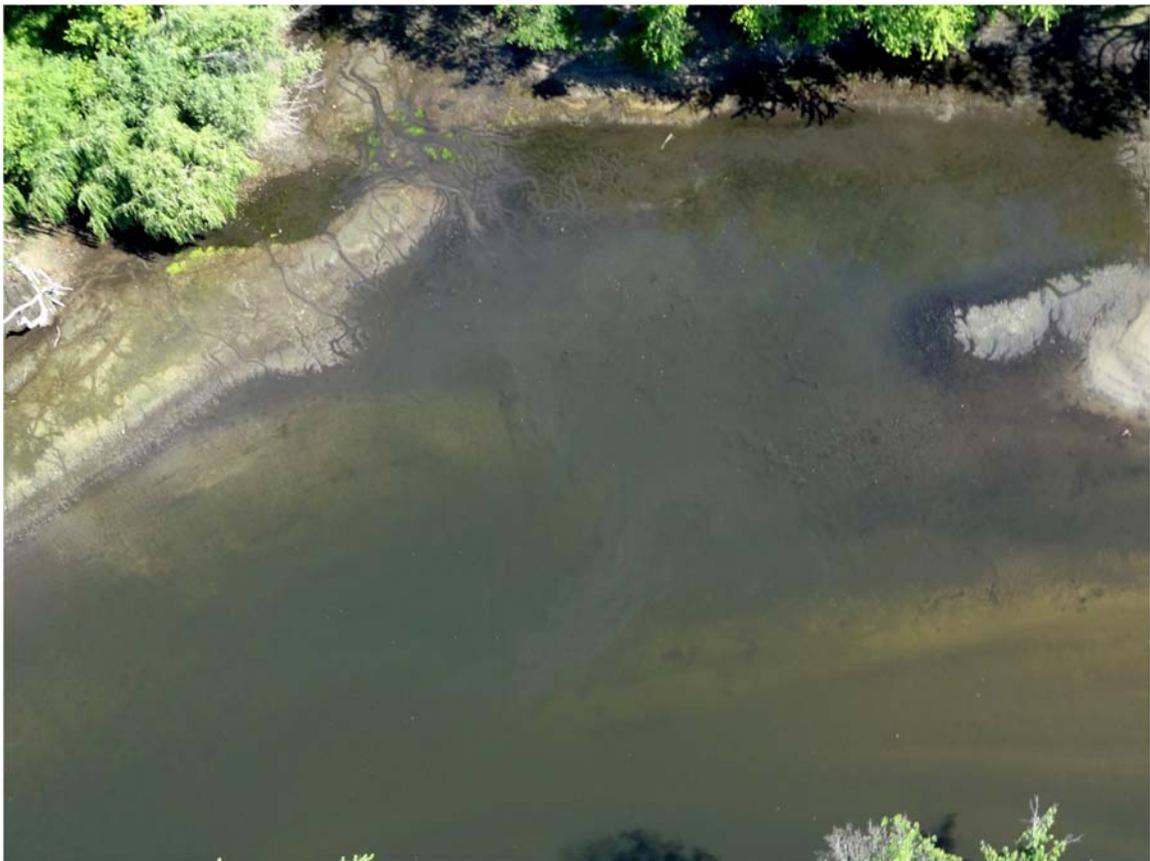
26. MP26.25 RDB sheen observed. Operations was notified and a sweep boat was deployed.

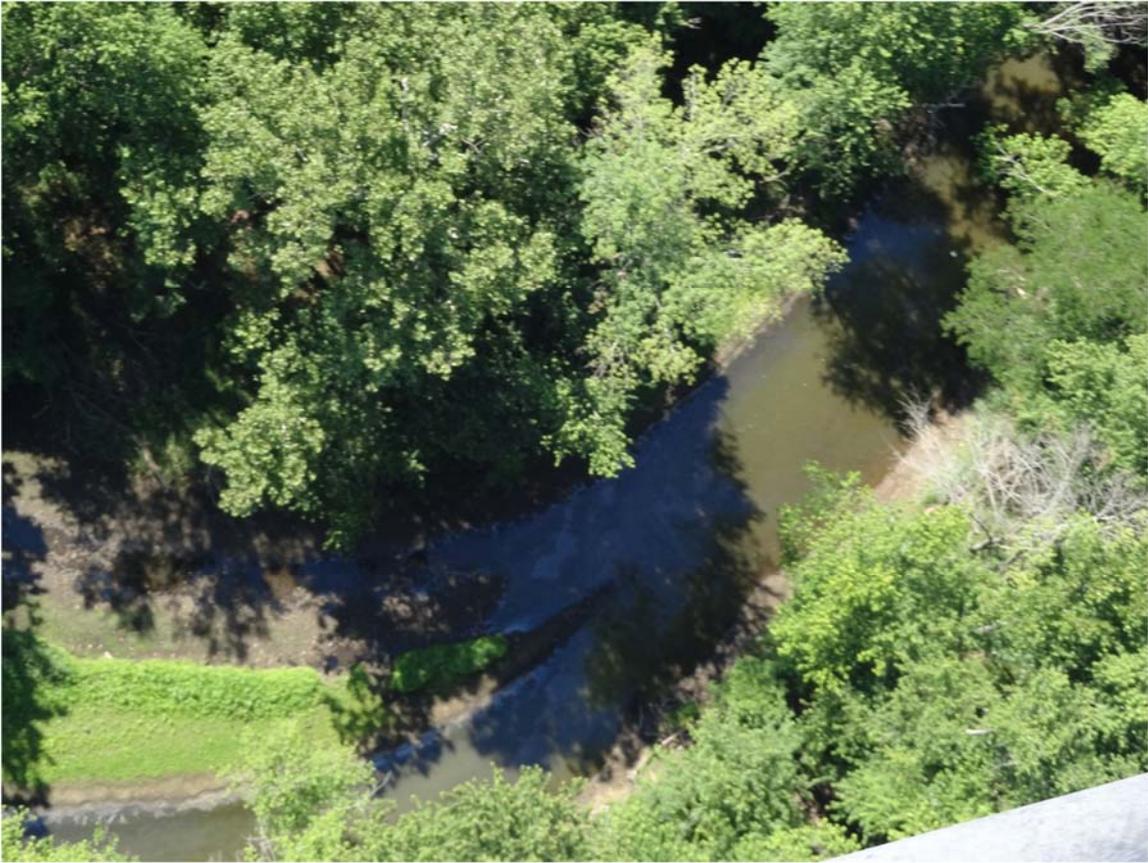
27. MP28.25 Oxbow sheen observed. Operations was notified.

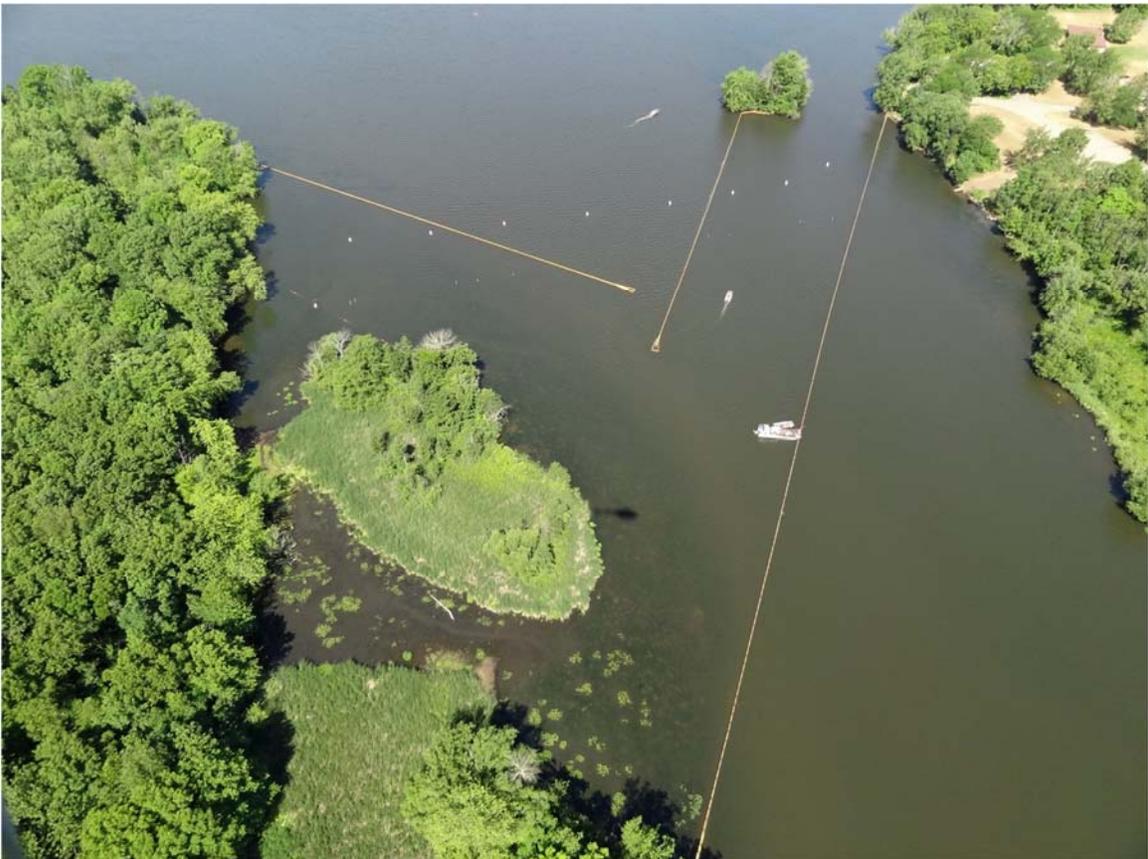
28. Morrow Lake Delta boom reconfiguration work continued.

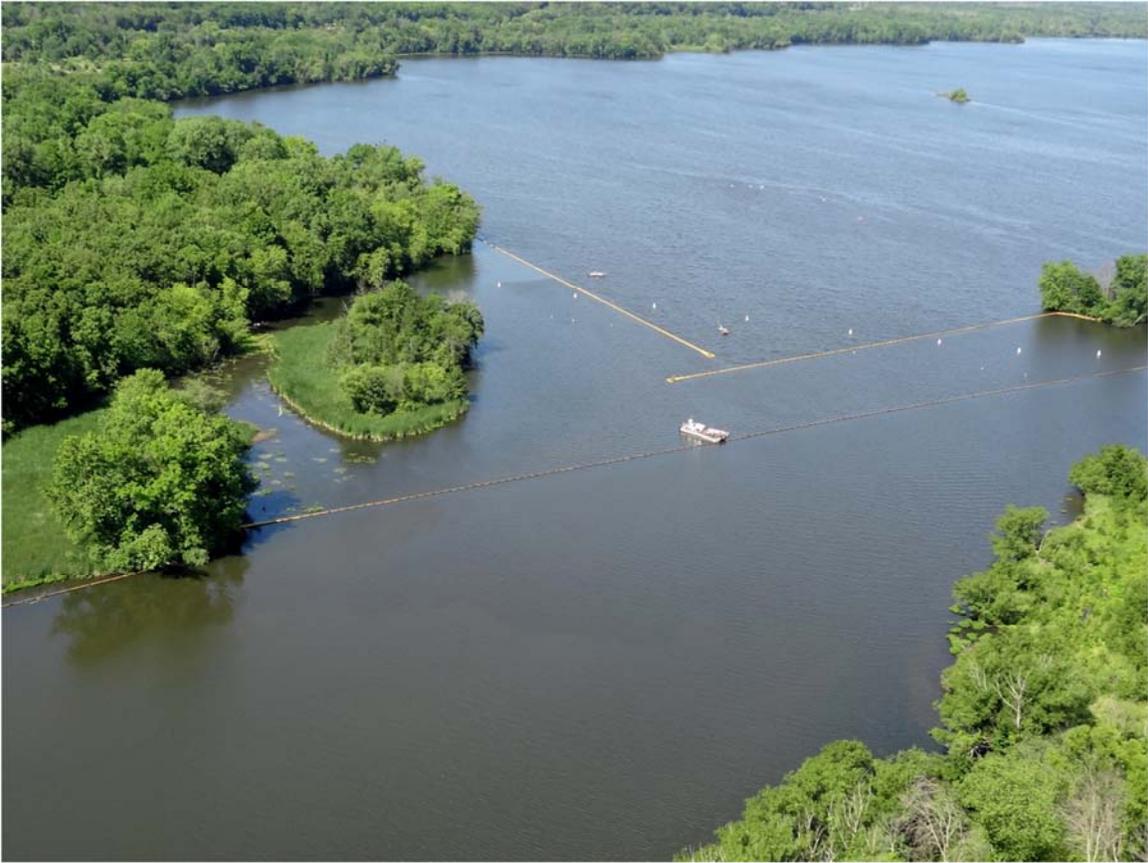
29. Morrow Lake Delta boom reconfiguration work continued.

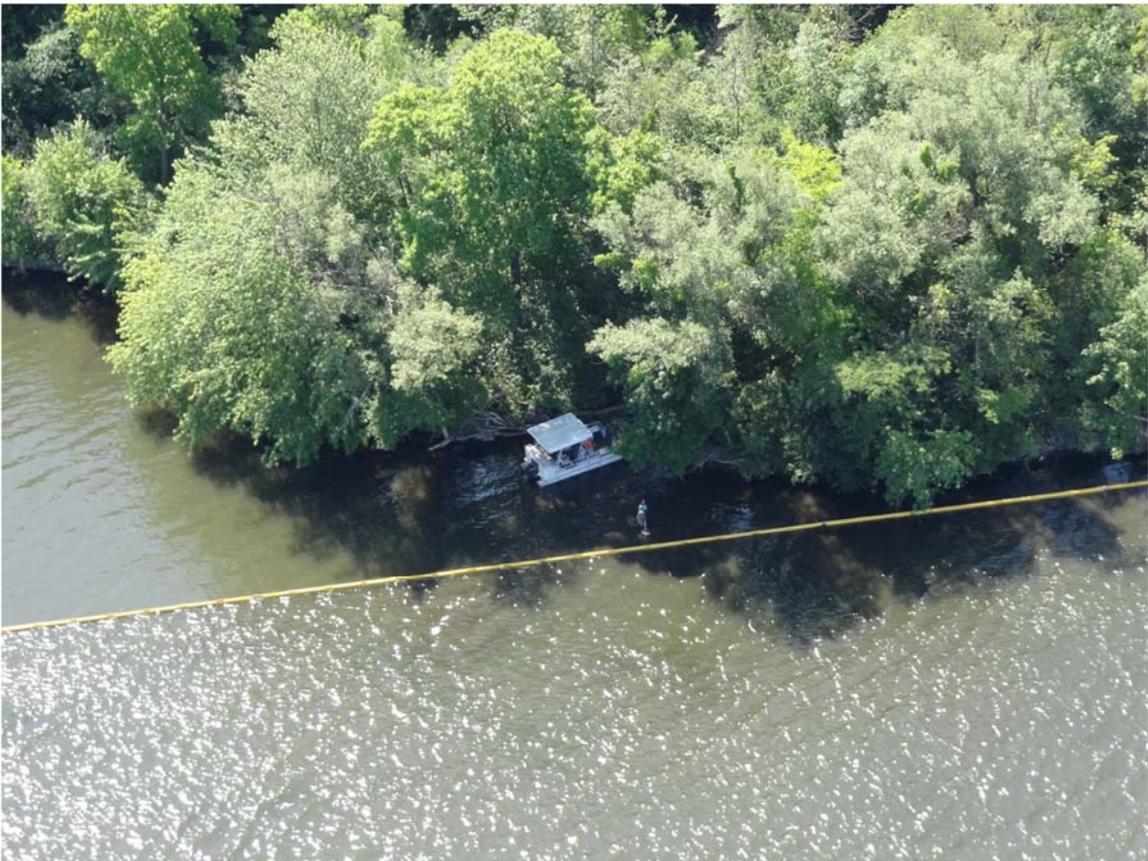
30. Morrow Lake Delta boom observed crew cleaning out boom.

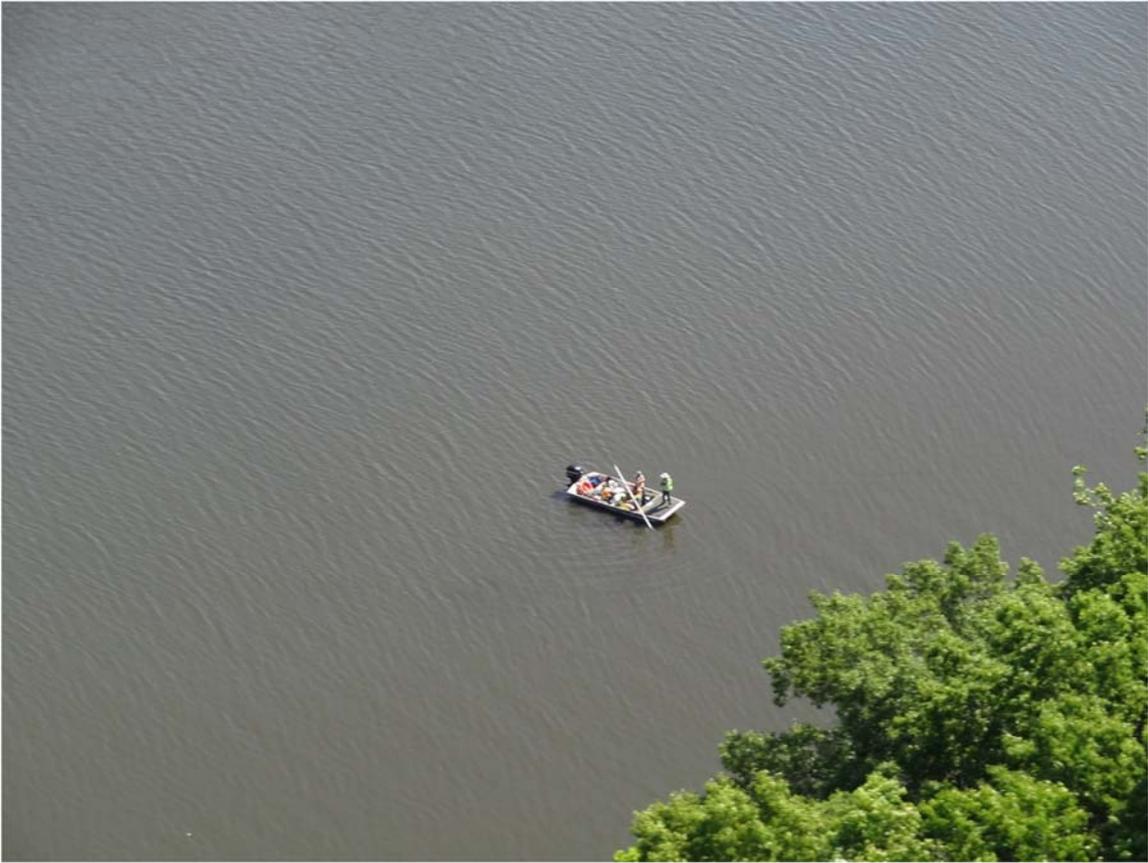
31. Morrow Lake Delta poling crew observed.

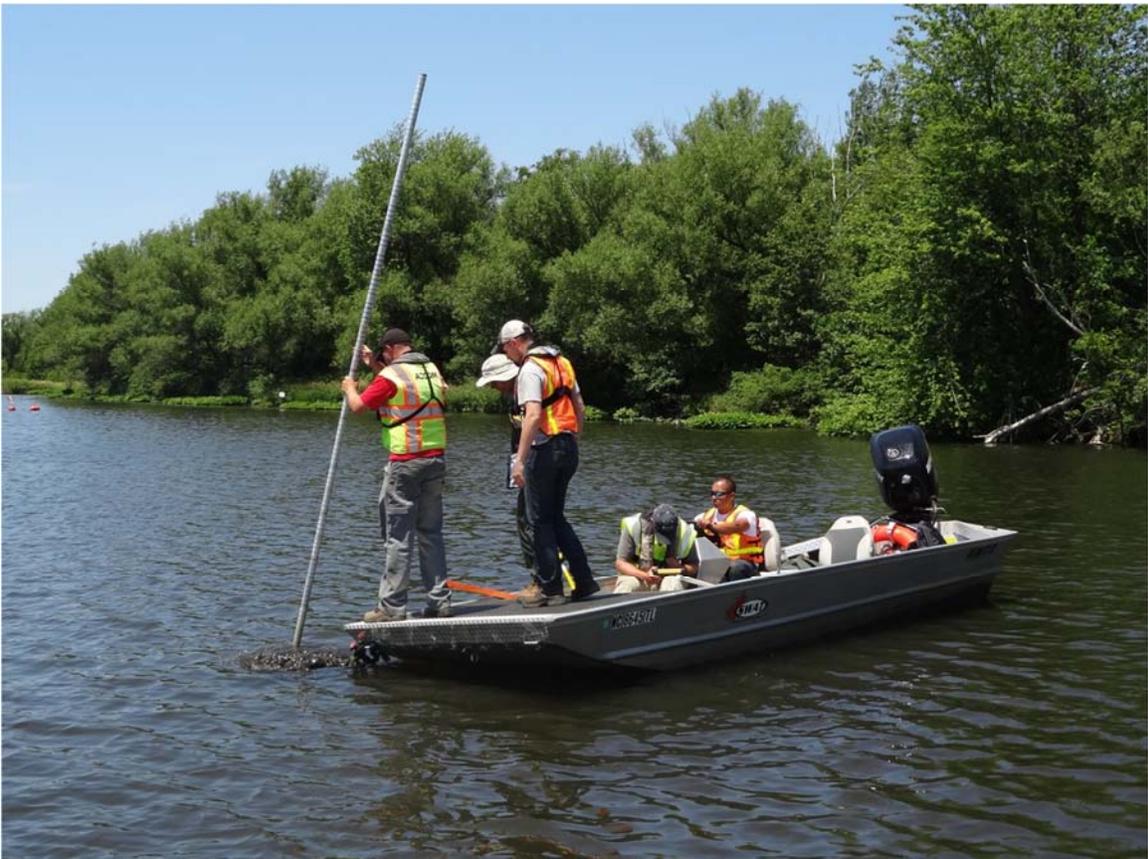
32. Morrow Lake Delta poling crew observed.

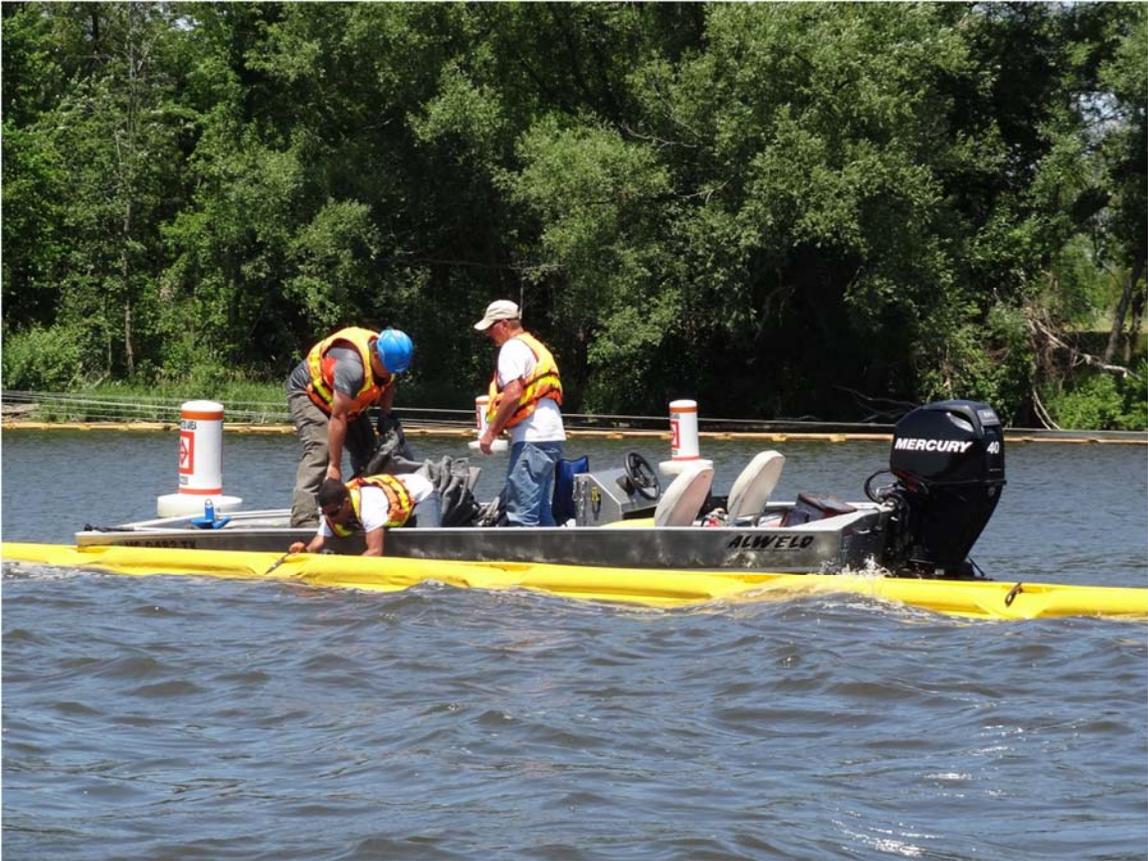
33. Morrow Lake Delta observed crew installing curtain on boom.

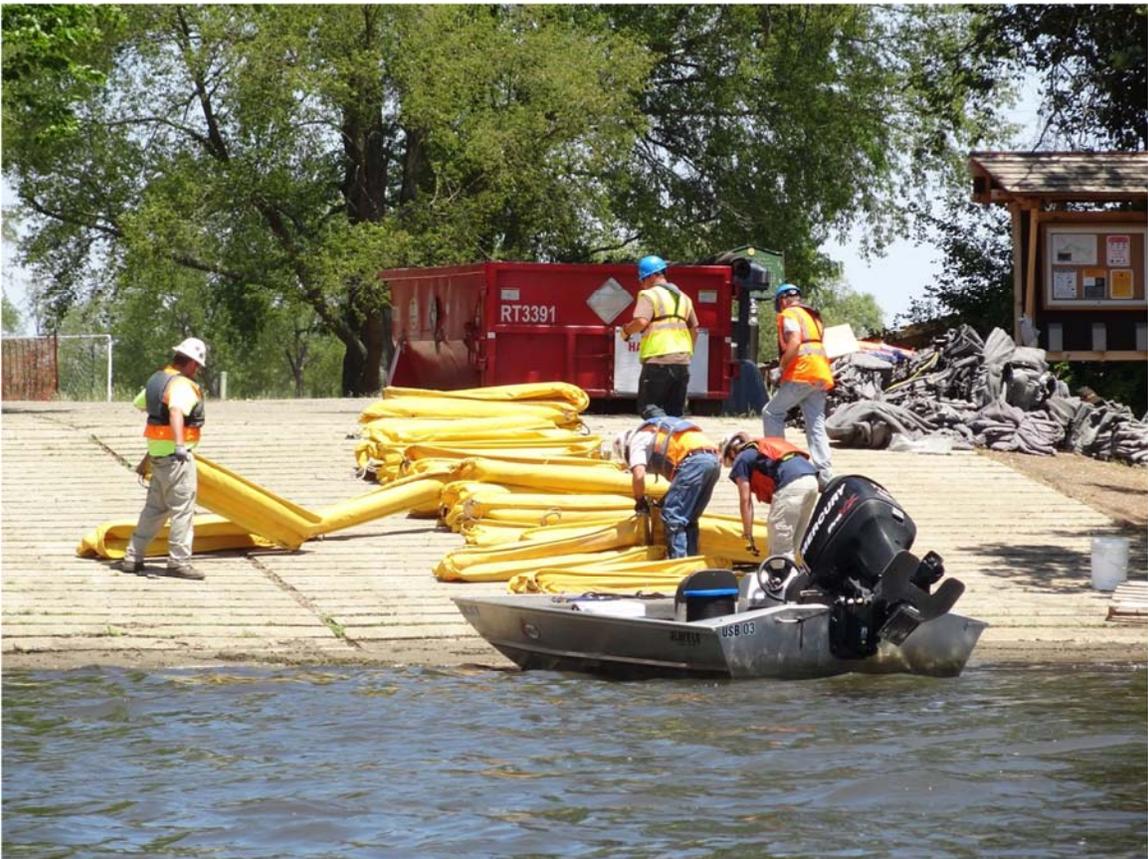
34. E4 Boat launch observed crews preparing to deploy boom.

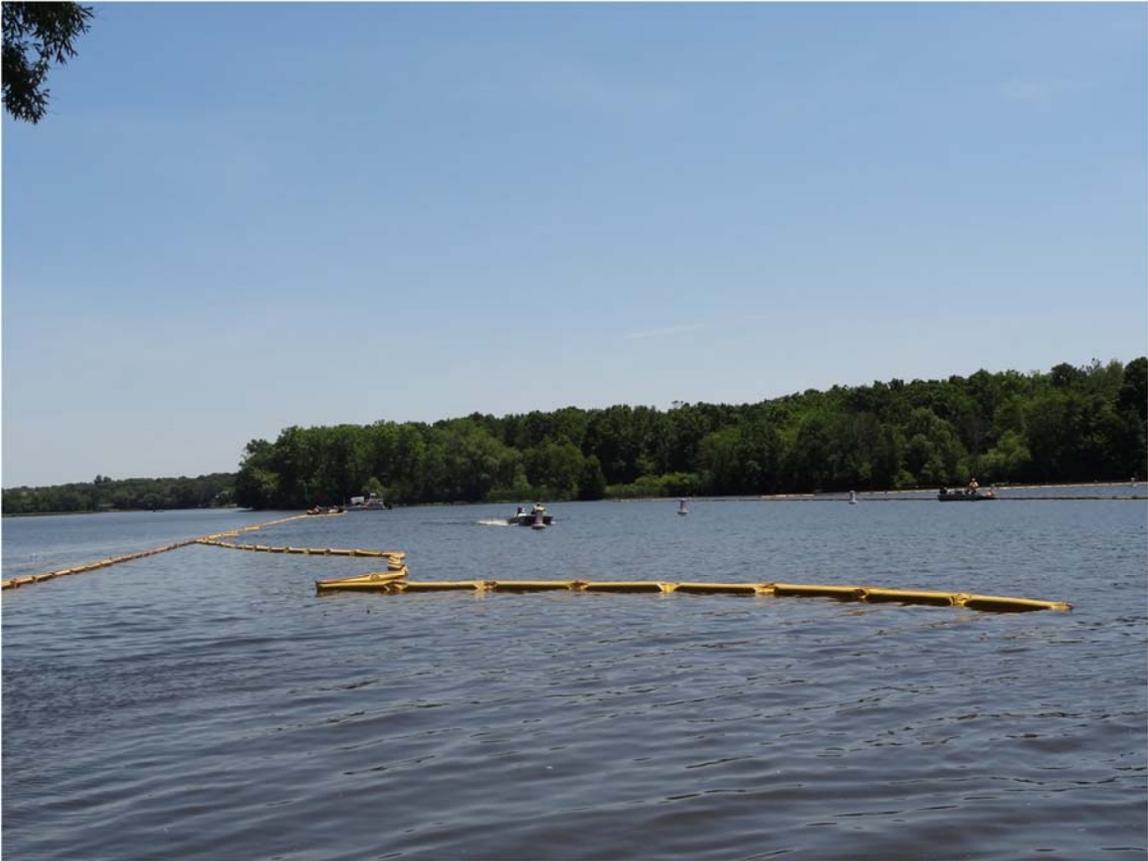
35. E4 Observed crews deploying boom.

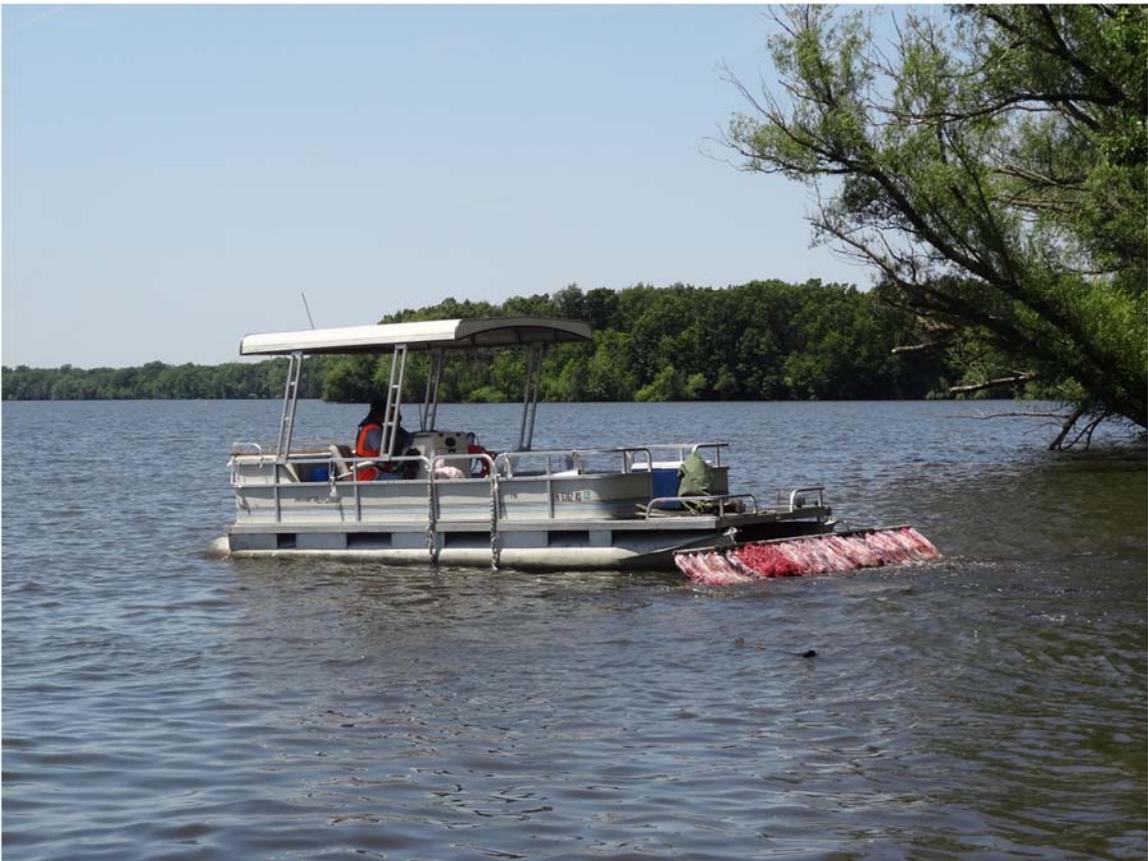
36. Morrow Lake sheen sweep boat observed.
