# Situation Photo Log

Friday, June 29, 2012

Kalamazoo River / Enbridge Spill

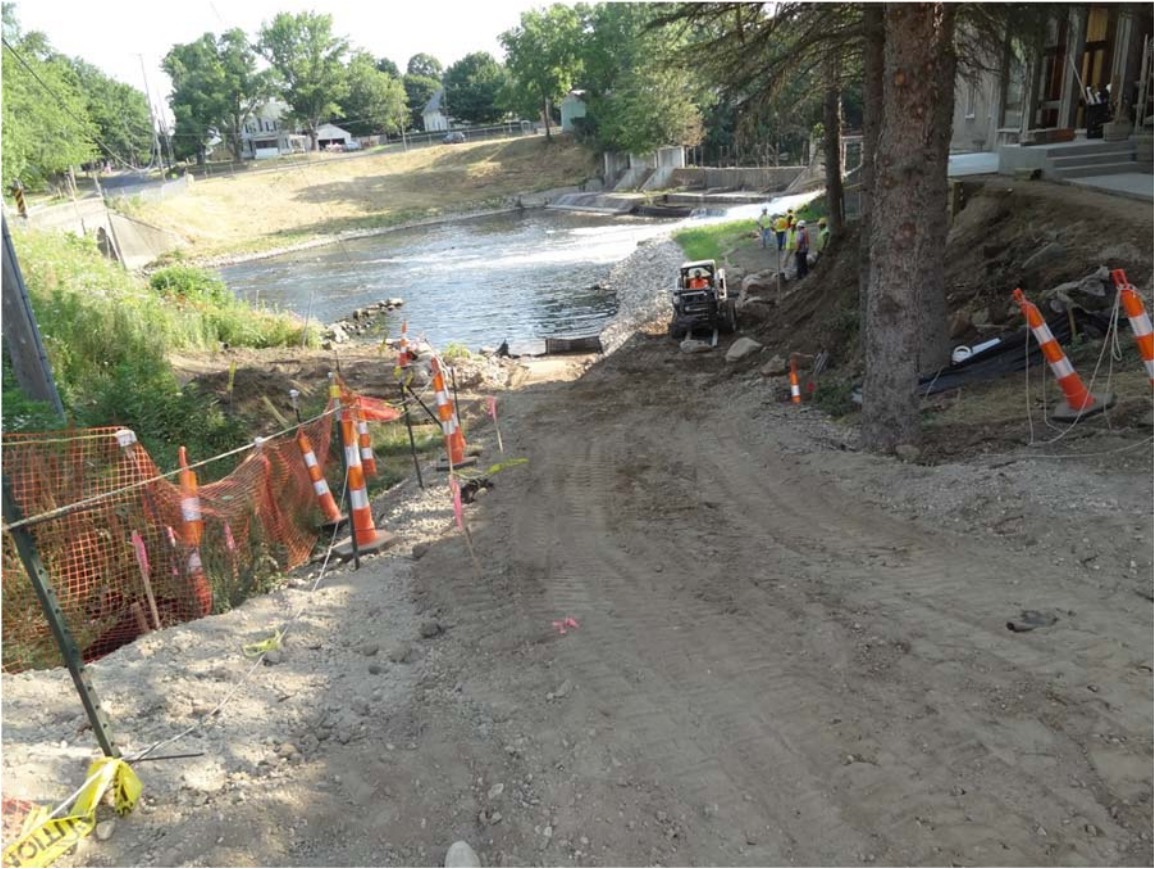
1. Ceresco Dam portage work continued below the dam.

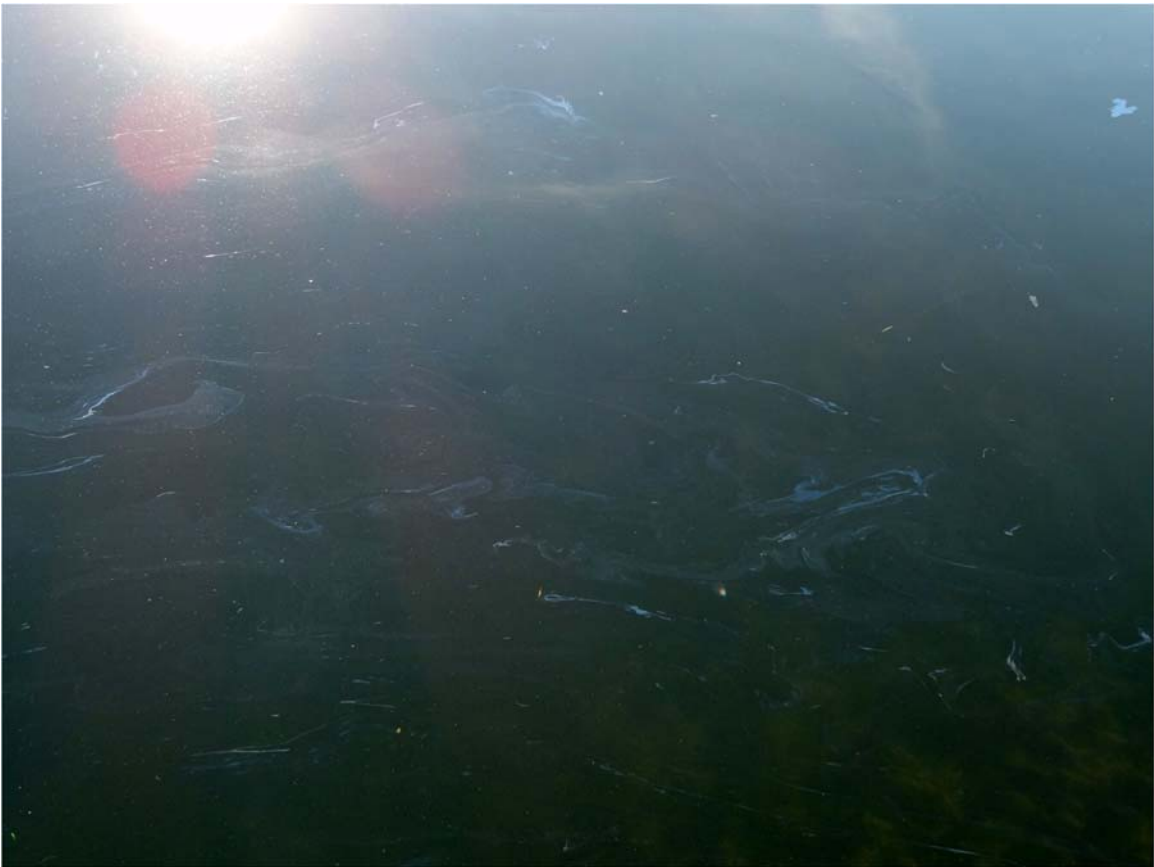
2. Ceresco Dam sheen observed above the dam. Operations was notified.

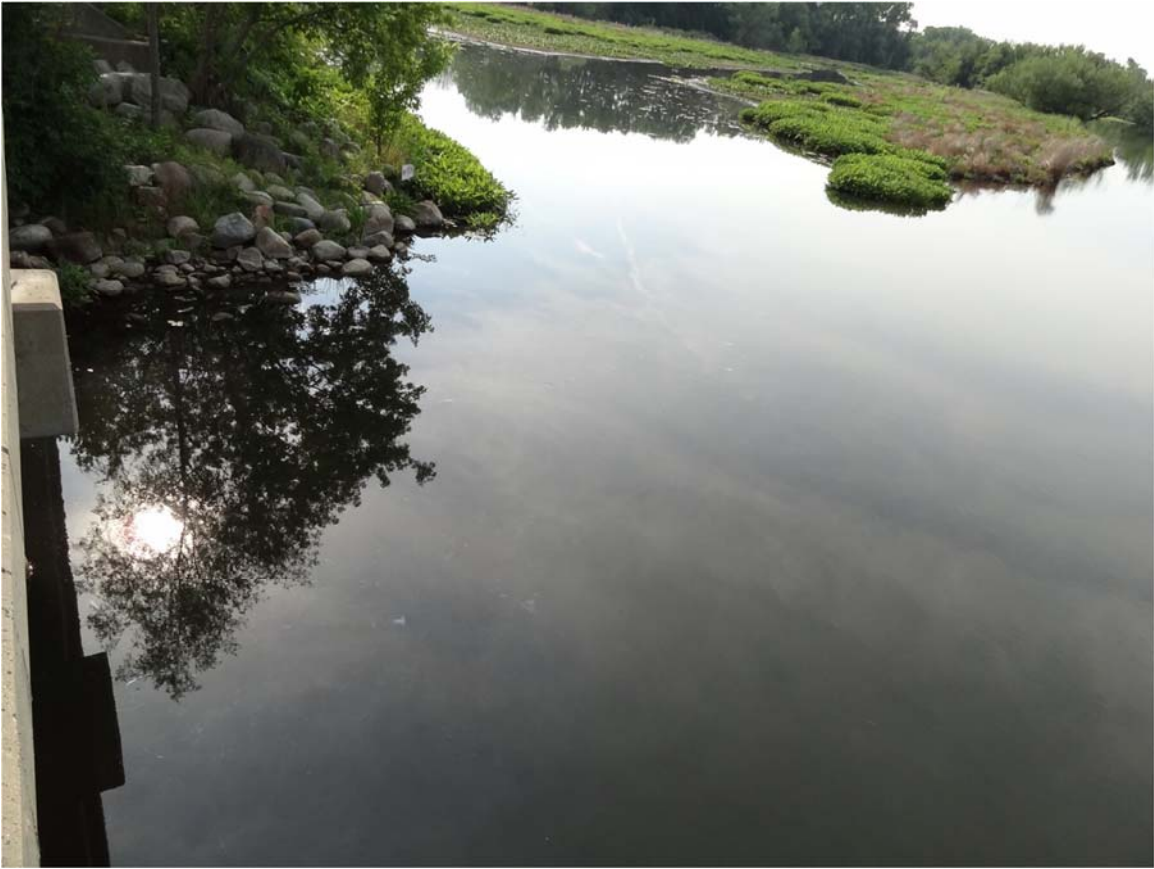
3. MP15.5 South Mill Pond north corner observed sheen flowing out of Mill Pond into river. Operations was notified.

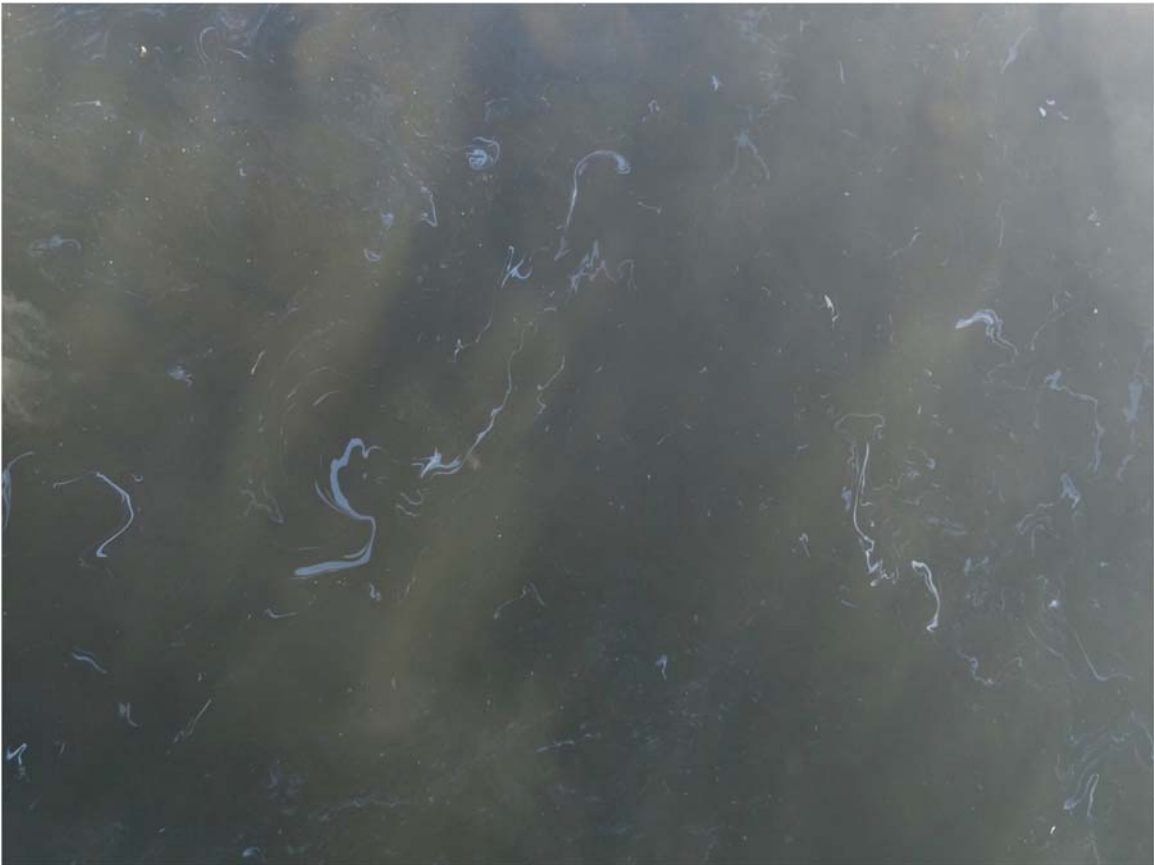
4. MP15.5 South Mill Pond north corner observed sheen flowing out of Mill Pond into river. Operations was notified.

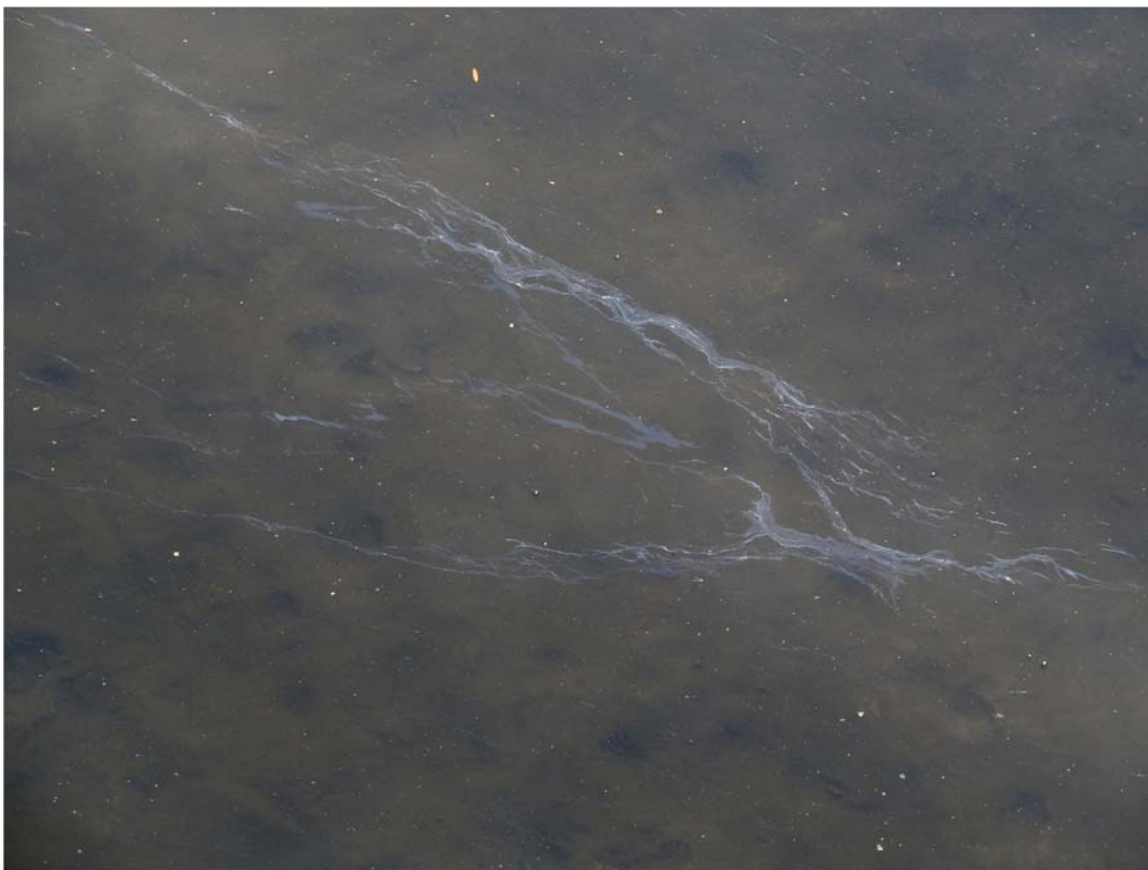
5. MP21.5 Custer Drive Bridge sheen observed. Operations was notified.  
This location is swept daily.

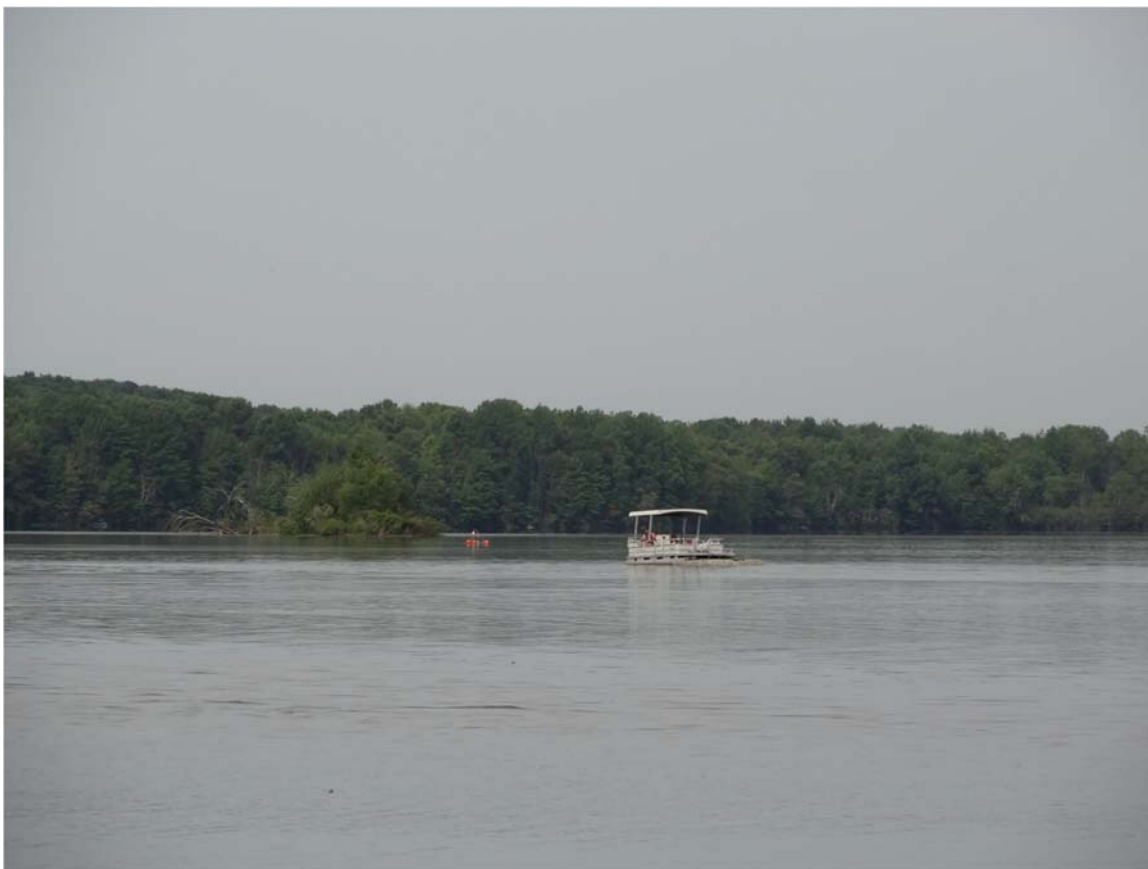
6. Observed sheen sweep boat operating in the Morrow Lake fan.

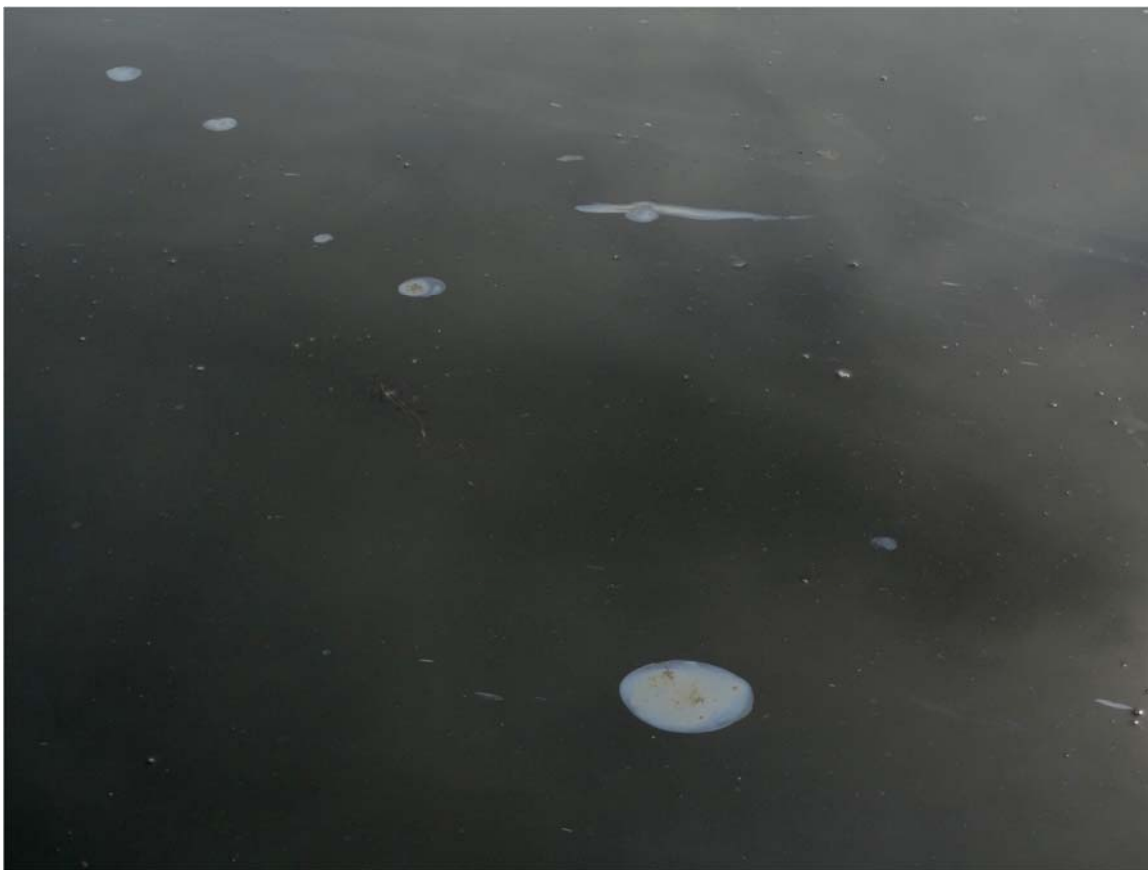
7. Sheen observed in the Morrow Lake Fan.

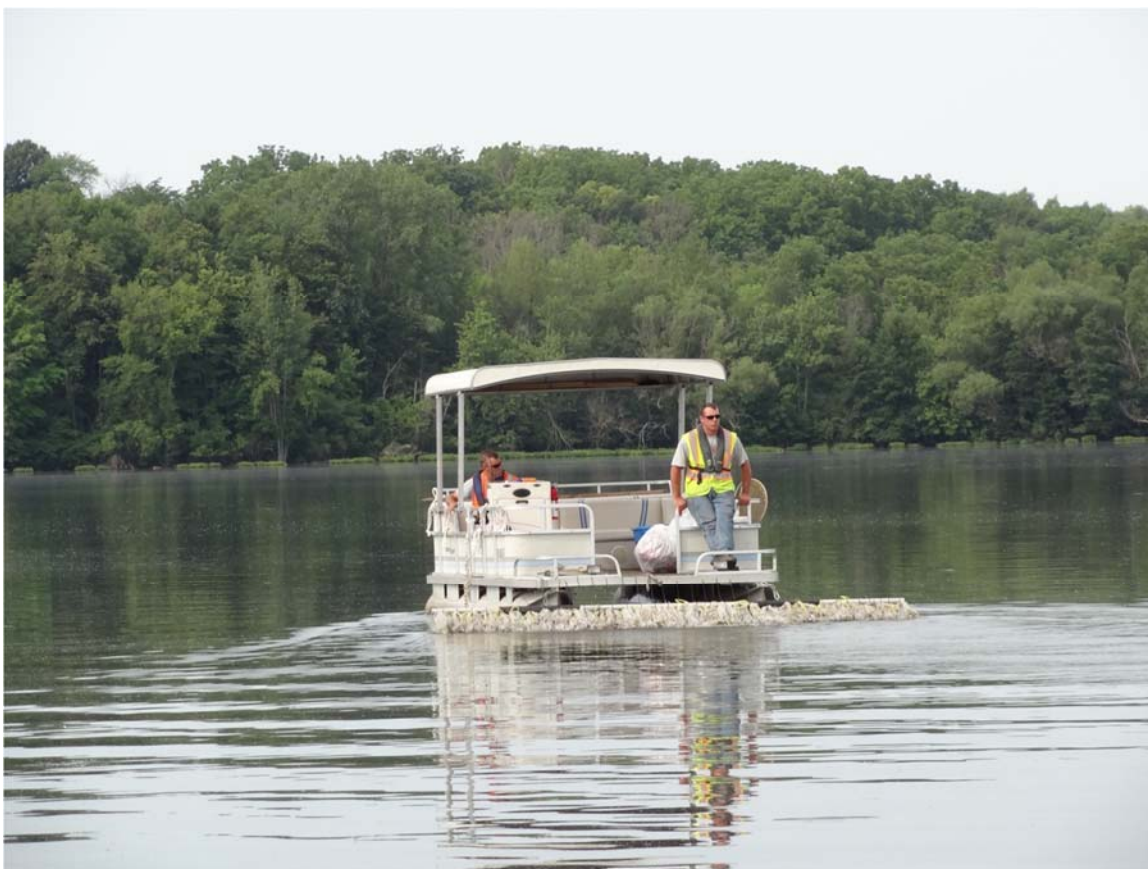
8. Observed sheen sweep boat operating in the Morrow Lake fan.

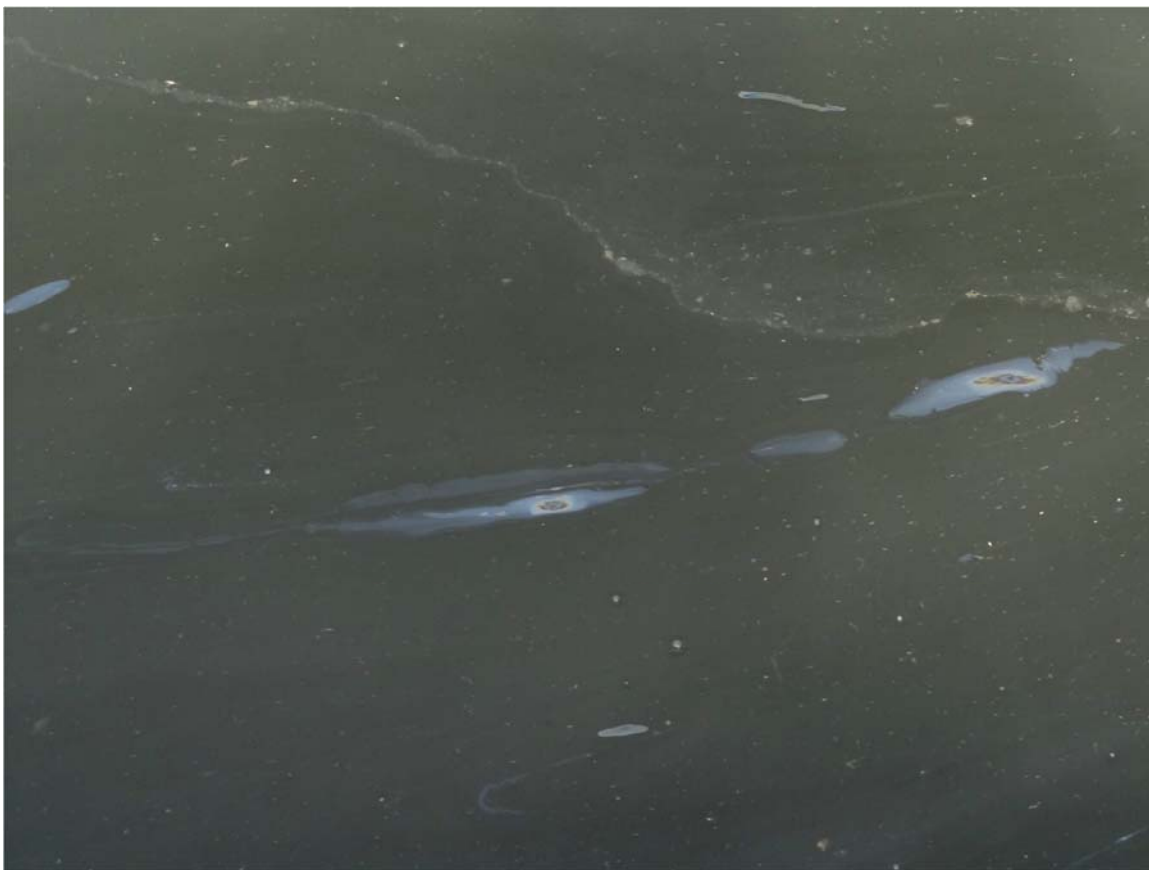
9. Sheen observed in the Morrow Lake Fan.

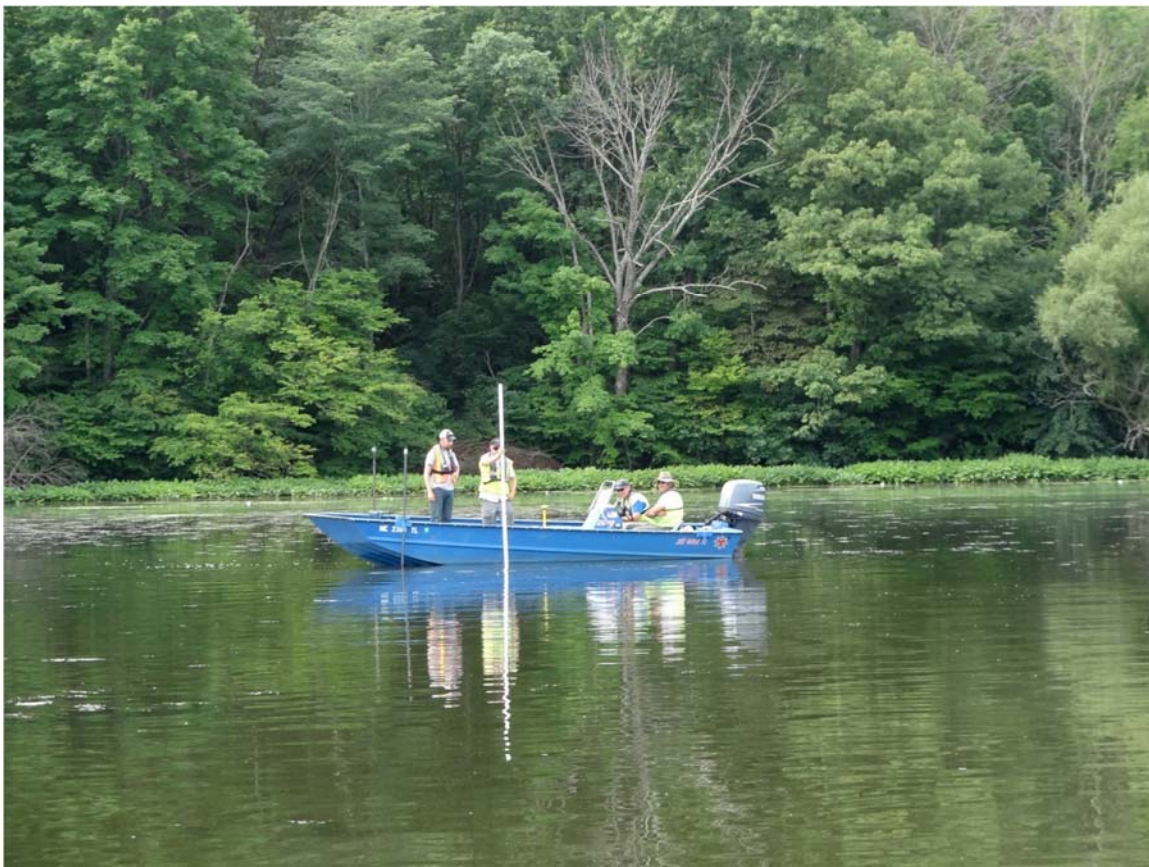
10. MP39.25 southwestern end of Lake Morrow, observed a poling crew.

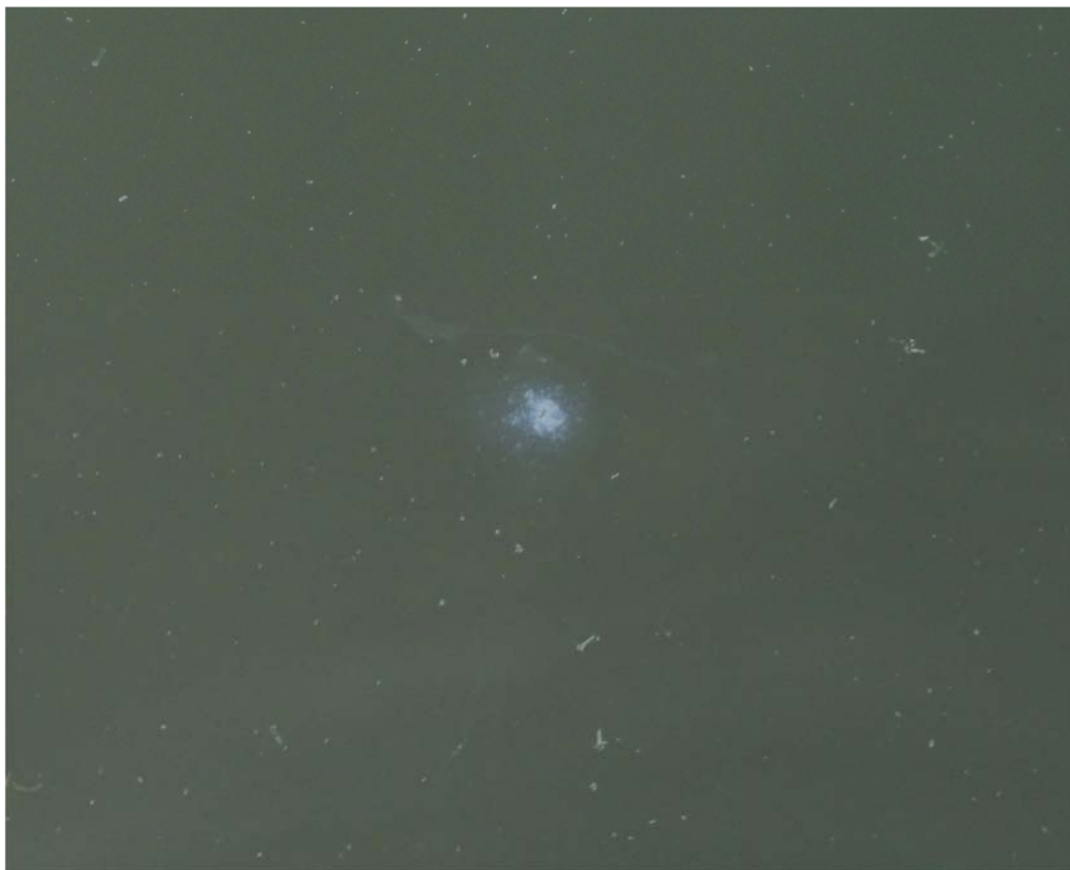
**11. MP39.25 southwestern end of Lake Morrow, observed spots of sheen.  
Operations was notified.**

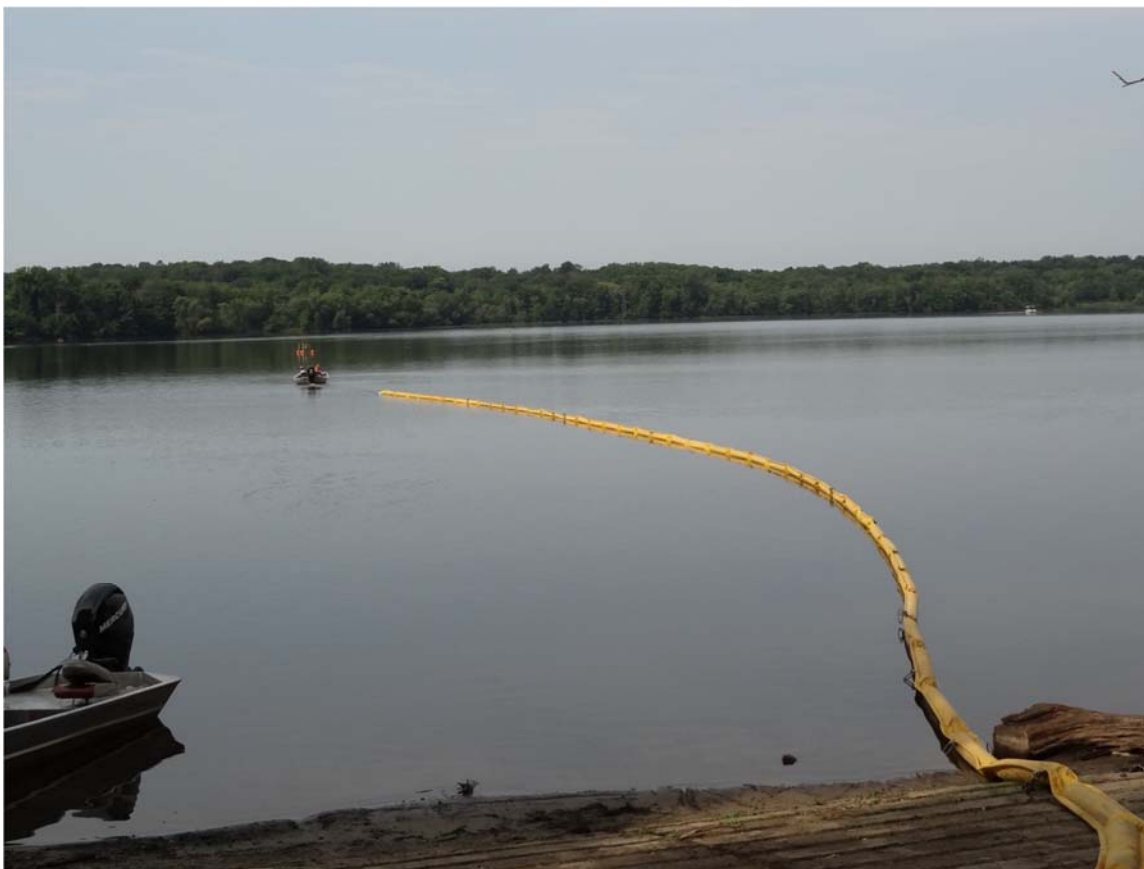
**12. MP37.75 Observed crews deploying boom from E4 boat launch.**

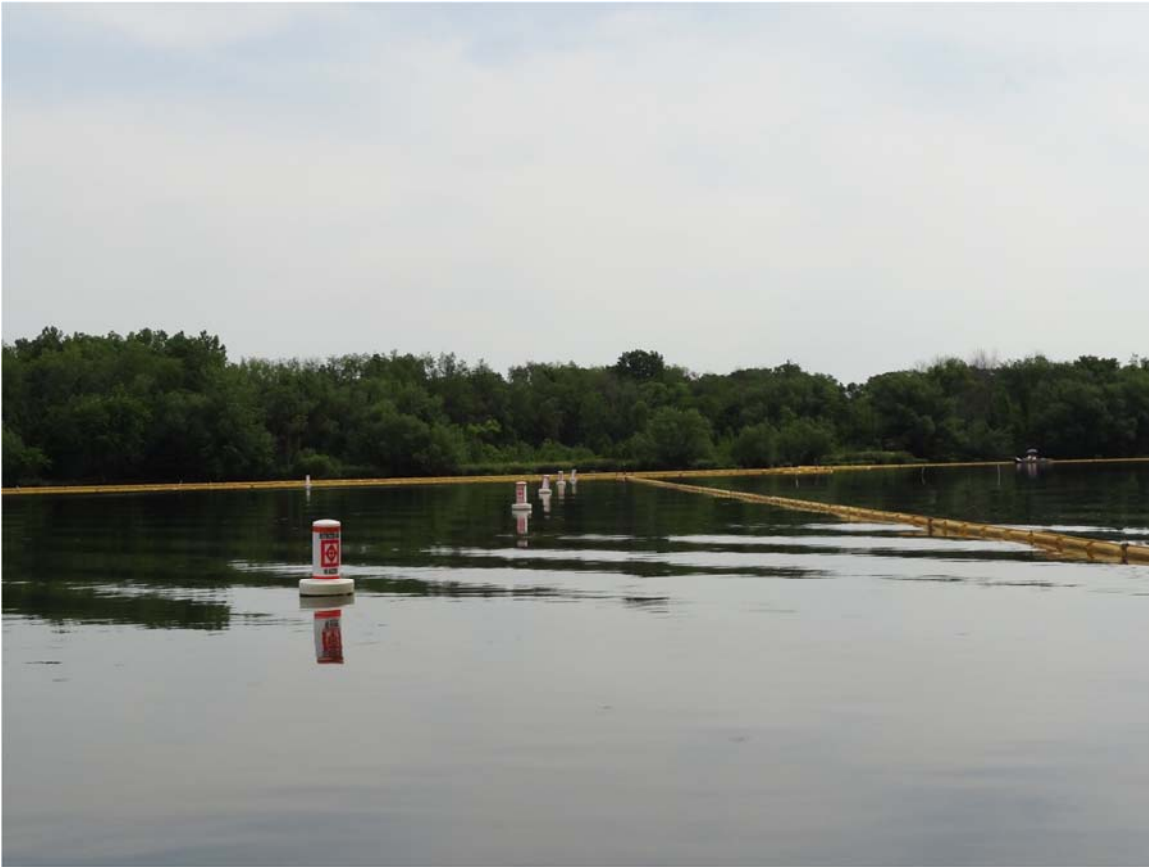
**13. Observed buoys relocated around new boom configuration.**

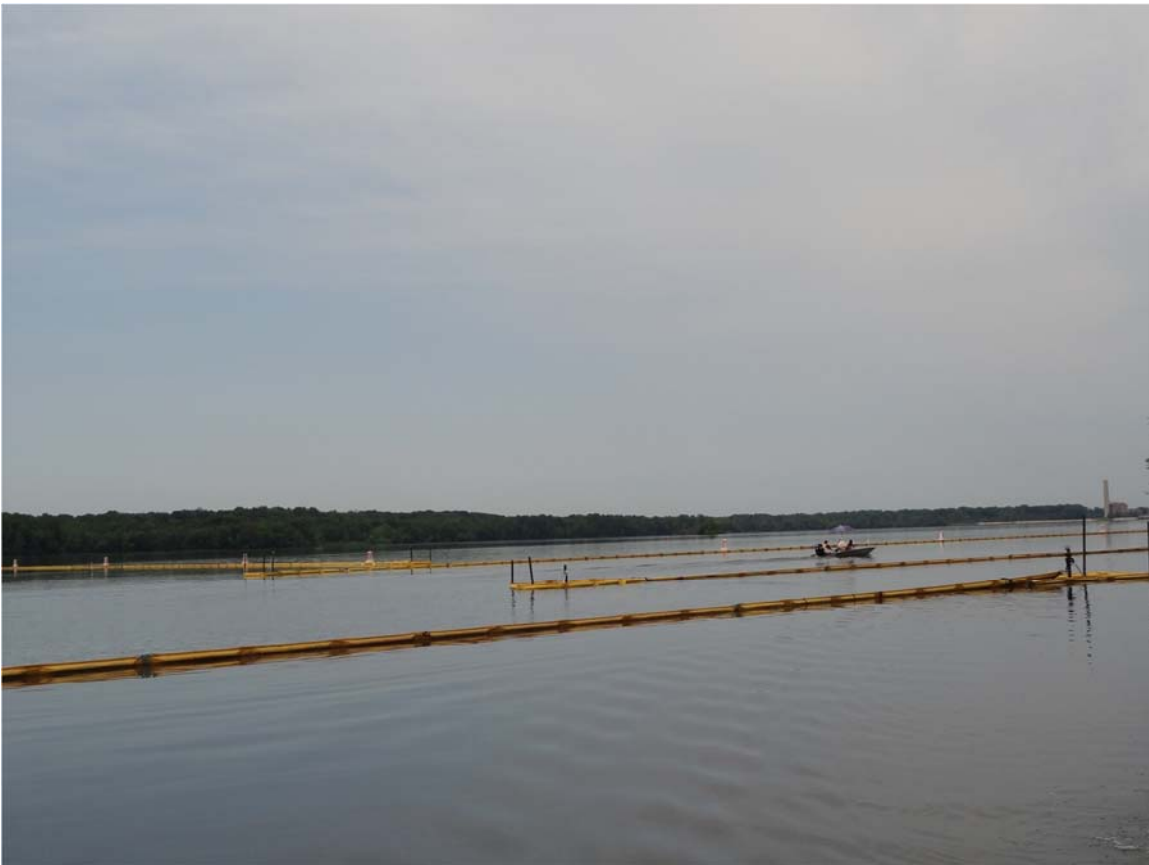
**14. Morrow Lake E4 boom system.**

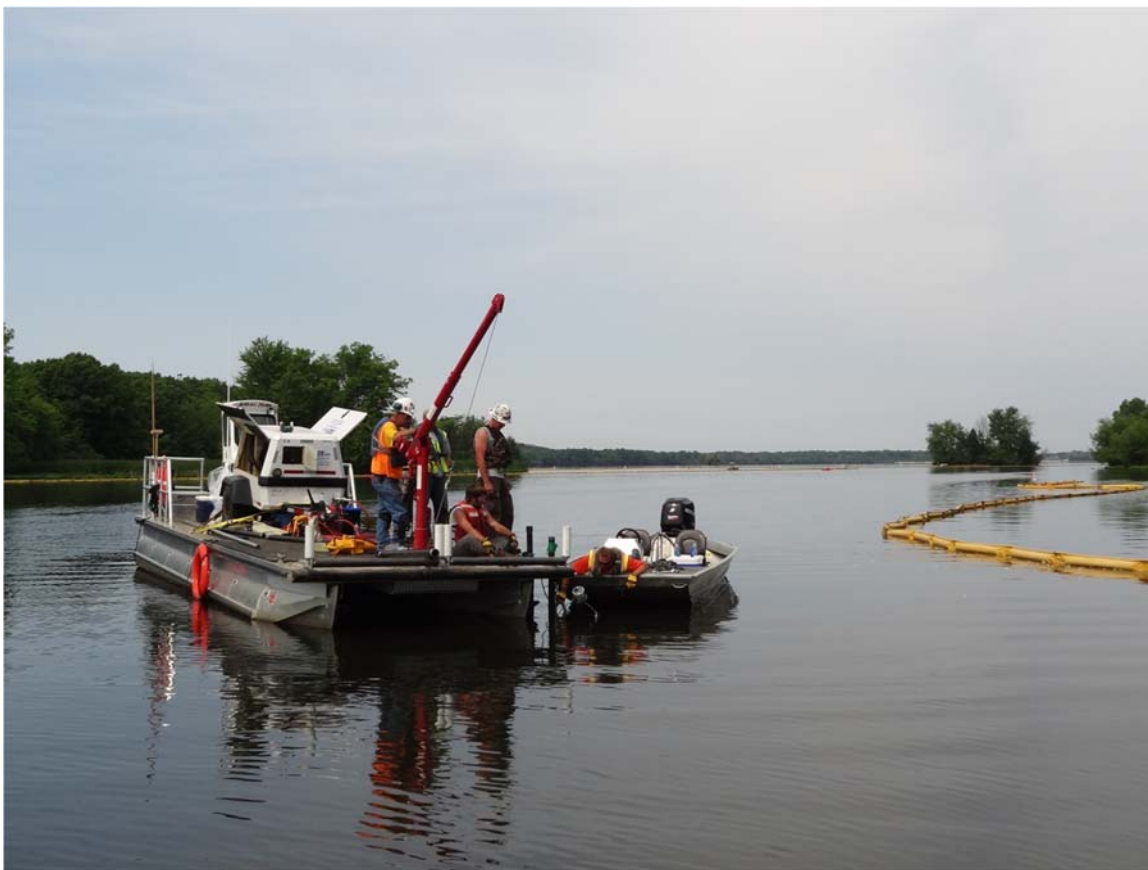
15. Morrow Lake Delta E4 boom system anchor installation.

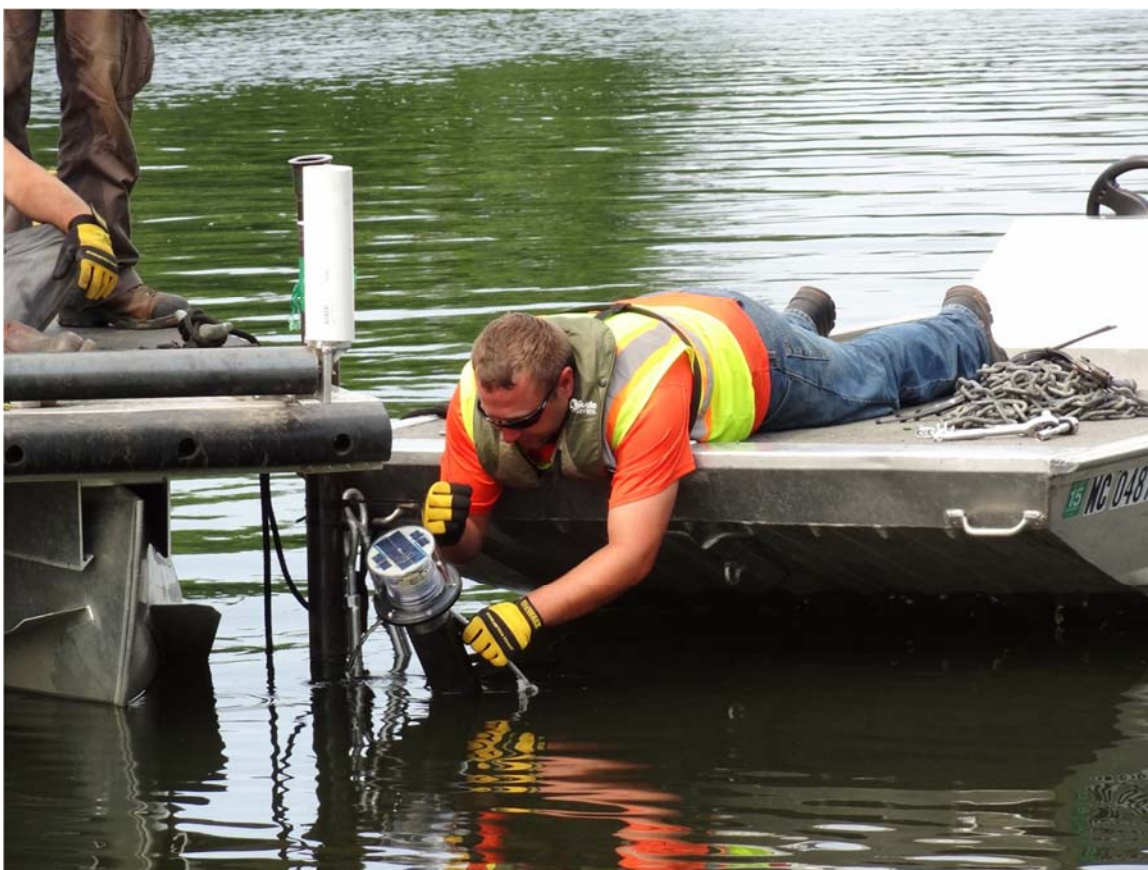
16. Morrow Lake Delta E4 boom system anchor installation, observed crew fixing broken anchor.

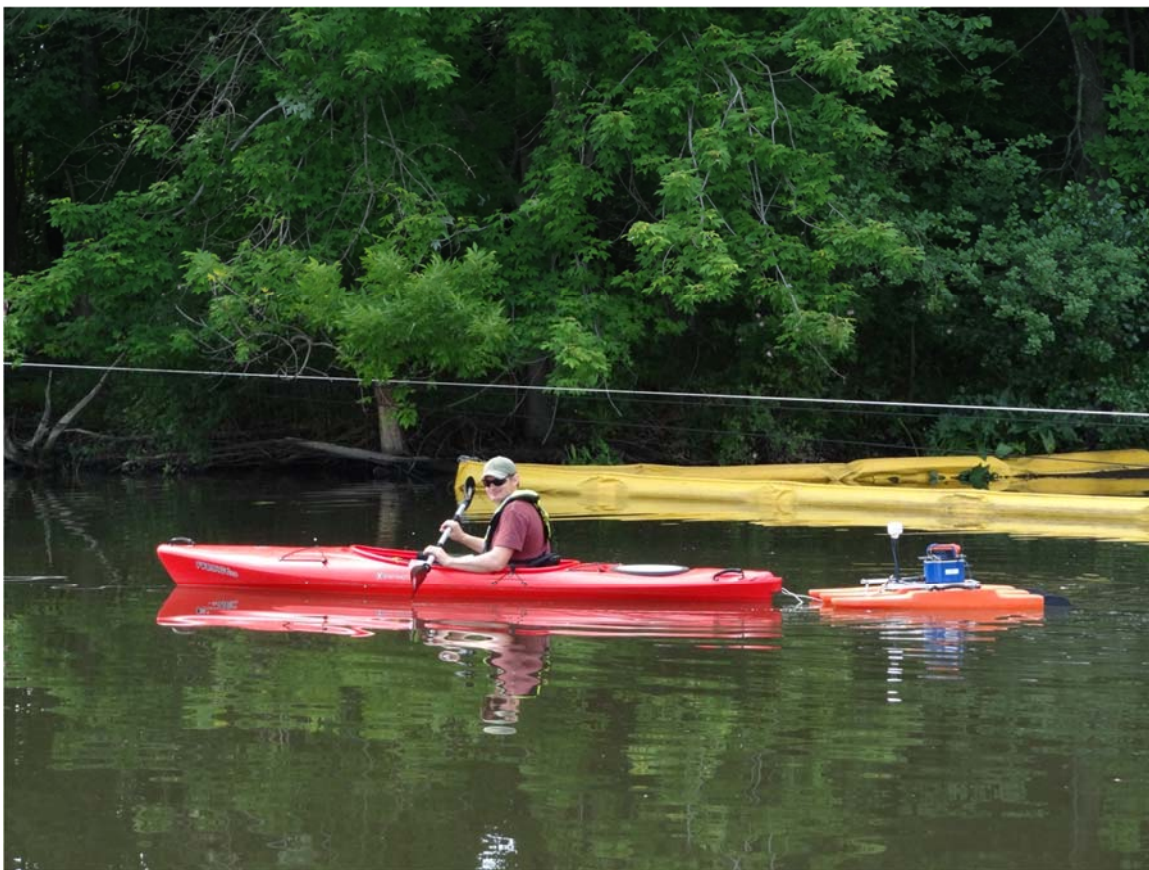
17. Morrow Lake Delta observed USGS performing velocity measurements.

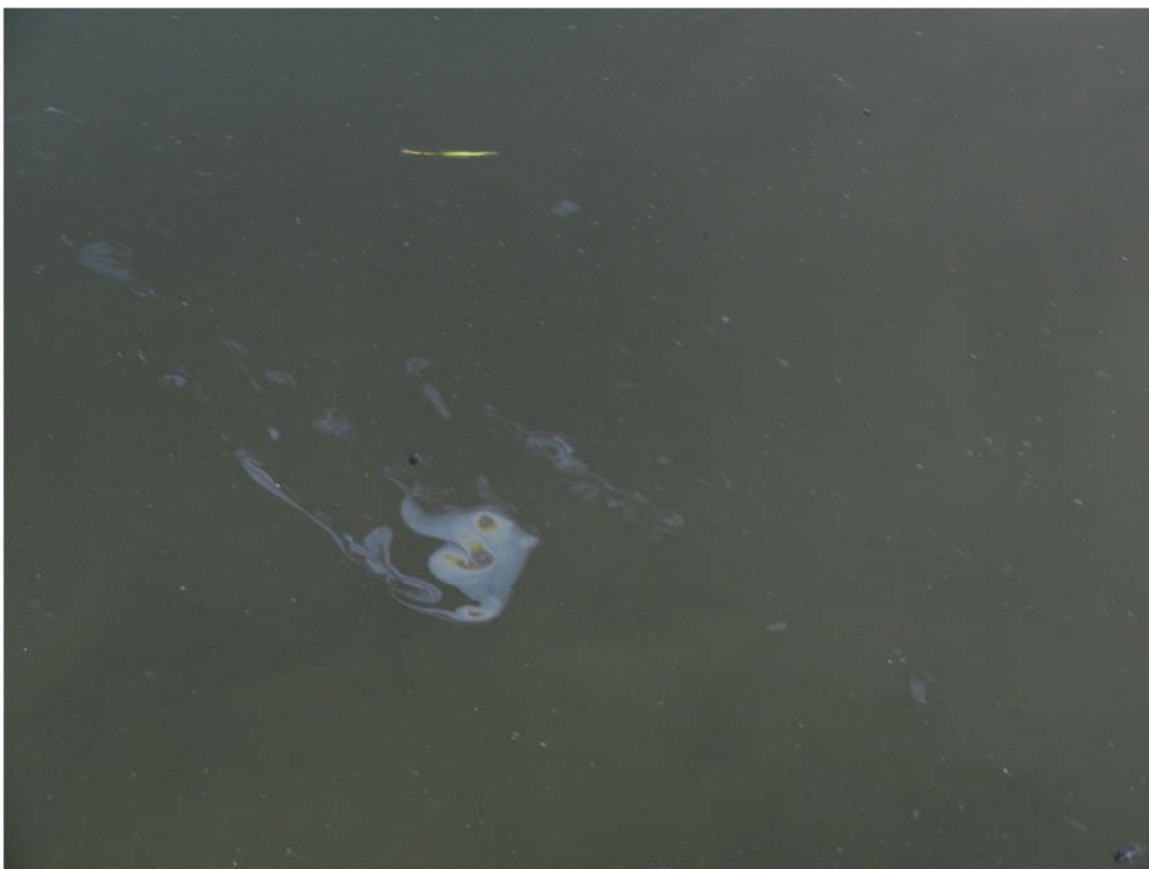
18. Morrow Lake Delta observed sheen.

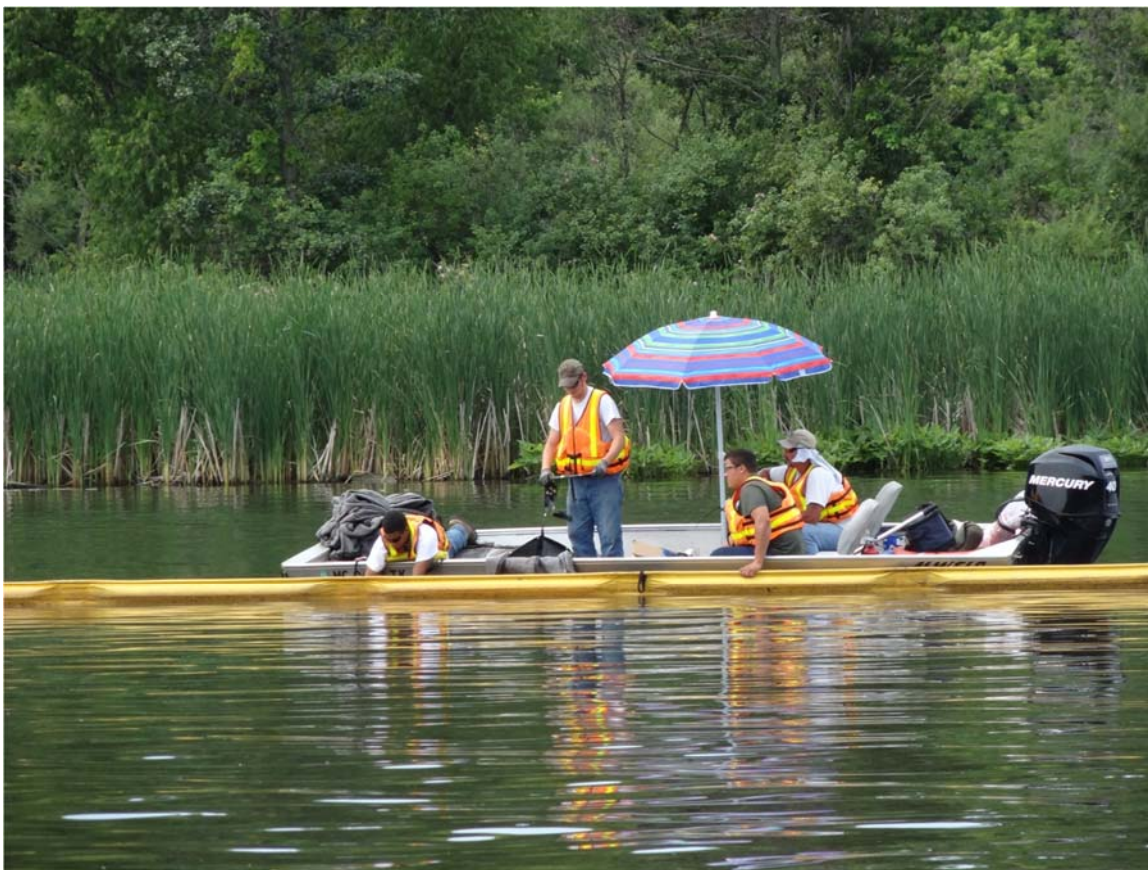
19. Morrow Lake Delta E4 boom system, observed crew installing curtain.

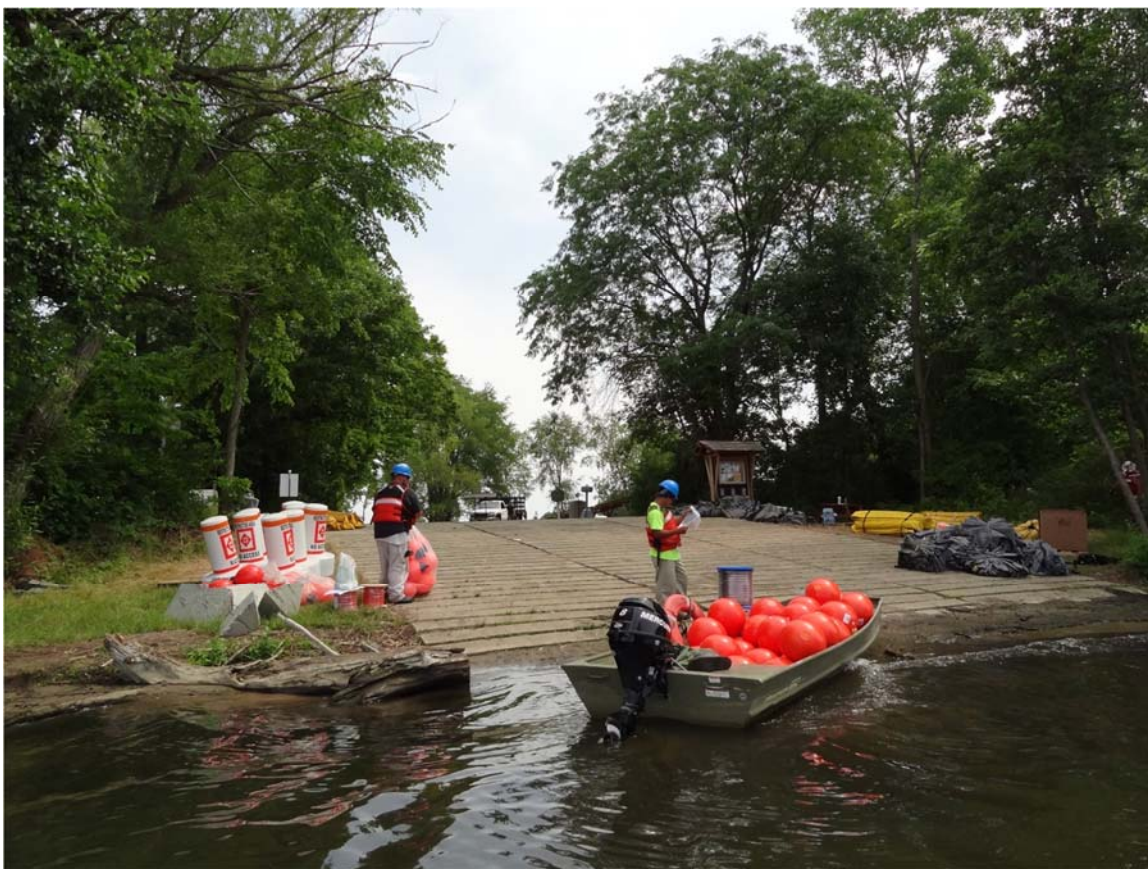
20. Morrow Lake Delta E4 boom system, observed crew deploying buoys.

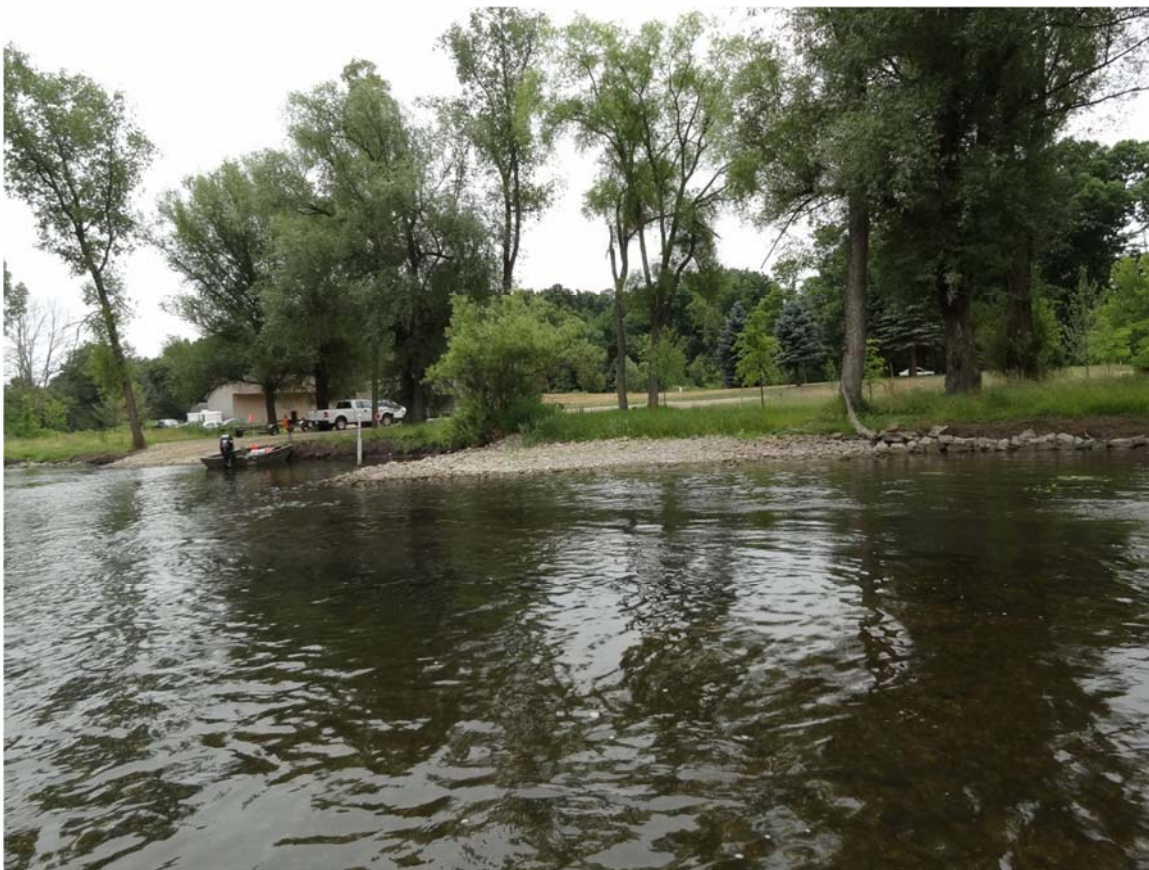
21. MP10.0 C3.2 boat launch sheen observed when boat reversed.

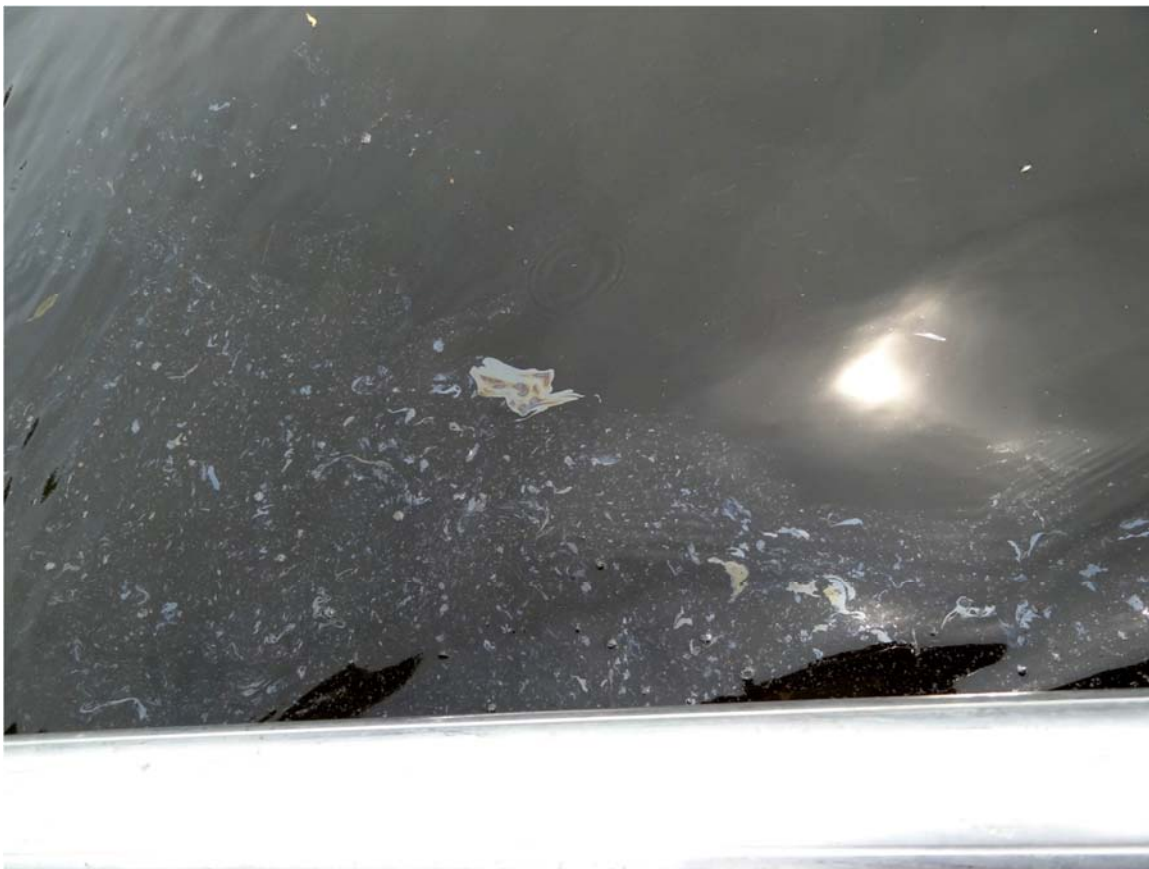
22. MP10.0 C3.2 boat launch sheen observed when boat reversed.
