# Situation Photo Log

Saturday, June 30, 2012

Kalamazoo River / Enbridge Spill

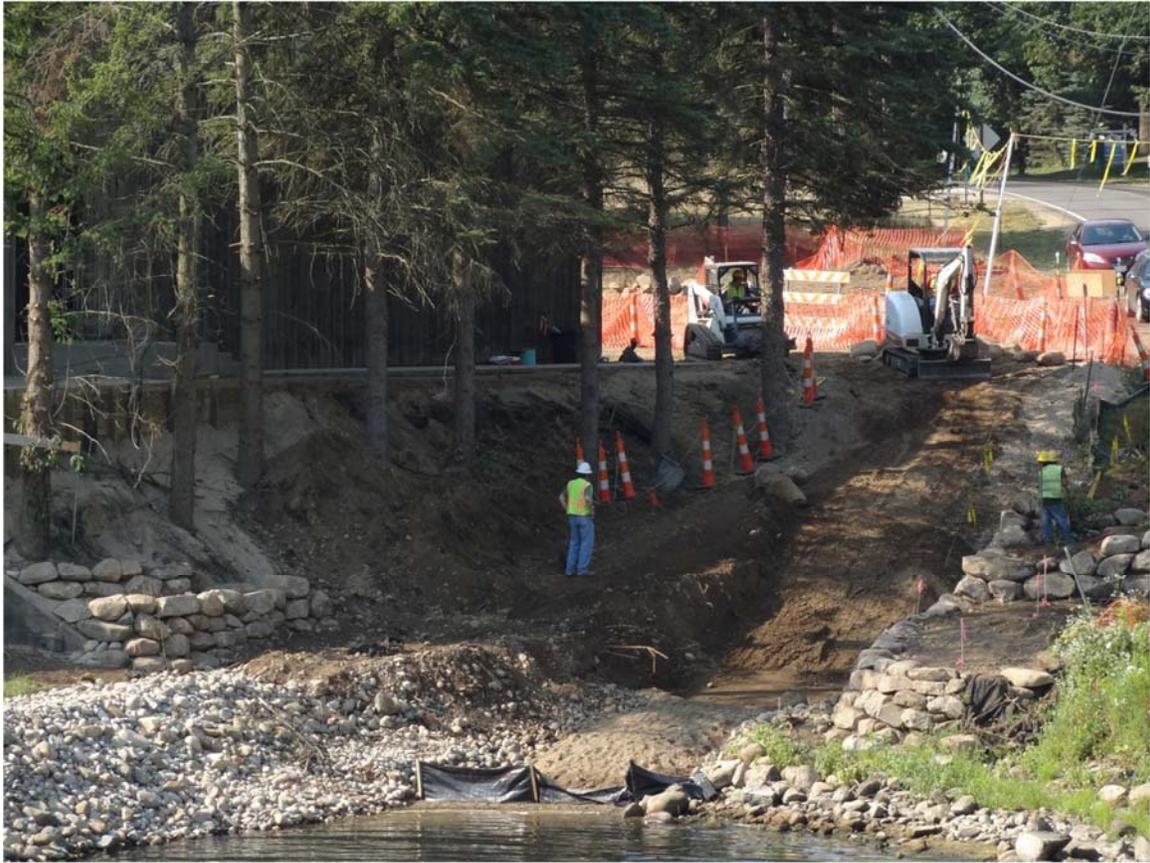
1. Ceresco Dam portage work continued below the dam.

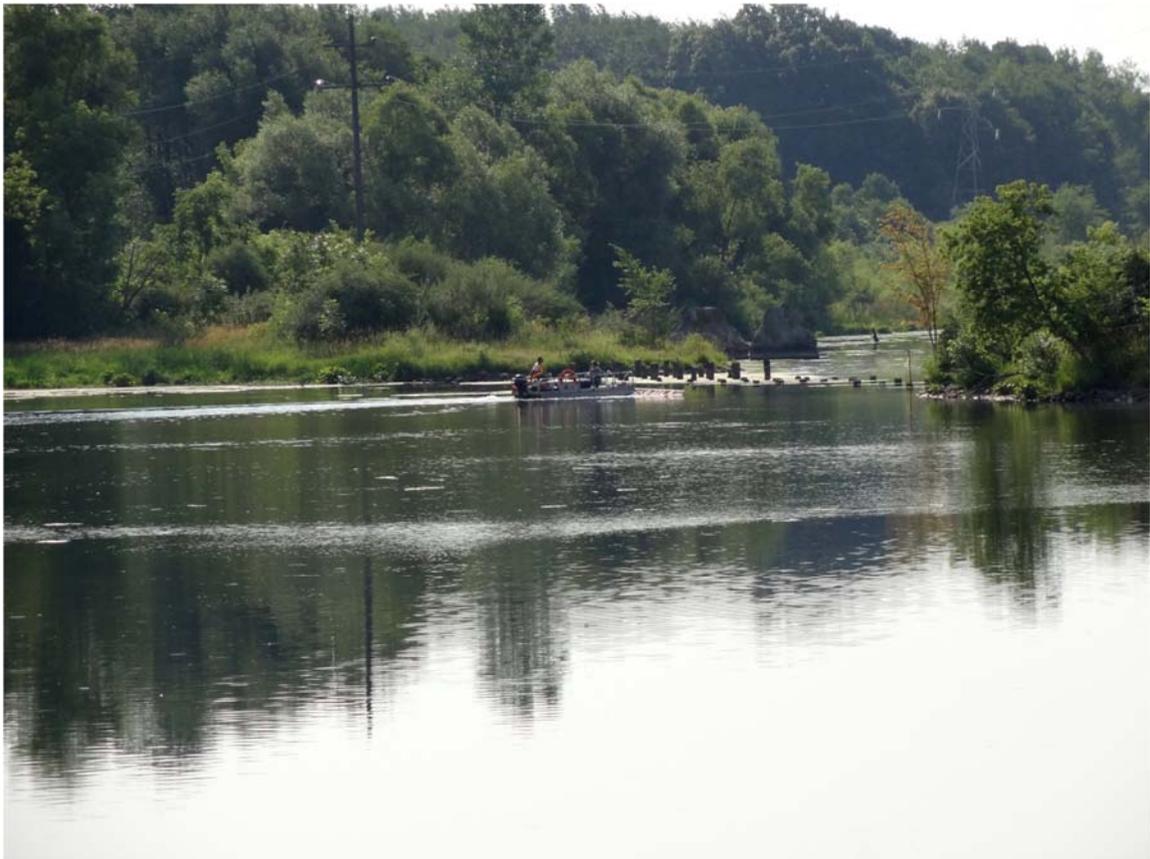
2. Ceresco Dam observed sheen sweep boat.

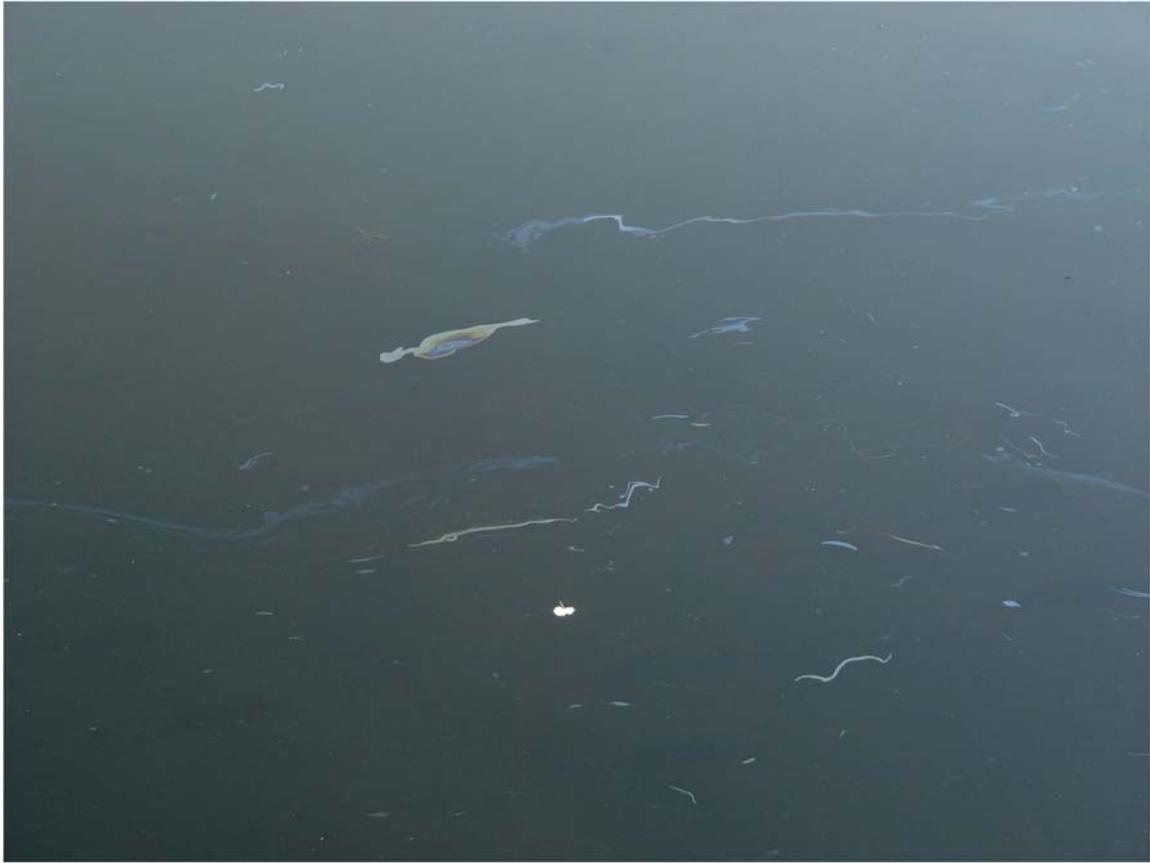
3. Ceresco Dam sheen observed along the south side of the dam at the dam.

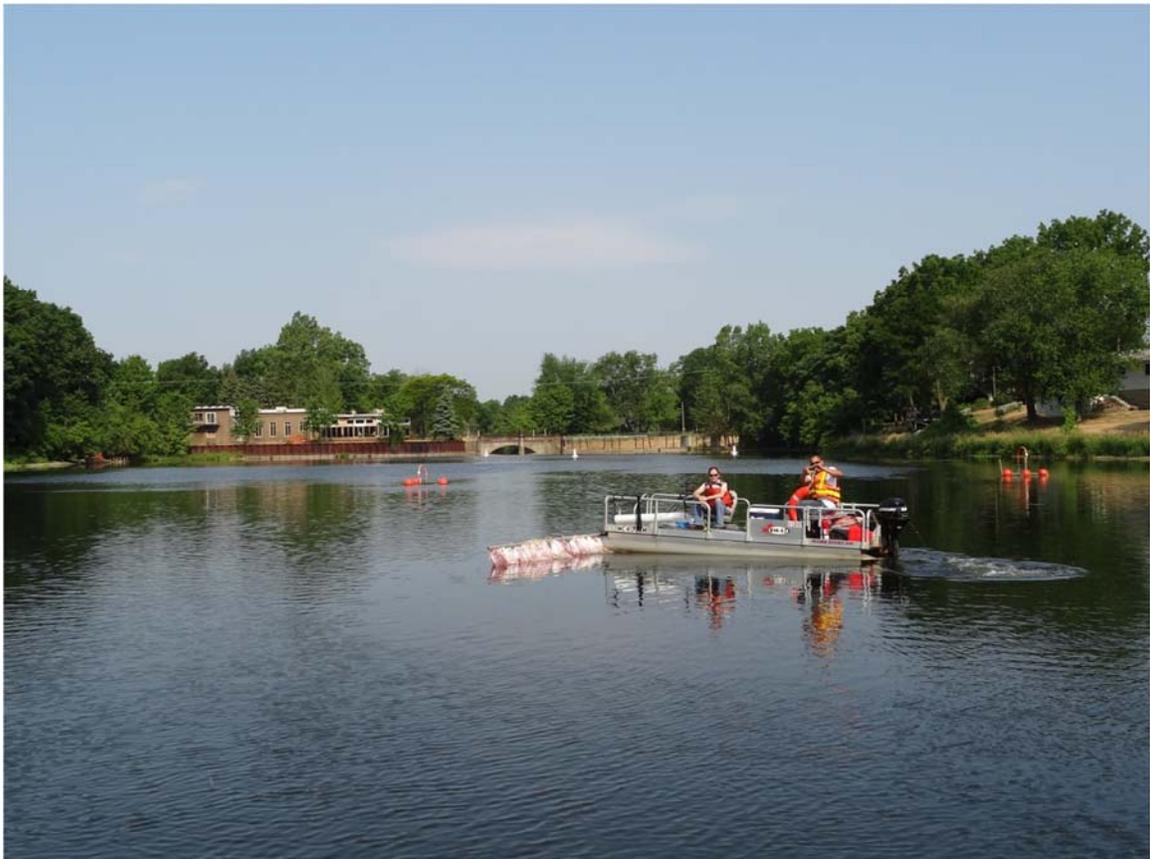
4. Ceresco Dam observed sheen sweep boat.

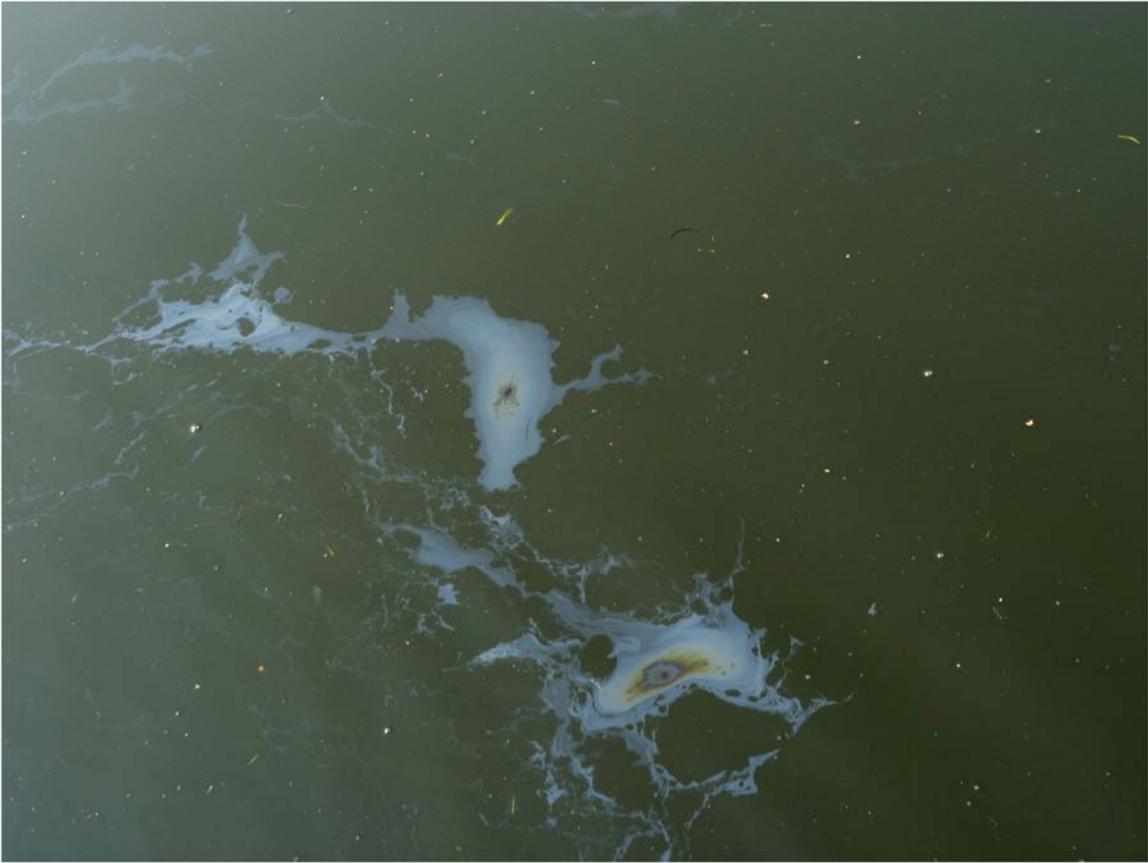
5. Ceresco Dam sheen observed along the south side of the dam at the dam. Sweep boat restricted from accessing this area.

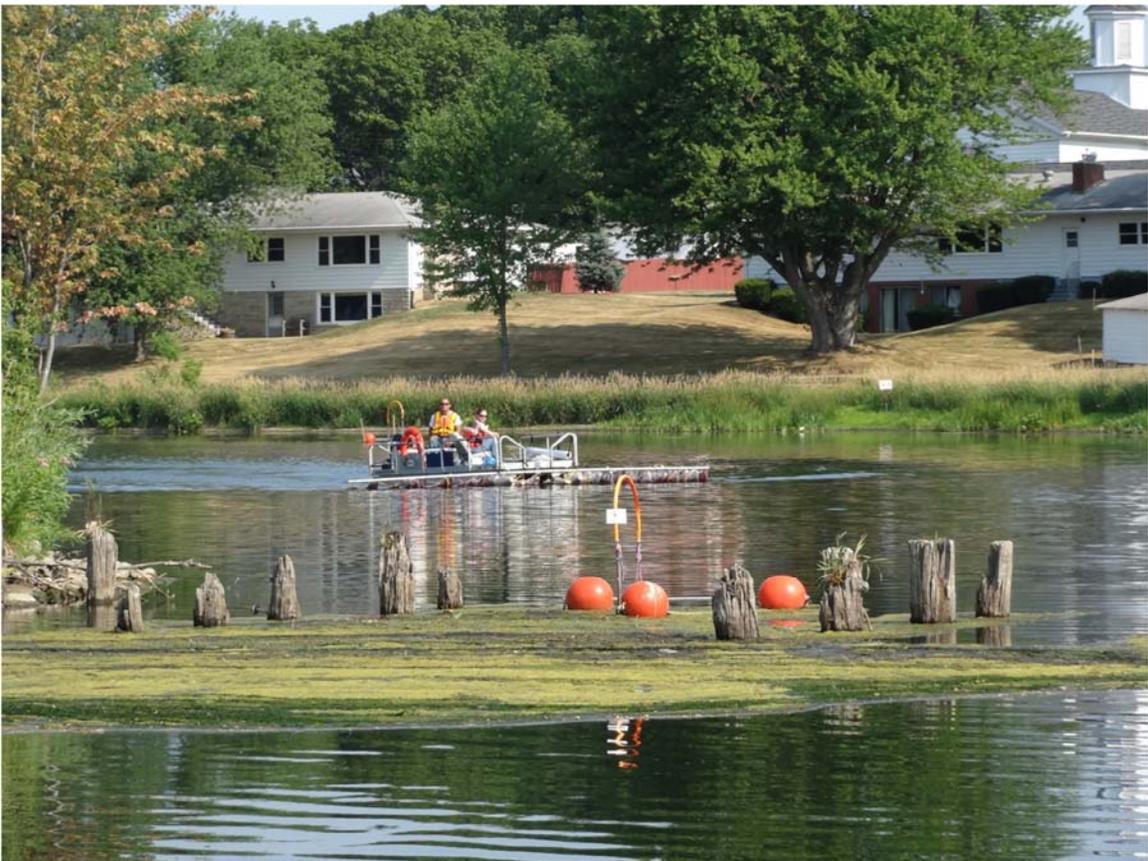
6. Observed sheen sweep boat operating around the railroad trestle.

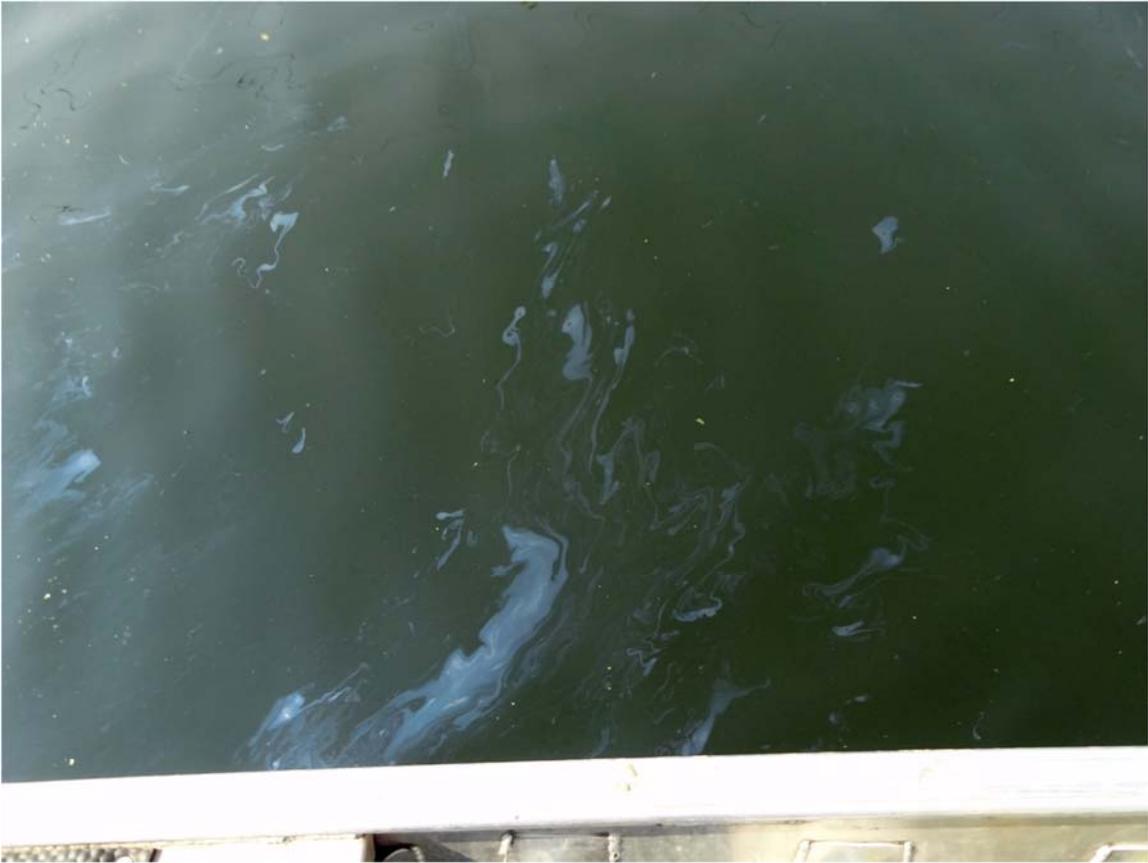
7. Observed sheen around the railroad trestle. Sheen sweep boat operating in the area.

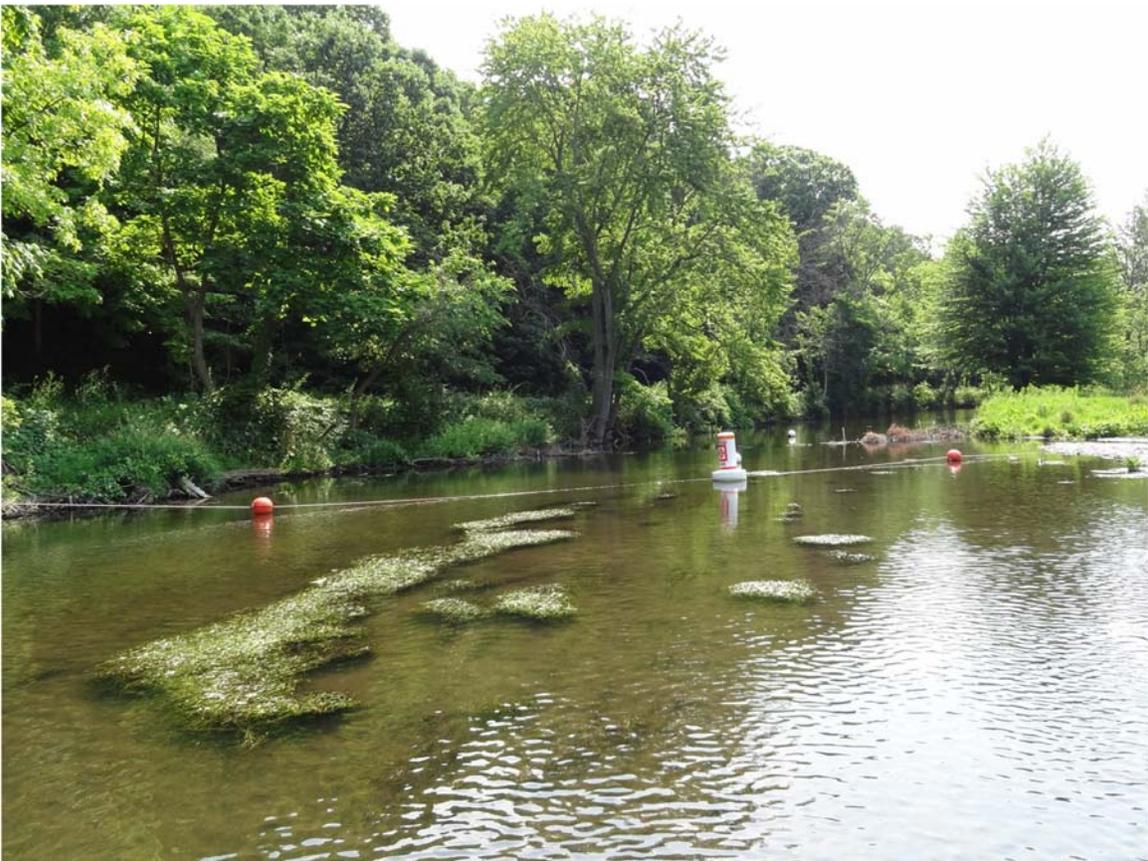
8. MP14.75 Sediment trap.

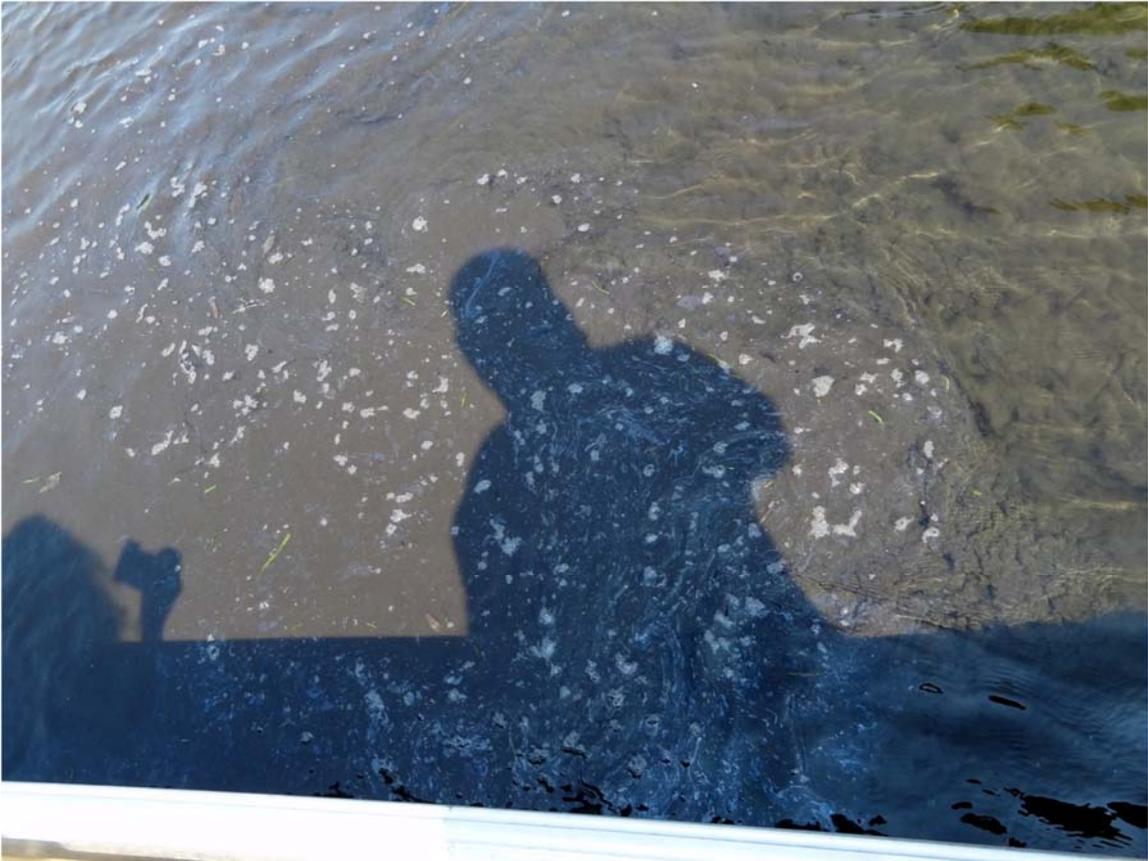
9. MP14.75 Sheen observed when boat reversed.

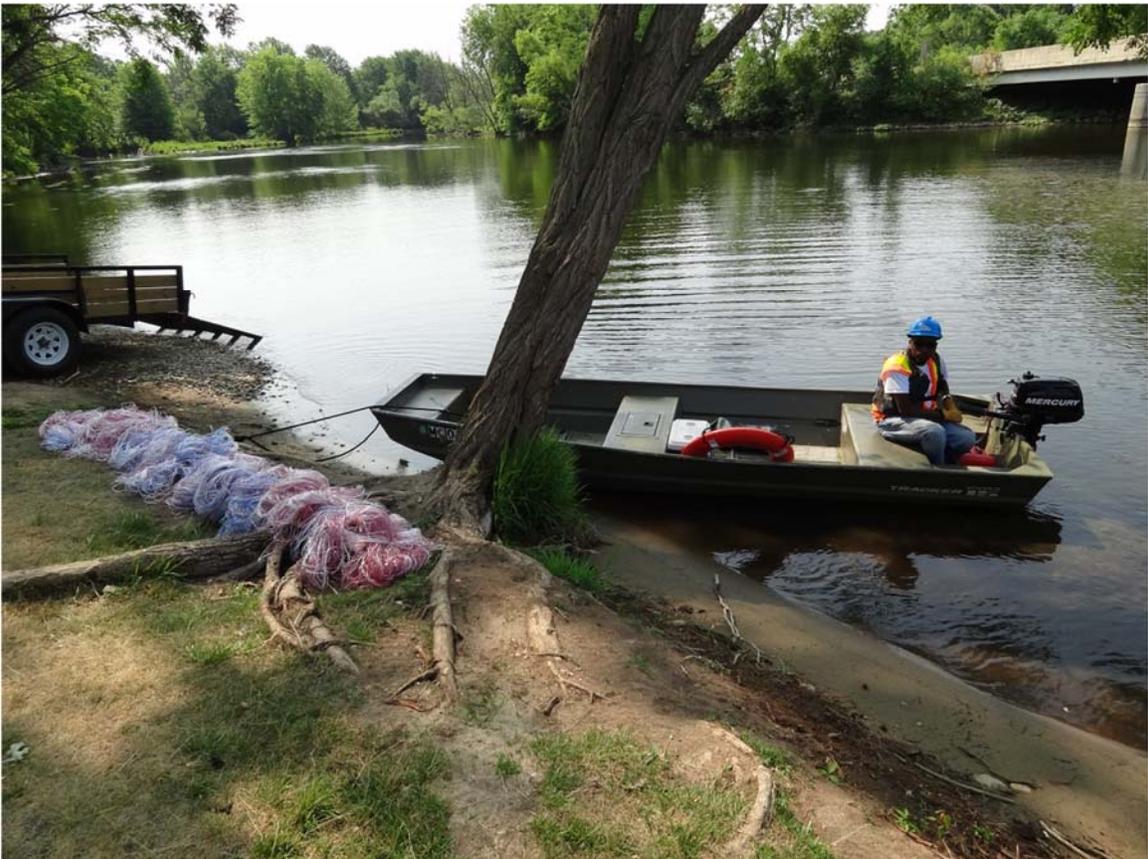
10. C5 Boat launch, observed sheen sweep boat deploying.

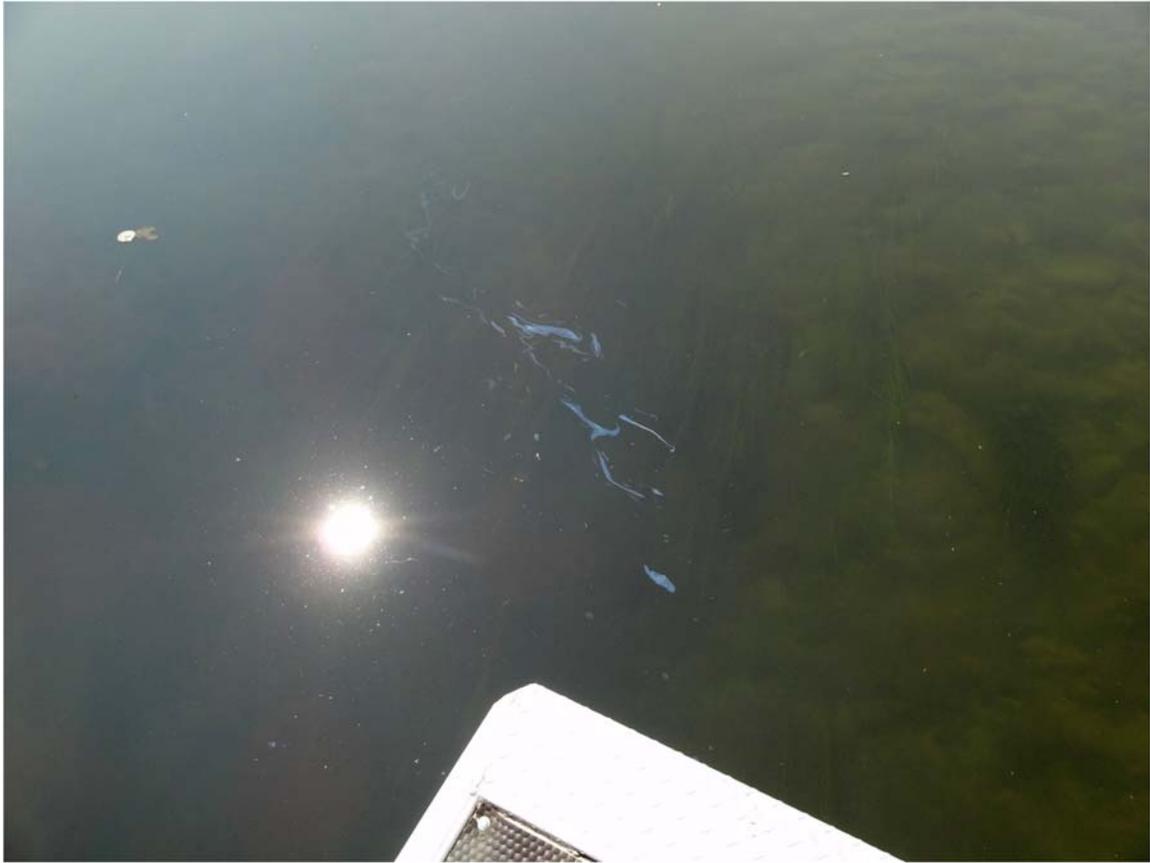
11. MP15.5 North end of south Mill Pond observed sheen flowing out into the river.

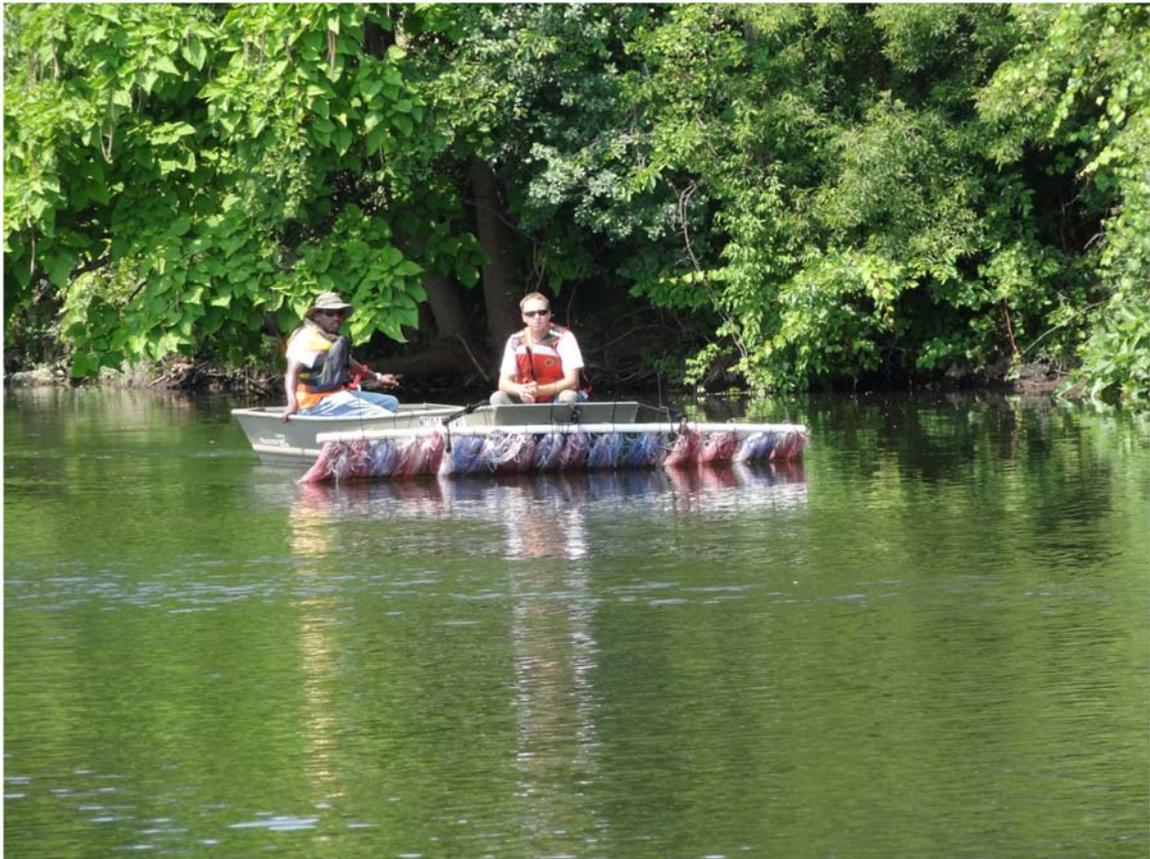
12. MP15.5 Observed sheen sweep boat operating in the area of sheen sighting.

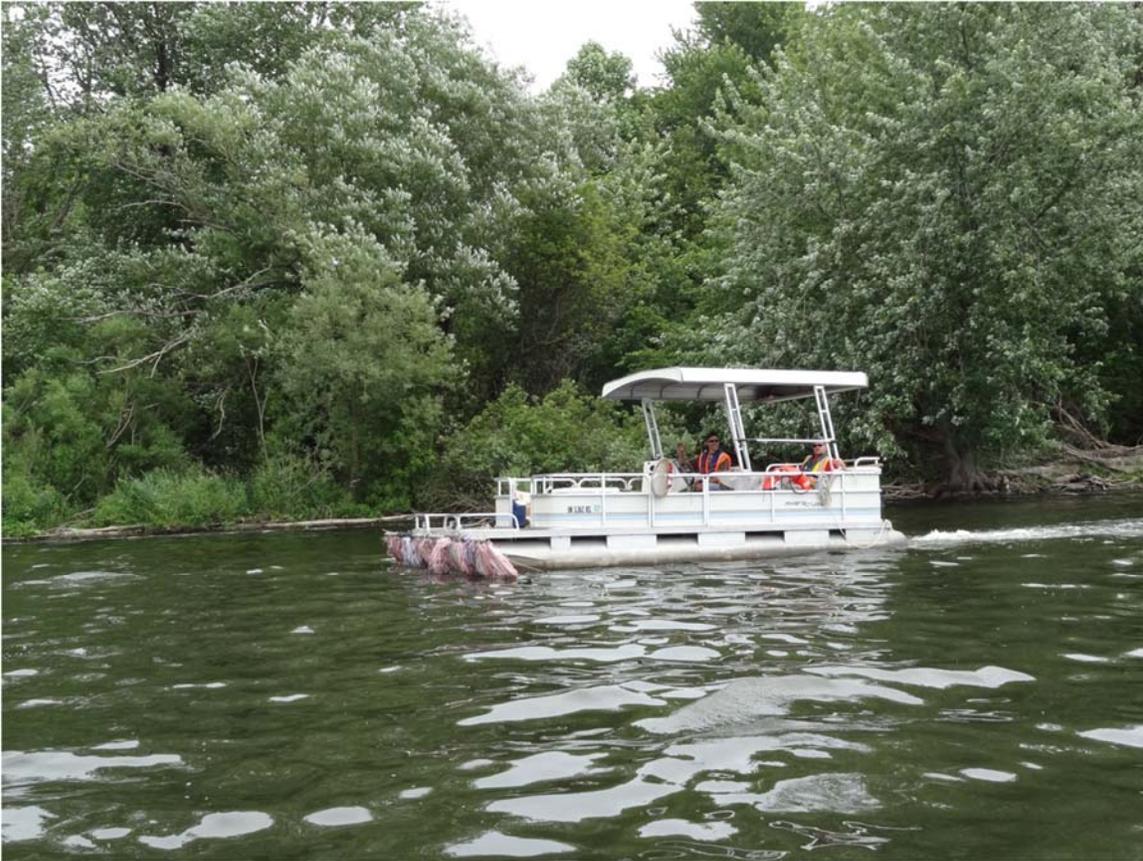
13. Morrow Lake observed sweep boat operating in the southeast corner.

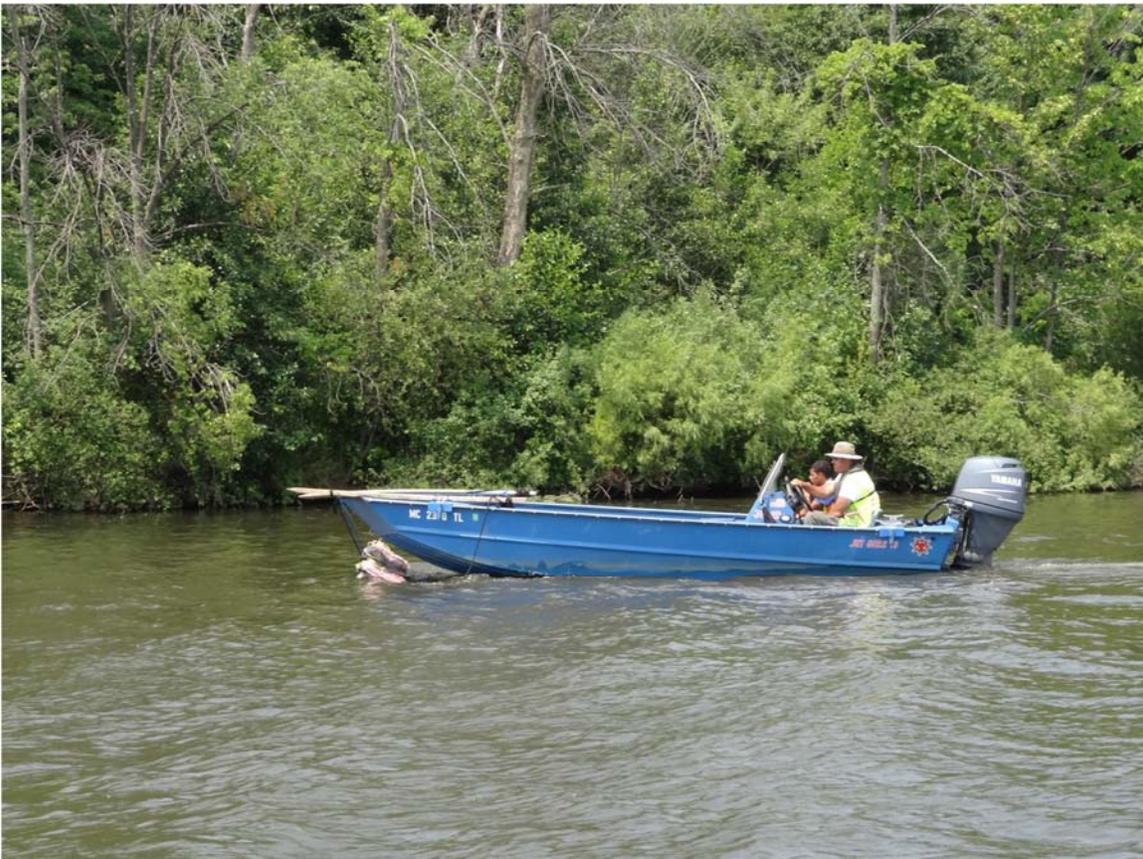
14. Morrow Lake observed additional sweep boat operating in the northeast cove.

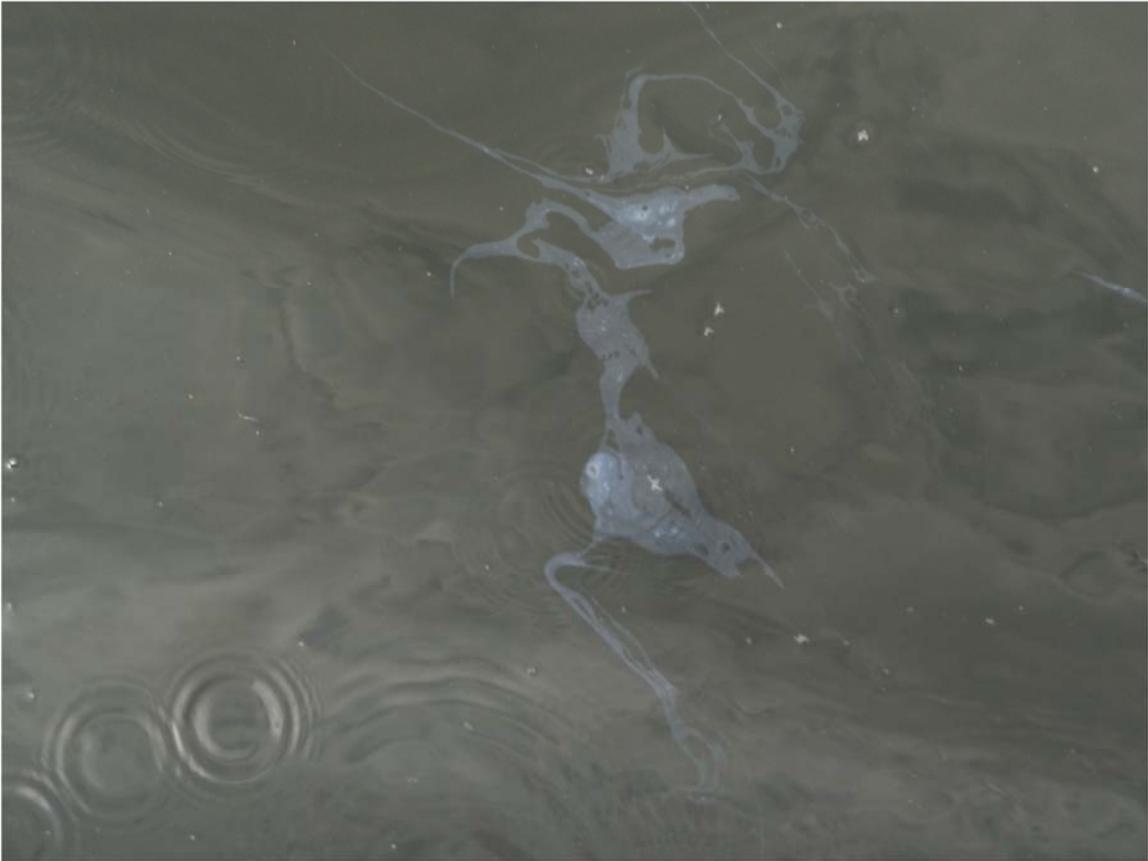
15. Morrow Lake sheen observed in the southeast cove. Sweep boat was operating in the area.

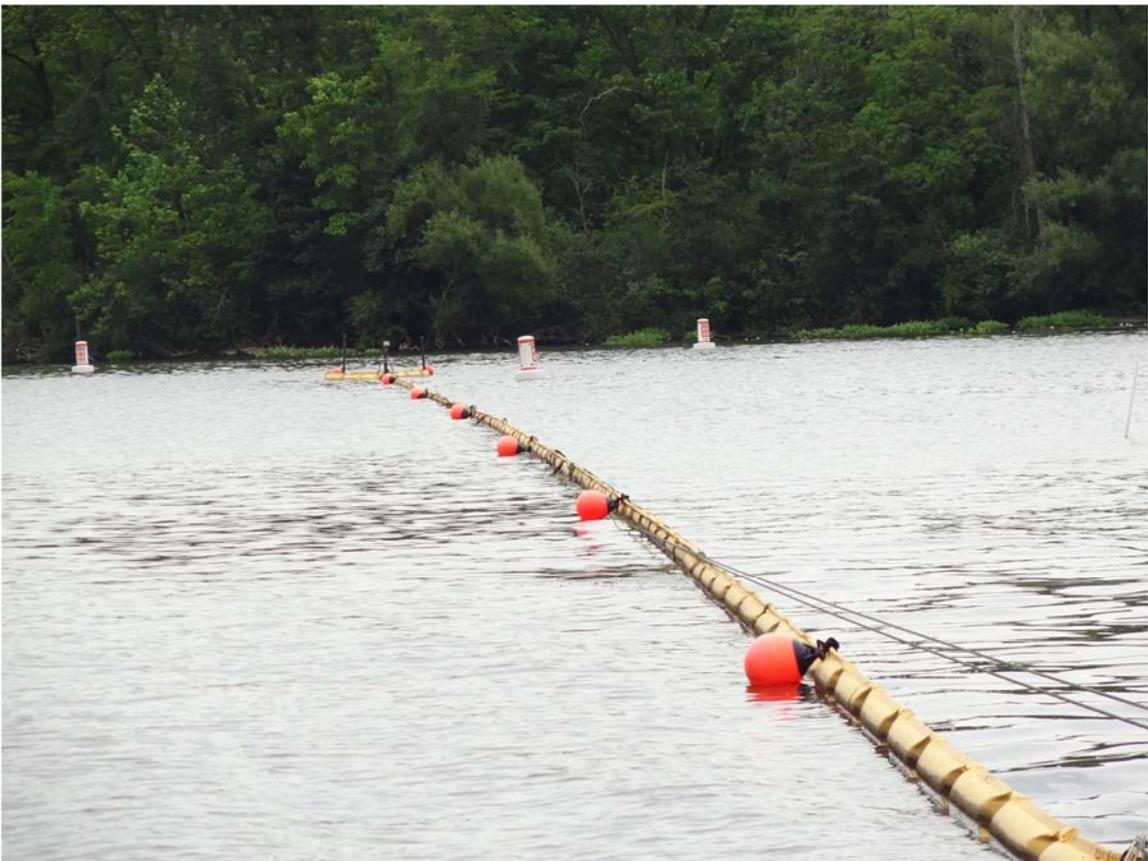
16. Morrow Lake Delta E4 boom system buoys deployed along the boom.

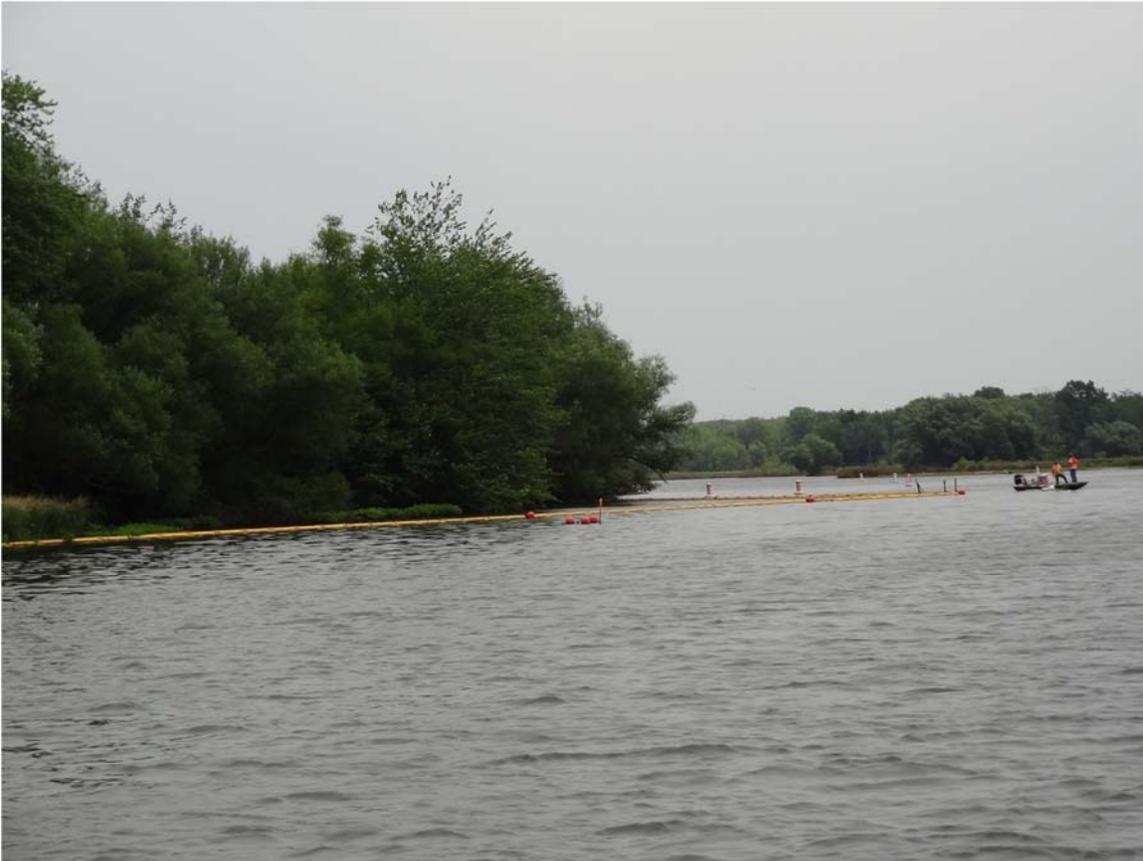
17. Morrow Lake Delta E4 boom system, new boom installed along the northern shore.

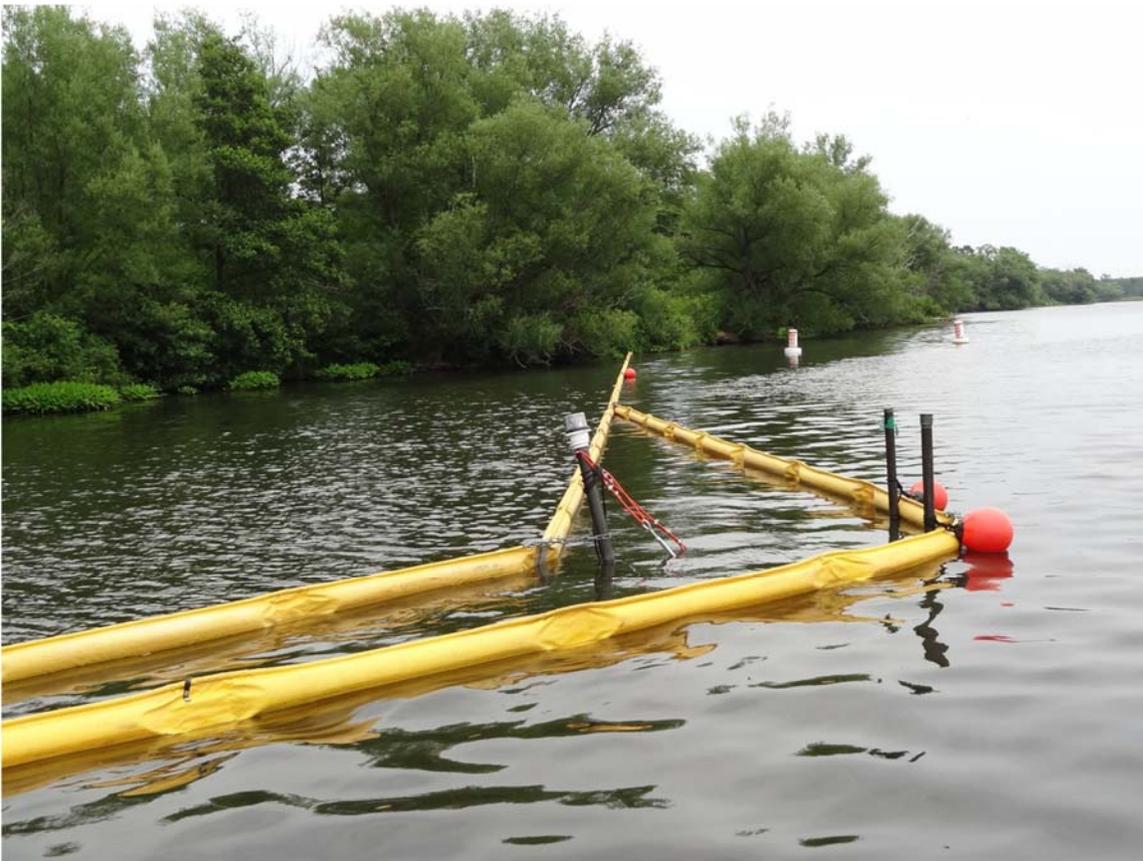
18. Morrow Lake Delta E4 boom system, new boom installed along the northern shore.

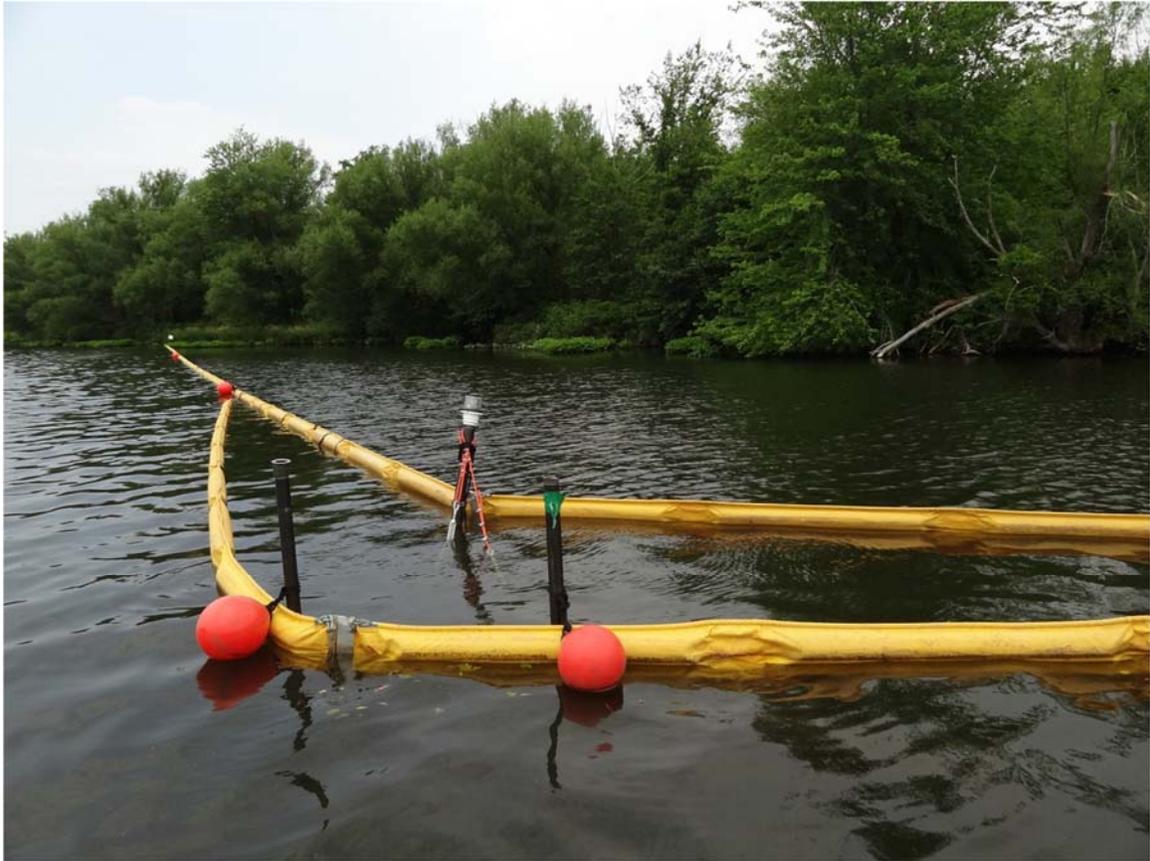
19. Morrow Lake Delta E4 boom system, new boom installed along the northern shore.

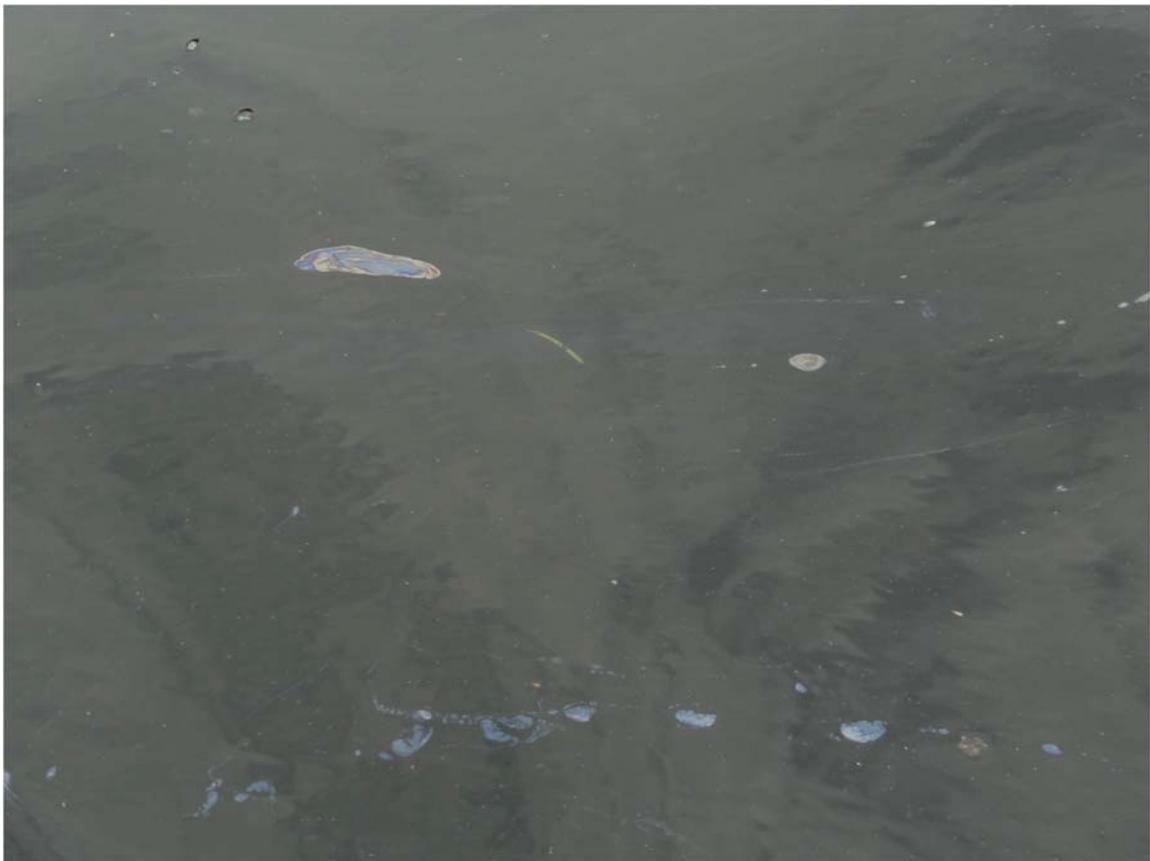
20. Morrow Lake sheen observed along the northern shoreline near newly installed boom. Sheen sweep boat operating in the Delta.

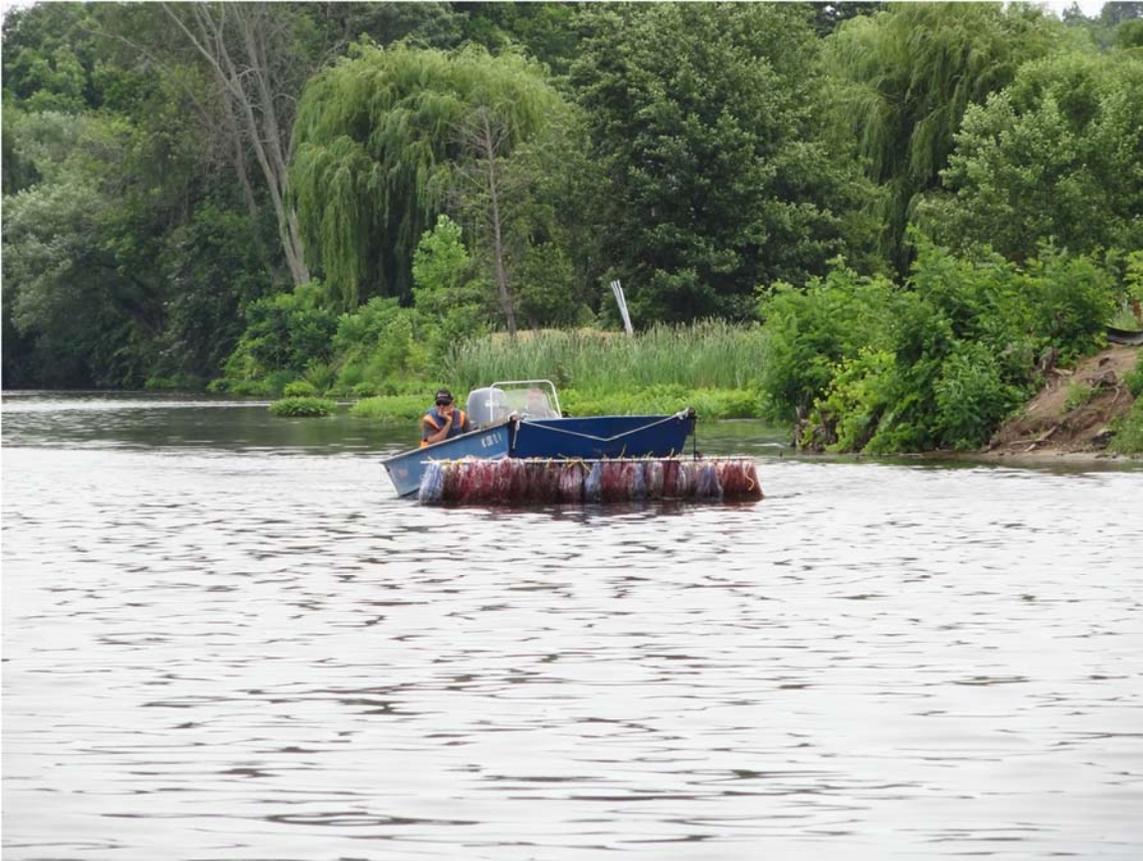
**21. Morrow Lake Delta observed sheen sweep boat operating along the southern shoreline.**

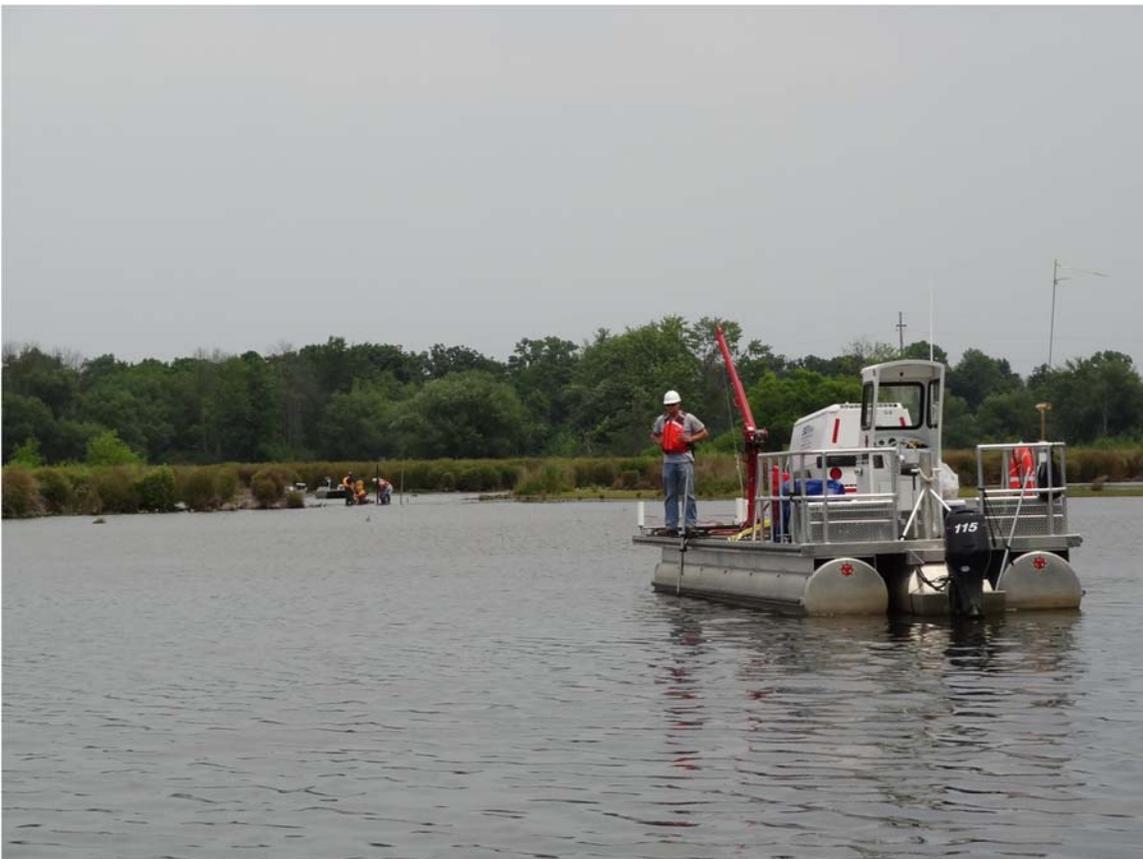
**22. Morrow Lake Delta observed crew installing E4 boom system anchor in the southeast corner of Delta.**

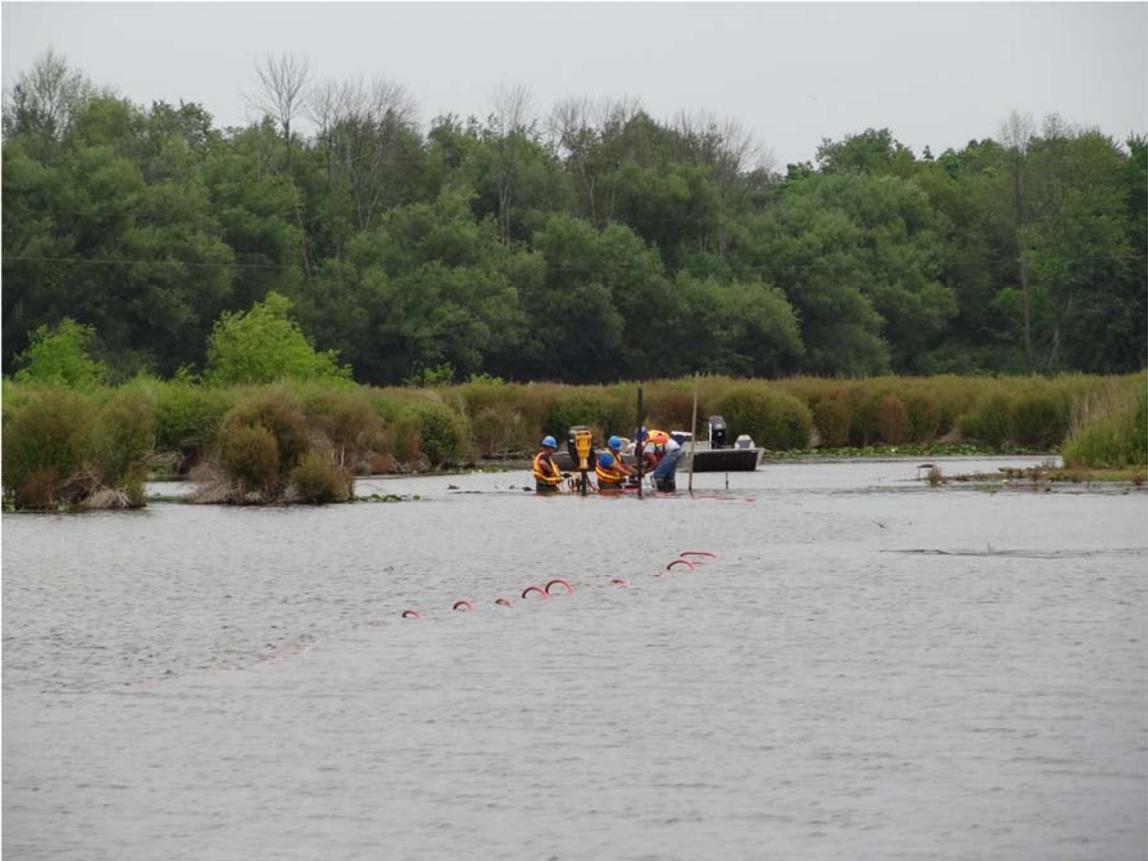
**23. Morrow Lake Delta observed crew installing E4 boom system anchor in the southeast corner of Delta.**
