# Situation Photo Log

Saturday, June 30, 2012

Kalamazoo River / Enbridge Spill

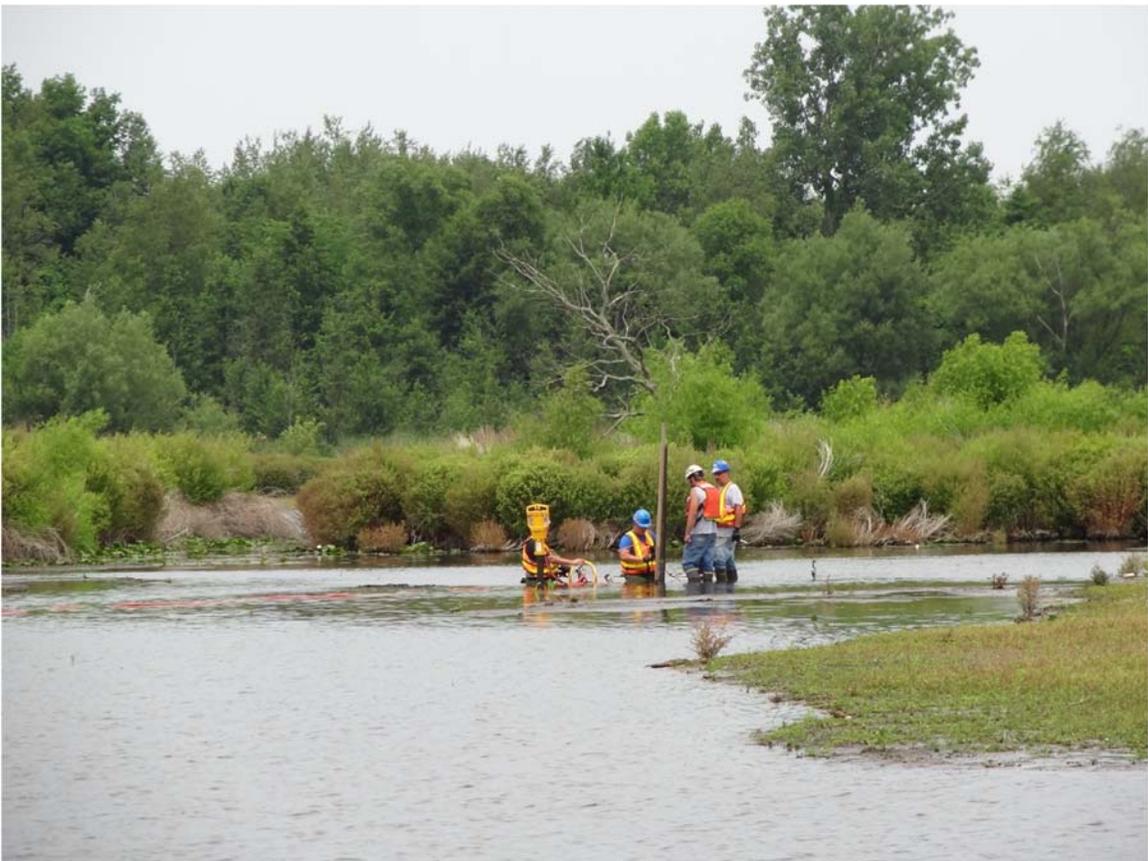
**24. Morrow Lake Delta observed crew installing E4 boom system anchor in the southeast corner of Delta.**

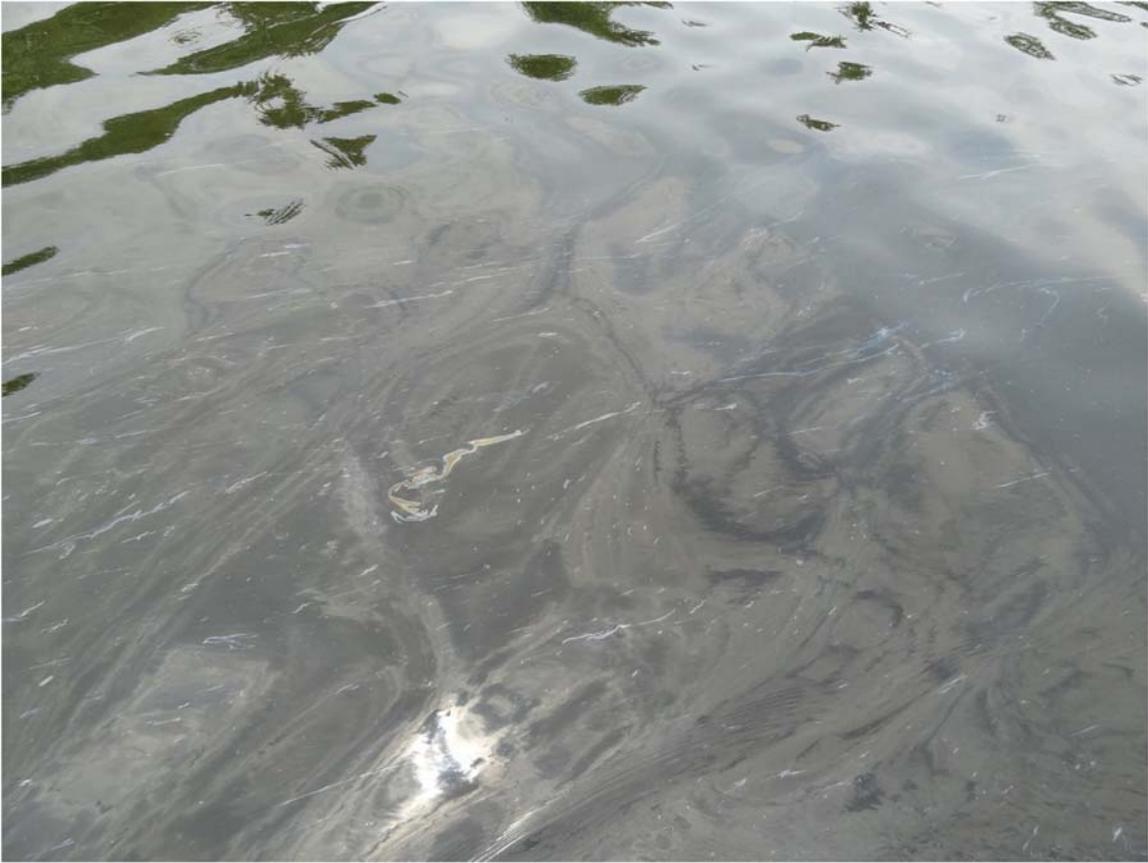
**25. Morrow Lake Delta observed sheen in the southeast corner of Delta.  
Sheen sweep boat was operating in the Delta.**

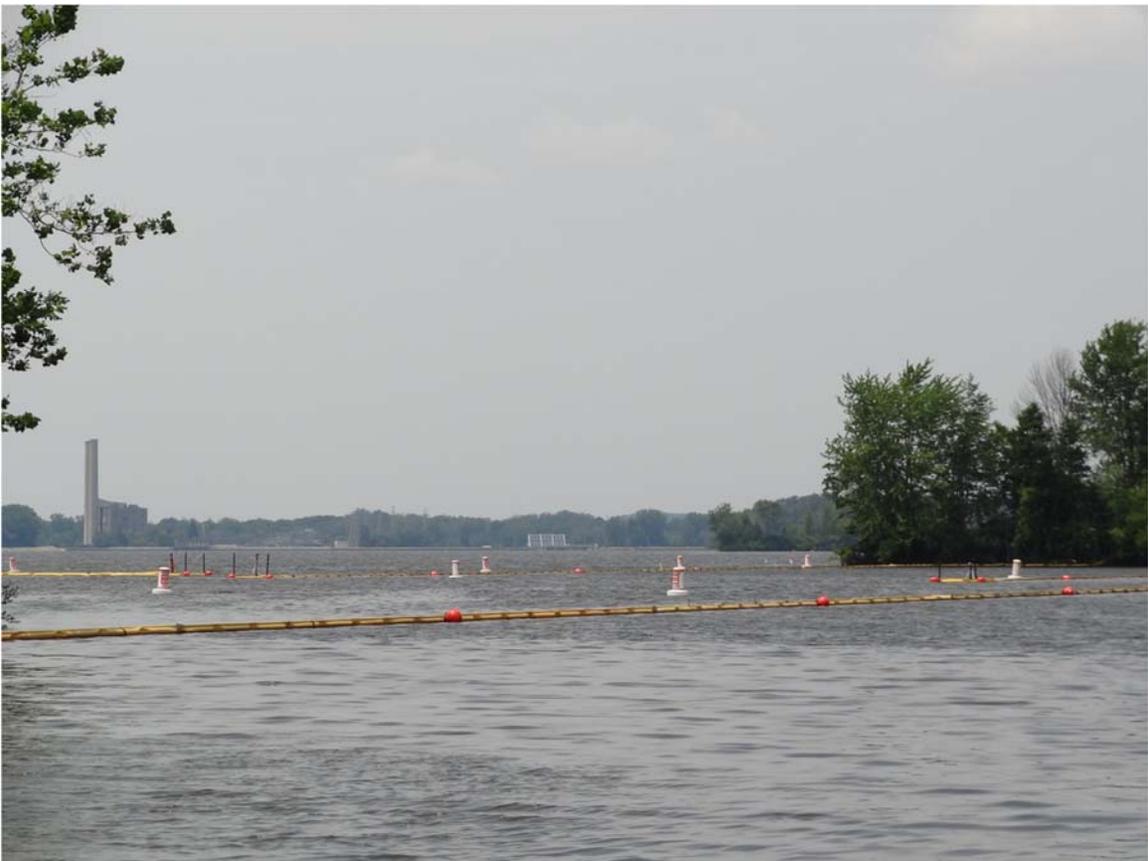
**26. Morrow Lake Delta E4 boom system. Buoys being deployed around the boom.**
