Situation Photo Log

Monday, July 2, 2012

Kalamazoo River / Enbridge Spill

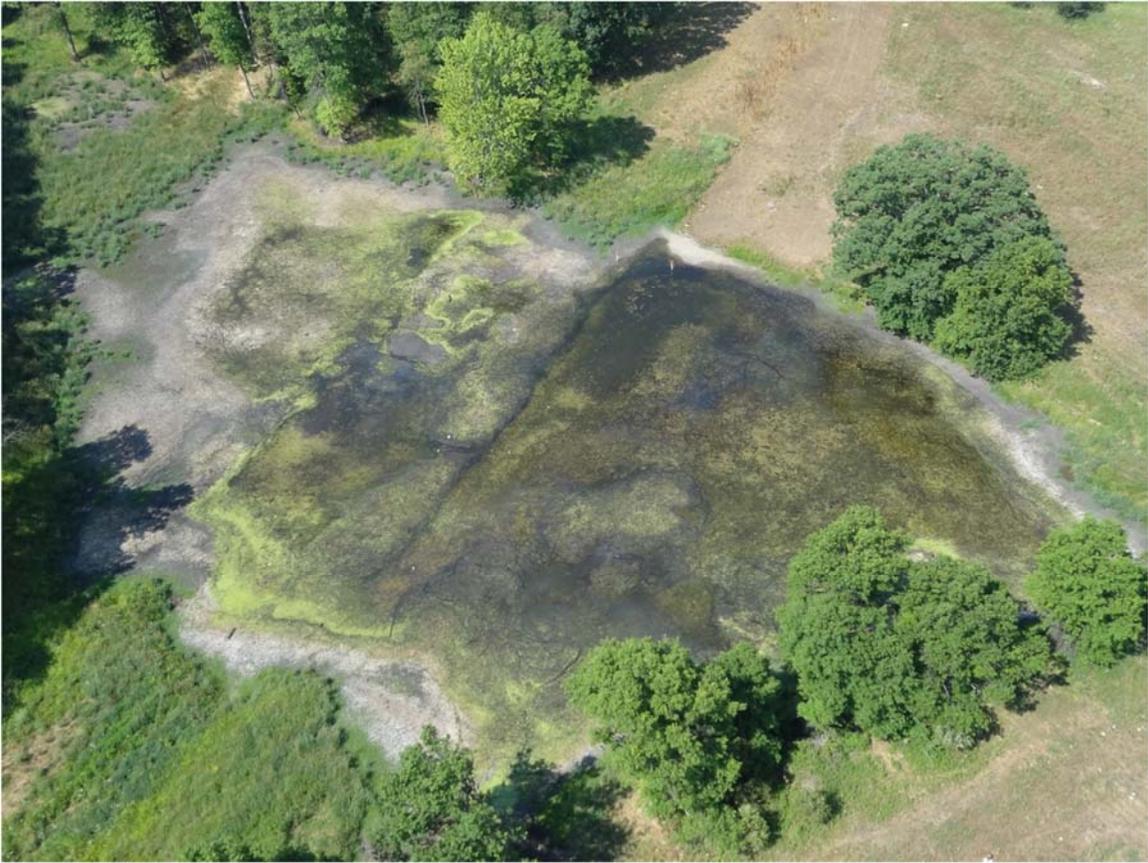
1. Source area pond no sheen observed, pond water levels quickly receding.

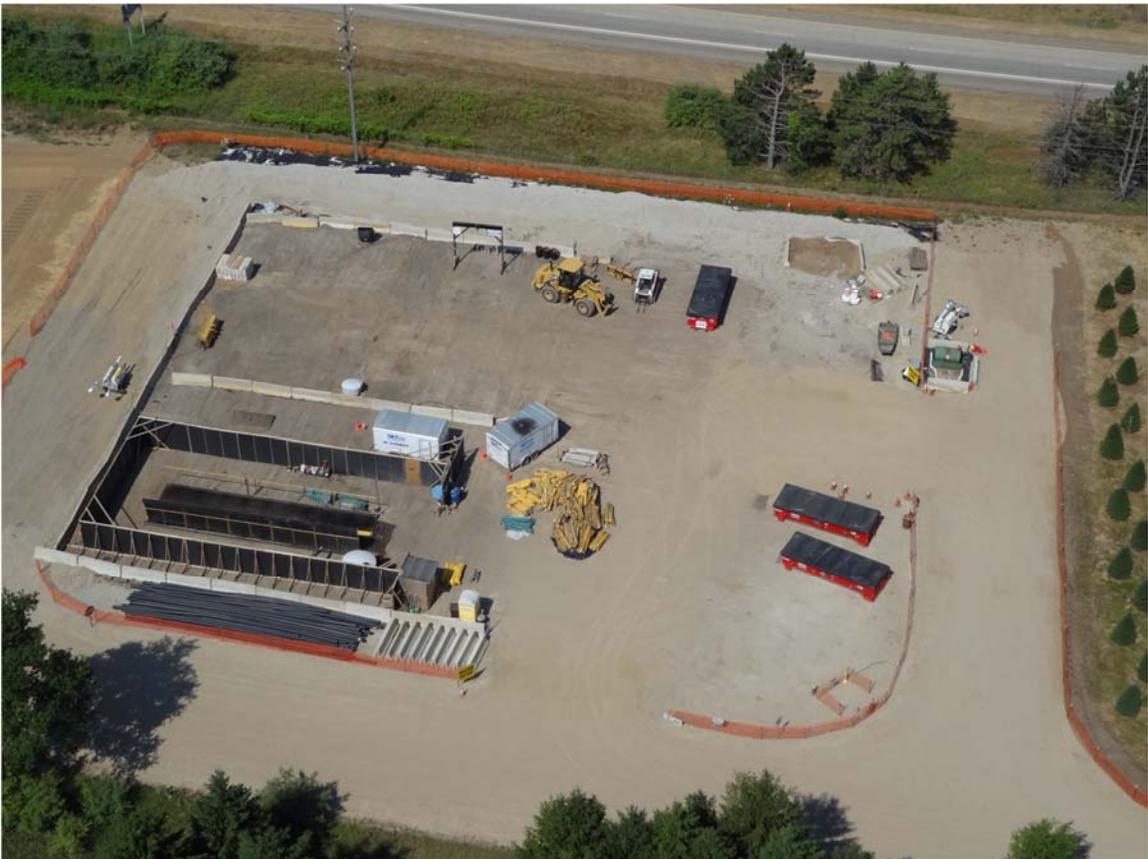
2. Frac-City observed boom staged at the decontamination pad.

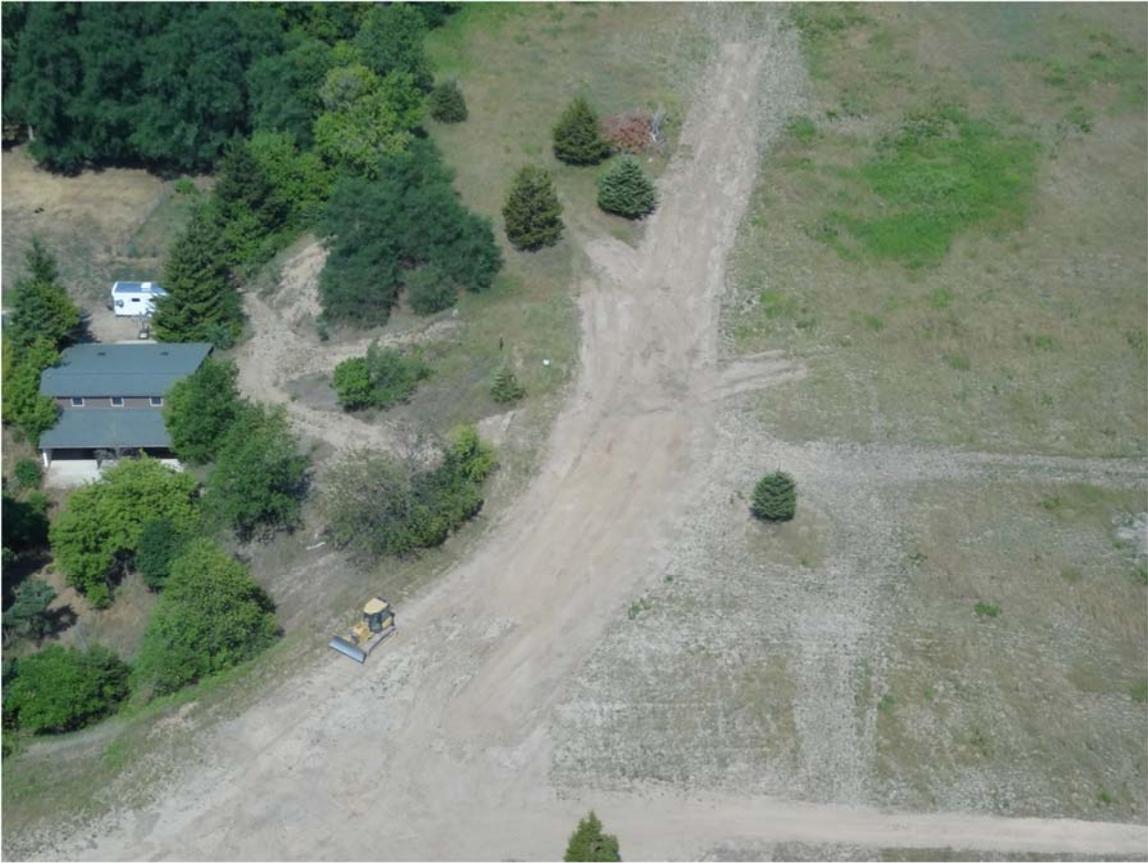
3. Former Talmadge Creek dewatering pad location. Observed soil grading occurring.

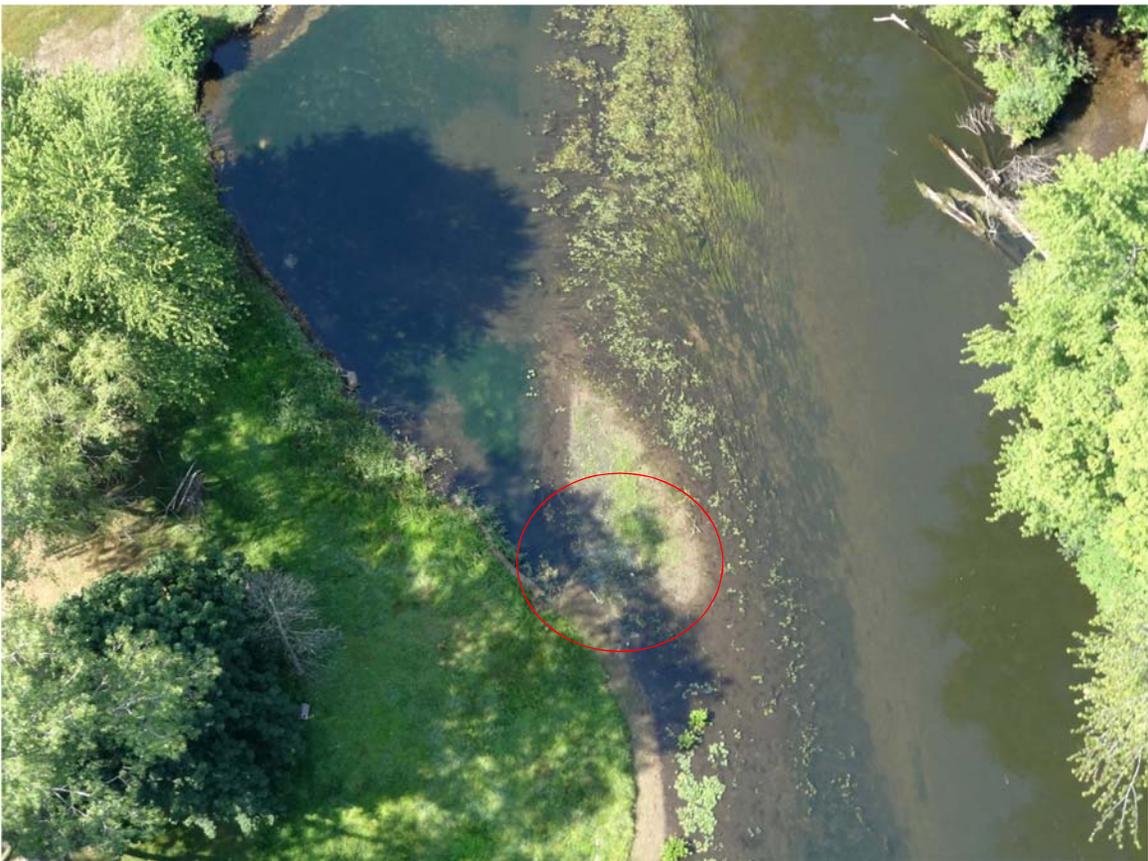
4. Confluence seen observed.

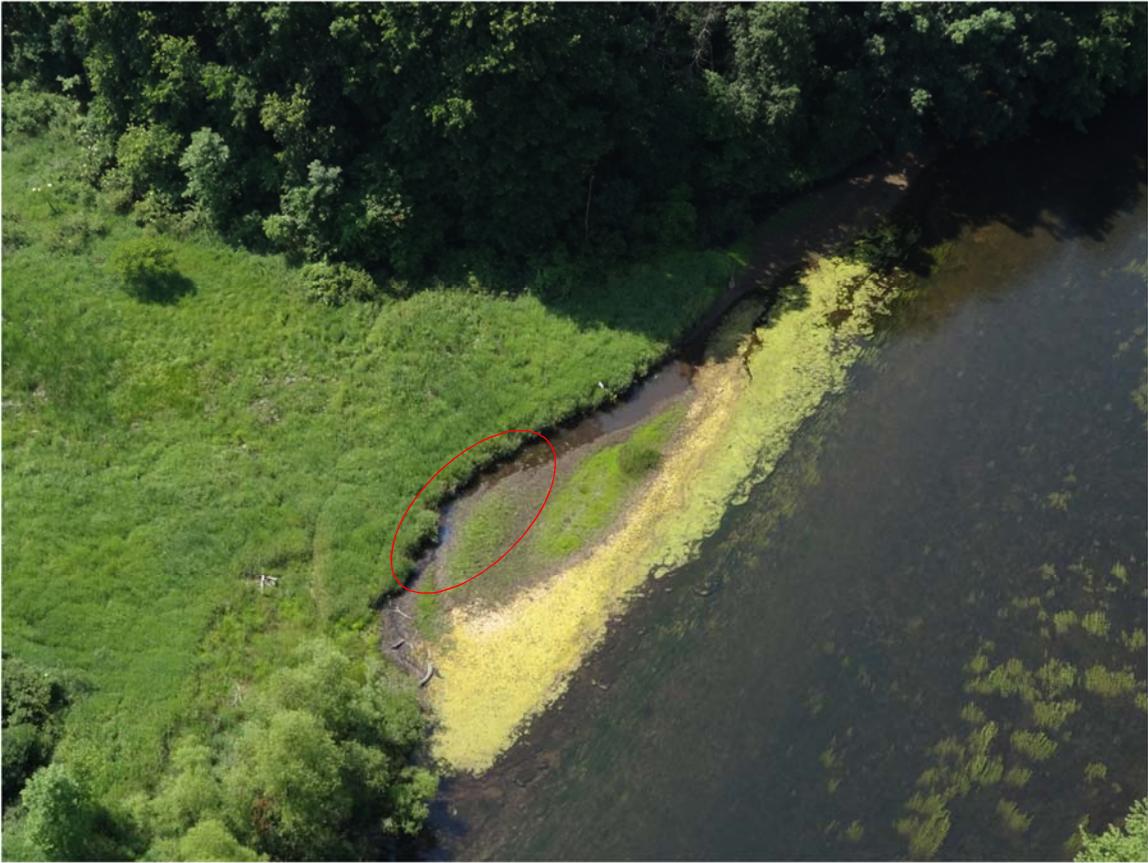
5. MP2.75 LDB sheen observed.

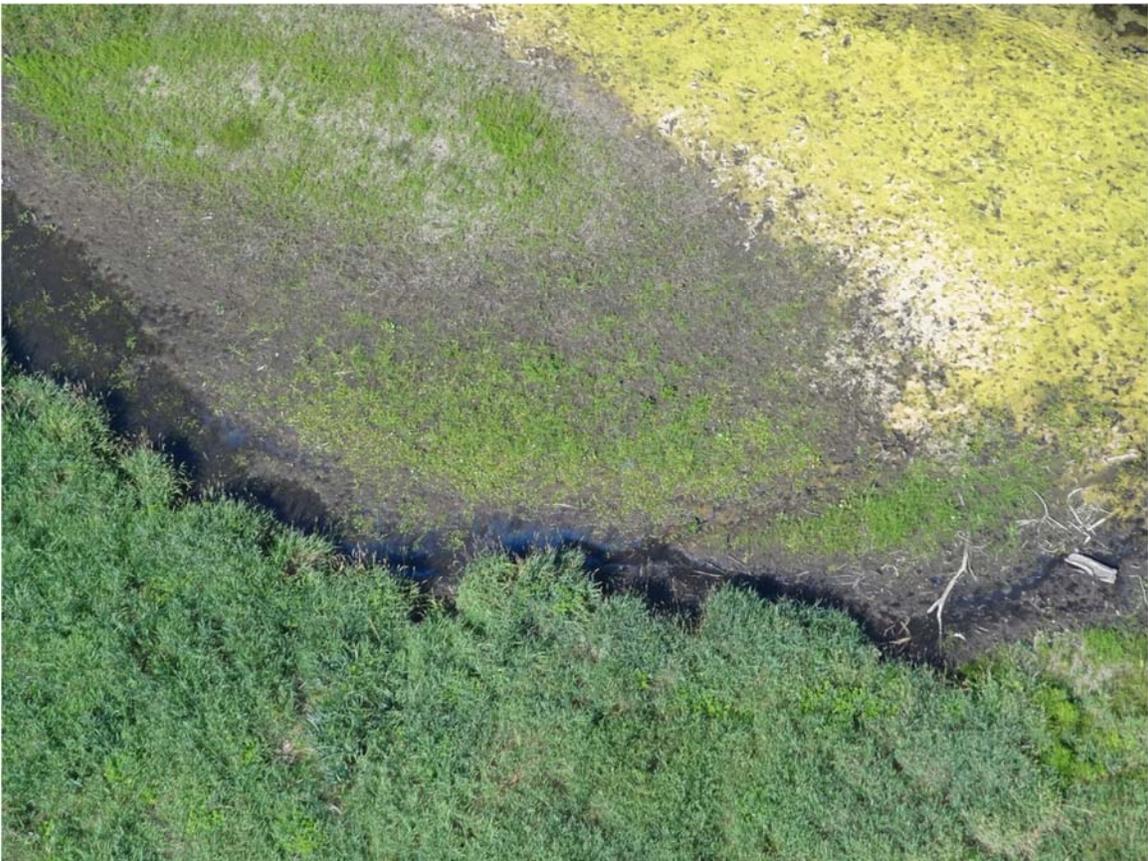
6. MP2.75 LDB sheen observed.

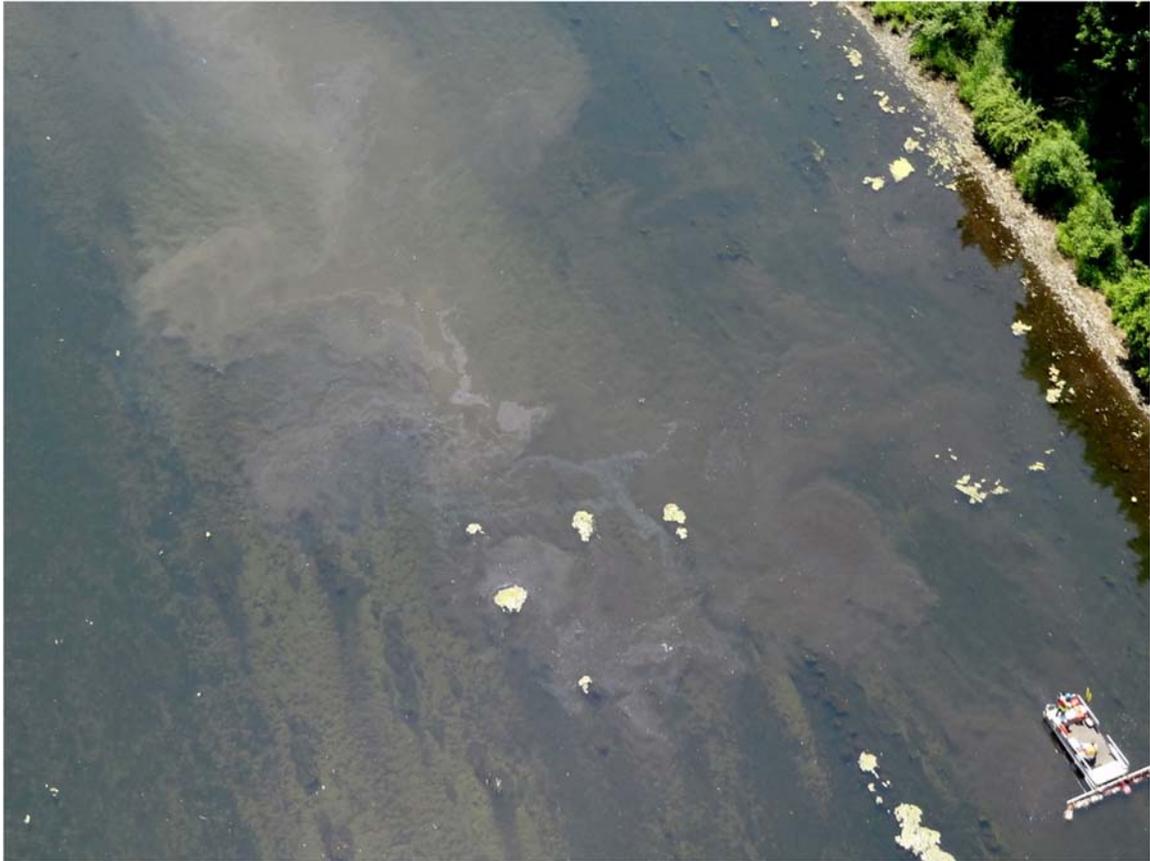
7. MP5.25 observed sheen sweep boat operating. Observed sheen within disturbed sediment.

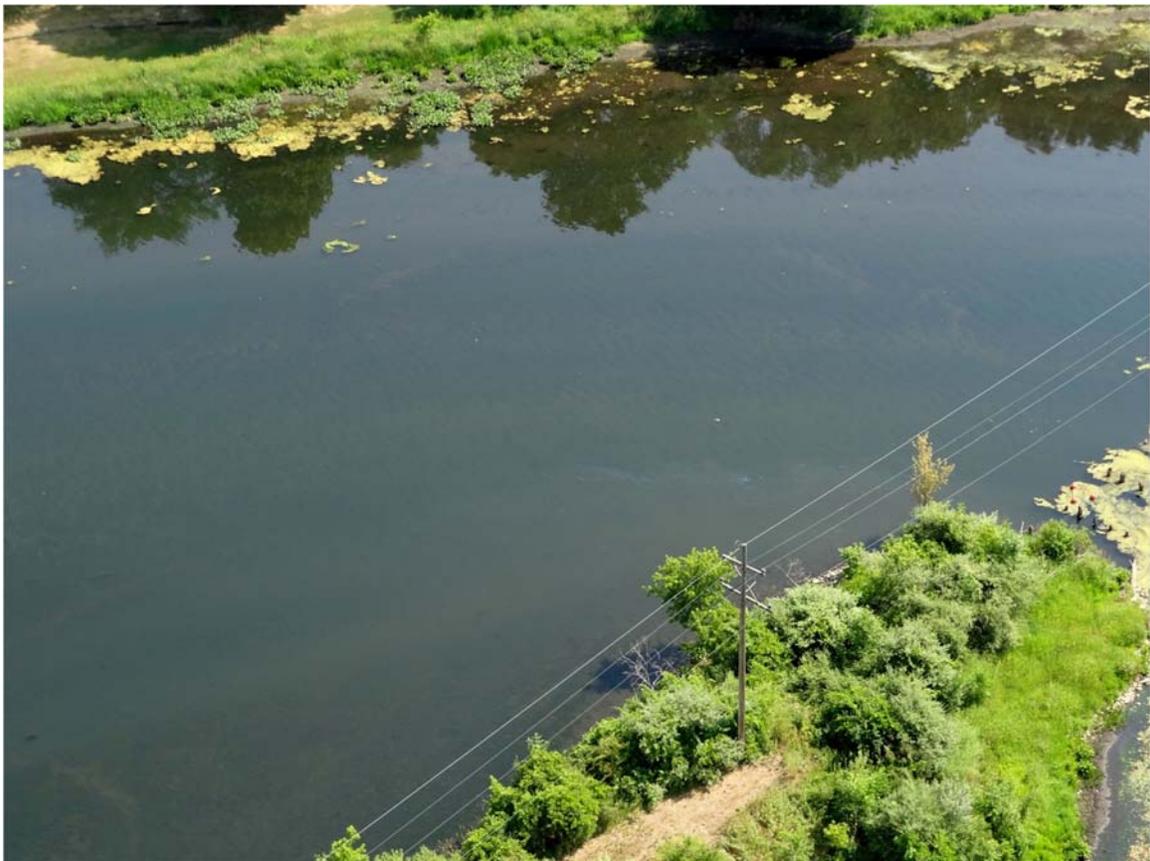
8. MP5.63 LDB sheen observed. Sweep boat was observed operating in the area.

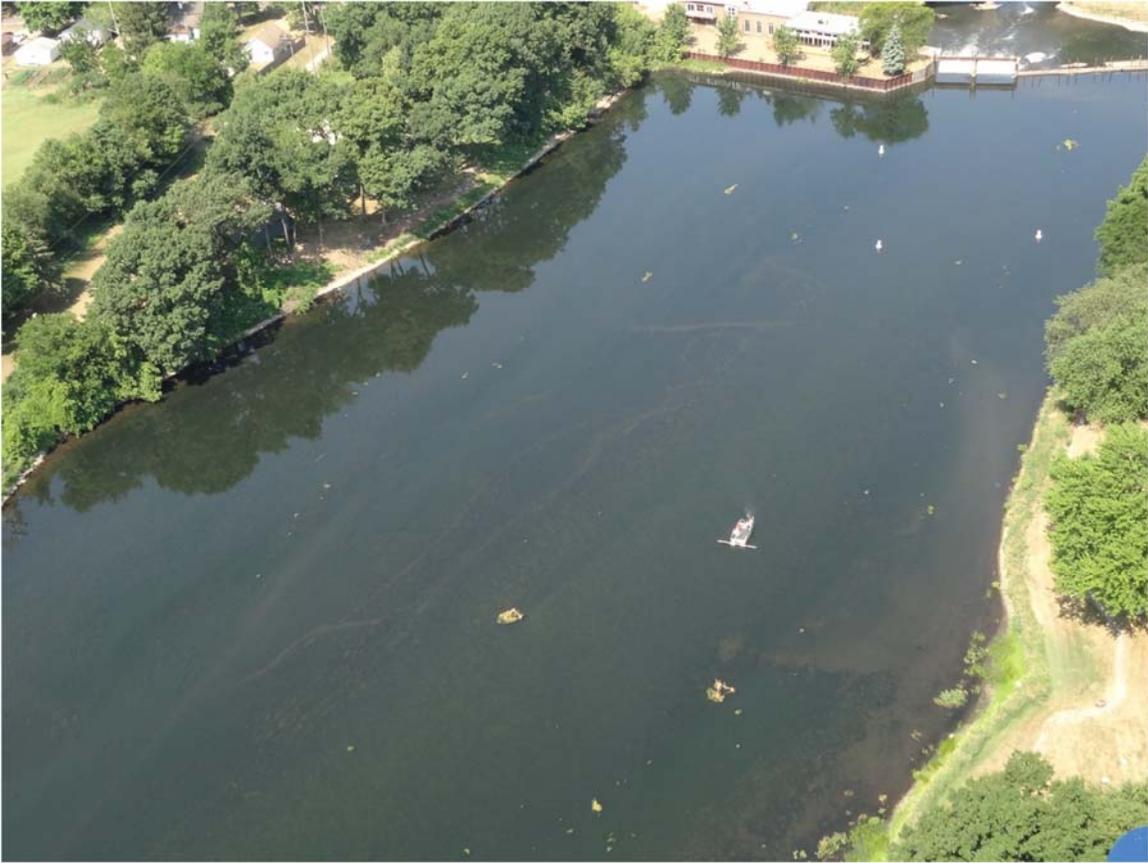
9. Ceresco Dam sheen sweep boat observed.

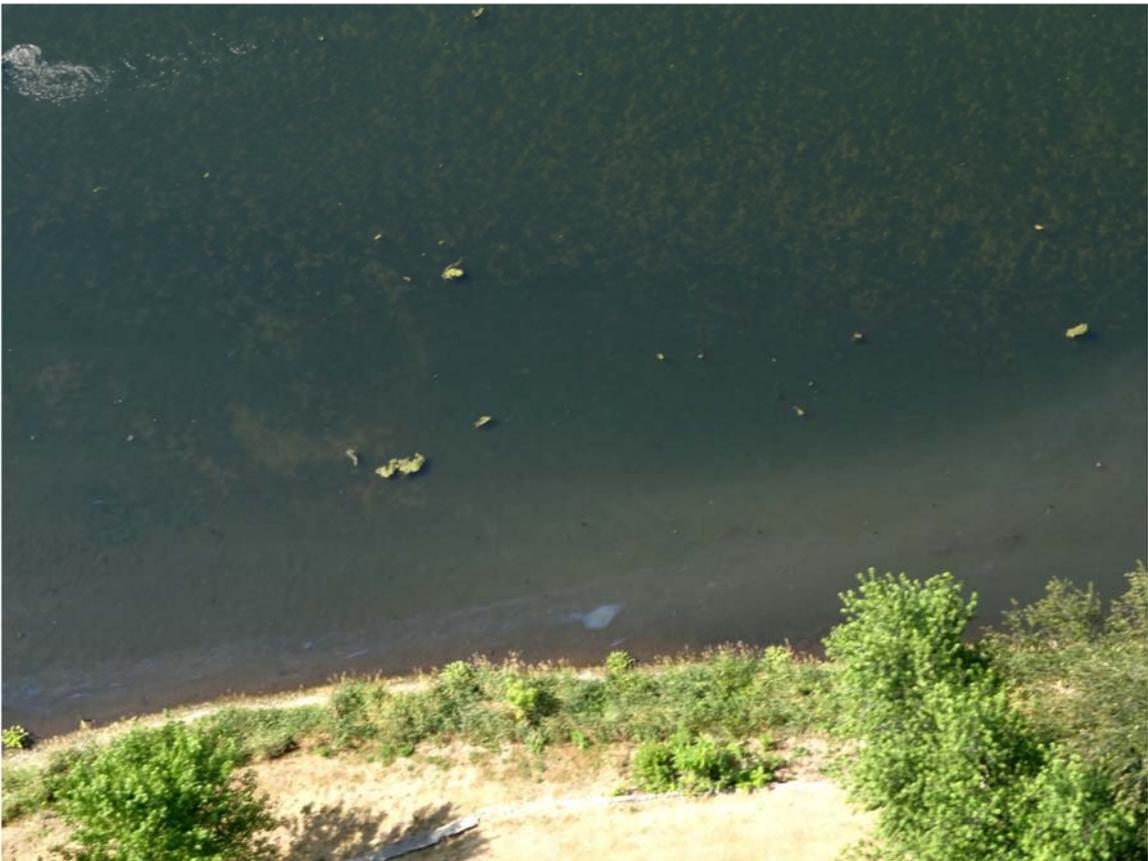
10. Ceresco Dam sheen observed along the RDB just upstream from the dam.

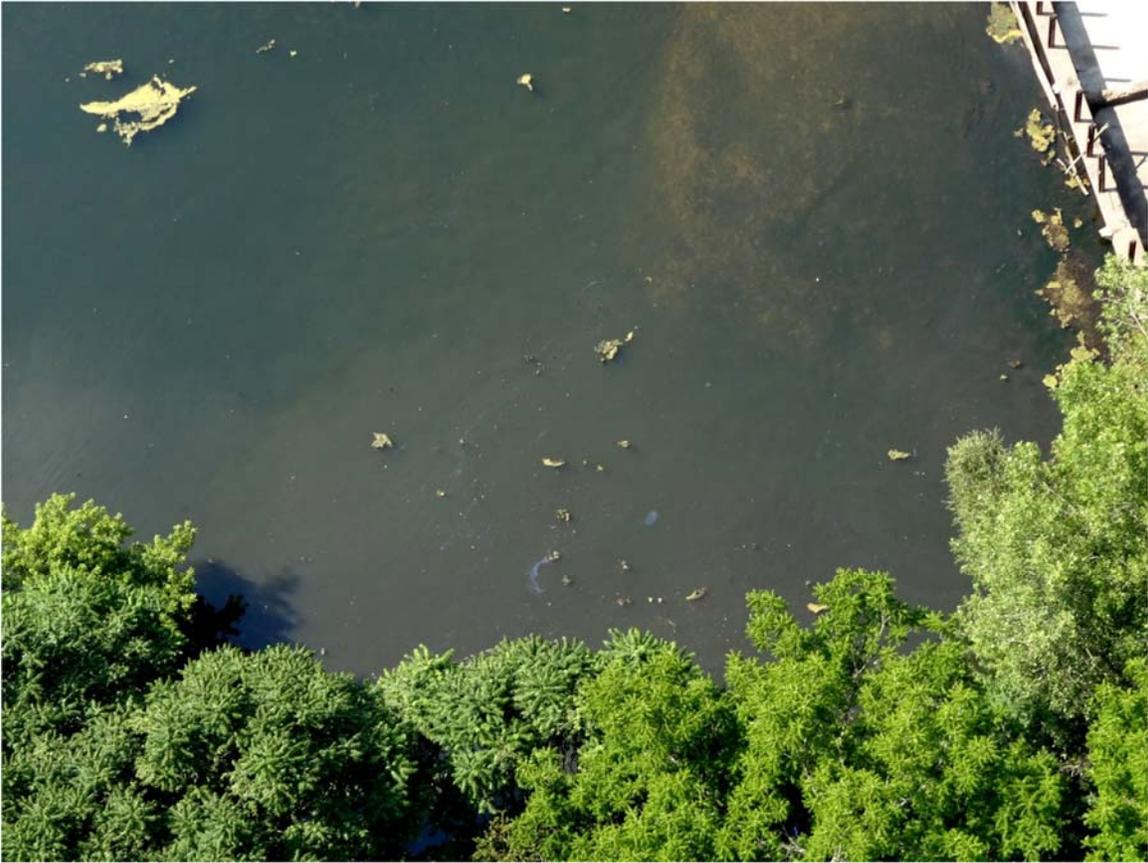
11. Ceresco Dam sheen observed along the RDB just above the dam.

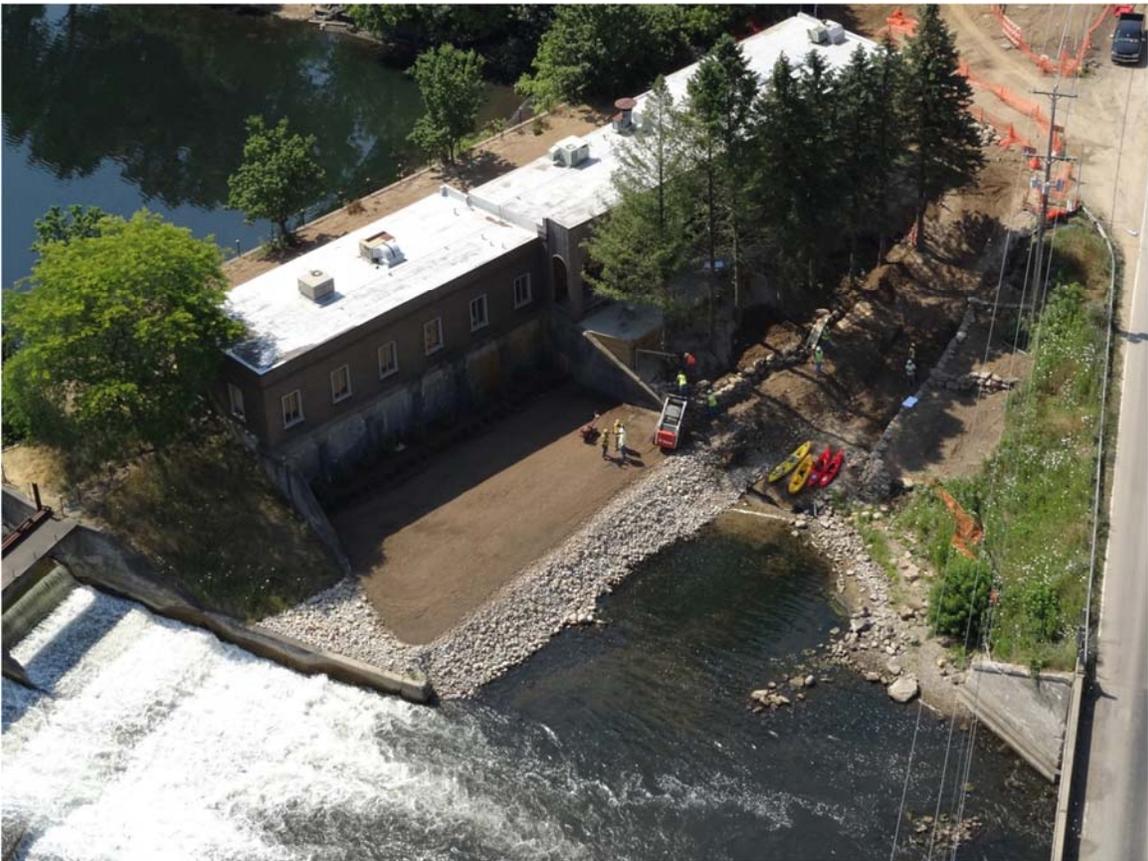
12. Ceresco Dam portage work observed below the dam.

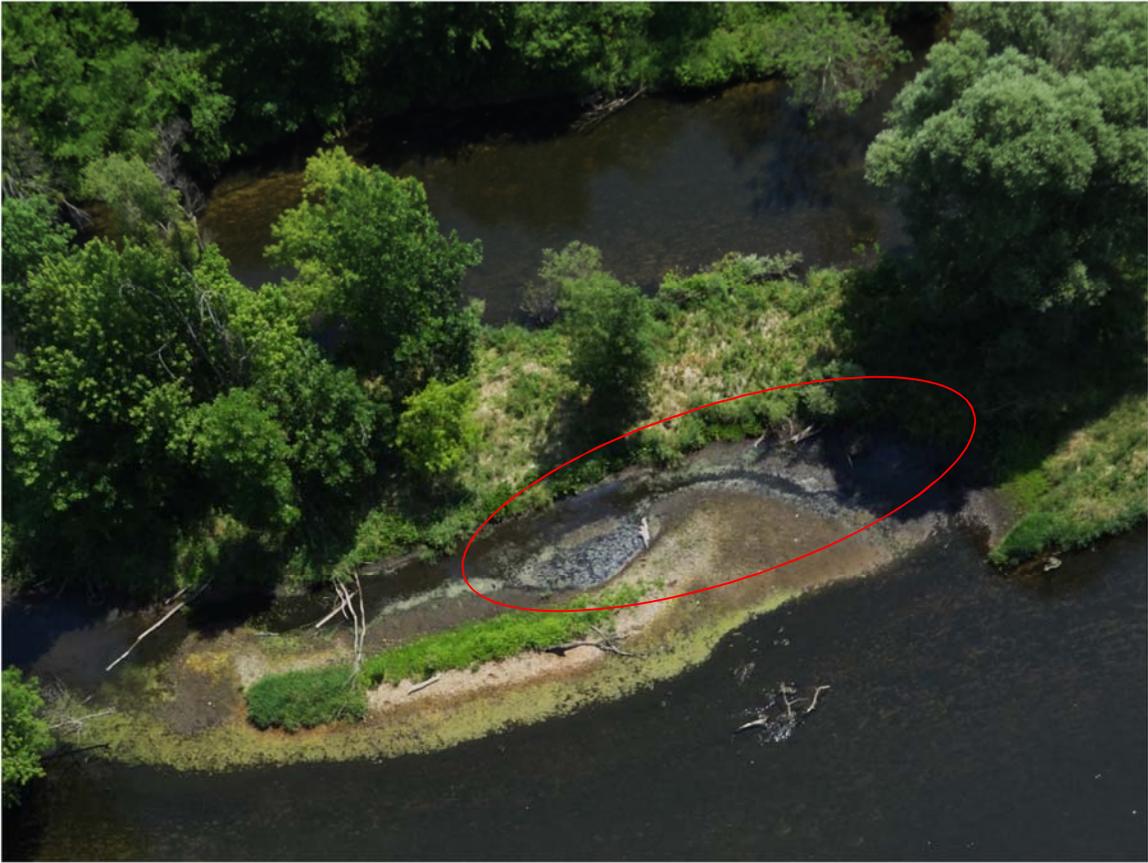
13. MP6.5 Island sheen observed.

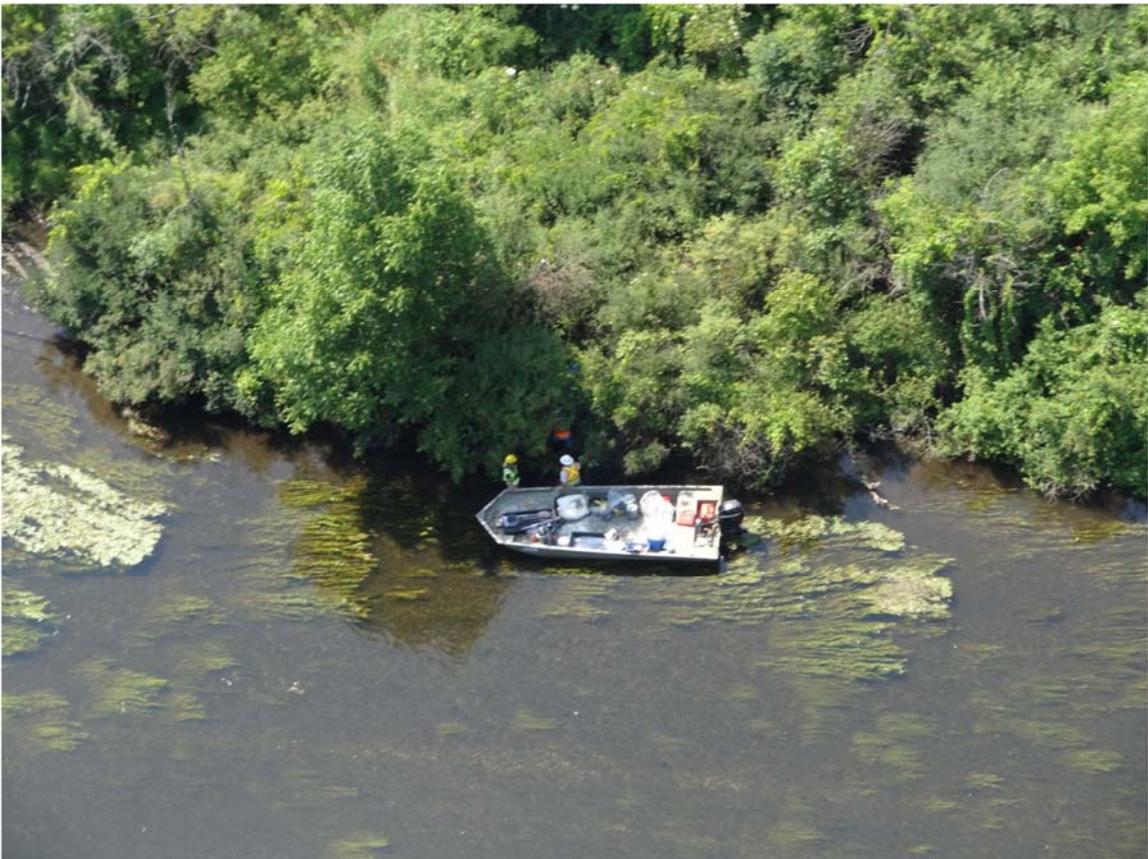
14. MP7.25 RDB observed RI crew.

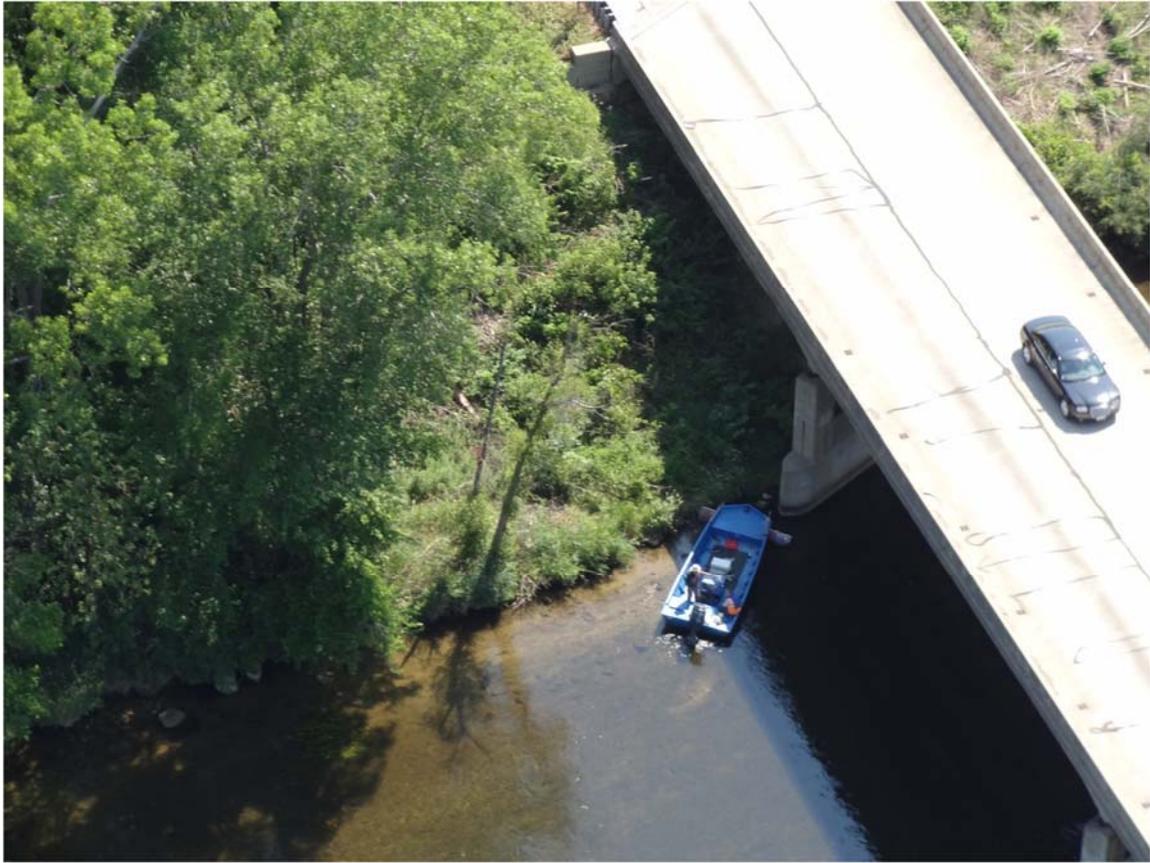
15. MP9.5 Historic Bridge Park observed sweep boat.

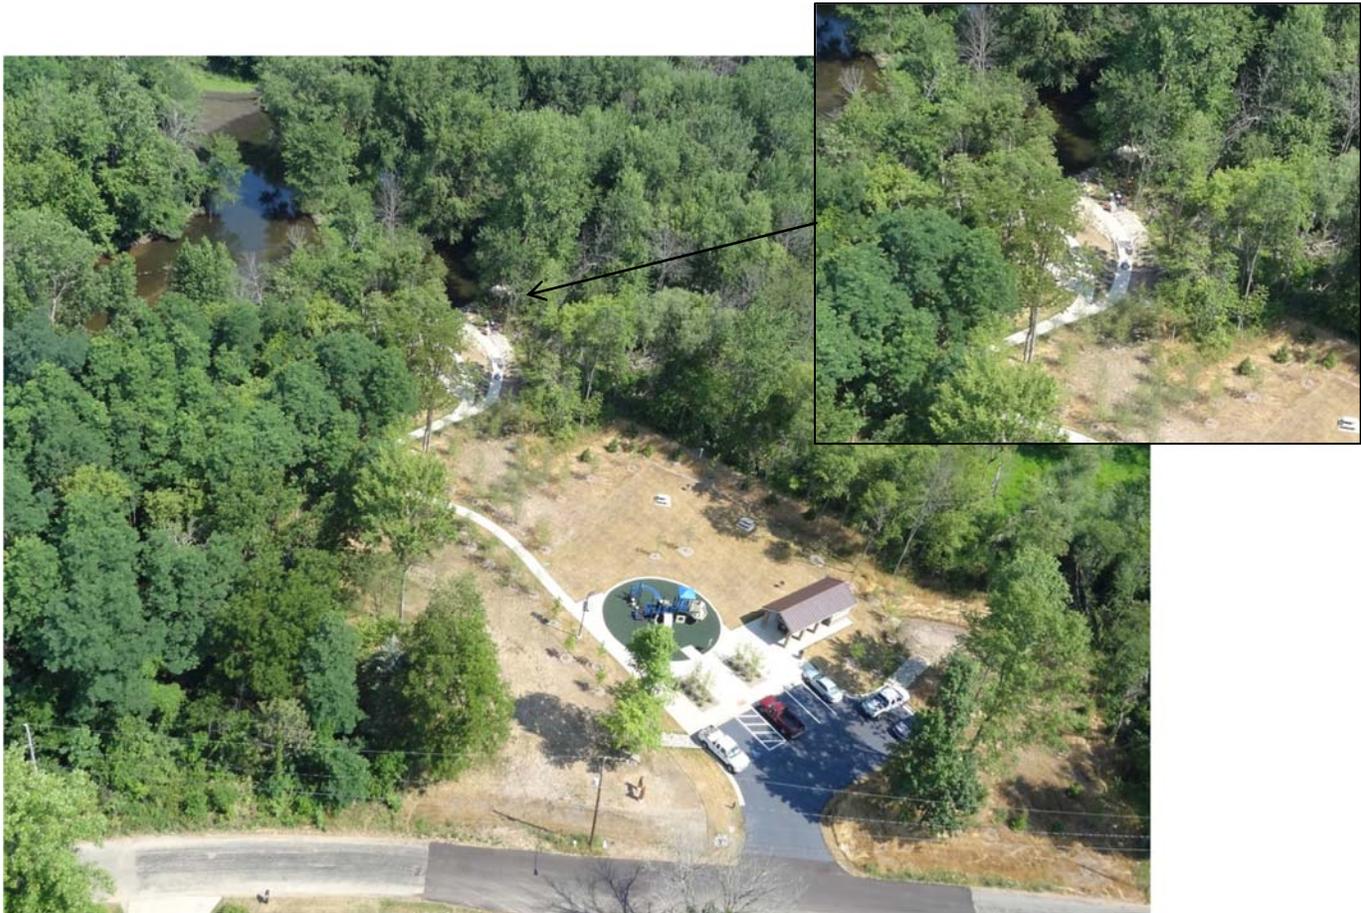
16. Paddler's Grove observed handicap boat launch being installed.

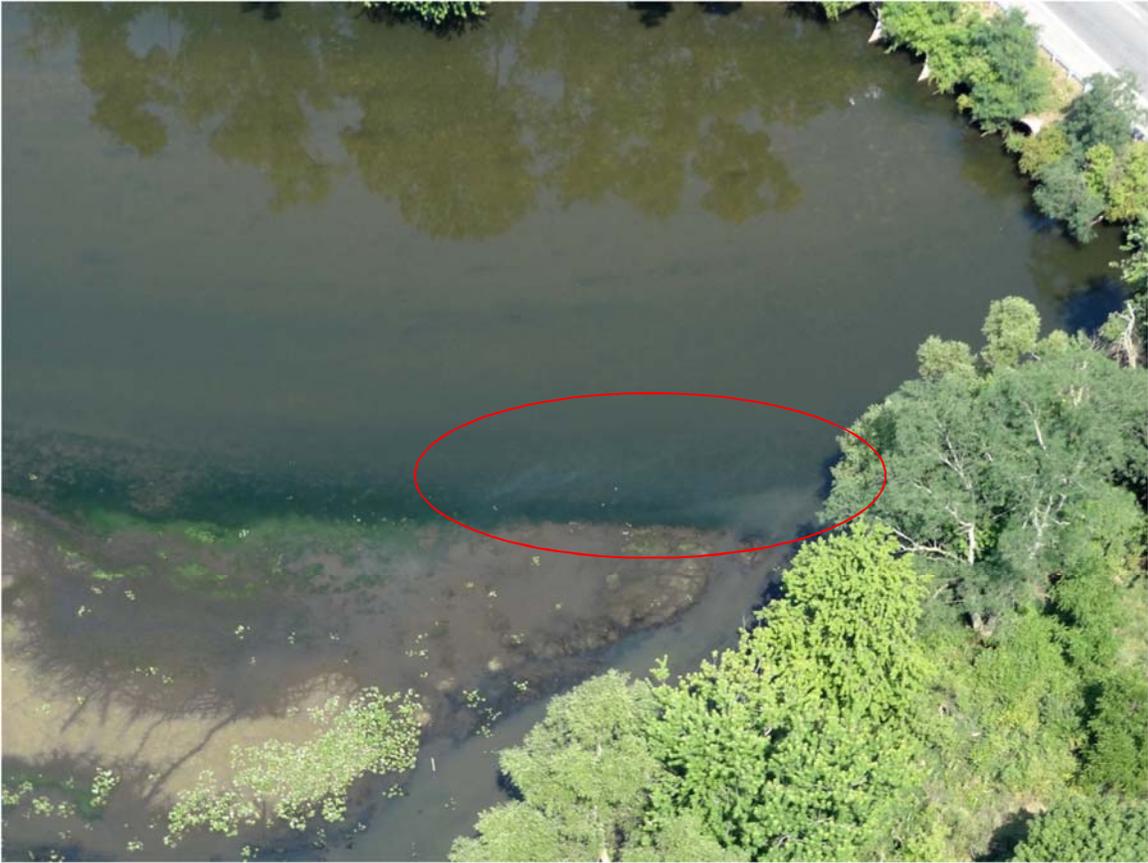
17. MP15.75 RDB North Mill Pond observed sheen.

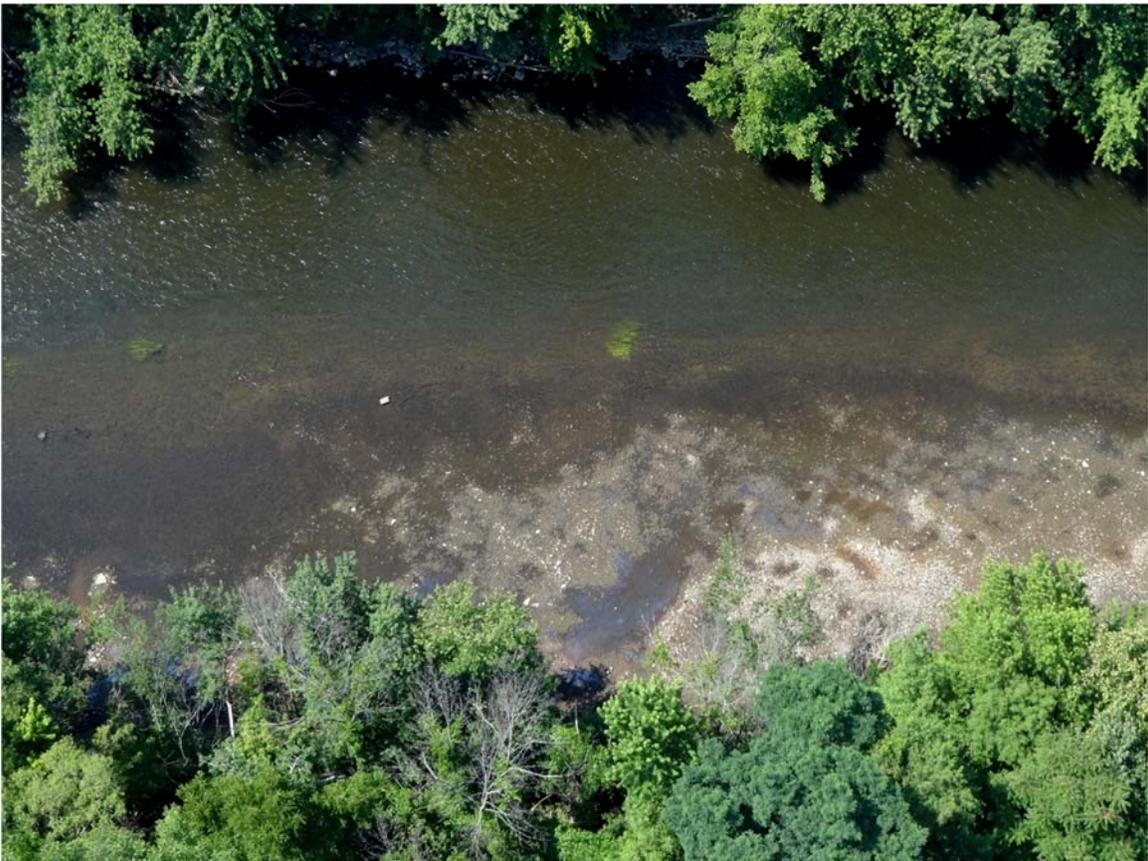
18. MP17.0 RDB sheen observed.

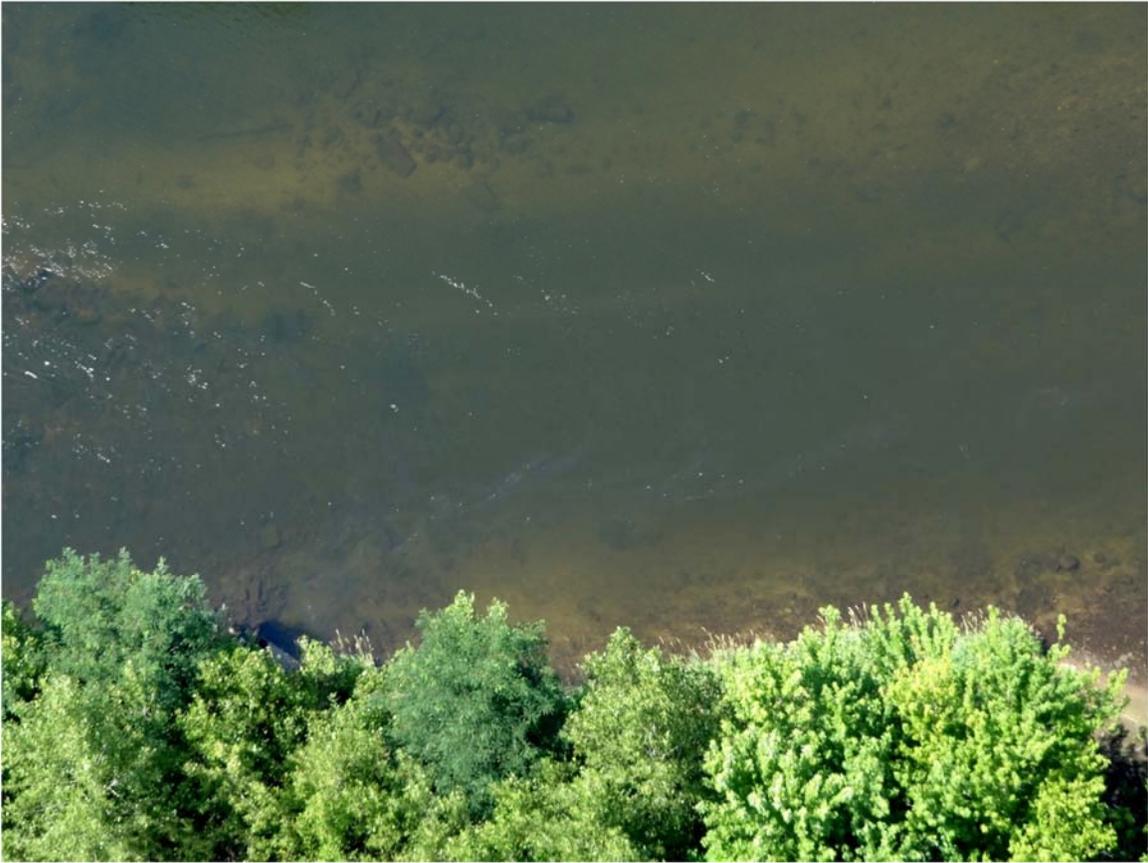
19. MP17.25 RDB sheen observed.

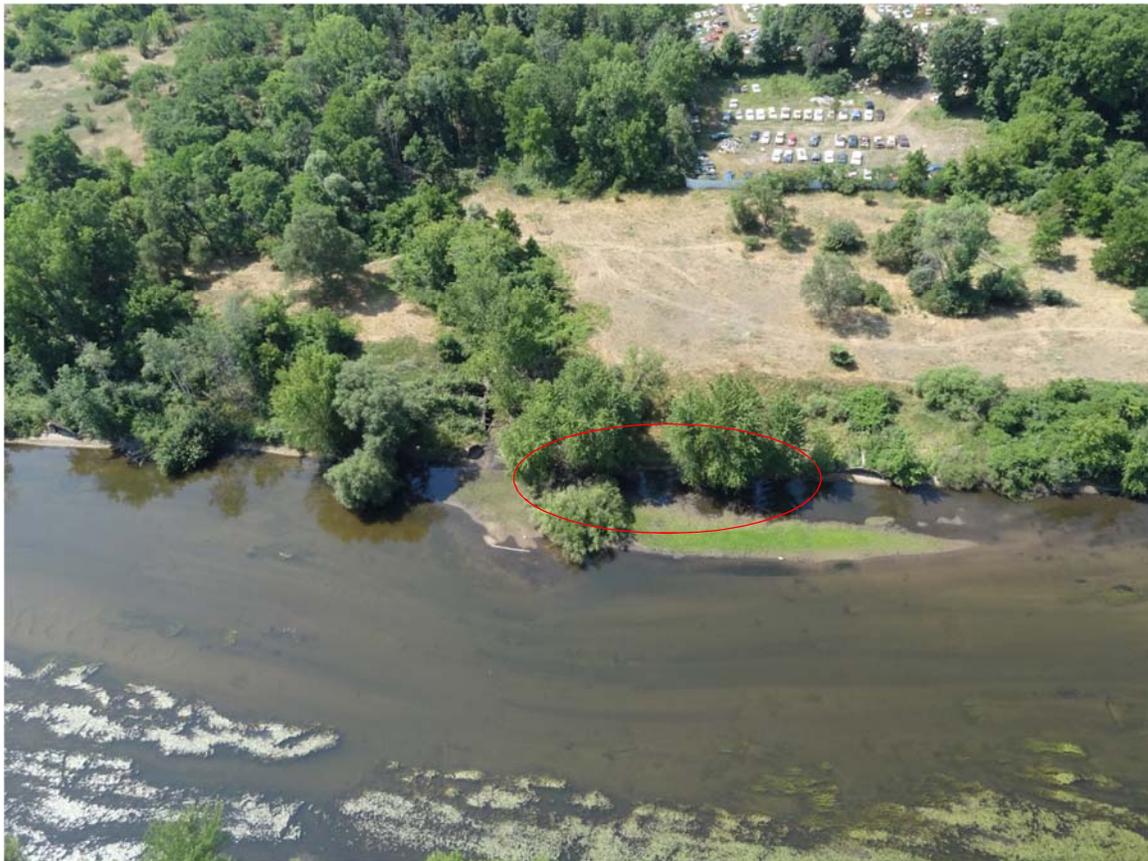
20. MP17.5 LDB sheen observed.

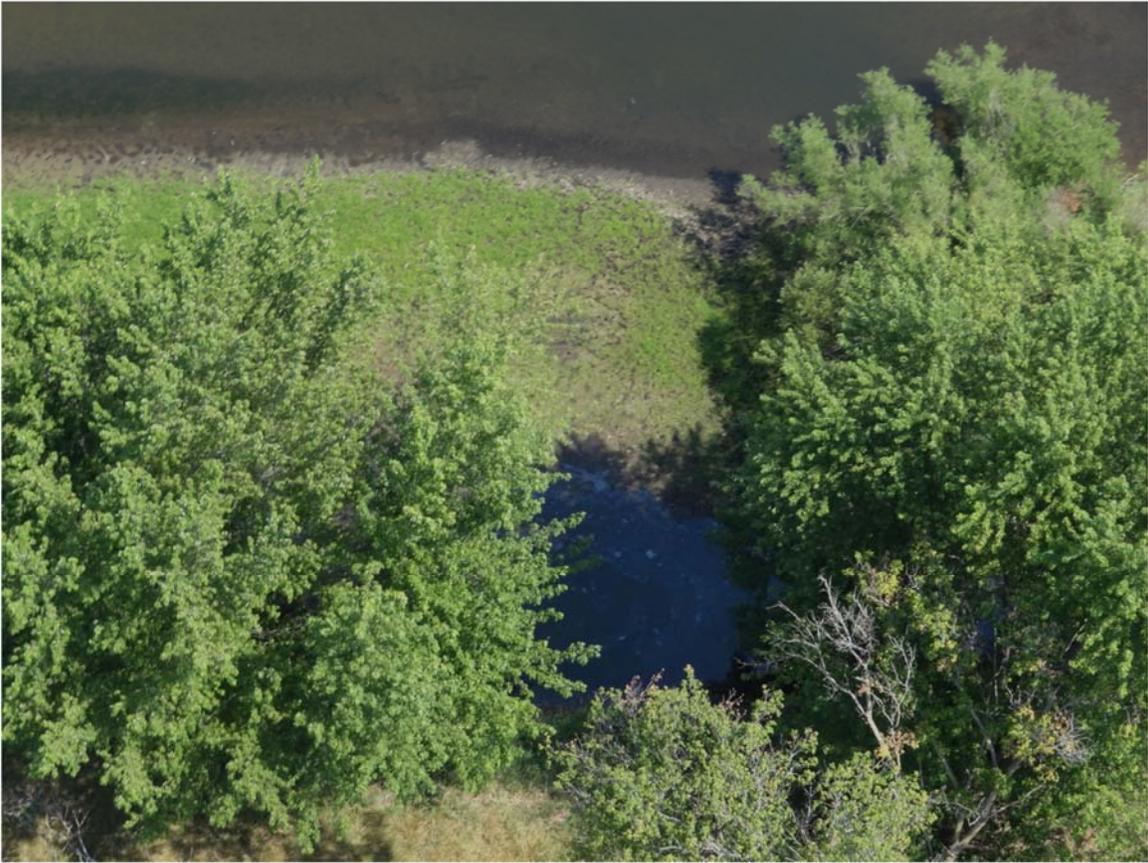
21. MP17.5 LDB sheen observed.

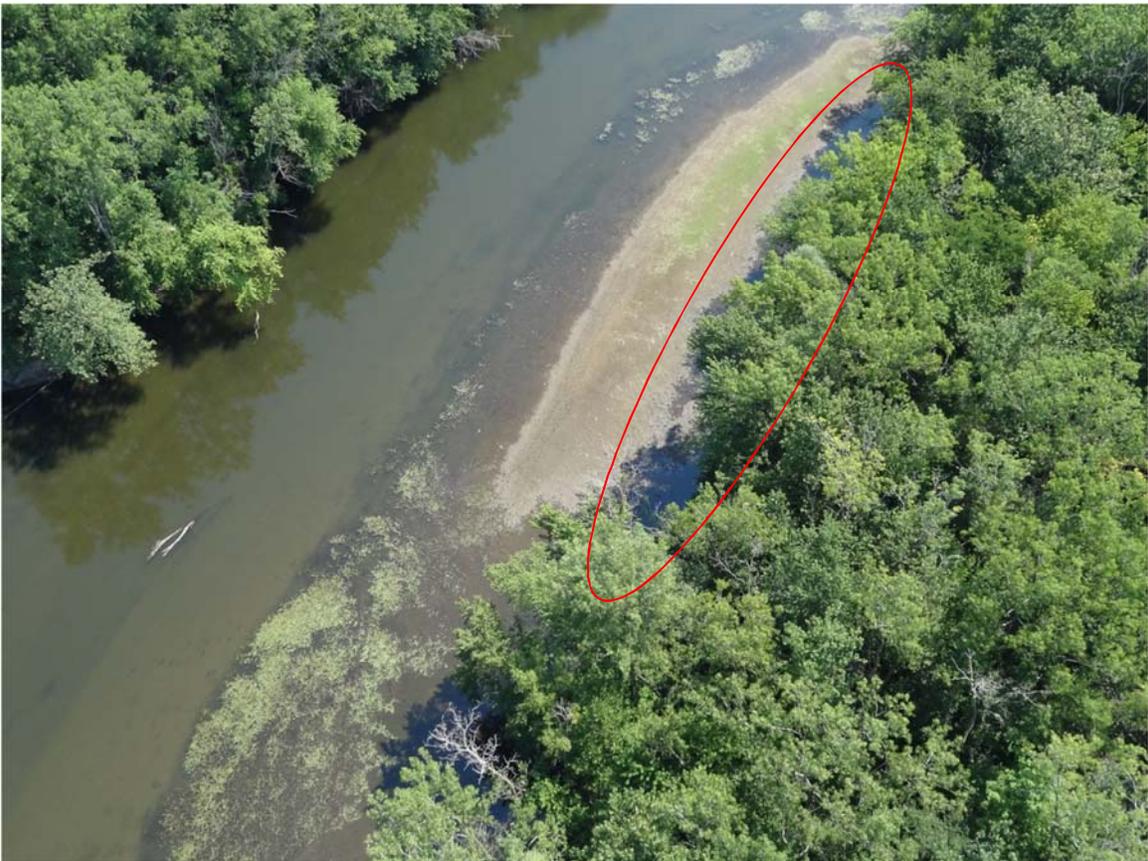
22. MP21.5 LDB sheen observed.

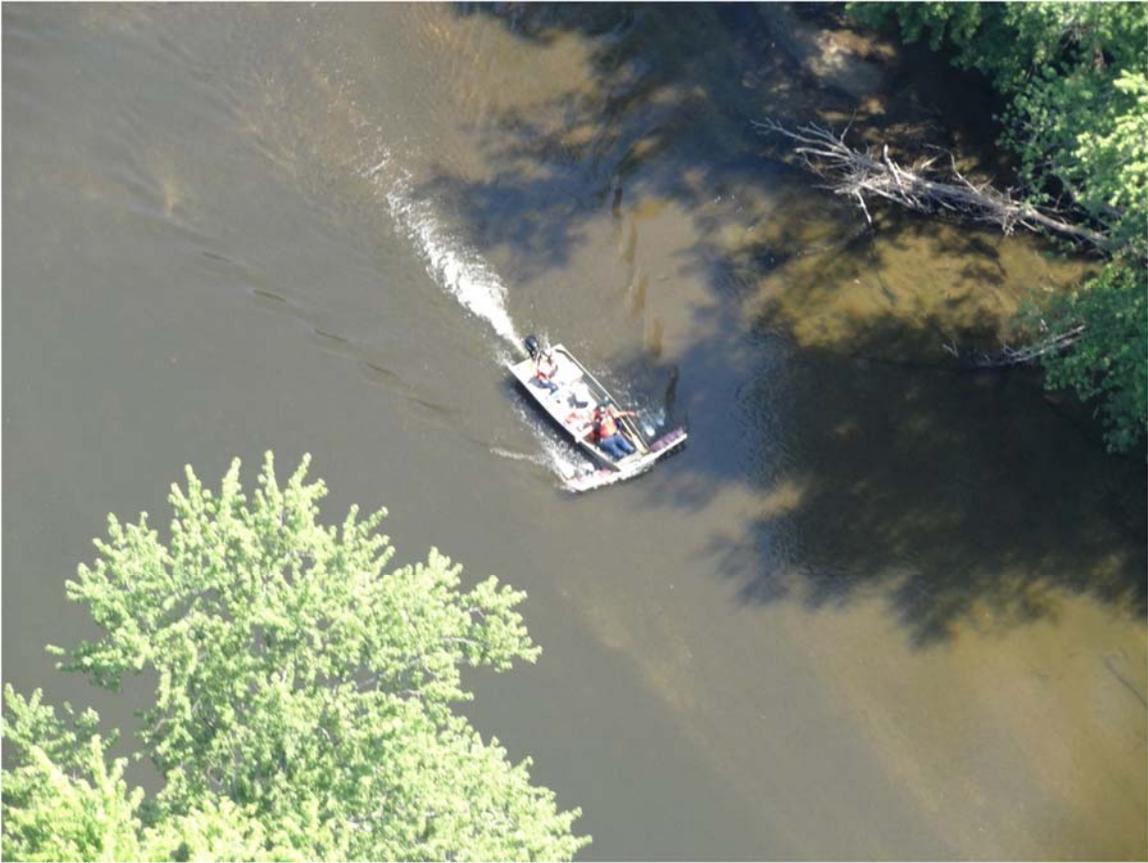
23. MP22.0 observed sheen sweep boat moving up stream.
